ARCHITECTURAL/HISTORIC INVENTORY FORM

1. Survey No. SC-AS-009-001		2. Survey Name: St. Charles Survey Phase 3: Mid-Town and Commons Neighborhoods	
3. County: St. Charles		4. Address (Street No.) 128	Street (name) North Sixth Street
5. City: St. Charles	Vicinity: <input type="checkbox"/>	6. UTM:	
7. Township/Range/Section:		8. Historic name (if known): Meyer-Pieper House; The Meyerdorf	
9. Present/other name (if known):		10. Ownership: <input checked="" type="checkbox"/> Private <input type="checkbox"/> Public	
11a. Historic use (if known): Domestic/single dwelling		11b. Current use: Domestic/single dwelling

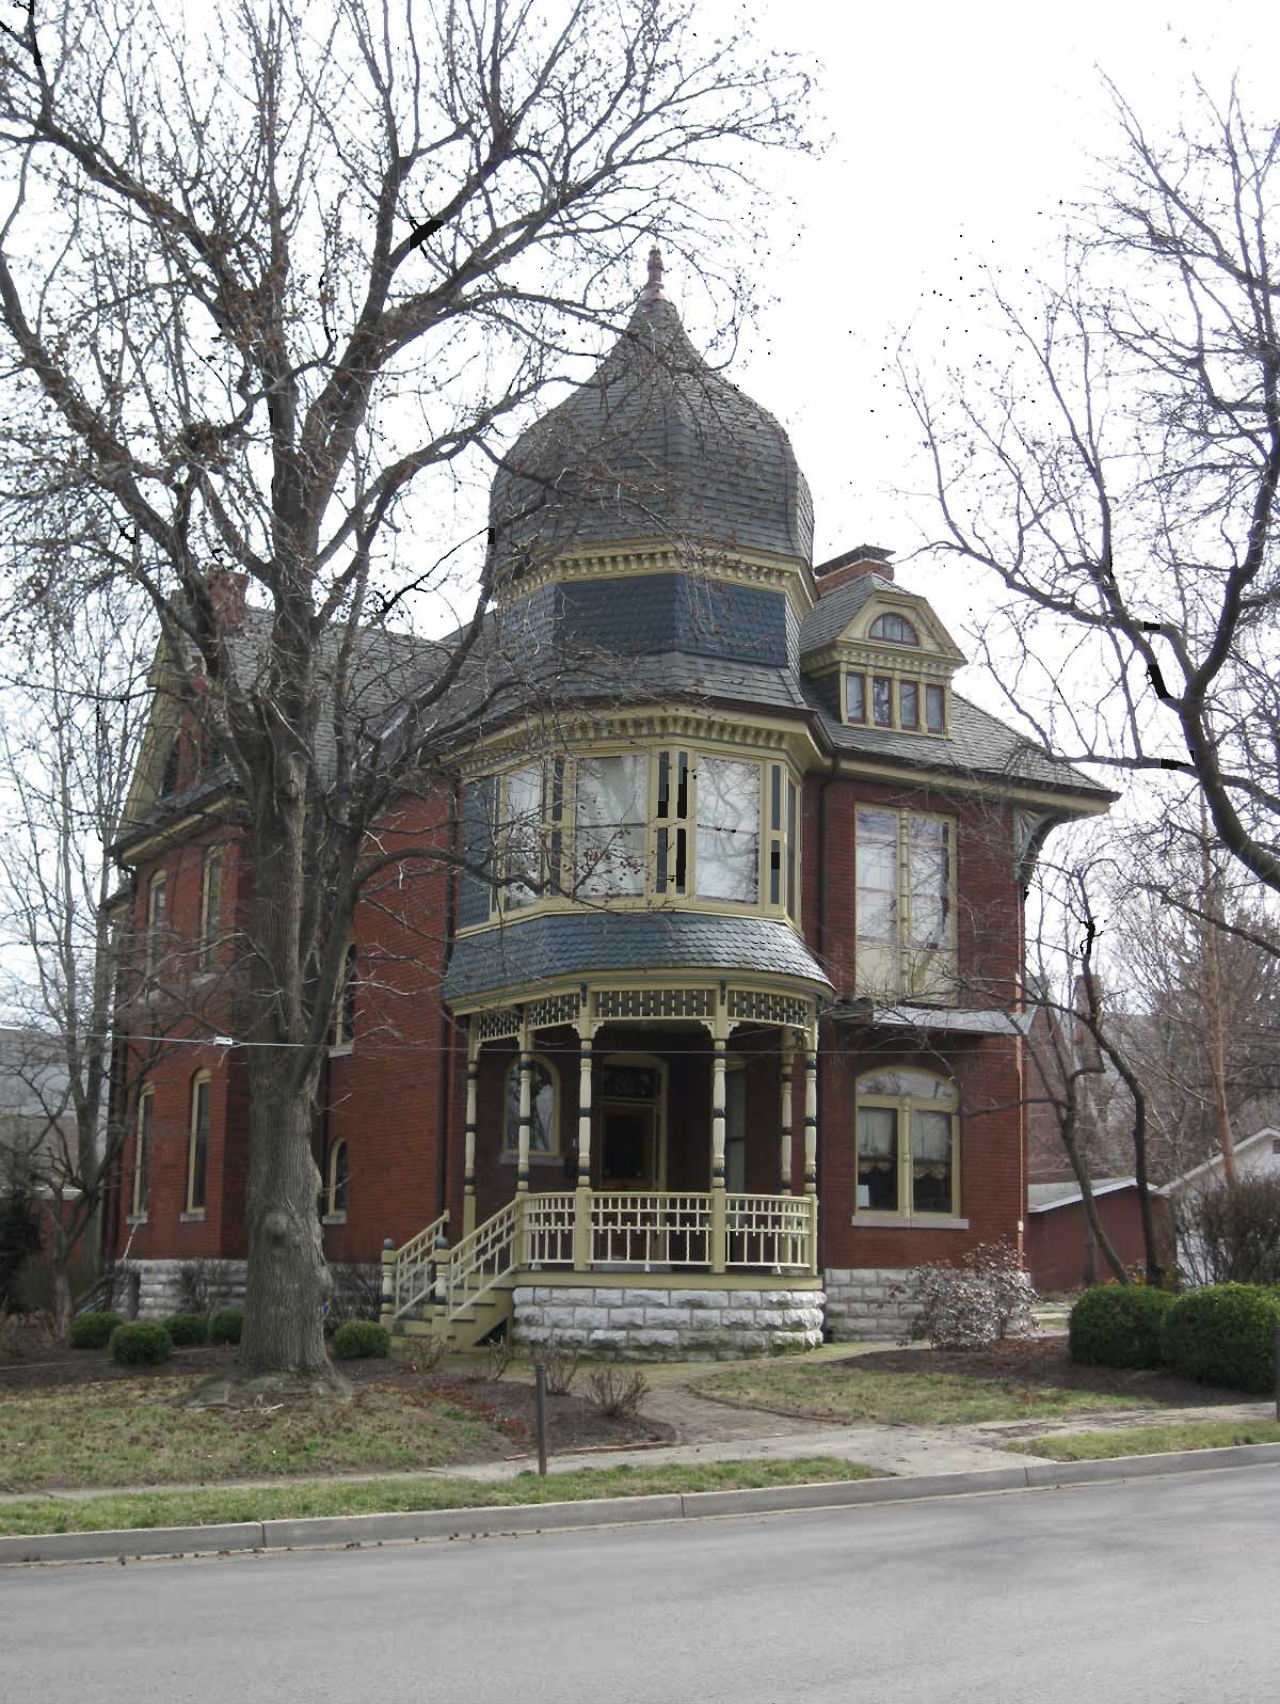
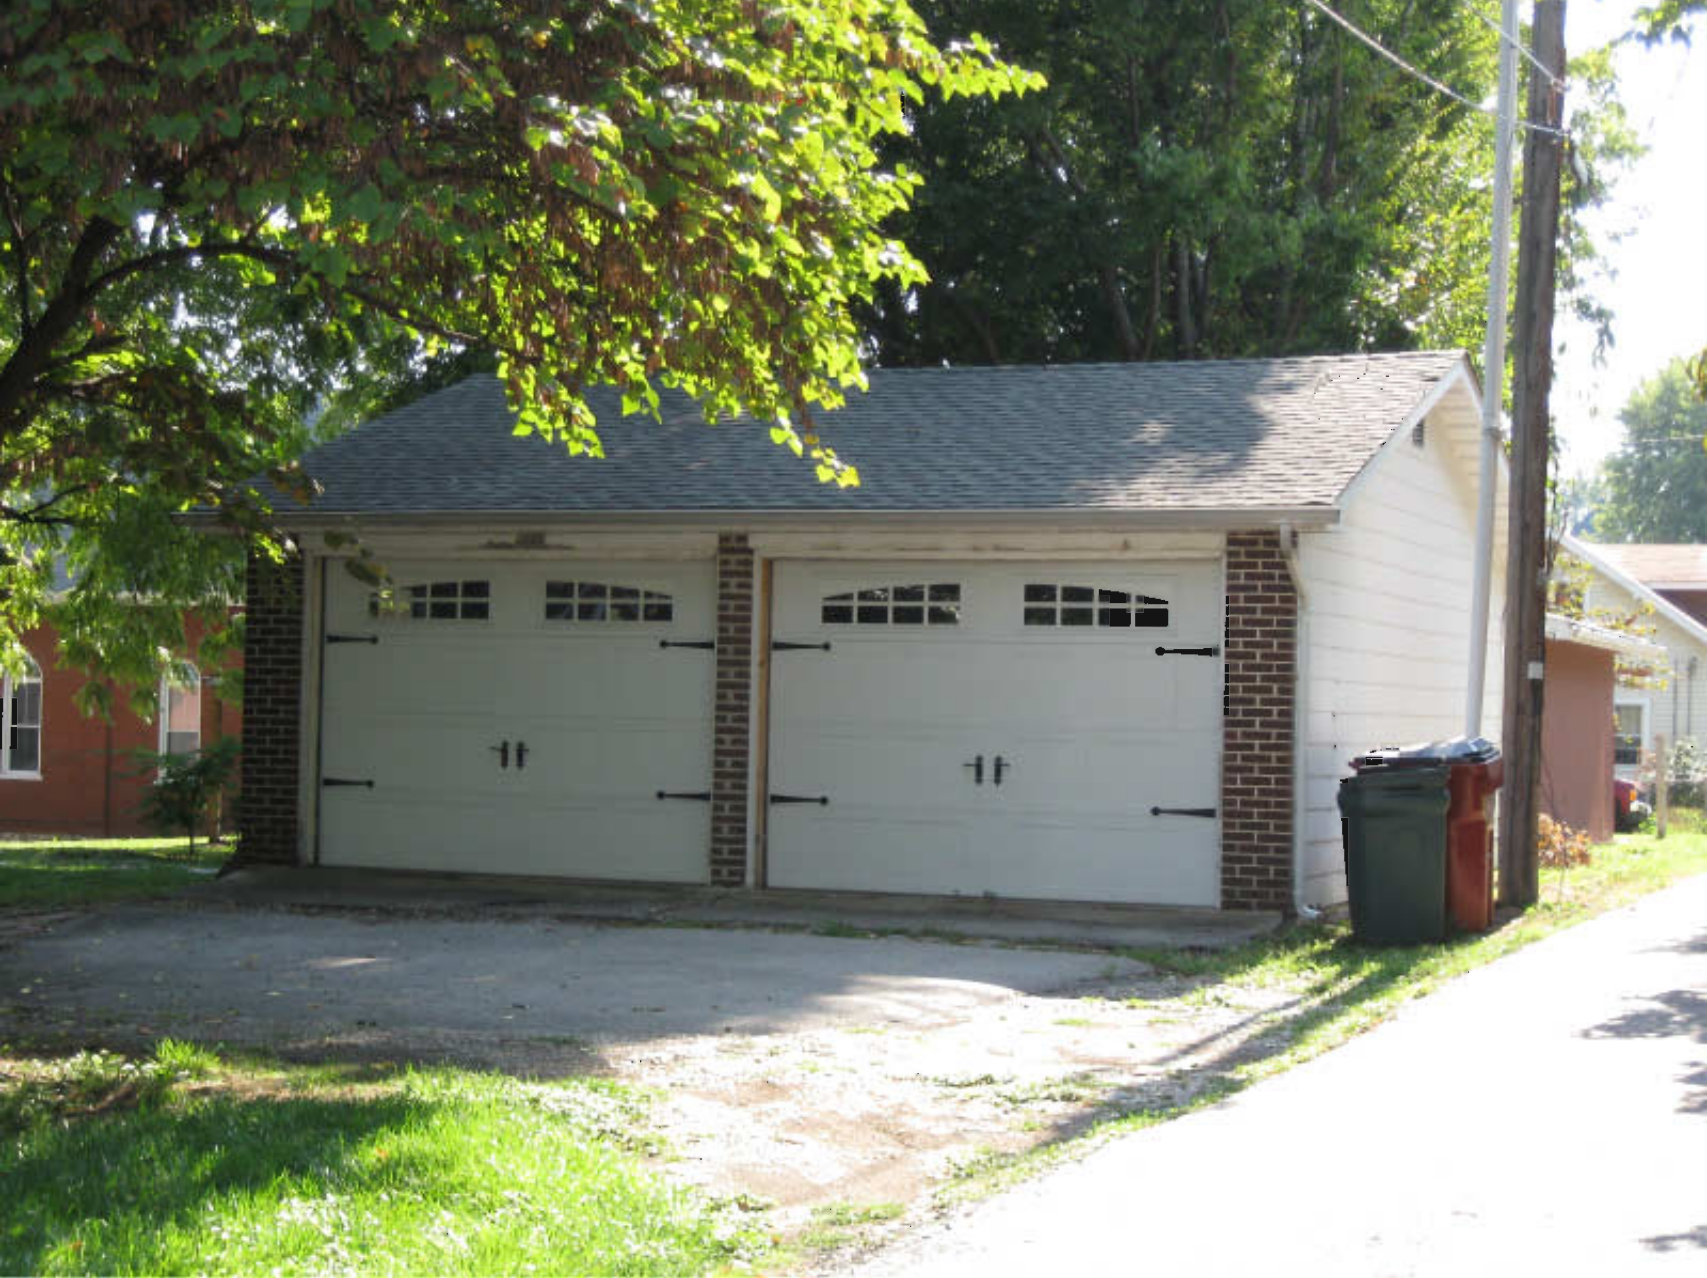
bays of the four-bay main façade have a round-arched stained glass window and, set within a segmental-arched opening, a half-glazed, paneled wood door topped by a stained glass transom. Throughout the house the openings are topped by radiating voussoirs and have cast stone sills. The doorway and stained glass window overlook the two-bay porch, which is recessed underneath the tower, and the west side of the porch is semicircular. The porch has a stone foundation, wooden stairs (on the north side) and deck, turned posts, ball-and-rod spindled frieze, brackets, and a stickwork balustrade. On the north wall, within the recessed porch area, is a 1/1 wood window set within a segmental-arched opening. To the south of the porch is a segmental-arched opening filled with paired 1/1 windows topped by a segmental-arched stained glass transom, and the mullion between the windows is decorated with a turned half post. The southernmost bay is a 1/1 window located in the canted corner. At the north end of the second floor of the main façade are the four 1/1 windows of the tower. These windows are separated by panels, and above the windows is a bracketed frieze matching the frieze that trims the onion-shaped dome. To the south of the tower is a pair of 1/1 windows set above jib doors, and above each window is a stained glass transom. The mullion between the jib windows is decorated with an ornate turned post, and the jib windows open onto a balcony that is missing its balustrade. A 1/1 window is in the canted corner, which is trimmed with ornate brackets. The north elevation has four openings on the first floor and five on the second: the westernmost window on each floor is a round-arched, stained glass window while the other openings are 1/1 windows set within segmental-arched openings. The side elevations of the projecting northern bay have a 1/1 window on each floor.

According to a couple of newspaper articles, the interior of the house has hand-grained mahogany and oak woodwork throughout, pocket doors, and marble mantels in the front parlor and dining room.

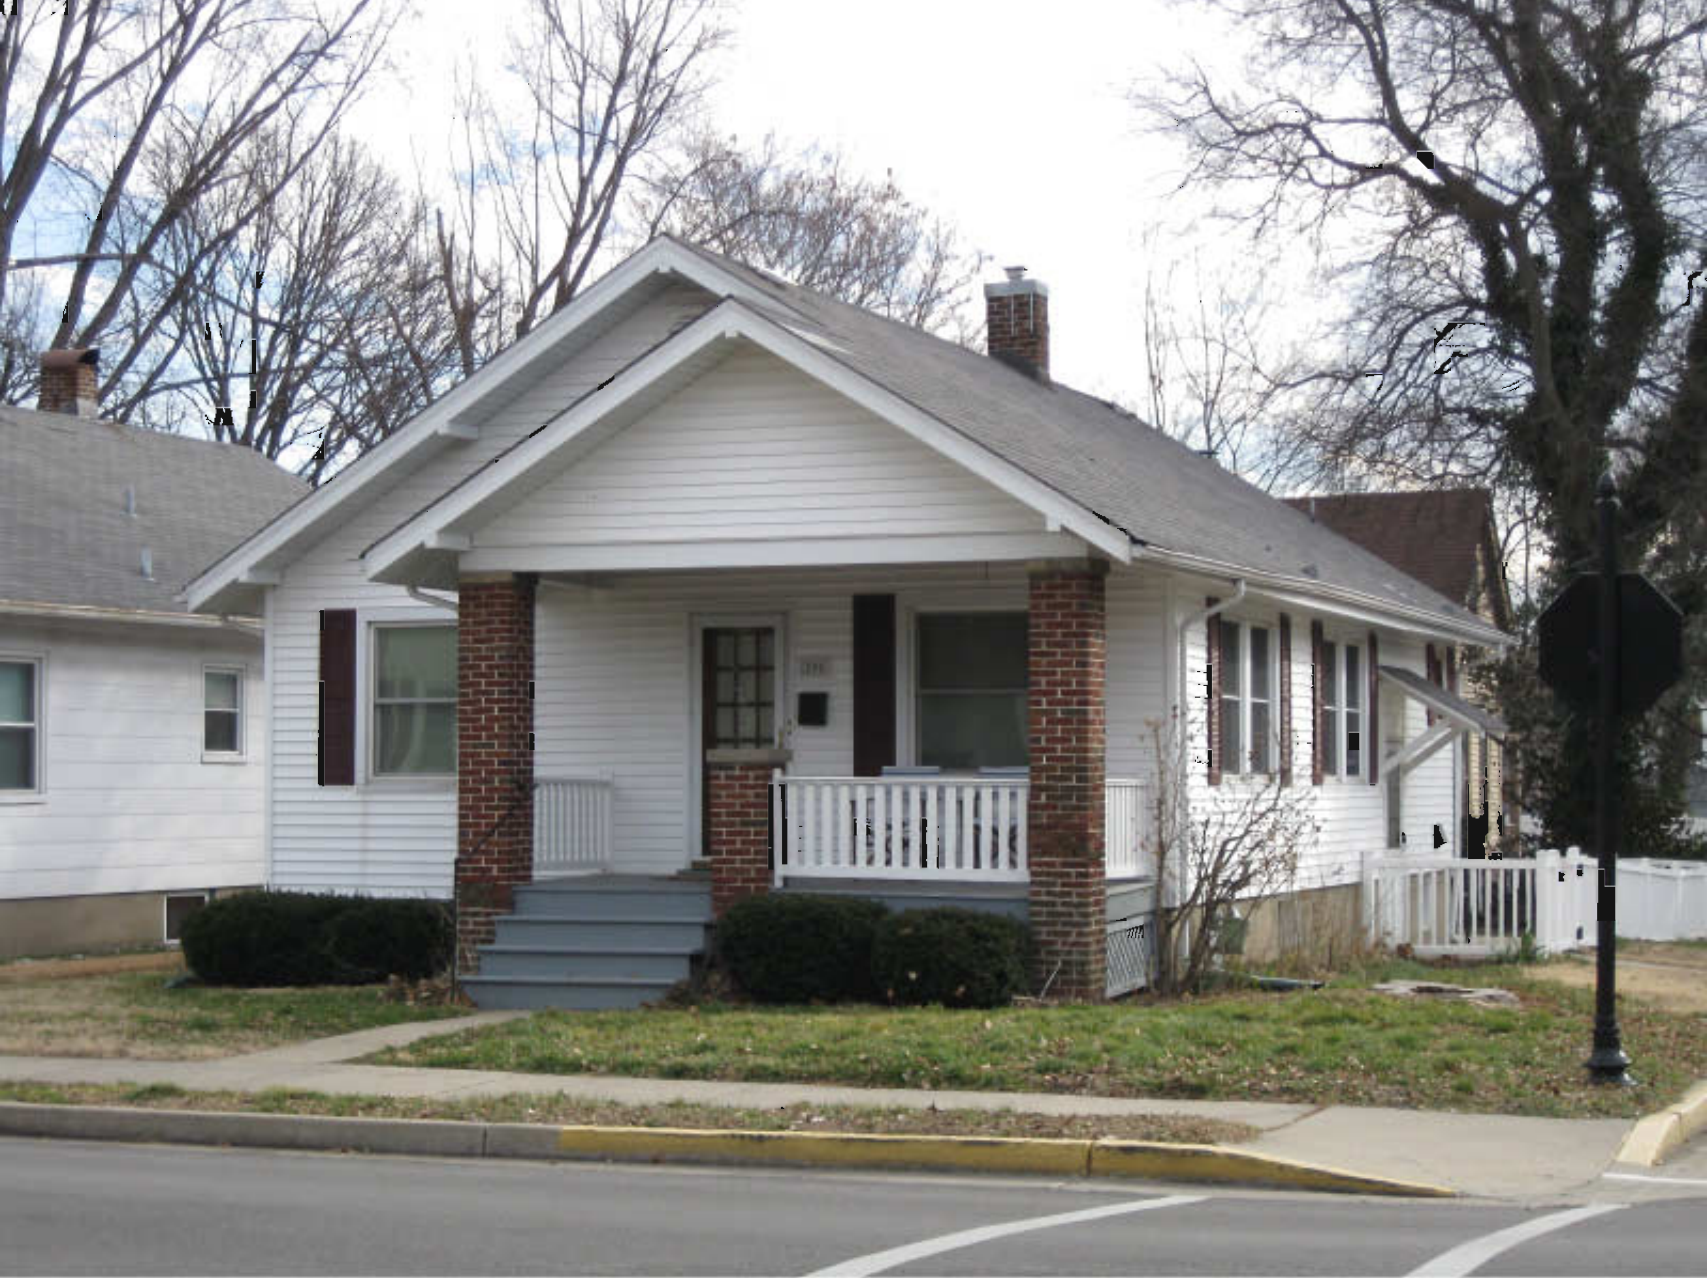
Located at the northeast corner of Sixth and Washington Streets, this one-story, front-gabled, frame bungalow rests on a poured concrete foundation that is pierced by three-light, wood basement windows. The walls are finished with vinyl siding and the asphalt roof, which is pierced by a straddle ridge brick chimney, has wide overhanging eaves. The three-bay main façade features a central, multi-light door flanked by wide 1/1 wood windows, and the right two bays are fronted by a portico that has a wooden stairway and deck, brick piers that support the gabled roof, and plain wood balustrade with wide balusters. At the top of the stair is a brick pedestal and, like the piers, it extends to the ground and has a concrete cap. The gable ends of both the house and porch are ornamented with purlins. The south elevation has, from left to right, two pairs of 1/1 windows, a half-glazed wood door at ground level, and a small single-light window. The doorway is protected by a shed roof supported by knee braces. On the north elevation are two pairs of 1/1 windows.

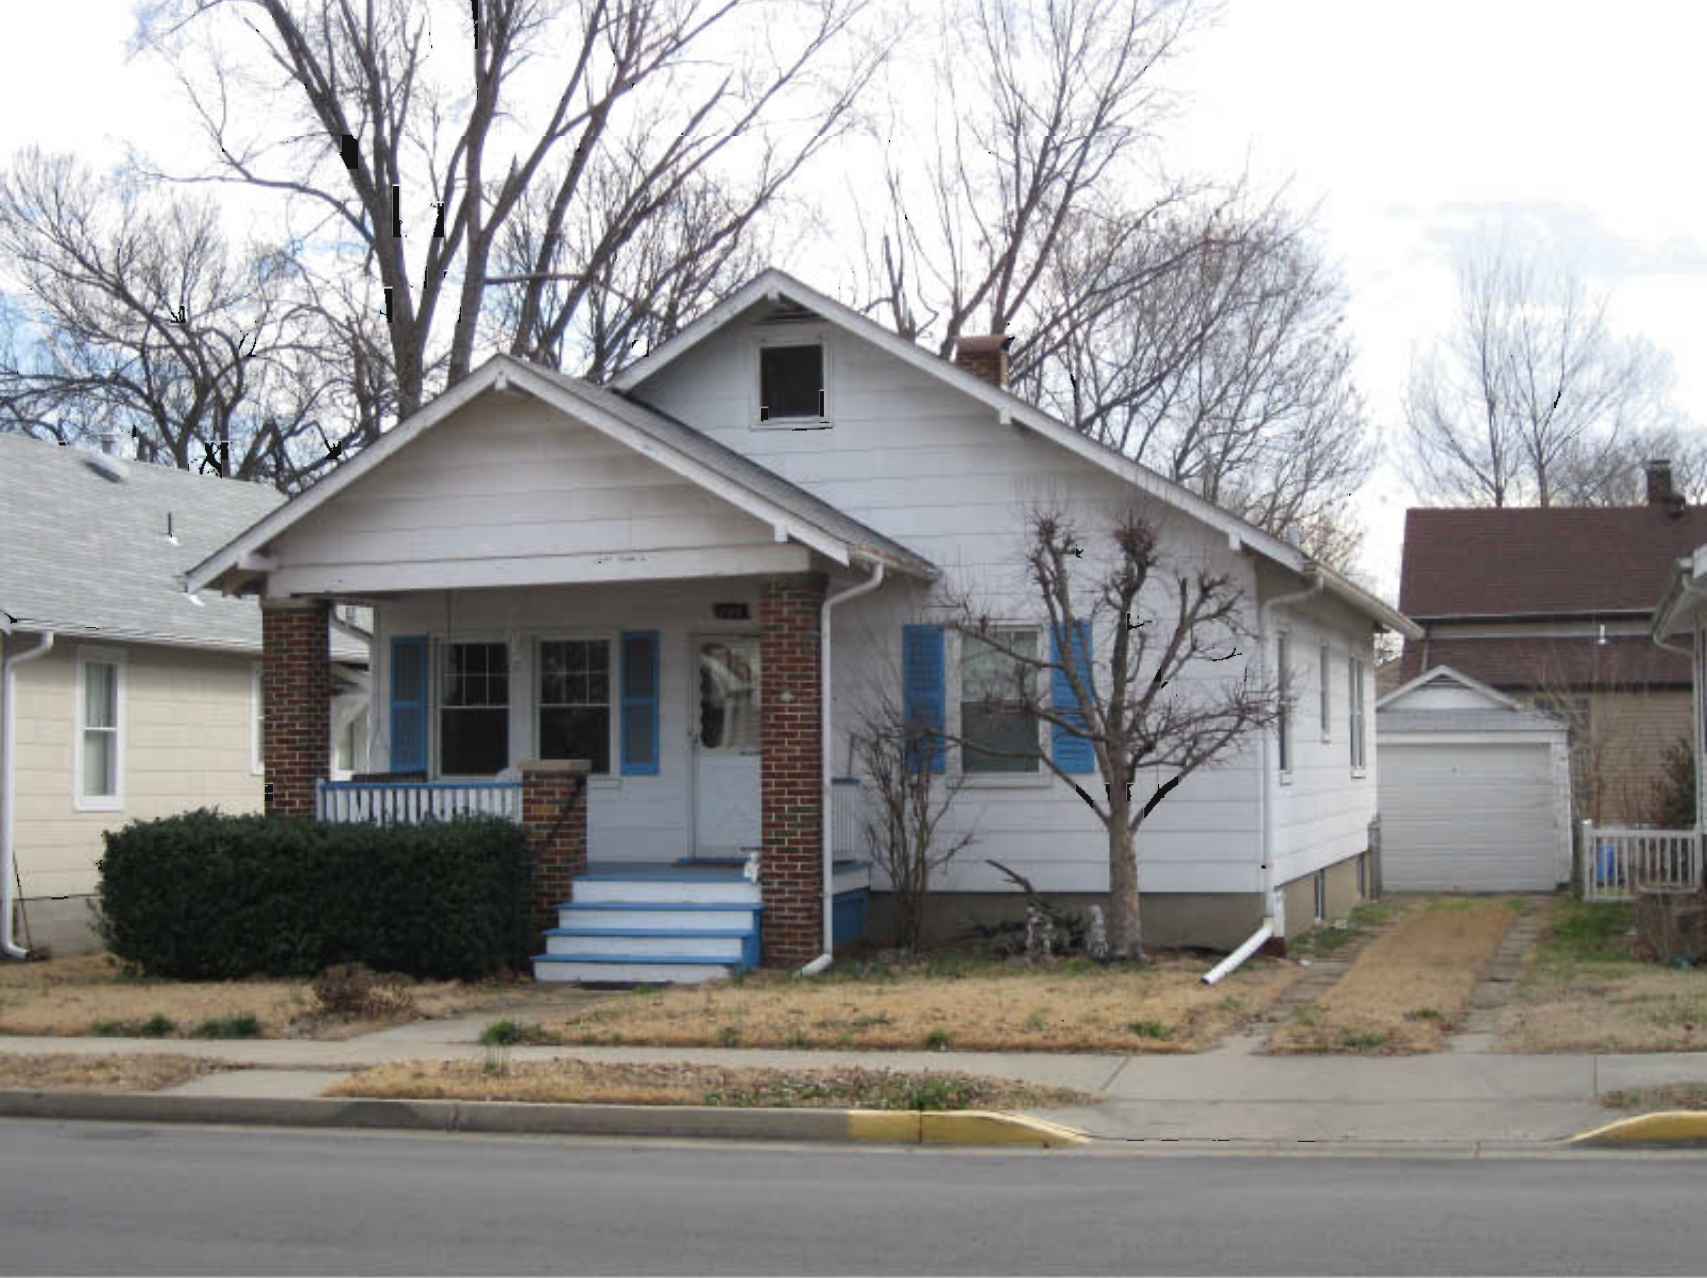
Situated on a small, flat lot, this one-and-one-half story, front-gabled, frame bungalow rests on a poured concrete foundation. The walls are clad in cement asbestos shingles and the asphalt roof, which is pierced by a straddle ridge brick chimney, has wide overhanging eaves. The three-bay main façade features a central wood door with three vertical lights, and to the left of the door is a pair of replacement 6/1 sash and to the right is a single 6/1 sash. The portico spans the left two bays and features a wooden stairway and deck, brick piers that support the gabled roof, stained bead board ceiling, and a plain wood balustrade with wide balusters. At the top of the stair is a brick pedestal and, like the piers, it extends to the ground and has a concrete cap. The area under the porch deck is filled with framed lattice panels. The gable ends of both the house and porch are ornamented with purlins, the eaves are painted bead board, and the eaves of the portico have exposed rafter tails. In the front gable is a three-light wood window. The south elevation has, from front to rear, a single 1/1 window, a short 1/1 window, and paired 1/1 windows, while the north elevation has two short single-light windows, paired 1/1 windows, a pair of short 1/1 windows, and a short 1/1 window. The windows on the side elevations are wood while those on the front appear to be vinyl.

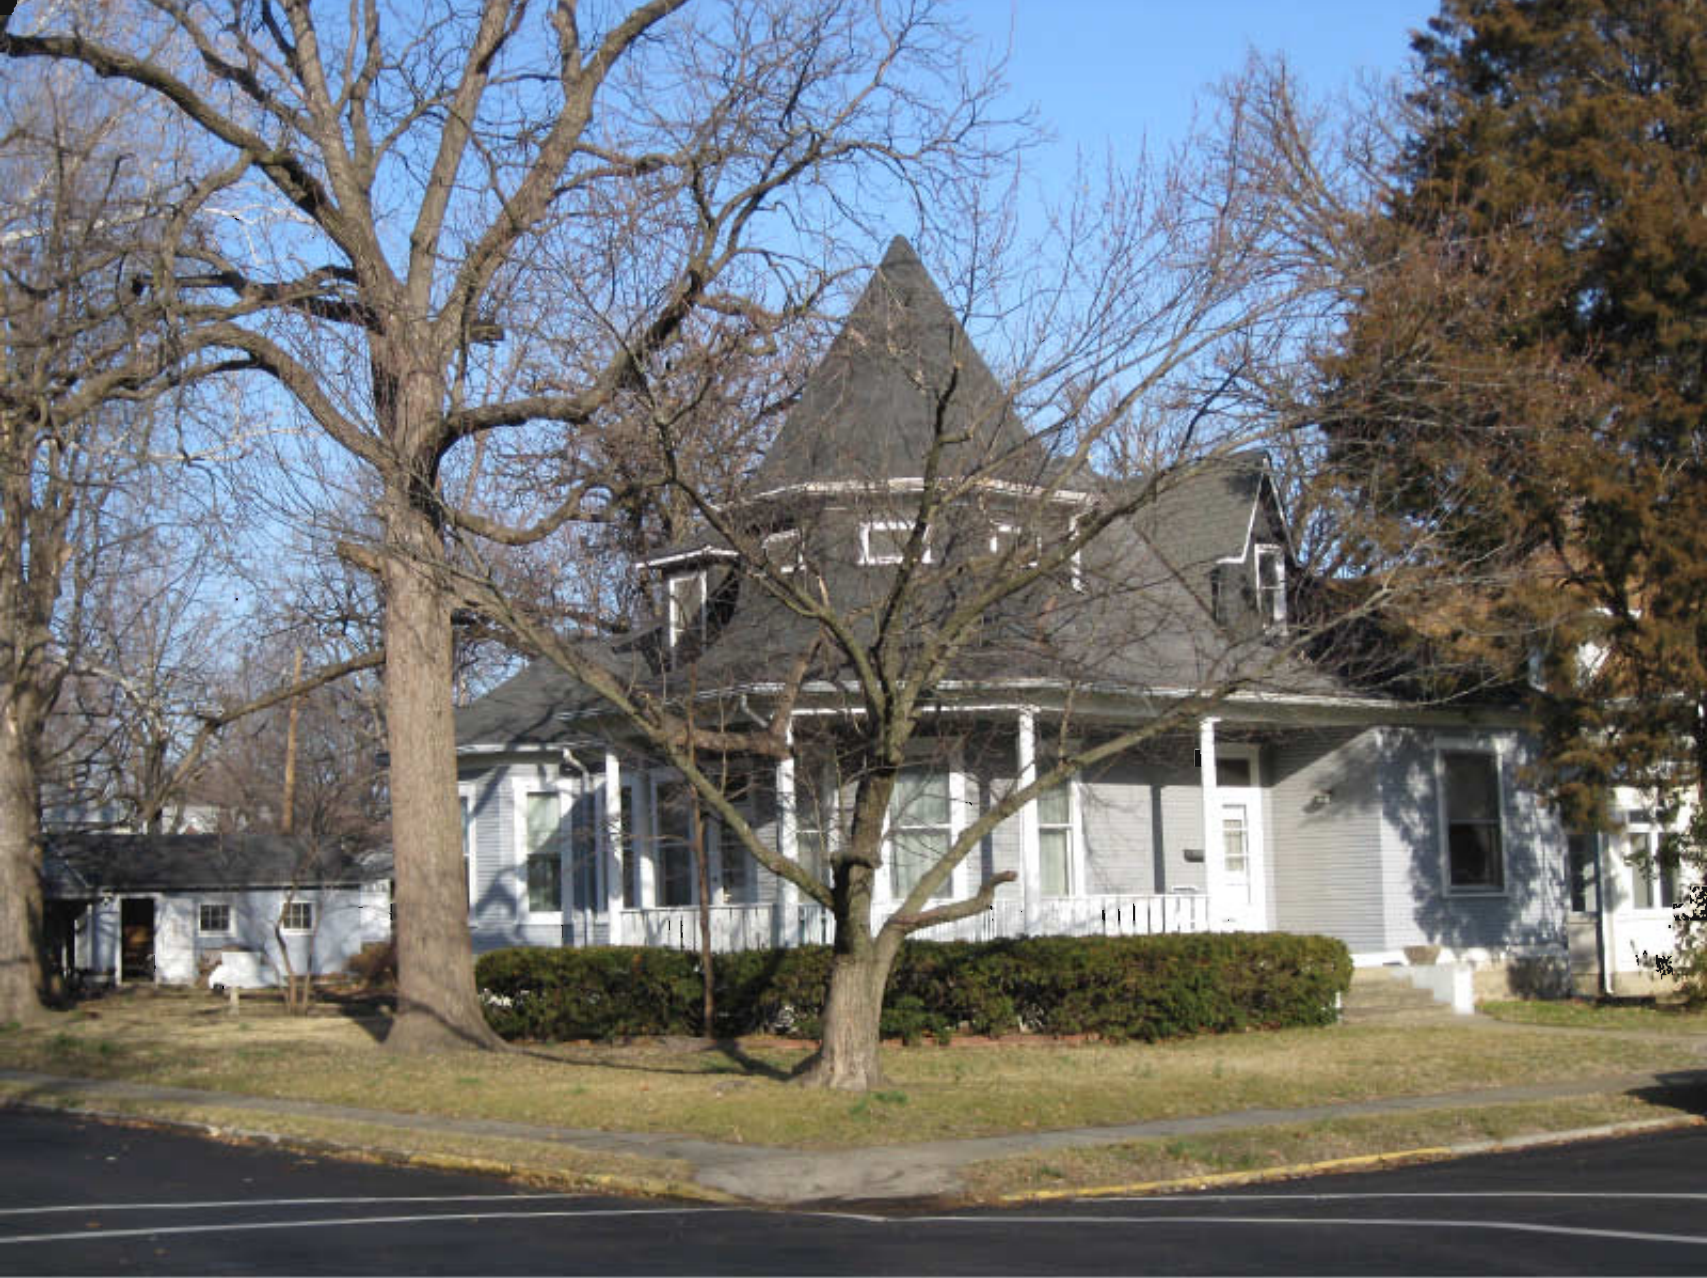
Located at the northwest corner of Sixth and Washington Streets, this one-and-one-half story, frame house is a good local example of the Queen Anne Free Classic style, with polygonal bays, a corner turret, and wraparound porch. The foundation is coursed, rusticated stone with a wooden watertable; the walls are clad with narrow weatherboard; and the steeply-pitched hip roof has wide overhanging boxed eaves trimmed with a wide fascia. The south slope of the roof is pierced by an interior brick chimney with four belt courses, and on each of the slopes is a dormer. The front dormer has a steeply-pitched gable roof and wing walls, while the other dormers have hipped roofs with wide overhanging eaves, and the walls of all are clad with roofing shingles. The dormers on the front and south slopes have a 1/1 wood window, the dormer on the north slope has a pair of 1/1 windows, and the one on the rear slope has a single-light window. At the southwest corner of the house is a polygonal tower that features four 1/1 windows on the first floor and small single-light windows in the upper level. The tower has a polygonal roof. To the north of the polygonal bay is an ornate paneled-and-glazed wood door topped by a single-light transom, and the entrance also has a four-light wood storm door. The doorway and polygonal bay are recessed under the porch roof, unlike the northernmost bay, which is a 1/1 window. Concrete stairs are at each end of the one-story wraparound porch, which has a wooden deck, Doric columns, and a balustrade with plain balusters arranged in groups of four. On the south elevation, to the west of the polygonal bay, is another doorway that matches the previously-described front door, and the porch terminates at this entrance. To the west of the entrance are two 1/1 wood windows and another polygonal bay that has three 1/1 windows. The north elevation has four 1/1 windows.

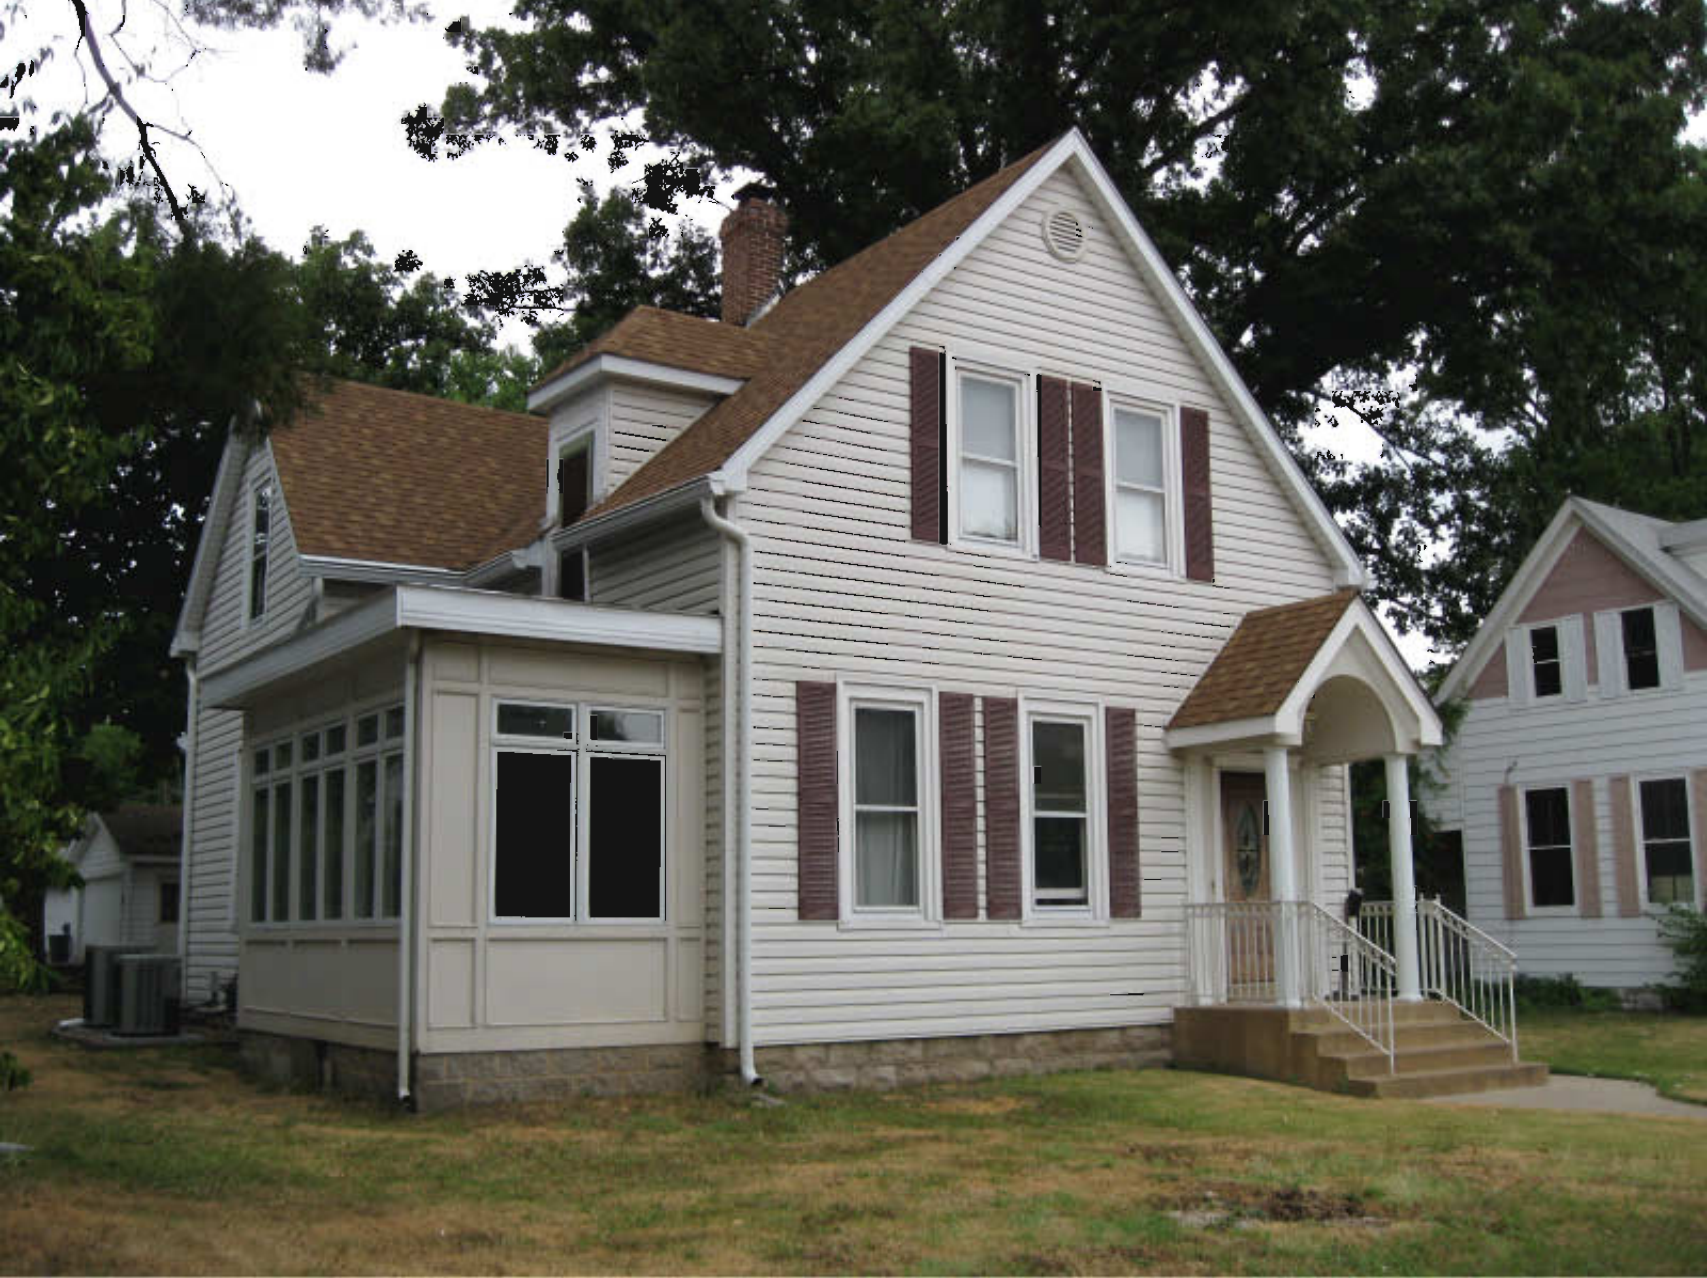
This one-and-one-half story, cross-gabled, frame house was built with a T-shaped plan, but between 1917 and 1929 a rear addition was made and more recently an addition was built at the southeast corner, giving the house an irregular shape. The walls of the house are clad with Dutch lap vinyl siding and the foundation is coursed rusticated stone with beaded joints. The left slope of the front-gabled wing is pierced by an interior brick chimney with corbelled cap, as well as a hipped dormer with a door that extends into the upper wall and provides access to the roof of the addition. A hipped dormer with 1/1 window is on each of the slopes of the rear wing, and the walls of all of the dormers are clad with Dutch lap vinyl siding. The north end of the main façade has a wood door with oval light filled with leaded glass, and the door opens onto a shallow one-bay portico with concrete stairs and deck, wrought iron railing, fluted columns and pilasters, and a gable roof with round-arched soffit. The 1929 and 1947 Sanborn maps show the house without a front porch, but the earlier maps show a one-bay porch at the entrance. To the left of the doorway are two 1/1 wood windows, and in the flat-roofed addition is a pair of single-light windows topped by transoms. In the upper half story are two 1/1 wood windows, and a circular ventilator is in the gable end. The house is noncontributing due to the addition at the southeast corner, the replacement of the front door, and the application of vinyl siding.

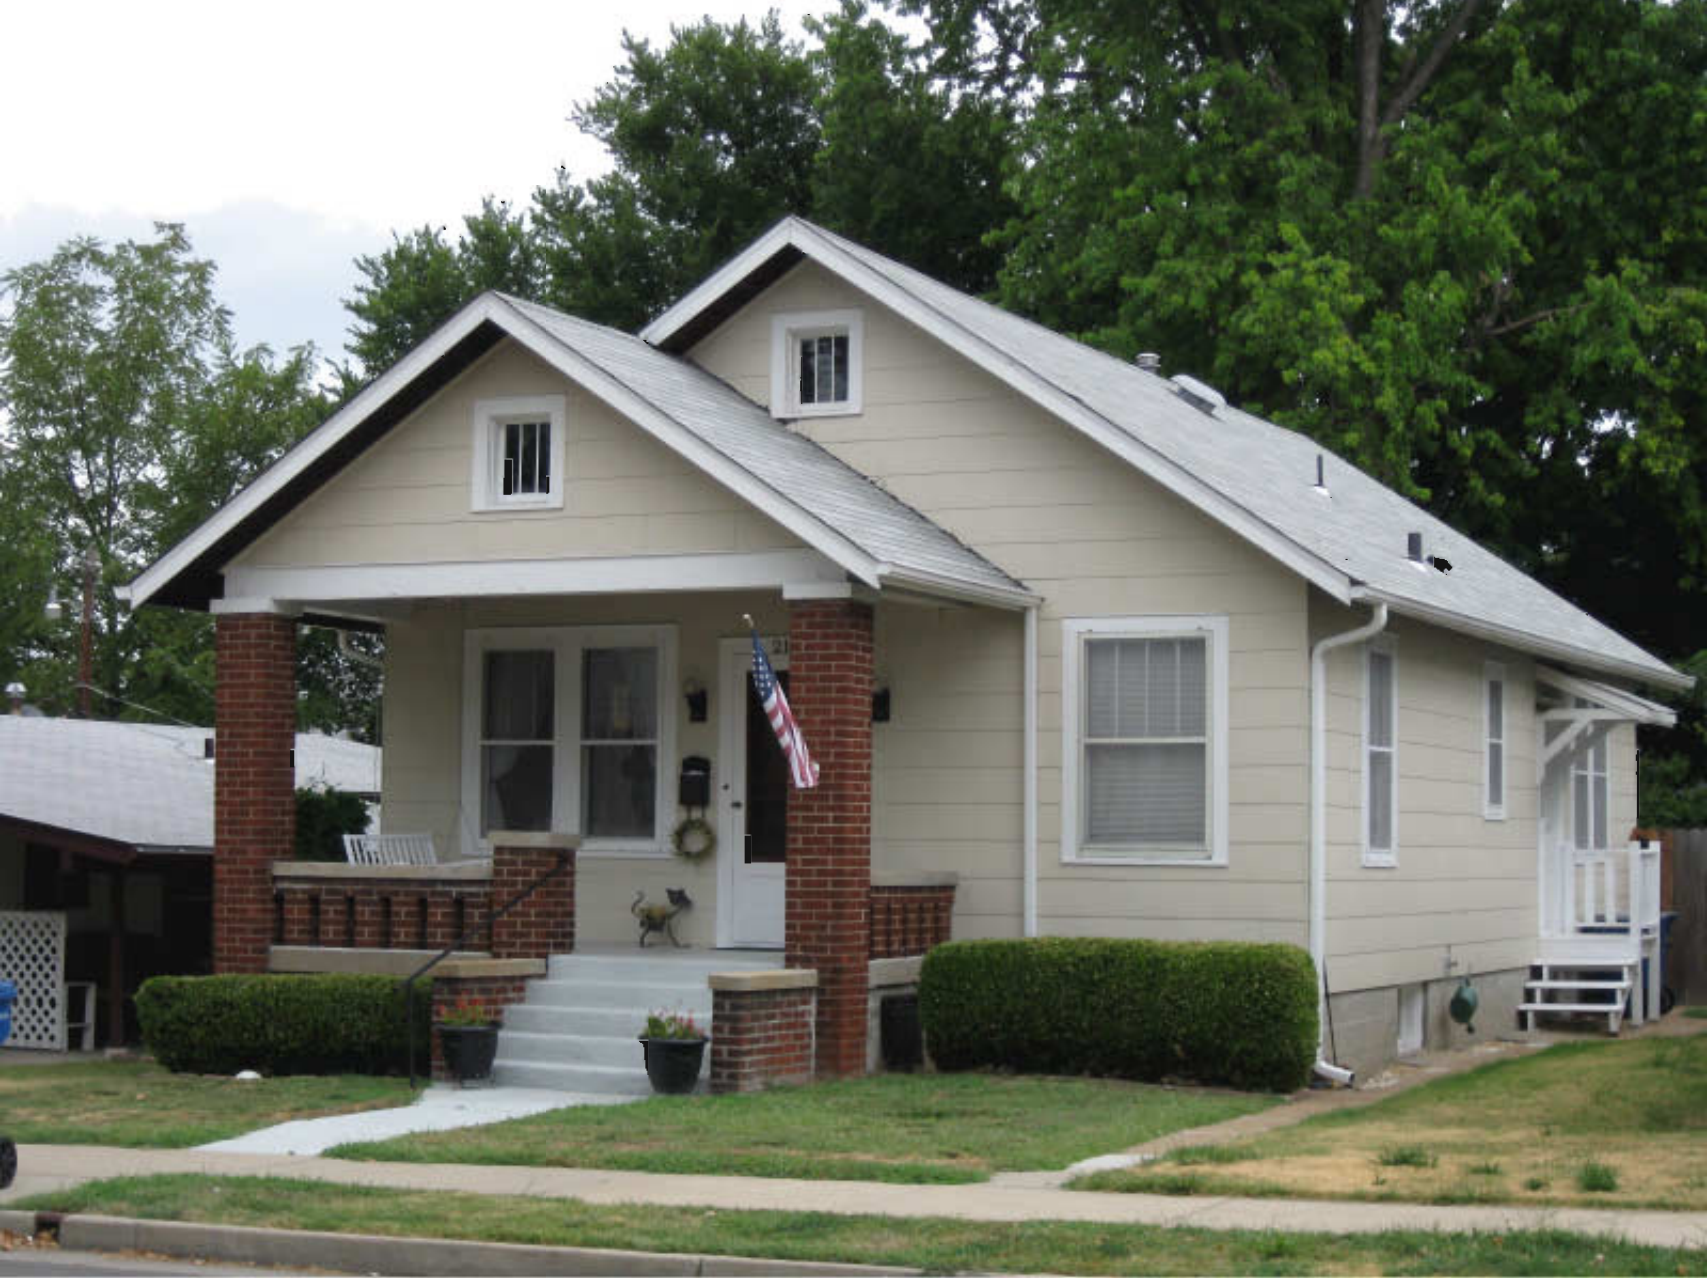
This one-and-one-half story, front-gabled, frame bungalow rests on a poured concrete foundation and the walls are clad in cement asbestos shingles. The front-gabled roof has wide overhanging eaves clad with stained bead board. The three-bay main façade features a central half-glazed wood door, and to the left of the door is a pair of 3/1 wood windows and to the right is a wide 4/1 wood window. The door opens onto a two-bay portico that has a concrete deck, concrete stairway flanked by brick knee walls with concrete copings, a brick pedestal at the top of the stair, brick piers with concrete caps supporting the front gabled roof, and a pierced brick balustrade with concrete coping. The piers and pedestal extend to the ground and the area between is filled with concrete. In the gable ends of the porch and house are three-light wood windows. The south elevation has, from left to right, a 3/1 wood window, a short 3/1 window, a half-glazed/three-panel wood door, and a pair of 3/1 windows. The door opens onto a one-bay stoop protected by a shed roof supported by knee braces. The stoop has a wood deck, stairway at the west end, and wood balustrade with plain wide balusters. At the west end of the north elevation are two short windows that are obscured by screens. To the east of these windows is a group of three 3/1 wood windows and a pair of shorter 3/1 windows.

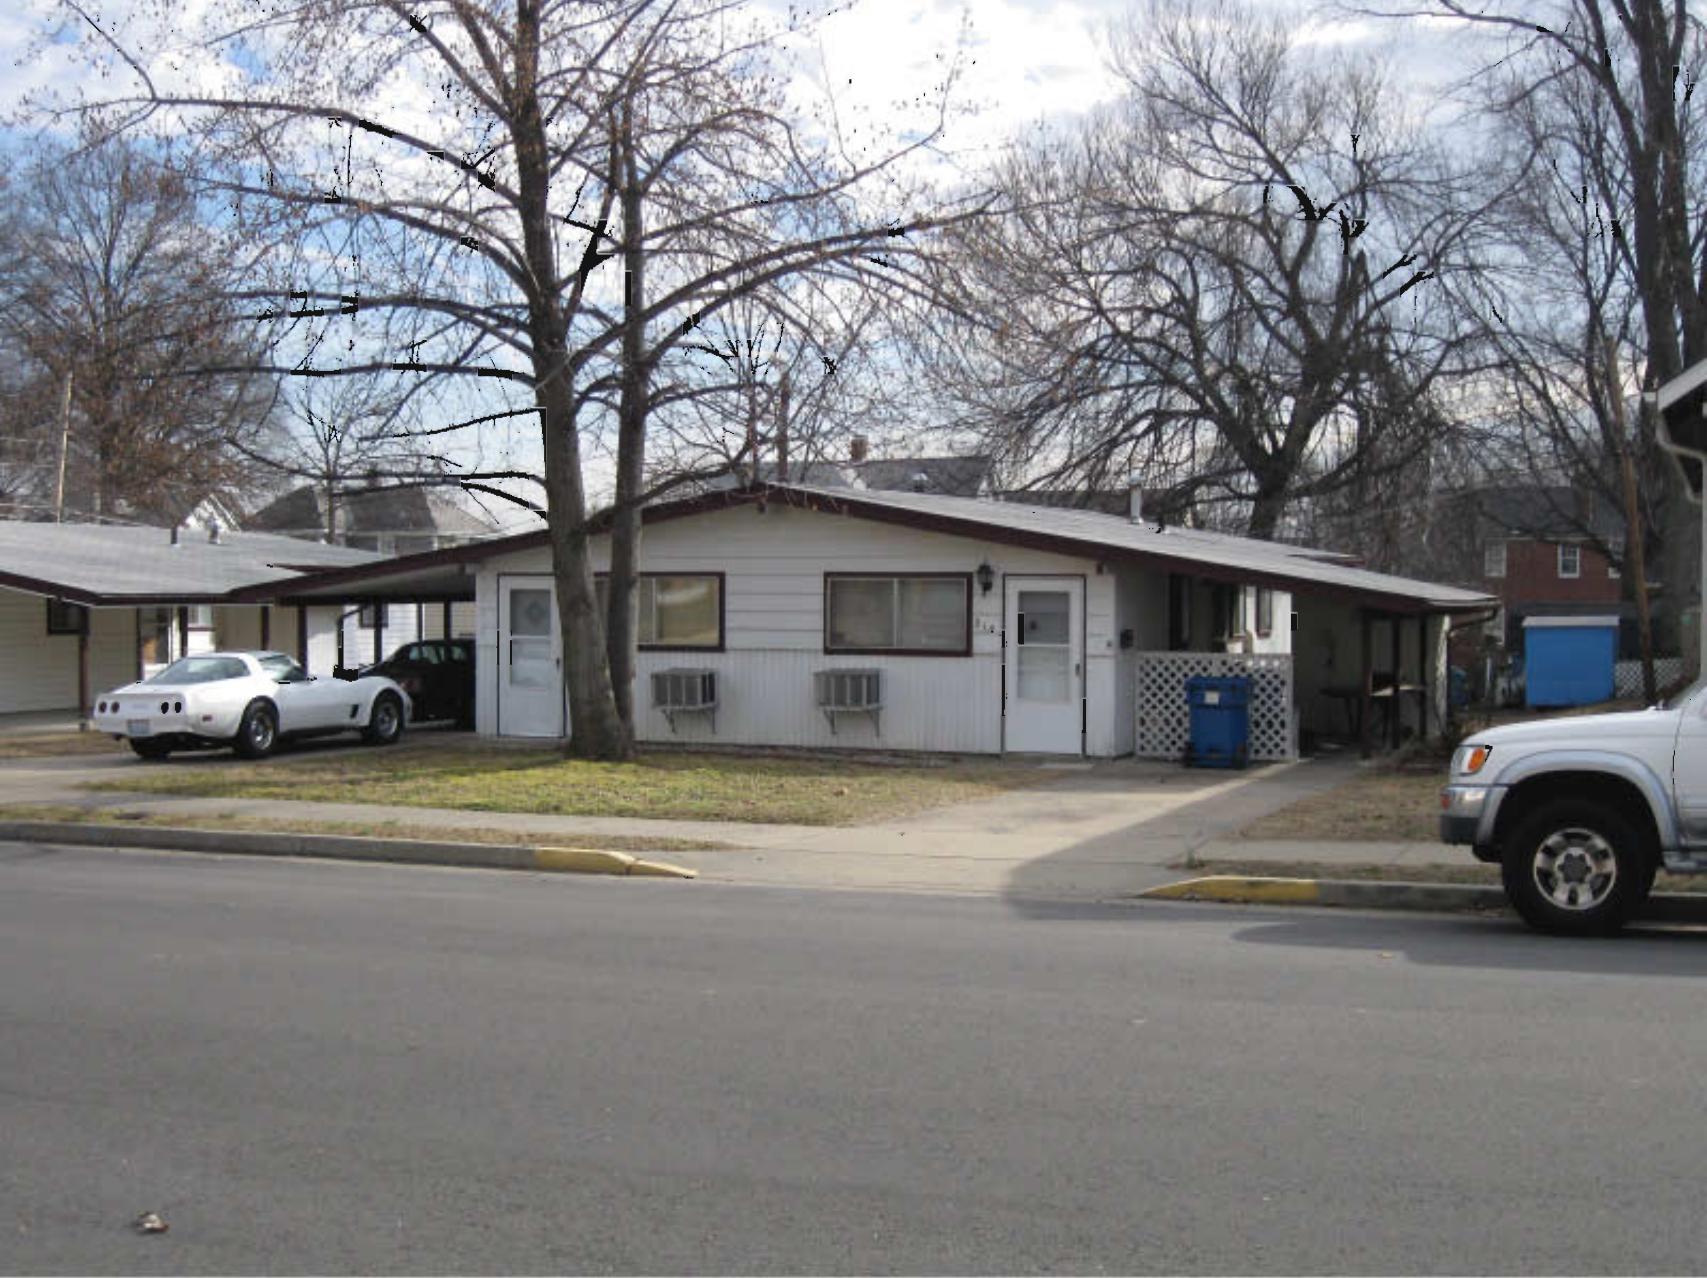
Situated on a flat, tree-shaded lot, this duplex is a one-story, frame structure crowned by a low front-gabled roof. The roof extends to create carports along each side of the building, and the roofs are supported by plain posts. The main façade is clad with lapped siding with a wainscot of vertical board, while the side elevations are finished with vertical board. The outer bays of the four-bay main façade have single-leaf entrances while the central two bays have sliding windows, and air-conditioning units pierce the wall under each window. The doors open onto concrete stoops accessed from the driveways. A small storage room clad with vertical board siding is at the rear of each carport.
