ARCHITECTURAL/HISTORIC INVENTORY FORM

1. Survey No. SC-AS-009-001		2. Survey Name: St. Charles Survey Phase 3: Mid-Town and Commons Neighborhoods	
3. County: St. Charles		4. Address (Street No.) 128	Street (name) North Sixth Street
5. City: St. Charles	Vicinity: <input type="checkbox"/>	6. UTM:	
7. Township/Range/Section:		8. Historic name (if known): Meyer-Pieper House; The Meyerdorf	
9. Present/other name (if known):		10. Ownership: <input checked="" type="checkbox"/> Private <input type="checkbox"/> Public	
11a. Historic use (if known): Domestic/single dwelling		11b. Current use: Domestic/single dwelling

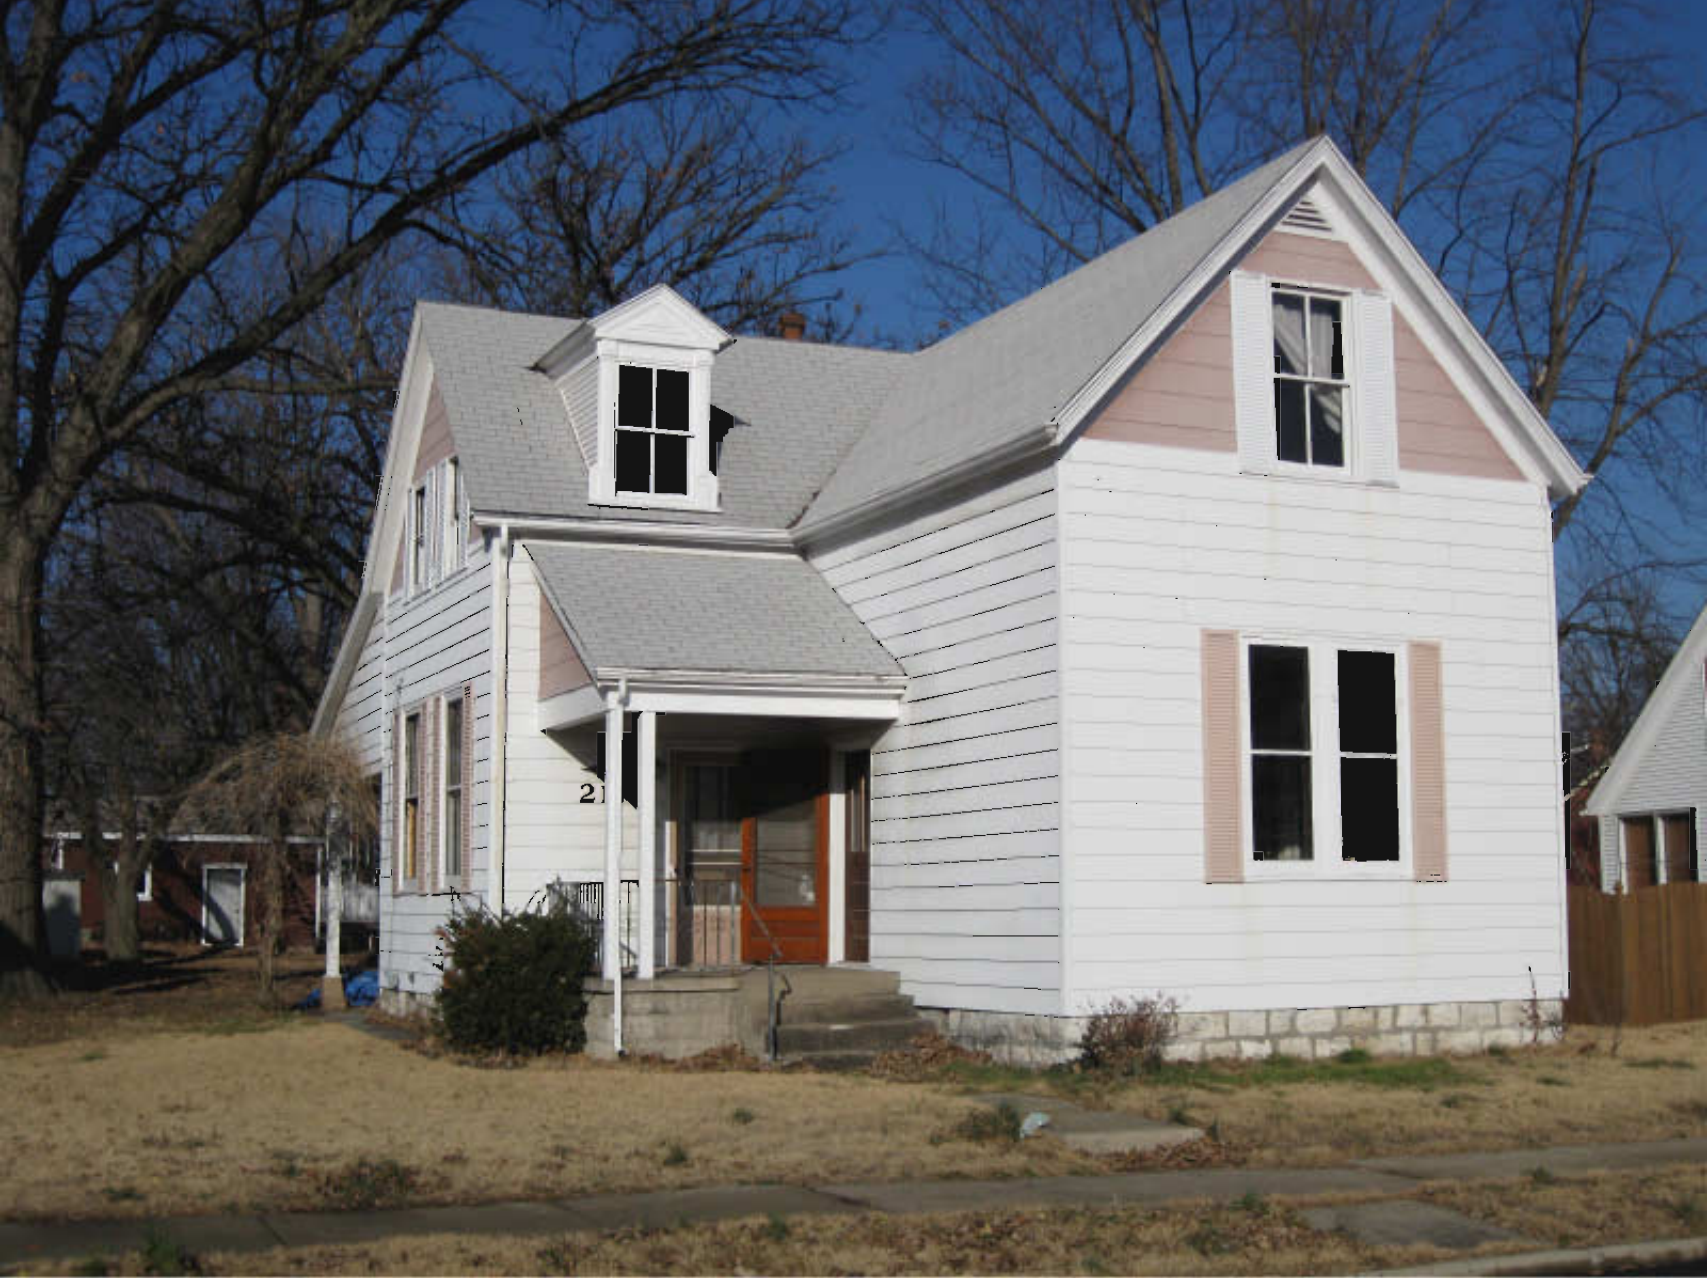
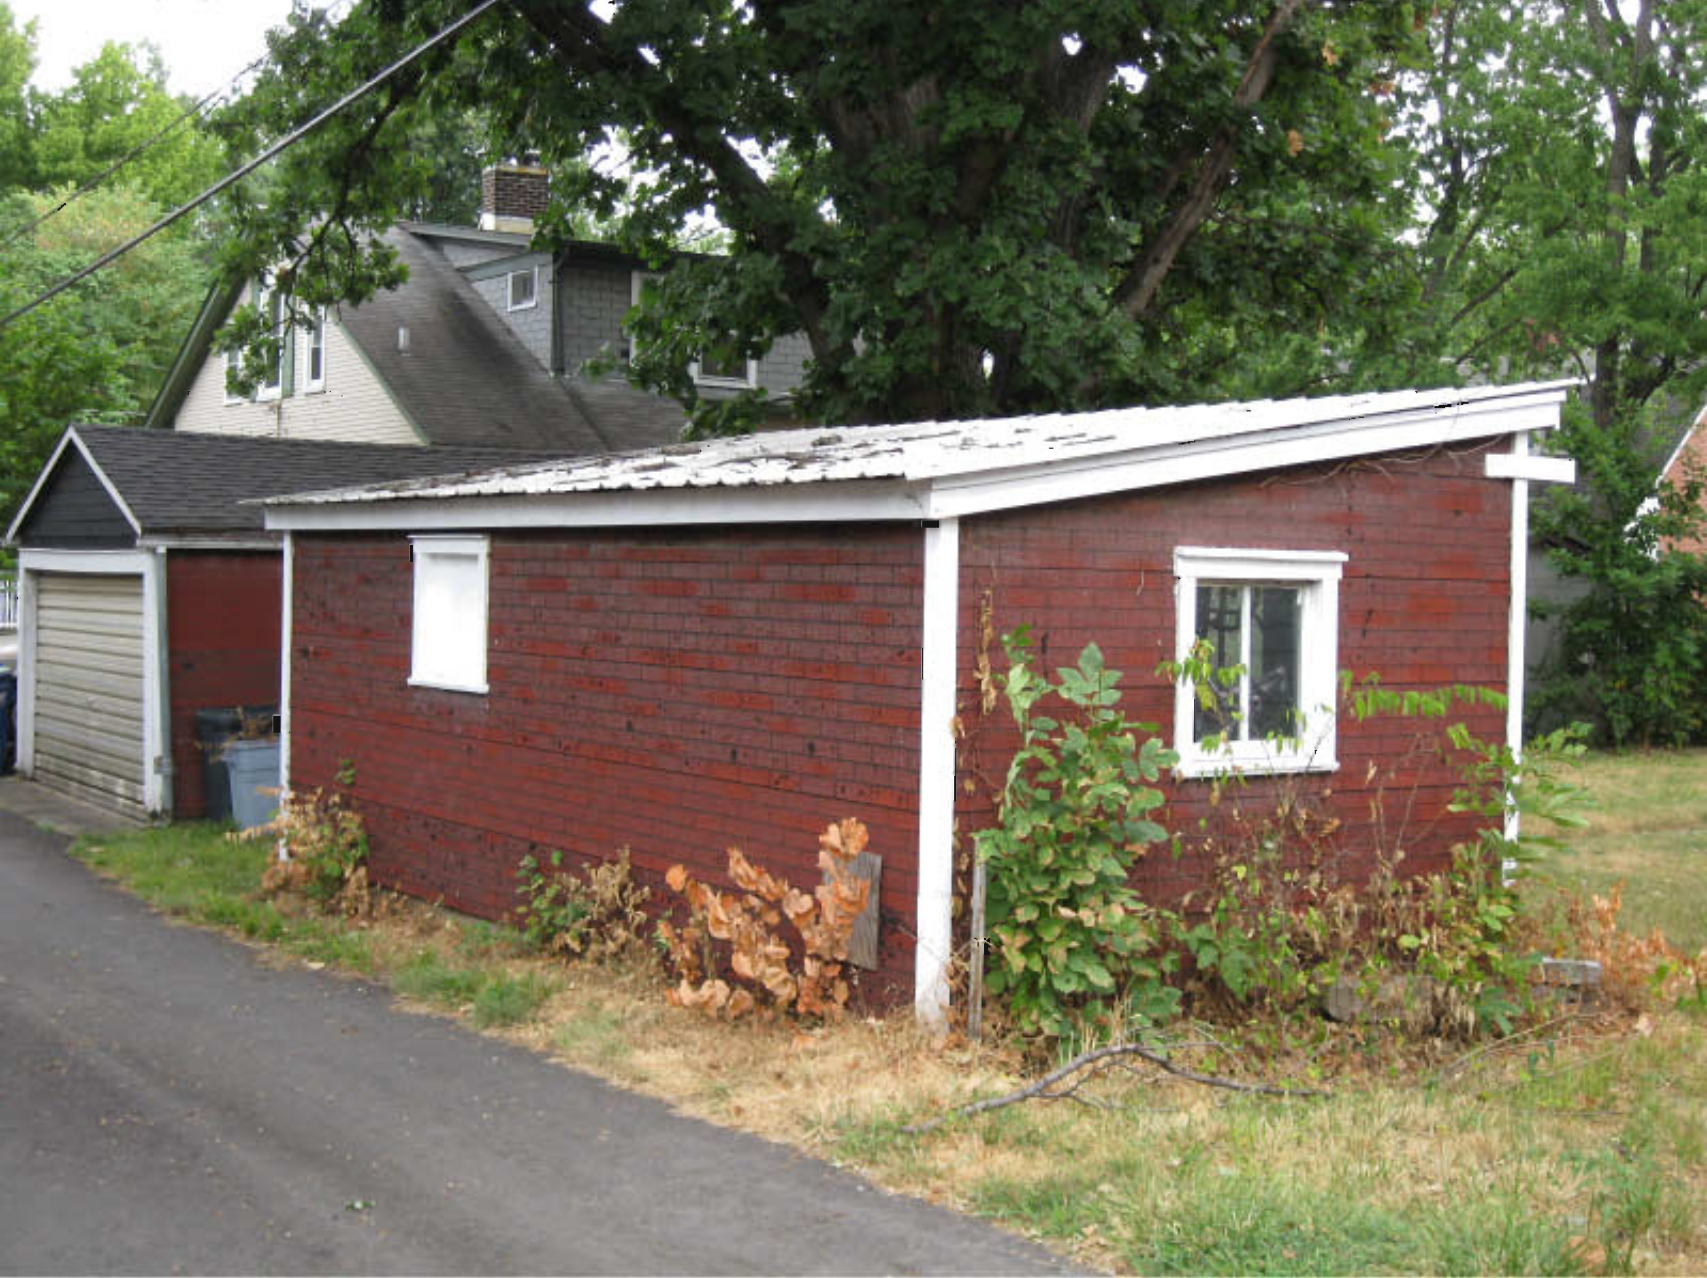
This one-and-one-half story, gabled, frame house has a T-shape plan, with the base of the T formed by a central front-gabled wing. The foundation is coursed rusticated stone with beaded joints, the walls are finished with aluminum siding, and the gable ends are clad with asbestos cement shingles. The front slope of each side-gabled wing has a gabled, pedimented dormer with 2/2 wood window, and the windows are framed by pilasters with raised panels, plinth blocks, and capitals formed by square raised panels. Above the windows is another raised panel and in the tympanum of each pediment is a triangular panel. The main façade is a three-bay elevation, with the entrance in the south wing, paired 1/1 wood windows in the gable-front wing, and a 2/2 wood window in the north wing. The entrance is a half-glazed, paneled wood door with three vertical lights, and the door opens onto a one-bay porch with concrete stairs and deck, wrought iron railing, and plain paired posts supporting a shed roof. On the south wall of the front-gabled wing is a matching door that opens onto the porch. The south wall of the south wing has two windows on each level, the north wall of the front-gabled wing has a 1/1 window, and the north wall of the north wing has a 2/2 window on each level. The Sanborn maps indicate that there was a partial-width rear wing but by 1929 it had been extended to the full width of the rear elevation. It has a shed roof and there is a recessed porch at the south end.

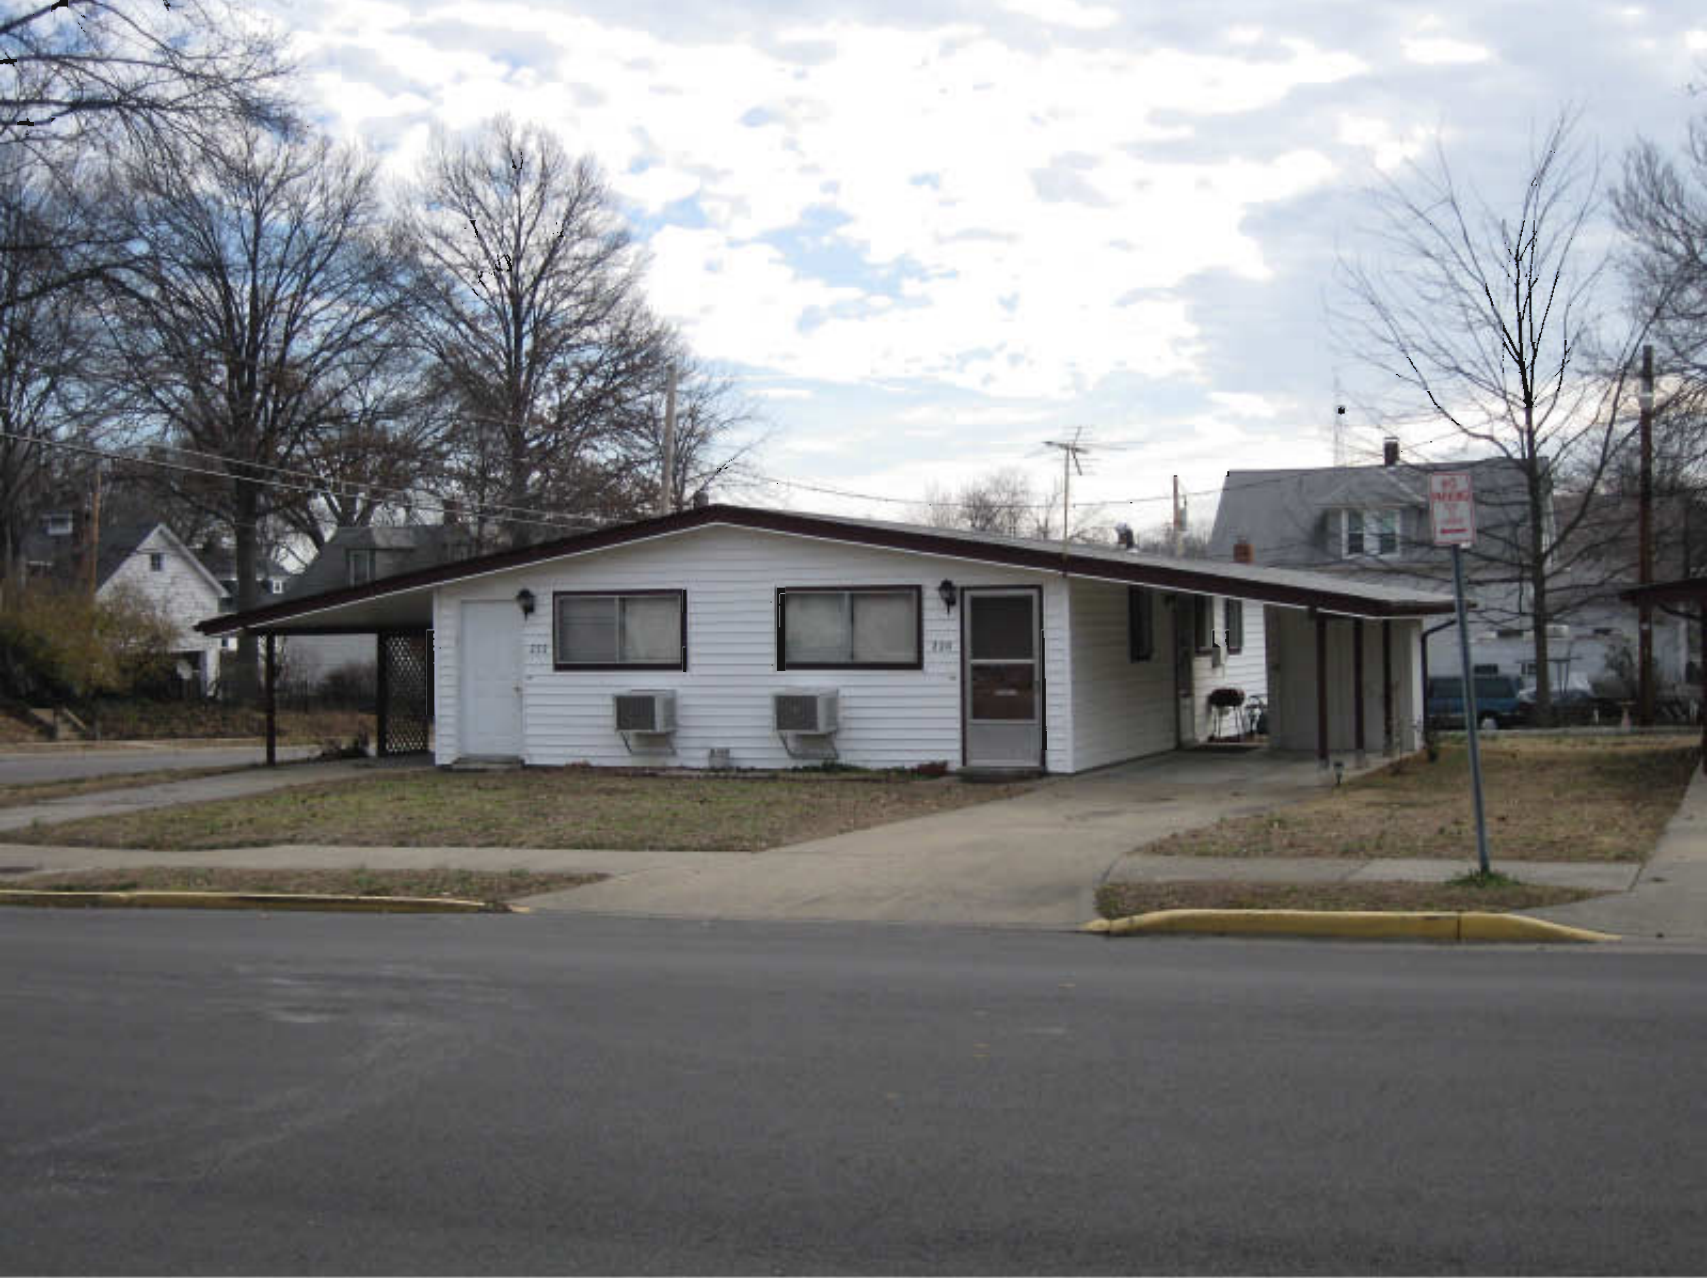
Situated at the southeast corner of Sixth and Monroe Streets, this duplex is a twin to the duplex next door at 214-216 North Sixth Street. It is a one-story, frame structure crowned by a low front-gabled roof. The roof extends to create carports along each side of the building, and the roofs are supported by plain posts. The main façade is clad with lapped siding with a wainscot of vertical board, while the side elevations are finished with vertical board. The outer bays of the four-bay main façade have single-leaf entrances while the central two bays have sliding windows, and air-conditioning units pierce the wall under each window. The doors open onto concrete stoops accessed from the driveways. A small storage room clad with vertical board siding is at the rear of each carport.

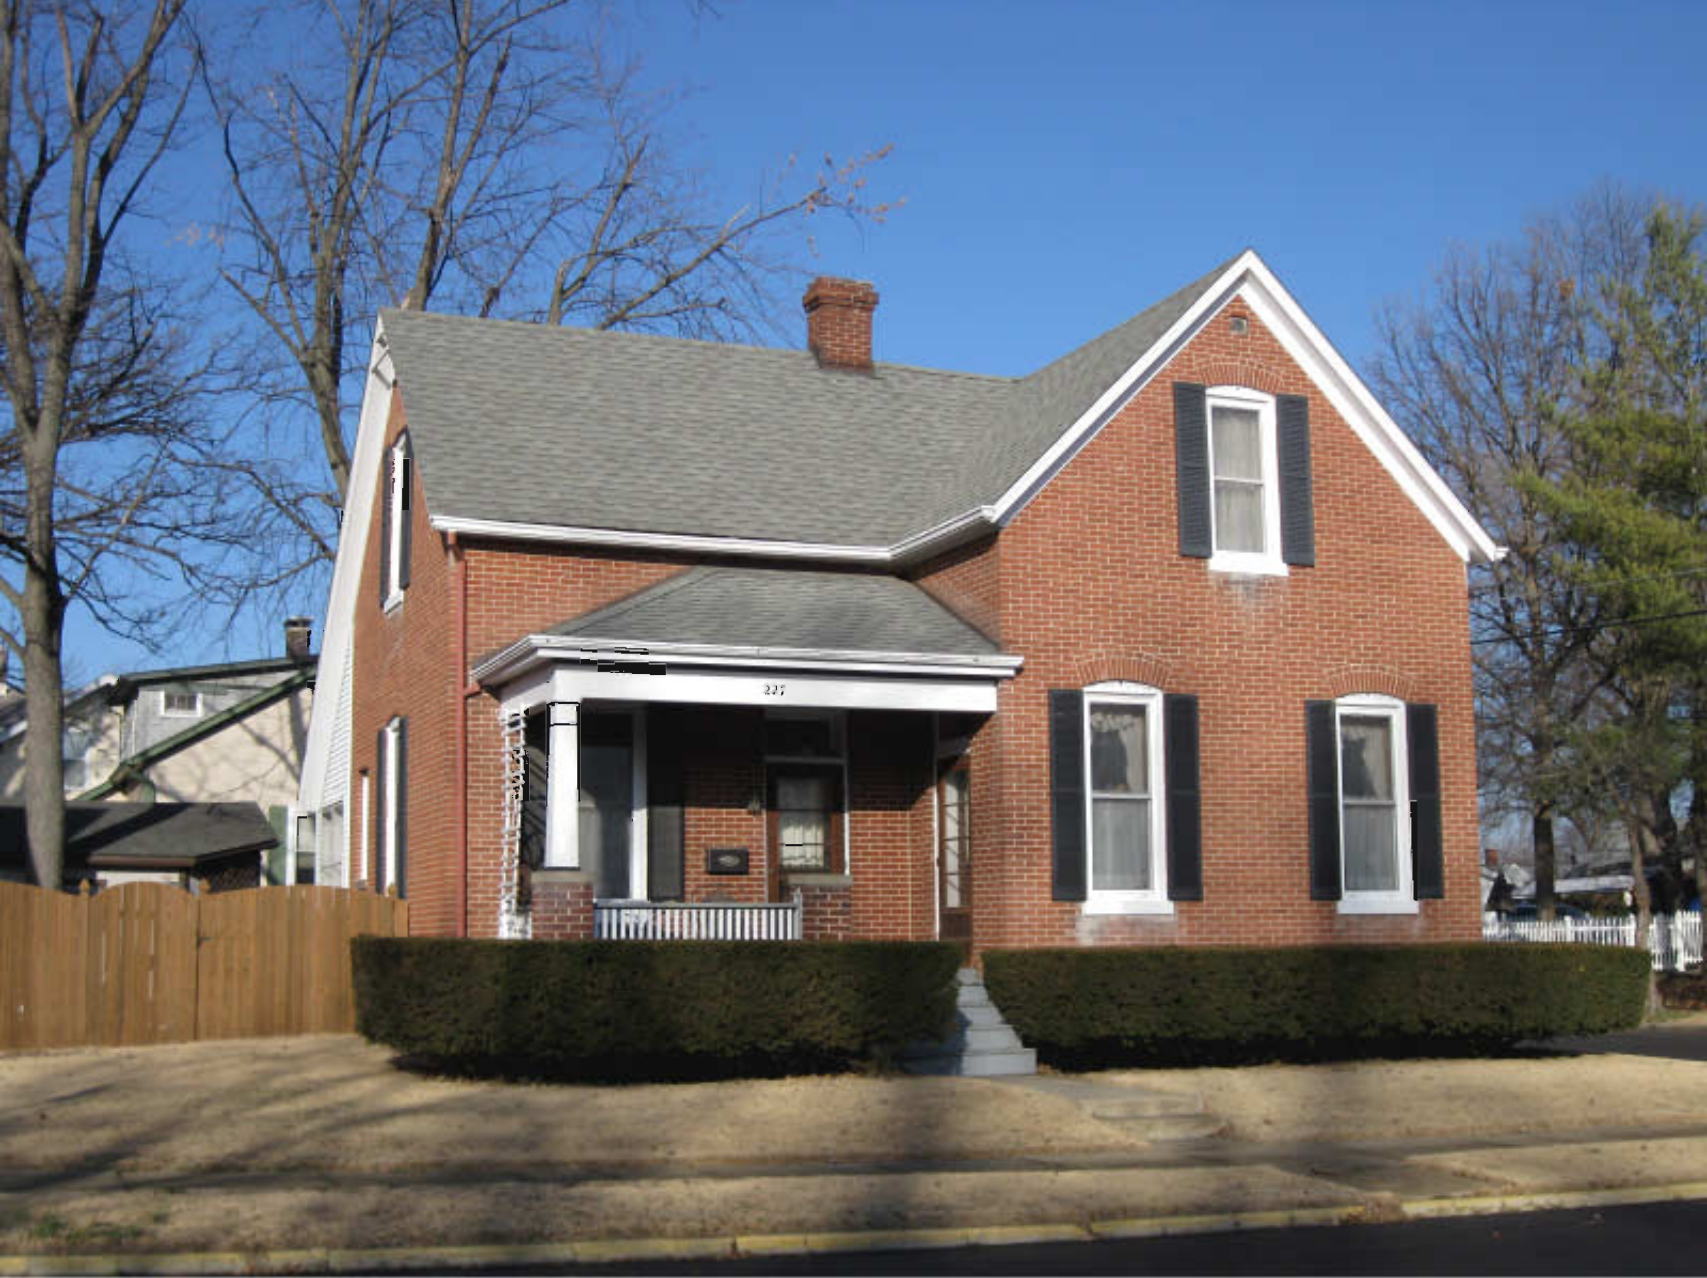
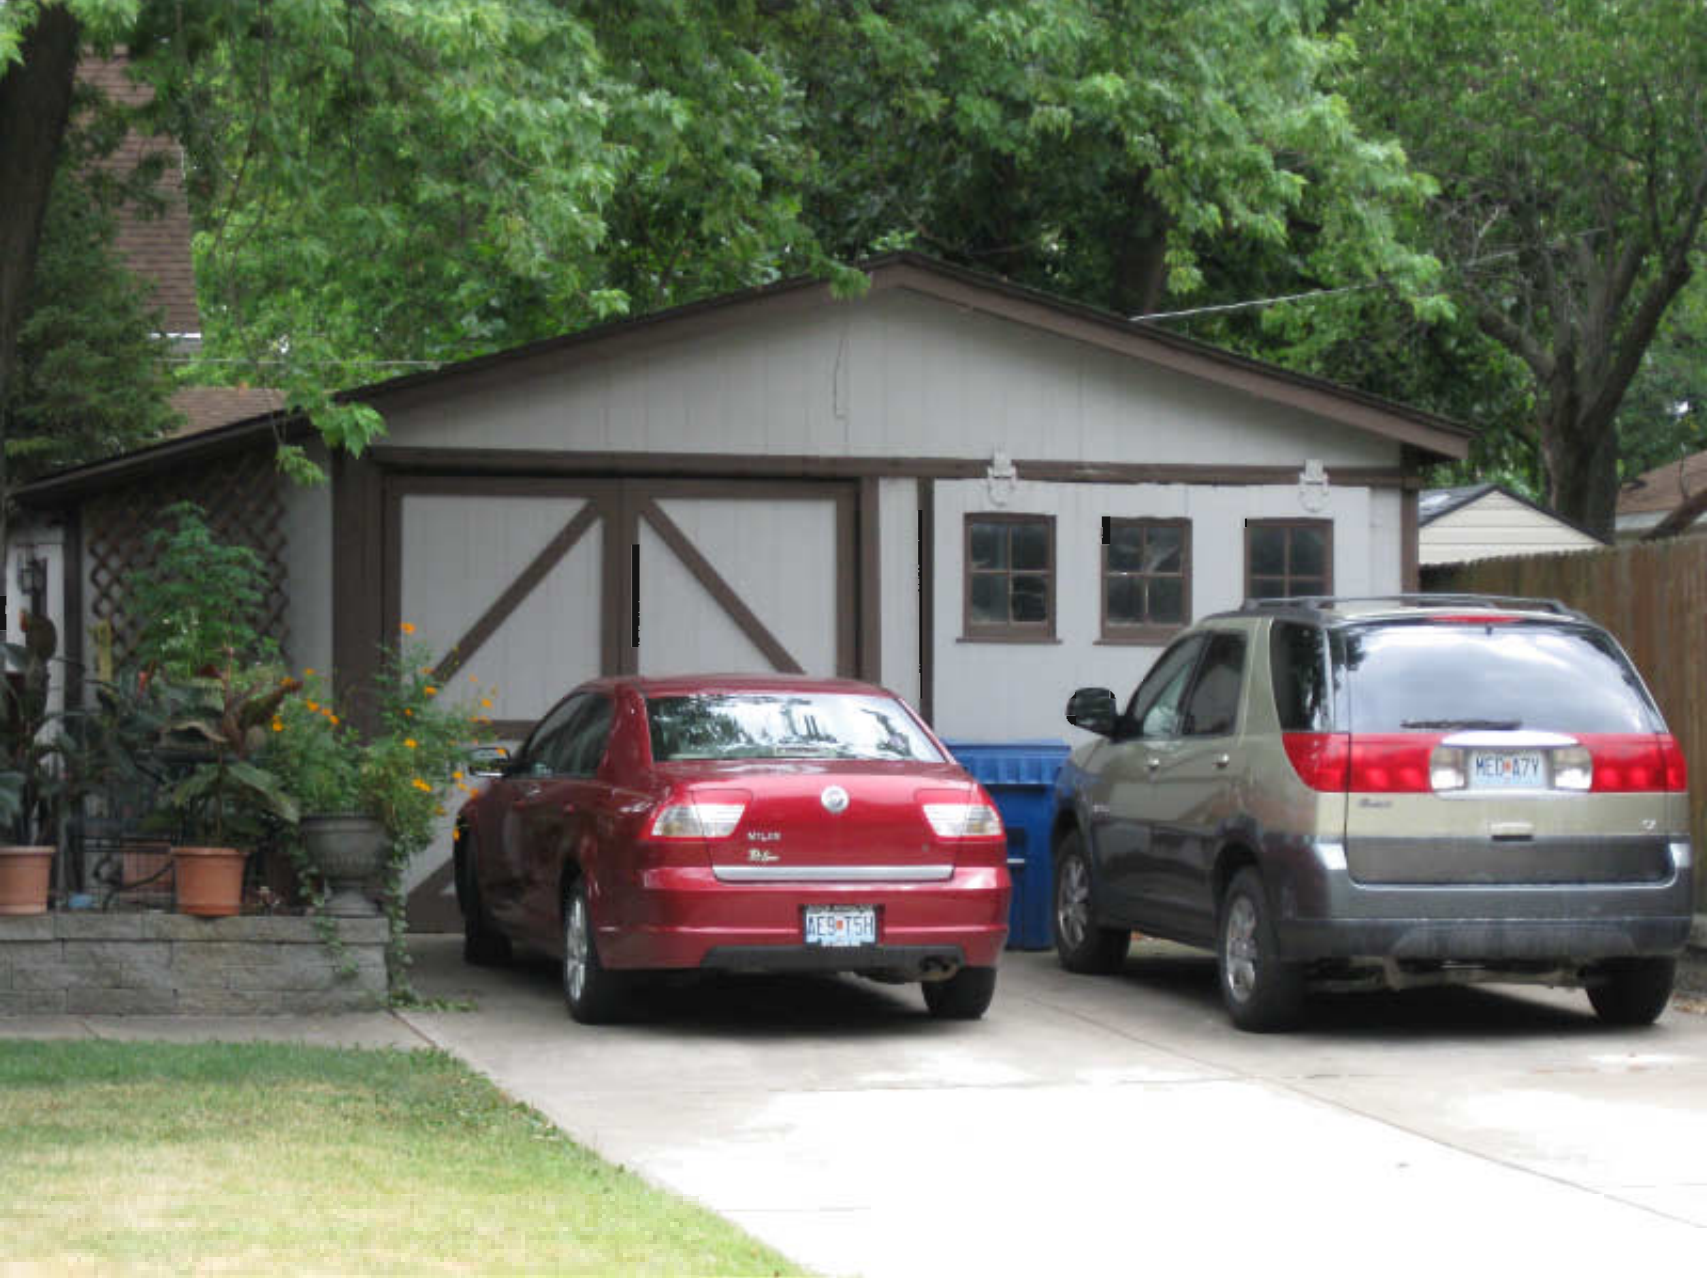
Situated on a corner lot, this gable-front-and-wing form house was originally T-shaped, but the rear porch at the southwest corner of the house has been enclosed, giving the house its present L-shape. The cross-gabled roof is pierced by two straddle-ridge, corbelled brick chimneys: one on the side-gabled wing and the other on the west end of the rear gabled wing. A small gabled dormer is on the north slope of the front-gabled wing and features a 1/1 window framed by pilasters with raised panels, and in the gable end is an incised triangular panel. The house rests on a coursed rusticated stone foundation, and the brick walls of the main façade are laid in a running bond pattern, while the other elevations are laid in a common bond pattern with every sixth course being Flemish bond. The openings throughout the house are segmental arched and are topped by radiating voussoirs that are formed by a soldier course topped with a header course of bricks. An incised panel is above each window and transom, and the 1/1 wood windows throughout the house have lug sills. The four-bay main façade features a window and door in the side-gabled wing and two windows in the front-gabled wing. The door is a half-glazed, paneled wood door topped by a single-light transom, and there is also a four-light, wood storm door. Spanning the front of the side-gabled wing is a gallery with scored concrete foundation, wooden deck and stairs, plain wood balustrade, and brick pedestals with concrete copings. The pedestal at the southeast corner of the porch supports a battered box column, which in turn supports a hip roof. The 1909 and 1917 Sanborn Insurance Maps show the porch was originally a single-bay portico, but between 1917 and 1929 it was enlarged to span both bays of the side-gabled wing. A doorway matching that of the main facade opens onto the gallery from the south wall of the front-gabled wing, and there is a 1/1 wood window in the upper half story of the east wall of this wing. The north elevation features two window openings. In the original brick portion of the south elevation are two 1/1 windows on the first floor and one in the upper half story, but the western first floor window appears to be a later alteration since it is a small, flat-arched opening with brick sill. The rear porch is enclosed with vinyl siding, and in the south wall is a pair of single-light windows.

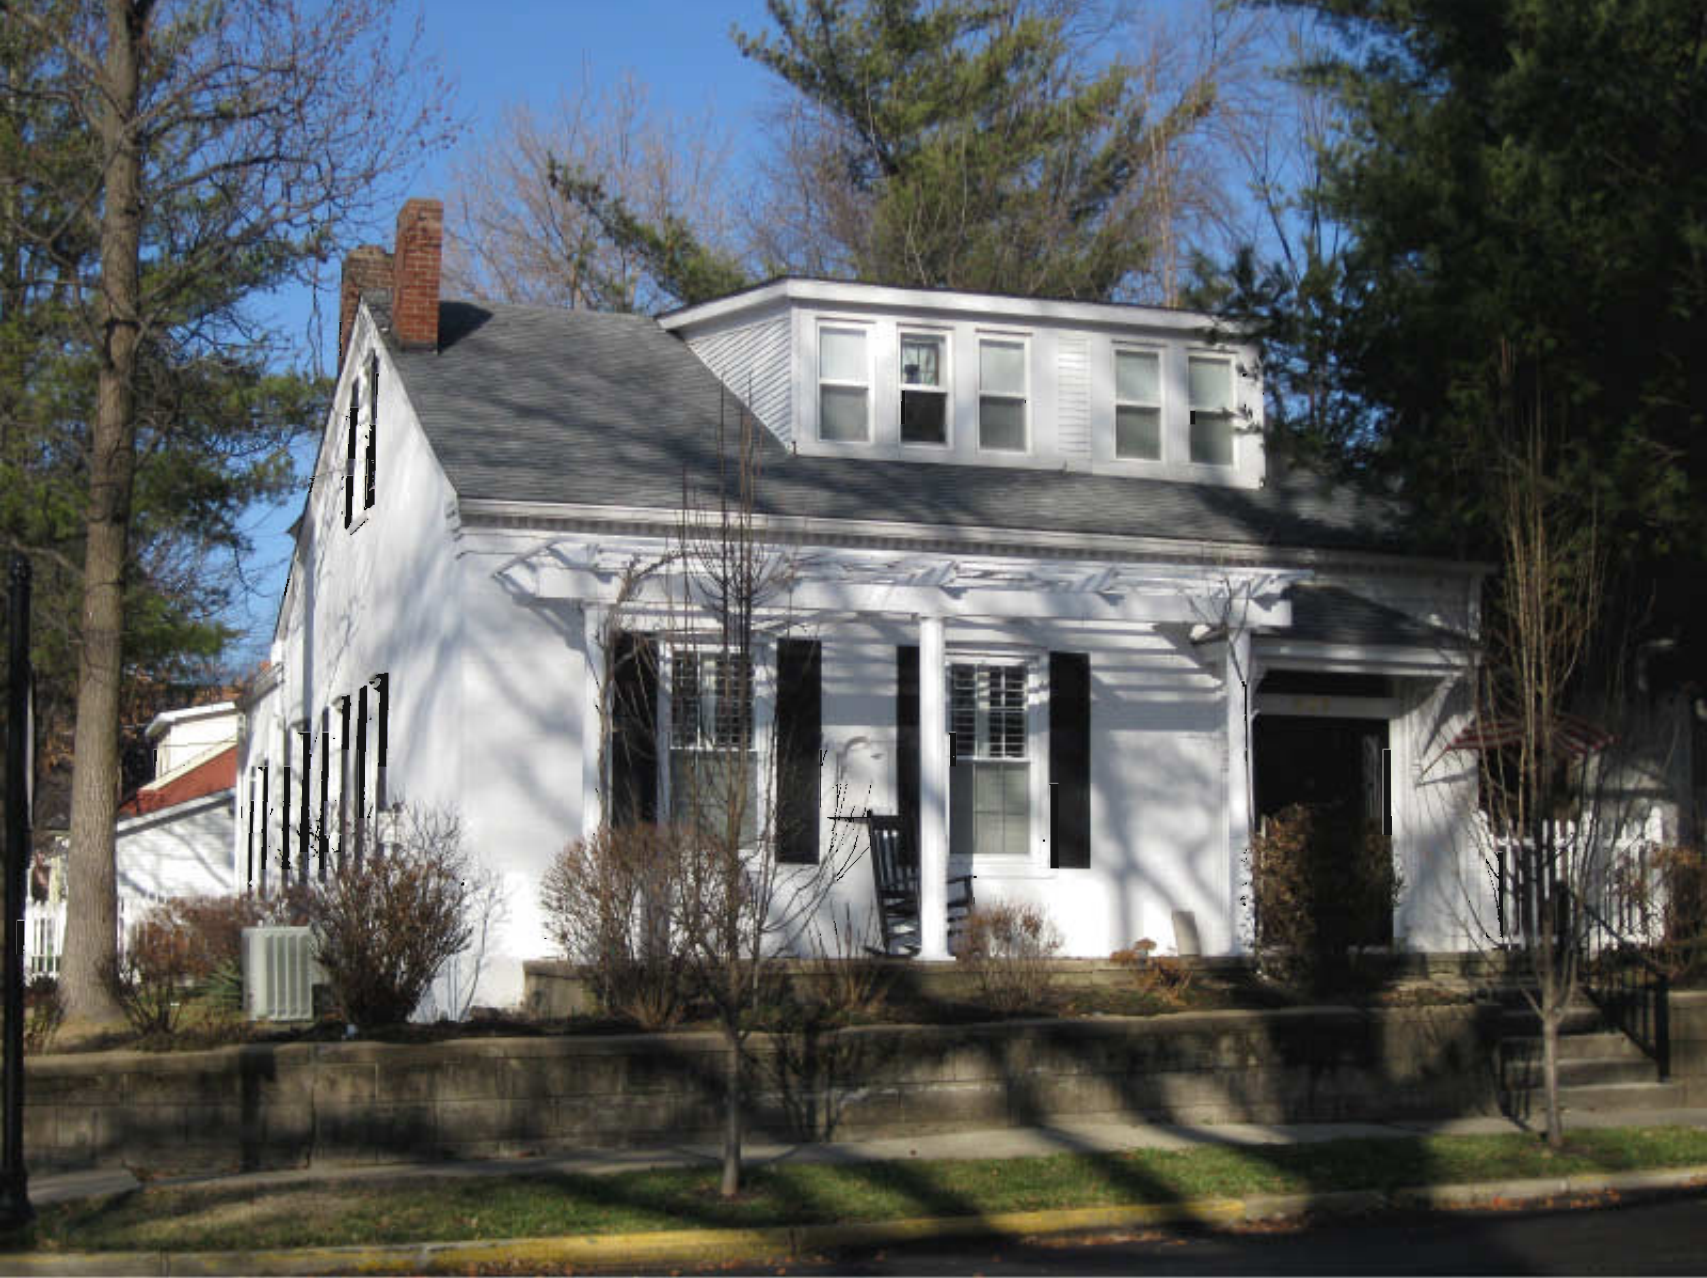
leaded glass transom. A dentil molding is below the transom and fluted pilasters on plinth blocks are to each side of the entrance. The door opens onto a stoop that is covered by a hip roof supported by ornate knee braces. To the left of the entrance are two 6/6 replacement windows that appear to be vinyl, and windows and doors throughout the house are set within low segmental-arched openings topped by radiating voussoirs. The windows have lug sills and retain their shutter hardware, but the existing shutters are vinyl. A concrete terrace with pergola spans the two southern bays of the façade. In the east end of the south elevation are three 6/6 vinyl windows on the first floor and one in the upper half story, and the rear wing has two 1/1 windows. The north elevation has a single window opening on each level.

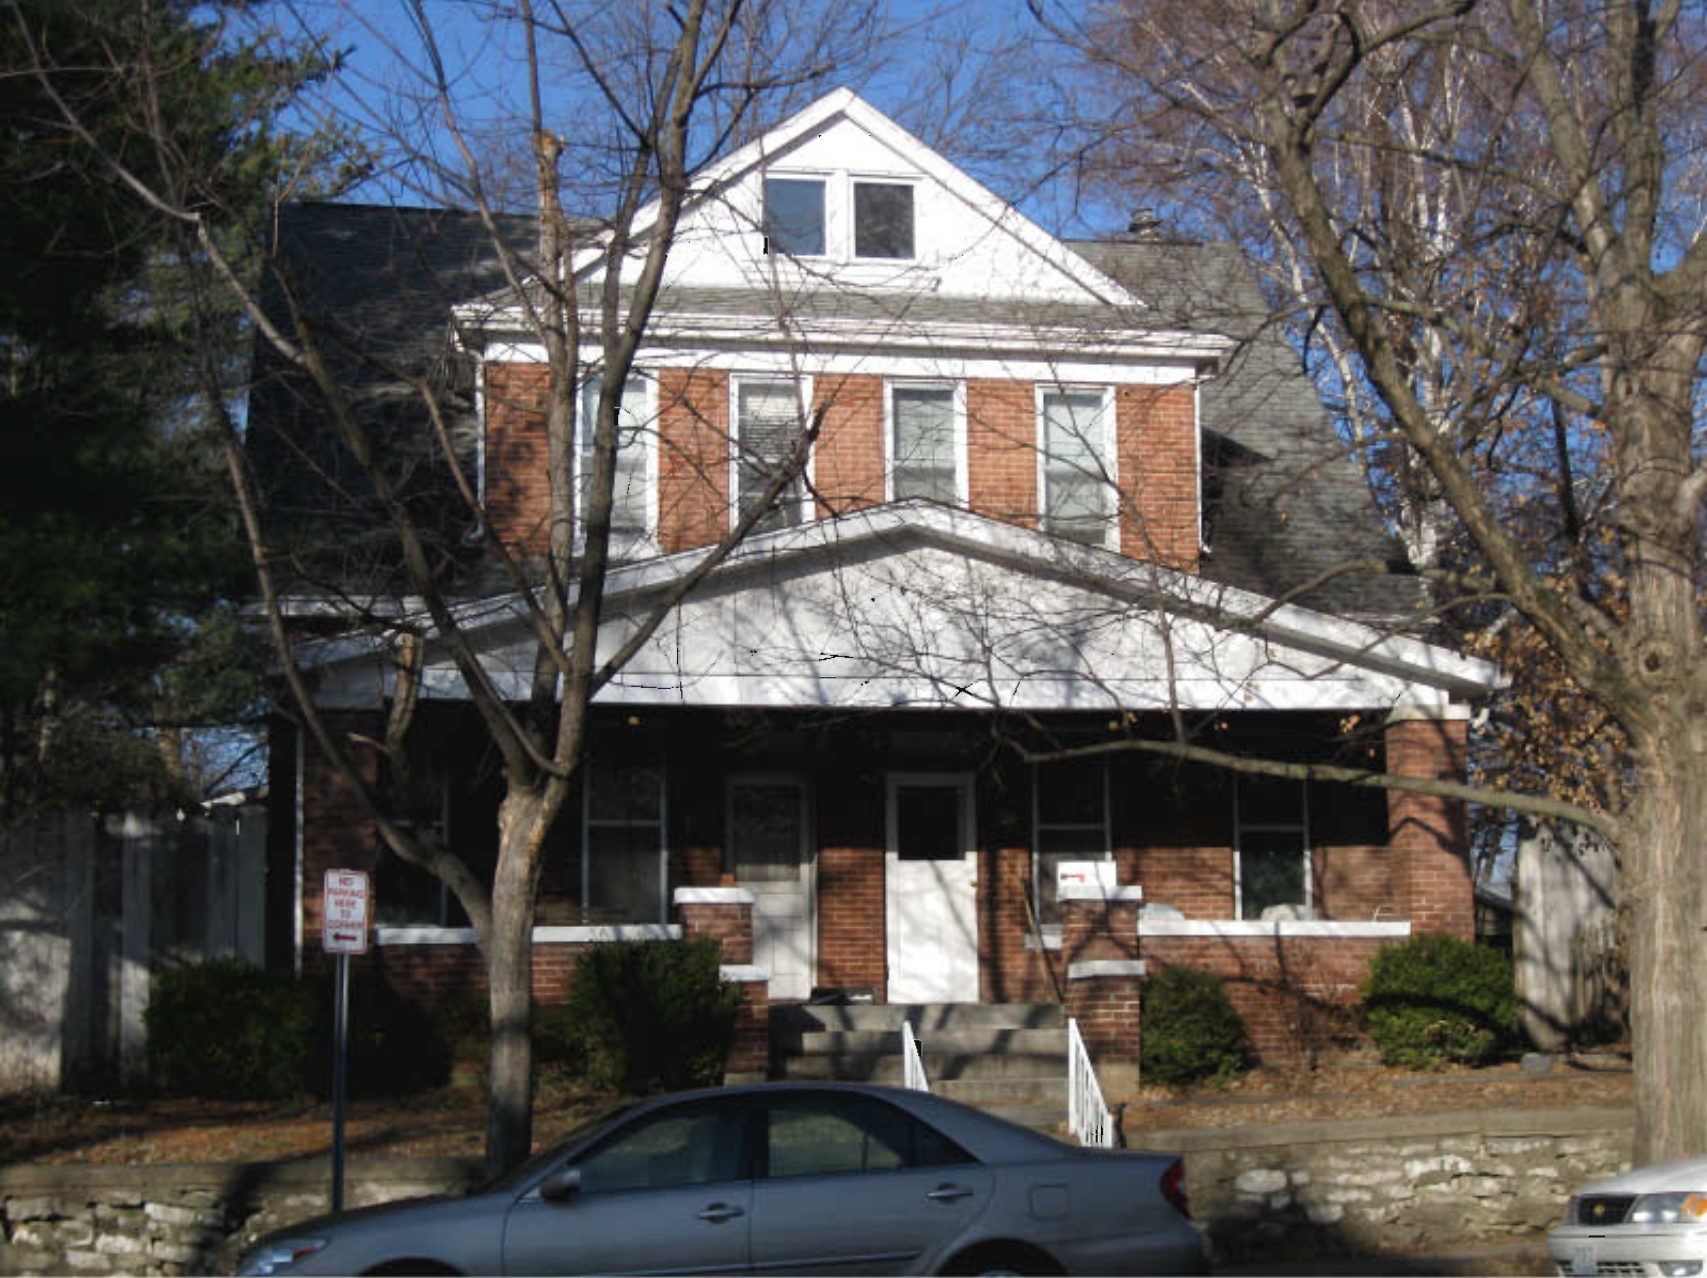
Facing east onto Sixth Street, this duplex is a one-and-one-half story, brick structure that rests on a coursed rusticated stone foundation and is crowned by a high side-gabled roof. The brick walls are laid in a common bond pattern with every sixth row being in a Flemish bond. The front slope of the roof is pierced by a large, brick, gabled wall dormer with four 1/1 windows. The dormer's gable end is pedimented, and the tympanum, which holds a pair of single-light windows, is finished with alternating rows of patterned shingles that create a circular pattern. The six-bay main façade has entrances in the center two bays and 1/1 wood windows in the outer bays. Windows throughout the house have lug sills and are set within segmental-arched openings topped by radiating voussoirs. The entrances are half-glazed, paneled wood doors (a single light set above a three panels), and the transoms have been covered. The northern entrance also has a Craftsman door (single light above two tall vertical panels) that serves as a storm door. The doors open onto a full-width gallery with concrete stairs flanked by brick knee walls, concrete deck, brick railing with concrete coping, brick pedestals and piers with concrete caps, and a gabled roof with stuccoed gable end. The Sanborn maps show that the gallery was originally four-bays wide, but between 1917 and 1929 it was lengthened, and details in the then-fashionable Craftsman style were employed. The side elevations feature three 1/1 windows on the first floor and two in the upper half story. The porches that span the north and south sides of the rear one-and-one-half story, gabled wing have been enclosed with vinyl siding.

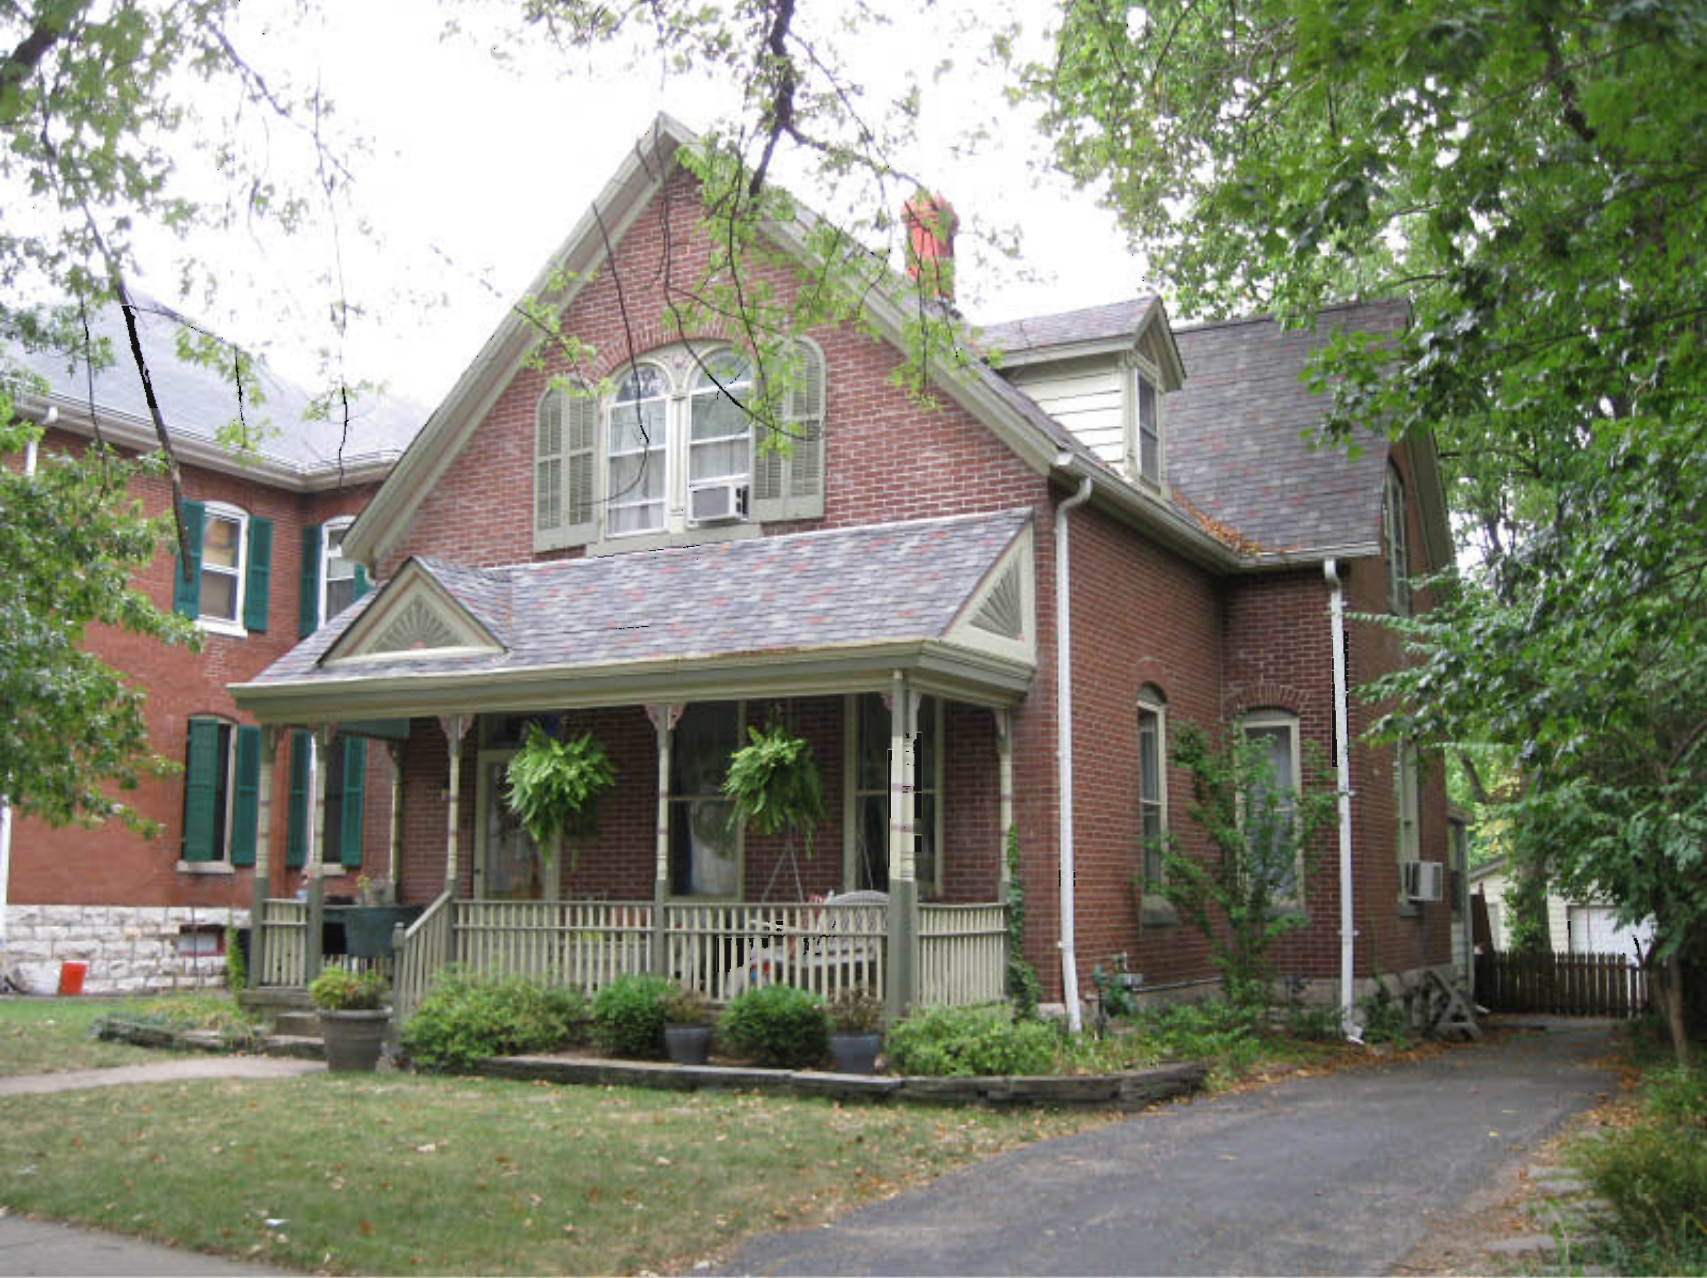
This Folk Victorian house is a one-and-one-half story, cruciform-shaped structure with high cross-gabled roof. Two brick chimneys with corbelled caps straddle the ridges of the front and rear gables, and gabled dormers are on the south slope of the front-gabled wing and the east slope of the north-gabled wing. The south dormer has a 1/1 window, wide paneled pilasters with plinth blocks, bullseye corner blocks, brackets, triangular panel with pierced foliated design in the gable end, and scalloped frieze. The dormer on the east slope is simpler, with paneled pilasters with plinth blocks and a triangular panel with a bullseye ornament. The house rests on a coursed, rusticated stone foundation and the walls are finished with bricks laid in a running bond pattern, except for the rear wall, which is in a five-course common bond. The north end of the three-bay main façade features a half-glazed, paneled wood door topped by a single-light transom, and there is also a 12-light, paneled, wood storm door. To the right of the door are two 1/1 wood windows with lug sills. Openings throughout the house are segmental-arched with radiating voussoirs, and between the top of the window and arch is a panel with sawn foliated ornamentation. A one-story gallery spans the façade and features a concrete deck, turned posts with corner brackets, and a plain balustrade (in addition to the hand and foot rails, there is another horizontal rail several inches underneath the hand rail). The gallery's high shed roof has a sunburst ornament at each end, and a gablet with sunburst ornament pierces the roof above the entrance. In the upper half story is a wide segmental-arched opening filled with a pair of round-arched, 1/1 wood windows, and the paneled mullion rests on a plinth block and is topped by a triangular sawn ornament with applied bullseye molding. Operable, round-arched, louvered wood blinds are at these windows, but no other windows have shutters, although hardware indicates that at one time some did. On the west wall of the north and south wings is a 1/1 window. The north and south elevations feature a 1/1 window at the west end, but the one on the north elevation is smaller and set higher in the wall, indicating that it overlooks a stairway. To the east, in the side-gabled wings, are paired 1/1 windows on each floor.
