ARCHITECTURAL/HISTORIC INVENTORY FORM

1. Survey No. SC-AS-009-001		2. Survey Name: St. Charles Survey Phase 3: Mid-Town and Commons Neighborhoods	
3. County: St. Charles		4. Address (Street No.) 128	Street (name) North Sixth Street
5. City: St. Charles	Vicinity: <input type="checkbox"/>	6. UTM:	
7. Township/Range/Section:		8. Historic name (if known): Meyer-Pieper House; The Meyerdorf	
9. Present/other name (if known):		10. Ownership: <input checked="" type="checkbox"/> Private <input type="checkbox"/> Public	
11a. Historic use (if known): Domestic/single dwelling		11b. Current use: Domestic/single dwelling

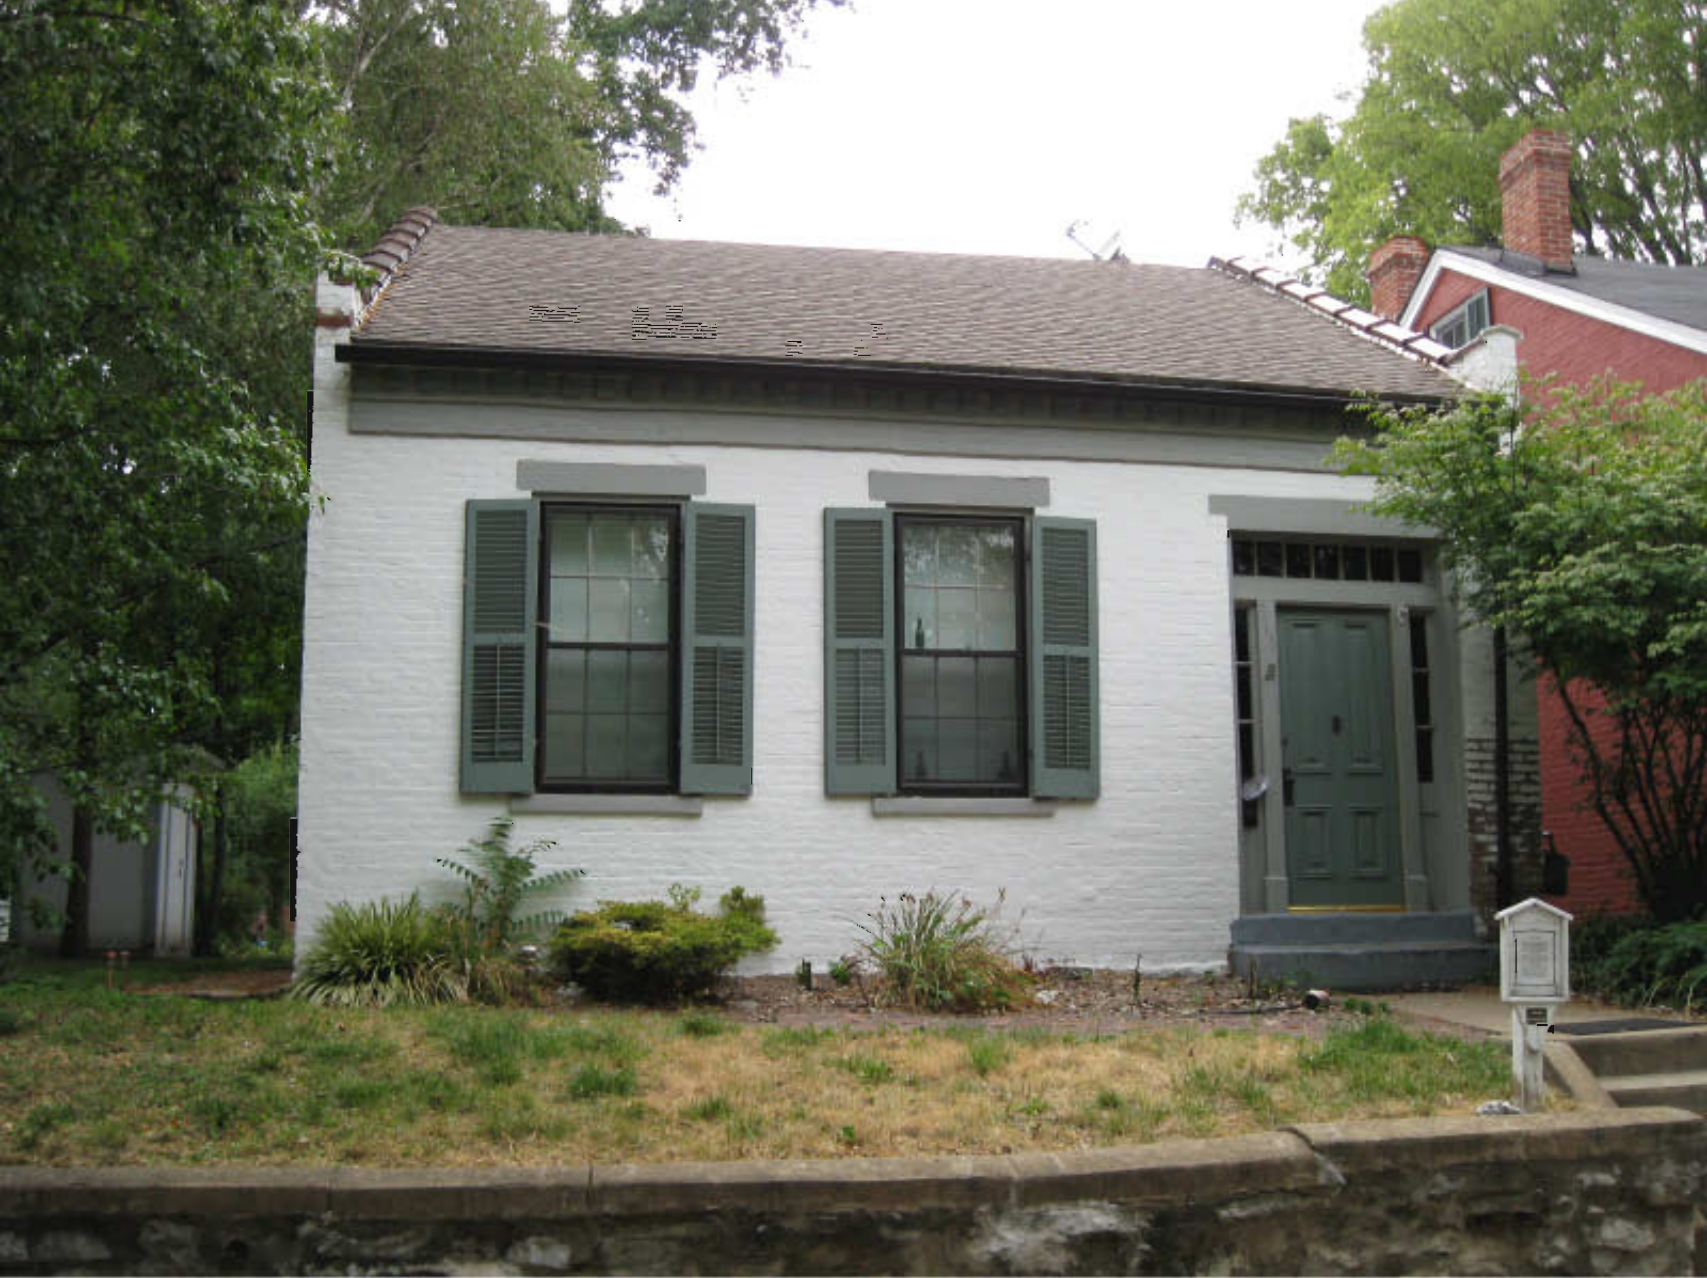
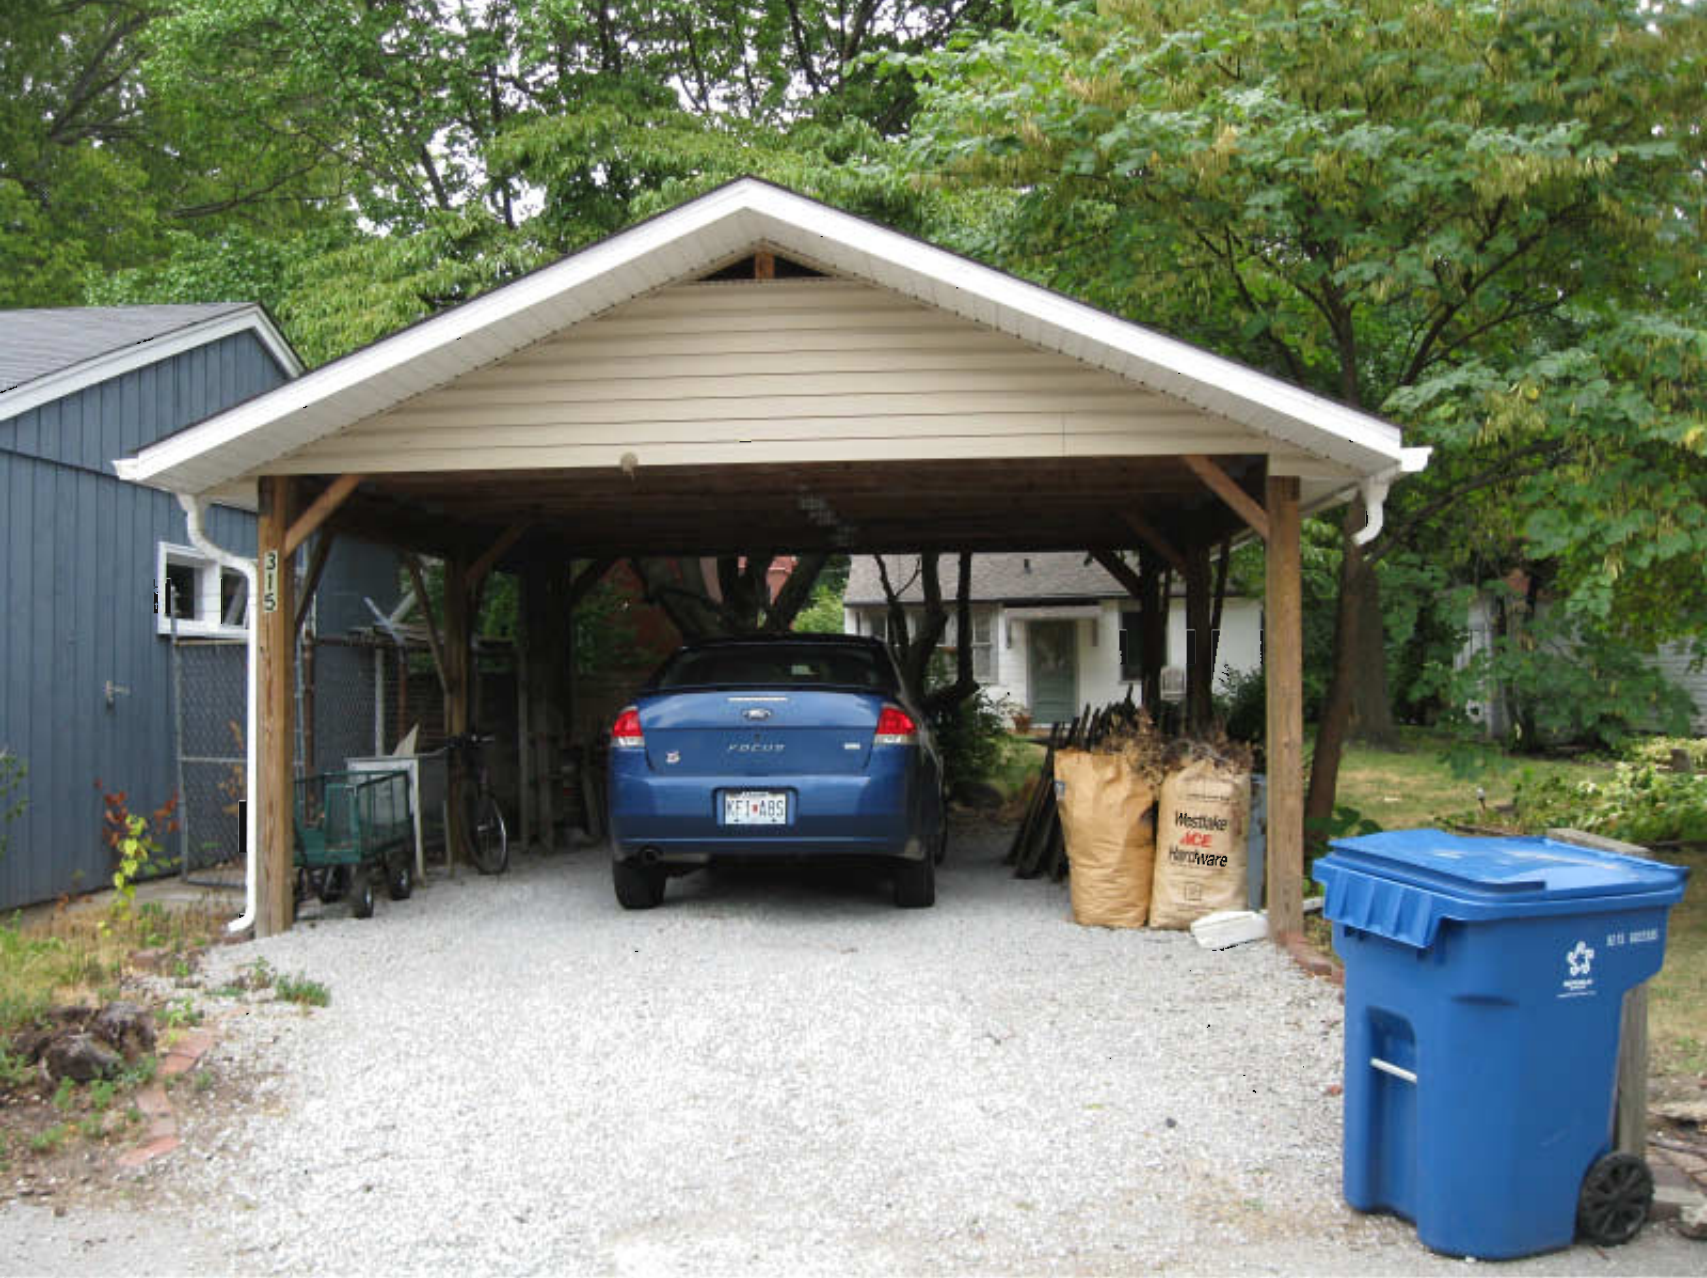
Situated on an elevated lot, this diminutive one-and-one-half story, painted brick, Federal style structure has a side-gabled roof with parapeted end walls, and the roof is trimmed with a denticulated brick frieze. The coursed rusticated stone foundation has also been painted. The house was originally L-shaped, but a frame addition was made to the north half of the rear elevation, giving it a rectangular plan. The entrance, which is located at the north end of the three-bay main façade, is a wood door with four raised panels, and the door is flanked by three-light sidelights set above paneled skirts. A seven-light transom spans the door and sidelights, and a stone lintel is above the transom. There is no porch or stoop—the door opens directly onto a set of steps. To the left of the entrance are two 6/6 wood windows with stone lintels and lug sills, and the windows are flanked by operable louvered wood shutters. The south elevation has two 6/6 windows on the first floor and another in the upper half story, and the windows have stone lintels and lug sills. On the south wall of the rear shed-roofed wing is a window that appears to be a 1/1 sash. The north elevation has a window on each level, and on the north wall of the rear addition is a group of 2/2 windows.

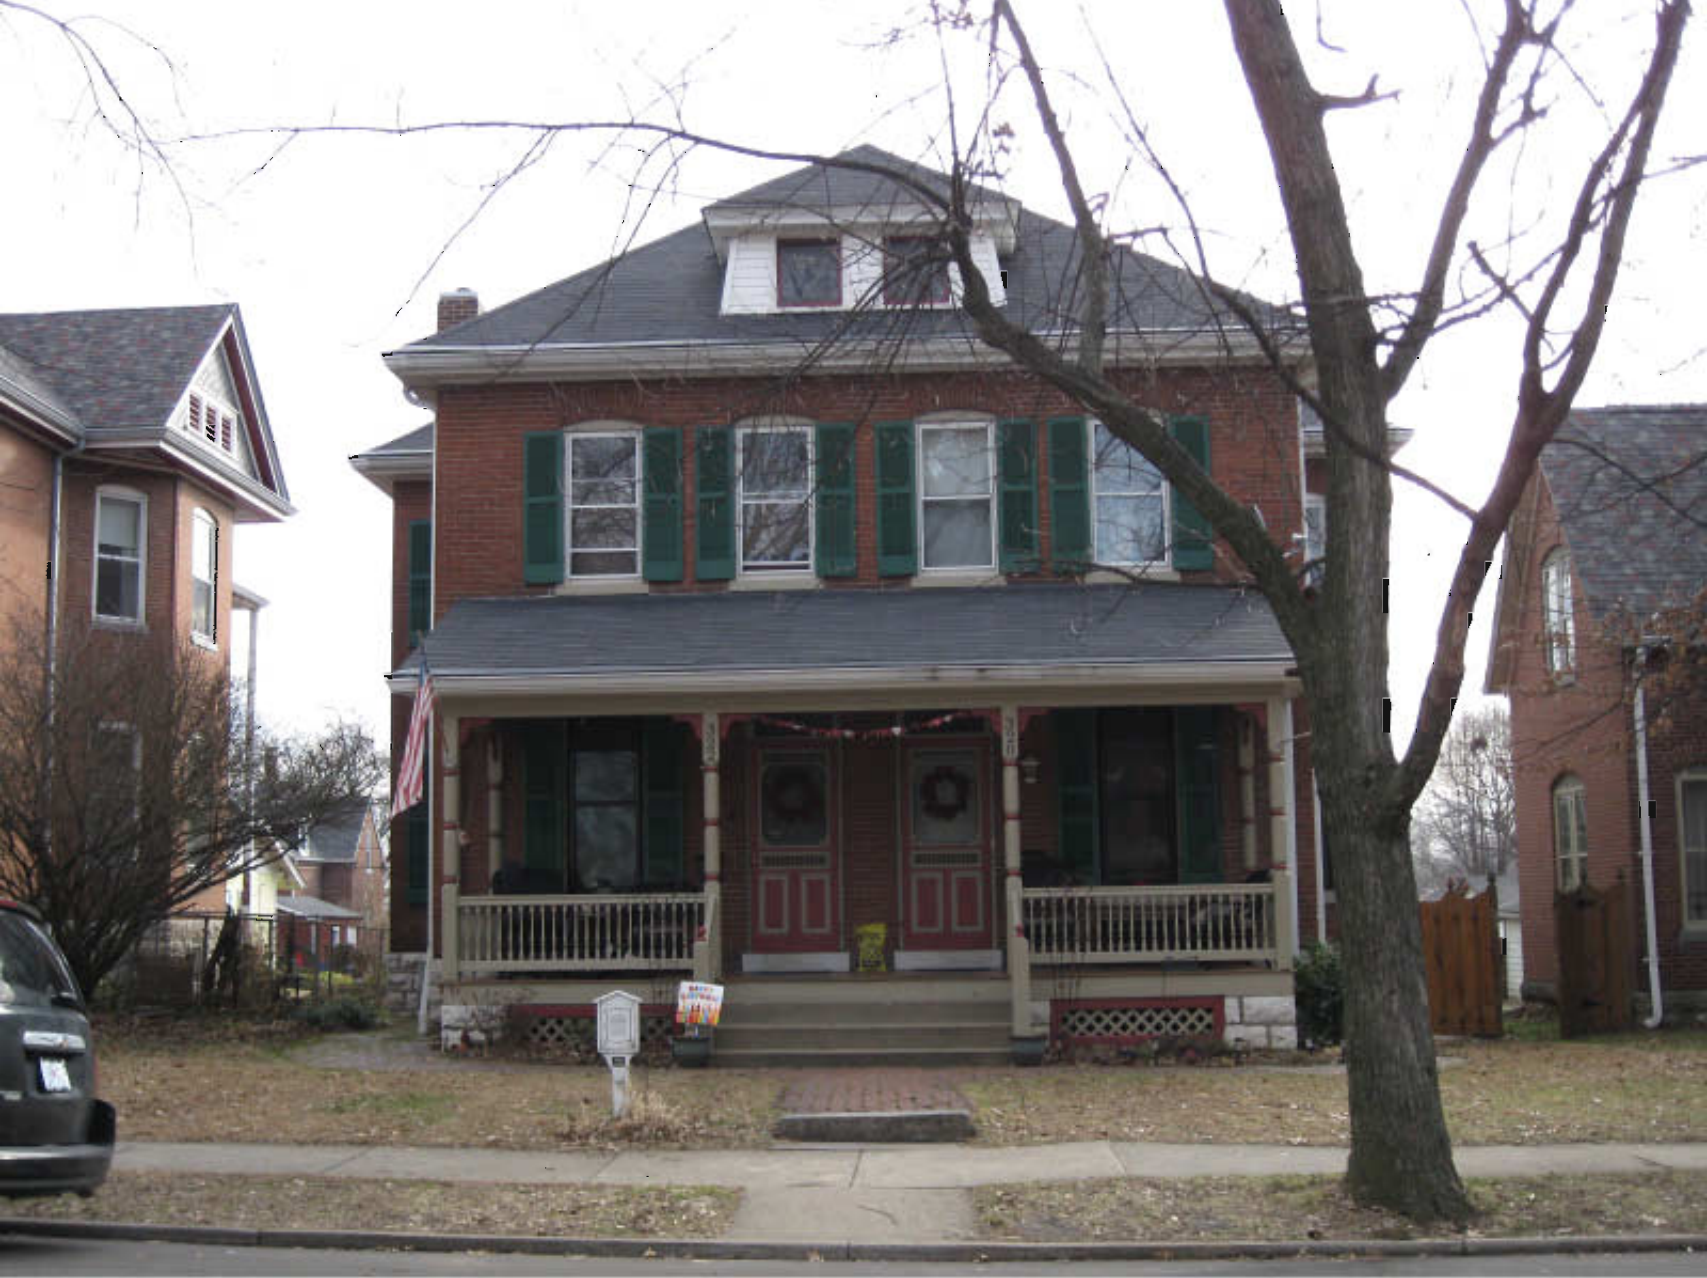
This two-and-one-half story, cruciform-plan duplex rests on a coursed rusticated stone foundation and the walls are finished with brick. The structure is crowned by a high hip roof with wide overhanging eaves, and on the front slope of the roof is a hipped dormer with two single-light windows and battered walls clad with vinyl siding. An interior end chimney is at the north and south side slopes while there is another at the east slope of the rear gabled wing. The main façade is a four-bay elevation, with the center two bays of the first floor holding half-glazed doors topped by single-light transoms, and paneled wood storm doors with ball-and-rod spindles are at each entrance. The outer bays and the four openings of the second floor have 1/1 wood windows with cast stone lug sills, and according to the City's address files the windows were replaced in 2011. Openings are segmental-arched with radiating voussoirs, and the windows are protected by louvered wooden blinds. Spanning the main façade is a one-story gallery with stone foundation piers in-filled with framed lattice panels, wooden stairway and deck, balustrade with turned balusters, turned posts with corner brackets, and shed roof. The west walls of the projecting north and south wings hold a 1/1 window on each floor. The west end of the north and south elevations have a 1/1 window on each floor, and in each of the projecting bays of the side elevations is a 1/1 window on each floor.

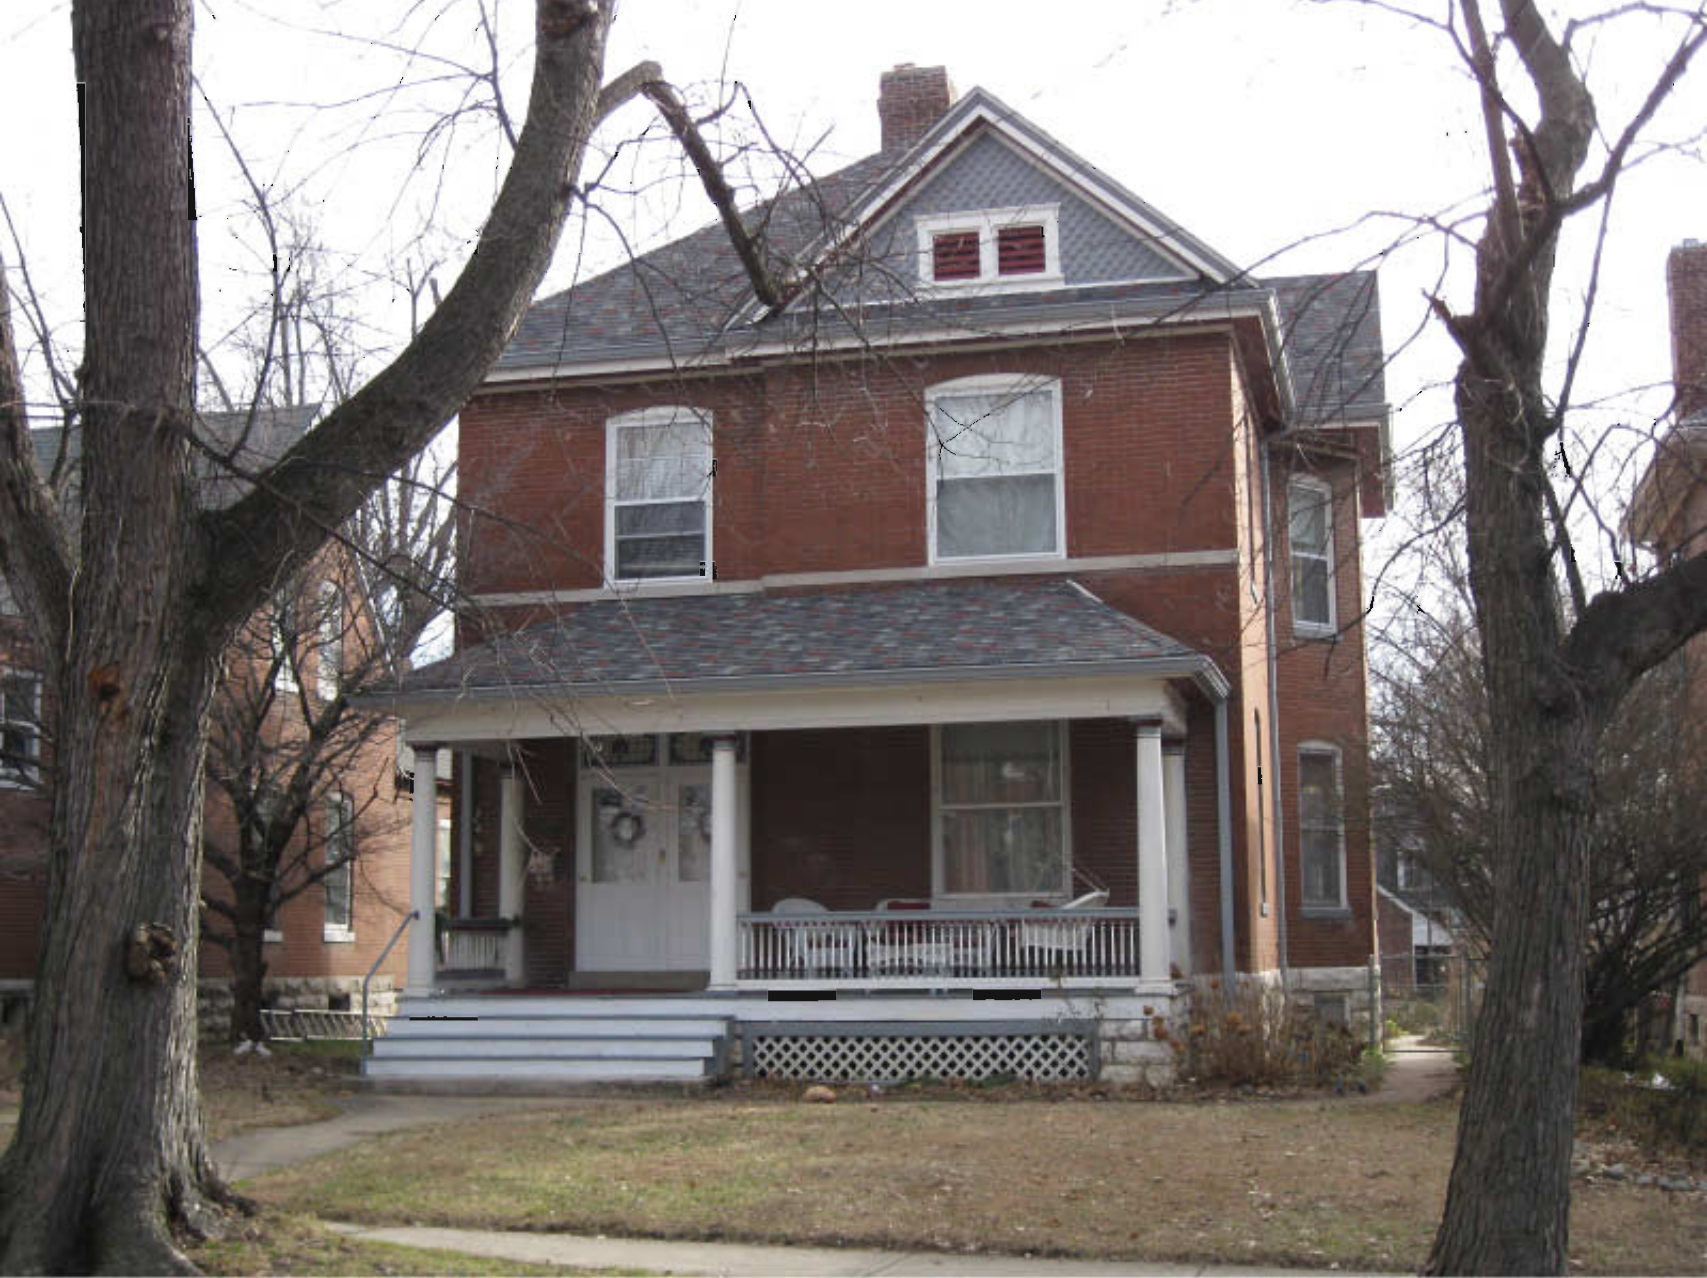
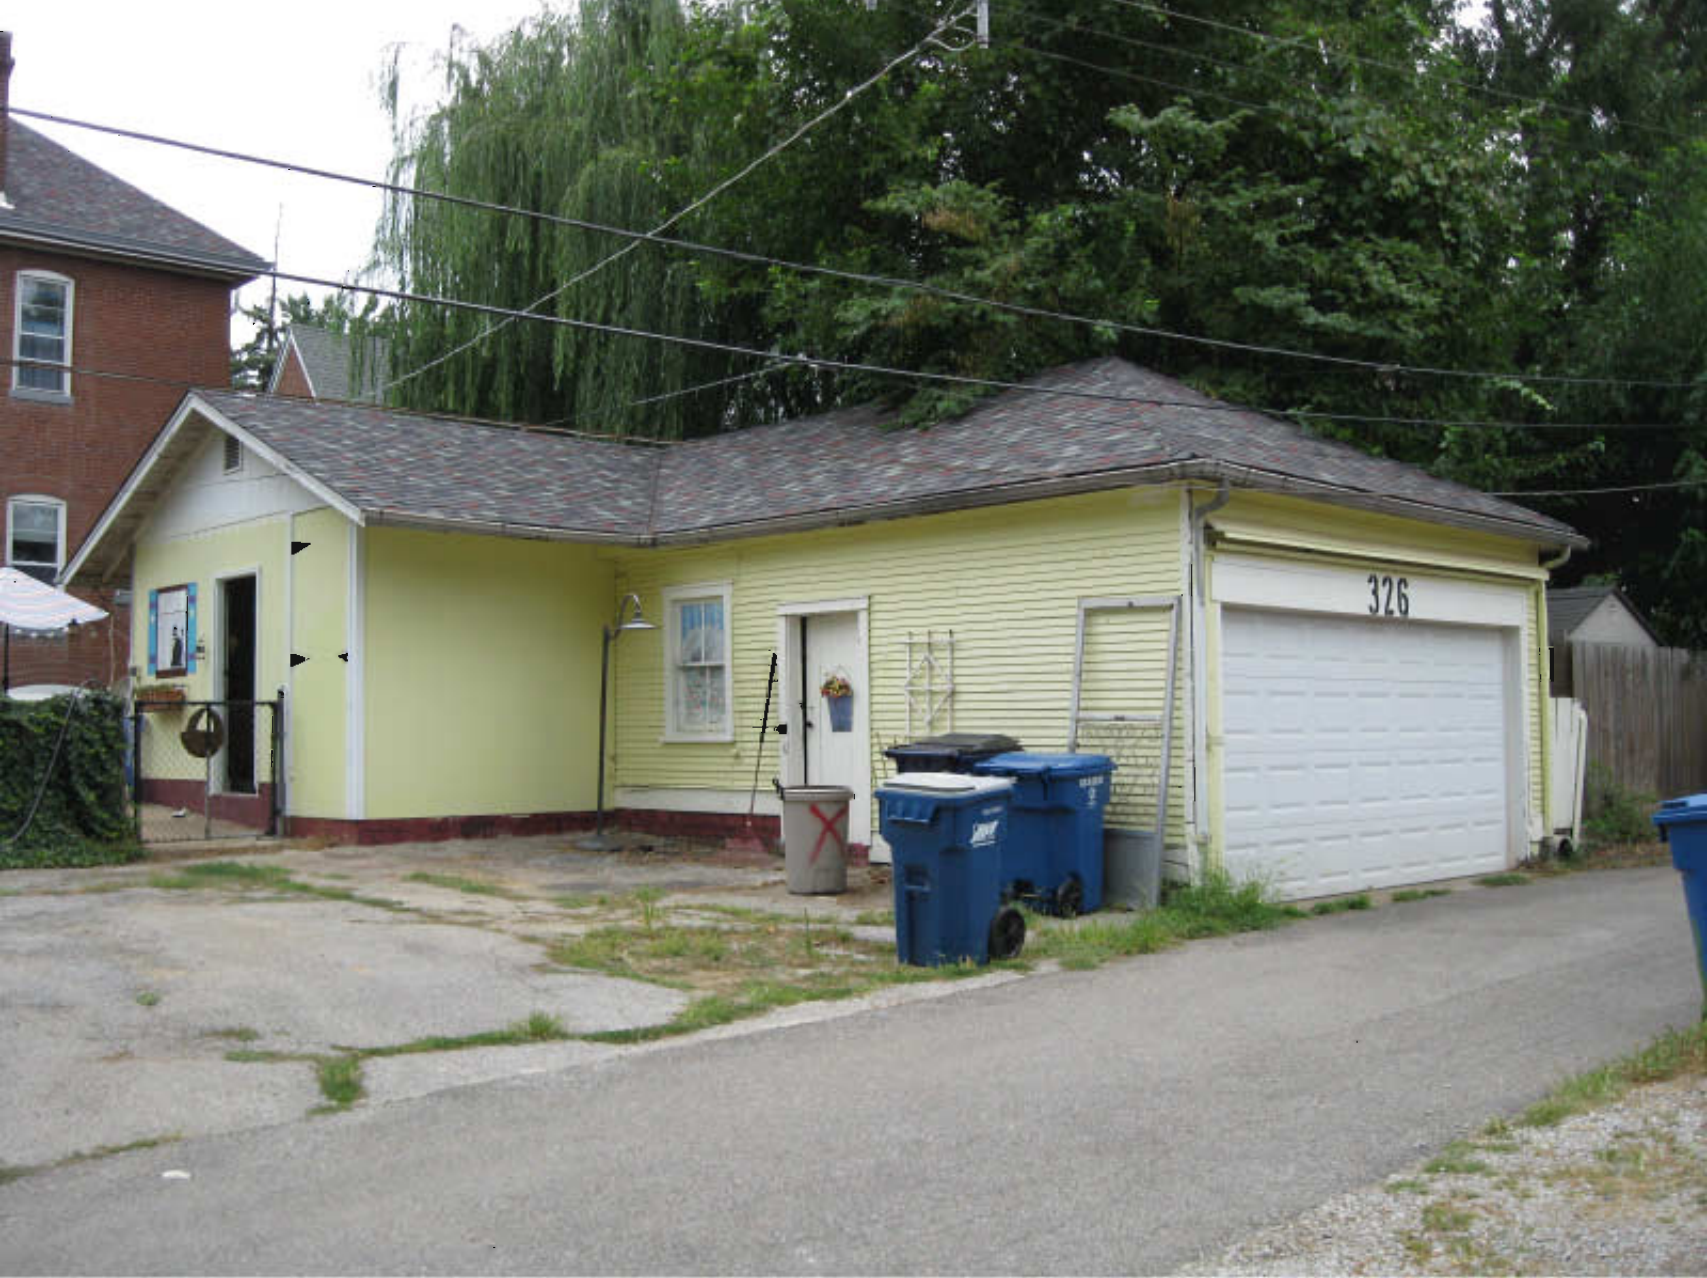
floors, indicating that it overlooks a stairway. A two-tiered porch spans the south elevation of the rear wing.

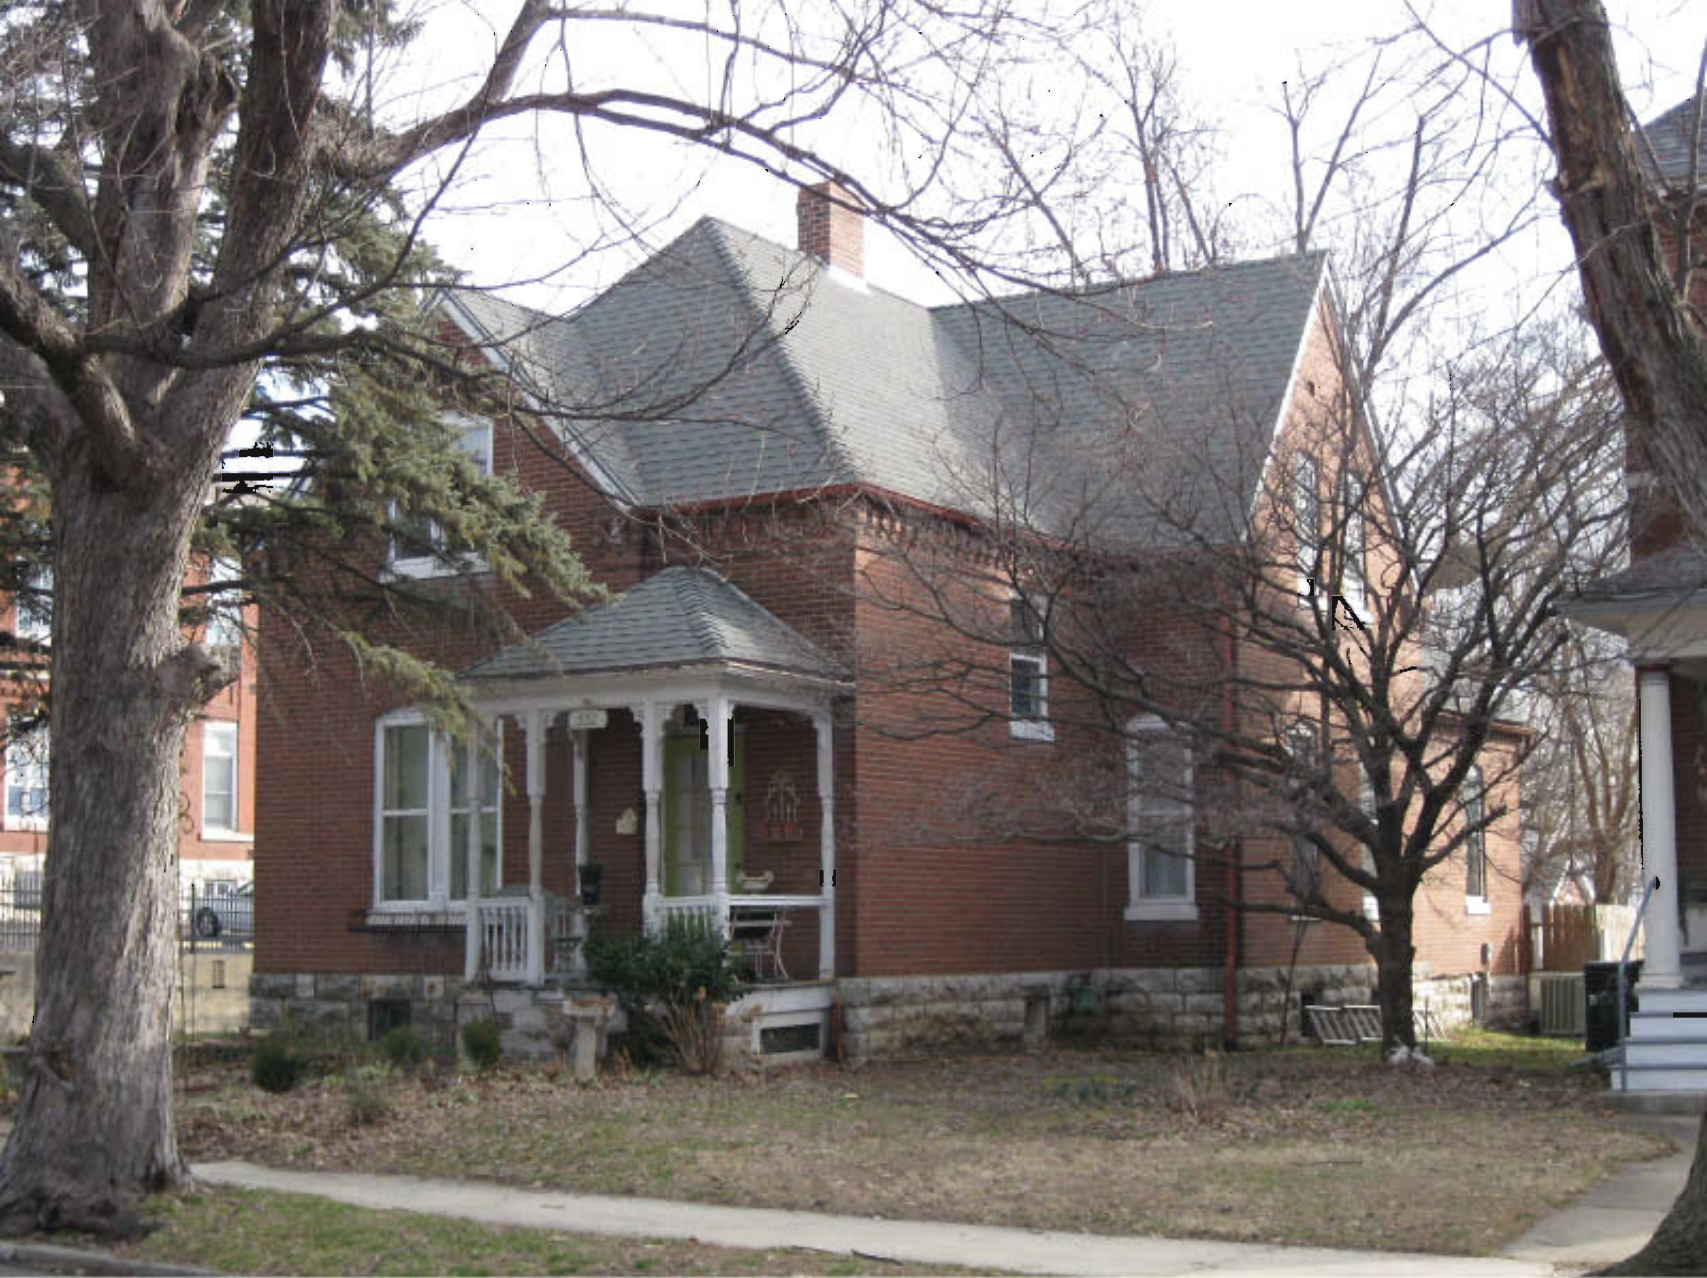
Located at the southeast corner of Sixth and Adams Streets, this house is a one-and-one-half story, cross-gabled, brick, Folk Victorian style structure. The house rests on a coursed rusticated stone foundation pierced by single-light basement windows, and the brick walls are laid in a running bond pattern. The high hipped roof has lower intersecting cross gables, and the roof is trimmed with a denticulated brick cornice with returns. A brick straddle ridge chimney rests on the hip roof, and a gabled dormer is on the north slope. The dormer has a wood 1/1 window flanked by wide pilasters with raised panels, and in the gable end are a triangular-shaped molding and a jigsawn gable ornament. The main façade is a two-bay elevation, with the entrance in the southern bay and paired 1/1 wood windows in the northern. Openings throughout the house are segmental-arched and have radiating voussoirs and lug sills, and above each window and transom is an incised panel with foliated pattern. The main entrance is a half-glazed, paneled wood door with single-light transom, and there is also an eight-light, paneled wood storm door. The paired windows to the north are separated by a fluted mullion with plinth blocks. The door opens onto a one-bay portico with wooden stairway and deck, balustrade with turned balusters, turned posts and half-posts with corner brackets, and a high hipped roof. In the gable end is another pair of 1/1 windows matching those below. On the west wall of each of the projecting side wings is a 1/1 window. The north elevation has two windows on the first floor and one in the gable end, while in the west end of the south elevation is a window high in the wall, which indicates it is overlooking a stairway, and to the east is a 1/1 window on each level of the gabled wing.

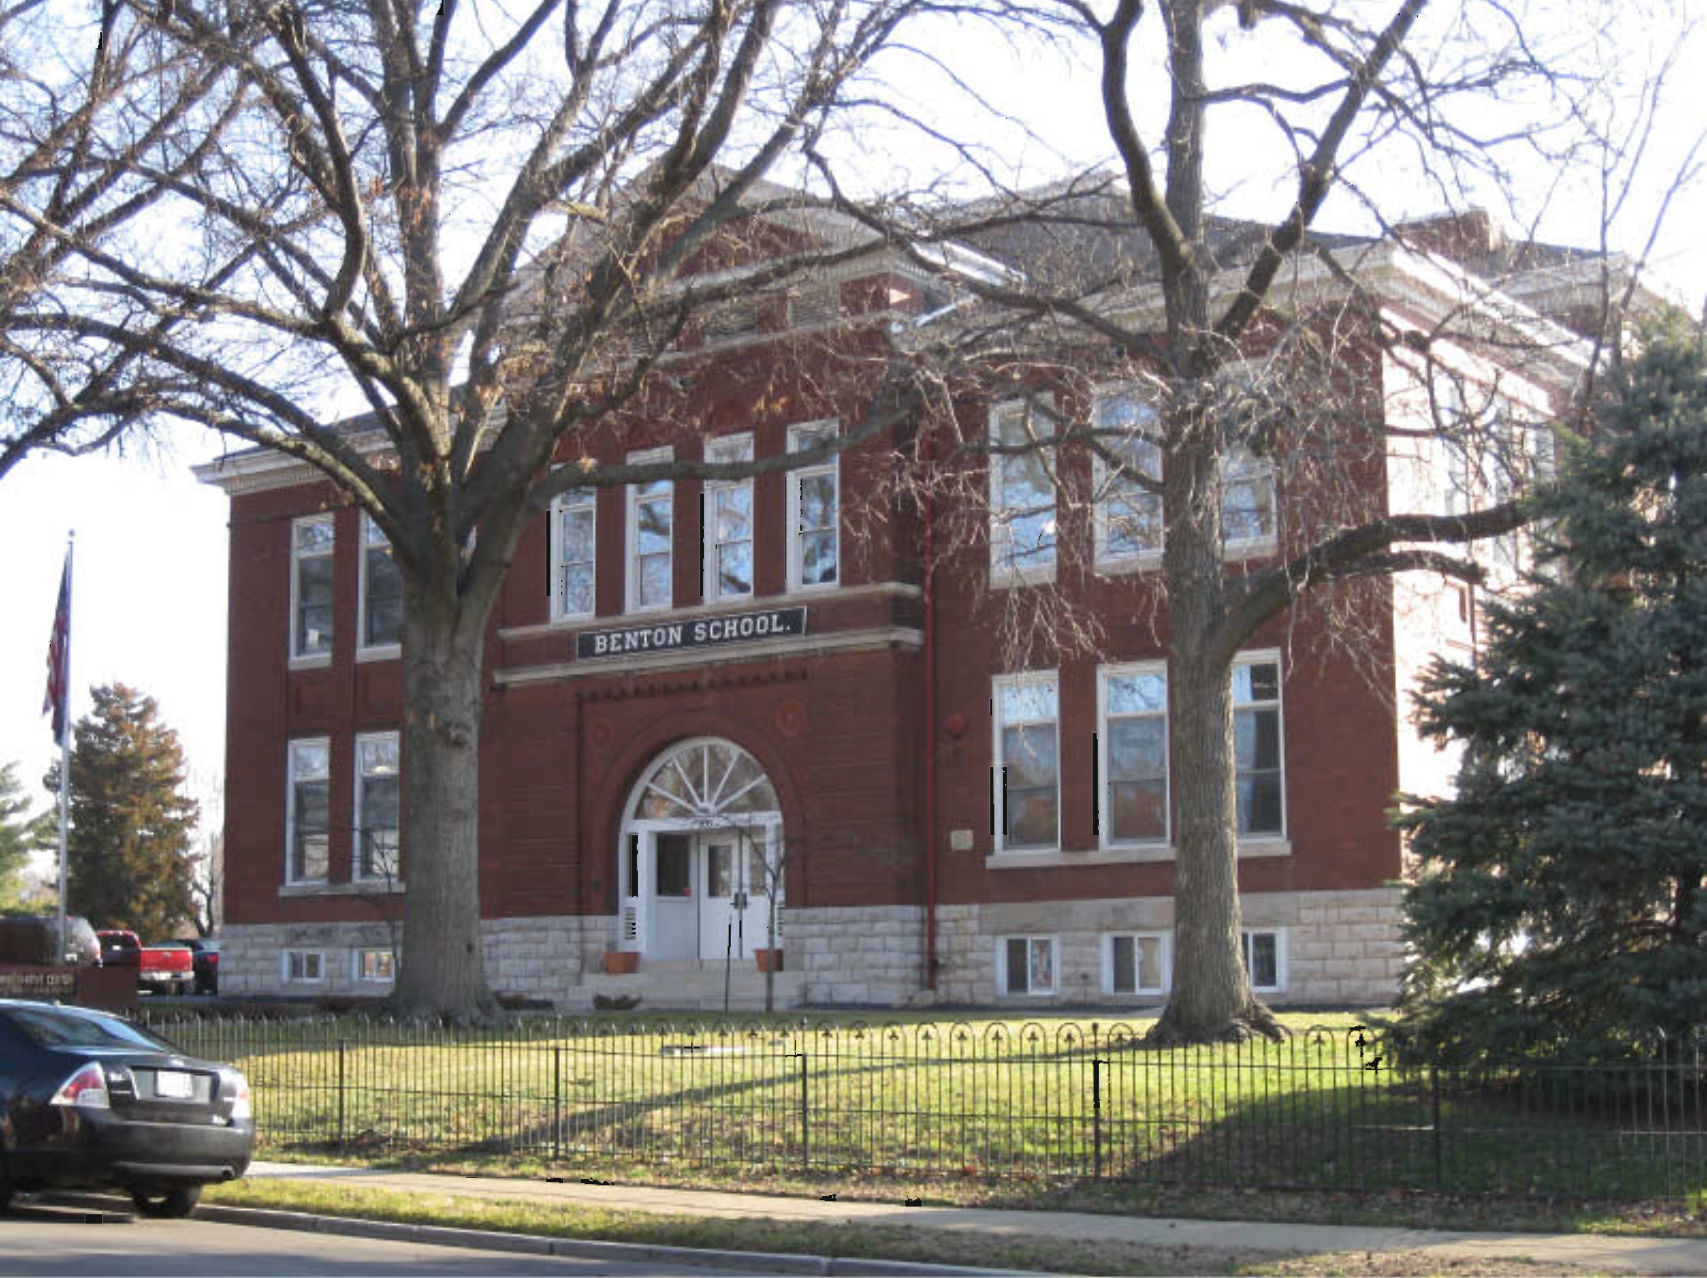
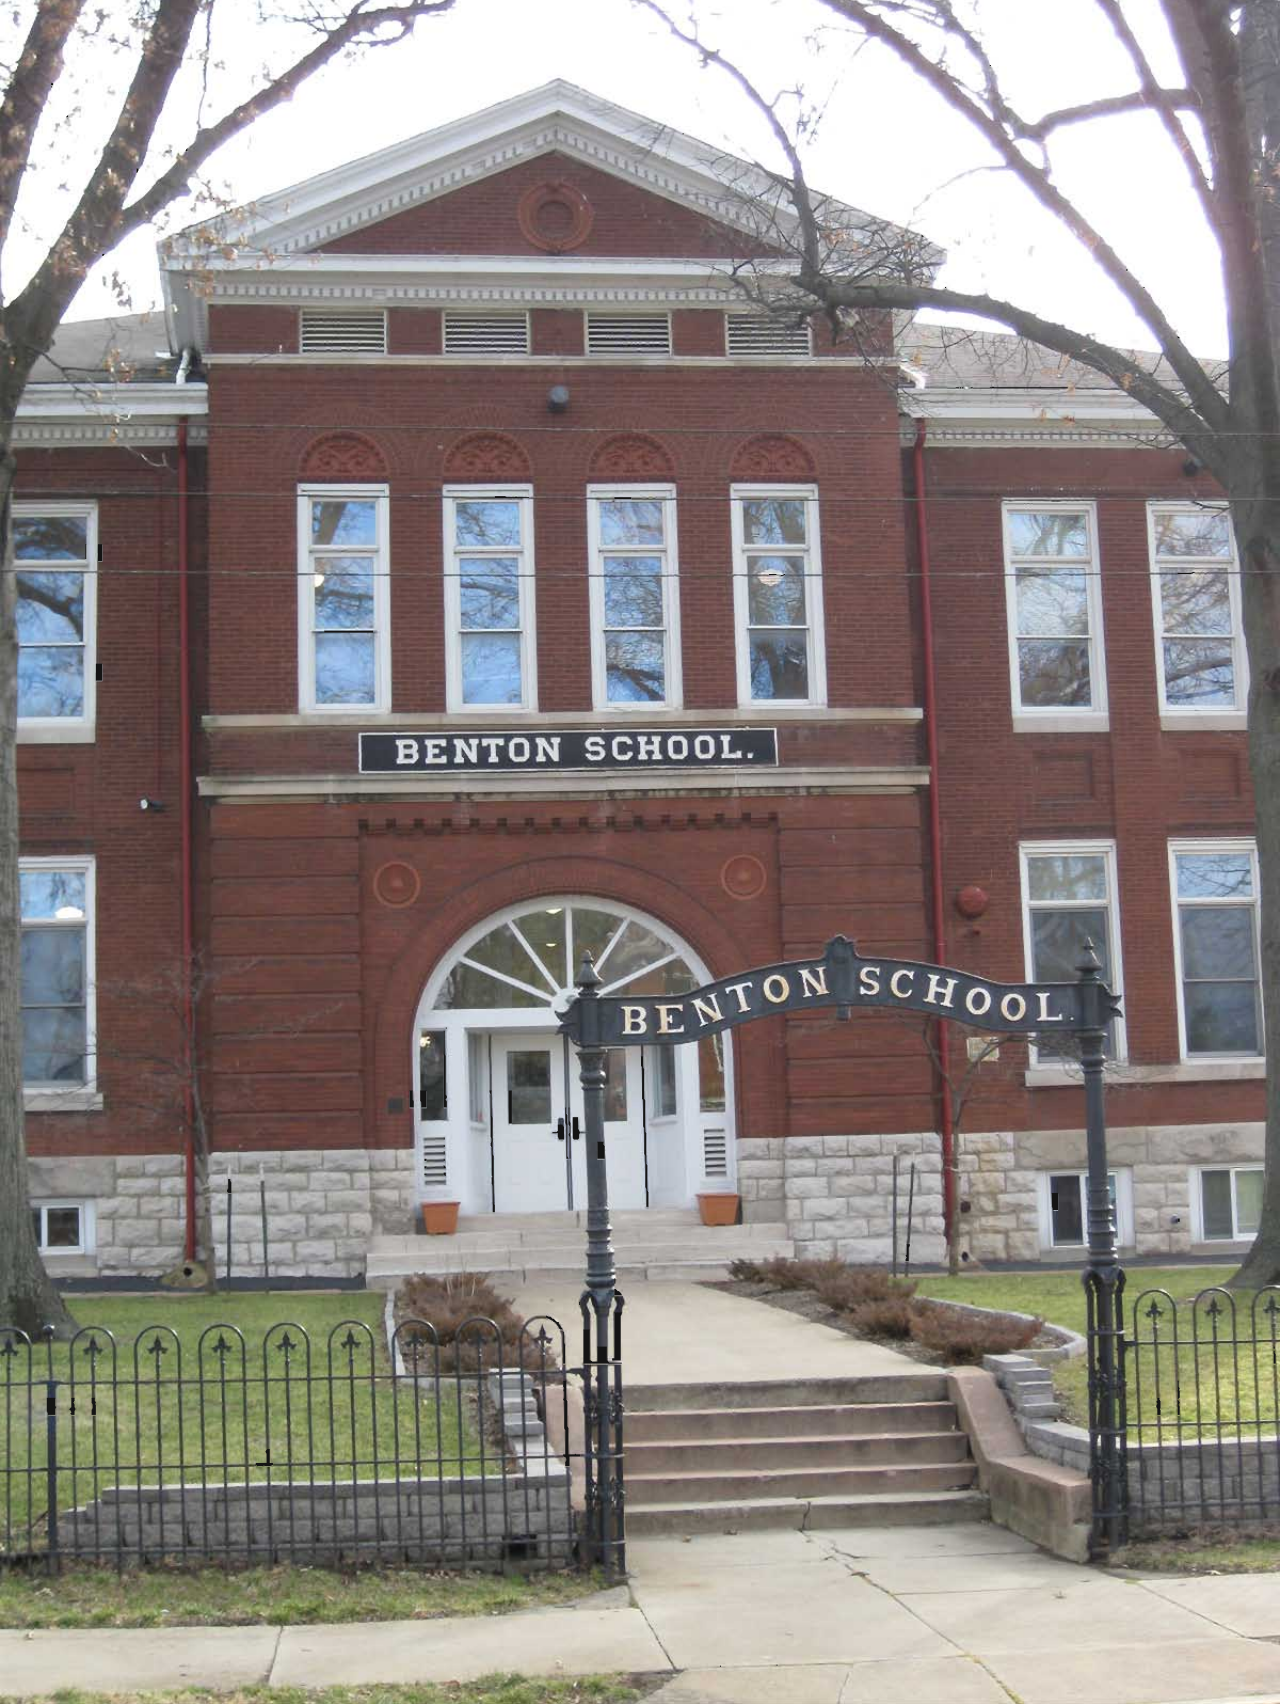
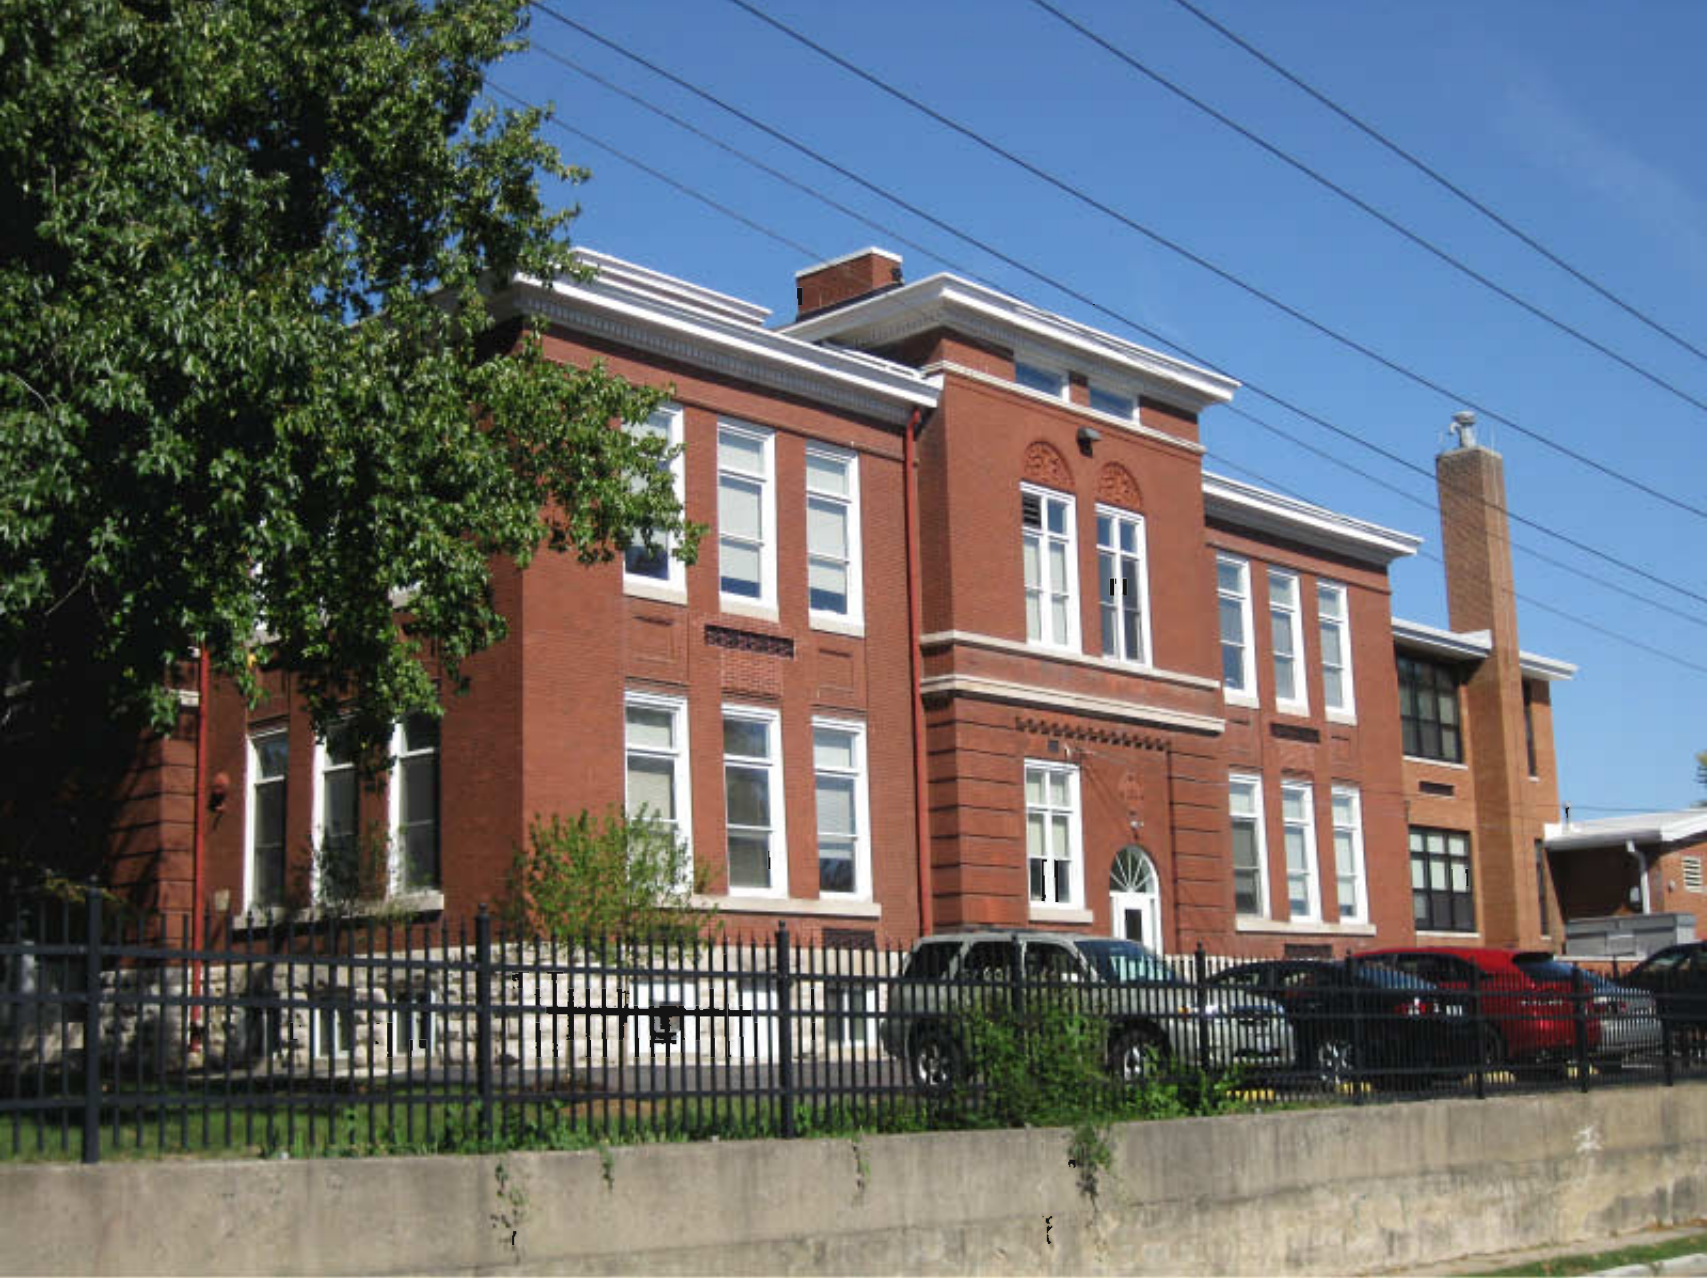
stone steps. To each side of the projecting gabled wing are three 1/1 windows topped by single-light transoms, and a continuous cast stone sill extends under each group of three windows. Two cast stone belt courses above the entrance form a sign panel, which holds the name of the building, "Benton School." Above the sign panel, in the front-gabled wing, are four 1/1 windows topped by single-light transoms, and above each of these windows is a round-arched, terra cotta panel with foliated design bordered by a bead-and-reel molding. Above these windows is a cast stone belt course, above which are four rectangular ventilators. On the second floor of the façade, to each side of the front-gabled wing, are three 1/1 windows with single-light transoms and cast stone sills. The area between the first and second floor windows have recessed panels, and under these are bead and reel moldings. The side elevations match the main façade except for the projecting wings, which have hipped roofs. The first floor of the projecting wings have a half-glazed door with single-light sidelights and fanlight and a pair of 1/1 windows with single-light transoms (the doors were originally paired half-glazed doors but were replaced in 2008). These two openings are set within a slightly recessed area framed by quoins and topped by a corbelled brick frieze. Above each door is a round terra cotta plaque with the date of construction, 1896. In the second floor are two pairs of 1/1 windows with single-light transoms topped by round-arched terra cotta panels with foliated design. Two belt courses are below the second floor windows (one serves as the window sill) and one is above. In the attic story are two single-light windows. On the rear of the building is a two-story, brick addition with one-story wing. The addition, which was constructed in 1953, has bands of 1/1 windows topped by transoms. In 1999 a modular classroom building with side-gabled roof and vertical board walls was attached to the rear wall of the 1953 addition. There are five 1/1 windows on the east elevation and none on the north.
