ARCHITECTURAL/HISTORIC INVENTORY FORM

1. Survey No. SC-AS-009-001		2. Survey Name: St. Charles Survey Phase 3: Mid-Town and Commons Neighborhoods	
3. County: St. Charles		4. Address (Street No.) 128	Street (name) North Sixth Street
5. City: St. Charles	Vicinity: <input type="checkbox"/>	6. UTM:	
7. Township/Range/Section:		8. Historic name (if known): Meyer-Pieper House; The Meyerdorf	
9. Present/other name (if known):		10. Ownership: <input checked="" type="checkbox"/> Private <input type="checkbox"/> Public	
11a. Historic use (if known): Domestic/single dwelling		11b. Current use: Domestic/single dwelling

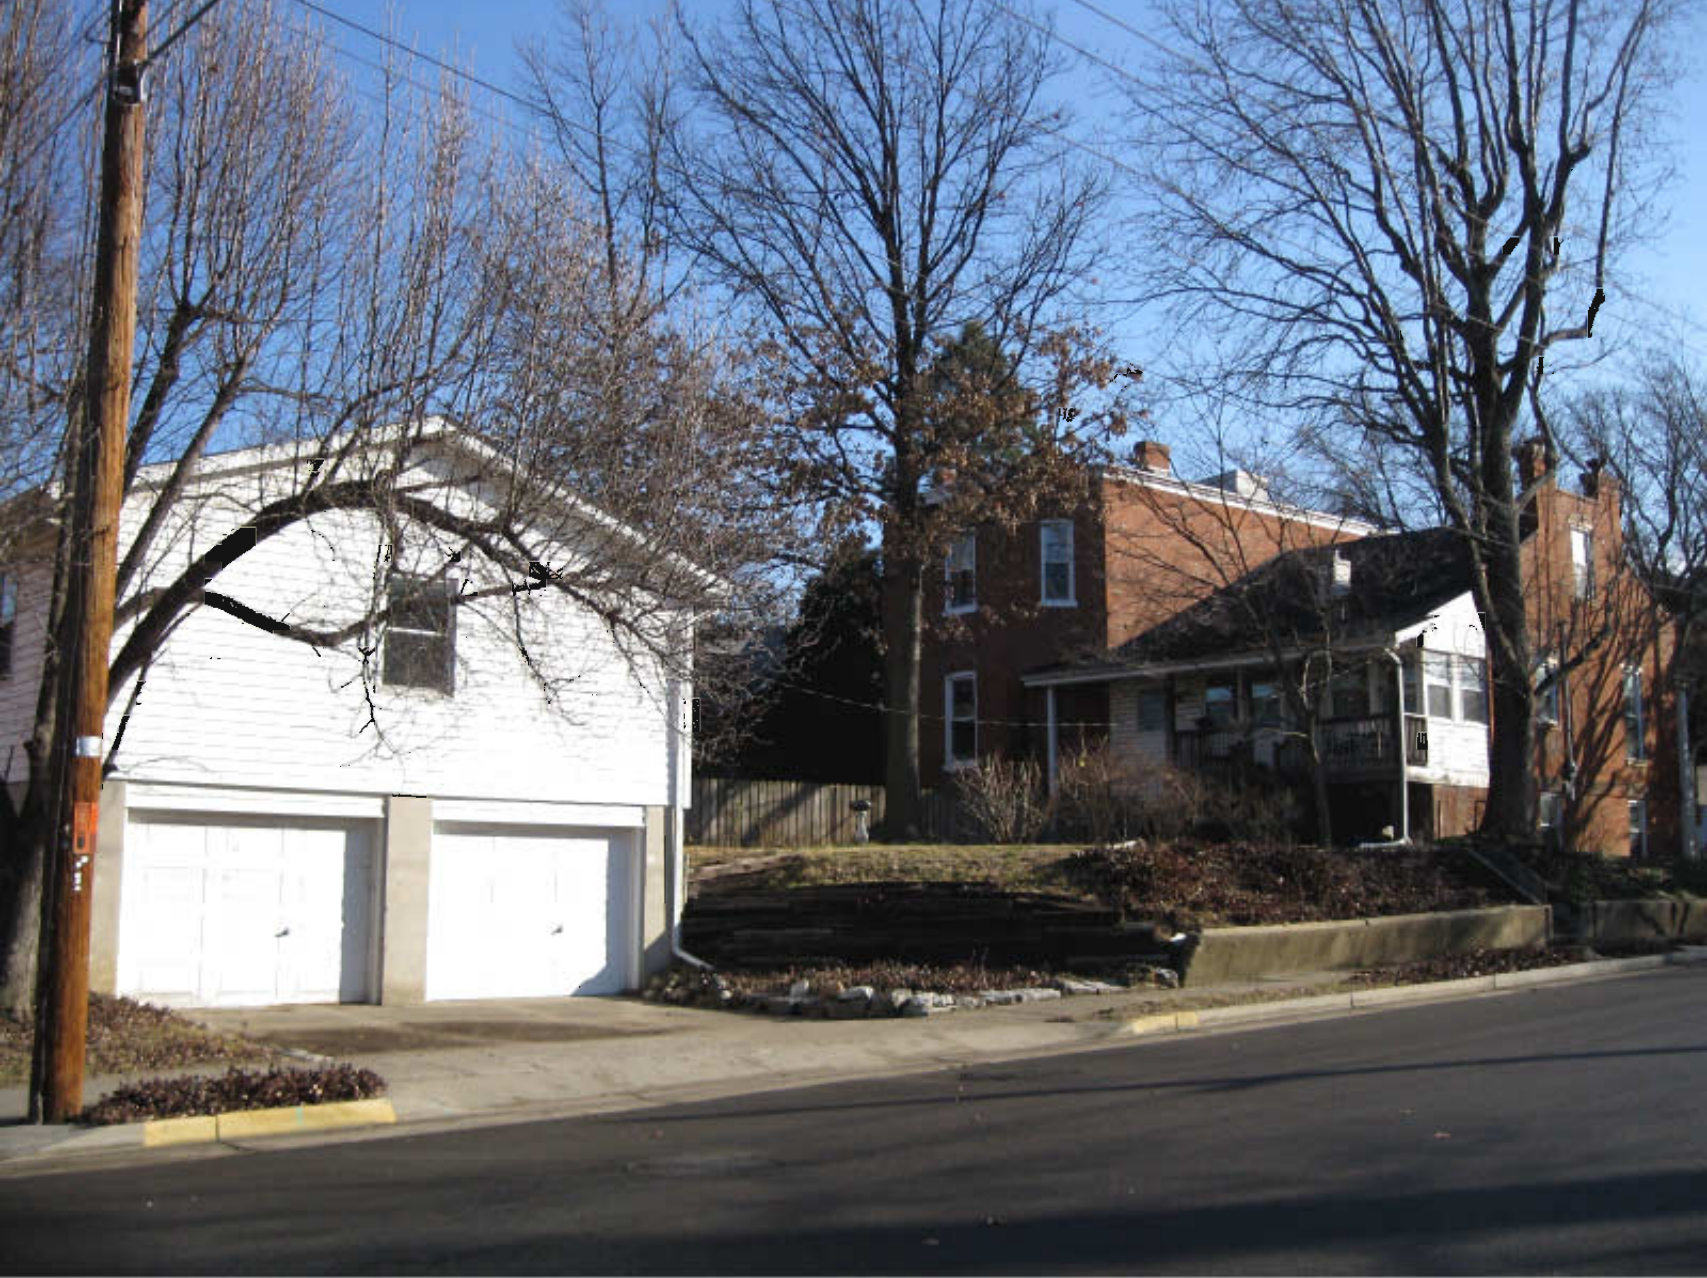
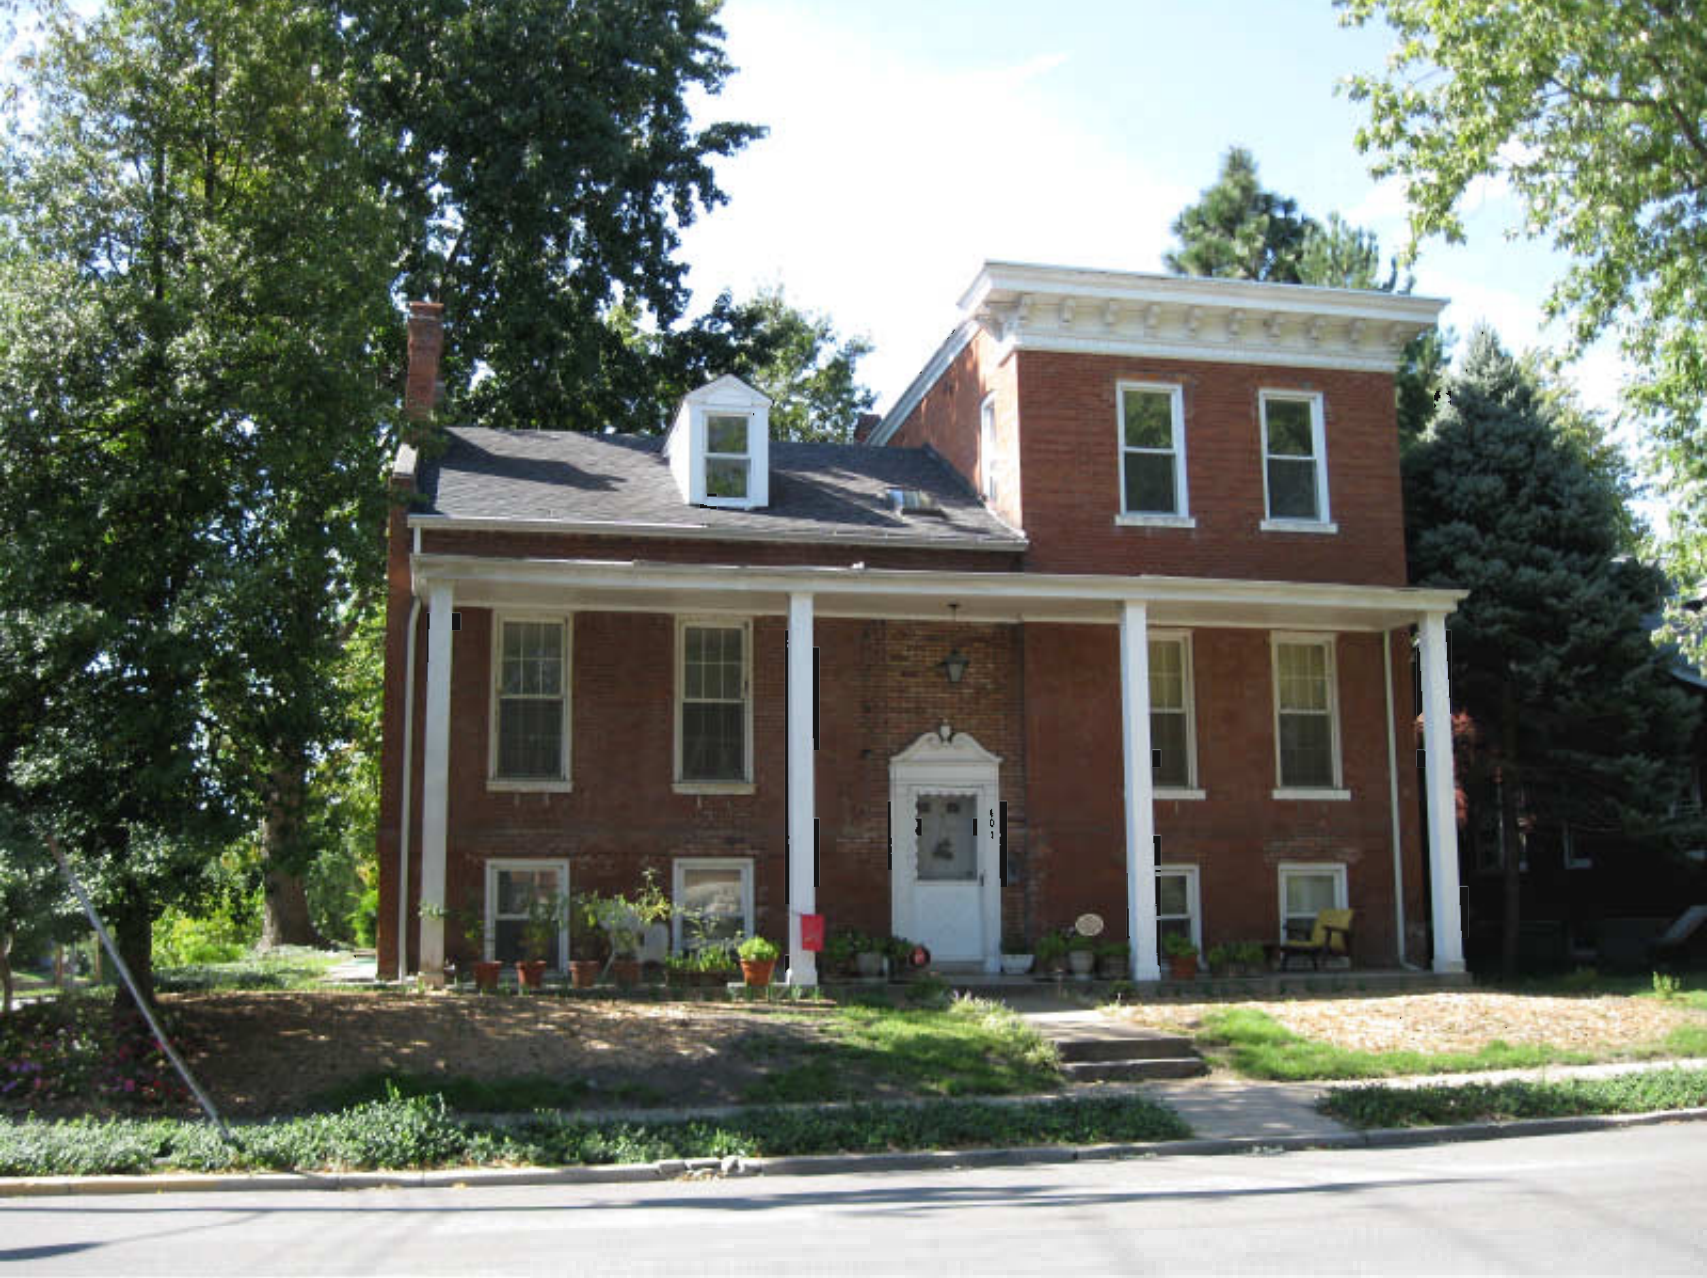
and a parapeted end wall with two chimneys is at the south end. The north half of the house is a two-story, brick structure with raised basement and flat roof trimmed with an ornate bracketed entablature. Two interior end chimneys are on the south wall and one is on the north. A historic photograph in the collection of the St. Charles County Historical Society shows that the entrance originally opened into the first floor, but it has been lowered to the basement level. The original frontispiece was composed of pilasters supporting an entablature, but the present frontispiece has a broken pediment. The doorway opened onto a raised, uncovered porch that extended from the entrance to the north, across the front of the addition. However, it has been replaced with a full-width gallery that has concrete deck at ground level and fluted aluminum columns supporting a flat roof. The windows have been replaced with 1/1 windows on the basement level, 6/6 windows on the first floor, and 1/1 windows in the second floor. The windows in the original portion of the house have cast iron sills, and the windows on the south elevation also have ornate cast iron lintels. It appears that the main façade also had the decorative lintels at one time, but they have been removed. The historic photograph shows that windows of the addition were set in segmental-arched openings, but these have been changed to flat arches. These windows have painted wood or stone sills. A gabled dormer with 1/1 window pierces the front slope of the gabled roof. A gallery originally spanned the rear of the south half of the building, but it has been enclosed. The rear wall of the 1881 addition is polygonal. The house is noncontributing due to the extensive alterations.

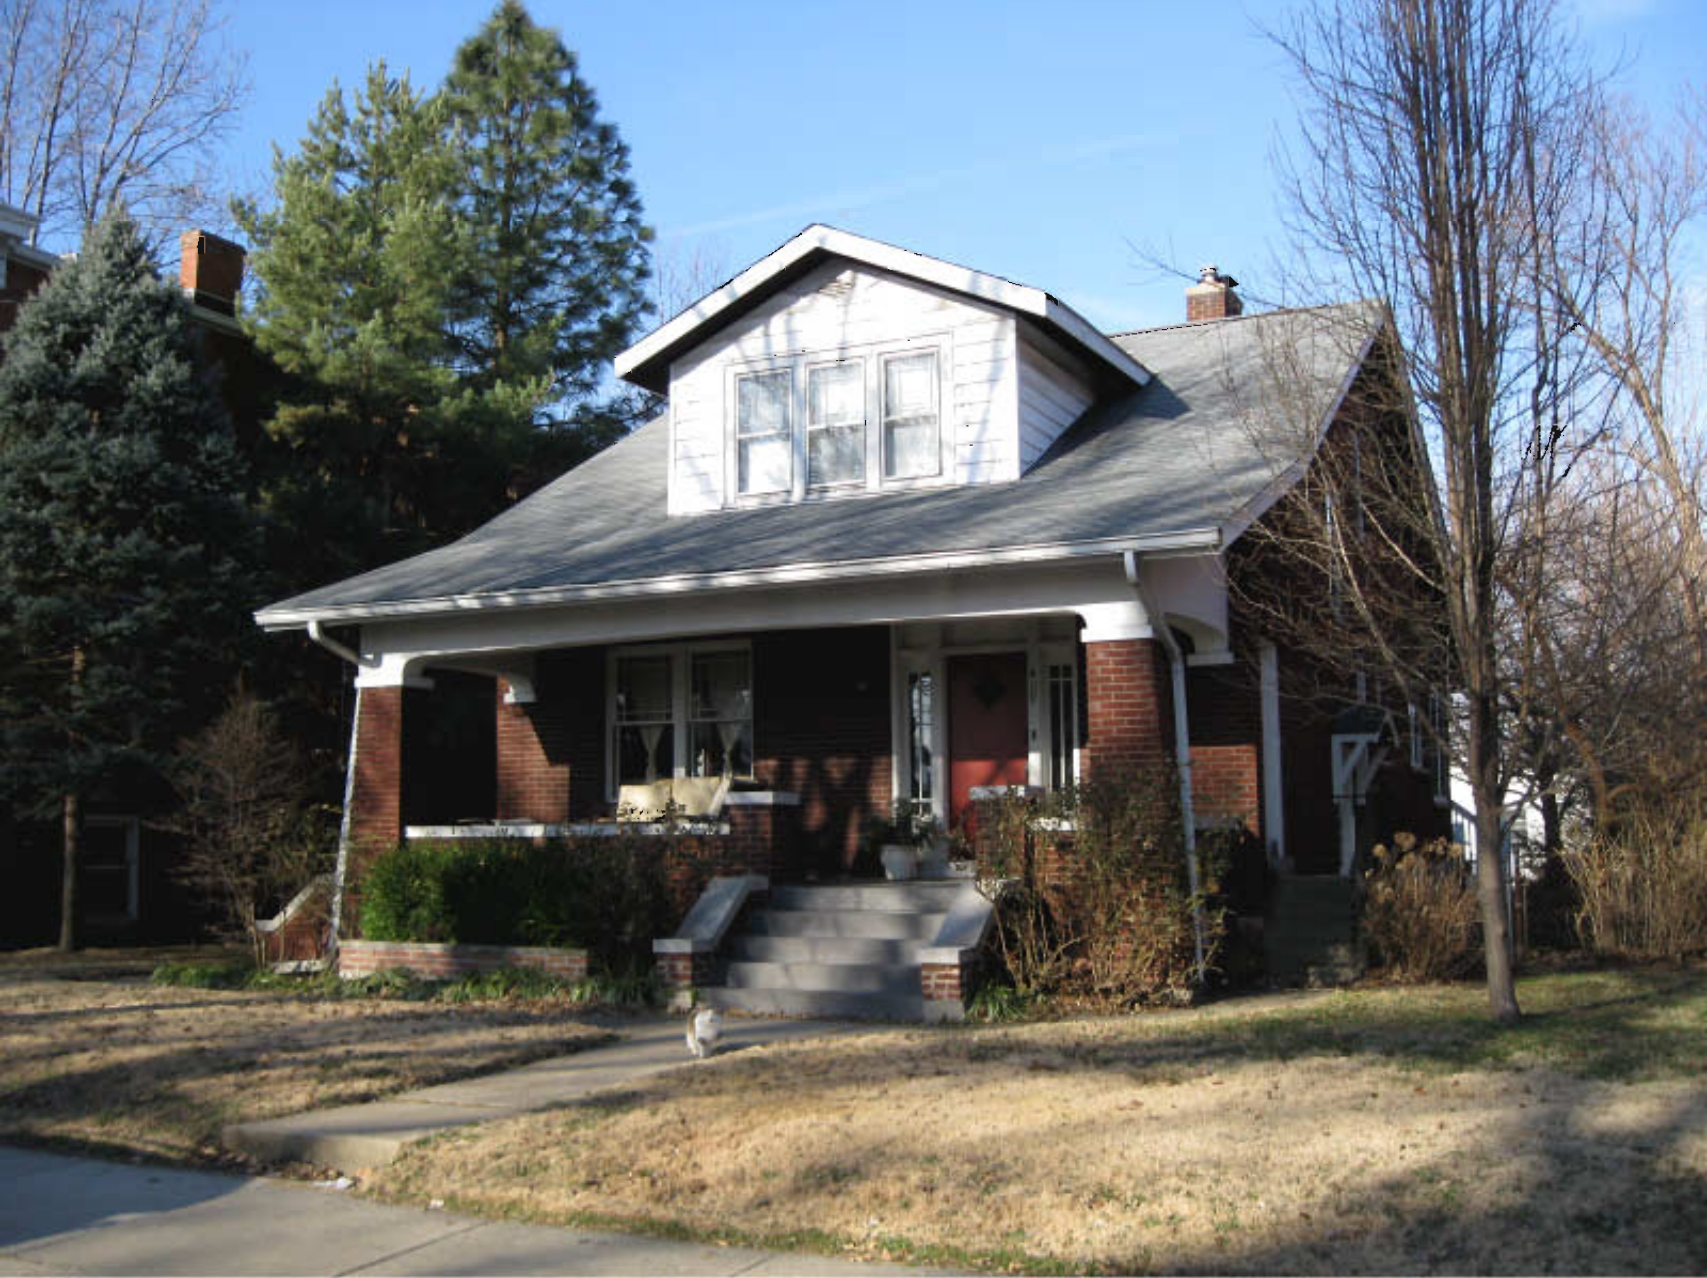
Built in 1933, this one-and-one-half story, side-gabled, brick bungalow rests on a scored concrete foundation. Large gabled dormers with bands of three double-hung windows pierce the front and rear slopes of the roof, and an interior brick chimney with concrete cap is also on the rear slope. The roof of the house and that of the dormers have wide overhanging eaves. The walls of the dormers are clad with vinyl siding, and the windows have muntins arranged around the perimeter of the upper and lower sashes. The two-bay main façade has a pair of windows in the left bay and the entrance in the right. Unlike the dormer windows, the windows throughout the first floor have upper sashes with muntins arranged around the perimeter but lower sashes with a single light. The Craftsman style wood door has six small lights set above two tall panels (the unpaneled wood door with diamond-shaped light shown in the photograph has been replaced with the Craftsman door). The transom has been covered; however, the entrance retains its original six-light sidelights (two small lights at the top and bottom, with two tall lights between). A full-width gallery spans the main façade, and on both the front and south sides is a wide concrete stair flanked by brick knee walls with concrete copings. At the top of the front stairway are brick pedestals with concrete caps, and at each corner of the porch are battered brick piers that support the basket-arched stucco frieze that trims the shed roof. The piers, which extend to the ground, have plain concrete caps and the imposts of the arches are corbelled bricks with stucco caps. The gallery has a concrete deck and a plain brick railing with concrete coping. The four openings in the lower level of the south elevation include single windows in the two eastern bays and paired windows in the western bays, and in the upper half story is a pair of windows. At the east end of the north elevation is an entrance that has been covered with a wood panel, but the concrete stoop with five steps remains in place. To the west of this enclosed entrance is an entrance at ground level. This half-glazed, paneled wood door has three small lights over three tall lights, and the door is protected by a gabled hood with round arched soffit. The hood is supported by knee braces. Three window openings are to the west of the ground-level entrance.

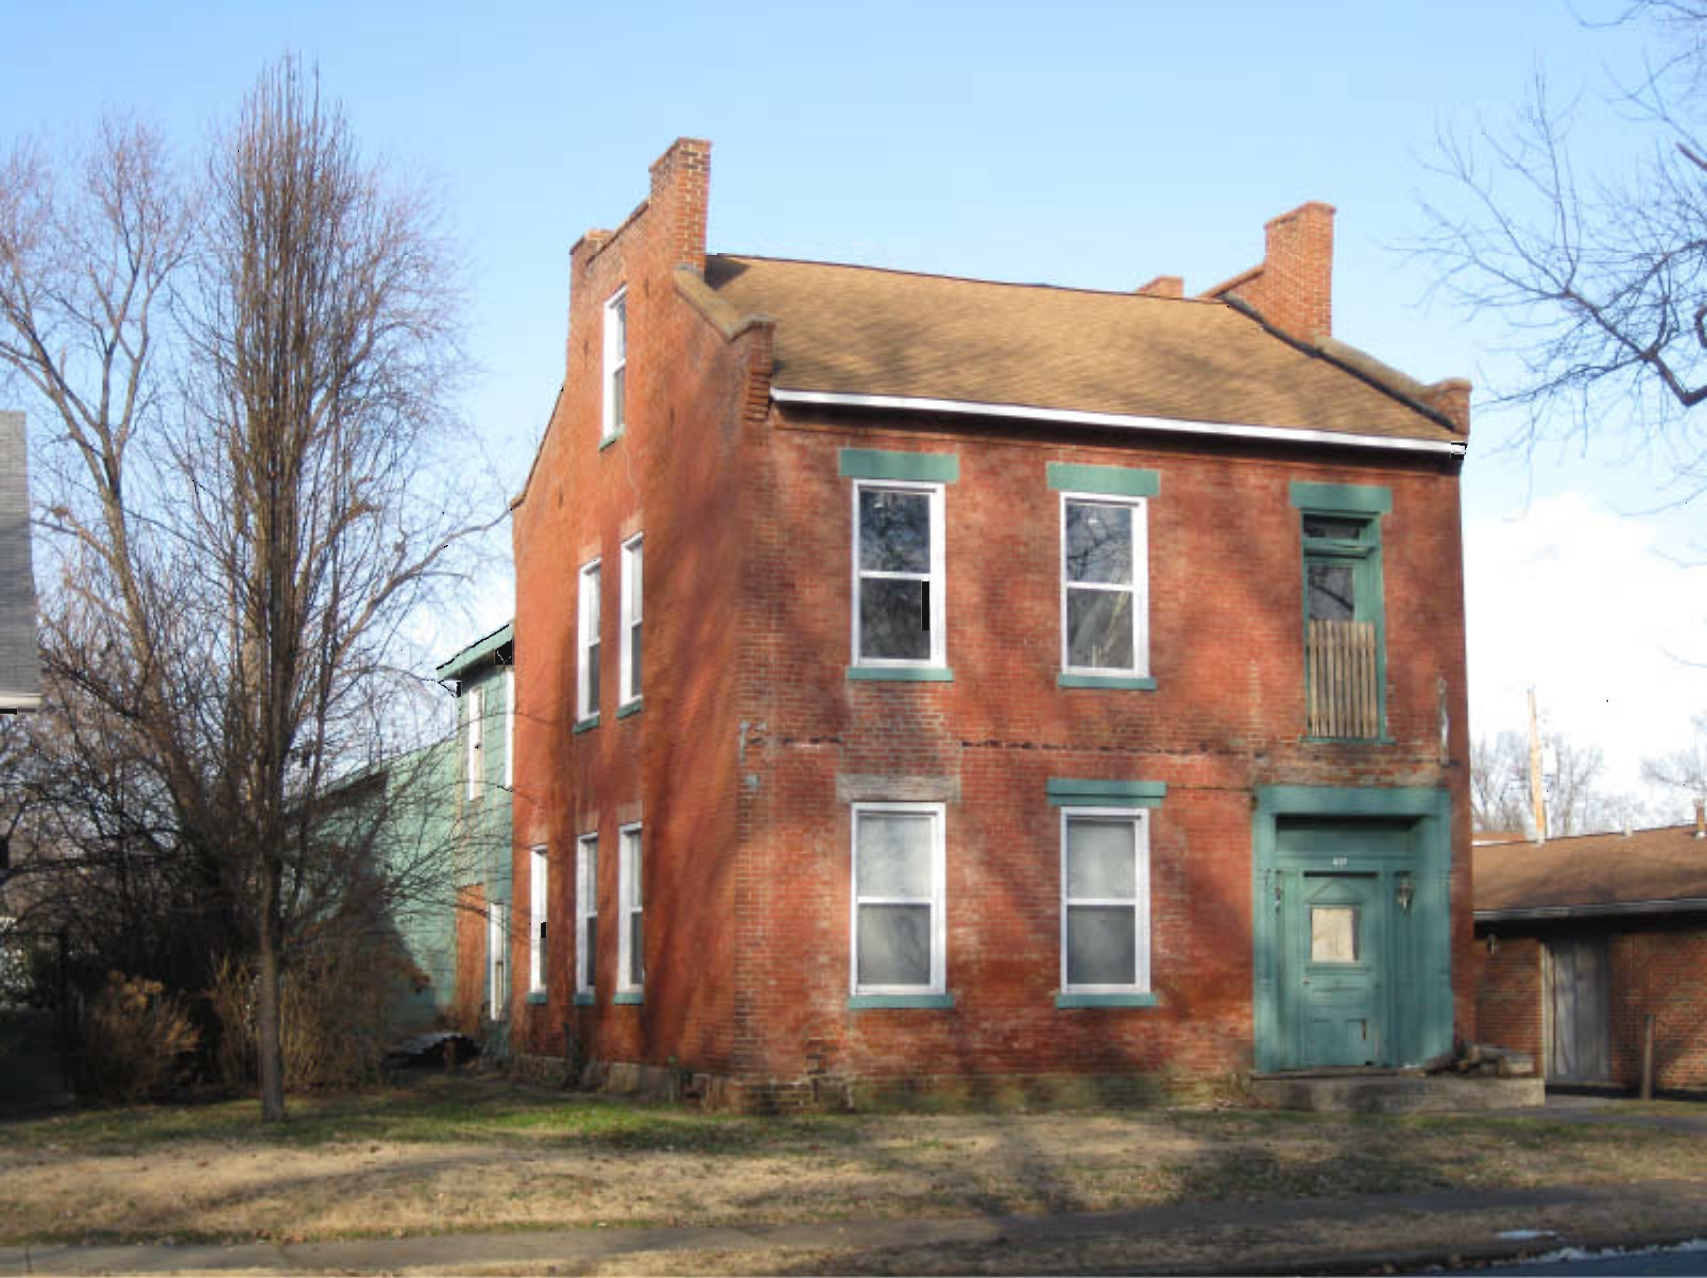
This two-and-one-half story, Federal style house has a brick foundation, brick walls in a five-course common bond pattern, and a side-gabled roof with parapeted end walls, each having paired chimneys. The main façade is a three-bay elevation, with entrance at the north end and 1/1 replacement windows with wood lintels and lug sills in the other two bays. The entrance, which has a deep paneled reveal, has had its transom and sidelights covered and its door replaced. The half-glazed wood door, which appears to date from the turn-of-the-twentieth century, has a horizontal panel and two vertical panels set under the glazing, and above is a triangular panel with incising. To each side of the door is a pilaster with molded capital and base, and the frontispiece also has classical pilasters but turned half-posts have been applied over them. The door opens onto a concrete stoop. The second floor of the main façade has a half-glazed, paneled wood door in the northern bay and two 1/1 windows. A railing has been placed over the door since there is no balcony. The house is shown without a porch on the 1869 Bird's Eye View of the city and on the 1900, 1929 and 1947 Sanborn maps, but the 1909 and 1917 maps show a one-story, one-bay porch. Based on roofing tar along the front of the building, it appears that at one time a one-story, full-width porch had been added. The south elevation of the main two-story section of the house has three windows on the first floor, two on the second, and one in the upper half story, while the north elevation has only one window on the first floor and one in the upper half story. A one-story brick wing that has a denticulated frieze spans the rear, and sometime after 1947 a second story was added. The second-floor addition has Masonite walls and a low gable roof, and a gabled, frame, two-car garage has been added to the rear of the house.

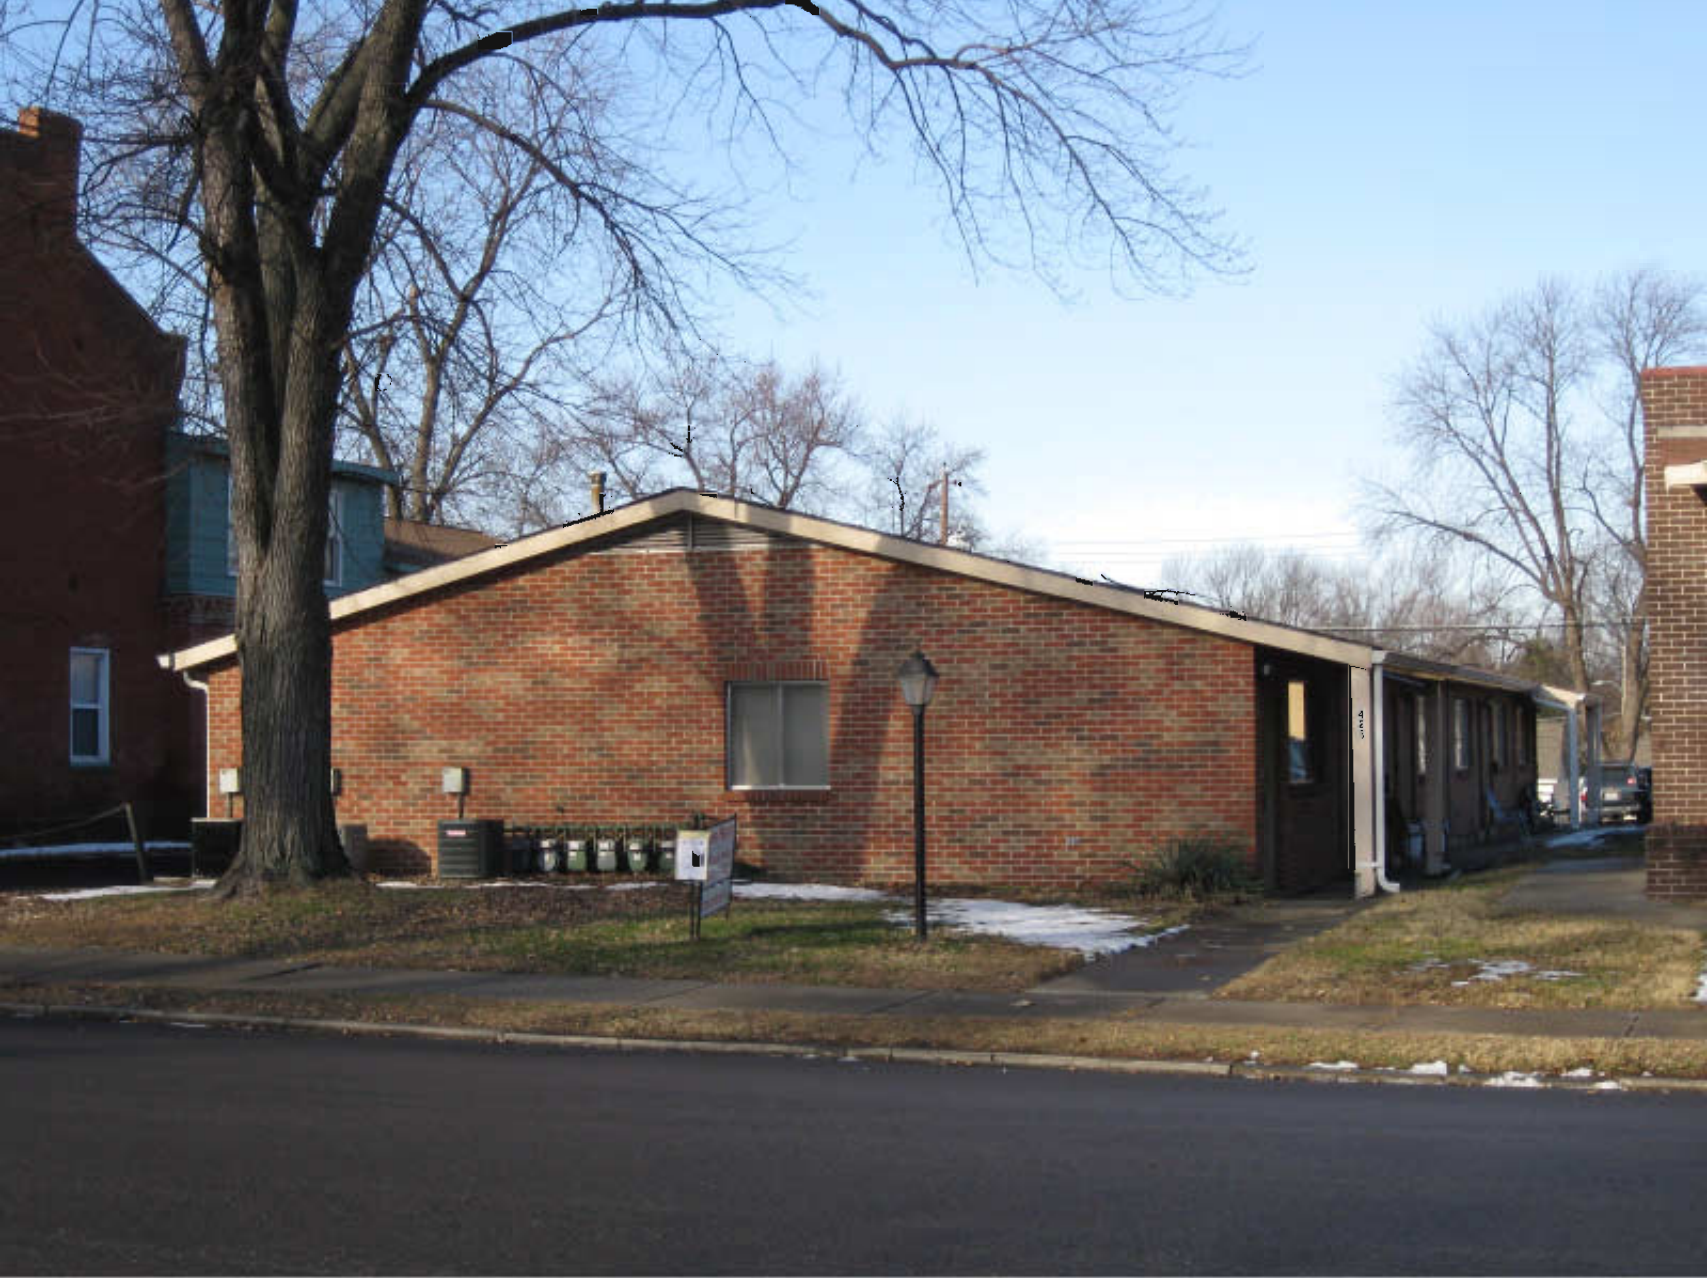
Rather than facing the street, this one-story, six-unit, gabled, brick apartment building faces north toward the neighboring property. The foundation is concrete and the walls are finished with bricks. The front-gabled street elevation has a single window opening, which is a two-light sliding window. The north facade has six half-glazed doors and six picture windows (d-ww-dd-ww-dd-ww-d), and an inset full-length gallery spans the north elevation and features plain wood posts and concrete deck. The south elevation has six pairs of sliding glass doors

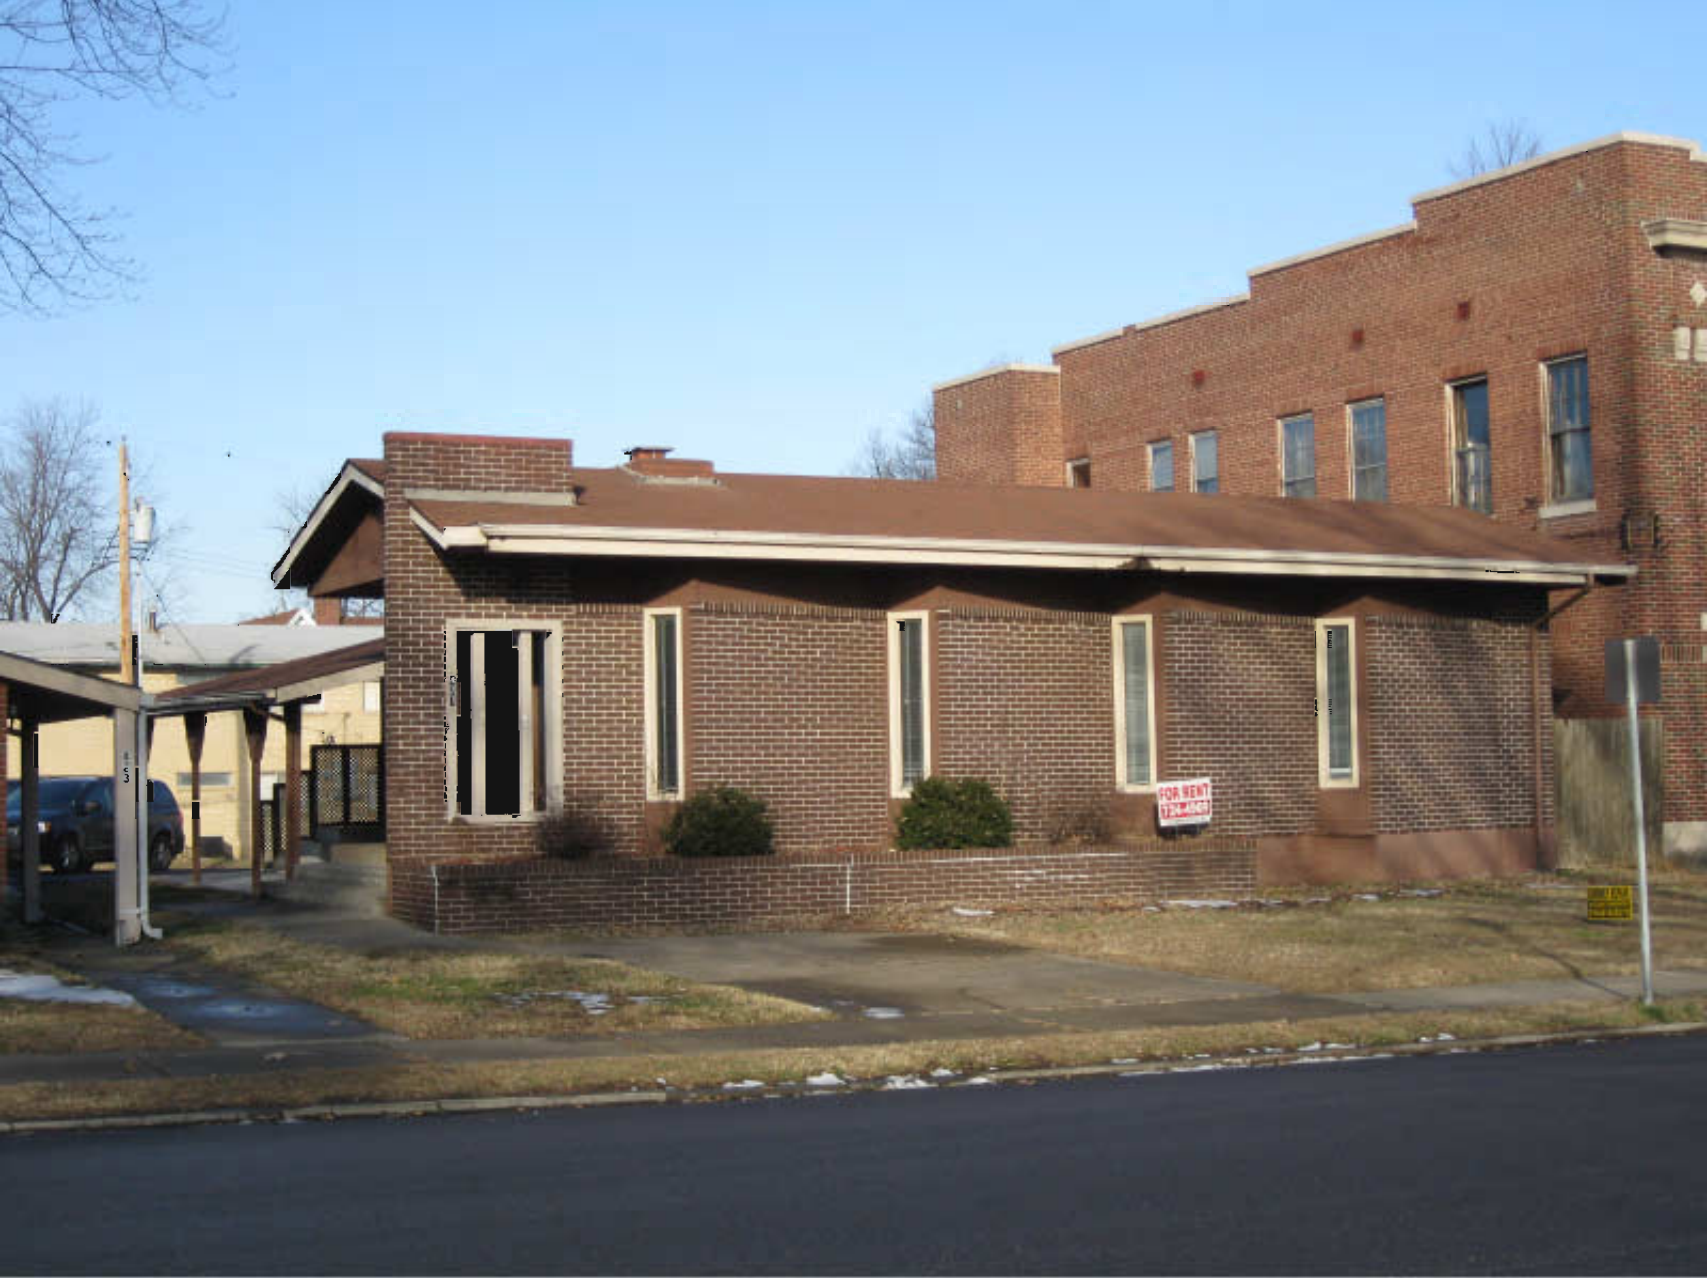
Built c. 1976, this structure is a one-story office building with walls finished in a combination of brick and wood. The entrance is in the south side elevation, facing the neighboring property rather than the street. The wall of the street (east) elevation is in a dog-tooth pattern, with an unglazed opening at the south end and four single-light windows to the north. It appears that the windows are replacements as the area underneath and to one side of each is in-filled with painted vertical board. The wall of this elevation is brick except for a band of stained vertical board siding above the four windows, and the brick wall at the southern bay projects above the roof. Located on the south side elevation, which is finished with vertical board siding, the main entrance has a pair of 15-panel wood doors flanked by single-light windows, and there is a door at the west end of the elevation. The gable end projects over the eastern three openings to create a covered porch, and the gable roof extends over the remainder of the elevation and is supported by plain posts with corner brackets. The building is less than 50 years old and is noncontributing.

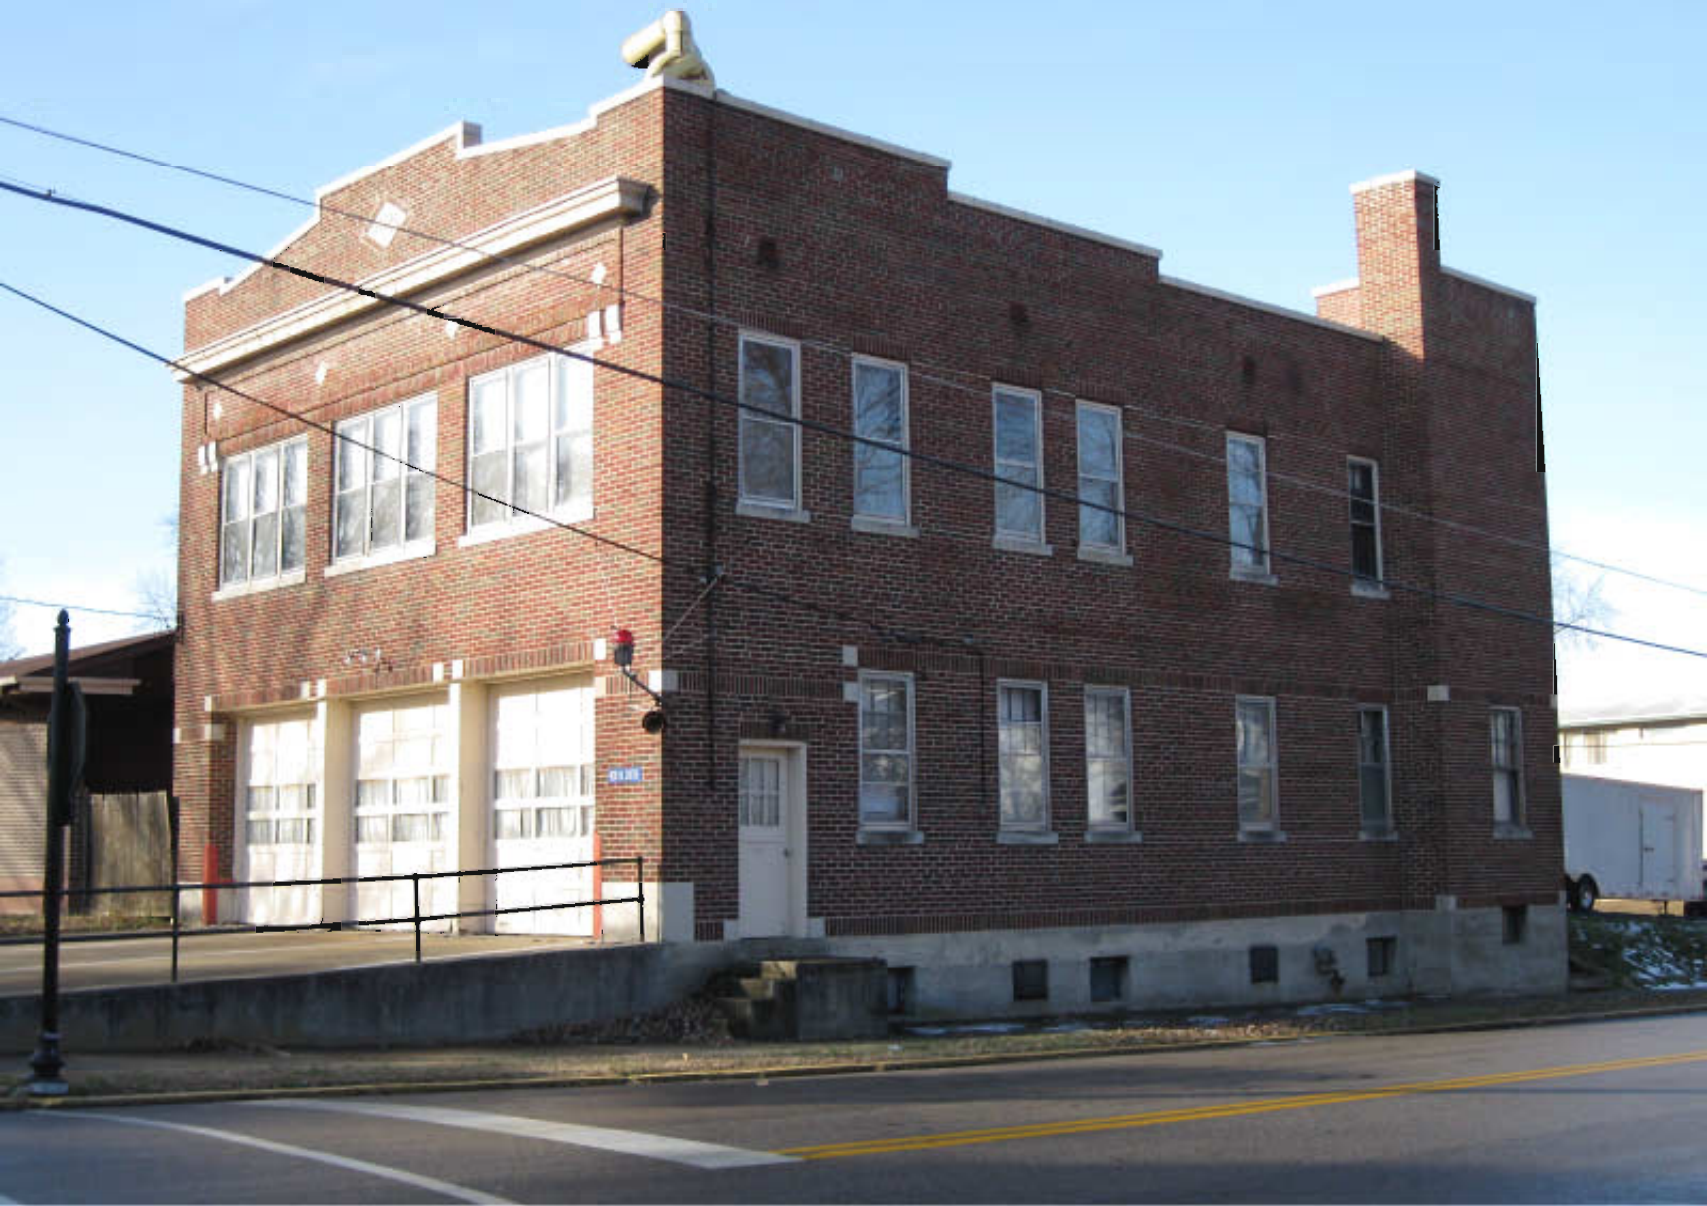
This two-story, brick building rests on a concrete foundation and is crowned by a flat roof encircled by a parapet with cast stone coping. The building is T-shaped, but the crosspiece of the T, which is at the rear of the building, only extends slightly beyond the base (side elevations). An interior end chimney is on the east side of the north wing. On the main façade the brick walls are laid in a running bond pattern, while on the side elevations they are in a common bond with every sixth course being Flemish bond. A belt course of soldier bricks and cast stone is slightly below the top of the first floor openings of the main façade, and this belt course wraps around the east end of the north elevation. The three-bay main façade features three paneled-and-glazed wood overhead doors on the first level and three groups of three 1/1 windows on the second. The top of each door is trimmed with a soldier course of bricks with cast stone corner blocks, and a single soldier course spans the top of the second floor windows and has at each end a pair of corbelled cast stone brackets. Windows throughout the building have cast stone sills. A sign panel created by projecting bricks is above the windows, and four cast concrete, diamond-shaped ornaments are within the panel. Above the sign panel is a cast stone cornice, above which is a soldier course of bricks and a diamond-shaped cast stone plaque with the date 1926. At the east end of the north elevation is a wood door with six lights set above a single panel, and the door opens onto a concrete stoop that has a set of four steps on the east side. To the west of the entrance are six 6/1 wood windows. A single soldier course with cast stone corner blocks extends along the top of the first floor windows. There are six 6/1 wood windows on the second floor, and each is trimmed with a flat jack arch of soldier bricks.

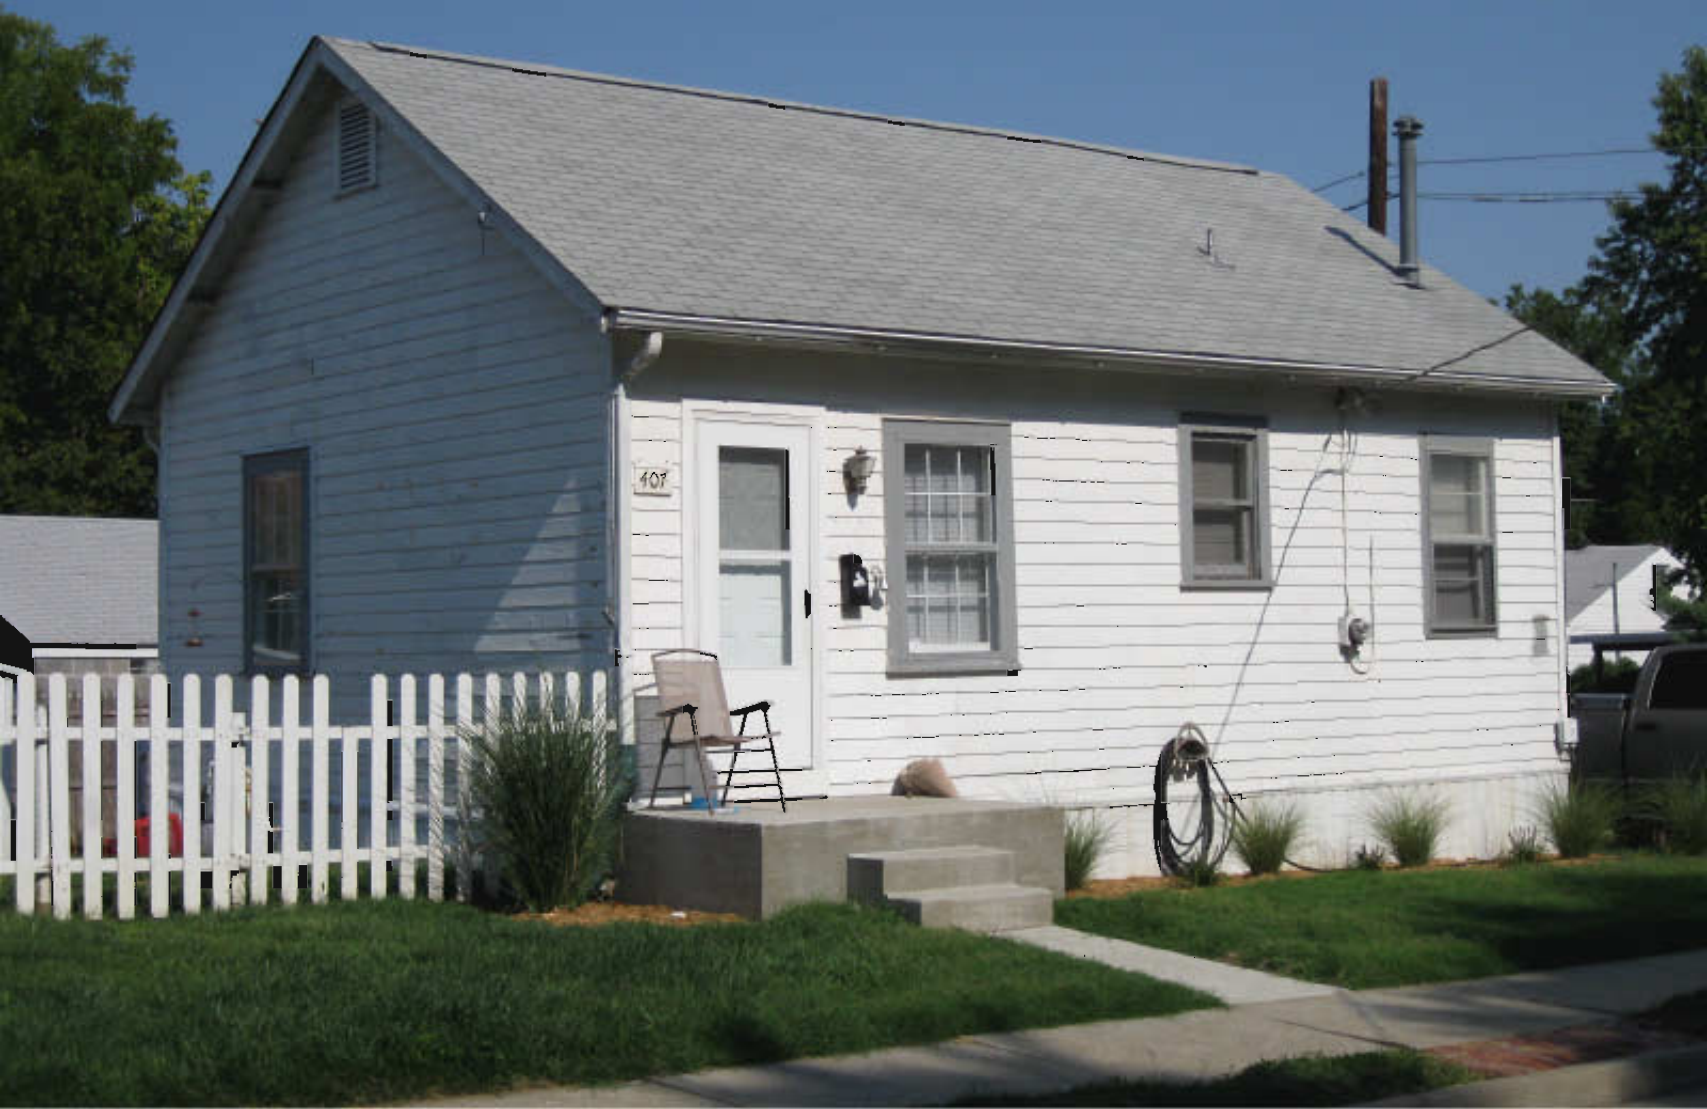
Facing east, this diminutive (588 square feet), one-story, side-gabled, frame, Minimal Traditional house was built circa 1947. The walls are finished with weatherboard siding, but the foundation is not visible due to the installation of a metal skirt. At the south end of the four-bay main façade is a six-panel door that opens onto a concrete stoop. To the right of the doorway is a 6/6 wood window, a small 1/1 window, and a 2/2 window (lights arranged horizontally). There is a single window opening on each side elevation; on the south elevation is a 6/6 wood window and on the north elevation is a 2/2 window.

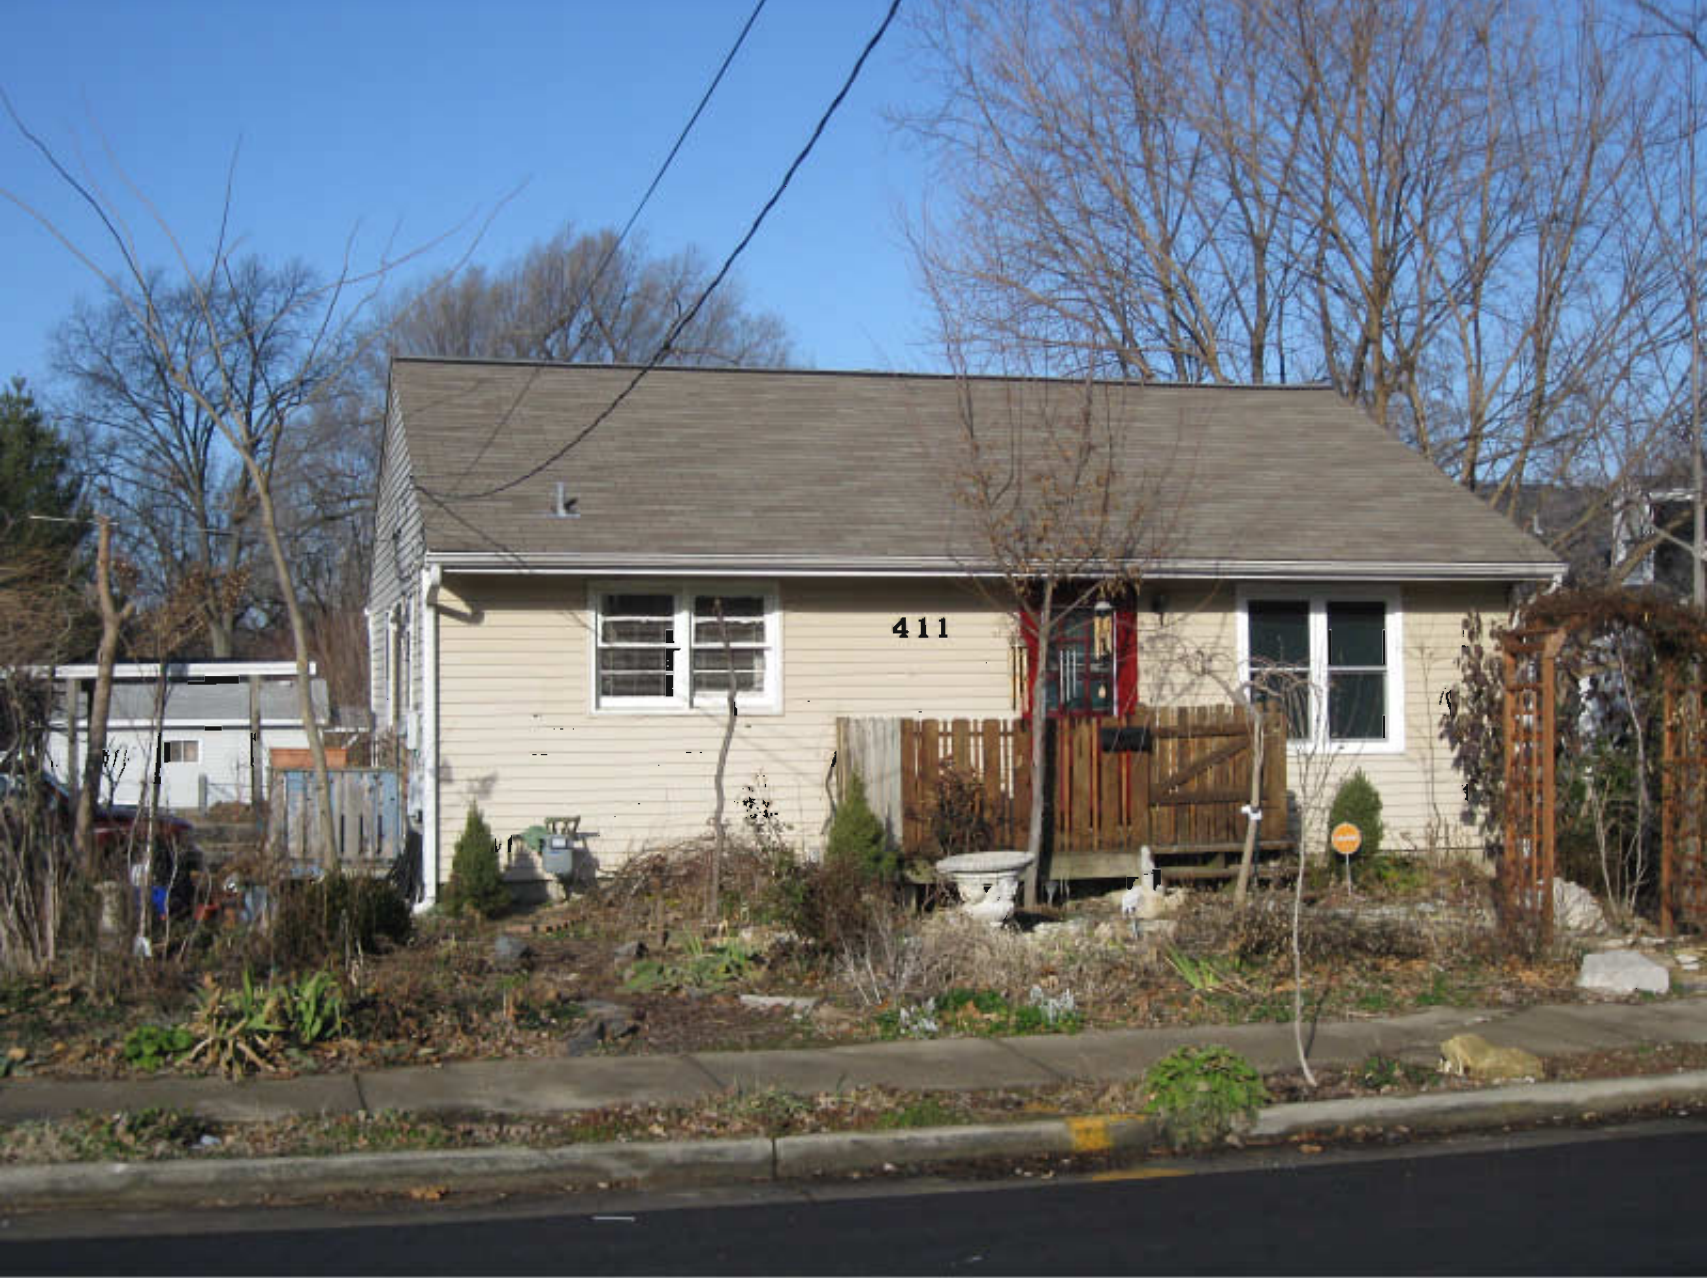
This small, one-story, side-gabled, frame, Minimal Traditional house was built in 1952. The foundation is concrete, the walls have been clad with vinyl siding, and the medium-pitched, side-gabled roof has wide overhanging eaves. The three-bay main façade has a central multi-light, wood door that opens onto a one-bay stoop with wood deck and stair, and the stoop has been enclosed with a wooden picket fence with gate. To the left of the door is a short pair of 2/2 wood windows (lights arranged horizontally) and to the right is a pair of 1/1 windows. The south elevation has a 1/1 window and a door that opens onto a single-bay, wood stoop.
