ARCHITECTURAL/HISTORIC INVENTORY FORM

1. Survey No. SC-AS-009-001		2. Survey Name: St. Charles Survey Phase 3: Mid-Town and Commons Neighborhoods	
3. County: St. Charles		4. Address (Street No.) 128	Street (name) North Sixth Street
5. City: St. Charles	Vicinity: <input type="checkbox"/>	6. UTM:	
7. Township/Range/Section:		8. Historic name (if known): Meyer-Pieper House; The Meyerdorf	
9. Present/other name (if known):		10. Ownership: <input checked="" type="checkbox"/> Private <input type="checkbox"/> Public	
11a. Historic use (if known): Domestic/single dwelling		11b. Current use: Domestic/single dwelling

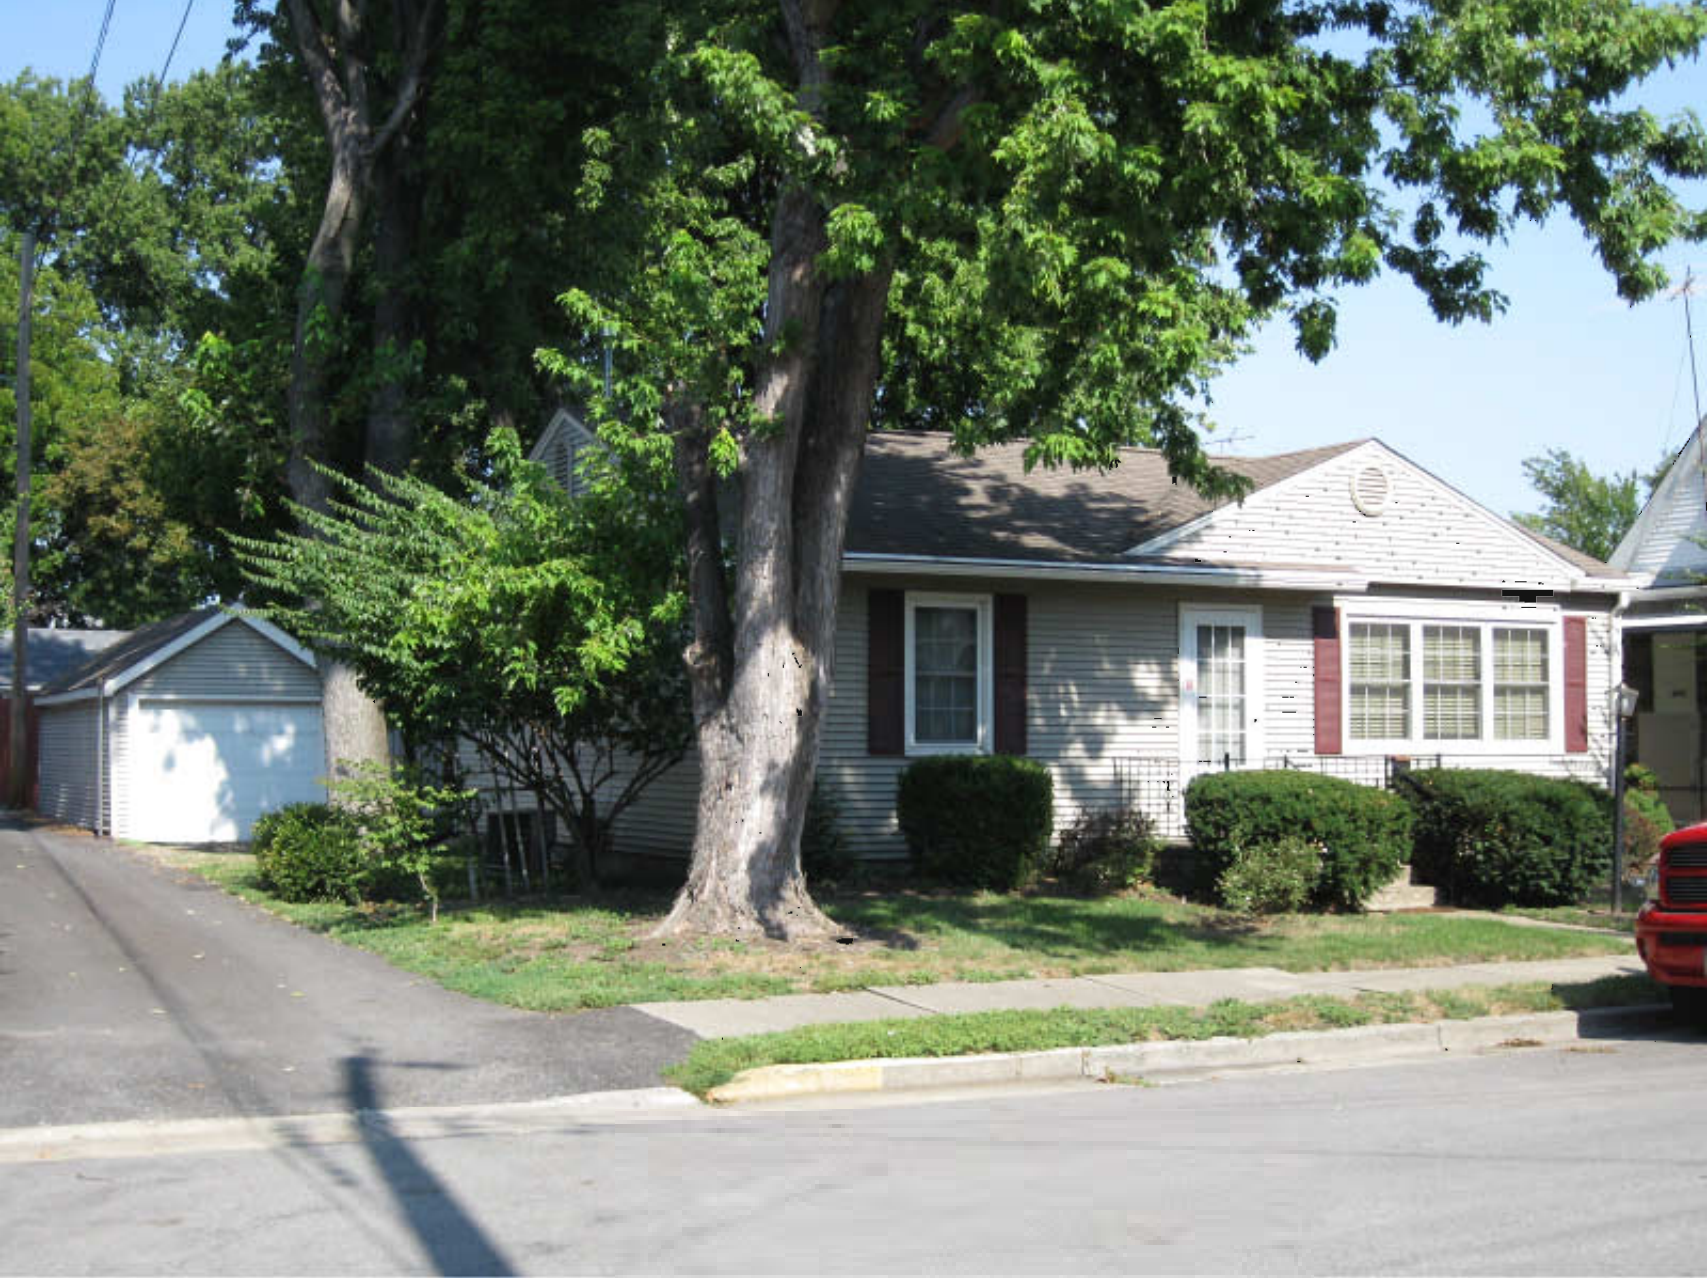
Built circa 1953, this one-story house is crowned by a low side-gabled roof with an intersecting front gable. The foundation is concrete and the walls are clad with vinyl. The three-bay main façade has a central six-panel door with multi-light storm door, and the door opens onto a one-bay concrete stoop with wrought iron railing. To the left of the entrance is a 6/6 window and to the right is a band of three 6/6 windows. The windows throughout the house are replacements. The north elevation has two short 6-light windows. The house is noncontributing due to the installation of vinyl siding and replacement of the windows.

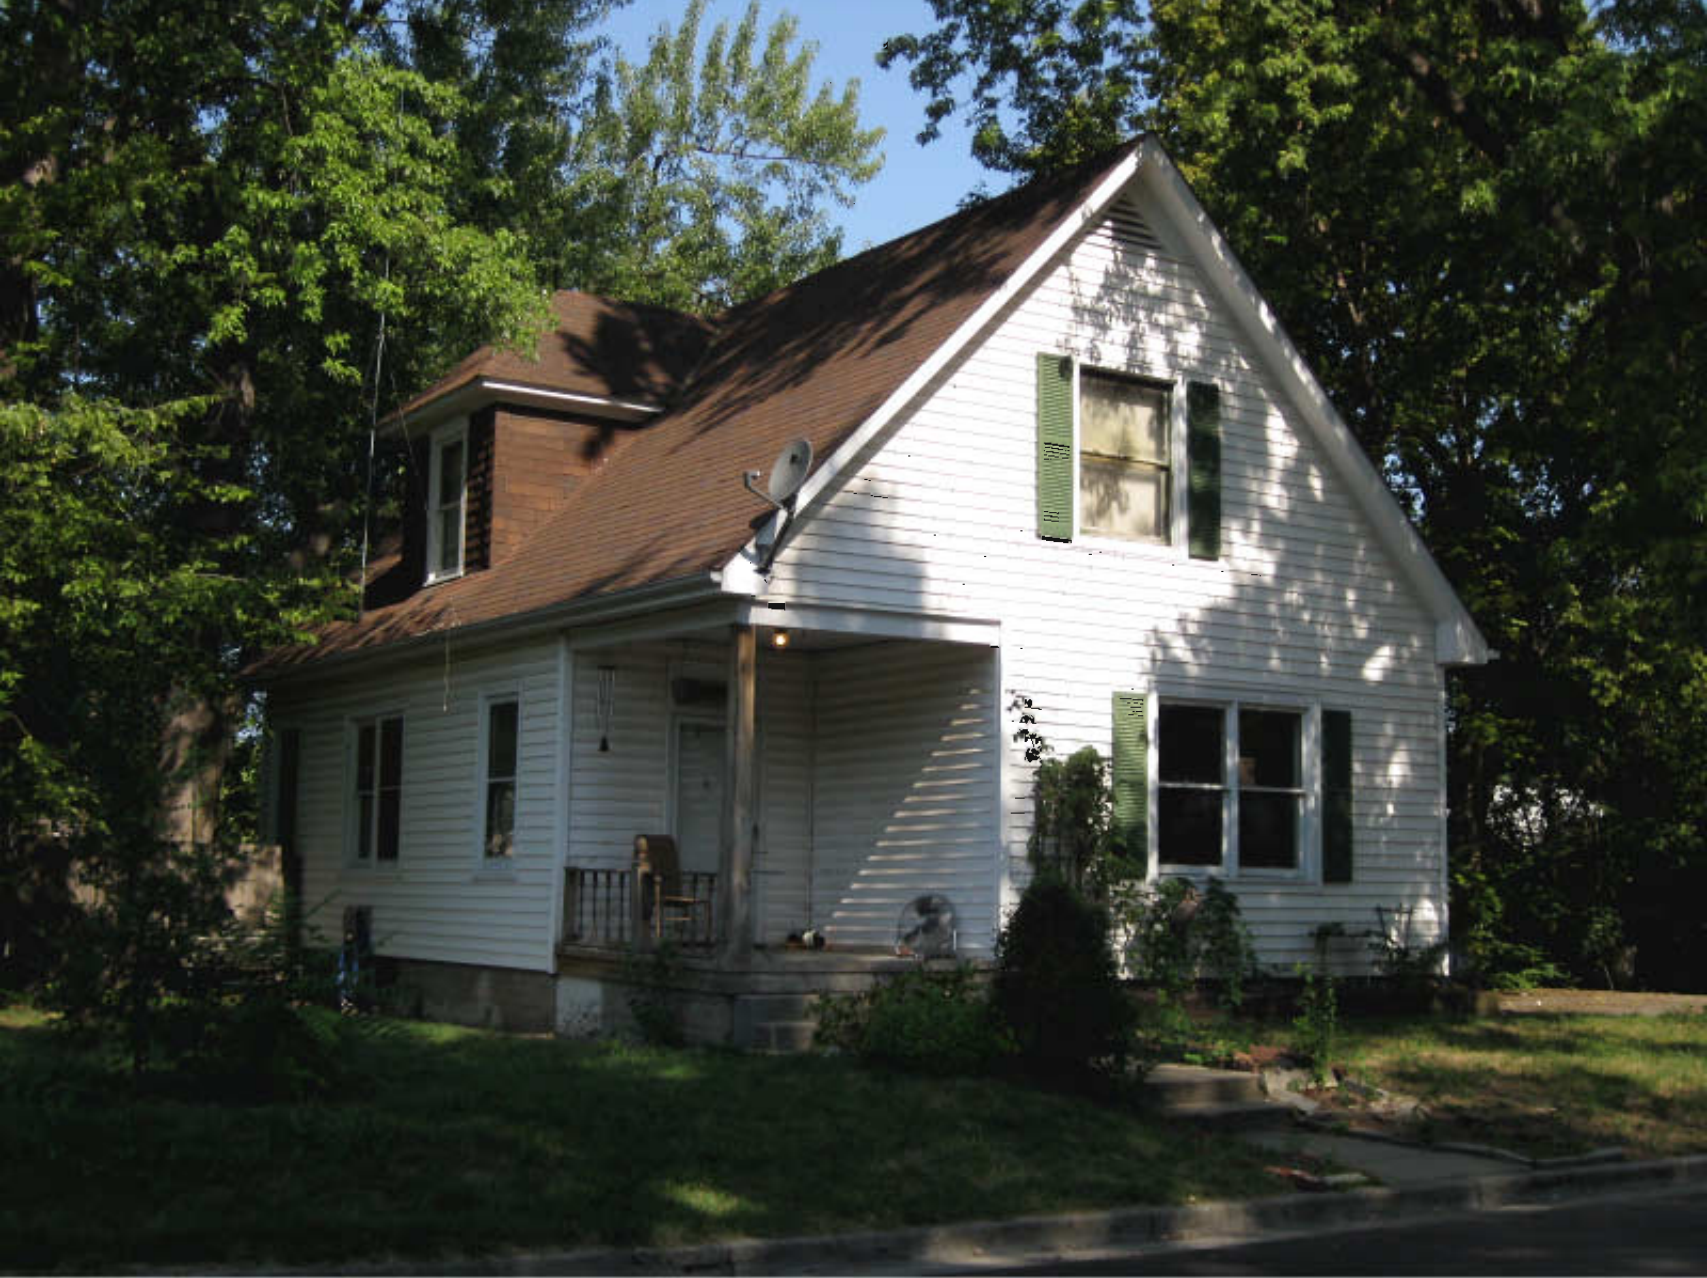
Built circa 1940, this house is a one-and-one-half story, frame, vernacular Gable Front structure. The house rests on a scored concrete foundation and the walls are clad with vinyl siding. A hipped dormer with wide overhanging eaves, 1/1 window, and walls clad with asphalt roofing shingles is on each of the side slopes of the steeply-pitched, front-gabled roof. One of the most distinguishing features of the house is its one-bay recessed porch, which has a plain wood post and balustrade with turned balusters, and opening onto this porch is a paneled door topped by a single-light transom. In the other bay of the two-bay main façade is a pair of 1/1 windows and in the upper half story is another 1/1 window. The south elevation features three openings: a pair of 1/1 windows in the center bay and a single window in each of the outer bays. There are four windows on the north elevation.

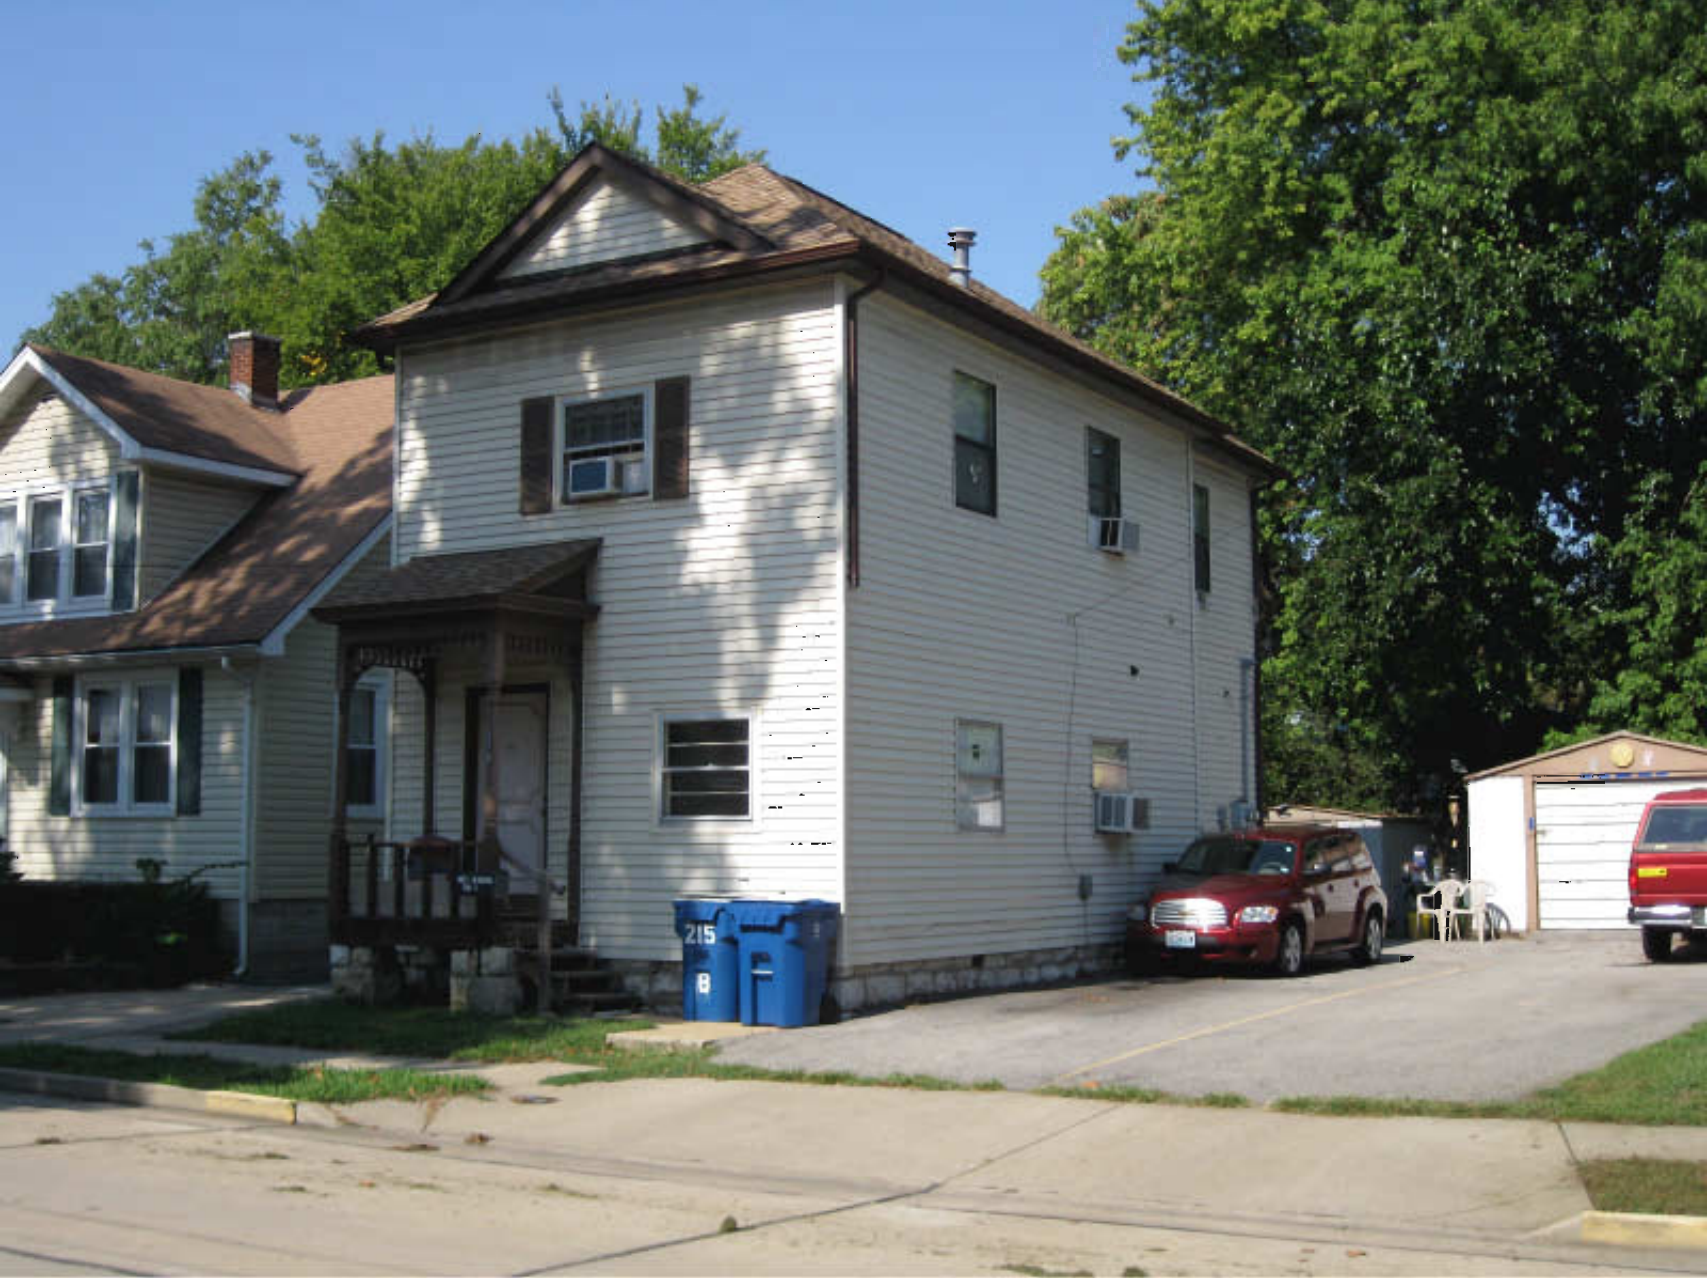
This two-story frame house has a coursed, rock-faced stone foundation; vinyl-sided walls; and a medium-pitched hip roof with intersecting gablet on the front slope. The plan is T-shaped, with a two-story rear wing forming the base of the T. The first floor of the main façade has two openings: a modern two-panel door and a 2/2 window (lights arranged horizontally). The door opens onto a one-bay portico with stone foundation piers, wood deck, turned posts supporting a shed roof, a frieze with rectangular slats, and corner brackets. The railing is not historic. The Sanborn Insurance Maps indicate that the house originally had a one-story, full-width gallery. The second floor of the main façade has a single window opening, which is an 8/8 replacement window. Window openings throughout the house have been shortened. The house is noncontributing due to the installation of vinyl siding, shortened window openings and replacement windows.

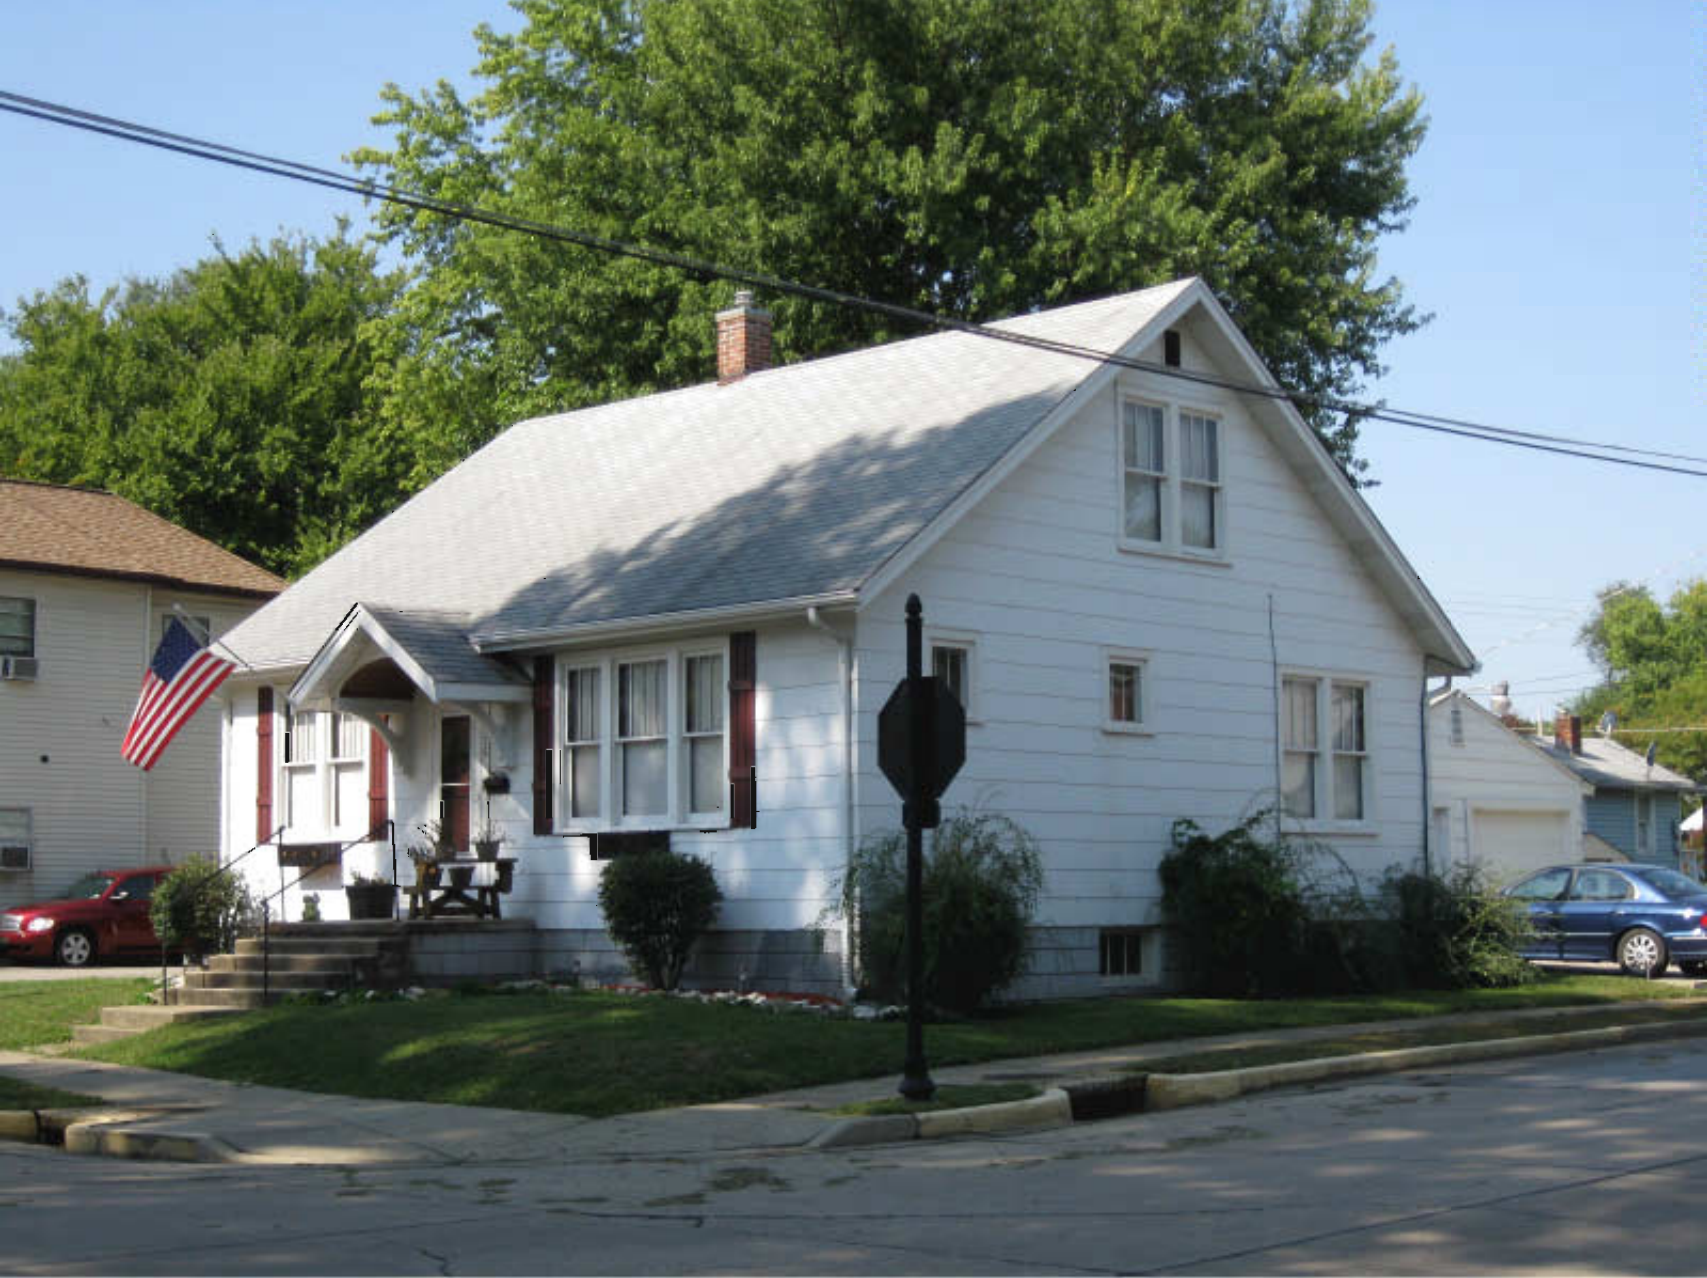
Situated at the southwest corner of Ninth and Monroe Streets, this one-and-one-half story, frame, side-gabled house rests on a scored concrete foundation that is pierced by three-light basement windows, and the walls are clad in cement asbestos shingles. A brick chimney with concrete cap straddles the ridge of the steeply-pitched, side-gabled roof. The three-bay main façade has a glazed-and-paneled wood door that opens onto a one-bay concrete stoop with scored concrete foundation and concrete stairs with plain handrails. The stoop is protected by a gable supported by knee braces, and the soffit is segmentally arched and finished with stained bead board. To the left of the entrance is a pair of 3/1 wood windows and to the right is a band of three windows, with a central 4/1 wood window flanked by narrower 3/1 windows. Two small three-light windows are on the east end of the north elevation, and to their west is a pair of 3/1 windows. Another pair of windows is in the upper half story. The south elevation has a 3/1 window at the east end and a pair of short 3/1 windows at the west end, and in the upper half story is a pair of 3/1 windows.

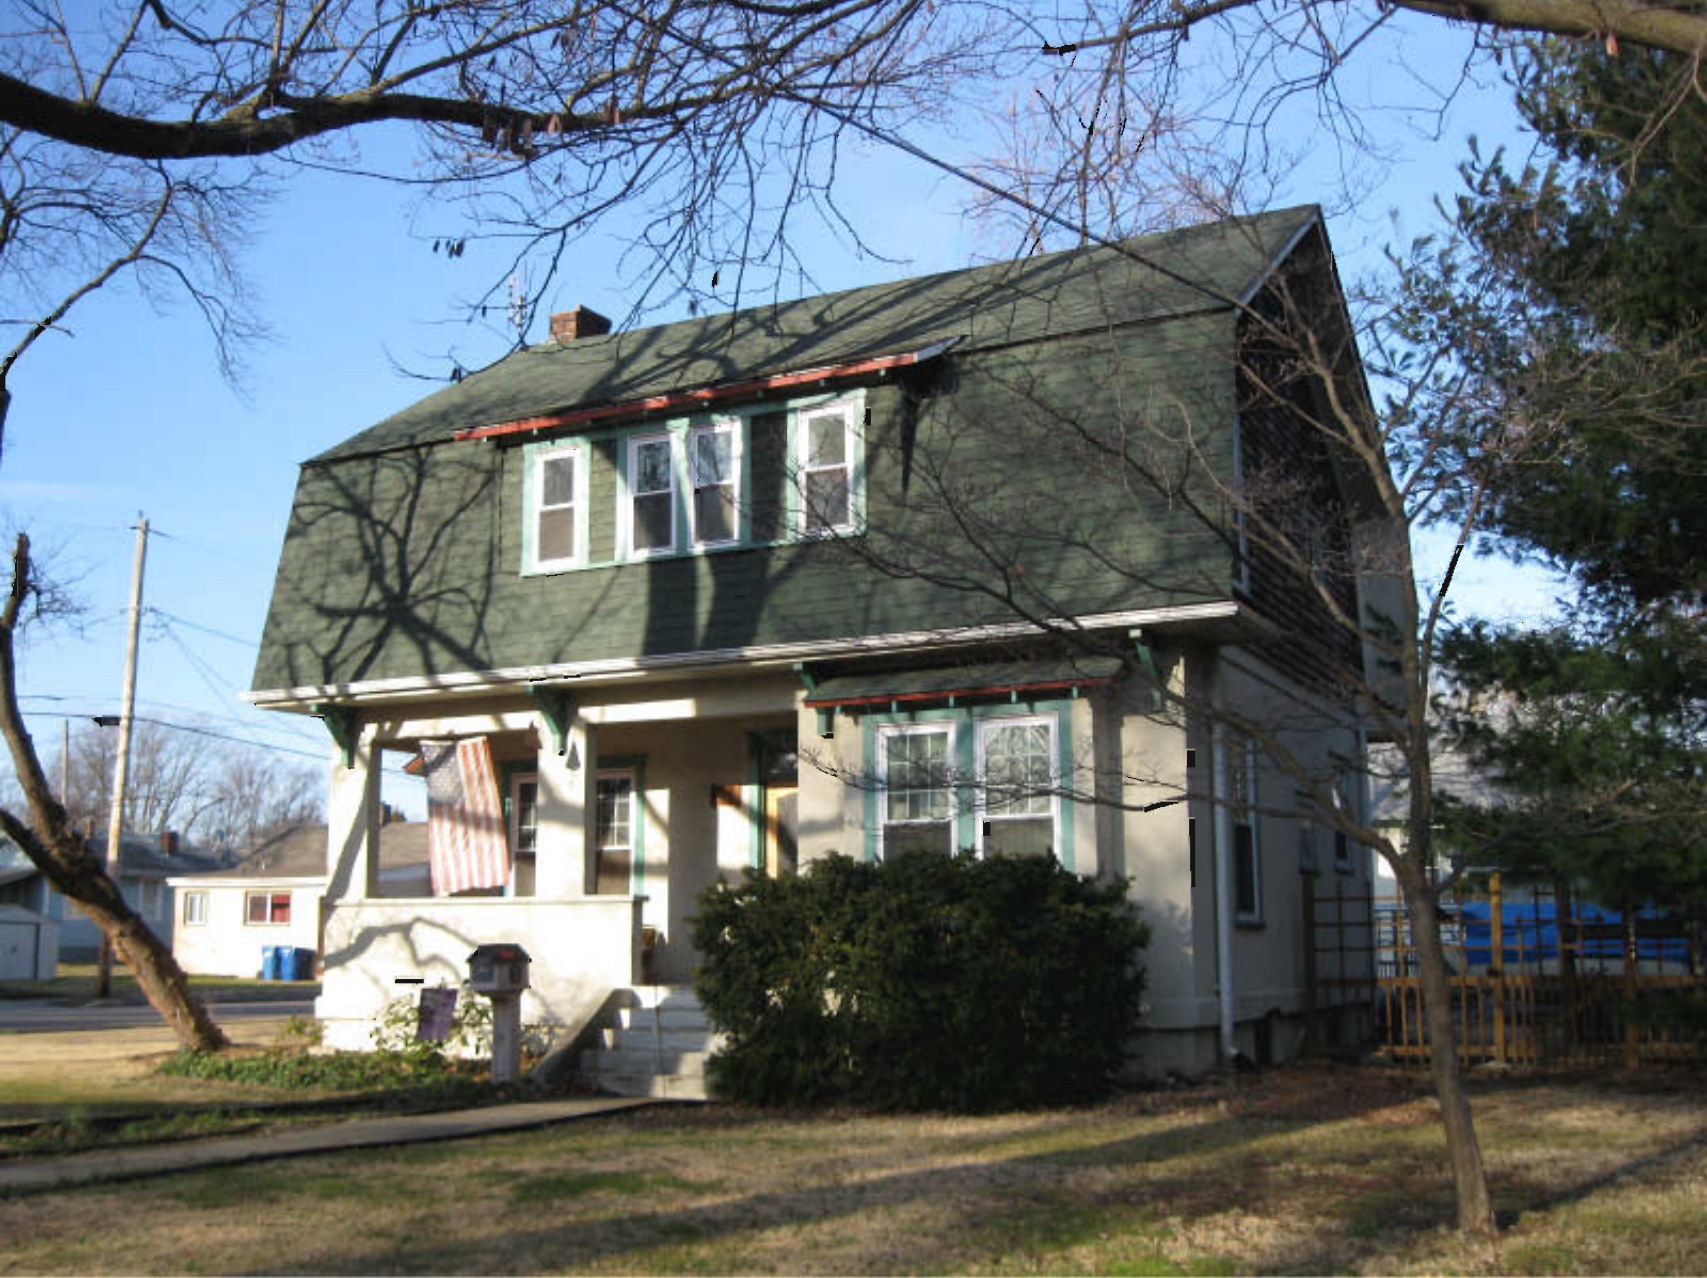
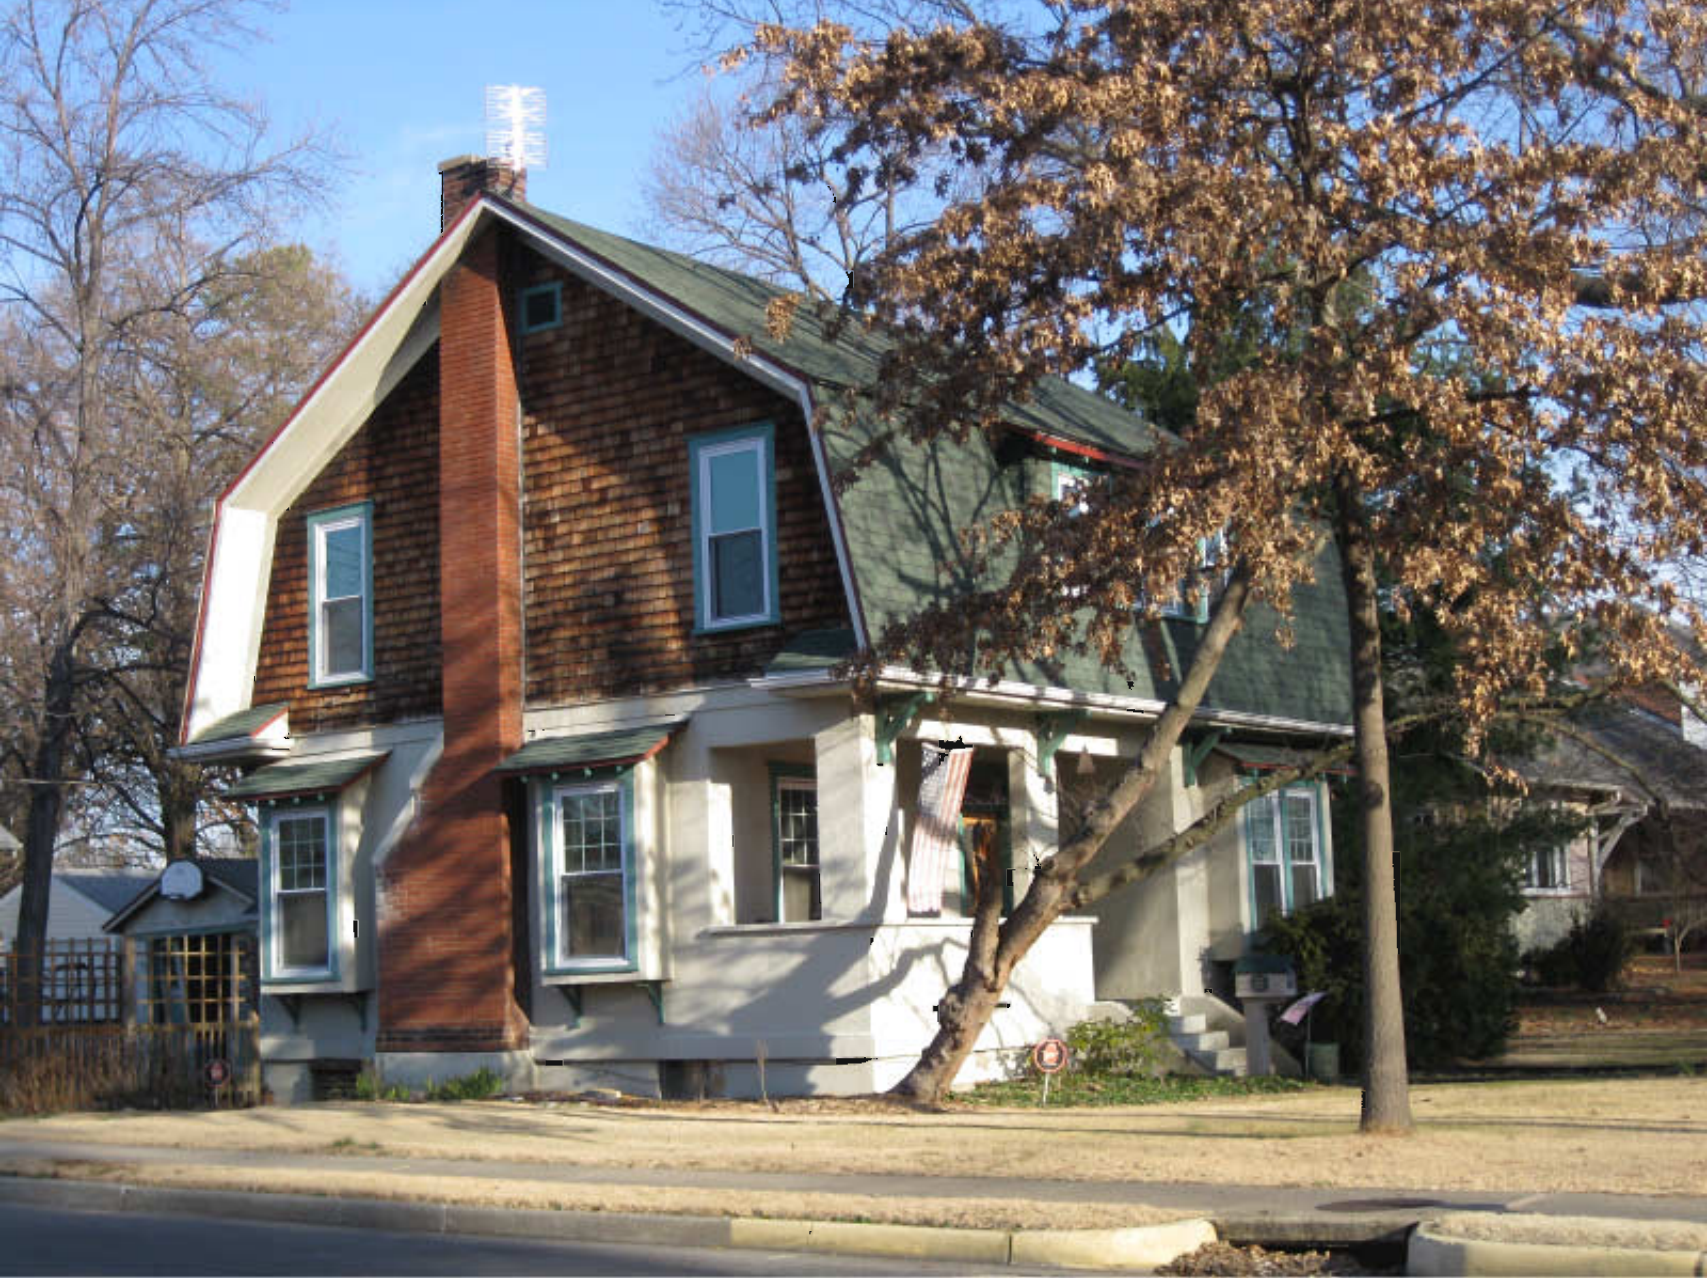
Located at the northwest corner of Ninth and Monroe Streets, this two-story, Dutch Colonial Revival style house is crowned by a side-gambrel roof that has wide overhanging eaves with knee braces, cornice returns, and end walls clad in unpainted wood shingles. On the lower front slope of the roof is a wide, shallow shed dormer with exposed rafter tails, walls clad with roofing shingles, and a pair of 1/1 windows flanked by single 1/1 windows. The lower rear slope of the roof has two shed dormers, each with a pair of 1/1 windows. The walls of the house, the watertable, and the foundation are finished with stucco, and two-light wood basement windows pierce the foundation. The three-bay main façade features a two-bay recessed porch at the south end, and opening onto the porch is a pair of 9/1 windows and a paneled-and-glazed wood door that has two leaded glass panes above two raised panels, and the area between has an applied foliated molding. The door is topped by a single light transom, and the surrounds of the doorway and windows throughout the house are plain with slightly shouldered lintels with molded caps. The recessed porch has a concrete stairway, wooden deck, stucco knee wall railing, and stucco piers. At the north end of the main façade is a box bay supported by knee braces and crowned by a shed roof with exposed rafter tails. The box bay has paired 9/1 windows, and the windows throughout the house are replacements. The south elevation has an exterior end brick chimney with one stepped shoulder capped by cast stone. On the first floor, to each side of the chimney, is a box bay supported by knee braces and crowned by shed roofs with exposed rafter tails. In each box bay is a 9/1 sash, while the two windows of the upper story are 1/1 sash.

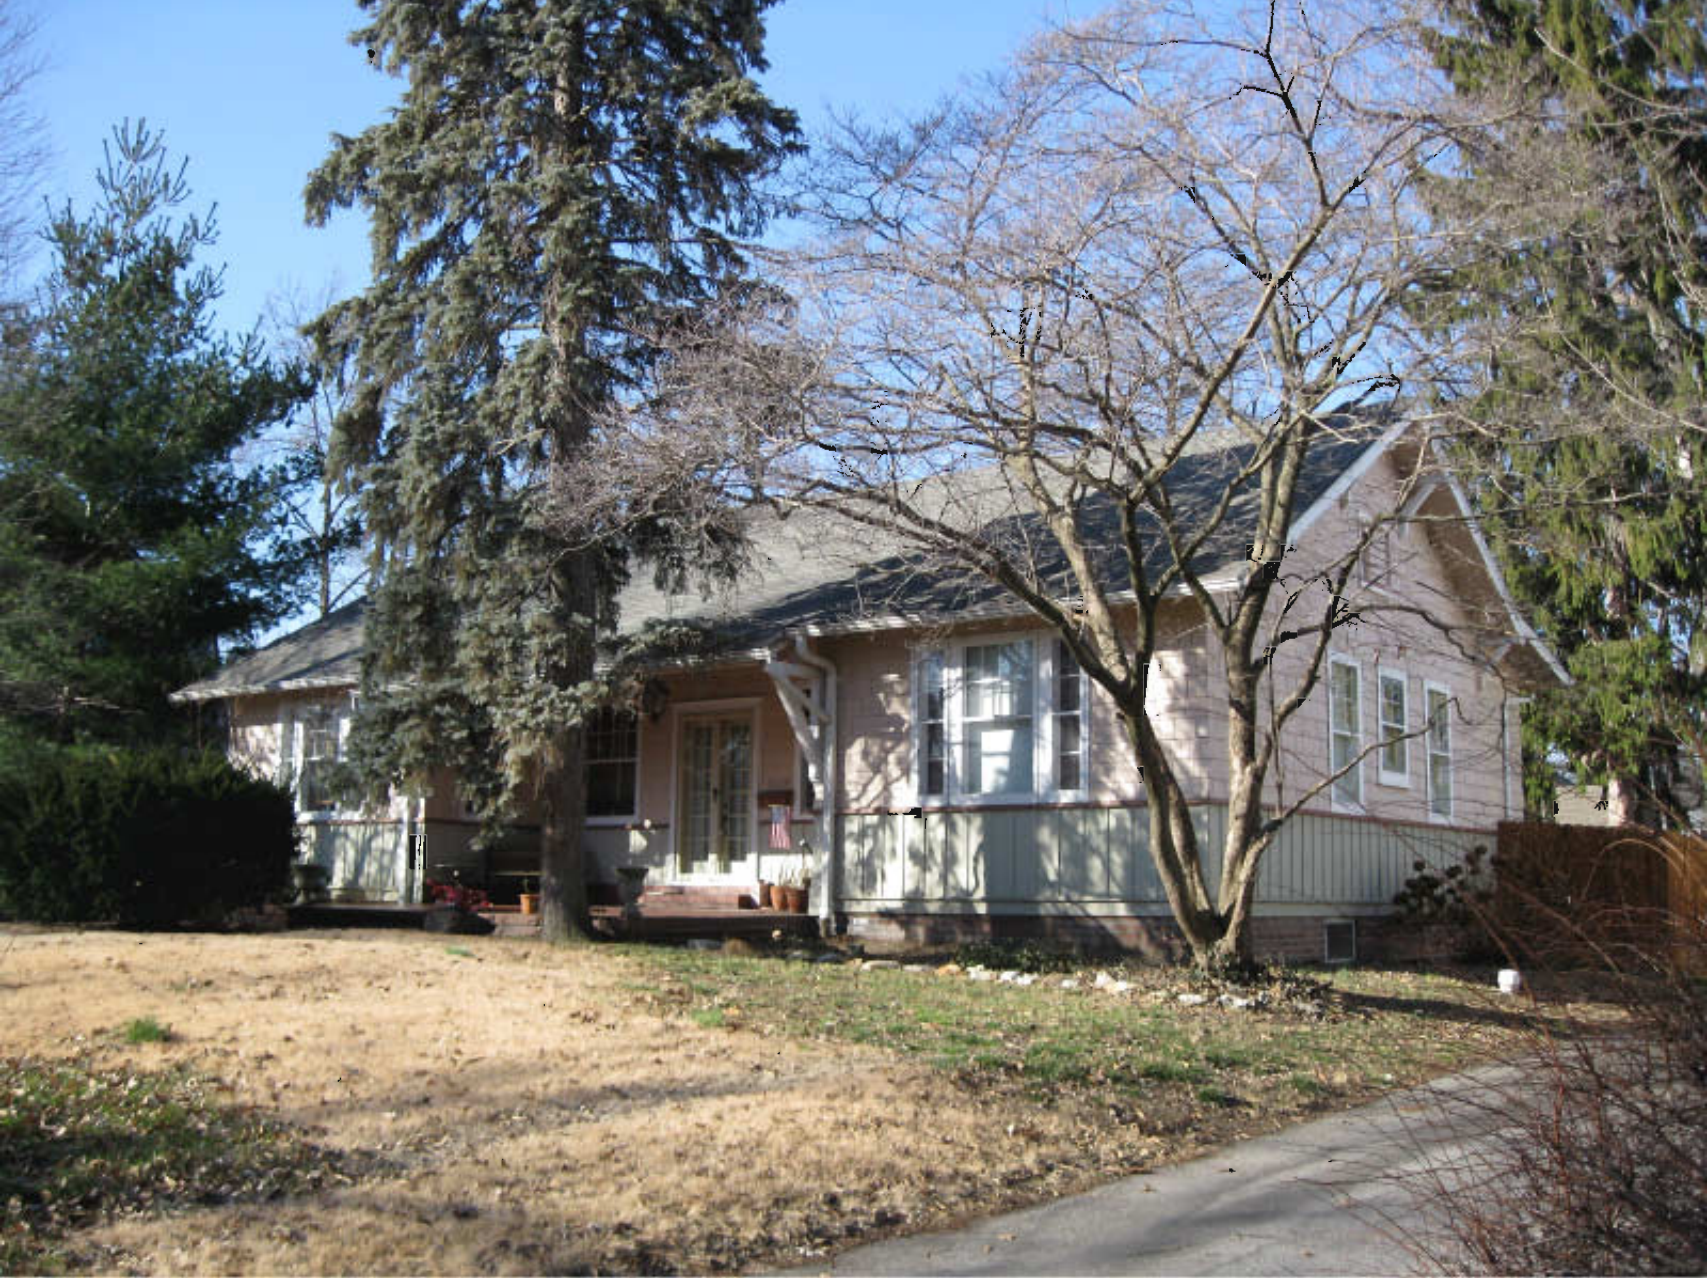
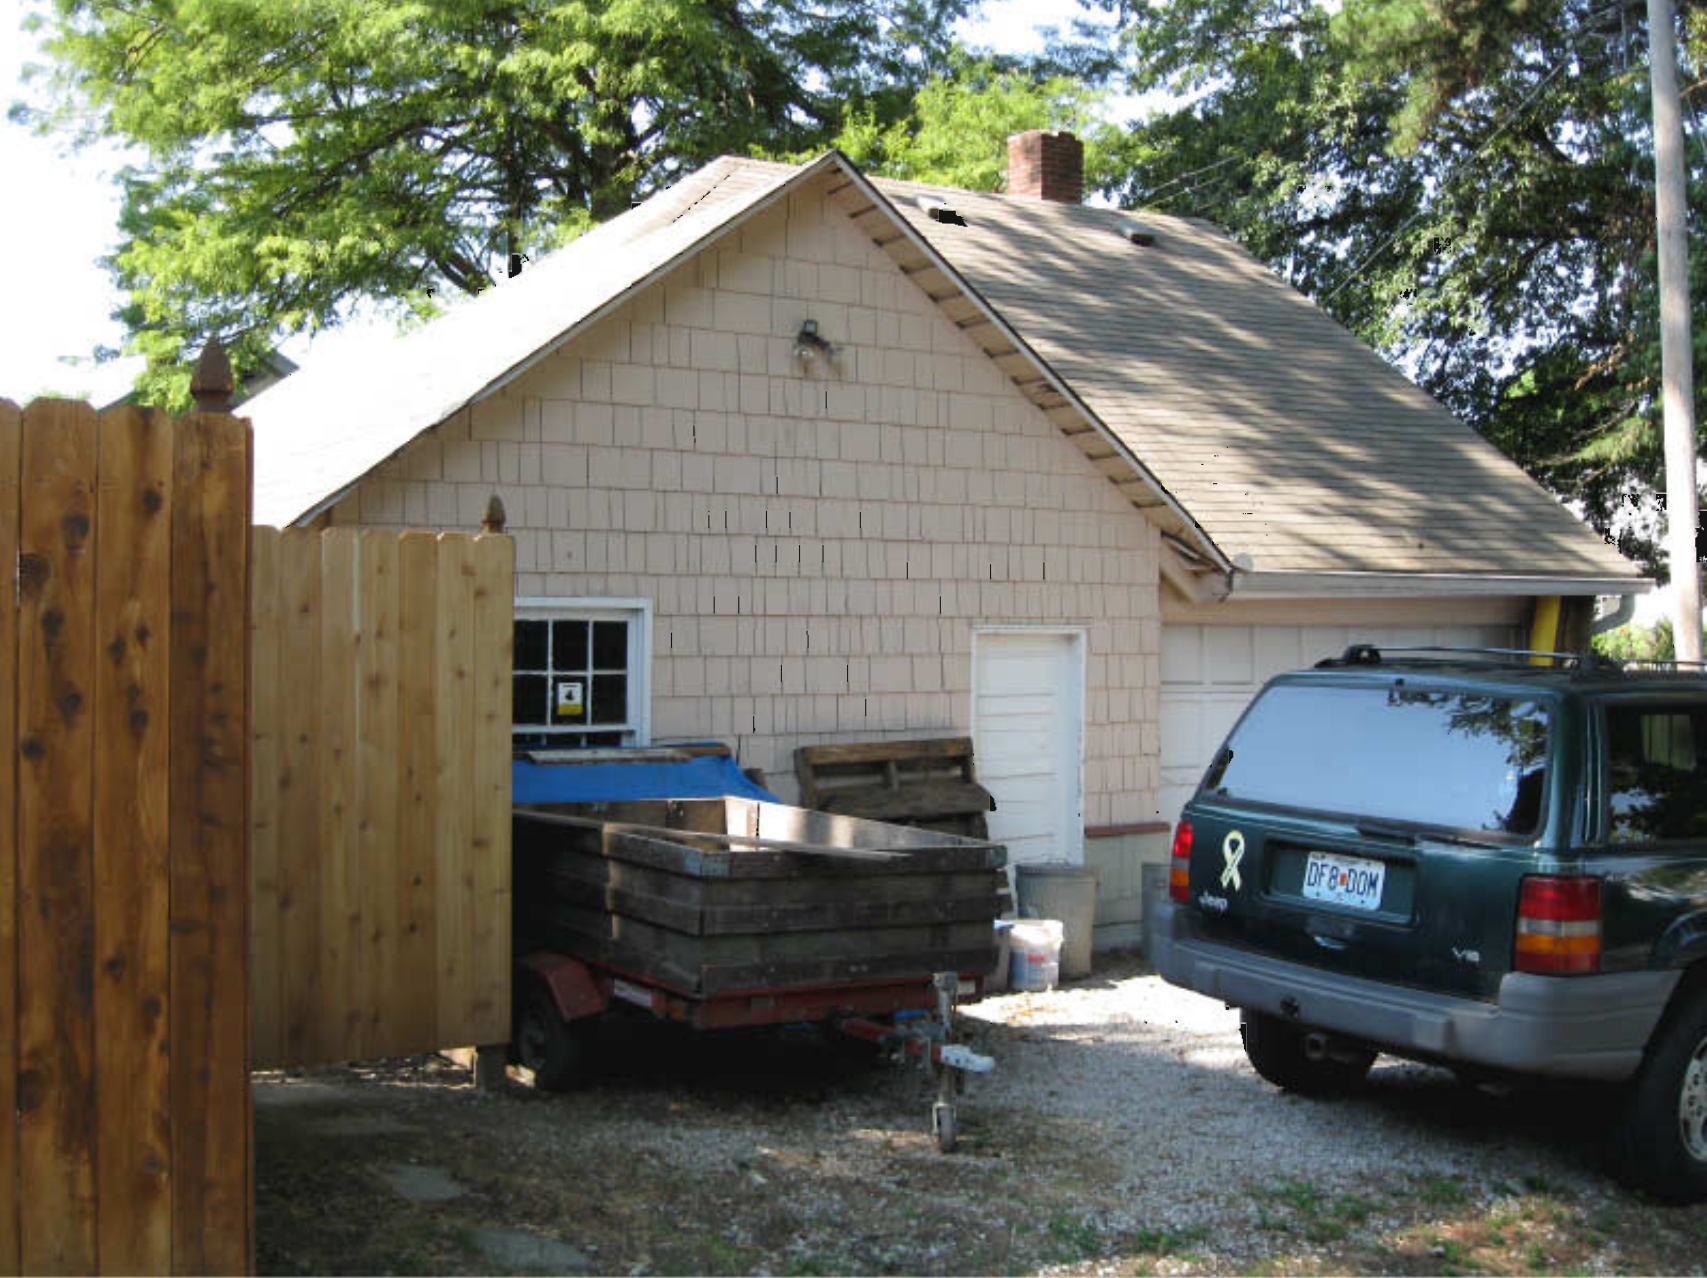
Built about 1913, this one-story, side-gabled house rests on a brick foundation pierced by two-light wood basement windows. Central recessed porches on both the front and rear elevations give the house an I-shaped plan. The walls are finished with wooden shingles and there is a board-and-batten wainscot. The medium-pitched, side-gabled roof has exposed rafter tails in the wide overhanging eaves and knee braces in the gable ends, and a brick chimney straddles the ridge of the roof. In each of the outer bays of the symmetrical, five-bay façade is a tripartite window composed of a central 8/1 wood window flanked by narrow 2/2 sidelights. The central three bays are recessed and feature a pair of narrow 12-light wood doors flanked by 8/1 windows, and another 8/1 window is located in both the north and south walls of the recessed porch area. The door and wainscoting in the porch area are set above a soldier course of bricks, and the porch deck and step immediately in front of the door are brick. The roof of the house extends over the porch deck and is supported by large knee braces. The north elevation has three 6/1 windows set fairly close together (the central window is shorter than the other two), and in the gable end is a rectangular ventilator. In 2010 small additions were built at the north and south ends of the rear elevation.

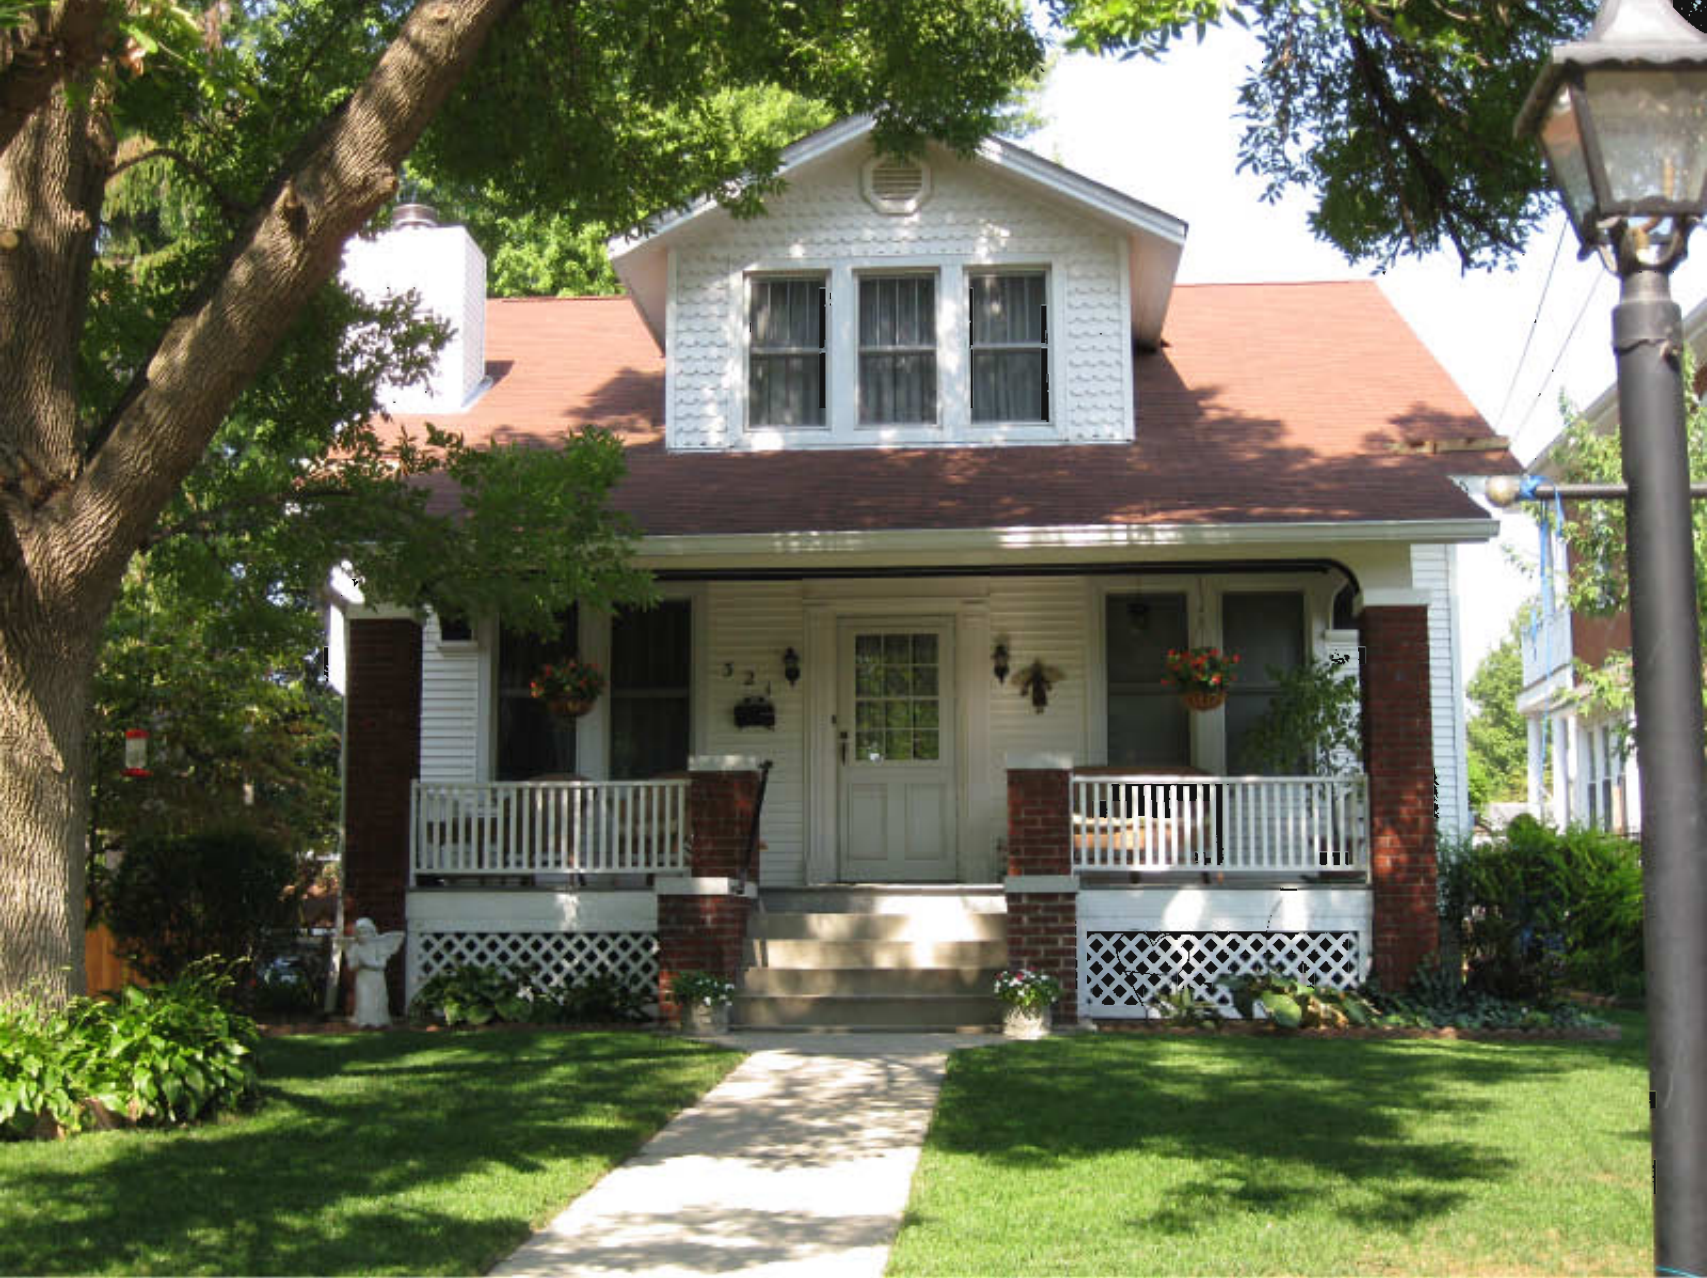
Located on a tree-shaded lot, this one-and-one-half story, frame bungalow rests on a scored concrete foundation pierced by three-light, wood basement windows. A large gabled dormer with group of three 4/1 windows is on the front slope of the high side-gabled roof, while the rear slope has a gabled dormer with two 4/1 windows. The walls of the front dormer are clad with vinyl fish scale shingles, while the walls of the house and rear dormer are clad with lapped vinyl siding. An interior brick chimney with cast stone cap pierces the rear slope of the roof and an exterior end chimney clad with vinyl siding is near the east end of the south elevation. The three-bay main façade has a central entrance, with a wooden door having three long vertical lights, and the classical frontispiece with fluted pilasters supporting a denticulated frieze appears to be a modern addition. To each side of the entrance is a pair of 4/1 windows. The door and windows overlook the ¾-width gallery that has brick piers and pedestals that extend to the ground, with the area between in-filled with paneled lattice panels. The piers support the shed roof, which has a basket-handle arched frieze, and the porch ceiling and soffits are finished with stained bead board. Brick knee walls with concrete copings flank the concrete stairway, but the gallery's deck is wood. A plain wood balustrade encircles the porch. On the south elevation, small stained glass windows flank the exterior chimney, and to the west are paired 4/1 windows and a pair of shorter 3-light windows. In the upper half story is a 4/1 window.
