ARCHITECTURAL/HISTORIC INVENTORY FORM

1. Survey No. SC-AS-009-001		2. Survey Name: St. Charles Survey Phase 3: Mid-Town and Commons Neighborhoods	
3. County: St. Charles		4. Address (Street No.) 128	Street (name) North Sixth Street
5. City: St. Charles	Vicinity: <input type="checkbox"/>	6. UTM:	
7. Township/Range/Section:		8. Historic name (if known): Meyer-Pieper House; The Meyerdorf	
9. Present/other name (if known):		10. Ownership: <input checked="" type="checkbox"/> Private <input type="checkbox"/> Public	
11a. Historic use (if known): Domestic/single dwelling		11b. Current use: Domestic/single dwelling

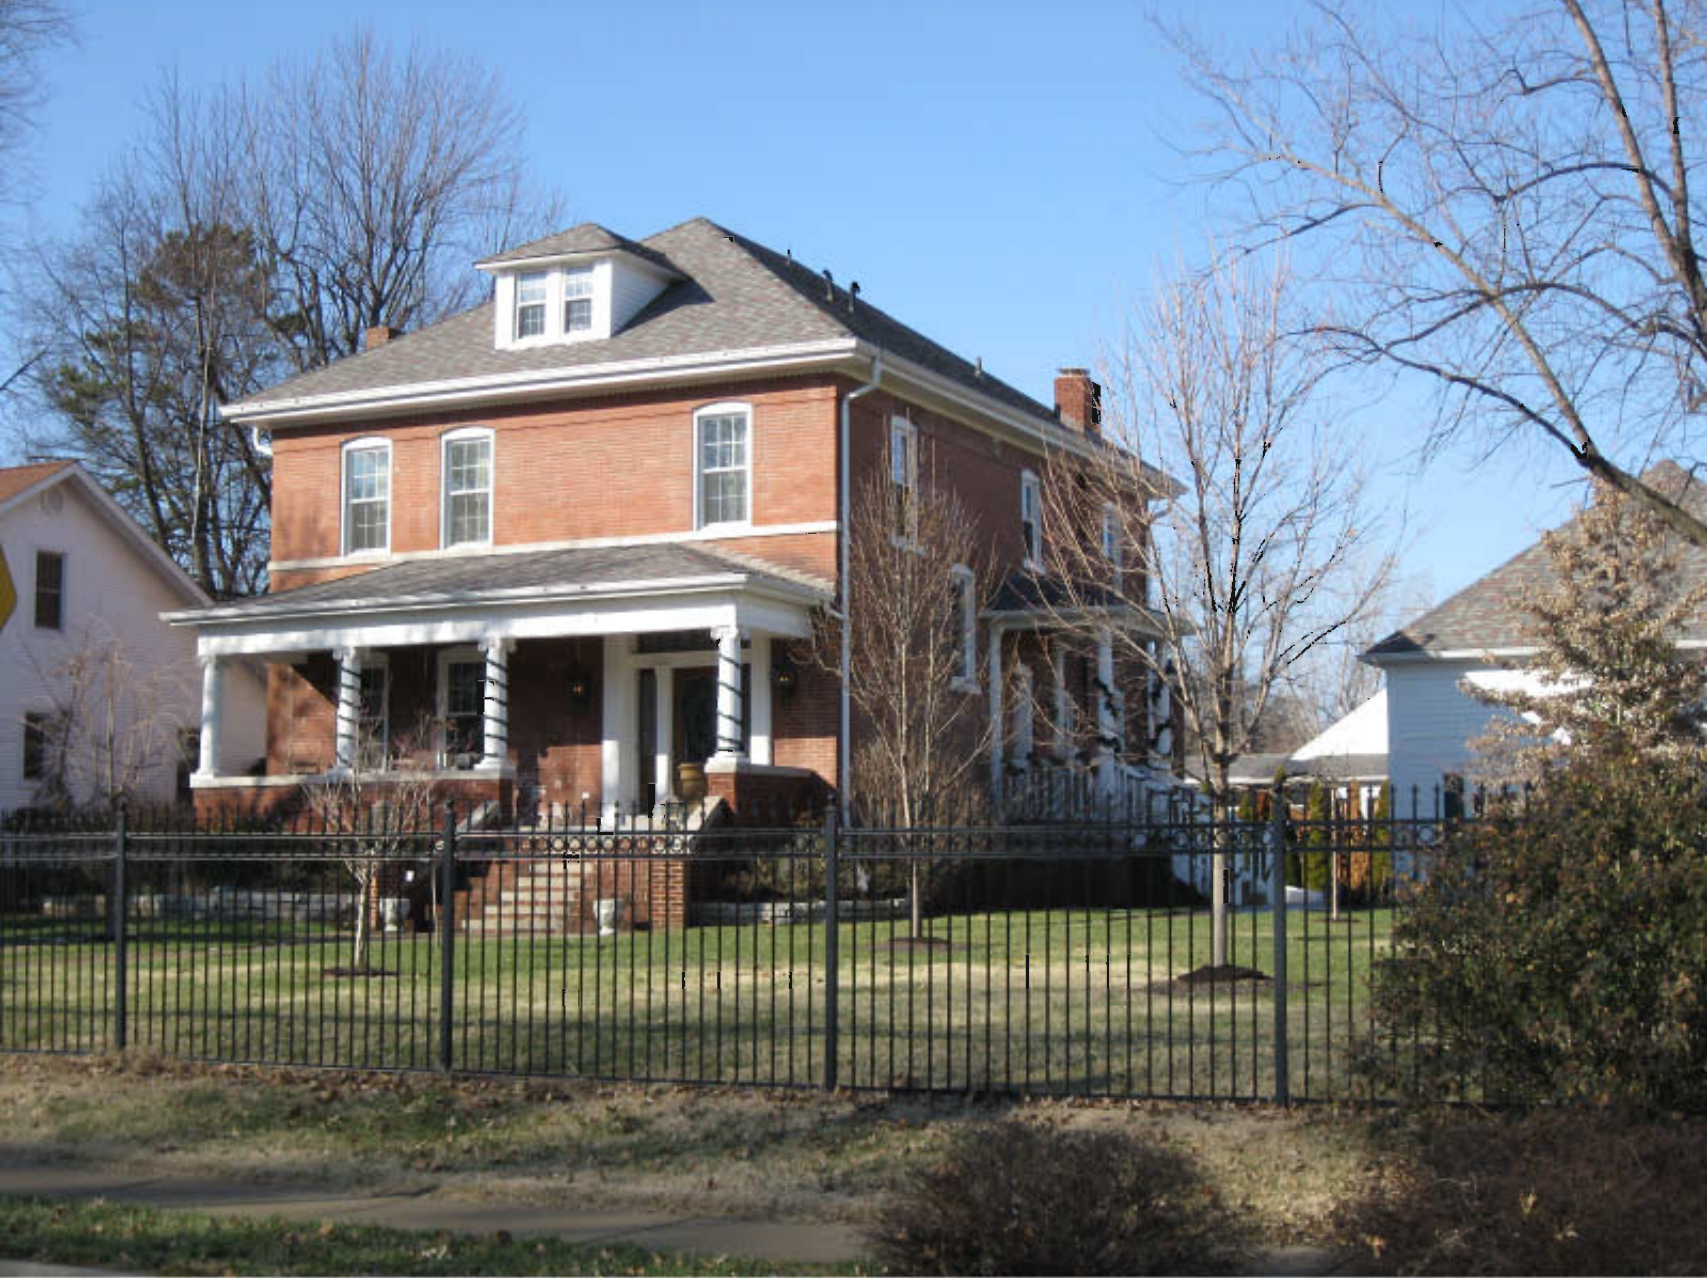
Situated at the southwest corner of Ninth and Adams Street, this house is a two-and-one-half story, brick, Colonial Revival style structure that is crowned by a high hip roof. The roof has wide overhanging eaves and is trimmed by a brick entablature with scalloped wood frieze. The front slope of the roof is pierced by a hipped dormer that has a pair of 6/6 windows and vinyl-sided walls, and an exterior end chimney projects through the eaves of both side elevations. The walls are laid in a running bond pattern, and a cast stone belt course is on the main façade between the first and second stories and serves as a sill for each of the second story windows. The entrance is located in the northernmost bay of the three-bay main façade. The ¾-glazed, paneled wood door and the sidelights are leaded glass, and a seven-light transom spans the door and sidelights. To the left of the entrance are two 6/6 windows set in segmental-arched openings, and on the second floor are three windows aligned with the first floor openings. Windows throughout the house are set in segmental-arched openings topped by radiating voussoirs, and the windows are replacements. The door opens onto a ¾-width gallery with brick stairway flanked by brick knee walls with concrete copings, concrete deck, brick half-wall railing with concrete coping, and Ionic columns supporting a hip roof. The house had been used for a daycare from 1963-2005, and during that period the front porch was partially enclosed. When the house was converted back to single-family use in 2005, the porch was re-opened and the brick piers were replaced with fluted Ionic columns. The first floor of the north elevation features, from east to west, a large stained glass window high in the wall, apparently overlooking a stairway; a paneled-and-glazed door topped by a three-light transom; a small 6/6 window; and a full-sized 6/6 window. The door opens onto a one-bay porch with wood deck and stairway, plain balustrade, and Doric columns supporting a hip roof. A photograph shows that prior to 2005 the porch had turned posts with corner brackets. There are three window openings on the second floor. Although the porch posts and windows have been replaced, the house retains sufficient integrity to contribute to the character of the district.

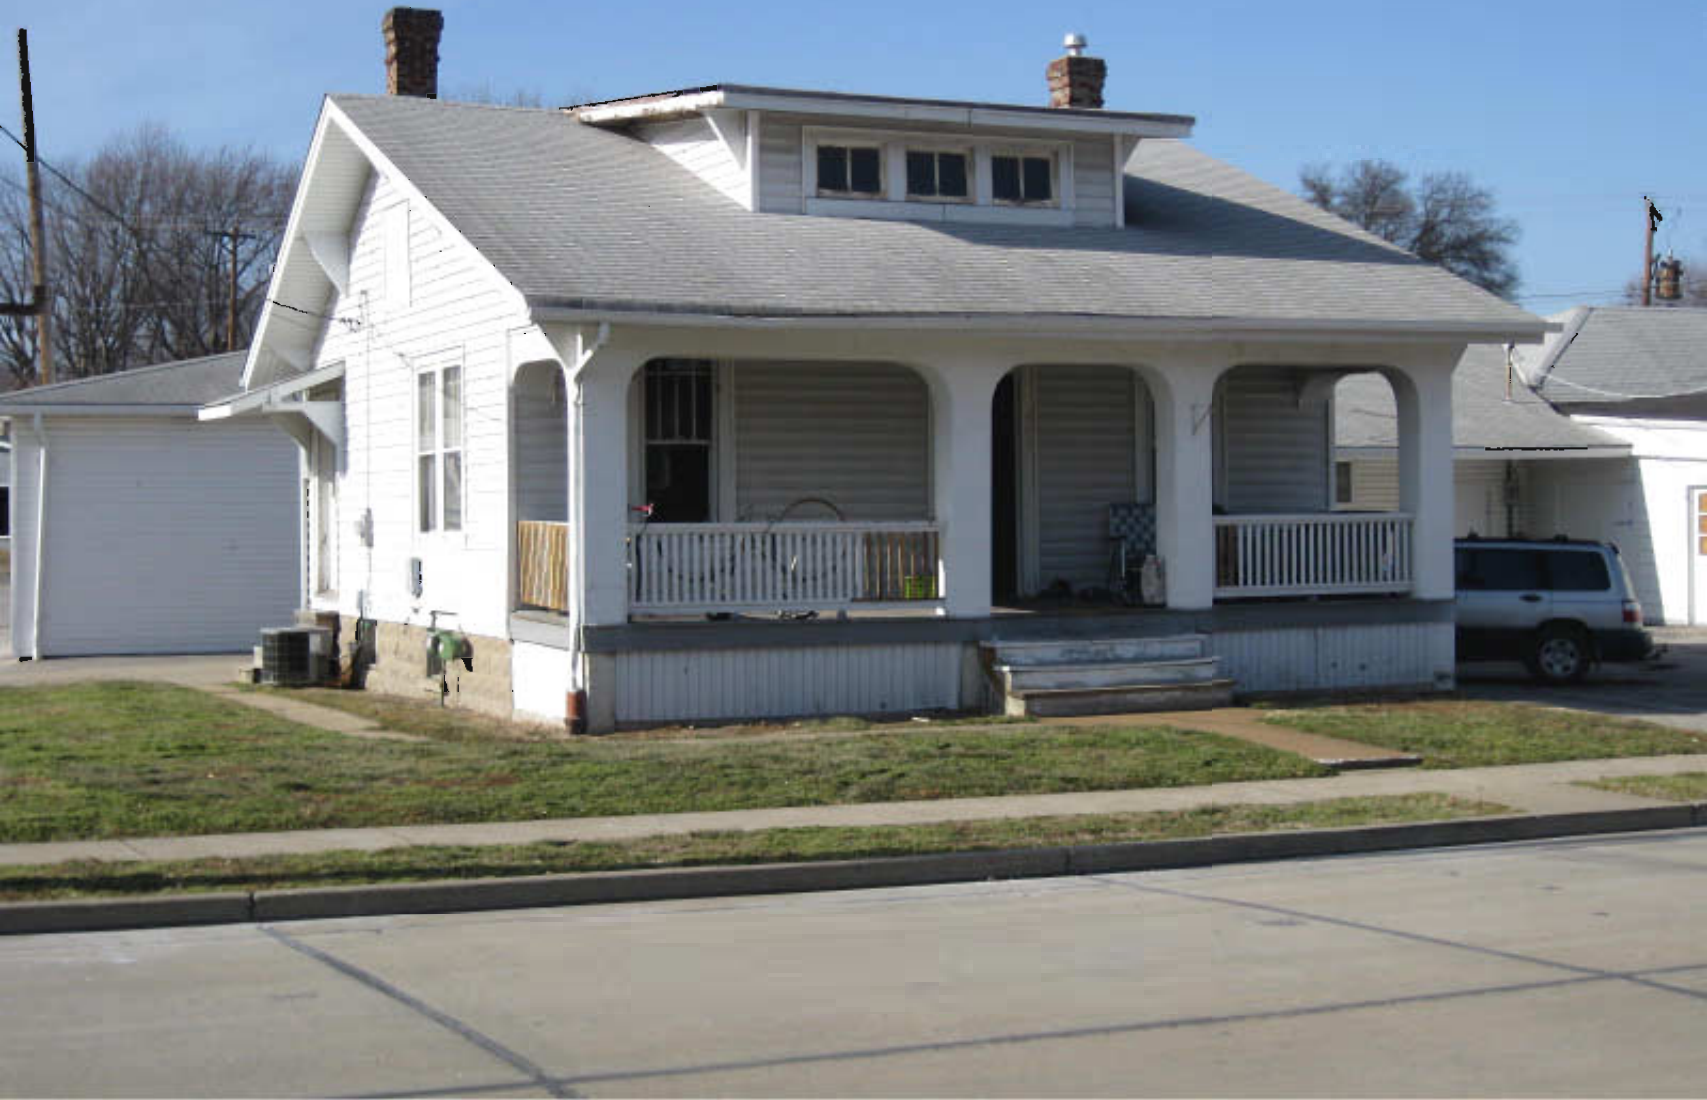
This one-and-one-half story, side-gabled, frame bungalow rests on a rusticated concrete block foundation that is pierced by two-light, wood windows, and the walls have been clad with vinyl siding. The side-gabled roof has wide overhanging eaves with knee braces, and on the front slope is a shed dormer with three 2-light wood windows. The dormer's walls are clad with vinyl siding and knee braces are on the east end of the side walls. Interior brick chimneys with corbelled caps are at each end of the rear slope of the roof. The center bay of the three-bay main façade has a 2/3-glazed wood door with three vertical lights over a single panel. The door is topped by a single-light transom, and to each side is an 8/1 wood window. The pane configuration of the upper sash is four small lights set above four tall lights. The door opens onto a full-width, inset gallery with wooden stairway and deck, plain wood balustrade, and stuccoed piers supporting the basket-handle arched frieze of the roof. The area under the porch deck has been covered with vertical board siding. On the east end of the south elevation is a pair of windows matching those of the façade, and at the west end is a half-glazed, three-panel wood door protected by a shed awning supported by knee braces. The window in the upper half story has been enclosed. On east end of the north elevation is a pair of 8-light windows and a full-size 8/1 window, and the window in the upper half story has been enclosed.

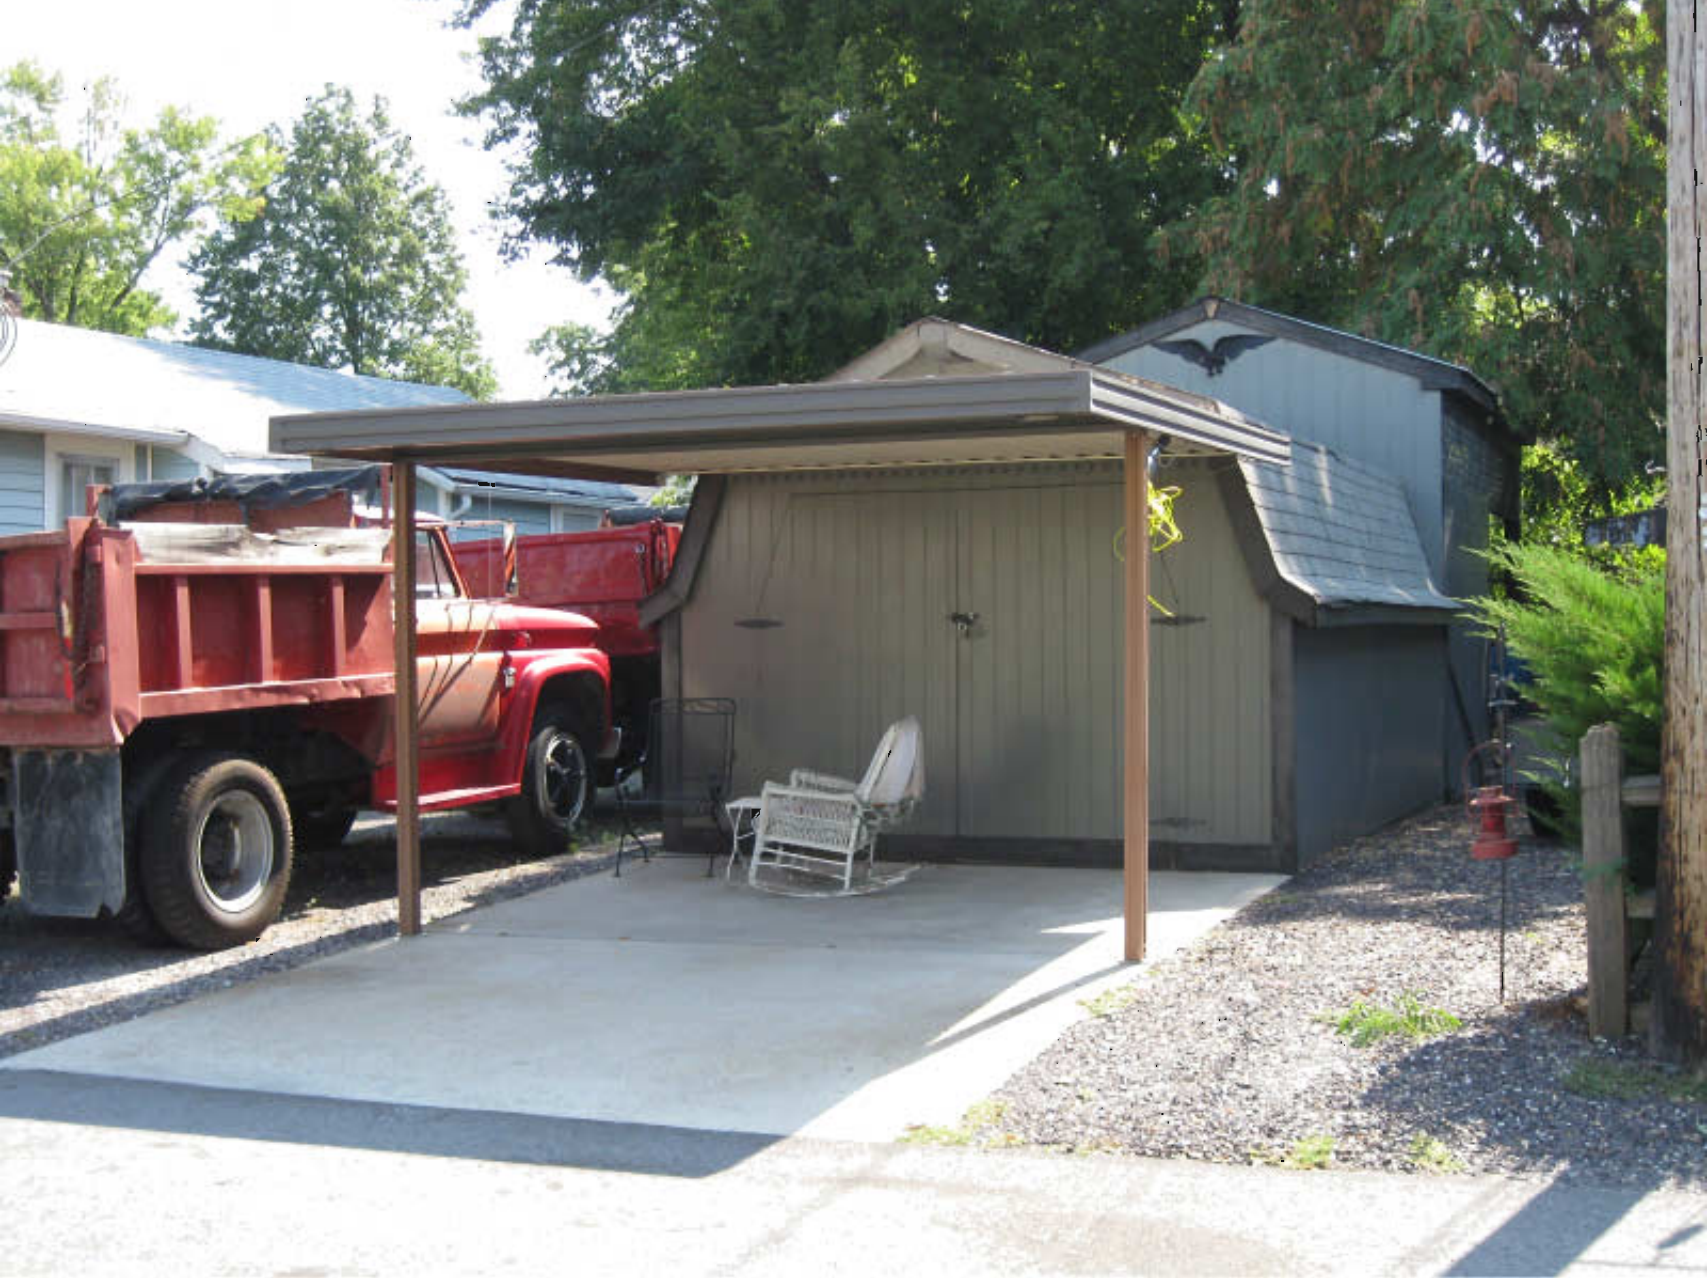
This property is associated with the house on the adjacent lot at 212 North Tenth Street. Located on a narrow lot only 28' wide, the structure consists of a frame storage building with gambrel roof, and attached to the front of the building is a carport with nearly flat metal roof supported by two metal posts. Attached to the rear of the gambrel-roofed structure is a taller gable-roofed wing that appears to have vertical board walls on the front (west) elevation and a combination of lattice and vertical boards on the sides.

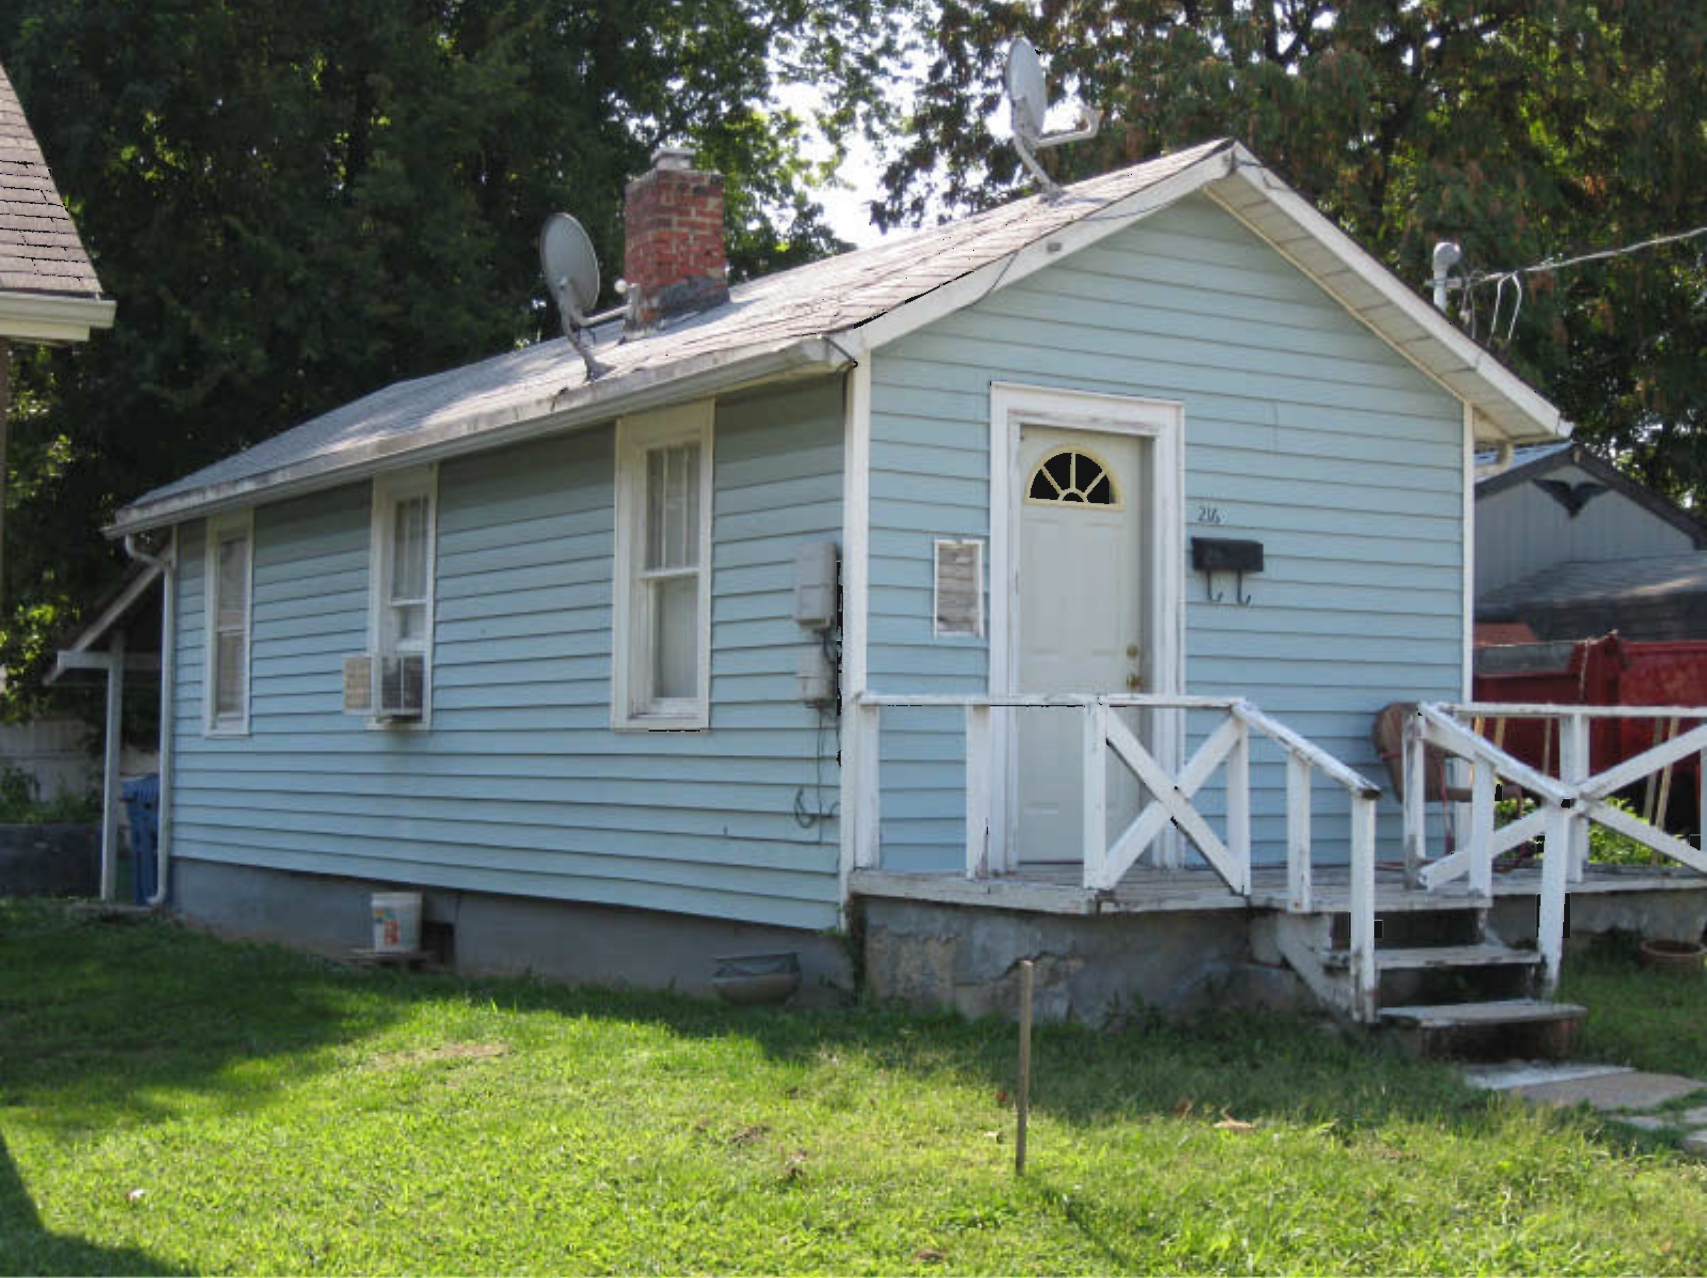
This one-story, frame, front-gabled, shotgun house was built about 1930 in the African American neighborhood known as "Goose Hill." The foundation is concrete and the walls are clad with vinyl siding, but a small rectangular area of the original weatherboard siding was left exposed on the main façade, revealing that the weatherboard has a very narrow exposure that is about half the width of the vinyl siding. An interior brick chimney pierces the north slope of the roof. The entrance is the only opening on the main façade, and it is a replacement paneled metal door with a fanlight. The door opens onto a full-width stoop with wood deck and stairs. The north elevation has three 3/1 wood windows.

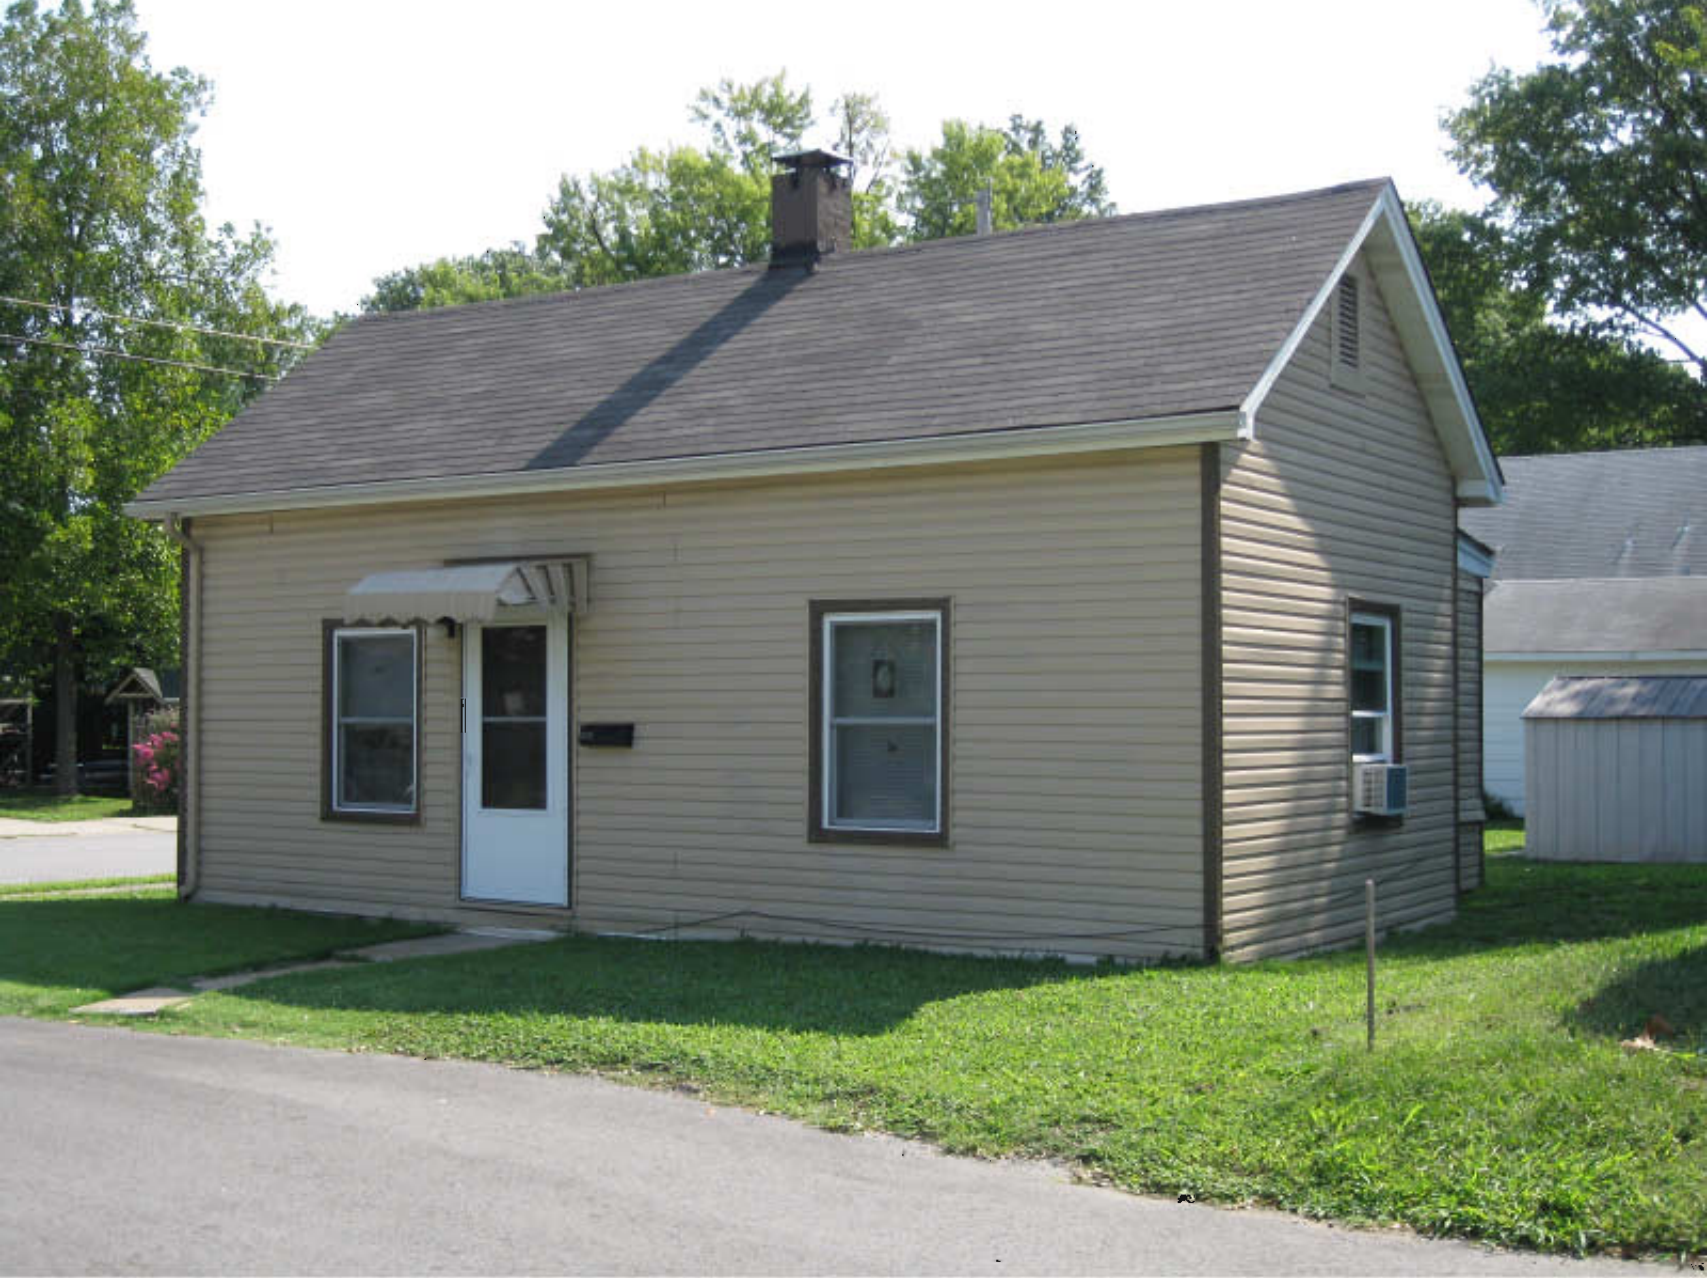
Situated on a small lot at the southeast corner of Tenth and Monroe Streets, this one-story, frame, side-gabled, hall-and-parlor house was built about 1900. A painted brick chimney straddles the ridge of the roof. Dutch-lap vinyl siding has been installed on the walls and the windows are replacement 1/1 sash. The asymmetrical three-bay main façade has what appears to be a half-glazed wood door obscured by a storm door, and above the door is a metal awning. The door opens directly onto the sidewalk, and to each side of the doorway is a 1/1 window. Both side elevations have a single 1/1 window, and a shed-roof addition spans most of the rear elevation. A small 1/1 window and a recessed door are on the north elevation of the addition, and the door opens onto a one-bay recessed porch. There are no openings on the south elevation of the addition.

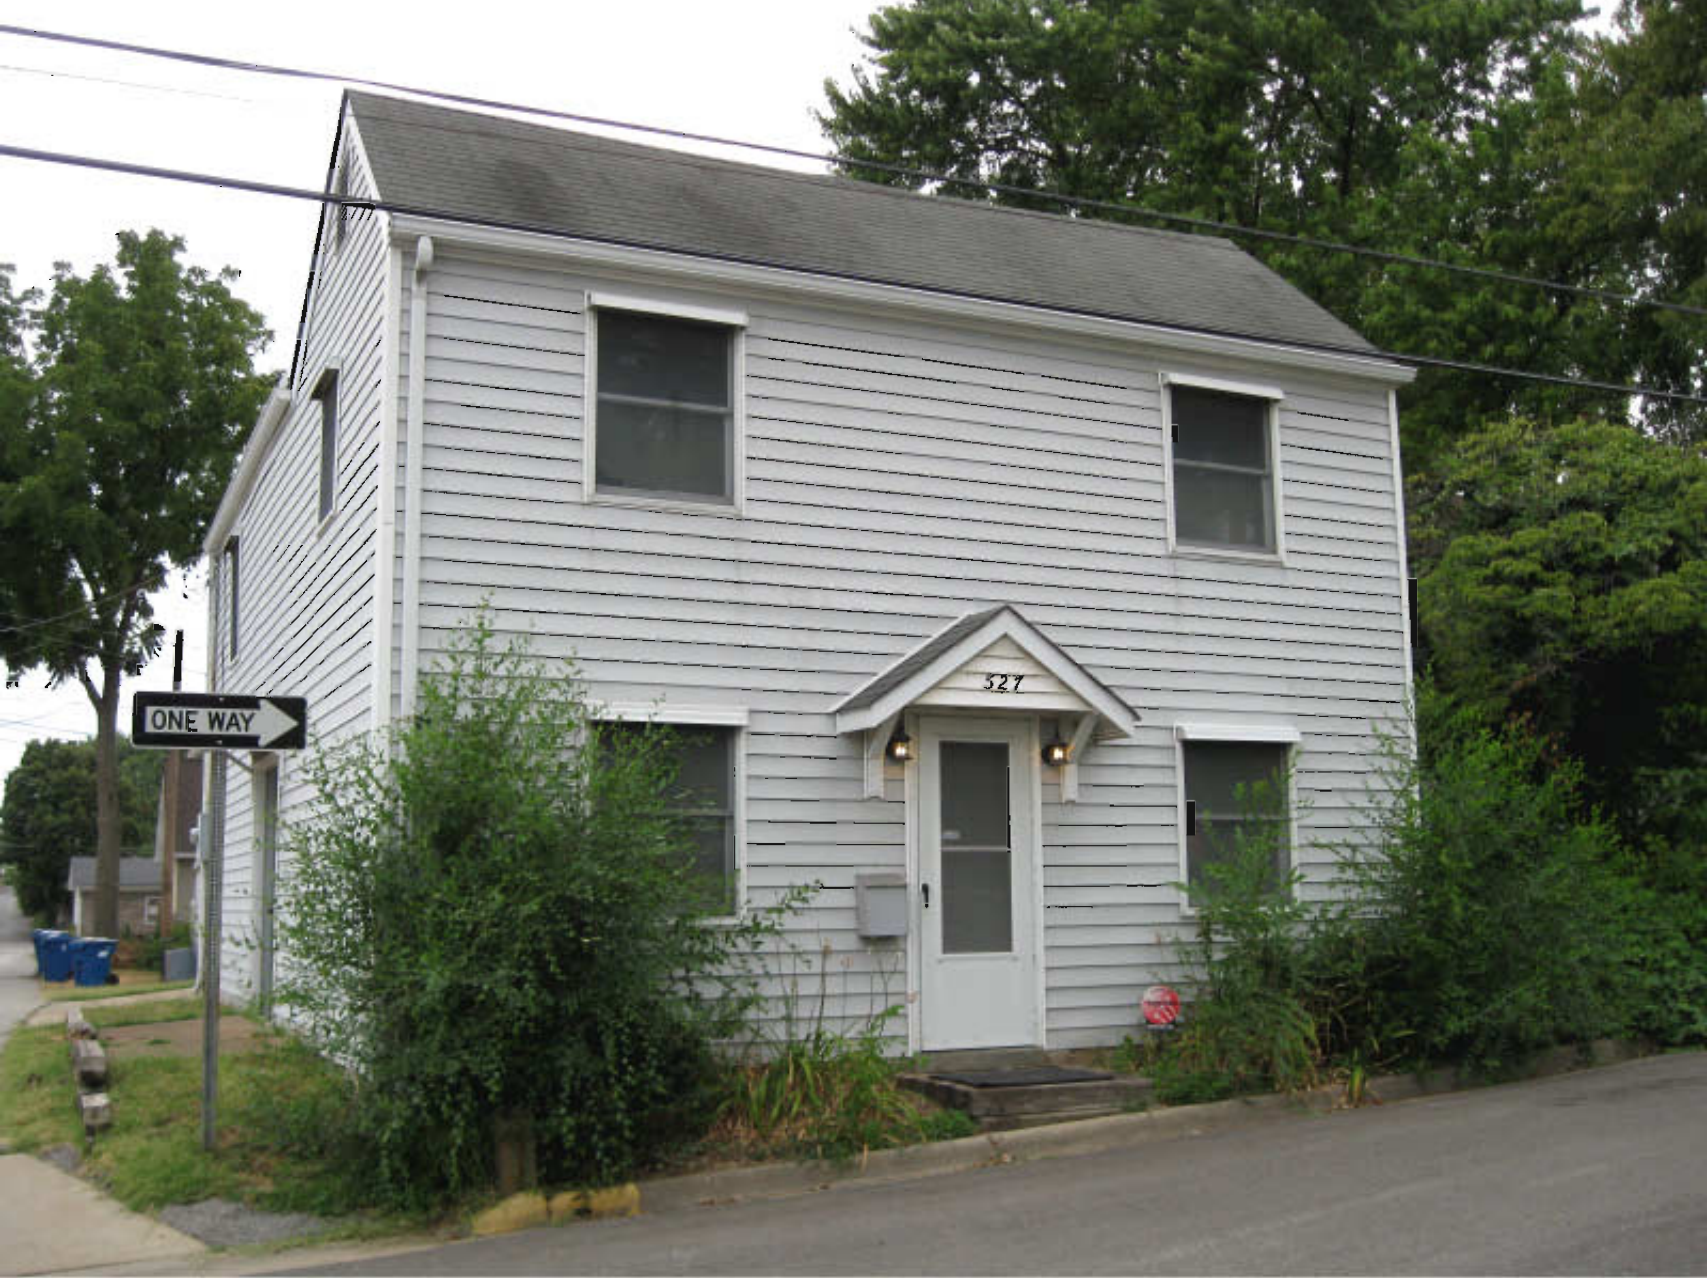
Facing north, this house is a two-story, frame, side-gabled structure that rests on a concrete foundation and is crowned by a medium-pitched, side-gabled roof with intersecting cross gable on the rear. The walls are finished with vinyl siding and the windows are vinyl. The first floor has a central 6-panel door protected by a gabled hood that is supported by knee braces. To each side of the entrance is a 1/1 window. The second floor of the façade has two 1/1 windows. The east elevation has paired, unpaneled doors on the first floor, and they are protected by a shed awning supported by knee braces. The second floor has two 1/1 windows. The west elevation has no openings on the first floor and two 1/1 windows on the second. Louvered ventilators are in the gable ends.

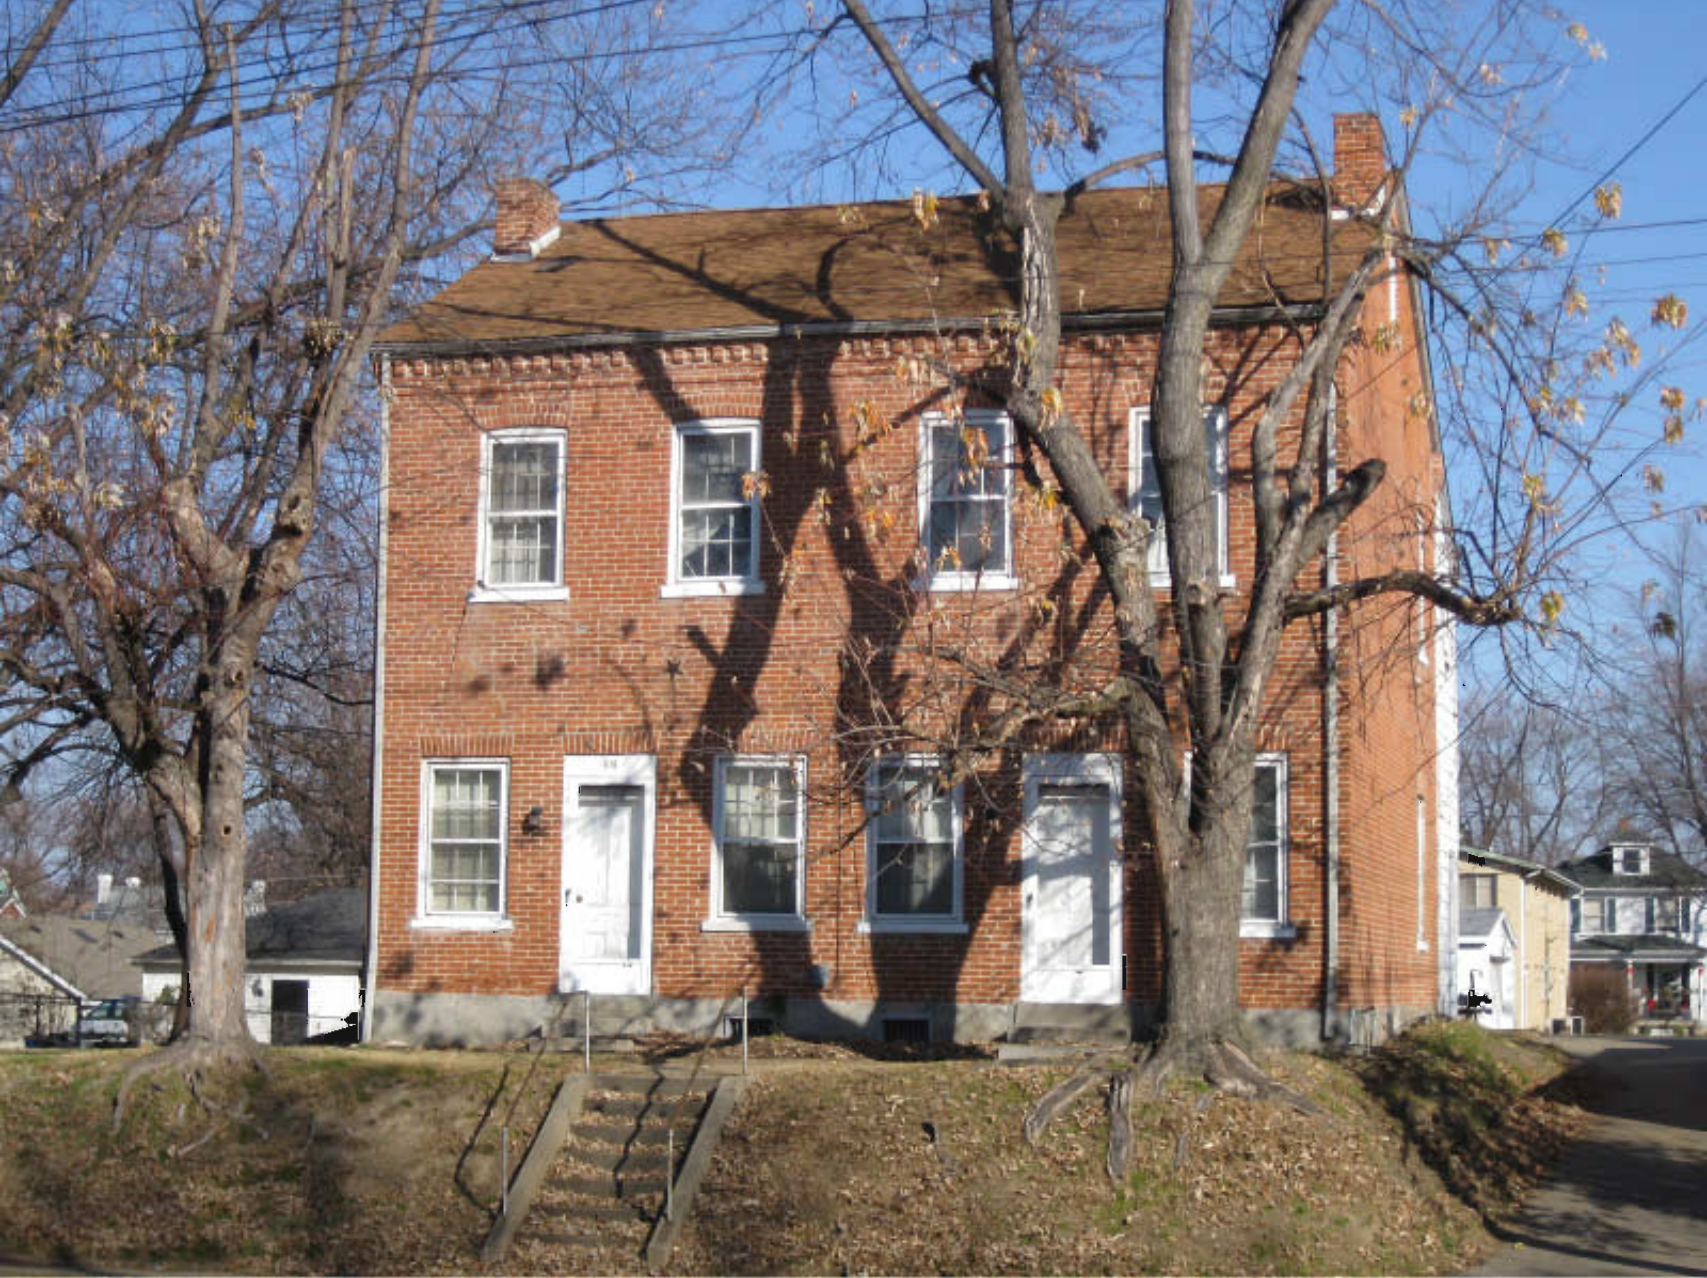
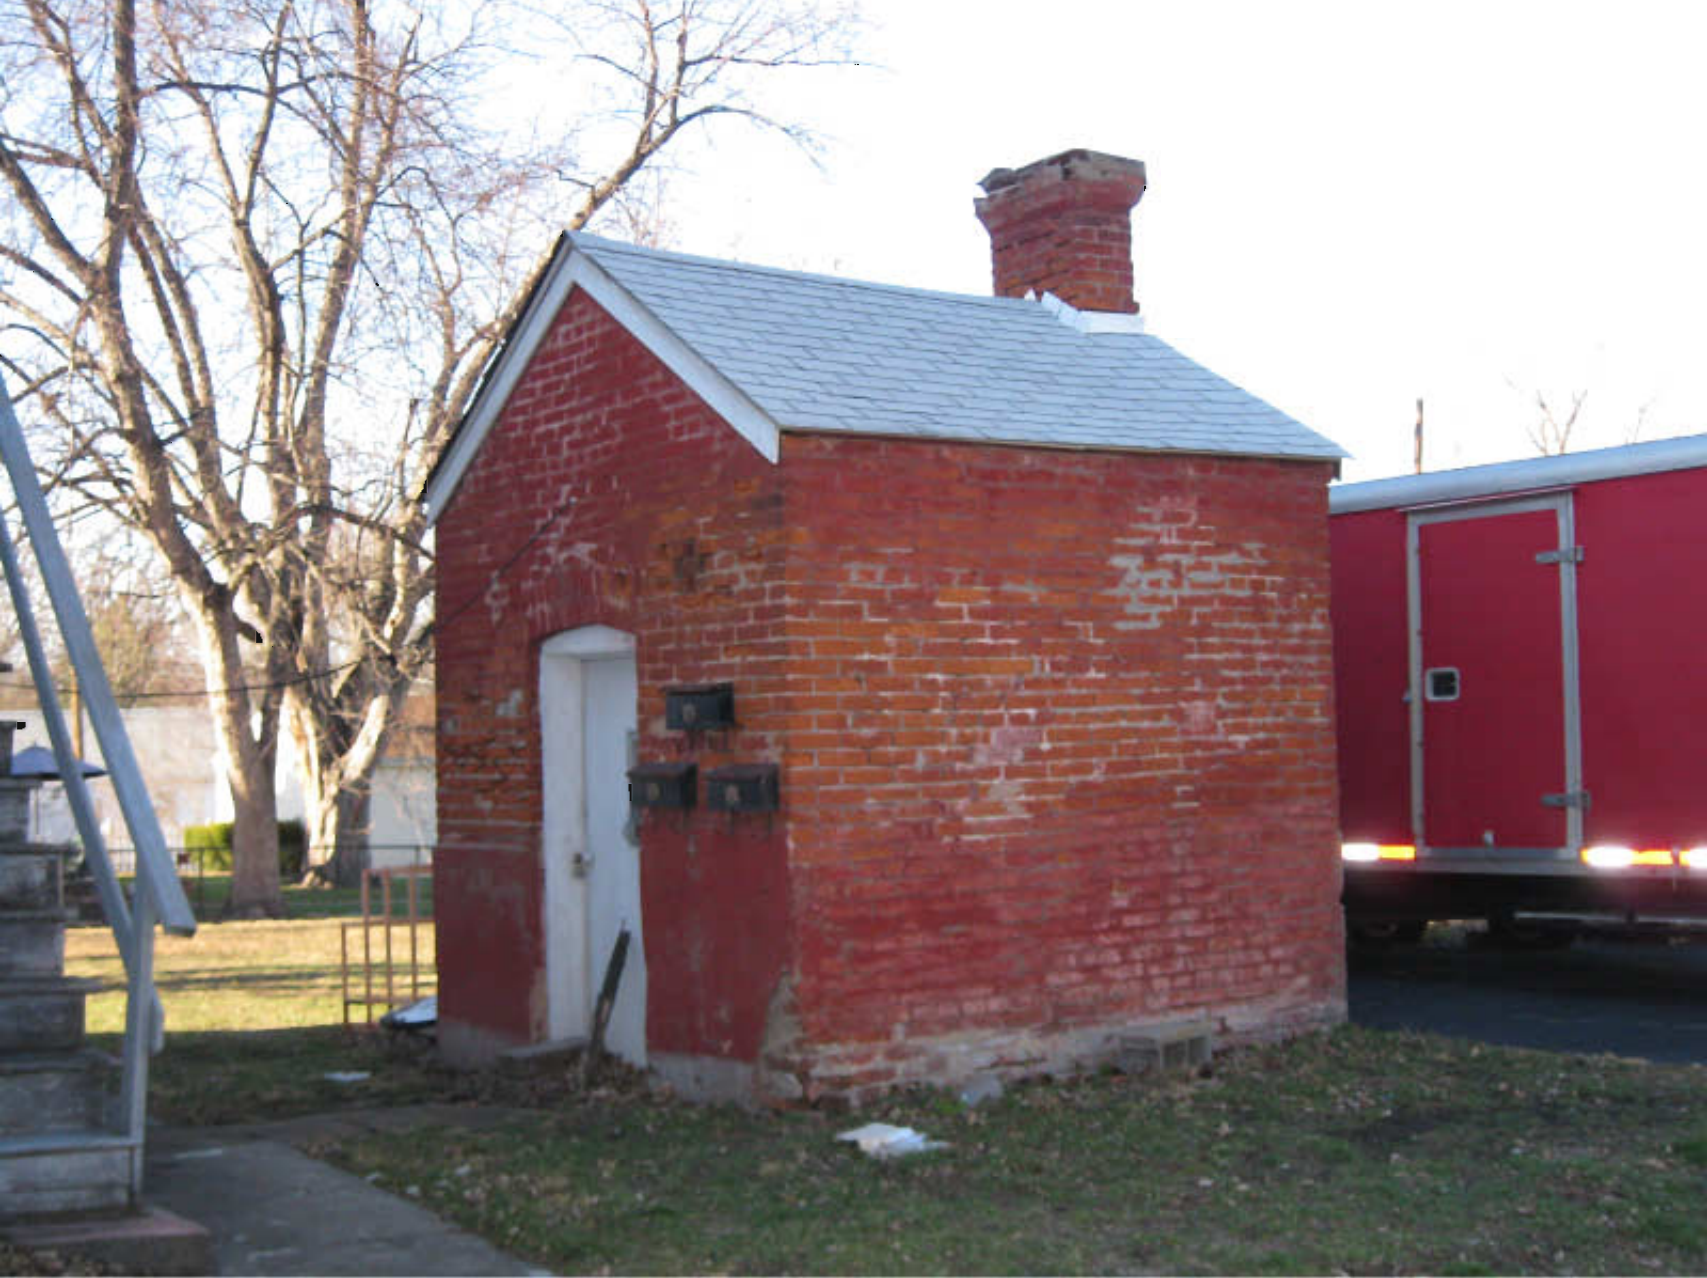
façade are topped by flat jack arches. Windows throughout the building have wood lug sills. The second floor of the main façade has four 6/6 wood windows. Each of the side elevations has one window on the east end of the first and second floors, and there is also a 6/6 window in the upper half story. A two-story, frame wing spans the rear elevation. It is unknown if it is an original feature but it is shown on the earliest Sanborn map of this block, which was produced in 1909. Its walls are finished with vinyl siding, and on the east and west elevations is a 6/6 wood window on the first floor and on the second floor is a small sash with muntins near the perimeter.
