ARCHITECTURAL/HISTORIC INVENTORY FORM

1. Survey No. SC-AS-009-001		2. Survey Name: St. Charles Survey Phase 3: Mid-Town and Commons Neighborhoods	
3. County: St. Charles		4. Address (Street No.) 128	Street (name) North Sixth Street
5. City: St. Charles	Vicinity: <input type="checkbox"/>	6. UTM:	
7. Township/Range/Section:		8. Historic name (if known): Meyer-Pieper House; The Meyerdorf	
9. Present/other name (if known):		10. Ownership: <input checked="" type="checkbox"/> Private <input type="checkbox"/> Public	
11a. Historic use (if known): Domestic/single dwelling		11b. Current use: Domestic/single dwelling

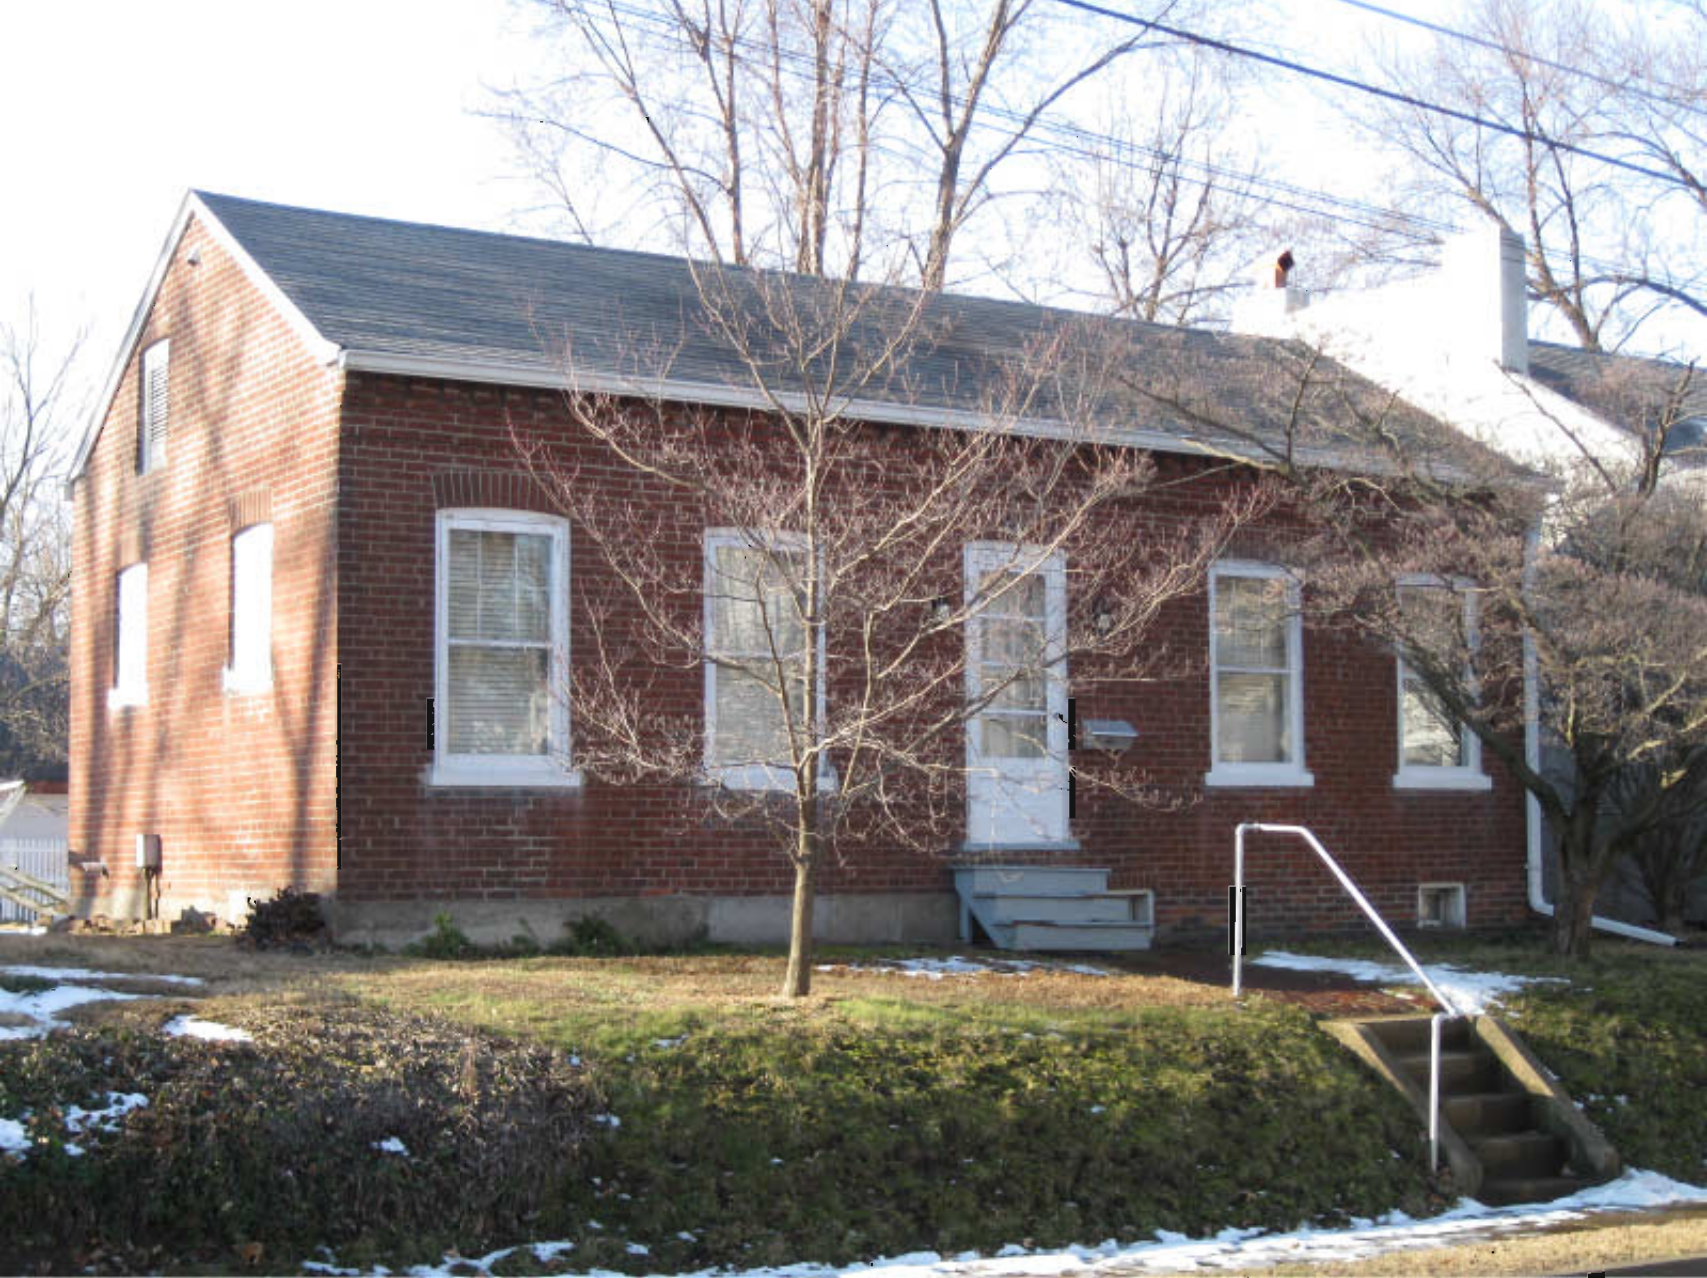
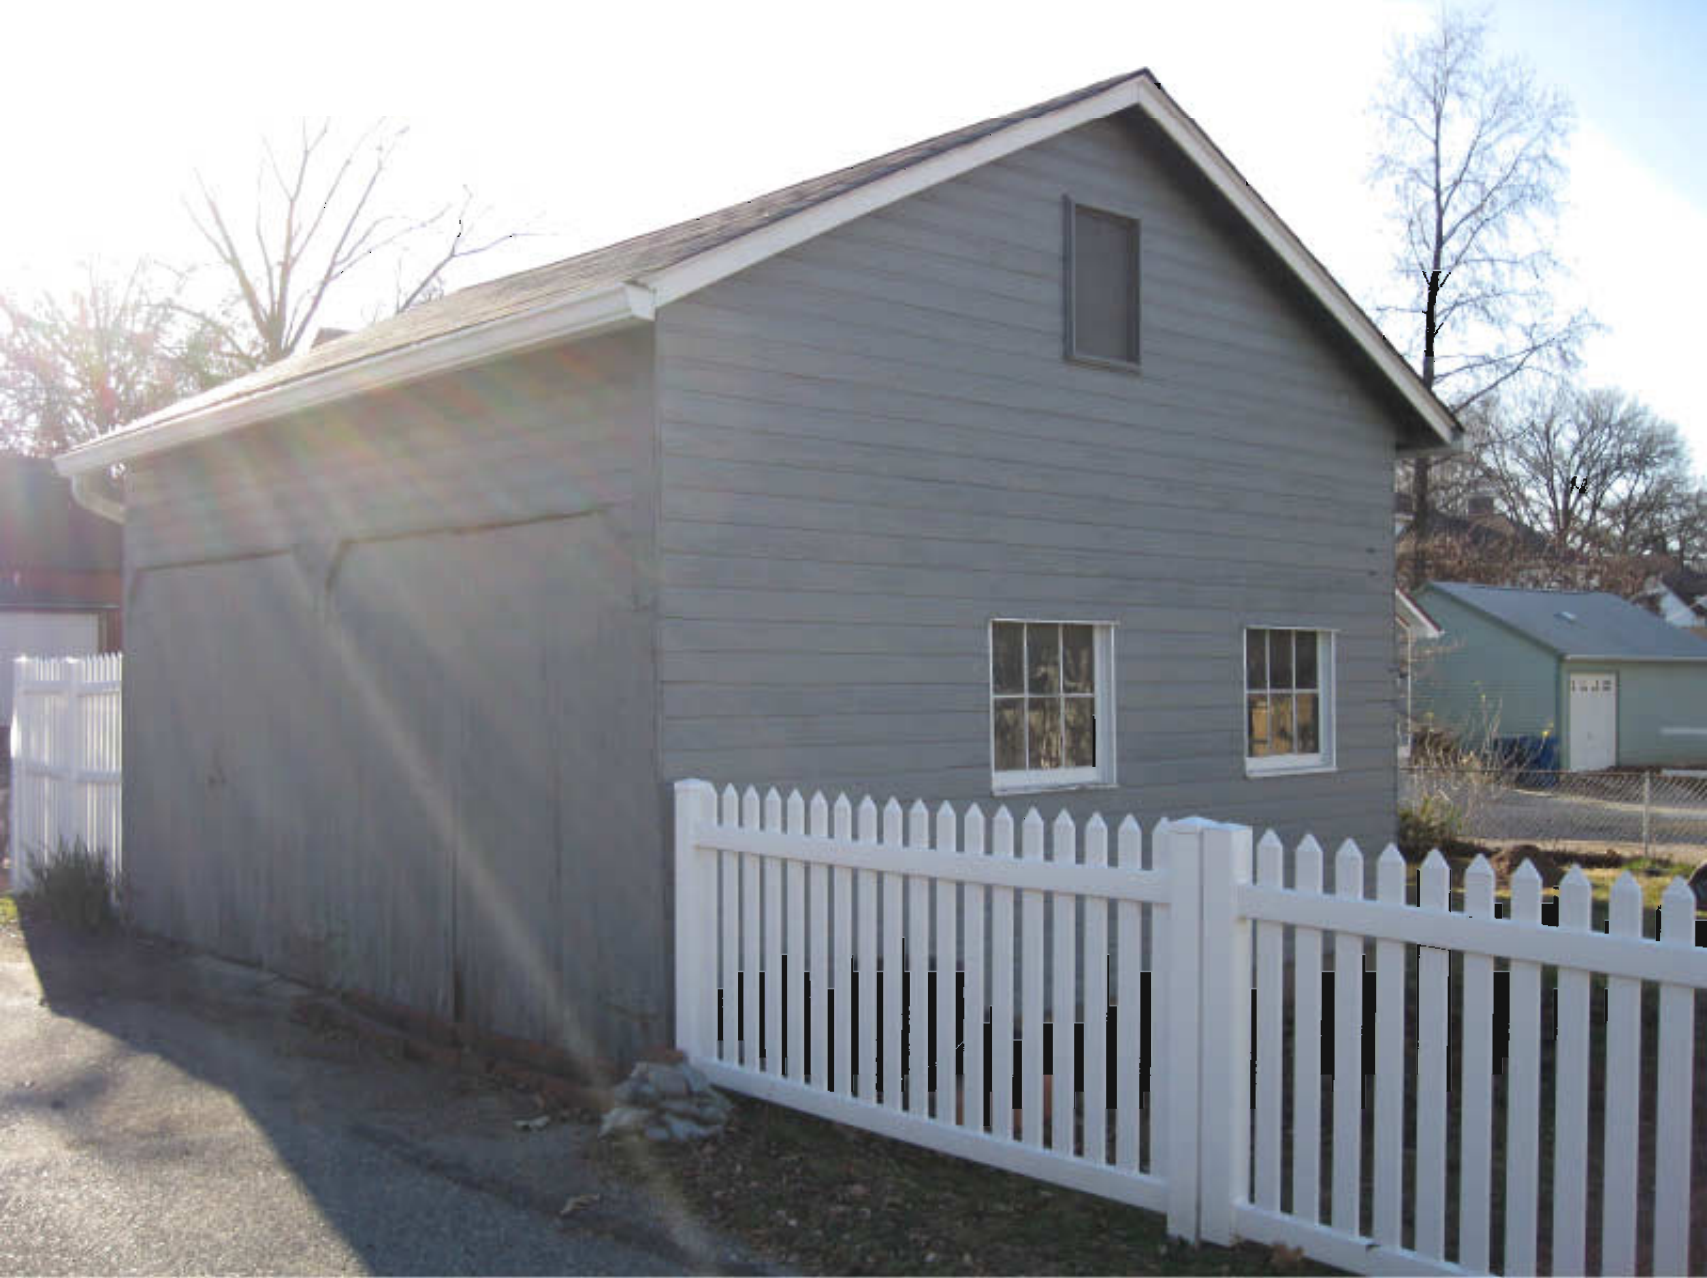
Facing north, this one-story, side-gabled, brick house rests on a brick foundation that has been partially parged. The brick portion of the house is L-shaped, and a frame addition is along the south and east sides of the rear ell (the house retains an L-shape). Single-light basement windows are on the west half of the façade and west elevation, and they are topped by flat jack arches. The brick walls are laid in a five-course common bond, and the medium-pitched roof is trimmed with a denticulated entablature. The five-bay main façade has a central 12-light wood door with a wood storm door having four horizontal lights, and the doors open onto a wooden stairway. To each side of the entrance are two 6/1 wood windows with wood lug sills. Although the windows do not appear to be original, they are historic alterations. Openings throughout the house are segmental arched and topped by radiating voussoirs. The east elevation has two small windows that have muntins situated near the perimeter, and the storm windows have the same design. At the south end of the gable end is a hinged wooden ventilator. The west elevation has two windows that match those of the east elevation, and in the rear wing is what appears to be a 6/1 window.

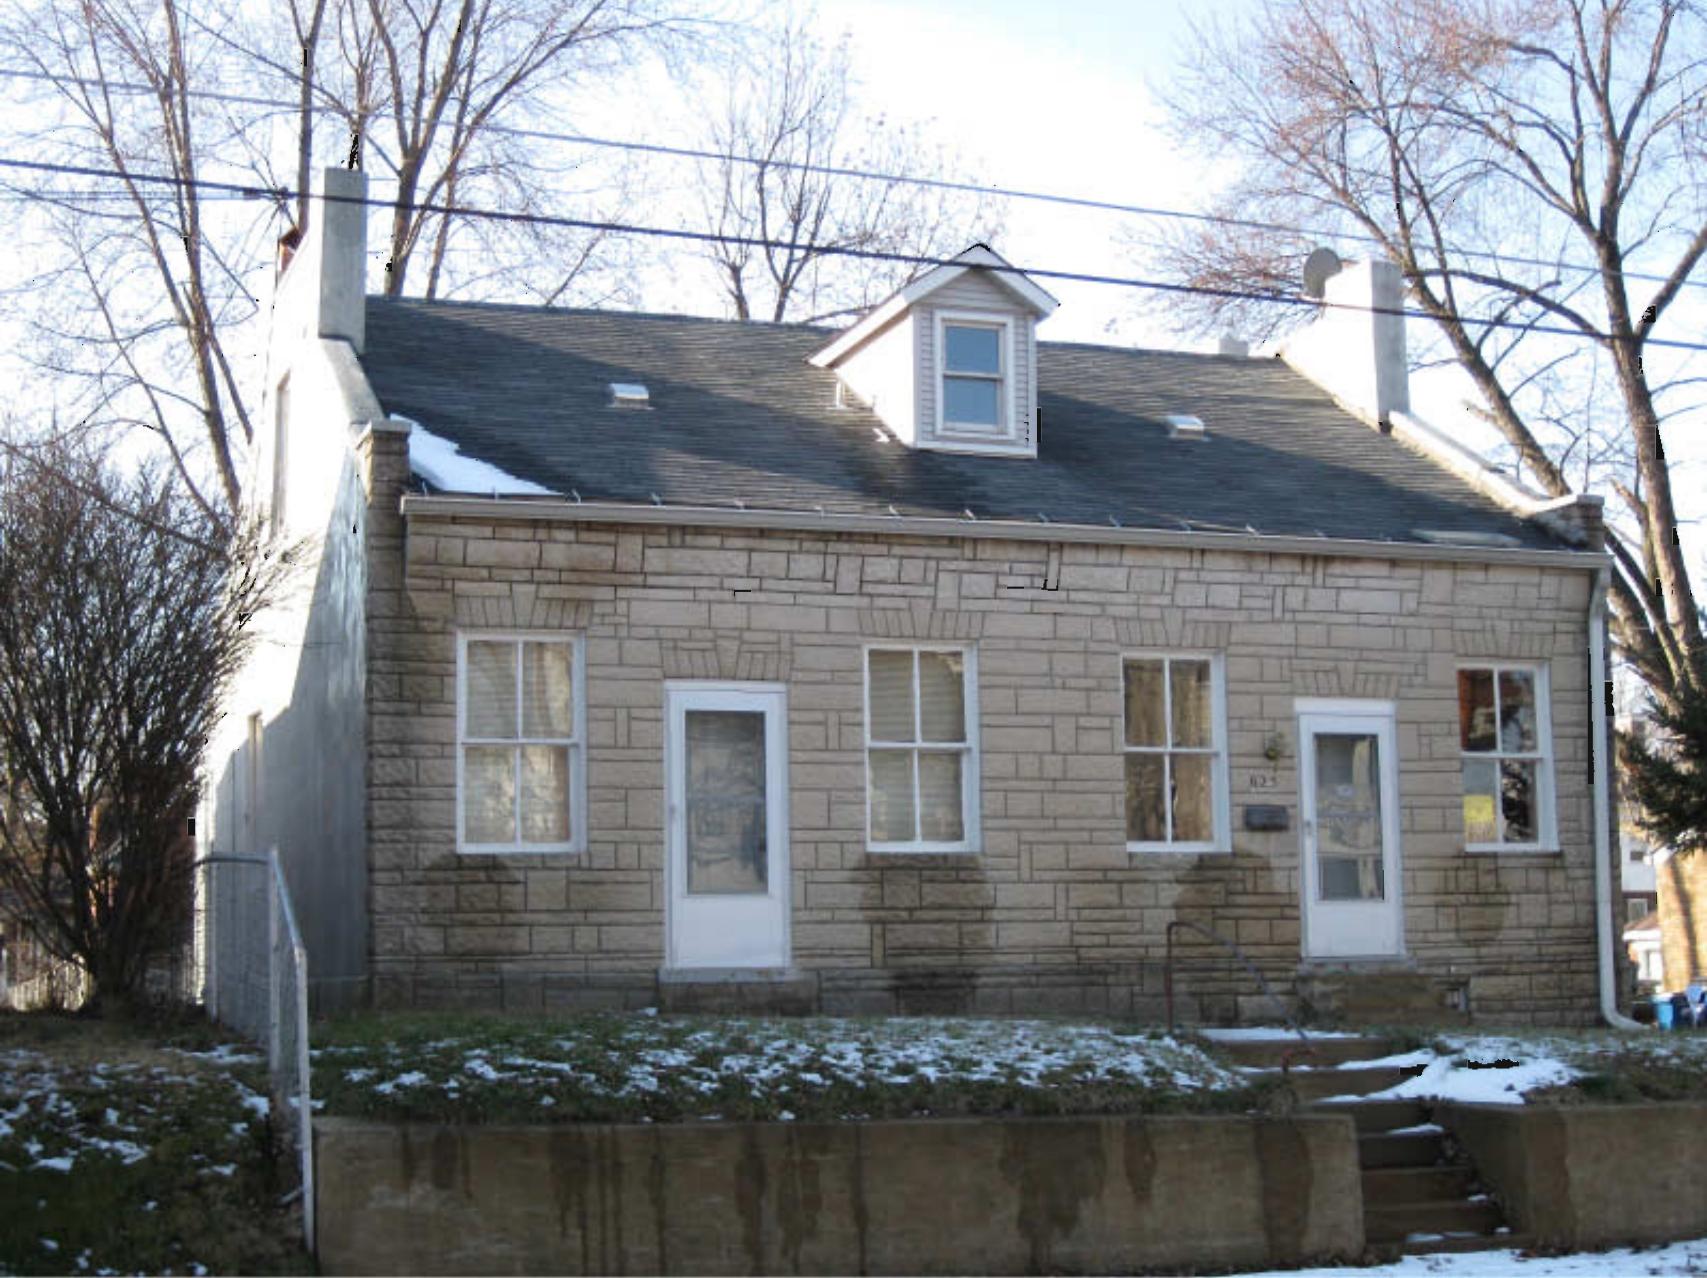
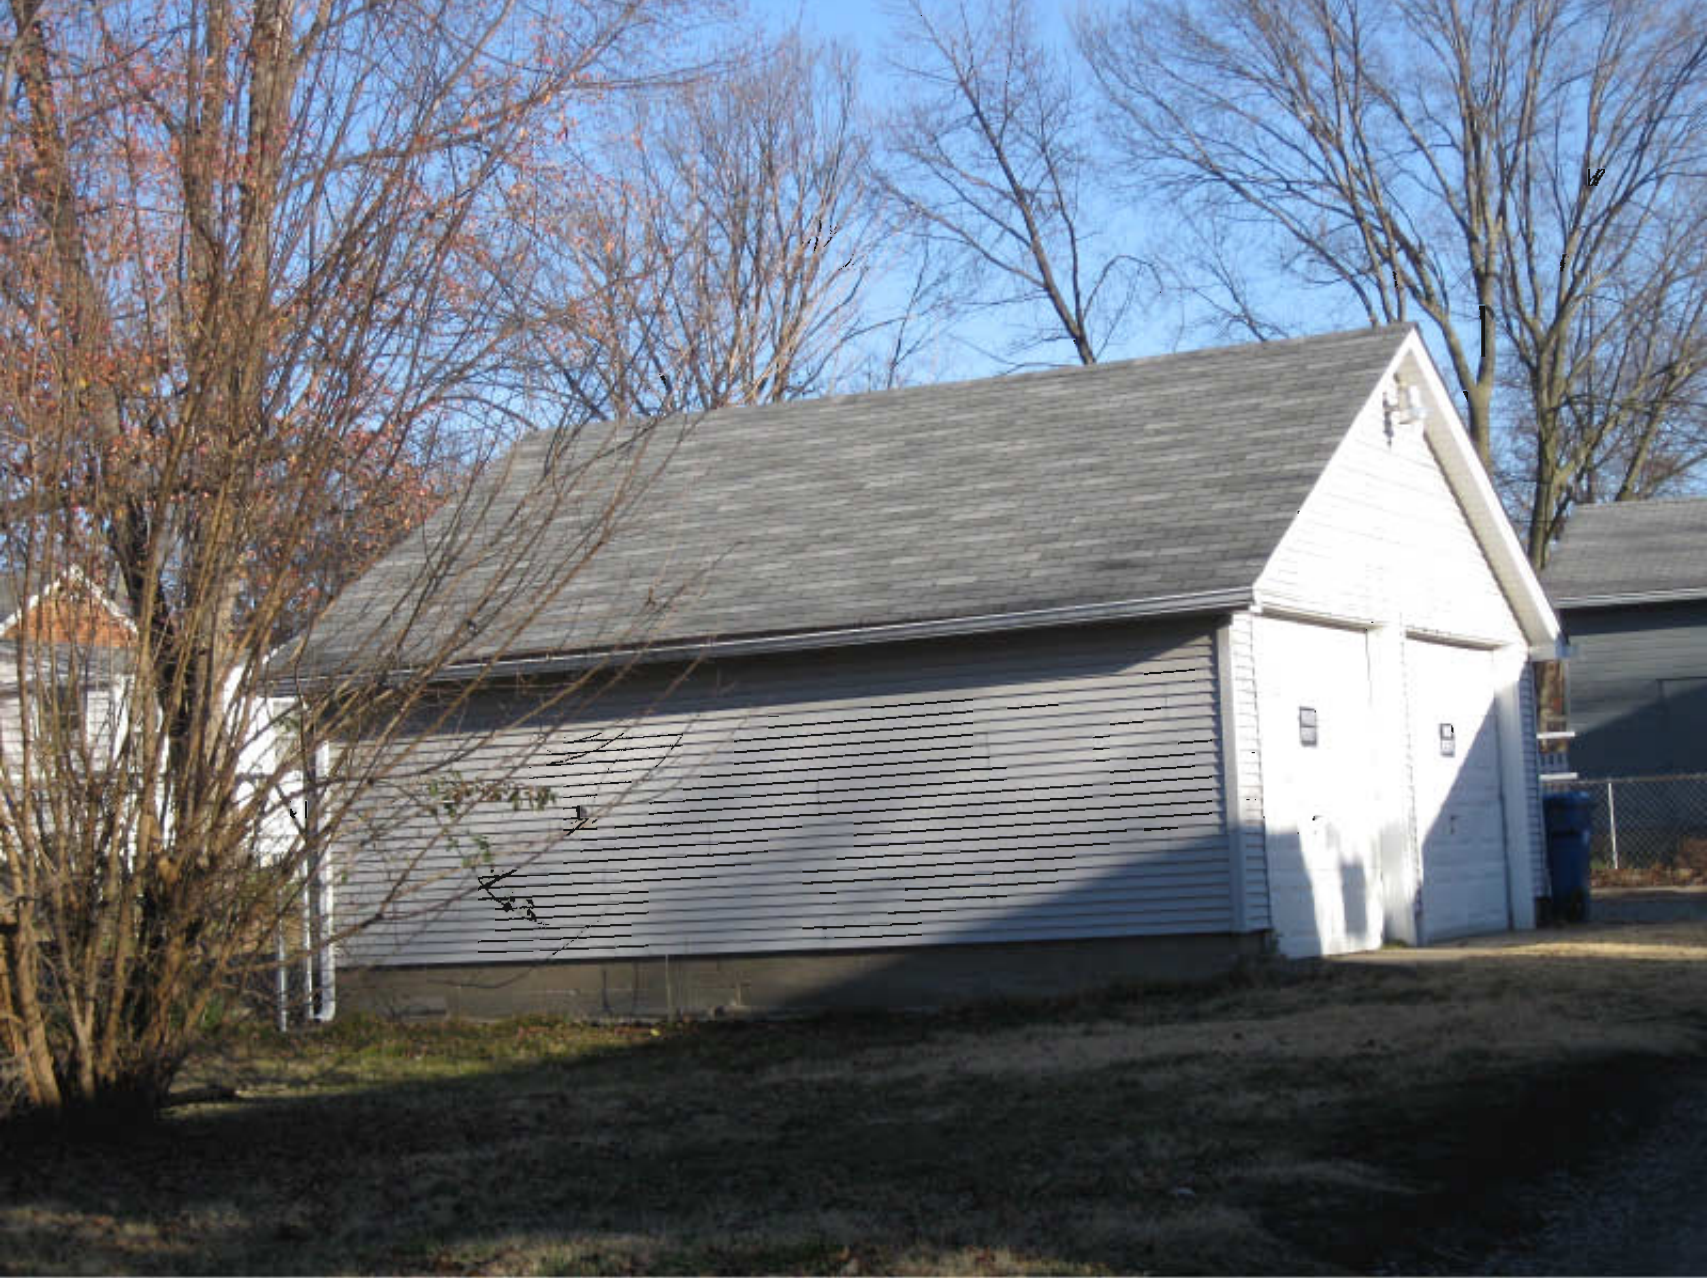
This one-and-one-half story, masonry house has a side-gabled roof with parapeted end walls, each with two chimneys, and a gabled dormer with 1/1 window is on the front slope of the roof. In the mid-20th century the front wall of the house was finished with simulated stone, similar to Perma-Stone. The side walls are stuccoed. The six-bay main façade (w-d-w-w-d-w) has two six-panel wood doors that open directly onto concrete steps, and windows are 2/2 wood sash. The west elevation has two 2/2 windows on the first floor and a 1/1 window in the upper half story. Since the simulated stone was likely added more than 50 years ago, the house is considered to be contributing.

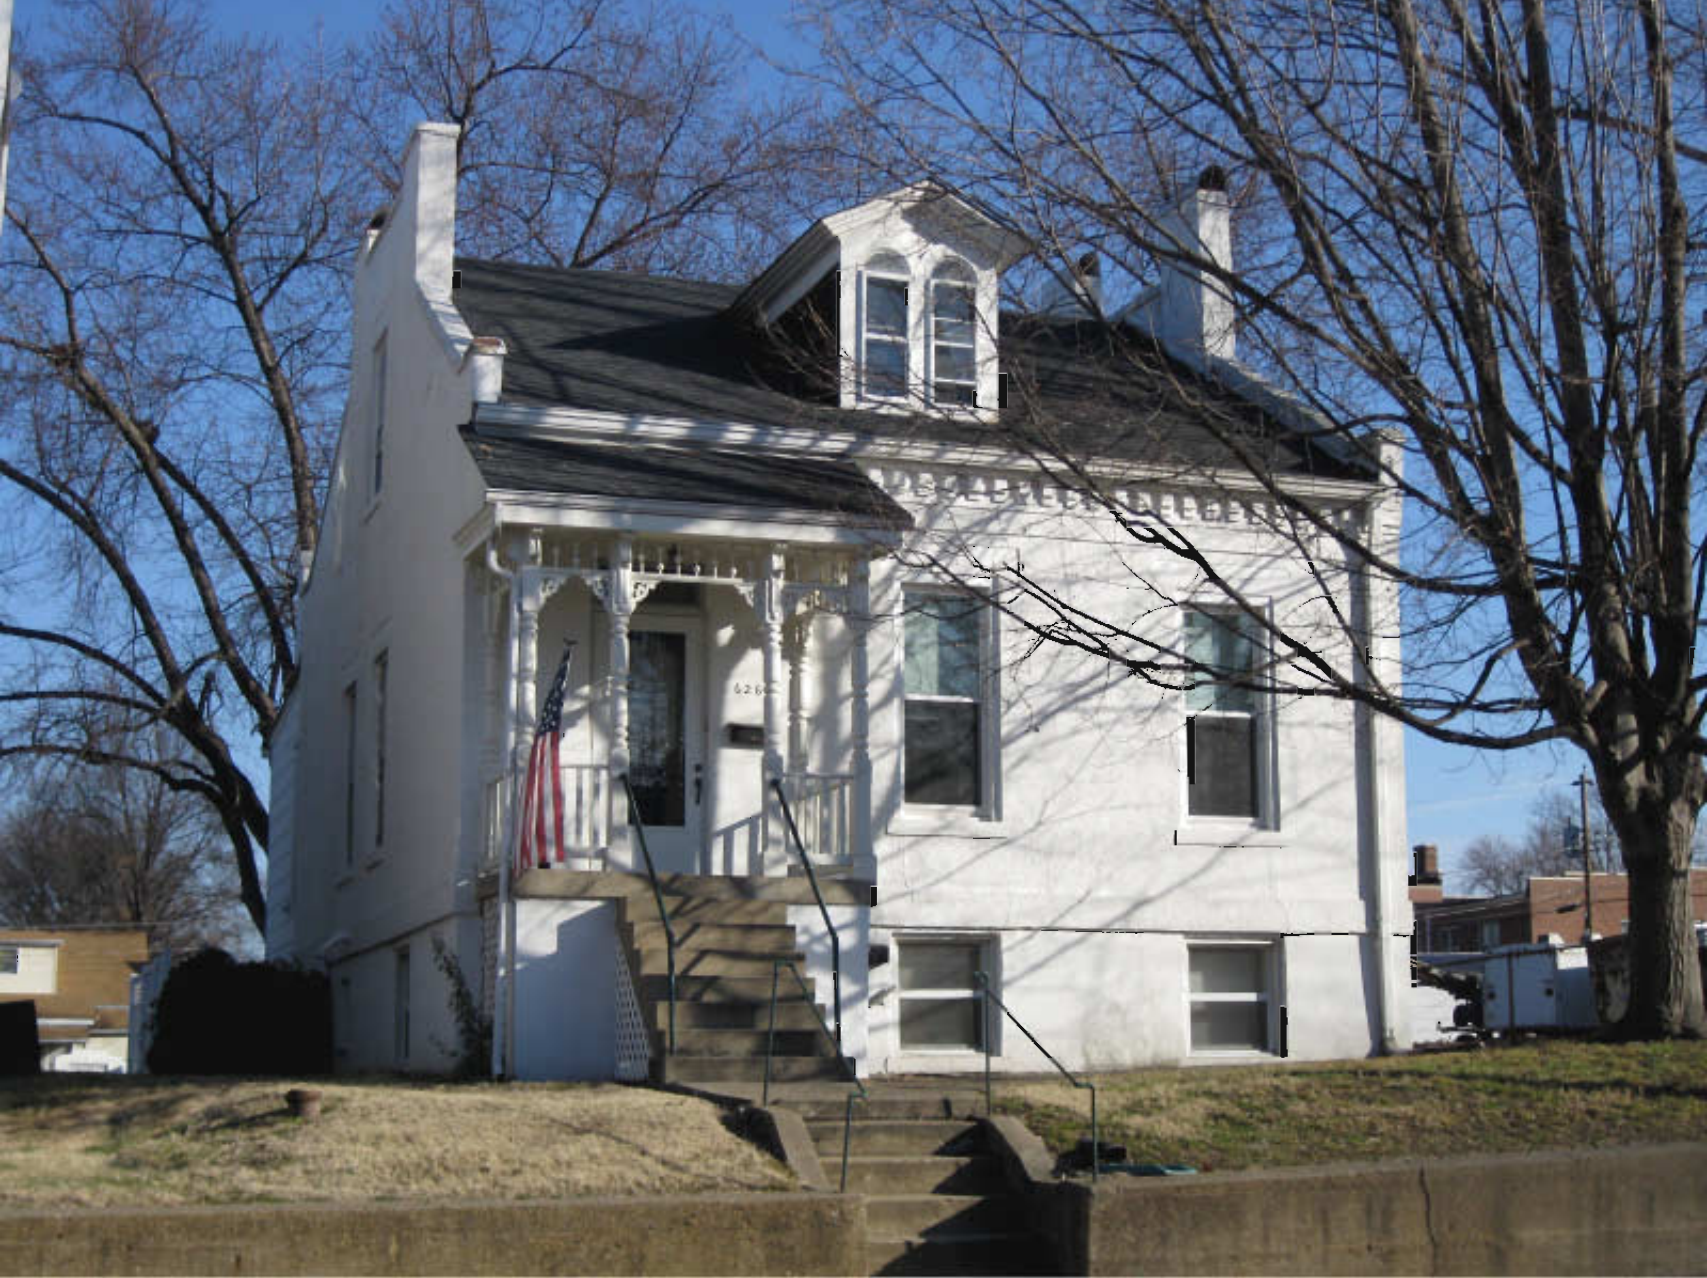
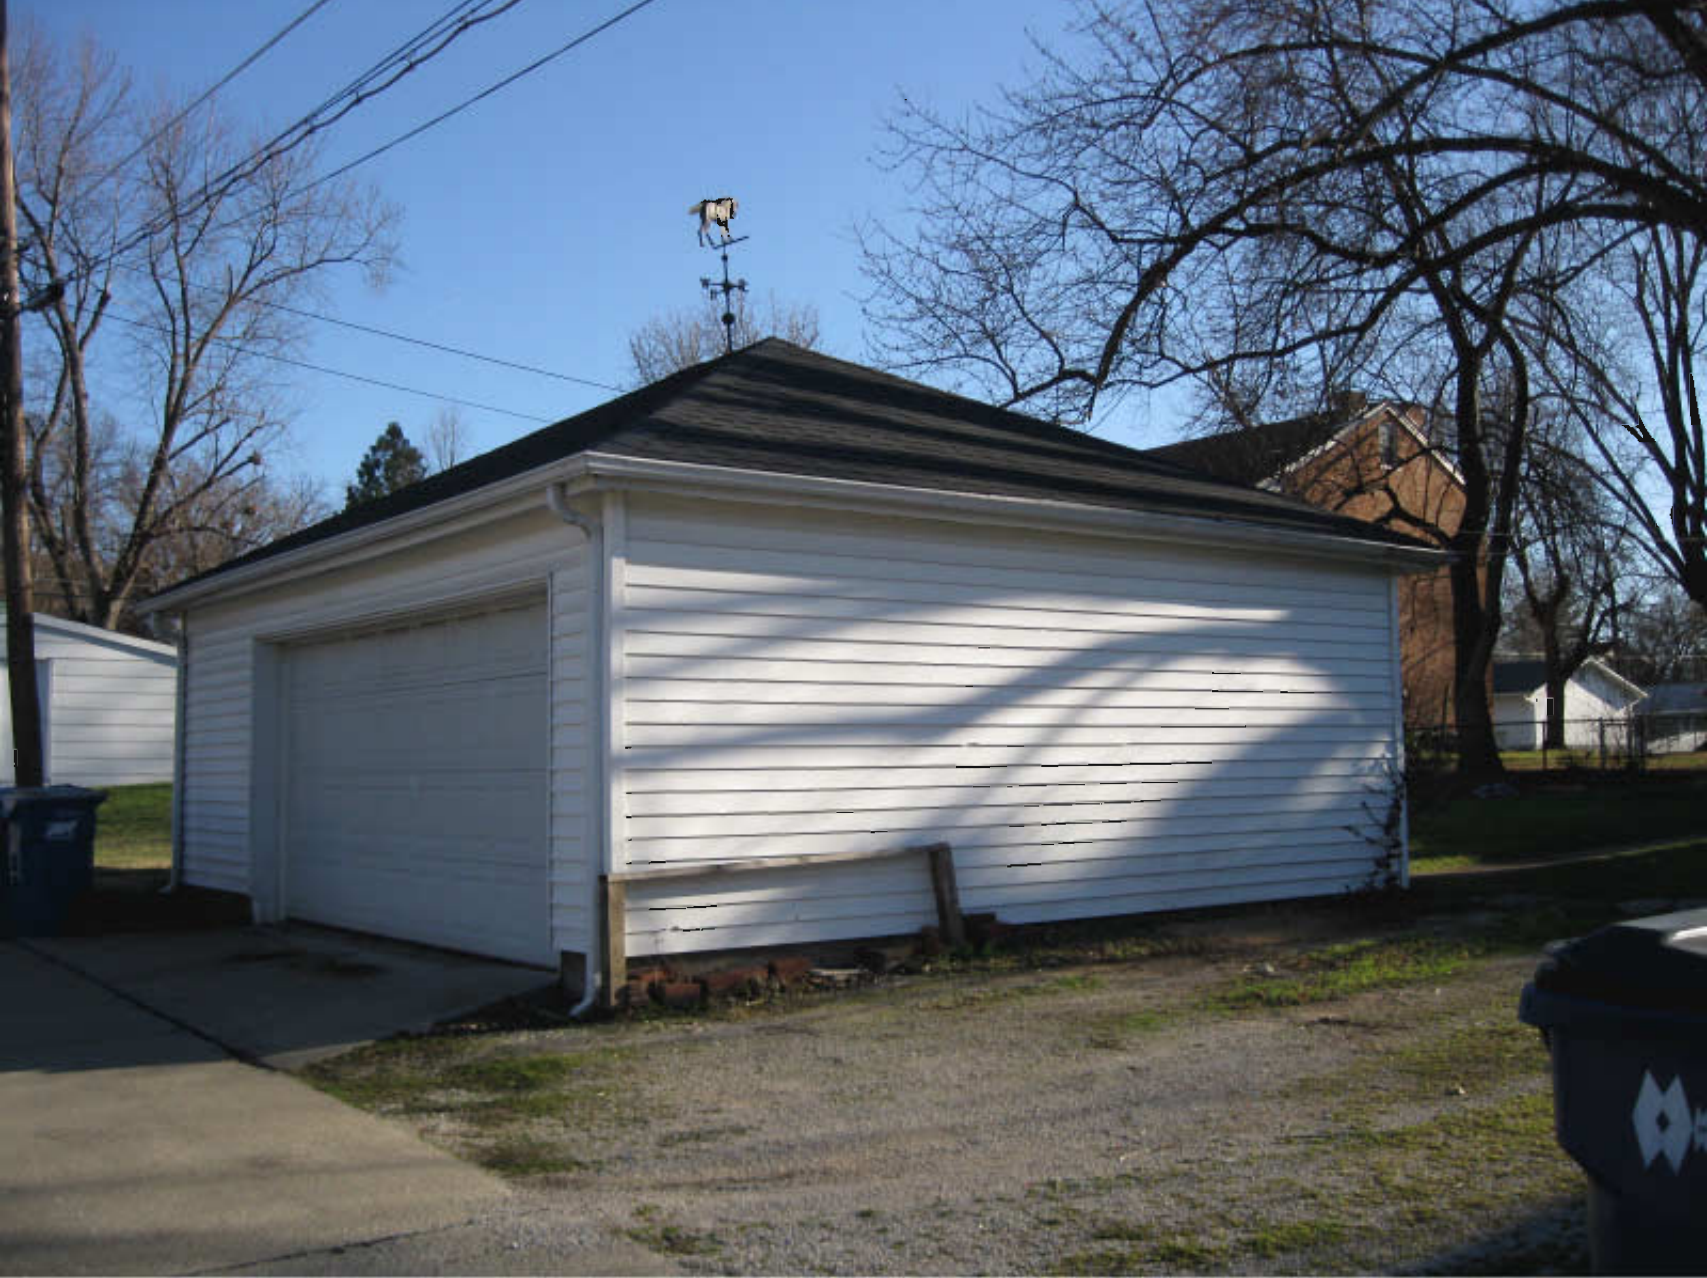
This one-and-one-half story, side-gabled, masonry, Federal style house has a raised basement. The walls of the house and foundation have been stuccoed, and there is a projecting water table that is also stuccoed. The side-gabled roof has parapeted end walls, each with paired chimneys. The roof is trimmed with a denticulated entablature, and on the front slope is a gabled dormer with paired round-arched openings containing single-light fanlights and 1/1 windows. Windows throughout the house are replacements. The three-bay main façade has two 1/1 windows and an entrance at the west end of both the basement level and first floor. The first floor the entrance is an ornate, half-glazed wood door topped by a single-light transom. The door opens onto a one-bay portico with stuccoed piers, concrete stairway having eight steps, concrete deck, plain wood balustrade, turned posts and half posts with corner brackets, a ball-and-rod spindled frieze, and a shed roof. To the east of the entrance are two 1/1 windows with wood lintels and lug sills. Both side elevations have two 1/1 windows on the basement level, two on the first floor, and one in the upper half story. A frame wing spans the rear elevation and has lapped siding, a 1/1 window on each side elevation, a shed roof, and stucco chimney.

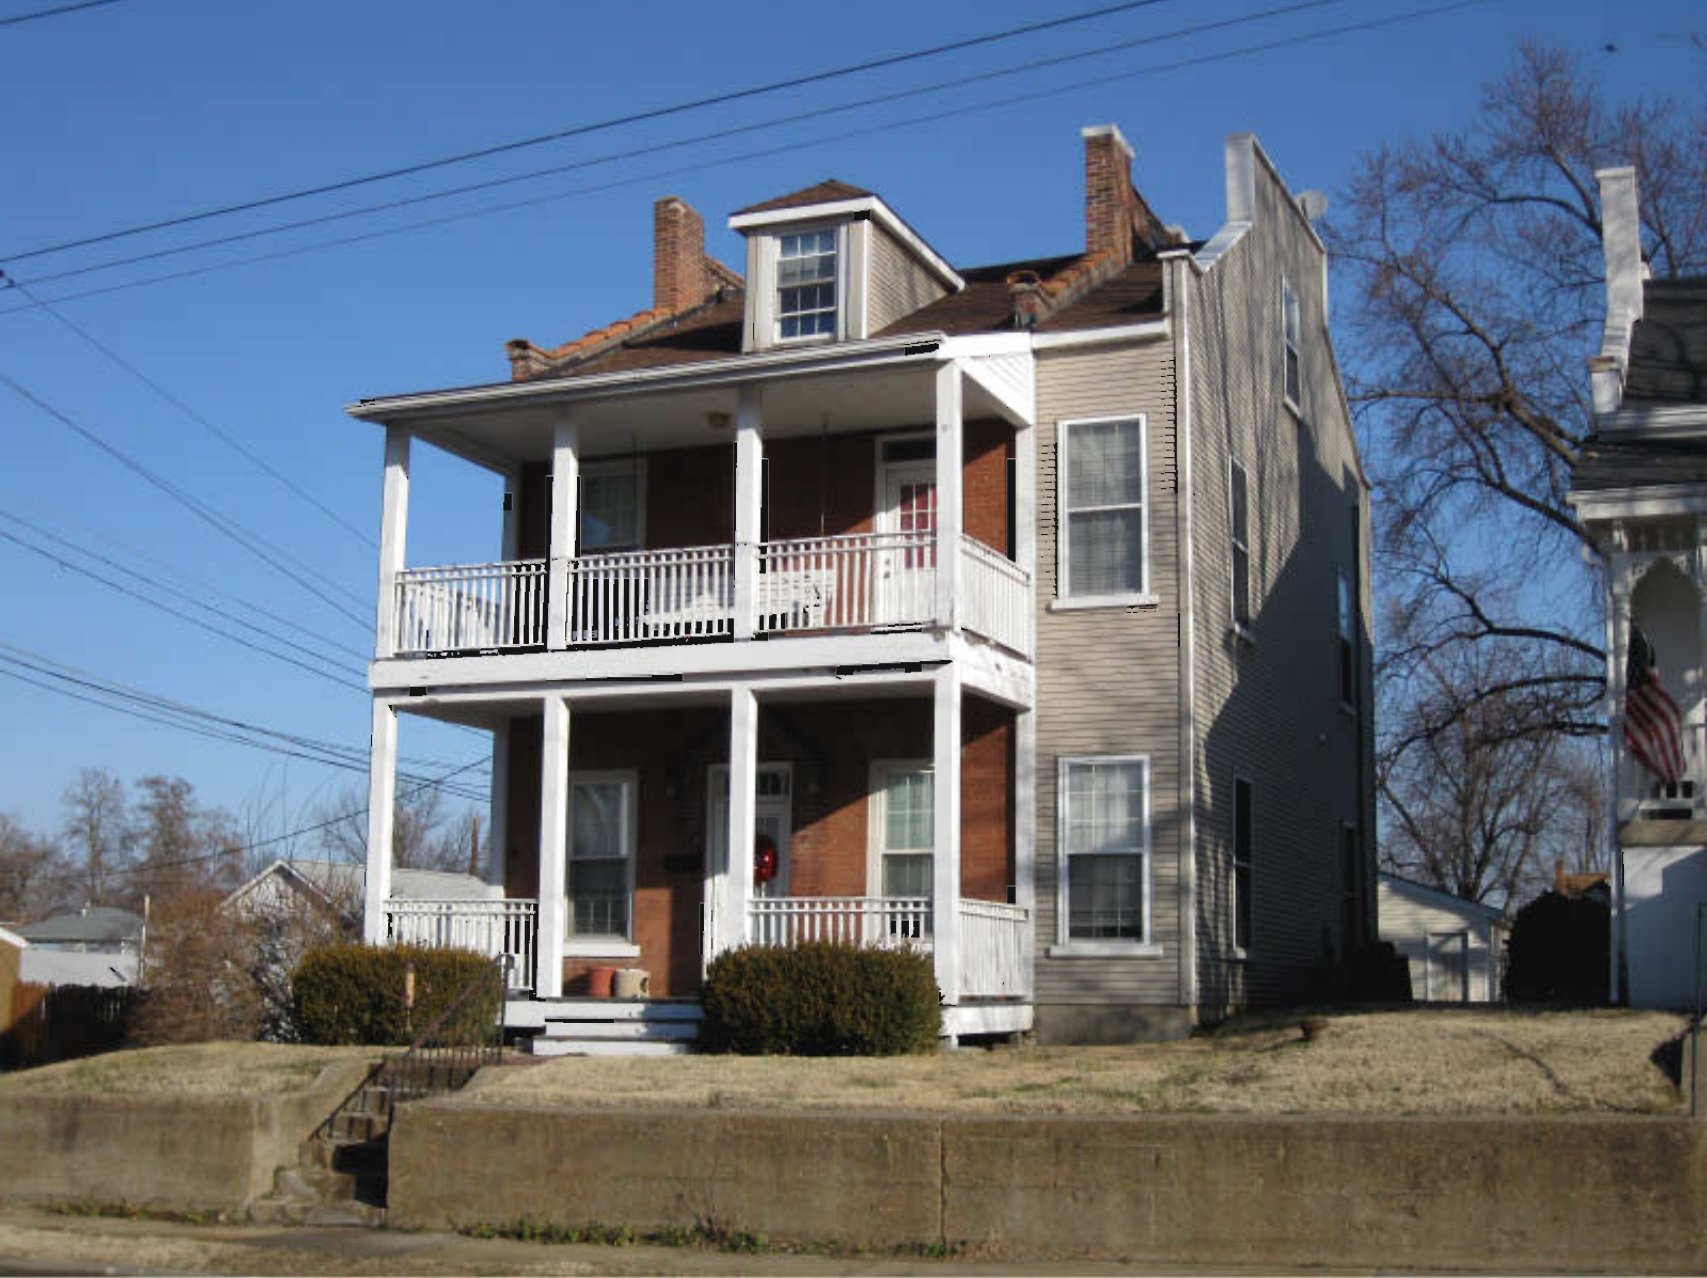
This two-and-one-half story, brick, side-gabled, Federal style house has parapeted end walls with paired chimneys, and on the front slope is a hipped dormer with a 6/6 window. This structure has been so extensively remodeled that it no longer contributes to the character of the district. A two-and-one-half story, one-bay wide, frame addition with parapeted end wall extends from the east elevation and is flush with the front wall of the house. The addition was built in 1994. The date the two-tiered gallery was constructed is not known, but it was after 1947. Windows throughout the house have also been replaced. The house rests on a coursed rock-faced stone foundation. The main façade has four bays (w-d-w-w), and the French door is topped by a six-light transom. To each side of the door is a 6/6 window and in the easternmost bay is a 9/9 window in the addition. The second floor has, from west to east, a 6/6 window, a half-glazed door topped by a transom, and a 9/9 window in the addition. The two-tier porch spans the three bays of the brick portion of the façade and features a wooden stairway and deck, plain balustrade with a secondary horizontal rail under the handrail, and plain posts supporting a shed roof. The west elevation has two windows on the first and second floors and one in the upper half story. The rear two-tier porch was enclosed in 1990.

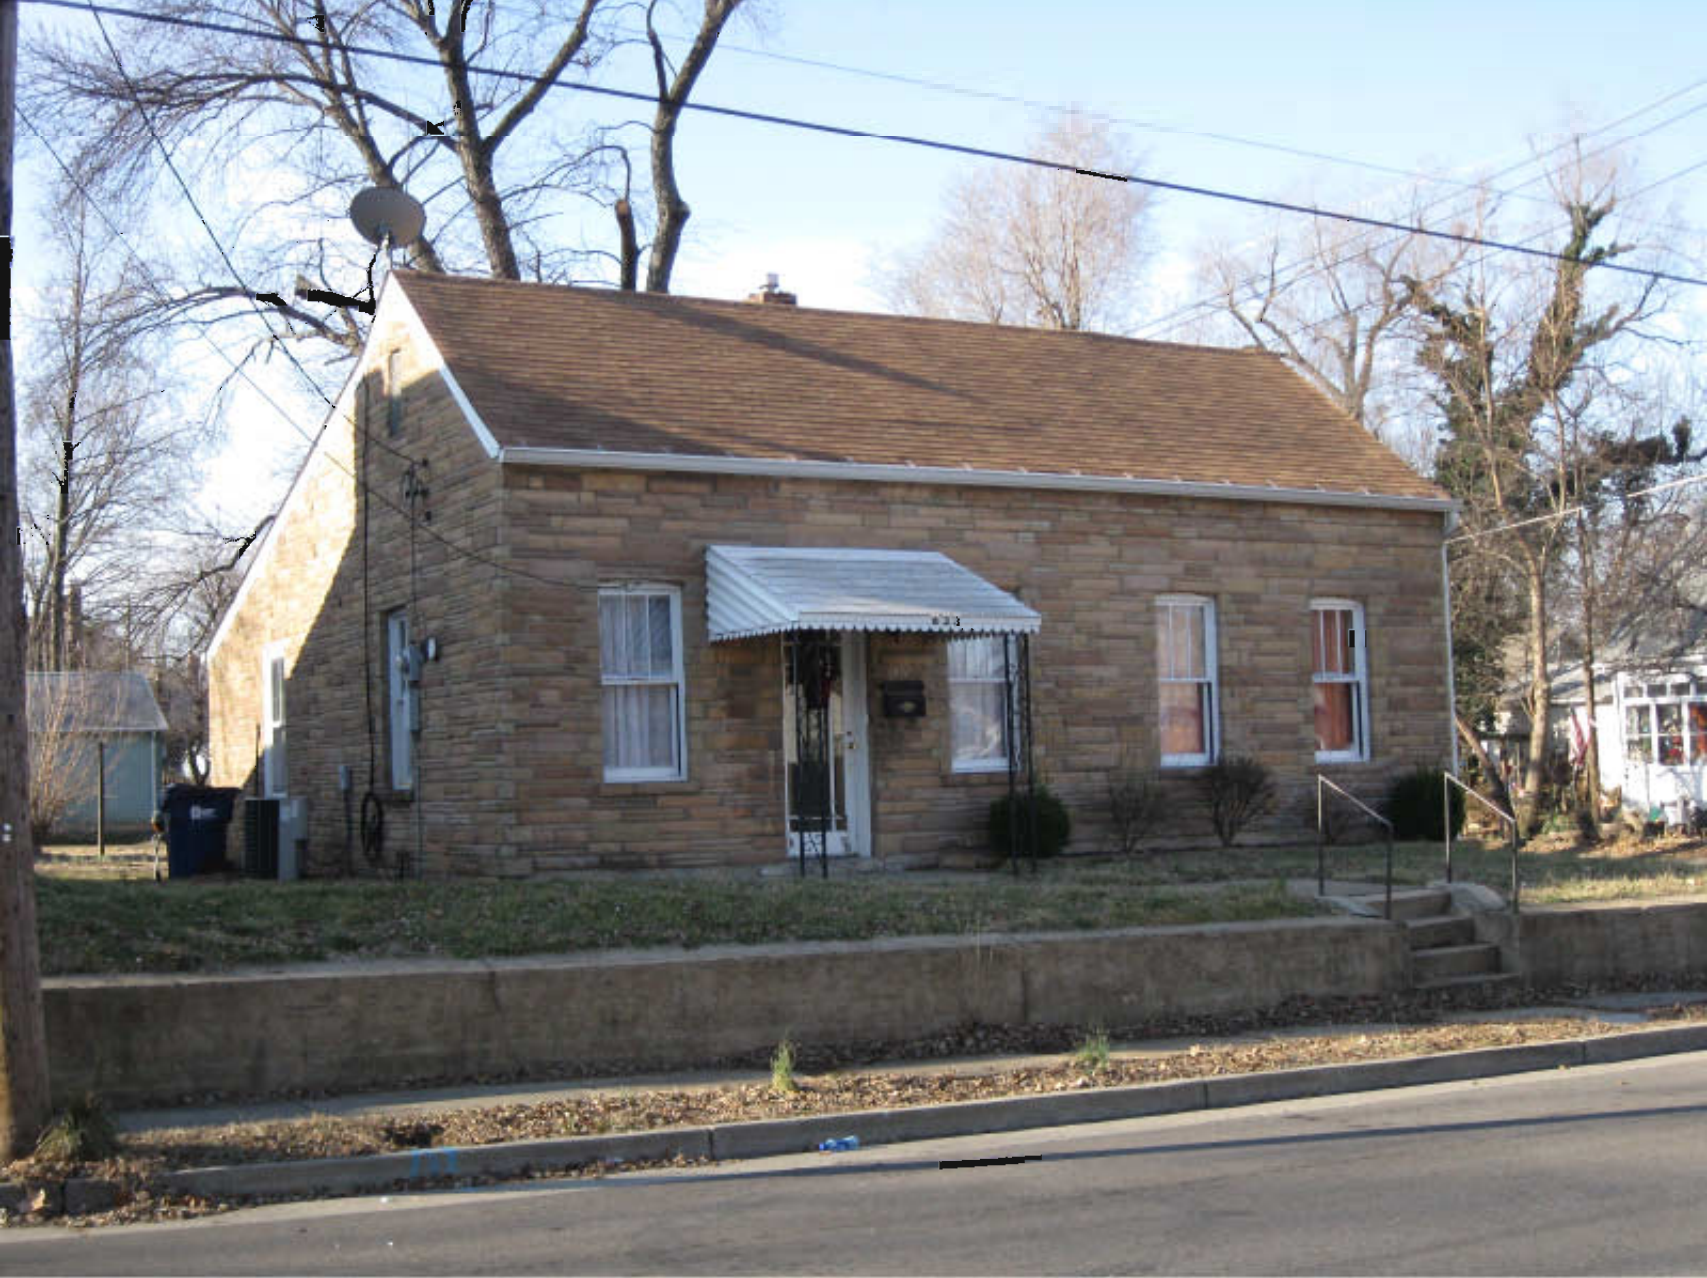
Situated at the southeast corner of Adams and Seventh Streets, this house is a one-story, side-gabled, masonry structure. The house was originally L-shaped, with a porch that extended from the east wall of the ell across the east end of the rear elevation. However, sometime after 1947 the rear porch was enclosed, giving the house a rectangular plan. The walls of the house, including the enclosed porch, were clad with simulated stone (Perma-Stone) sometime after 1947. In the second bay from the east, the five-bay main façade has a glazed wood door that has muntins set near the perimeter of the glass. The door opens onto a concrete stoop at ground level, and a metal shed awning supported by wrought iron posts have been added. To the east of the entrance is a 3/1 wood window and to the west are three 3/1 windows. The west elevation has paired 3/1 windows and a single 3/1 window, and the east elevation has two 3/1 windows, one of which is in the enclosed porch. Since the simulated stone was likely added more than 50 years ago, the house is considered to be contributing.

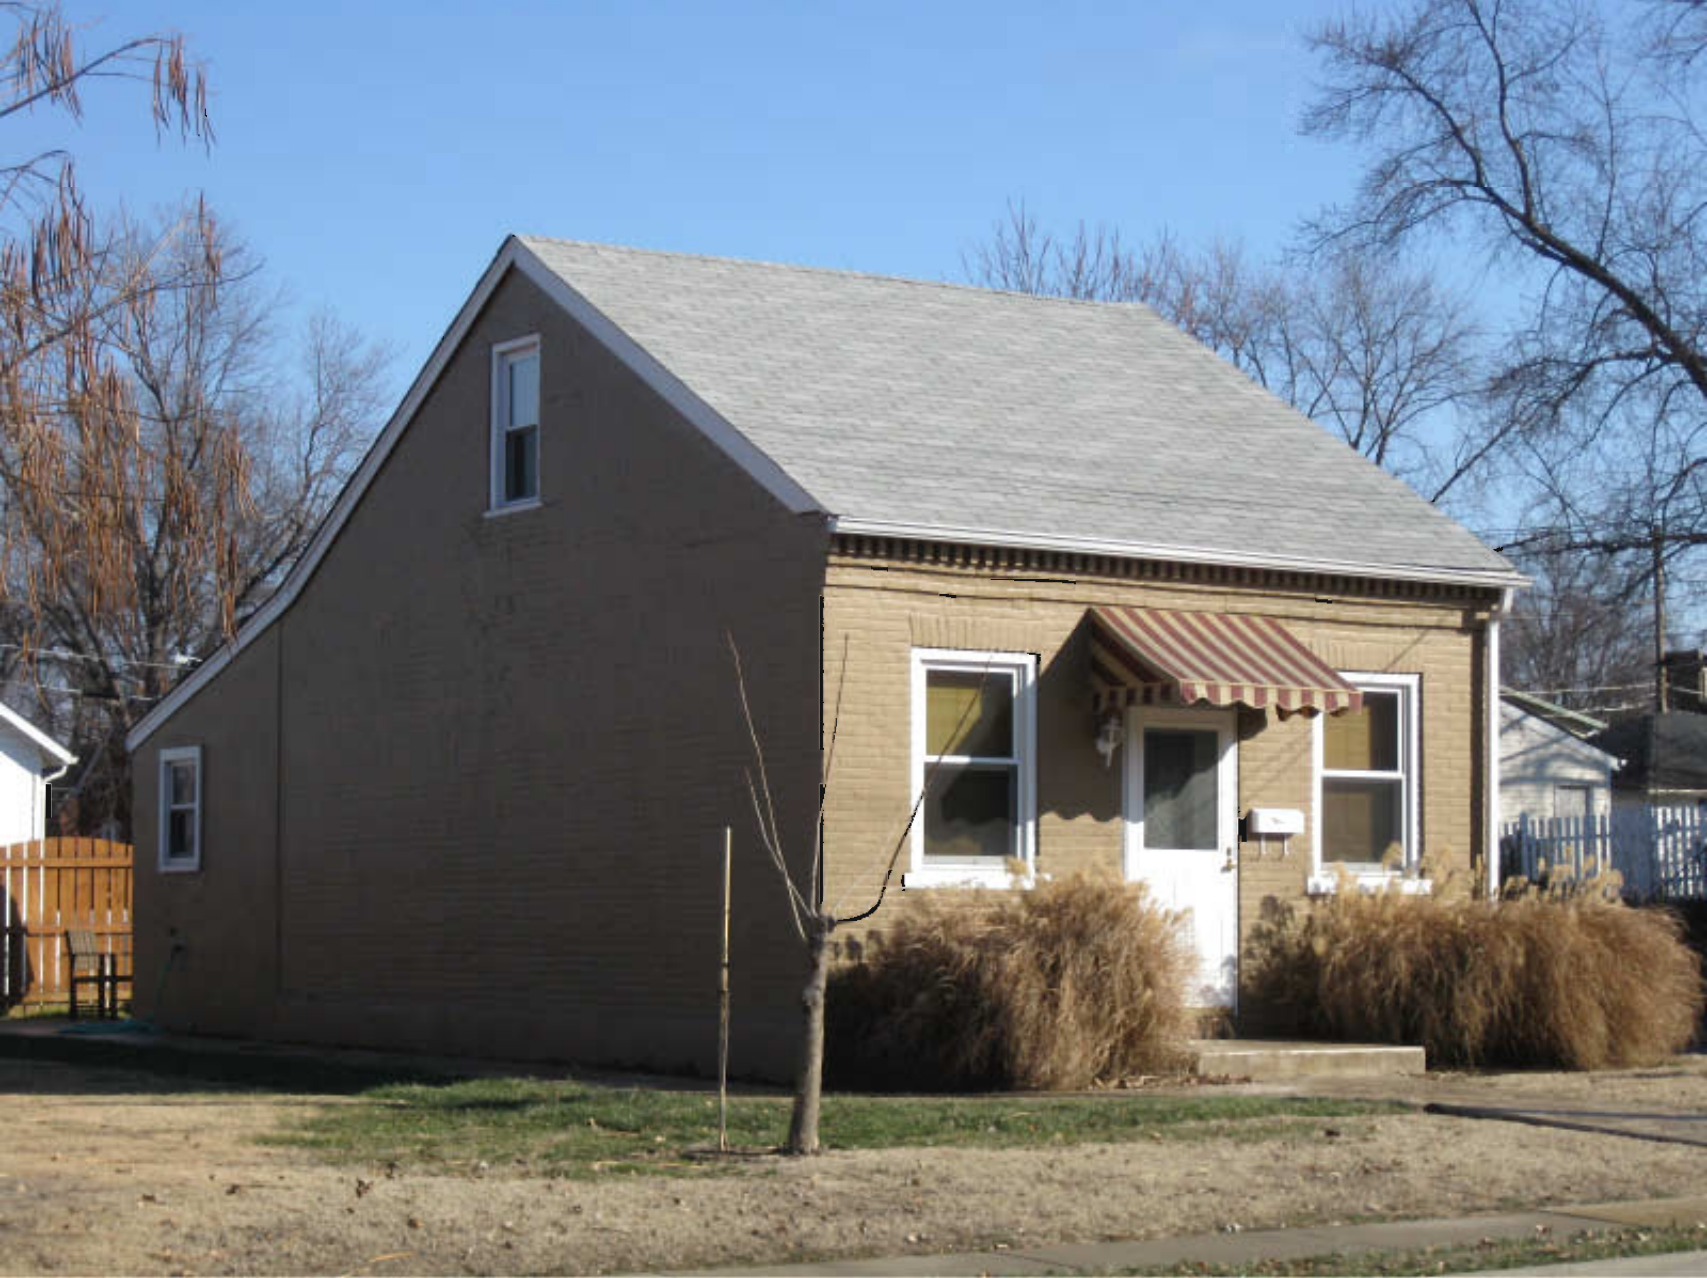
Located at the northwest corner of Adams and Seventh Streets, this small house is a one-and-one-half story, side-gabled, brick, Federal style structure. The foundation has been parged and the brick walls, which have been painted, are in a running bond pattern on the main façade and a seven-course common bond on the other elevations. The high side-gabled roof is trimmed with a denticulated brick frieze. The three-bay main façade has a central entrance with a glazed door that is partially obscured by a half-glazed storm door, and the doors open onto a one-bay concrete stoop that is covered by a canvas awning. There is a transom above the door, but its pane configuration could not be determined due to the awning. To each side of the entrance is a 1/1 window with wood lug sills and jack arches. Photographs from the 1940s and 1970s available on the Saint Charles County Historical Society's web site show that the windows had been 6/6 sash and they had louvered blinds. The photographs also show there was an interior end chimney on the east end of the front slope of the roof. Windows throughout the house have been replaced with 1/1 sash, and the porch that spanned the rear elevation was enclosed between 1917 and 1929 with stucco walls. The east elevation has a 1/1 window on the first floor and upper half story, and there is a small window in the enclosed rear porch (only the windows of the main façade have jack arches). A wood bulkhead on this elevation provides access to a cellar. The west elevation has a window in the enclosed porch and another in the upper half story.
