ARCHITECTURAL/HISTORIC INVENTORY FORM

1. Survey No. SC-AS-009-001		2. Survey Name: St. Charles Survey Phase 3: Mid-Town and Commons Neighborhoods	
3. County: St. Charles		4. Address (Street No.) 128	Street (name) North Sixth Street
5. City: St. Charles	Vicinity: <input type="checkbox"/>	6. UTM:	
7. Township/Range/Section:		8. Historic name (if known): Meyer-Pieper House; The Meyerdorf	
9. Present/other name (if known):		10. Ownership: <input checked="" type="checkbox"/> Private <input type="checkbox"/> Public	
11a. Historic use (if known): Domestic/single dwelling		11b. Current use: Domestic/single dwelling

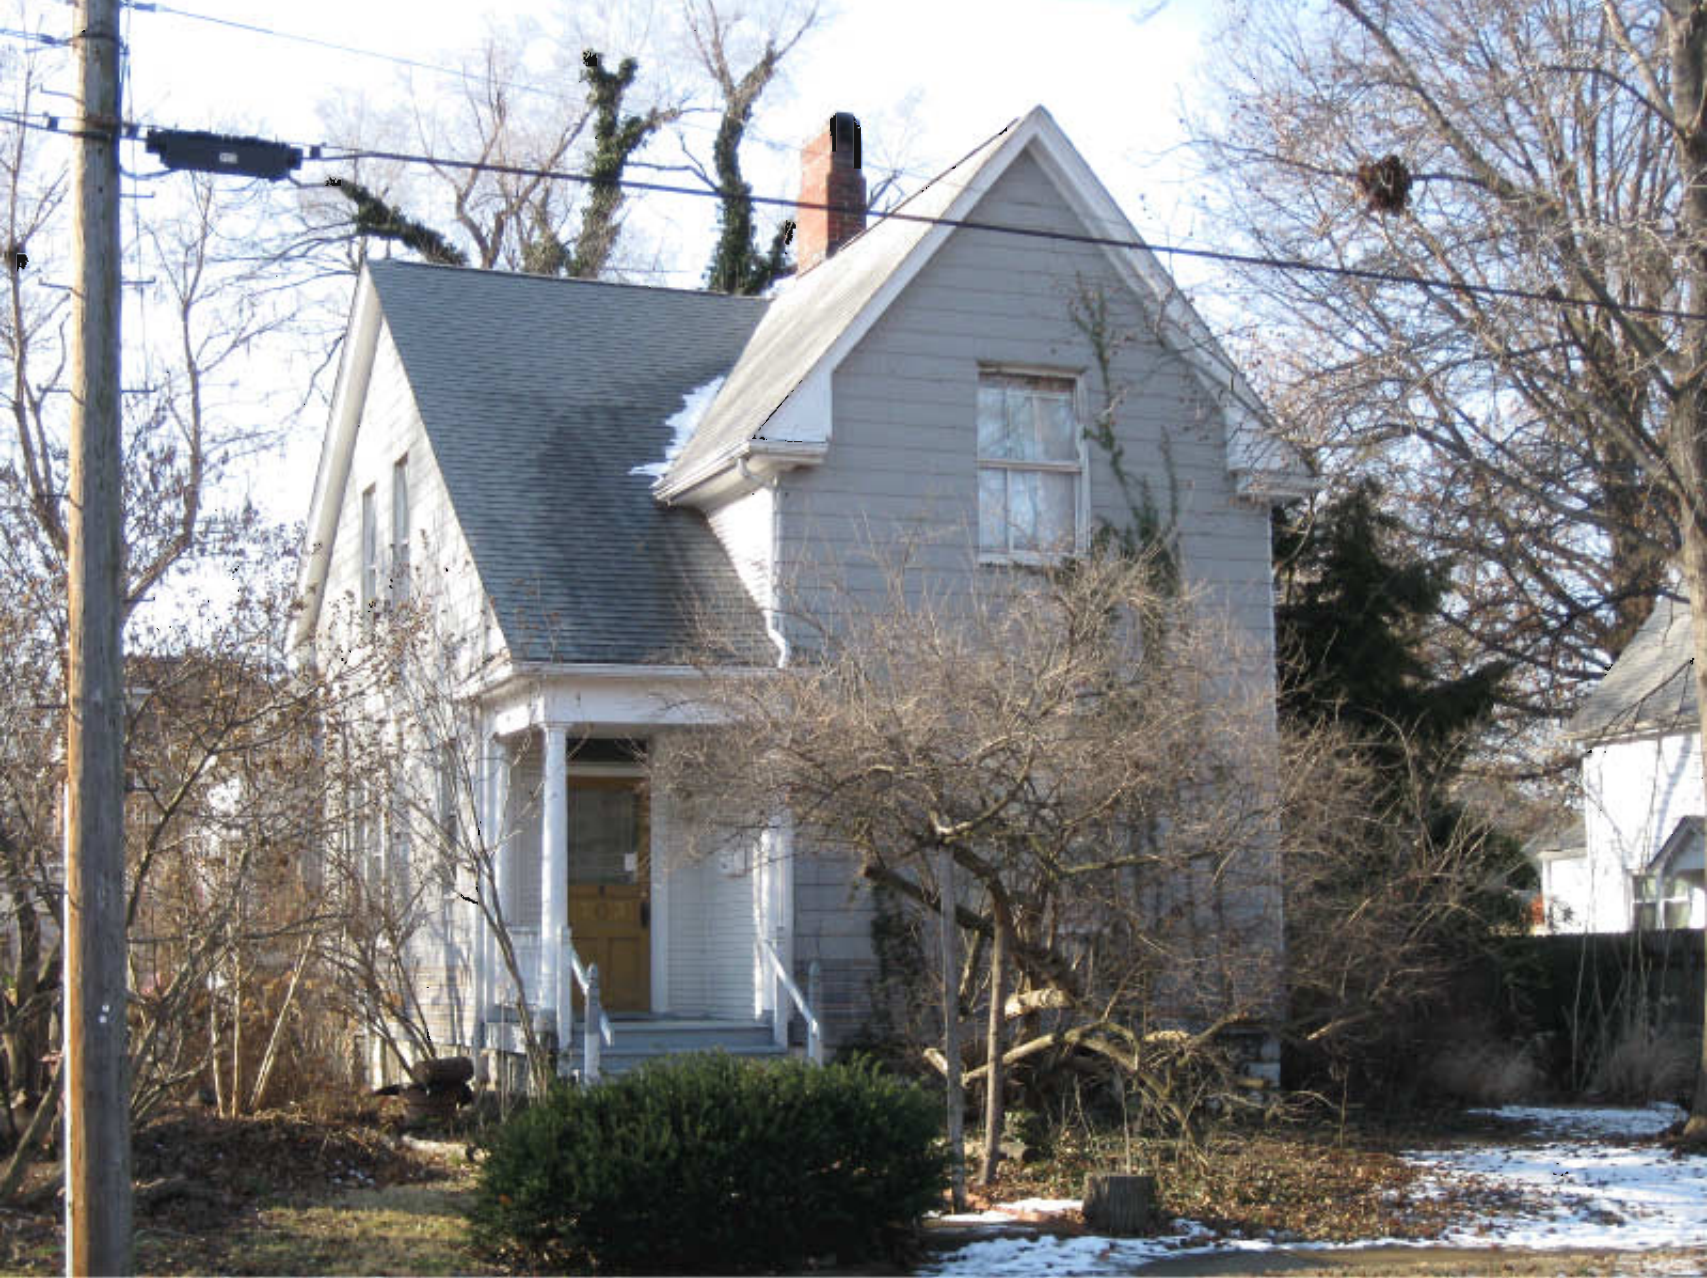
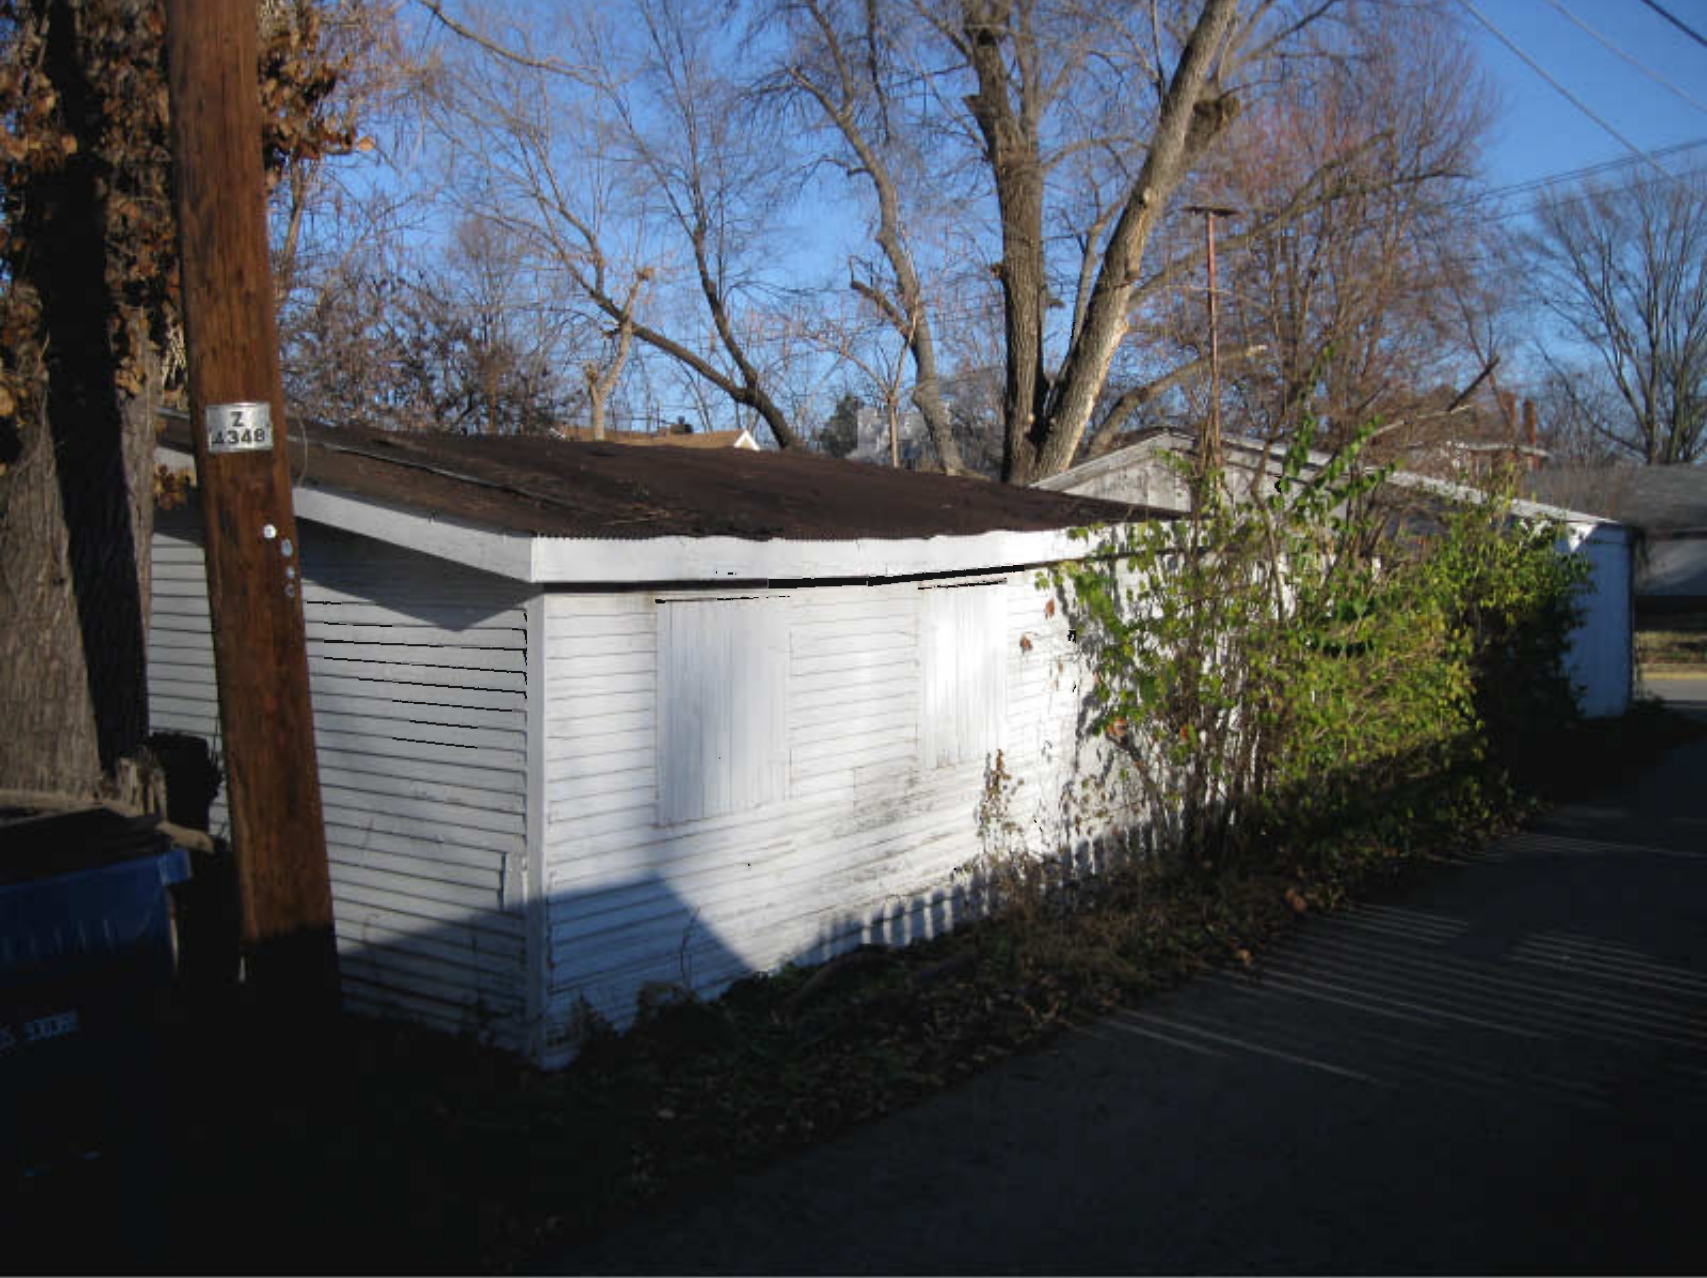
Situated at the southwest corner of Adams and Seventh Streets, this one-and-one-half story, frame house has a high side-gabled roof intersected by cross gables. The stone foundation is pierced by single-light basement windows, and the walls were originally finished with narrow weatherboard siding, but the siding is only exposed in the recessed porch at the northeast corner. The other walls are finished with a combination of asphalt siding in a stone pattern, which is placed on the lower walls, and cement asbestos shingles. The steeply-pitched, cross-gabled roof has cornice returns, and a brick chimney straddles the ridge of the front gable and an interior brick chimney is on the east slope of the rear gable. The two-bay main façade has a half-glazed, three-panel wood door in the east bay, and it is topped by a single-light transom. The door opens onto the recessed one-bay porch that has stone foundation piers in-filled with wooden lattice panels, a wooden stairway and deck, balustrade with turned balusters, and a Doric column and half columns supporting the roof. In the west bay of the first floor is a wide 1/1 wood window, and a narrower 3/3 replacement window with in-fill above is in the upper half story. The first floor of the east elevation has a central tripartite window composed of a 1/1 window flanked by narrow 1/1 windows. To each side of the tripartite window is a 1/1 window, and in the upper half story are two 1/1 windows. A porch at the southeast corner of the house projects beyond the east wall of the house, and the porch has been enclosed with bands of 1/1 windows topped by single-light transoms.

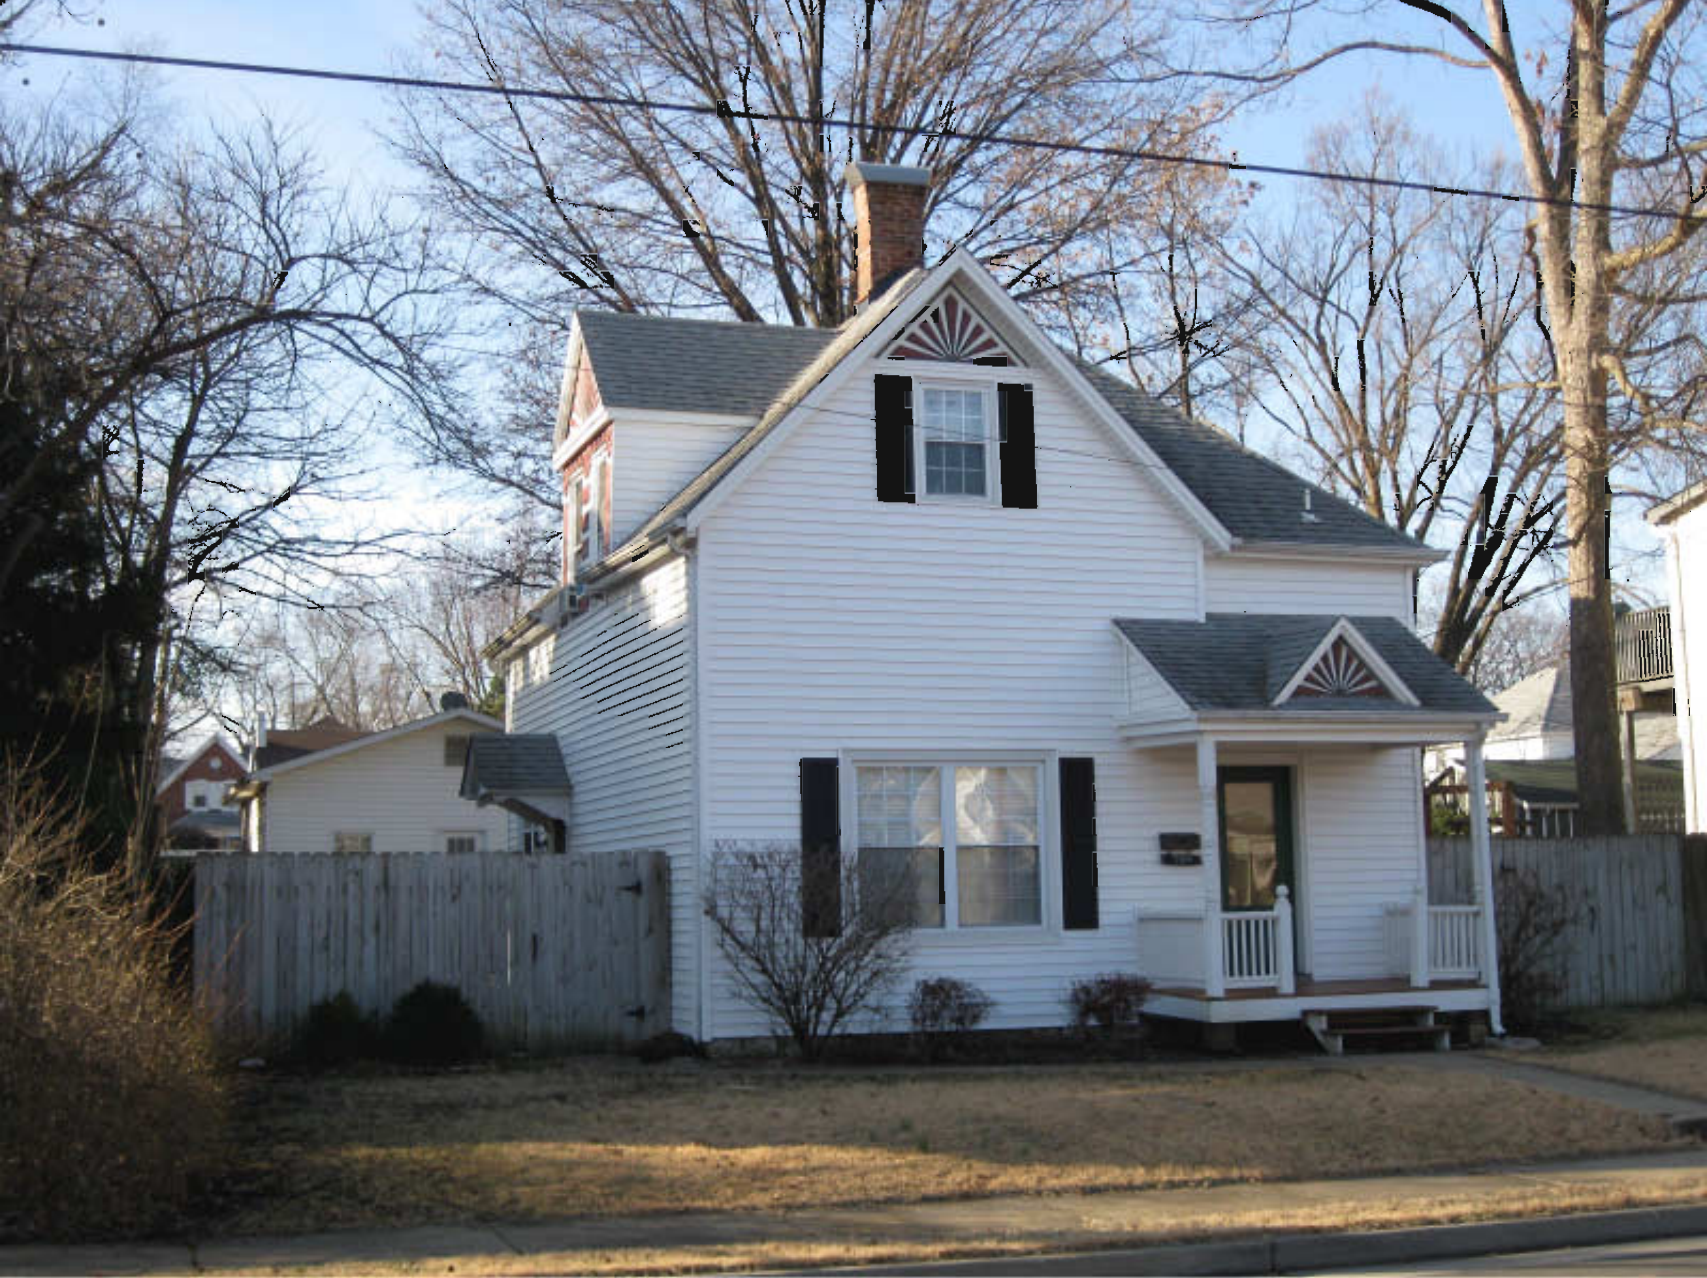
This one-and-one-half story, frame house rests on a coursed rock-faced stone foundation and is crowned by a high hip roof with intersecting cross gables. A brick chimney straddles the ridge of the hip roof, and in the front gable end is a sunburst ornament. A pedimented, gabled wall dormer intersects the east slope of the roof and features paired 9/9 windows with decorative trim, and the tympanum is filled with a sunburst ornament. The walls of the house have been clad with vinyl siding and the windows have been replaced with vinyl 9/9 and 6/6 sash (the openings may have been shortened). The first floor of the main façade has two bays: in the left bay is a pair of 9/9 windows and in the right bay is glazed metal door. The door opens onto a one-bay portico that has a wood deck, plain balustrade, and turned posts supporting a shed roof that has an intersecting gablet with a sunburst ornament in the gable end. The upper half story has a 6/6 window. The east elevation has an entrance protected by a gabled hood supported by brackets, and to the south is a pair of windows. The side elevations could not be easily seen due to a privacy fence. The house is noncontributing due to the installation of vinyl siding and the replacement of the windows.

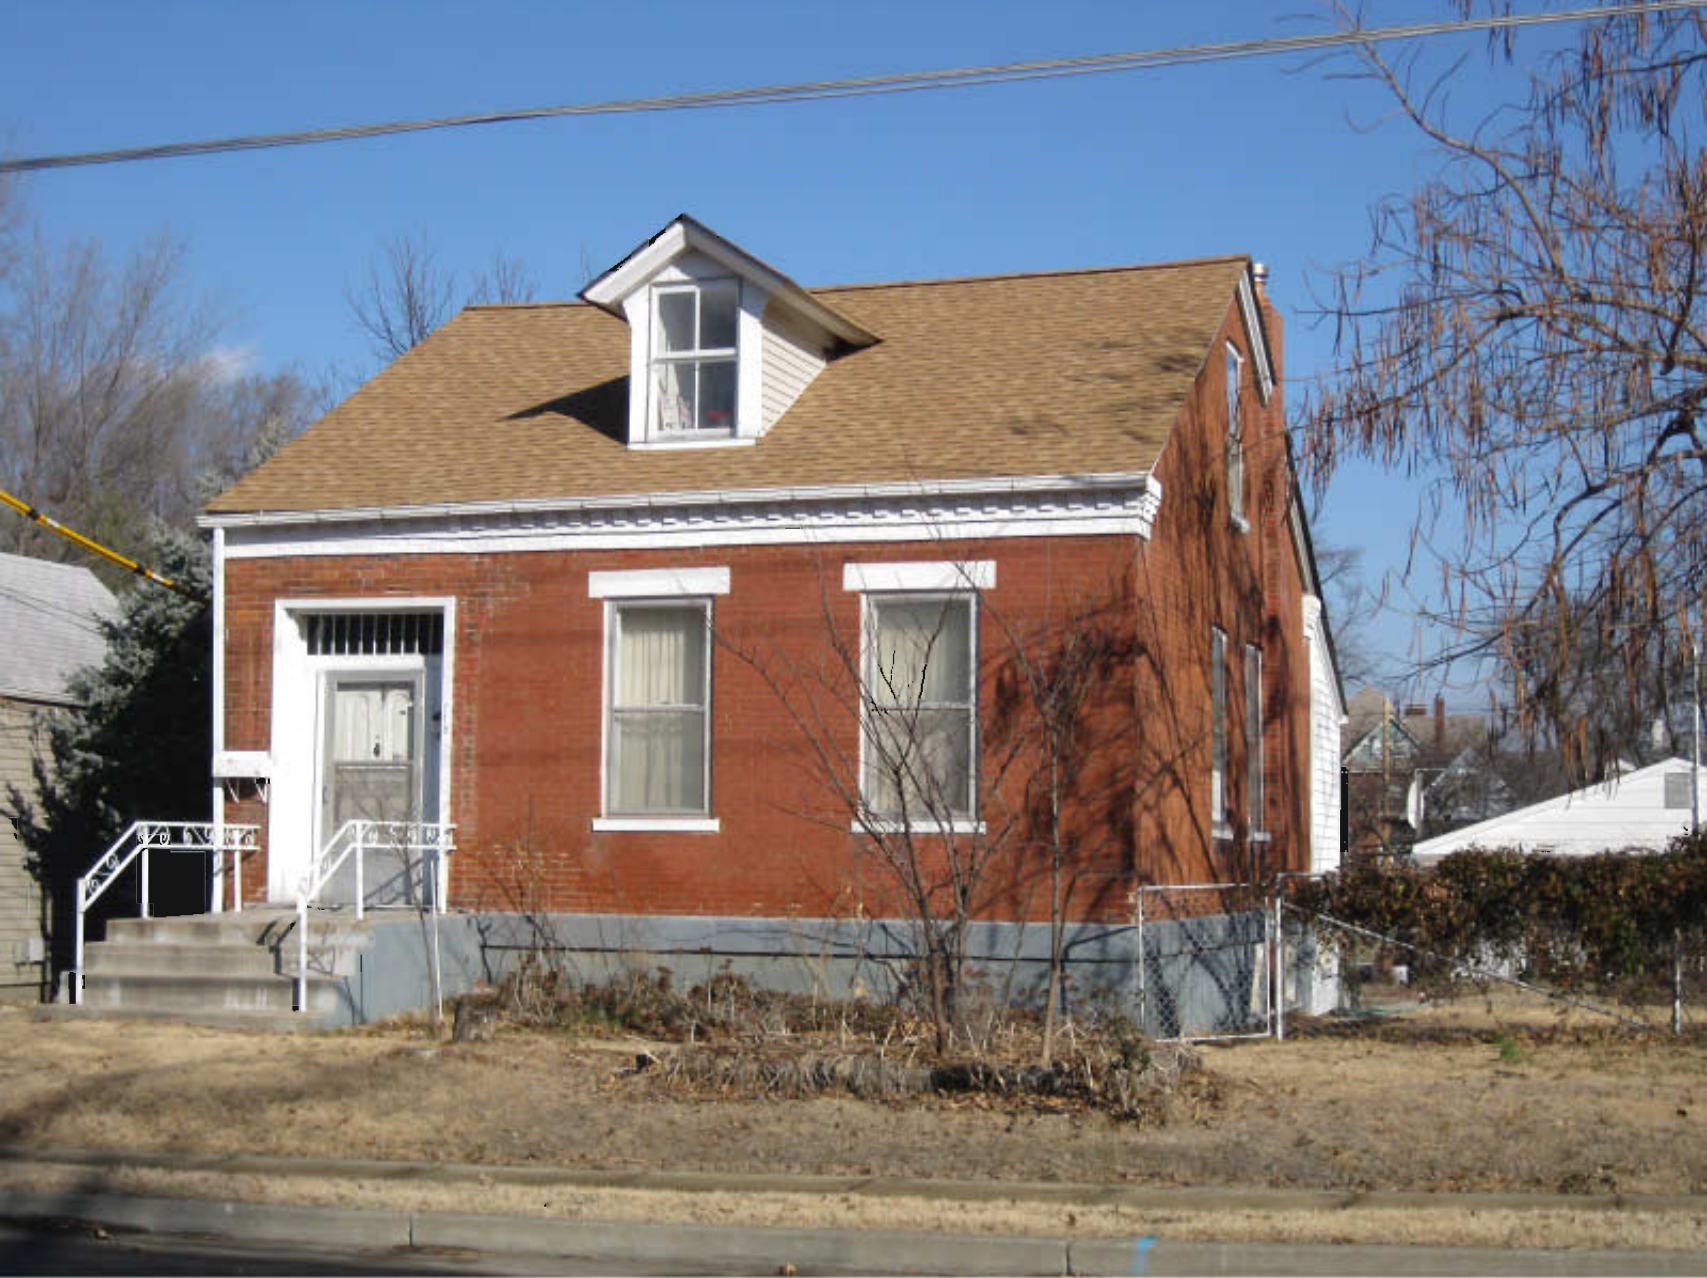
Facing south, this house is a one-and-one-half story, brick, side-gabled, Federal style structure. The foundation and water table have been stuccoed, and the brick walls on the main façade are in a running bond pattern while the other elevations are in a seven-course common bond. The medium-pitched, side-gabled roof is trimmed with a denticulated frieze that has returns, and a gabled dormer with a 2/2 vinyl window and vinyl-sided walls is on the front slope. The three-bay main façade has an entrance in the west bay and two replacement 1/1 windows in the eastern two bays, and the windows have painted wood lug sills and lintels. The wood door has four raised panels, with the upper two being round-arched in the Italianate mode. The sidelights have been covered or in-filled, but the 11-light transom that spans the entire opening is intact. The door opens onto a one-bay concrete stoop, but the Sanborn Insurance Maps show that the house previously had a one-bay portico, although it may not have been original. The east elevation has two segmental-arched window openings on the first floor and one in the upper half story. The windows on the first floor are 1/1 sash while the one in the upper half story is a 6/6 sash. The west elevation has a 1/1 window on the first floor and a 6/6 window in the upper half story, and windows on the side elevation are topped by radiating voussoirs. The gallery that spanned the rear elevation was enclosed between 1917 and 1929.

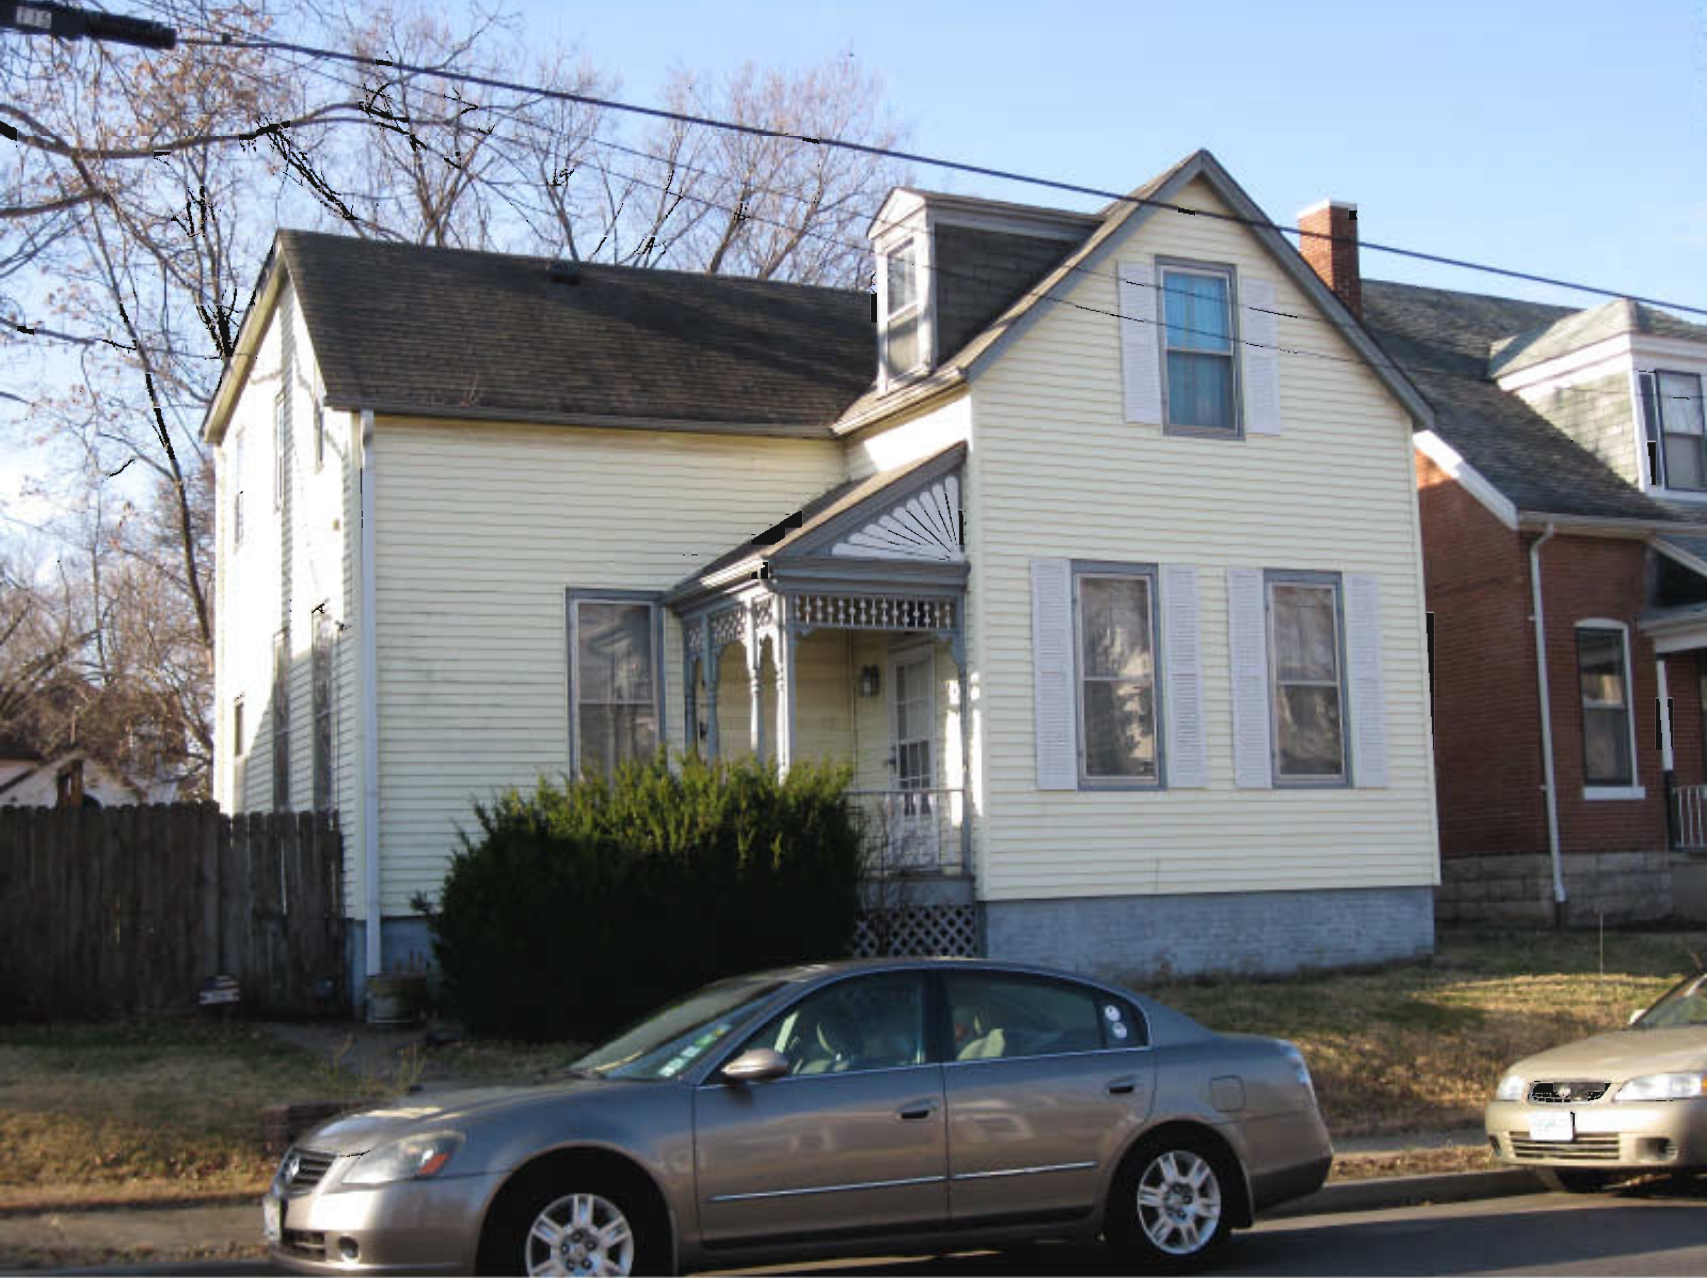
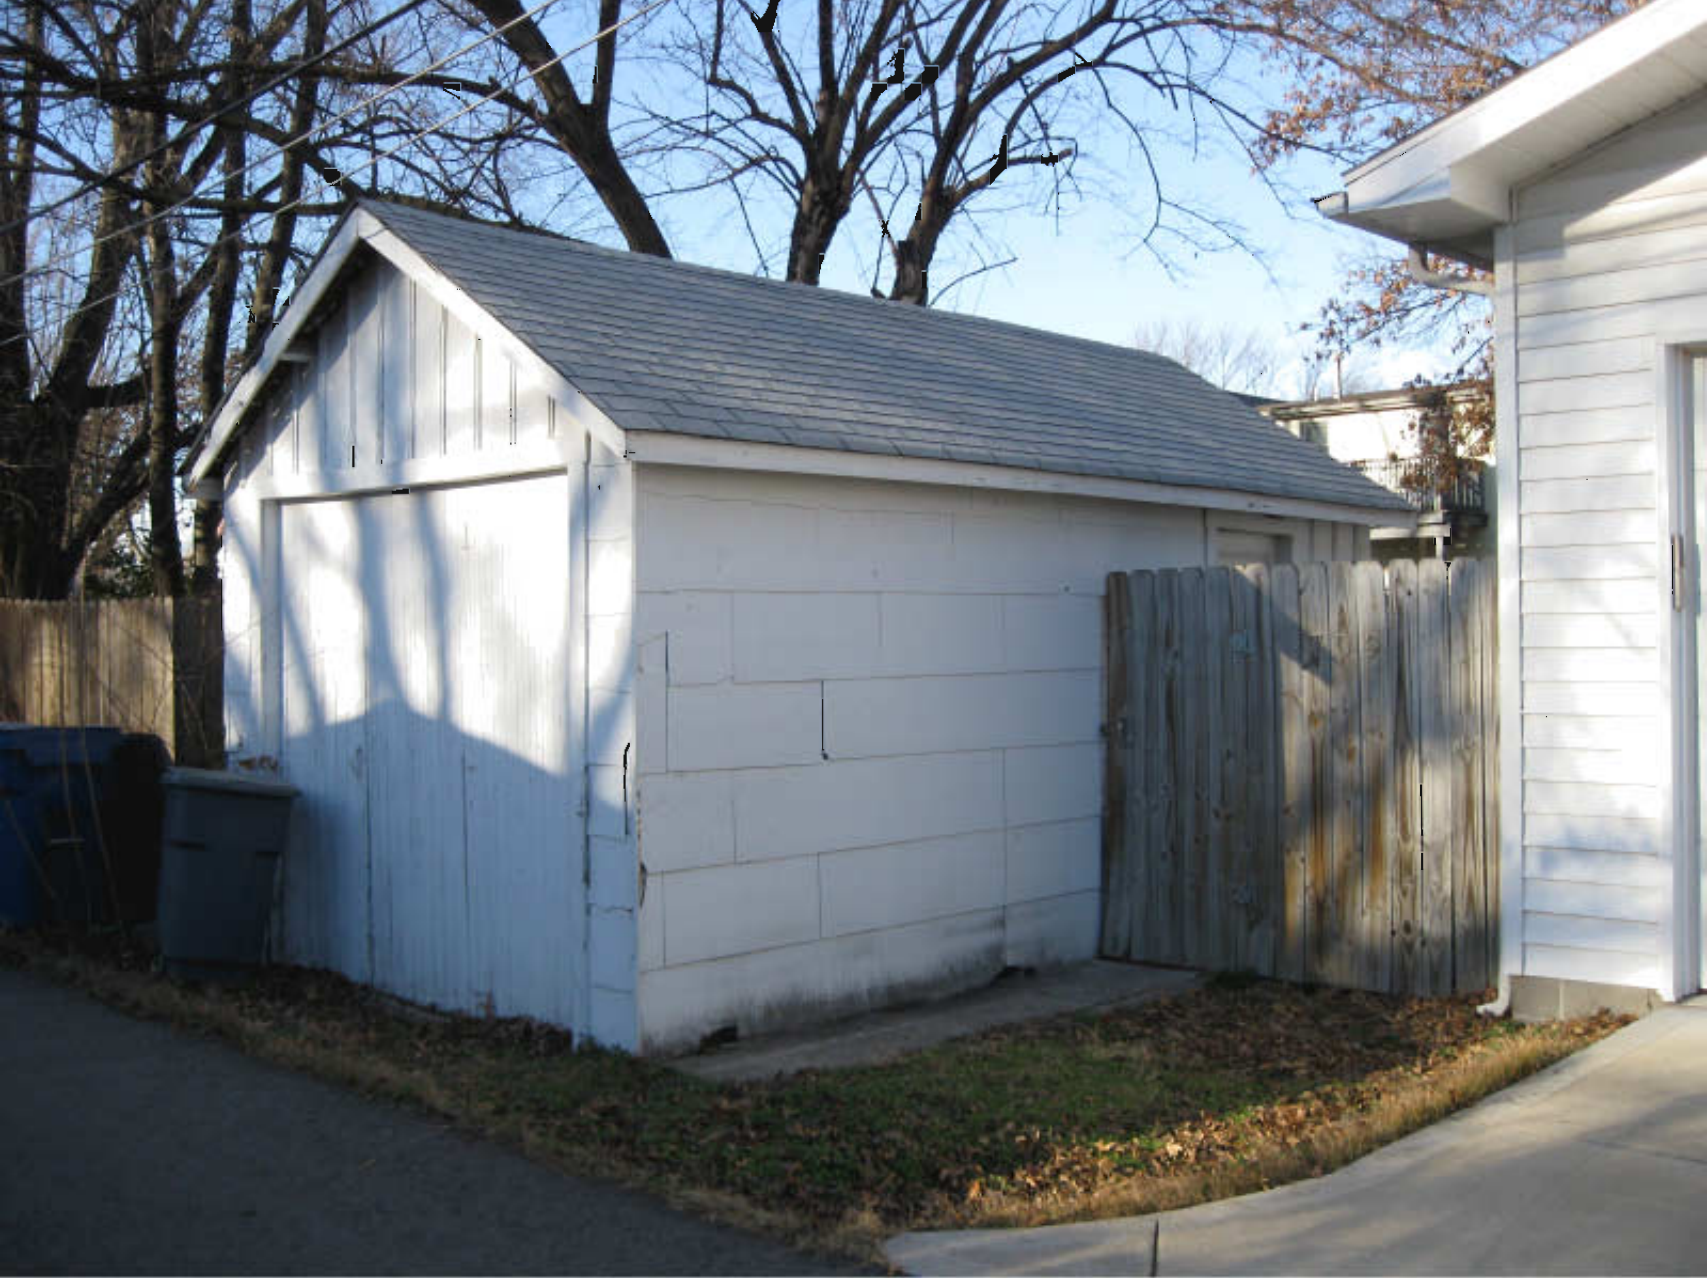
This house is a gable-front-and-wing form, Folk Victorian structure. The front-gabled portion of the house is 1 ½-stories but the wing is 2 full stories (it appears that the side-gabled wing was originally 1 ½-stories but the rear slope was raised to create a full two stories). The walls have been clad in vinyl siding and the brick foundation has been painted. A pedimented, gabled dormer is on the east slope of the front-gabled wing, and it has a 2/2 wood window with fluted surrounds with plinth blocks and bullseye corner blocks. The walls of the dormer are finished with asphalt roofing shingles. The main façade has three 2/2 wood windows, and the entrance is situated on the east wall of the front-gabled wing. The door, which appears to be paneled, has a three-light sidelight and multi-light storm door. The door opens onto a one-bay portico nestled within the L of the façade, and it has a wooden stairway on the east side, wooden deck, balustrade with turned balusters, turned posts with corner brackets, a ball-and-rod spindled frieze, and a shed roof with sunburst pattern in the end wall. In the upper half story of the front-gabled wing is a 2/2 window. The west elevation has a single 2/2 window, while the east elevation has three 2/2 windows on the first floor and three 1/1 windows on the second.

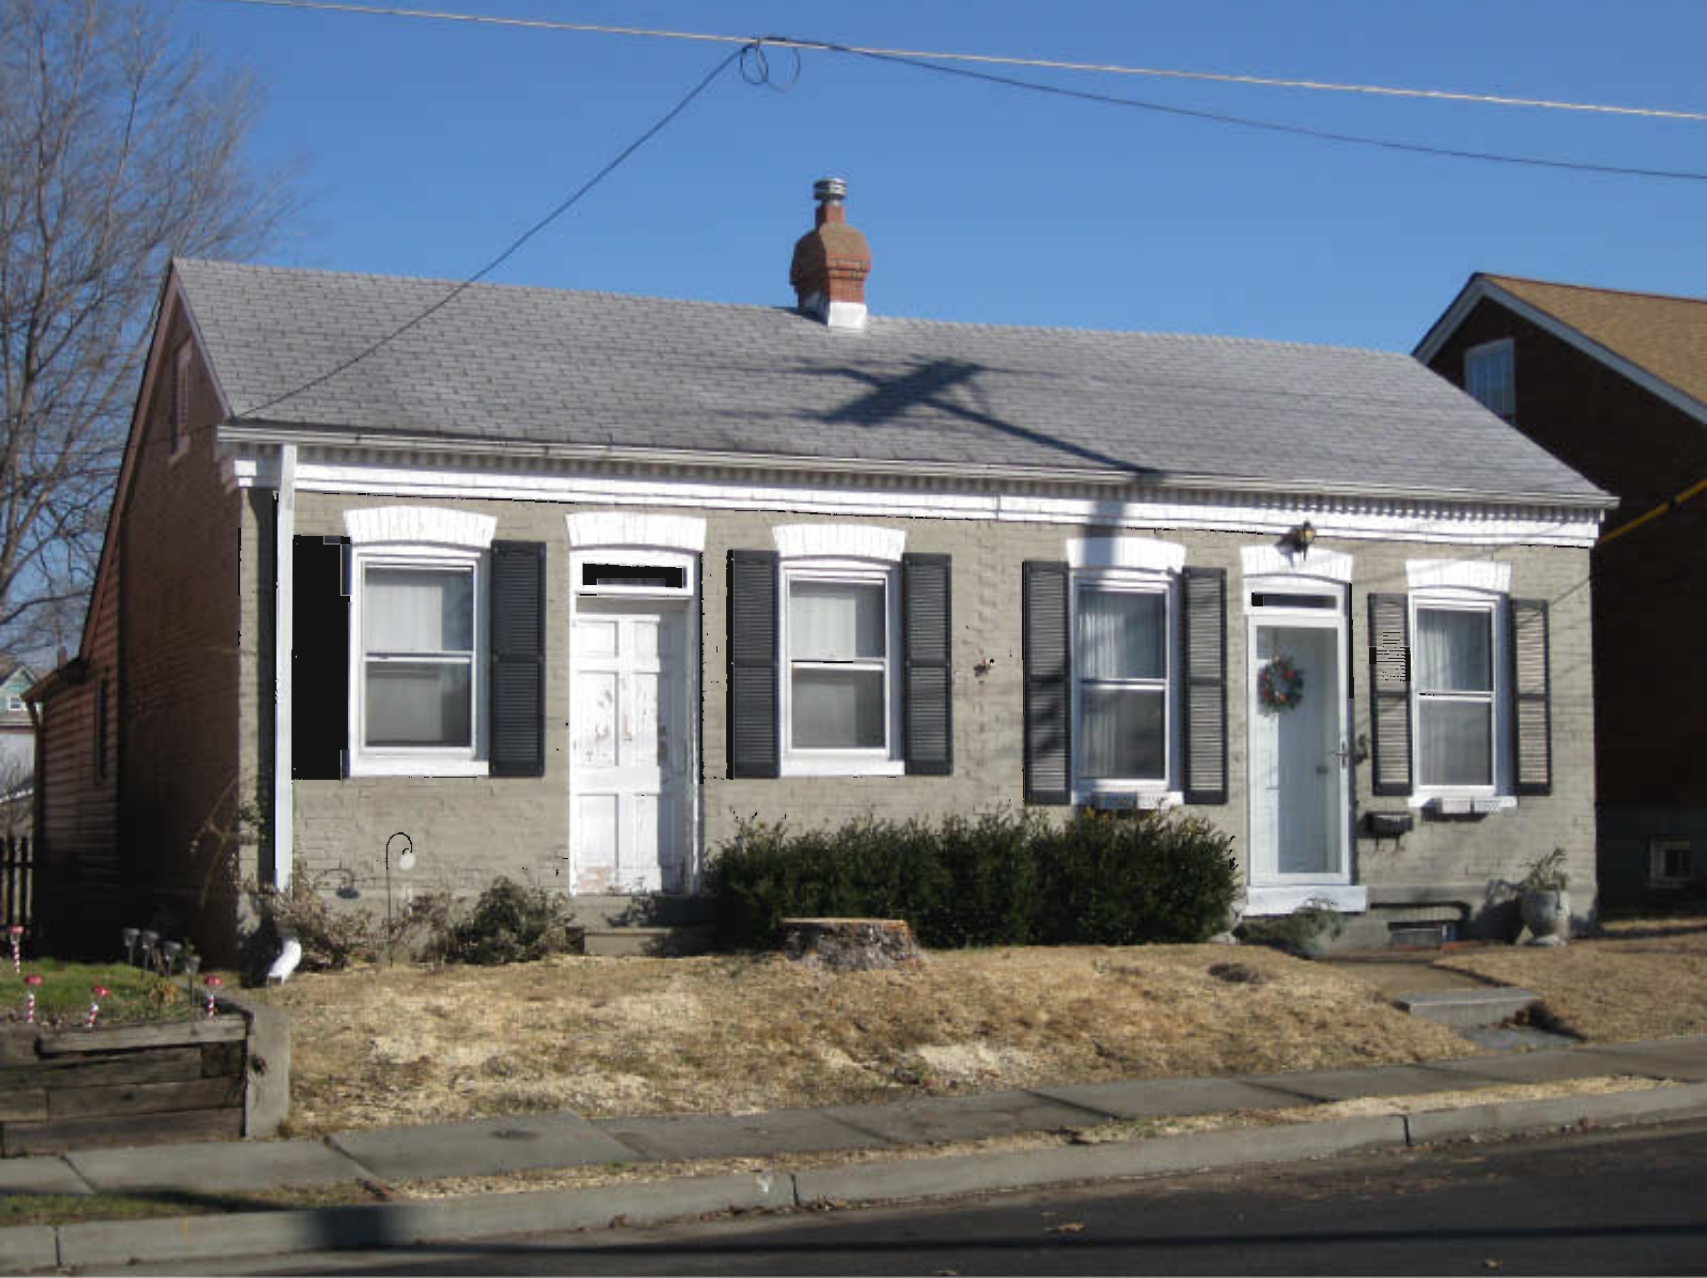
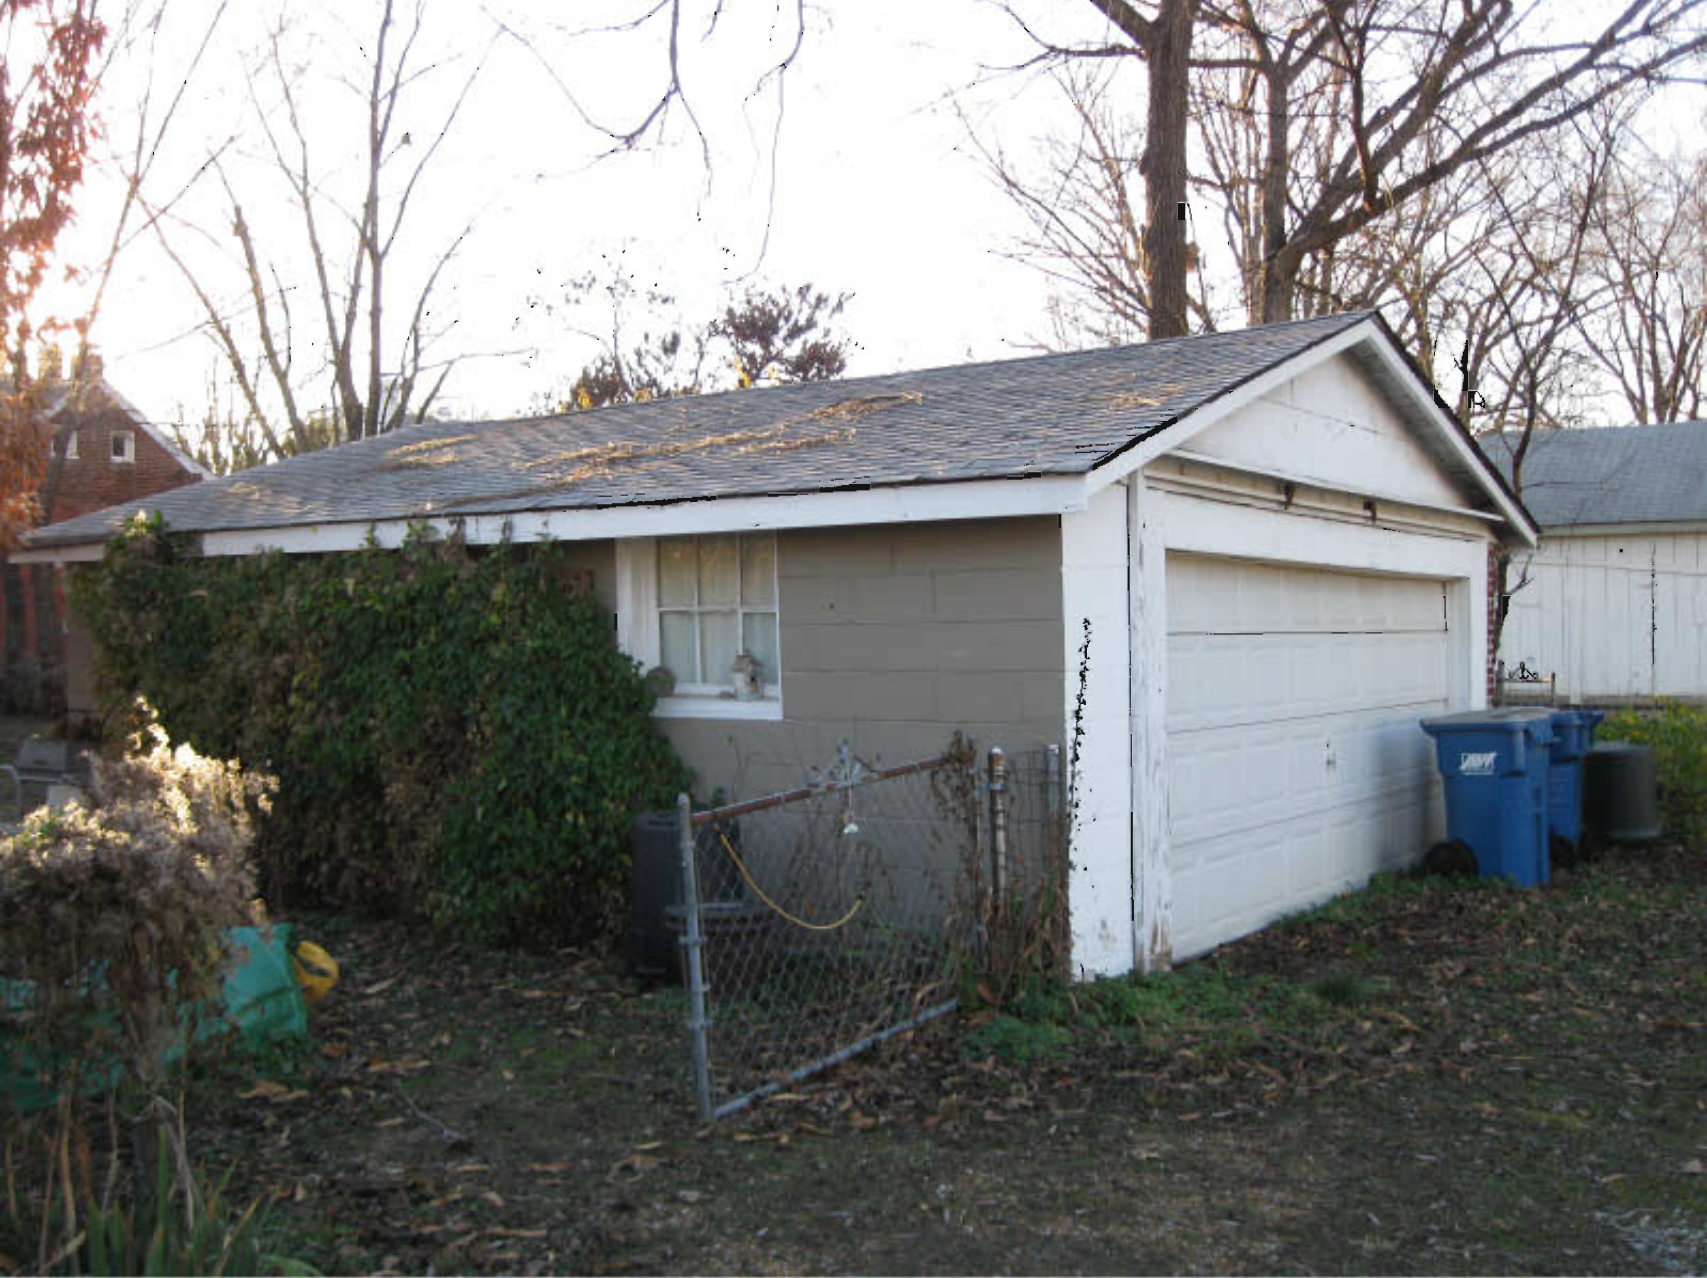
This one-story, brick, side-gabled, Federal style structure rests on a foundation that has been parged with concrete. The medium-pitched, side-gabled roof has a central straddle ridge brick chimney with corbelled cap, and the roof is trimmed with a denticulated entablature with returns. The main façade is a six-bay elevation (w-d-w-w-d-w), and all openings, which are segmental-arched, are topped by radiating voussoirs. The six-panel wood doors are topped by six-light transoms and the windows are 1/1 sash. Each of the doors opens onto a step. The west elevation has one window opening, and it is in the frame wing that runs the length of the house. This wing is shown on the earliest Sanborn map of this area, which was published in 1909. A rectangular ventilator is in the gable end of the brick portion of the house. The east elevation has only one window opening and it is in the frame wing.
