ARCHITECTURAL/HISTORIC INVENTORY FORM

1. Survey No. SC-AS-009-001		2. Survey Name: St. Charles Survey Phase 3: Mid-Town and Commons Neighborhoods	
3. County: St. Charles		4. Address (Street No.) 128	Street (name) North Sixth Street
5. City: St. Charles	Vicinity: <input type="checkbox"/>	6. UTM:	
7. Township/Range/Section:		8. Historic name (if known): Meyer-Pieper House; The Meyerdorf	
9. Present/other name (if known):		10. Ownership: <input checked="" type="checkbox"/> Private <input type="checkbox"/> Public	
11a. Historic use (if known): Domestic/single dwelling		11b. Current use: Domestic/single dwelling

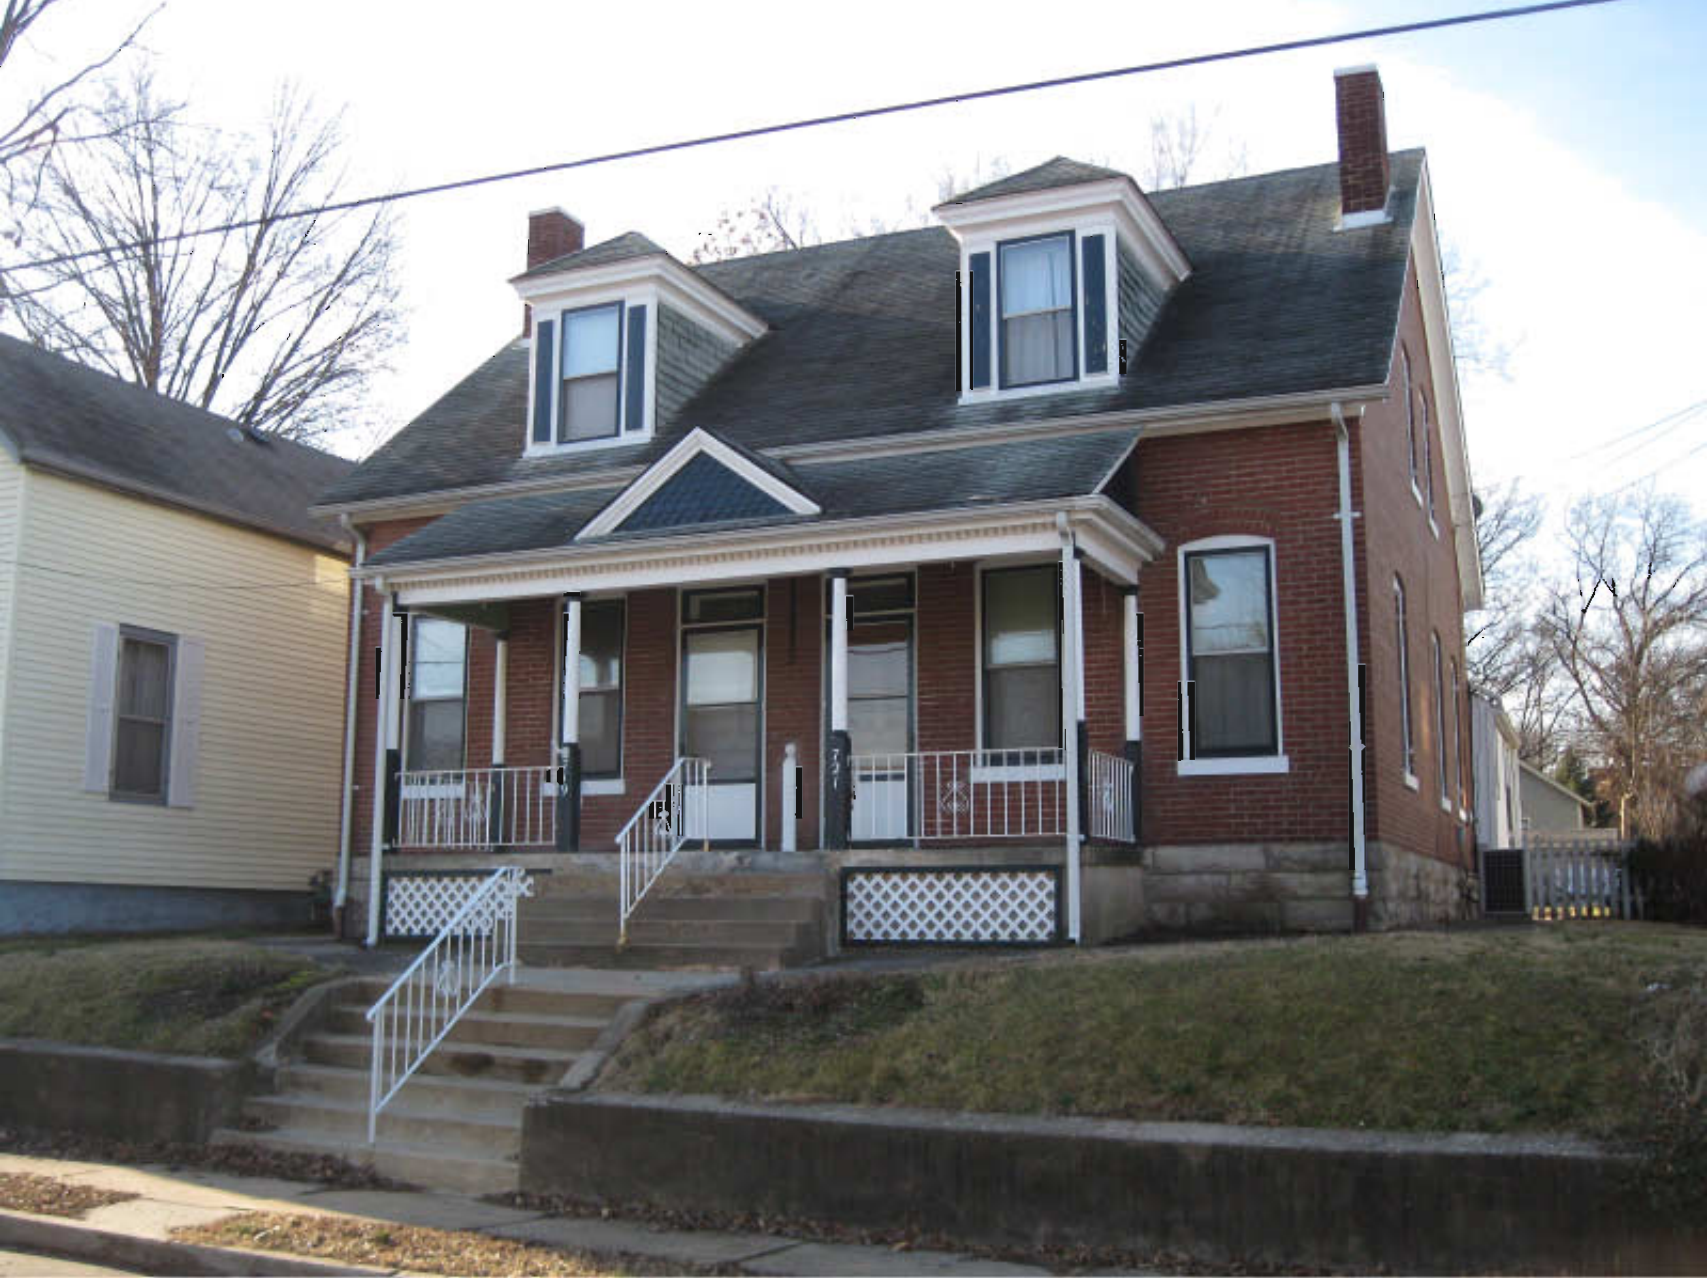
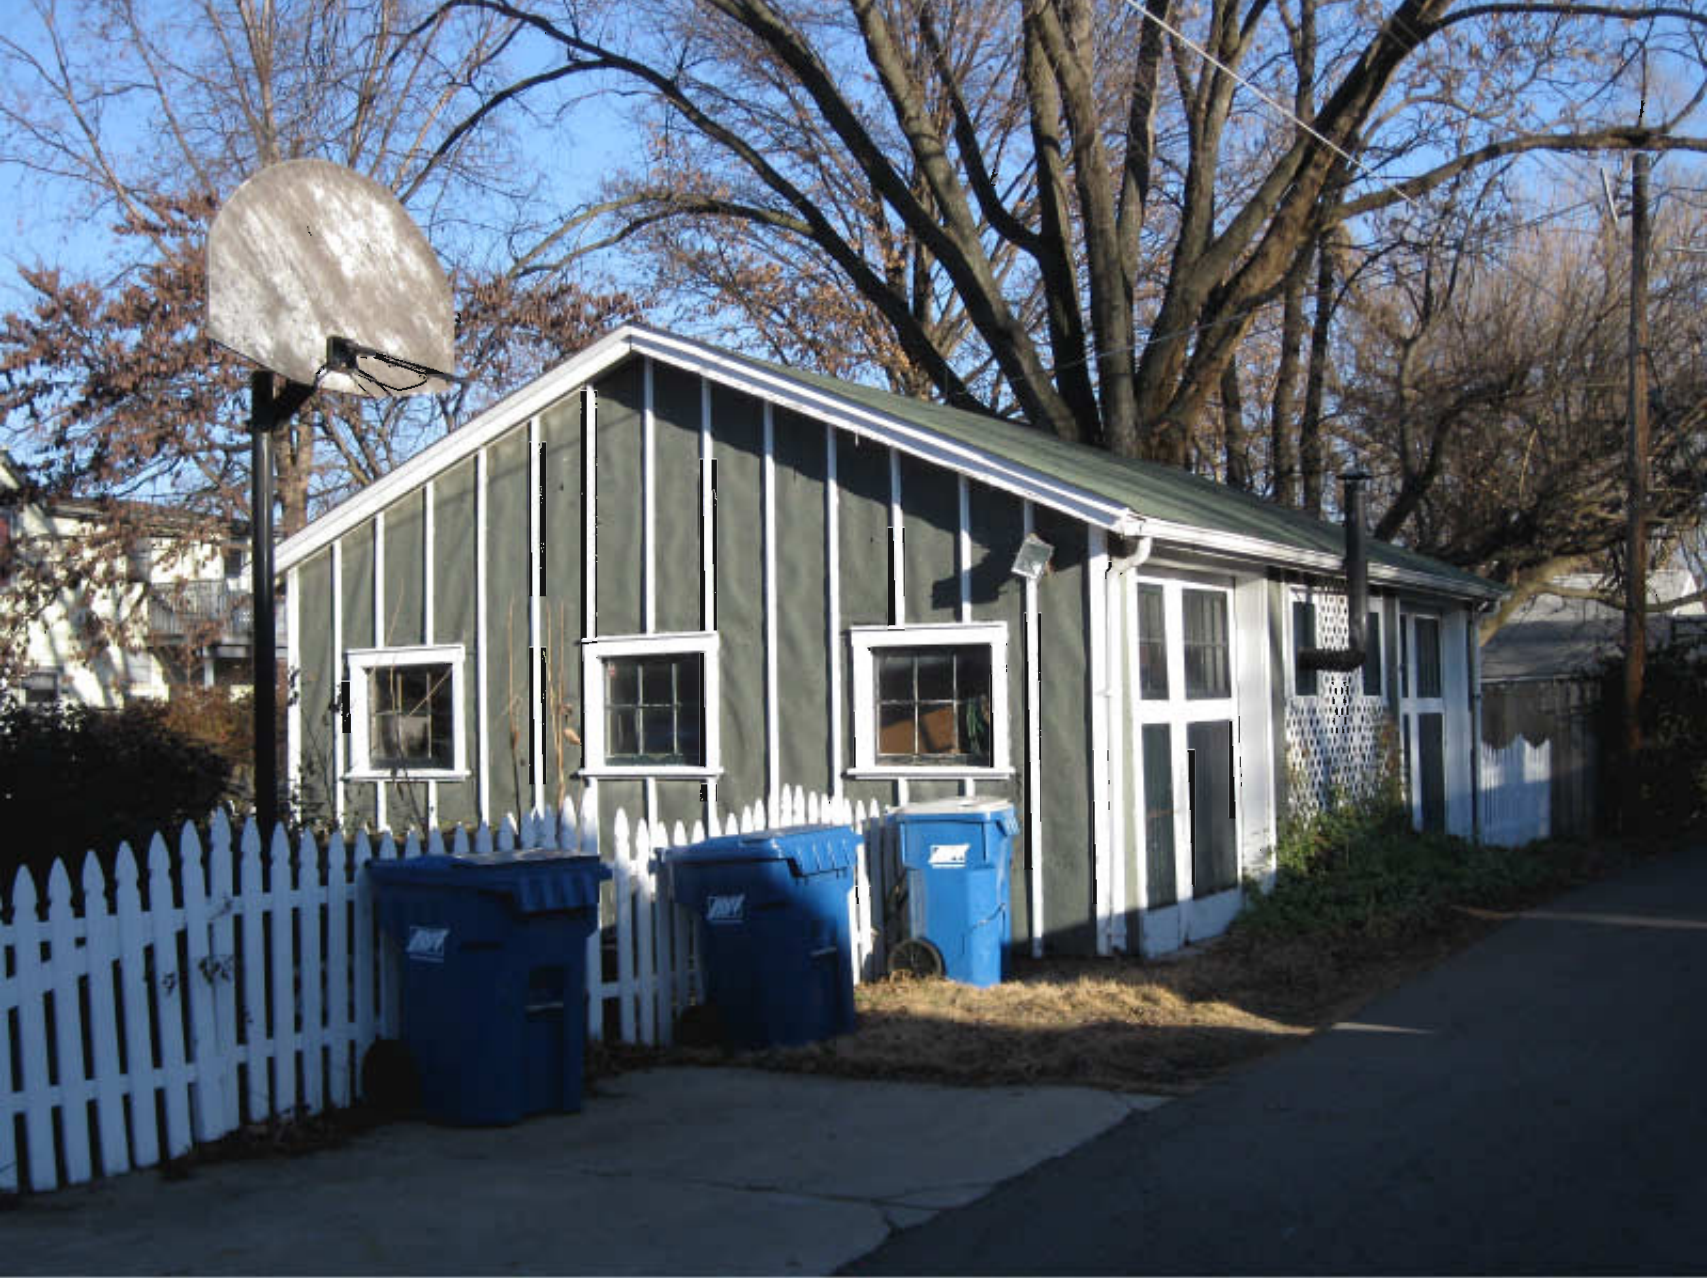
a shed roof intersected by a central gablet, and the end walls of the shed roof and the tympanum of the gablet are finished with wood shingles that form a circular pattern. The porch roof is trimmed with a denticulated frieze. Both side elevations have three windows on the first floor and two in the upper half story. Porches at the southeast and southwest corners of the house were enclosed after 1947. The southeast porch is enclosed with asphalt Bricktex siding and the southwest porch is enclosed with vertical board siding.

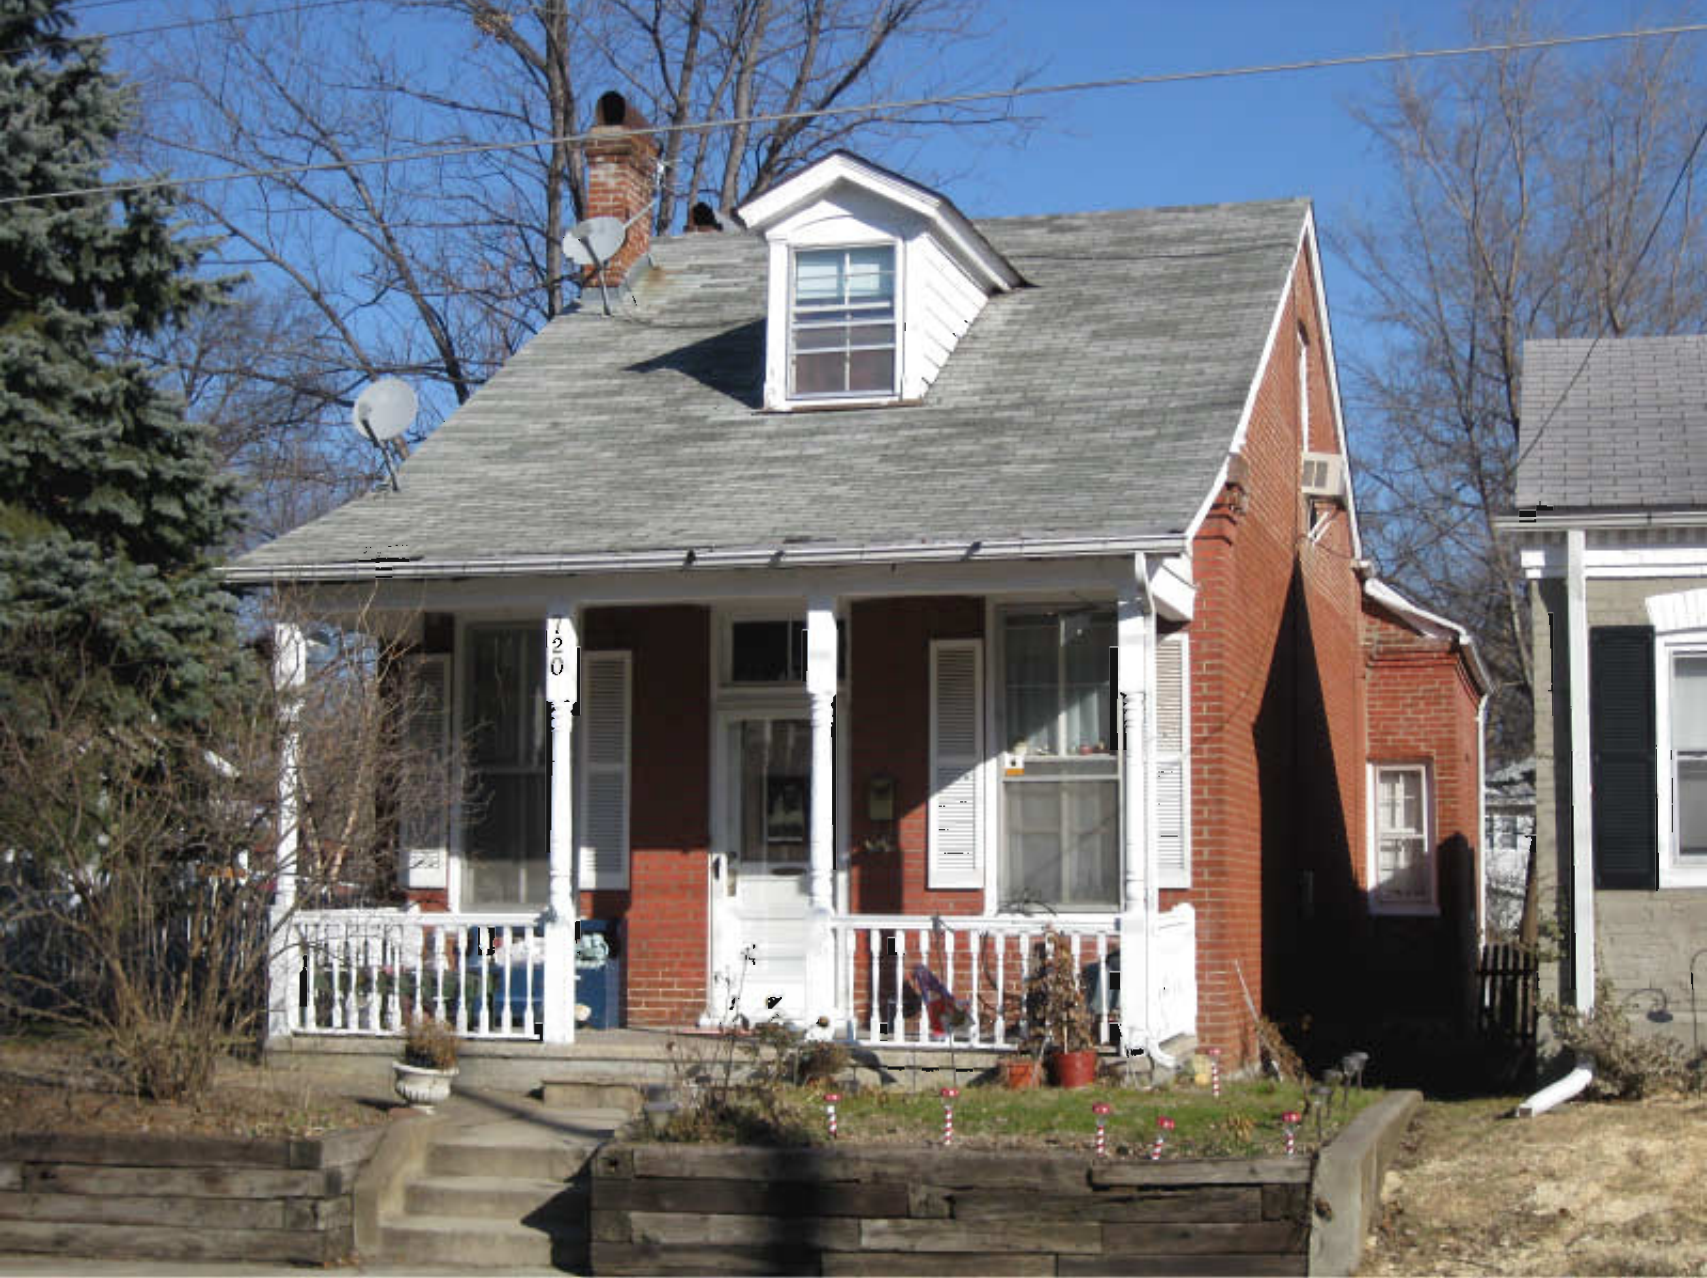
Facing south, this house is a one-and-one-half story, brick, side-gabled, Federal style structure, but a full-width gallery with turned posts was added between 1947 and 1976, impacting the house stylistically. The foundation is coursed rock-face stone, and the brick walls are laid in a five-course common bond pattern. The roof is trimmed with a denticulated entablature, but since the gallery was added only the returns are visible. On the front slope of the roof is a gabled dormer with 2/2 wood window flanked by pilasters with molded capitals, and the dormer's walls are clad in weatherboard siding. An interior end brick chimney is on the front and rear slopes at the west end. The three-bay main façade has a central half-glazed, three-panel wood door topped by a two-light transom, and to each side of the entrance is a 4/4 wood window with undersized vinyl shutters. A gallery spans the main façade and features a concrete deck, turned wood posts, wood balustrade having turned balusters, a shed roof, and bead board ceiling. A circa 1976 photograph shows that the balustrade at that time had plain balusters. The west elevation has two 6/6 windows on the first floor and another in the upper half story, and they are in segmental-arched openings that are topped by radiating voussiors. A gabled rear wing projects slightly from the east wall of the house, and the roof of the wing is trimmed with a corbelled cornice. There are no windows on the first floor of the east elevation except for a 4/4 window in the rear wing, and there is another 4/4 window on the south side of the rear wing. A 6/6 window is in the upper half story.

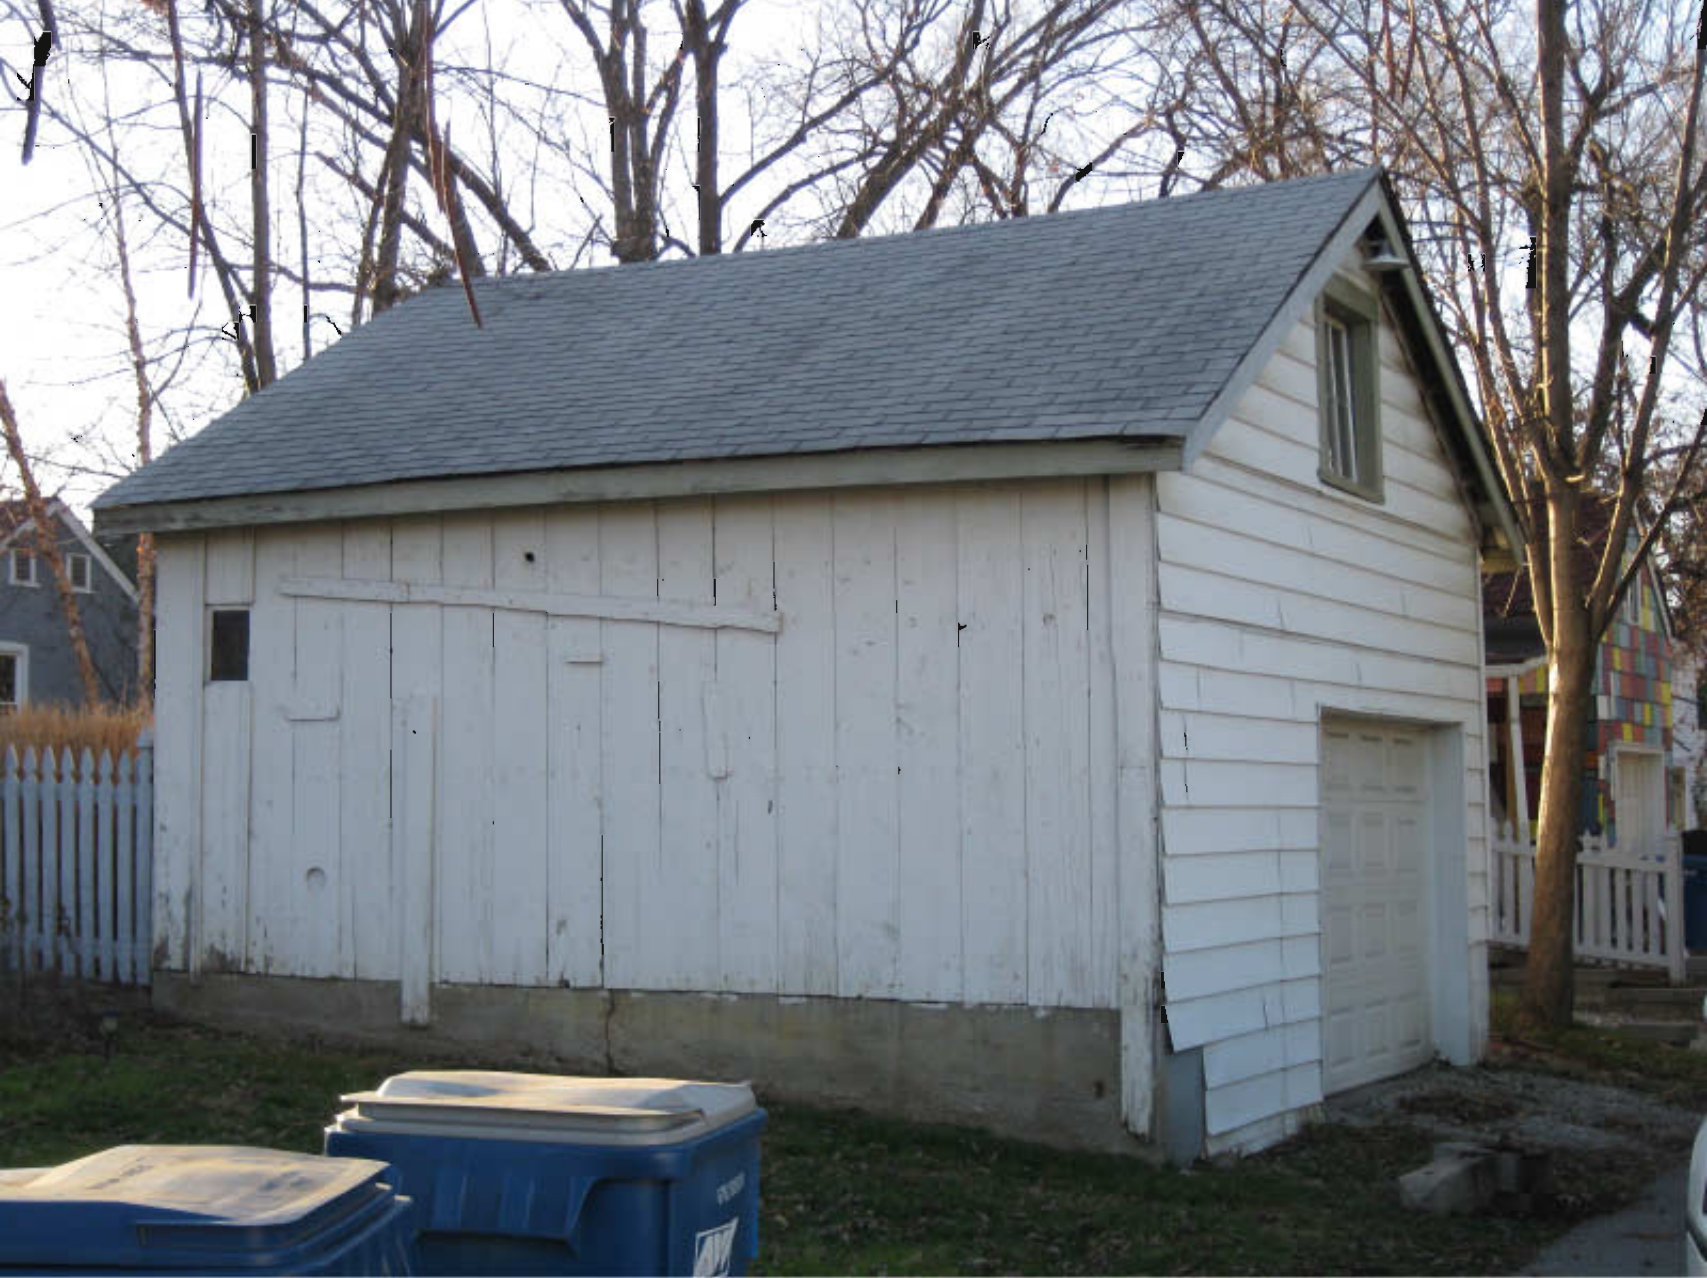
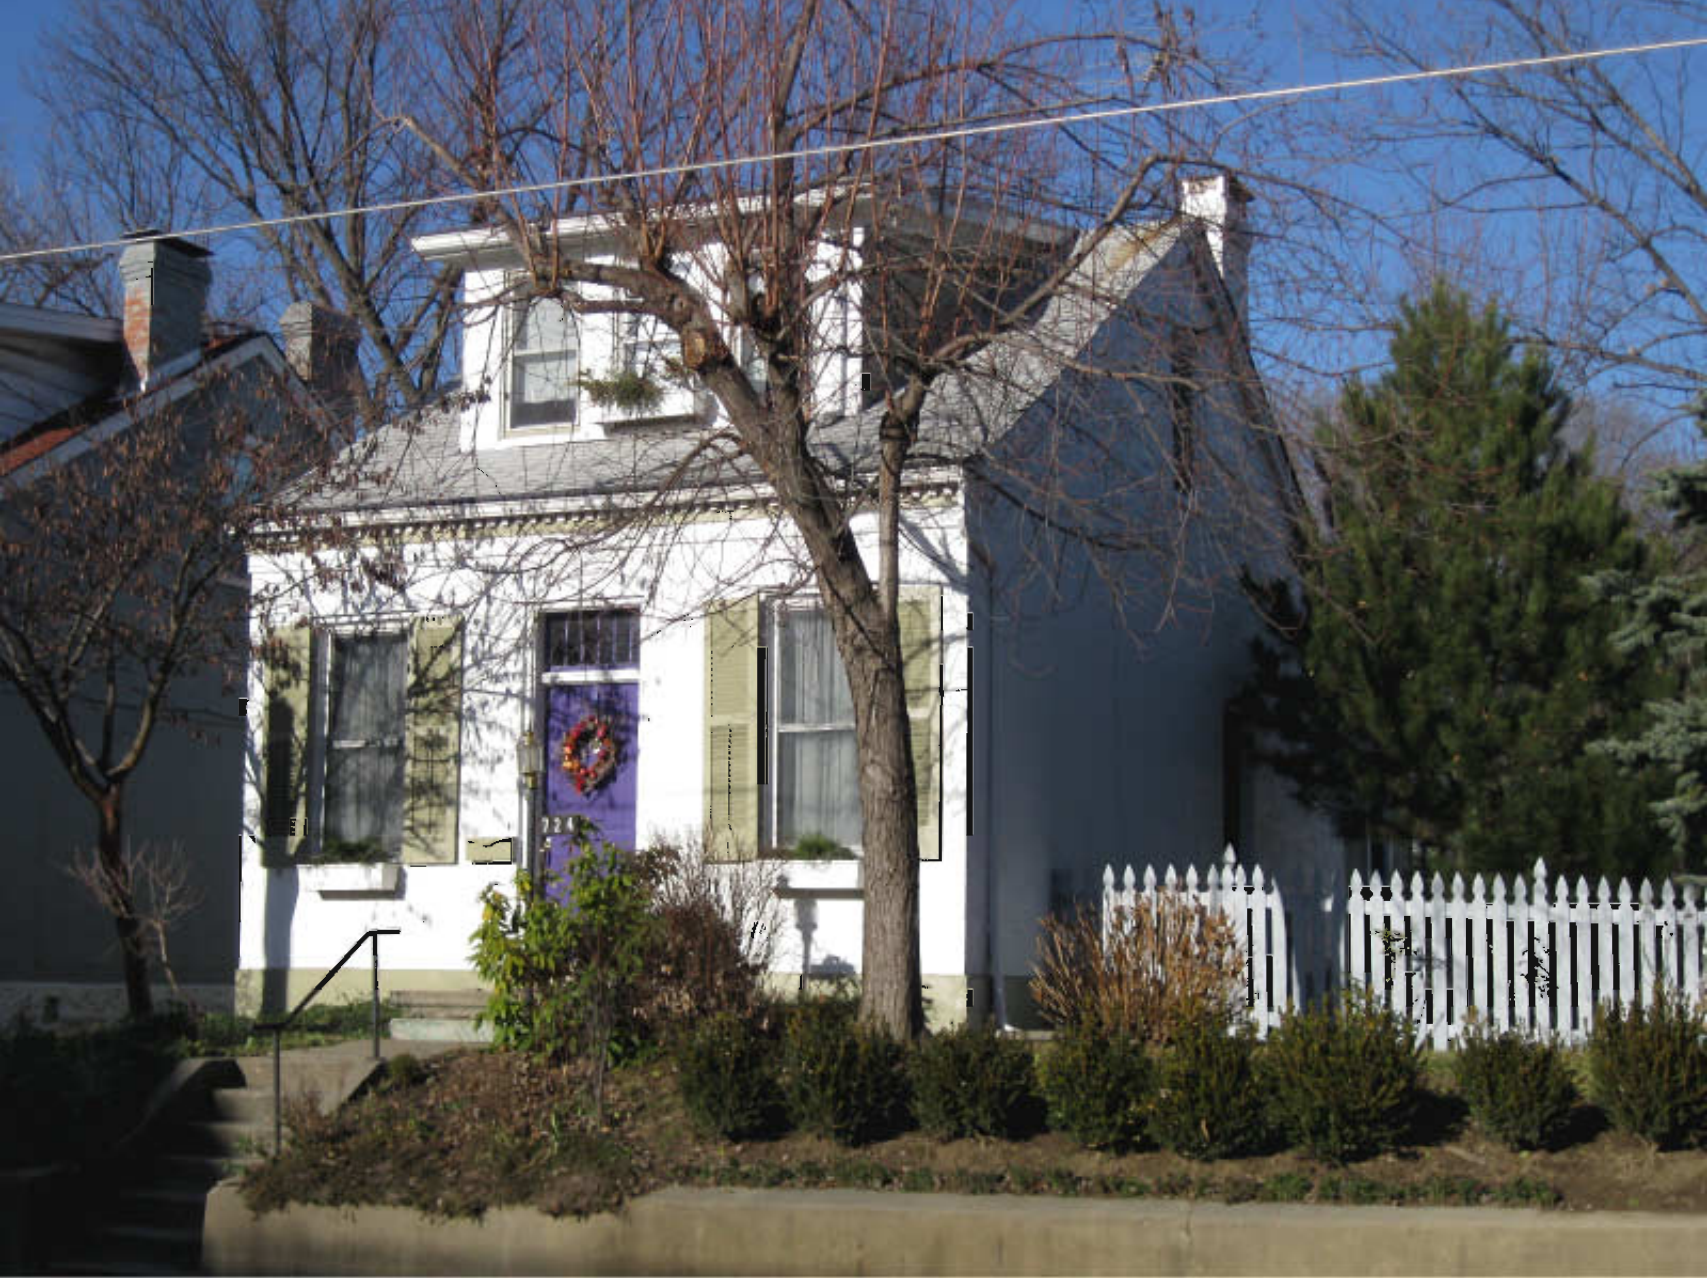
Situated on a narrow elevated lot, this house is a one-and-one-half story, brick, side-gabled, Federal style structure. The house has a one-story, frame, rear wing with a shed roof, and the wing is shown on the 1909 Sanborn Insurance Map, which is the earliest Sanborn map to cover this block. The Sanborn maps show a porch on the east side of the rear wing, but it was enclosed sometime after 1947. The foundation of the house is finished with scored stucco and the brick walls, which are laid in a five-course common bond, have been painted. The steeply-pitched, side-gabled roof is trimmed with a denticulated entablature with returns, and on the front slope is a wide shed dormer with three 1/1 windows. An interior end brick chimney with corbelled cap is at the east end of the rear slope of the roof, and another is on the west side of the rear wing. The three-bay main façade has a central six-panel door topped by a six-light transom, and the door opens onto a one-bay concrete stoop. To each side of the entrance is a 1/1 window with louvered wood blinds. Windows throughout the house are replacements, and the flat-arched openings have wooden lintels and lug sills. The west elevation has only one opening on the first floor, and it is a window in the rear wing. Another 1/1 window is in the upper half story. The east elevation has a single window on the first floor of the brick portion of the house and another in the upper half story. The openings in the rear wing could not be readily seen from the street.

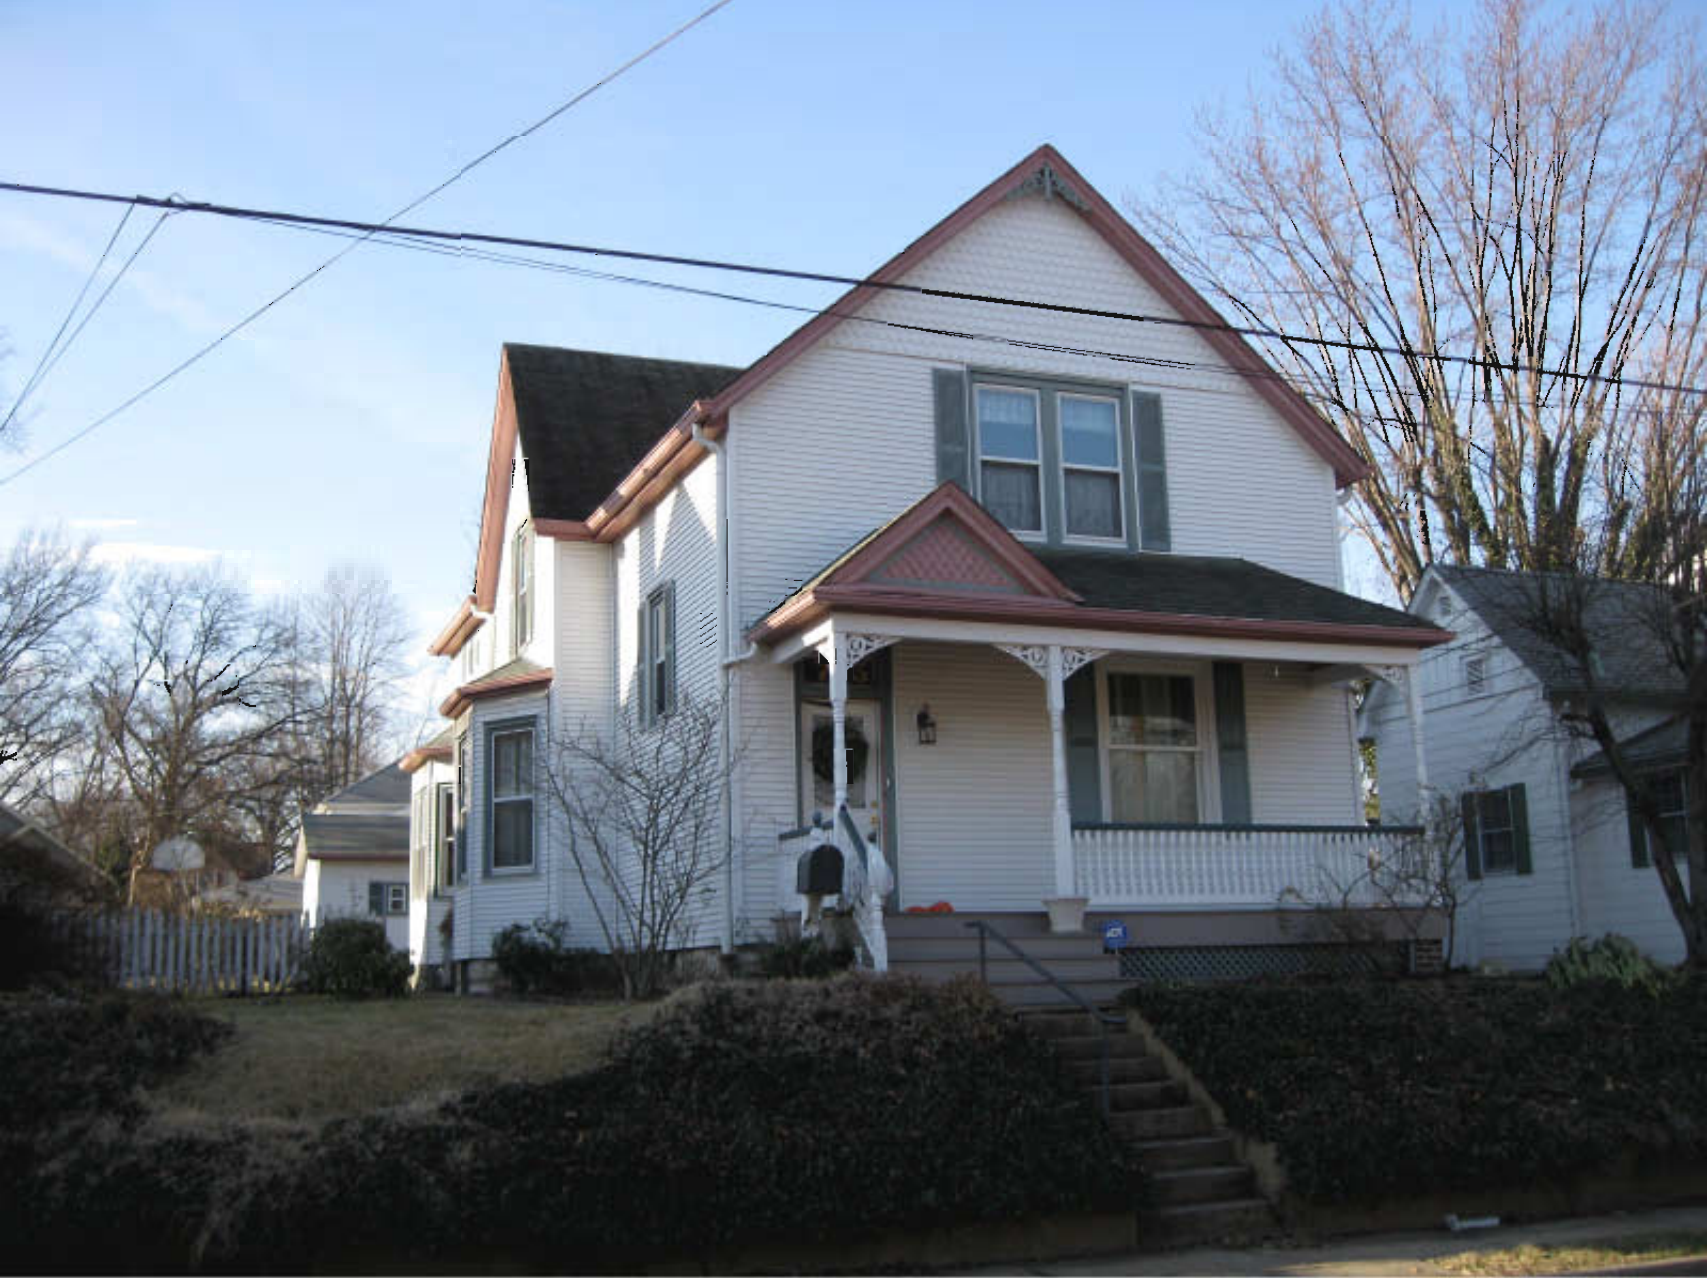
This two-story, front-gabled, frame, Folk Victorian house rests on a coursed rock-faced stone foundation and the walls have been clad with vinyl siding, except for the gable end, which is clad in vinyl fish scale shingles. The steeply pitched, front-gabled roof has intersecting cross gables, and a sawn gable ornament is in the front gable. The entrance is in the east bay of the two-bay main façade, and it is a half-glazed wood door topped by a single-light transom. There is also an ornate paneled wood screen door with spindlework. A wide 1/1 wood window is to the west of the door, which opens onto a one-story, ¾-width gallery that has brick foundation piers in-filled with wood lattice panels, a wood stairway and deck, a balustrade with turned balusters, turned posts with sawn corner brackets, and a hip roof that is intersected by a pedimented gablet at the east end. The tympanum is finished with wood shingles. The second floor has a single opening filled with a pair of 1/1 windows. The first floor of the west elevation has a 1/1 window in the front-gabled wing and two in the west gabled wing, and a 1/1 window is in the second floor of the west wing. The east elevation has a polygonal bay with three windows on the first floor and a 1/1 window on the second floor of the east gabled wing. The only opening on the east side of the front-gabled wing is a window that is between floors, indicating it overlooks a stairway. The rear wing was enlarged in 1992 by the addition of a second story, and a polygonal bay was added to the first floor of the east elevation.

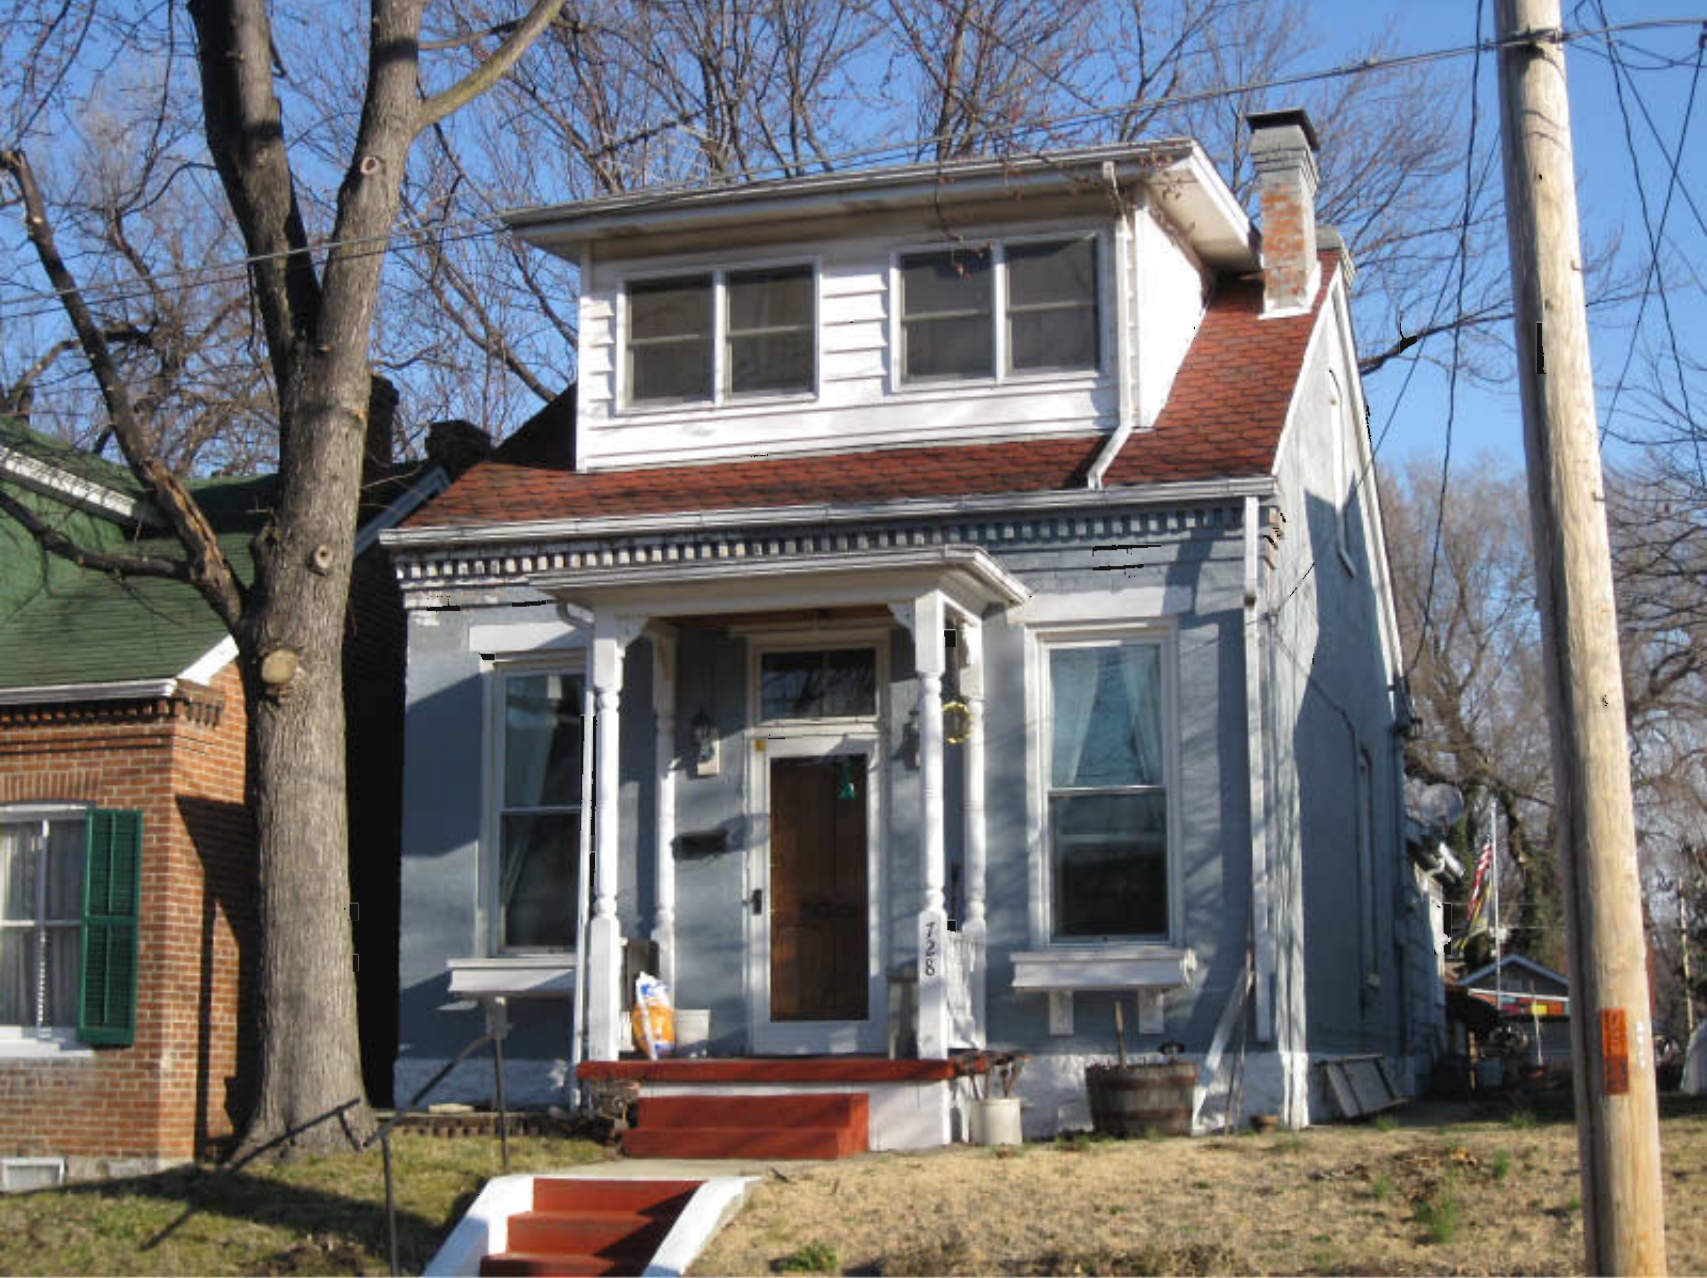
This house is a one-and-one-half story, brick, side-gabled, Federal style structure that rests on a stone foundation and the foundation and walls have been painted. The roof is finished with fish scale shingles that appear to be asphalt, and the roof is trimmed with a denticulated entablature with returns. There are four interior end brick chimneys with corbelled caps, one at each end of the front and rear slopes. A wide shed dormer that was added in 1981 is on the front slope and features two pairs of 1/1 windows and vinyl-sided walls. The main façade has a central entrance, which is a four-panel wood door topped by a two-light transom, and to each side is a 1/1 window. Windows throughout the house are replacement sash, and they have wooden lintels and lug sills. The house originally did not have a porch, but a one-bay portico was added between 1917 and 1929. It features a concrete deck and stairway, balustrade with turned balusters, turned wood posts with corner brackets, and a nearly flat roof. The openings on the side elevations are segmental arched. The east elevation has a window on the first floor and another in the upper half story, while the west elevation has no openings on the first floor and a window in the upper half story. A brick rear wing projects slightly beyond the west wall of the house, and to the east of the wing it appears that a porch was enclosed.

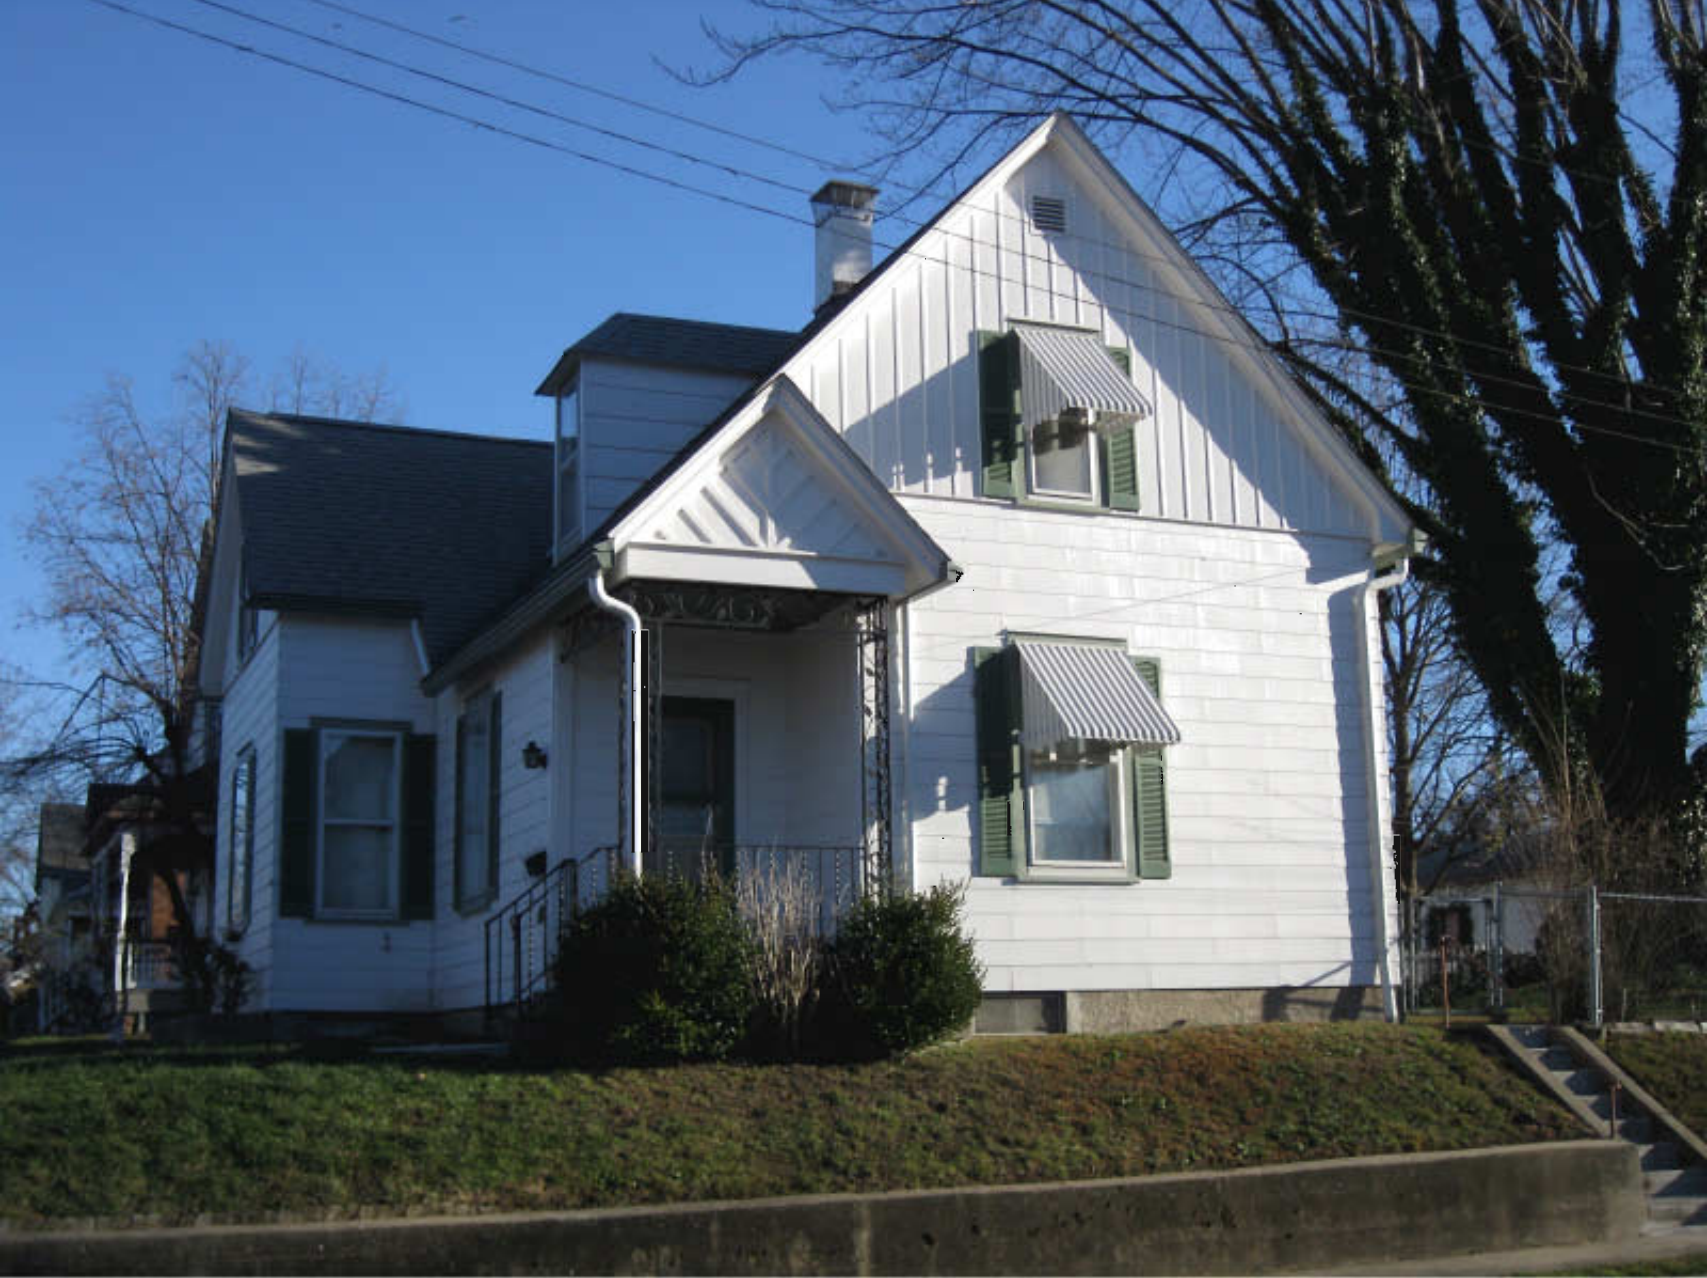
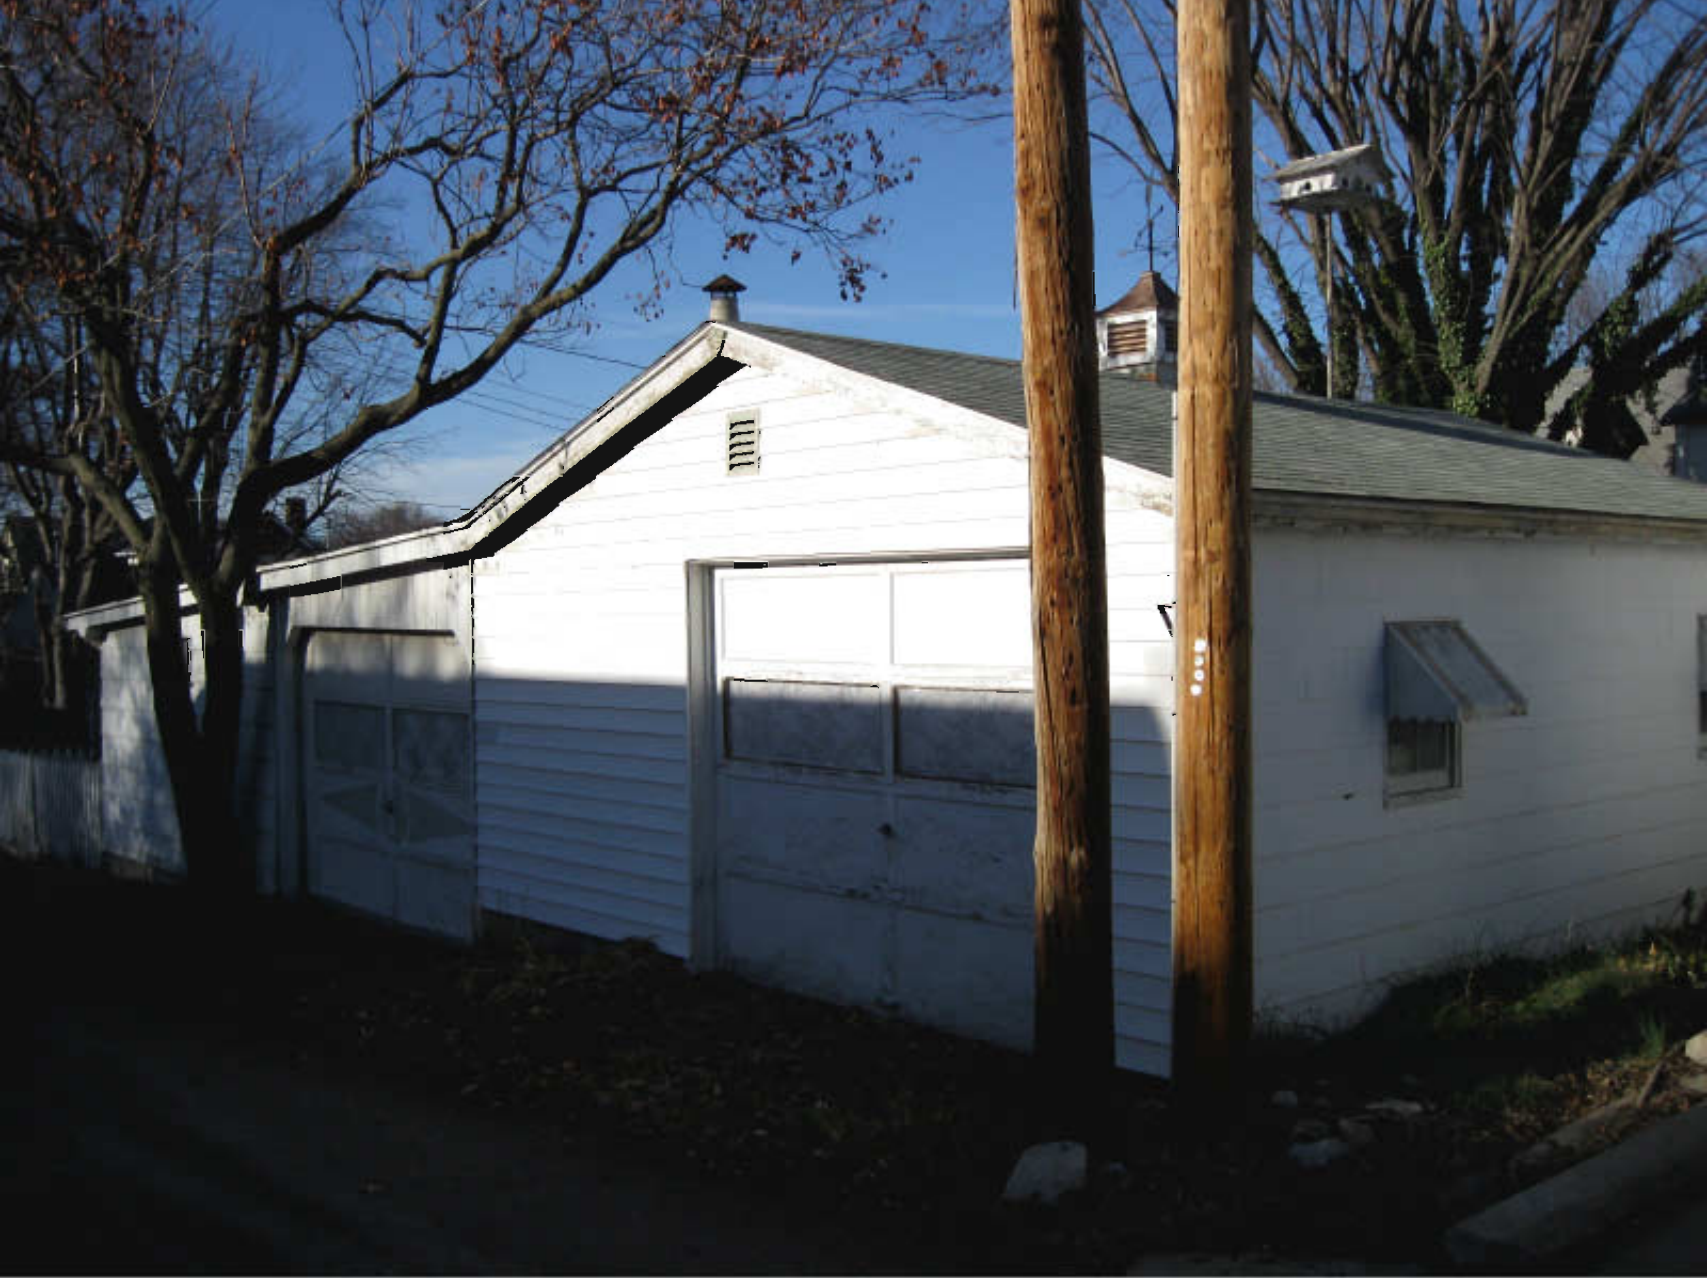
Although the address of this one-and-one-half story, frame house is 729 Adams, it actually faces west onto Eighth Street. The house rests on a foundation that has been parged and is crowned by a high cross gable roof that has a straddle ridge chimney. A hipped dormer is on the north slope of the front (west) gable and on the east slope of the north gable, and a shed dormer flanked by hipped dormers are on the south slope of the front gable. The hipped dormers have a 1/1 window while the shed dormer has a pair. The walls of the house appear to be clad in Masonite siding while the gable ends are finished with board-and-batten siding. The two-bay main façade has a half glazed door in the northern bay, which is recessed, and a 1/1 window in the southern bay. The door opens onto a one-bay portico with concrete deck and stairway, which is on the north side; wrought iron posts, frieze and railing; and gable roof. According to the Sanborn maps, the portico was added between 1917 and 1929. On the north (Adams Street) elevation is a 1/1 window in the west gabled wing and one in the north gabled wing, and there is a 1/1 window in the upper half story. A shed roof addition extends from the east wall of the northern wing.
