ARCHITECTURAL/HISTORIC INVENTORY FORM

1. Survey No. SC-AS-009-001		2. Survey Name: St. Charles Survey Phase 3: Mid-Town and Commons Neighborhoods	
3. County: St. Charles		4. Address (Street No.) 128	Street (name) North Sixth Street
5. City: St. Charles	Vicinity: <input type="checkbox"/>	6. UTM:	
7. Township/Range/Section:		8. Historic name (if known): Meyer-Pieper House; The Meyerdorf	
9. Present/other name (if known):		10. Ownership: <input checked="" type="checkbox"/> Private <input type="checkbox"/> Public	
11a. Historic use (if known): Domestic/single dwelling		11b. Current use: Domestic/single dwelling

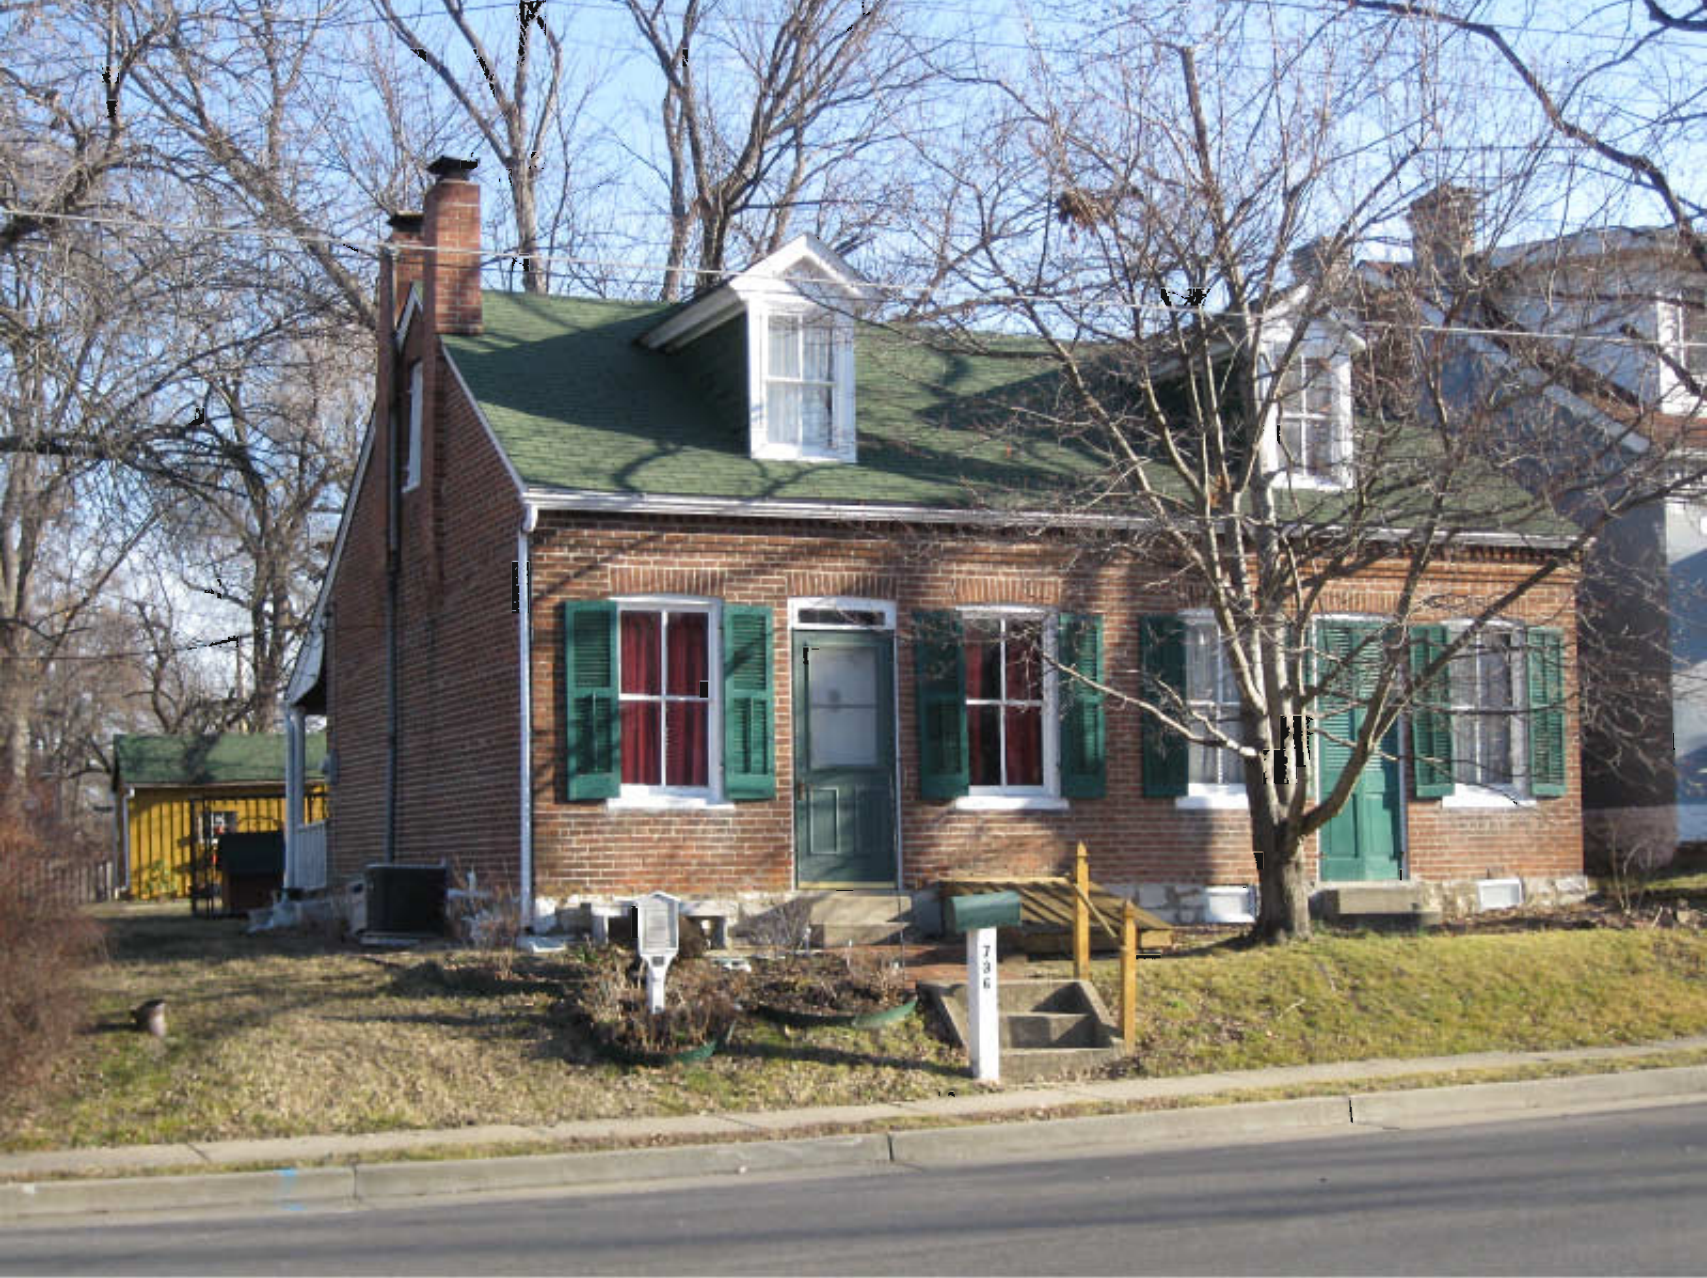
Situated at the northeast corner of Adams and Eighth Streets, this one-and-one-half story, brick, side-gabled house rests on a coursed rock-faced stone foundation. The front wall of the foundation is pierced by single-light basement windows, and a wooden bulkhead is under the first floor window in the third bay from the west. The steeply-pitched, side-gabled roof is trimmed with a denticulated frieze with returns, and on the front slope are two gabled dormers with 2/2 wood windows framed by fluted surrounds with plinth blocks and bullseye corner blocks. At each end of the front and rear slopes is an interior end brick chimney, but the two on the west end project slightly from the wall of the upper half-story. The brick walls are laid in a six-course common bond pattern, and the openings, which are slightly arched, are topped by jack arches. On the main facade are entrances in the second and fifth bays from the west, and the doors open onto concrete stairs. The western entrance is a six-panel door topped by a multi-light transom, and over the door is a half-glazed storm door and single-light transom. The eastern entrance is covered by full-height paneled and louvered wood shutters. To each side of the entrances are 2/2 wood windows with louvered wood shutters. The first floor of the side elevations have no openings, but a 2/2 window is in the upper half story of each. A rear wing was added in 1994, giving the house an L-shape. The one-and-one-half story wing is constructed of board-and-batten siding. A gallery spans the rear elevation of the house and west wall of the addition.

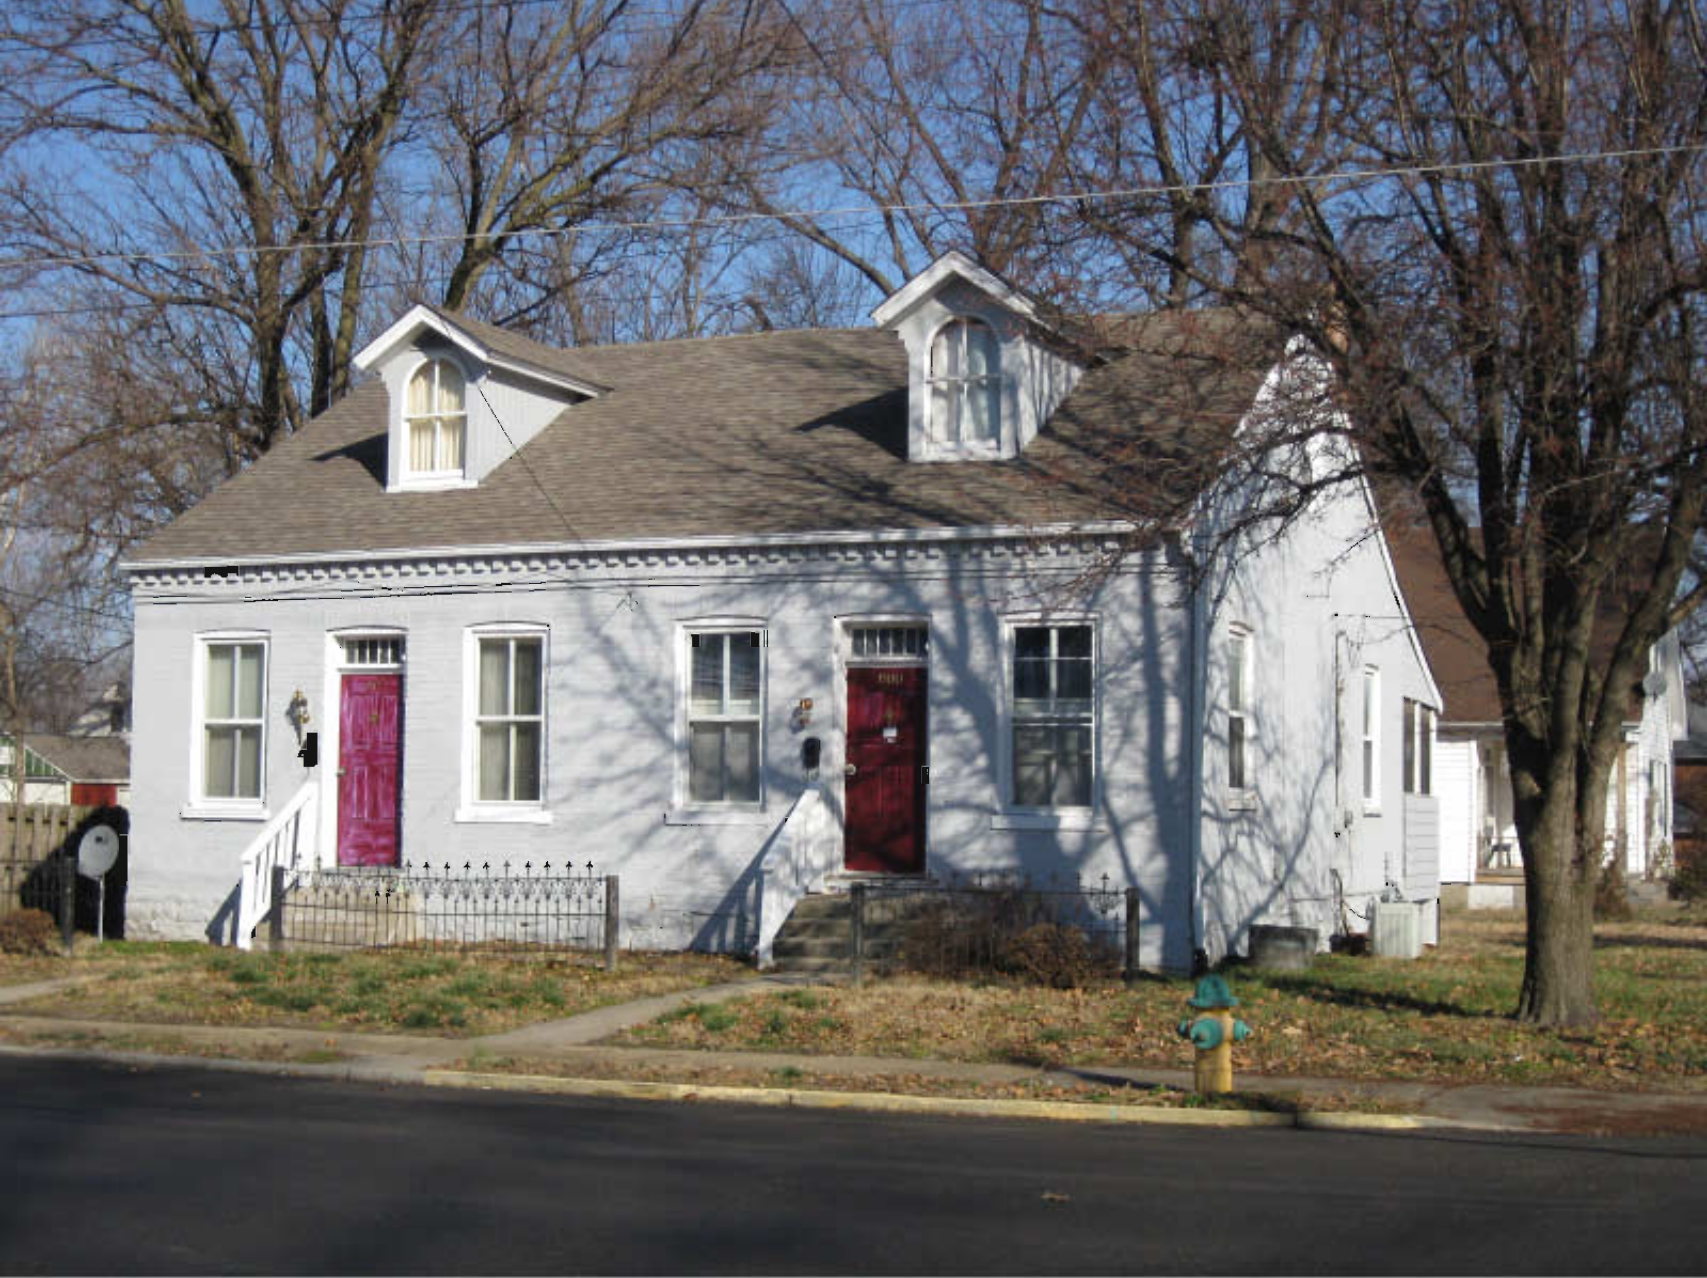
Situated at the northwest corner of Adams and Eighth Streets, this one-and-one-half story, brick, side-gabled house rests on a coursed rock-faced stone foundation, which has been painted. The steeply-pitched, side-gabled roof is trimmed with a denticulated frieze with returns, and interior end brick chimneys are at each end of the rear slope of the roof. On the front slope are two gabled dormers with round-arched, 2/2 wood windows. The walls of the dormers are finished with vertical board siding, and there are decorative brackets to each side of the windows. The front brick wall is laid in a running bond pattern while the other elevations are laid in a five-course common bond, and the walls have been painted. On the six-bay main façade are entrances in the second and fifth bays from the west, and the doors open onto concrete stairs. The four-panel doors, which appear to be metal, are topped by six-light transoms. To each side of the entrances are 2/2 wood windows with wood lug sills, and all openings are slightly arched and topped by jack arches. The first floor of the side elevations have two 2/2 windows, and another window is in the upper half story of each side elevation. A gallery originally spanned the rear elevation, but the west half has been enclosed with lapped siding while the east half has knee walls of lapped siding above which is screening.

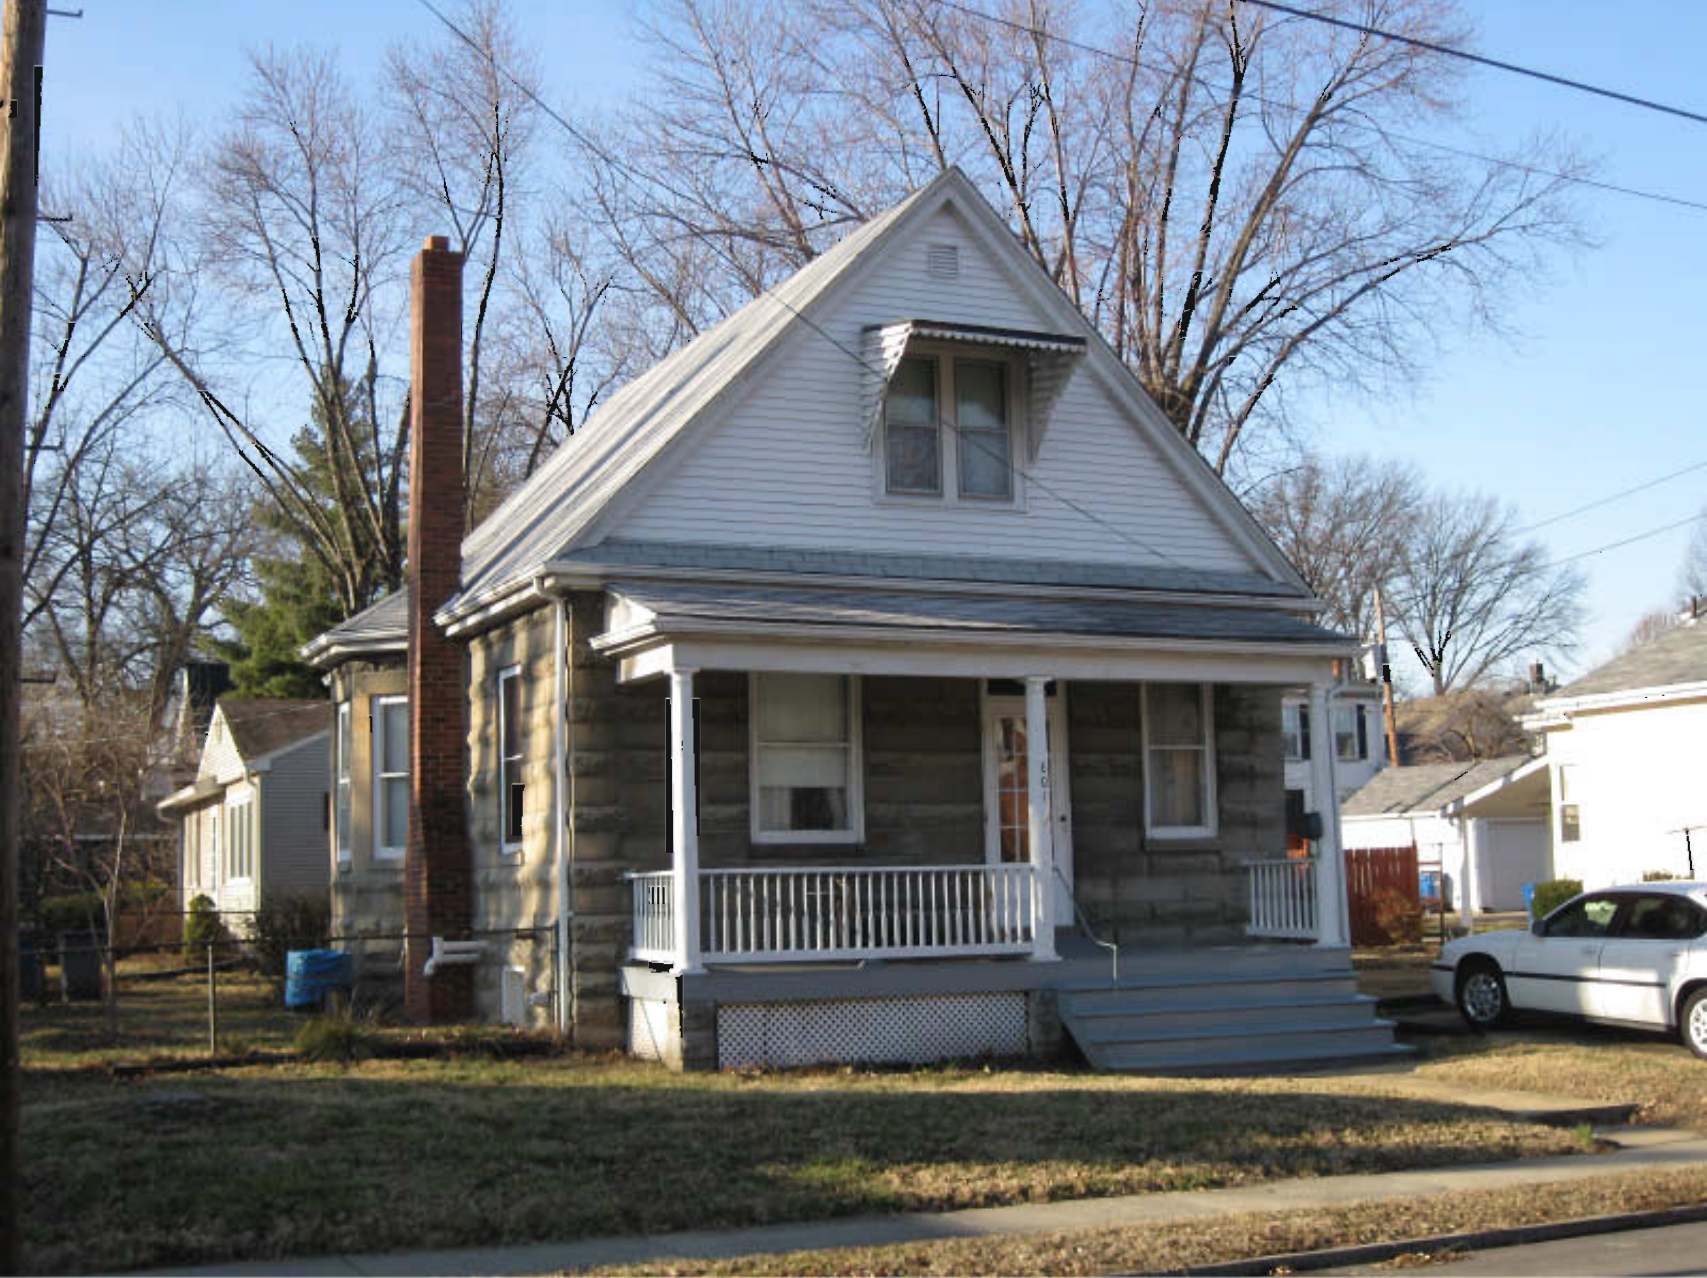
Located at the southwest corner of Adams and Eighth Street, this one-and-one-half story, front-gabled house rests on a rusticated concrete block foundation and the walls are constructed of alternating courses of rusticated and smooth concrete blocks. The gable end is pedimented and the tympanum is clad with vinyl siding. The three-bay main façade has what appears to be a wood door topped by a single-light transom, and there is also a multi-light wood storm door. To each side of the entrance is a 1/1 wood window. A ¾-width gallery spans the façade and features rusticated concrete block foundation piers, wooden stairway and deck, a balustrade with slender turned balusters, and Tuscan columns supporting a shed roof. In the upper half story is a pair of 1/1 windows topped by a metal awning. The east elevation is highlighted by a polygonal bay with three 1/1 windows, and to the north of this bay is an exterior end brick chimney. To the north of the chimney is another window. There are two window openings on the west elevation, but the southern one has been partially enclosed.

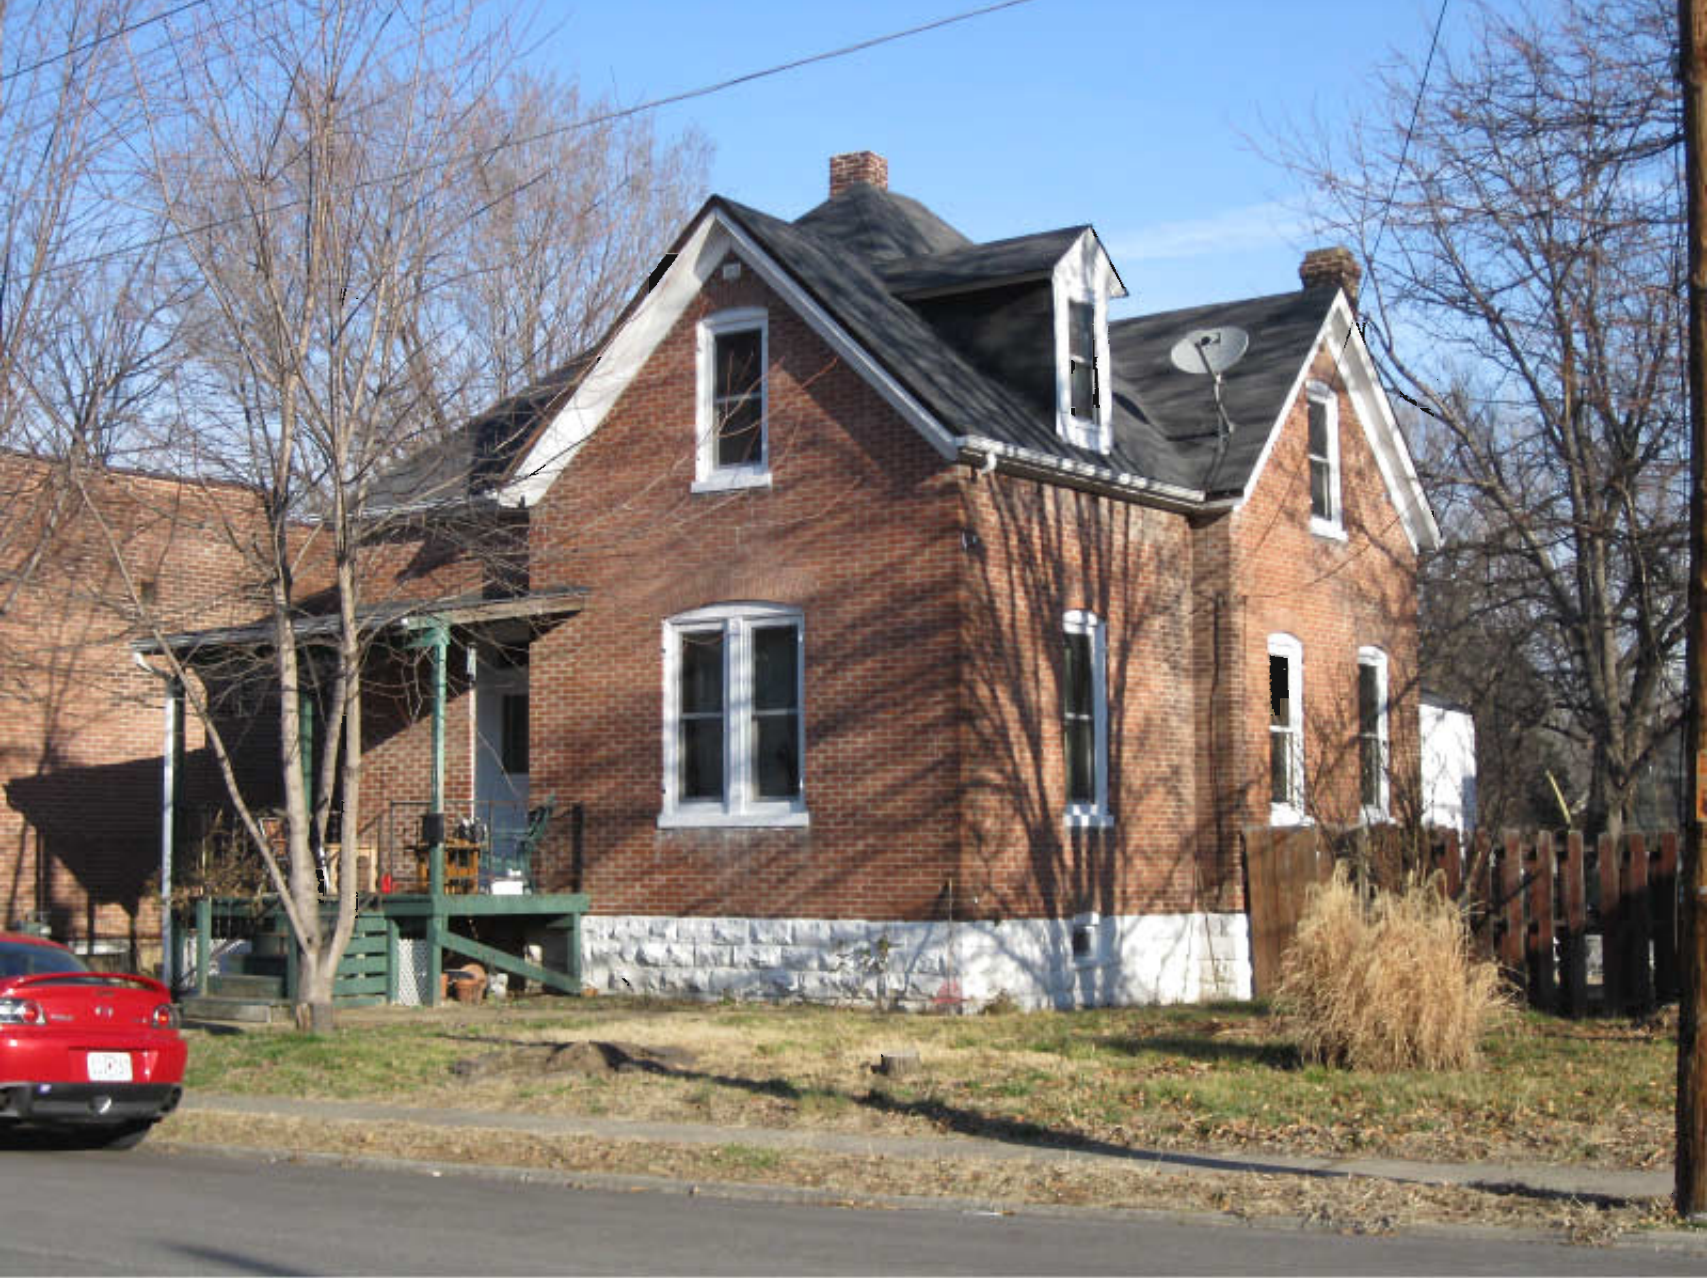
This one-and-one-half story, brick house rests on a coursed, rock-faced stone foundation that has been painted. The bricks on the main façade are laid in a running bond pattern, but on the side elevations they are in a common bond with every sixth course being Flemish bond. A high hip roof with intersecting cross gables crowns the house, and brick chimneys pierce the west slope of the hip roof and the north slope of the eastern cross gable. On the east slope of the front cross gable and the north slopes of the east and west cross gables are gabled dormers with 1/1 windows framed by fluted moldings with bullseye corner blocks and plinth blocks. The walls of the dormers are clad with asphalt roofing shingles. The entrance is in the western bay of the two-bay main façade, and it is a half-glazed, three-panel wood door topped by a single-light transom. The door opens onto a one-bay gallery with wooden deck and stairway, wrought iron railing, and plain posts supporting a shed roof. Photographs in the collection of the St. Charles County Historical Society show that the porch originally had turned posts with corner brackets, a spindled frieze, an ornate balustrade, and a hip roof with intersecting gablet. In the eastern bay of the façade is a large opening that holds a pair of 1/1 windows that are separated by a fluted mullion with a plinth block and bullseye corner block. Above the windows, which appear to be replacements, is an incised wood panel. The segmental-arched openings throughout the house are topped by radiating voussoirs and have wooden lug sills. In the upper half story is another 1/1 window. The eastern elevation has three 1/1 windows on the first floor and one in the upper half story. The west elevation has a stair window set high in the wall just south of the cross-gabled wing, and in the wing is a 1/1 window on each level. A window is also on the south wall of the wing. A frame addition extends from the rear elevation.

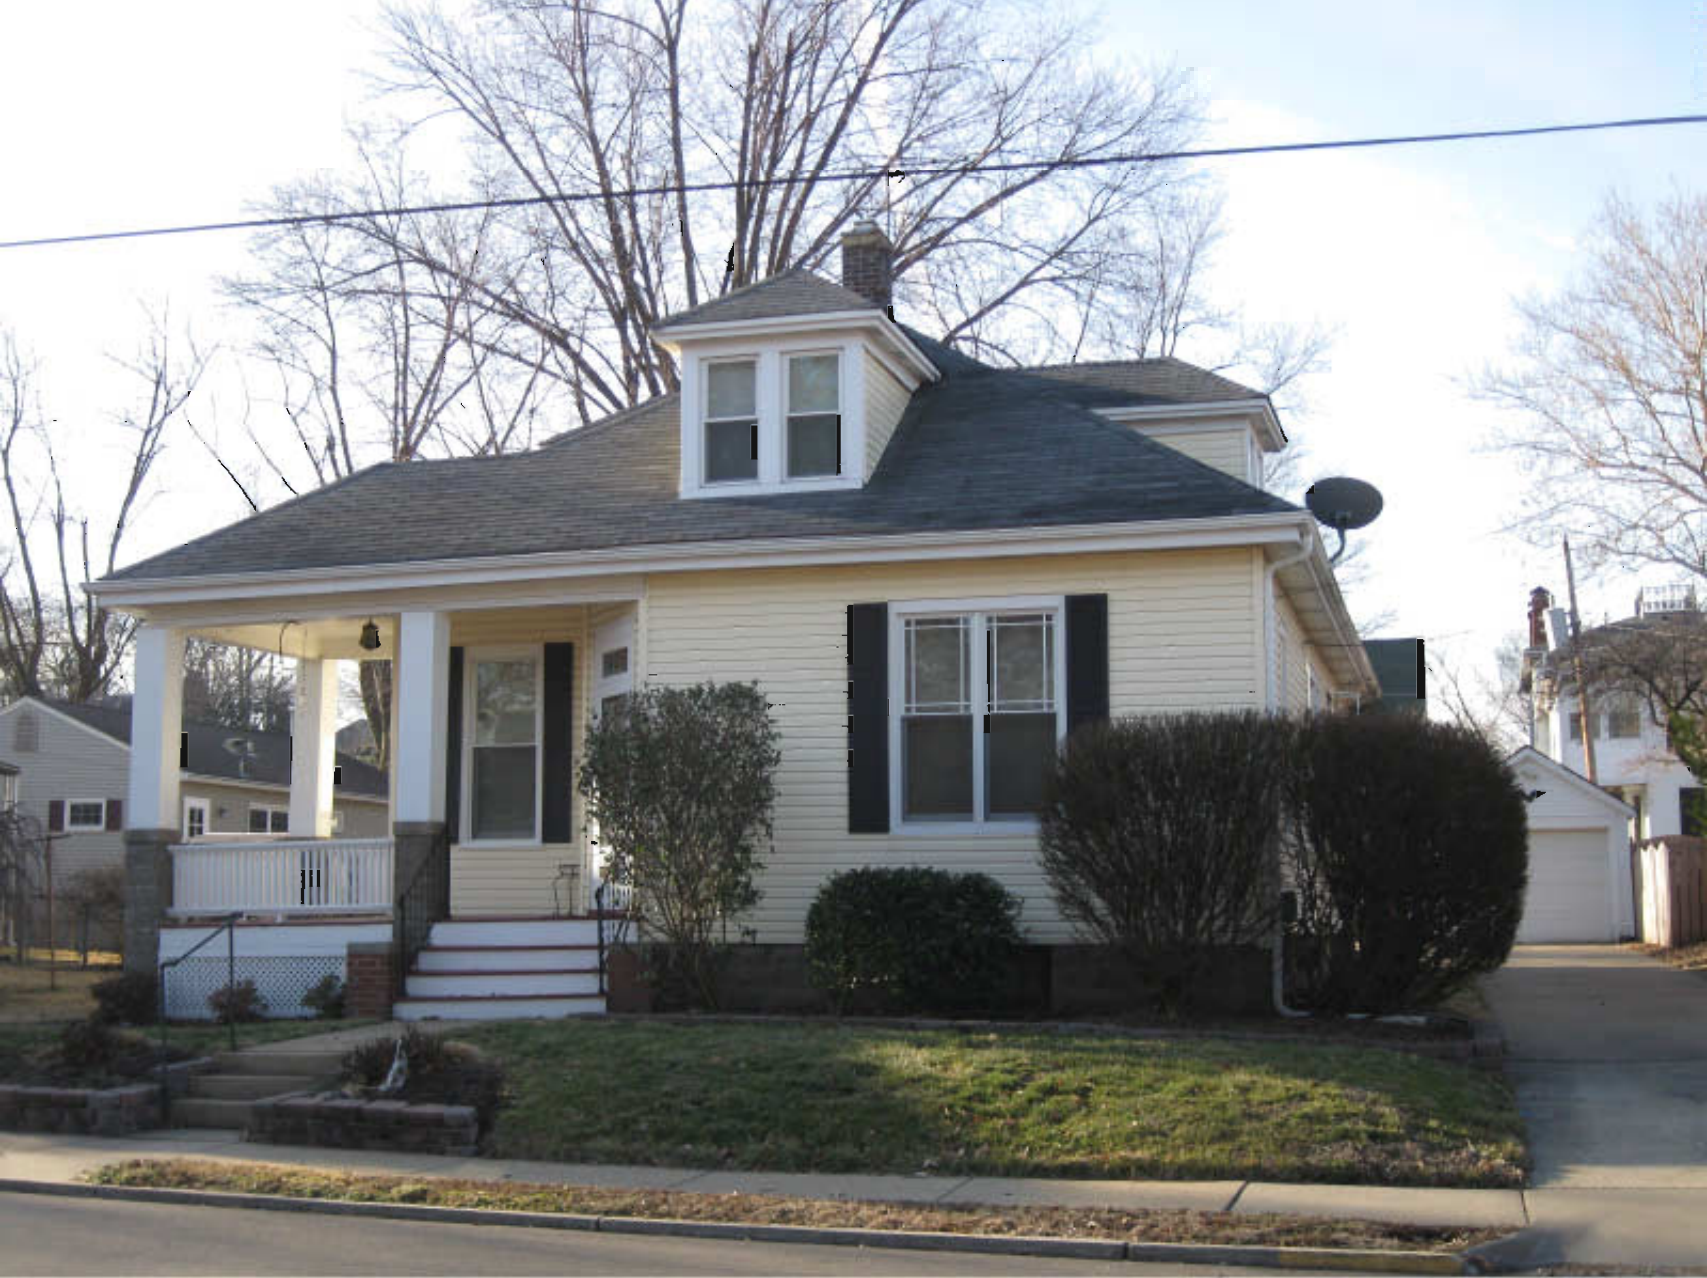
This one-and-one-half story, frame house rests on a rusticated concrete block foundation, has walls clad with vinyl siding, and is crowned by a hip roof with wide overhanging eaves. An interior brick chimney is on the front slope, partially straddling the ridge of the roof, and hipped dormers are on the front and side slopes. The dormers have paired 1/1 windows and walls finished with vinyl siding. The main façade is L-shaped, but the wall is canted where the base and shaft of the L meet. The main entrance, which is located in the canted wall, is a multi-light wood door with an 8-light wood storm door, and there is a single-light transom. To the east of the entrance is a 1/1 window and to the west are paired windows that have upper sashes with muntins near the perimeter of the glazing and single-light lower sashes. Windows throughout the house are replacement wood clad windows. A gallery extends across the eastern two bays and wraps around the eastern wall of the house. The gallery has a wooden stairway flanked by brick knee walls, a wooden deck, box columns resting on concrete block pedestals that extend to the ground, and a plain balustrade. It appears that the columns and pedestals may be replacements. The east elevation has a 1/1 window and paired 1/1 windows. The west elevation has four openings, all of which are 1/1 windows except for the opening in the second bay from the north, which holds a 1/1 window flanked by narrow 1/1 windows, and each of the three are topped by a single-light transom. The house is noncontributing since it has been clad with vinyl siding and the windows have been replaced.

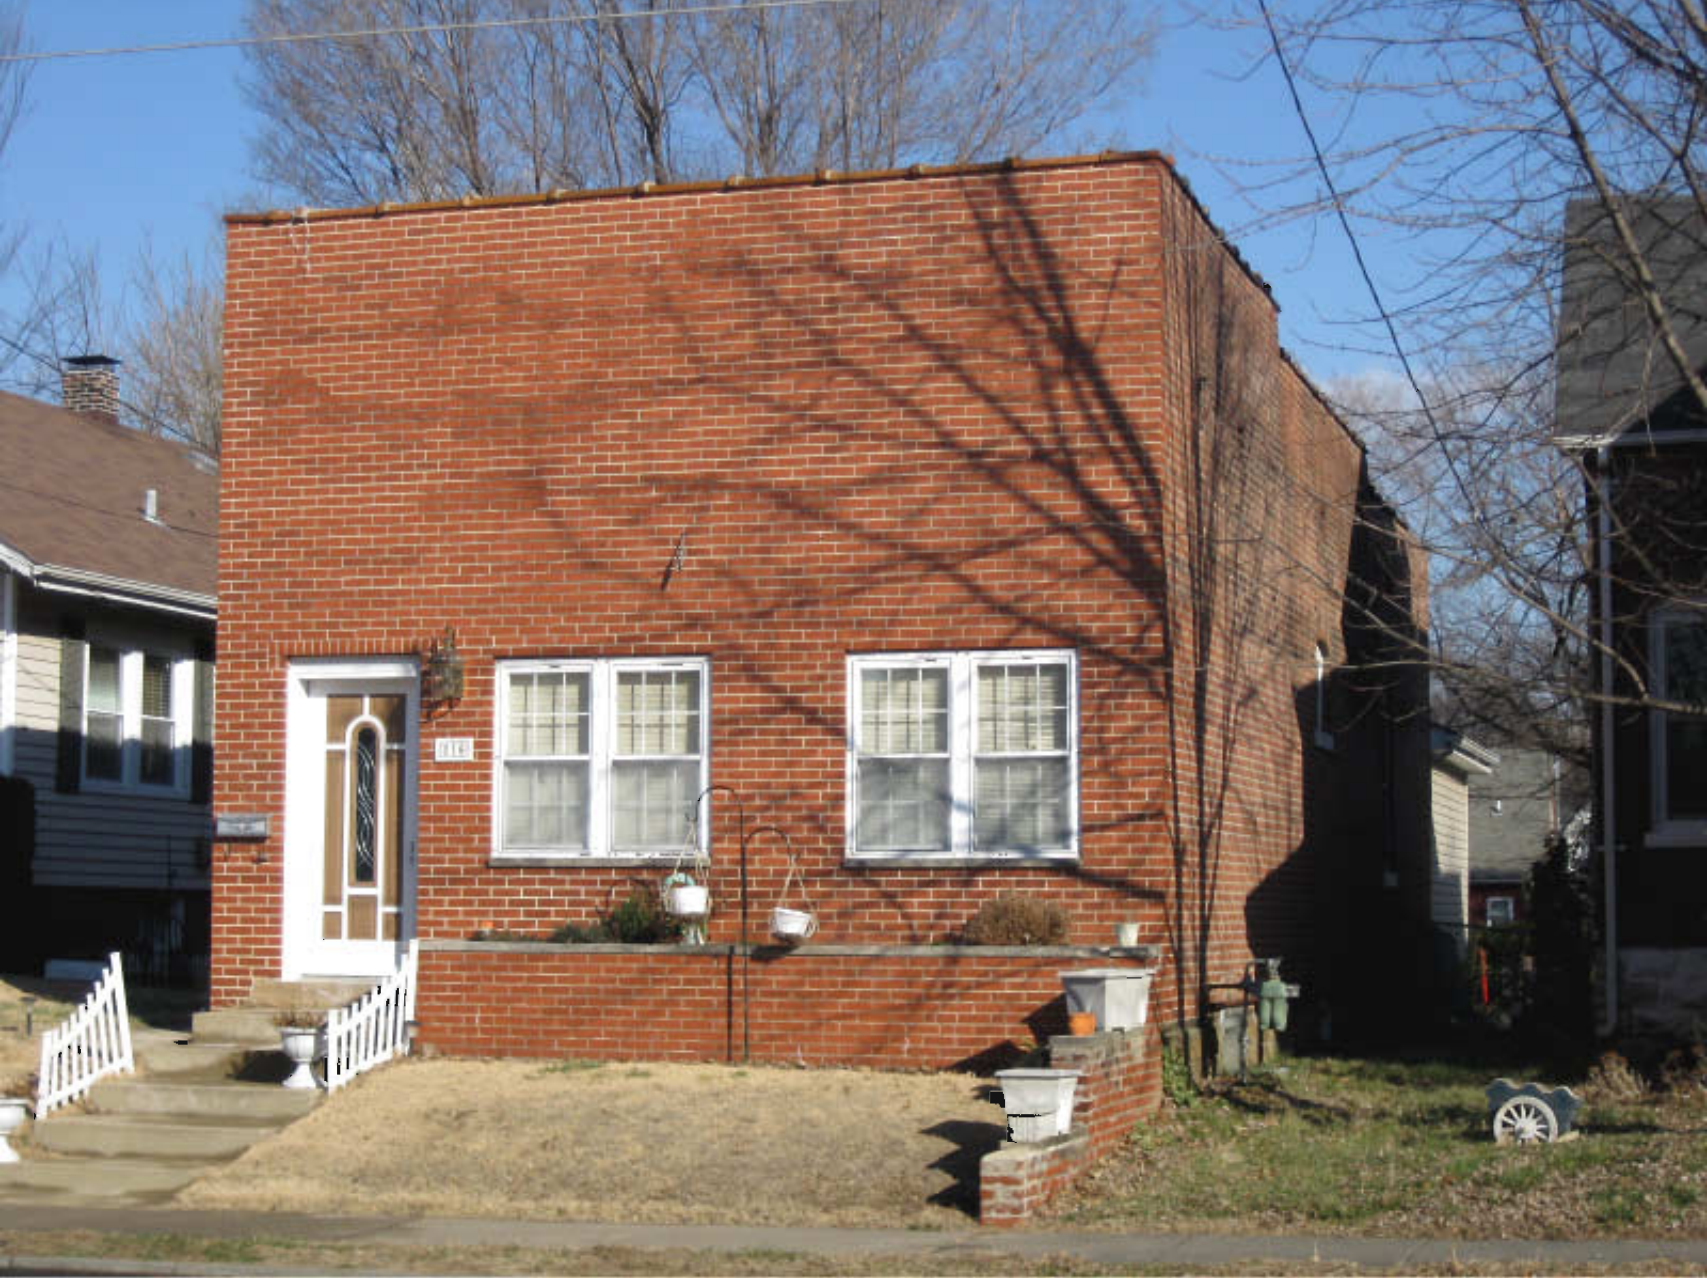
This one-story, brick building with parapeted shed roof was originally a grocery store. The façade was a storefront, and pressed metal covered the upper wall above the display windows and transoms. It appears that rather than merely having the storefront infilled, the facade was totally rebuilt. In the western bay is a modern paneled door with leaded glass panel and to the east are two pairs of vinyl 6/6 windows. The openings on the main façade are flat-arched, while those on the side elevations are segmental arched. The door opens directly onto a concrete stairway, and a brick planter with concrete coping extends along the eastern two bays. On each side elevation is a short hopper window and a 1/1 window, and the parapets of the side walls are stepped. The parapet has a terra cotta coping, and on the western parapet is a chimney. The foundation is scored concrete. A frame addition extends from the rear wall. This building is noncontributing since the storefront was removed after 1961, resulting in the loss of its historic and architectural integrity.

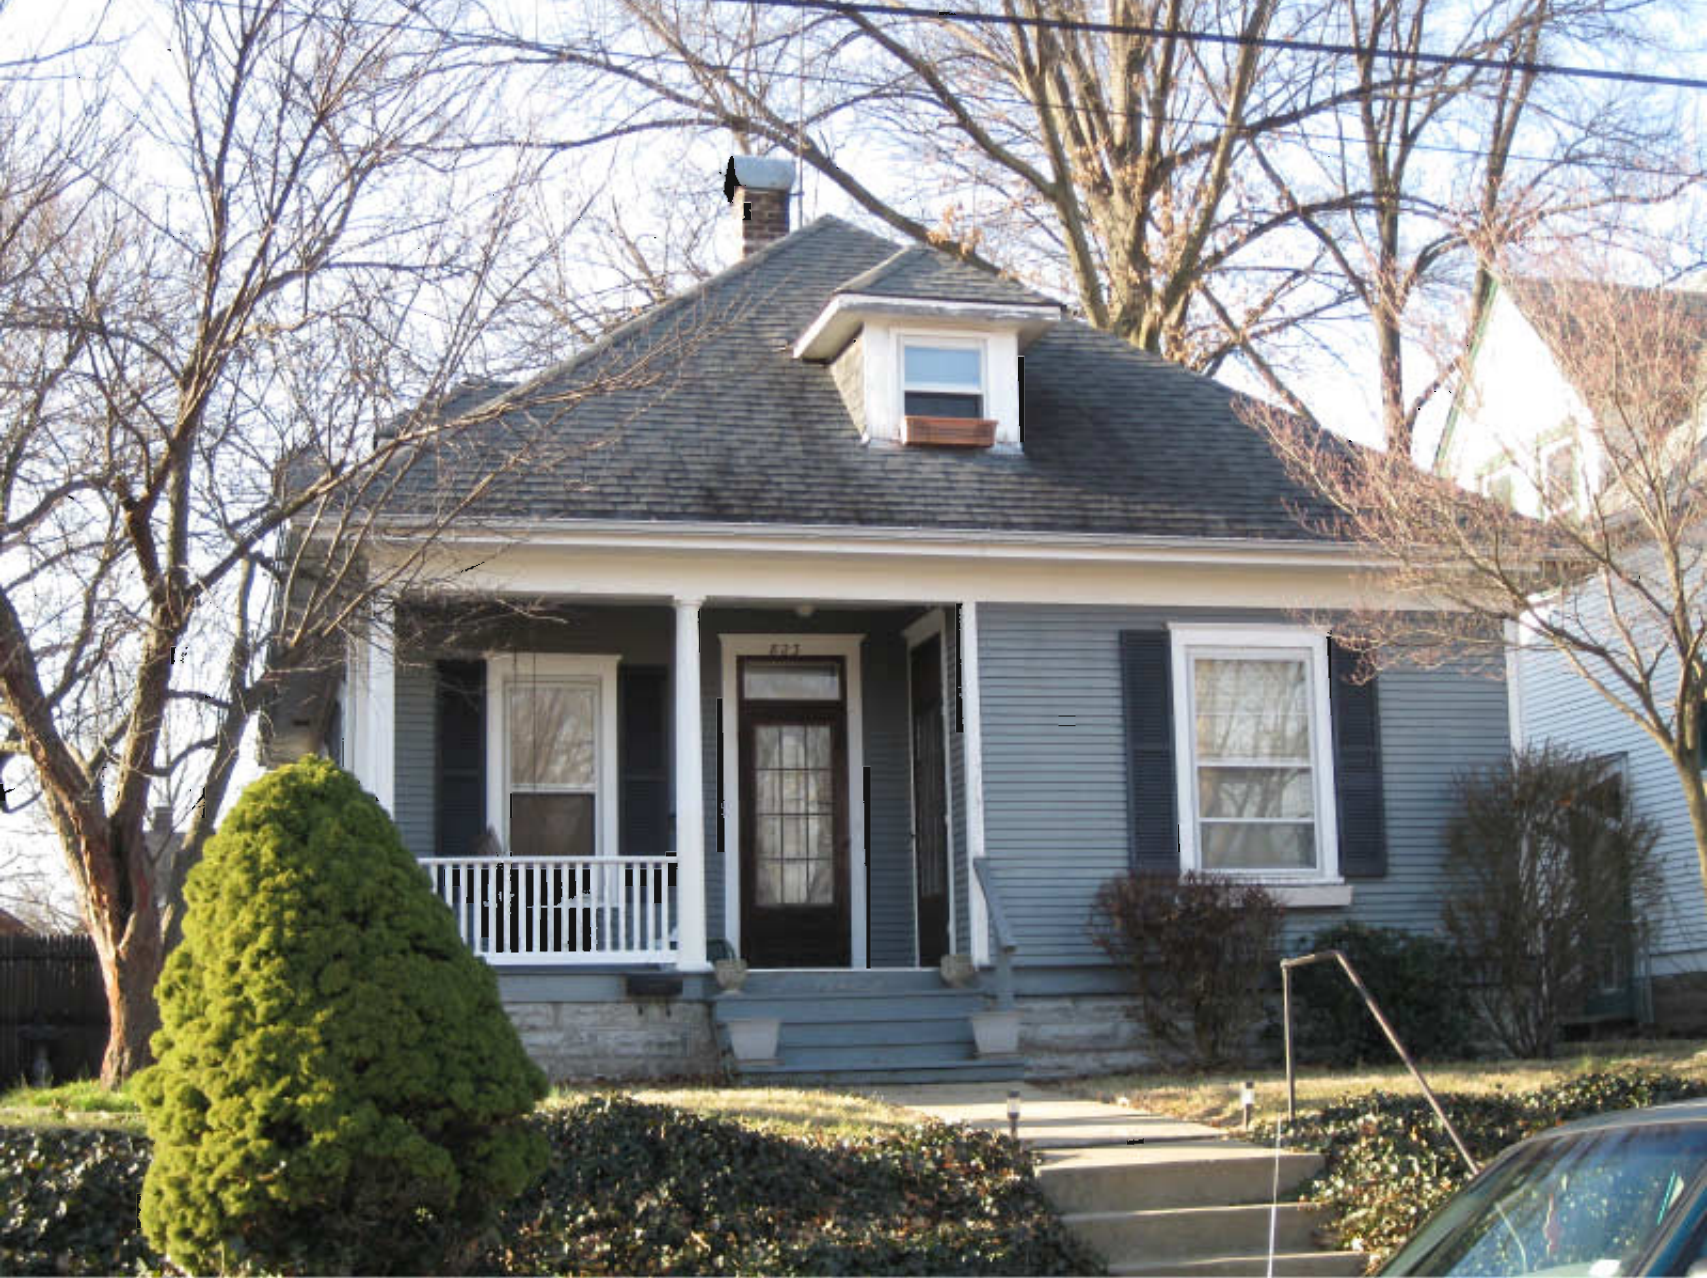
This Colonial Revival style house is a one-and-one-half story, frame structure with weatherboard siding, wooden water table, and a rusticated concrete block foundation. The house is crowned by a high hip roof with wide overhanging eaves and a straddle ridge chimney. A wide frieze trims the roof, and on the front and east slopes are hipped dormers with 1/1 windows and walls finished with asphalt roofing shingles. There are recessed galleries at the northeast and southeast corners, giving the house a T-shaped plan. The two-bay front gallery has a wooden stairway and deck, plain wood balustrade, and slender Tuscan columns. In the easternmost bay is a 1/1 window, and to the west is a wood door with oval light. The door is topped by a single-light transom, and the openings throughout the house have plain trim with molded caps. A matching doorway is at the west end of the porch. Both doors are protected by 12-light, paneled wood storm doors. In the westernmost bay of the façade is a 1/1 window. The west elevation has three 1/1 windows and an atrium window, and the east elevation has two windows.

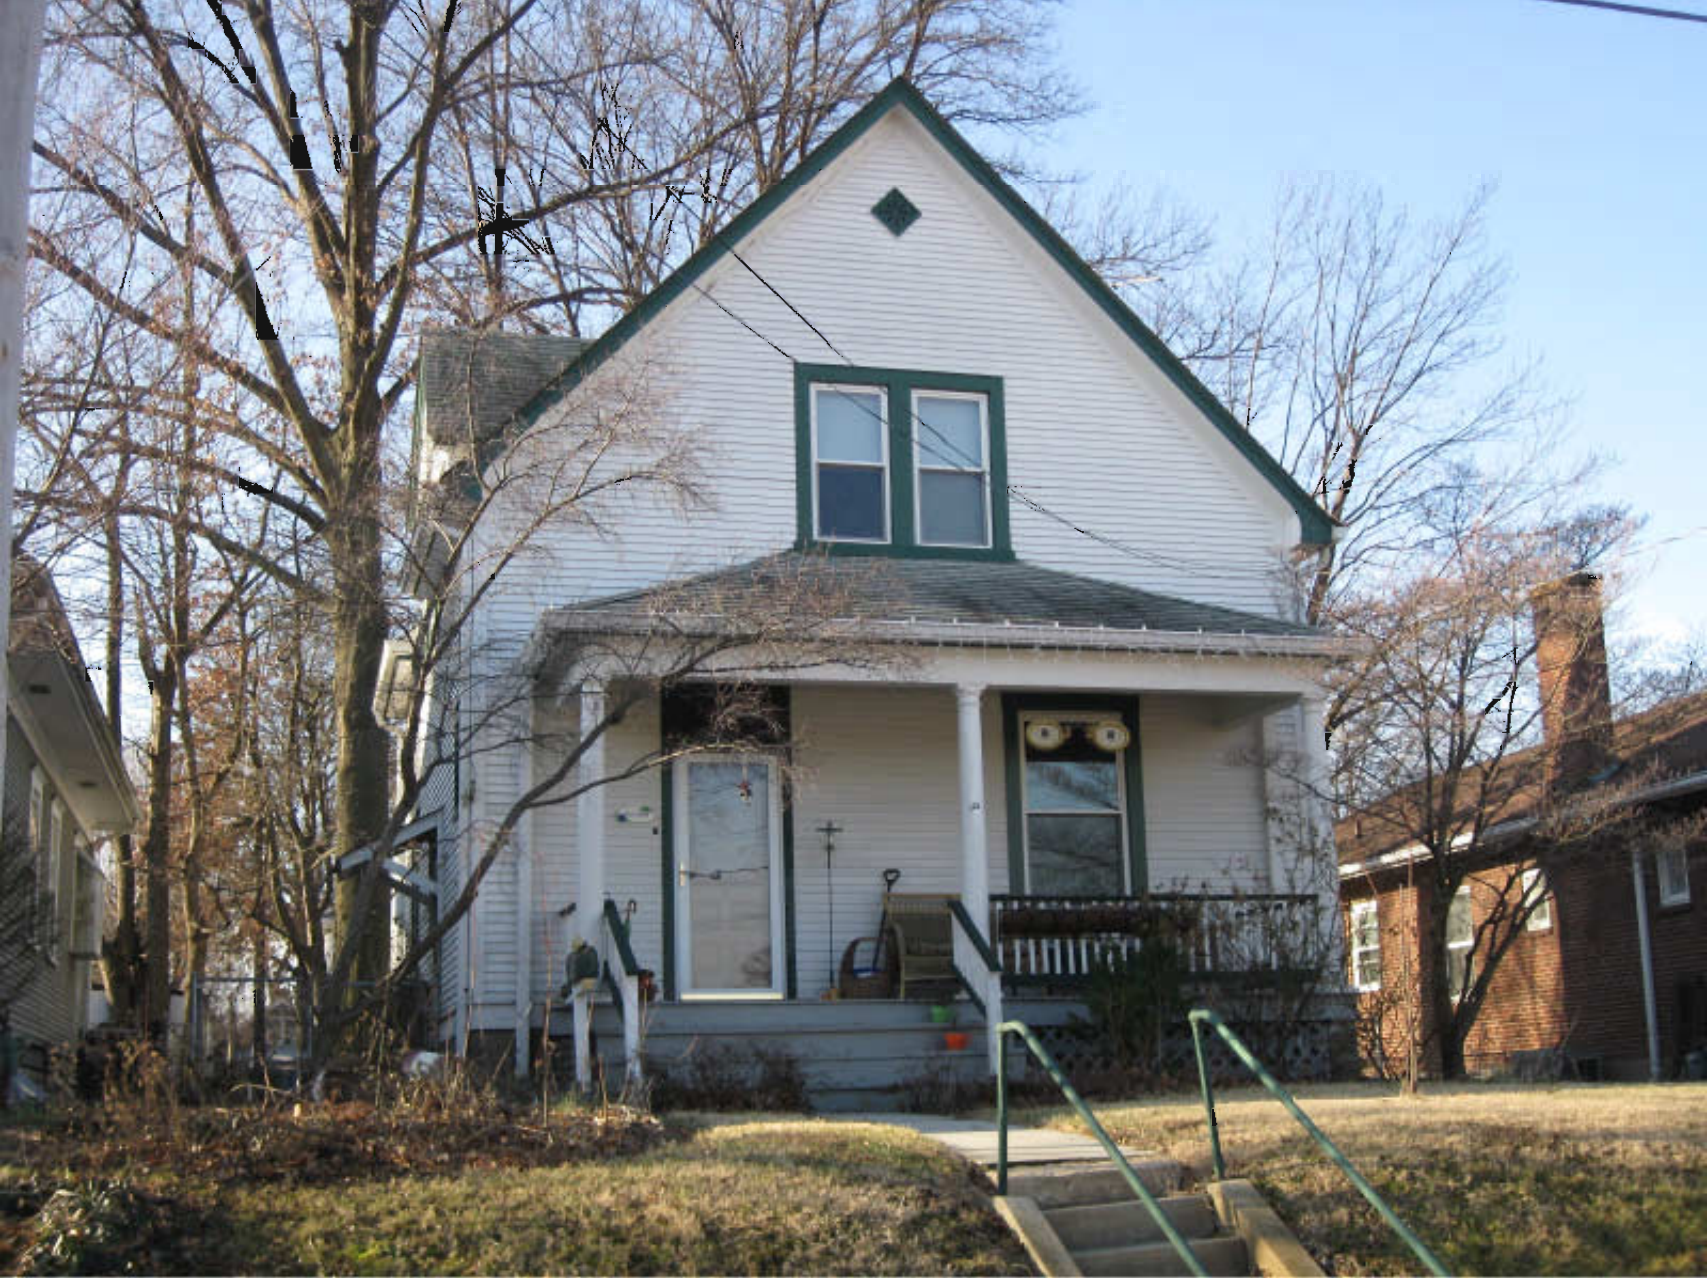
Situated on an elevated lot, this house is a one-and-one-half story, frame, Gable Front structure with a Colonial Revival style gallery. The rusticated concrete block foundation is trimmed with a wooden water table, and there are three-light basement windows. The walls of the house are finished with weatherboard siding, and the steeply-pitched, front-gabled roof is trimmed with a wide frieze. Wall dormers pierce each side slope of the roof, and each dormer has two 1/1 windows and walls finished with weatherboard siding. A half-glazed, four-panel wood door is in the eastern bay of the two-bay main façade, and the glazing is oval in shape and the door is trimmed with applied moldings. A transom is above the door and to the west is a 1/1 window. The door opens onto a ¾-width gallery that has a wide wooden stairway, wood deck, balustrade with turned balusters, and Tuscan columns supporting a high hip roof. Directly above the porch roof is a pair of 1/1 windows, and in the gable end is a small diamond-shaped ventilator. On the west elevation are two 1/1 windows. On the east elevation is a small stained glass stair window situated high in the wall, a door at ground level, and paired 1/1 windows. The half-glazed wood door is protected by a shed dormer supported by knee braces. The one-story, shed-roof porch on the east half of the rear elevation has been enclosed, and on its east elevation is a 1/1 window.
