ARCHITECTURAL/HISTORIC INVENTORY FORM

1. Survey No. SC-AS-009-001		2. Survey Name: St. Charles Survey Phase 3: Mid-Town and Commons Neighborhoods	
3. County: St. Charles		4. Address (Street No.) 128	Street (name) North Sixth Street
5. City: St. Charles	Vicinity: <input type="checkbox"/>	6. UTM:	
7. Township/Range/Section:		8. Historic name (if known): Meyer-Pieper House; The Meyerdorf	
9. Present/other name (if known):		10. Ownership: <input checked="" type="checkbox"/> Private <input type="checkbox"/> Public	
11a. Historic use (if known): Domestic/single dwelling		11b. Current use: Domestic/single dwelling

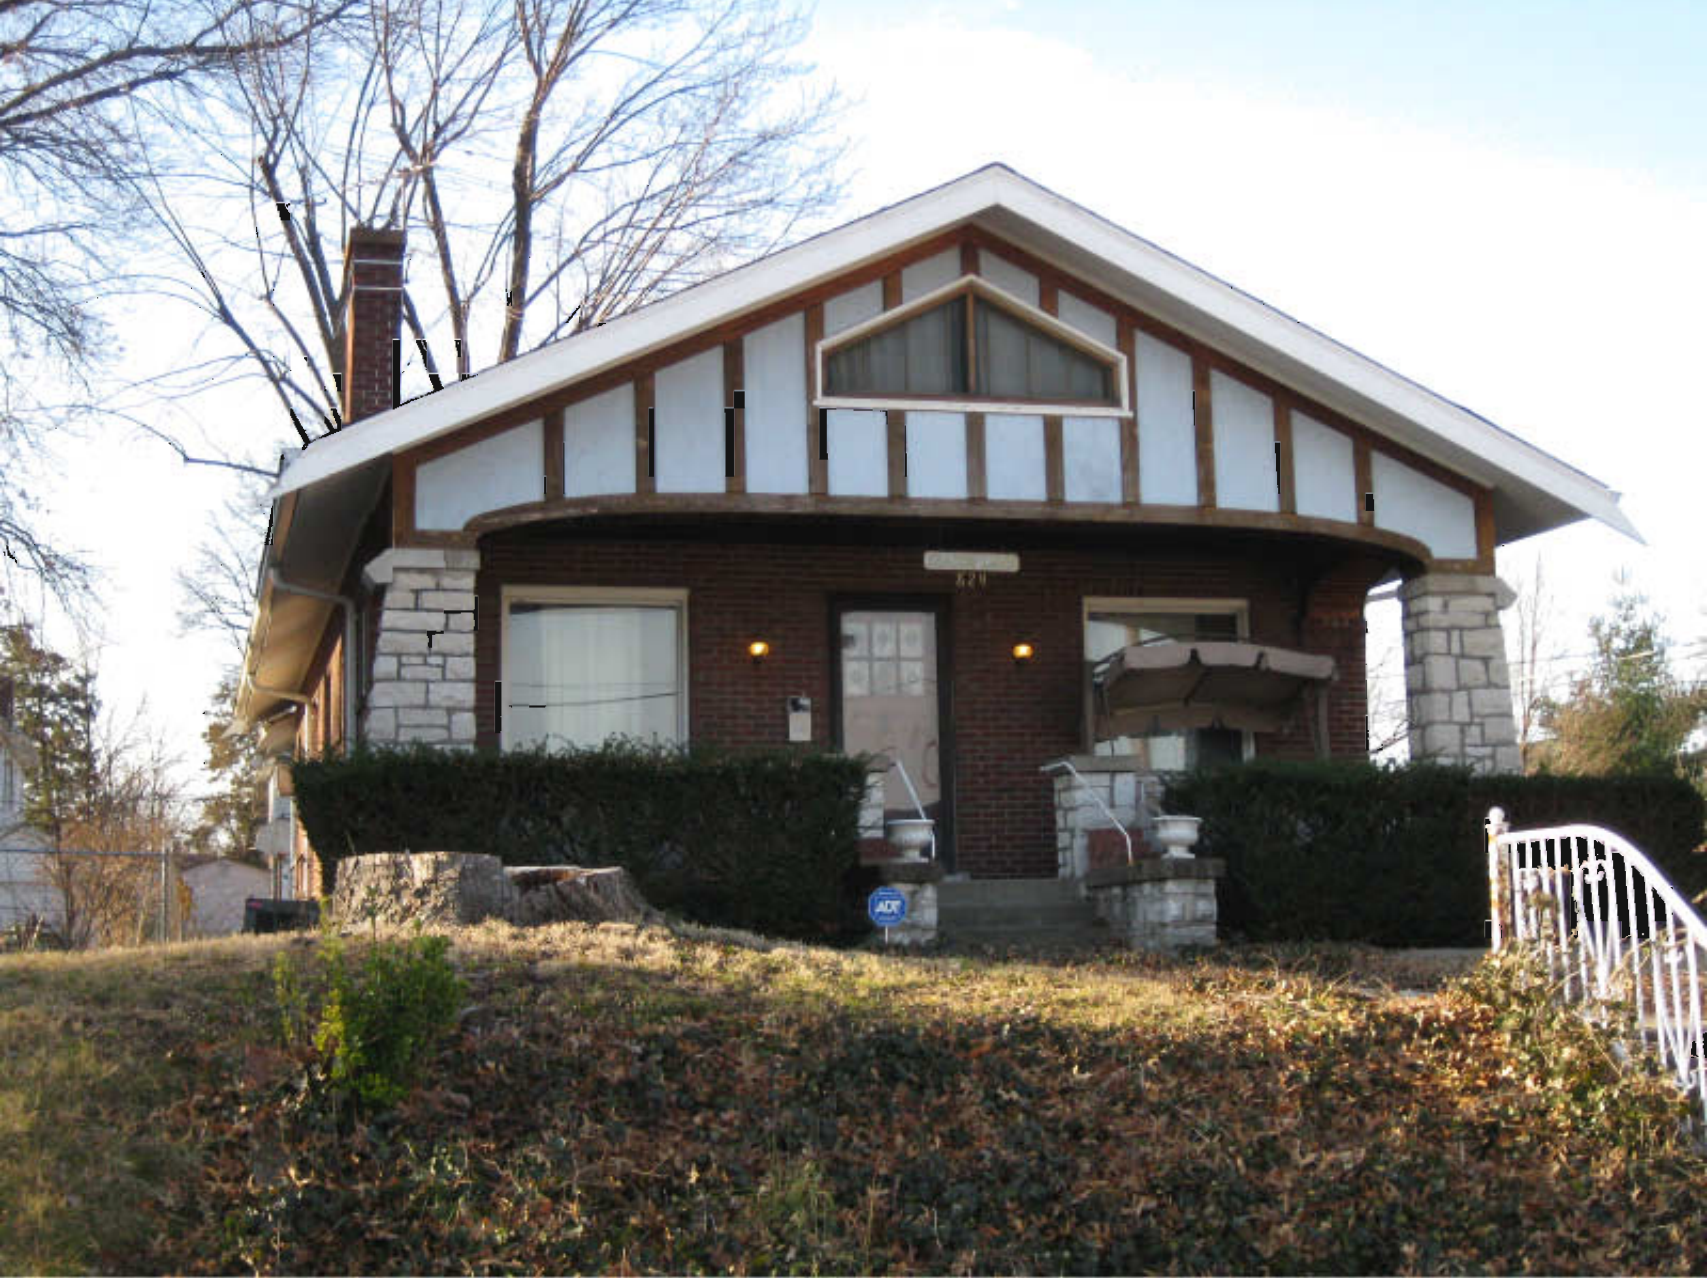
Located at the southeast corner of Adams and Ninth Streets, this one-story, front-gabled, masonry, Craftsman bungalow rests on a concrete foundation and the walls are finished with textured brick laid in a running bond pattern, except for the first course above the foundation, which is a rowlock course. The medium-pitched, front-gabled roof has wide overhanging eaves, and the front gallery is recessed under the main roof. The gable end is finished with stucco and decorative half-timbering, and a seven-light pentagonal window is in the gable end. There is an interior end brick chimney near the front (north) of the east slope of the roof and another near the rear of the west slope. The three-bay main façade has a central paneled-and-glazed, Craftsman style door with six lights set over two vertical panels. To each side of the entrance is a sheet glass replacement window. A circa 1940s photograph in the collection of the Saint Charles County Historical Society shows that there were originally paired windows in the two openings, but it could not be determined whether they were 4/4 double-hung sash or 8-light casements. The entrance opens onto a full-width gallery with concrete stairway flanked by stone knee walls, stone pedestals at the top of the stairway, concrete deck, wrought iron railing, and battered stone piers supporting a basket-handle arched frieze. The stone piers have cast stone caps that extend downward on the outer side (the east side of the east pier and the west side of the west pier). A plaque with the name Shadow Lawn hangs from the front gallery. On the west elevation is a long, narrow stained glass window with a Prairie style motif, and to the south is a frame box bay with paired 6/6 windows and weatherboard siding. To the south of the box bay is a 1/1 window and directly below the box bay is an opening into the garage underneath the house. The garage opening is filled with three wooden doors, each with four lights set above a single panel finished with vertical boards. These doors are protected by a hip roof supported by scroll brackets with drop pendants. On the west elevation, from front to rear, are two small stained glass windows, two 1/1 windows and two short 2/2 windows.

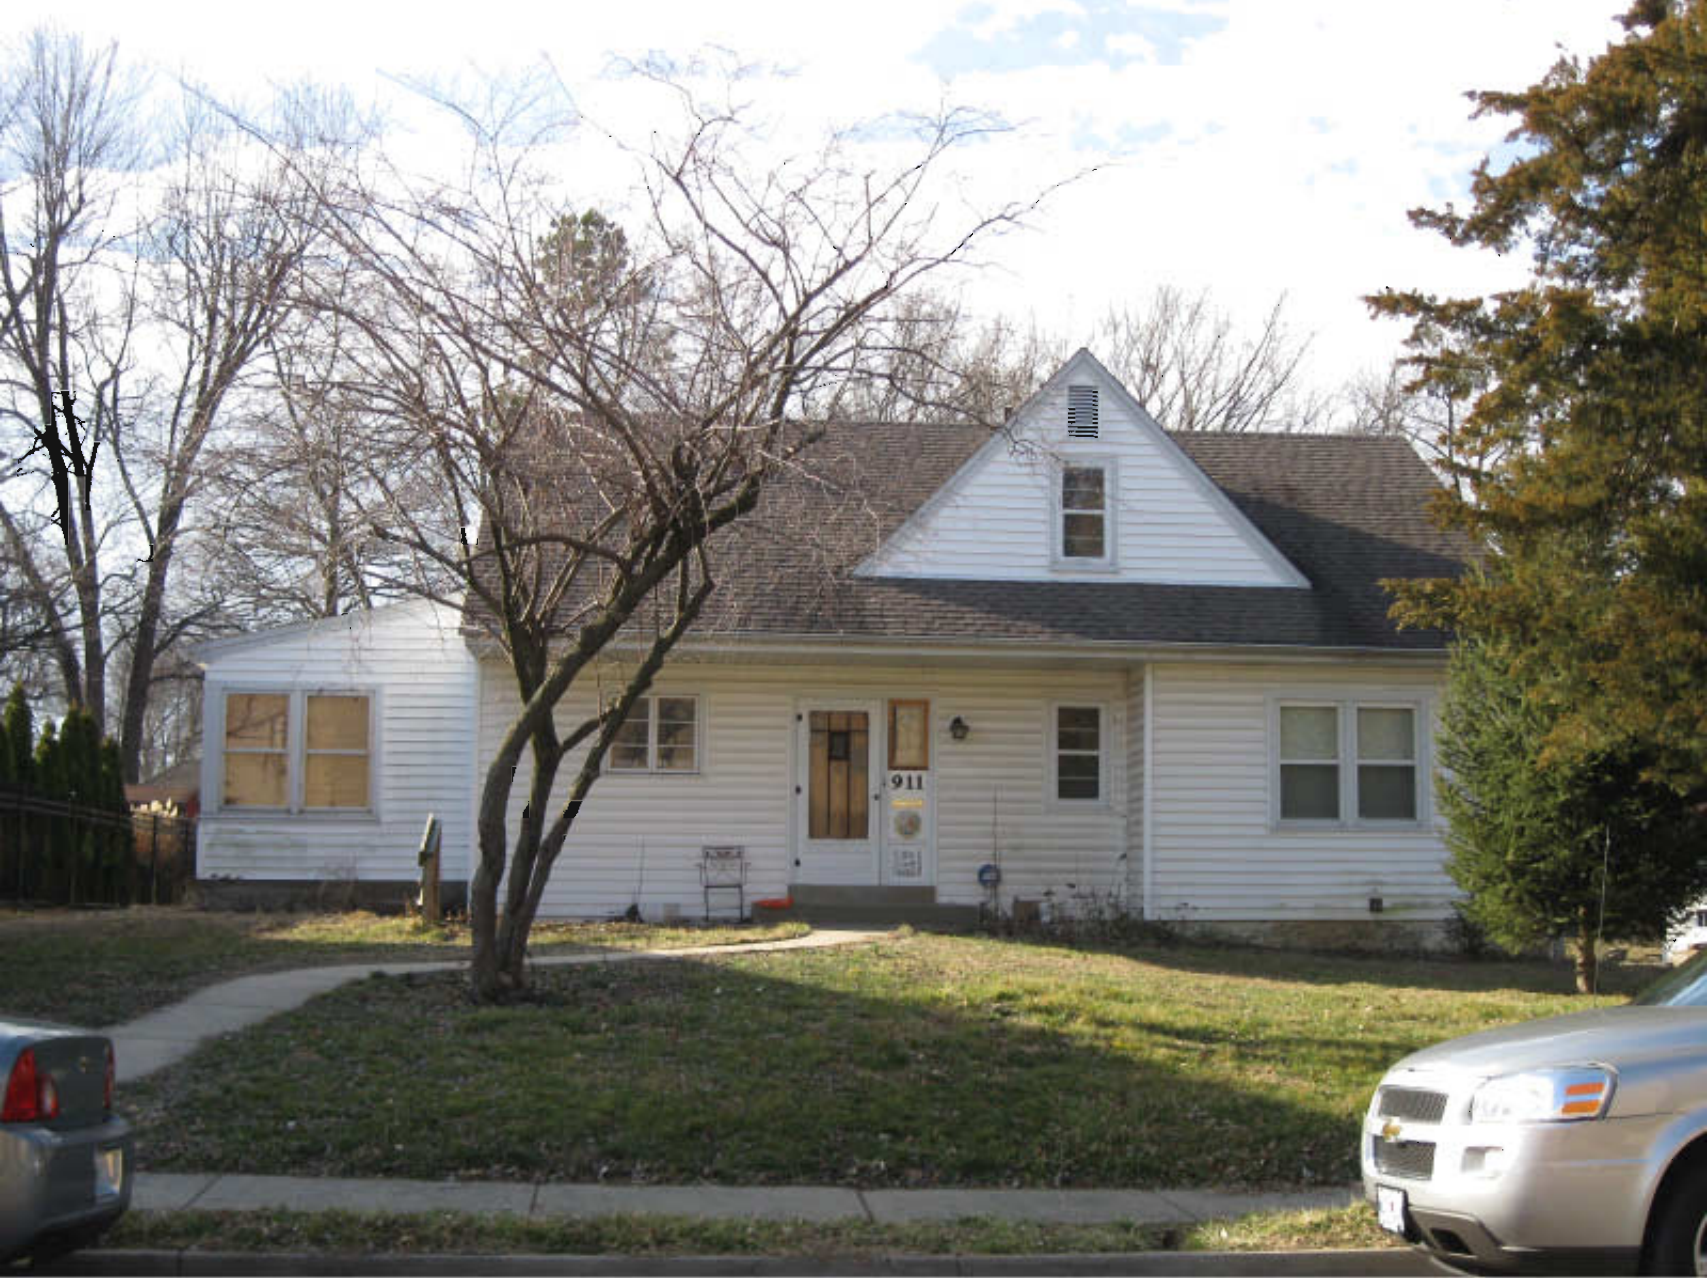
This one-and-one-half story, frame, Minimal Traditional form house was originally rectangular in plan but an addition on the east elevation has given it an L-shaped plan. The foundation is concrete and the walls are finished with a variety of materials: on the main (north) façade and west elevations the walls are clad with aluminum or vinyl siding, on the rear the walls are cement asbestos shingles, and on the rear and part of the east wall of the addition the walls are finished with wood shingles. The house is crowned by a high side-gable roof with intersecting front gable, and on the rear slope is an interior brick chimney. The eastern three bays of the four-bay main façade are slightly recessed, providing some protection for the entrance, which is located in the second bay from the east. It appears that the entrance may have been reworked. The wood door has three stepped lights and to the right is a short stained glass window. The door opens onto a concrete stairway with two steps. To the left of the entrance is a pair of short, three-light windows and to the right is a 2/2 window (the lights are horizontal). In the westernmost bay is a pair of 1/1 windows, and in the gable end is a 2/2 window. A shed-roof addition extends from the east elevation and features paired 1/1 windows on the north elevation. The house is noncontributing due to the vinyl siding, replacement of some of the windows, and east addition.

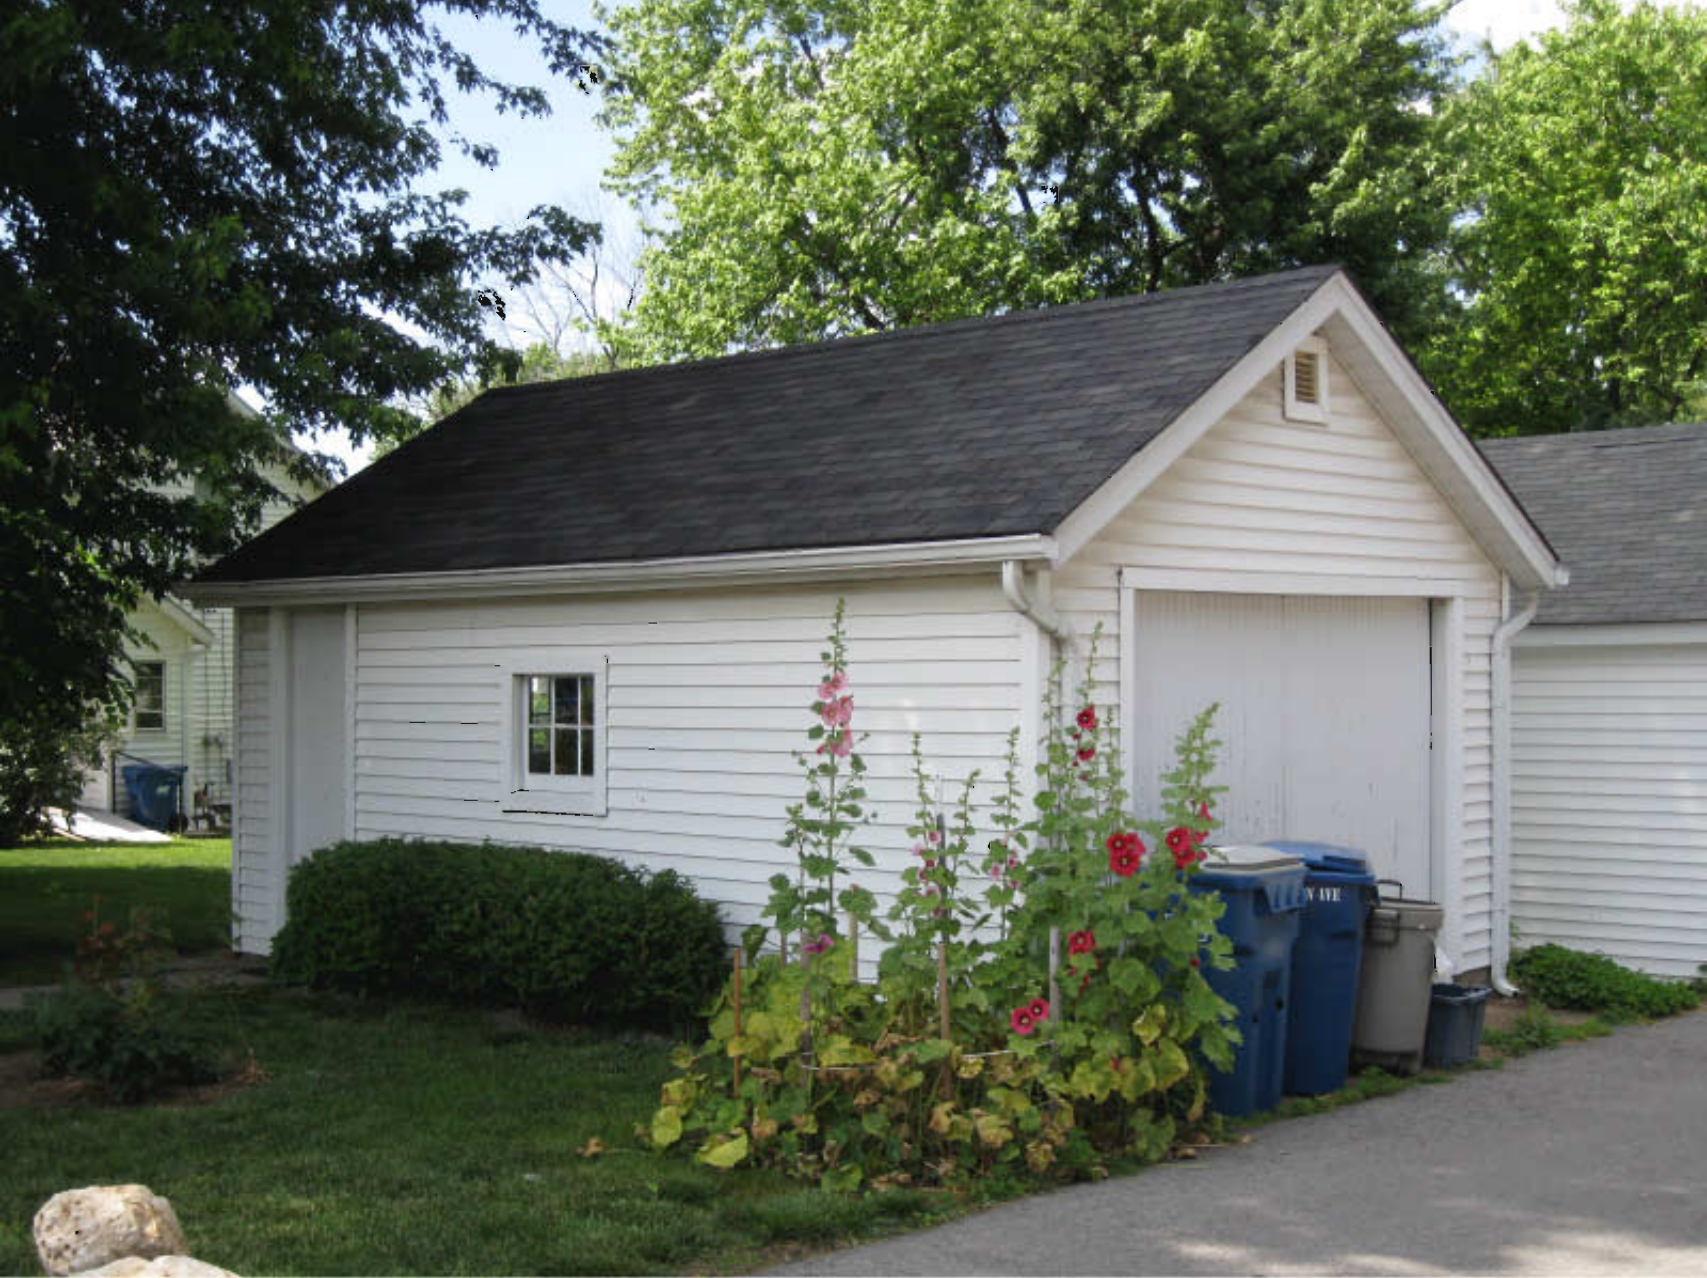
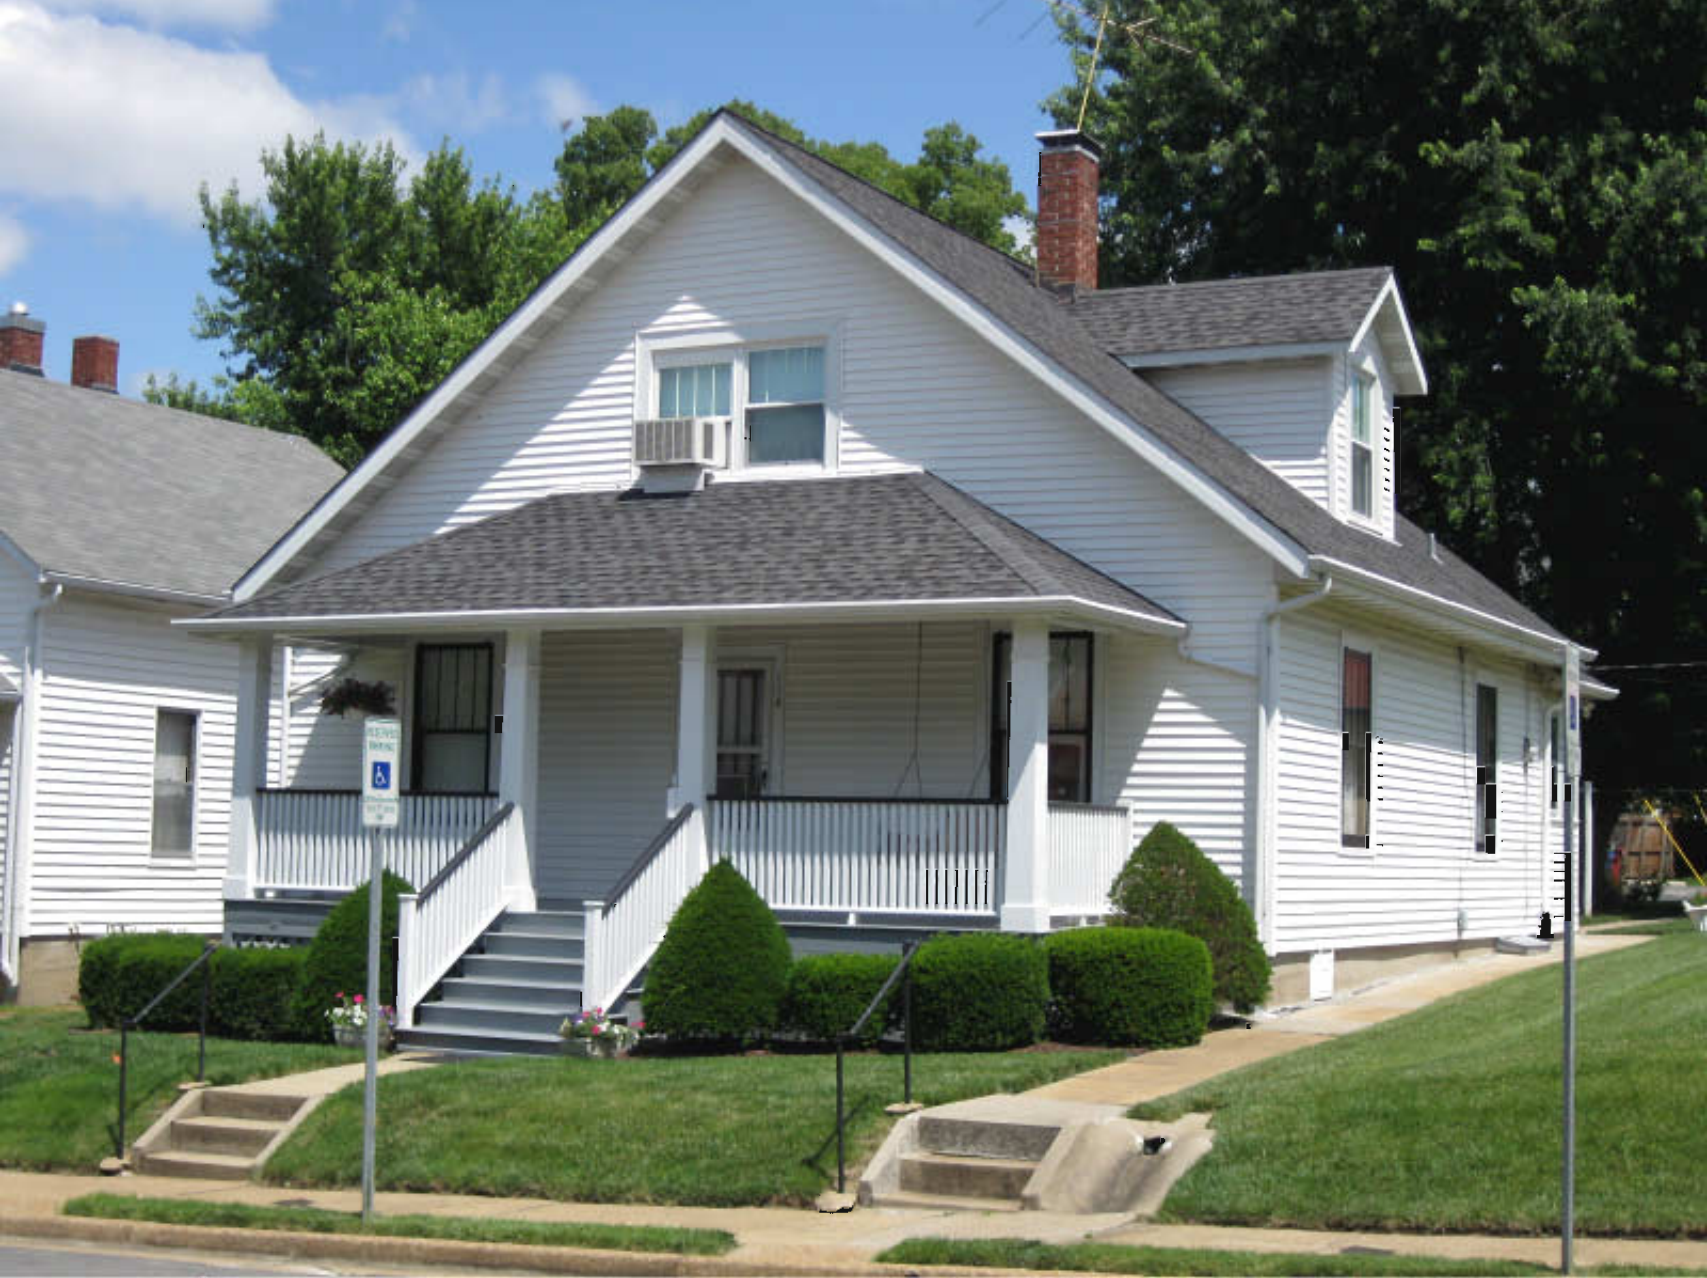
Situated on a slightly elevated lot, this one-and-one-half story, frame house has a front-gabled roof with wide overhanging eaves. The walls are finished with vinyl siding and the foundation is concrete. Each side slope of the roof has a gabled dormer with 4/1 wood window, and an interior brick chimney is situated at the intersection of the main roof and roof of the southern dormer. Facing west, the main façade is a three-bay elevation that has a central half-glazed wood door with four vertical lights, and to each side of the door is a 4/1 wood window. The door opens onto a ¾-width gallery with wooden deck and stairway, plain wood balustrade, and box columns supporting a steeply-pitched hip roof. The area underneath the porch deck is filled with framed lattice panels. Above the porch, in the upper half story, is a pair of short 4/1 windows. Each of the side elevations has two 4/1 windows. A one-story, hip-roofed wing extends from the south end of the rear elevation.

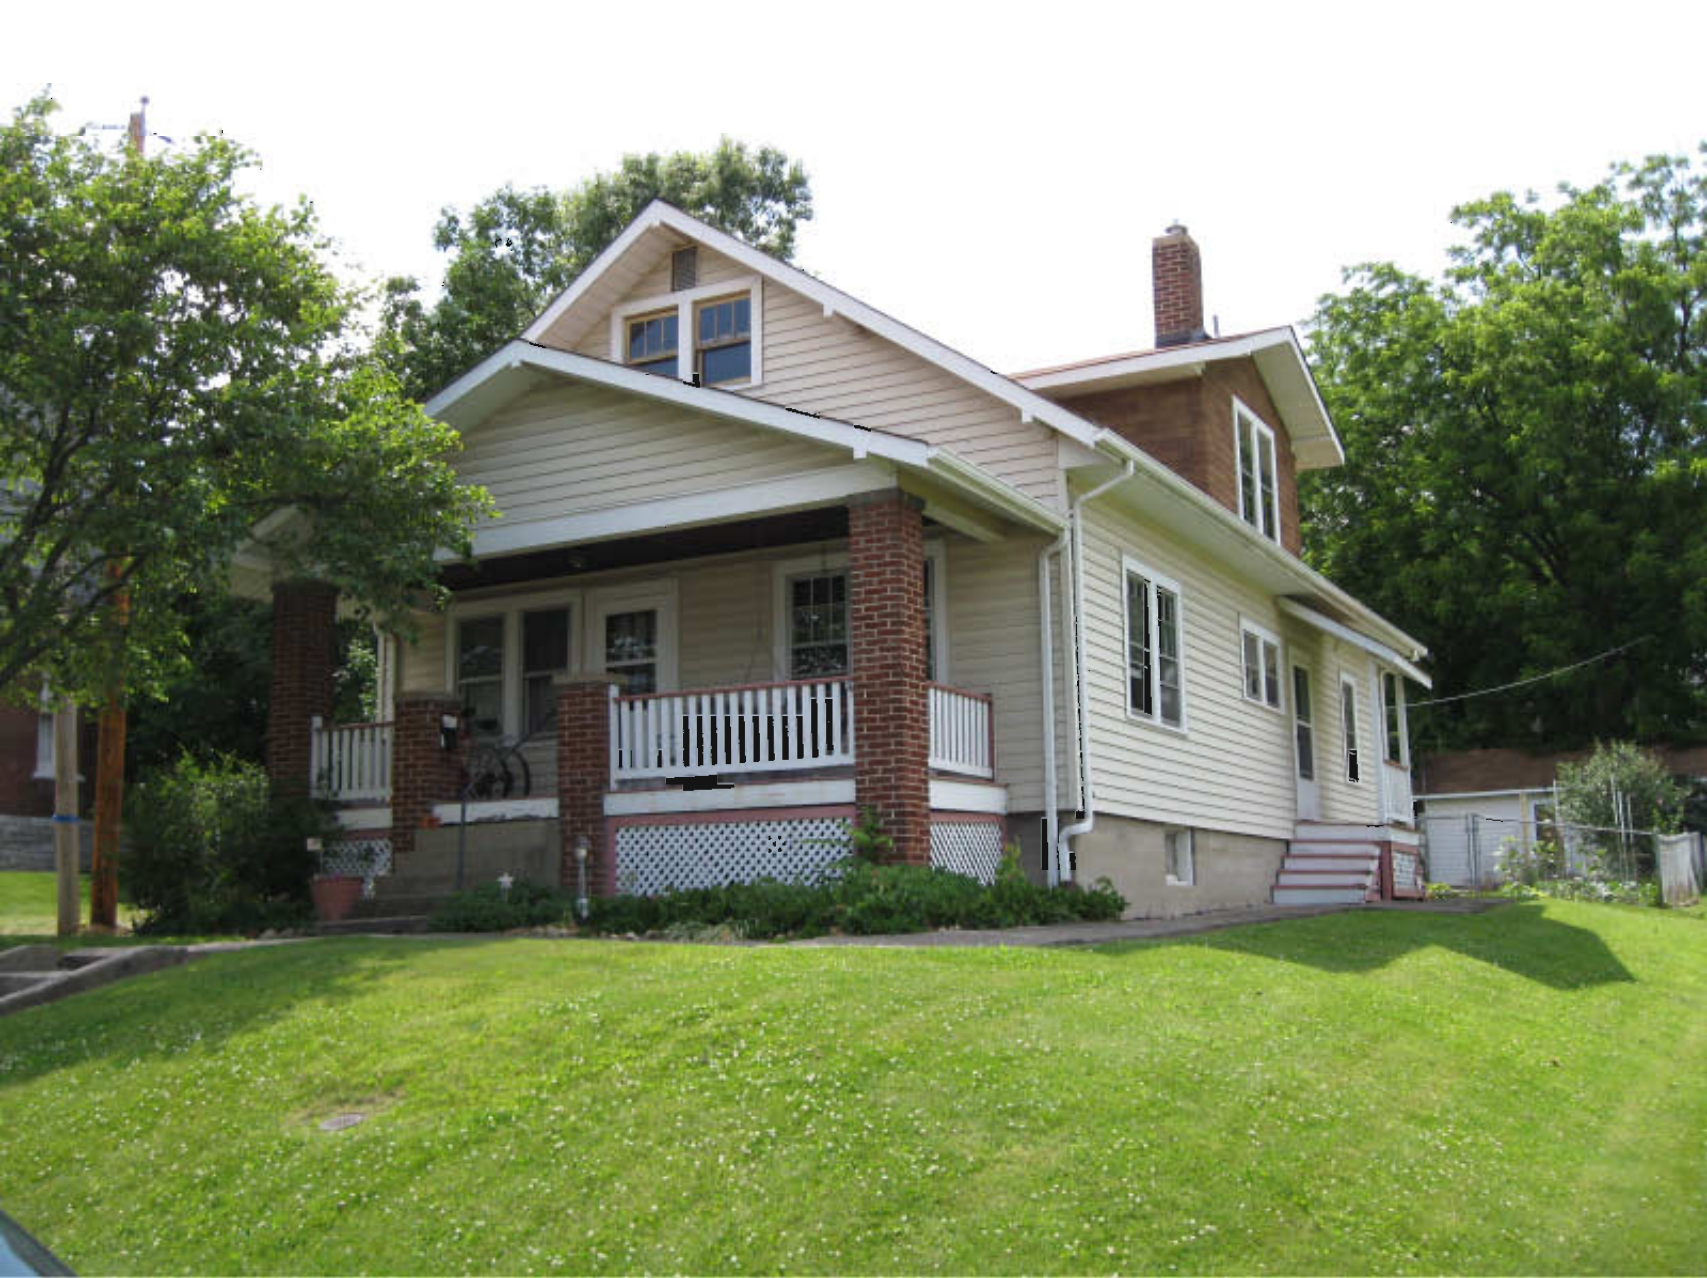
Situated on an elevated lot, this house is a one-and-one-half story, front-gabled, frame bungalow that rests on a concrete foundation pierced by three-light basement windows. The walls are clad with vinyl siding and the roof has wide overhanging eaves and decorative wood purlins in the gable ends. Large gabled dormers with paired 3/1 windows and walls clad with asphalt roofing shingles are on each of the side slopes of the roof. In the dormers' gable ends are purlins, and an interior brick chimney pierces the east slope of the roof of the northern dormer. The three-bay main façade has a multi-light wood door situated between paired 3/1 wood windows. The façade is asymmetrical, with the door set much closer to the southern pair of windows than to the northern pair. The door opens onto a ¾-width gallery that has a wooden deck, wood balustrade with plain wide balusters, and a gabled roof with wide overhanging eaves and purlins in the gable end. The brick piers that support the roof, like the pedestals to each side of the concrete stairway, extend to the ground, and below the porch deck the area between the piers and pedestals is filled with framed lattice panels. Above the porch roof, in the upper half story, is a pair of short 3/1 wood windows. The north elevation has, from left to right, a pair of 3/1 windows, a short pair of 3/1 windows, a half-glazed wood door and a single 3/1 window. The door opens onto a one-bay, shed-roof porch with a wood stair at the east and west sides, wood deck, plain posts, and plain wood balustrade with wide balusters. The area under the porch deck is filled with framed lattice panels. The south elevation has, from right to left, a pair of 3/1 windows, a short 3/1 window, and a single 3/1 window.

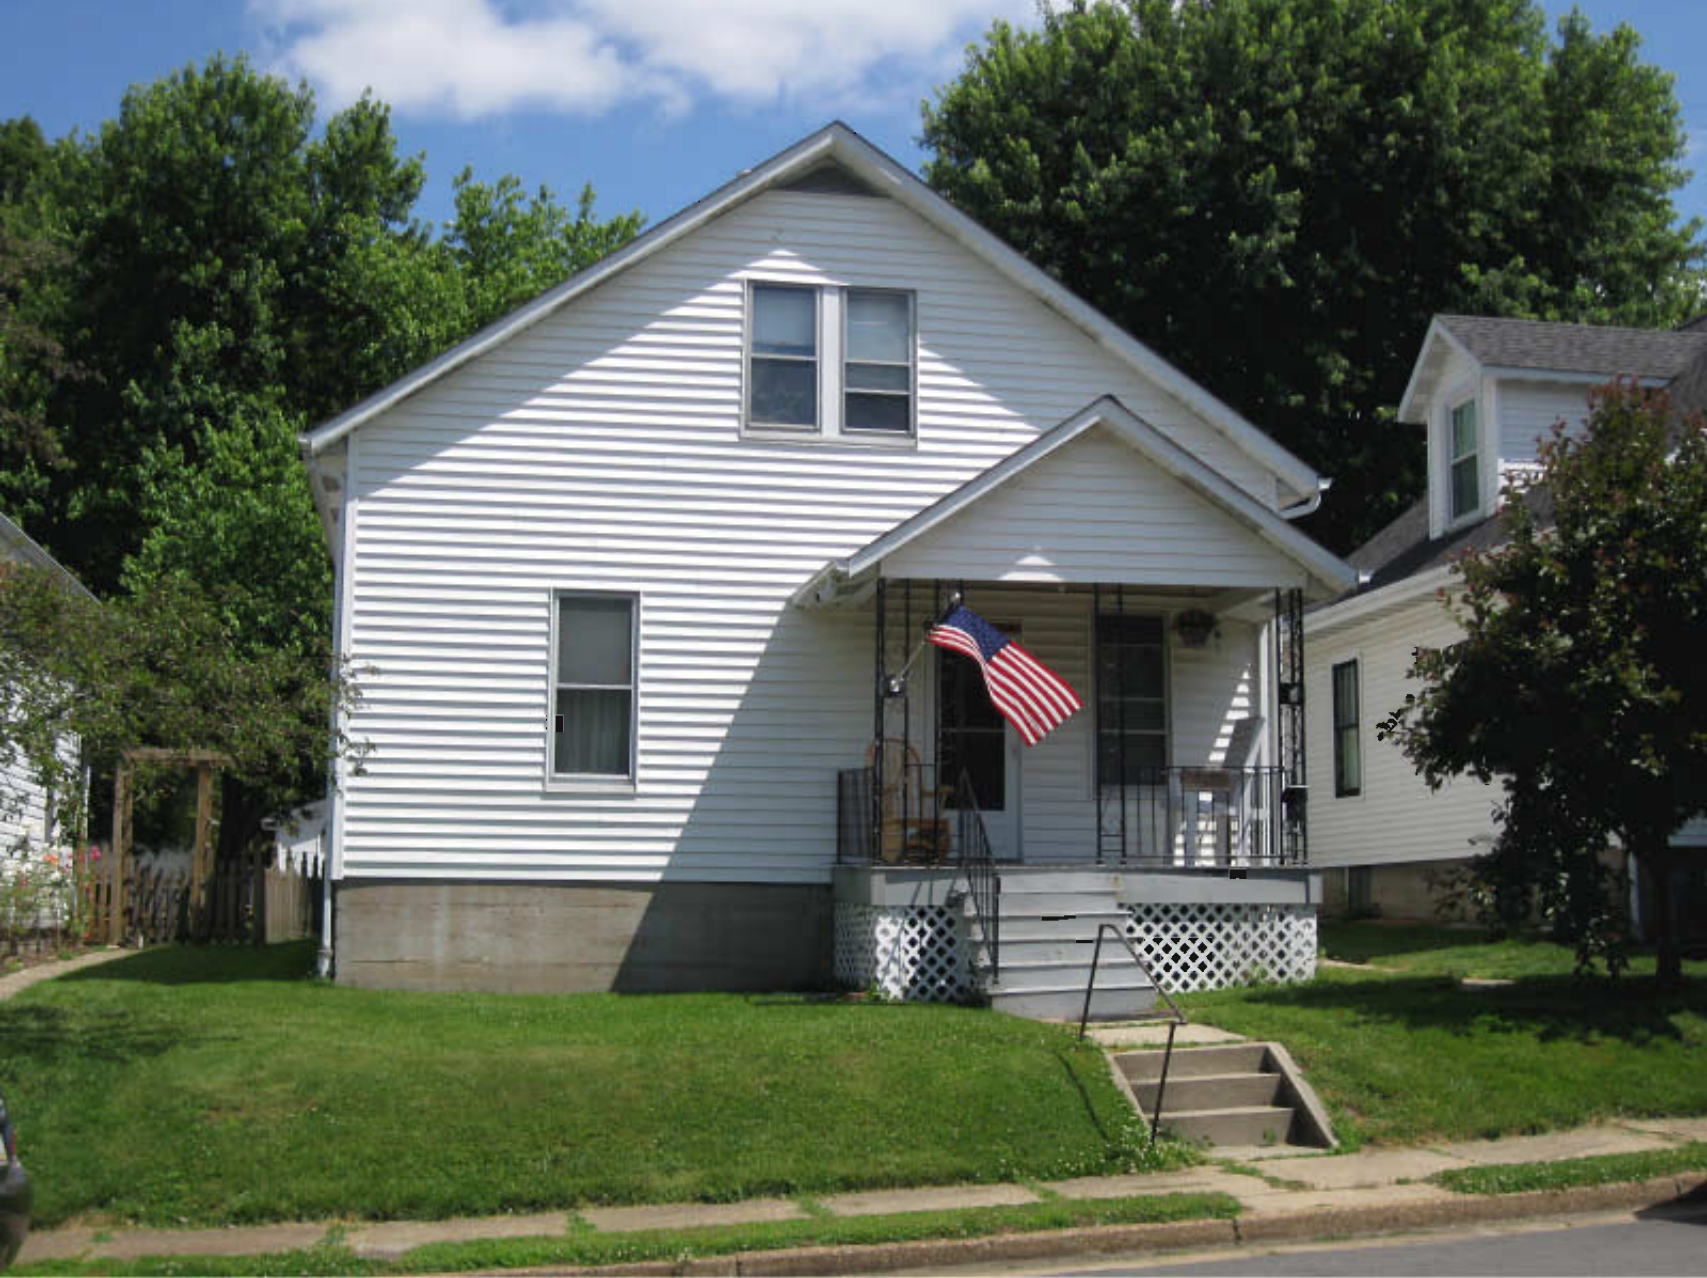
Facing west, this house is a one-and-one-half story, frame, front-gabled structure that rests on a concrete foundation. The north slope of the roof is pierced by two interior brick chimneys and the walls have been clad with vinyl siding. The three-bay main façade has a central doorway flanked by 1/1 windows that appear to be replacements, but it is difficult to tell. The door is set close to the southern window, and a two-bay, gabled portico is at the south end of the facade. The portico features a wooden deck and stairs, wrought iron posts and iron railing, and unframed lattice is under the porch deck. In the upper half story of the façade is a pair of 1/1 windows. The south elevation has two 1/1 windows while the north elevation has three, with the center window being shorter than the others. The house is noncontributing due to the installation of vinyl siding, replacement of the windows, and the replacement of the porch posts and railing.

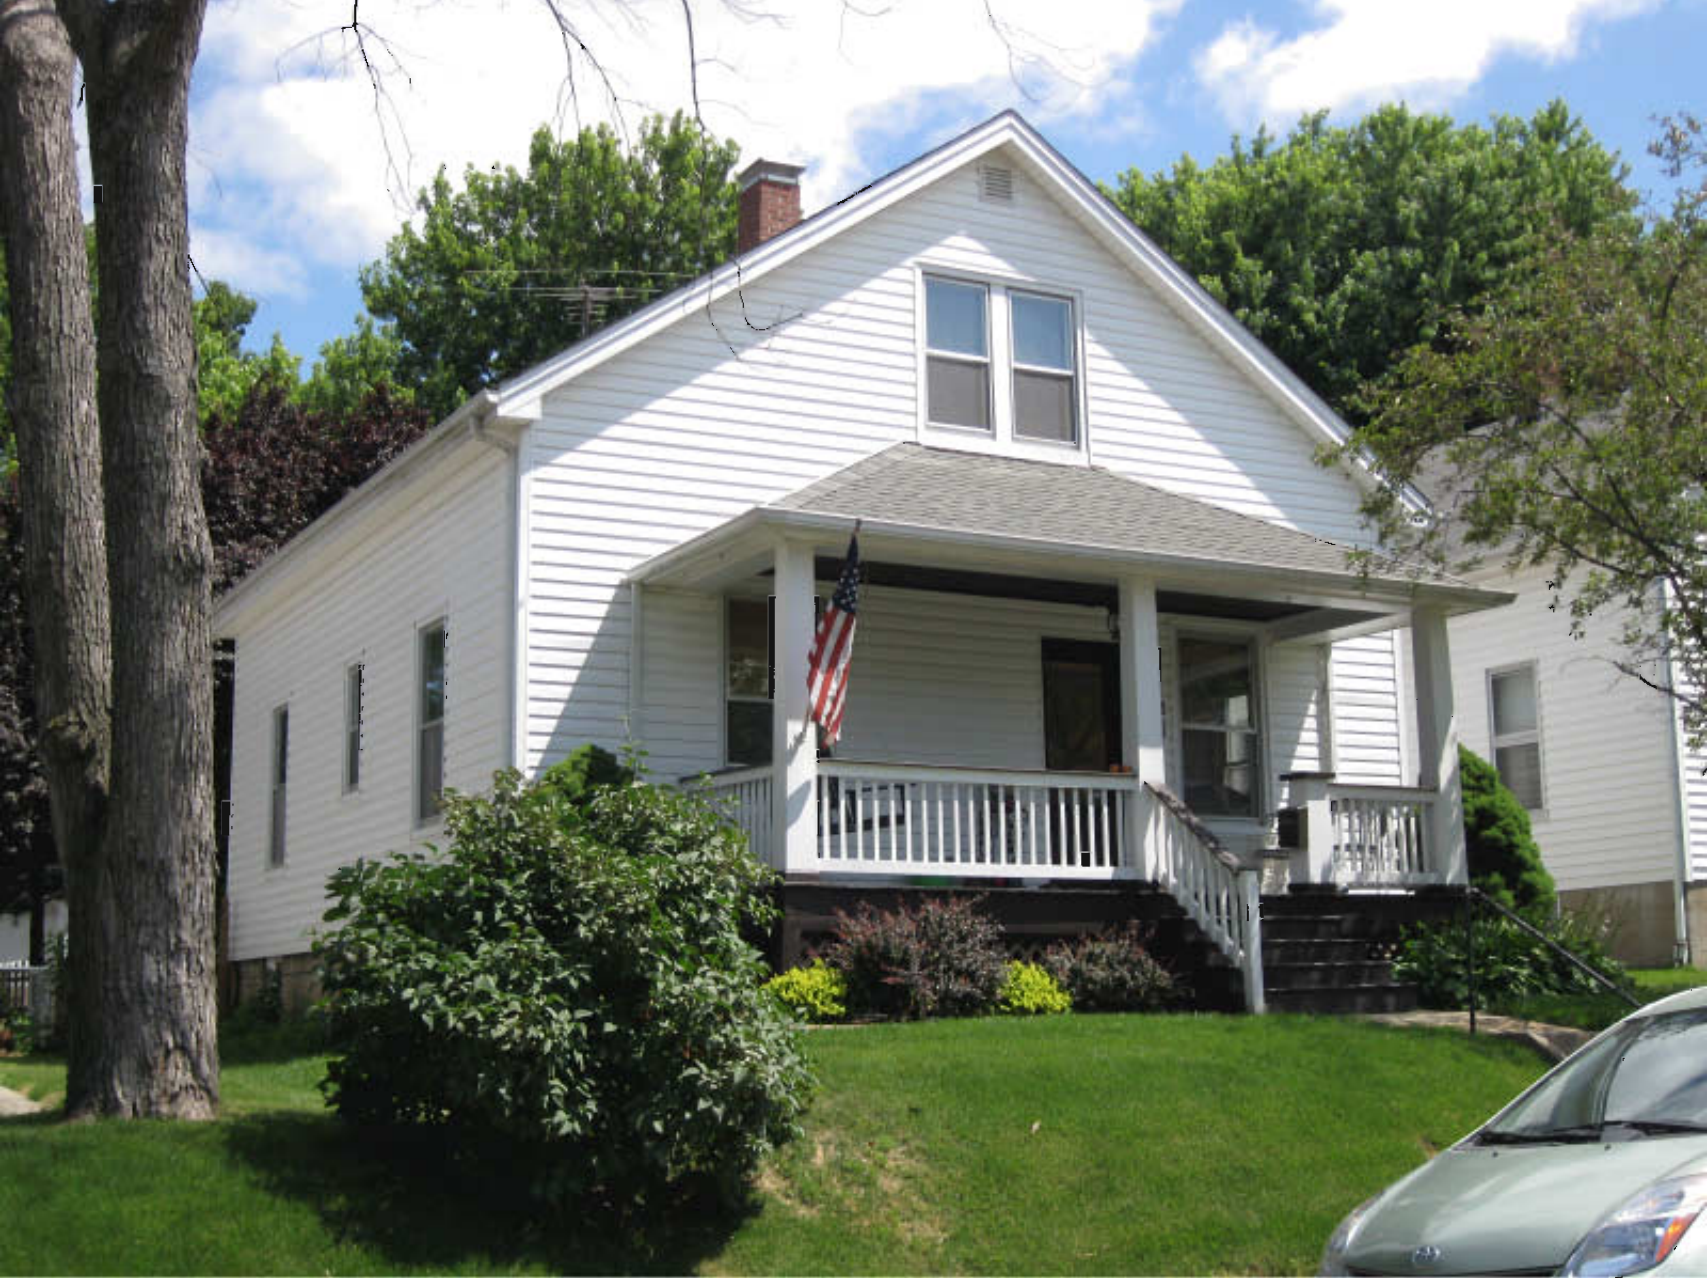
Situated on an elevated lot overlooking Benton Avenue, this one-and-one-half story, frame, front-gabled house rests on a scored concrete foundation and the walls are clad with vinyl siding. An interior brick chimney pierces the left slope of the roof. The three-bay main façade has a door flanked by 1/1 windows, and the door is set close to the south window. The ¾-width gallery has a wooden deck and stairway, plain wood balustrade, and box columns supporting a steeply-pitched hip roof, and the porch ceiling is stained bead board. Above the porch roof is a pair of 1/1 windows. The south elevation has two 1/1 windows while the north elevation has three, with the center window being shorter than the other two.

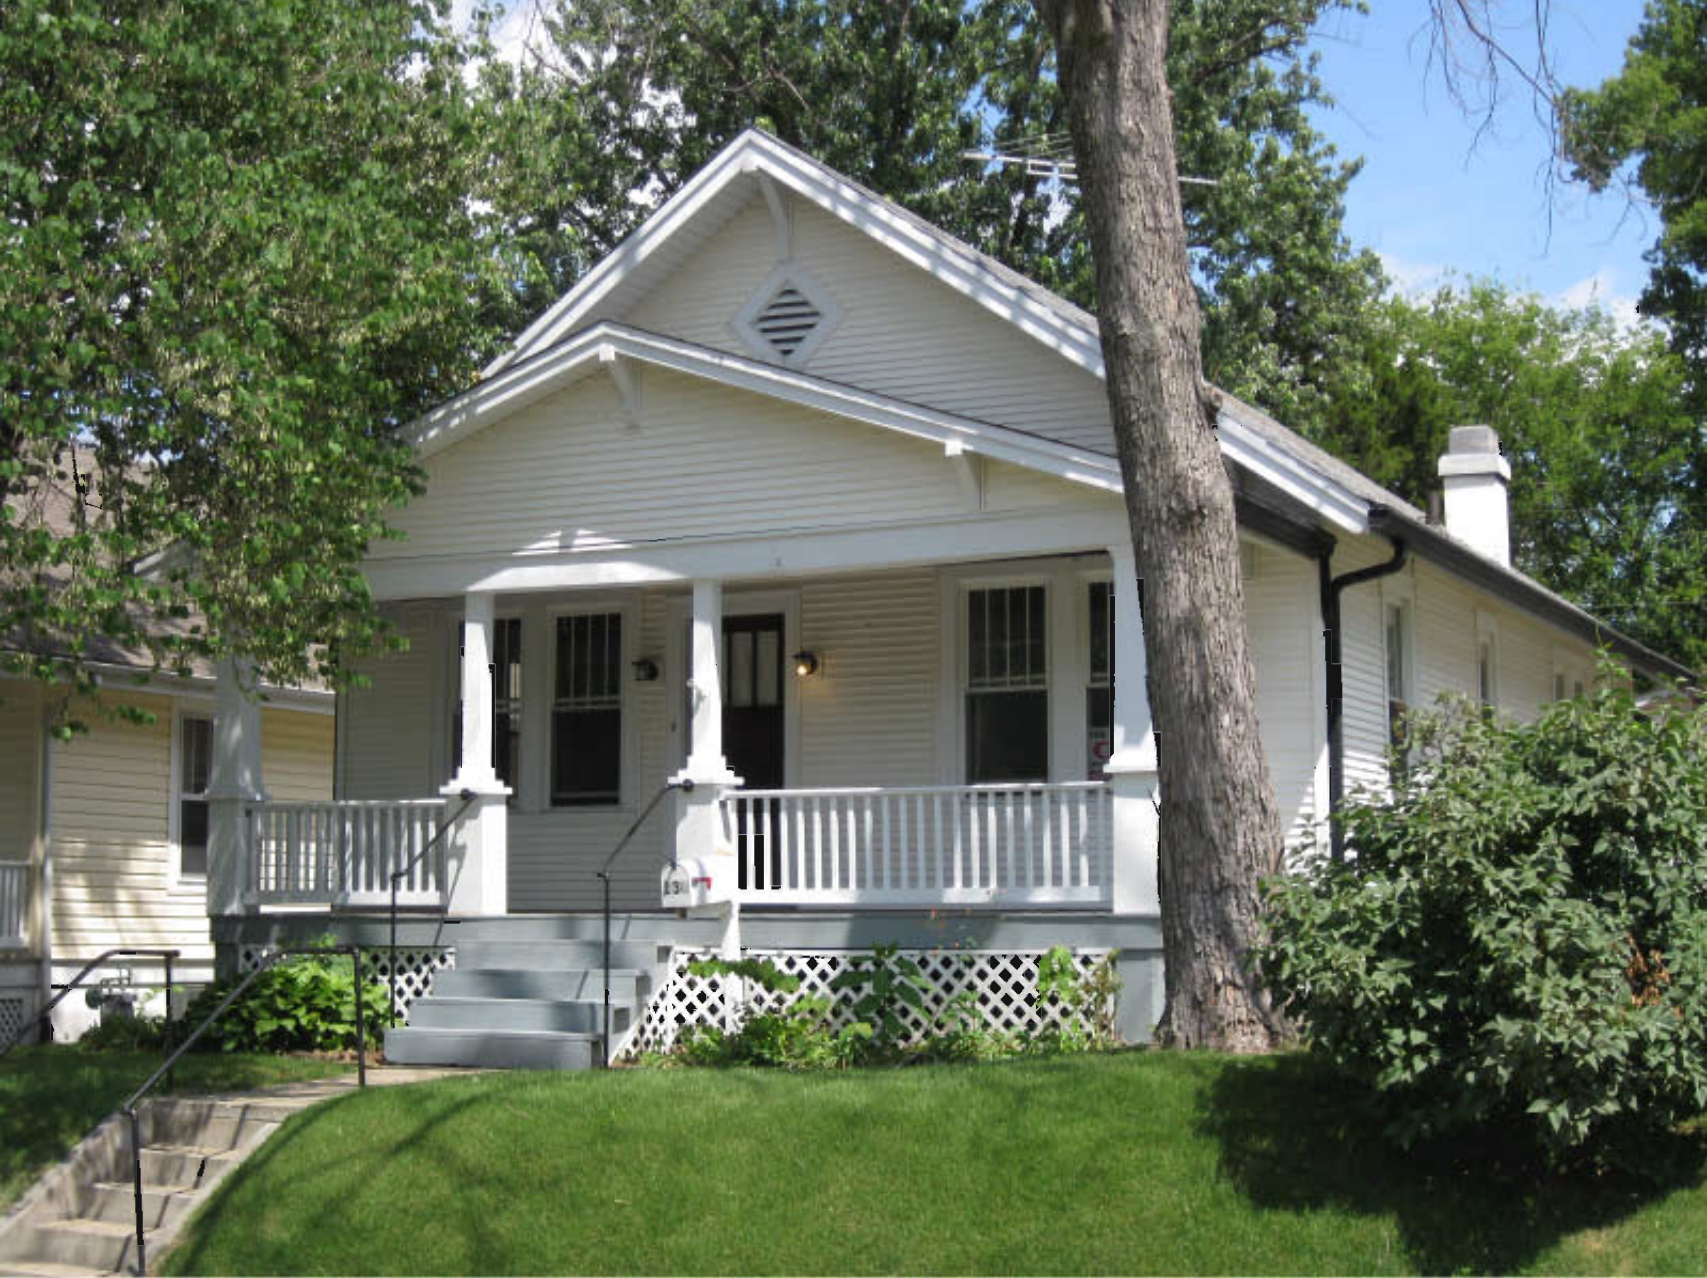
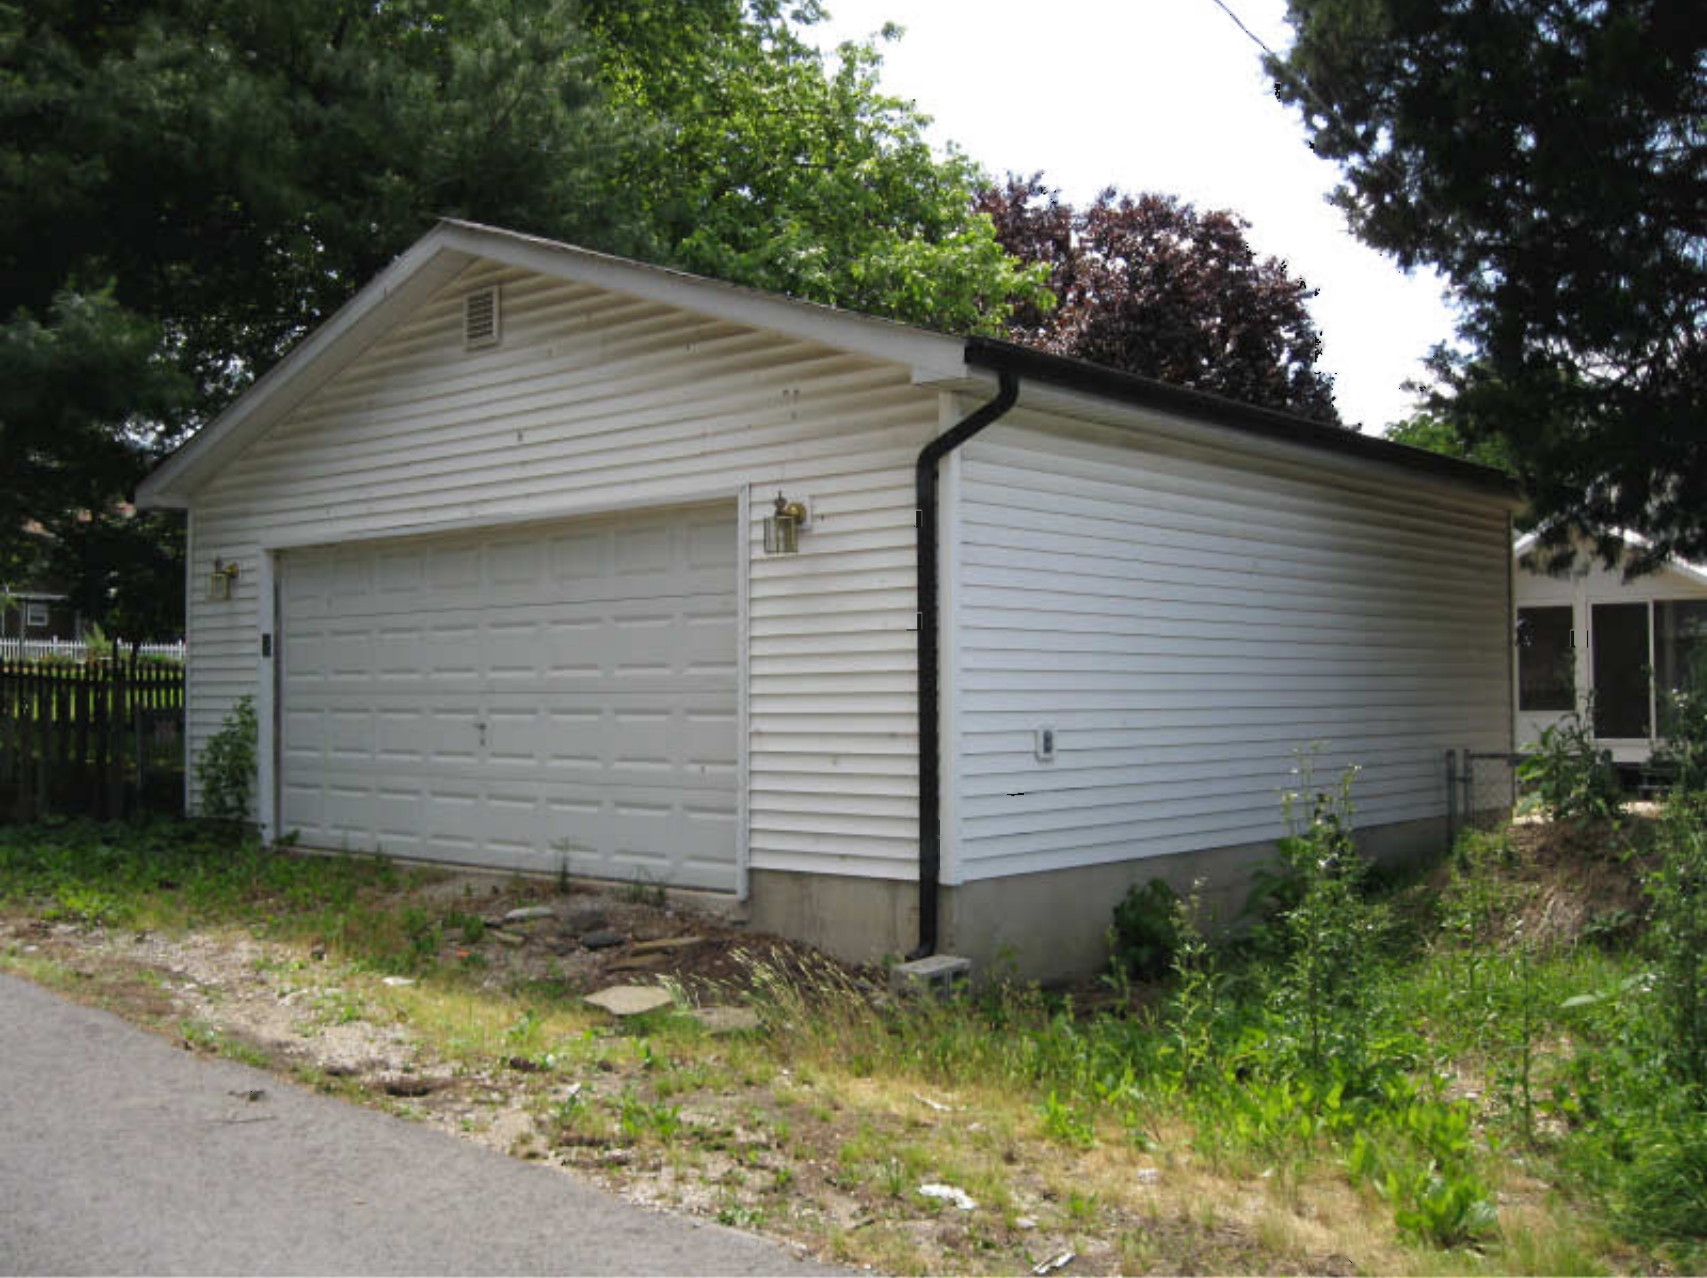
This one-story, front-gabled bungalow rests on a concrete foundation and the walls are clad with vinyl siding. The roof is pierced by a straddle ridge brick chimney and there is an interior end stucco chimney on the right slope. The main façade is dominated by a ¾-width, gabled gallery, and the gable ends of the gallery and main roof are decorated with knee braces. The gallery features a wooden deck and stairway, plain balustrade, box columns resting on stucco pedestals, and a stained bead board ceiling. A 1/3-glazed wood door with three vertical lights is in the center bay of the three-bay main façade, and to each side of the door is a pair of 4/1 windows that appear to be replacements. The north elevation has, from right to left, two pairs of 4/1 windows and a short single window, while the south elevation has, from left to right, a 4/1 window, a short 1/1 window and a pair of 4/1 windows. A gabled, screened porch extends from the south half of the rear elevation. The house is noncontributing due to the installation of vinyl siding and replacement of the windows.
