ARCHITECTURAL/HISTORIC INVENTORY FORM

1. Survey No. SC-AS-009-001		2. Survey Name: St. Charles Survey Phase 3: Mid-Town and Commons Neighborhoods	
3. County: St. Charles		4. Address (Street No.) 128	Street (name) North Sixth Street
5. City: St. Charles	Vicinity: <input type="checkbox"/>	6. UTM:	
7. Township/Range/Section:		8. Historic name (if known): Meyer-Pieper House; The Meyerdorf	
9. Present/other name (if known):		10. Ownership: <input checked="" type="checkbox"/> Private <input type="checkbox"/> Public	
11a. Historic use (if known): Domestic/single dwelling		11b. Current use: Domestic/single dwelling

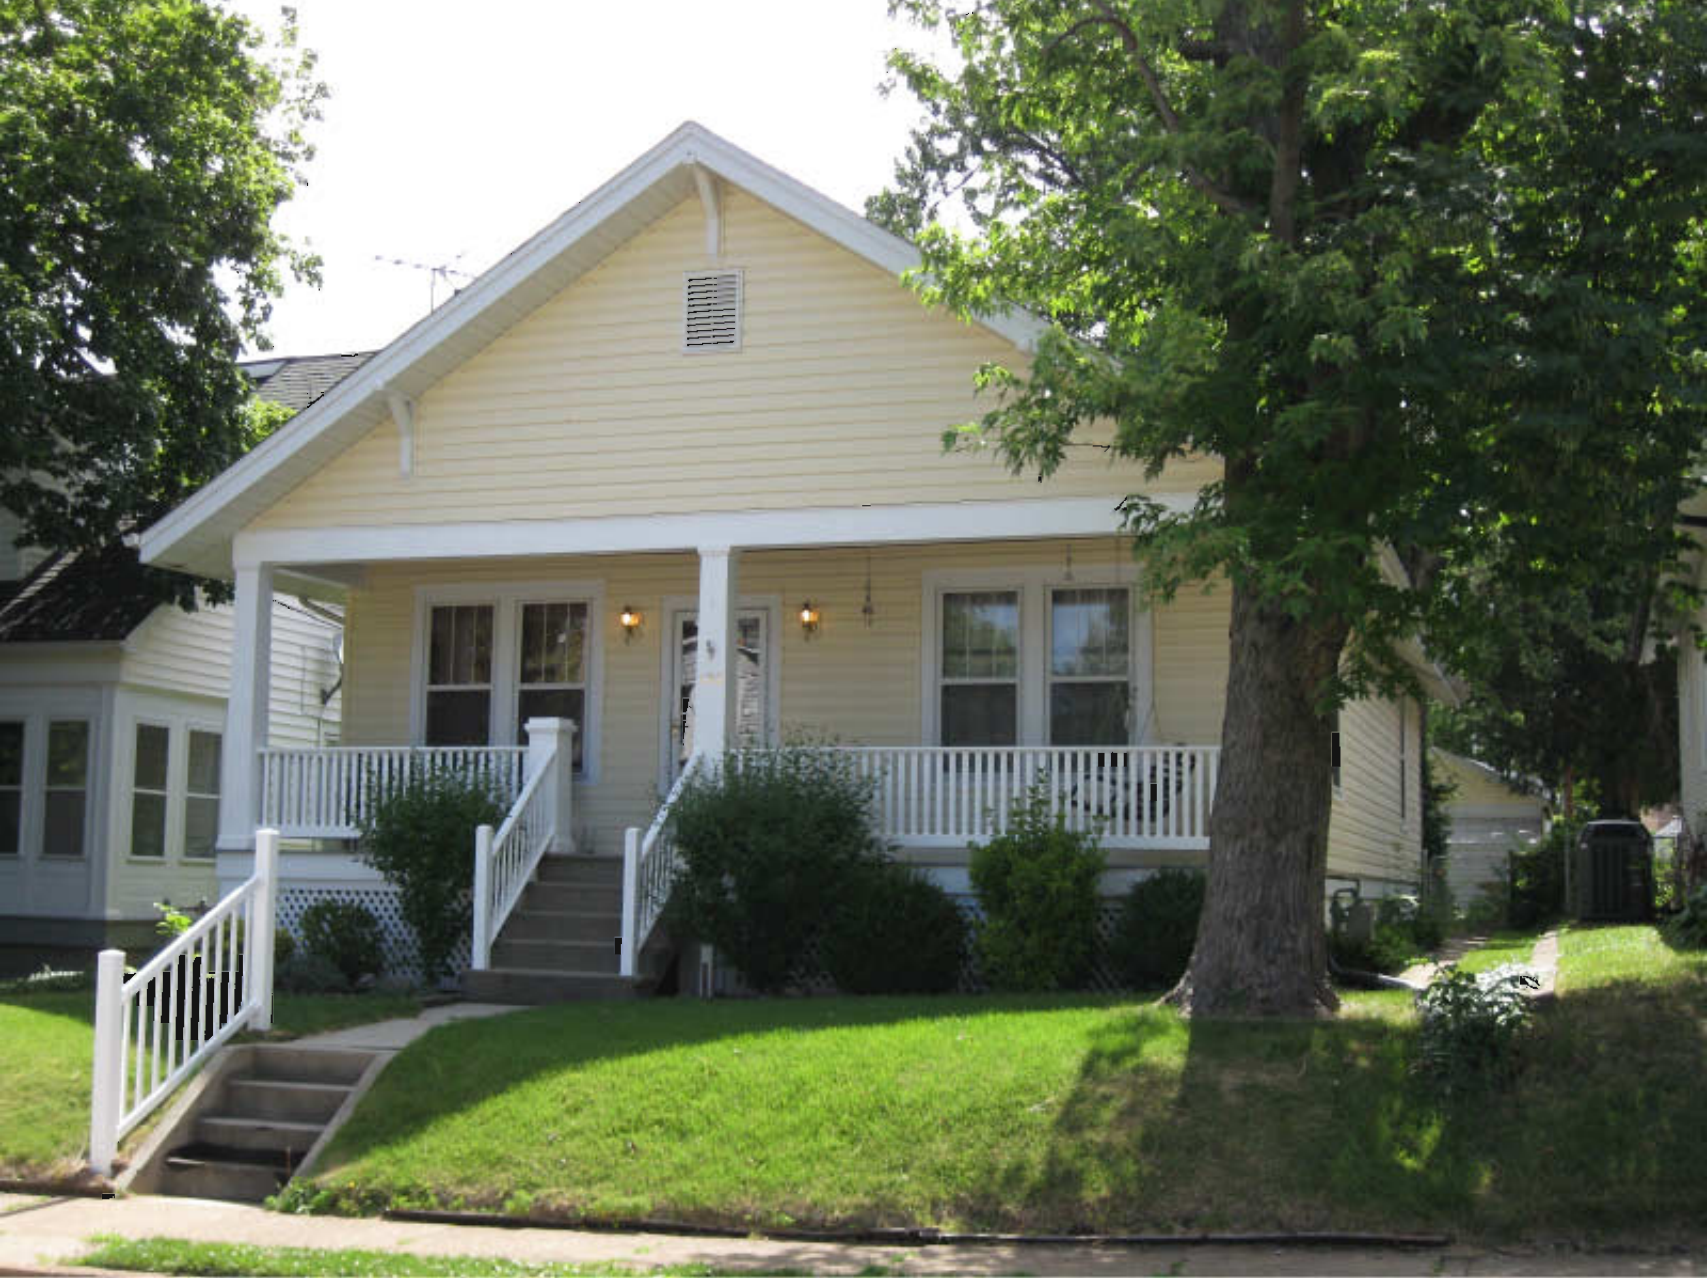
Facing west, this bungalow is a one-story, frame, front-gabled structure that has a full-width gallery set under the main roof. In the gable end are knee braces and a rectangular ventilator, and the roof, which is pierced by a straddle ridge brick chimney, has wide overhanging eaves. The foundation is concrete and the walls have been clad in vinyl siding. The three-bay main façade has a half-glazed wood door that has four vertical lights, and to each side of the door is a pair of 3/1 wood windows. The door, which is set closer to the northern windows than to the southern, opens onto the gallery, which has scored concrete foundation piers in-filled with framed lattice panels, wooden stairs and deck, slightly battered box columns with molded capitals, a plain balustrade, and stained bead board ceiling. The south elevation has three openings: a central small transom-type window flanked by 3/1 windows. The north elevation also has three openings, but they consist of paired 3/1 windows flanked by single 3/1 windows.

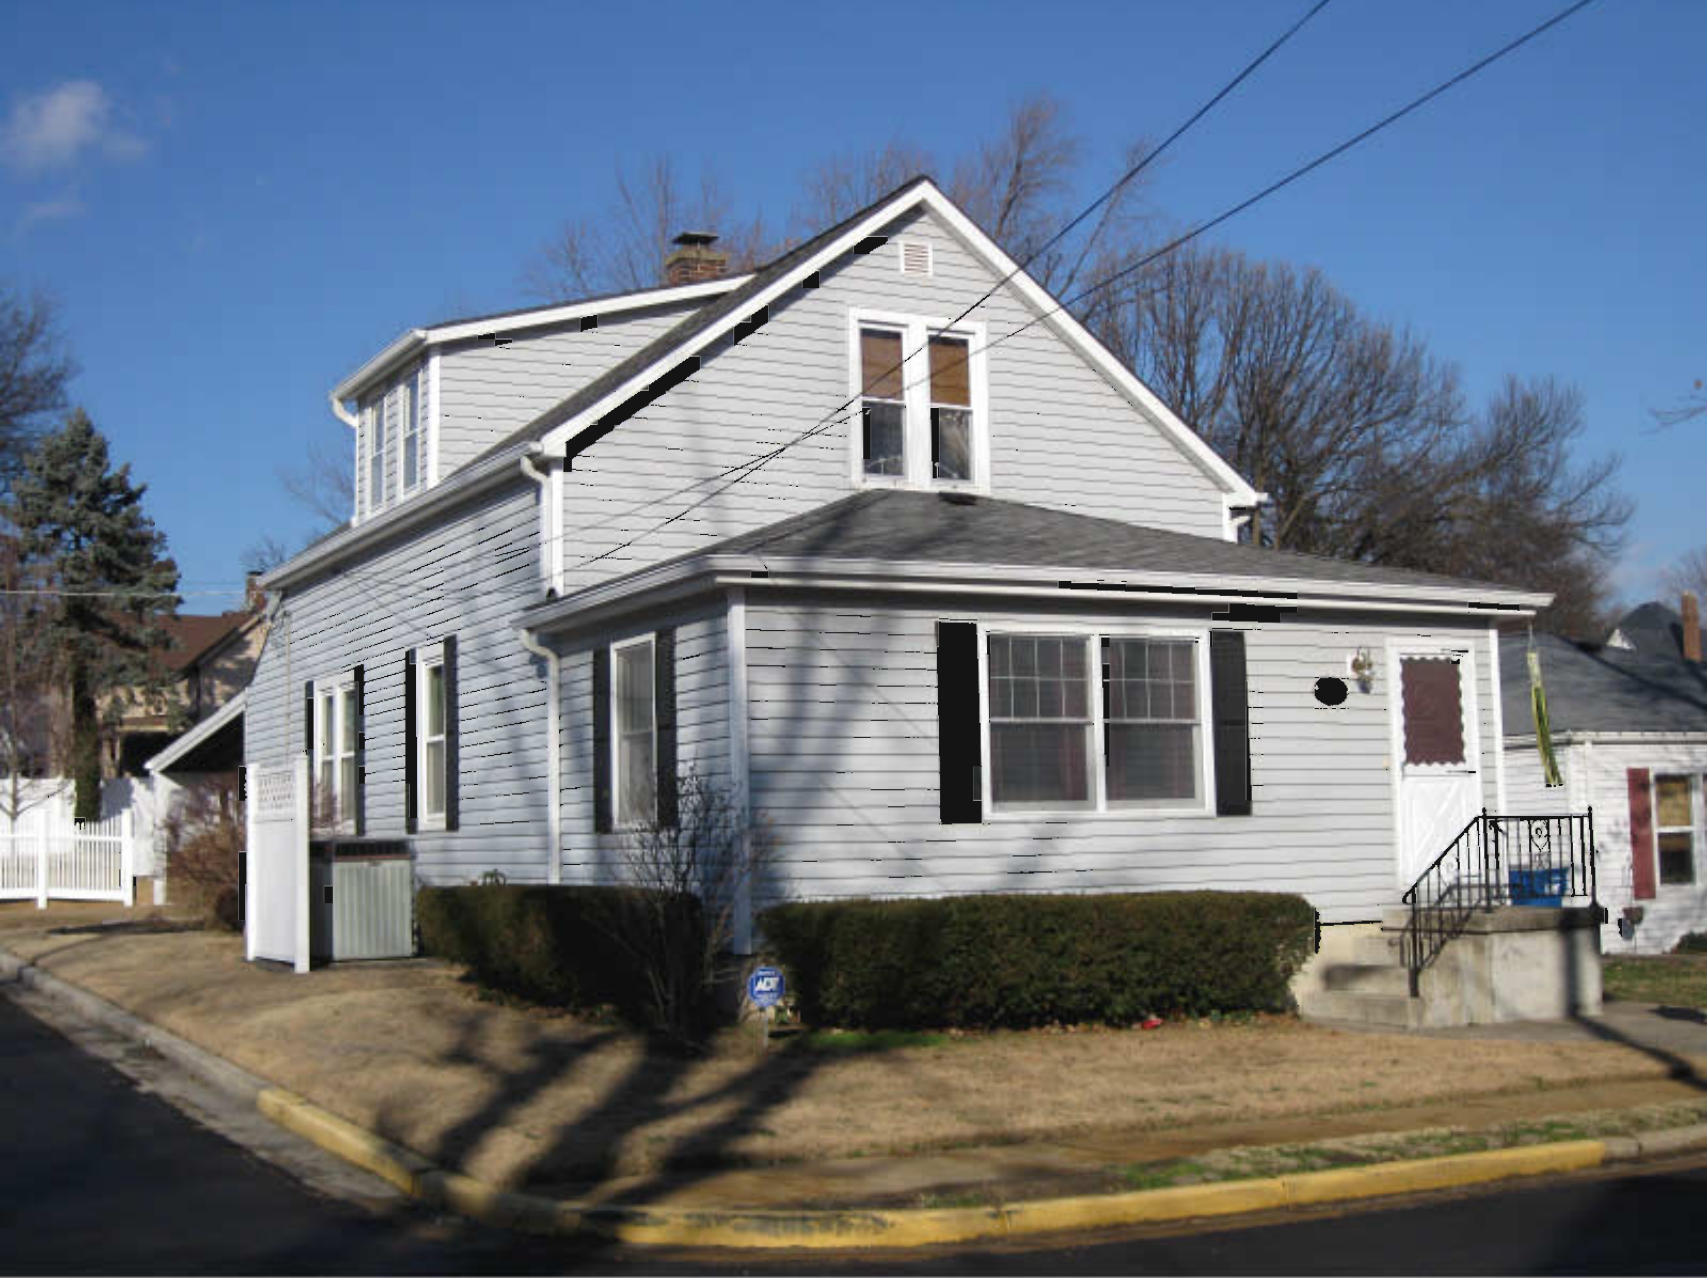
Situated at the northwest corner of Benton Avenue and Washington Street, this front-gabled, one-and-one-half story, frame house has a rusticated concrete block foundation and walls clad in vinyl siding. The one-story, full-width gallery with hip roof has been enclosed and also appears to have been enlarged (the depth appears to be deeper than it would have been historically). A straddle ridge brick chimney pierces the roof, and on each side slope is a shed dormer that has two 1/1 windows and walls clad in vinyl siding. On the two-bay main façade the enclosed porch features a pair of 8/1 windows and a wood door with square panels filled with circular panels, and the door is protected by a metal storm door. The door opens onto a concrete stoop, which has a stairway at the south end and a wrought iron railing. In the upper half story is a pair of 1/1 windows. The south elevation has, from right to left, an 8/1 window in the enclosed porch, a 1/1 window and a pair of 1/1 windows. Vinyl louvered shutters are to each side of the first floor windows of the front and south elevations. The north elevation has two 1/1 windows and a short pair of 1/1 windows, and a small addition extends from the west end of the north elevation and features a door on the east side. A two-car carport with shed roof and plain posts has been added to the rear elevation and is accessed from Washington Street. The house is noncontributing due to the enclosure of the front porch, the application of vinyl siding, and the replacement of the windows.

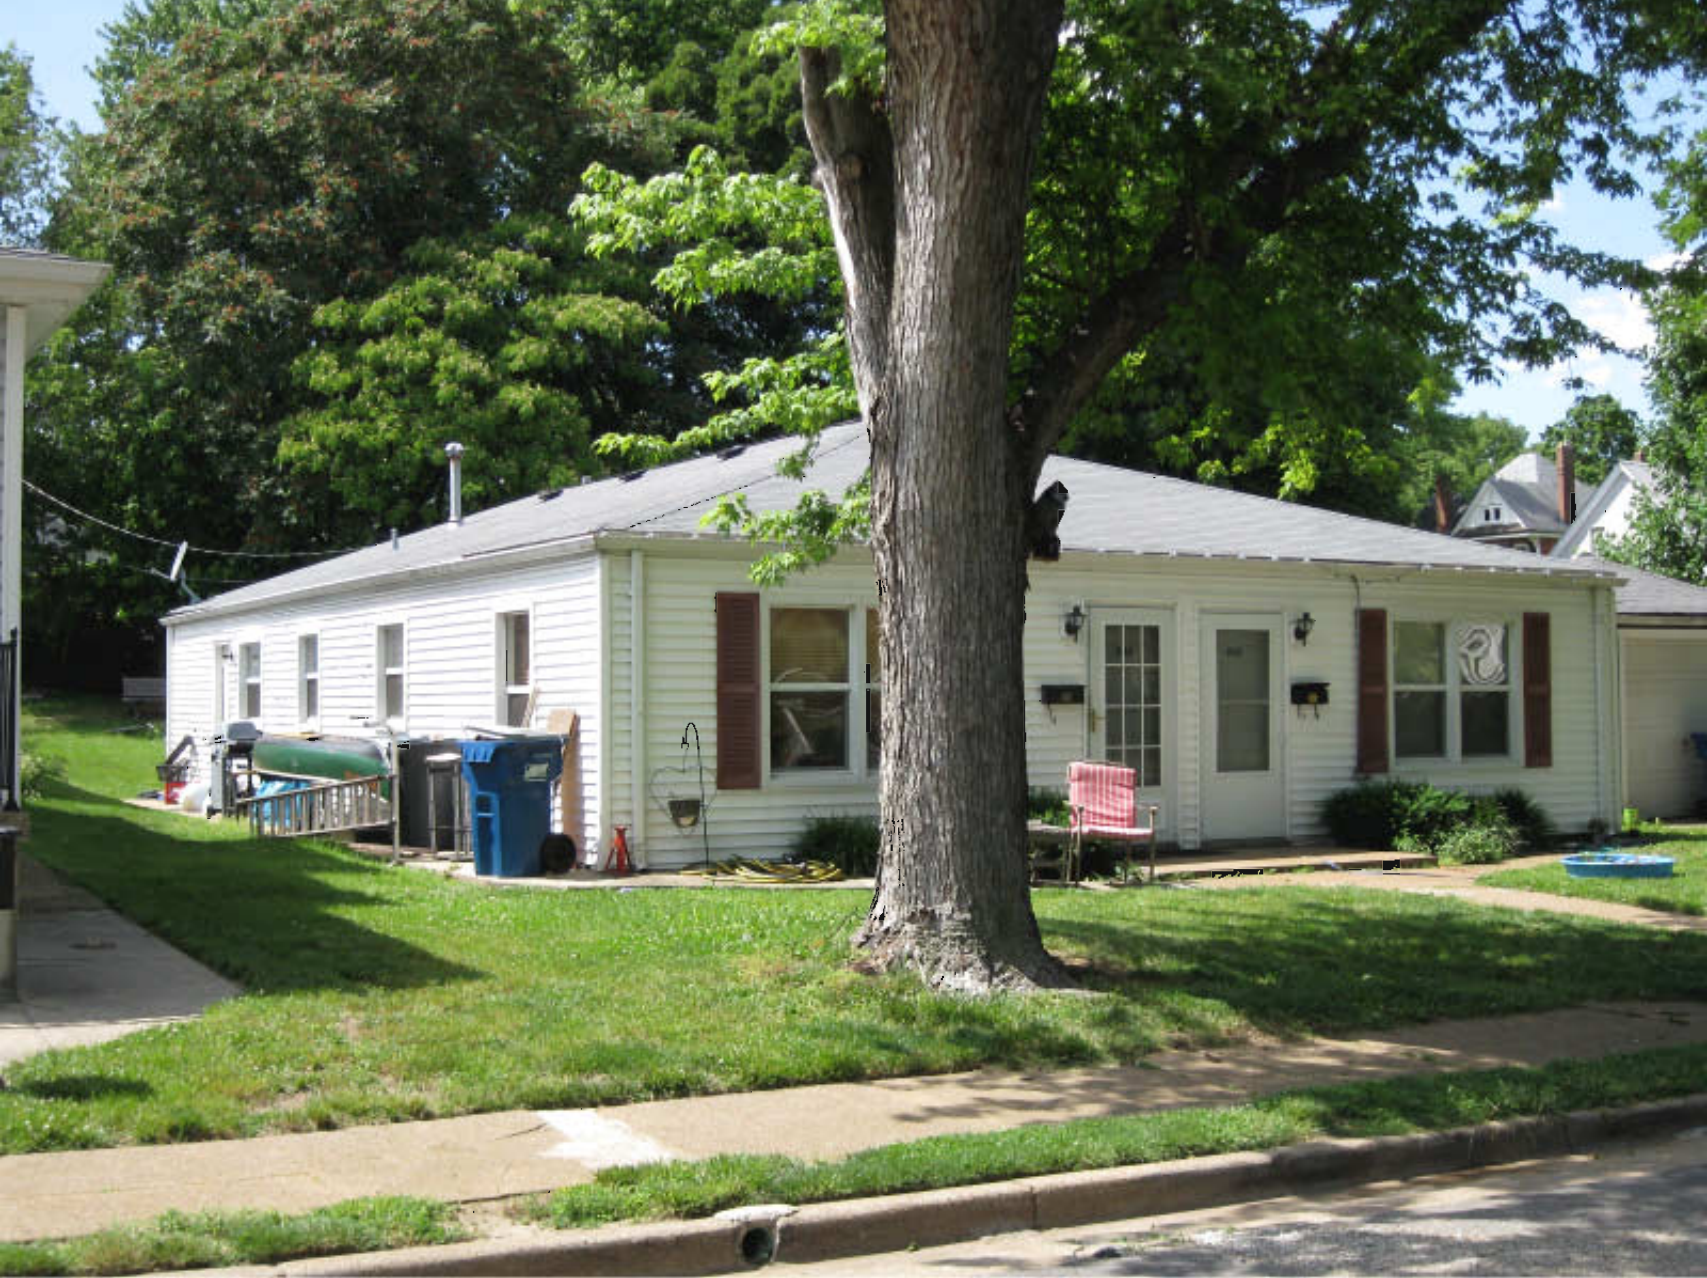
Situated on a flat lot, this one-story, frame duplex rests on a concrete foundation and is crowned by a low hip roof. The walls are finished with vinyl siding and the windows throughout appear to be vinyl 1/1 sash. The four-bay main façade has six-panel doors in the center two bays, and the doors are protected by non-matching storm doors that open onto a concrete stoop. In each of the outer bays is a pair of 1/1 windows framed by vinyl louvered shutters. Each side elevation has four window openings and a doorway at the west end. The building is noncontributing due to the application of vinyl siding and replacement of the windows.

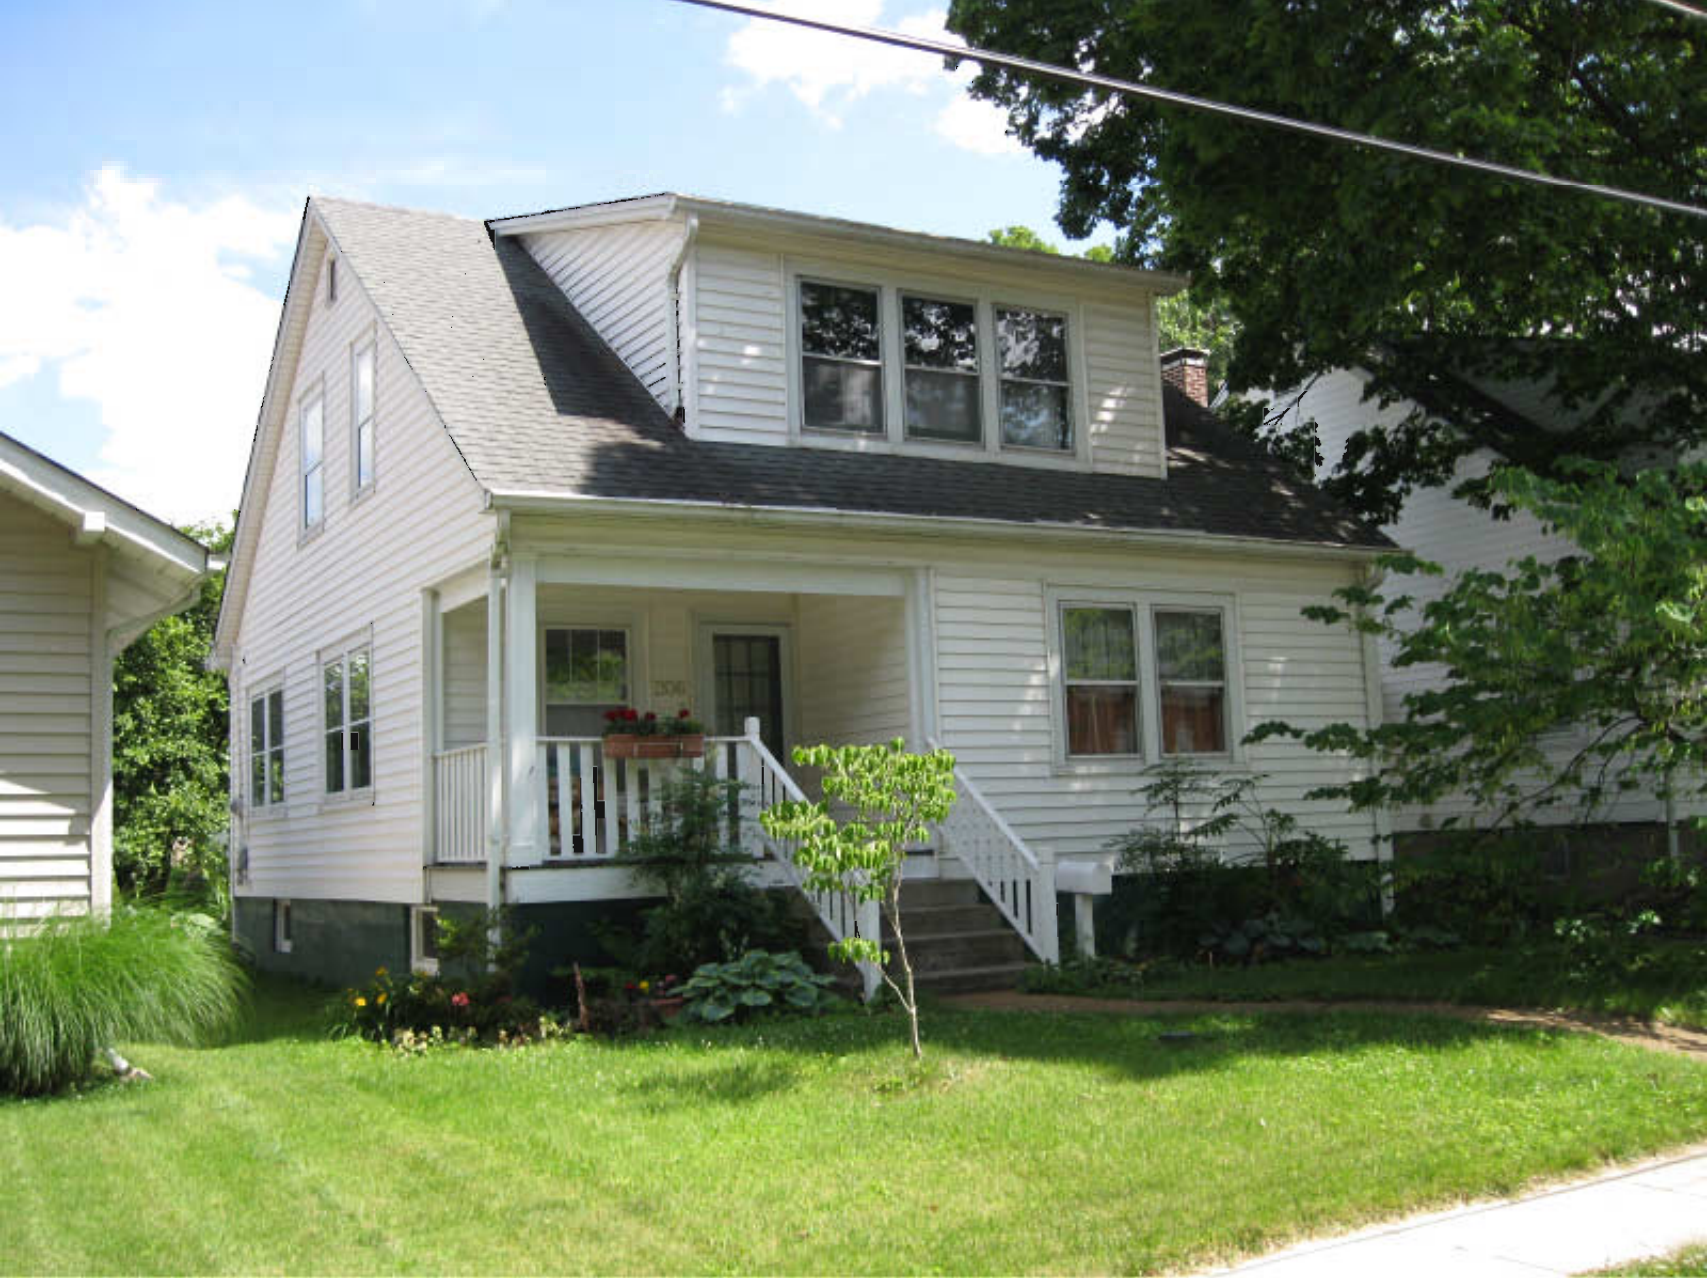
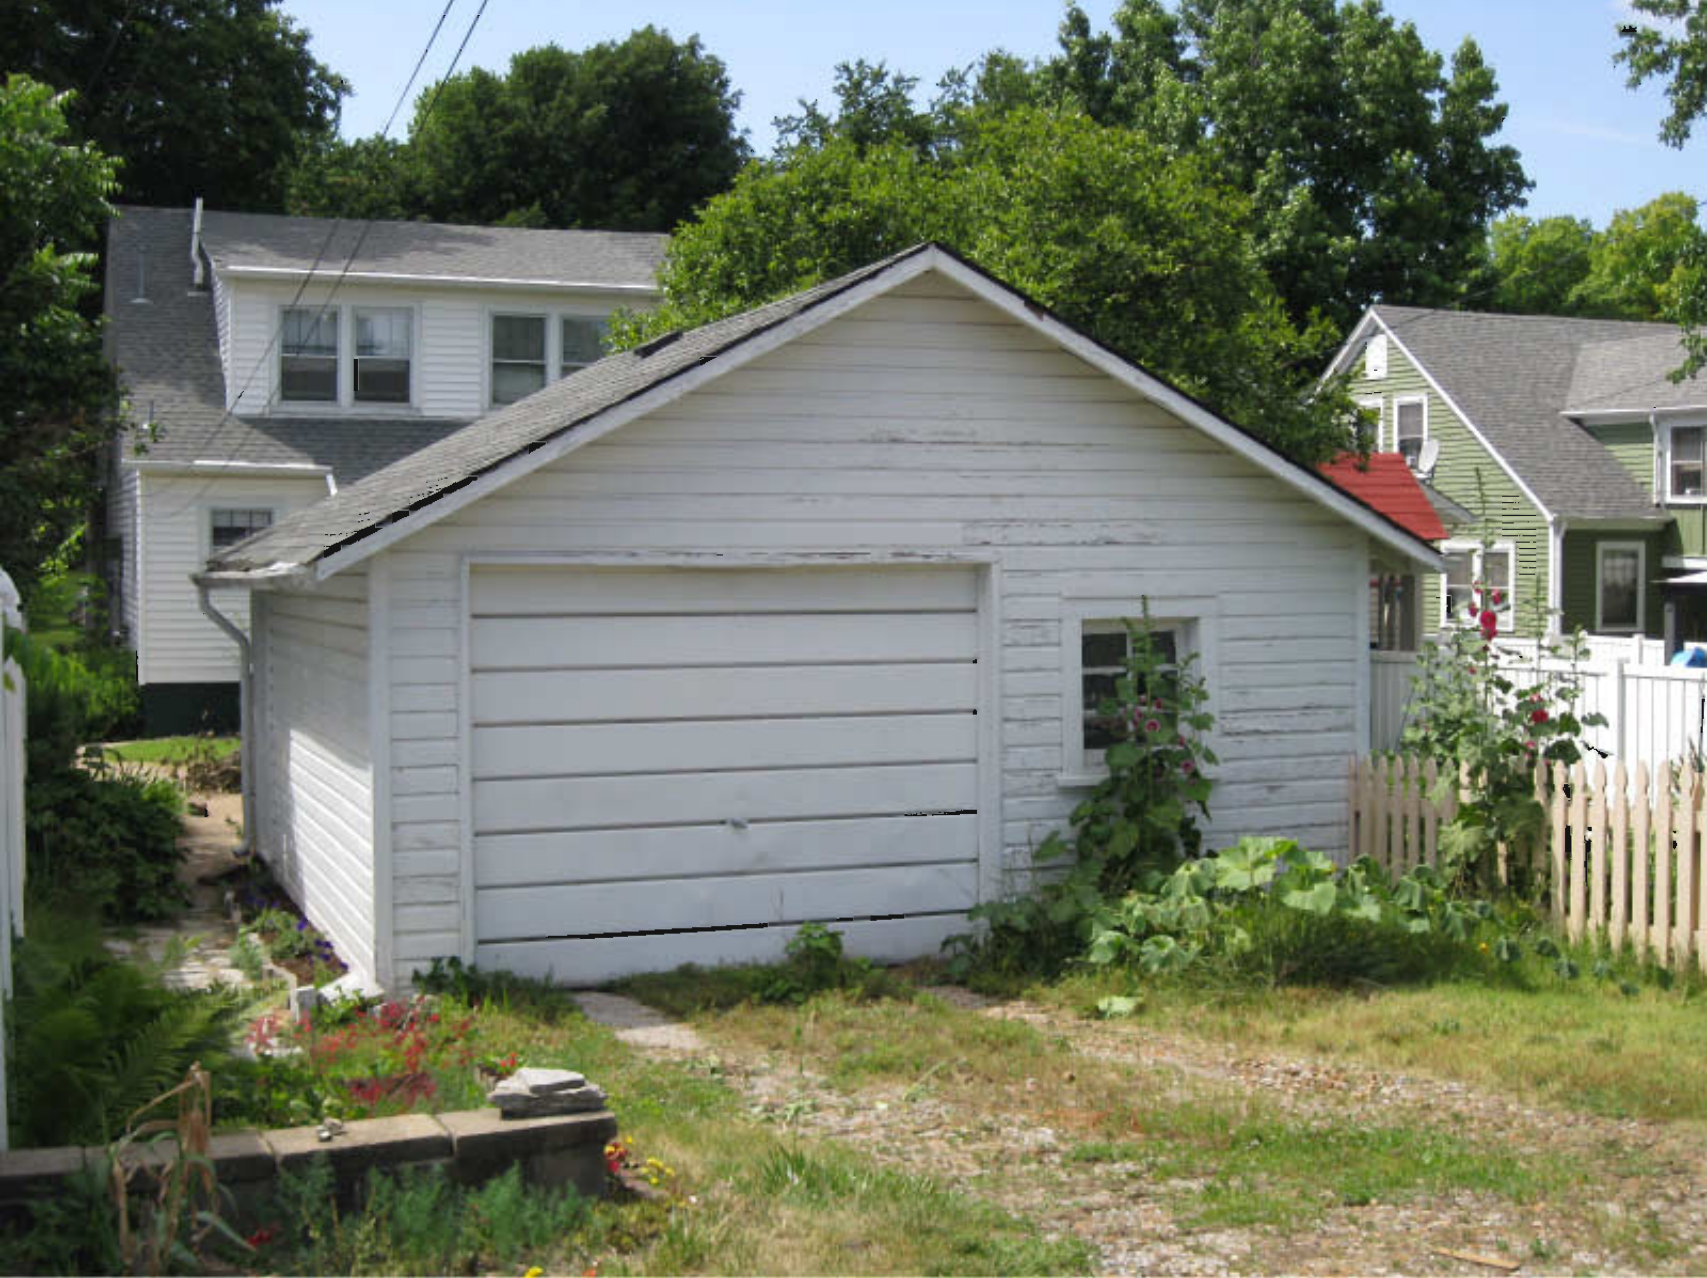
This one-and-one-half story, side-gabled, frame house rests on a concrete foundation and the walls have been clad with vinyl siding. The front and rear slopes have large shed dormers with vinyl-sided walls. The front dormer has a group of three 3/1 wood windows while the rear dormer has two pairs of 3/1 windows. The main façade is a three-bay elevation, with the southern two bays opening onto the recessed porch. The main entrance is a multi-light wood door, and to the left is a 3/1 wood window and to the right is a pair of 3/1 windows. The two-bay recessed porch features a concrete foundation, stairway and deck; a paneled box column with molded capital; and a plain balustrade with wide balusters. The north elevation features two pairs of 3/1 windows on the first floor and two single 3/1 windows in the upper half story. The first floor of the south elevation has a central entrance at ground level, and the entrance is protected by a canvas awning. To each side of the entrance is a 3/1 window, and in the upper half story are two windows that are stepped. The house is similar to those at 202 and 212 North Benton Avenue.

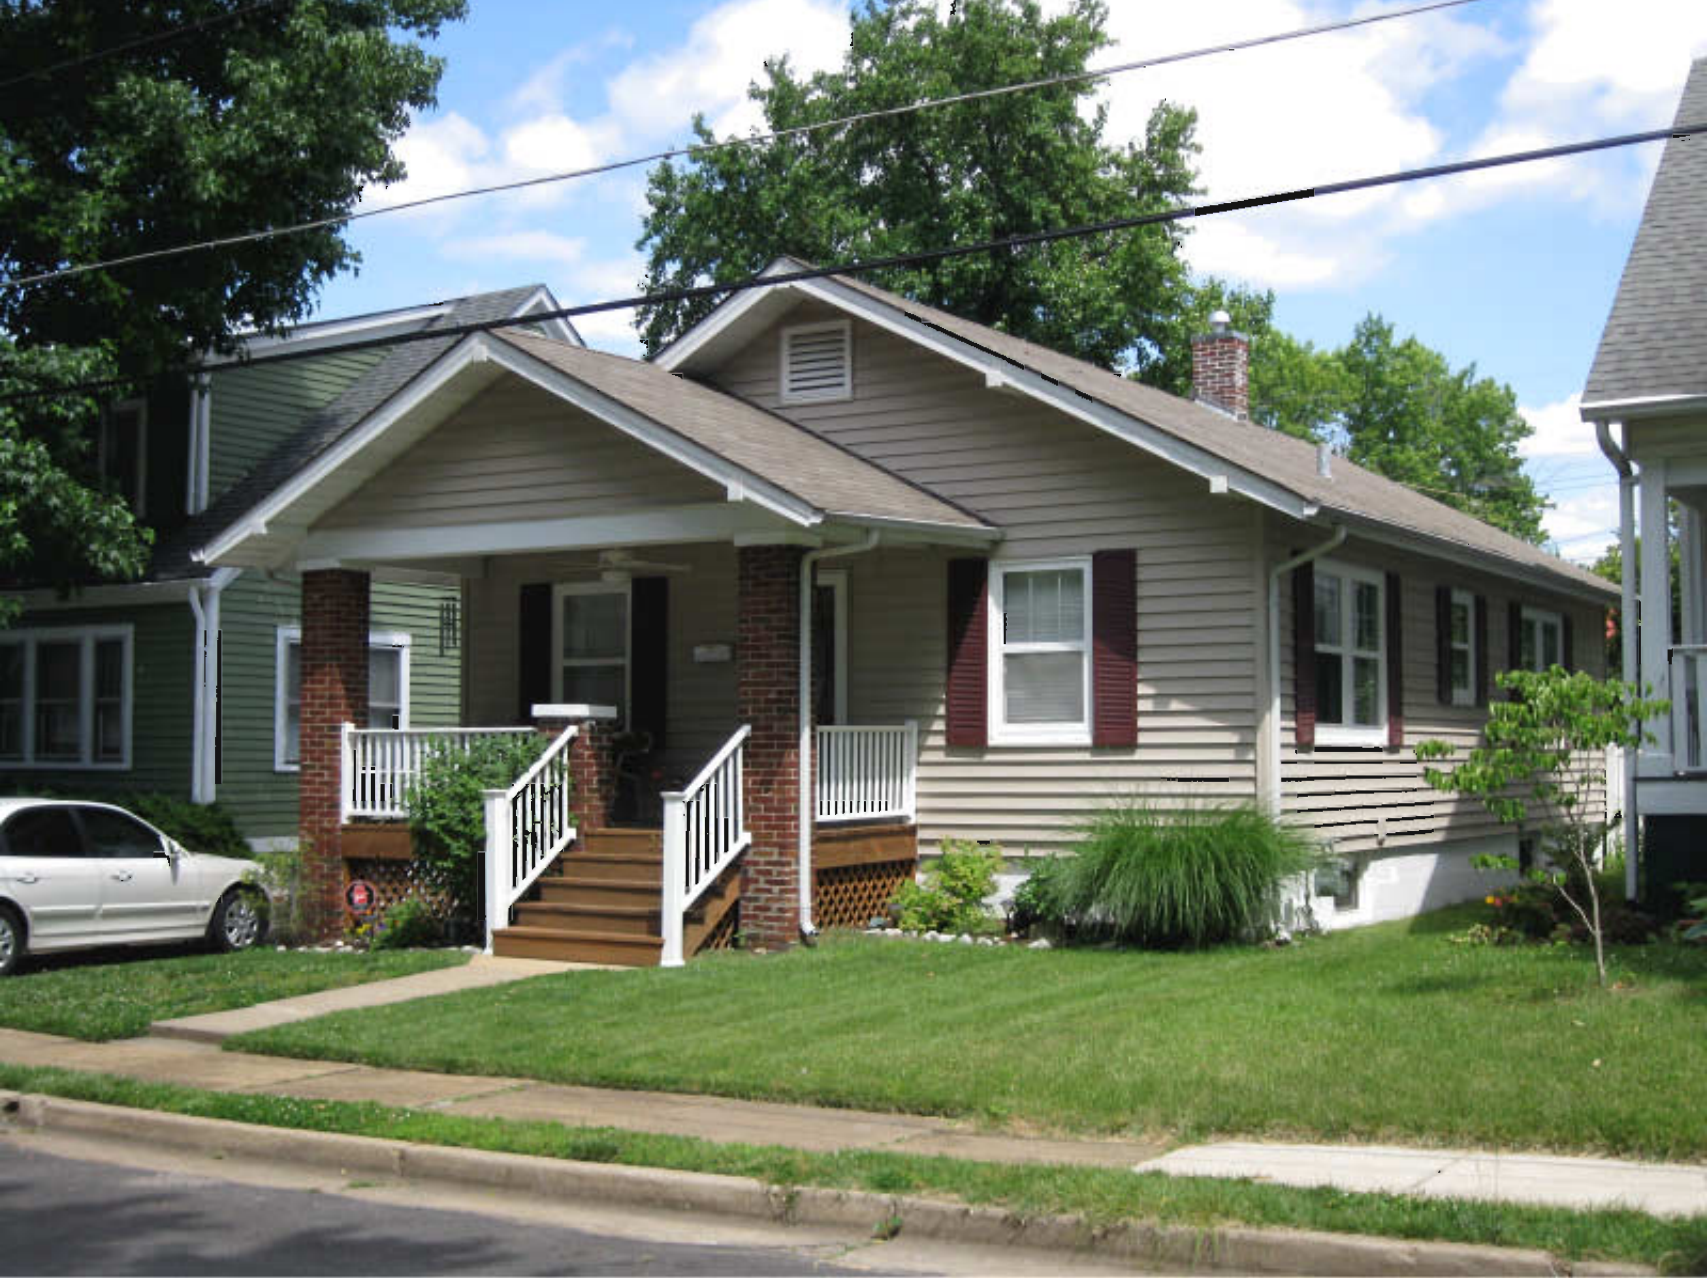
This one-story, front-gabled, frame bungalow rests on a concrete foundation and its walls are clad in vinyl siding. The roof has wide overhanging eaves, purlins in the front gable, and a brick chimney on the south slope near the peak. The three-bay main façade features a central metal replacement door with oval, leaded glass light and to each side is a 6/1 wood window with vinyl louvered shutters. The door opens onto a two-bay porch with gable roof having wide overhanging eaves and purlins in the gable end. The roof is supported by brick piers with concrete caps, and the piers extend to the ground and the area under the porch deck is filled with latticework. There is a brick pedestal with concrete coping at the top of the stairway, and the porch deck and stairs are wood but the plain balustrade appears to be vinyl. The north elevation has, from right to left, a single 6/1 window, paired 6/1 windows, a door at ground level, and a short 6/1 window. The door is protected by a braced shed roof and the windows have vinyl louvered shutters. On the south elevation is a pair of 6/1 windows to each side of a small 6/1 window, and these are framed by vinyl louvered shutters.

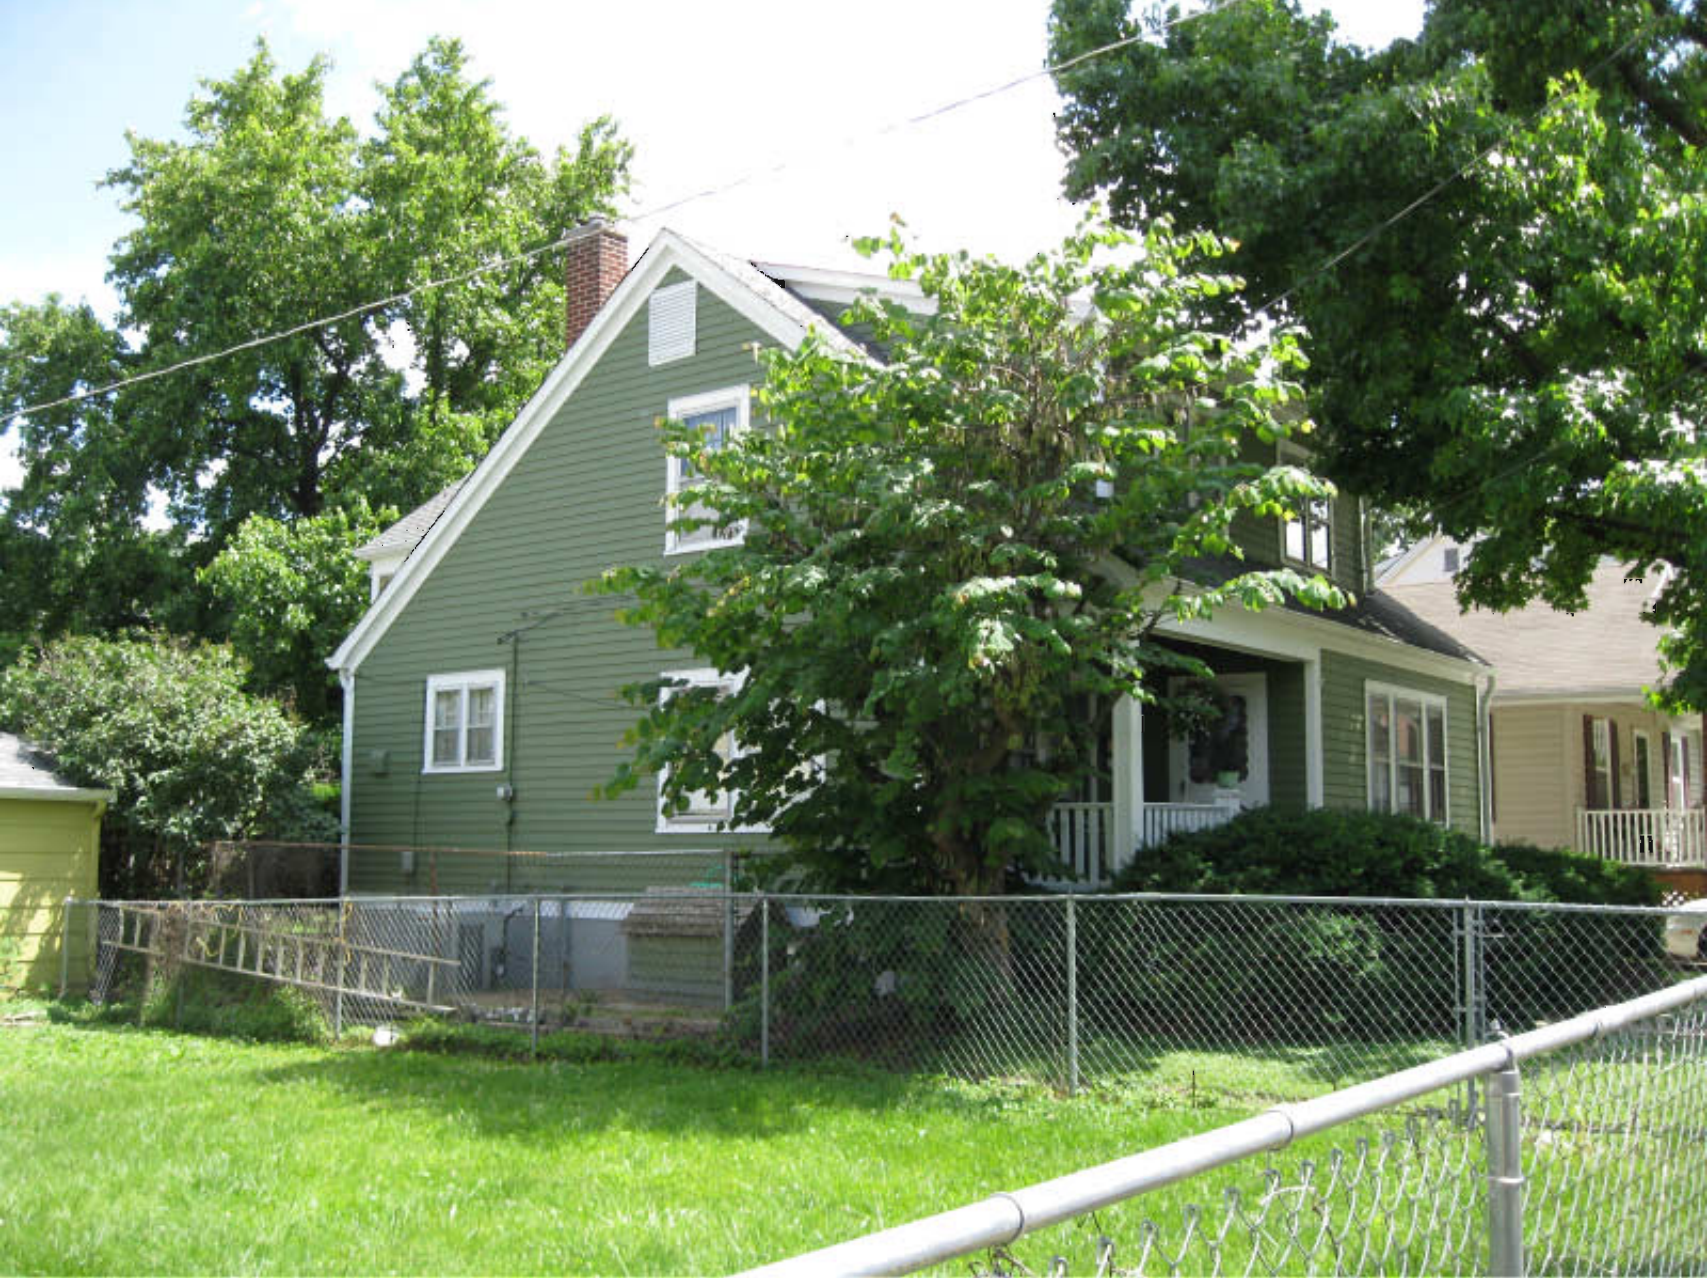
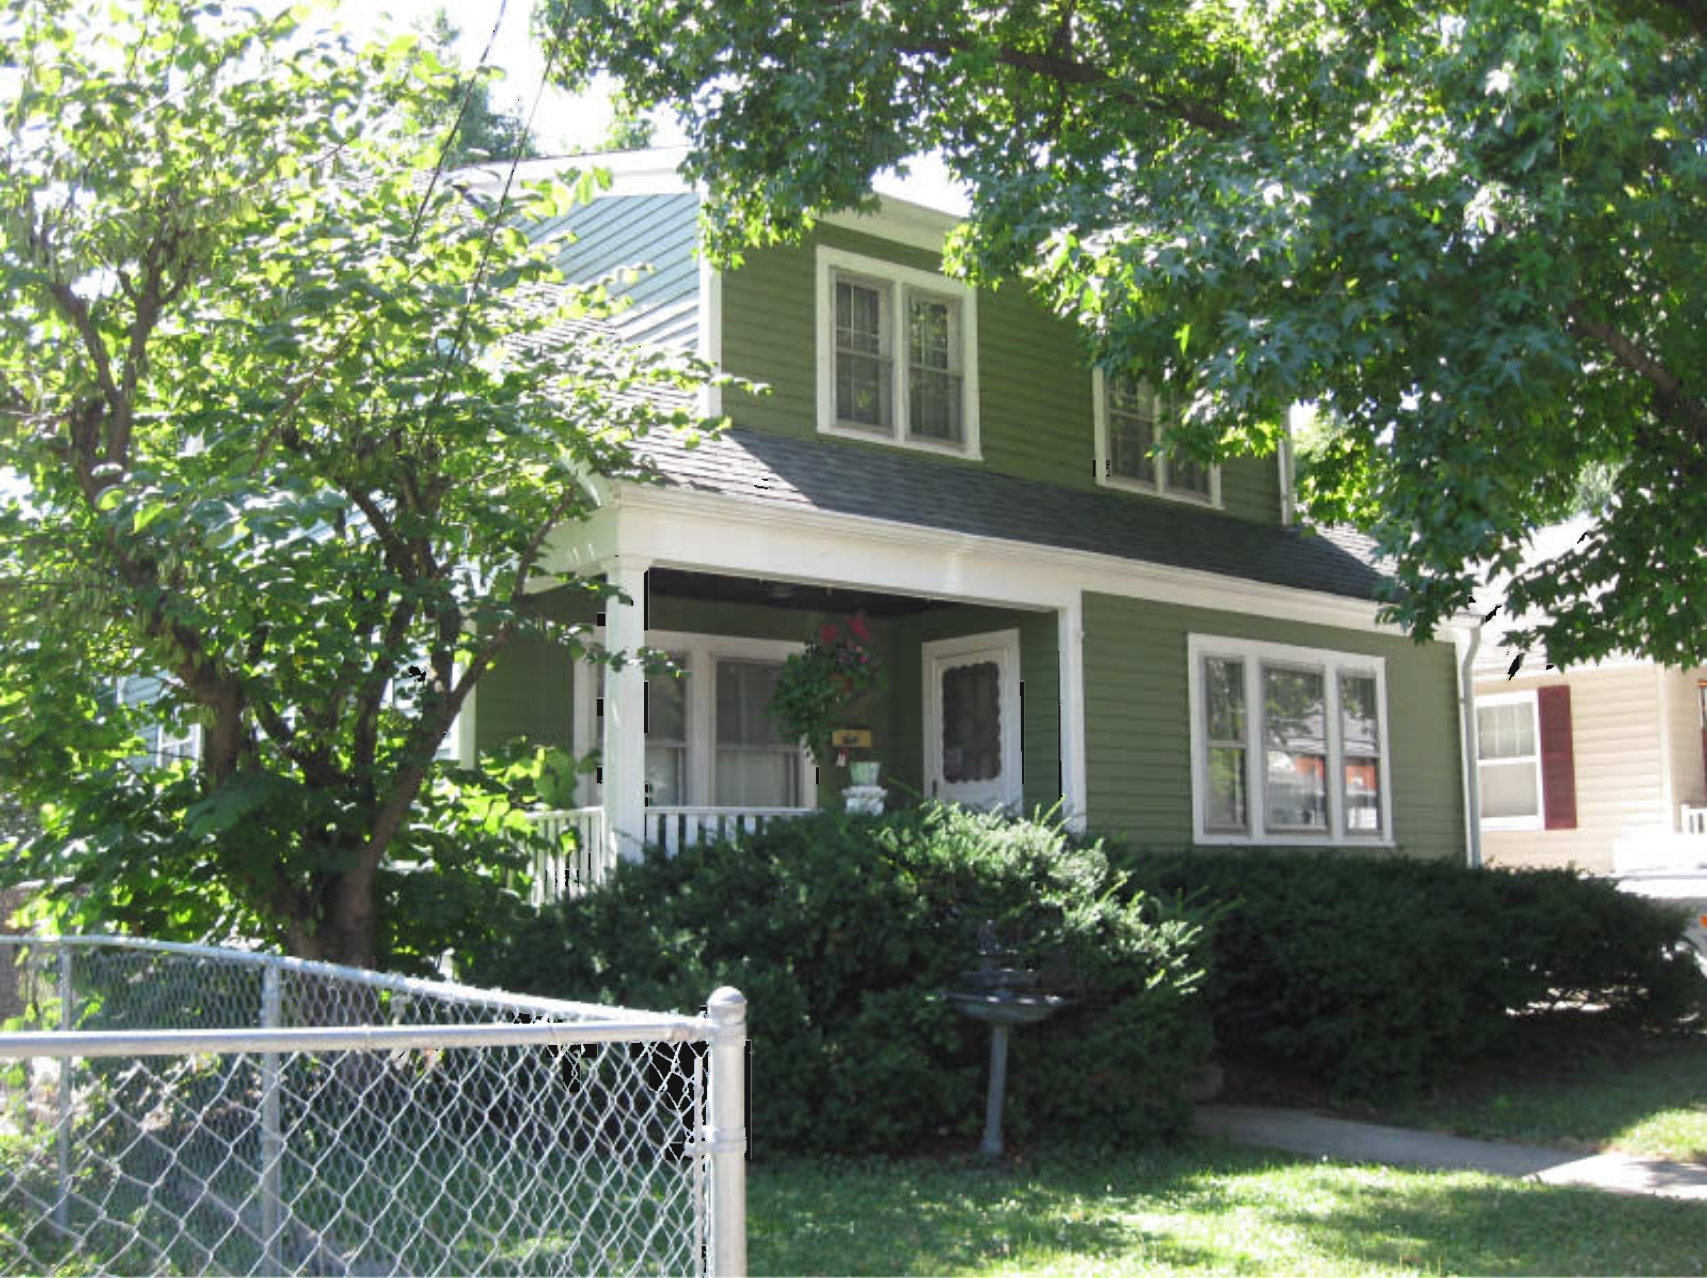
Facing west, this house is a one-and-one-half story, side-gabled, frame structure that rests on a concrete foundation and the walls are clad with wood weatherboard siding. The north end of the rear slope of the steeply-pitched roof is pierced by an interior end brick chimney, and there is a wide shed dormer on the front slope and a gabled dormer on the rear. The front dormer has two pairs of six-light casement windows but the openings on the rear dormer were not visible. The main façade has two openings: paired 6/1 wood windows in the left bay and in the right bay is a tripartite window composed of a 6/1 wood window flanked by narrow 6/1 windows. A recessed porch is at the northwest corner of the house, and the main entrance is located on the south wall of the porch but the door is obscured by a metal storm door. The porch features a concrete stairway, wooden deck, paneled box column with molded capital, and a plain wood balustrade. The north elevation has two pairs of 6/1 windows, with the eastern pair being small, and in the upper half story is a single 6/1 window. On the south elevation, from left to right, is a pair of 6/1 windows, a short 6/1 window and another pair, and in the upper half story are two 6/1 windows.

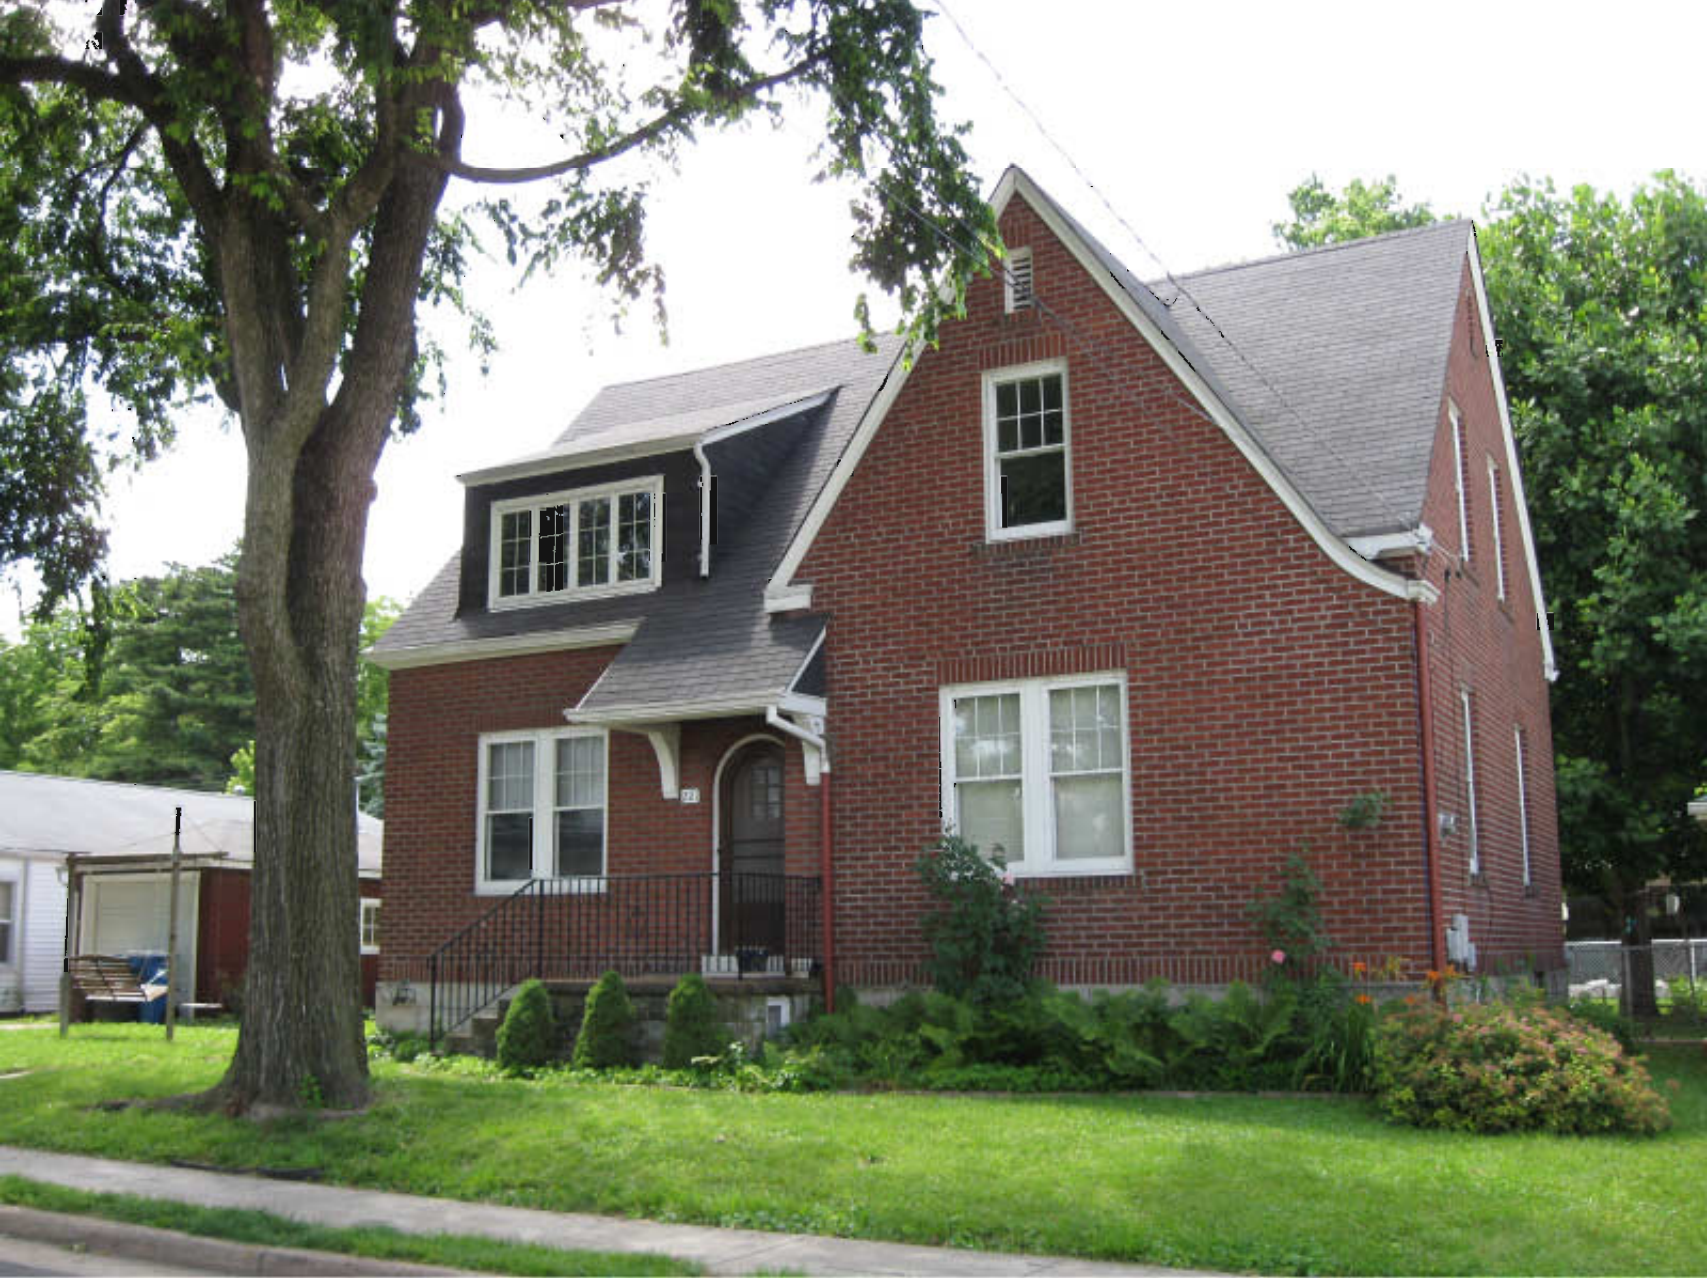
This one-and-one-half story, Tudor Revival style house has a scored concrete foundation, walls finished with bricks laid in a running bond pattern, and a high cross gabled roof. The front gabled portion of the building projects slightly from the remainder of the house. Immediately above the foundation is a soldier course of bricks, and the windows throughout have brick sills and flat jack arches. An interior brick chimney pierces the rear slope of the roof and on the front slope is a shed-roofed dormer with group of four six-light casements, and the dormer walls are finished with roofing shingles. The steep gabled roof is trimmed with cornice returns, and the northern eave line of the front gable is curved and extends lower than the southern eave line. The three-bay main façade has a central round-arched, vertical board door with six small lights, and there is a round-arched wood screen door. The entrance is protected by a shed roof that is an extension of the main roof, and it is supported by knee braces. The door opens onto a concrete stoop with stairway on the south side, and the stoop and stairway have wrought iron railings. To each side of the entrance is a pair of 6/1 wood windows with brick lug sills and in the front gable is a 6/1 window. The north elevation has two 6/1 windows on both the first floor and upper half story. The first floor of the south elevation has a doorway topped by a transom and flanked by 6/1 windows, and the door opens onto a one-bay concrete porch. The porch has wrought iron posts supporting a balcony, and both the porch and balcony have wrought iron railings. A door in the upper half story opens onto the balcony.
