ARCHITECTURAL/HISTORIC INVENTORY FORM

1. Survey No. SC-AS-009-001		2. Survey Name: St. Charles Survey Phase 3: Mid-Town and Commons Neighborhoods	
3. County: St. Charles		4. Address (Street No.) 128	Street (name) North Sixth Street
5. City: St. Charles	Vicinity: <input type="checkbox"/>	6. UTM:	
7. Township/Range/Section:		8. Historic name (if known): Meyer-Pieper House; The Meyerdorf	
9. Present/other name (if known):		10. Ownership: <input checked="" type="checkbox"/> Private <input type="checkbox"/> Public	
11a. Historic use (if known): Domestic/single dwelling		11b. Current use: Domestic/single dwelling

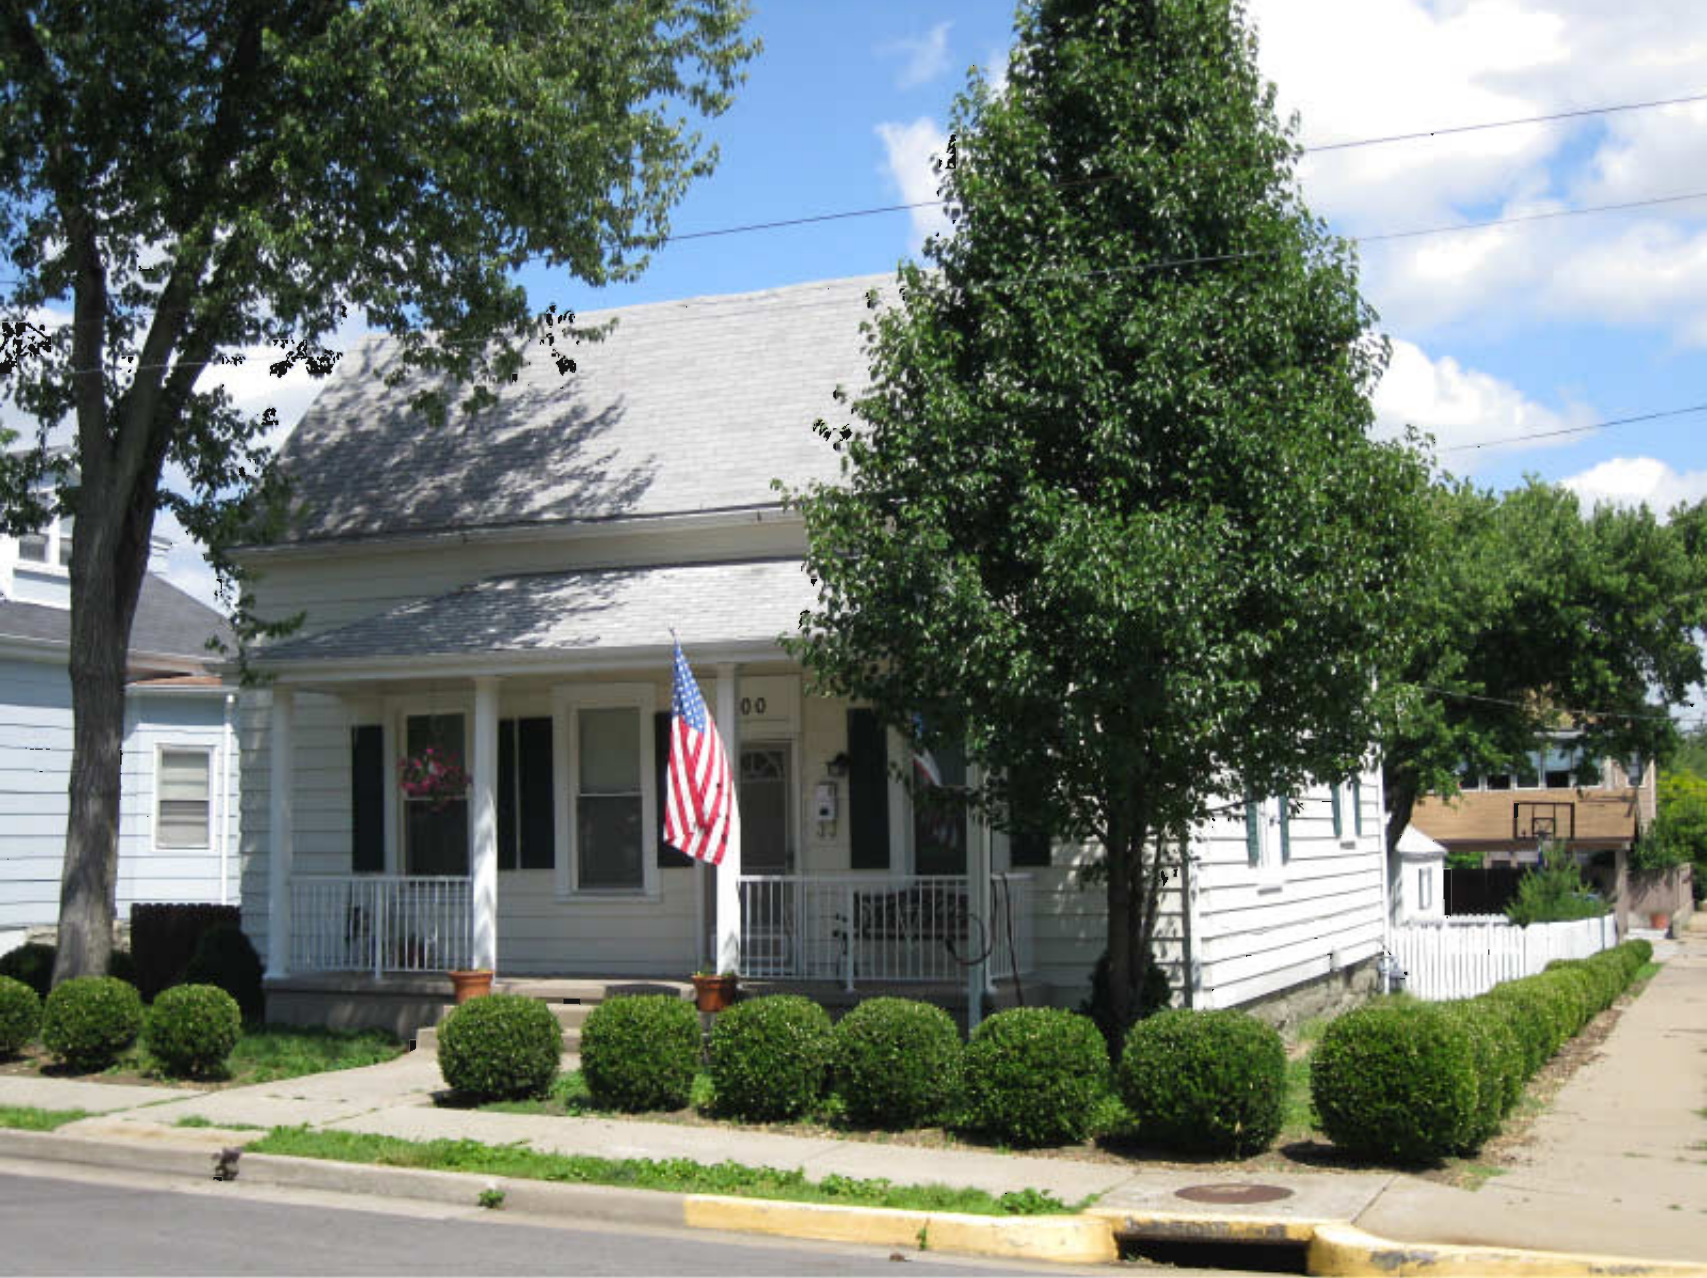
Located at the northeast corner of Benton Avenue and Monroe Street, this house is a one-and-one-half story, gabled, L-shaped, frame structure. The house rests on a rusticated concrete block foundation and the walls have been clad with aluminum siding. A $\frac{3}{4}$ -width gallery spans the four bays of the main façade and features a concrete deck, fluted metal box columns, wrought iron handrail, and hip roof. The main entrance is in the second bay from the south and is a replacement metal door with fanlight, and the transom has been covered or enclosed. The other three bays contain replacement 1/1 vinyl windows framed by vinyl louvered shutters that are too short for the openings. The south elevation has two 1/1 vinyl windows on the first floor and a 1/1 window and a very small window in the upper half story, and the north elevation has a 1/1 window on both levels. The house is noncontributing due to the application of aluminum siding, replacement of the windows and door, and alterations to the porch.

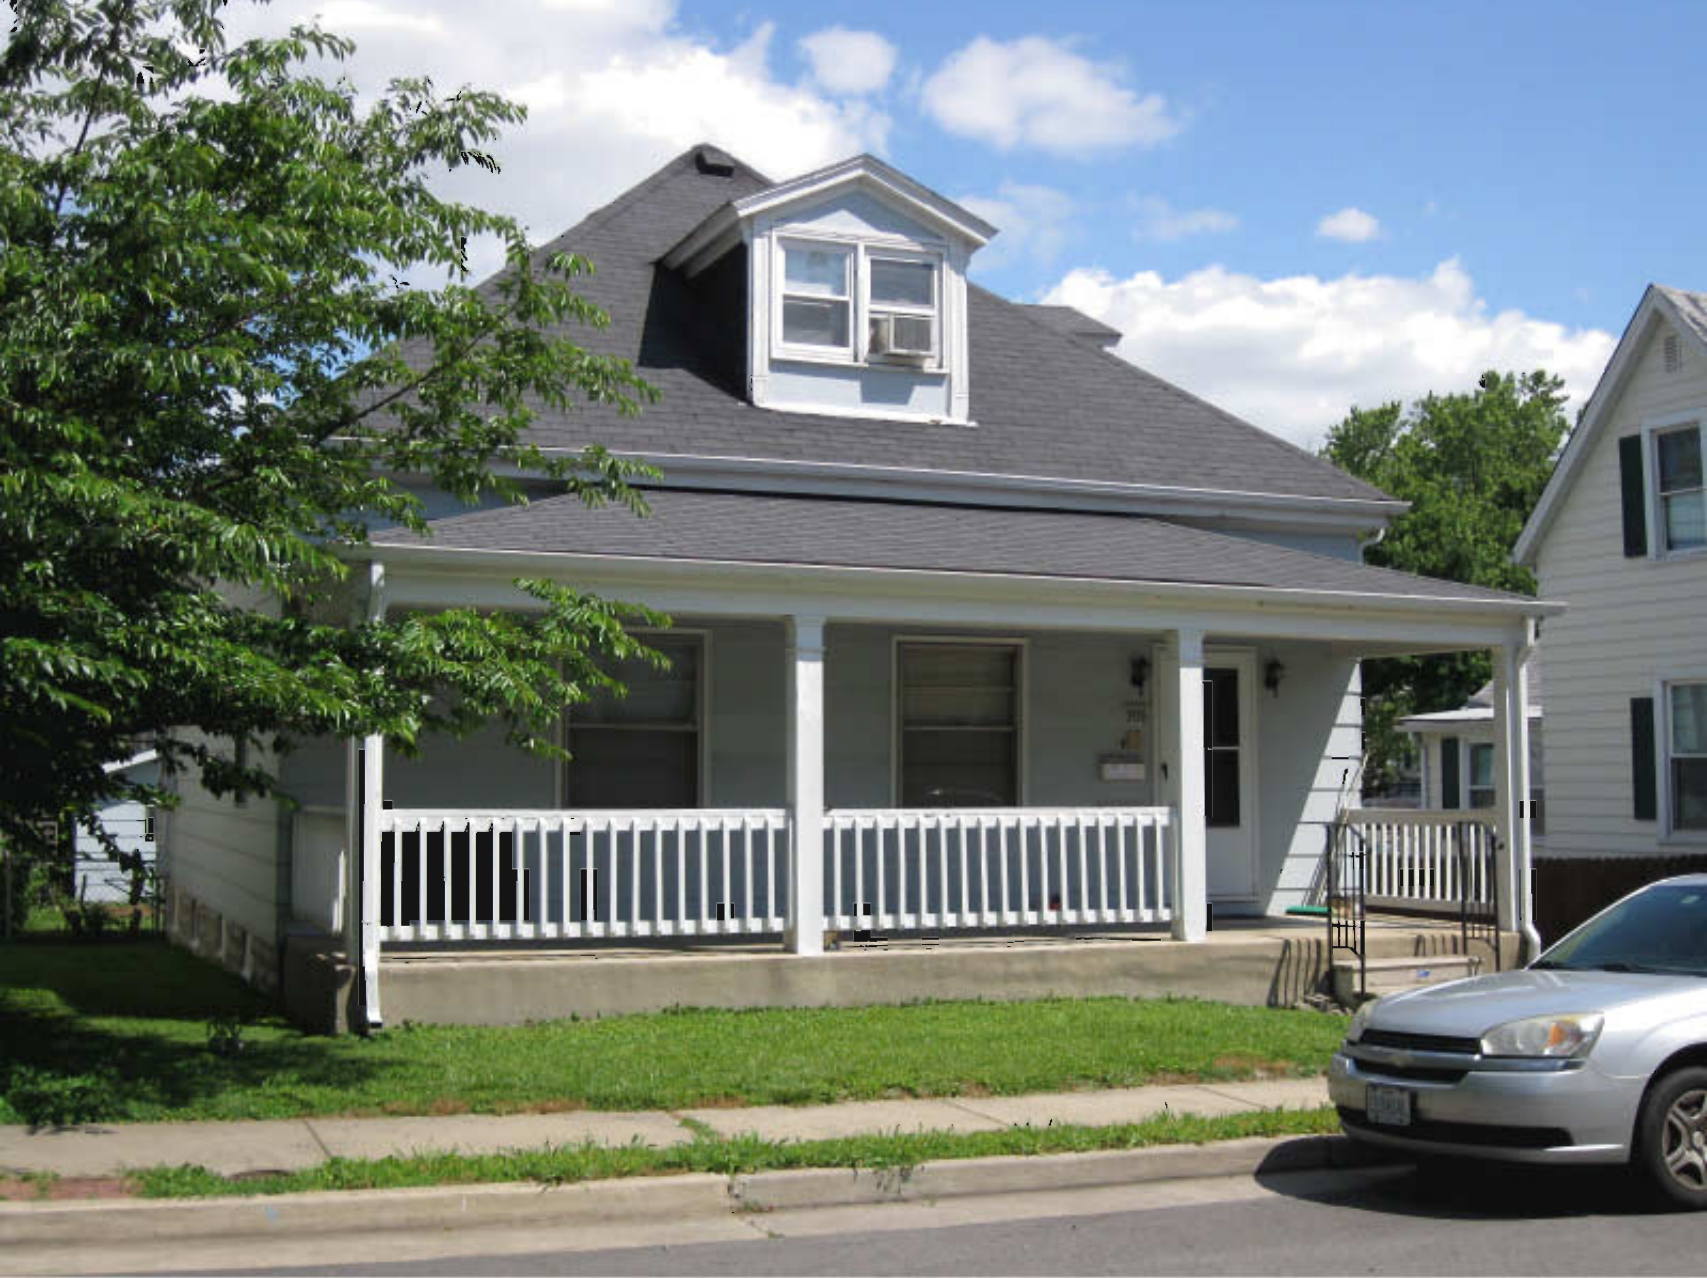
This one-and-one-half story, frame, Pyramidal form folk house rests on a rusticated concrete block foundation, and the basement windows have been boarded. The walls and the exterior end chimney on the south elevation are clad with aluminum siding. Gabled dormers pierce the west and south slopes of the pyramidal roof, while a shed dormer is on the rear slope. Paired 1/1 windows are in each of the three dormers, and the two gabled dormers are pedimented and have fluted pilasters to each side of the paired windows. The main façade is a three-bay elevation, with the entrance in the southern bay and wide 2/2 wood windows (lights arranged horizontally) in the other two bays. The windows were likely replaced in the 1960s. The door appears to be partially glazed, but it is obscured by a screen door. A gallery spans the full-width of the façade, but it was built sometime after 1947 since the 1909-1947 Sanborn maps show a one-bay porch at the entrance. The gallery has a concrete deck, wood box columns with molded capitals, hip roof, and a deck-style balustrade that has the balusters nailed to the front of the hand and foot rails. The south elevation has a 1/1 window at the west end and a polygonal bay with 2/2 wood windows (lights arranged horizontally). The house is noncontributing due to the aluminum siding, windows that likely date to the 1960s, and replacement porch.

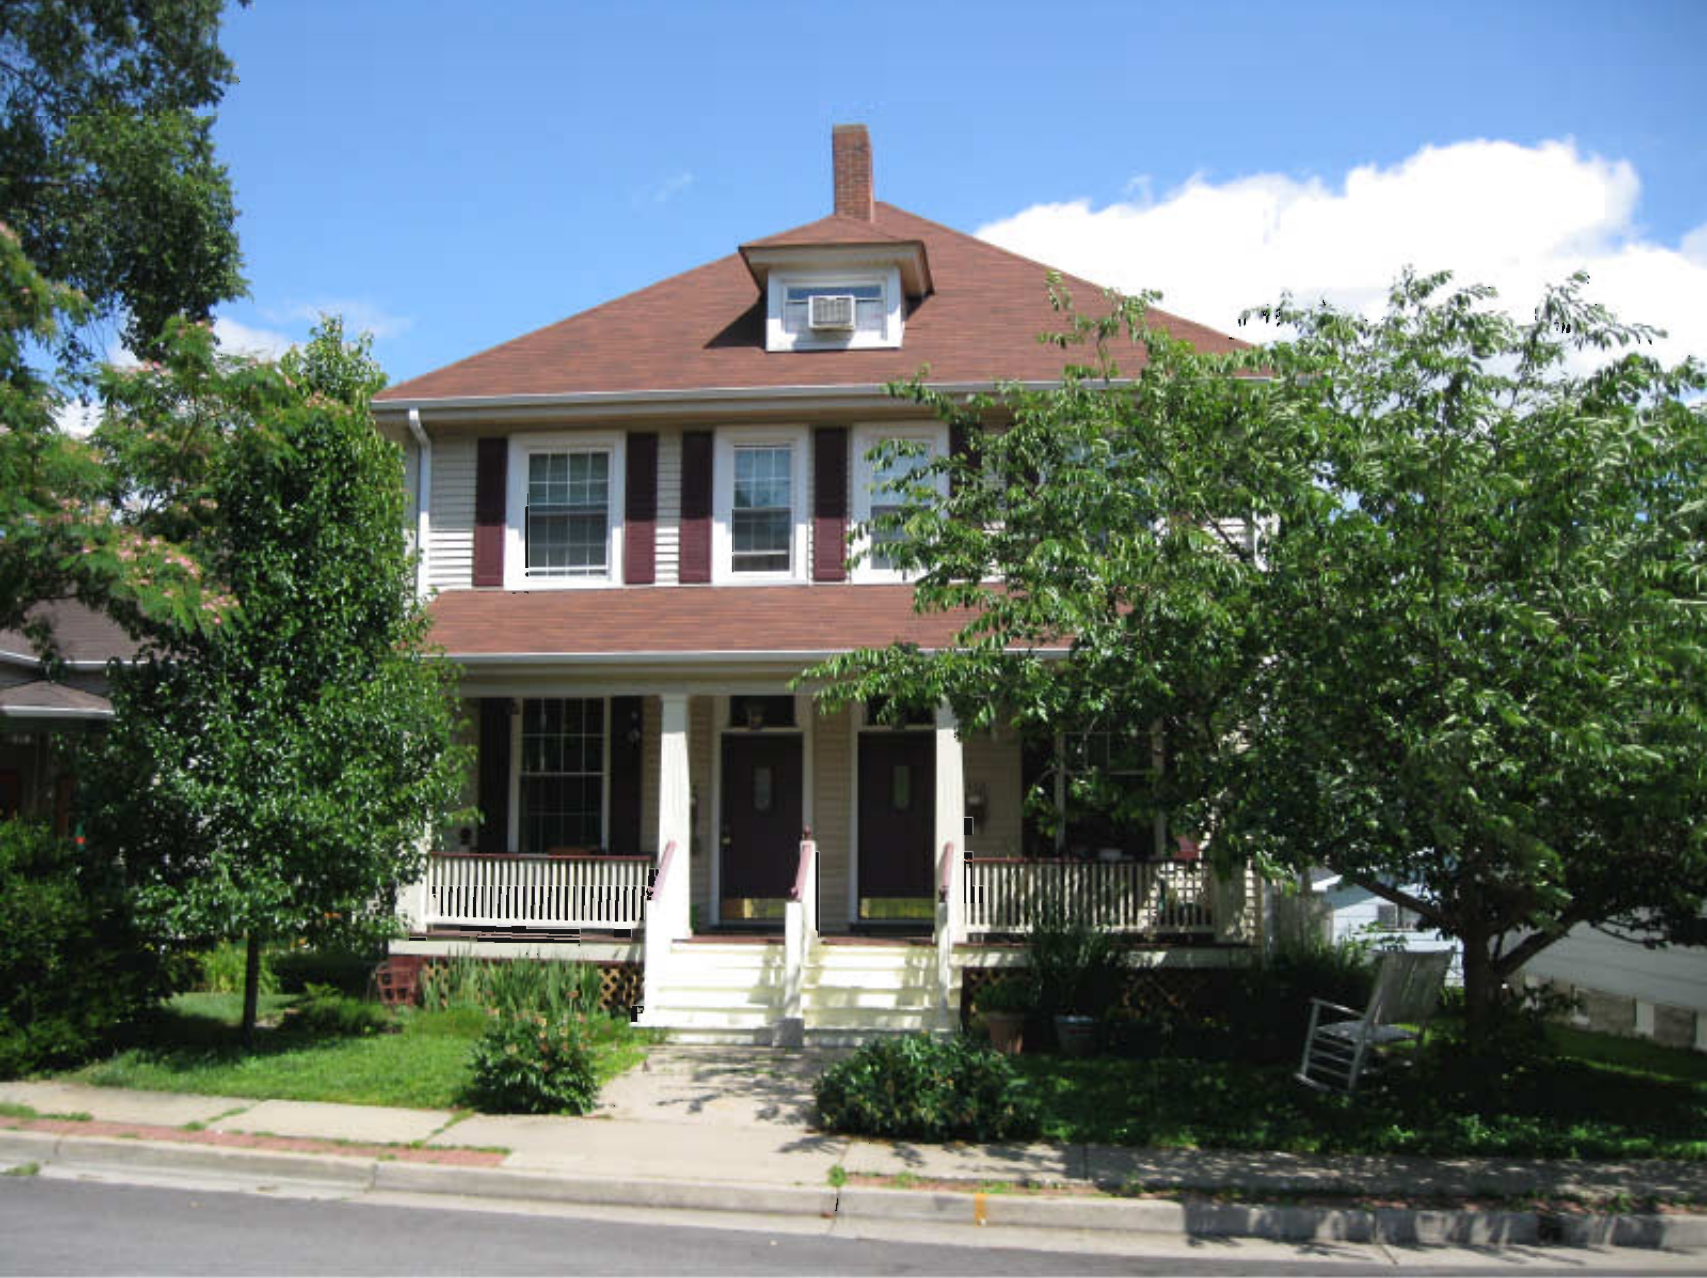
This two-and-one-half story, frame duplex rests on a stone foundation and is crowned by a pyramid roof with wide overhanging eaves. The front slope of the roof is pierced by a brick chimney and a dormer with hip roof with wide overhanging eaves. The window of the dormer has been in-filled with an air conditioner and is partially boarded. The walls of the house and dormer have been clad with vinyl siding, and the windows and doors have been replaced, resulting in the structure being counted as noncontributing. In the center two bays of the four-bay main façade are paneled doors with small leaded glass lights, and above the doors are single-light transoms. In the outer bays are 8/8 vinyl windows framed by vinyl louvered shutters. The second floor features two 6/6 vinyl windows in the center bays and 8/8 windows in the outer bays. A one-story gallery spans the main façade and features a wide, central, wooden stairway; wooden deck; box columns; plain wood balustrade; and shed roof. Each of the side elevations has three windows on each floor, and the windows at the west end of the elevations are 6/6 sash while the others are 1/1. A one-and-one-half-story, gabled wing extends from the rear elevation. This wing originally had a porch on both the north and south elevations, but the northern porch has been enclosed.

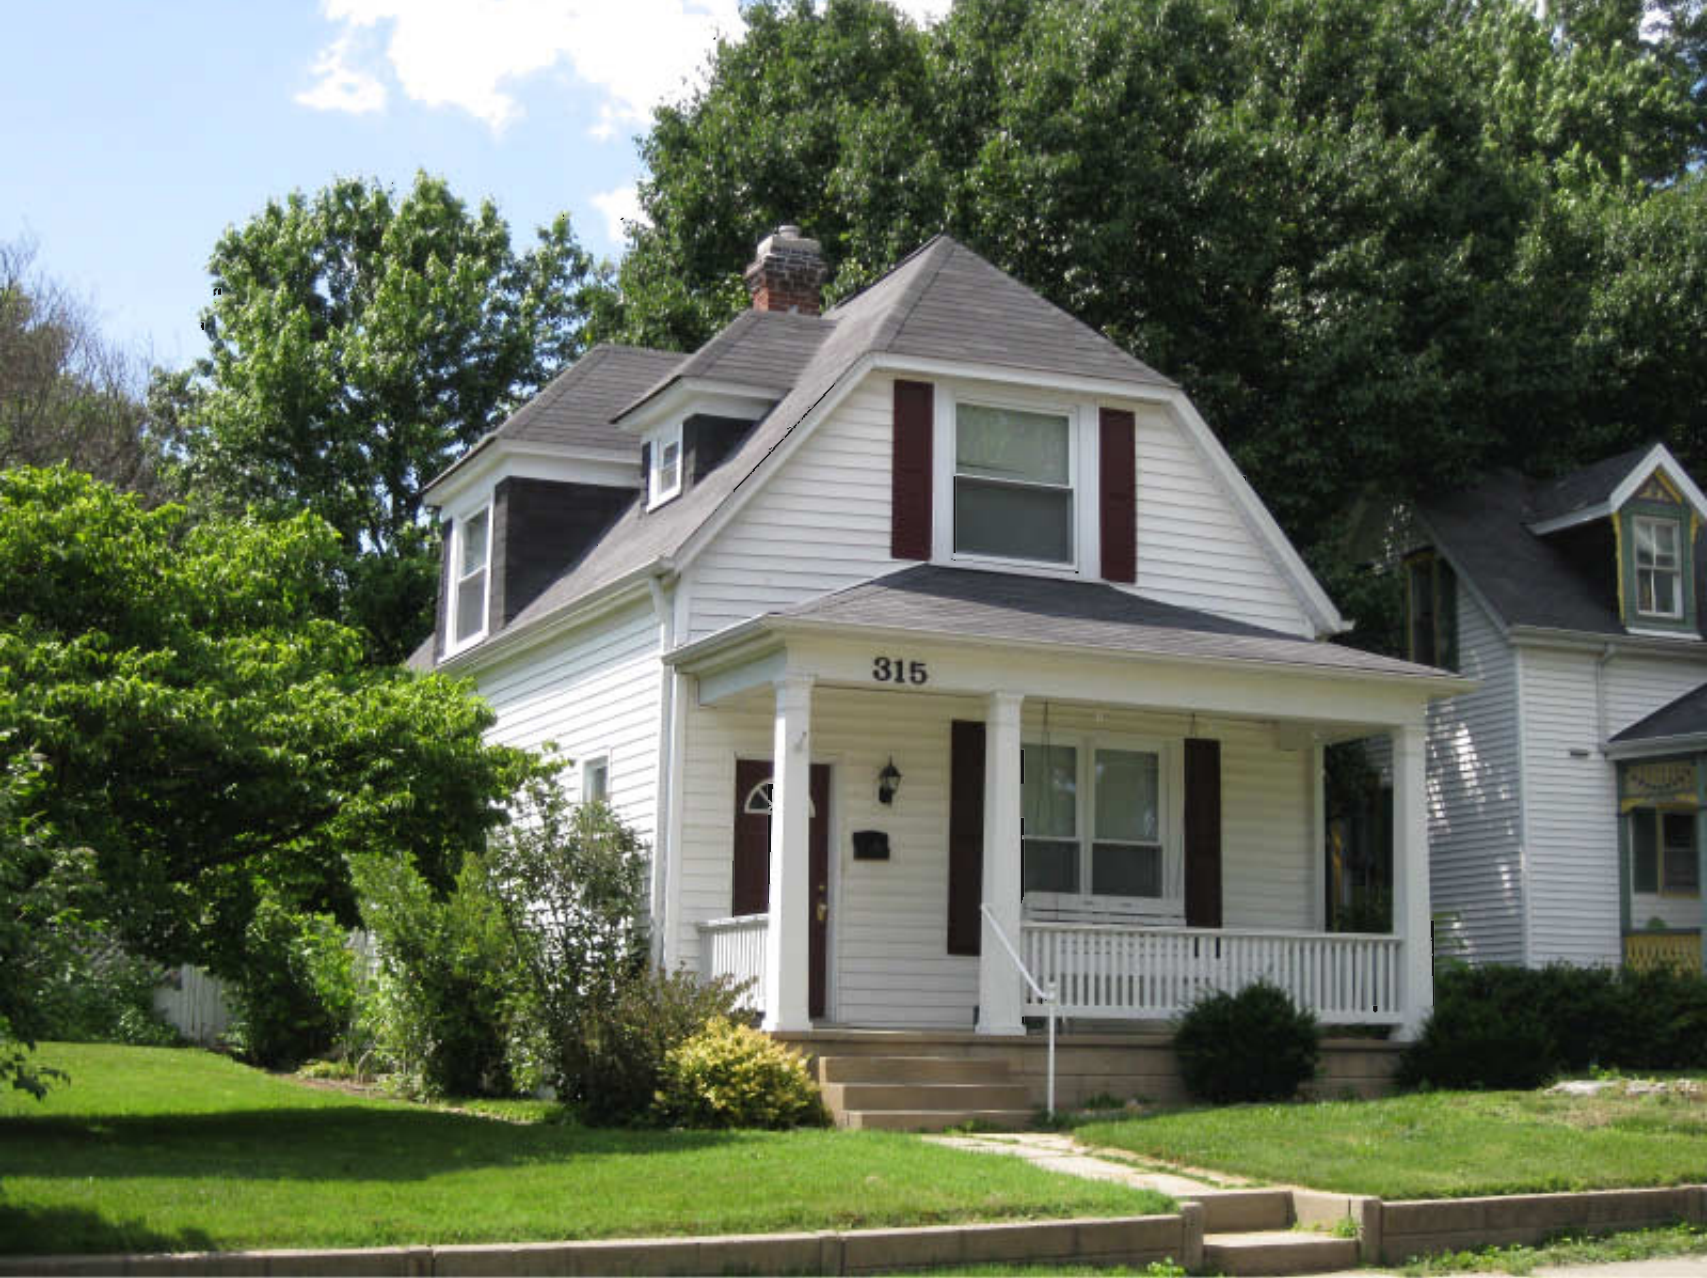
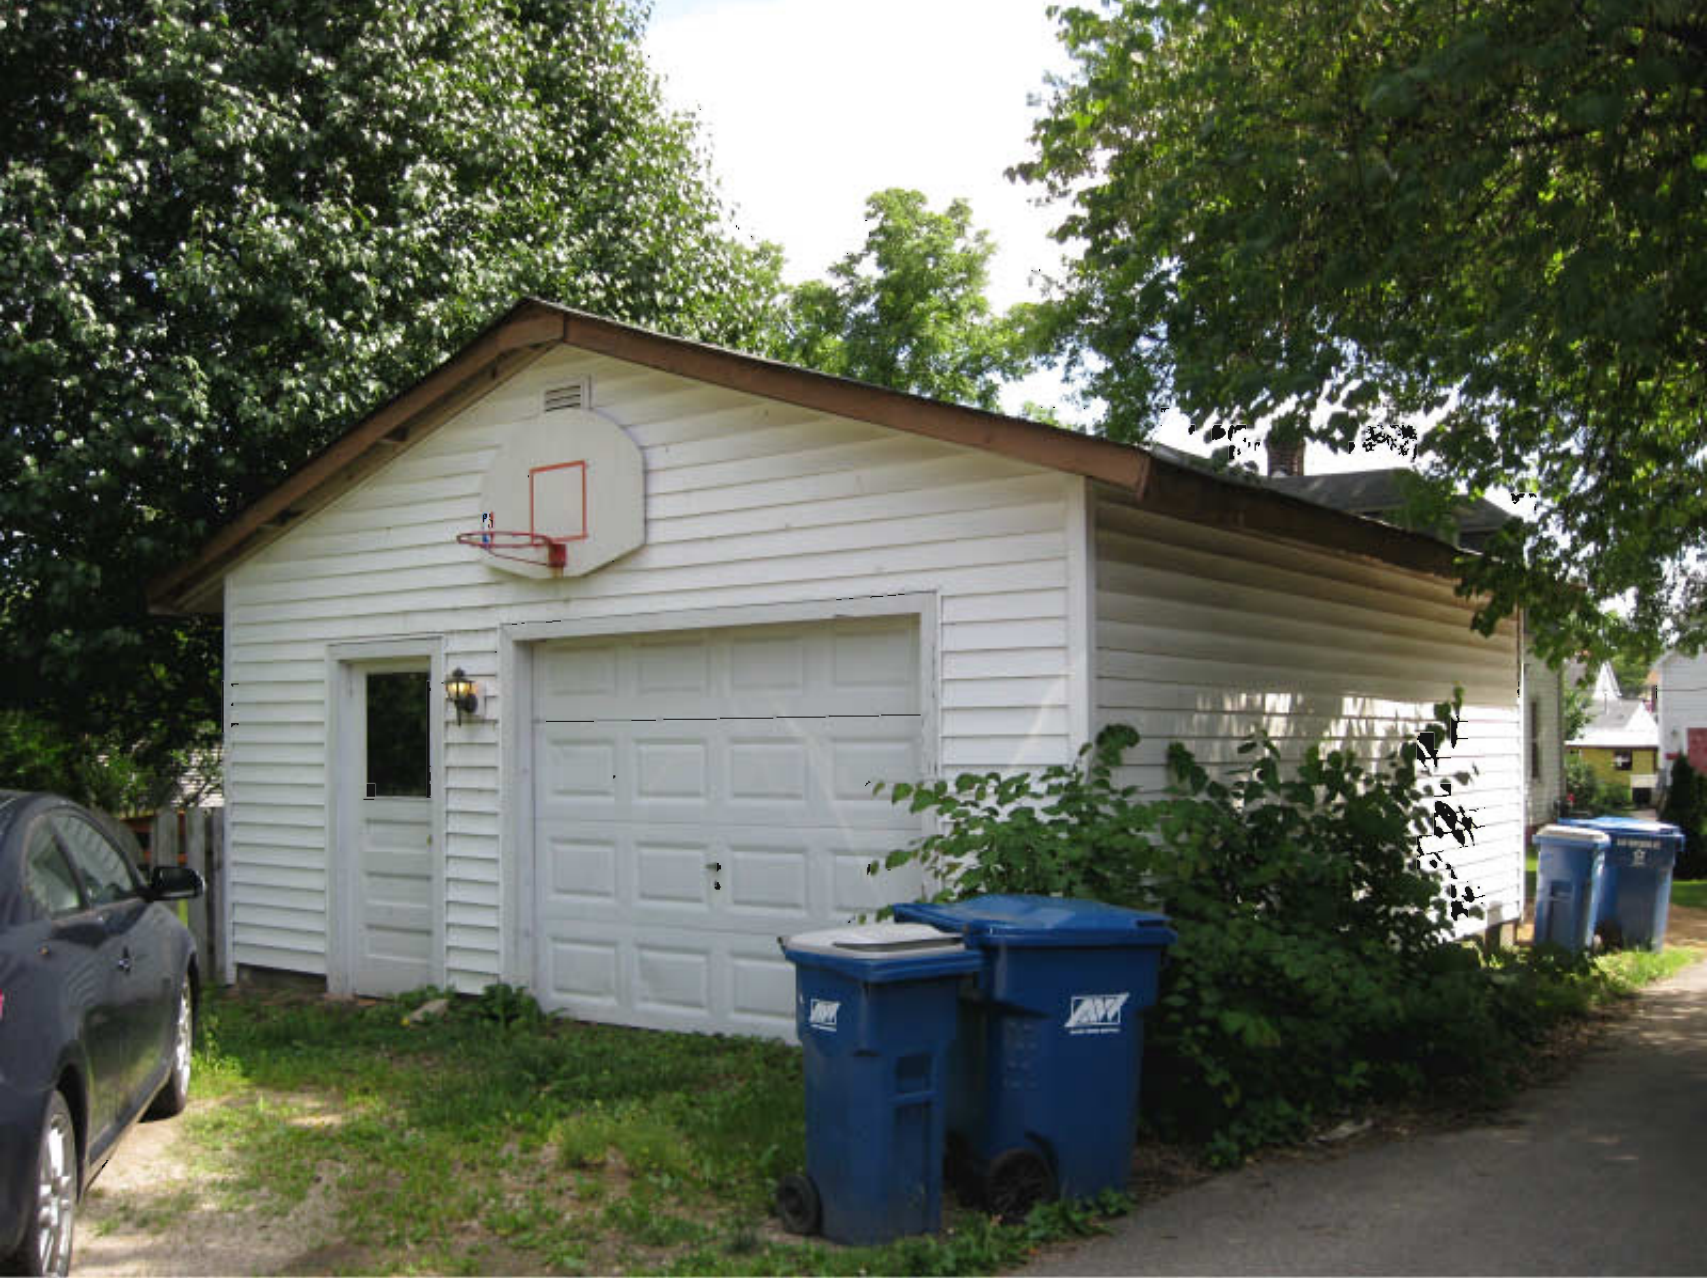
Facing east, this one-and-one-half story, frame house has walls finished with vinyl siding and a high, clipped front gable roof that is pierced by a brick straddle-ridge chimney and three dormers. Two hipped dormers are on the south slope, with the one near the front of the house being smaller than the other. The dormers' roofs are trimmed with wide frieze boards, the walls are clad in roofing shingles, and each has a 1/1 window. A hipped dormer is also on the north slope. The two-bay main façade features a replacement door with fanlight and to the north is a pair of 1/1 windows with louvered vinyl shutters. The door opens onto a one-story, full-width gallery with scored concrete foundation and concrete deck, plain wood balustrade, box columns with molded capitals, and a medium-pitched hip roof. The Sanborn Insurance maps indicate that the house originally had a recessed porch at the southeast corner but it was enclosed and the present porch was added between 1917 and 1929. In the upper half story is a wide 1/1 window with shutters. The north elevation features from front to rear a 1/1 window; a small 1/1 window high in the wall, indicating its location along a stairway; and two 1/1 windows in the rear one-story wing.

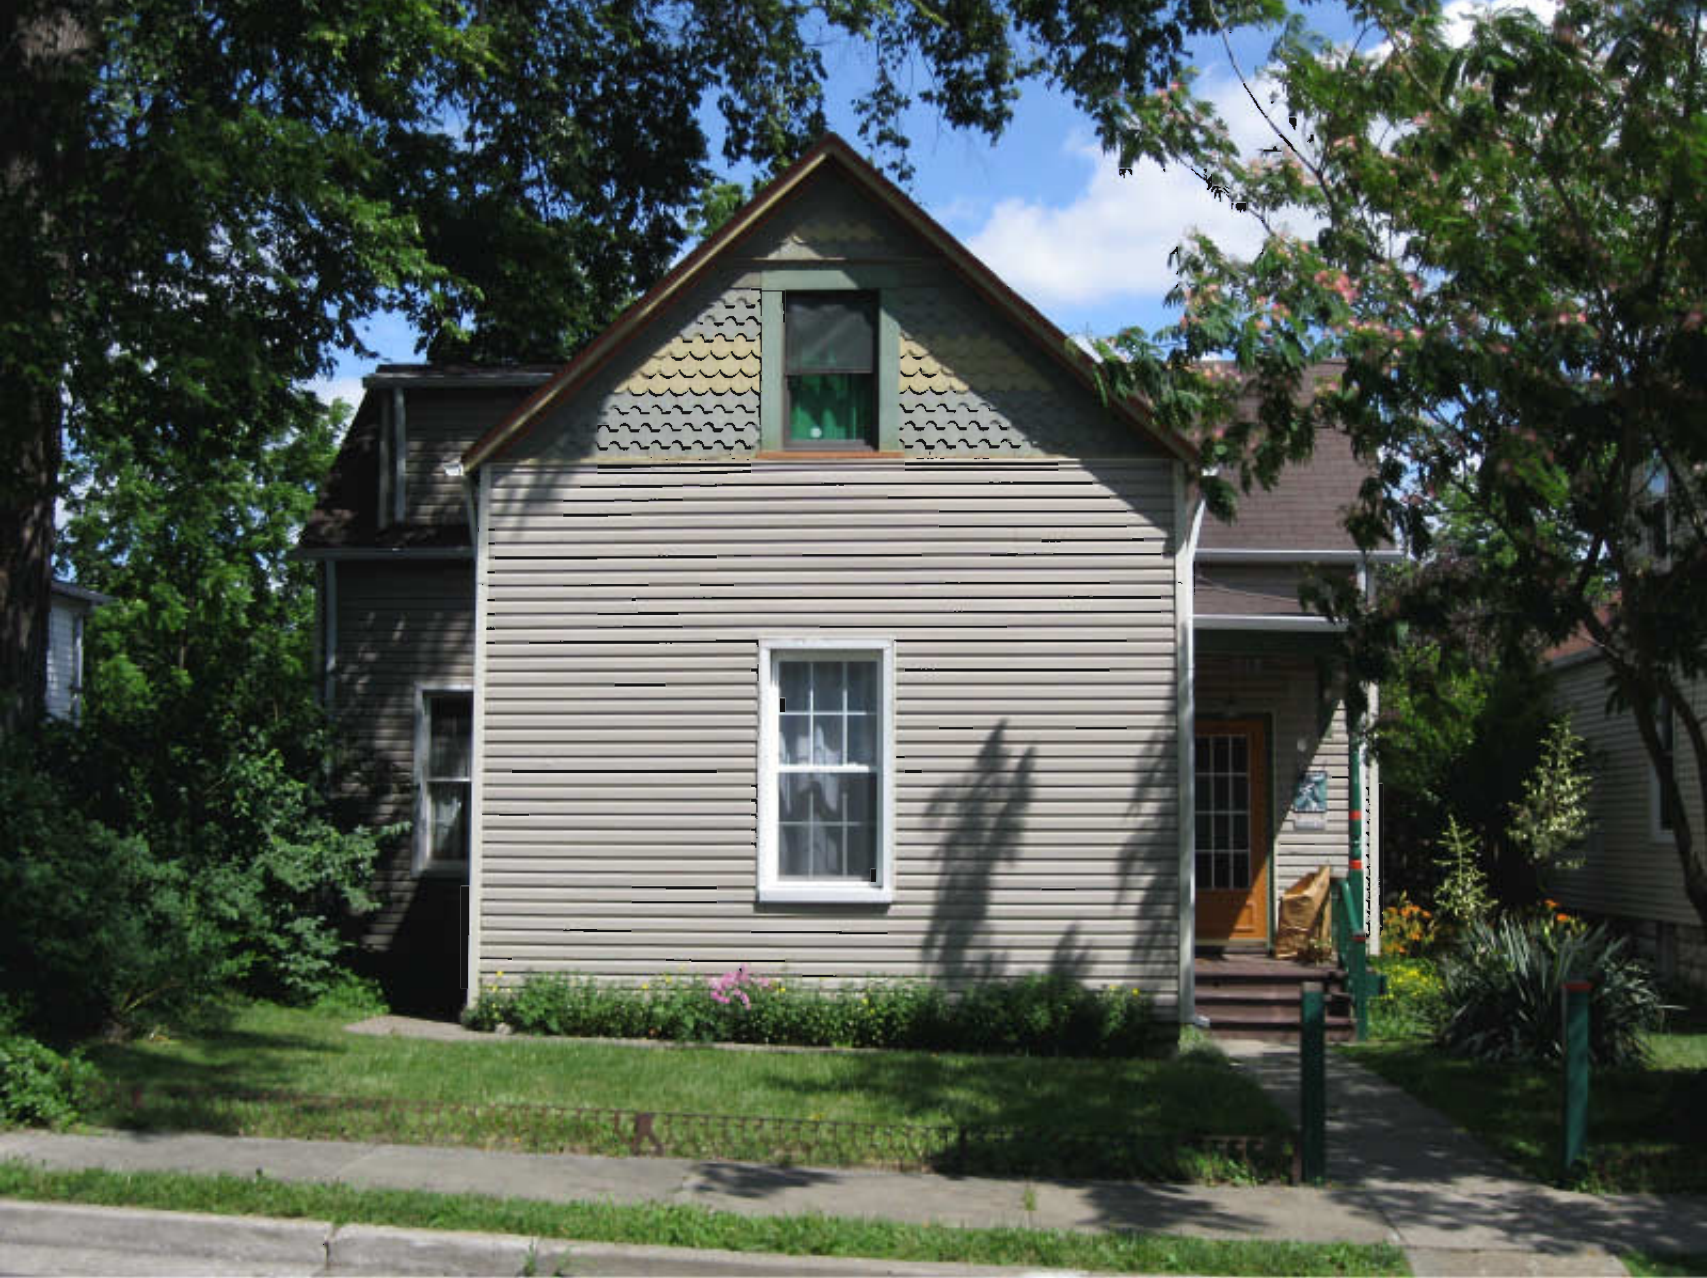
Situated on a tree-shaded lot, this one-and-one-half story, frame, T-shaped house rests on a low stone foundation. The walls are clad in vinyl siding but the front gable end is finished with imbricated wood shingles. The medium-pitched, cross-gabled roof has two straddle ridge brick chimneys: one is on the roof of the front-gabled wing and the other is on the north wing. A shed dormer with no window openings is on the front slope of the north wing and a wide shed dormer with two windows is on the rear. The main façade has three bays: a 6/6 vinyl window in the north wing, a 6/6 window in the front-gabled wing, and the main entrance—a replacement French door—in the south wing. The door opens onto a one-bay porch that has a wooden stairway and deck, turned post supporting a shed roof, and balustrade with turned balusters. Another French door on the south elevation of the front-gabled wing opens onto the porch, and to the left of the door is a 6/6 vinyl window. On the south side of the south wing is a 6/6 window on the first floor and a 1/1 window in the upper half story. Although the house has vinyl siding and replacement windows and door, it is being counted as a contributing since it retains its imbricated wood shingles in the gable end and its wood porch details.

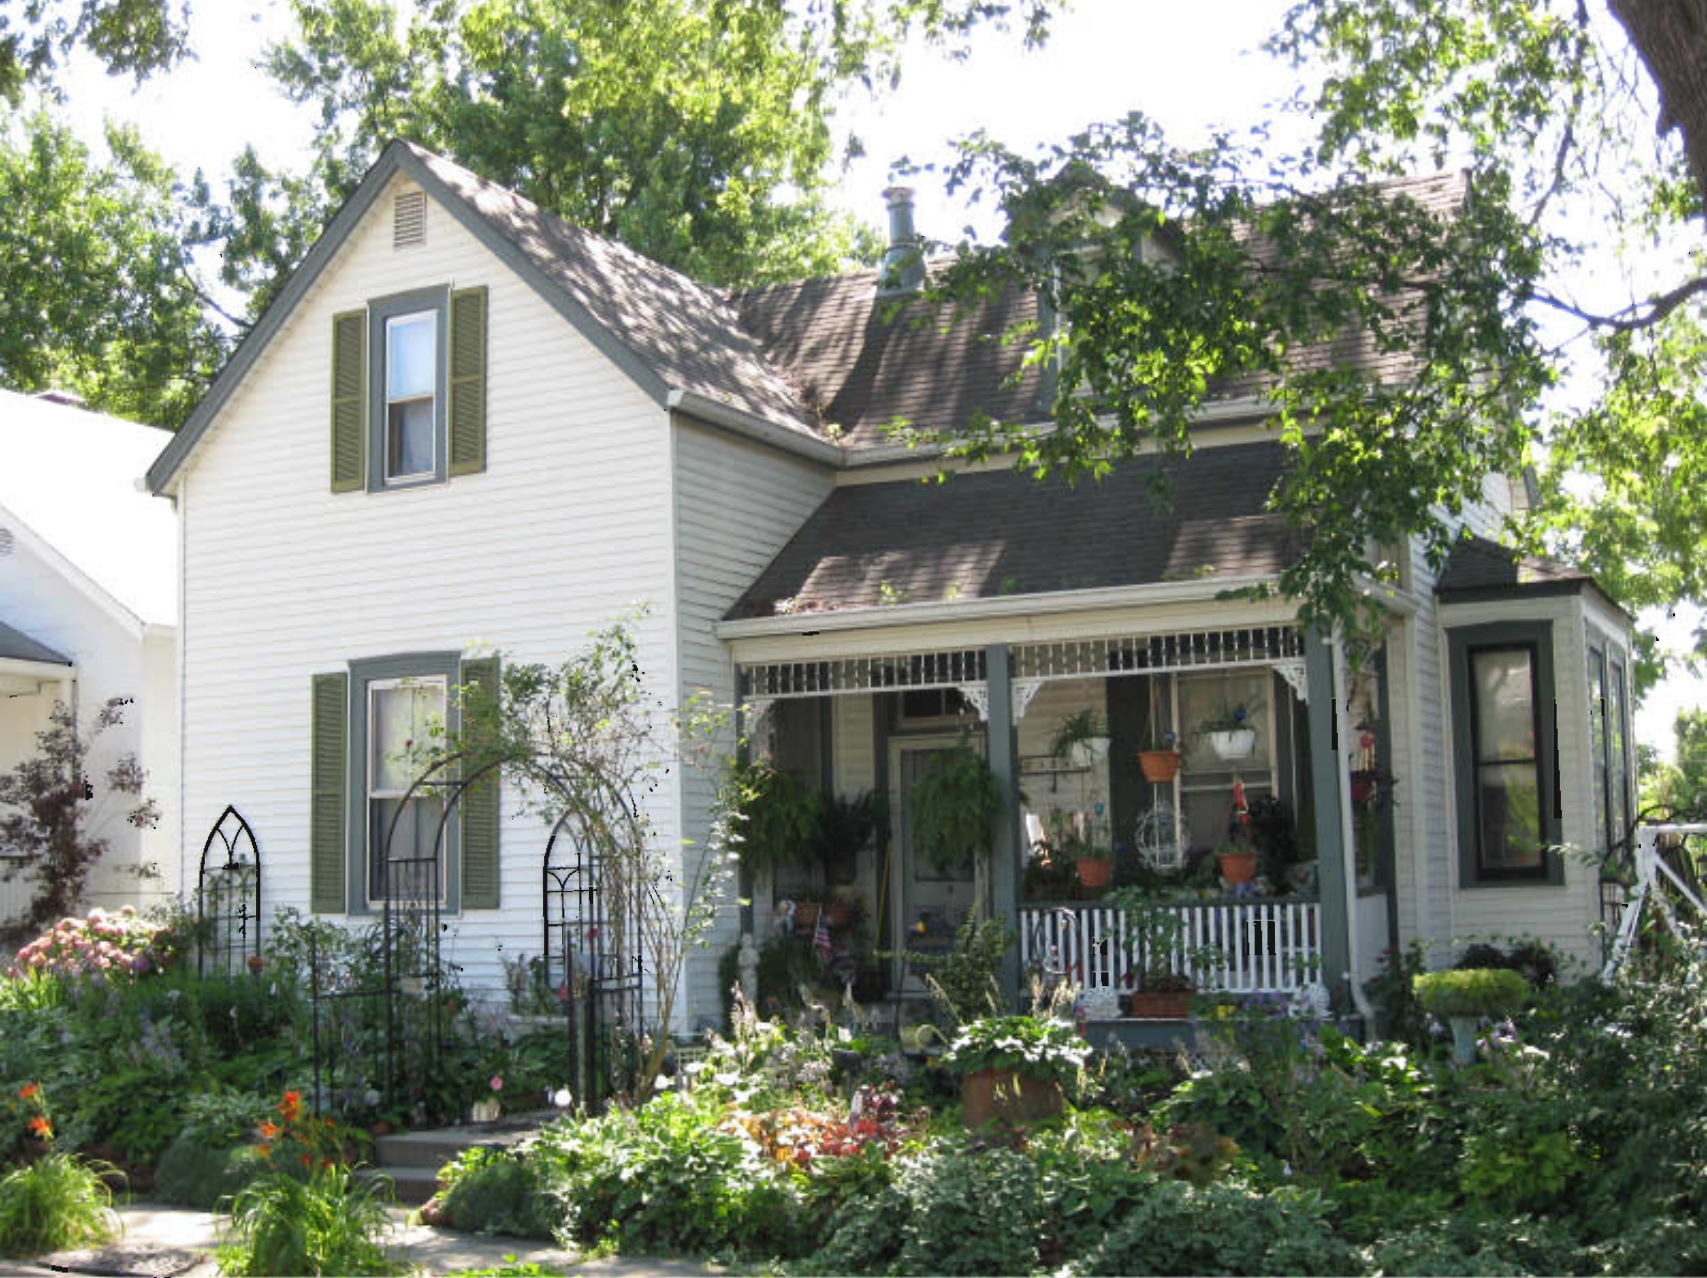
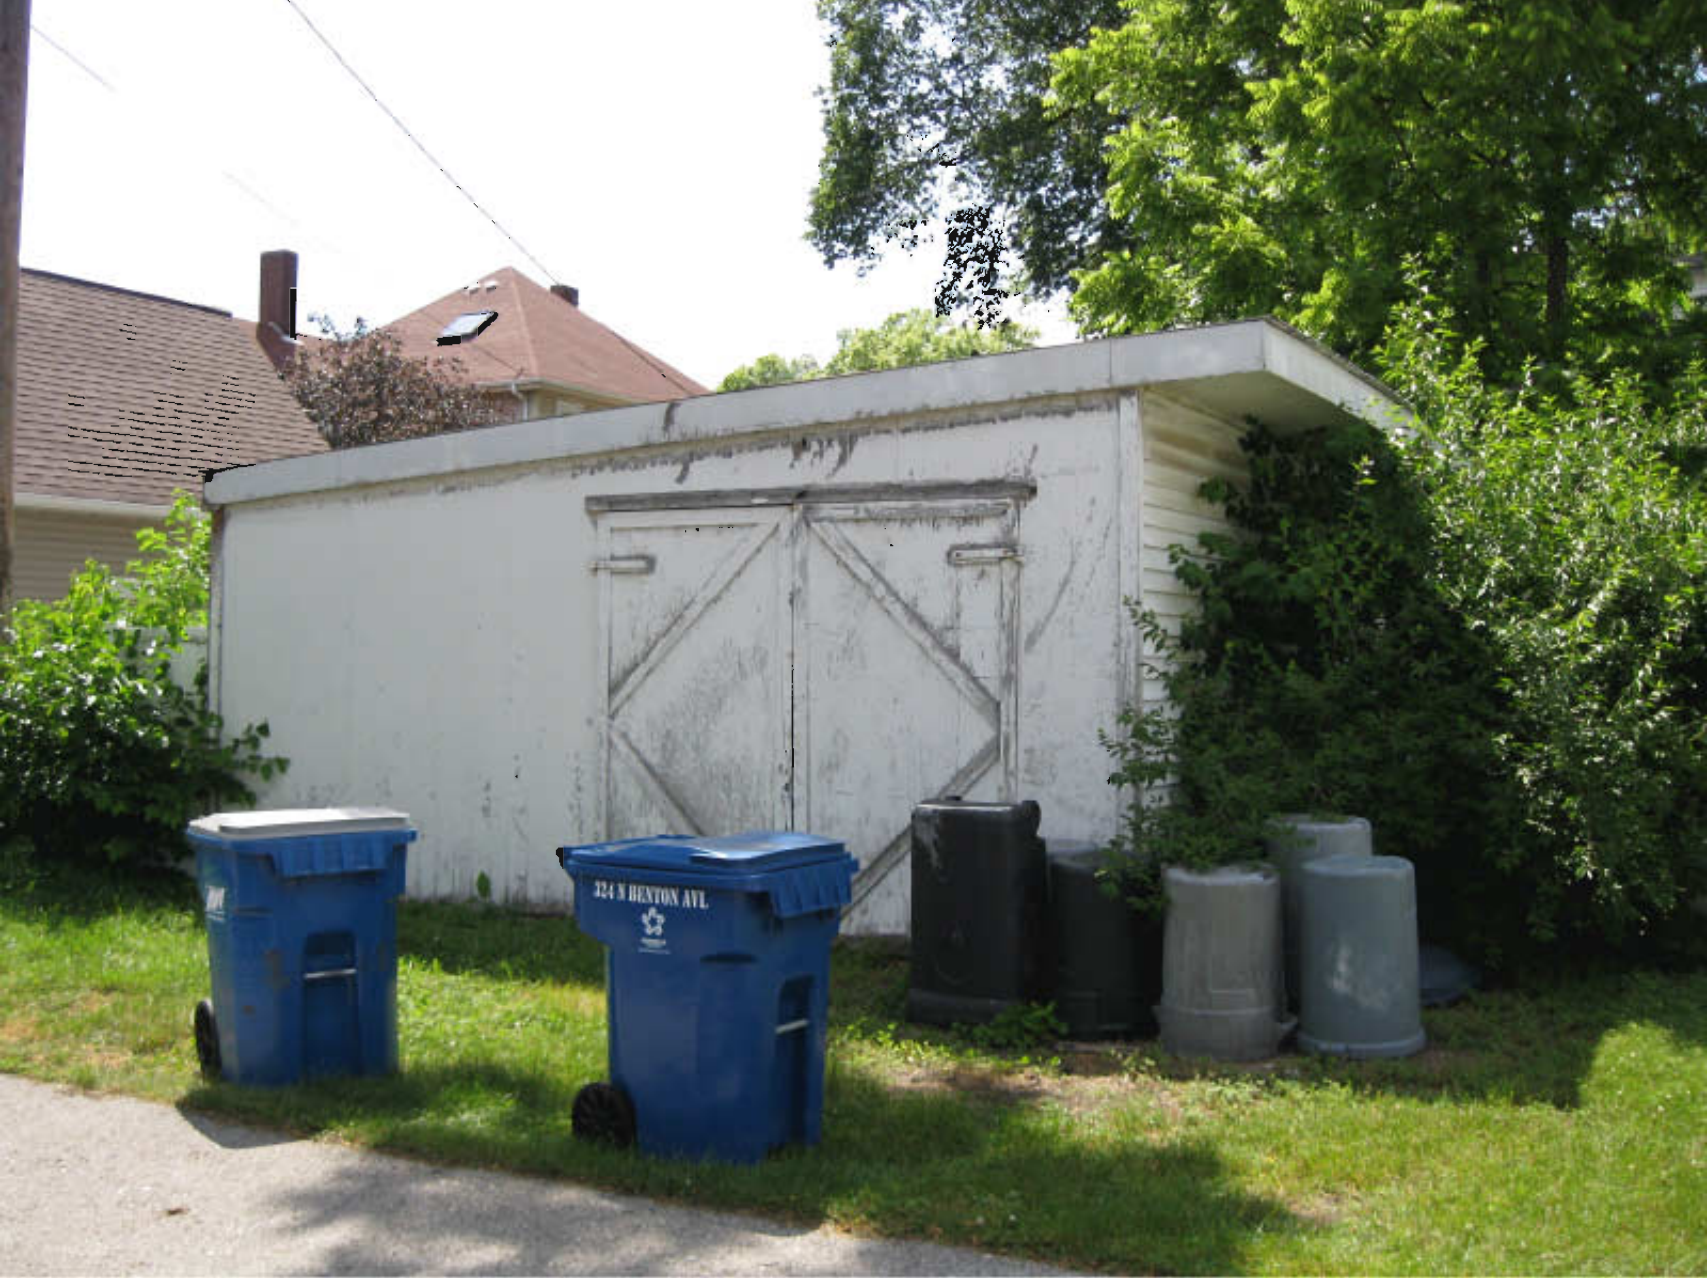
Built c. 1885, this one-and-one-half story, frame, gable-front-and-wing form, Folk Victorian house is clad with vinyl siding. On the west and north slopes of the roof are gabled dormers with vinyl-clad walls and 2/2 wood windows with plain wide surrounds. The three-bay main façade features a 2/2 window in the projecting front-gabled wing and in the south wing is a half-glazed, two-panel wood door topped by a two-light transom and another 2/2 window. The windows throughout the house have plain surrounds topped by molded, slightly peaked lintels. The house is highlighted by a two-bay gallery with wood deck and stairs, plain balustrade, plain wood box columns and pilasters, ornate pierced corner brackets, ball-and-rod spindled frieze, and hip roof. On the south wall of the front-gabled wing, another window opens onto the porch. The north elevation has two windows while the south elevation features a box bay with paired 1/1 windows in its south wall and single 1/1 windows on its east and west walls. Another window is in the upper half story.
