ARCHITECTURAL/HISTORIC INVENTORY FORM

1. Survey No. SC-AS-009-001		2. Survey Name: St. Charles Survey Phase 3: Mid-Town and Commons Neighborhoods	
3. County: St. Charles		4. Address (Street No.) 128	Street (name) North Sixth Street
5. City: St. Charles	Vicinity: <input type="checkbox"/>	6. UTM:	
7. Township/Range/Section:		8. Historic name (if known): Meyer-Pieper House; The Meyerdorf	
9. Present/other name (if known):		10. Ownership: <input checked="" type="checkbox"/> Private <input type="checkbox"/> Public	
11a. Historic use (if known): Domestic/single dwelling		11b. Current use: Domestic/single dwelling

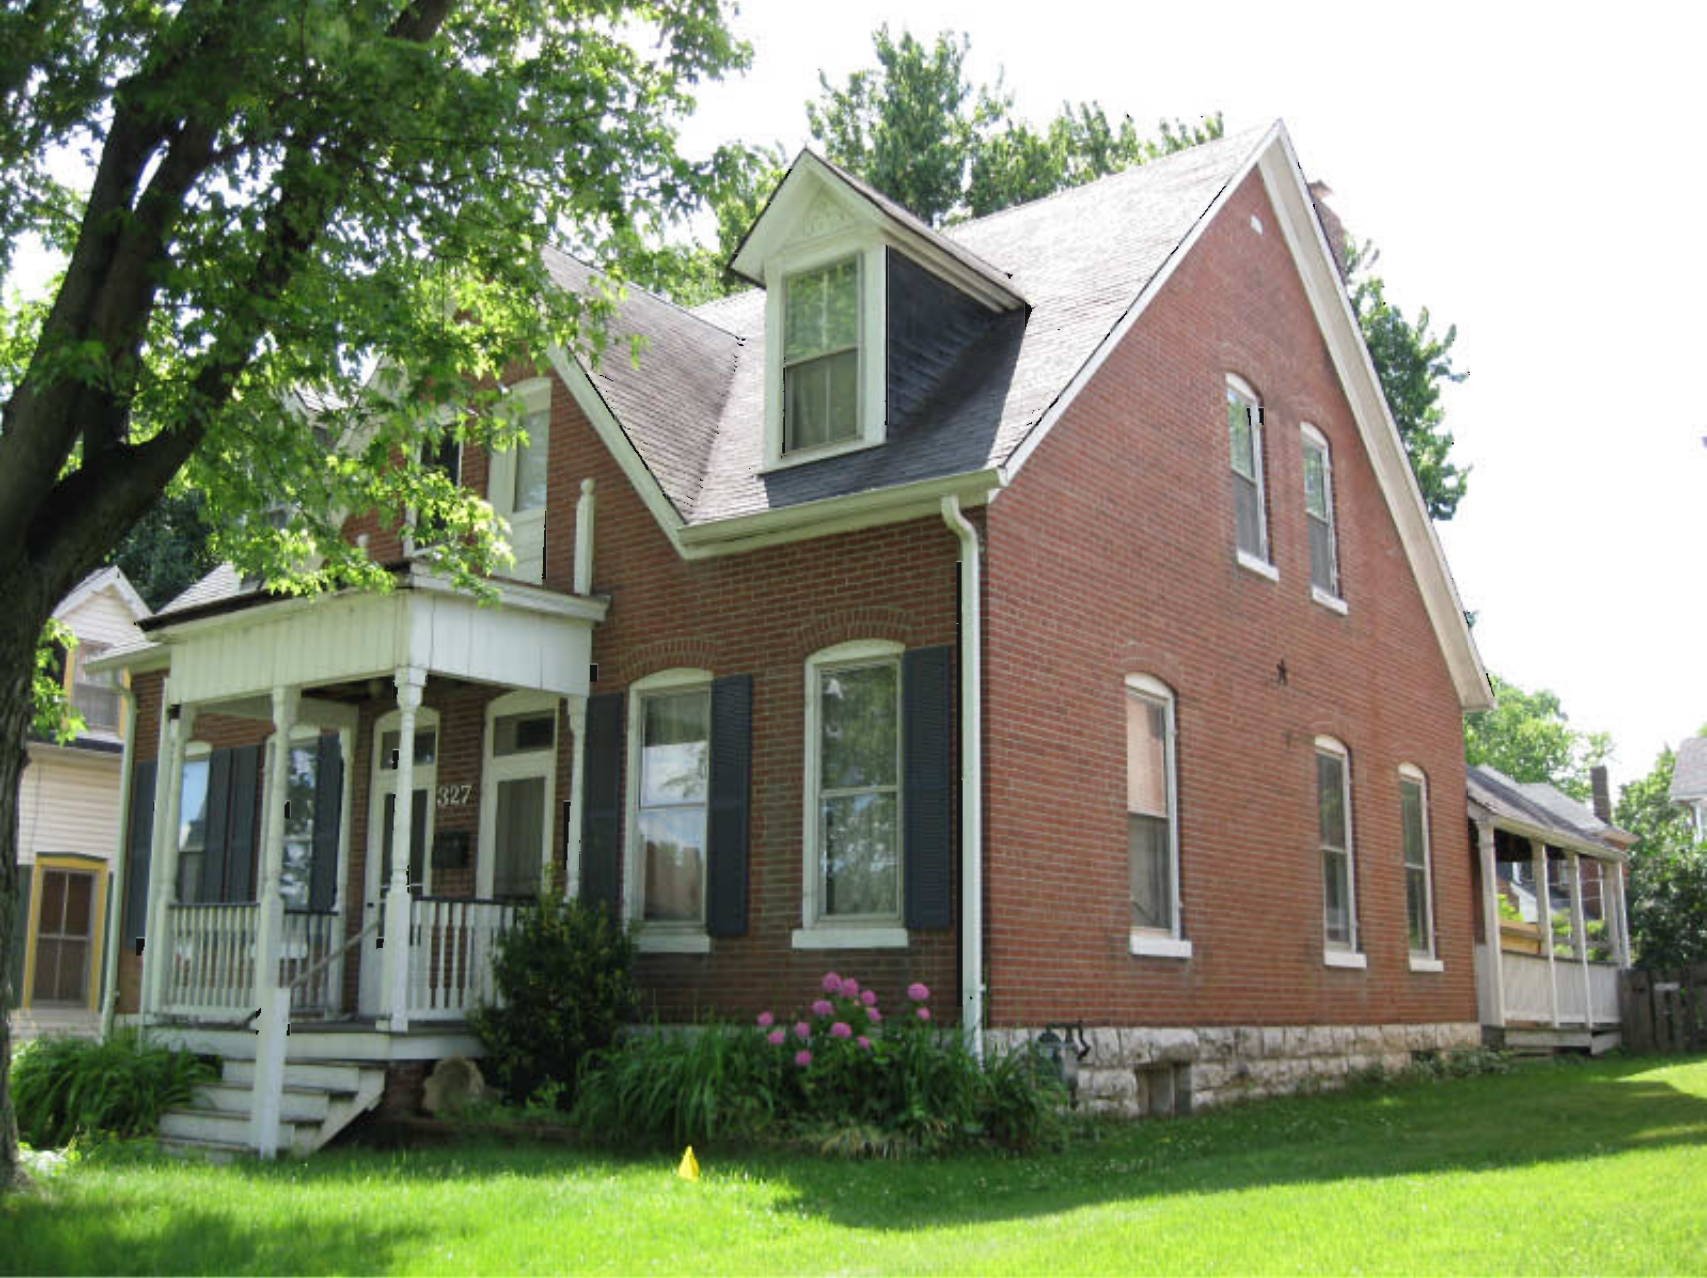
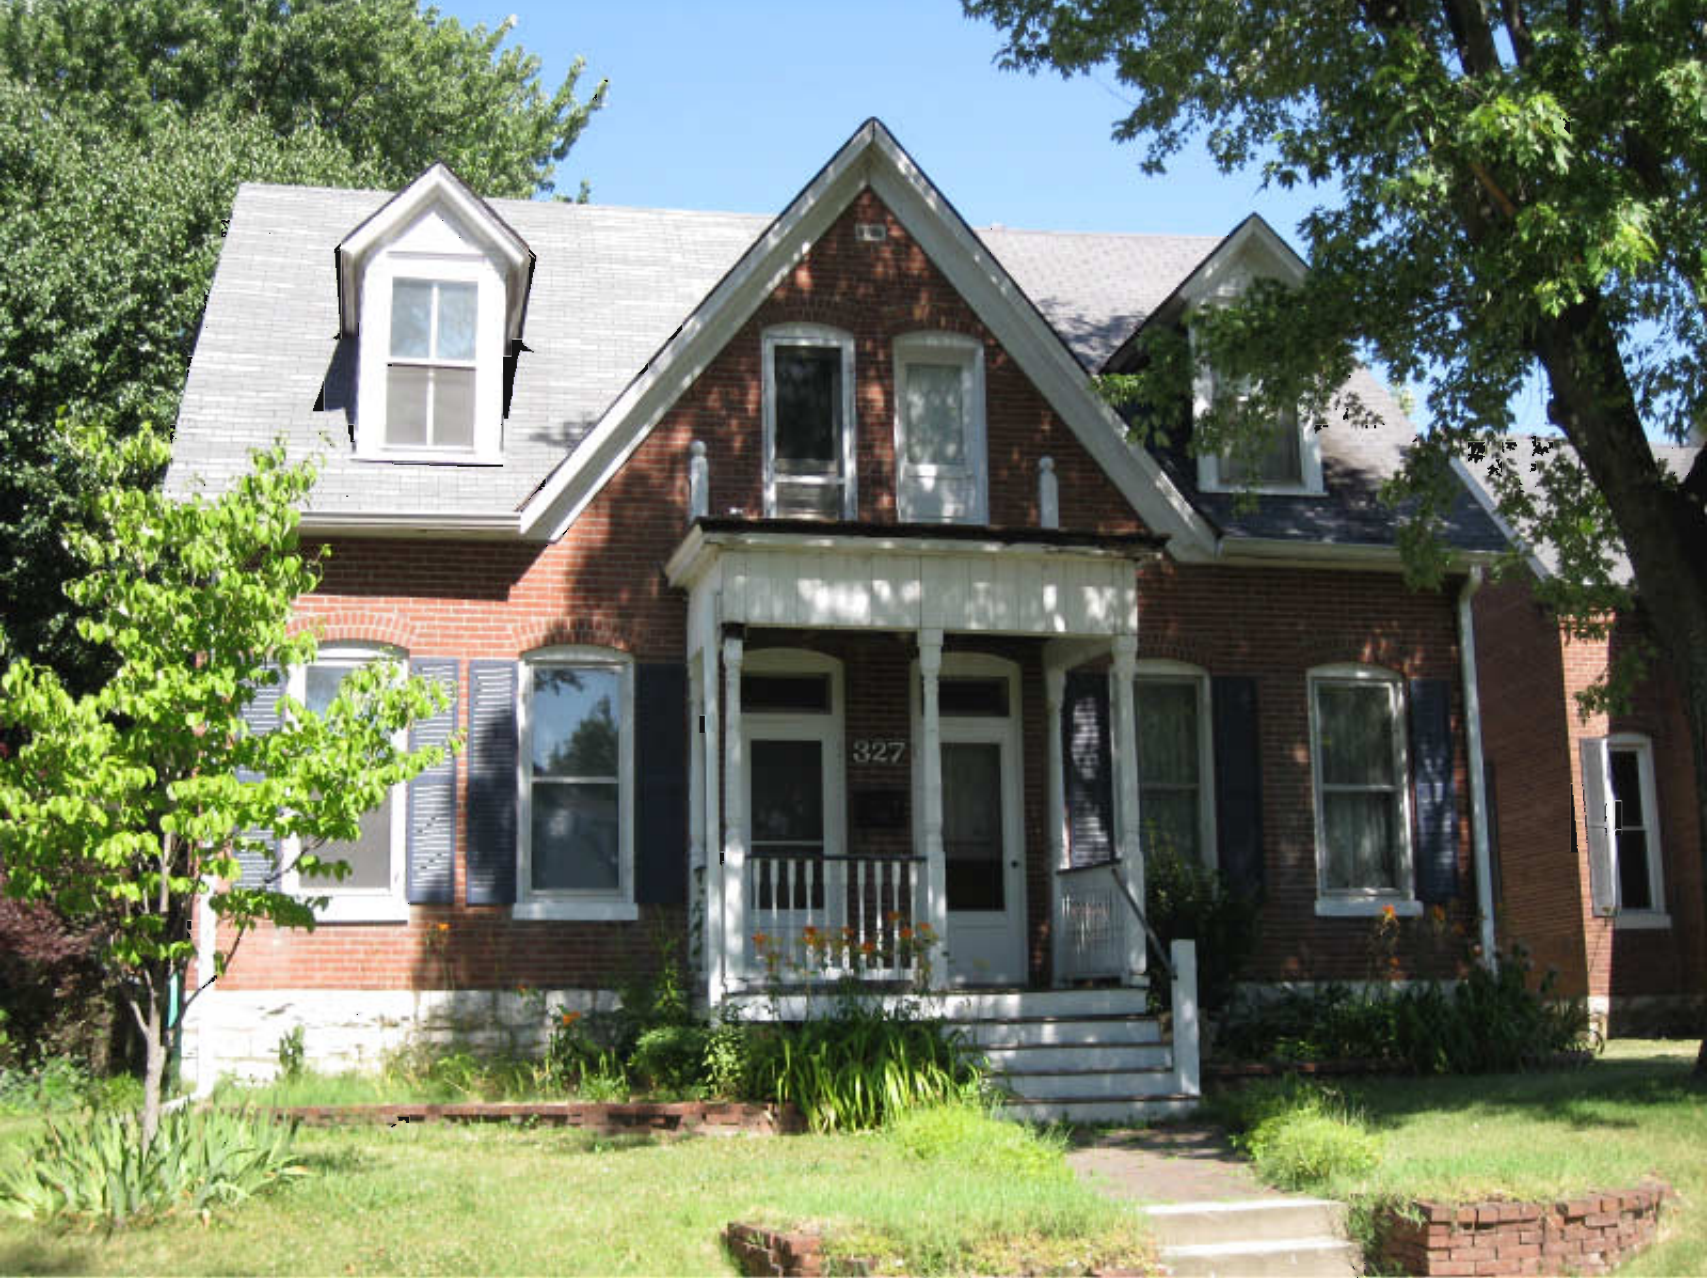
Originally built as a duplex, this one-and-one-half story, Centered Gable Folk house rests on a foundation of coursed, rock-faced stone. The bricks on the main façade are laid in a running bond pattern while the other elevations are in a five-course common bond. The steep side-gabled roof has a central, intersecting, steep front gable flanked by gabled dormers. In the centered gable are two segmental-arched openings topped by a double row of radiating voussoirs. Half-glazed, paneled wood doors fill the openings, and the area above each door is incised. The doors open onto the roof of the central two-bay porch discussed below. To each side of the front gable is a gabled dormer with walls clad in roofing shingles, and the pediments above the 2/2 wood windows are incised. An interior end chimney is at the north and south ends of the rear slope of the roof, and gabled dormers are

also on the rear slope, to each side of the gabled rear wing that gives the house a T-shaped plan. Half-glazed wood doors are in the center two bays of the six-bay, symmetrical main façade, and the doors are topped by single-light transoms. The doors open onto a one-story, two-bay porch that has a wood stairway (aligned with the northern door), wood deck, turned posts supporting a flat roof, and balustrade with turned balusters. The roof's balustrade is missing but newel posts are still attached to the wall. To each side of the doors are two 1/1 wood windows, and vinyl louvered shutters have been installed. The doors and windows throughout the house are set in segmental-arched openings topped by double rows of radiating voussoirs, and incised panels are above each entrance and window. The painted lug sills under the windows appear to be wood, and the windows apparently originally had shutters, as evidenced by the remaining shutter hardware. Both side elevations have three window openings on the first floor and two in the upper half story. The rear wing, which is centered on the west elevation, has a lower gabled roof than the house, and galleries span the north and south sides. The galleries have wood decks, plain wood balustrades, slender chamfered box columns with molded capitals, and shed roofs. The openings on the north and south elevations of the rear wing could not be seen.

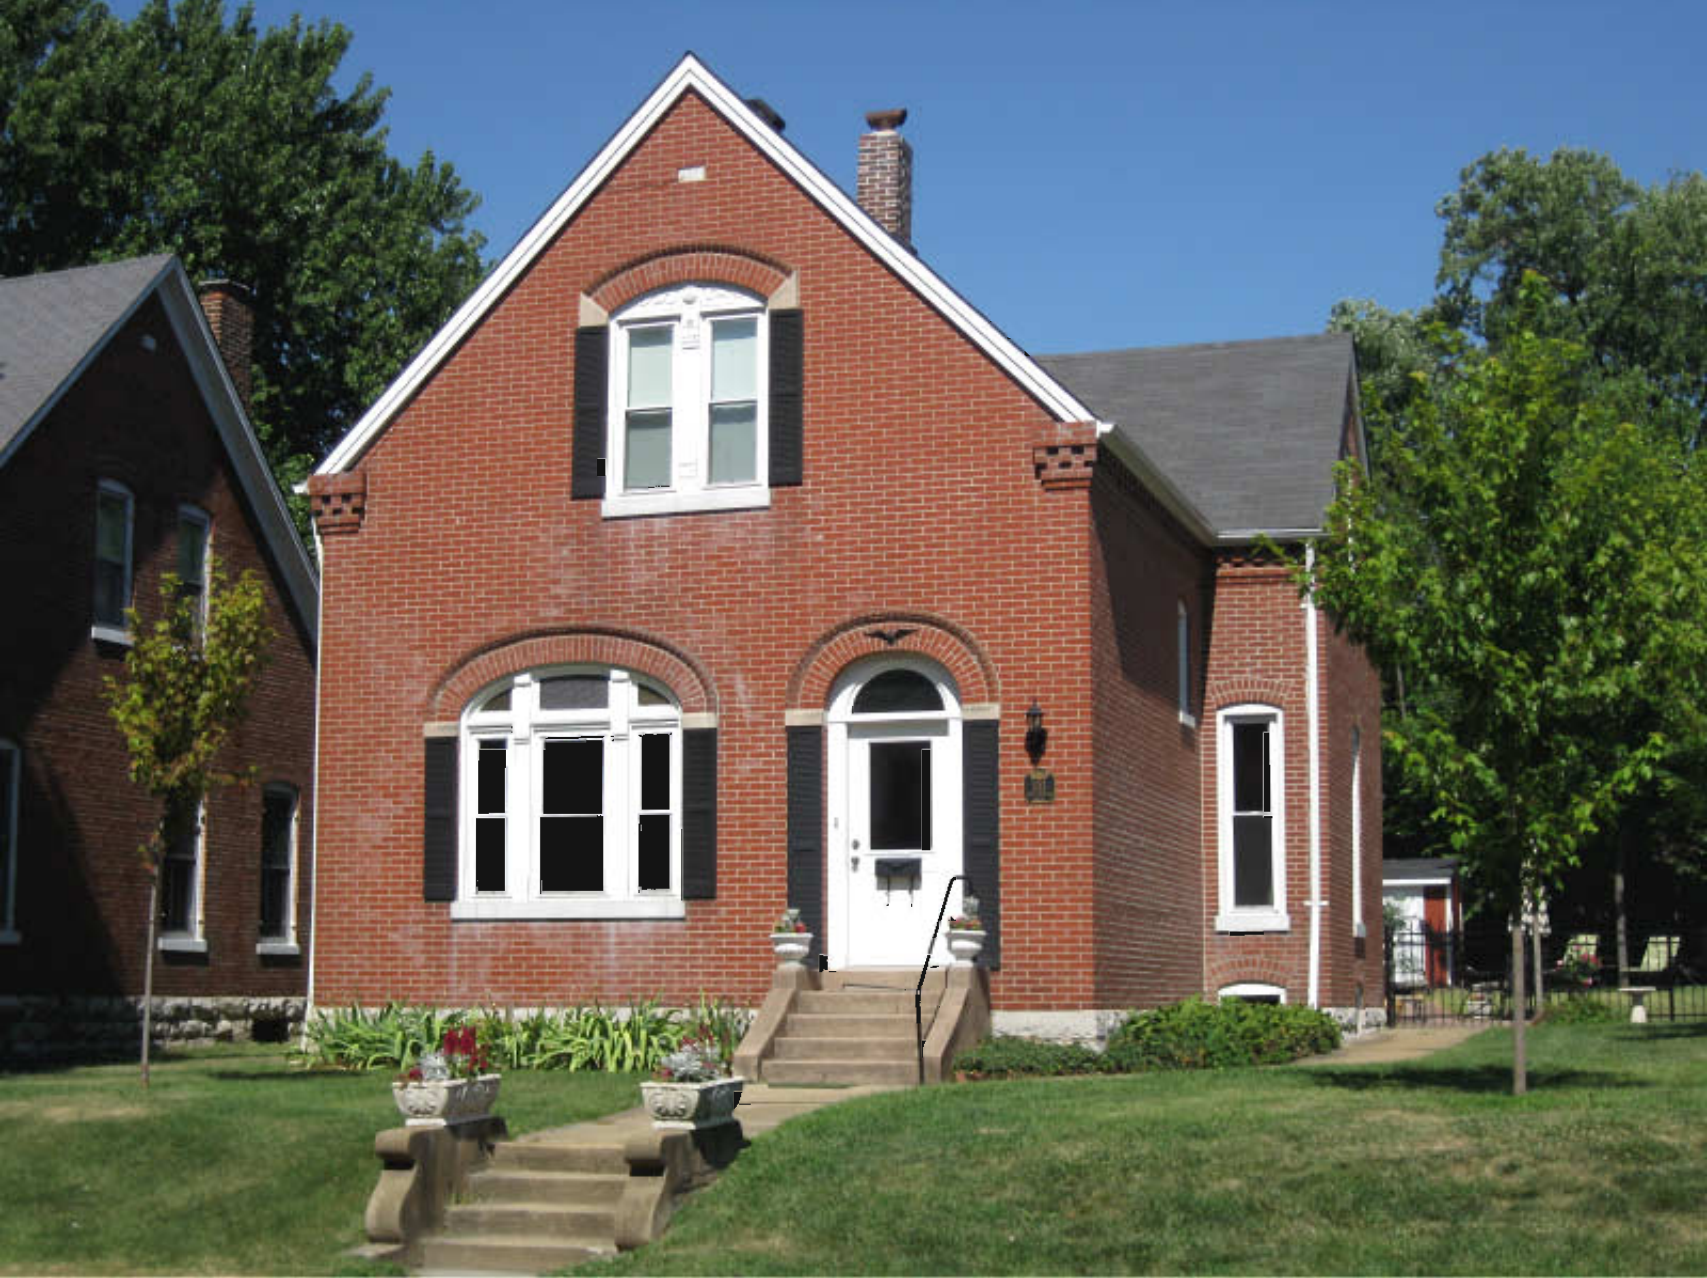
Located at the southwest corner of Benton Avenue and Adams Street, this house is a one-and-one-half story, brick, cross-shaped structure with high cross-gabled roof that is trimmed with a denticulated brick frieze with cornice returns. A straddle ridge chimney rests atop the roof of the front-gabled wing and a gabled dormer is on the south slope. Additional gabled dormers are on the west slope of the north wing and both slopes of the rear wing, and all have walls finished with roofing shingles. The dormers are very ornate, with 1/1 windows framed by fluted surrounds with plinth blocks, bullseye corner blocks, applied diamond-shaped moldings, and brackets. The gable end of each dormer is decorated by a projecting ball surrounded by foliated incising, and the roof of each is trimmed with a scalloped frieze. The house rests on a coursed rusticated stone foundation, and the brick walls of the street elevations are laid in a running bond pattern while the other walls are in a six-course common bond. Other than the dormers, all openings in the house are segmental arched. The two-bay main façade has a half-glazed door and a single-light fanlight, and the opening is topped by a brick hood mold with stone spring blocks. The door opens directly onto a concrete stairway with five steps. To the left of the doorway is a wide opening with a 1/1 window flanked by narrow 1/1 windows that appear to be replacements, and above the windows is a three-part fanlight. The mullions are fluted and have decorative moldings near the top, and the opening is crowned by a brick hood mold with stone spring blocks. In the upper half story is a pair of 1/1 windows separated by a fluted mullion with plinth blocks at the top and bottom, and the area above the windows is incised with a foliated pattern and has a central applied bullseye molding. The windows are topped by a brick hood mold, and like the other windows throughout the house, this pair has painted lug sills. On the east wall of both the north and south wings is a narrow 1/1 window. Except for the openings of the main façade, the windows are topped by a double row of radiating voussoirs. On the north elevation is a short 1/1 window high on the wall, indicating that it overlooks a stairway. On the north wall of the north wing is a 1/1 window on both the first floor and upper half story. A shed-roof gallery spans the north elevation of the rear wing, but it has been enclosed by a band of 1/1 windows set above lapped siding. The south elevation has a 1/1 window in the front-gabled wing and a 1/1 window on both levels of the south wing, but the openings in the rear wing were not visible.

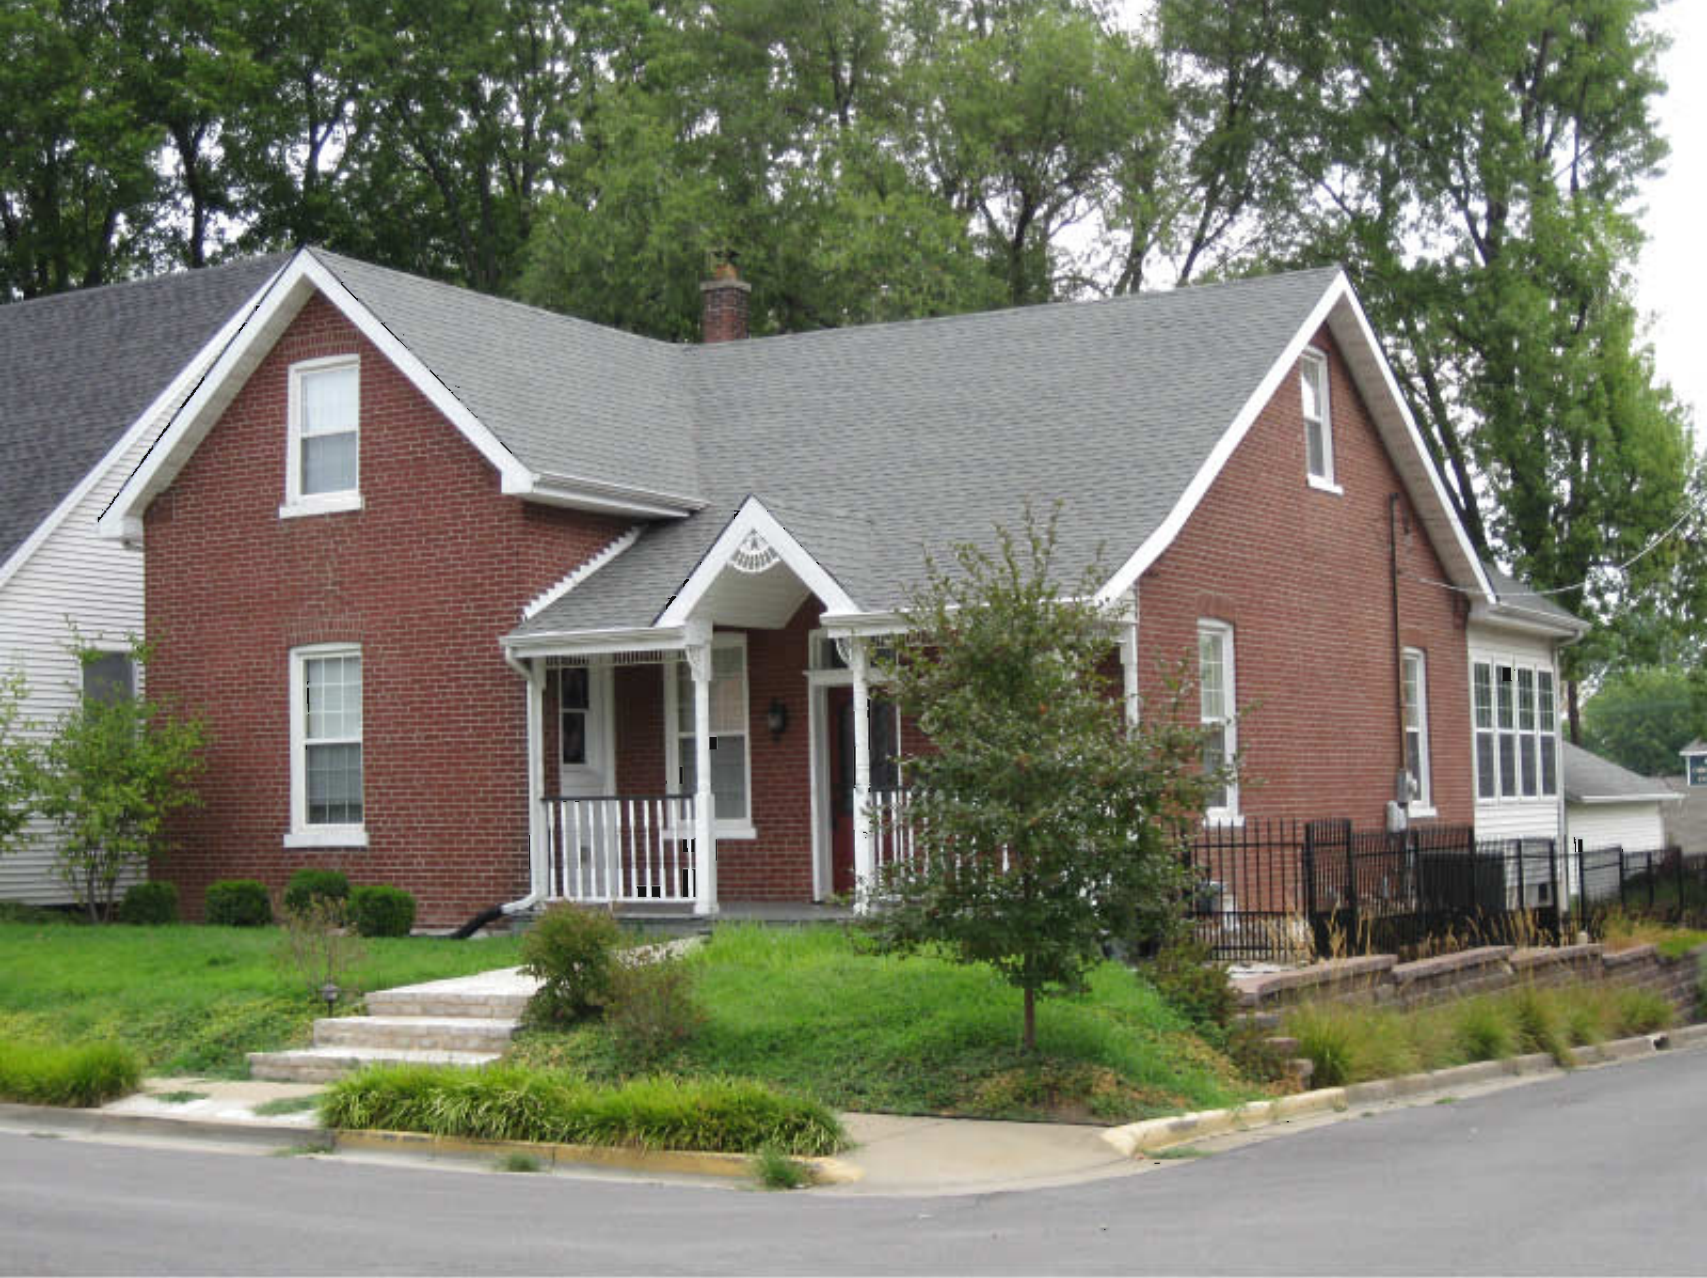
This one-and-one-half story, brick, gable-front-and-wing form house was built between 1900 and 1909 as a duplex, with the front-gabled wing being one residence and the side-gabled wing another. The 1909 Sanborn Insurance Map shows the structure without a front porch, but by 1917 one had been built. The house rests on a coursed rusticated stone foundation, and an interior brick chimney pierces the north slope of the rear gable roof. The bricks in the west wall of the front-gabled wing are laid in a common bond pattern with every sixth course being Flemish bond, but the other walls are laid in a five-course common bond. The four-bay main façade features a 9/9 window in the northern front-gabled bay and in the side-gabled wing is a half-glazed wood door flanked by 9/9 windows. The door, which is topped by a single-light transom, appears to be a replacement, and

windows throughout the house are vinyl 9/9 sash set in low segmental-arched openings. A gallery spans the three southern bays and features a wooden deck, turned posts, ball-and-rod spindled frieze and corner brackets, and a balustrade with turned balusters. The porch's shed roof has an intersecting gablet at the entrance. It appears that there had been a doorway in the south wall of the front-gabled wing, but it has been converted into a window. In the upper half story of the front-gabled wing is a 6/6 vinyl window, and the south elevation features two 9/9 windows on the first floor and a 6/6 window on the second. A frame addition is at the southeast corner of the house.

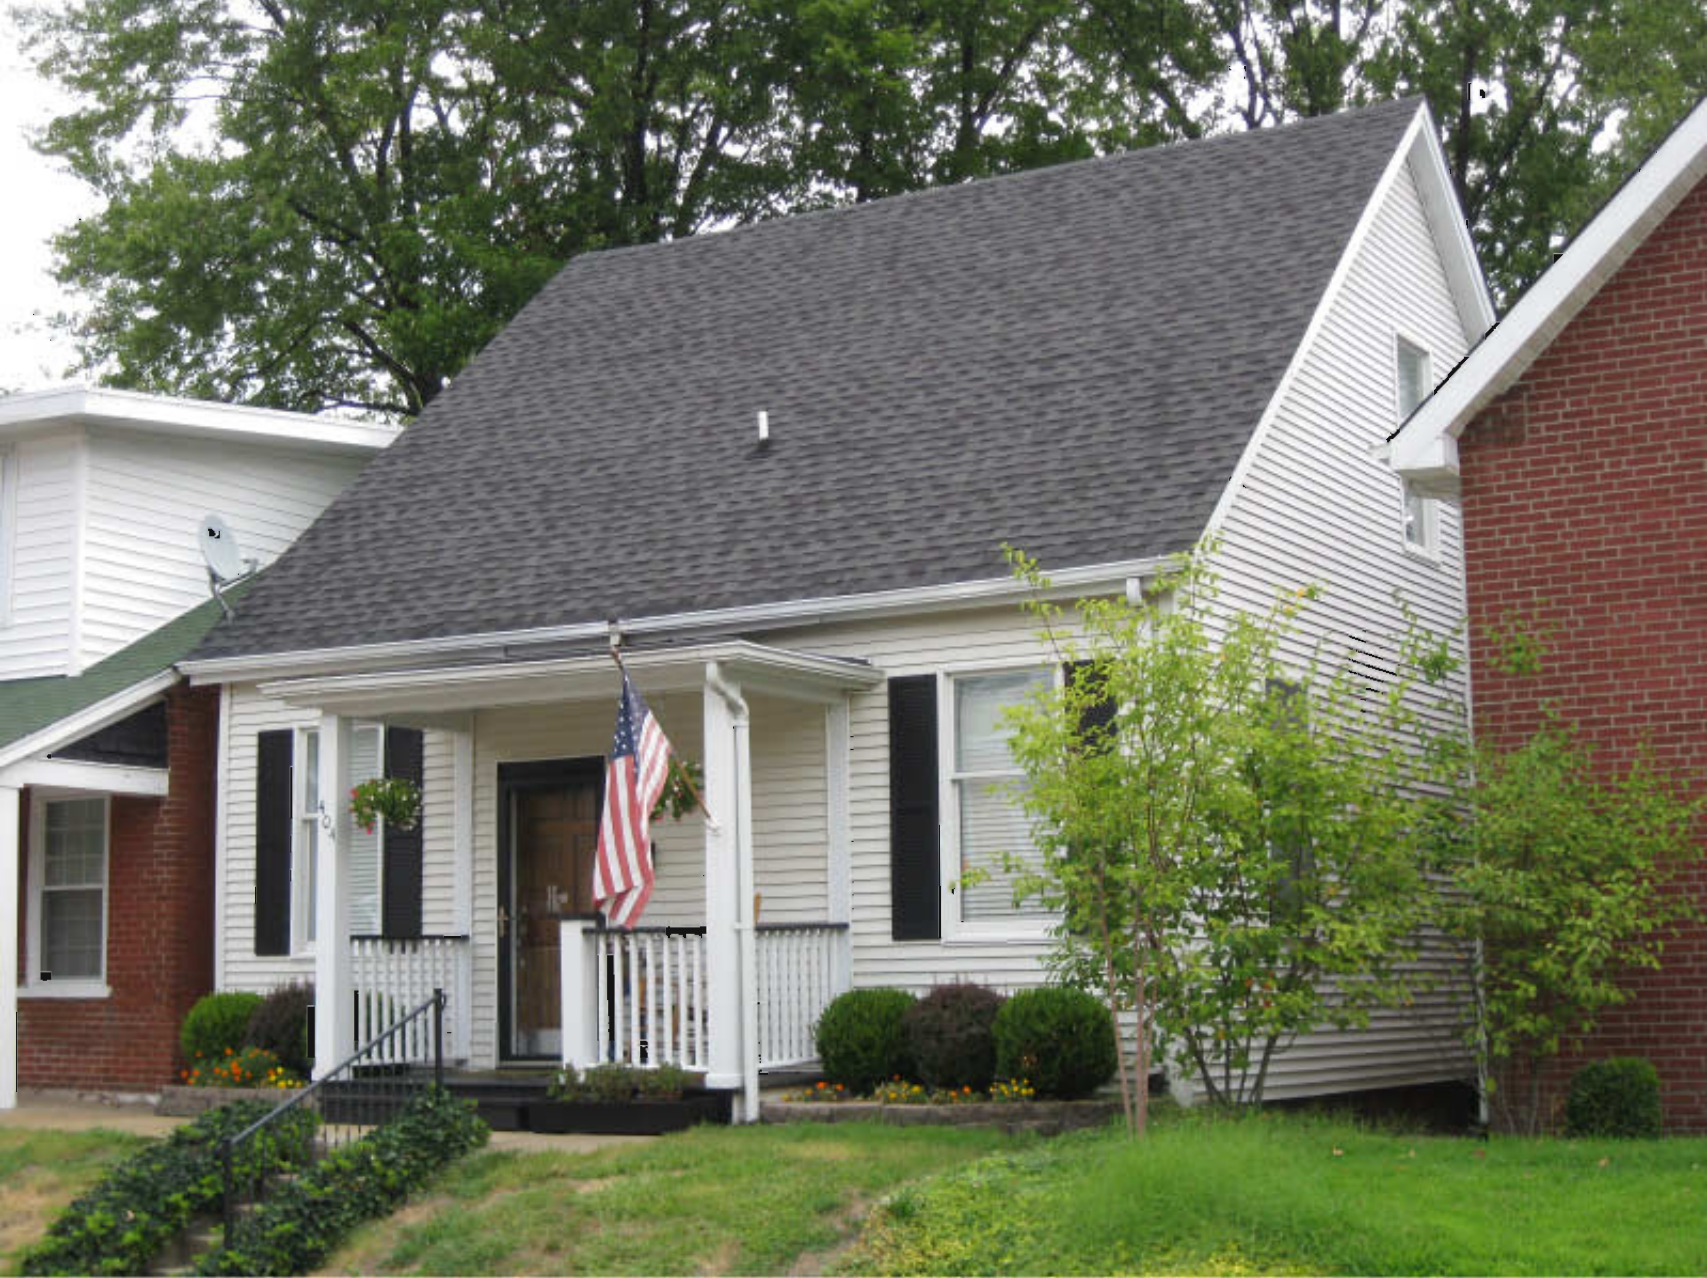
Built circa 1907, this one-and-one-half story, frame, Cape Cod style house is crowned by a steeply-pitched, side-gabled roof. The foundation is brick and the walls have been clad with vinyl siding. The three-bay main façade features a six-panel wood door flanked by 1/1 wood windows, and the upper sashes are shorter than the lower sashes. The door opens onto a one-bay portico that has a wooden deck, plain wood balustrade, and box columns supporting a low hip roof. The neighboring houses are set extremely close to this house, so it is difficult to see the side elevations, but the south elevation appears to have two first floor windows and one in the upper half story while the north elevation has one on each level.

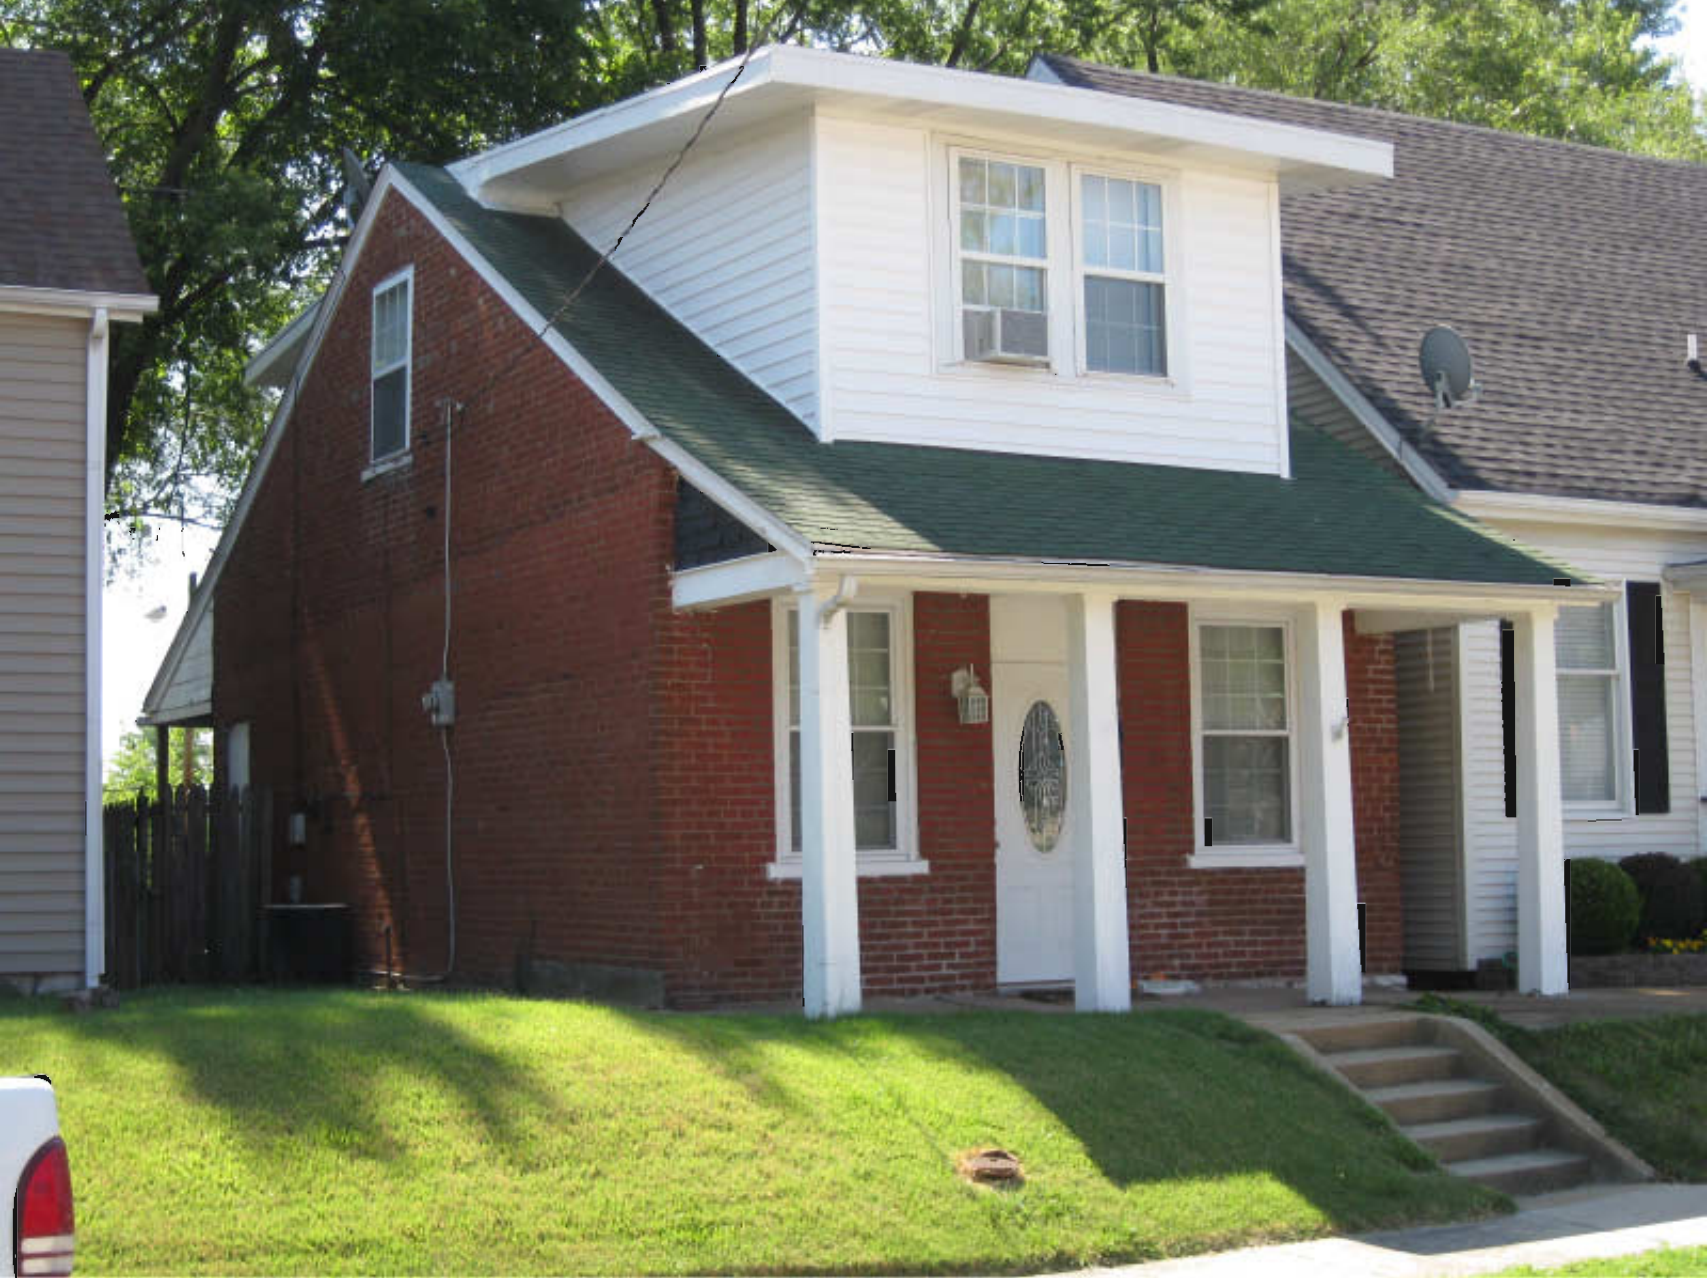
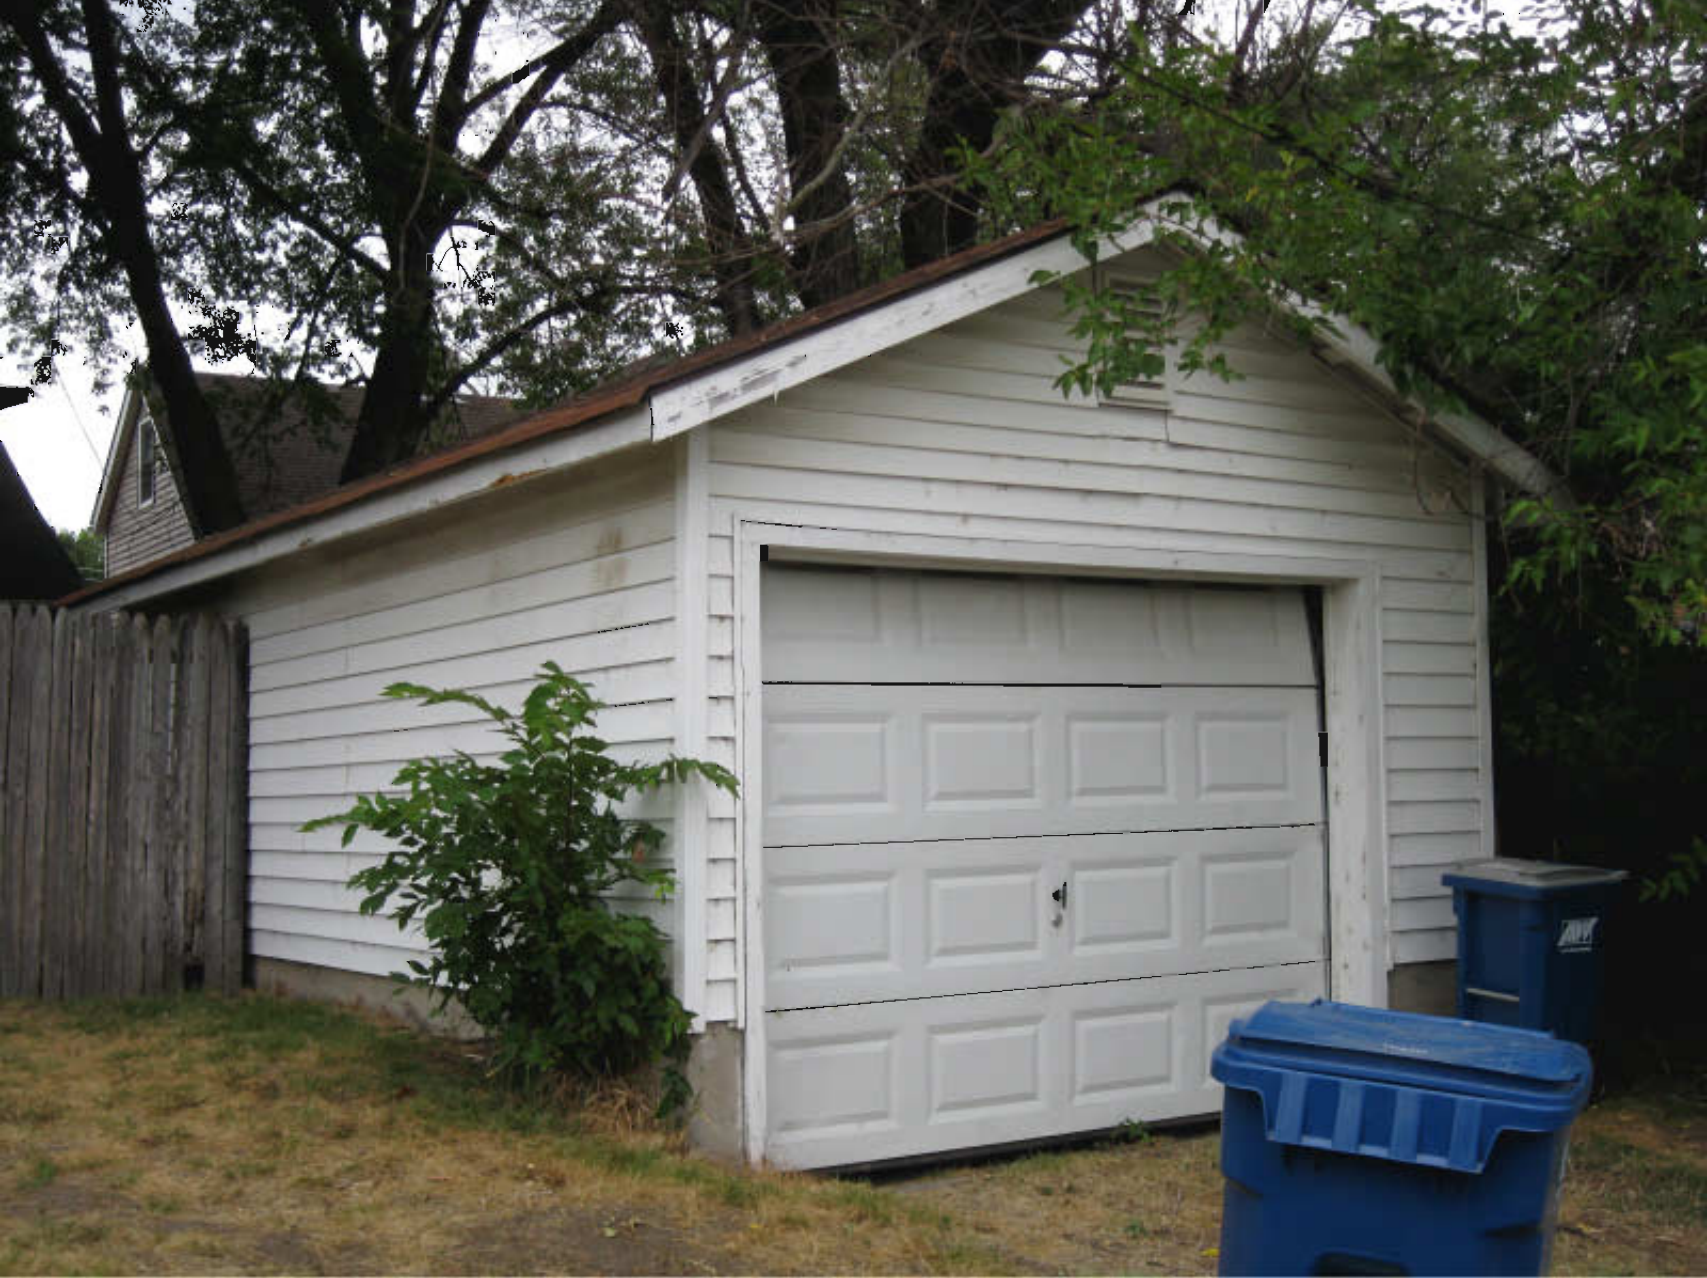
Situated on an elevated lot, this diminutive, one-and-one-half story, side-gabled house rests on a low stone foundation and the brick walls are laid in a seven-course common bond pattern. A large shed-roof dormer with wide overhanging eaves and paired 6/6 vinyl windows dominates the front slope of the roof, and there is an interior end chimney on the south end of the rear slope. The dormer's walls are finished with vinyl siding. The three openings of the main façade are segmental arched, and the center bay holds a replacement door with oval leaded glass light and the transom has been enclosed. To each side of the door is a 9/9 vinyl window with painted lug sills. The door opens onto a full-width gallery with concrete deck at ground level and tapered box columns supporting a shed roof. The 1909 and 1917 Sanborn Fire Insurance maps show the house with a partial-width porch (probably a single-bay portico), and the 1929 and 1947 maps show a full-width gallery. The house is situated extremely close to the neighboring property to the south, so it is difficult to see the south elevation, but it appears that there is one window on both the first and upper stories. The north elevation has no first floor openings and one 6/6 window in the upper half story. The house is noncontributing due to the replacement of the windows and door and the addition of the large dormer that overpowers the house.

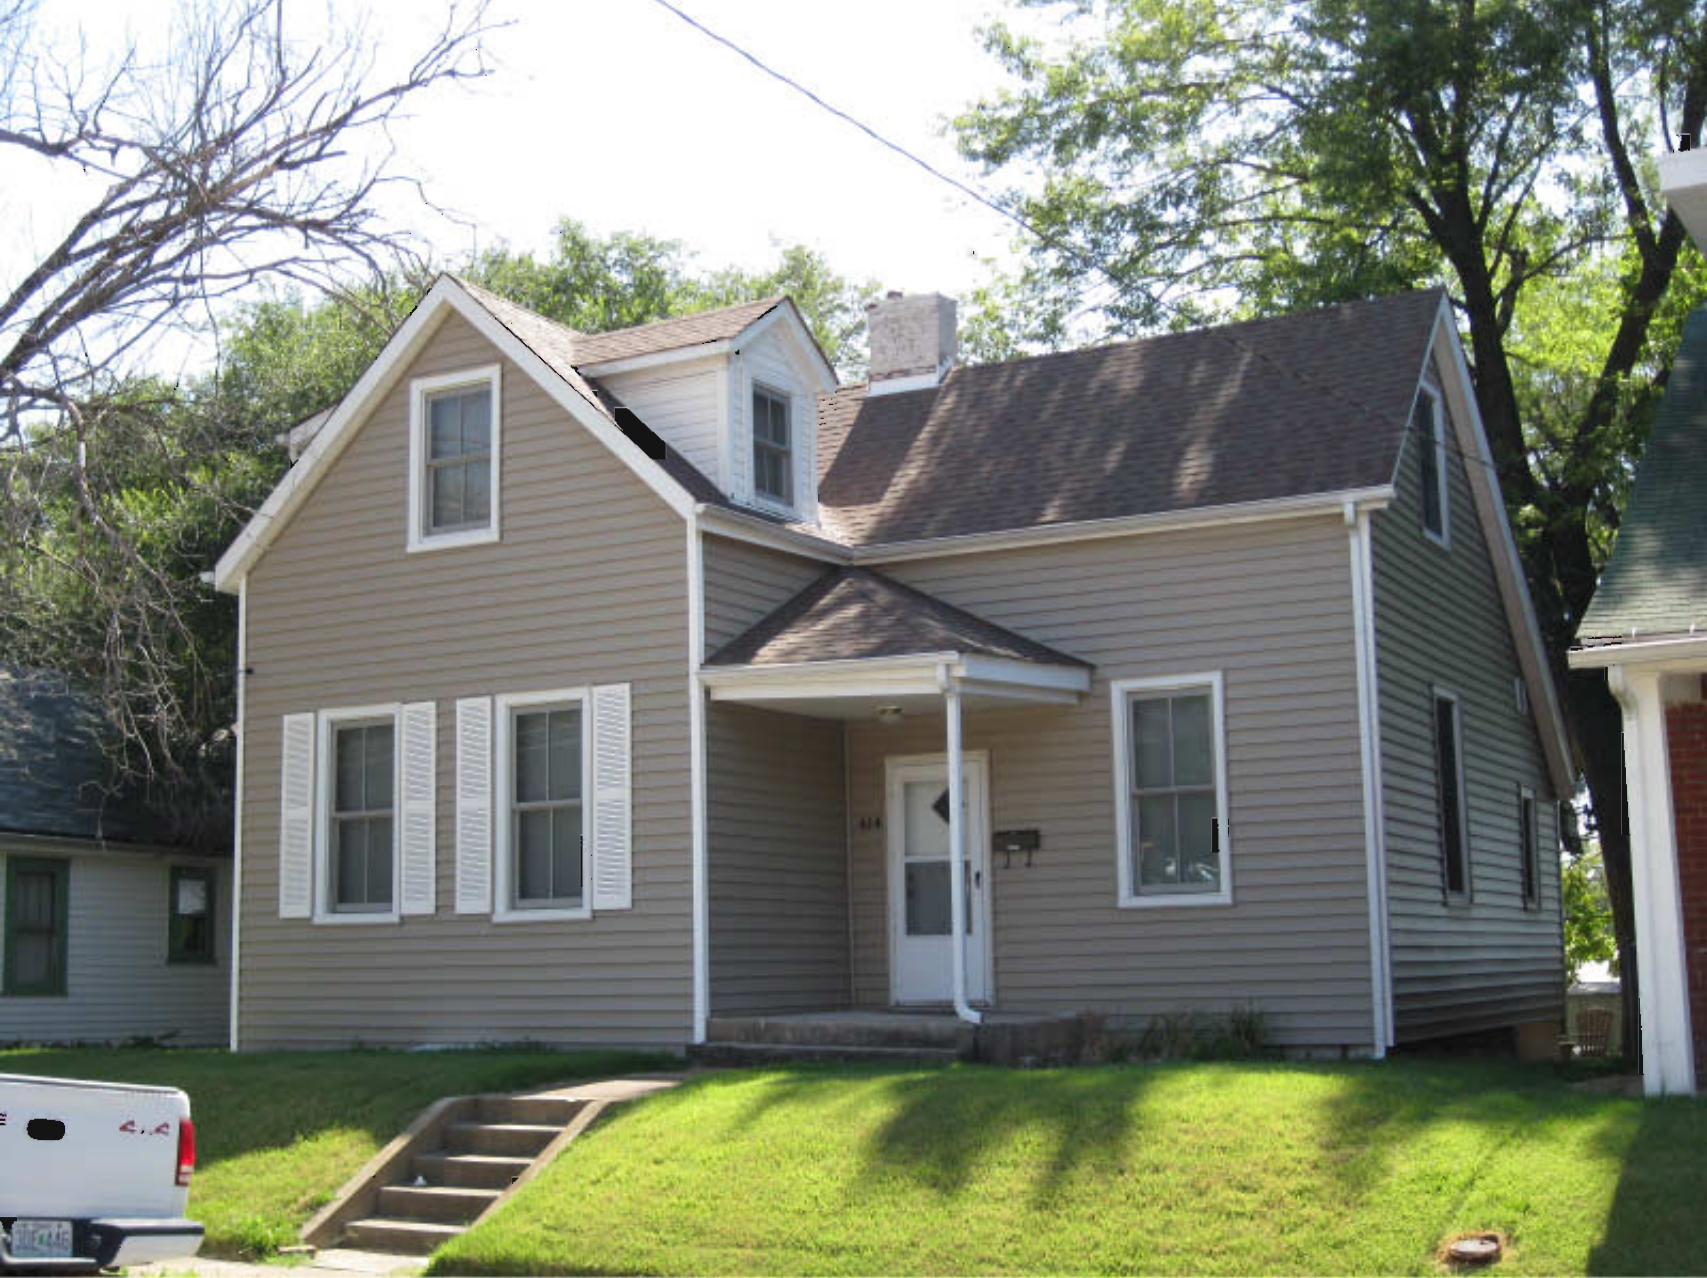
This one-and-one-half story, frame, gable-front-and-wing form house rests on a low stone foundation and the walls are clad with vinyl siding. A painted brick, straddle ridge chimney rests upon the roof of the side-gabled wing, and dormers are on both slopes of the front-gabled wing. The south dormer is gabled with a single 2/2 window while the north dormer has a shed roof with four 2/2 windows. The first floor of the main façade has four openings: two 2/2 windows in the front-gabled wing, a replacement door with diamond-shaped light and panels, and another 2/2 window. The door opens onto a one-bay portico with concrete deck, plain post and a steep hip roof. In the upper half story of the front-gabled wing is a 2/2 window. The south elevation has a window on the first and upper levels, and the north elevation has two windows.
