ARCHITECTURAL/HISTORIC INVENTORY FORM

1. Survey No. SC-AS-009-001		2. Survey Name: St. Charles Survey Phase 3: Mid-Town and Commons Neighborhoods	
3. County: St. Charles		4. Address (Street No.) 128	Street (name) North Sixth Street
5. City: St. Charles	Vicinity: <input type="checkbox"/>	6. UTM:	
7. Township/Range/Section:		8. Historic name (if known): Meyer-Pieper House; The Meyerdorf	
9. Present/other name (if known):		10. Ownership: <input checked="" type="checkbox"/> Private <input type="checkbox"/> Public	
11a. Historic use (if known): Domestic/single dwelling		11b. Current use: Domestic/single dwelling

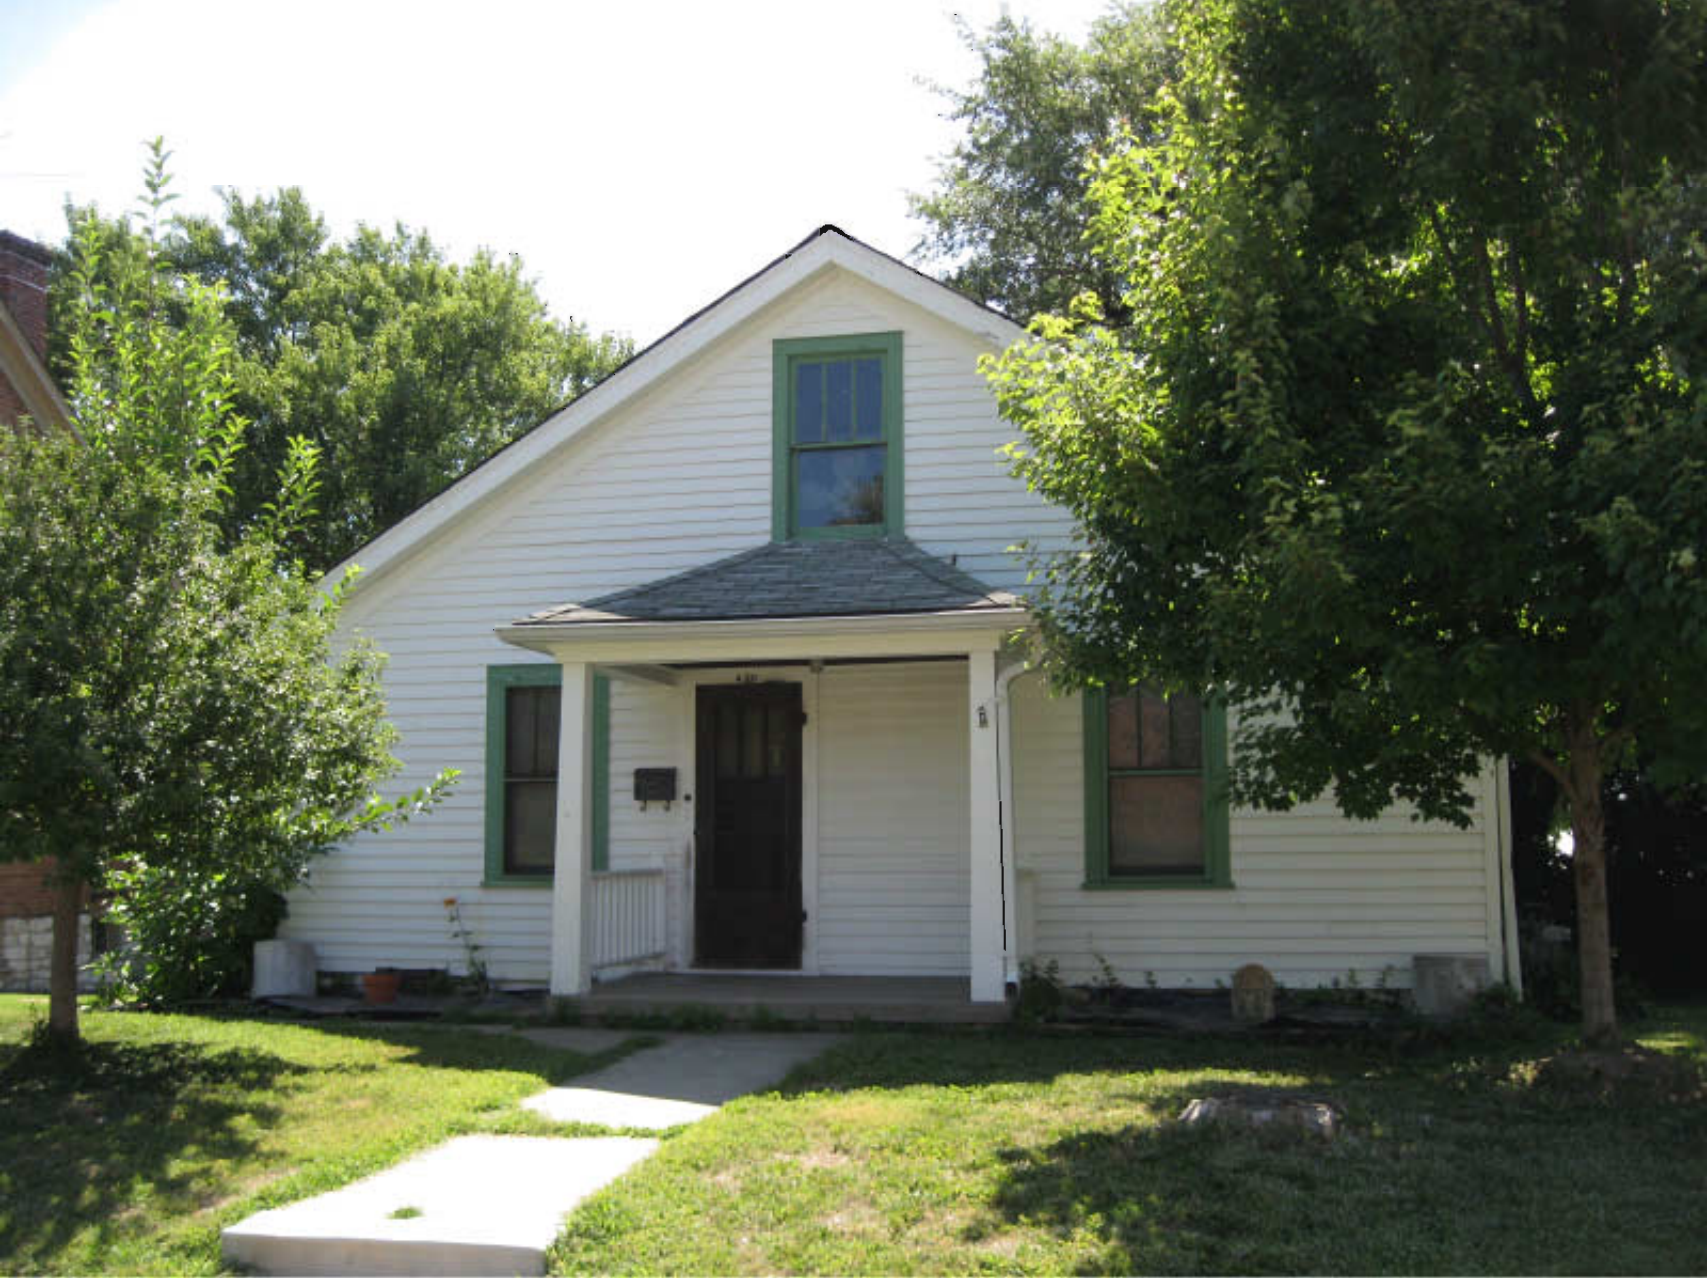
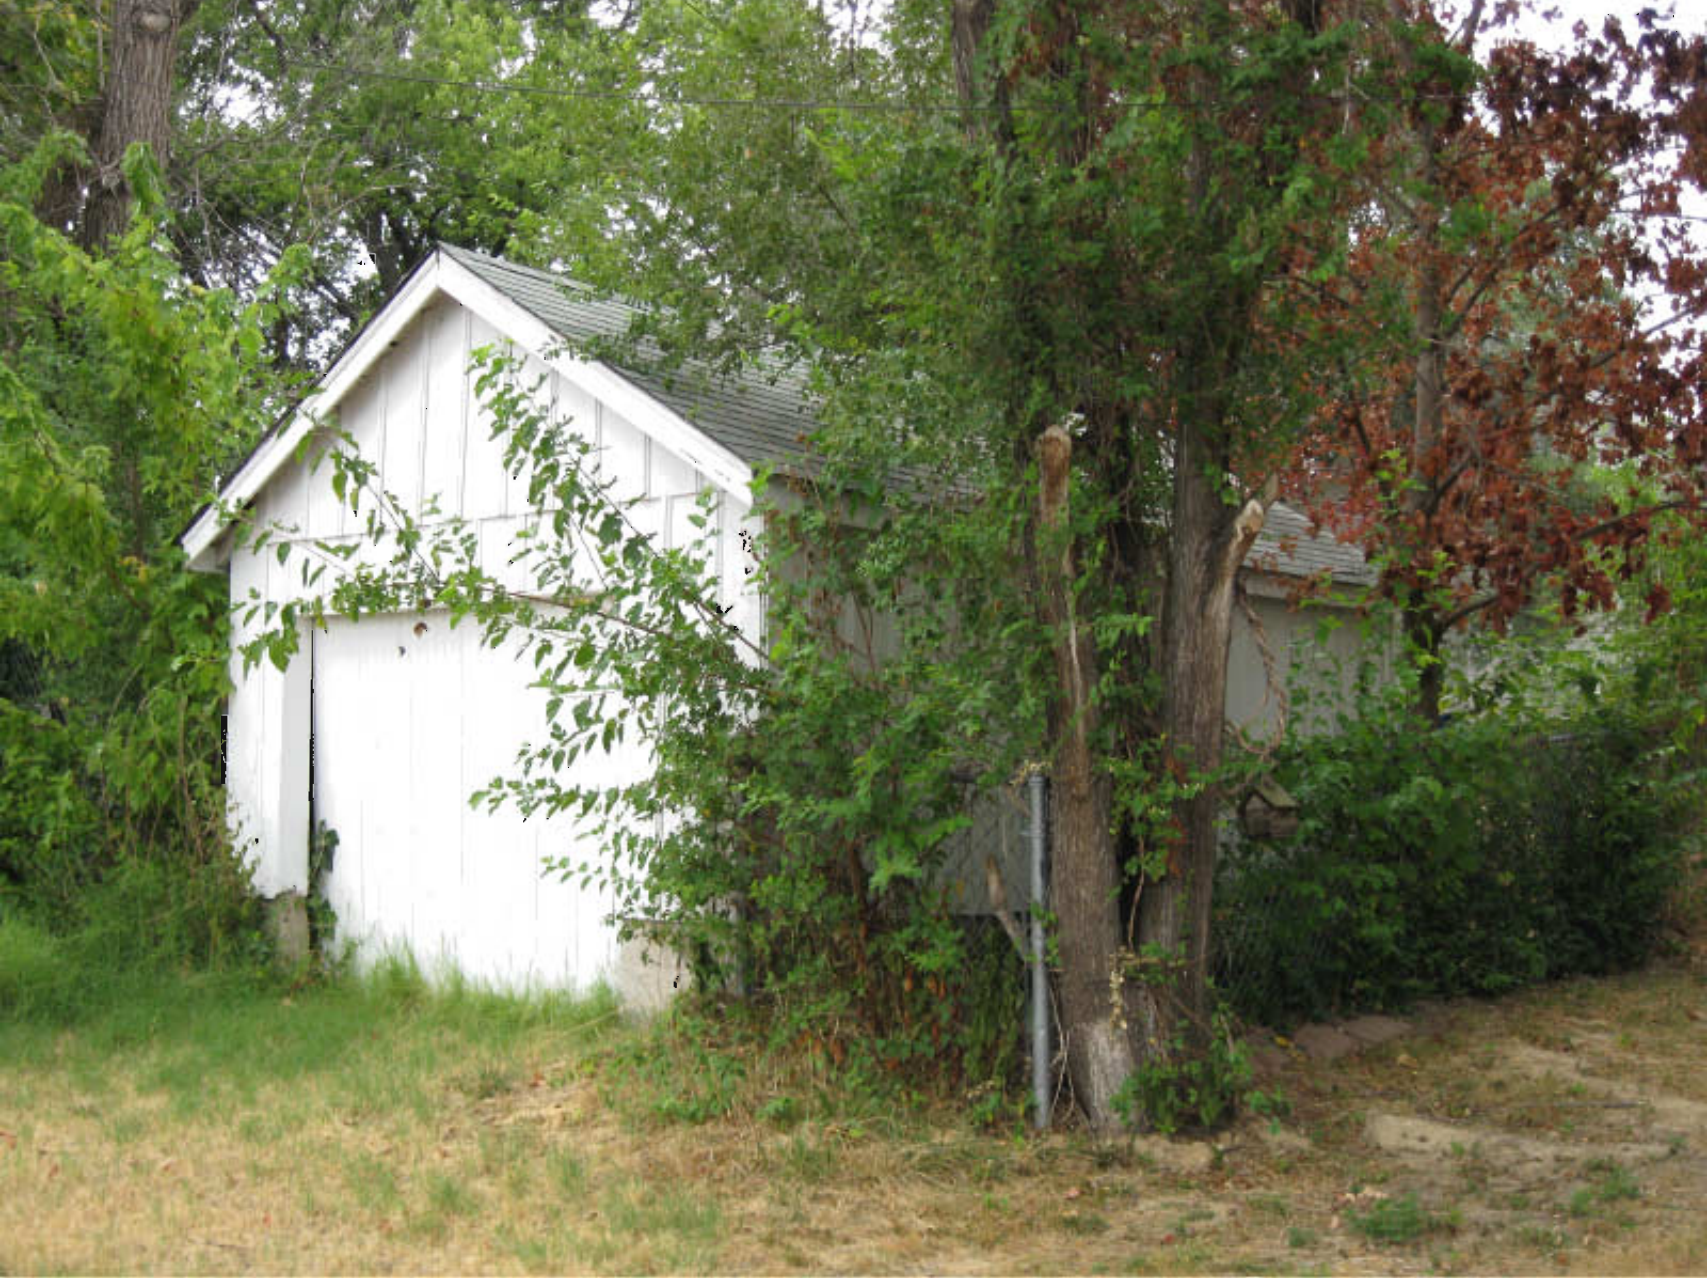
Located on a tree-shaded lot, this one-and-one-half story, front-gabled, frame house rests on a scored concrete foundation and the walls are finished with weatherboard siding. An interior brick chimney pierces the north slope of the roof, which has wide overhanging eaves. A glazed wood door with three vertical lights is in the center bay of the three-bay main façade, and to each side of the door is a 3/1 wood window. The door opens onto a one-bay portico that features a concrete deck, plain wood balustrade, and battered box columns supporting a high hip roof. In the upper half story is another 3/1 wood window. Like the windows on the main façade, those on the side elevation are 3/1 wood sash. From front to rear, the south elevation has a single window, a short window, and paired windows, and the north elevation has a single window, paired windows and a short pair of windows.

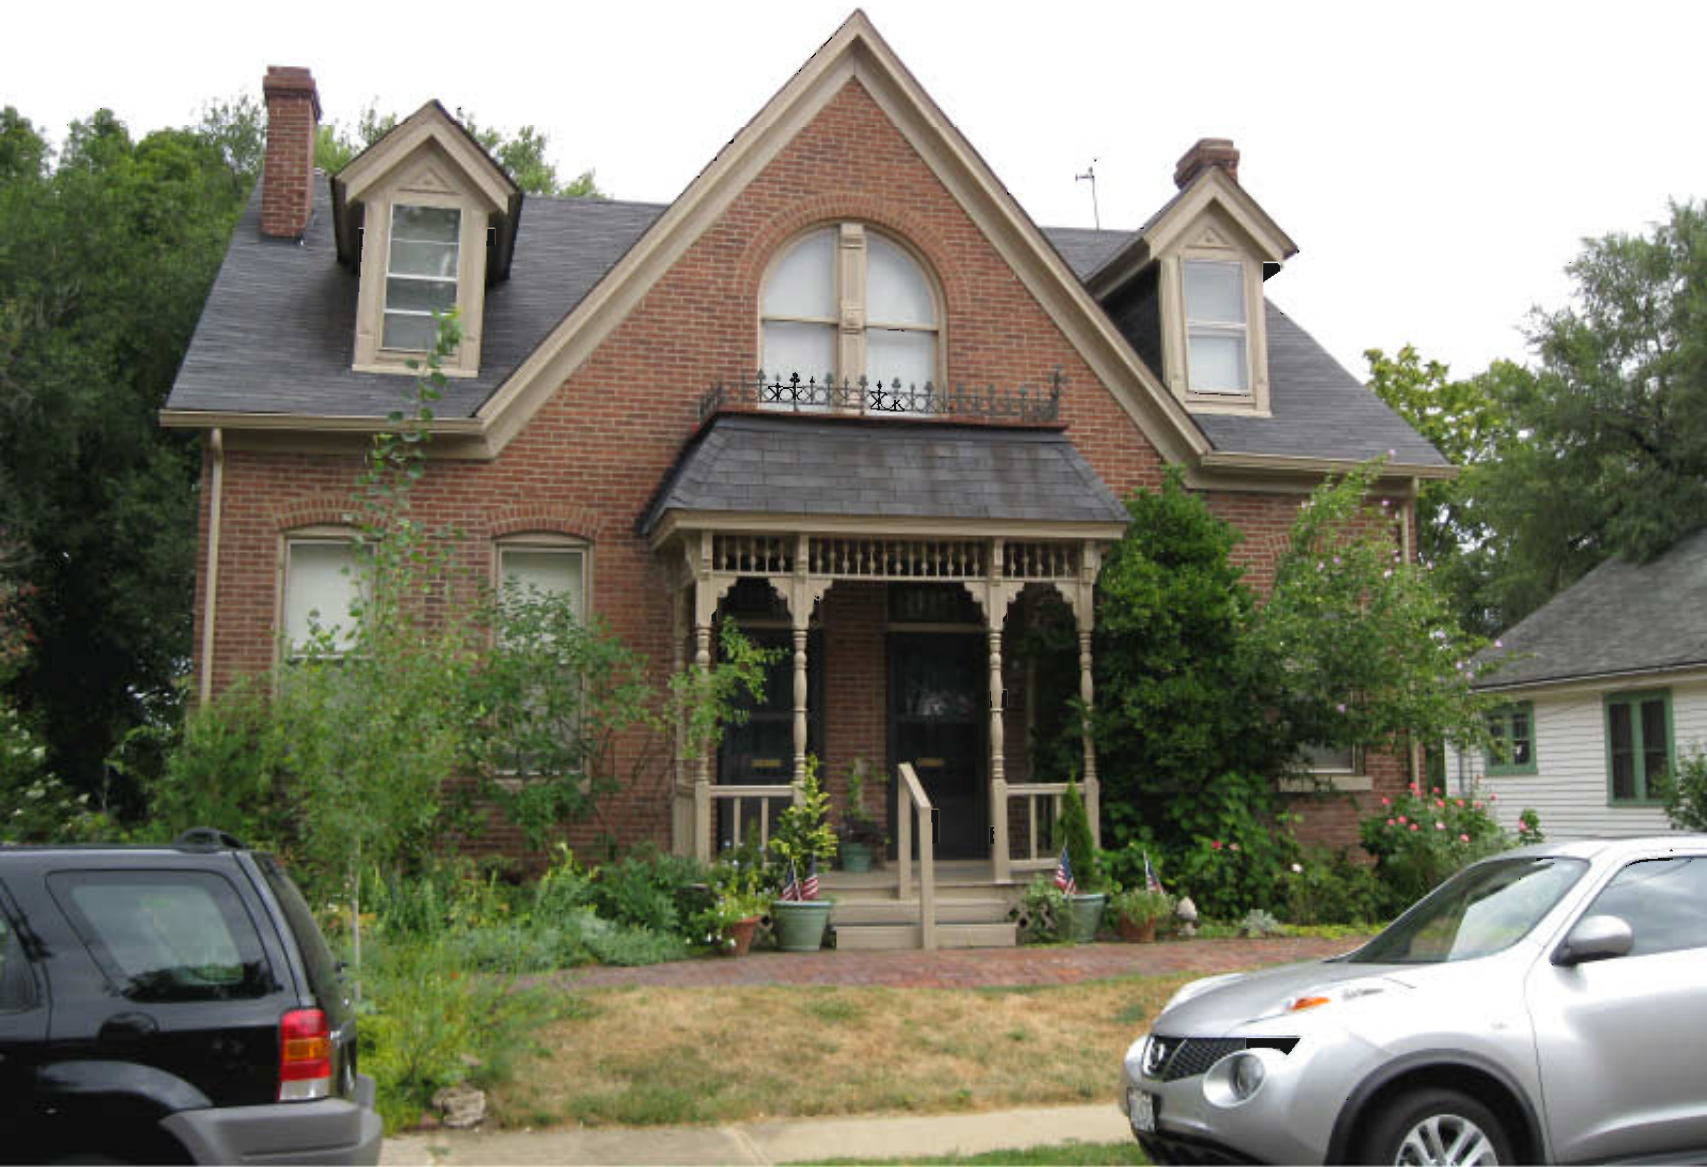
openings on the first floor and two in the upper half story. The first floor window at the west end of each side elevation is a 1/1 wood window while the others are 2/2 sashes. Shed-roofed galleries span the north and south sides of the rear wing.

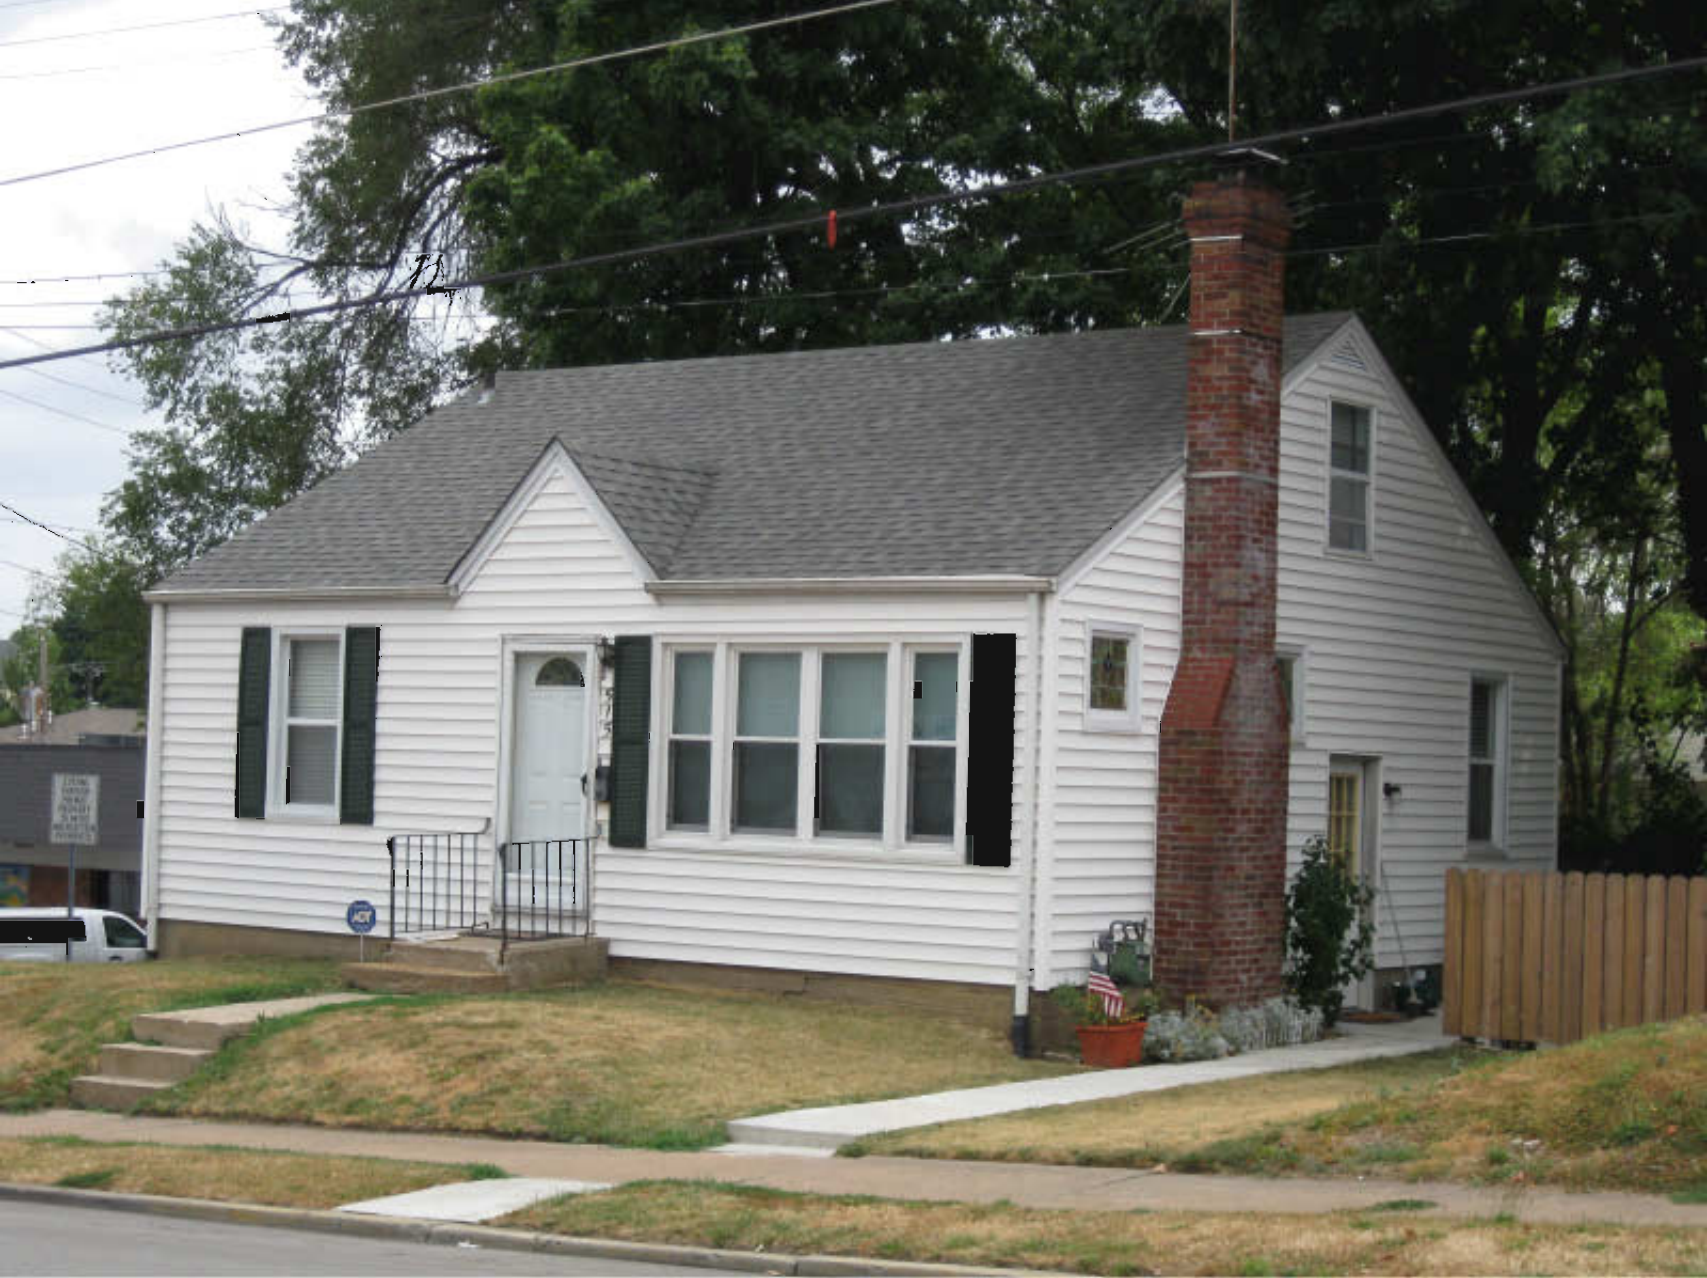
Facing north, this one-and-one-half story, side-gabled, frame, Minimal Traditional form house rests on a concrete block foundation and the walls are finished with vinyl siding. The three-bay main façade has an entrance in the center bay, and above the entrance is a gablet. The door, which is a replacement, is a paneled metal door with a leaded glass fanlight in the upper part, and it opens onto a one-bay, concrete stoop with metal railings. To the east of the entrance is a 1/1 window and to the west is a band of four 1/1 windows (the center two are wider than the other two). The west elevation has a small art glass window to each side of an exterior end, shouldered, brick chimney with corbelled cap, and to the south is a half-glazed replacement door and a 1/1 window. In the upper half story is a 1/1 window. A garage in the basement level is accessed from a paneled and glazed wood overhead door on the east elevation, and the basement windows are two-light wood sash. There are two windows on the first floor of the east elevation and another in the upper half story.

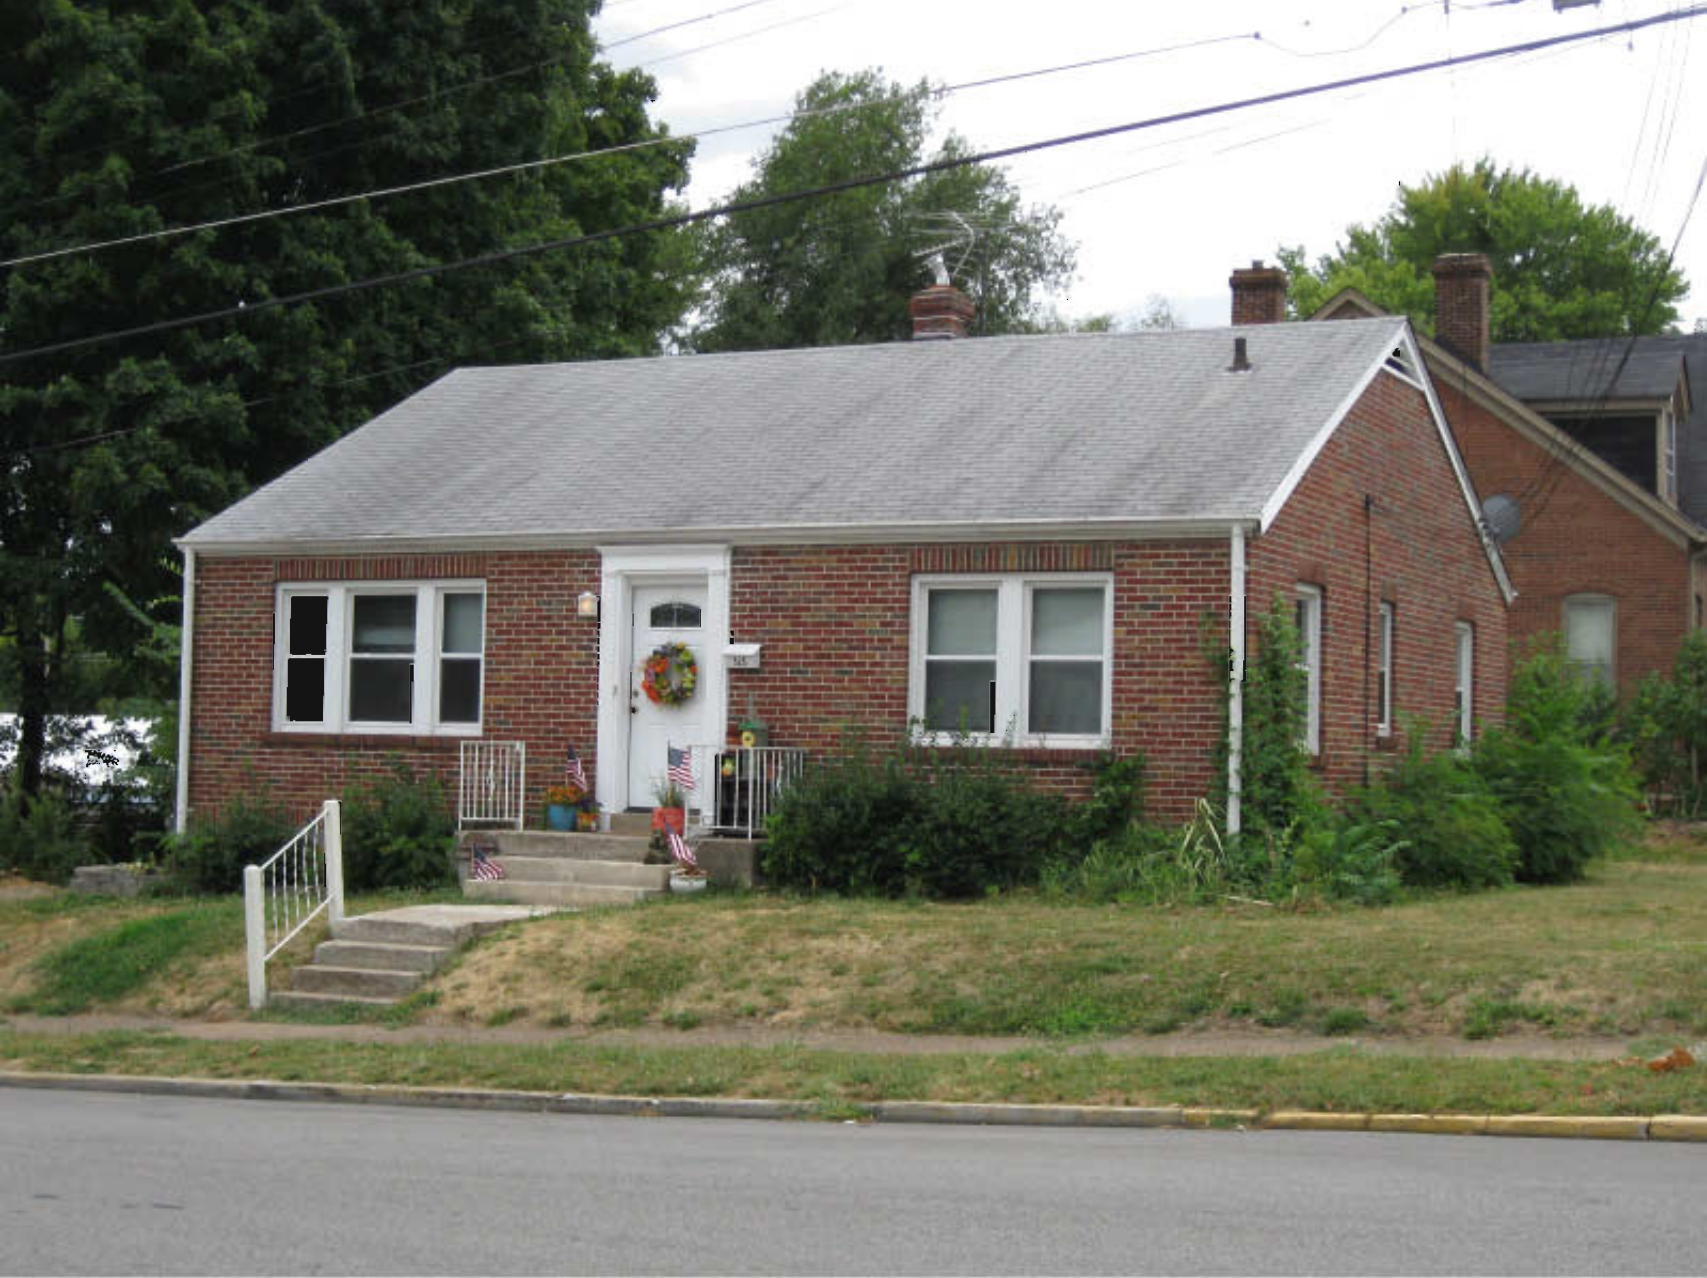
This one-story, brick, side-gabled, Minimal Traditional form house, which has a Colonial Revival frontispiece at the entrance, rests on a scored concrete foundation. The variegated brick walls are laid in a running bond pattern, but the course directly above the foundation is a soldier course. An interior brick chimney pierces the rear slope of the medium-pitched, side-gabled roof. The three-bay main façade has a central entrance, and to the west is a pair of 1/1 windows and to the east is a tripartite window composed of a 1/1 window flanked by narrower 1/1 windows. The windows throughout the house are replacements, and they have brick sills and flat jack arches. The door is a replacement paneled and glazed door with small segmental-arched light in the upper part, and the frontispiece has pilasters supporting an entablature. The door opens onto a one-bay, concrete stoop with metal handrail. The west elevation has a narrow 4/4 window in the central bay and two 1/1 windows, while the east elevation has four 1/1 windows.

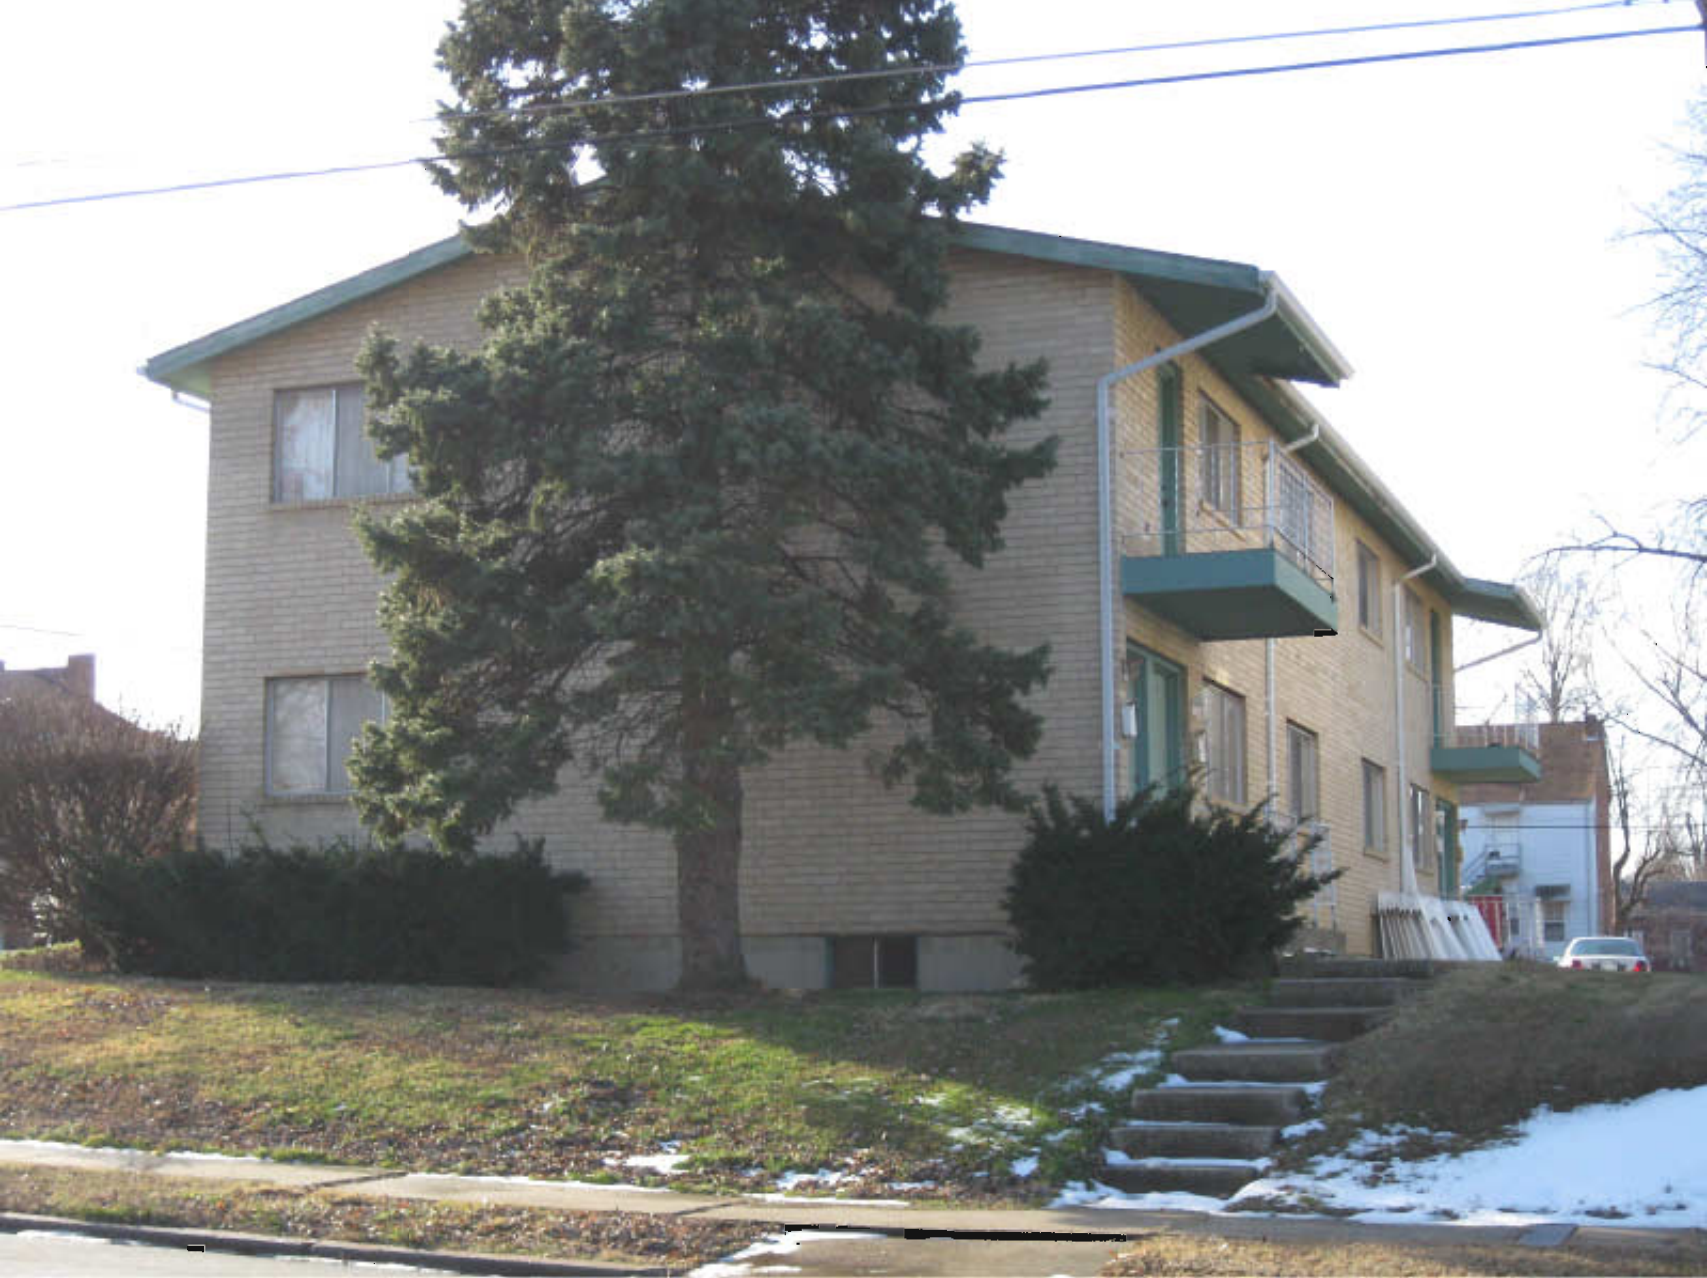
Built in 1966, this two-story, blond brick apartment building has a low gable roof and concrete foundation pierced by two-light basement windows. The ridge of the roof is perpendicular to the street, and the entrances are on the west elevation, facing the neighboring property. The main façade has six bays: in the outer bays are paired paneled doors and in the other bays are three-part sliding windows with brick sills. The doors open onto one-bay concrete stoops with metal railings, and the stoops are protected by second floor balconies. The second floor has a door in each of the outer bays and windows matching those of the first level. At each entrance is a one-bay balcony, and the roof of the building extends over the two balconies. The north (street) elevation has a three-part window on the east end of each floor. The building is noncontributing since it is less than 50 years old.

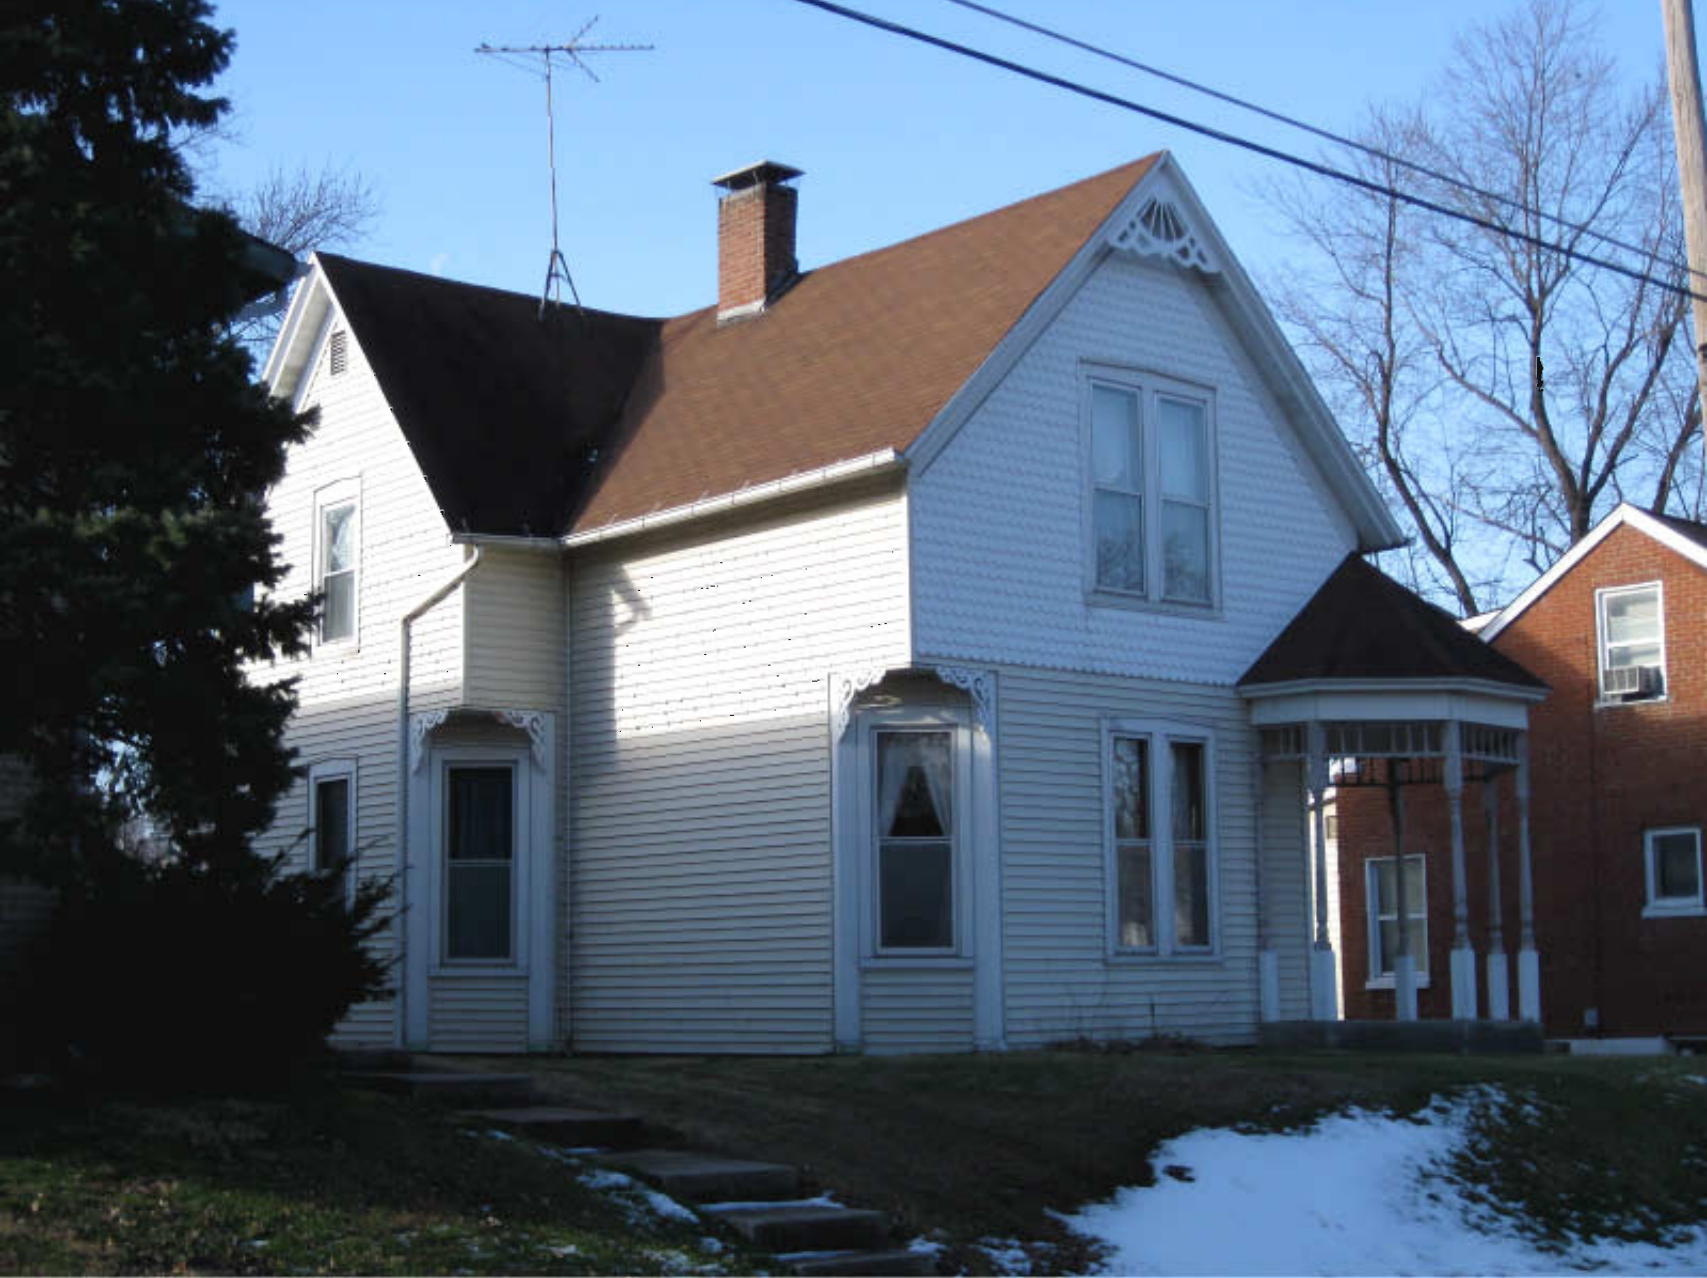
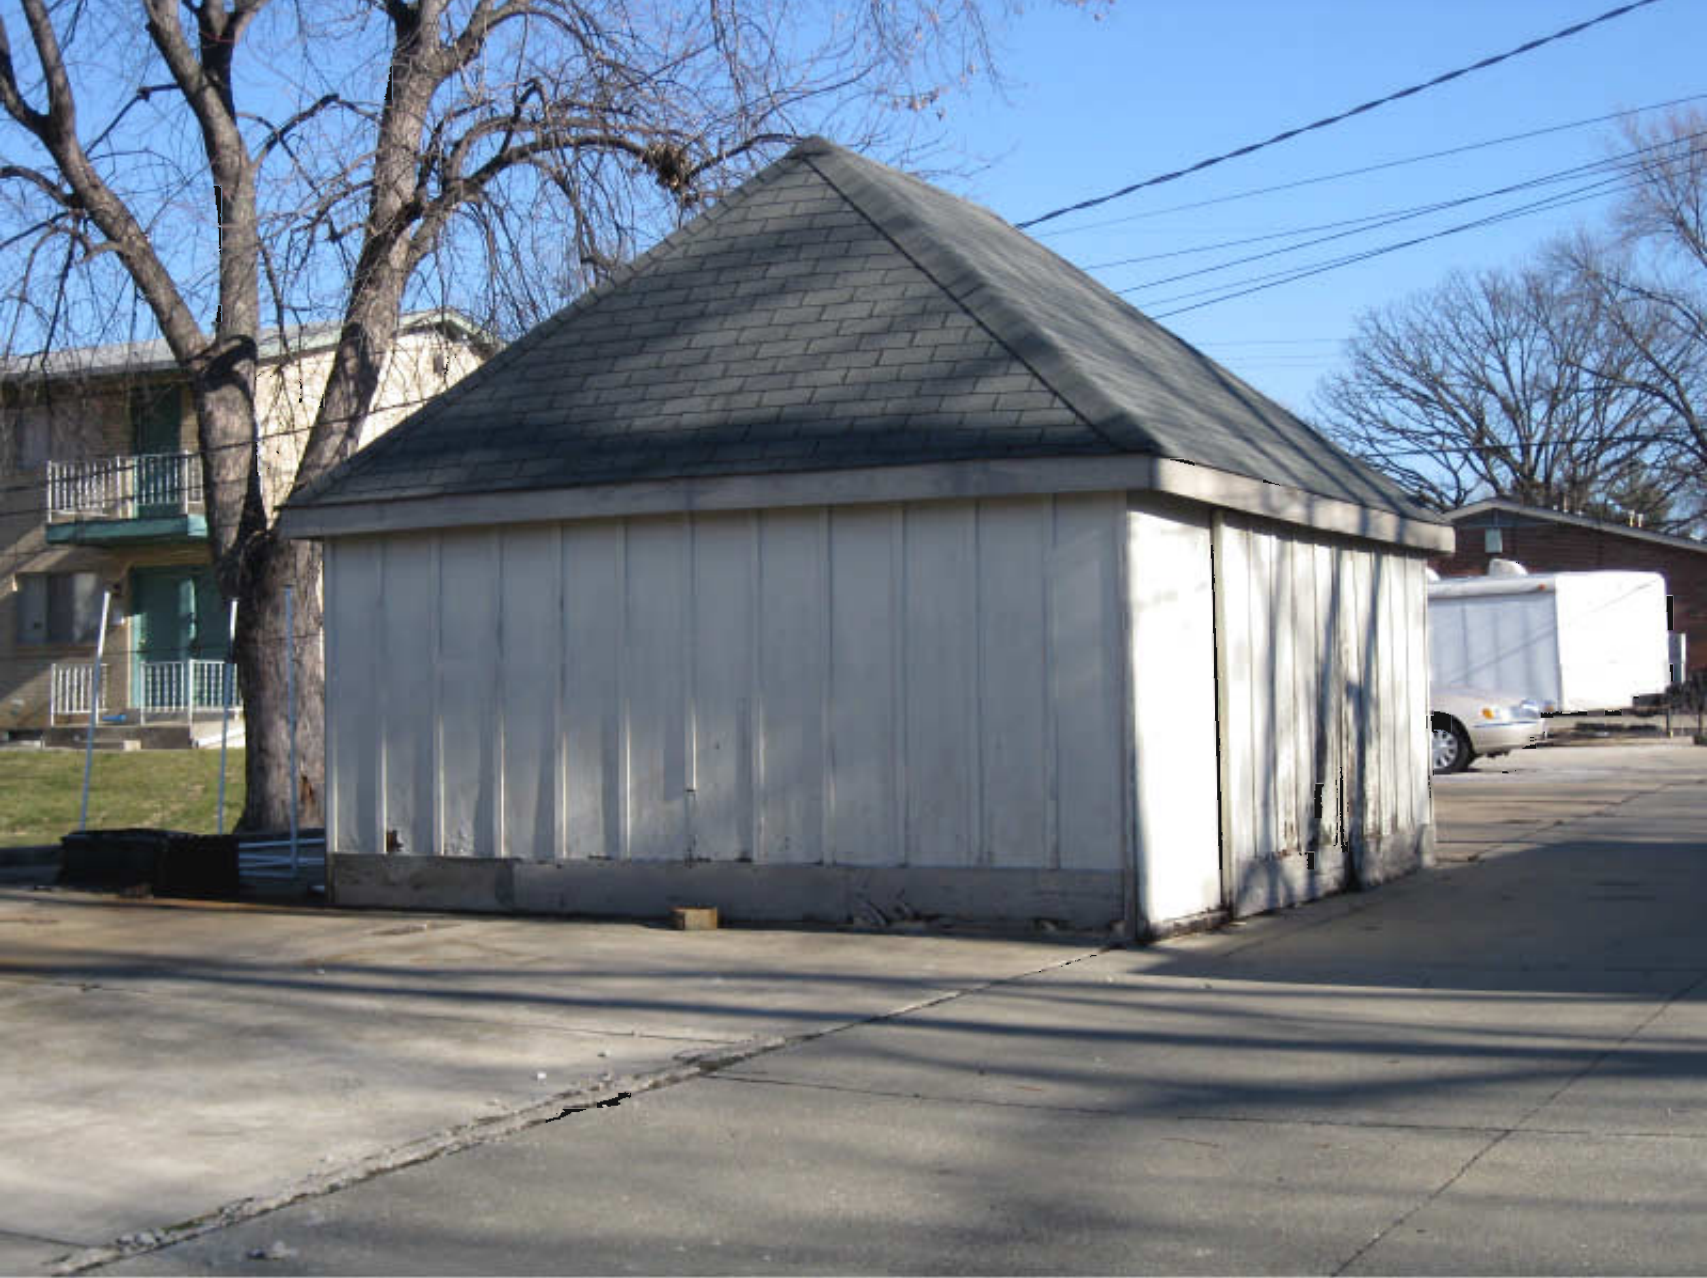
This one-and-one-half story, frame, Queen Anne style house has a cross-shaped plan. The foundation is coursed rock-faced stone and the walls have been clad with vinyl siding, except for the upper half story of the front-gabled wing, which is clad with vinyl shingles. The cross-gabled roof has wide overhanging eaves and a gable ornament is in the front gable. A brick chimney straddles the ridge of the front-gabled wing and an exterior end brick chimney is on the south wall of the rear one-story wing. The corners of the first floor of the front-gabled wing and the north corners of the side wings are canted, and in the cutaway bays are ornate brackets, except for the northwest corner where the entrance is located. The half-glazed wood door, which is topped by a single-light transom, opens onto a polygonal pavilion/portico that has a concrete deck and stairs, balustrade with ornate turned balusters, turned posts with corner brackets, a spindled frieze, and polygonal roof. (The portico is shown as rectangular on the 1917 Sanborn map but as polygonal on the 1929 and 1947 maps.) To the east of the entrance is a pair of 1/1 wood windows and in the northeast canted corner is a single window. The window and door surrounds throughout the house are plain with peaked lintels. In the upper half story of the façade is a pair of 1/1 windows. The first floor of the eastern gabled wing has a 1/1 window in the northern canted corner and one on the east wall, and there is another window in the upper half story. The west elevation has a 1/1 window in the upper wall, immediately south of the portico. The western gabled wing also has a 1/1 window in the northern canted corner, but the window on the first floor of the west wall is a short 6/1 sash and in the upper half story is a short 1/1 window.
