ARCHITECTURAL/HISTORIC INVENTORY FORM

1. Survey No. SC-AS-009-001		2. Survey Name: St. Charles Survey Phase 3: Mid-Town and Commons Neighborhoods	
3. County: St. Charles		4. Address (Street No.) 128	Street (name) North Sixth Street
5. City: St. Charles	Vicinity: <input type="checkbox"/>	6. UTM:	
7. Township/Range/Section:		8. Historic name (if known): Meyer-Pieper House; The Meyerdorf	
9. Present/other name (if known):		10. Ownership: <input checked="" type="checkbox"/> Private <input type="checkbox"/> Public	
11a. Historic use (if known): Domestic/single dwelling		11b. Current use: Domestic/single dwelling

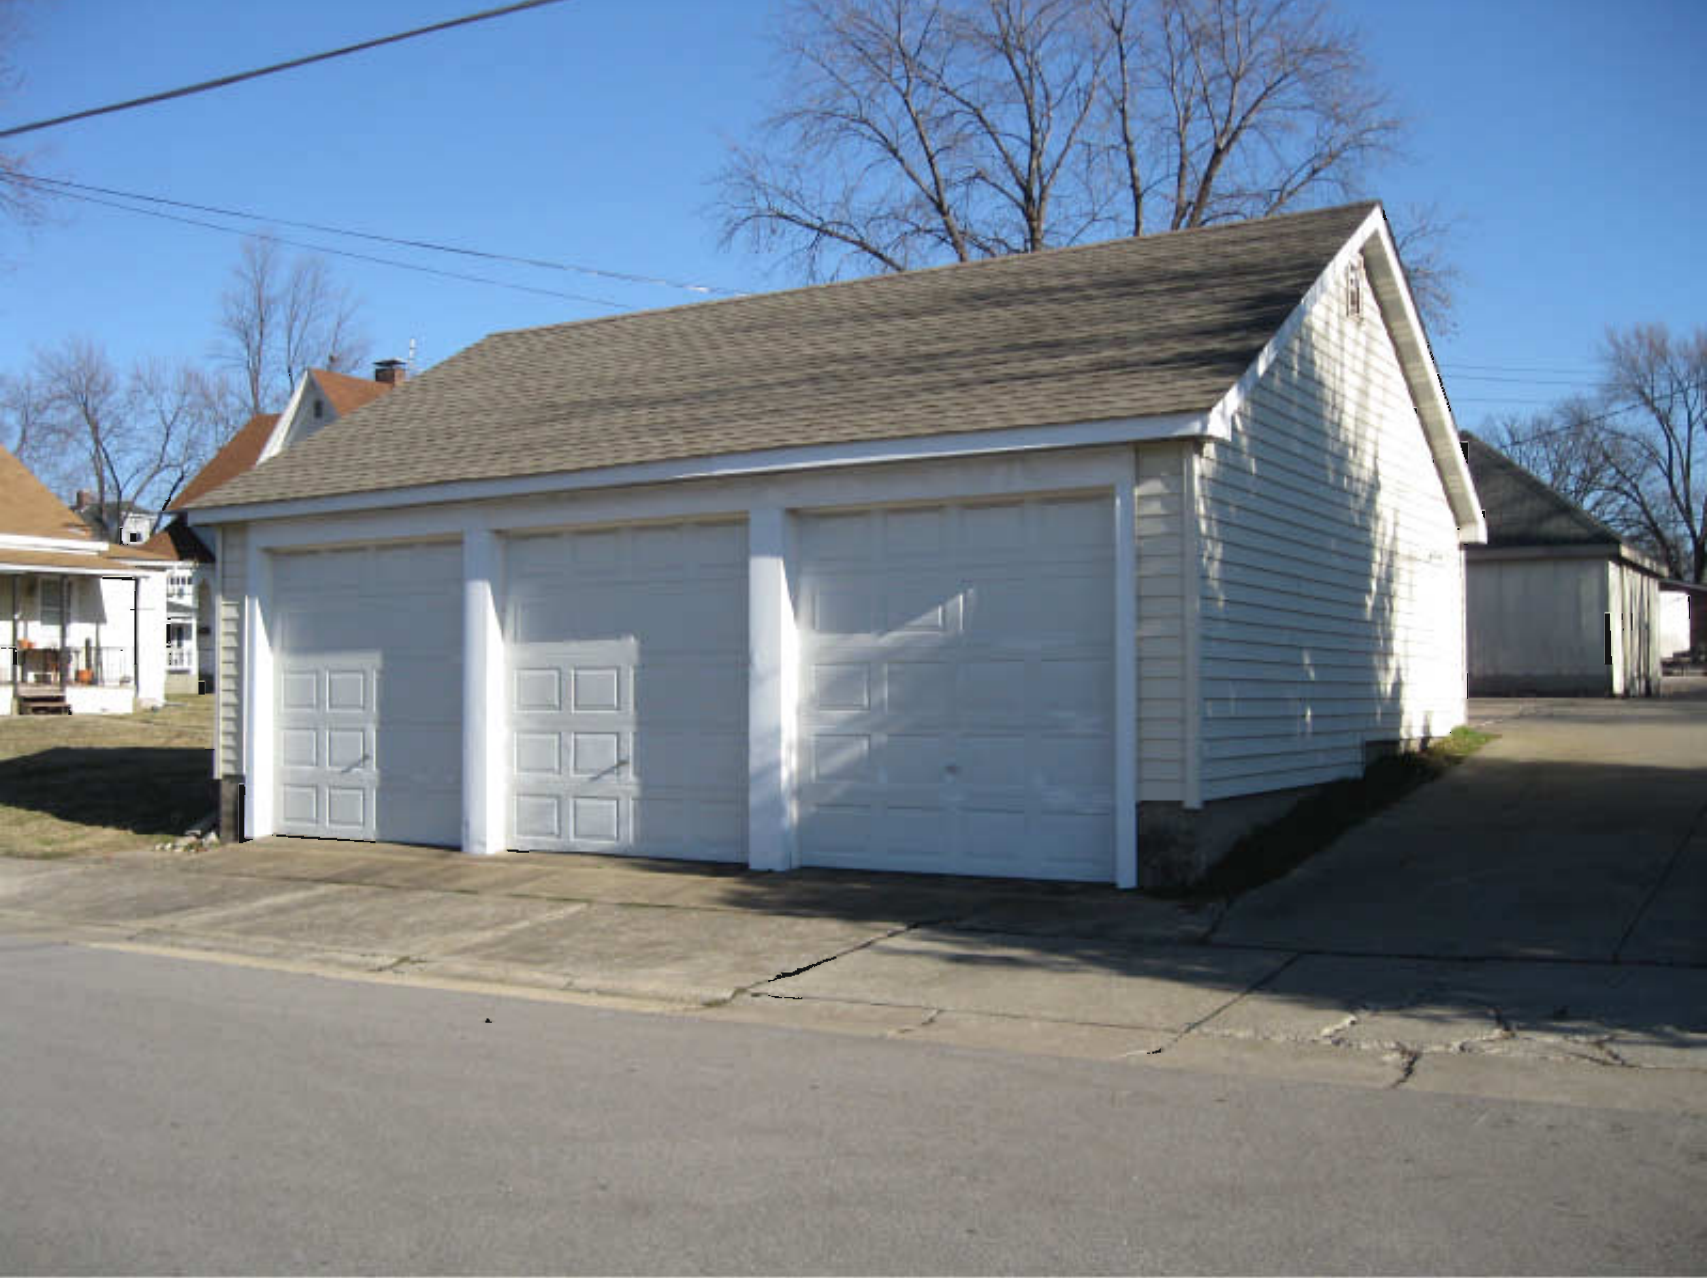
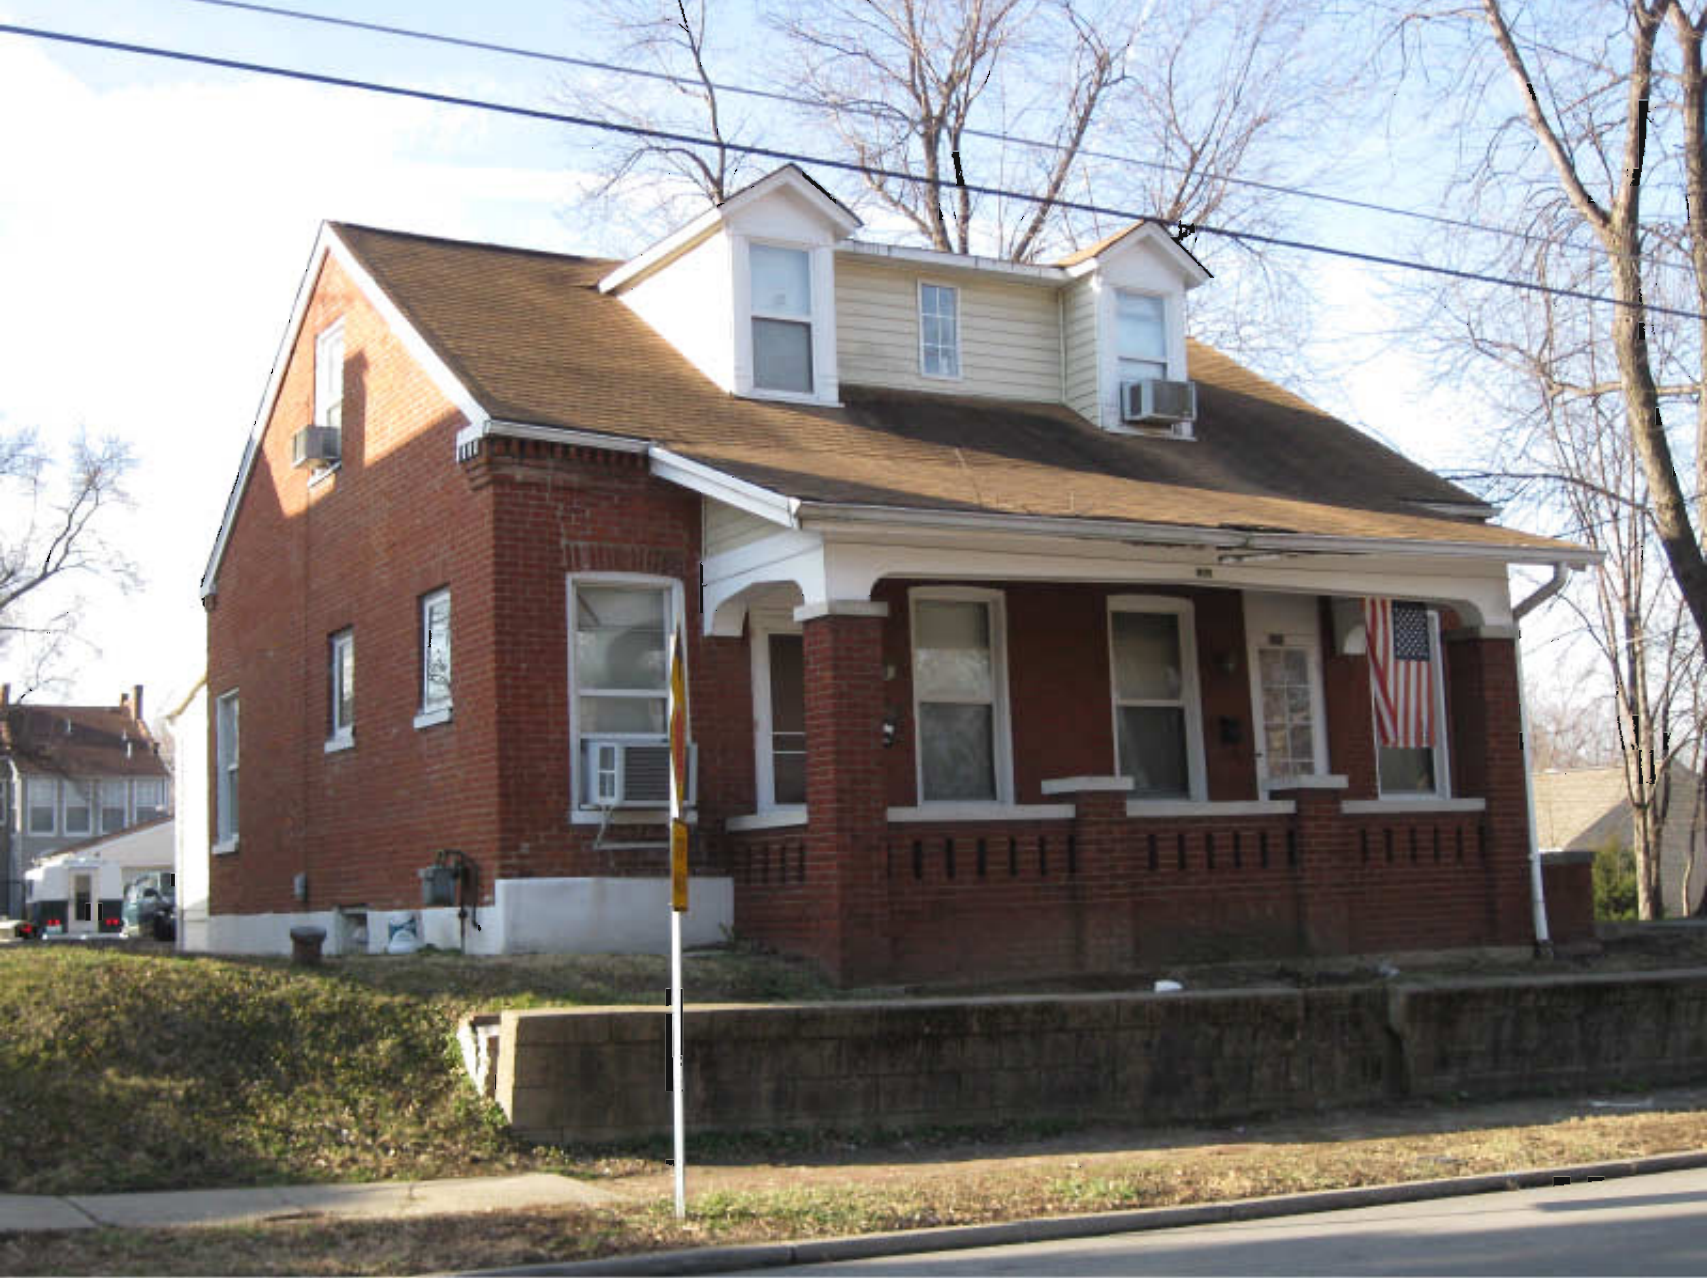
surrounds that have plinth blocks and bullseye corner blocks. The addition between the two dormers has a six-light vinyl window, and the rear dormer has two 1/1 windows. In the second and fifth bays of the six-bay main façade are entrances, which are wood doors with stepped lights, and the transoms appear to have been infilled. A screen door is at the eastern entrance and a multi-light paneled wood door is at the western. In the other four bays are 1/1 wood windows that are set within low segmental-arched openings. Spanning the central four bays is a gallery that appears to have been built shortly after the 1947 Sanborn Insurance map was prepared. On the west side of the gallery is a concrete stairway flanked by brick knee walls. The gallery features a concrete deck, pierced brick railing with concrete coping, textured brick pedestals and piers, and a shed roof. The roof is trimmed with a frieze that has a basket-handle arch on the north side and Tudor arches on the east and west ends. The west elevation has a pair of 1/1 windows on the north end and a single 1/1 window, and another window is in the upper half story. The first floor of the eastern elevation has two short stained glass windows and a 1/1 window, and there is a 1/1 window in the upper half story.

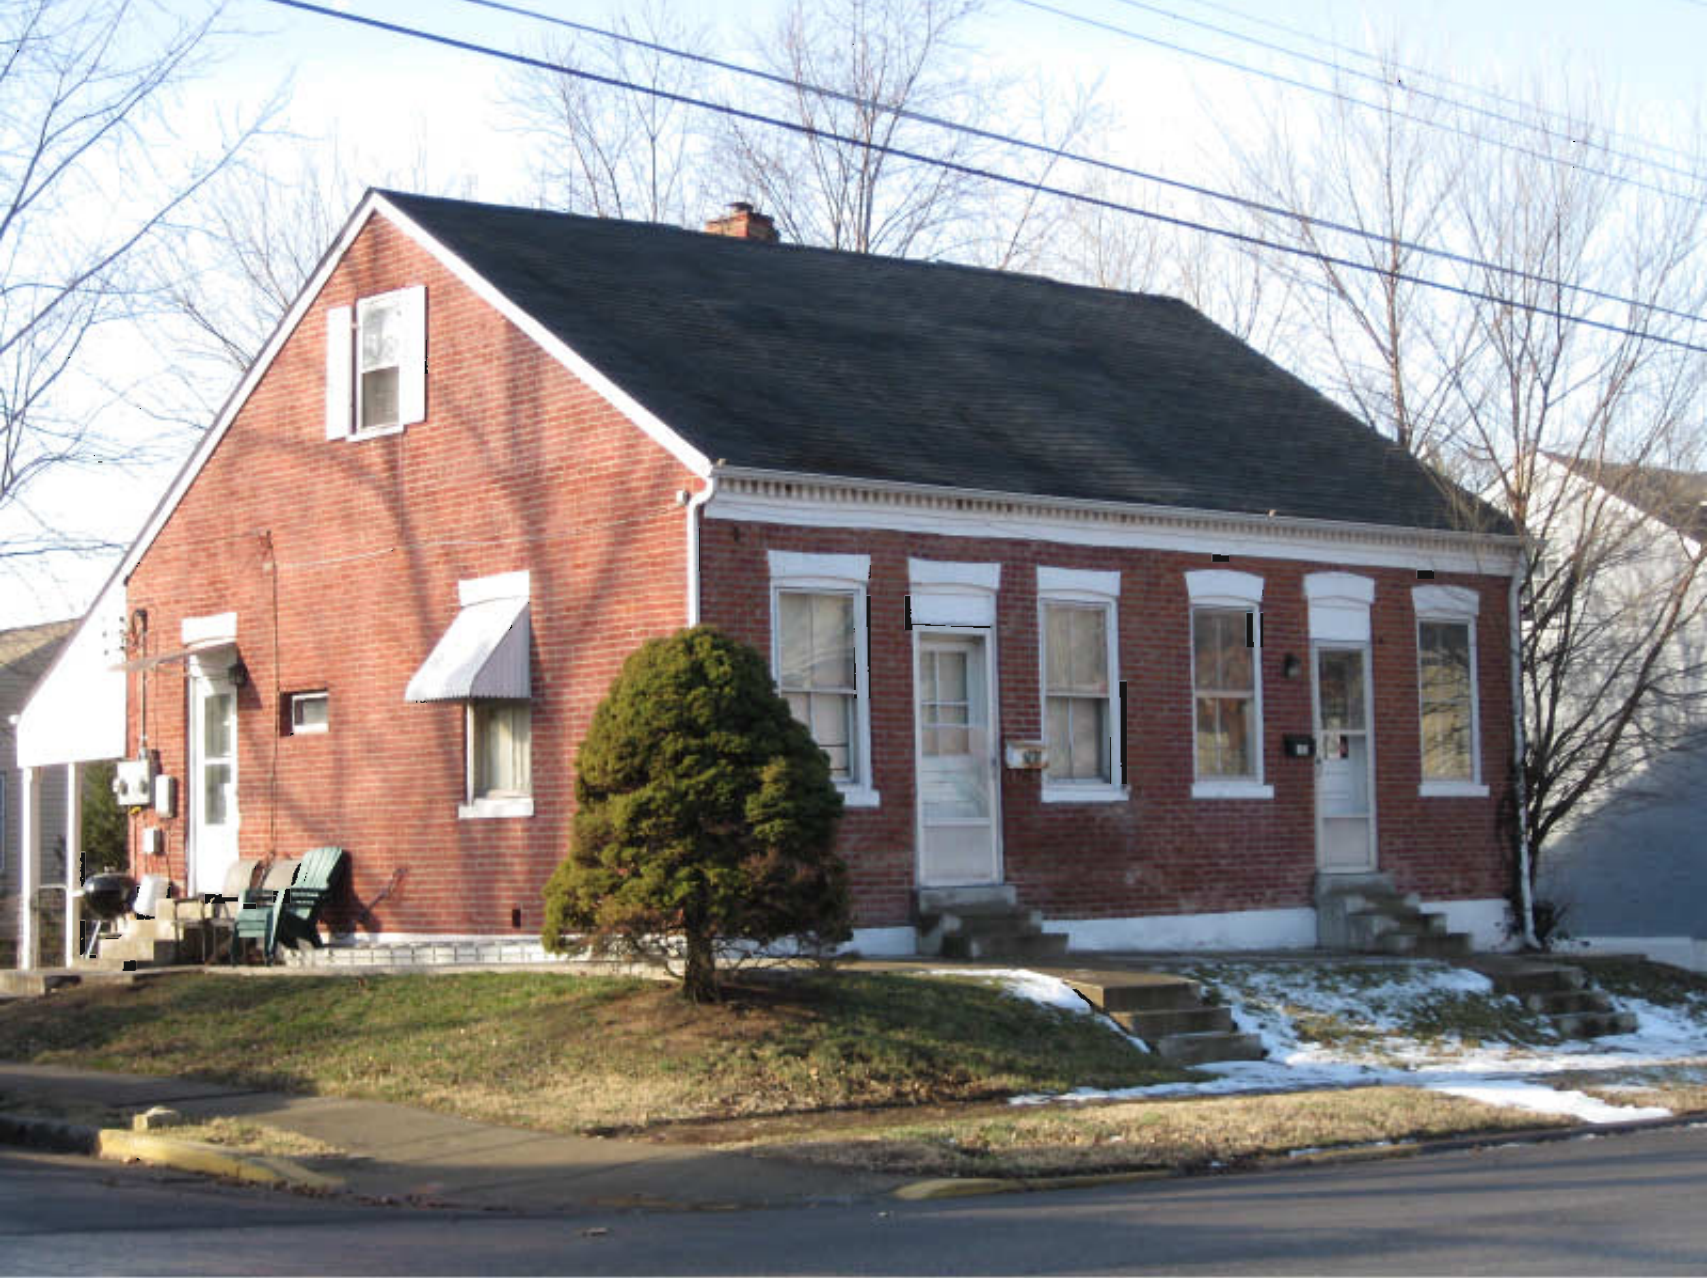
Located at the southwest corner of Clark and Seventh Streets, this one-and-one-half story, brick, Federal style structure has a high side-gabled roof trimmed with a denticulated entablature. On the rear slope of the roof are two shed dormers with 1/1 windows and an interior brick chimney with corbelled cap. The foundation is coursed rock-faced stone, but it has been parged on the facade and east elevation. On the six-bay main façade there are entrances in the second and fifth bays, and they are half-glazed, paneled wood doors (4 lights over 3 panels), but the transoms are not visible due to wood panels above the storm doors. The doors open directly onto concrete stairways. The other four openings on the façade contain 2/2 wood windows. All of the openings on the façade are segmental-arched, but the eastern three are topped by jack arches made with a single soldier course while the western three have radiating voussoirs formed by two courses of rowlocks. On the north end of the first floor of the eastern elevation is a 2/2 window, and to the south is a small transom-type window and a paneled-and-glazed wood door (3 horizontal lights over 3 horizontal panels) that is covered by a metal awning. The door opens onto a concrete stairway. There are two window openings on the first floor and one in the upper half story of the west elevation. They are 2/2 sash, except the one on the south end of the first floor; this opening has been partially infilled and holds a small sliding window. A partial-width gallery on the rear elevation has a shed roof supported by chamfered posts. What was likely a summer kitchen is at the southwest corner of the house, butted up against the rear wall at the end of the gallery and extending several feet beyond the west elevation. The only opening is a door on the east elevation. Since the kitchen is connected to the house it is not being inventoried as a separate building.

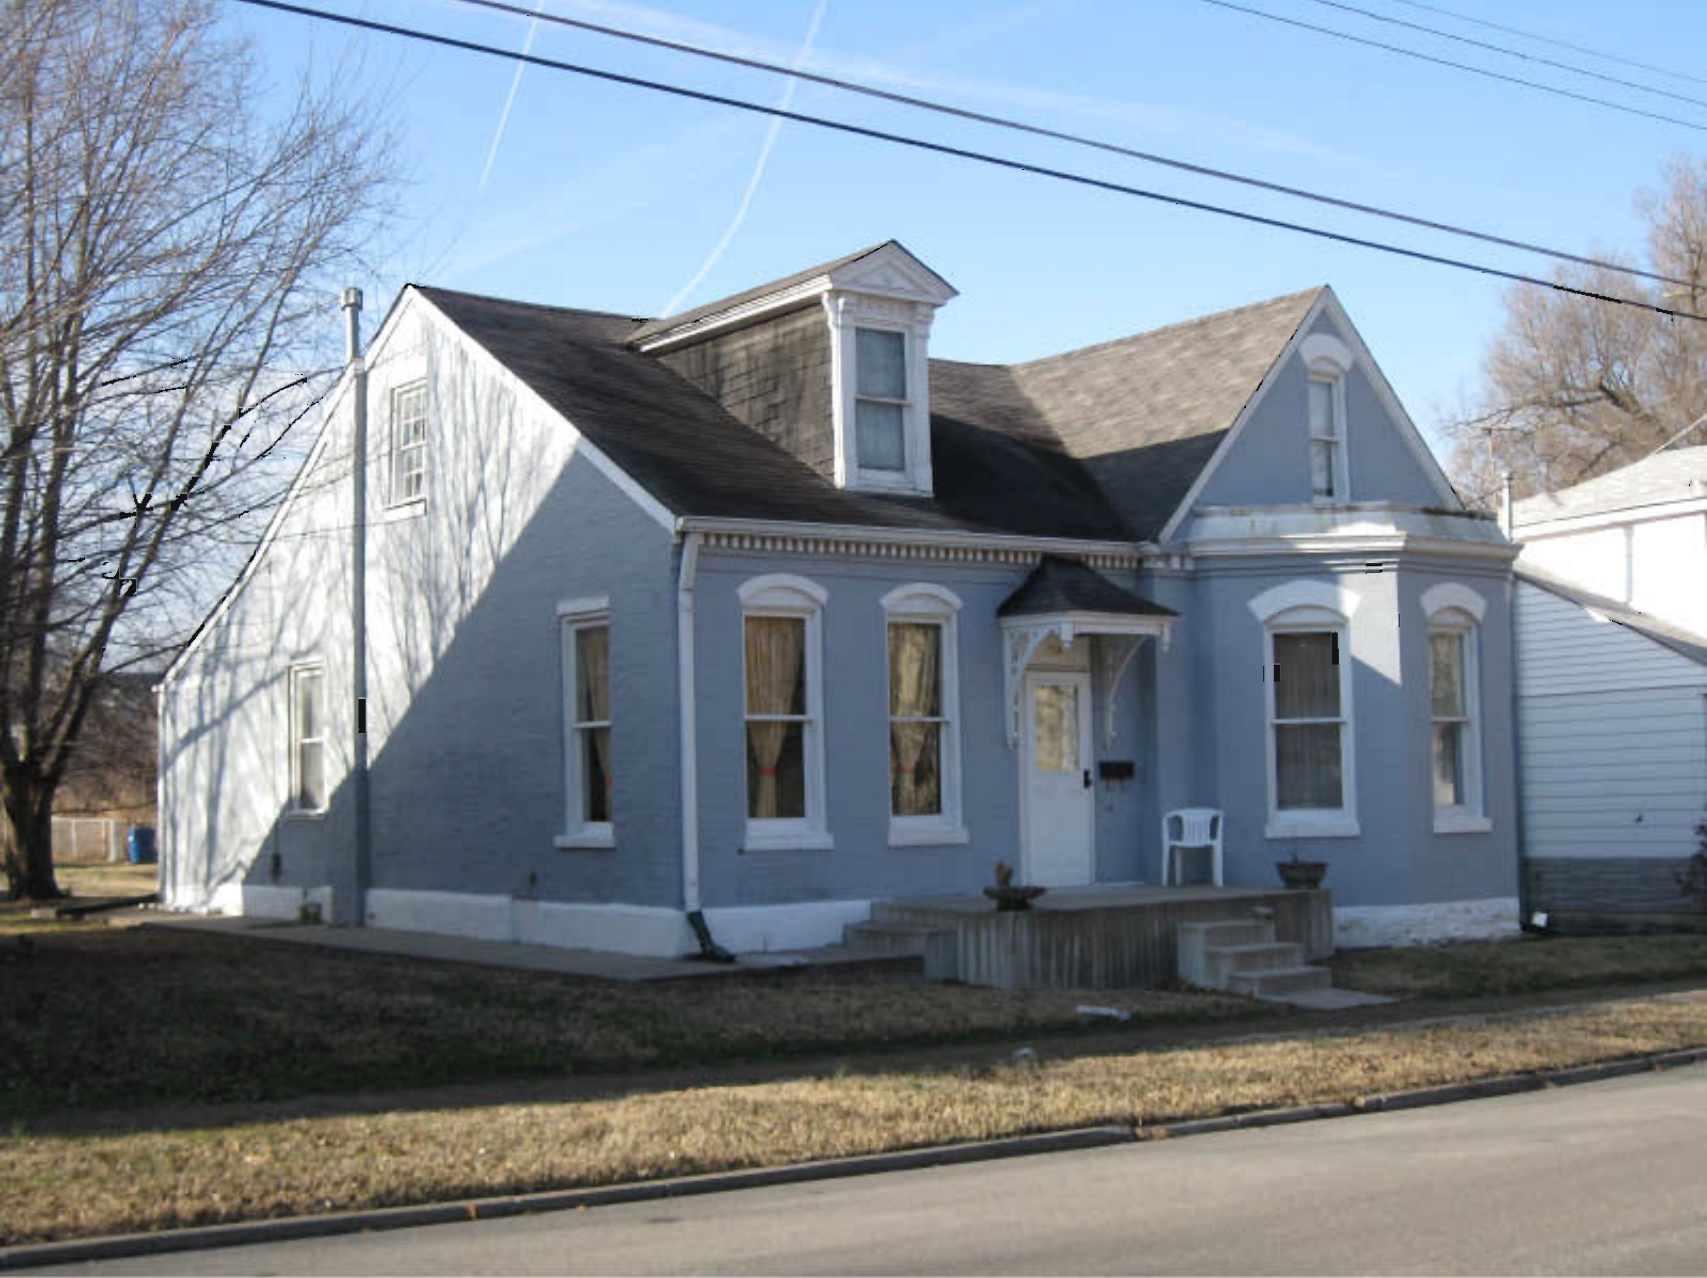
This one-and-one-half story, painted brick house has a cross gable roof that is trimmed with a denticulated entablature. It appears that the eastern, side-gabled portion of the house may have been built first and the front-gabled west section added later. The coursed rock-faced stone foundation has been parged on the east half of the façade and on the east elevation. On the front and west slopes of the roof are pedimented gabled dormers with 1/1 windows framed by pilasters with plinth blocks and brackets, and in the frieze and tympanum are applied circular moldings. The walls of the dormers are finished with roofing shingles. The four-bay main façade has two 1/1 wood windows in the easternmost bays, and to the west is the entrance, which is a half-glazed wood door. The door opens onto a two-bay concrete stoop that has a concrete stairway on both the north and east sides. Directly above the door is a hood with a bellcast hip roof supported by large, ornate brackets with ball-and-rod spindles, a dogtooth frieze, and drop pendants. The westernmost bay is located in the front-gabled wing, and on the first floor is a polygonal bay with a low mansard roof trimmed with a plain frieze. The polygonal bay has three 1/1 windows, and in the upper half story is another 1/1 window. The openings on the main façade are segmental arched and have incised wood panels directly under the arches. On the first floor of the east elevation are two 1/1 windows and in the upper half story is a 6/6 window, and these openings are flat-arched. An exterior end chimney was located on the east elevation—only the chimney stack below the roofline is intact. On the west elevation are two segmental-arched openings; the one on the north end is a 1/1 wood window topped by an incised panel while the southern window appears to be a 6/6 sash.

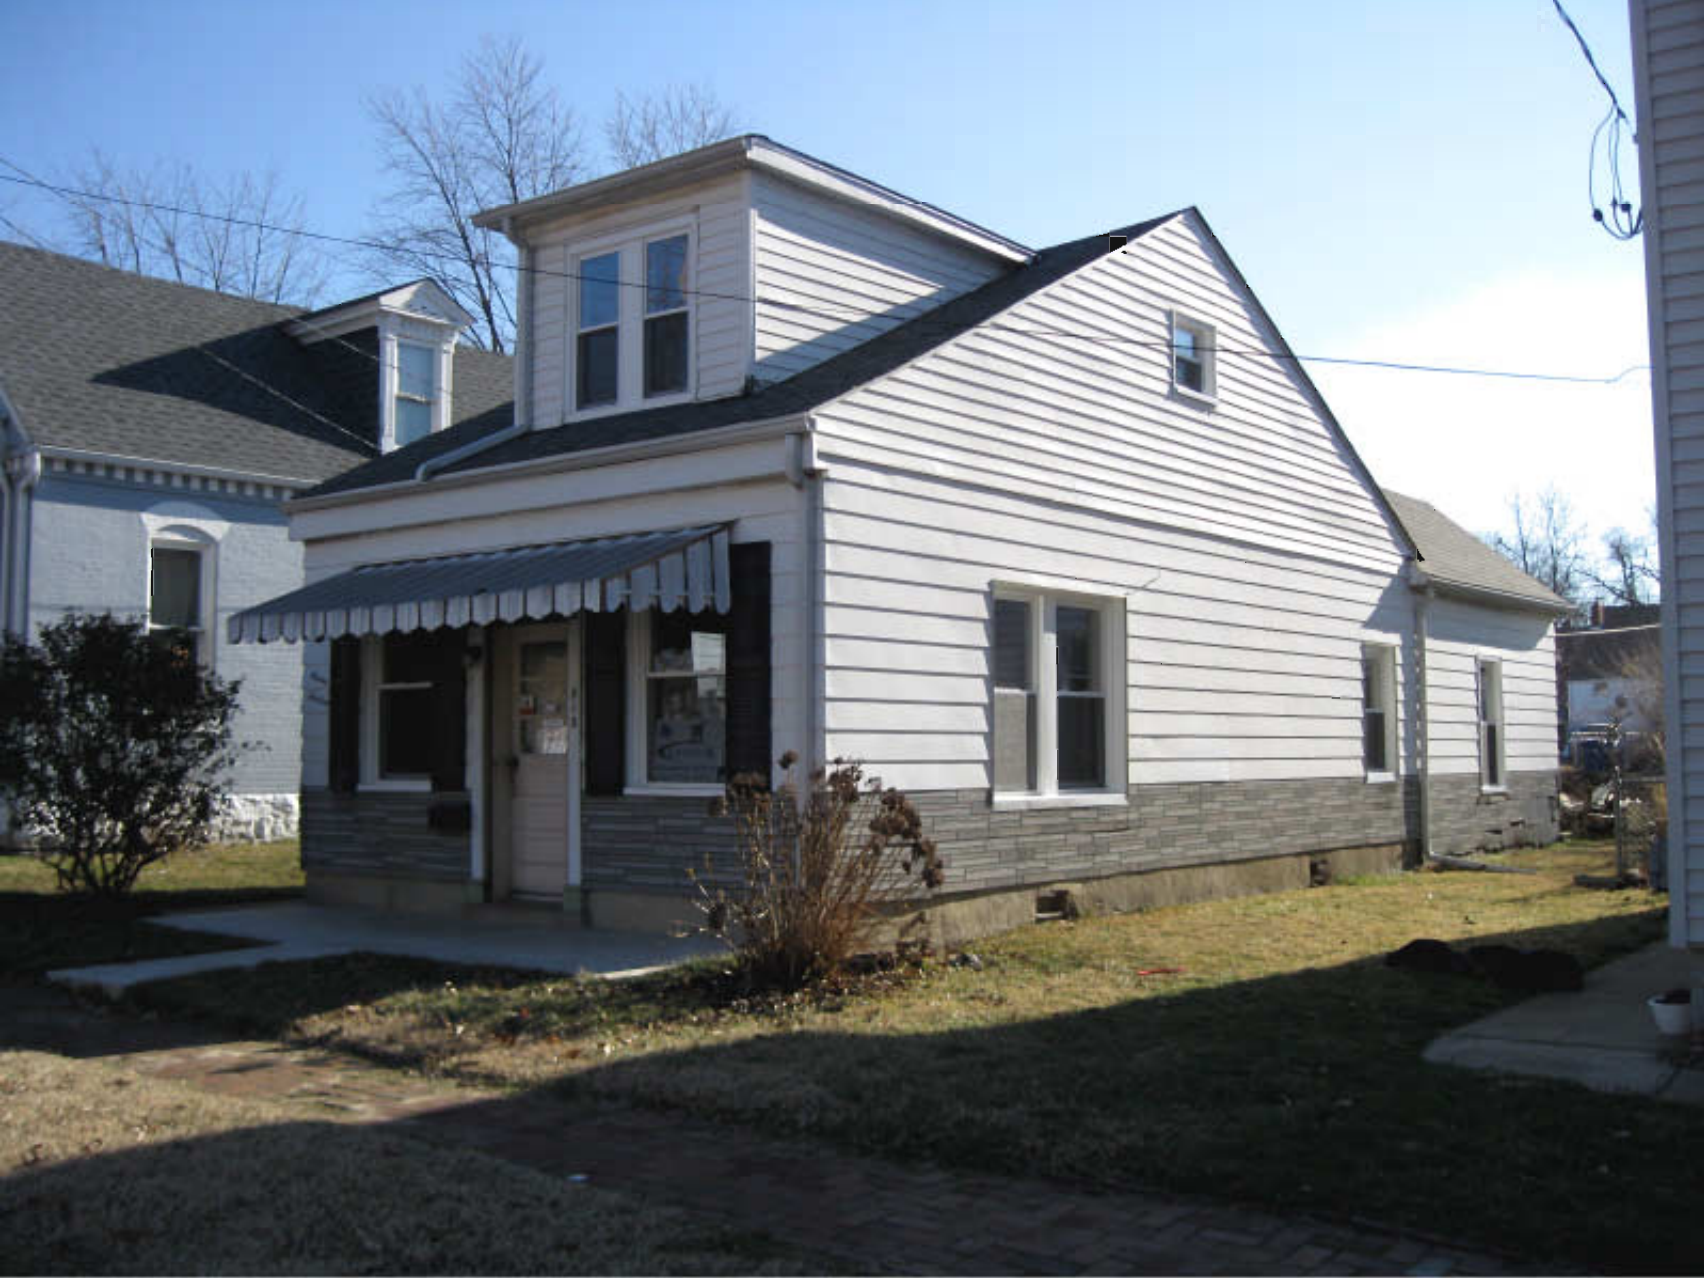
Although the Sanborn Insurance maps indicate that this diminutive, one-and-one-half story, side-gabled cottage is masonry, it has been clad in aluminum siding, except for the lower walls, which are finished with asphalt shingles. The foundation has been parged with concrete, and a large hipped dormer with paired 1/1 windows has been added to the front slope of the roof. The three-bay main façade has a central half-glazed wood door flanked by 1/1 vinyl windows, and a metal awning spans all three openings. (The 6/6 wood sash were replaced in 2012 with the vinyl 1/1 windows.) The door opens onto concrete steps and a concrete stoop, which is at ground level, is enclosed by a metal railing. There are two windows on the first floor of the east elevation and one in the upper half story. On the west elevation are paired 1/1 windows and two single 1/1 windows (one is in the rear gabled wing), and in the upper half story is a short 1/1 window. The porch along the east side of the rear wing has been enclosed, giving the house a rectangular plan. The house has lost integrity due to the vinyl and asphalt siding and the replacement of the windows.

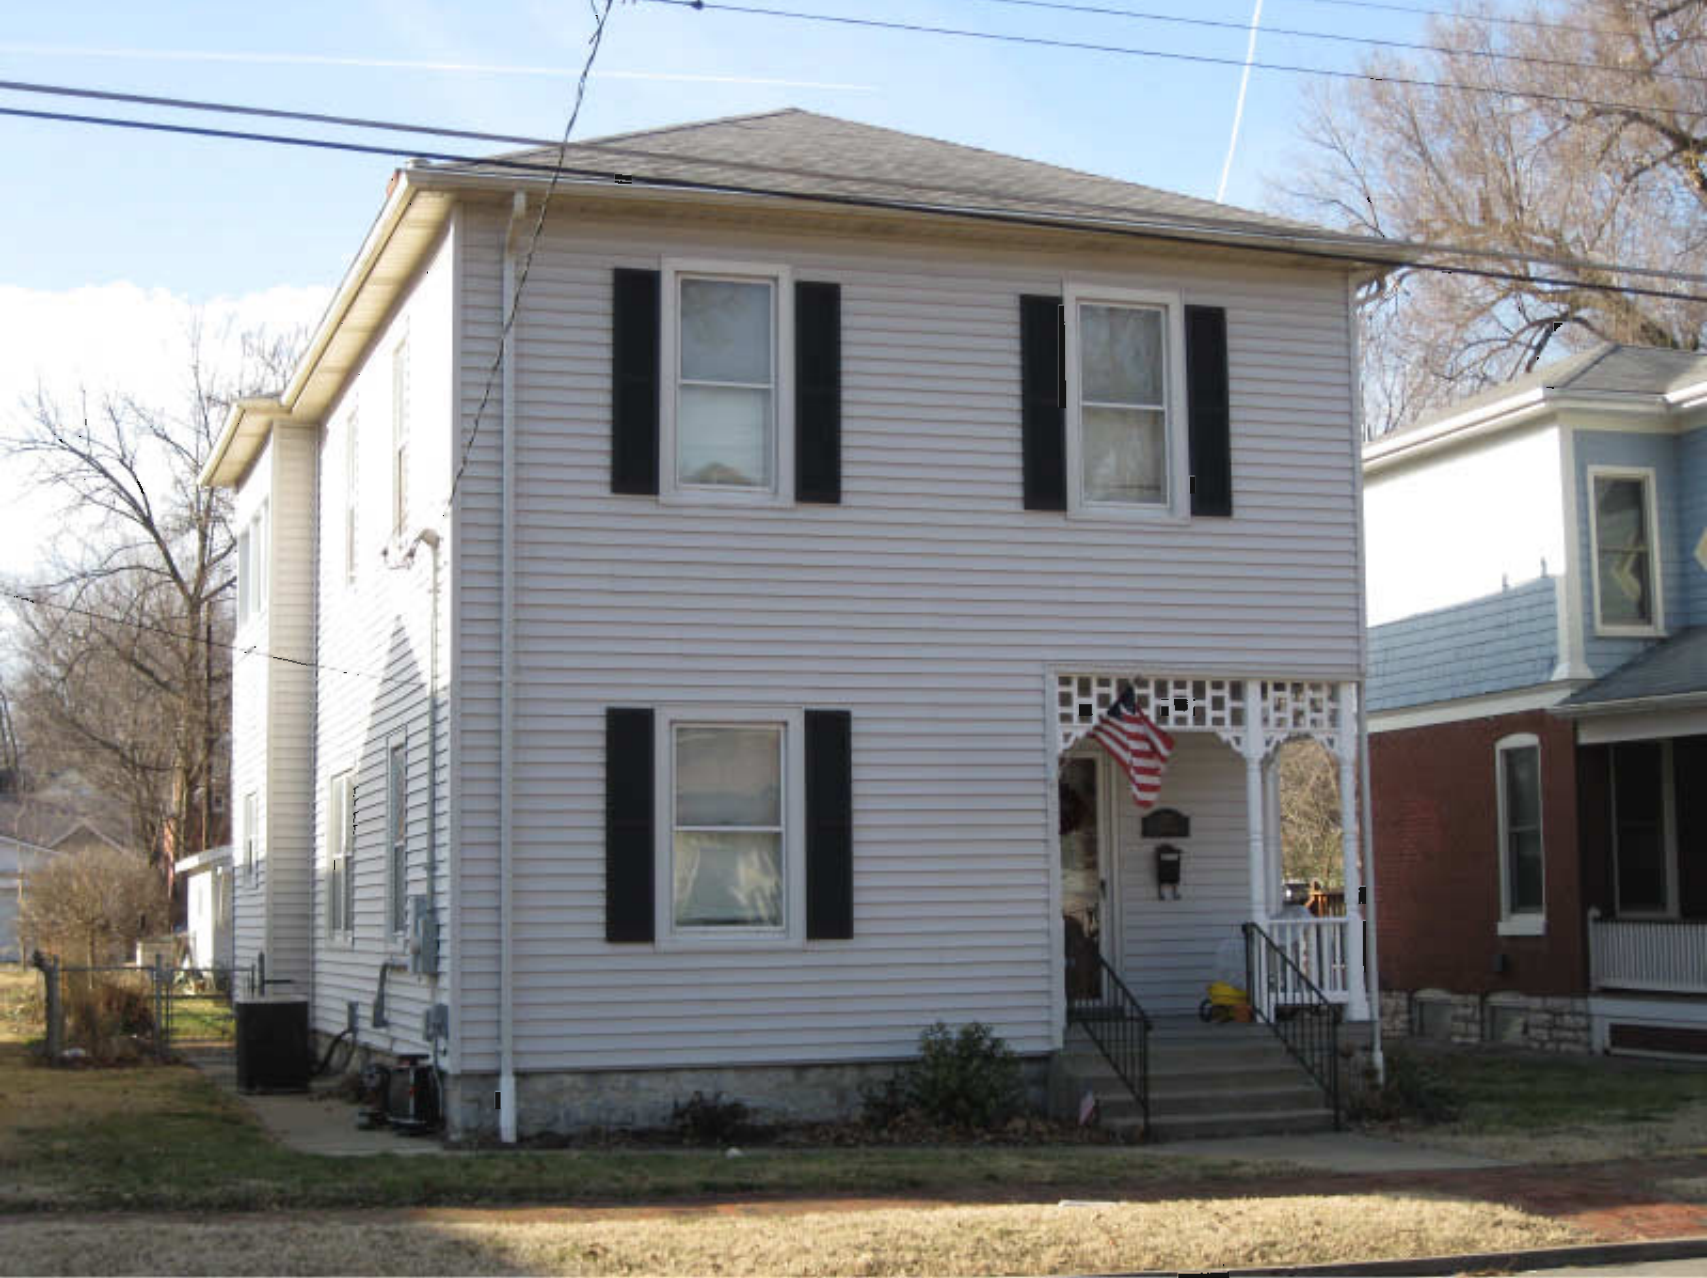
This two-story, frame house rests on a coursed rock-faced stone foundation and has vinyl-sided walls. The pyramidal roof has wide overhanging eaves, and an interior end brick chimney and a small gablet pierce the eastern slope. The main façade is a two-bay elevation, with the entrance in the western bay, which is recessed. The half-glazed, paneled wood door opens onto a one-story recessed porch that has a concrete stairway, wooden deck, plain balustrade, turned posts with corner brackets, and a stickwork frieze. In the eastern bay is a 1/1 wood window and on the second floor are two 1/1 windows. The first floor of the east elevation has, from front to rear, a 1/1 window, paired windows, and in the southern bay, which projects slightly, is a pair of short windows. The Sanborn Insurance Maps show that the rear wing was originally one story, with a porch along the east side (flush with the east elevation); however, sometime after 1947 the rear wing was extended to the east and a second story was added. There are two windows on the first floor of the west elevation, a stair window between floors, and three windows on the second floor.

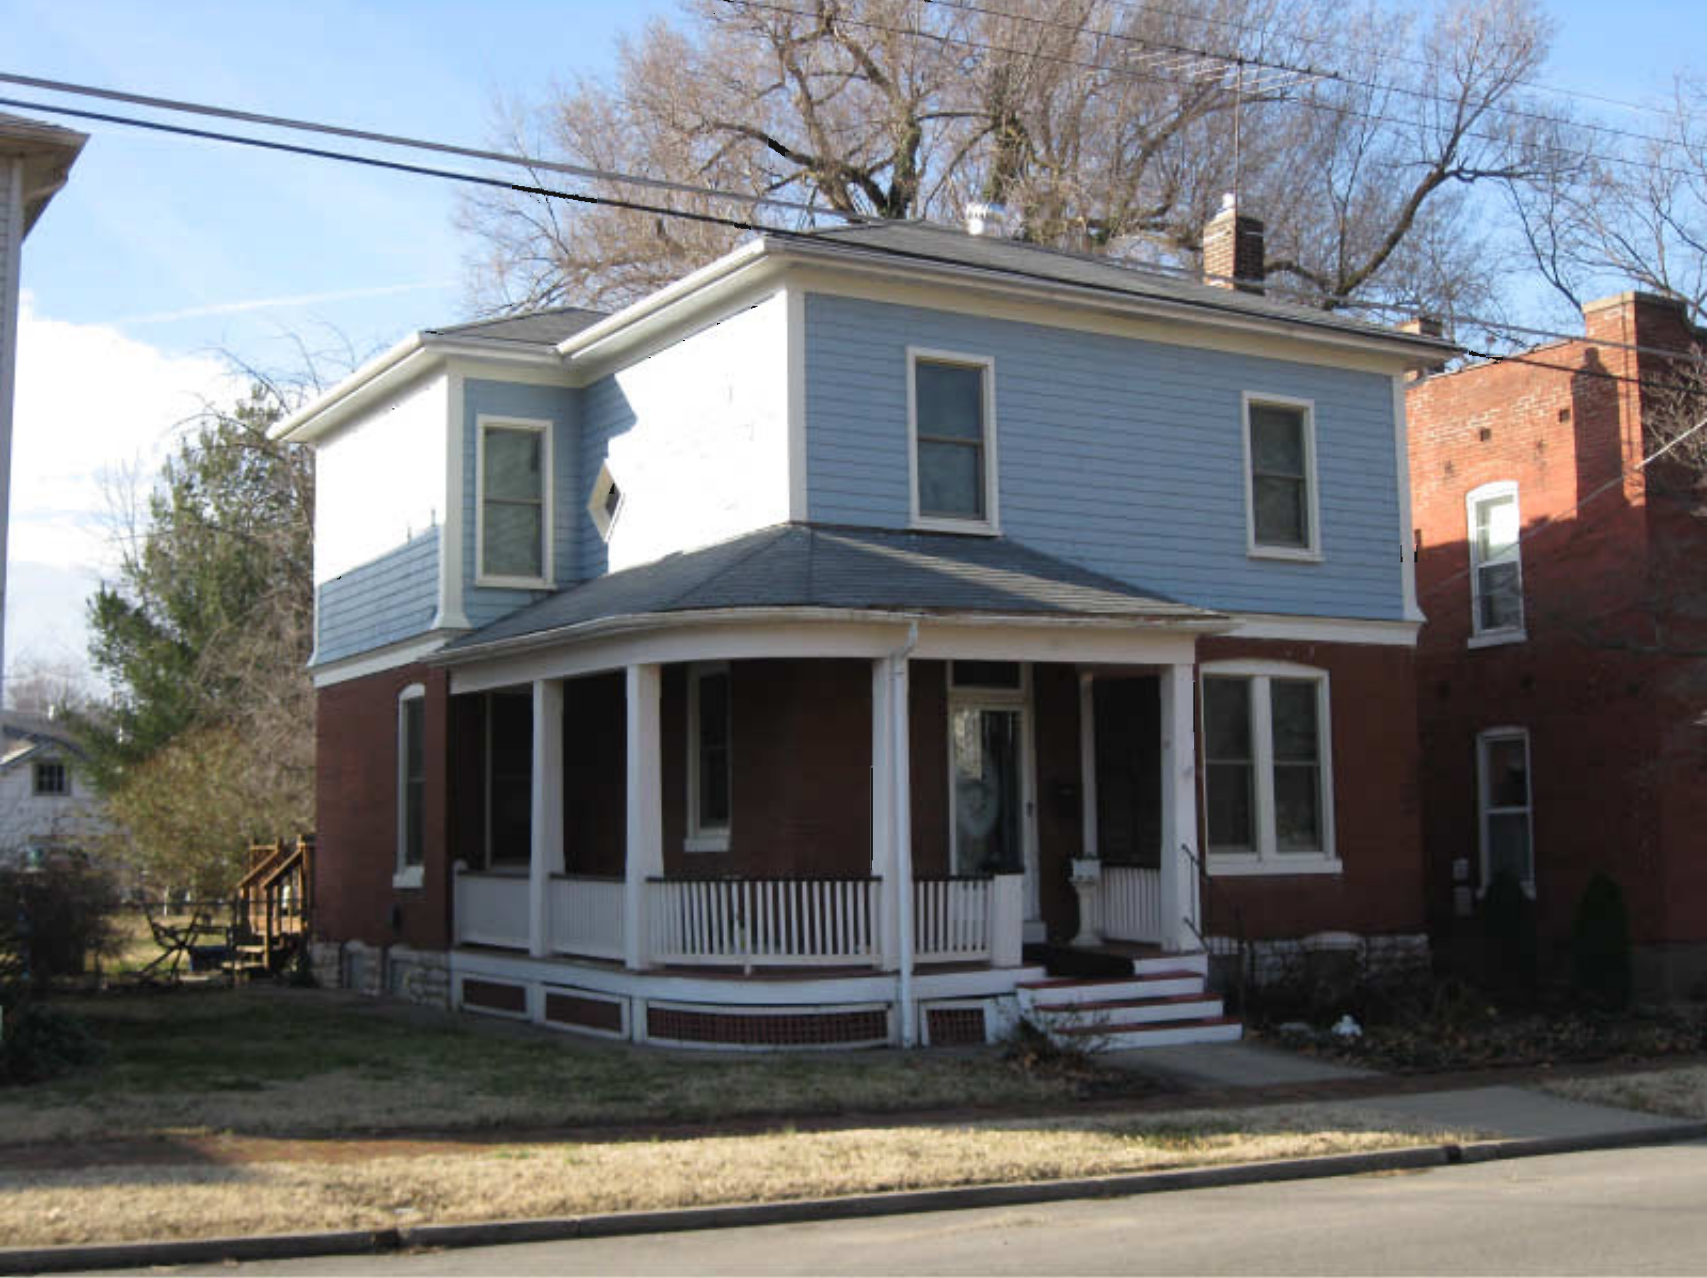
Built c. 1913, this two-story, L-shaped house has first floor walls finished with brick laid with red mortar, while the second floor is clad with wood shingles. A wide wooden belt course separates the floors. The second floor walls, which are trimmed with wide corner boards, are bellcast (they flare outward just above the belt course). The coursed, rock-faced stone foundation is pierced by two-light basement windows set within segmental-arched openings that extend upward into the first floor brick wall, and these windows are topped by radiating voussoirs. The low hipped roof has wide overhanging eaves and is trimmed by a plain frieze, and an interior end chimney pierces the west slope. In the eastern bay of the two-bay main façade is a wood door with etched glass and applied moldings, and the door is topped by a single-light transom. The door opens onto a one-story, wraparound gallery that has a wooden stairway and deck, plain wood balustrade, and box columns supporting the roof. In the western bay of the façade is a pair of 1/1 windows set within a segmental-arched opening (the first floor openings are segmental-arched while the second floor openings are flat-arched). On the south end of the first floor of the west elevation is a hanging box bay with paired 1/1 windows, a shed roof, and shingled walls that are bellcast. The second floor of this elevation has three windows. The east elevation has two windows on the first floor and a small diamond-shaped window on the second. The north wall of the projecting east wing has a window on each floor. According to the City's address files, a room addition and rear deck were constructed in 1994.

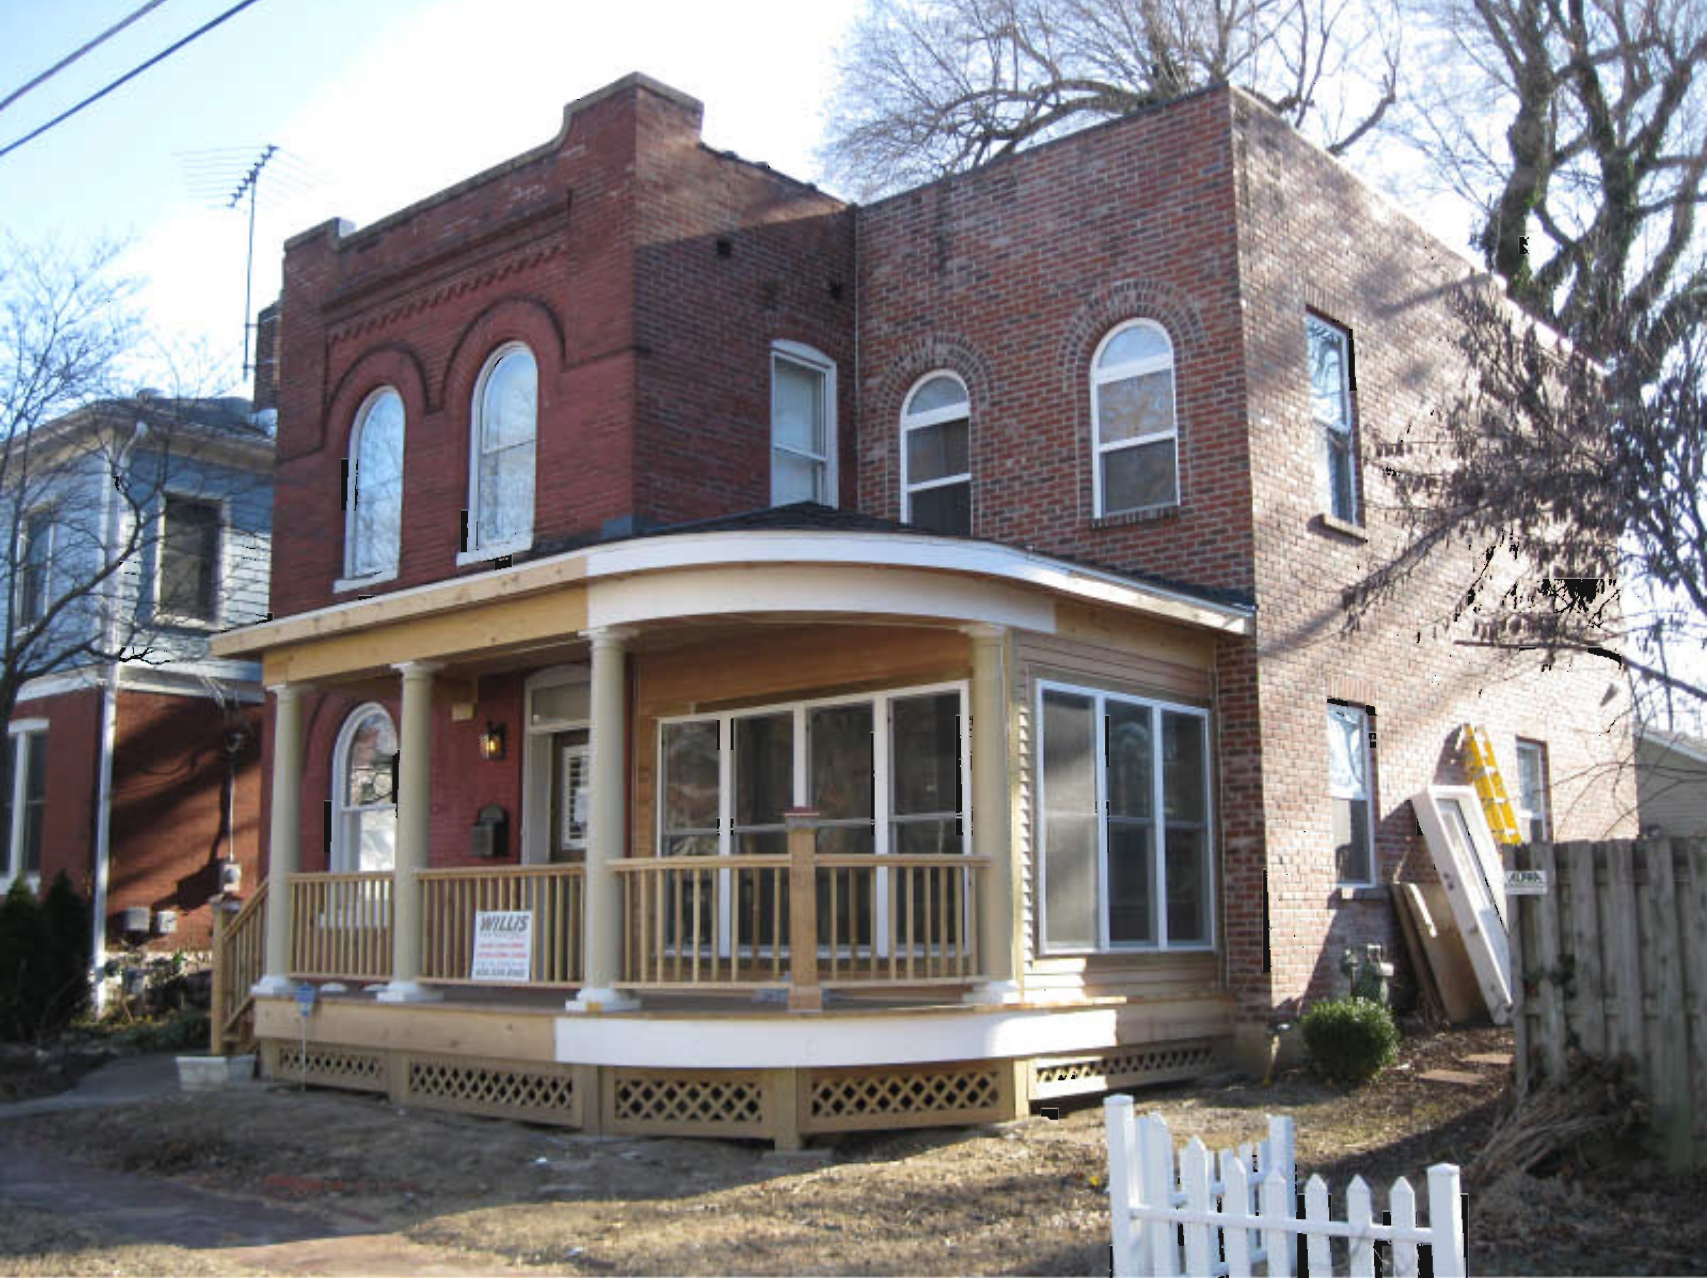
This two-story, brick house has a flat, parapeted roof, and the parapet has a concrete coping on the main façade and terra cotta coping on the other elevations. On the façade the parapet is trimmed with a corbelled course and denticulated molding, and two interior end chimneys are on the eastern parapet. The concrete foundation is pierced by single-light basement windows that are set within segmental-arched openings that extend slightly upward into the brick walls of the house, and the openings are topped by brick jack arches. The western bay of the two-bay main façade has a half-glazed, three-panel wood door topped by a transom (the glass of the transom appears to have been painted). To the east of the entrance is a wide, round-arched, 1/1 wood window and on the second floor are two matching windows. These windows are topped by radiating voussoirs with molded bricks. The door opens onto a one-story wraparound gallery that has a wooden deck, plain wood balustrade, Tuscan columns, and hip roof. The stairway is on the east side of the porch. The 1917 Sanborn Insurance Map indicates that the house originally had a one-bay porch at the entrance, but the 1929 and 1947 maps show that the porch had been enlarged to extend the full width of the façade. Sometime after 1947 the porch was altered again, extending from the doorway to the west, wrapping around the west elevation. In 2007 the two-story addition was constructed at the south half of the west elevation, and in 2012-2013 the porch was replaced with another wraparound porch, but the new porch is larger, extending 6' further to the west. The portion of the porch along the west wall of the house was enclosed with lapped siding and bands vinyl 1/1 windows. On the east elevation are two 1/1 windows on the first floor and three on the second, and these openings are segmental-arched. The house is noncontributing due to the two-story addition and reconfigured porch with enclosure.
