ARCHITECTURAL/HISTORIC INVENTORY FORM

1. Survey No. SC-AS-009-001		2. Survey Name: St. Charles Survey Phase 3: Mid-Town and Commons Neighborhoods	
3. County: St. Charles		4. Address (Street No.) 128	Street (name) North Sixth Street
5. City: St. Charles	Vicinity: <input type="checkbox"/>	6. UTM:	
7. Township/Range/Section:		8. Historic name (if known): Meyer-Pieper House; The Meyerdorf	
9. Present/other name (if known):		10. Ownership: <input checked="" type="checkbox"/> Private <input type="checkbox"/> Public	
11a. Historic use (if known): Domestic/single dwelling		11b. Current use: Domestic/single dwelling

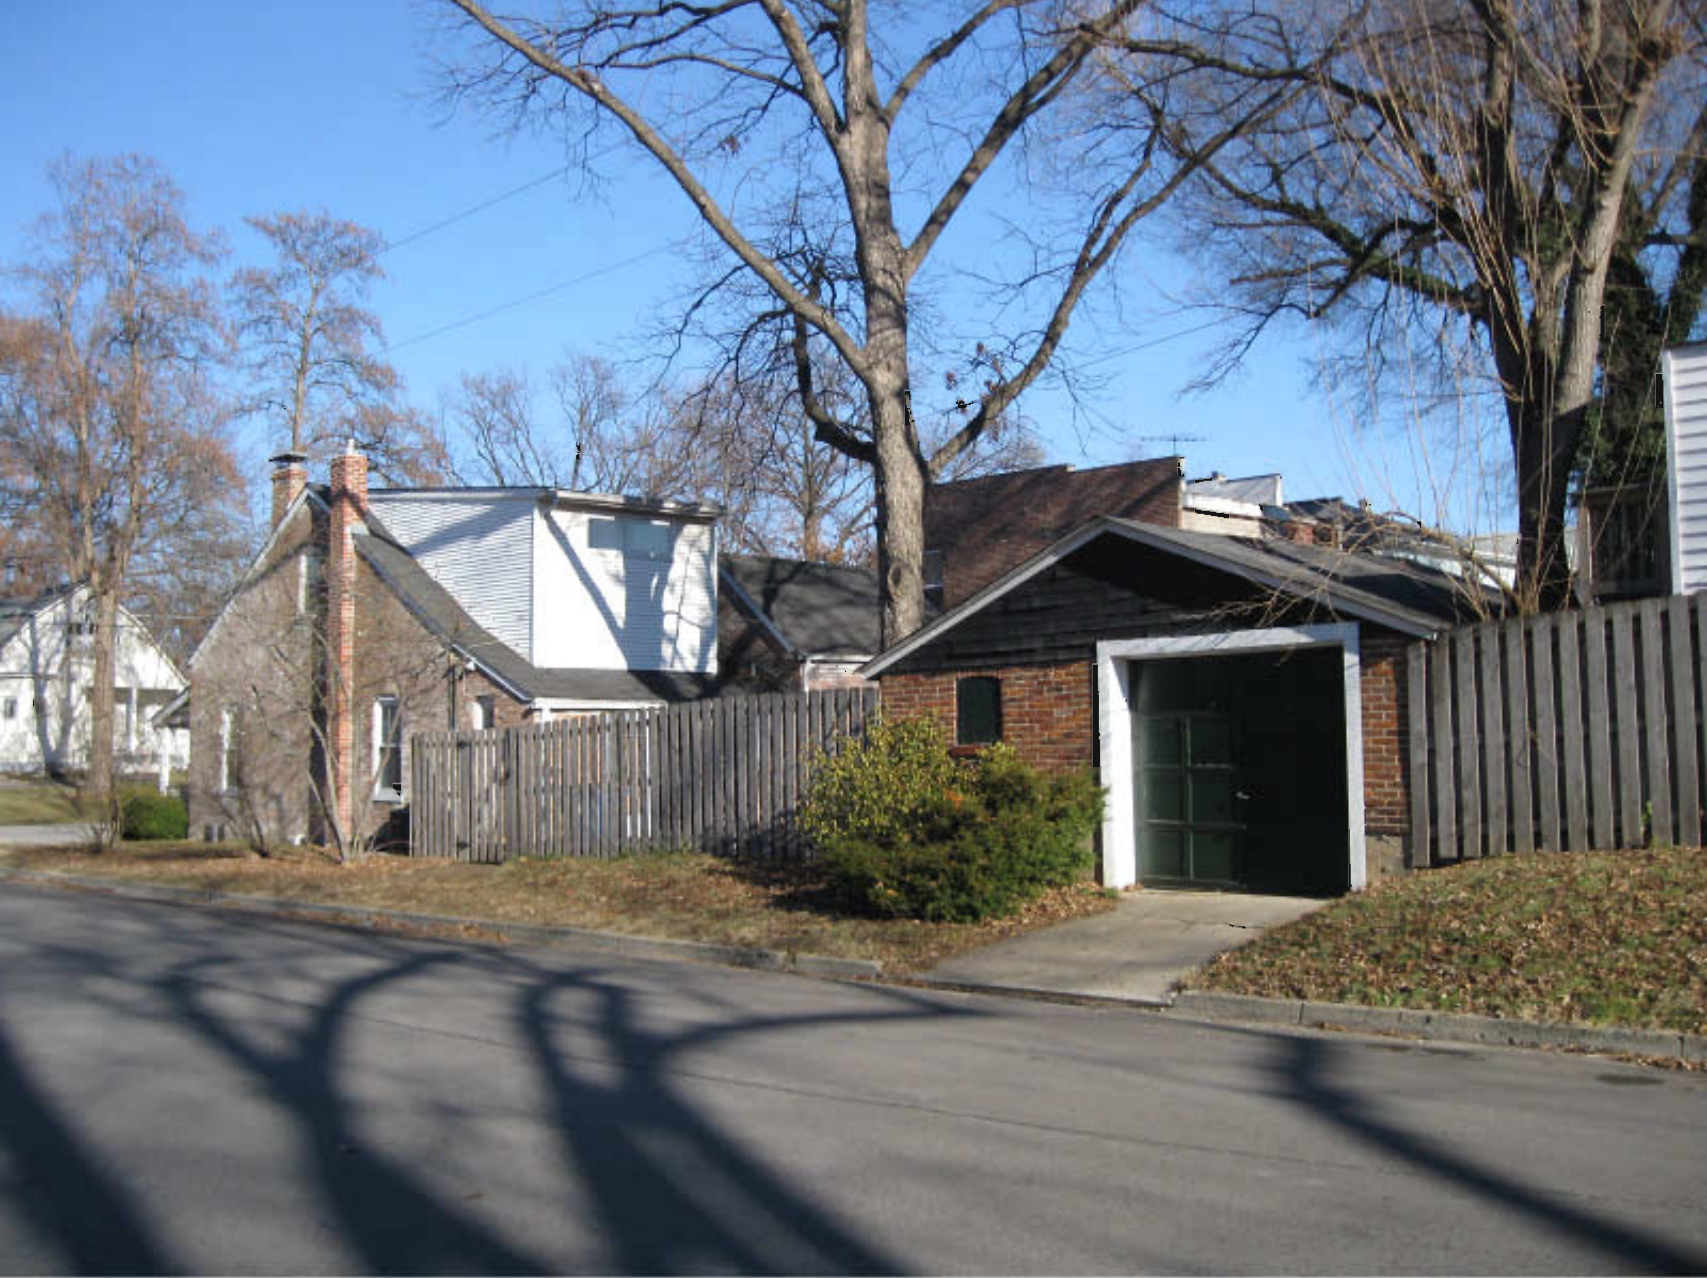
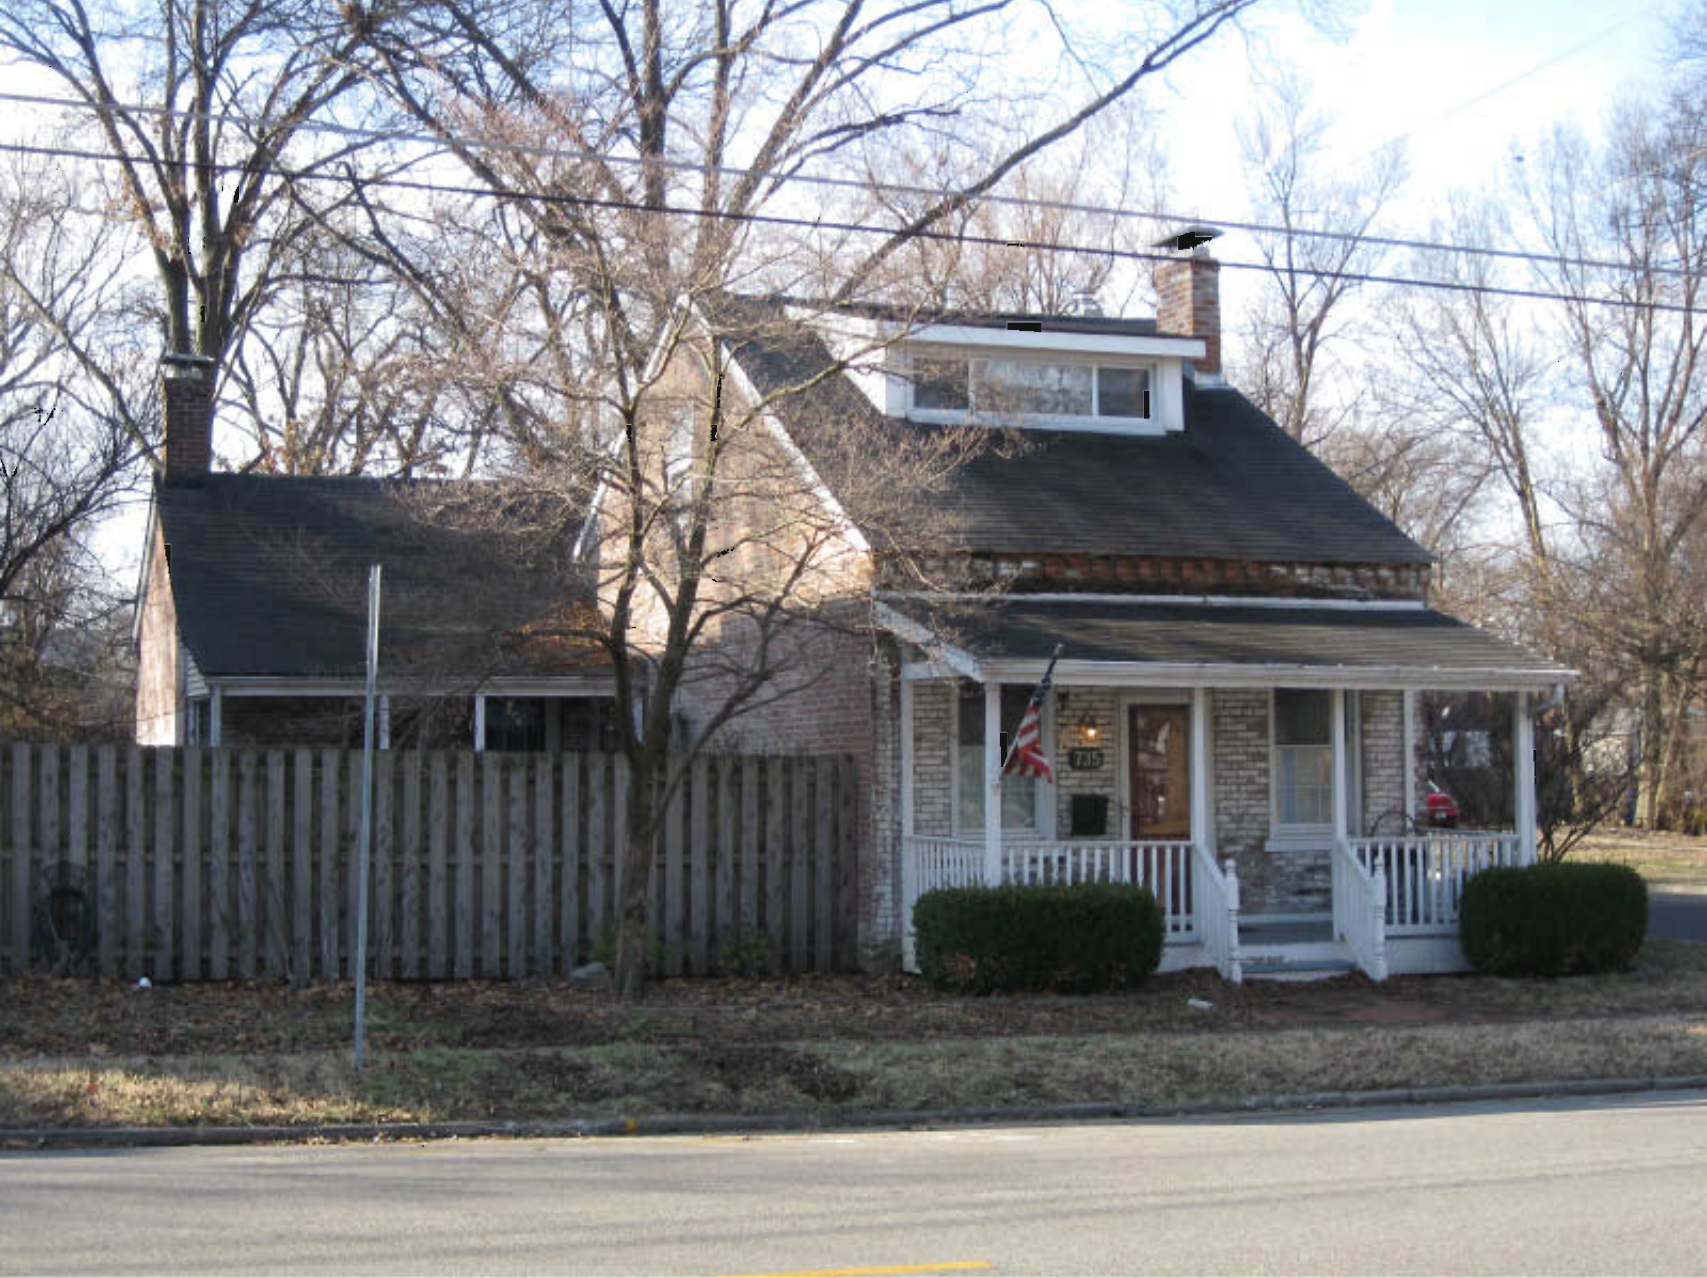
This one-and-one-half story, side-gabled, brick, Federal style house has a one-story, side-gabled, brick wing that extends from the south end of the east elevation, giving the house an L-shaped plan. This wing is shown on the earliest Sanborn Insurance map of this block, which was published in 1909, but its front porch was added sometime after the 1947 Sanborn map was prepared. A porch along the rear of the house extended to the west wall of the wing, but the addition was enclosed with brick after 1947. The house rests on a coursed rock-faced stone foundation and its roof is trimmed with a denticulated frieze. There is an interior end brick chimney on the west end of the front slope; an exterior end chimney on the west elevation (at the rear slope); and a straddle ridge chimney at the east end of the wing. On the front slope of the roof is a low shed dormer with sliding windows, and a large shed-roof addition is on the rear slope. The three-bay main façade has a central six-panel door topped by a four-light transom, and to each side is a 6/6 wood window. The segmental-arched openings are topped by jack arches and have wooden lug sills. The door opens onto a full-width gallery with wooden deck, plain wood balustrade, and wood posts supporting the shed roof. The Sanborn maps show that this porch was added between 1917 and 1929, and since this is a historic addition the house retains sufficient integrity to contribute to the district. The first floor of the west elevation has two 6/6 windows and in the enclosed porch is a small window that appears to be a 4/4 sash (it is partially obscured by the fence). In the upper half story is a 1/1 window. There appears to be a 6/6 window on the first floor and upper half story of the east elevation. The north elevation of the wing has a paneled door and 6/6 window, and the door opens onto a full-width gallery with plain posts supporting a shed roof. The wing is partially obscured by a privacy fence.

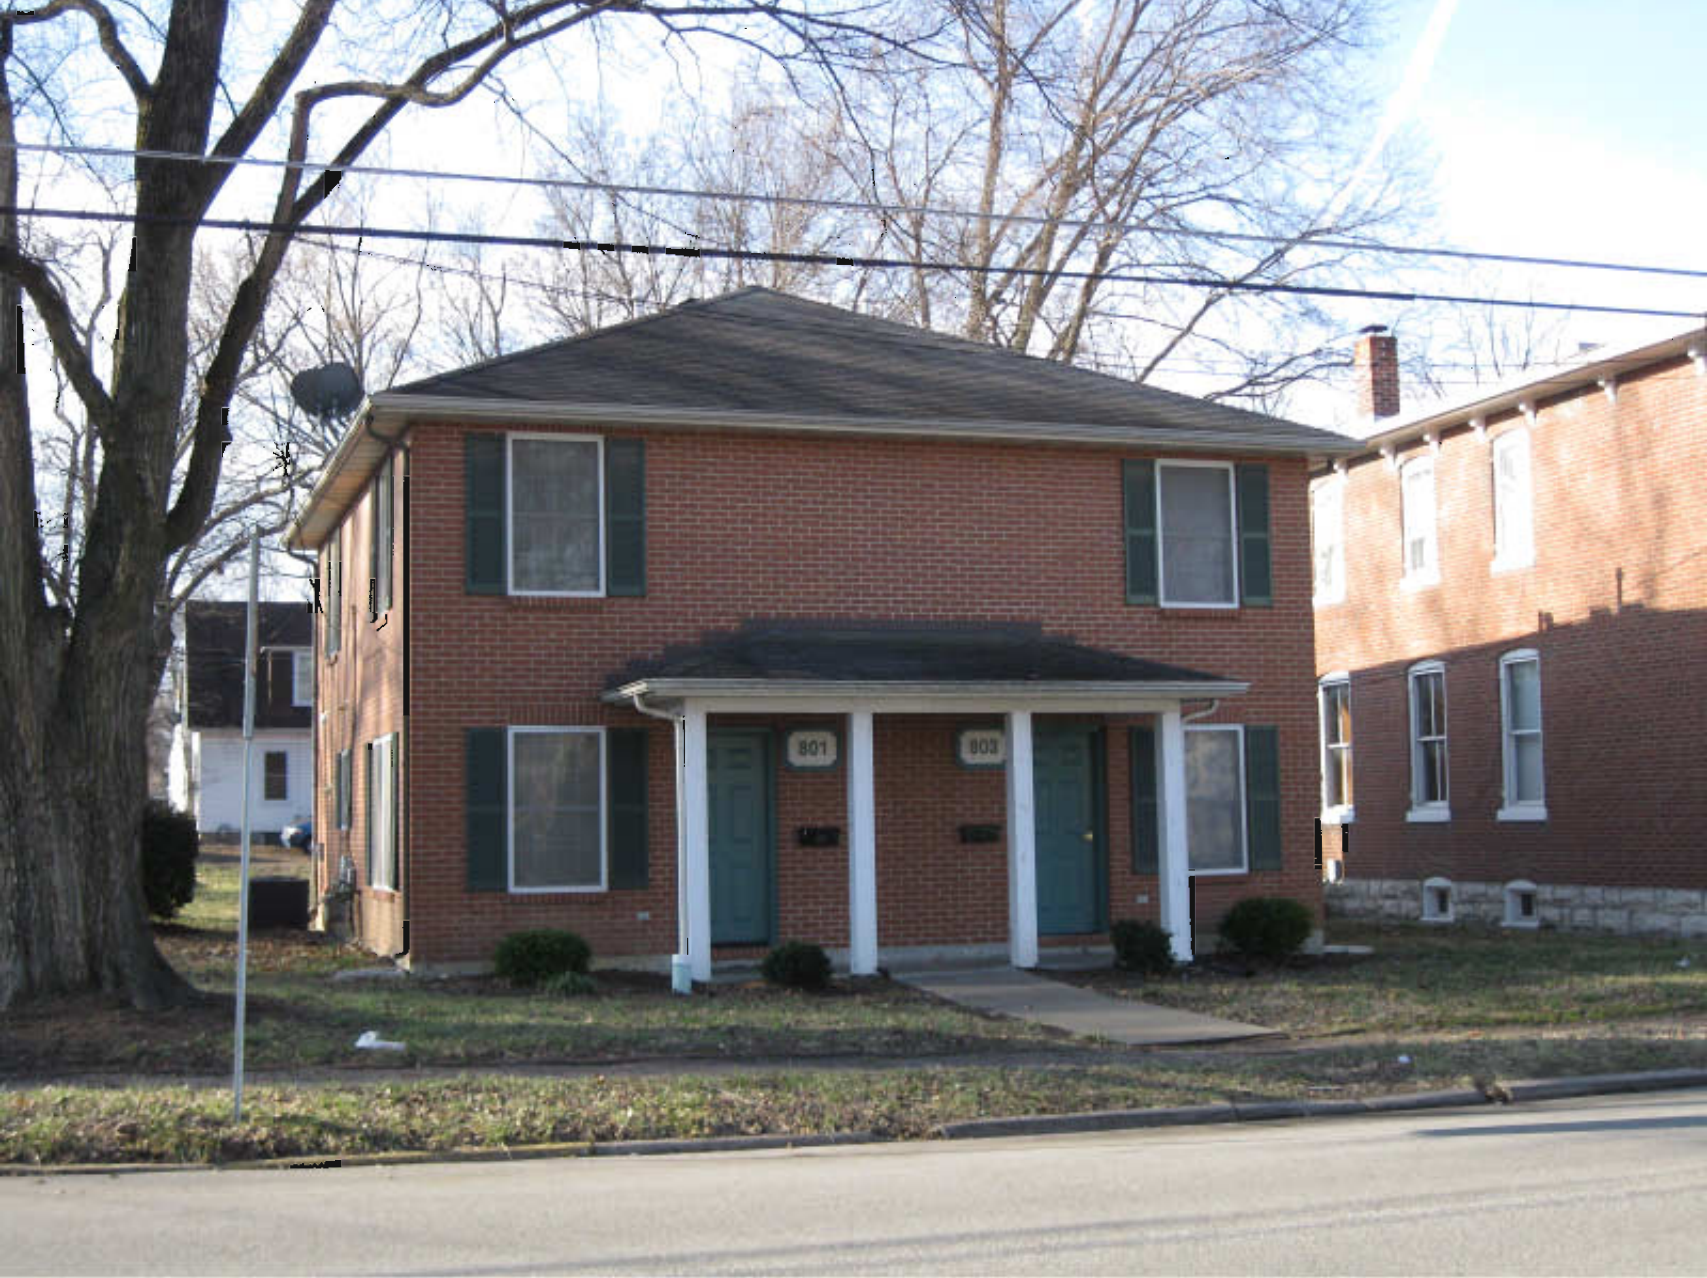
This two-story, brick duplex rests on a concrete foundation and is crowned by a pyramidal roof with wide overhanging eaves. A one-story, hipped wing is centered on the rear elevation, giving the duplex a T-shaped plan. The brick walls are laid in a running bond pattern, and openings have brick sills and jack arches. The first floor of the four-bay façade has six-panel metal doors in the center two bays and 8/8 windows in the outer bays. The doors open onto a one-story gallery with concrete deck at ground level and box columns supporting a hip roof. The second floor of the façade has two 8/8 windows aligned with the windows of the first floor. The first floor of both side elevations have a pair of 8/8 windows at the north end and a short 8/8 window, and on the second floor are two 8/8 windows. All windows have vinyl louvered shutters. Since the building was constructed only five years ago, it is noncontributing.

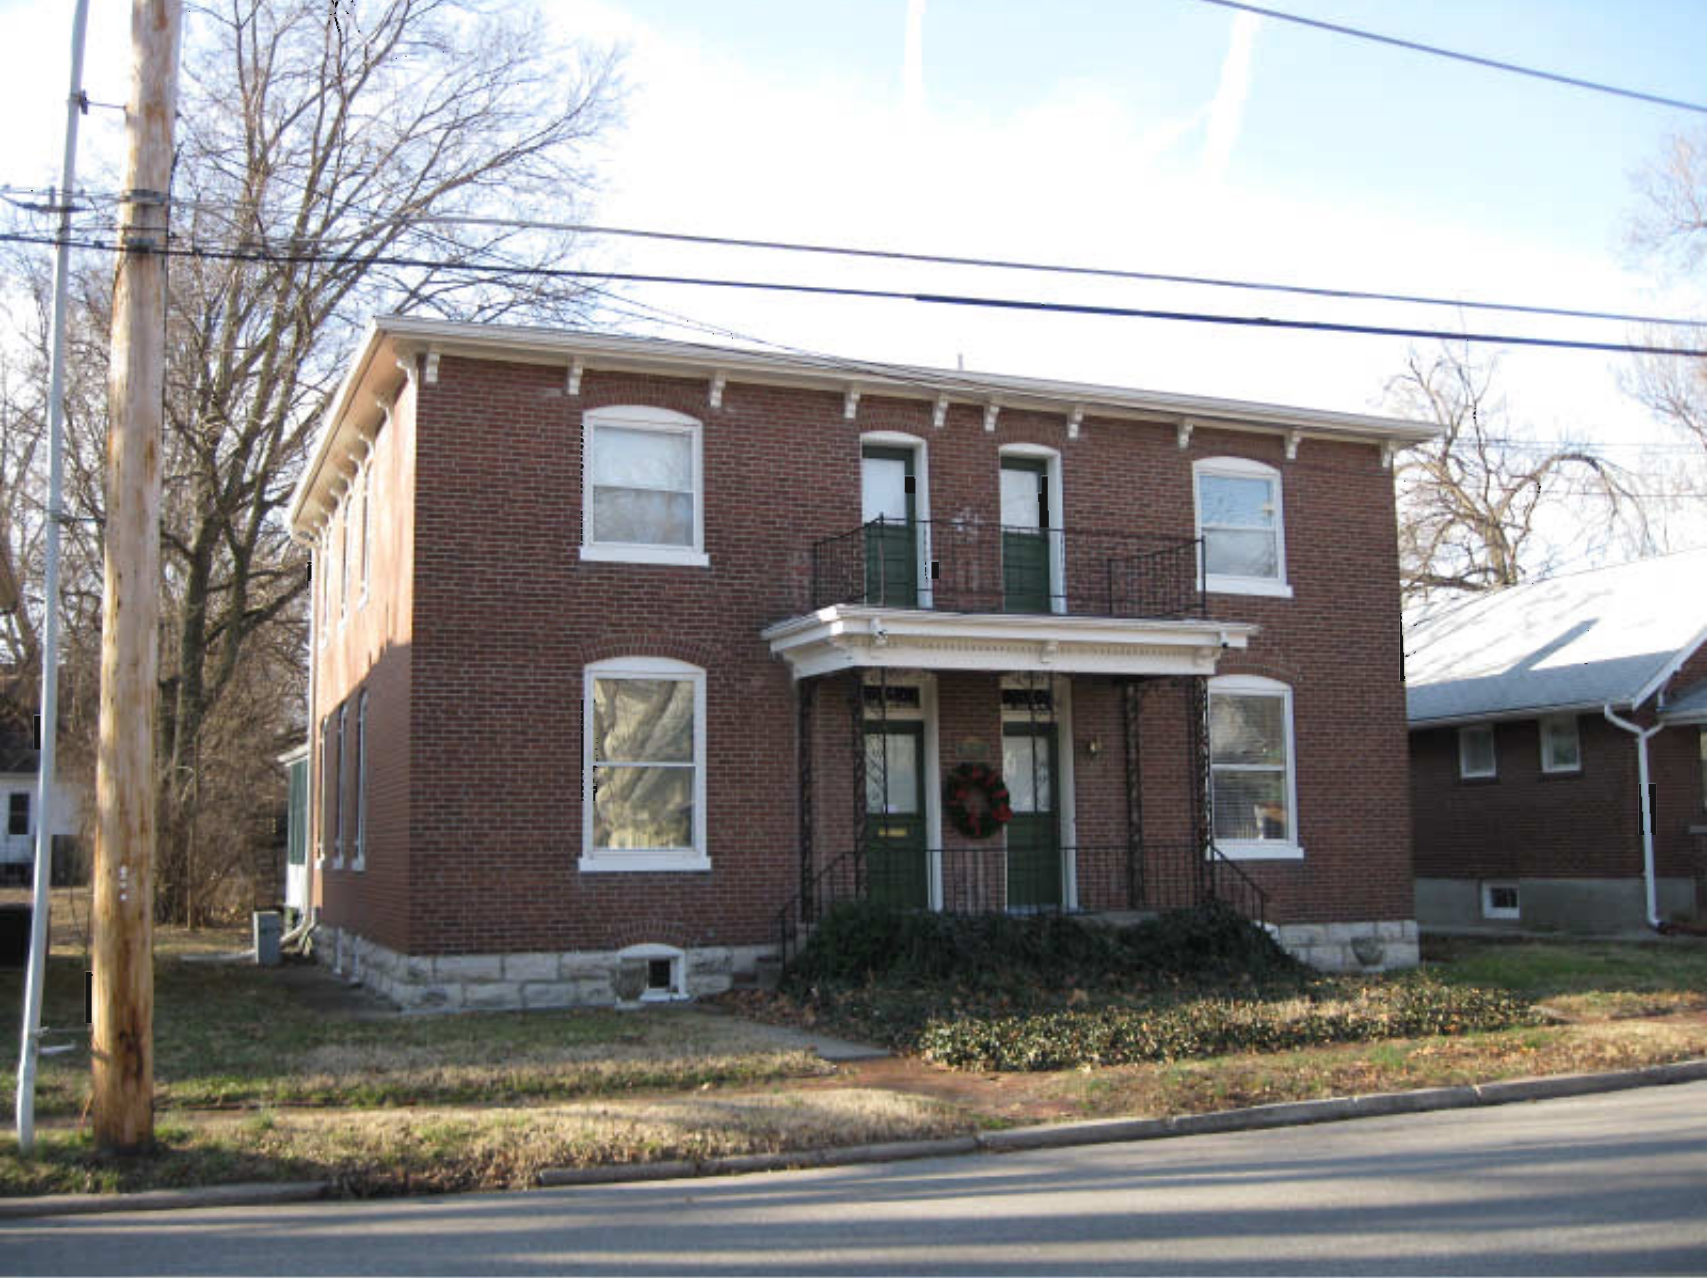
Facing north, this two-story, brick, Italianate style duplex rests on a coursed rock-faced stone foundation that is pierced by two-light basement windows. These segmental-arched window openings extend upward into the brick wall and are topped by radiating voussoirs. The brick walls are laid in a common bond pattern, with every sixth course being Flemish bond. The low hip roof has wide overhanging eaves with ornate sandwich brackets, and interior end brick chimneys are on the east and west slopes. In the center two bays of the four-bay main façade are half-glazed, three-panel wood doors topped by single-light transoms, and in the outer bays are wide 1/1 windows. Openings throughout the building are segmental-arched and are topped by radiating voussoirs, and the windows have wooden lug sills. The doors open onto a one-story, two-bay portico with flat roof that forms a balcony. The stairways at the east and west sides of the portico are concrete, as is the deck, and the posts and the railings on the first floor and roof are wrought iron. The roof is trimmed with a denticulated and bracketed entablature. The openings on the second floor of the façade are shorter than those of the first story. In the center two bays are half-glazed, three-panel doors that do not have transoms, and the doors open onto the balcony. In the outer bays are 1/1 windows. Each side elevation has three windows on each floor: those at the north end are 1/1 sash while the others are 2/2 sash, and all apparently originally had shutters since they retain shutter hardware. A one-and-one-half story, brick wing is centered on the rear elevation and has one-story, shed-roofed porches along the east and west elevations.

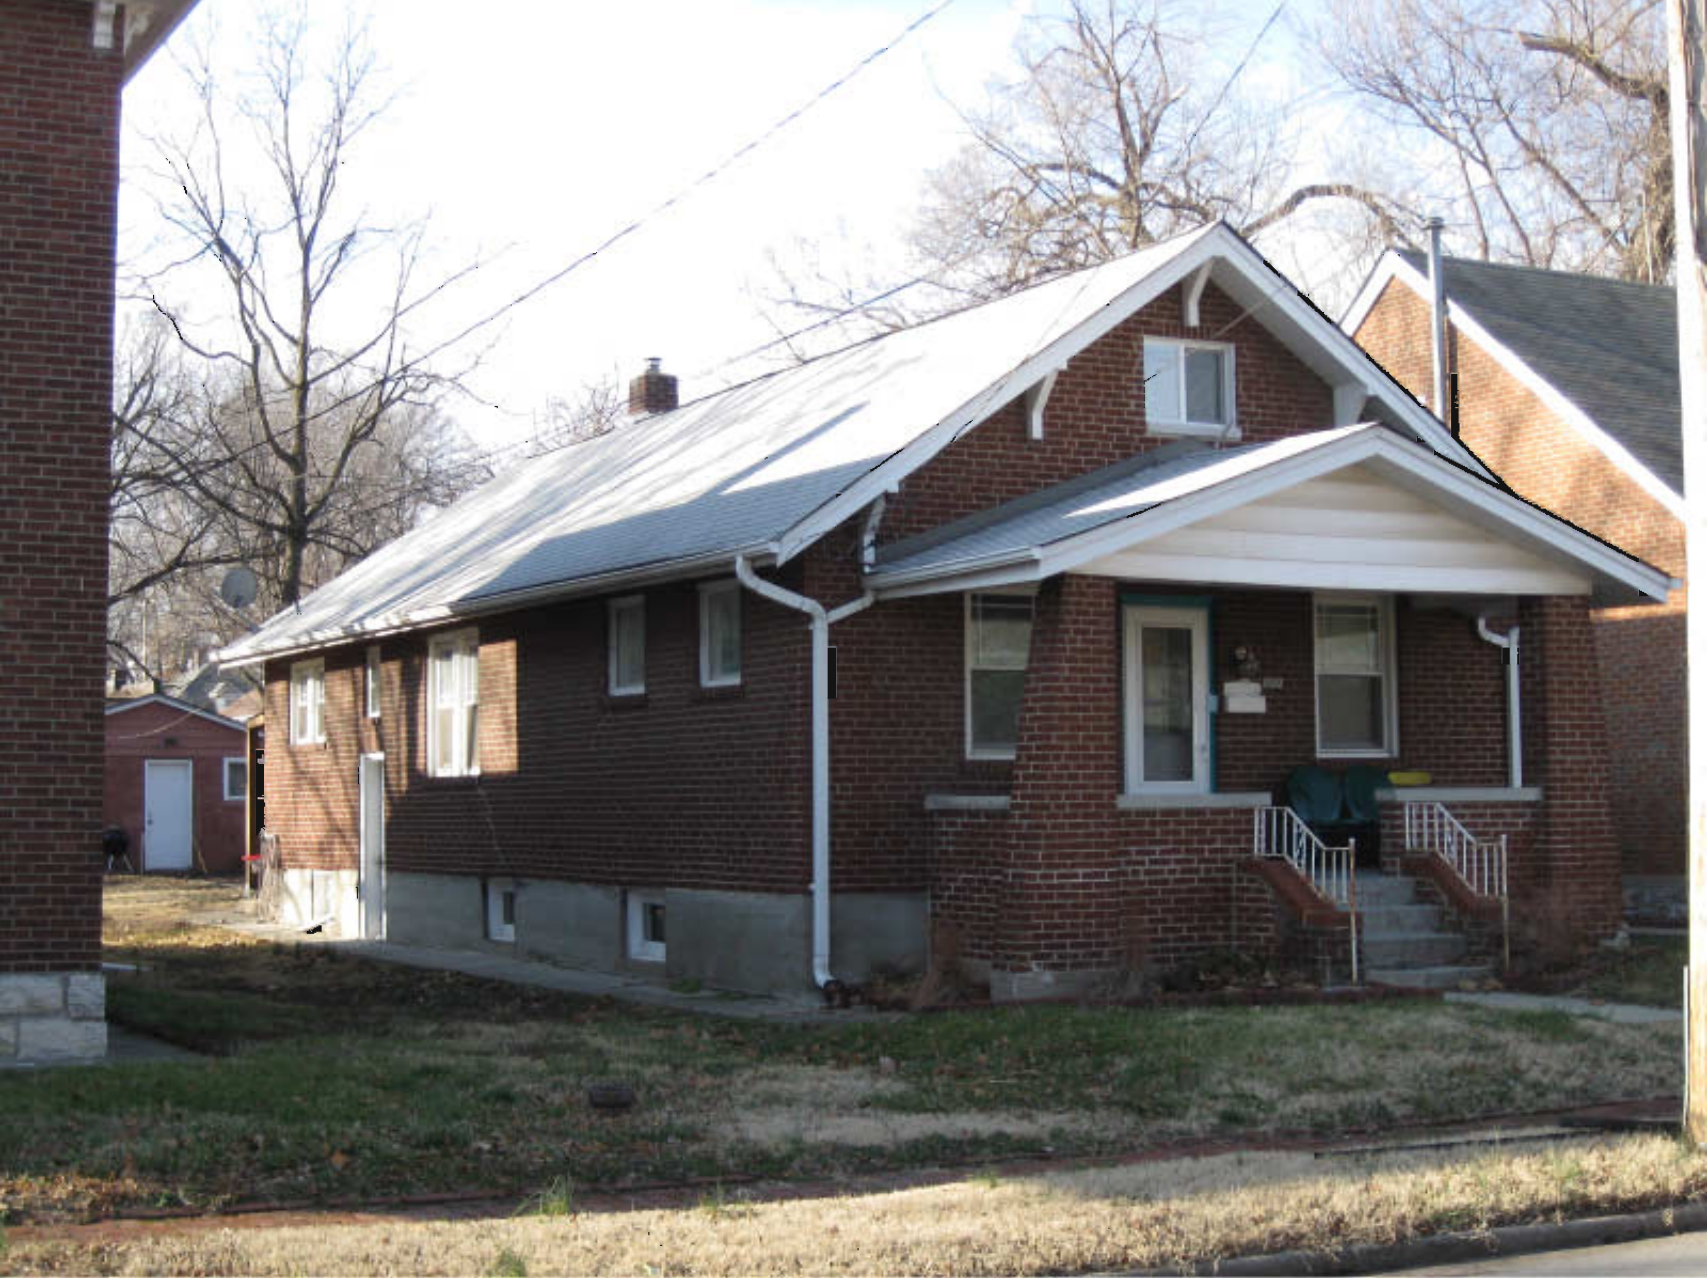
Facing north, this one-and-one-half story, front-gabled, brick bungalow rests on a concrete foundation pierced by two-light basement windows. The brick walls are laid in a common bond pattern, with every sixth course being Flemish bond. The front-gabled roof has wide overhanging eaves, knee braces in the gable end, and an interior brick chimney on the west slope. The center bay of the three-bay main façade holds a replacement half-glazed door with nine lights, and to each side is a window that has an upper sash with muntins set near the perimeter and a single-light lower sash. The openings are topped by jack arches and the windows have brick lug sills. The door opens onto a ¾-width gallery with concrete stairway framed by sloped brick knee walls, concrete deck, battered brick piers that extend to the ground, brick railing with concrete coping, and gabled roof. The gable end of the porch has been clad with vinyl siding, and the soffits throughout the house have also been clad in vinyl. In the upper half story is a two-light sliding window. The west elevation has three windows like those of the façade, and the east elevation has two small stained glass windows at the north end, paired windows, a door at ground level with a small window above, and a pair of short windows.

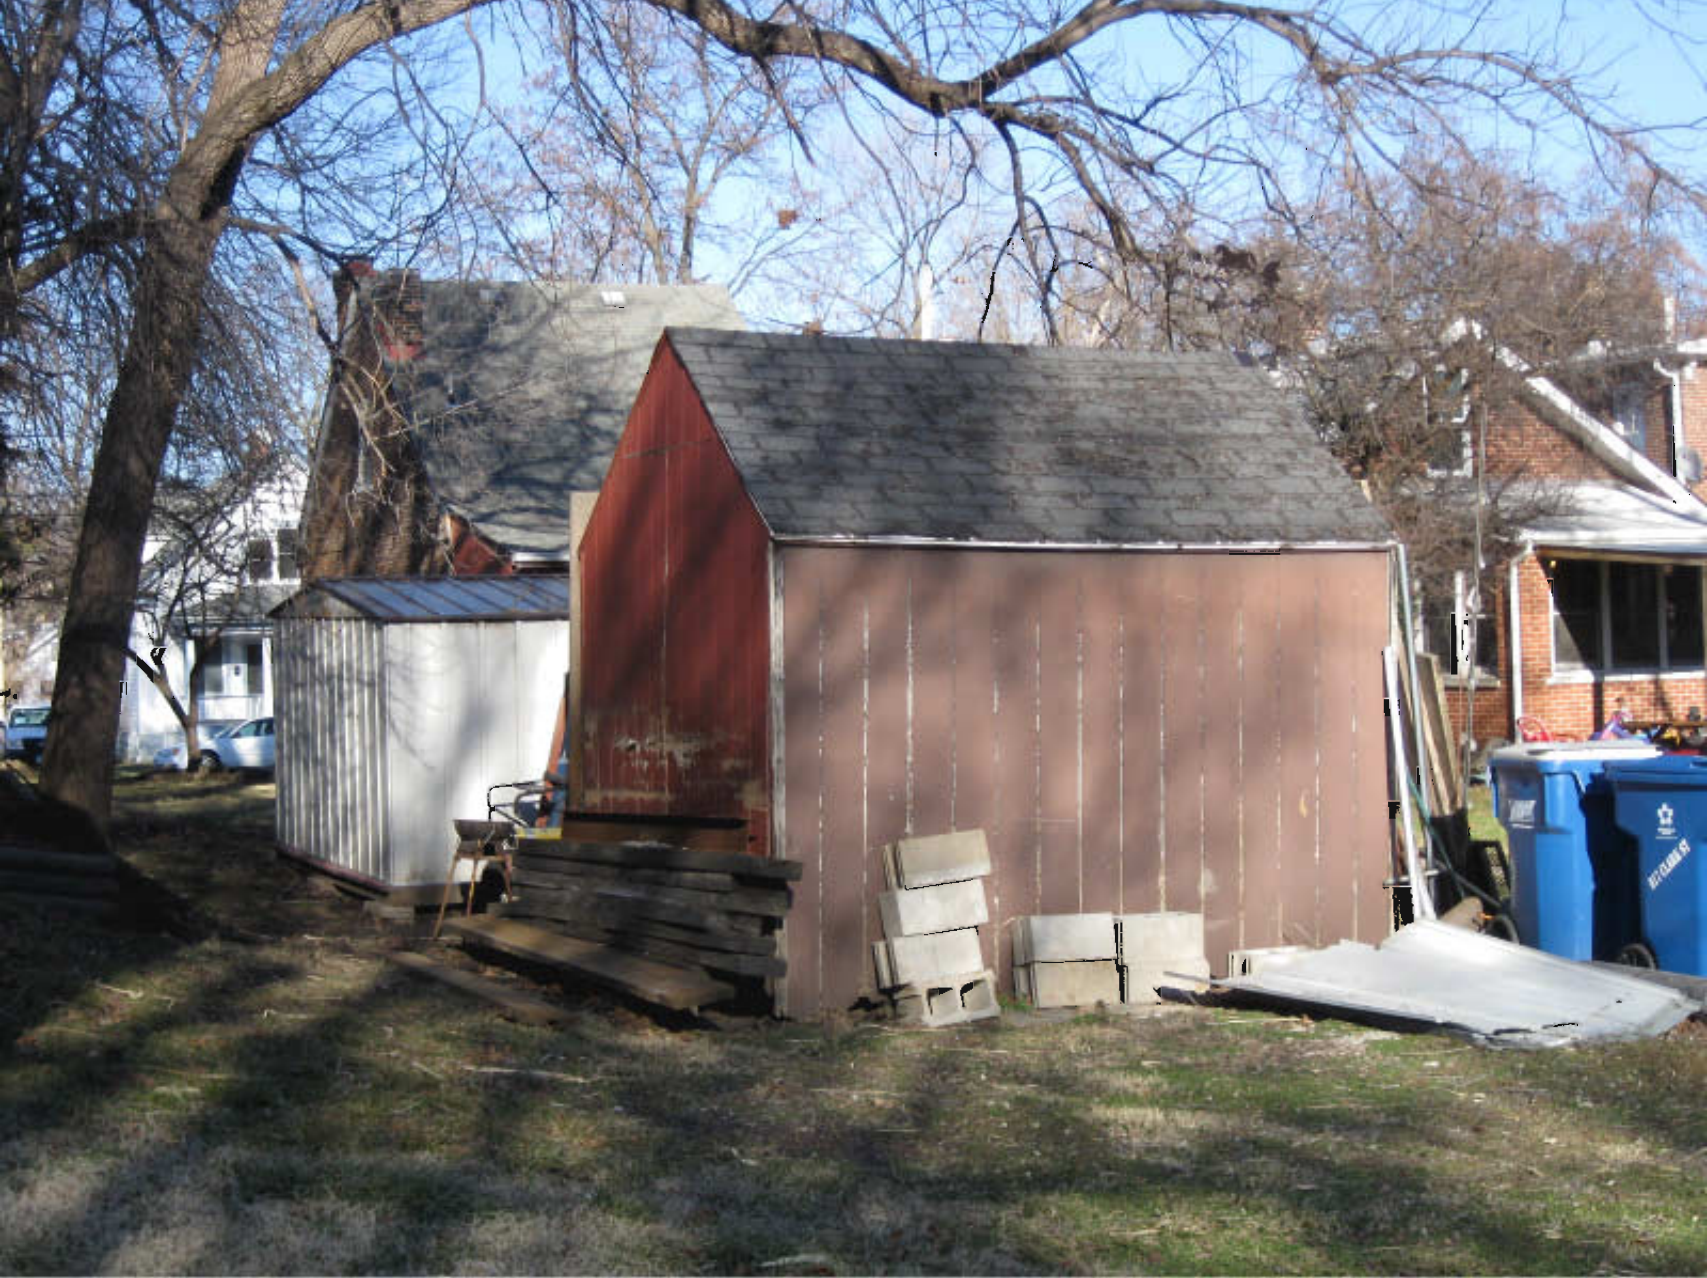
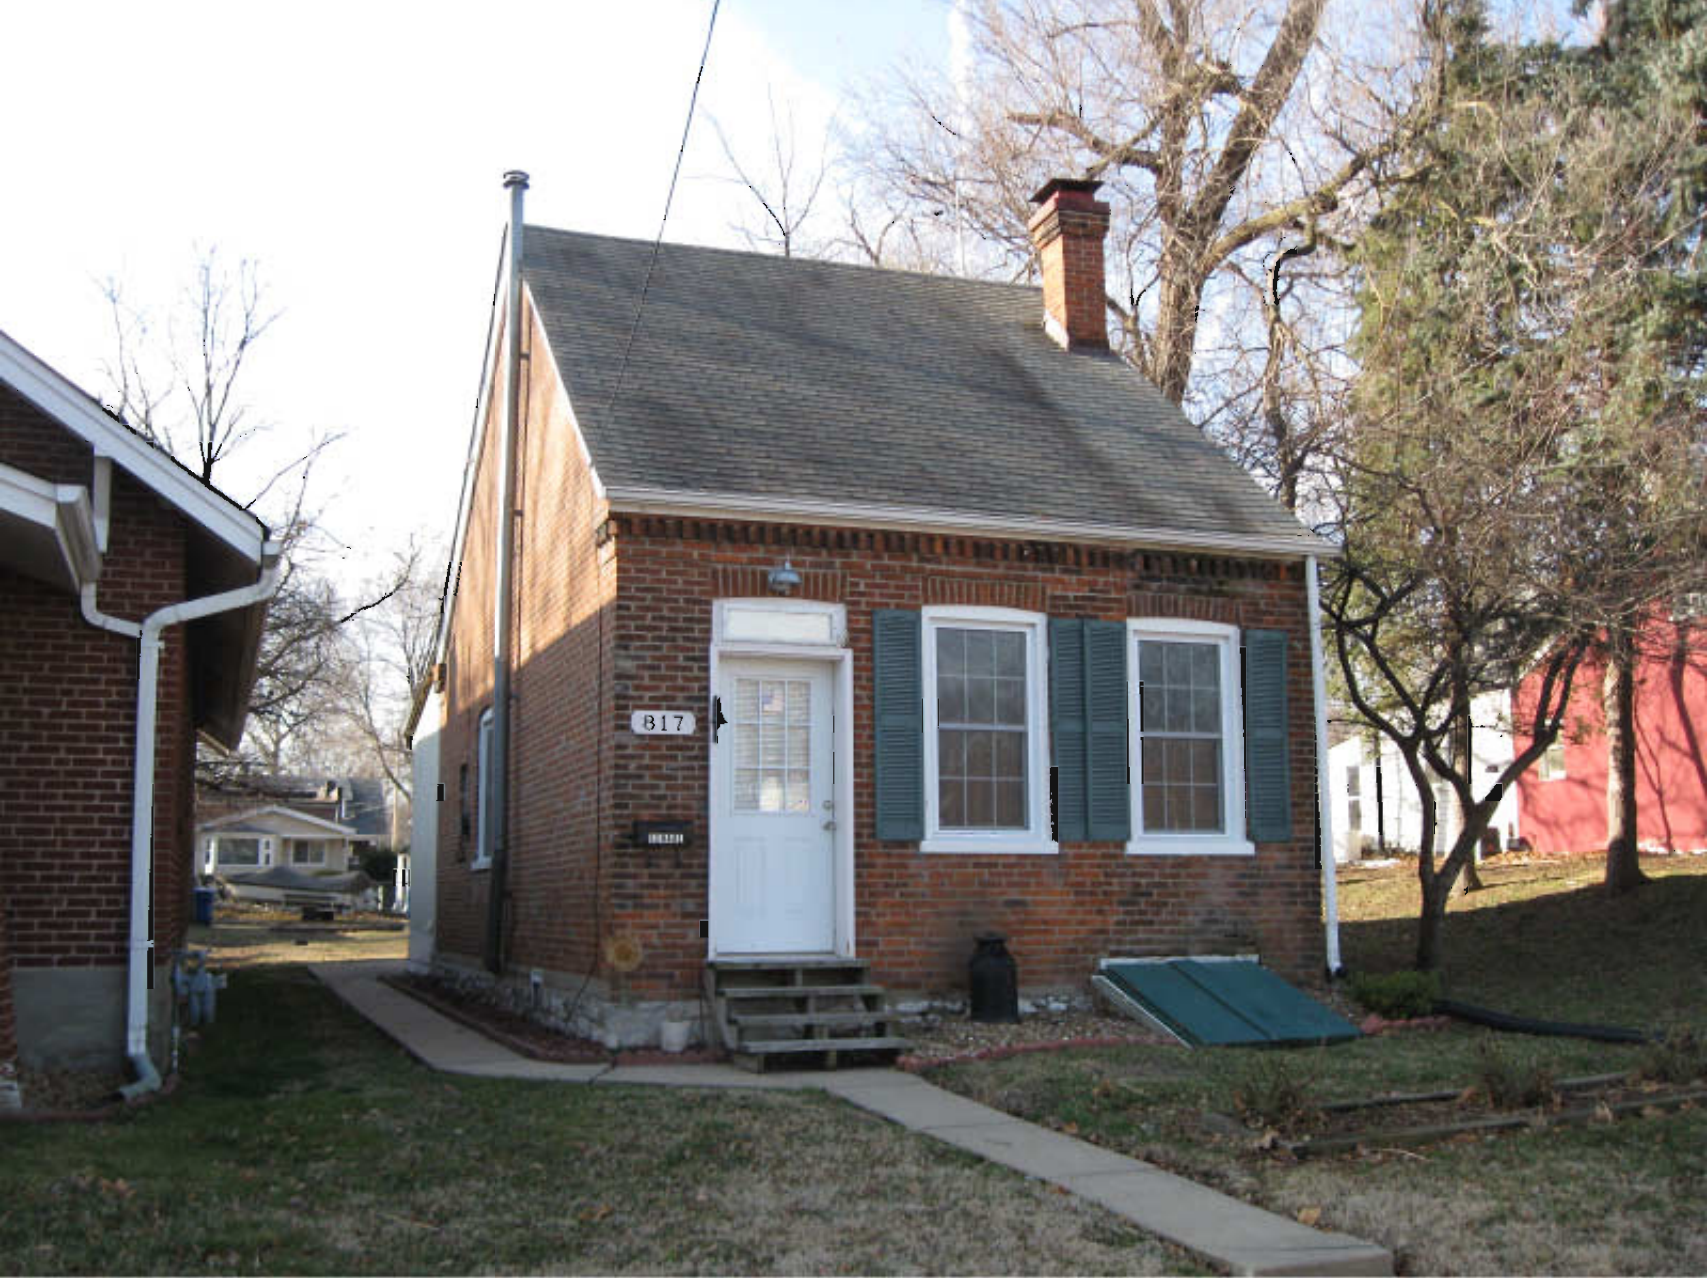
This diminutive one-and-one-half story, side-gabled, brick, Federal style cottage rests on a coursed rock-faced stone foundation, and on the main façade is a wooden bulkhead that provides access to the cellar. The bricks are laid in a running bond pattern on the façade and a seven-course common bond on the other elevations. The side-gabled roof is trimmed with a denticulated frieze with returns, and interior end chimneys are on the west end of the front and rear slopes. In the eastern bay of the three-bay main façade is a replacement half-glazed (9 lights over 2 panels) door that is topped by a transom that appears to be covered. The door opens onto a wooden stairway with four steps and plain wood hand rails. To the right are two replacement 6/6 windows. Openings throughout the house are segmental arched and are topped by jack arches, and the windows have wooden lug sills. The east and west elevations have a window on each floor and an additional small window opening has been cut at the south end of the east elevation. A shed-roof porch originally spanned the rear elevation but it was enclosed between 1917 and 1929. The walls of the enclosed porch are finished with vertical board siding.

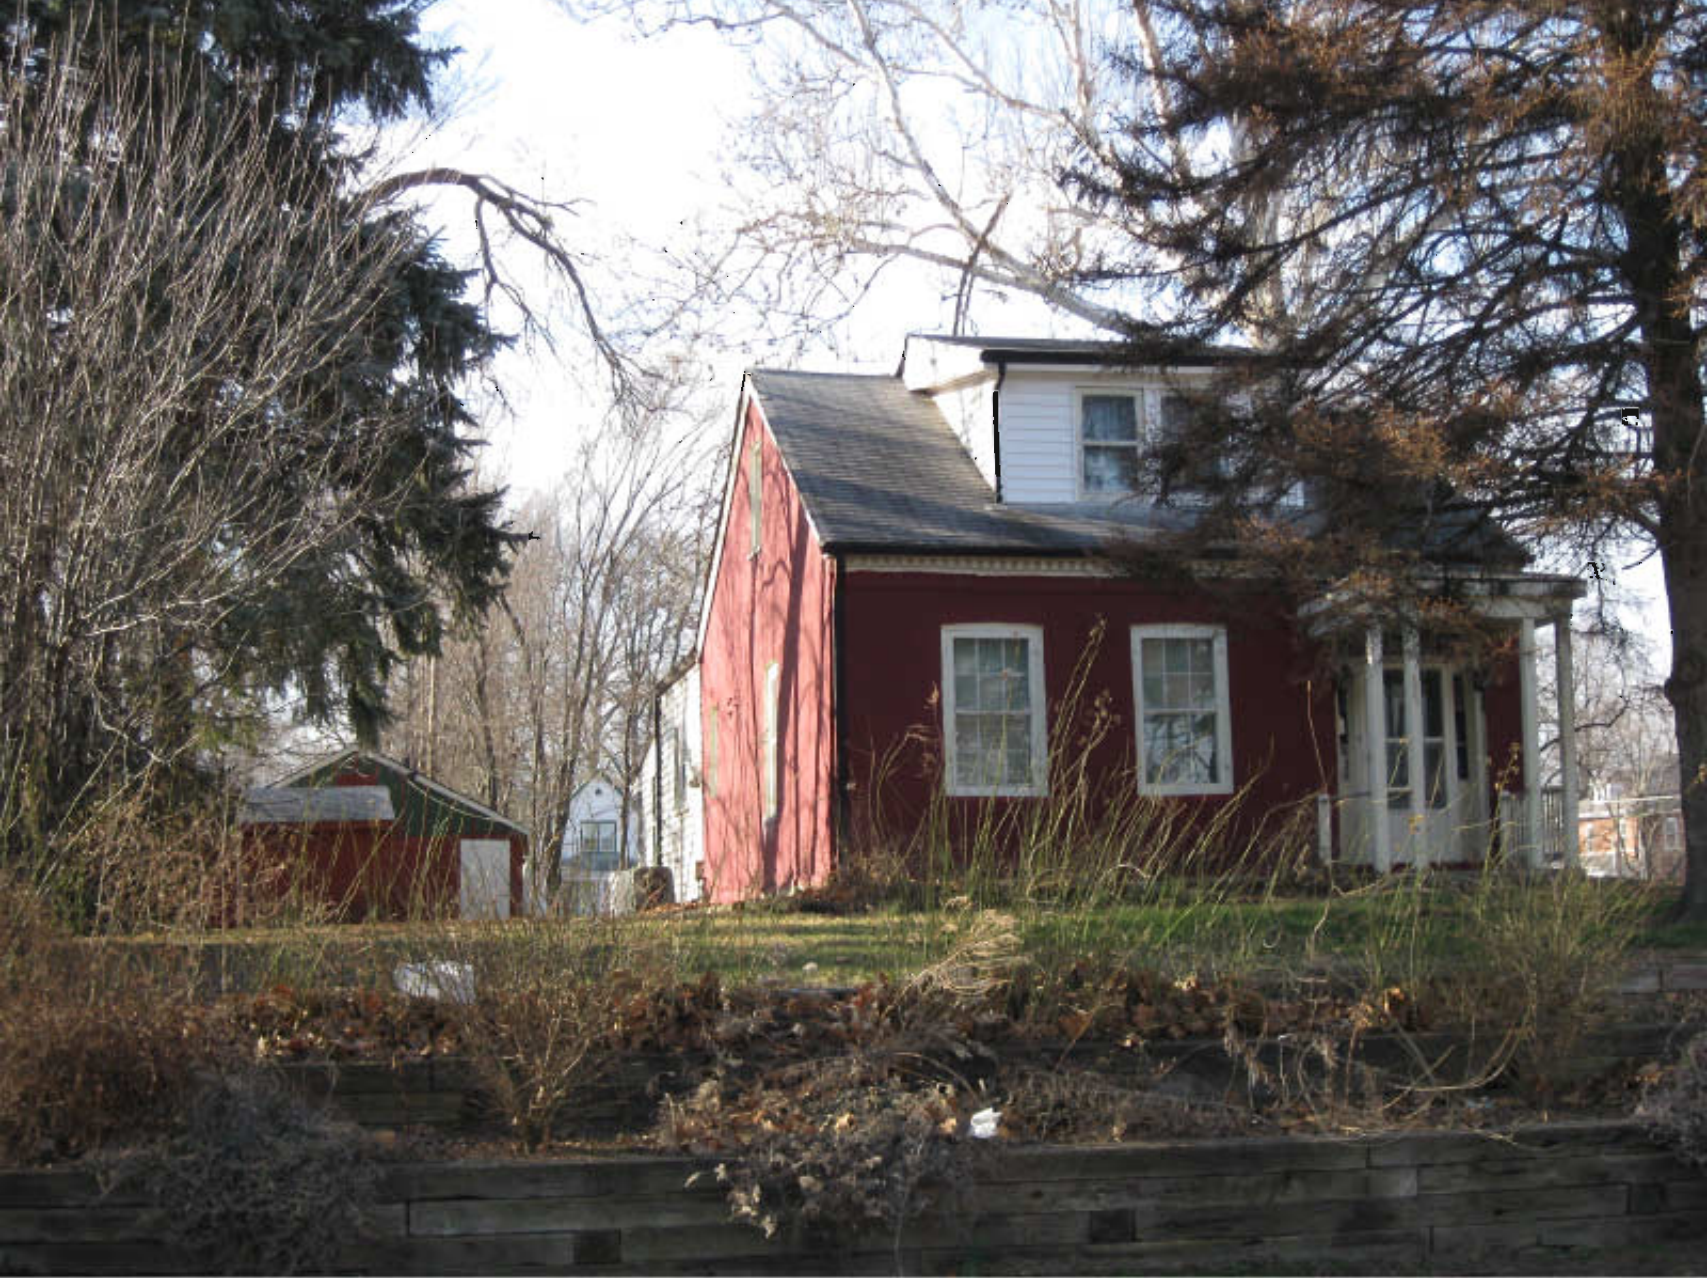
Situated further from the street than other houses on the block, this structure is a one-and-one-half story, side-gabled, brick, Federal style building. The 1917-1947 Sanborn Insurance maps show that the house had an L-shaped plan due to the existence of a masonry wing that extended from the south half of the east elevation, but it is no longer extant. Two frame additions—one gabled and one with a shed roof—extend along the rear of the house, which now has a rectangular plan. The high side-gabled roof is trimmed with a denticulated entablature and a dormer with paired 1/1 windows and walls finished with vinyl siding has been added to the front slope. It appears that the dormer originally had a shed roof but a side-gabled roof was added over it. A deteriorated interior brick chimney is on the east slope of the gabled rear addition. The foundation has been parged with concrete and the brick walls have been painted. The entrance is in the western bay of the three-bay main façade, and it is a half-glazed wood door with three vertical lights. The door is topped by a nine-light transom and to each side is a three-light sidelight set above a molded skirt. Various colors of glass appear in the transom and sidelights. The door opens onto a one-bay portico with concrete deck, paired square posts, a plain balustrade, and low hipped roof. To the east of the entrance are two 6/6 wood windows set in slightly arched openings, and below the windows are wooden lug sills. The west elevation has a 6/6 window on each level, and the east elevation has two windows on the first floor and one in the upper half story.

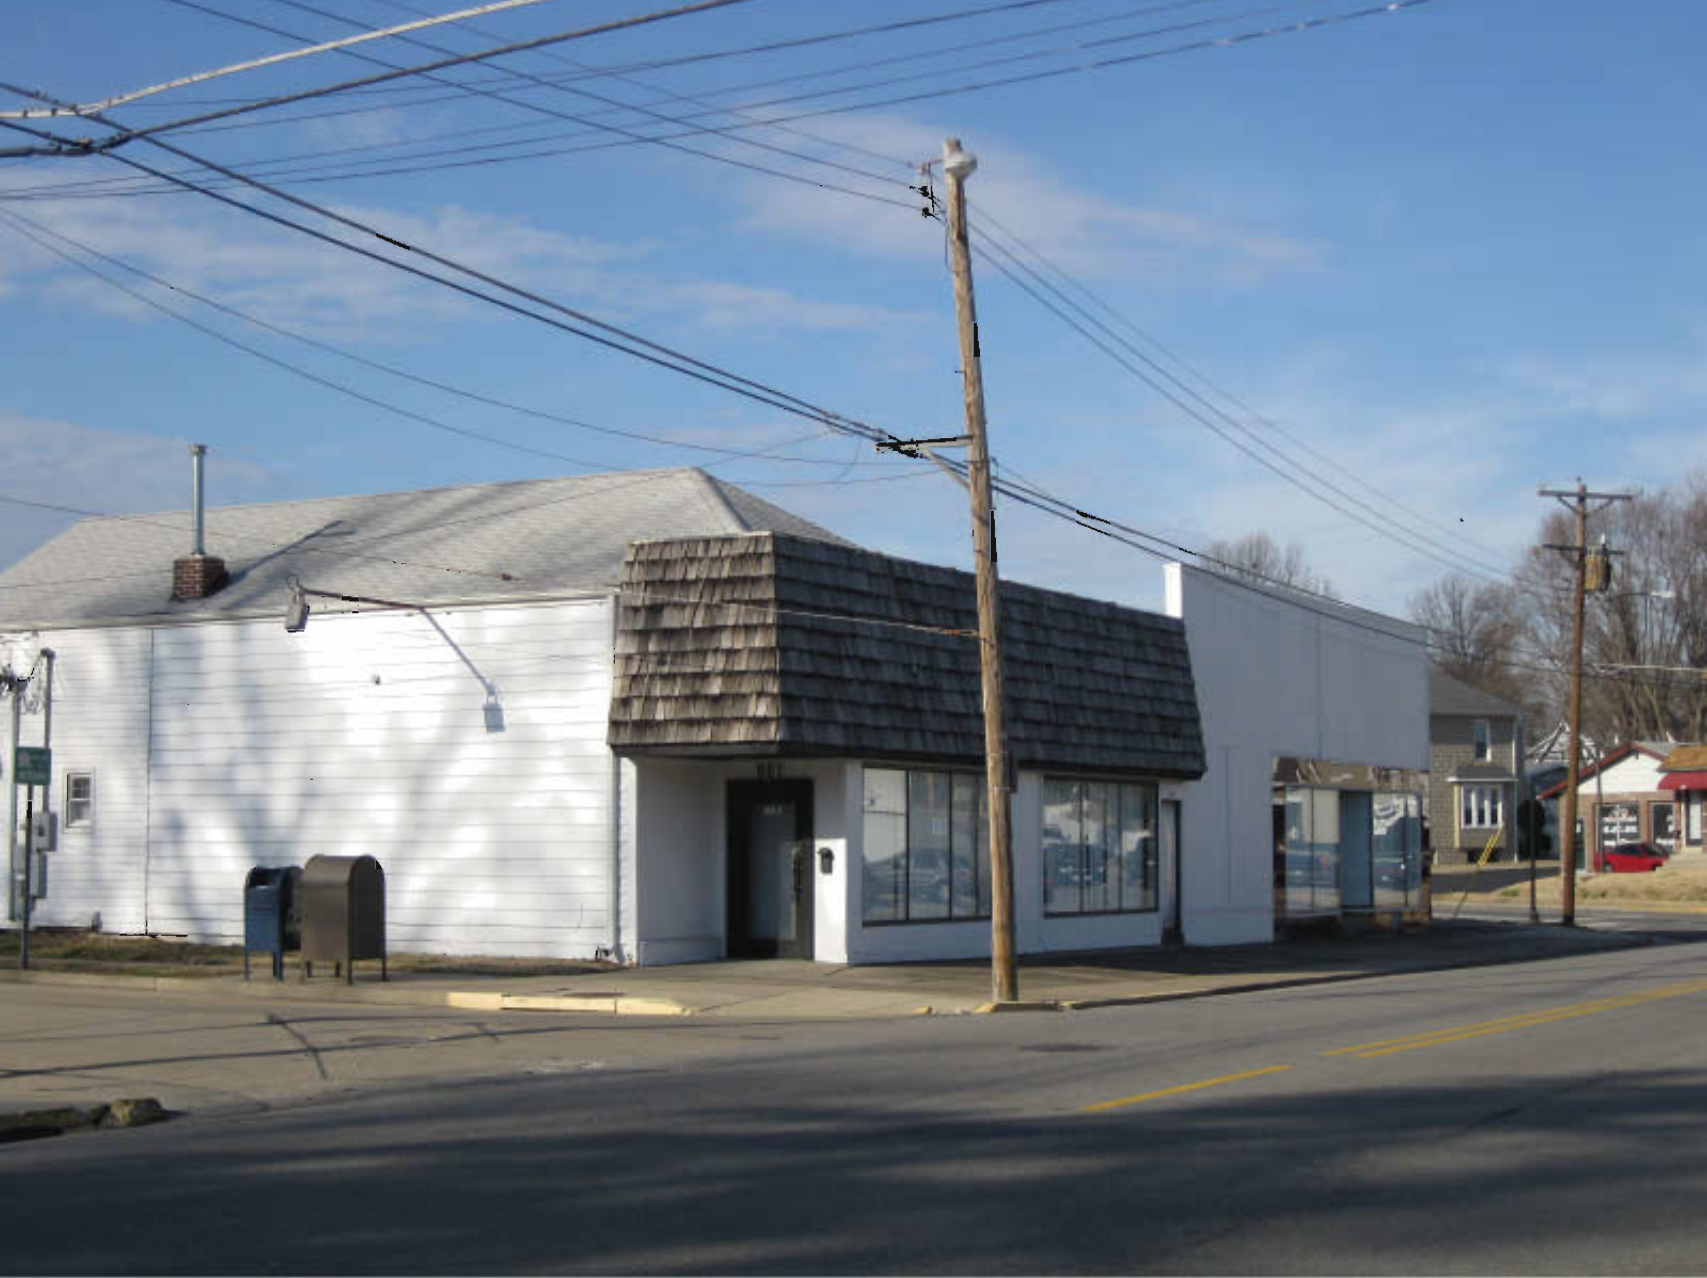
This commercial building was originally two separate buildings (901 and 903 Clark), but an addition was constructed between the two to create one building, and numerous other additions have also been built. The walls are clad in a variety of materials: the north façade is clad in flush board siding, with the boards laid diagonally; the east elevation is finished with vinyl siding and vinyl Dutch lap siding; and the west elevation is finished with vinyl and Bricktex asphalt siding. The roof is complex, being hipped at the east end and gabled at the north, with a flat roof between the two. Interior brick chimneys pierce the east slope of the hip roof and the west slope of the gable roof. The north façade is divided into two storefronts. The eastern storefront has a glazed door at the northeast corner, facing east, and to the west are two three-light display windows. A wood shingled mansard has been added above this storefront. To the west are a glazed door and another storefront featuring a recessed glazed wood door flanked by display windows. Immediately surrounding the western storefront is carrara glass in poor condition, and the upper wall forms a parapet or false front at the gable end. A one-car garage addition is on the west elevation and features a shed roof with the north wall forming a false front. The overhead door on the north façade is a paneled wood door.
