ARCHITECTURAL/HISTORIC INVENTORY FORM

1. Survey No. SC-AS-009-001		2. Survey Name: St. Charles Survey Phase 3: Mid-Town and Commons Neighborhoods	
3. County: St. Charles		4. Address (Street No.) 128	Street (name) North Sixth Street
5. City: St. Charles	Vicinity: <input type="checkbox"/>	6. UTM:	
7. Township/Range/Section:		8. Historic name (if known): Meyer-Pieper House; The Meyerdorf	
9. Present/other name (if known):		10. Ownership: <input checked="" type="checkbox"/> Private <input type="checkbox"/> Public	
11a. Historic use (if known): Domestic/single dwelling		11b. Current use: Domestic/single dwelling

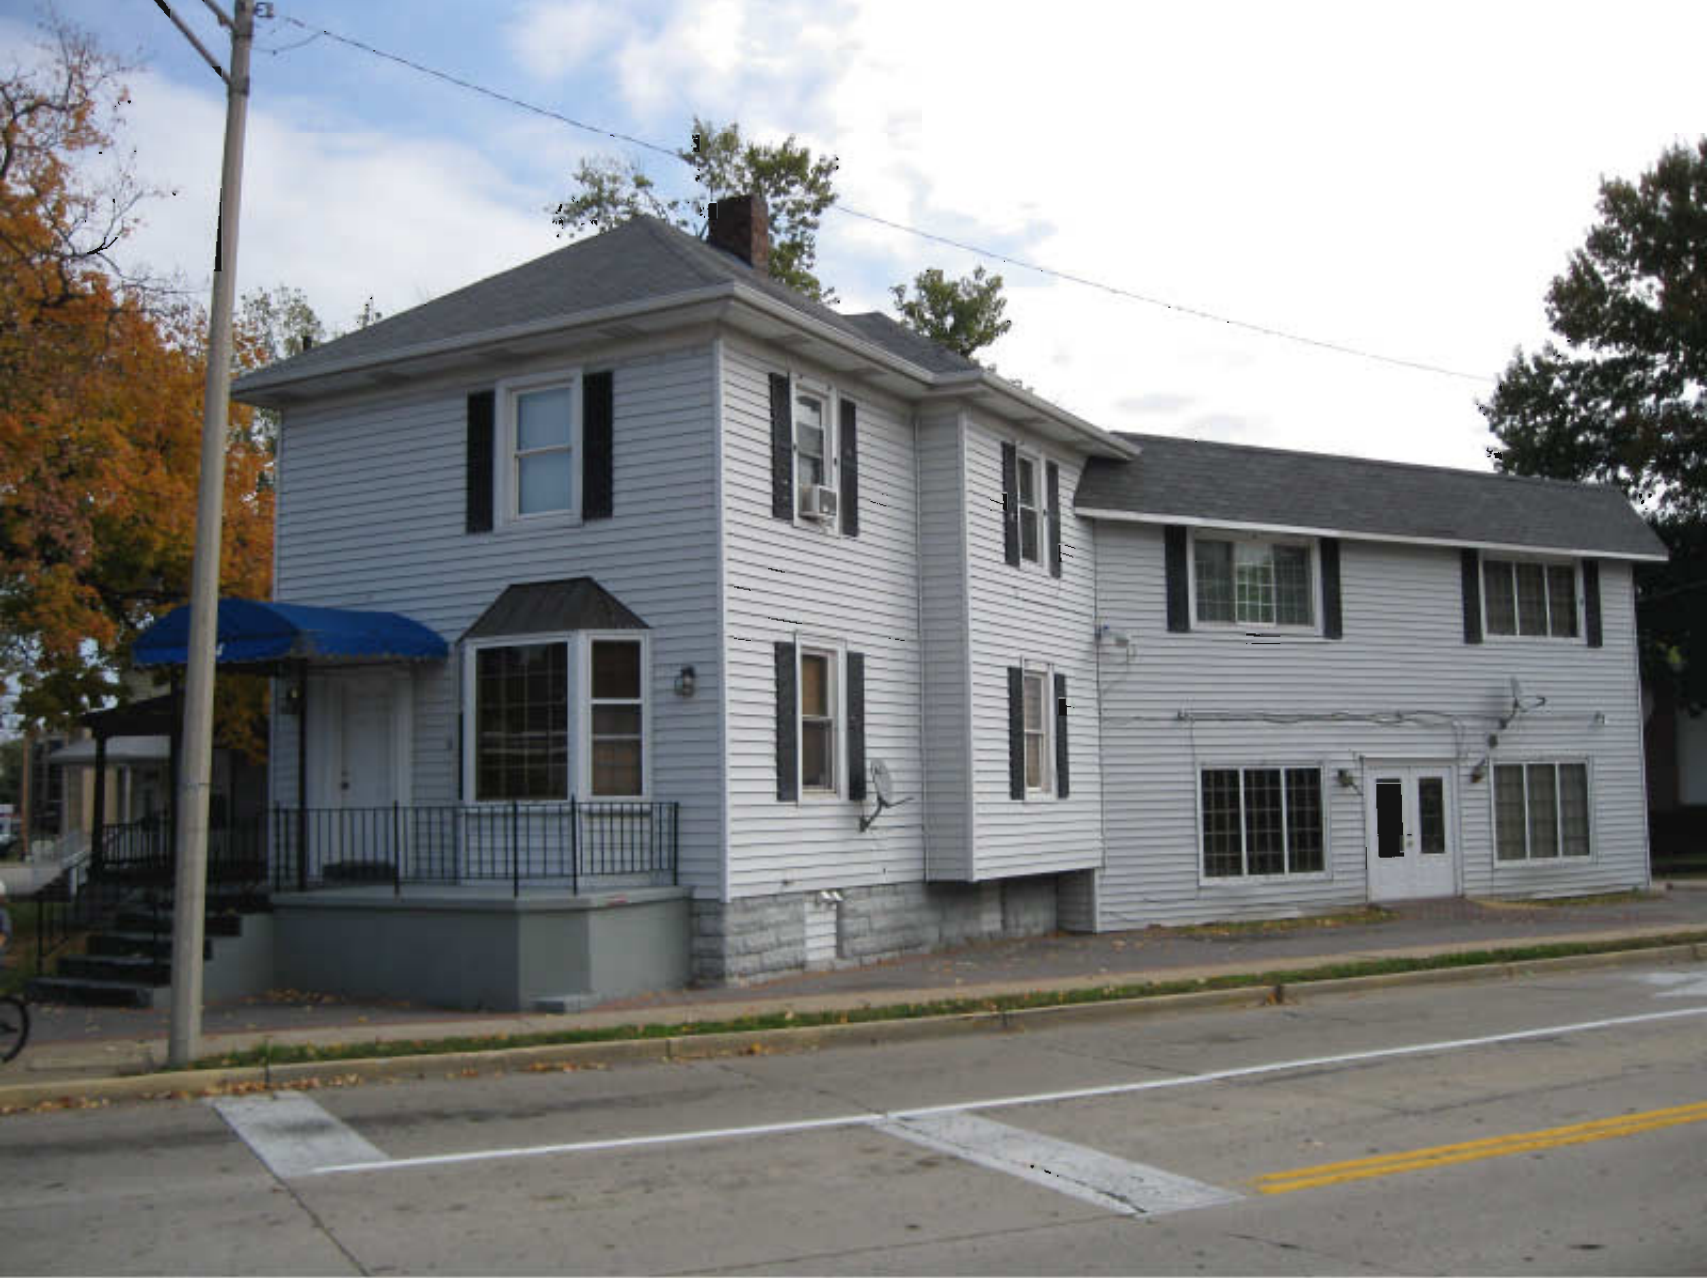
This house is a two-story, frame structure that rests on a rusticated concrete block foundation and the walls are finished with vinyl siding. The pyramidal roof has wide overhanging eaves, and a brick chimney straddles the ridge. The entrance is located at the left end of the two-bay main façade, and it is a six-panel metal door with classical frontispiece. To the right of the entrance is a replacement polygonal bay window that has multi-light windows and a standing seam metal roof. A full-width concrete stoop spans the façade and has a concrete stair with five steps and a wrought iron railing, and a round-arched canvas awning extends from the entrance to the top of the stairway. The second floor of the main façade has a single 1/1 window that is aligned with the first floor window. The north elevation has one 1/1 window on the first floor and three on the second. The south elevation has two bays, with the eastern bay projecting slightly, and there are two 1/1 windows on each floor. A large two-story addition extends across the rear elevation, projecting beyond each side elevation. Facing Monroe Street, the south elevation of the addition has paired half-glazed doors flanked by three multi-light fixed sash on the first floor, and on the second floor are two bands of three multi-light fixed sash. The house is noncontributing due to the installation of vinyl siding, replacement of windows, and the large addition.

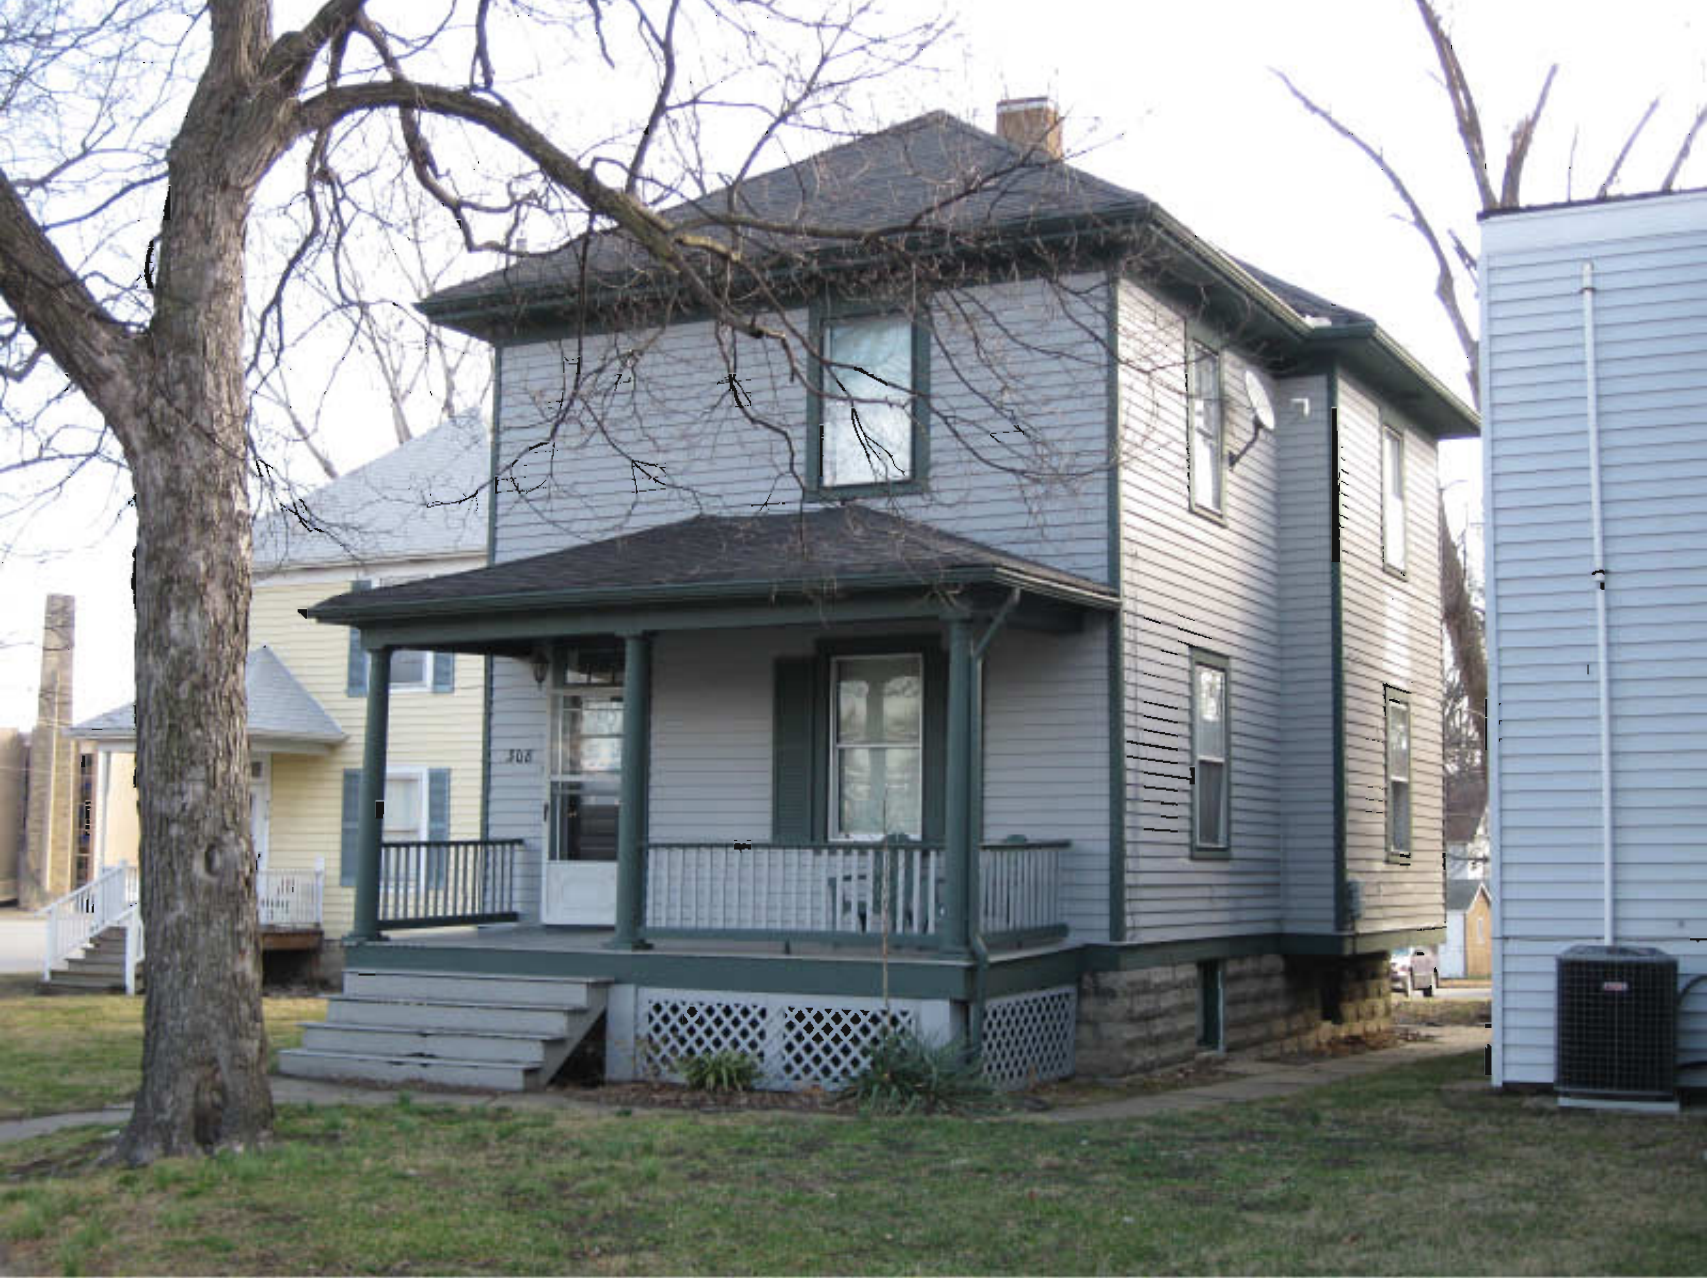
This house is a two-story, frame structure that rests on a rusticated concrete block foundation that is pierced by single-light basement windows, and the walls are finished with weatherboard siding. The pyramidal roof has wide overhanging eaves, and an interior brick chimney projects through the right side slope. The entrance is located at the left end of the two-bay main façade, and it is a half-glazed wood door with three horizontal lights over three horizontal panels. The door is topped by a three-light transom, and to the right of the door is a 1/1 wood window. The door opens onto a one-story, full-width, Colonial Revival gallery that has concrete piers in-filled with lattice panels, wooden stairway and deck, Doric columns supporting a hip roof, and a plain wood balustrade. A single 1/1 wood window is on the second floor of the main façade. At the west end of the south elevation is a 1/1 window on each floor, and to the east is a projecting two-story box bay that has a 1/1 window on each floor. The first floor of the north elevation has a 1/1 window and a pair of short windows, and all are near the rear. The second floor has three 1/1 windows and at the eastern end is a sleeping porch with a band of six-light casement windows.

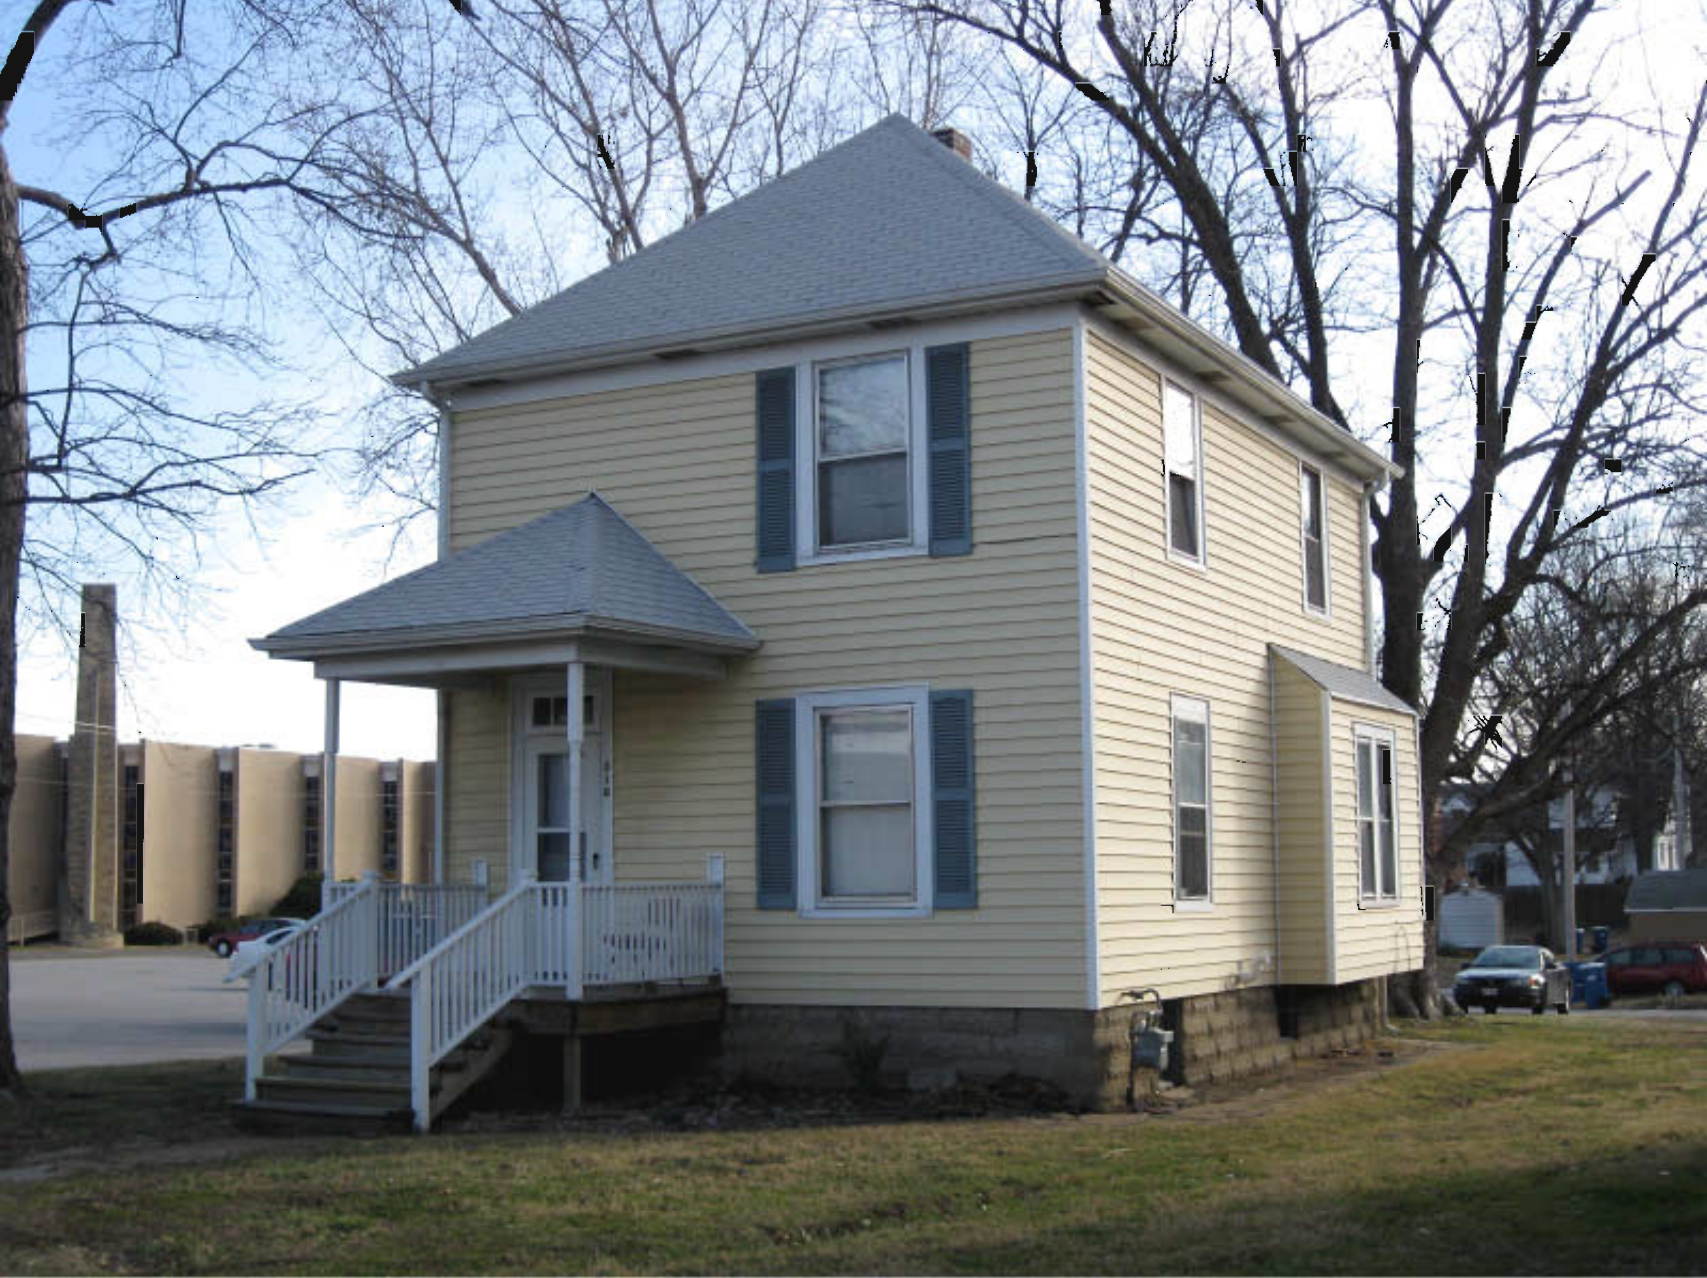
This two-story, frame house rests on a rusticated concrete block foundation and the walls have been clad with vinyl siding. The pyramidal roof has wide overhanging eaves, and an interior brick chimney pierces the left slope. The entrance is located at the left end of the two-bay main façade, and it is a half-glazed, paneled wood door topped by a three-light transom. The door opens onto a one-story, single-bay portico with wood stairway and deck, turned posts supporting a pyramidal roof, and plain balustrade. To the right of the entrance is a 1/1 wood window, and on the second floor is a single window opening aligned with the first floor window. The south elevation has a 1/1 window at the west end, and at the east end is a one-story box bay with shed roof and paired 1/1 windows. The second floor has two 1/1 windows. The north elevation has one 1/1 window on the first floor and two on the second, and a shed roof addition on the rear has a pair of windows on the second story.

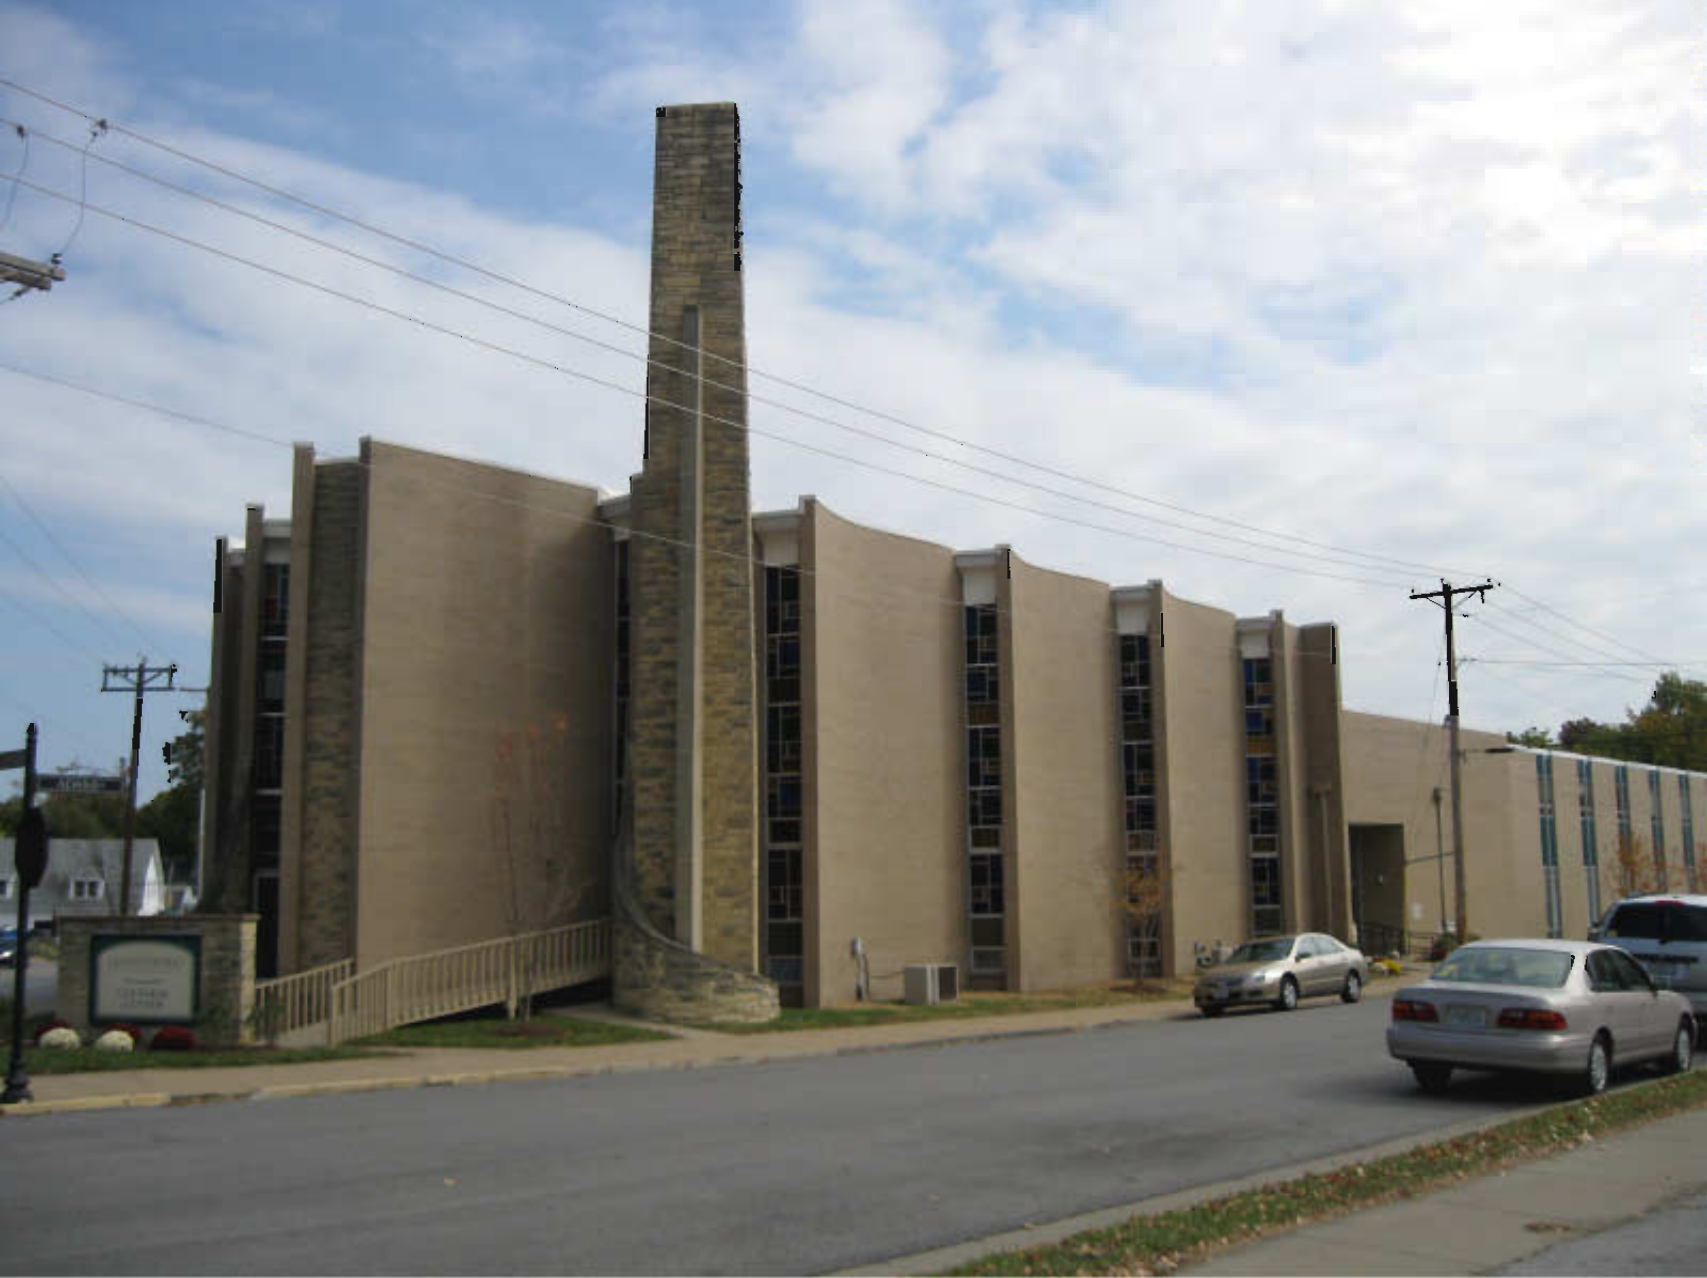
The sanctuary to the Old Baptist Church was built in 1970 after the earlier church building was demolished in 1969. The educational wing was built in 1961 and was retained when the old church was demolished. The Mid-Century Modern, Brutalism design features a concrete foundation, blond brick walls with stone accents, and a flat roof. The two street elevations are stepped, and in the stepped area are floor to ceiling steel windows with glass panes of various colors. Near the southwest corner of the building is a stone steeple with cast stone accents, and a round stone wall wraps around the base of the steeple. A triangular brick wall with inset stone panel is at the southwest corner of the building, and to each side is a single-leaf, glazed metal door. A wooden handicap ramp is at the right door.

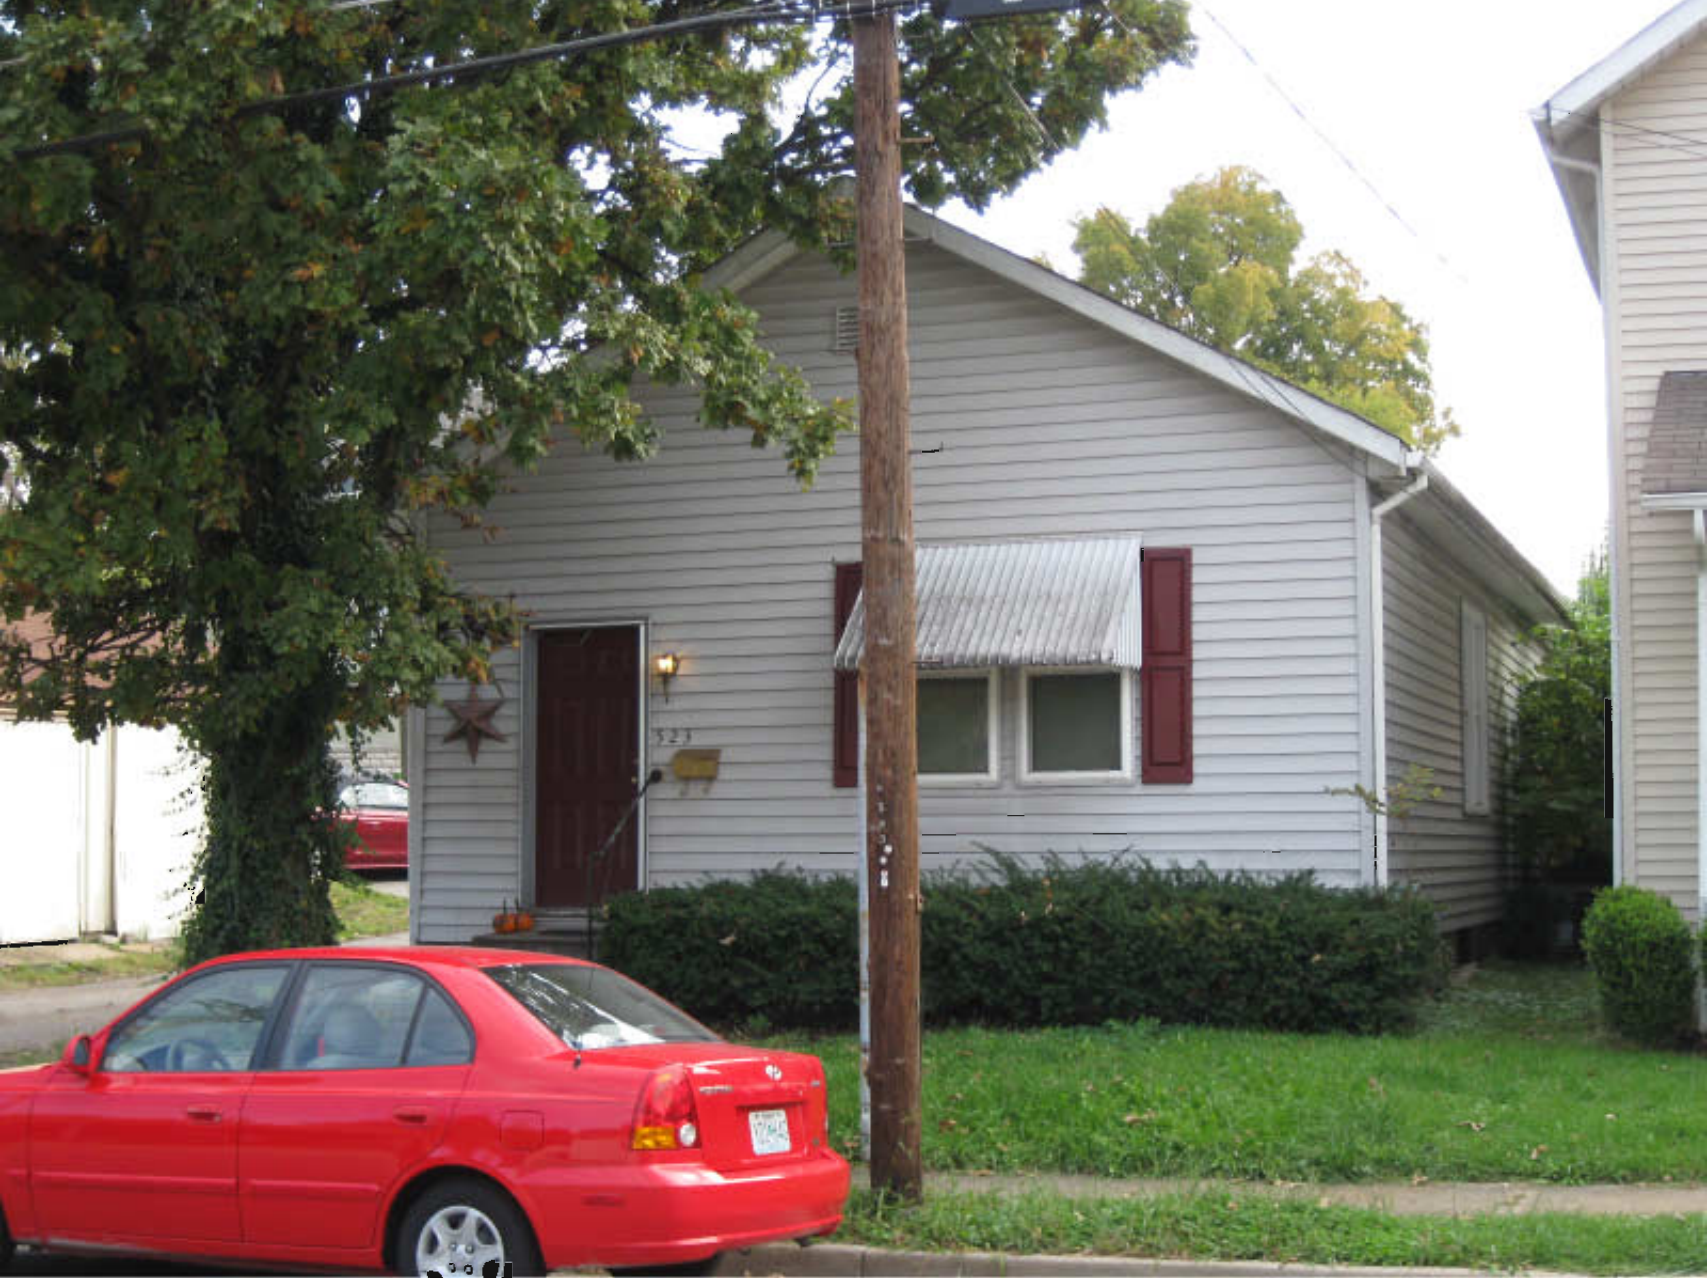
This one-story, front-gabled, frame house rests on a concrete foundation and its walls have been clad with vinyl siding. The roof has wide overhanging eaves, and an interior brick chimney is situated on the east slope of the roof, near the peak. The Sanborn Insurance maps show that there was originally a recessed porch at the northeast corner of the house, but it has been enclosed. The two-bay main façade has a paneled metal door in the east bay and a pair of 1/1 windows topped by a metal awning, and the windows have a single set of paneled vinyl shutters. The door opens onto a one-bay concrete stoop with stairway having three steps. There are four window openings on the east elevation, and windows throughout the house appear to be replacements. The house is noncontributing due to the enclosure of the porch, installation of vinyl siding, and replacement of the windows.

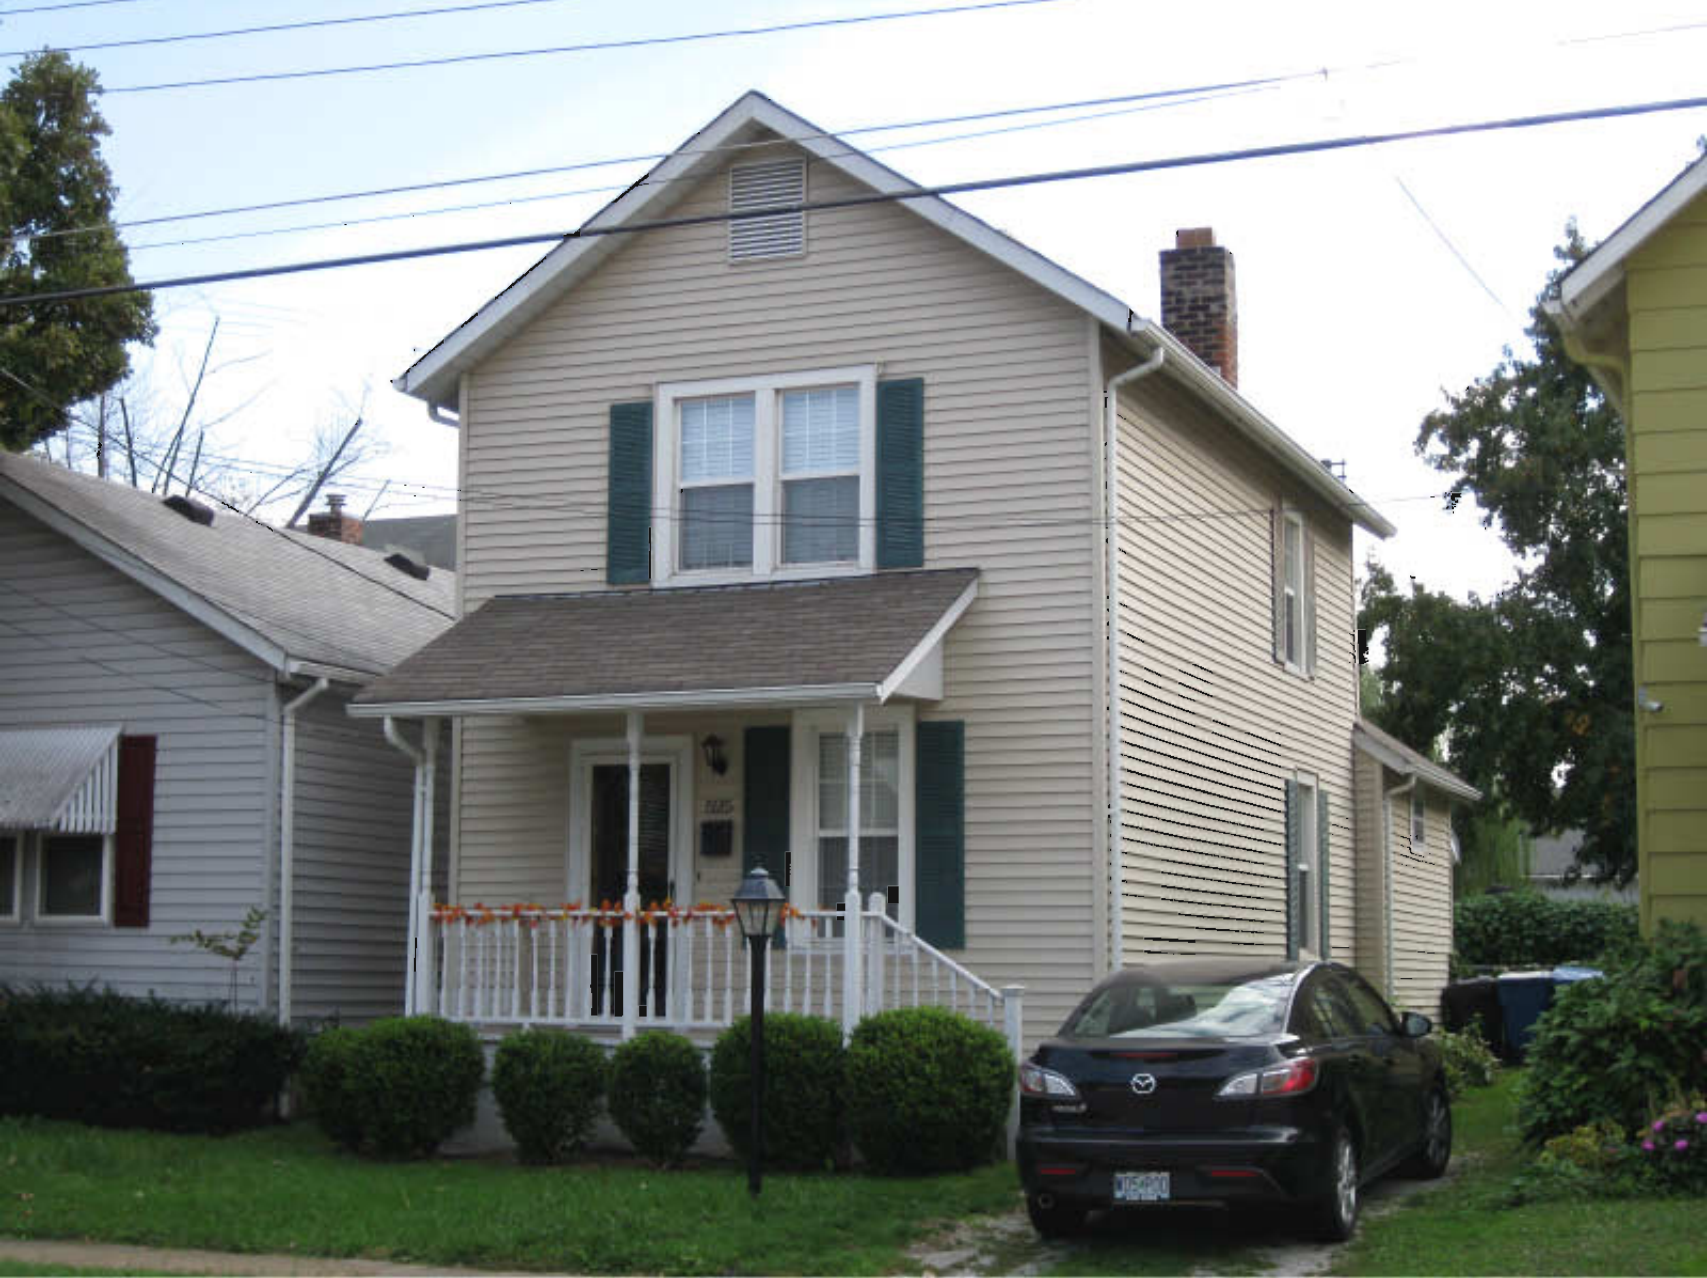
Situated on a narrow lot, this two-story, frame structure rests on a concrete foundation and the walls are clad with vinyl siding. An interior brick chimney pierces the west slope of the medium-pitched, front-gabled roof, which has wide overhanging eaves. The first floor of the façade features a paneled door in the eastern bay and a 6/6 window in the western bay. The windows throughout the house are replacement vinyl sash, and all have vinyl louvered shutters. The door opens onto a one-story, ¾-width gallery with concrete foundation, wood deck, a balustrade with turned balusters, and turned posts supporting a shed roof. The gallery's stairway is located on the west side of the porch and opens onto the driveway. The second floor of the façade features a pair of 6/6 windows, above which is a rectangular ventilator. The east elevation has a single window on the first floor and two on the second, while the west elevation has one on each floor. A one-story wing is on the rear, but the porch that originally spanned the west elevation of the wing has been enclosed. The house is noncontributing due to the replacement of the windows and installation of vinyl siding.

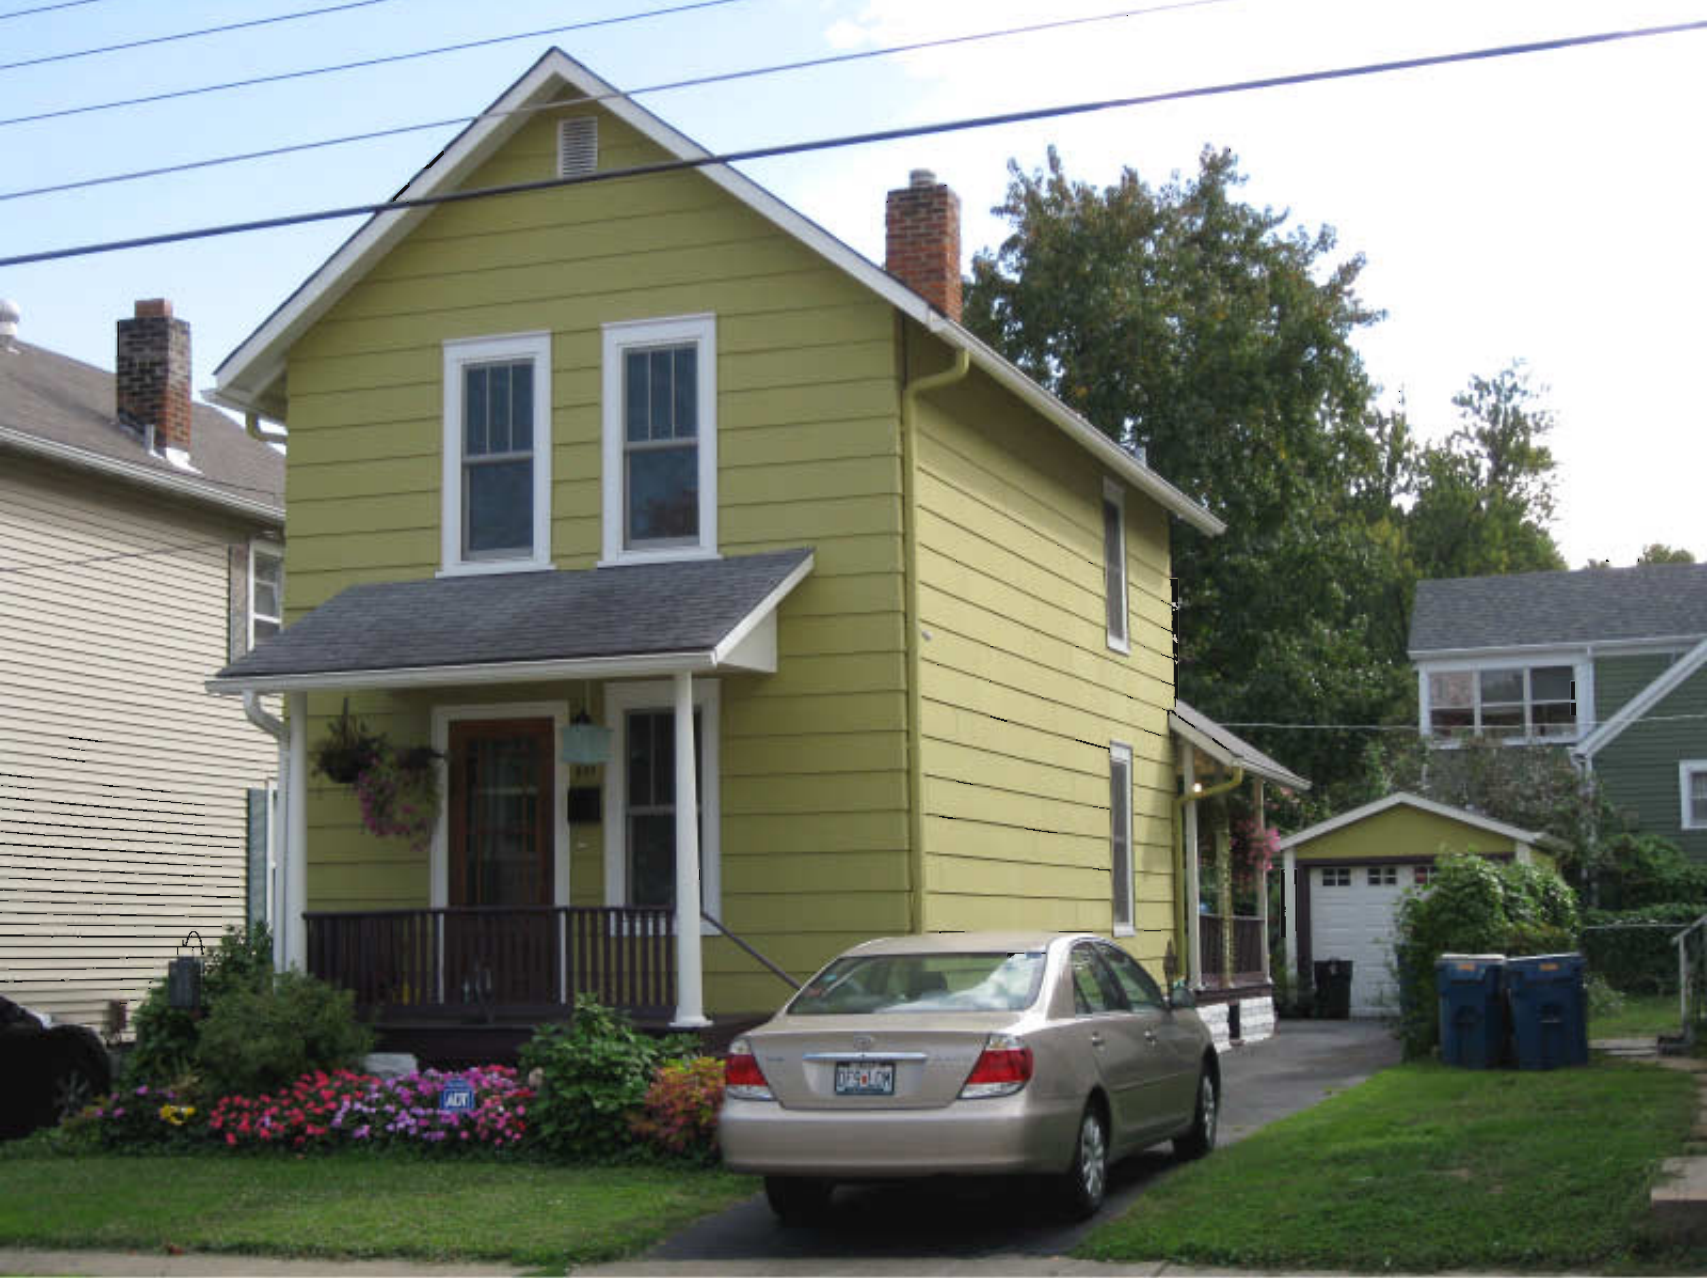
Situated on a narrow lot, this two-story, frame structure rests on a rusticated concrete block foundation and the walls are clad with Masonite siding. An interior brick chimney pierces the west slope of the medium-pitched, front-gabled roof, which has wide overhanging eaves. The first floor of the façade features a half-glazed wood door with wood multi-light storm door in the eastern bay and a 3/1 window in the western bay. The door opens onto a one-story, ¾-width gallery with wood deck, framed lattice panels under the deck, a plain wood balustrade, and slender colonettes supporting a shed roof. The stairway is located on the west side of the porch and opens onto the driveway. The second floor of the façade features two 3/1 windows, which replicate the originals that were replaced in 2009. The east elevation has a single window on the first floor and two on the second, while the west elevation has one on each floor. A one-story wing is on the rear and has a window on the east elevation and a porch on the west.

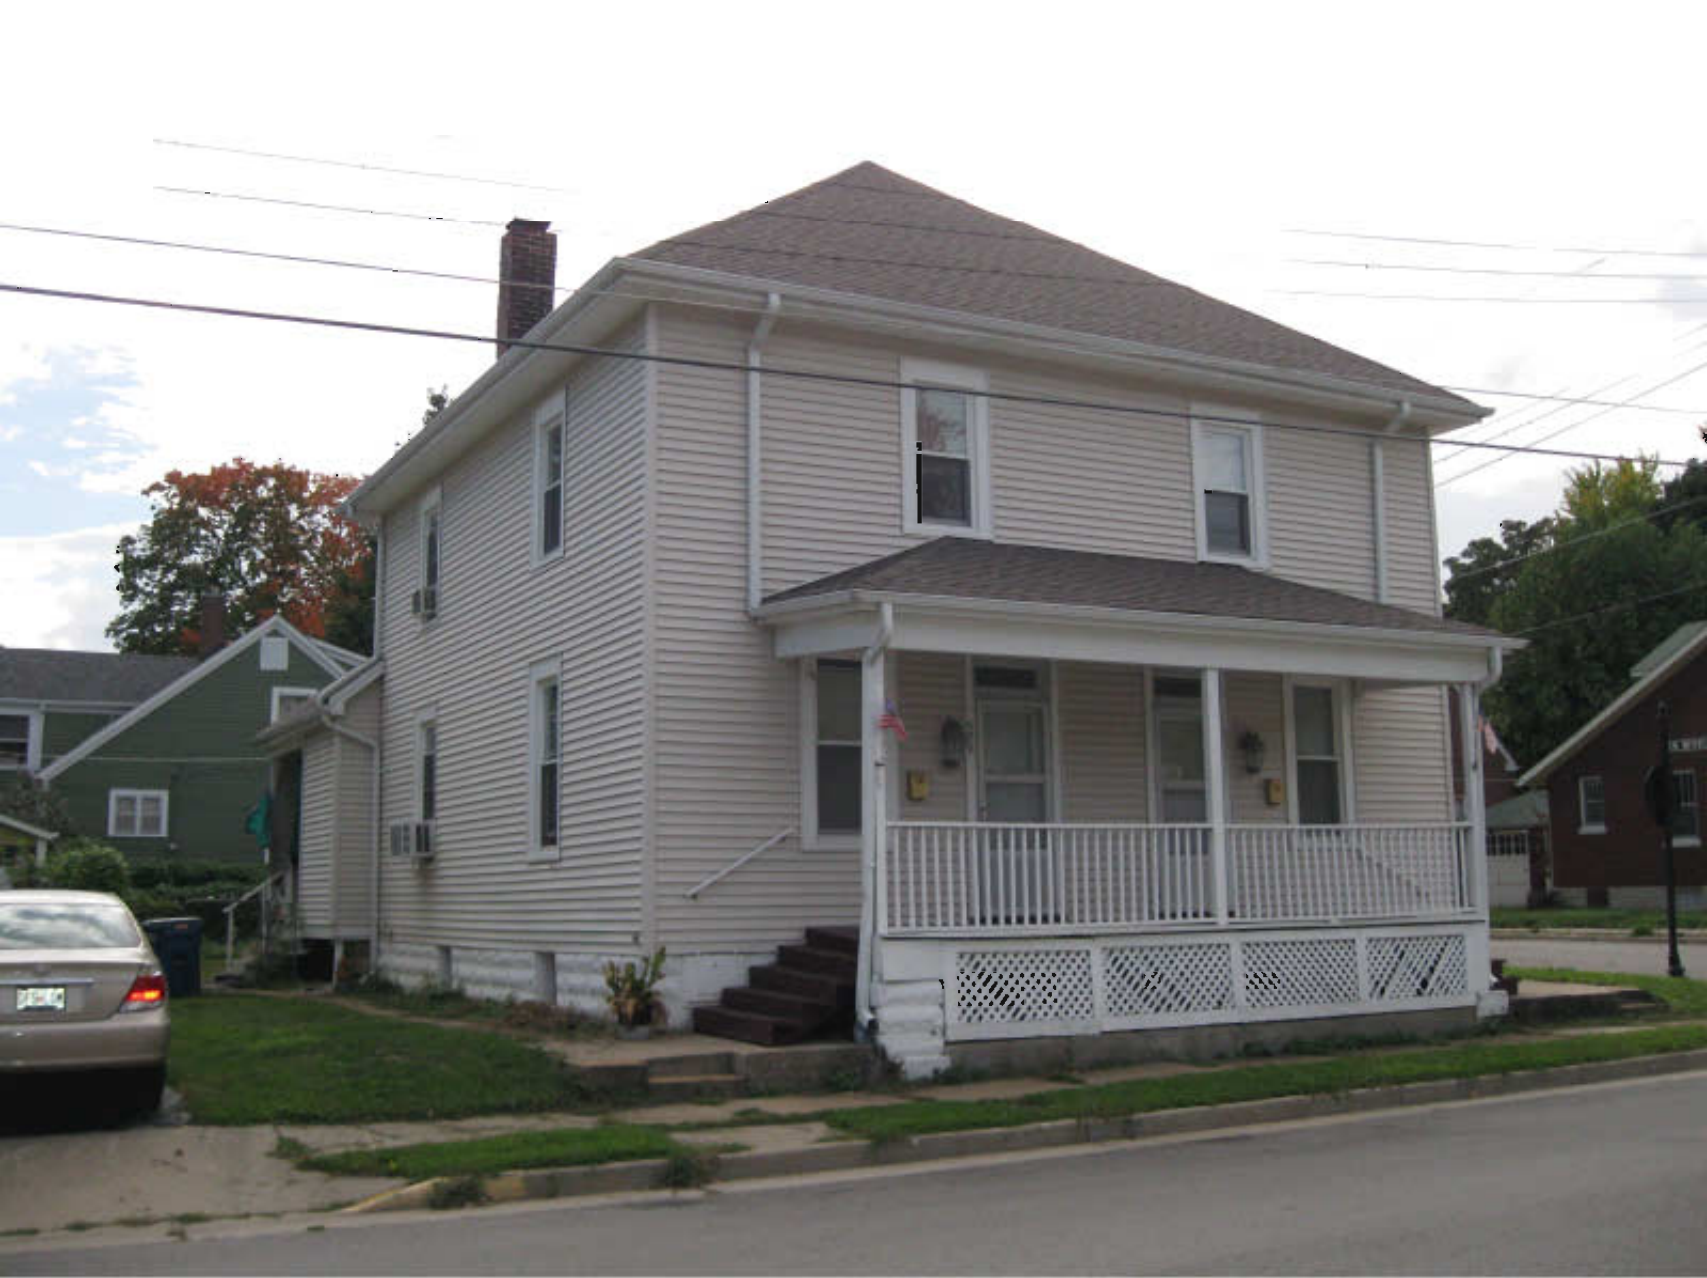
Located at the southeast corner of Monroe Street and Benton Avenue, this duplex is a two-story, frame structure that rests on a rusticated concrete block foundation and is crowned by a pyramidal roof. Interior end brick chimneys pierce the east and west slopes of the roof. The walls have been clad with vinyl siding and the windows have been replaced with 1/1 vinyl sashes. The first floor of the main façade has four openings: half-glazed, paneled wood doors topped by single-light transoms are in the center two bays and in the outer two bays are windows. The doors open onto a one-story, ¾-width gallery that has rusticated concrete block foundation piers in-filled with framed lattice panels, a wooden deck, wooden stairway on both the east and west sides, a plain wood balustrade, and plain posts supporting a steep hip roof. The second floor has two 1/1 windows. There are two windows on each floor of the side elevations, and a one-story rear wing has galleries along the east and west elevations. The duplex is noncontributing due to the replacement of the windows and installation of vinyl siding.

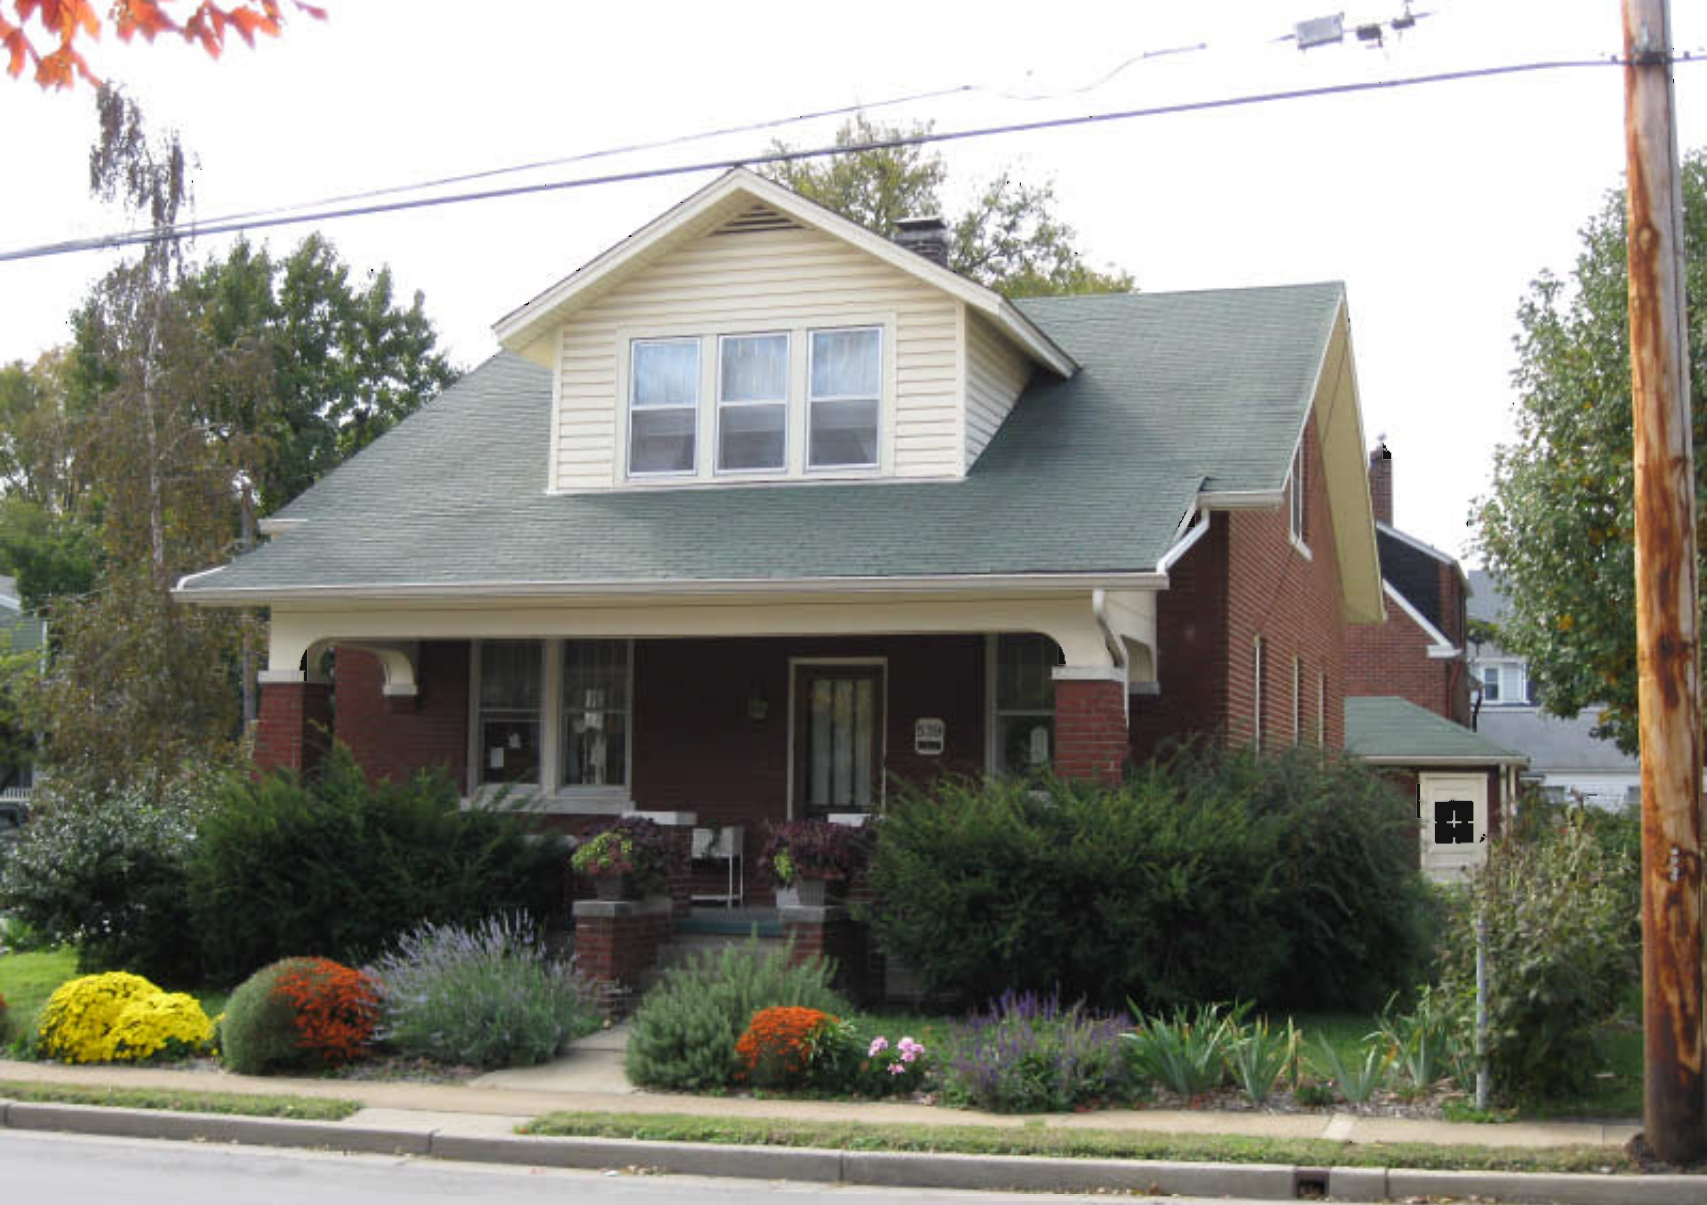
Situated at the southwest corner of Monroe Street and Benton Avenue, this one-and-one-half story, side-gabled, brick bungalow rests on a scored concrete foundation that is pierced by three-light basement windows. The brick walls are laid in a running bond pattern, but immediately above the foundation is a soldier course. A brick chimney straddles the ridge of the roof, which has wide overhanging eaves, and the front and rear slopes have large gabled dormers with bands of three 4/1 wood windows and vinyl-clad walls. The asymmetrical, three-bay main façade has a Craftsman-style, glazed wood door with three vertical lights in the center bay, and to the right is a single 4/1 wood window and to the left is a pair. The door opens onto a one-story, ¾-width gallery with concrete stairway flanked by brick knee walls, concrete deck, brick railing with concrete coping, and battered brick piers supporting the shed roof, which has a basket-handle arched frieze. Four 4/1 windows are on the first floor of the east elevation and a pair is in the upper half story. Windows throughout the house have painted wood sills and flat jack arches. The west elevation has three 4/1 windows on the first floor and a pair in the upper half story.
