ARCHITECTURAL/HISTORIC INVENTORY FORM

1. Survey No. SC-AS-009-001		2. Survey Name: St. Charles Survey Phase 3: Mid-Town and Commons Neighborhoods	
3. County: St. Charles		4. Address (Street No.) 128	Street (name) North Sixth Street
5. City: St. Charles	Vicinity: <input type="checkbox"/>	6. UTM:	
7. Township/Range/Section:		8. Historic name (if known): Meyer-Pieper House; The Meyerdorf	
9. Present/other name (if known):		10. Ownership: <input checked="" type="checkbox"/> Private <input type="checkbox"/> Public	
11a. Historic use (if known): Domestic/single dwelling		11b. Current use: Domestic/single dwelling

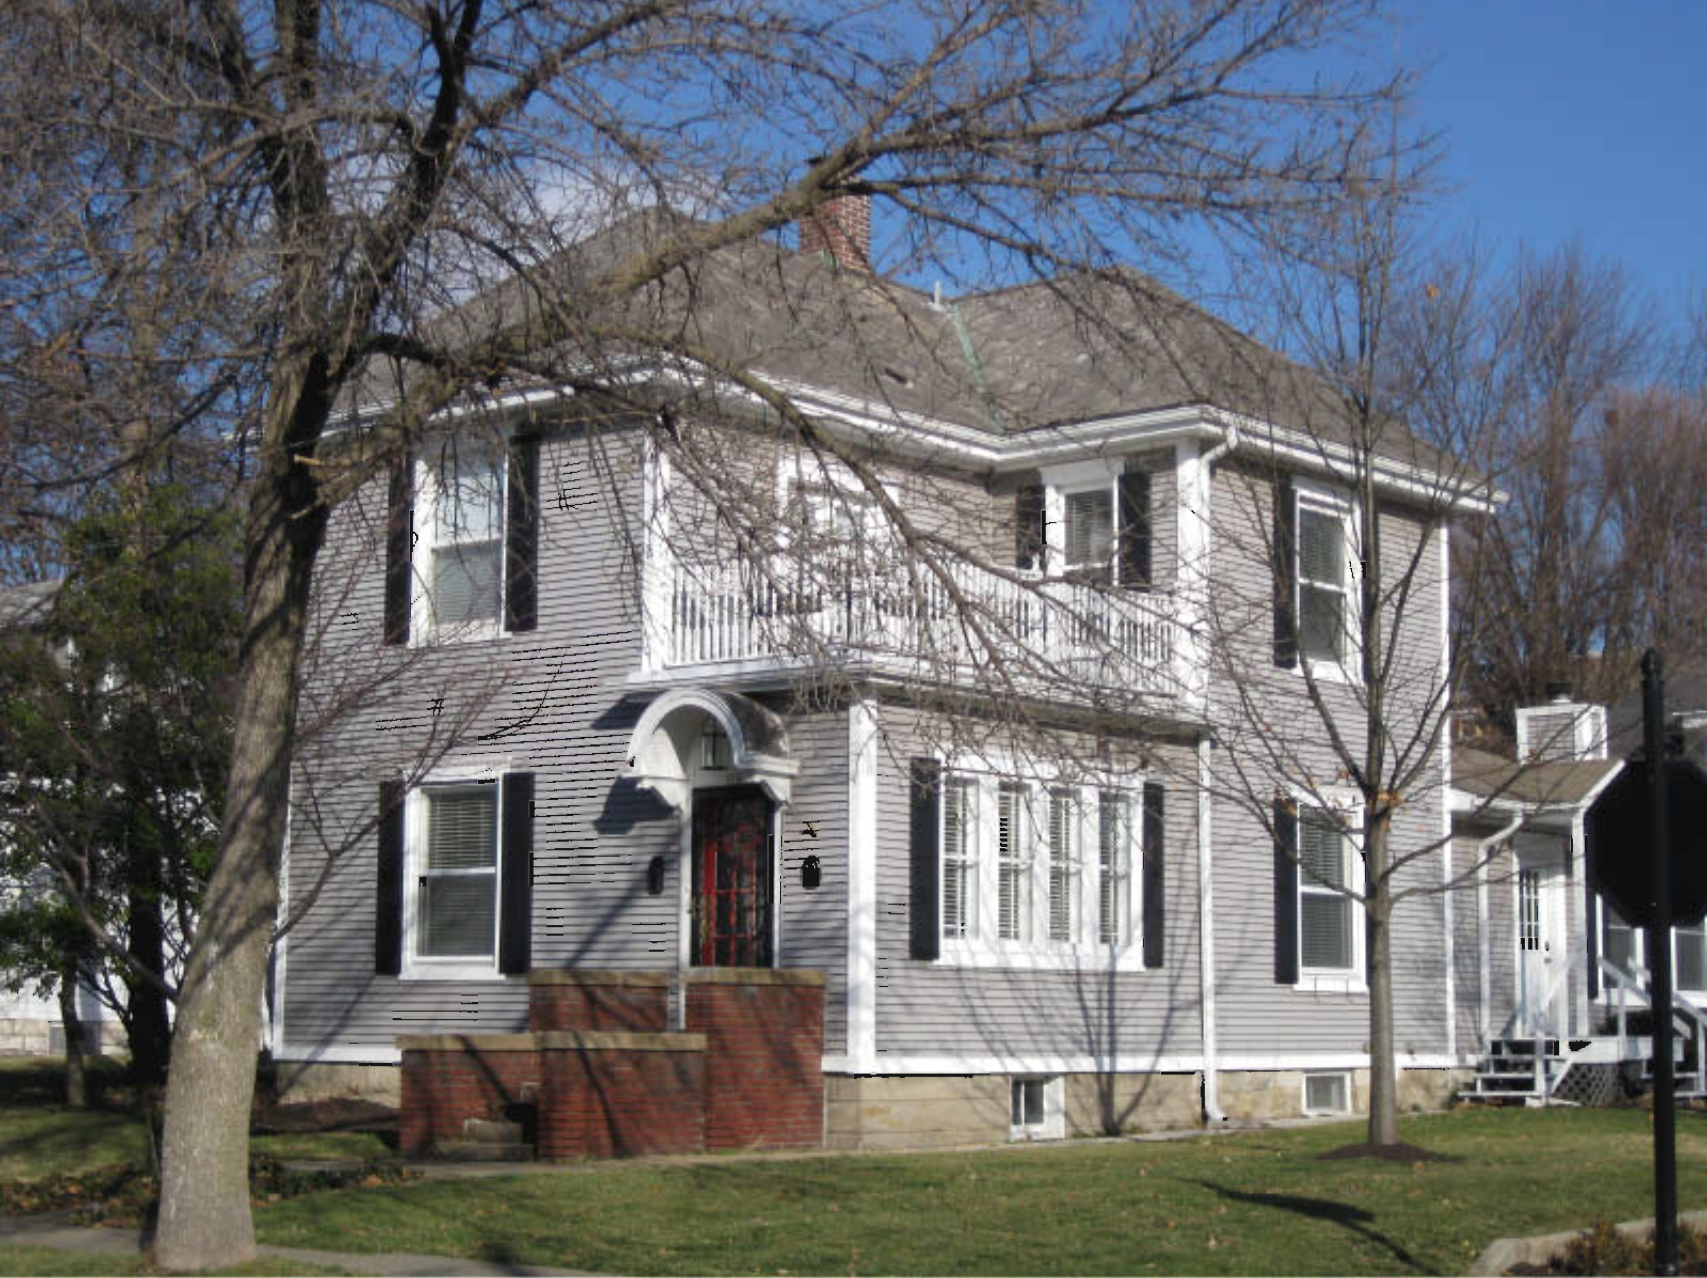
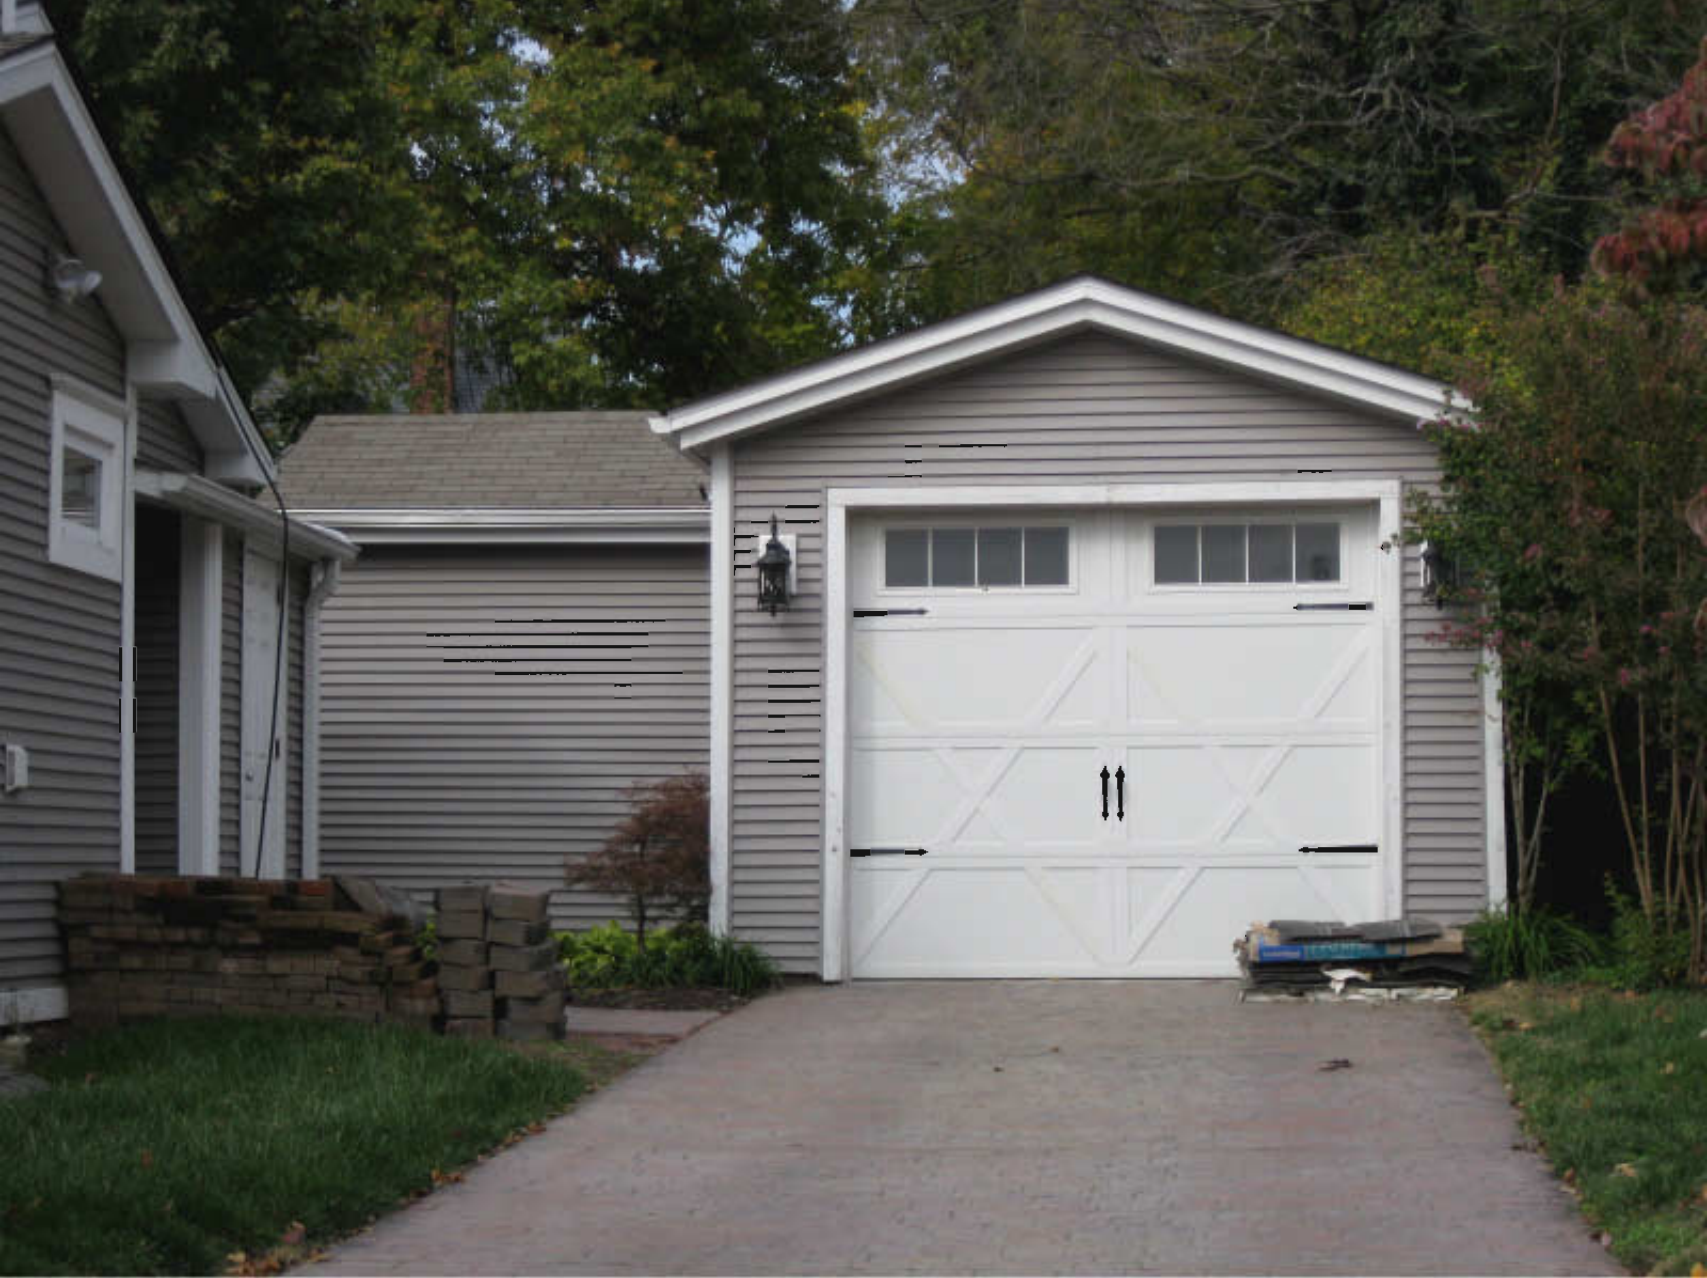
Located at the northwest corner of Monroe Street and Benton Avenue, this two-story, frame house originally had a cruciform-shaped plan, but the one-story porch at the southeast corner was enclosed between 1917 and 1929 and the one-story porch at the northwest corner was enclosed between 1929 and 1947, giving the house an irregular shape. The house rests on a coursed rock-faced stone foundation, except for the enclosed front porch, which has a scored concrete foundation. Two-light basement windows pierce the foundation of the house and the enclosed porch. A brick chimney straddles the ridge of the cross-hip roof, which has wide overhanging eaves. At the time the photograph was taken, the roof had asbestos roofing shingles, but they have recently been replaced with asphalt shingles. The walls are finished with narrow vinyl siding trimmed with corner boards and a water table. The first floor of the façade has a wide 1/1 window in the west bay and a multi-light wood French door in the east bay in the enclosed porch area. Above the door is a blind fanlight, and a round-arched hood supported by console brackets protects the door, which opens onto a one-bay concrete stoop with a stairway having six concrete steps. The stoop and stairway are framed by brick knee walls with concrete copings. On the second floor of the façade is a 1/1 window, and on the rooftop of the enclosed porch is a deck enclosed by a balustrade with turned balusters. The east elevation features a band of four windows at the south end, in the enclosed porch, and these have muntins arranged along the perimeter. To the north is a 1/1 window. The south end of the second floor of the east elevation has paired French doors that provide access onto the deck, and at the north end is a 1/1 window. There is a 1/1 window on the second floor of the south wall of the east projecting wing. In 1993 a one-story addition was constructed on the rear elevation, and the east wall has a half-glazed door and two 1/1 windows. The door opens onto a one-bay gabled porch. An interior end chimney finished with siding is at the north end of the addition. The west elevation of the historic front portion of the house features two 1/1 windows on each floor, and on the south wall of the west projecting wing is a 1/1 window on each floor.

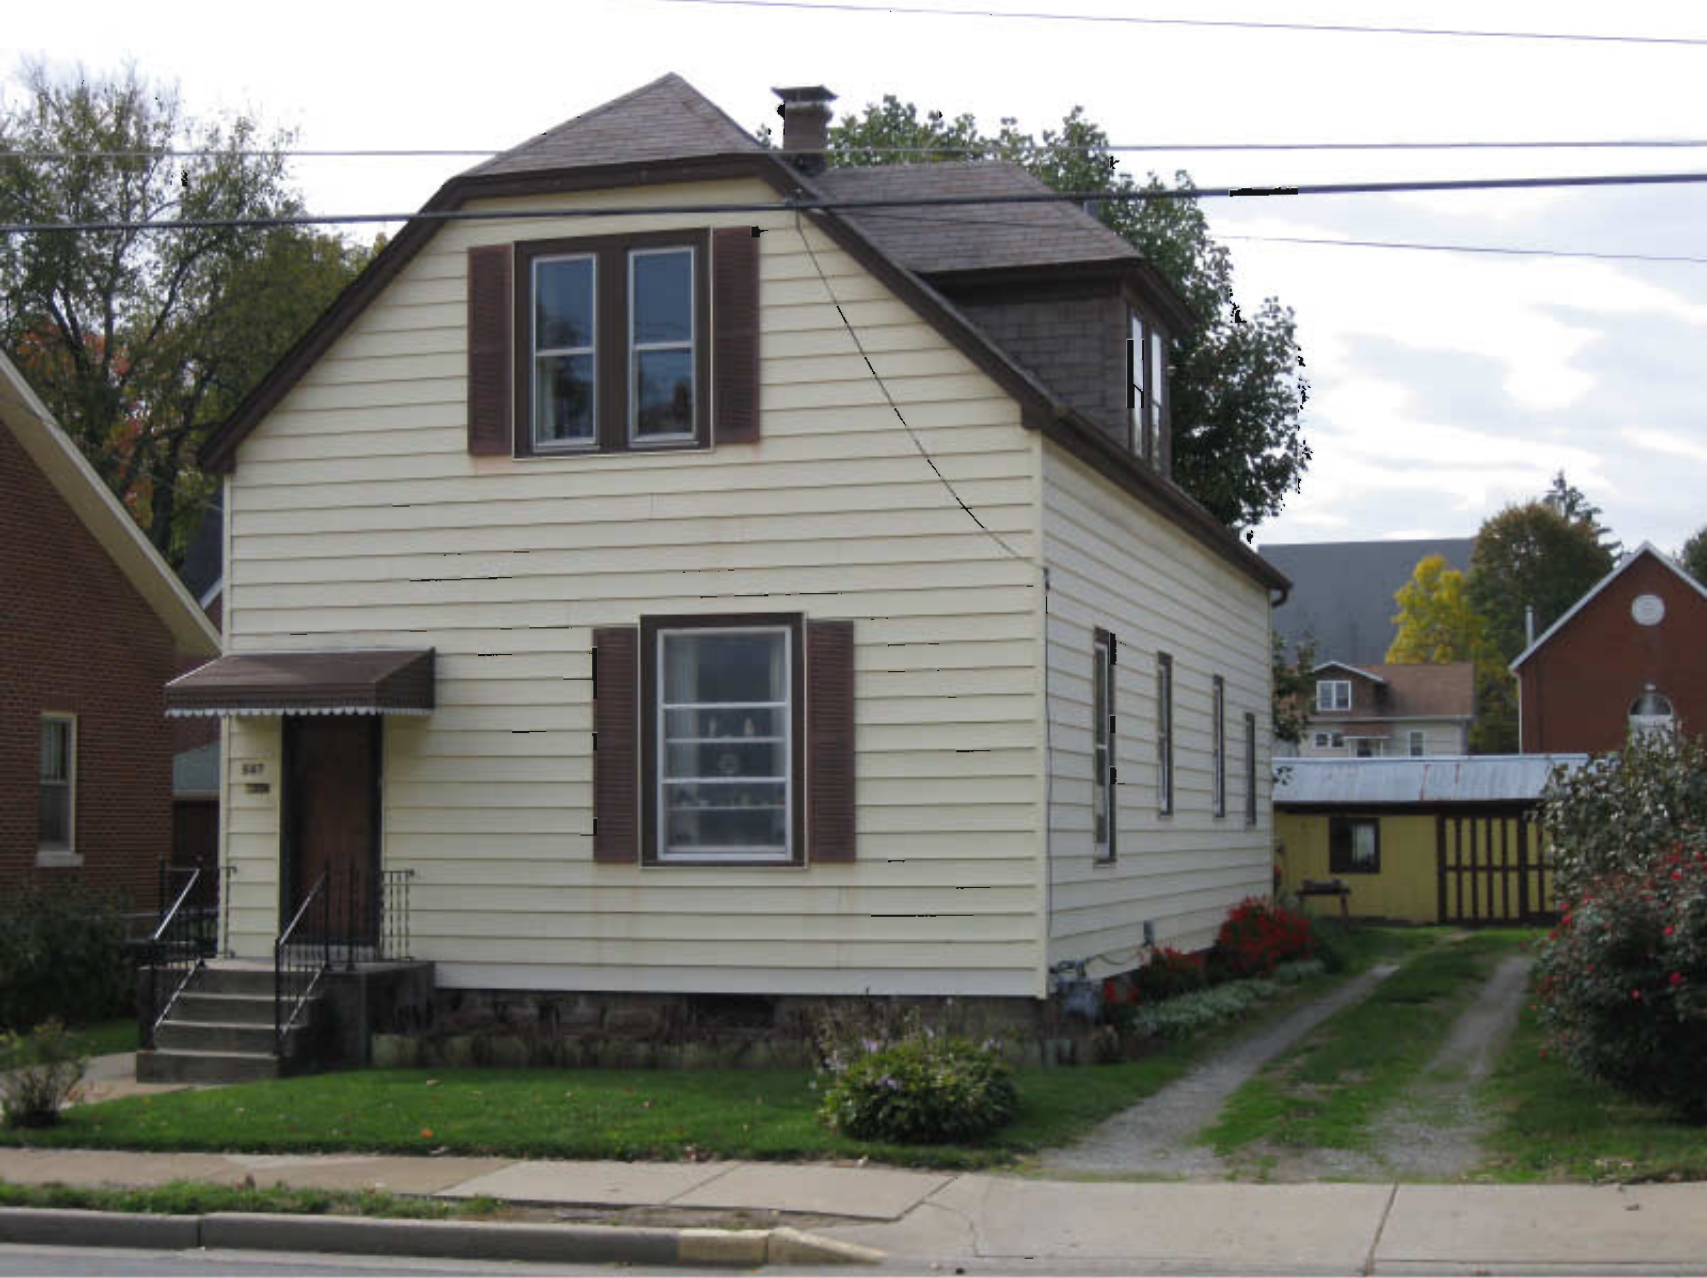
Built circa 1908, this one-and-one-half story, frame, Front Gabled cottage rests on a rusticated concrete block foundation and the walls are finished with vinyl siding. The steeply-pitched gable is clipped, and there is a brick chimney straddling the ridge. On both side slopes is a dormer with high hip roof, paired 1/1 windows, and walls clad with roofing shingles. On the east slope is an additional dormer near the rear, and this dormer has a shed roof and paired windows. The Sanborn Insurance Maps indicate that there was originally a recessed porch at the northeast corner of the house, but it was enclosed sometime after 1947. The first floor of the main façade has a paneled door in the east bay and a 1/1 wood window in the west. The door opens onto a concrete stoop with stairway having four steps, and the stair and stoop are lined with wrought iron railings. The stoop is protected from the weather by a metal awning over the door. In the upper half story of the façade is a pair of 1/1 windows, and the windows on the façade are framed by vinyl louvered shutters. The west elevation has four windows while the east elevation has three, and a recessed porch is at the southeast corner of the structure. Although the house retains its original windows, it is noncontributing due to the installation of vinyl siding and the enclosure of the recessed front porch.

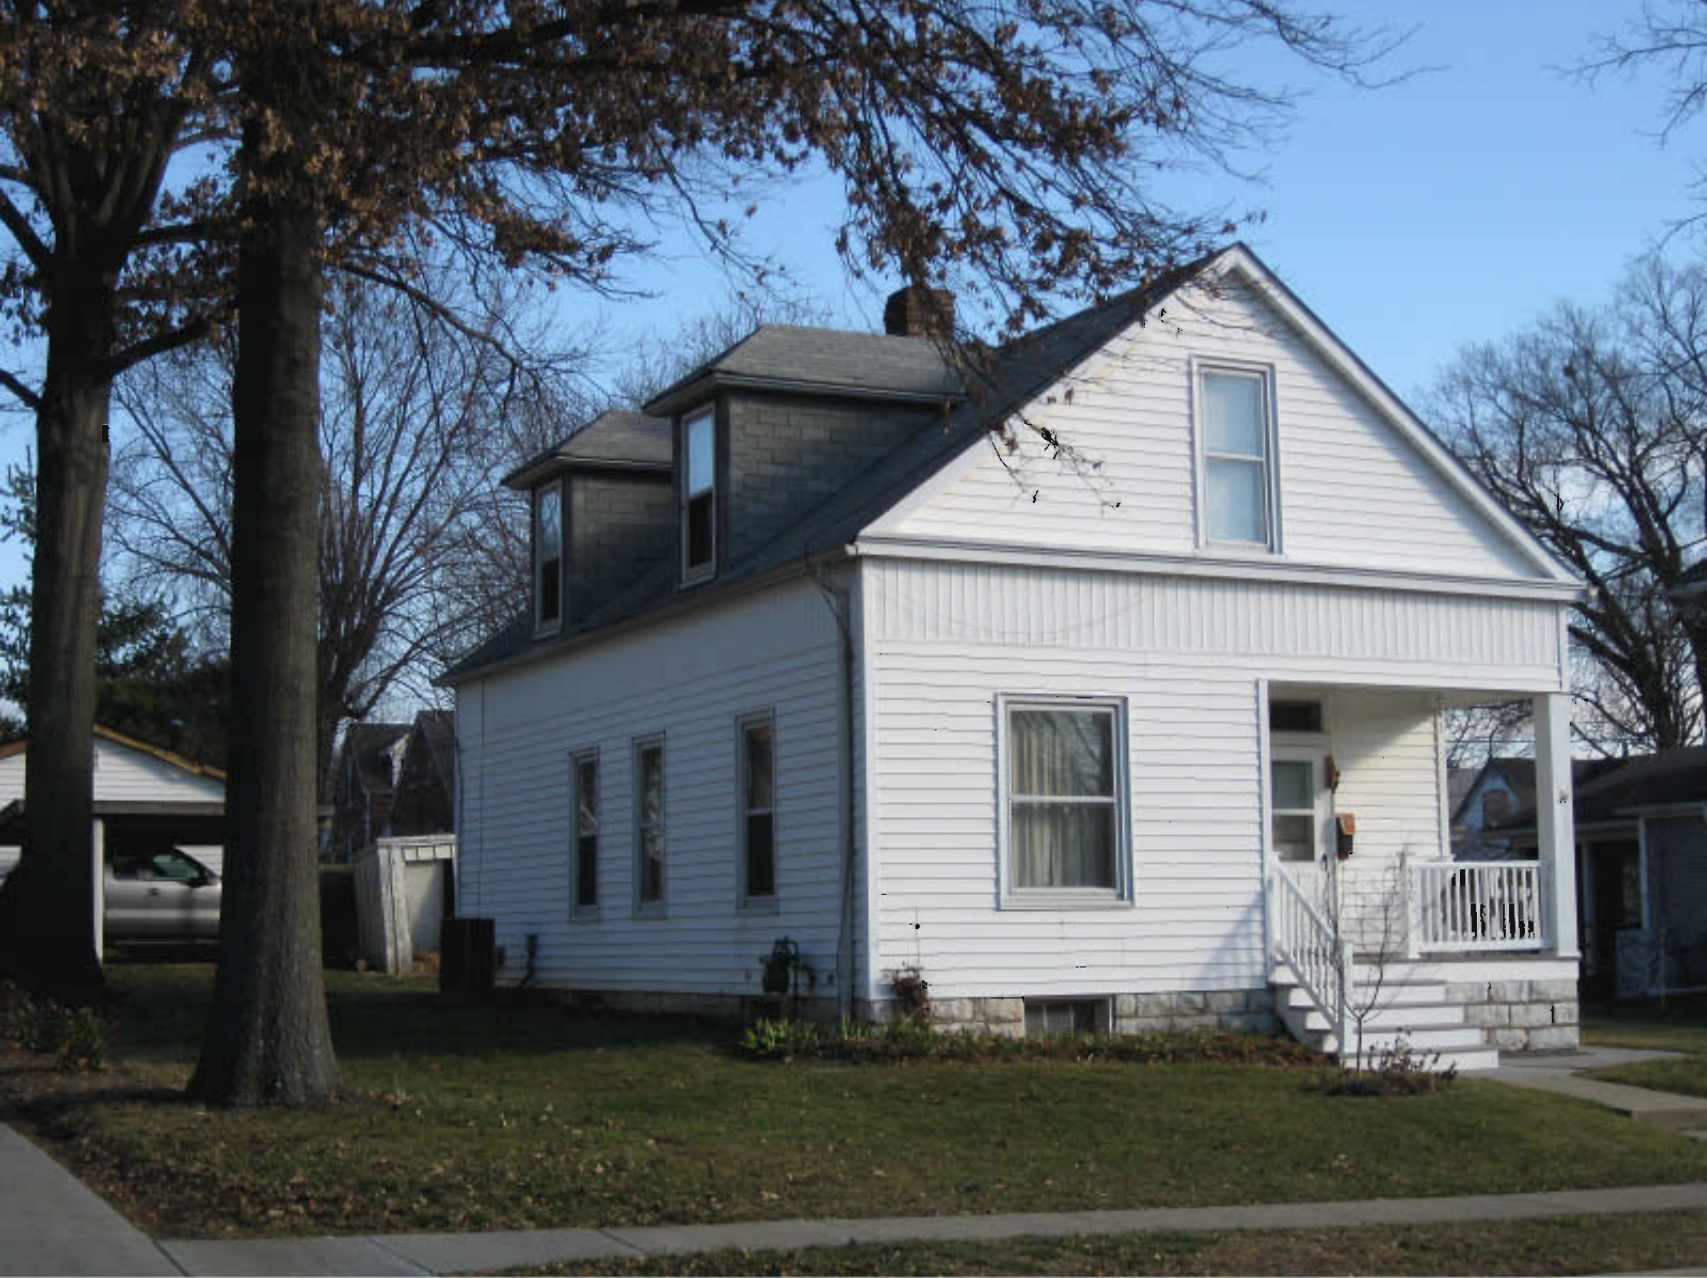
Facing south, this one-and-one-half story, frame, Gable Front cottage is distinguished by its one-bay recessed porch at the southeast corner of the façade. The front gable is pedimented, and a brick chimney with corbelled cap straddles the ridge of the roof. On each side slope of the roof are two dormers with hipped roofs having wide overhanging eaves, and each dormer has a 1/1 window and walls clad with asphalt roofing shingles. The foundation is coursed rock-faced stone, and it is pierced by three-light basement windows. Vinyl siding has been installed on the walls and in the tympanum, but a wide frieze or belt course has been created with vertical siding (it is unknown if this design imitates the original design of the house). The two-bay main façade features a wide 1/1 window in the west bay, and a half-glazed wood door topped by a single-light transom is in the east bay and opens onto the recessed porch, which features a wooden stairway and deck, a box column and plain balustrade. The column and balustrade appear to be vinyl. In the upper half story is a 1/1 window. Three 1/1 windows are on each side elevation, and there is a recessed porch at the northeast corner of the house.

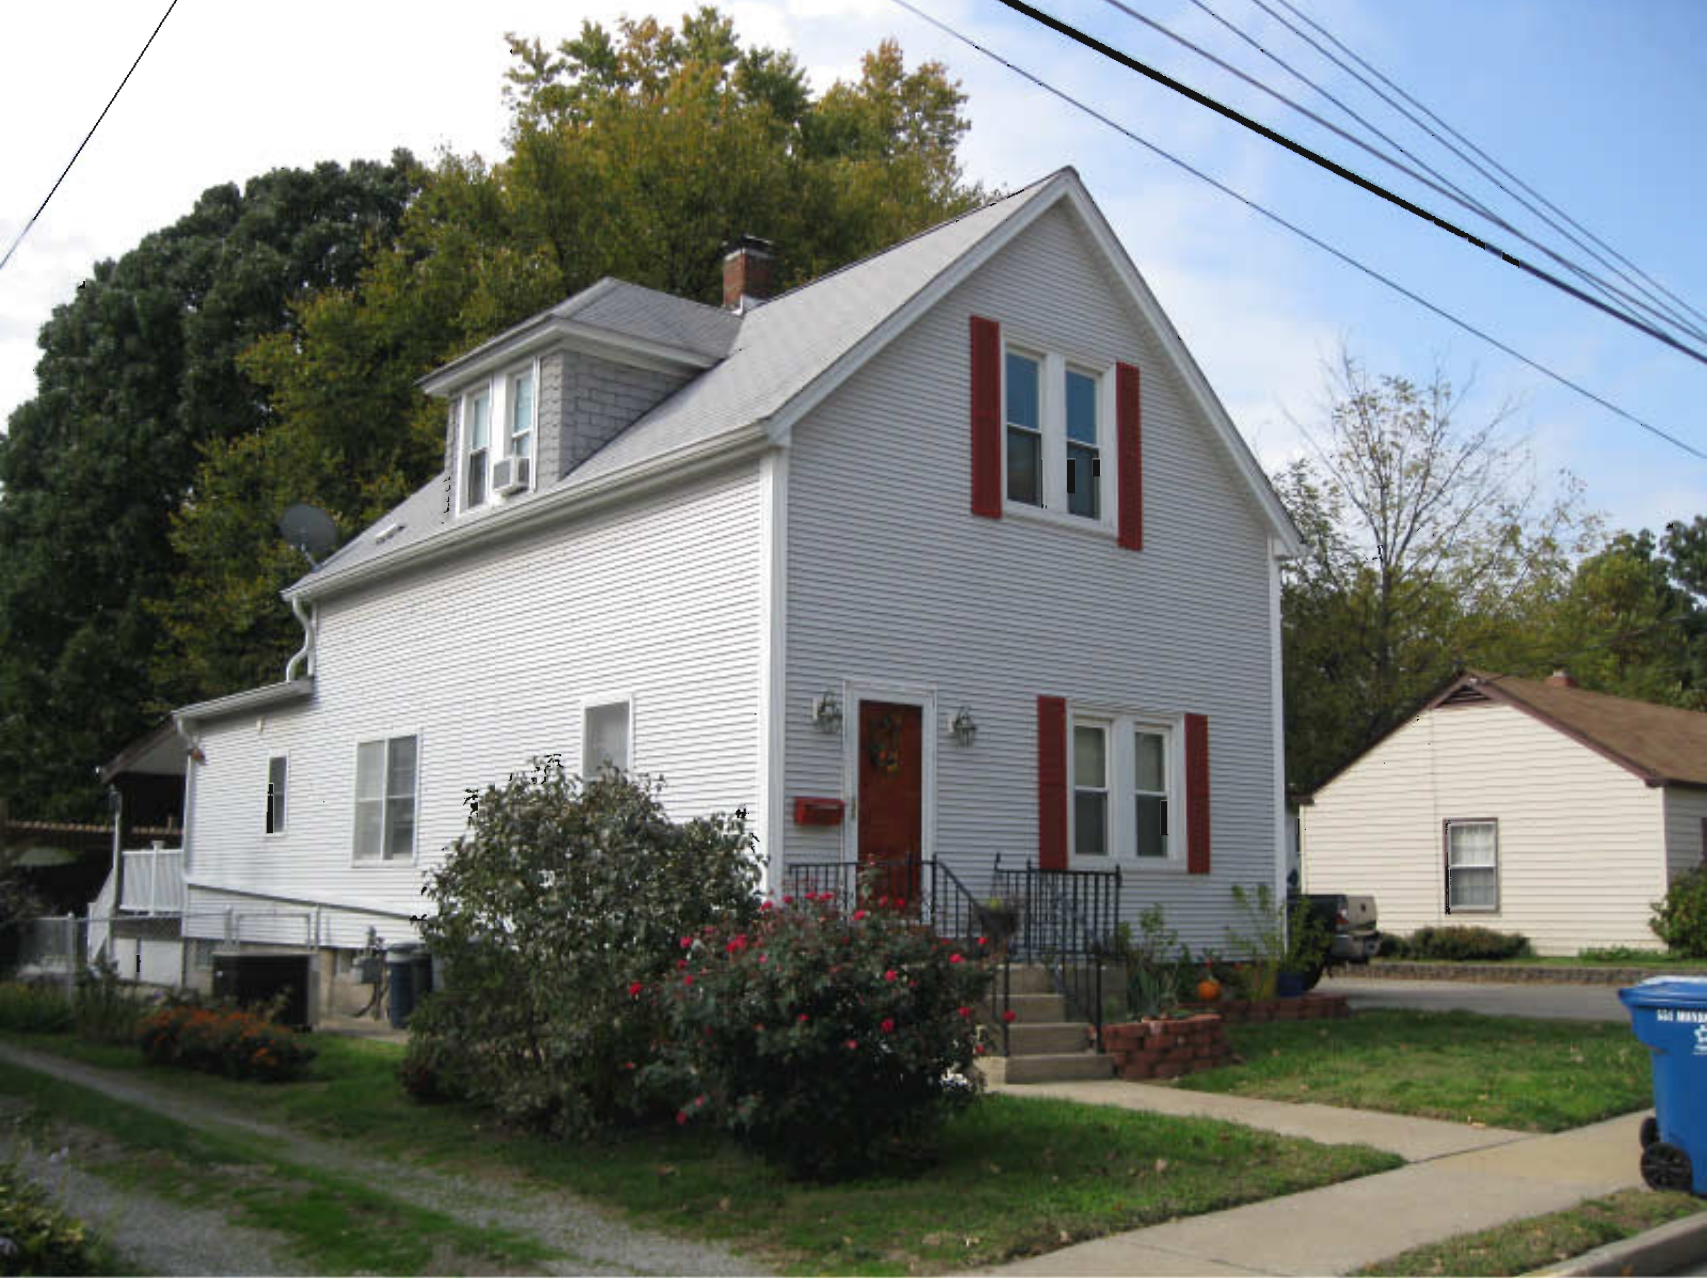
Built circa 1913, this one-and-one-half story, frame, Gable Front cottage rests on a scored concrete foundation and the walls are finished with vinyl siding. A brick chimney straddles the ridge of the steeply-pitched, front-gabled roof, and on each side slope is a hipped dormer with paired 1/1 windows and walls clad with asphalt roofing shingles. The Sanborn Insurance Maps show that there was originally a recessed porch at the northeast corner of the house and a porch along the east elevation of the one-story rear wing, but both were enclosed sometime after 1947. The two-bay main façade has a paneled door in the east bay and paired 1/1 windows in the west, and in the upper half story is another pair of 1/1 windows. The door opens onto a one-bay concrete stoop with stairway having four steps, and the stoop and stairs are framed by wrought iron railings. The west elevation has two windows in the 1 ½-story section and one window in the one-story rear wing, while the east elevation has a single and a pair of 1/1 windows in the front section and a 1/1 window in the rear wing. The house is noncontributing due to the installation of vinyl siding and the enclosure of the recessed front porch.

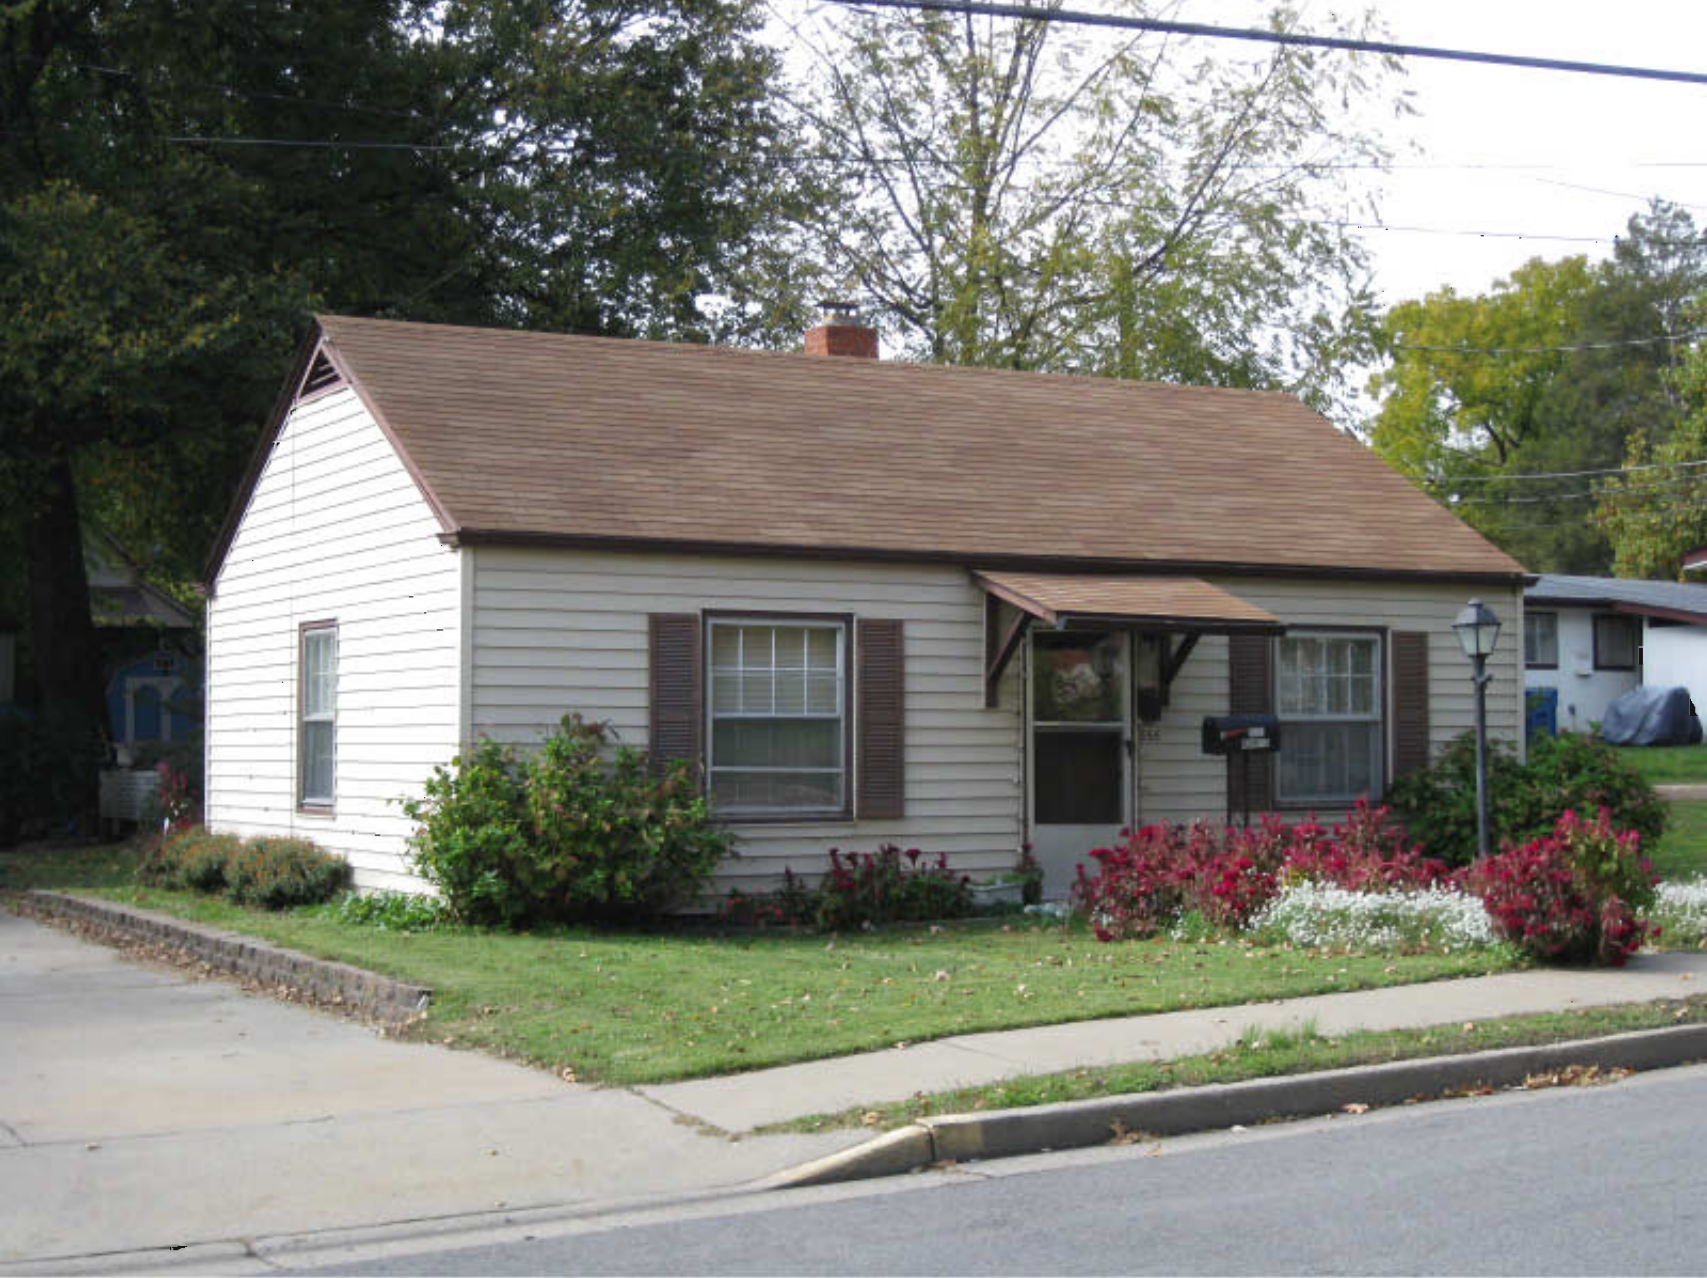
This one-story, frame house has a side-gabled roof that has an interior brick chimney on the rear slope. The foundation is not visible, and the walls are finished with vinyl siding. The three-bay main façade features a central entrance with paneled wood door having a fanlight. The door opens onto a one-bay stoop that is covered by a shed-roof awning supported by knee braces. To each side of the door is a wide 8/8 window framed by louvered vinyl shutters. The east elevation has a 6/6 window and the west elevation has a 6/6 window and a door protected by a metal awning.

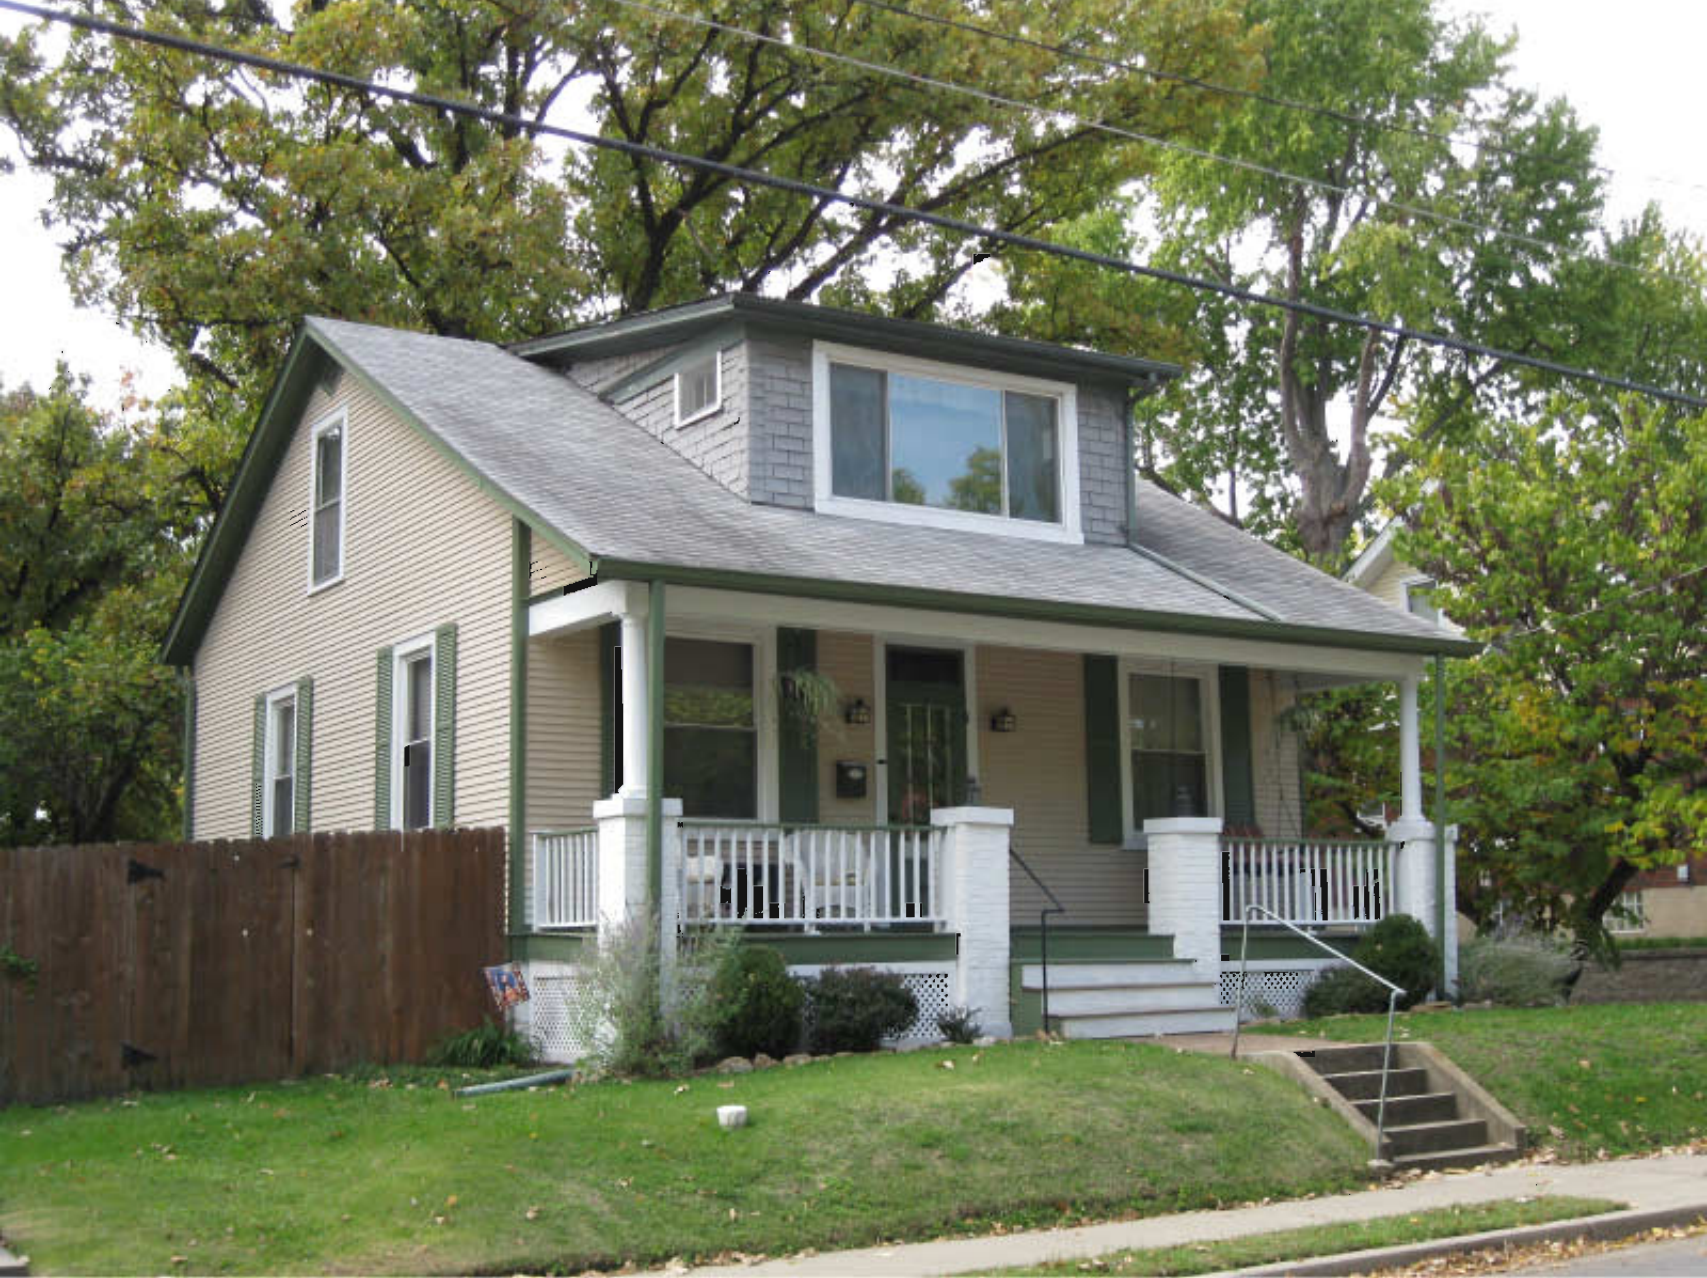
Situated on an elevated lot, this one-and-one-half story, frame, side-gabled bungalow rests on a scored concrete foundation that is pierced by three-light basement windows. The walls are finished with narrow weatherboard siding trimmed with corner boards and a wide wooden water table. The medium-pitched roof has wide overhanging eaves, a large shed-roof dormer on the front slope and an interior brick chimney on the rear slope. On the front wall of the dormer is a large tripartite window that appears to be a replacement and on the side walls are small three-light windows. The walls of the dormer are finished with asphalt roofing shingles. The three-bay main façade has a central entrance that is a glazed wood door with three vertical lights, and above is a single-light transom. The door is protected by an 8-light paneled wood storm door, and to each side of the entrance is a wide 1/1 wood window. The entrance opens onto a full-width gallery with wood stairway and deck, plain wood balustrade, and four painted brick pedestals that extend to the ground, with the area between in-filled with lattice panels. Two of the pedestals are at the top of the stairway, and those at the corner of the porch support Doric columns, which in turn support the shed roof that is an extension of the main roof of the house. The east elevation has two 1/1 windows on the first floor and one in the upper half story while the west elevation has a 1/1 window and a sliding window on the first floor and in the upper half story is a 1/1 window flanked by smaller 1/1 windows.

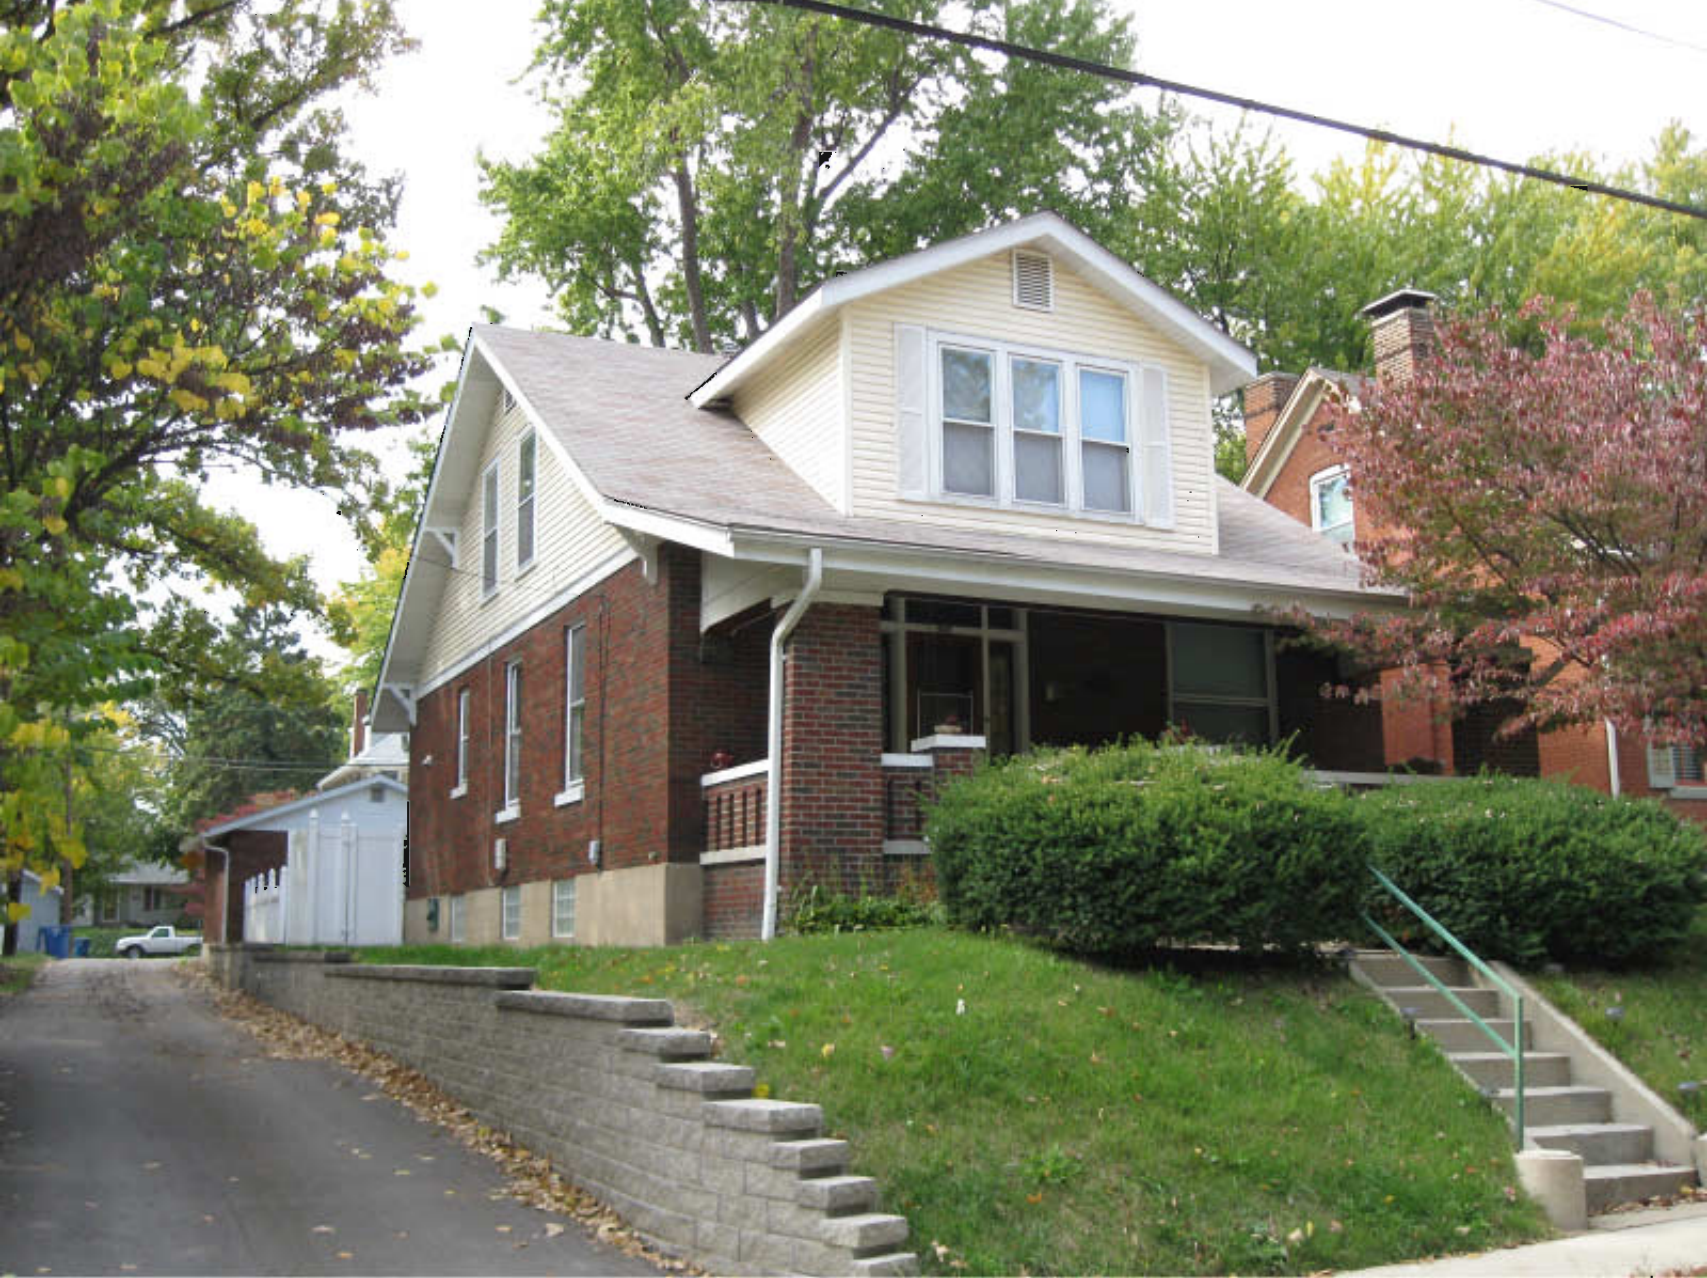
Situated on an elevated lot, this one-and-one-half story, side-gabled, brick bungalow rests on a scored concrete foundation that is pierced by glass block basement windows. The roof has wide overhanging eaves decorated with knee braces, and on the front slope is a gabled dormer with band of three 1/1 windows and walls finished with vinyl siding. The rear slope of the roof has an interior brick chimney and a gabled dormer with two 1/1 windows. The walls are finished with variegated, textured bricks laid in a running bond pattern and the gable ends are clad with vinyl siding. A glazed wood door with wood screen door is in the left bay of the two-bay main facade, and the door is flanked by stained glass sidelights. Above the door is a single-light transom, and each sidelight is also topped by a single-light transom. To the right of the entrance is a wide 1/1 wood window. The door opens onto a full-width gallery with brick foundation, concrete stairway flanked by brick knee walls, concrete deck, pierced brick railing with concrete coping, brick pedestals, and piers supporting the shed roof. The east elevation has three 1/1 windows on the first floor and two in the upper half story. The west elevation has, from front to rear, a 1/1 window, paired 1/1 windows, and a 1/1 window, and there are two 1/1 windows in the upper half story. The windows have flat jack arches and painted wood sills.

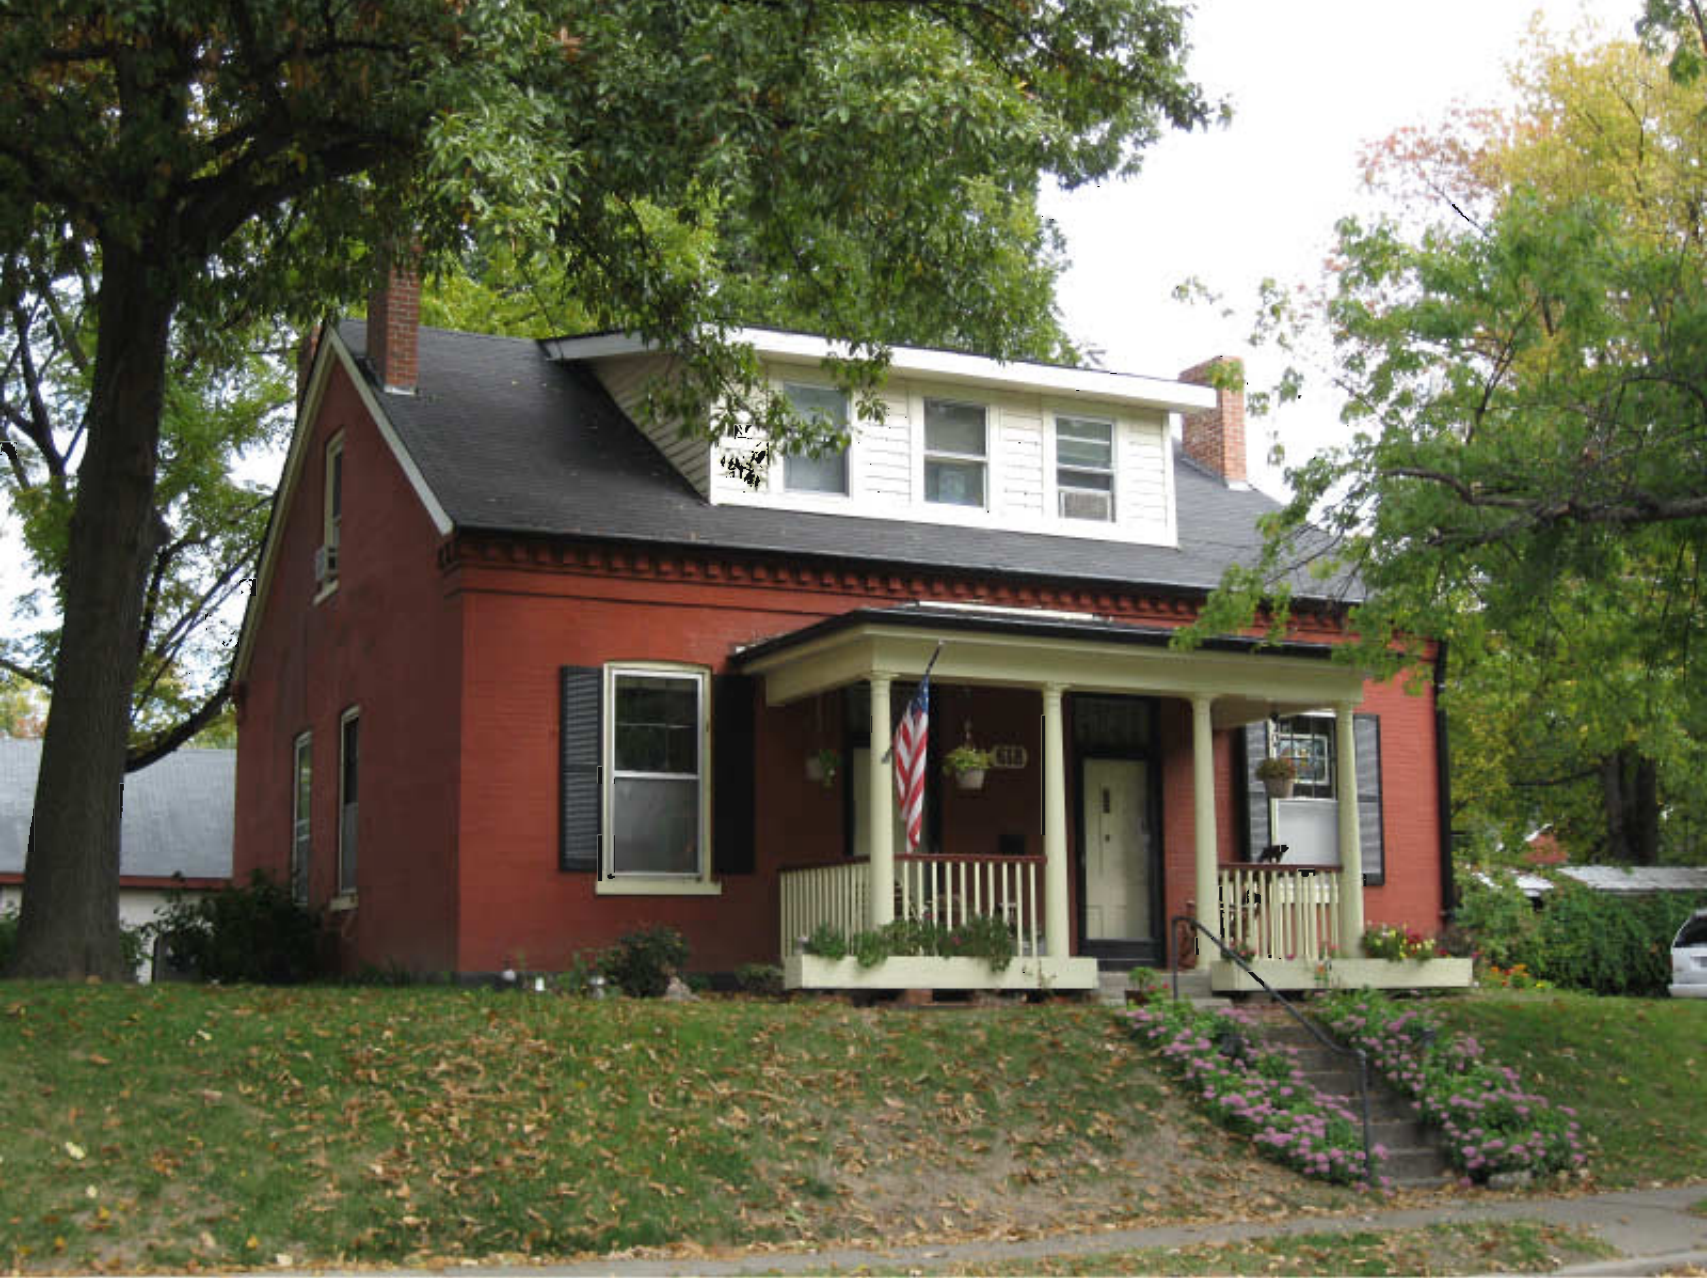
This one-and-one-half story, side-gabled, painted brick, Federal style structure rests on a coursed, rock-faced stone foundation. The roof is trimmed with a brick entablature with denticulated frieze with returns, and there are interior end chimneys at each end of the house on both the front and rear slopes of the roof. A shed roof dormer has been added to the front slope and features three 1/1 windows and vinyl-sided walls. The center two bays of the four-bay main façade have four-panel doors topped by six-light transoms, and a gallery spans the center two bays and features a concrete deck, plain wood balustrade, and colonettes supporting a low hip roof. The house was apparently built without a front gallery but the Sanborn Insurance Maps indicate that one was added between 1917 and 1929, and it is in the Colonial Revival mode. In the outer bays are 6/6 wood windows set in low segmental-arched openings with radiating voussoirs and painted wood lug sills. Each side elevation has two 6/6 windows on the first floor and one in the upper half story, and they are set within low segment-arched openings. On the east elevation is a wooden bulkhead that provides access to a cellar.
