ARCHITECTURAL/HISTORIC INVENTORY FORM

1. Survey No. SC-AS-009-001		2. Survey Name: St. Charles Survey Phase 3: Mid-Town and Commons Neighborhoods	
3. County: St. Charles		4. Address (Street No.) 128	Street (name) North Sixth Street
5. City: St. Charles	Vicinity: <input type="checkbox"/>	6. UTM:	
7. Township/Range/Section:		8. Historic name (if known): Meyer-Pieper House; The Meyerdorf	
9. Present/other name (if known):		10. Ownership: <input checked="" type="checkbox"/> Private <input type="checkbox"/> Public	
11a. Historic use (if known): Domestic/single dwelling		11b. Current use: Domestic/single dwelling

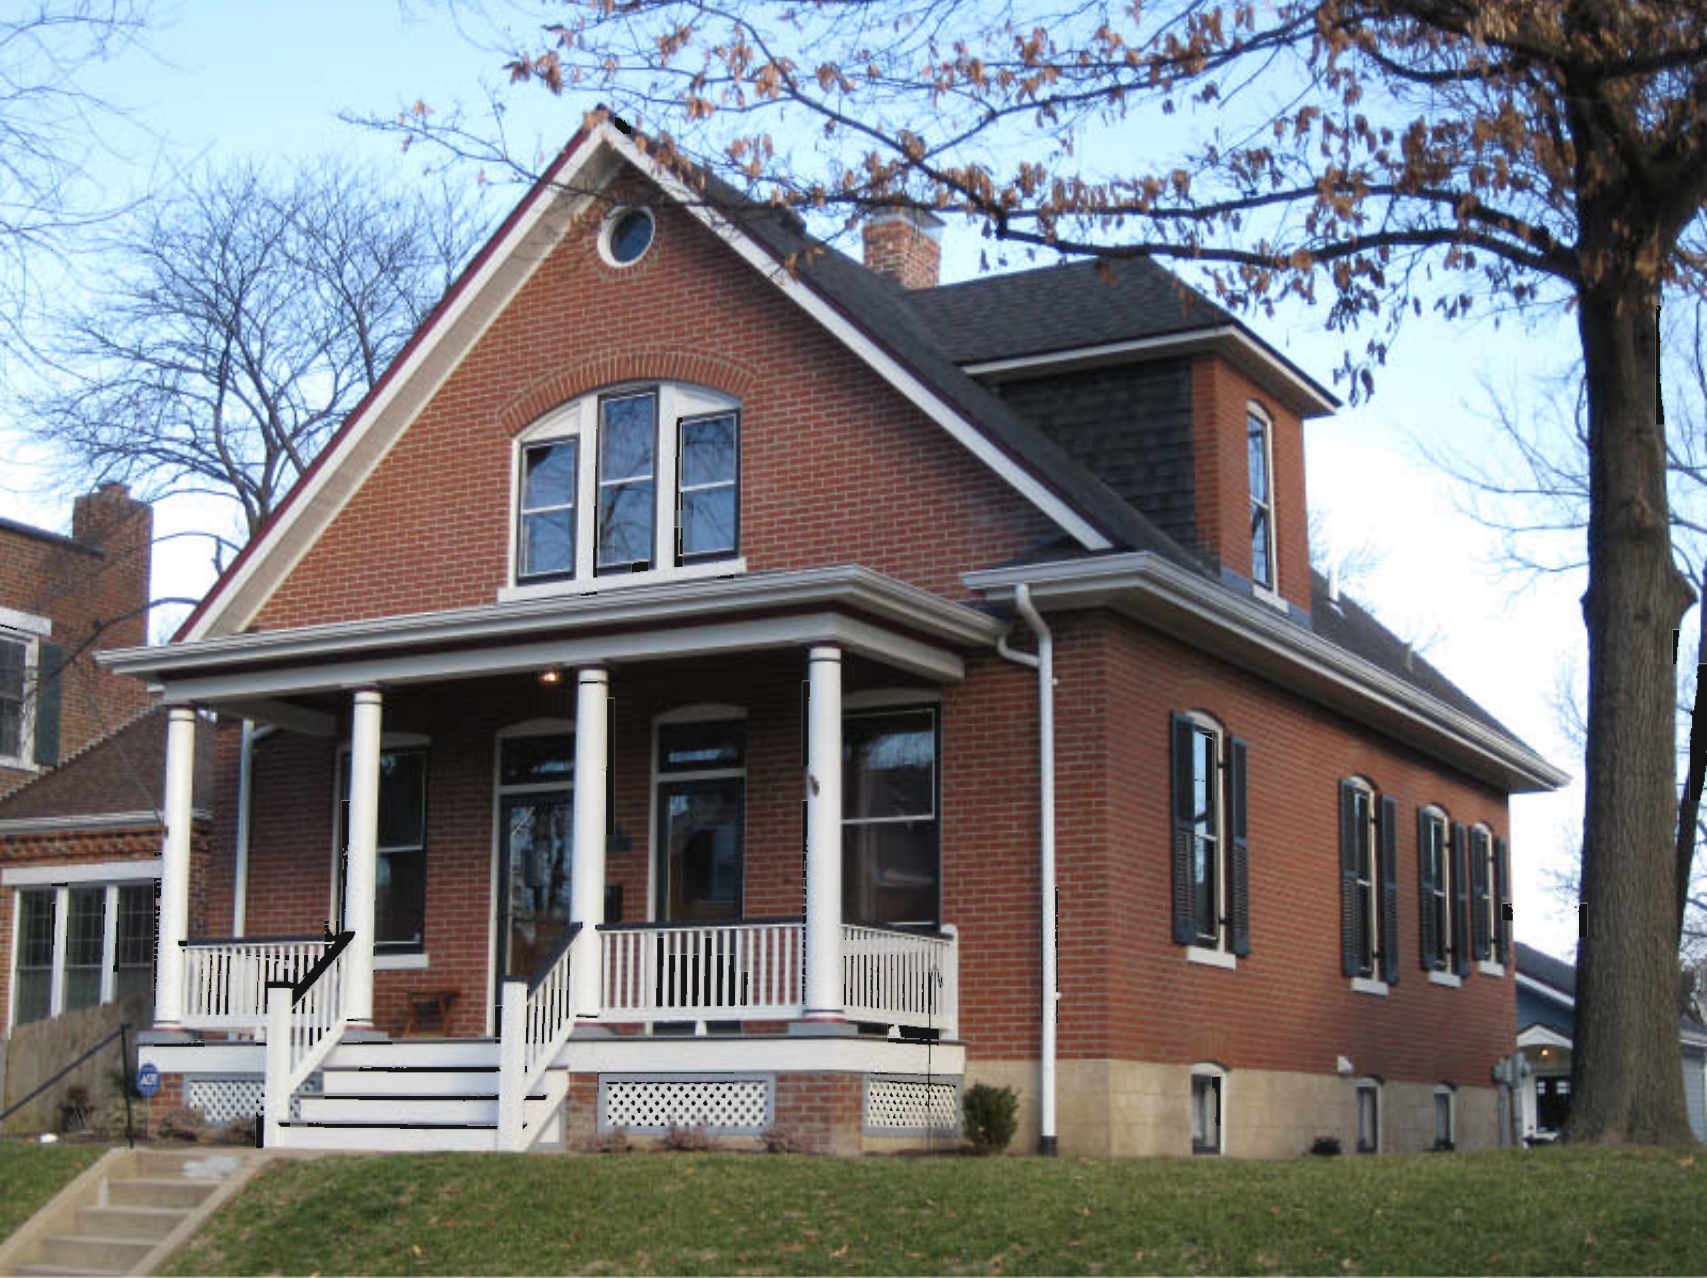
This one-and-one-half story, gable-front, brick, Colonial Revival style house rests on a scored concrete foundation that has beaded joints, and the foundation is pierced by single-light basement windows. Like the other openings throughout the house, the basement windows are set within segmental-arched openings that are topped by radiating voussoirs composed of a soldier course topped by a header course of bricks. The walls of the house are laid in the running bond pattern, and the steeply-pitched, front-gabled roof has wide overhanging eaves with bead-board soffits and cornice returns. A brick chimney straddles the ridge of the roof, and on each side slope is a hipped dormer with wide overhanging eaves, brick front wall with 1/1 window, and side walls finished with asphalt roofing shingles. The center two bays of the four-bay main façade have half-glazed, paneled wood doors (3 horizontal panels below the glass and 1 above) topped by single-light transoms, and in the outer bays are 1/1 wood windows. A ¾-width gallery spans the four bays and features brick foundation piers in-filled with framed wood lattice panels, wood deck and stairway, plain wood balustrade, and Doric columns supporting a low hip roof. A wide segmental-arched opening in the upper half story holds a Palladian-influenced tripartite window composed of a 1/1 window flanked by shorter 1/1 windows topped by triangular panels. Above this opening is a round single-light oculus. The west elevation has three 1/1 windows while the east elevation has four, and all have operable wood louvered blinds.

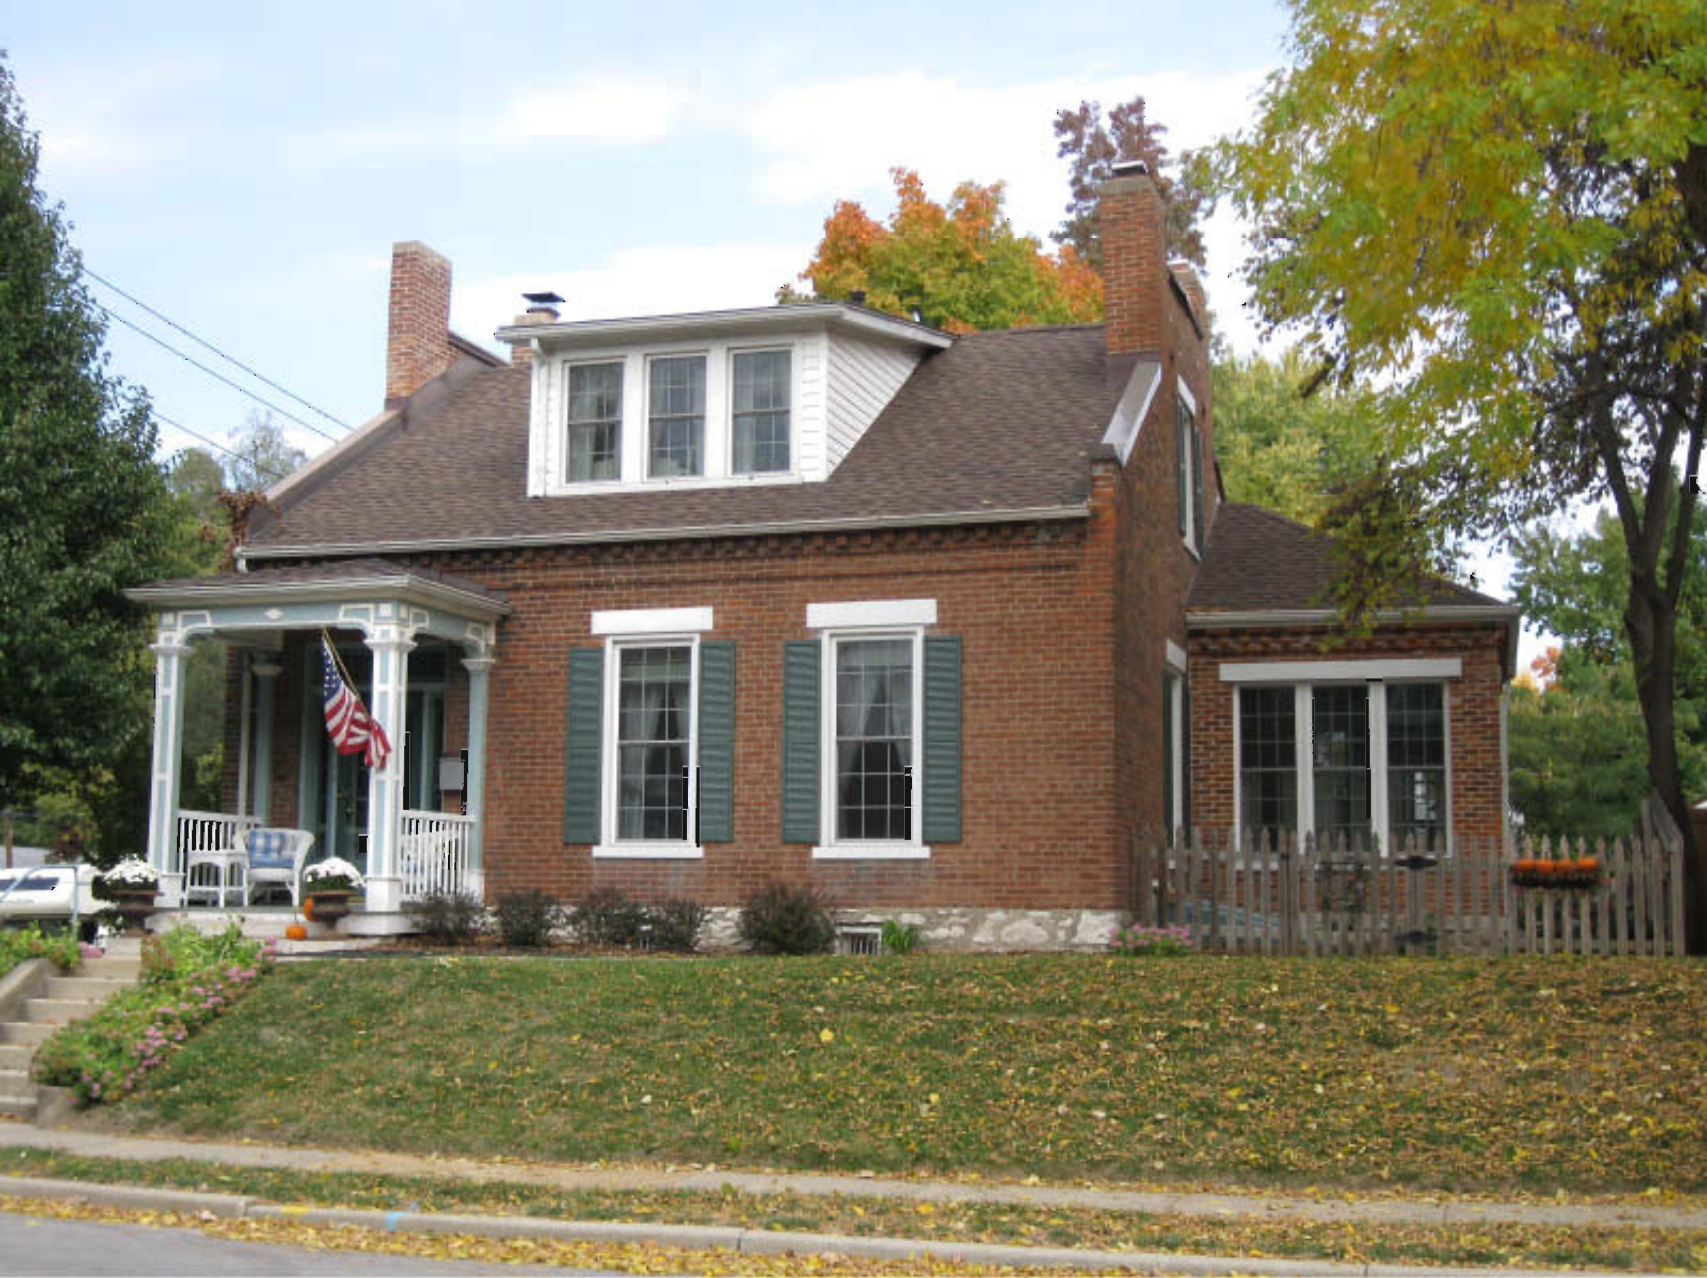
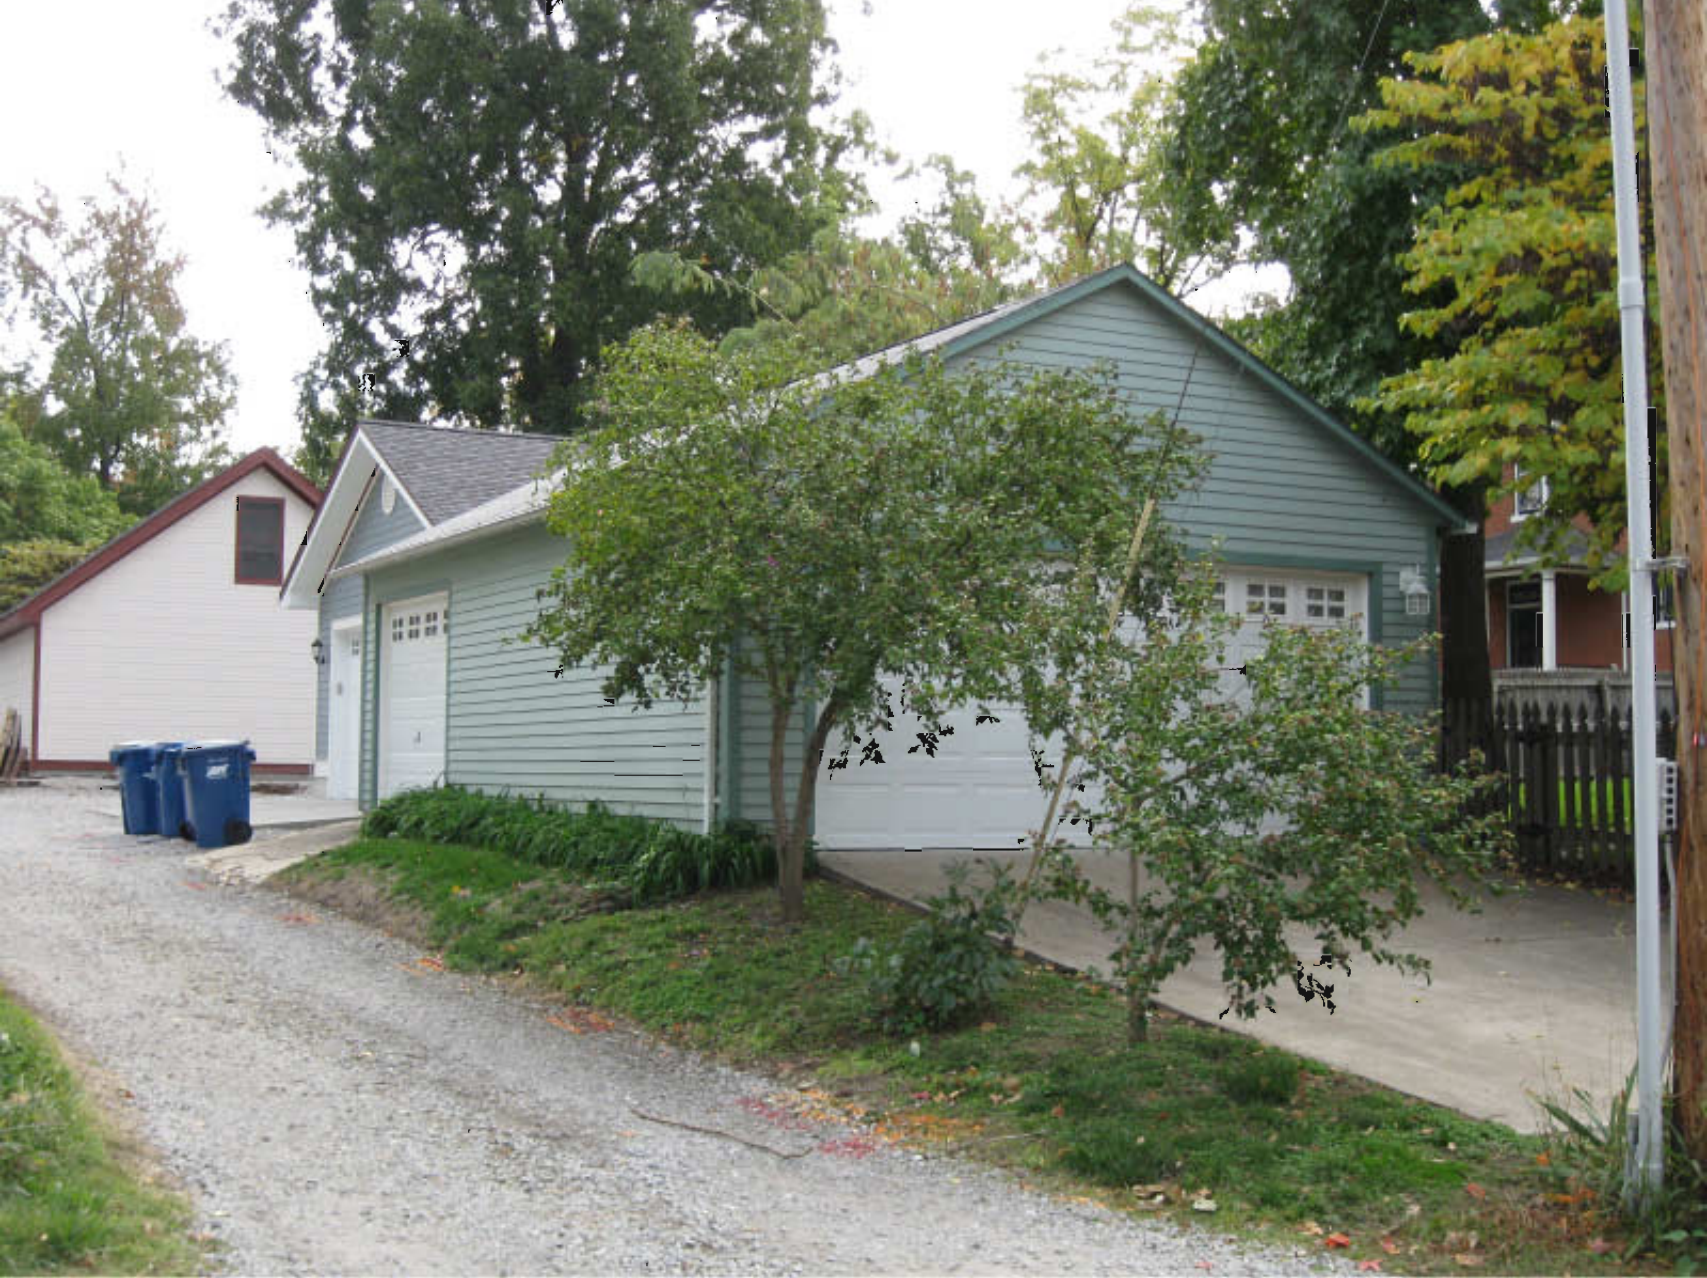
Situated at the northeast corner of Monroe and Seventh Streets, this one-and-one-half story, brick, Federal style house has a side-gabled roof with parapeted end walls, each with two chimneys. The roof is trimmed with a frieze that has a denticulated cornice, and on the front slope of the roof is a shed dormer with band of three 6/6 windows and vinyl-sided walls. The foundation is stone and the brick walls are laid in a seven-course common bond. The three-bay main façade features an entrance in the western bay and two 9/9 windows. The windows are replacements and have painted wood lug sills and lintels. The entrance is a 15-light, wood French door with five-light sidelights and a ten-light transom. The door opens onto a one-bay portico with wooden deck, plain wood balustrade, and box columns and pilasters supporting a low hip roof with arched frieze. The box columns are paneled, but the pilasters are plain, and the columns and pilasters are both topped by molded capitals. The frieze is decorated with

patterned moldings, such as squares and diamond-shaped. The portico likely is not original, but the earliest Sanborn map for this block shows that it had been built before 1909. The west elevation has a 9/9 window on the first floor and a 6/6 window in the upper half story. The one-story rear wing, which was added between 1917 and 1929, has a band of three 6/6 windows on the west elevation. Louvered vinyl shutters have been added to the windows. The east elevation has a 9/9/ window on the first floor and a 6/6 window in the upper half story. North of the first floor window is an addition that was constructed in 2010. This addition replaced a porch that had been added between 1917 and 1929. The addition is brick and has a high hip roof trimmed with a denticulated frieze. The south elevation features a band of 9/9 windows.

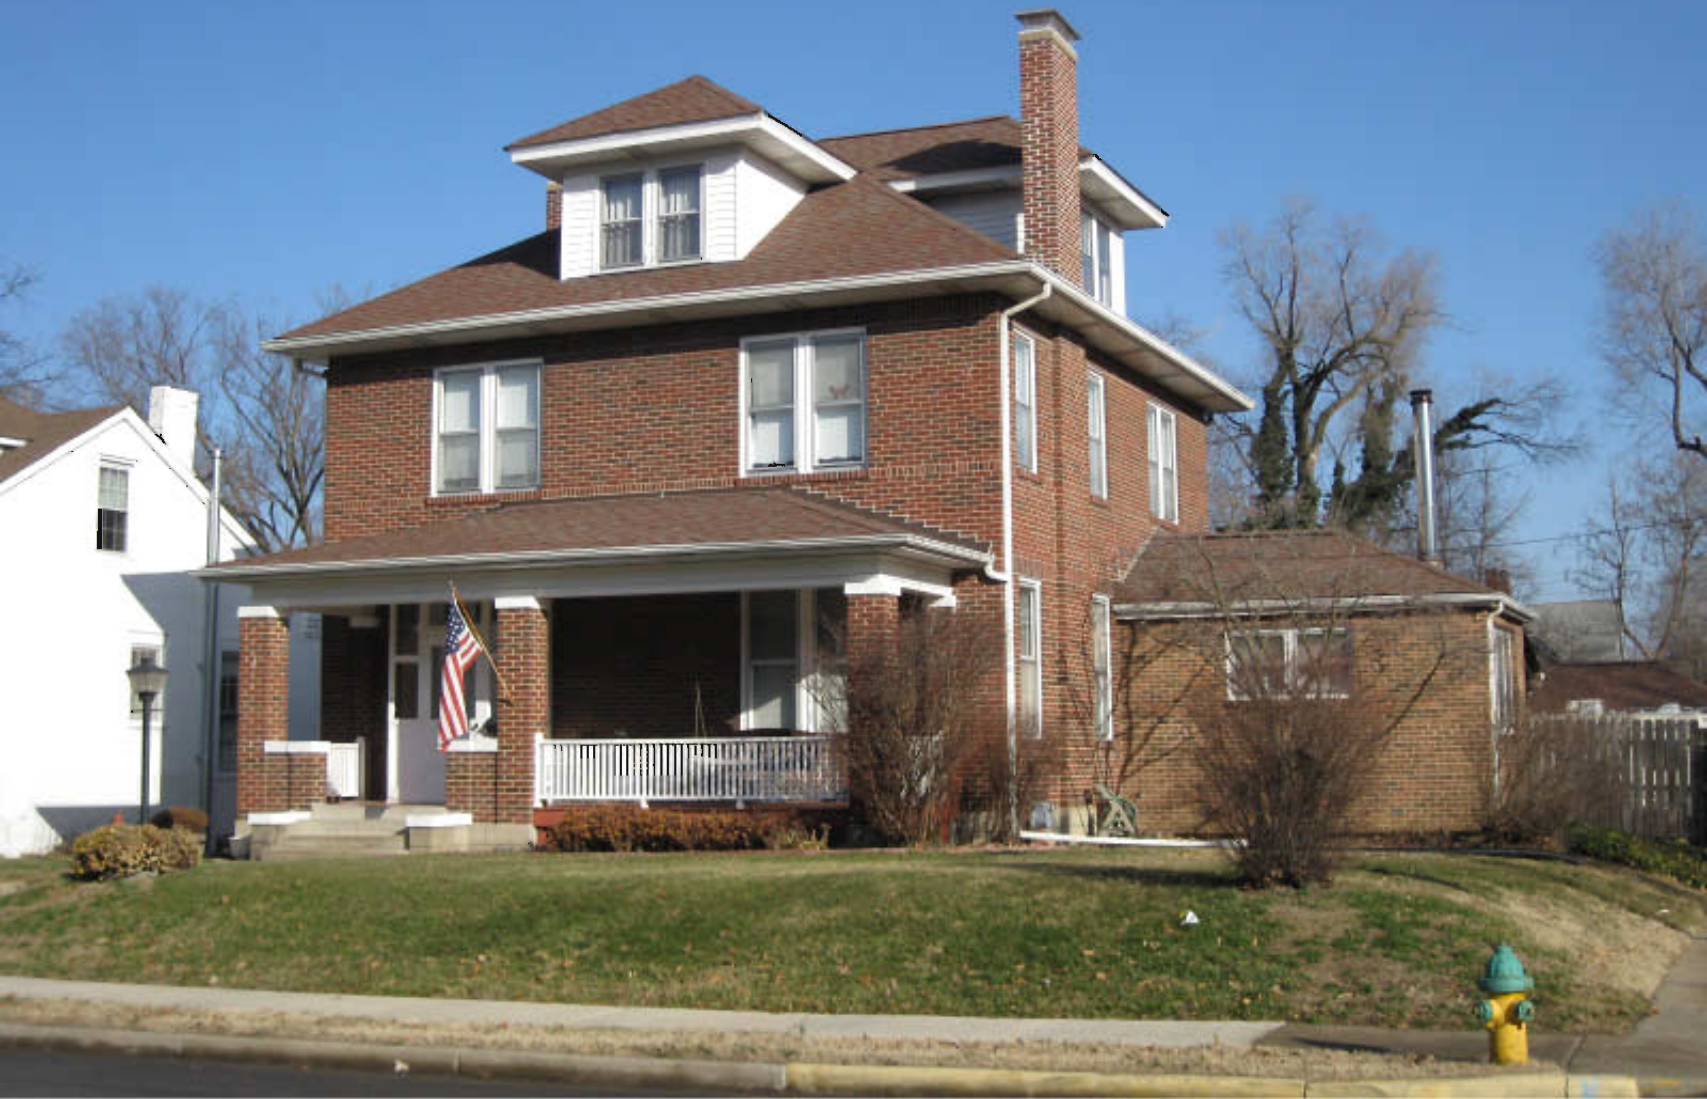
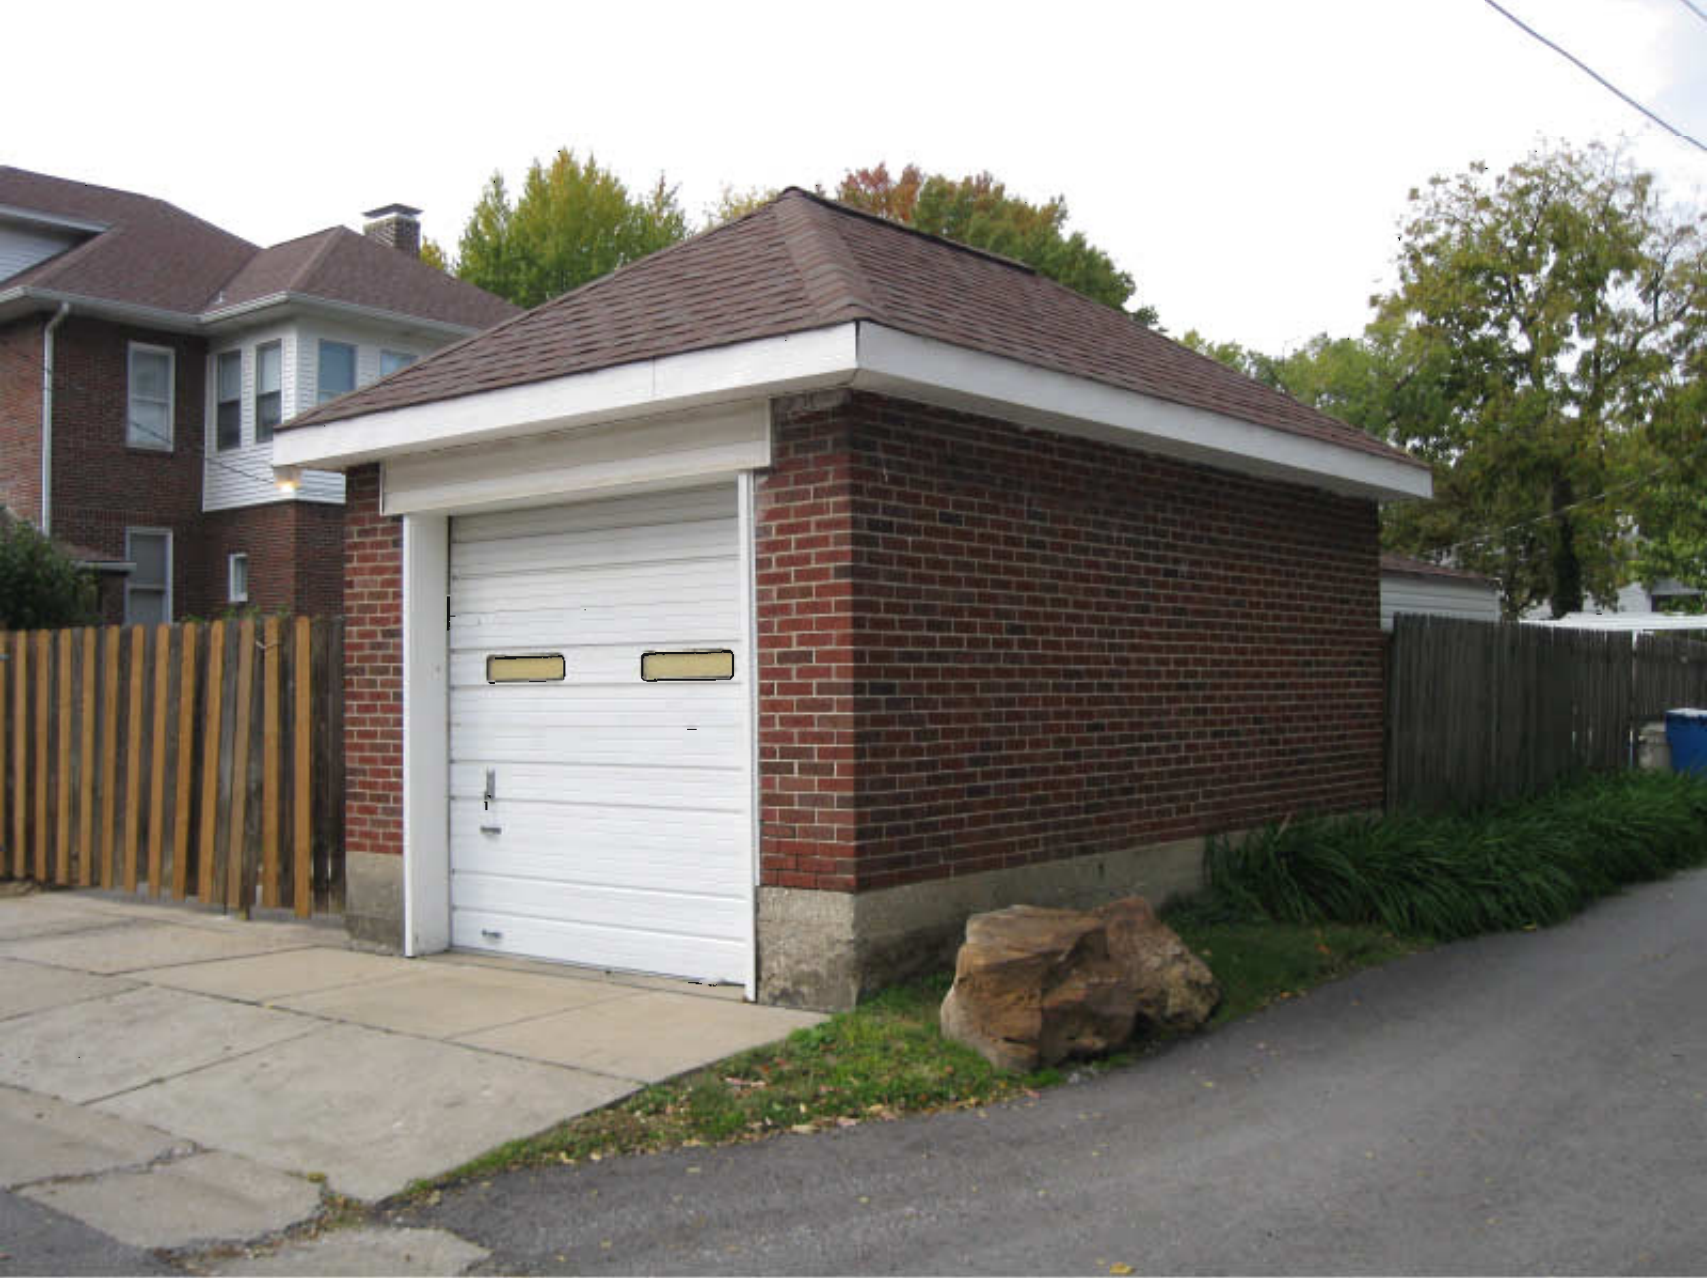
Situated at the northwest corner of Monroe and Seventh Streets, this house is a two-and-one-half story, brick, American Foursquare that rests on a scored concrete foundation and is crowned by a high hipped roof with wide overhanging eaves. Tall, exterior end, brick chimneys pierce the east and west slopes of the roof, and hipped dormers with paired 1/1 windows and vinyl-sided walls are on the front (south) and east slopes. The brick walls are laid in a running bond pattern, but rowlocks form the first course above the foundation. Belt courses of soldier bricks are above the first and second floor windows, and a belt course of rowlocks is at the sill-level of the second floor windows. The first floor of the west end of the two-bay main façade has a four-panel wood door flanked by single-light sidelights, and the door and sidelights are each topped by a single-light transom. A vestibule has been added in front of the doorway and features half-glazed walls and a three-panel, wood door topped by a transom. To the east of the doorway is a pair of 1/1 windows, and the door and windows open onto a one-story, ¾-width gallery. The gallery has a concrete stairway flanked by scored concrete knee walls with concrete copings, a concrete deck, and brick piers and pilasters supporting a hip roof. The railing at the top of the stairway is a brick knee wall with concrete coping, but a plain wood balustrade encloses the remainder of the porch. Two pairs of 1/1 windows are on the second floor. The first floor of the east elevation has a 1/1 window to each side of the exterior end chimney, and to the north, in the one-story, brick, hipped addition is a band of three 1/1 windows. (The south wall of the addition has a pair of short 1/1 windows.) The second floor of the east elevation has a 1/1 window to each side of the chimney, and to the north is a pair of 1/1 windows. On the first floor of the west elevation, from front to rear, is a 1/1 window; at ground level is a door protected by a shed awning supported by knee braces; and a pair of single-light casement windows that appear to be replacements. Directly above the doorway is a window halfway between floors, indicating that it overlooks a stairway, and on the second floor is a small transom window flanked by 1/1 windows. What appears to have been a sleeping porch is at the western half of the rear elevation. Its west elevation has paired 1/1 windows on the first floor and two 1/1 windows on the second, and the walls are clad with vinyl siding.

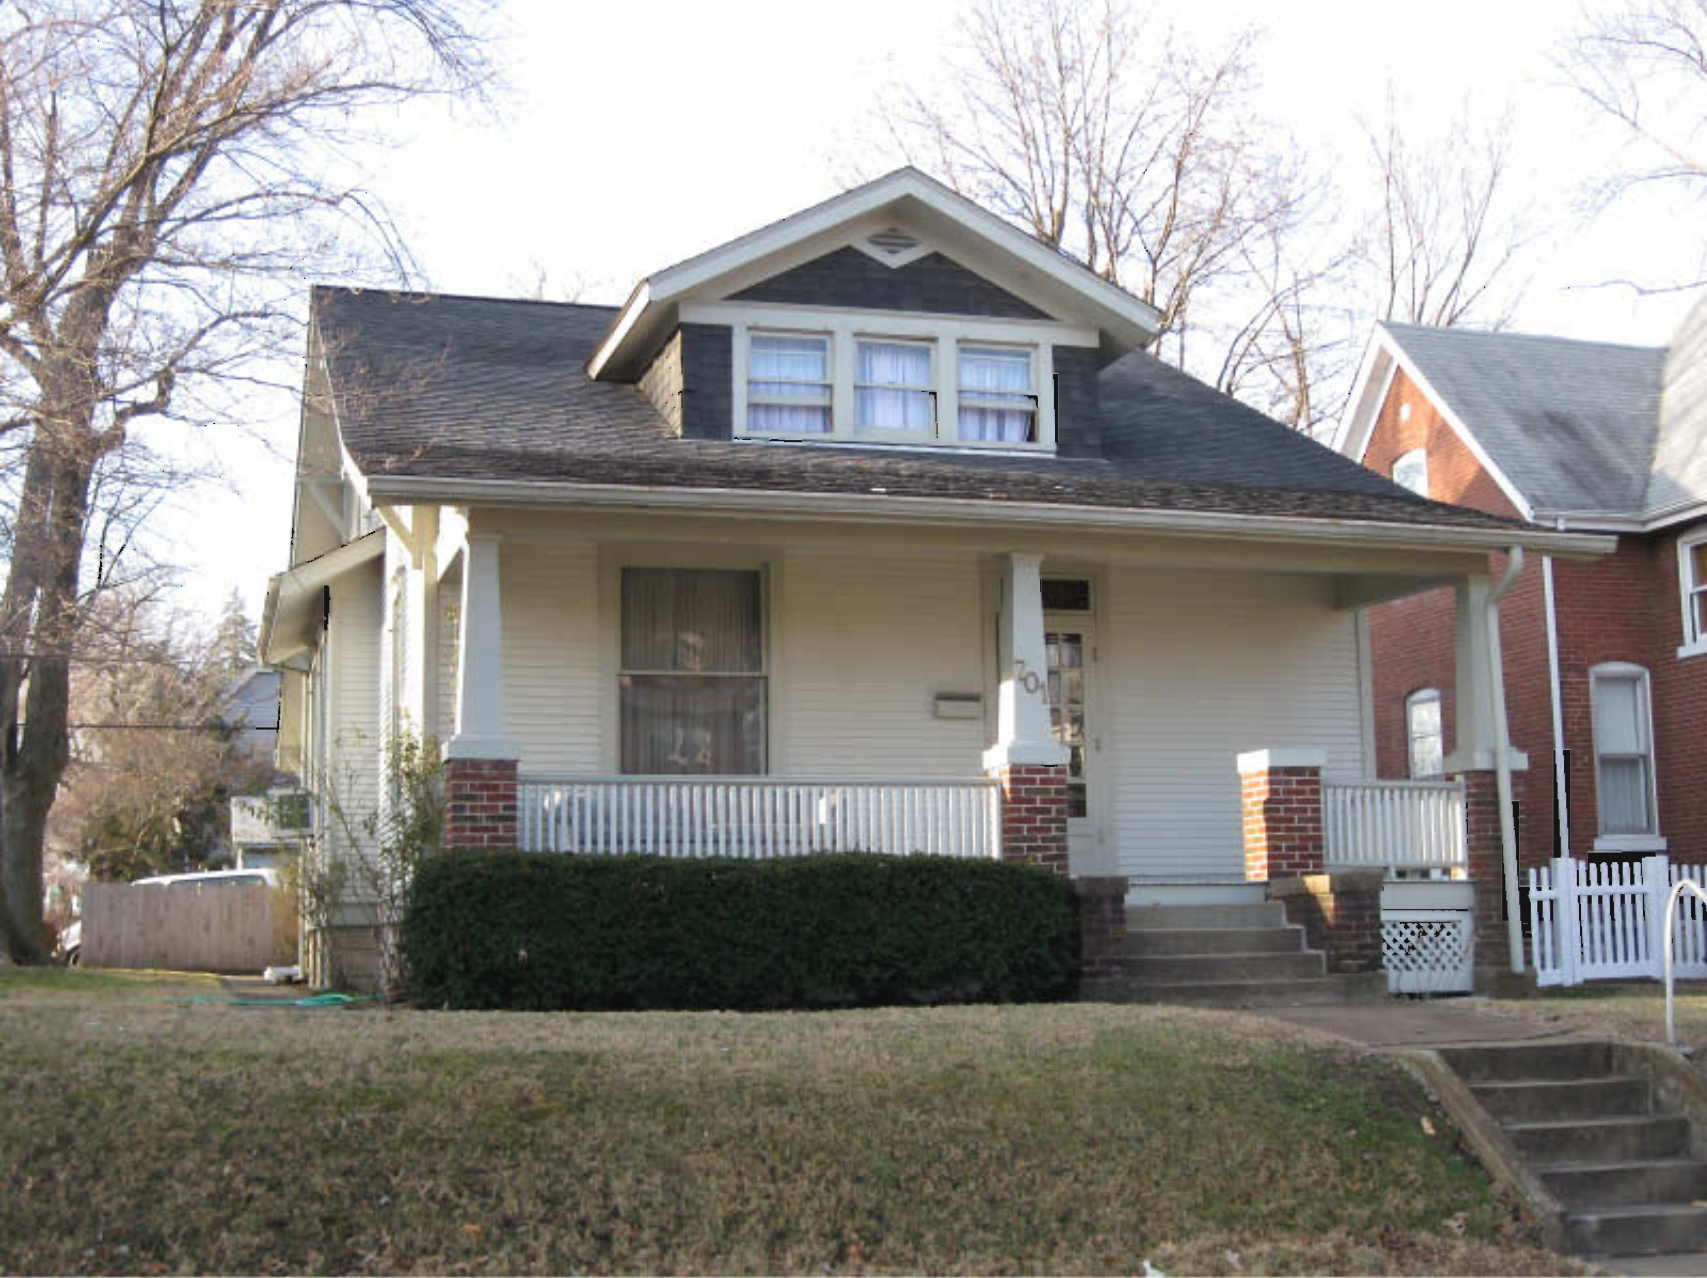
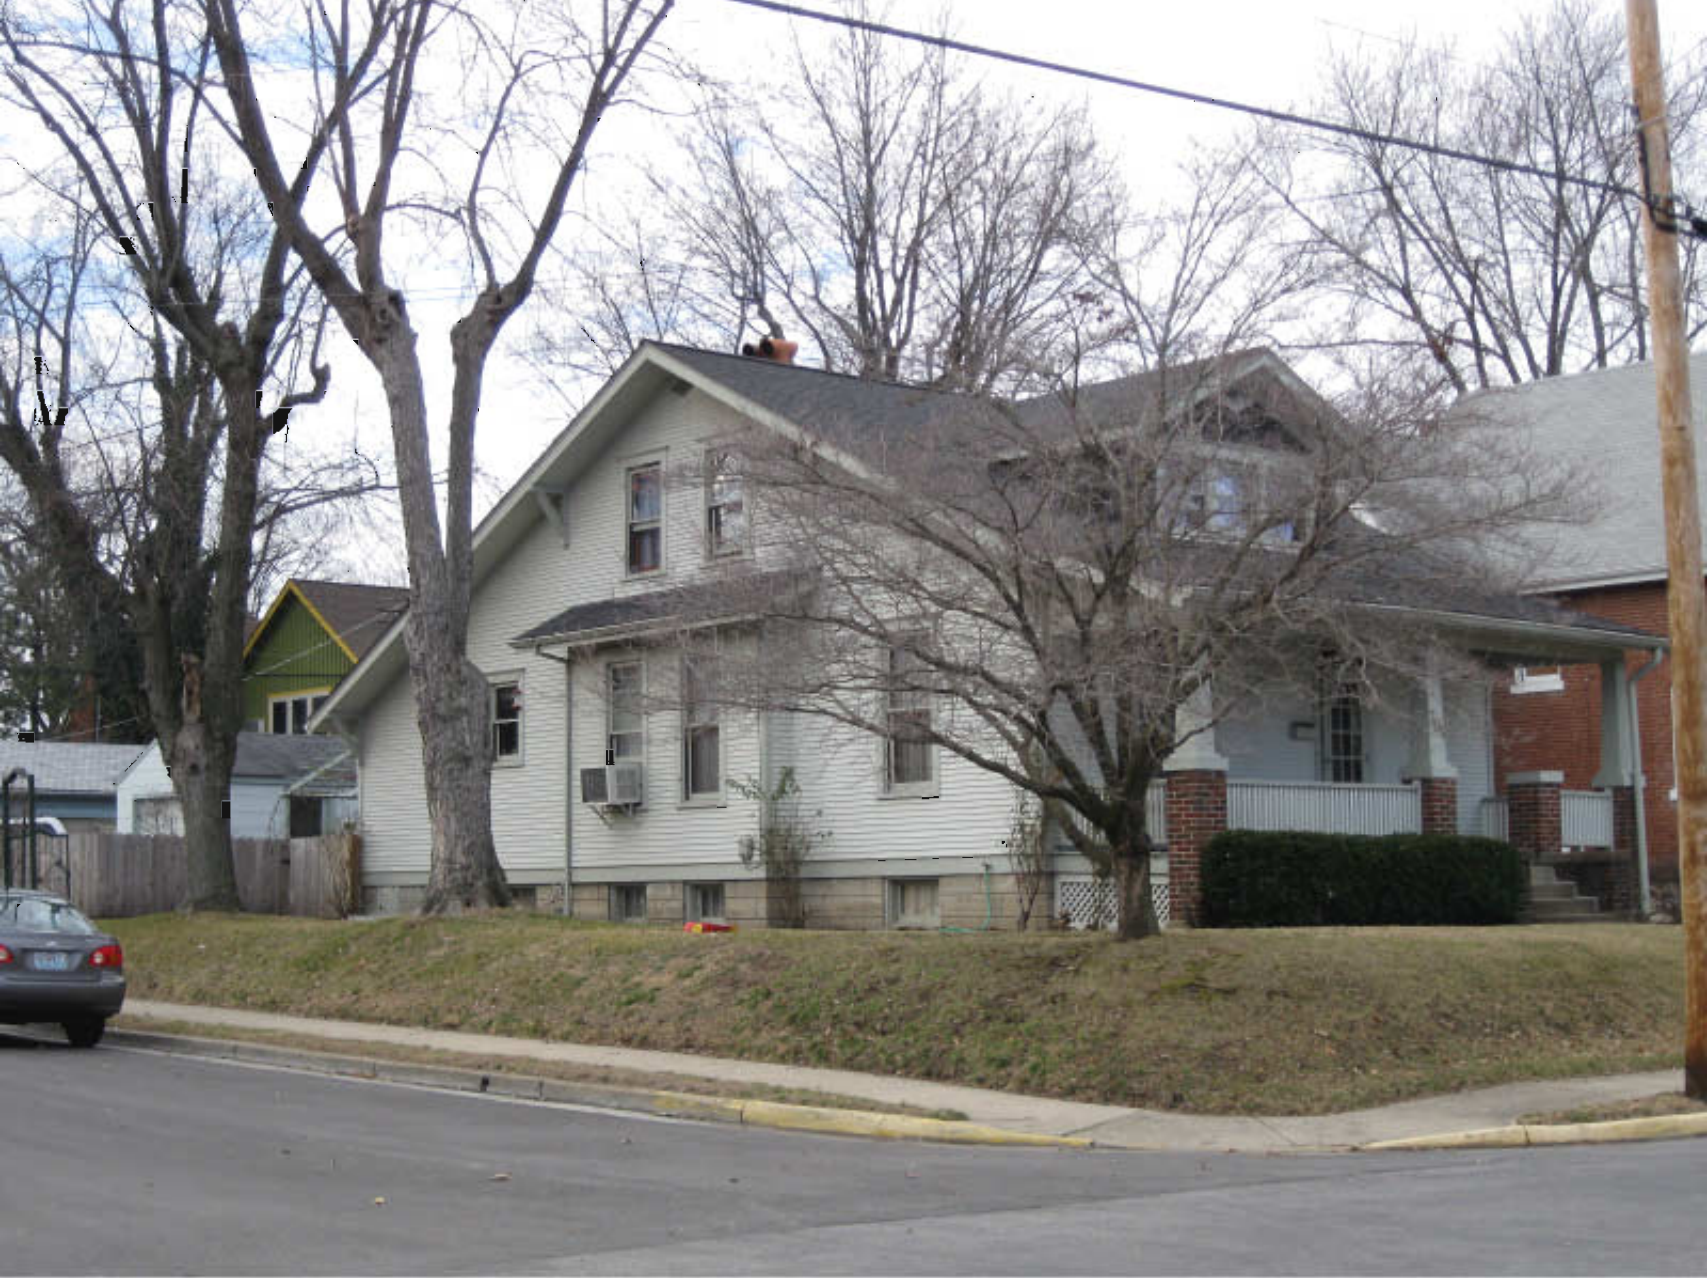
Situated on a tree-shaded lot, this one-and-one-half story, side-gabled, frame bungalow rests on a scored concrete foundation that has three-light basement windows. The walls are finished with narrow weatherboard siding trimmed with corner boards and a wide wooden water table. The medium-pitched roof has wide overhanging eaves with decorative knee braces in the gable ends, and the rear slope of the roof is pierced by an interior chimney. On the front slope is a dormer with pedimented gable roof and a band of three 1/1 wood windows. The walls of the dormer are finished with asphalt roofing shingles. The entrance is in the west bay of the two-bay main façade, and it is a glazed wood door with three vertical lights. The door is topped by a single-light transom and protected by a multi-light paneled wood storm door. To the east of the entrance is a wide 1/1 wood window. A gallery spans the main façade and features a concrete stairway flanked by brick knee walls, a wooden deck, brick pedestals that extend to the ground, wood lattice panels under the porch deck, and a plain wood balustrade. Battered box columns rest on three of the four pedestals and support the shed roof. The west elevation has four 1/1 windows on the first floor and two in the upper half story. The east elevation is highlighted by a box bay with shed roof and two 1/1 windows, and to each side of the box bay is a 1/1 window. Two 1/1 windows are in the upper half story, above the box bay.

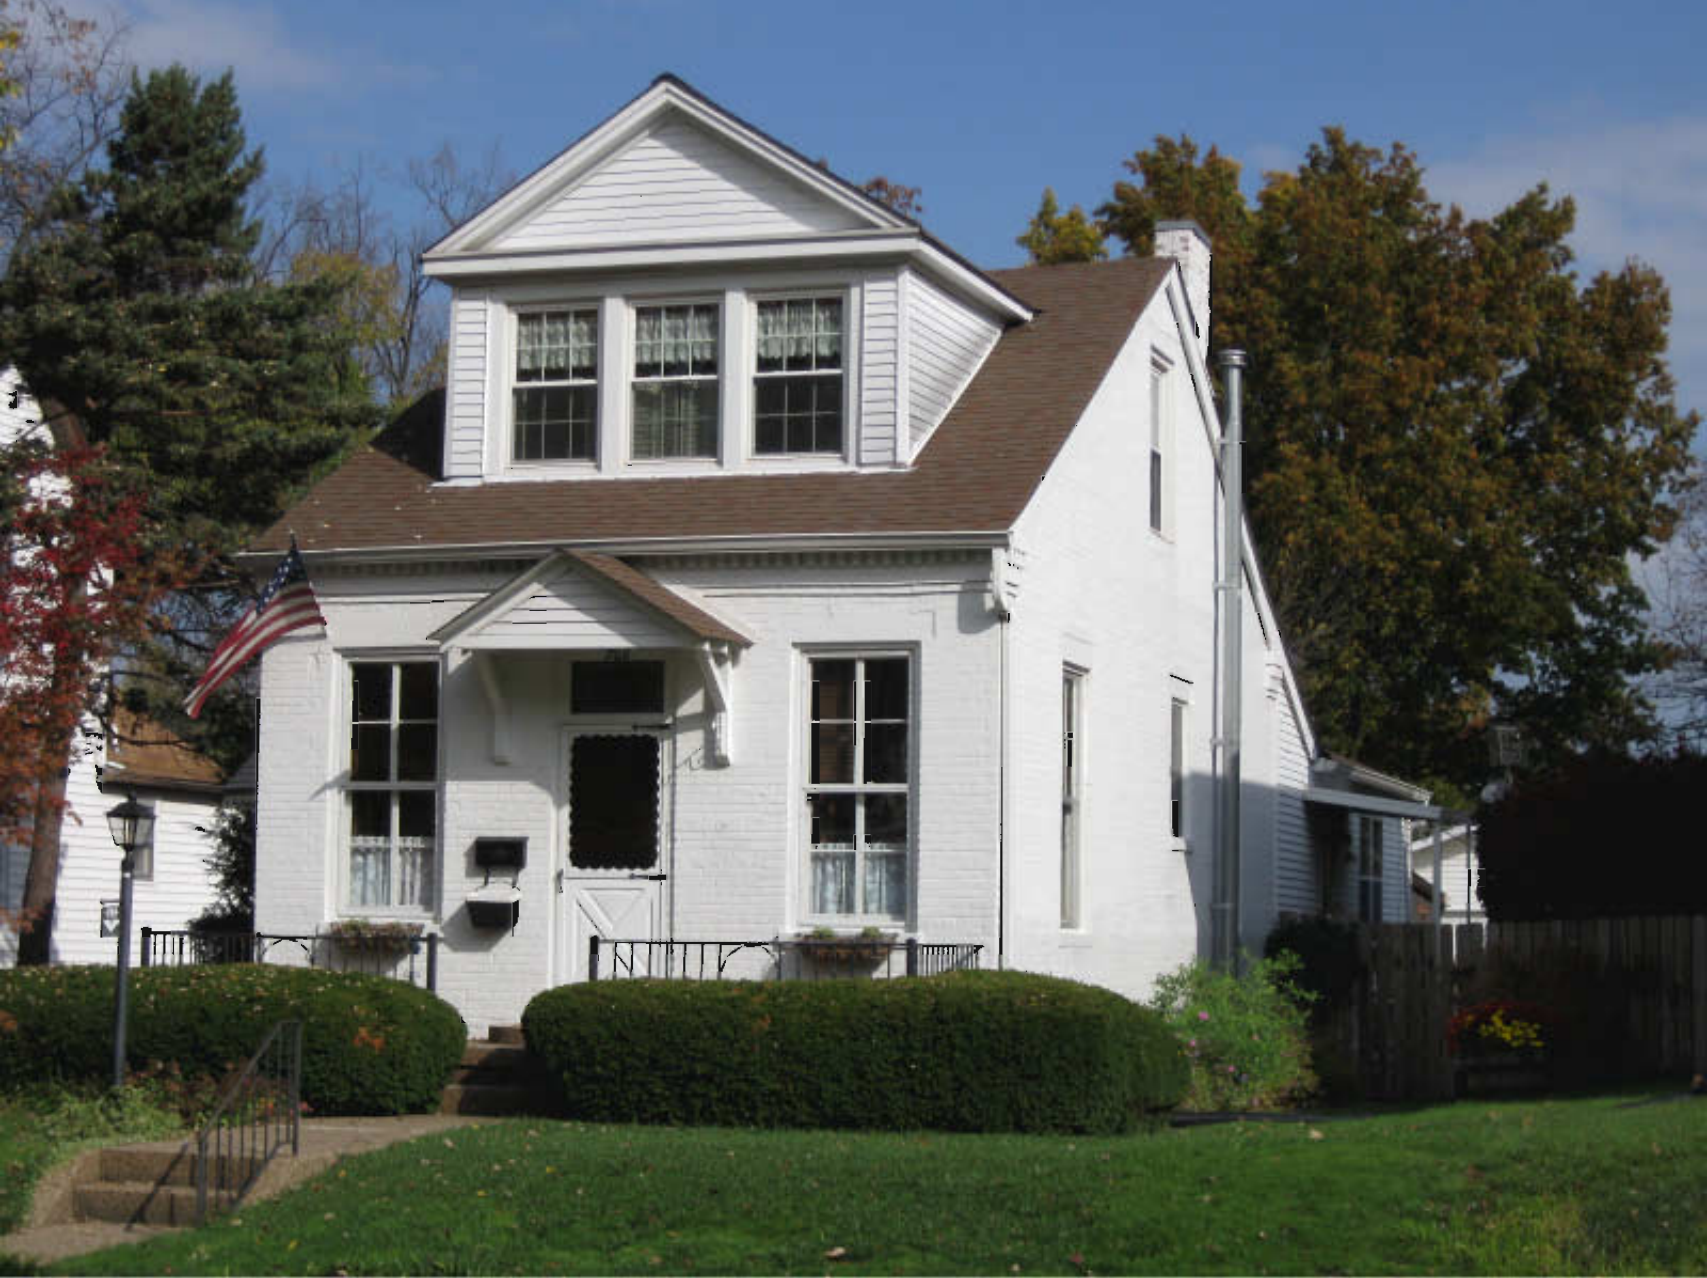
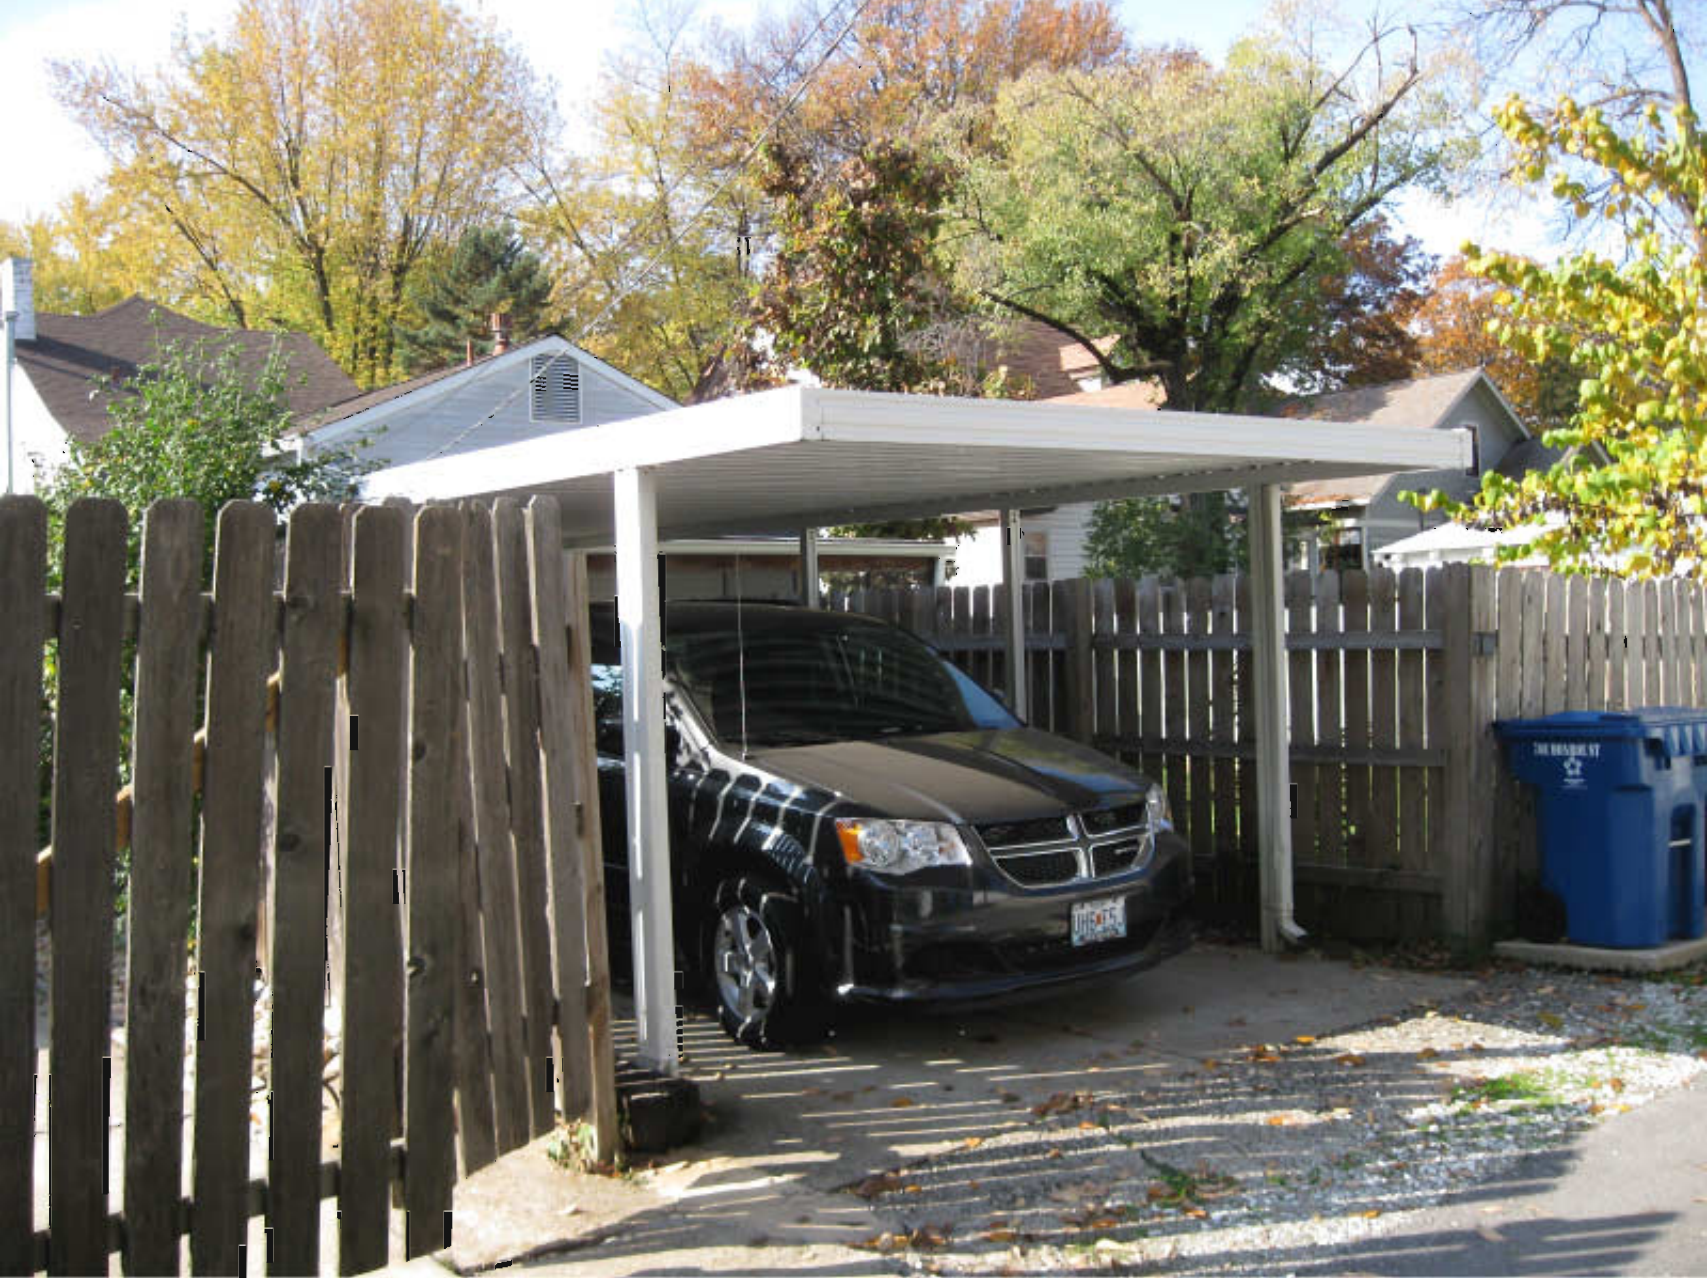
Facing south, this house is a one-and-one-half story, side-gabled, masonry, Federal style structure. The brick walls and foundation have been painted, as has the interior end chimney on the east end of the rear slope of the roof. A brick denticulated entablature with cornice returns trims the roof, and a large dormer with pedimented gable roof, band of three 6/6 windows and vinyl-sided walls has been added to the front slope. The three-bay main façade has a central multi-panel door with four small lights, and above the door is a single-light transom and a gabled hood supported by knee braces. A half-glazed, metal storm door is at the entrance, which opens onto a full-width, concrete terrace with a plain iron railing. To each side of the entrance is a 4/4 wood window, and the windows have painted wood or stone lintels and lug sills. The east elevation has three 6/6 wood windows on the first floor (the center one being small) and a 6/6 window in the upper half story. At the south end of the west elevation is a polygonal bay that has multi-light windows, and based on information in the Historical Society's address files, this bay window was added in the 1940s. Those in the canted corners appear to be casements while the central opening appears have a multi-light fixed window flanked by multi-light casements. In the upper half story is a 6/6 window. A frame room addition was constructed on the rear elevation in 1982.
