ARCHITECTURAL/HISTORIC INVENTORY FORM

1. Survey No. SC-AS-009-001		2. Survey Name: St. Charles Survey Phase 3: Mid-Town and Commons Neighborhoods	
3. County: St. Charles		4. Address (Street No.) 128	Street (name) North Sixth Street
5. City: St. Charles	Vicinity: <input type="checkbox"/>	6. UTM:	
7. Township/Range/Section:		8. Historic name (if known): Meyer-Pieper House; The Meyerdorf	
9. Present/other name (if known):		10. Ownership: <input checked="" type="checkbox"/> Private <input type="checkbox"/> Public	
11a. Historic use (if known): Domestic/single dwelling		11b. Current use: Domestic/single dwelling

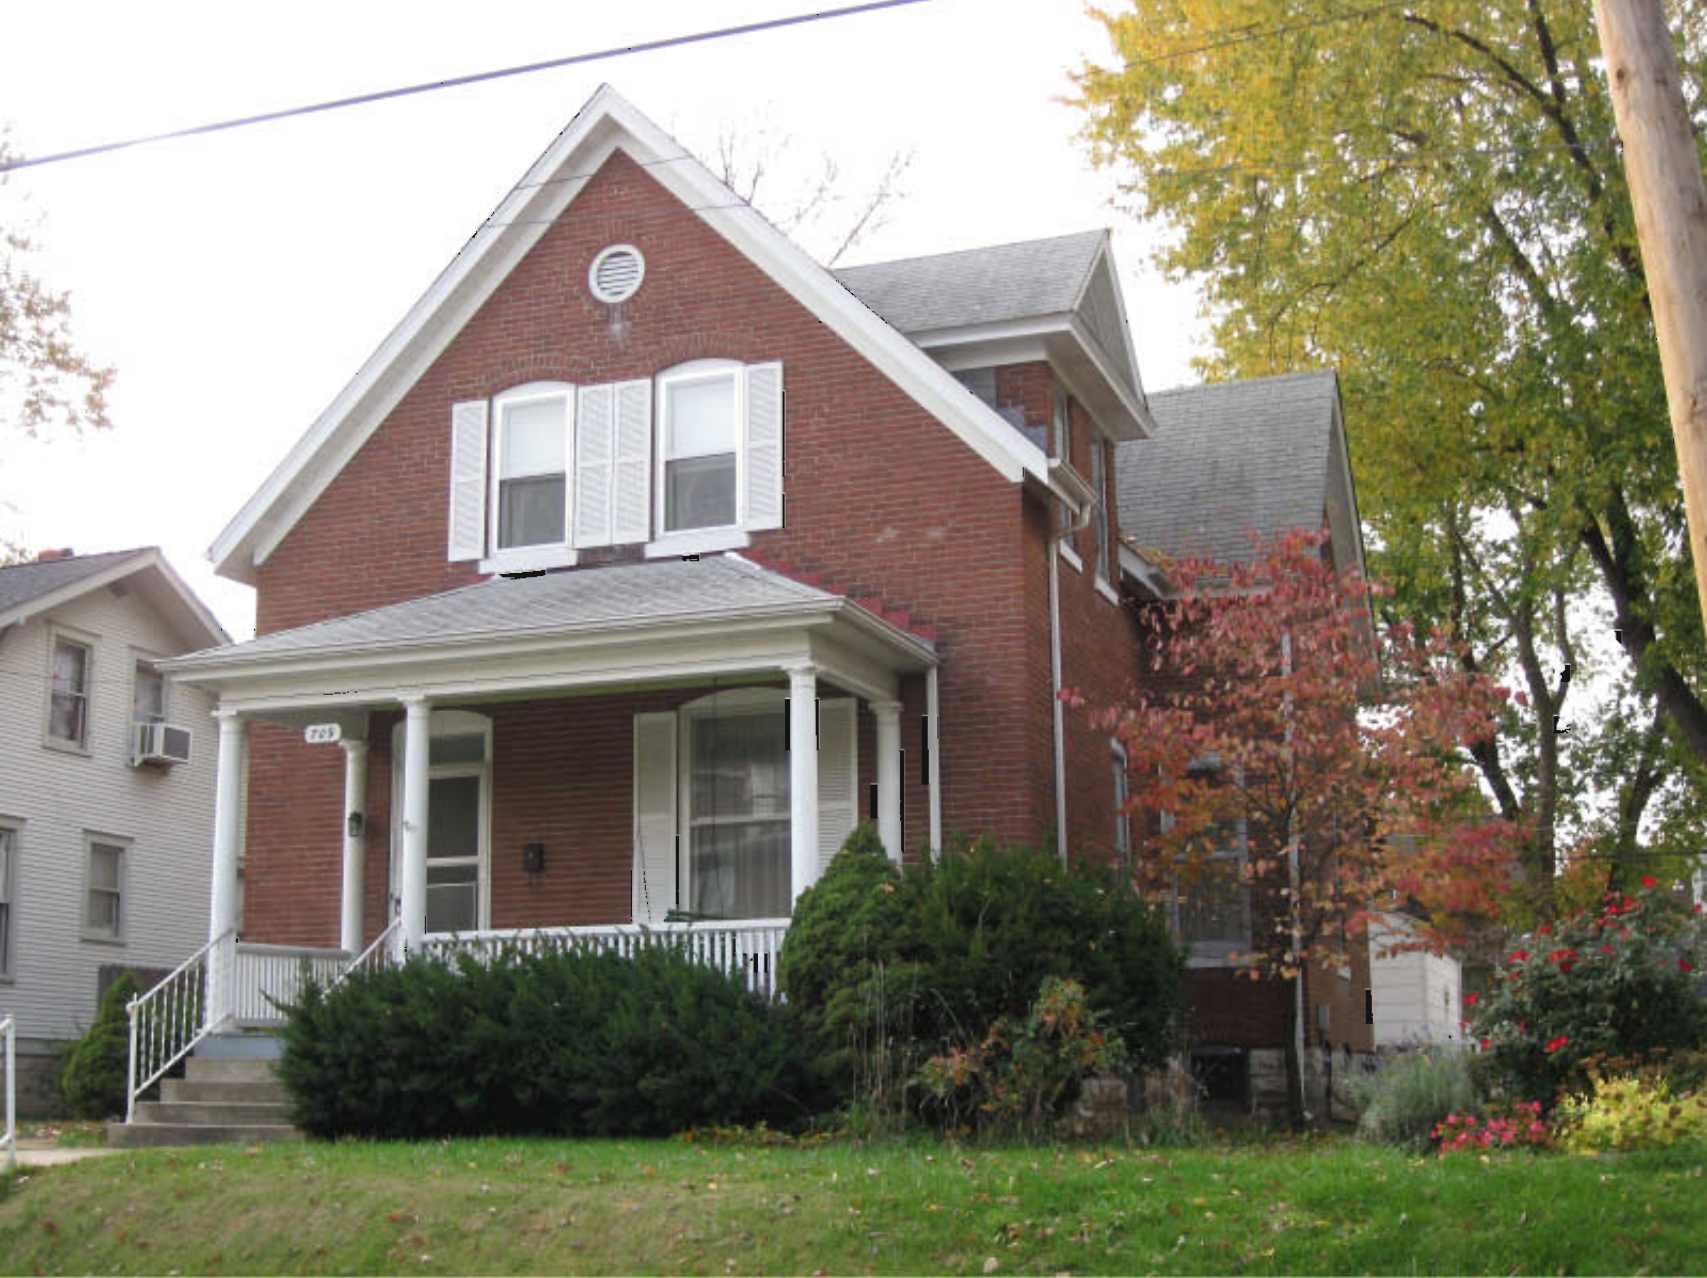
This house is a one-and-one-half story, brick, T-shaped structure that rests on a coursed, rock-faced stone foundation that is pierced by single-light basement windows topped by brick radiating voussoirs. The brick walls are laid in a common bond pattern, with every sixth course being Flemish bond. The high cross-gabled roof is trimmed with a raking board, and a pedimented gabled wall dormer is on the west side of the front-gabled wing and two are on the rear. Each dormer has two 1/1 windows and a tympanum clad with asphalt roofing shingles, and a brick chimney straddles the ridge of the roof of the western dormer of the rear elevation. The two-bay main (north) façade features a half-glazed, paneled wood door topped by a single-light transom, and to the west of the entrance is a wide 1/1 wood window. The openings throughout the house are segmental-arched with radiating voussoirs, and the windows have painted wood lug sills. The door opens onto a one-story, ¾-width gallery that has a concrete stairway, wooden deck, plain wood balustrade, and Doric columns and half columns supporting a high hip roof. In the upper half story are two 1/1 windows, above which is a round ventilator. On the north wall of each of the side-gabled wings is a 1/1 window. A 1/1 window is on the north end of the east elevation, and to the south, high in the wall, is a 1/1 window that apparently overlooks a stairway. The east elevation of the east gabled wing has a 1/1 window on each floor. On the west elevation is a 1/1 window on the first floor, above which is a gabled wall dormer, and on the west elevation of the west gabled wing is a 1/1 window on each level.

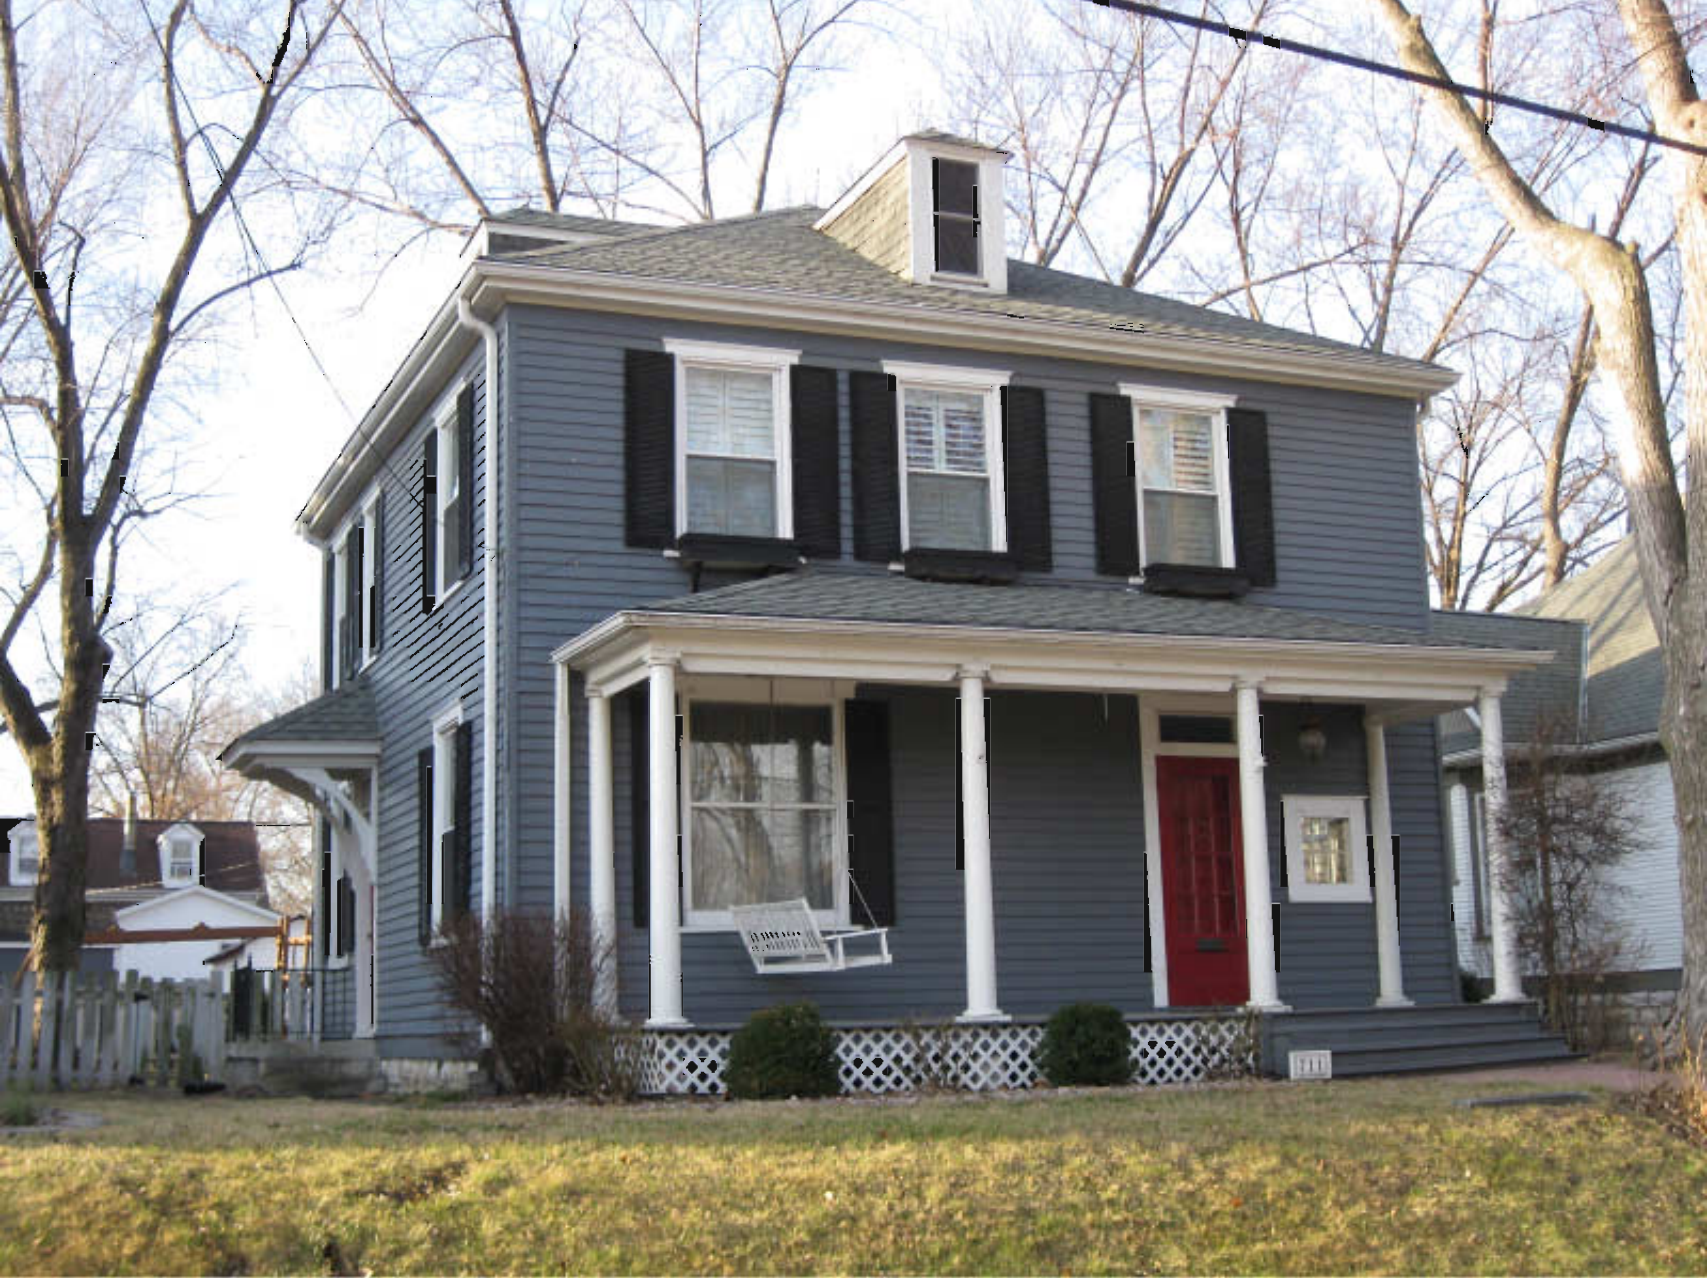
Facing north, this house is a two-and-one-half story, frame, Colonial Revival style structure that rests on a coursed rock-face stone foundation and has walls finished with weatherboard siding trimmed with corner boards and a wooden water table. Small hipped dormers are on the front and east slopes of the pyramidal roof, and an interior brick chimney pierces the west slope. Each of the dormers has a 1/1 window and walls finished with asphalt roofing shingles. The three-bay main façade is asymmetrical and features a wide 1/1 wood window on the east end, and the entrance and a small six-light wood window are at the west end. The door appears to be a wood French door that has had the glass painted, and over the door is a 12-light, paneled wood storm door. A single light transom is above the door, which opens onto a one-story, $\frac{3}{4}$ -width gallery with wooden stairway and deck and Tuscan columns supporting a hipped roof. The second floor of the façade has three 1/1 windows. The three-bay east elevation also has a doorway flanked by 1/1 windows on the first floor and three 1/1 windows on the second. The five-panel wood door is topped by a single-light transom, and the door opens onto a stoop that is protected by a hipped awning supported by knee braces. The west elevation has three windows on the first floor (the center window is small) and two on the second. It appears that the windows on the main façade are original while those on the side elevations have been replaced, and vinyl louvered shutters have been added.

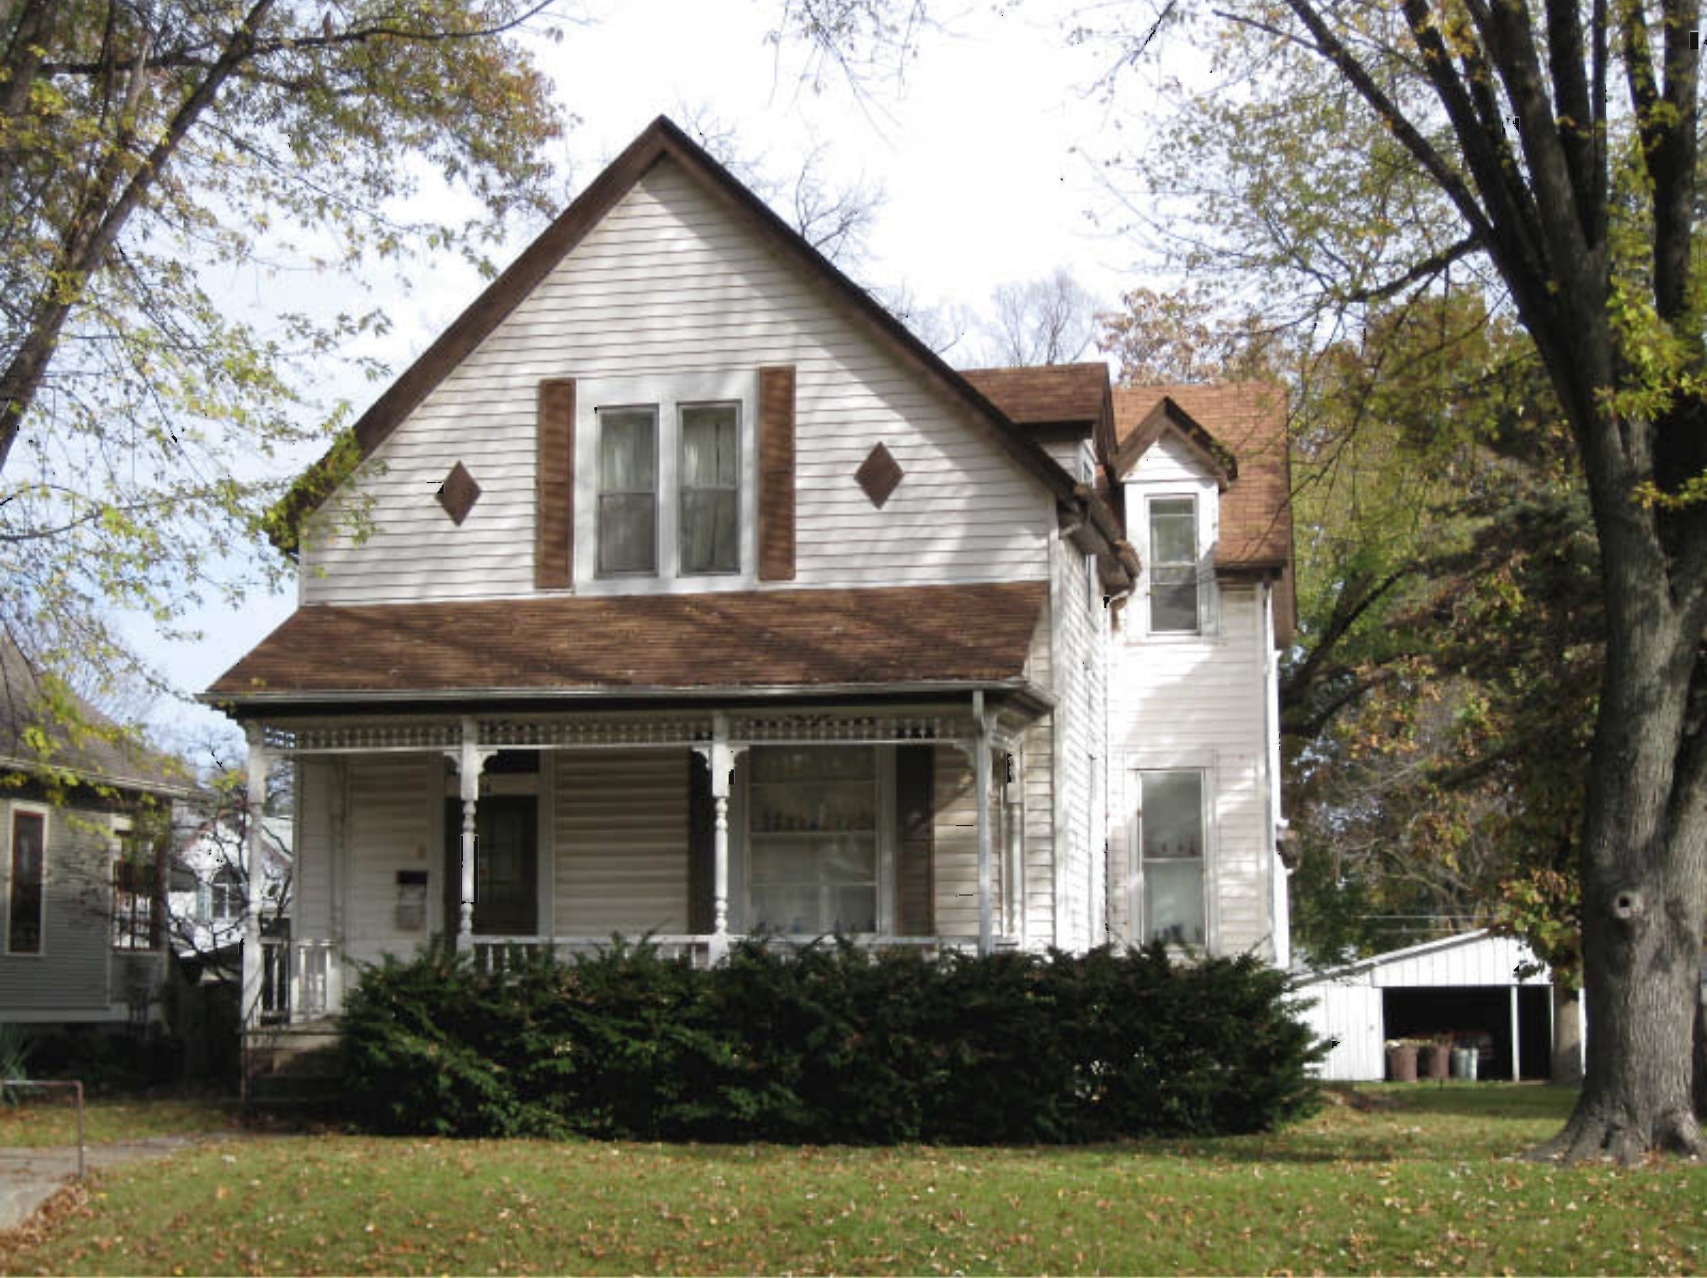
This one-and-one-half story, frame, Folk Victorian house rests on a coursed rock-faced stone foundation and is crowned by a steeply-pitched, cross-gable roof. The walls of the house have been clad in vinyl siding. The west bay of the two-bay main façade features a half-glazed, paneled wood door topped by a single-light transom, and in the east bay is a wide 1/1 window (the storm window is 2/2). The first floor window and door have peaked lintels that have a sunburst pattern. The door opens onto a one-story, ¾-width gallery that has brick foundation piers, concrete stairway, wooden deck, turned wood posts with corner brackets, a ball-and-rod spindled frieze, balustrade with turned balusters, and a shed roof. In the upper half story of the facade is a pair of 1/1 windows. The east wall of the front-gabled wing has a 1/1 window on the first floor and another above in a gabled wall dormer, and the east wall of the side-gabled wing has a 1/1 window on both levels. The south wall of the side-gabled wing has a window on the first floor and a wall dormer above.

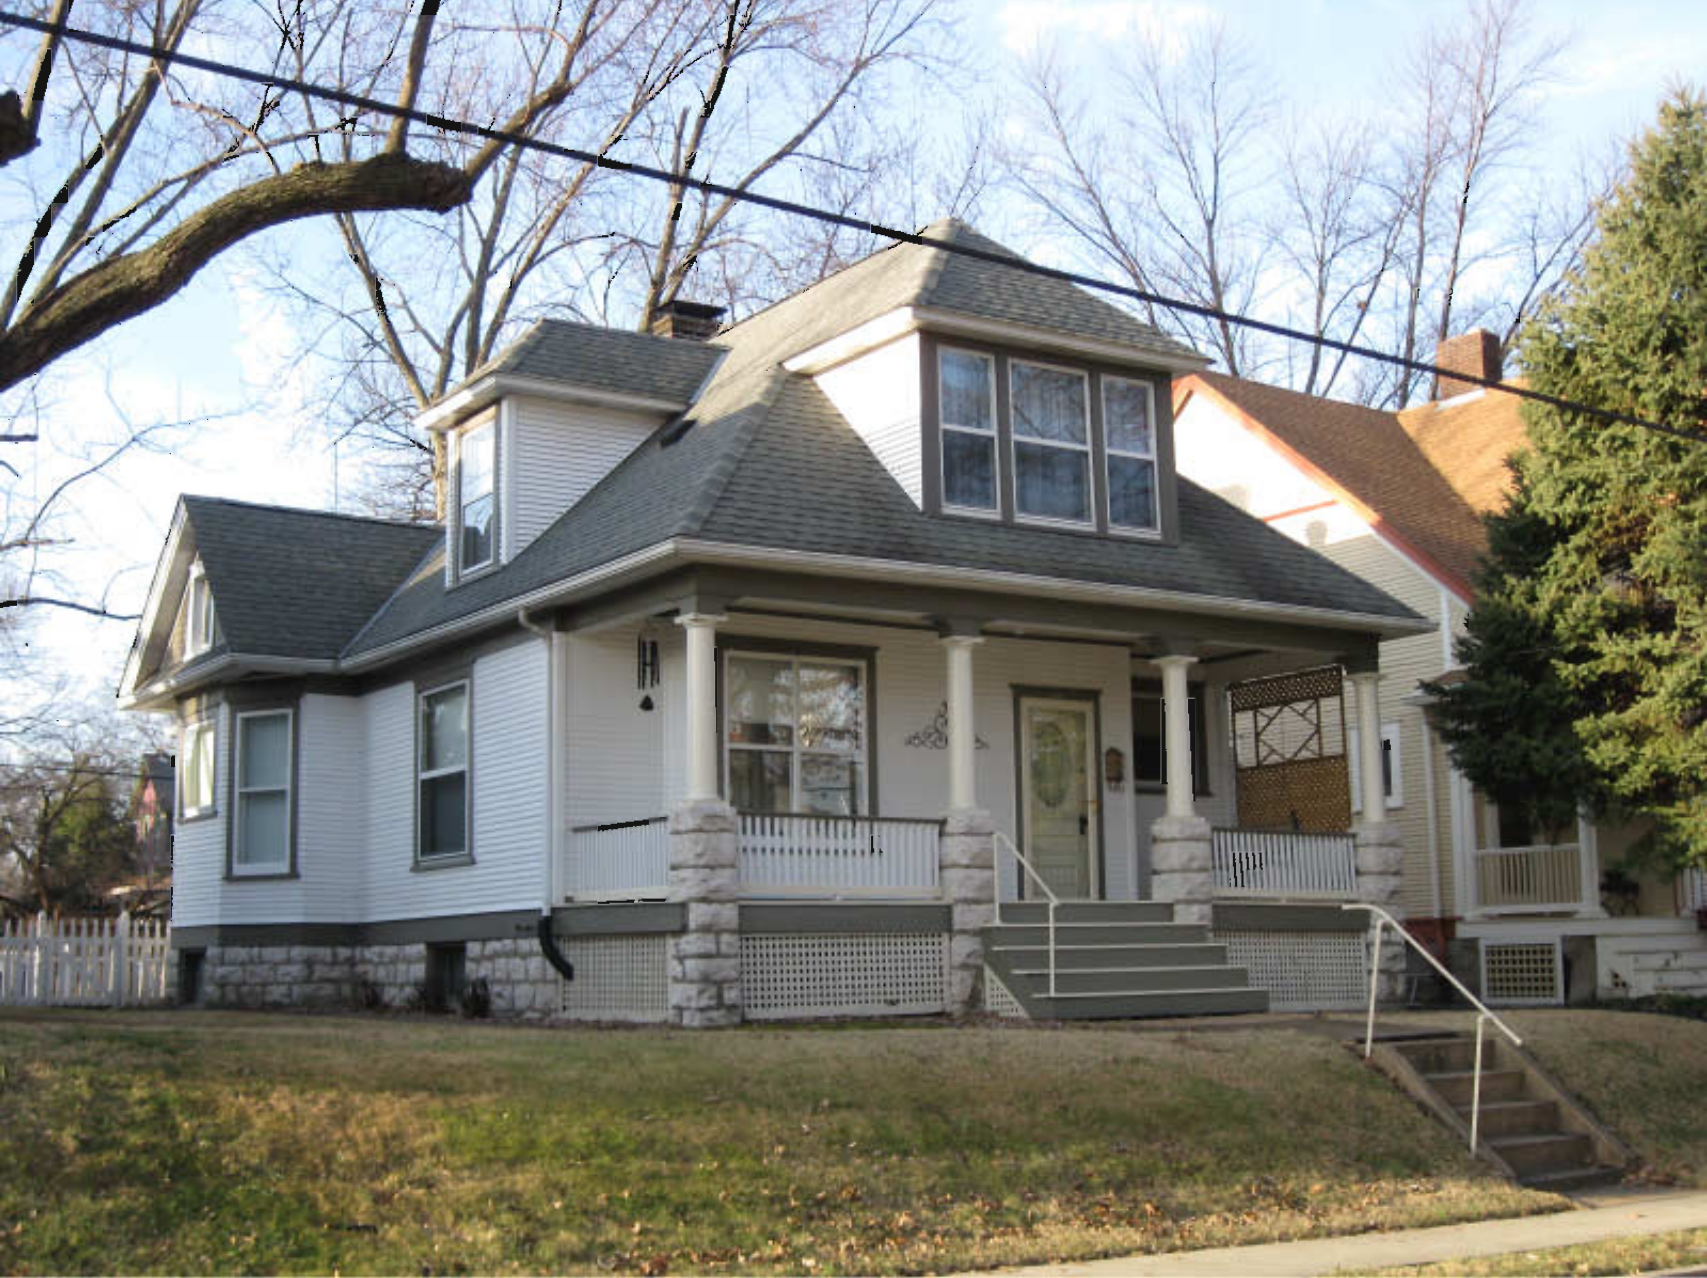
Situated on an elevated lot, this one-and-one-half story, frame, Colonial Revival style structure rests on a coursed, rock-faced stone foundation. The beaded, lapped, weatherboard siding is trimmed with corner boards, a water table and plain frieze. The high hip roof has wide overhanging eaves and an intersecting cross gable on the east side, and an interior brick chimney pierces the west slope of the roof. Hipped dormers are on the front and east slopes while a large shed dormer is on the west. The front dormer has a band of three 1/1 windows, with the center one being wider than the other two, while the dormer on the east slope has a single 1/1 window and the shed dormer on the west slope has three 1/1 windows. In the center bay of the three-bay main façade is a paneled wood door with oval light, and to the left of the door is pair of 1/1 windows and to the right is a single-light window. The east end of the front wall and the western bay are set back from the remainder of the wall. The door opens onto a one-story gallery that is inset under the main roof, which is supported by Doric columns resting on stone pedestals that extend to the ground and form foundation piers. Between each pier, under the porch deck, is a wooden lattice panel. The porch stairway and deck are wood, and the porch is enclosed by a plain wood balustrade. The east elevation has a 1/1 window at the north end and to the south is a cutaway gabled bay with a central, short single-light window flanked by 1/1 windows in the canted corners. The gable end is pedimented and a single-light window is in the tympanum, which is finished with wooden shingles. The west elevation has three 1/1 windows.

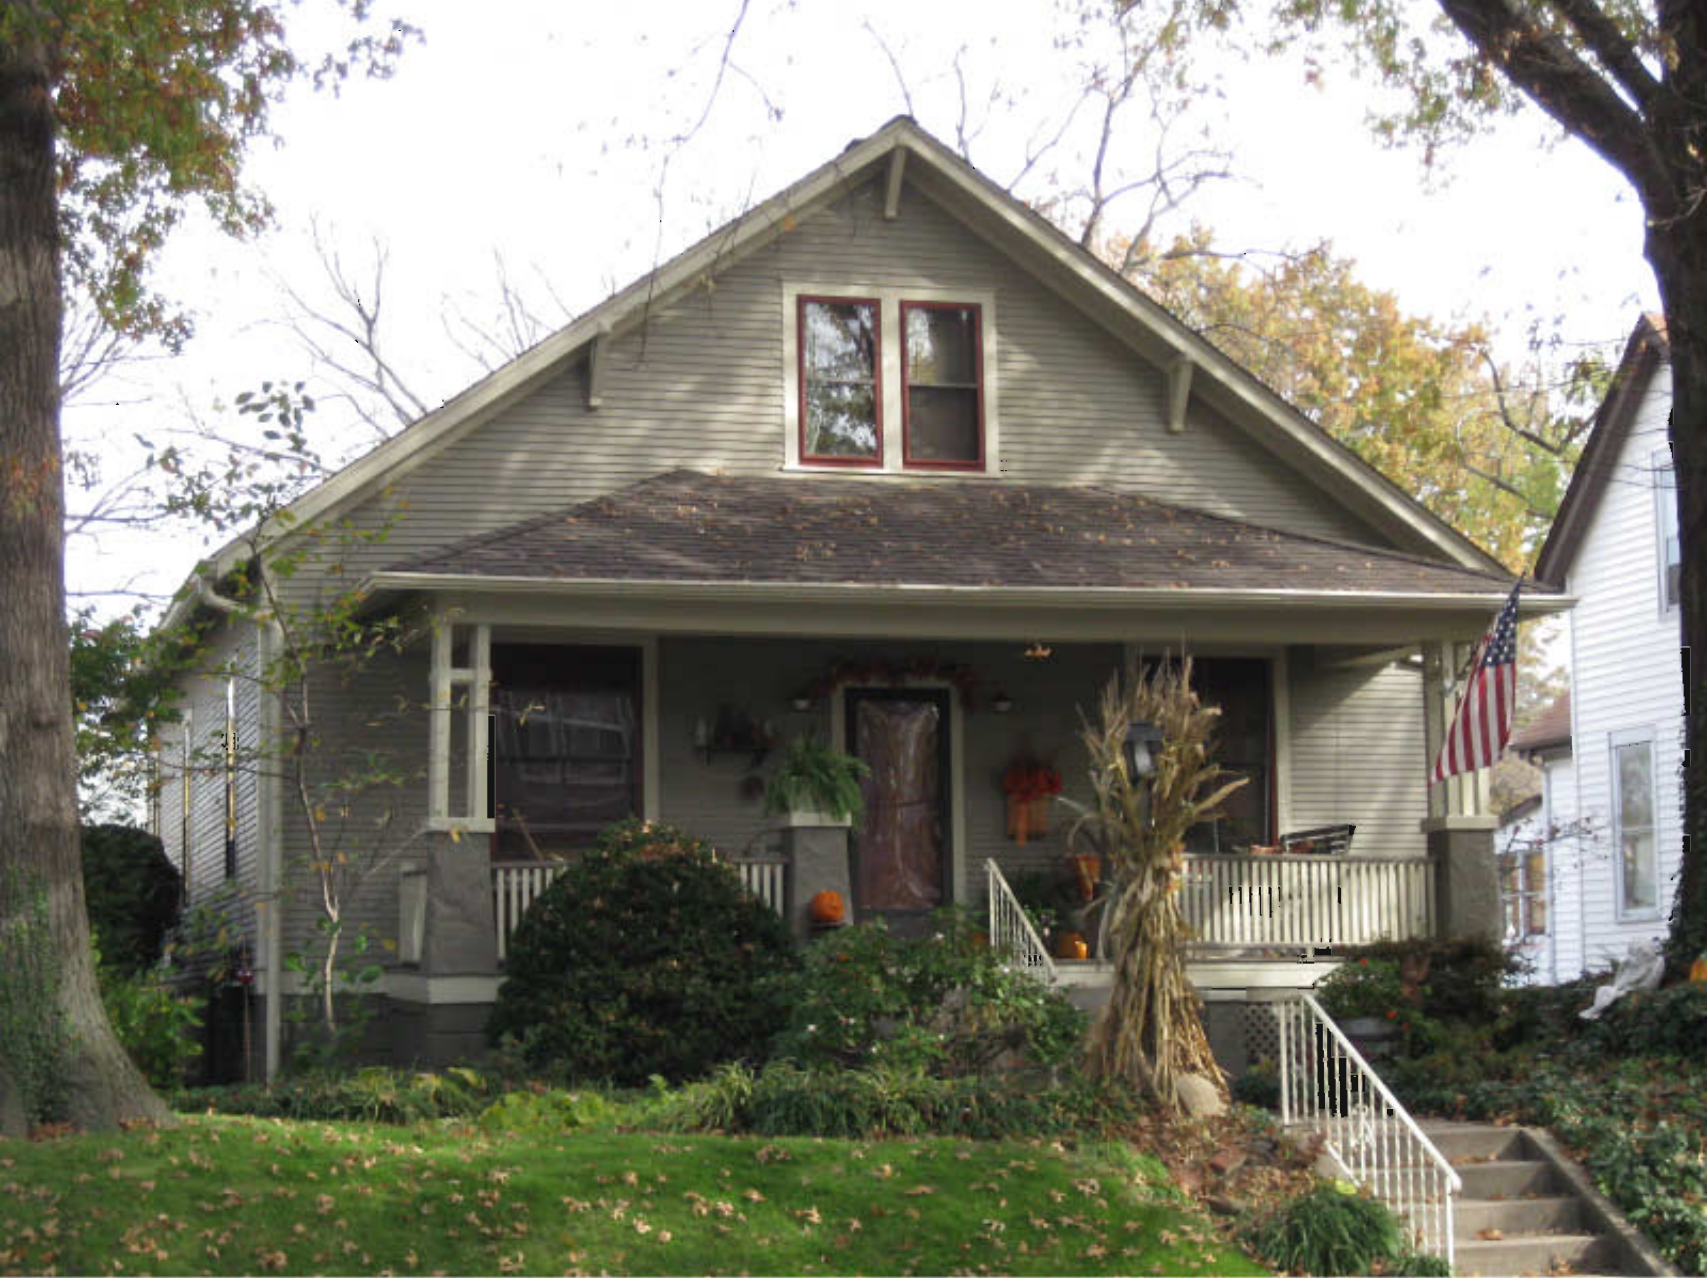
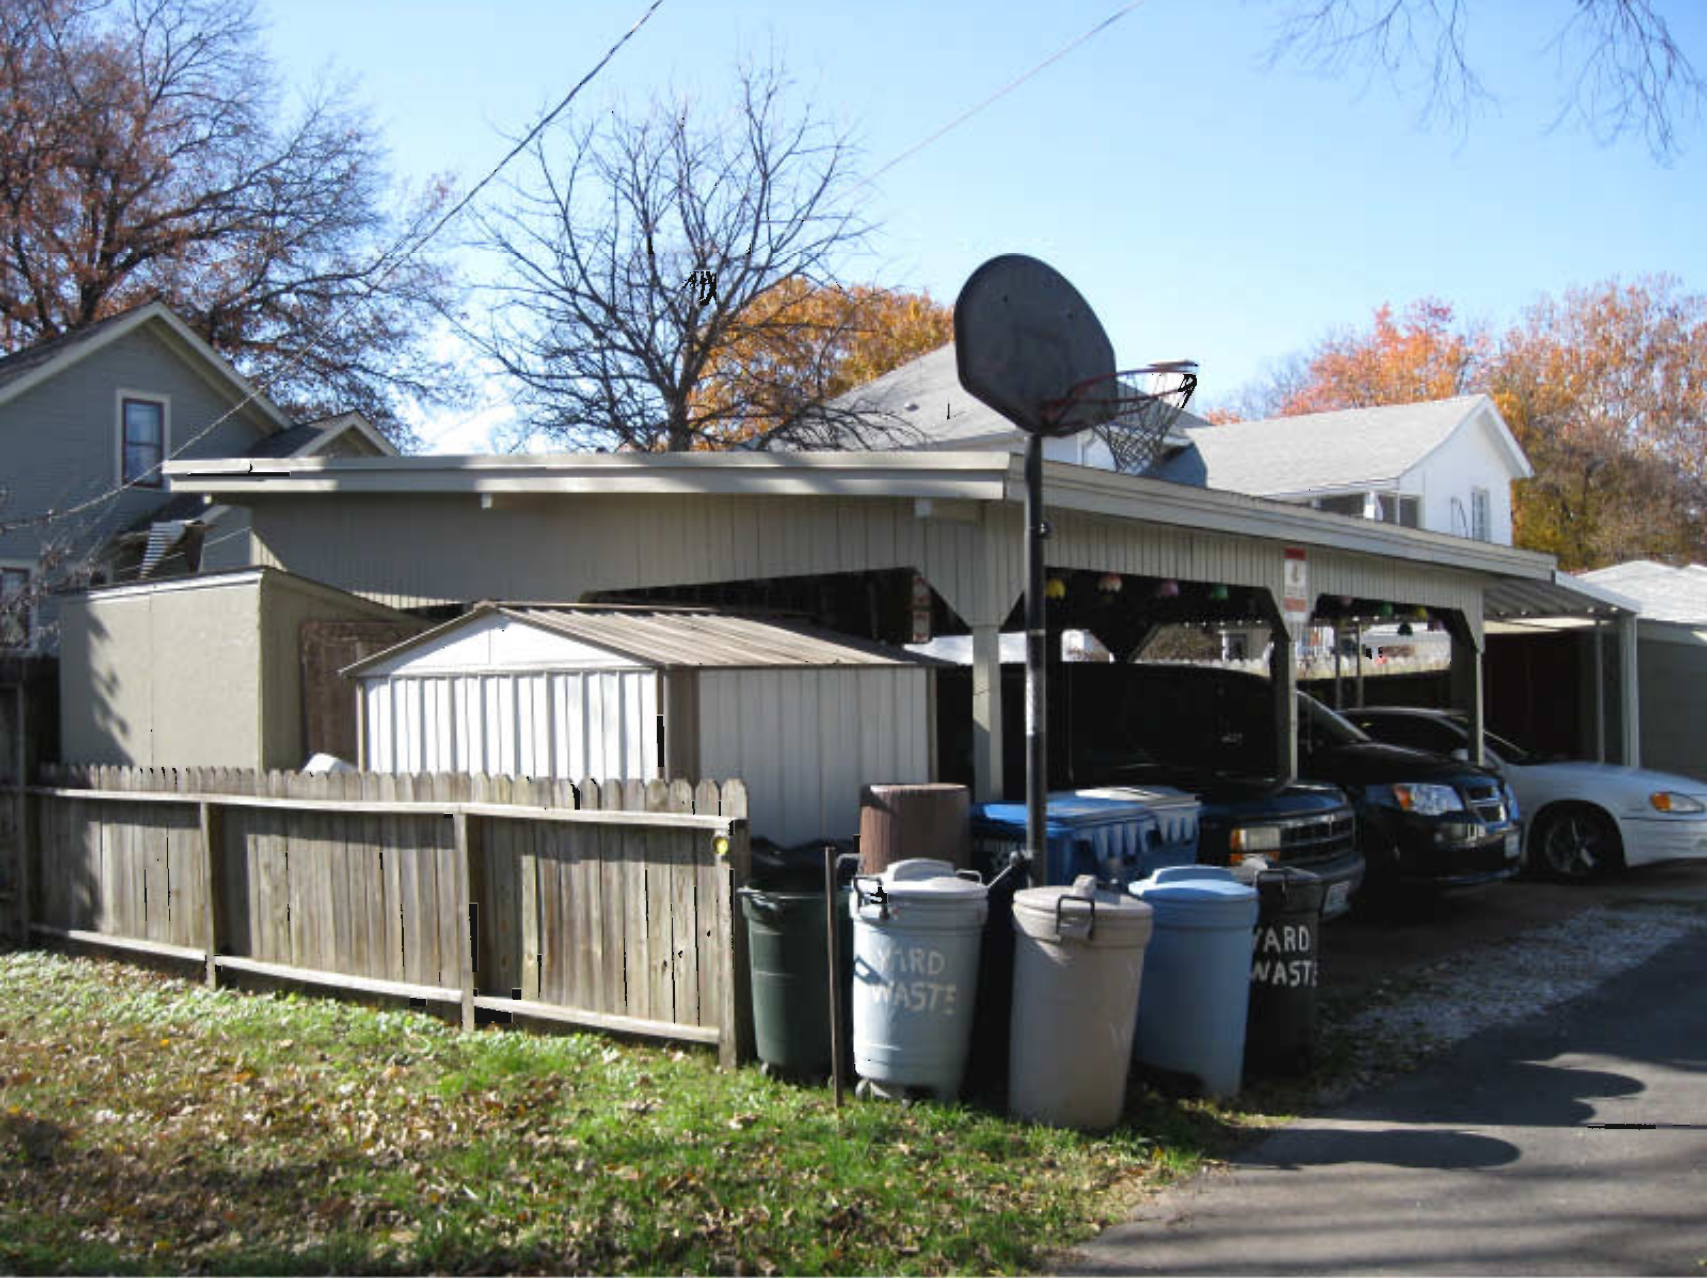
Situated on an elevated, tree-shaded lot, this one-and-one-half story, front-gabled, frame, Craftsman bungalow rests on a scored concrete foundation and the walls are finished with weatherboard siding. The front-gabled roof has wide overhanging eaves with exposed rafter tails and in the gable end are decorative knee braces. An interior brick chimney pierces the east slope of the roof. A paneled door is in the center bay of the three-bay main façade, and in the outer bays are wide double-hung windows with the upper sash having muntins near the top rail and the stiles while the lower sash has a single light (windows throughout the house have this design). The door opens onto a one-story, $\frac{3}{4}$ -width gallery with scored concrete foundation piers in-filled with wooden lattice panels, a central concrete stairway flanked by stucco knee walls, wooden deck, plain wood balustrade, two battered stucco pedestals at the top of the stairway and two at each corner that support groups of four slender posts that in turn support the hip roof. In the upper half story of the façade is a pair of windows. On the south end of the east elevation is a box bay with a band of three windows and a shed roof, to the right is a single window, and at the north end is an addition that has paired multi-light wood casement windows. There is a one-story rear ell on the west half of the rear elevation and the addition is on the east end, giving the house a rectangular plan. The west elevation has three window openings, one of which is in the one-story rear ell.

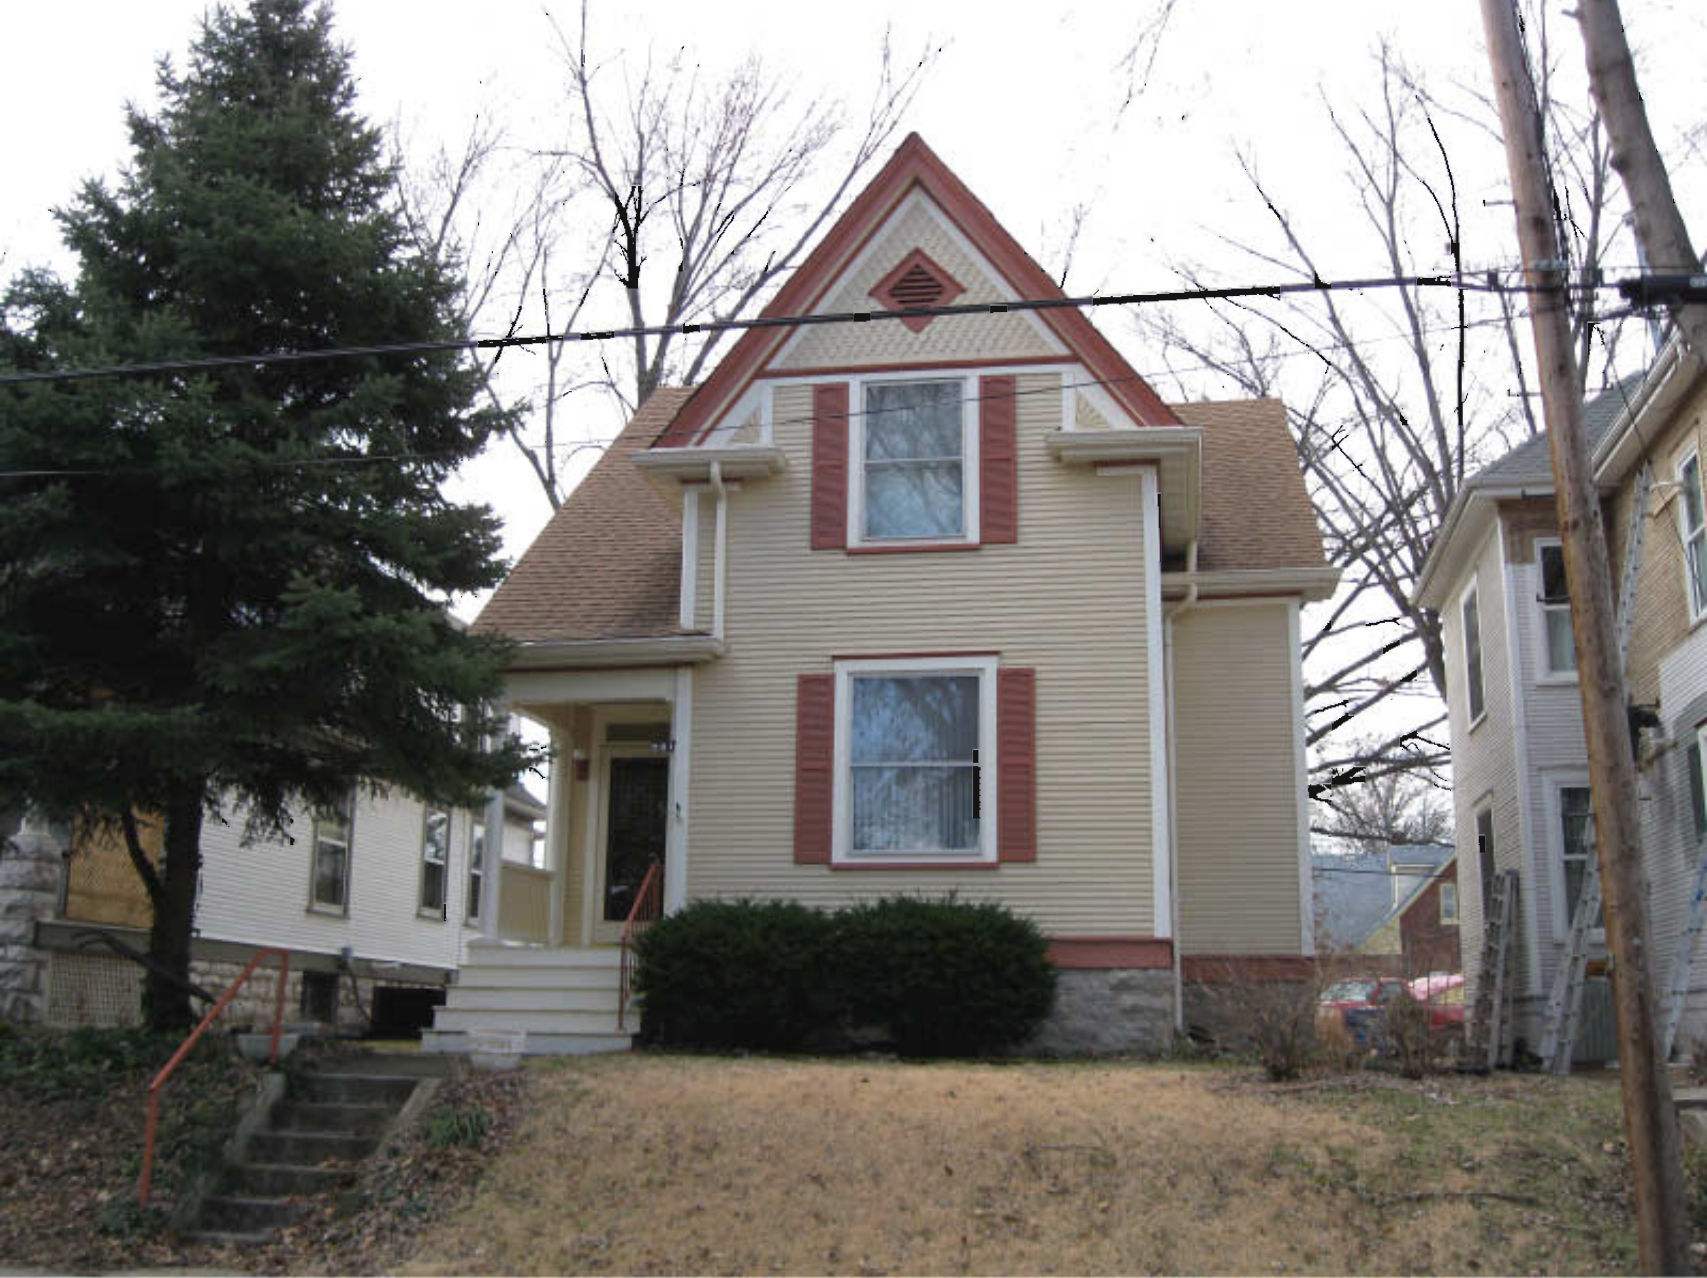
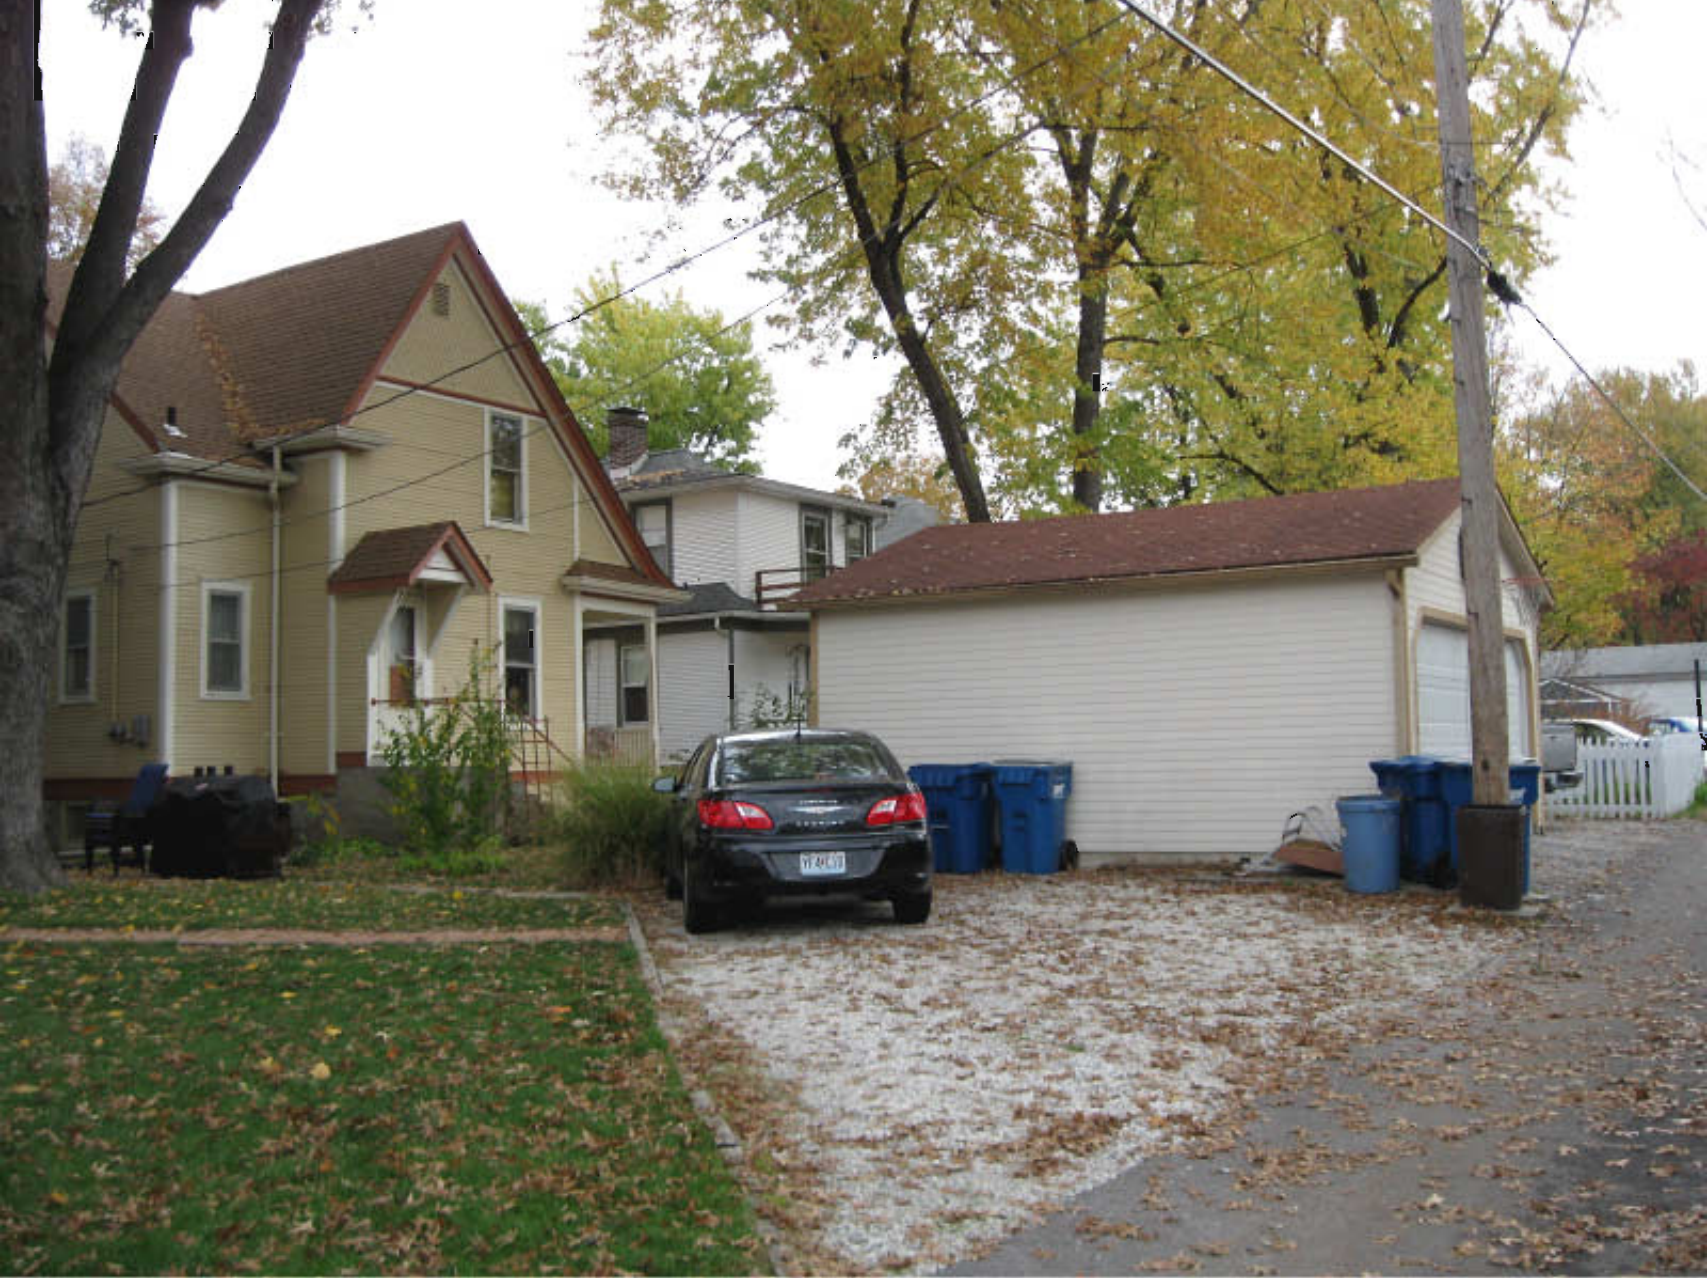
Situated on an elevated lot, this two-story, frame, Queen Anne Free Classic style house has a cruciform-shaped plan. The house rests on a coursed, rock-faced stone foundation pierced by single-light basement windows, and the joints are beaded. The steeply-pitched, cross-gabled roof has wide overhanging eaves and cornice returns, and a brick chimney straddles the ridge of the front-gabled wing. The walls are finished with beaded weatherboard siding and trimmed with wide corner boards and a water table. The gable ends of all four elevations are finished with scalloped, imbricated shingles, but the front gable end is further decorated with triangular sunburst panels placed directly above the cornice returns. The front gable end also has a diamond-shaped ventilator. The two-bay main façade has a door in the eastern bay, which is recessed, and a wide 1/1 window in the western bay. The half-glazed, three-panel, wood door is topped by a single-light transom, and the door opens onto a one-story, single-bay, recessed porch that has a wide wooden stairway with five steps, a wooden deck, plain wood balustrade, and a Doric column and half columns. The second story of the front-gabled wing has a 1/1 window. On the east elevation, from front to rear, is a small window, a tripartite window with a wide 1/1 window flanked by narrower 1/1 windows, a 1/1 window, and a recessed doorway. The door opens onto a porch that projects several feet from the east elevation, and the porch has brick foundation piers in-filled with wood lattice panels, a wood deck, chamfered wood posts with molded capitals, and a plain balustrade. The west wall of the front-gabled wing has a 1/1 window, and on the west wall of the west wing are three windows on the first floor and two on the second.

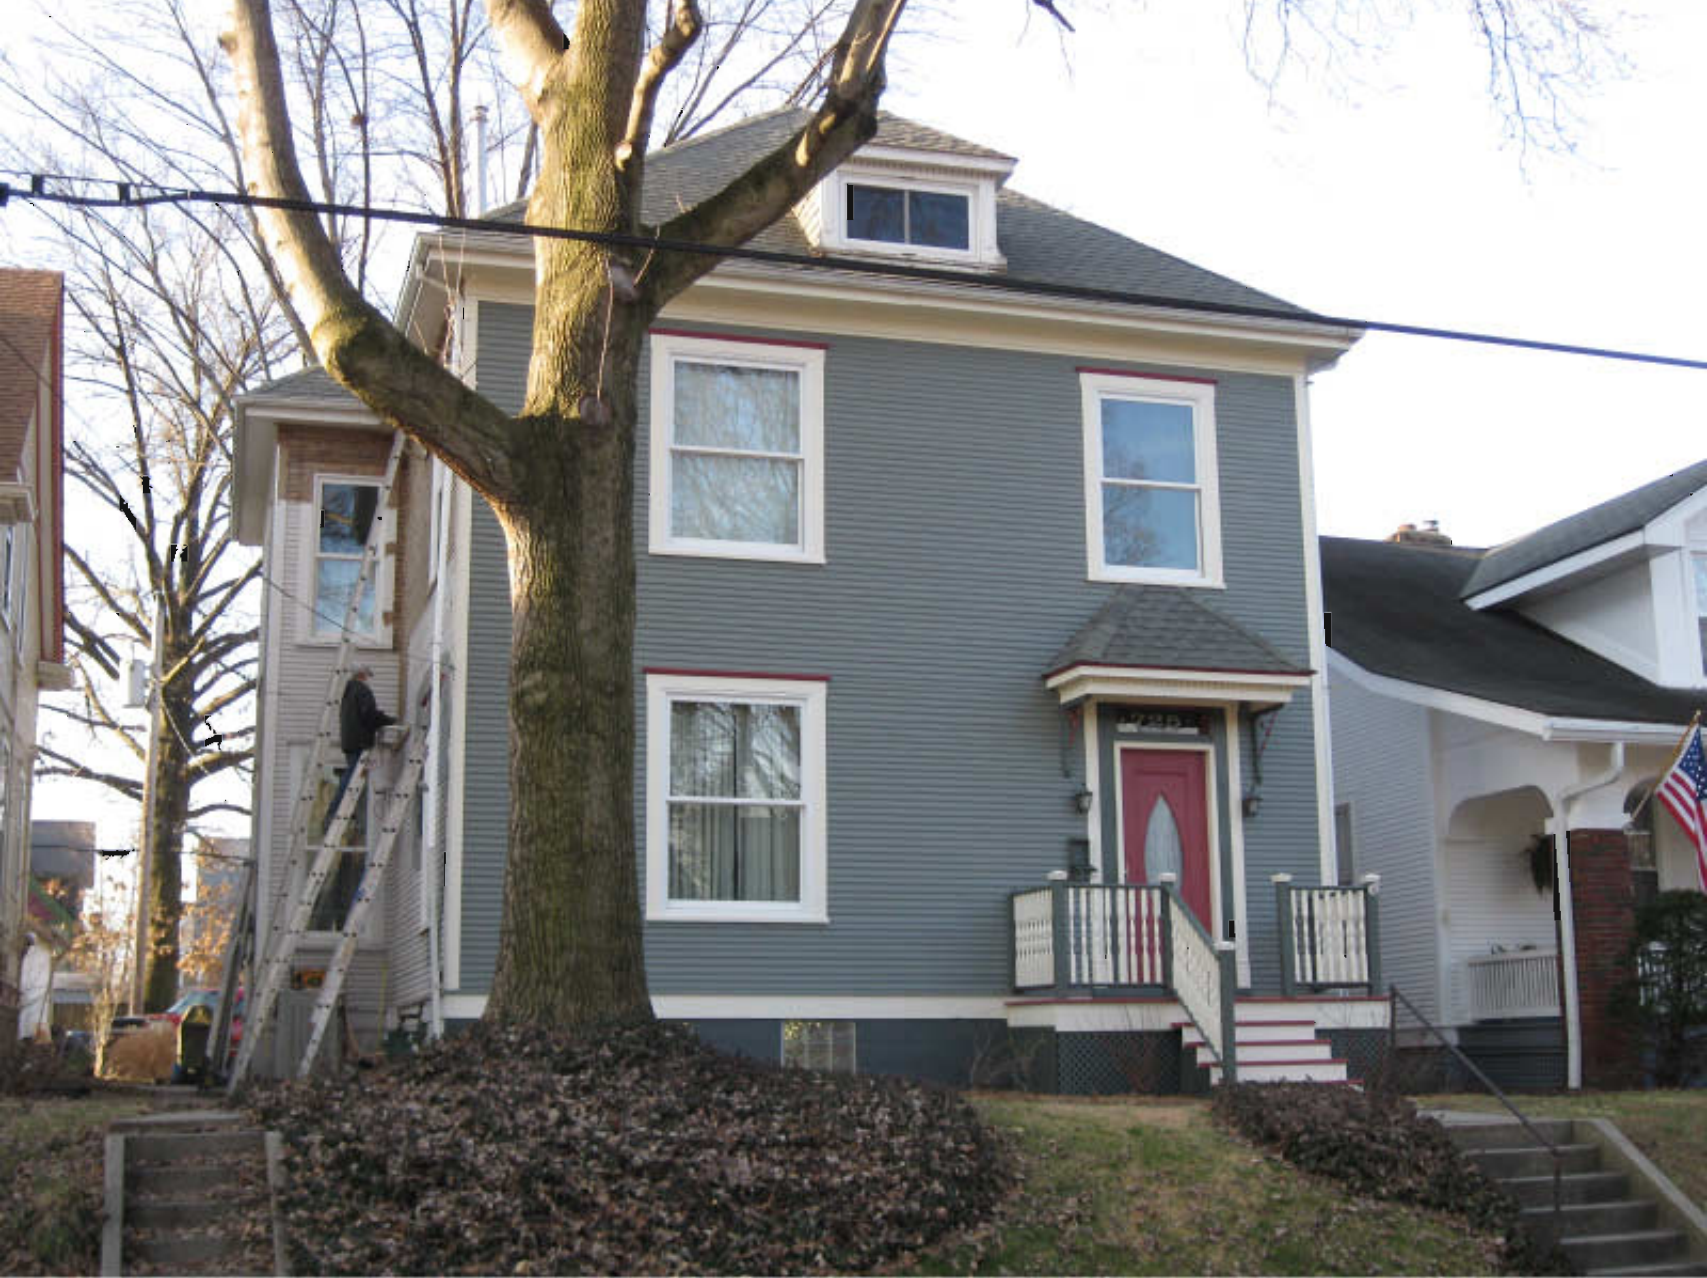
Facing north, this two-and-one-half story, frame, Pyramidal-form house rests on a scored concrete foundation that has glass block basement windows. The walls of the house are finished with narrow, beaded weatherboard siding trimmed with wide corner boards and a water table. The pyramidal roof has wide overhanging eaves trimmed with a frieze, and on the front slope of the roof is a hipped dormer with a sliding window. Above the window are dentils and to each side is a raised panel. The house has an L-shaped plan, with a wing projecting from the south end of the east elevation. The entrance is in the west bay of the two-bay main façade and a wide 1/1 wood window is in the east bay. The glazed wood door is topped by a single-light transom and trimmed with moldings having bullseye corner blocks. The door, which is protected by a high hipped awning trimmed with dentil moldings and supported by knee braces with ball-and-rod spindles, opens onto a one-bay stoop with wooden stairway, deck, and balustrade having turned balusters. There are two 1/1 windows on the second floor, and windows throughout the house have plain trim that is slightly shouldered and the lintels have molded caps. The north end of the east elevation has a 1/1 window on each floor, and in the projecting wing is a 1/1 window on each floor of both the north and east elevations.
