ARCHITECTURAL/HISTORIC INVENTORY FORM

1. Survey No. SC-AS-009-001		2. Survey Name: St. Charles Survey Phase 3: Mid-Town and Commons Neighborhoods	
3. County: St. Charles		4. Address (Street No.) 128	Street (name) North Sixth Street
5. City: St. Charles	Vicinity: <input type="checkbox"/>	6. UTM:	
7. Township/Range/Section:		8. Historic name (if known): Meyer-Pieper House; The Meyerdorf	
9. Present/other name (if known):		10. Ownership: <input checked="" type="checkbox"/> Private <input type="checkbox"/> Public	
11a. Historic use (if known): Domestic/single dwelling		11b. Current use: Domestic/single dwelling

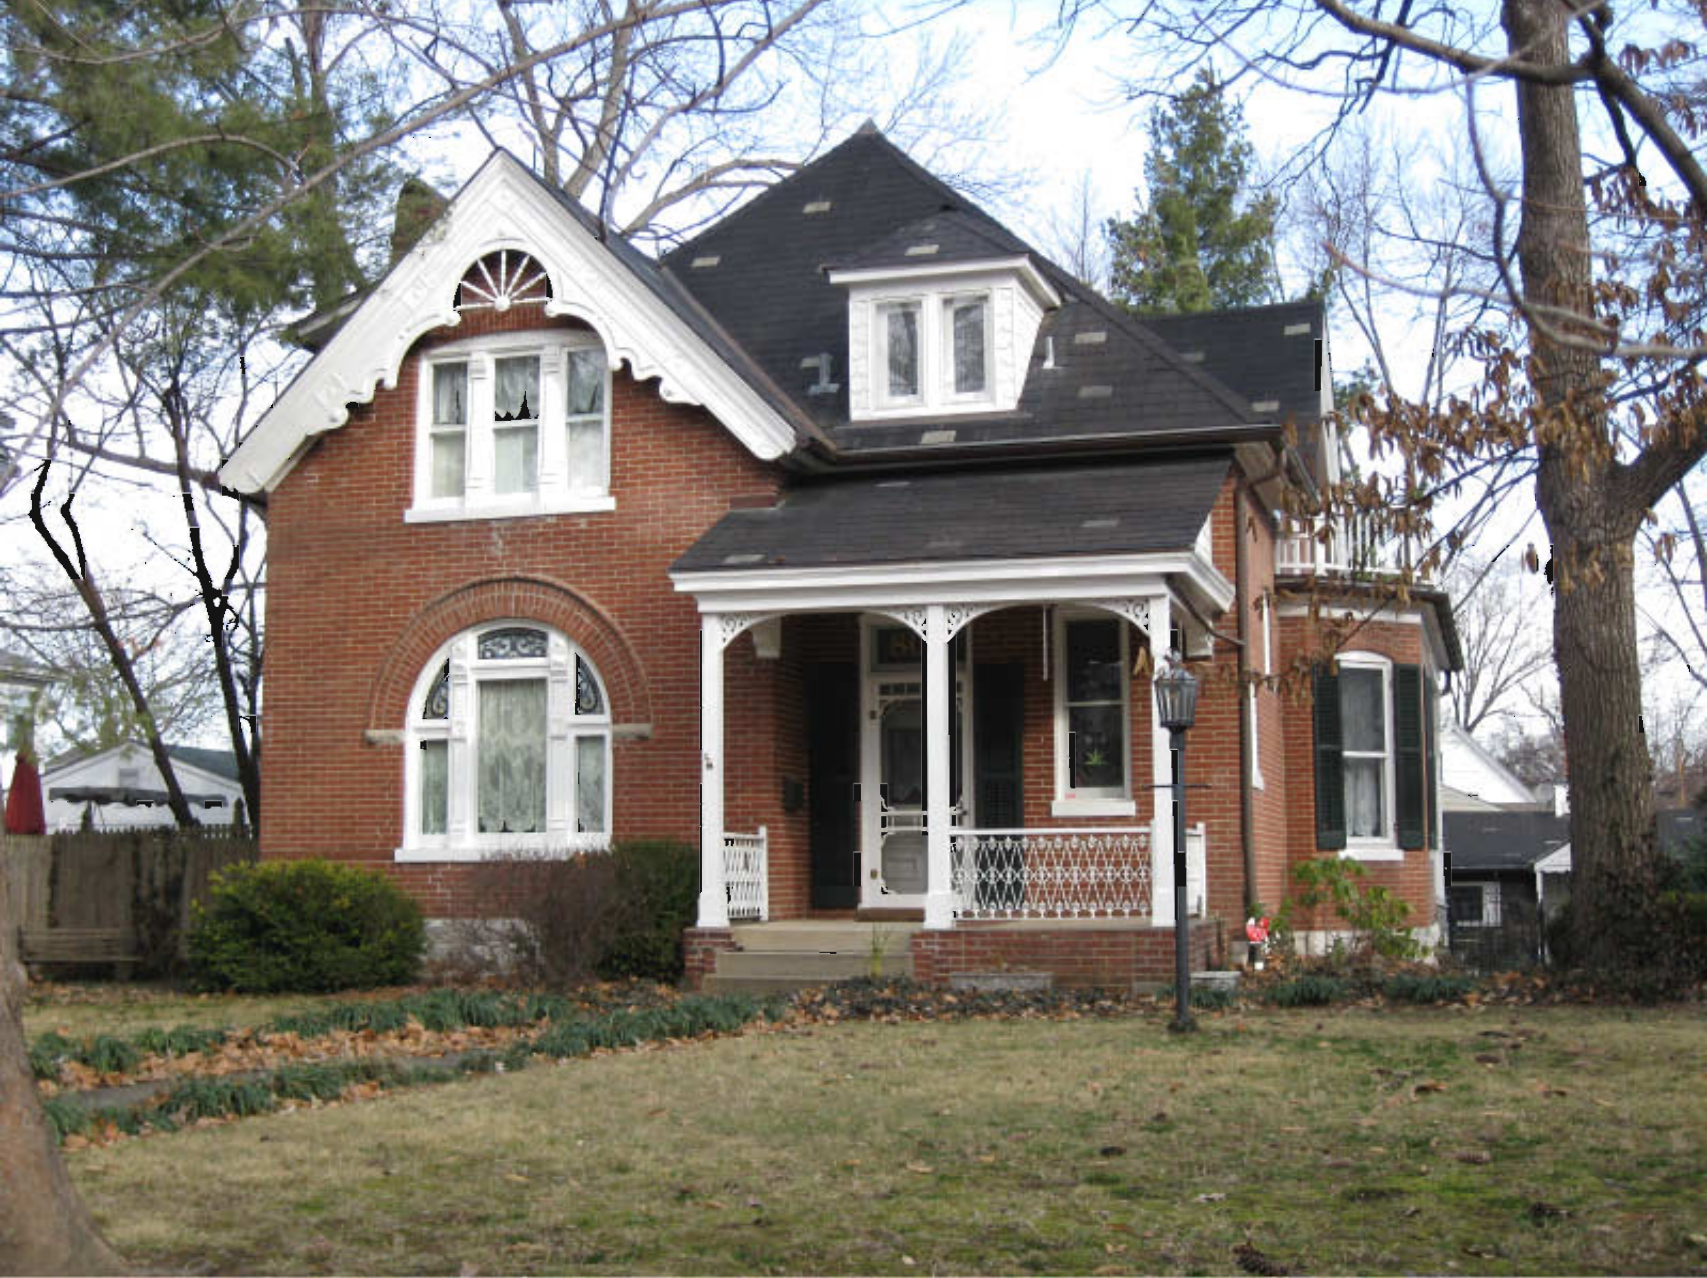
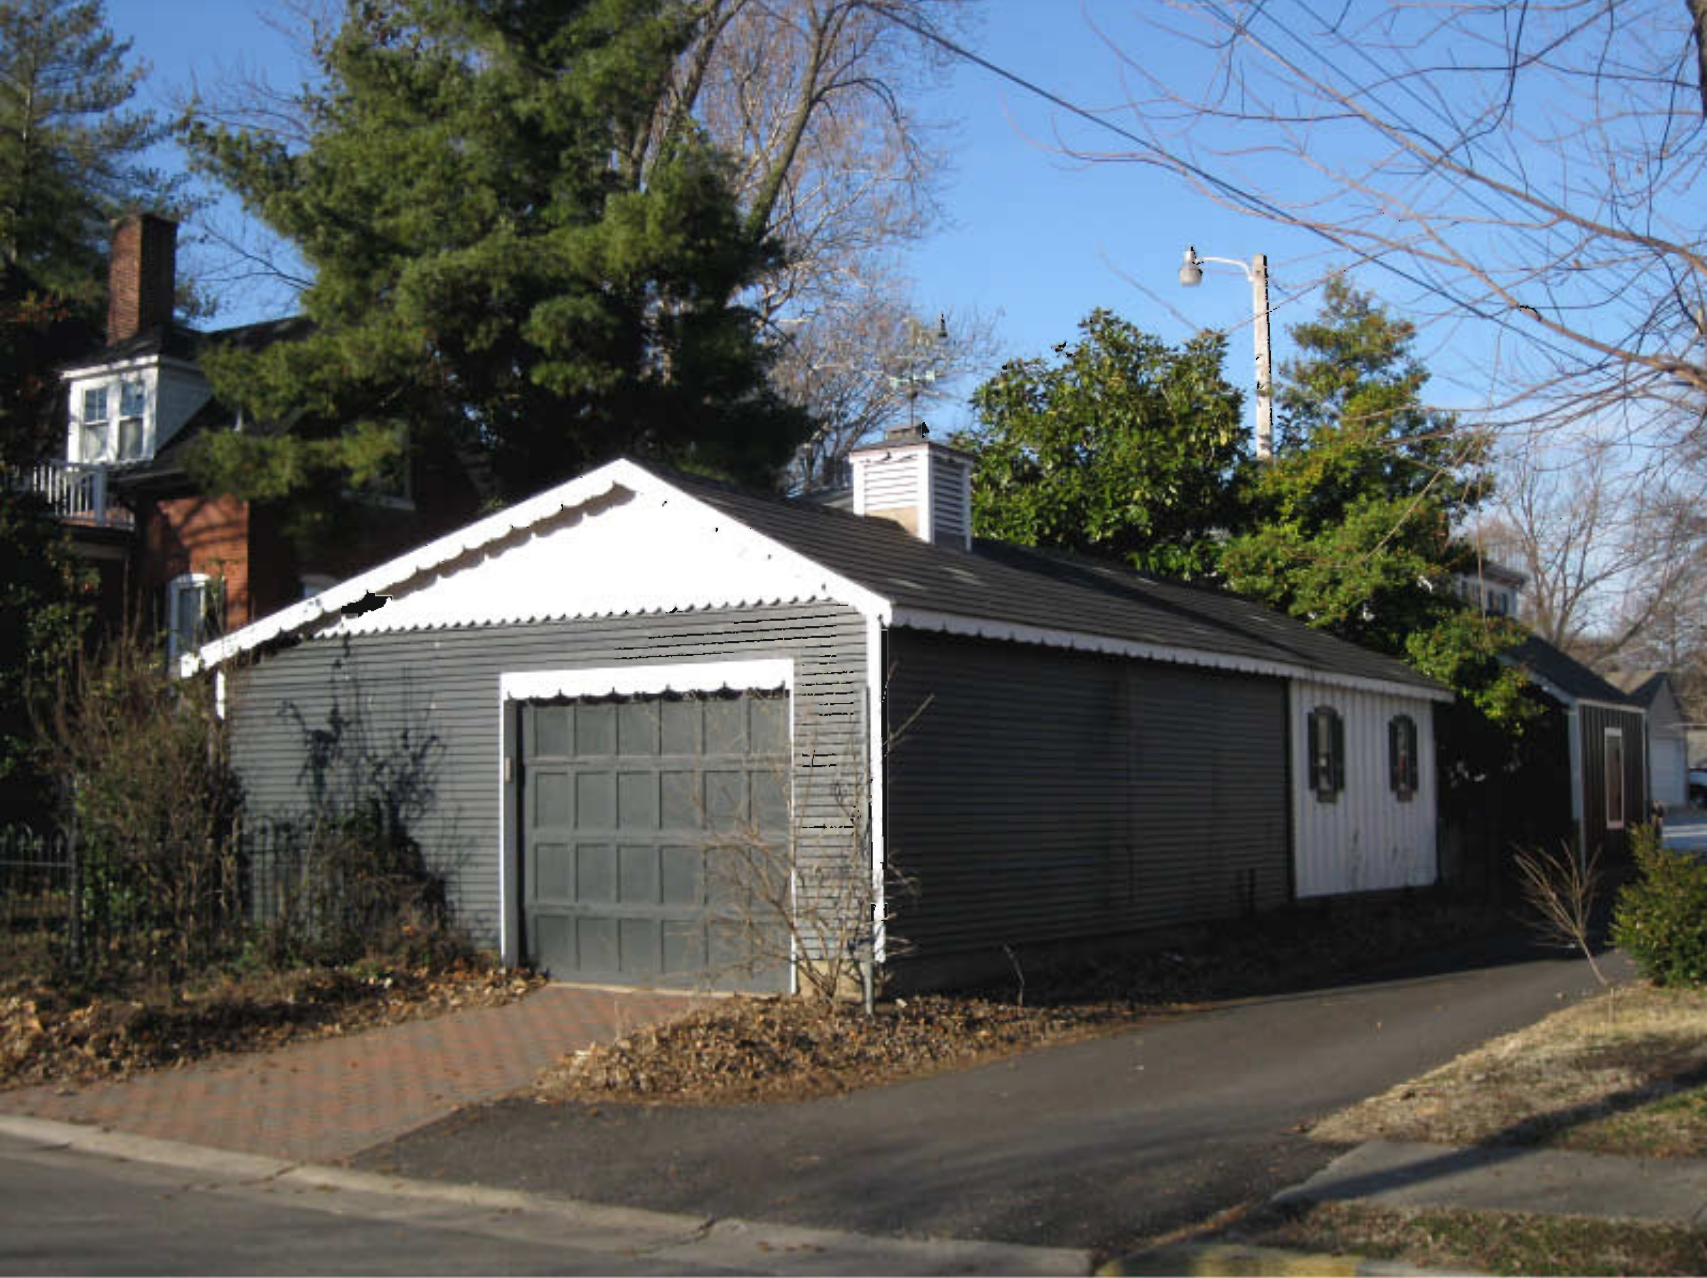
rock-faced stone foundation and the brick walls are laid in a running bond pattern. The center bay of the L-shaped, three-bay main façade holds the entrance, which is a paneled-and-glazed wood door topped by a single-light transom. The door has two small panels above the glazing and below is a horizontal panel under which are two small panels. A wooden screen door with spindles and brackets is at the entrance, which is set within a segmental-arched opening with incised wood panel, and there are floor-length louvered wood blinds. To the east of the doorway is a double-hung, stained glass window set within a segmental-arched opening with incised panel. The windows throughout the house have stone lug sills. The door opens onto a two-bay gallery that has a concrete stairway and deck, chamfered posts with jigsawn spandrels, and a delicate, lacy wrought iron railing. The end walls of the shed roof of the porch are finished with fish scale shingles. On the first floor of the front-gabled bay is a round-arched opening with a large single-light window flanked by shorter single-light sidelights, and above the window and sidelights are stained glass transoms. The mullions between the window and sidelights have fluted pilasters with plinth blocks and applied bullseye and raised panel moldings, and the transom bars have applied scalloped moldings. The opening is topped by a round-arched brick hood mold with rock-faced stone spring blocks, which are carved into a bullseye at the outer ends. A terra cotta belt course is at sill level of the first floor of the front-gabled wing. In the upper half story is a tripartite window with three 1/1 windows separated by fluted mullions with plinth blocks at the bottom and top, and those on the top have three small globular moldings. The east elevation has, from front to rear, two small leaded glass windows stepped in the wall, a polygonal bay with three 1/1 windows framed by louvered wood blinds, a door matching that of the main façade, and a 1/1 window with louvered wood blinds. The door opens onto a one-bay porch with turned posts, plain wood balustrade, wood deck, and wood stairway at the north side. A balcony enclosed by a plain balustrade extends over the top of the roofs of the polygonal bay and porch, and in the upper half story of the east gabled wing are paired doors opening onto the balcony.

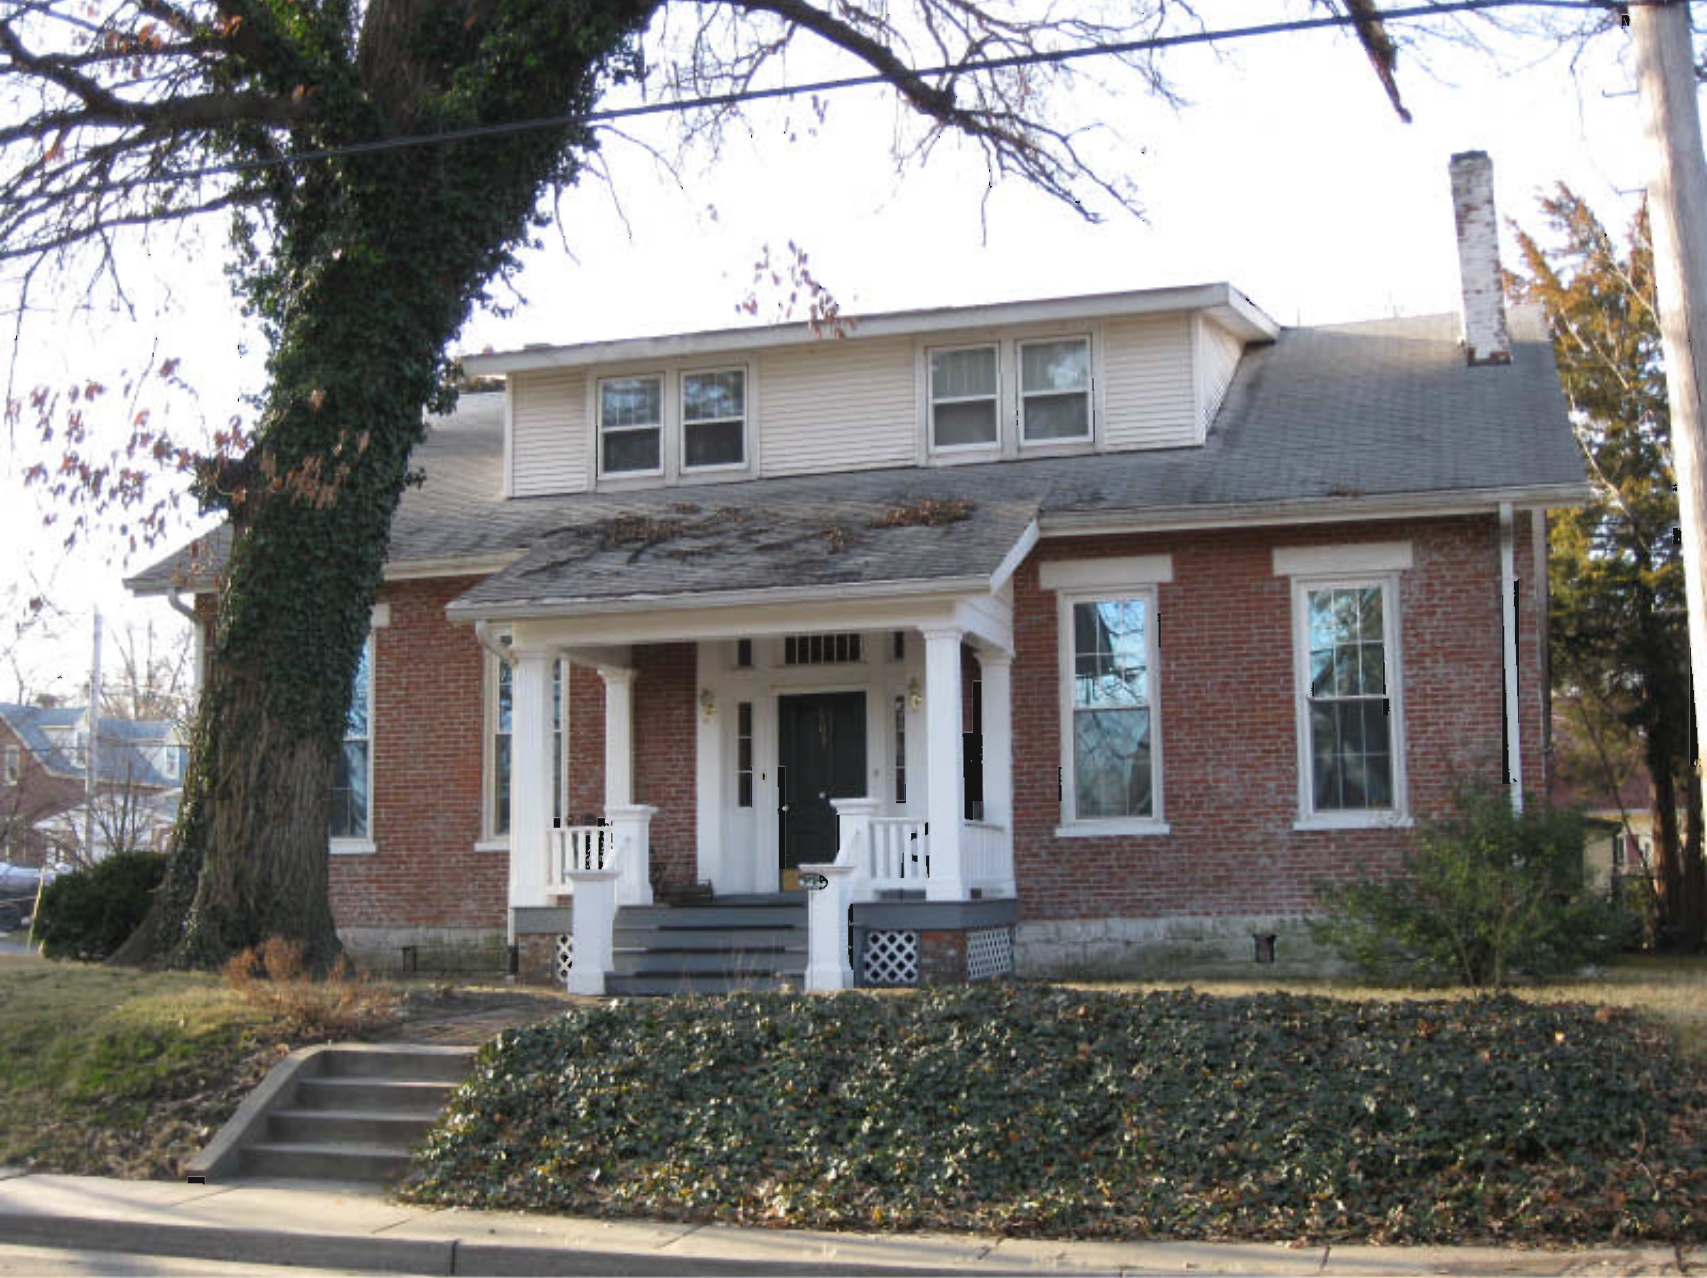
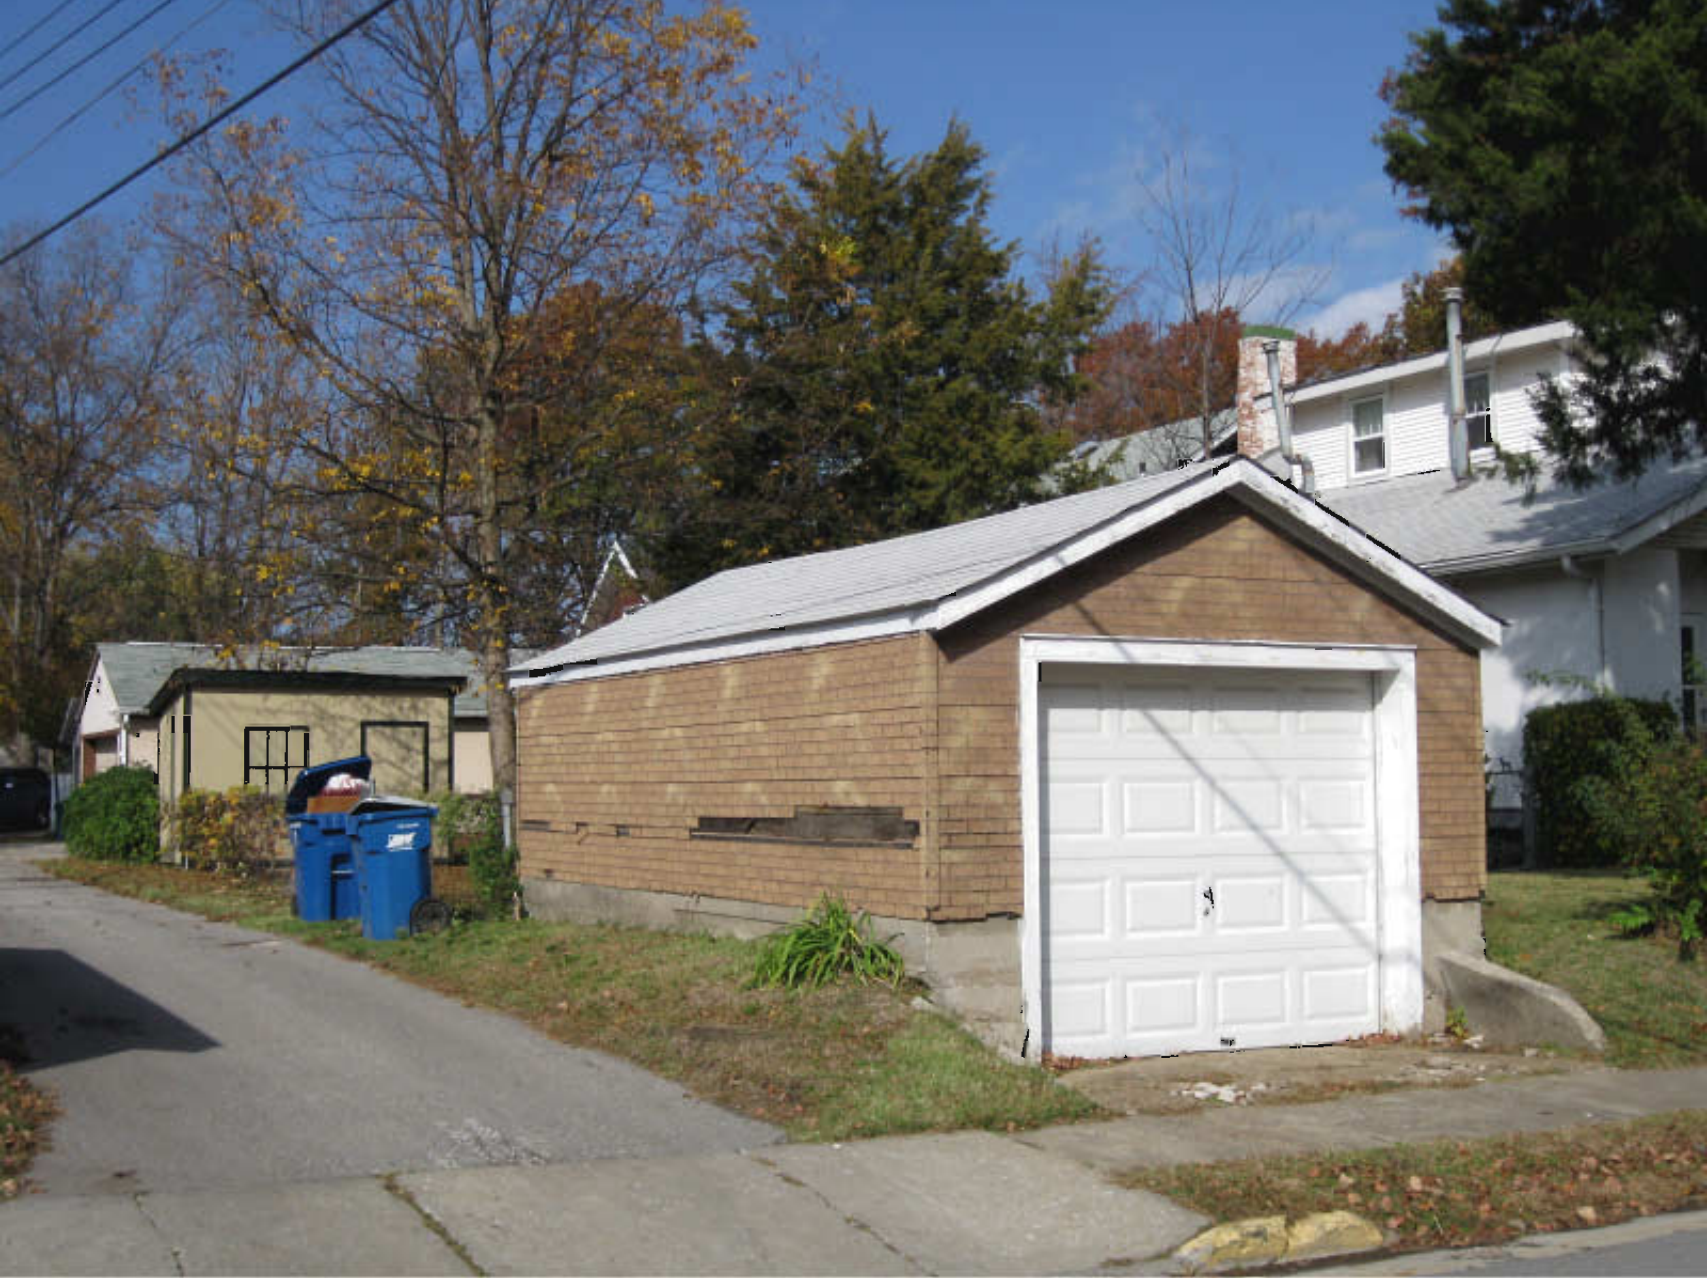
brick jack arches, except for the paired windows on the east elevation, which have a wooden lintel. The west elevation is painted while the paint has been removed from the façade and east elevation. The full-width rear porch, which is supported by brick foundation piers, has been enclosed with a combination of screen and vertical board siding.

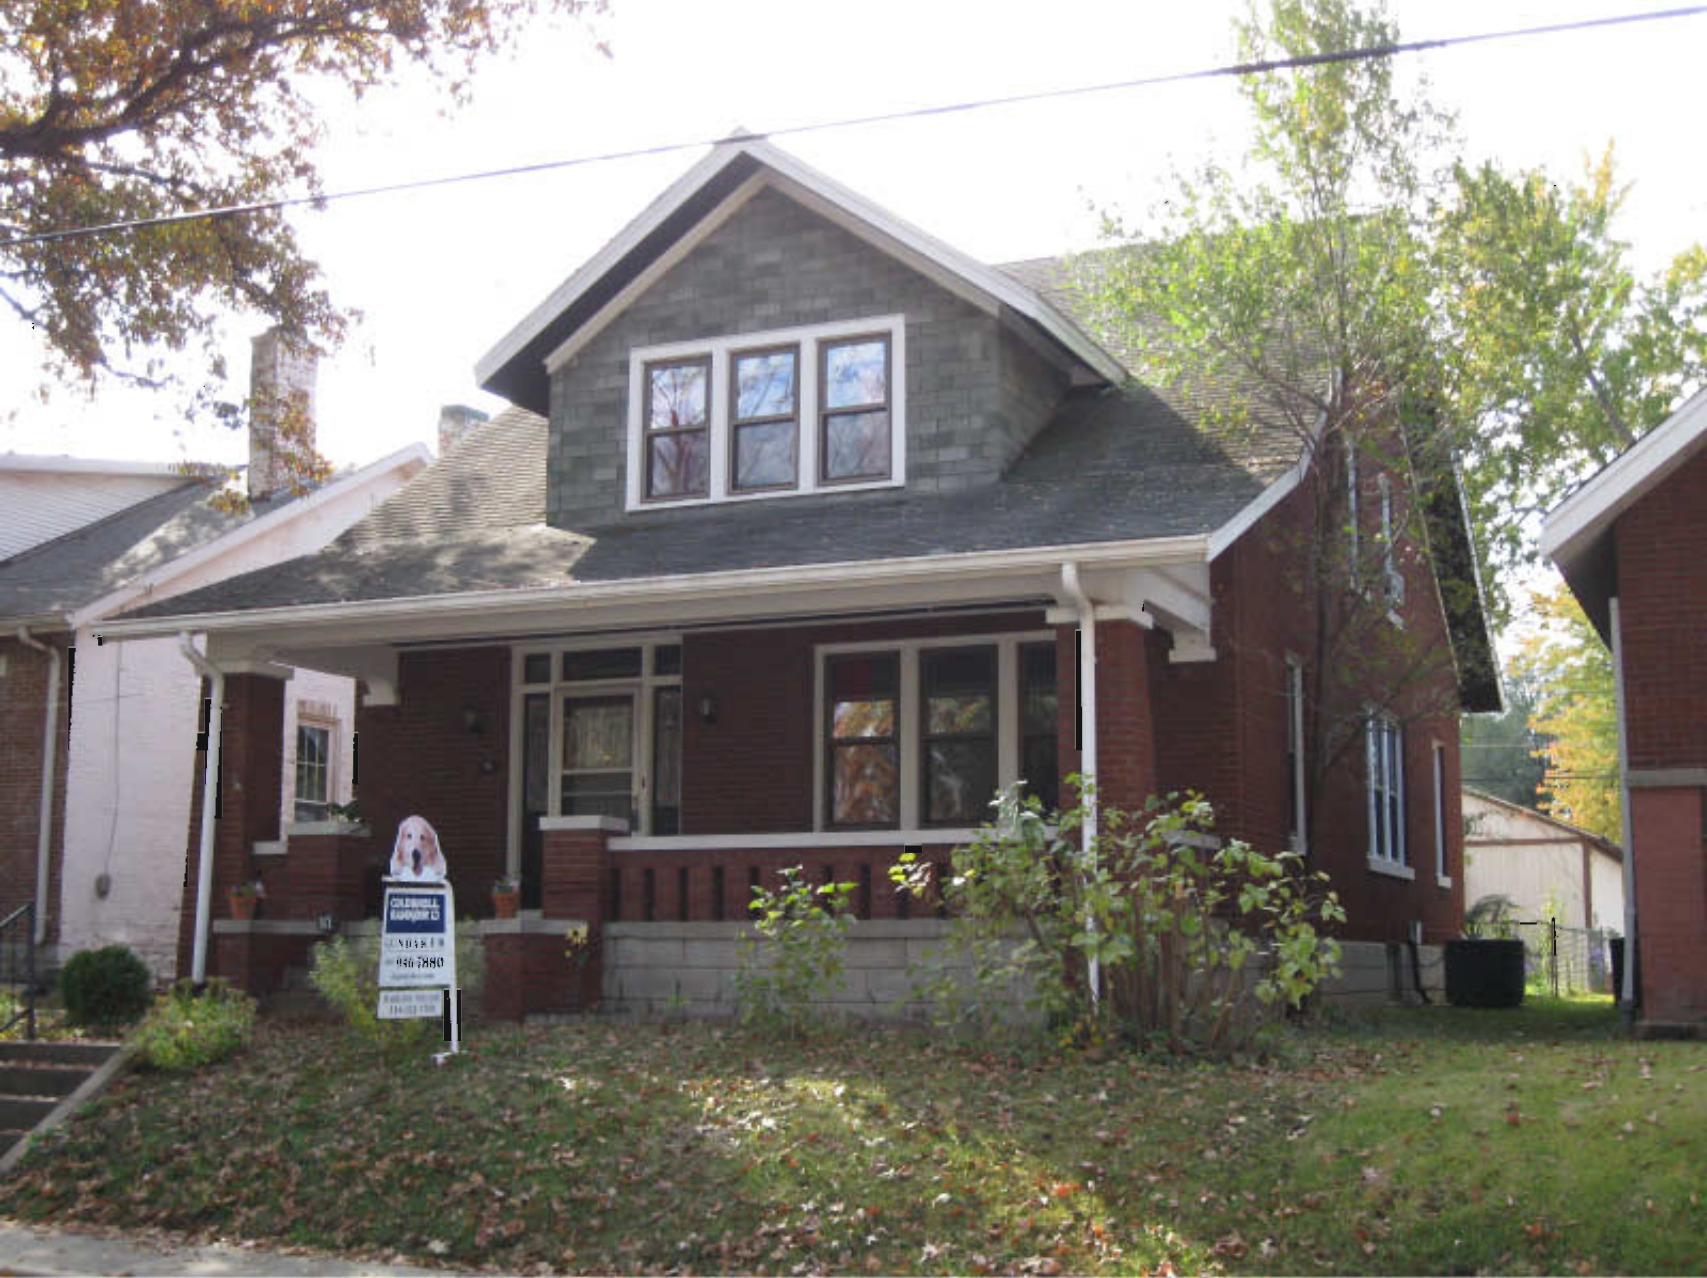
Situated on an elevated lot, this one-and-one-half story, side-gabled, brick bungalow rests on a scored concrete foundation pierced by three-light wood basement windows. The textured brick walls are laid in a running bond pattern, except for the first course above the foundation, which is a soldier course. The openings throughout the house have flat jack arches and cast concrete sills. The steeply-pitched, side-gabled roof has wide overhanging eaves, and the soffits are stained bead board. An interior brick chimney with concrete cap pierces the rear slope of the roof, and on both the front and rear slopes is a gabled dormer with band of three 1/1 windows. The walls of the dormers are clad with asphalt roofing shingles and the soffits are finished with stained bead board. In the eastern bay of the two-bay main façade is a glazed wood door topped by a single-light transom, and to each side of the door is an art glass sidelight set above a stained wood panel and topped by a single-light transom. To the west of the entrance is a band of three 1/1 wood windows with anodized metal storm windows. The door opens onto a full-width gallery that features a scored concrete foundation and battered brick piers that extend to the ground. The piers have concrete capitals and support the hip roof trimmed with a basket handle frieze. The gallery has a concrete deck, concrete stairway flanked by brick knee walls with concrete copings, brick pedestals at the top of the stairway, and a pierced brick railing. Like the soffits, the porch ceiling is stained bead board. The west elevation has three openings on the first floor—a band of three 1/1 windows flanked by single 1/1 windows—and two windows in the upper half story. On the first floor of the east elevation, from front to rear, is a pair of 1/1 windows, a short 1/1 window, and an entrance at ground level. The doorway is protected by a gabled awning supported by knee braces, and above the awning, halfway above the first and upper half stories, is a 1/1 window that apparently overlooks a stairway. In the upper half story are two 1/1 windows.

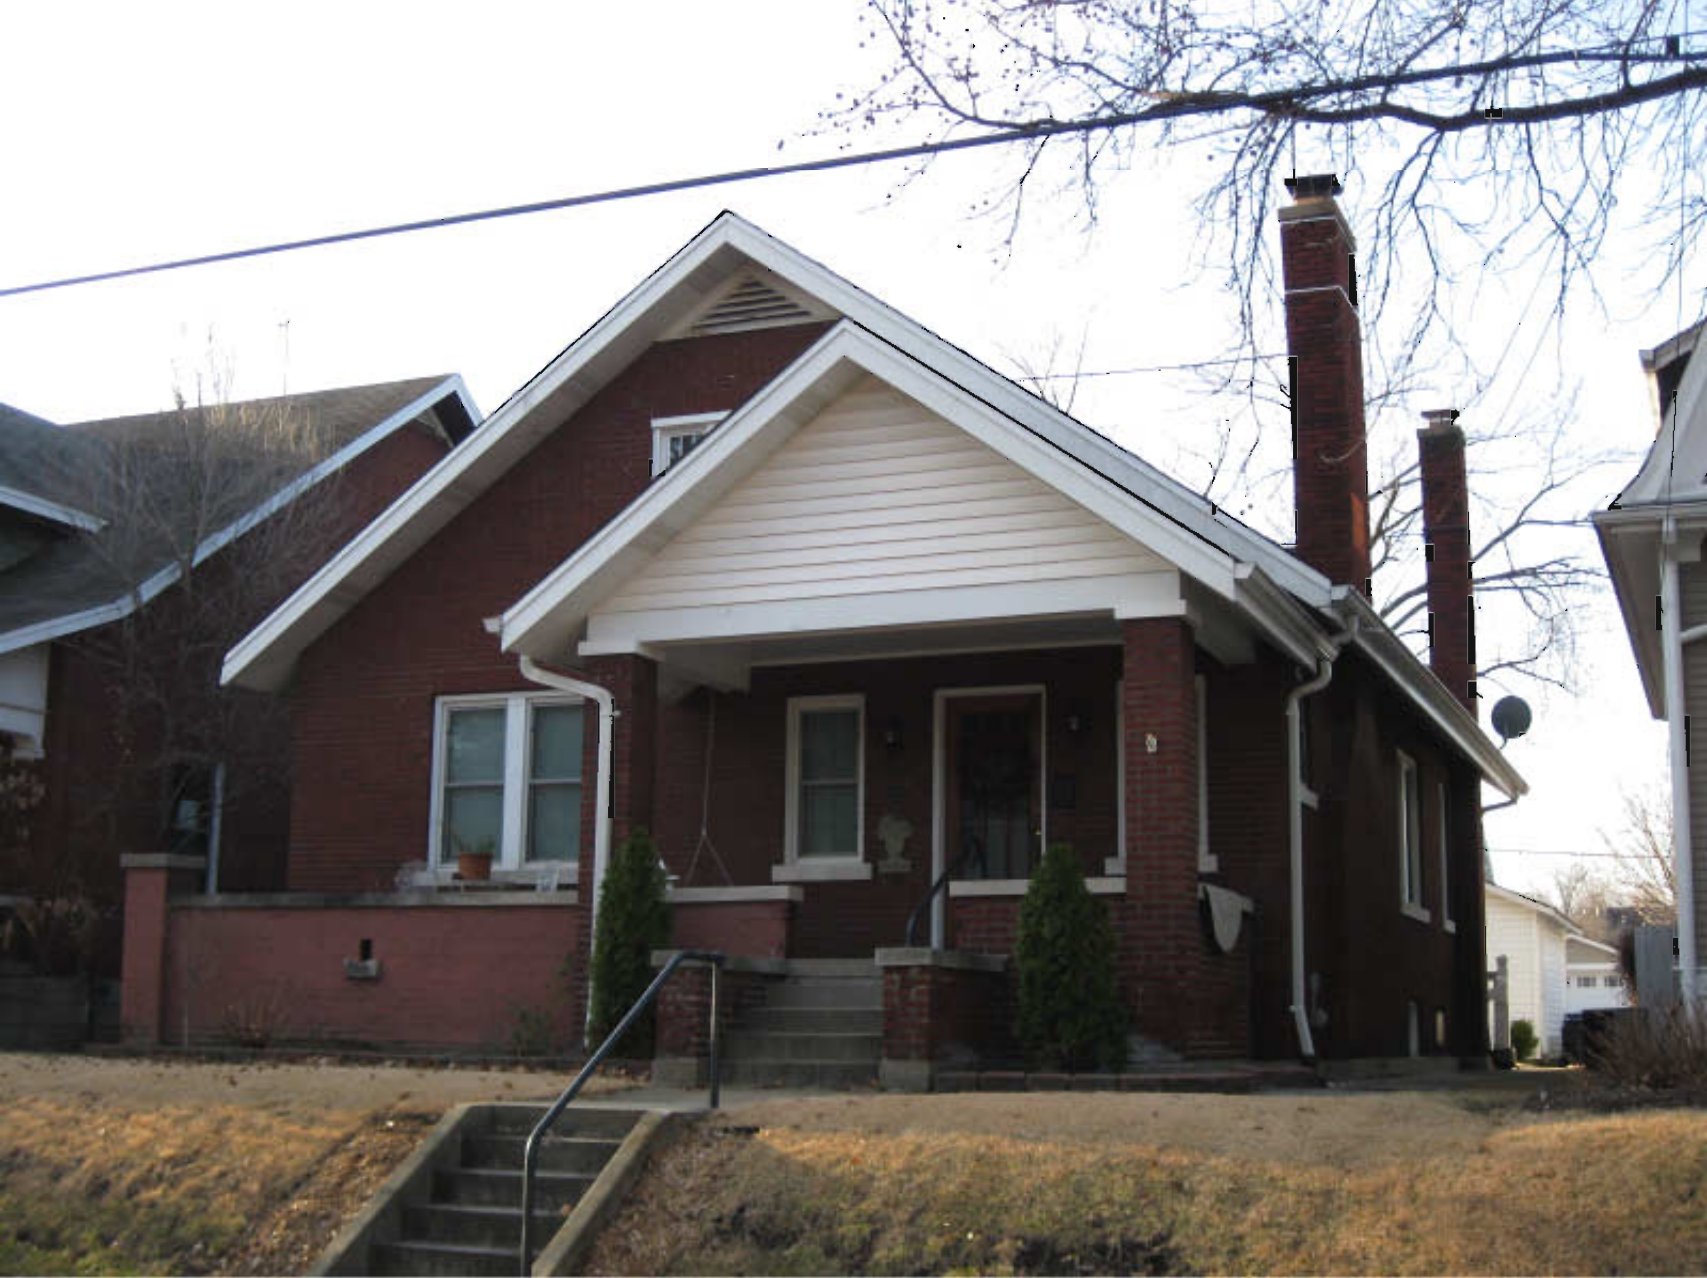
This one-and-one-half story, front-gabled, brick bungalow rests on a low concrete foundation and the bricks, which are textured, are laid in a running bond pattern. The gable roof has wide overhanging eaves and the west slope is pierced by two exterior end brick chimneys with tall smoke stacks. The four-bay main façade has, from east to west, a pair of 1/1 windows, a single 1/1 window, a glazed wood door with three vertical lights, and a 1/1 window. The openings have cast stone lug sills and jack arches. The eastern three bays are protected by a gabled portico with concrete stairway flanked by brick knee walls, concrete deck, and brick piers supporting the gable roof. The porch deck extends the full width of the house, creating a terrace at the easternmost bay, and both the terrace and porch have brick railings with concrete copings. The gable end of the porch has been clad with vinyl siding. In the upper half story is a band of three 3/1 windows. The east elevation has three 1/1 windows and the west elevation has, from front to rear, short art glass windows flanking the northernmost exterior end chimney, paired 1/1 windows and a single window.

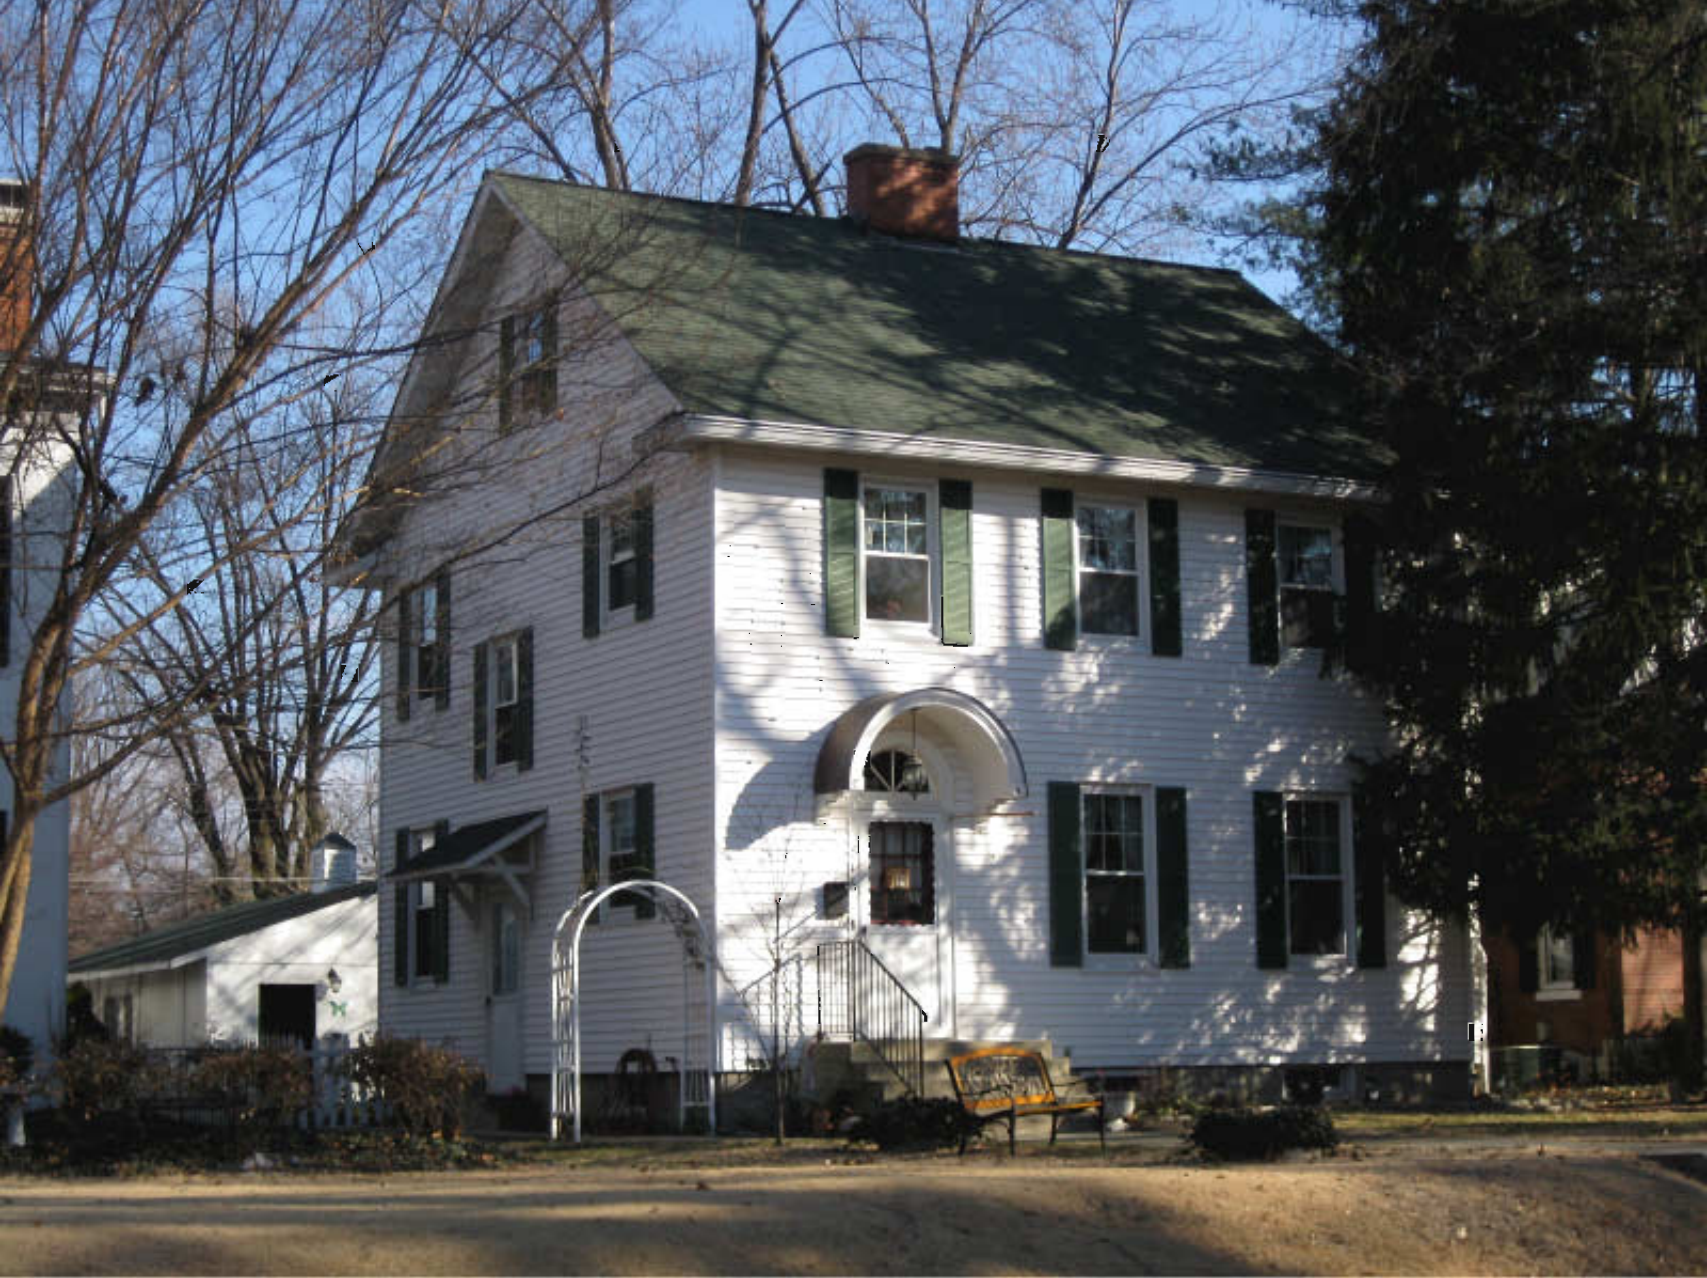
This two-and-one-half story, side-gabled, frame, Colonial Revival style house is situated on an elevated lot. The concrete foundation is pierced by three-light basement windows, and the walls have been clad with vinyl siding. The roof has wide overhanging eaves and cornice returns, and a brick chimney with concrete cap straddles the ridge. The westernmost bay of the three-bay main façade has a half-glazed wood door with nine lights, and the door is topped by a four-light fanlight. The door opens onto a concrete stoop with four steps and a wrought iron railing on the west side, and a round-arched awning supported by scroll brackets protects the stoop. To the east of the doorway are two 6/1 vinyl replacement windows, and on the second floor are three 6/1 windows. Vinyl louvered shutters are to each side of the windows. On the first floor of the west elevation is a door, which is flanked by 6/1 windows, and the door is protected by a shed awning supported by knee braces. Directly above the awning is a window that apparently overlooks a stairway, and on the second floor are two 6/1 windows and there is another in the upper half story. The house is noncontributing due to the installation of vinyl siding and replacement of the windows.

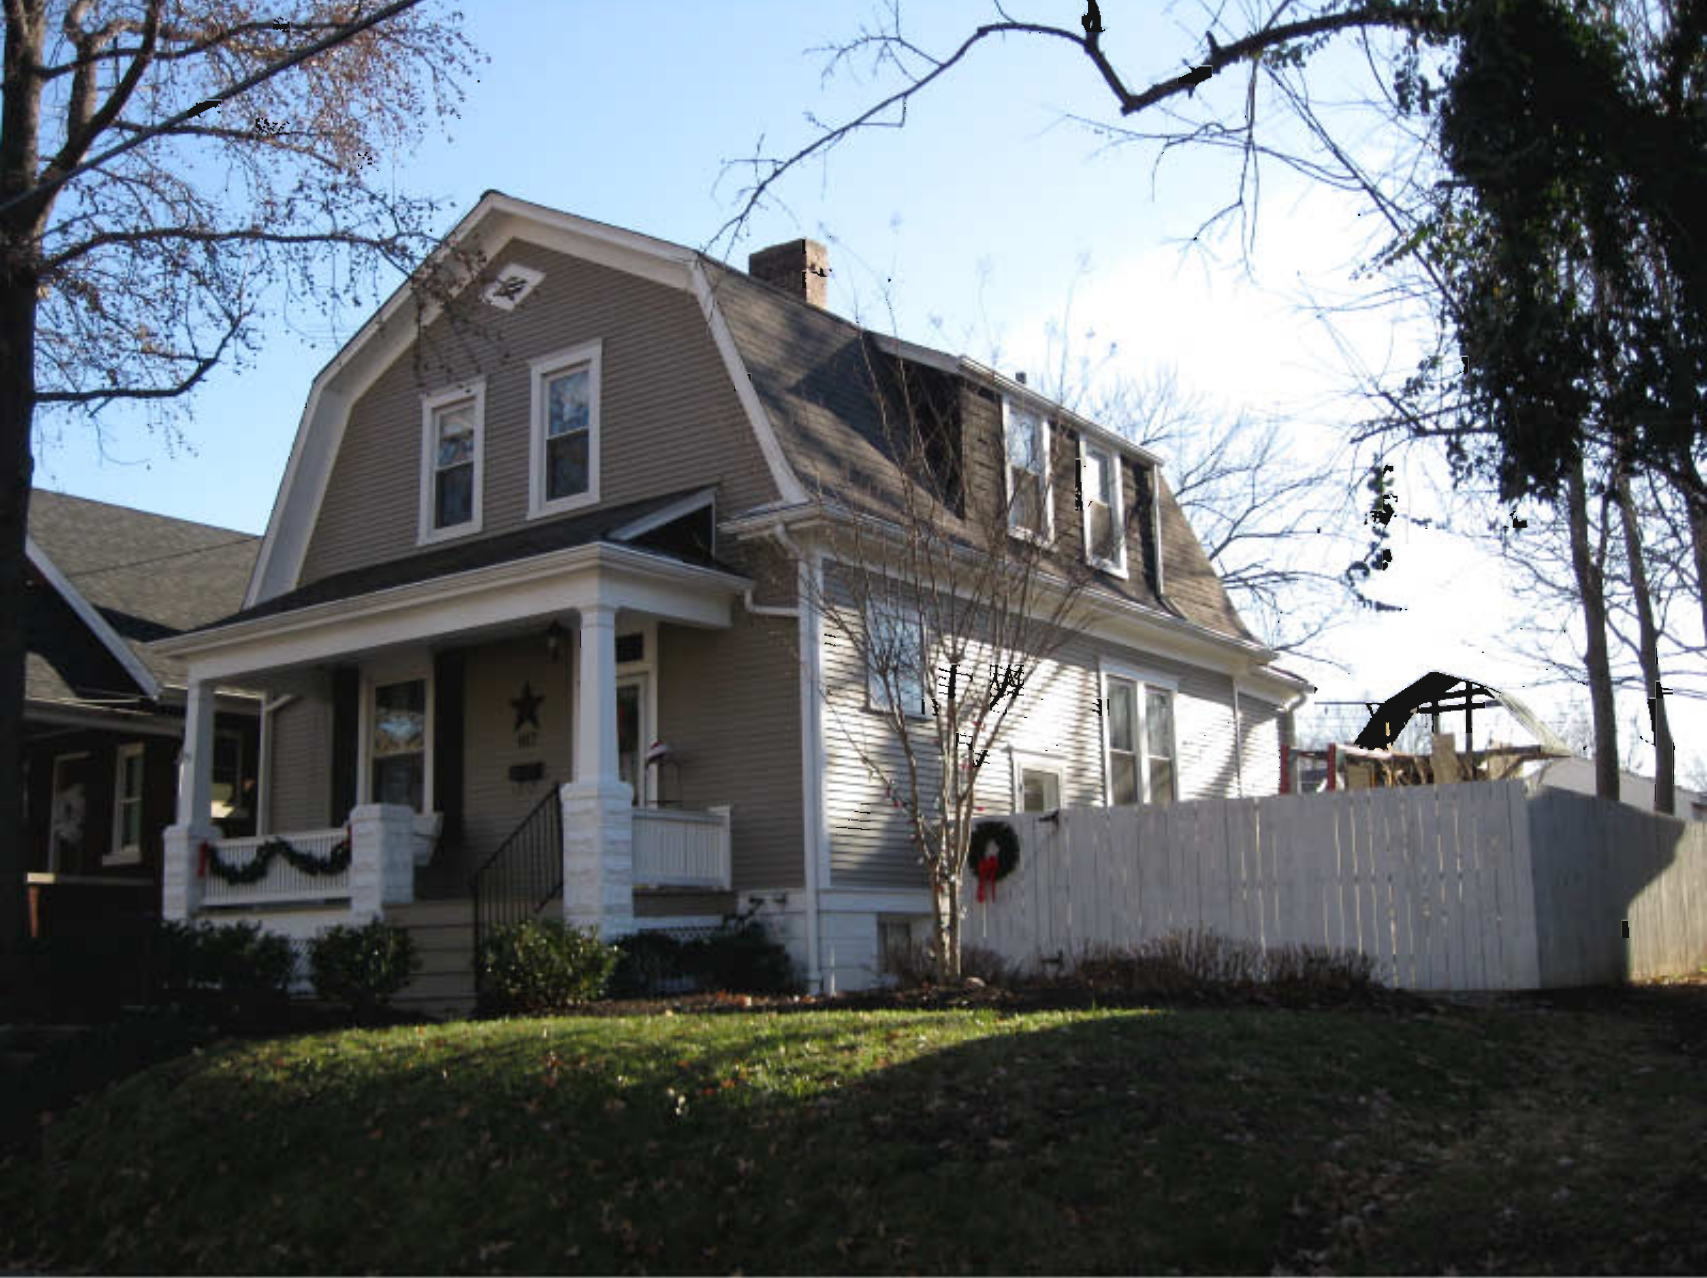
Resting on a scored concrete foundation, this two-story, frame, Dutch Colonial Revival style structure has walls clad with narrow weatherboard siding. The front-gambrel roof, which has wide overhanging eaves, is trimmed by a wide fascia and cornice returns. On the upper west slope is an interior brick chimney, and on the lower east and west slopes are shed dormers with two 1/1 windows and walls clad with asphalt roofing shingles. The two-bay main façade has a wide 1/1 window in the east bay, and in the west bay is a half-glazed wood door topped by a single-light transom. The openings throughout the house are trimmed with plain surrounds having slightly eared lintels with molded caps, and the windows appear to be replacement sash. The door opens onto a one-story, ¾-width gallery that has a wooden stairway and deck, cast concrete pedestals that extend to the ground to form foundation piers, wooden lattice panels under the deck, battered box columns resting on the corner pedestals and supporting the shed roof, and a plain wood balustrade. In the upper story of the façade are two 1/1 windows, above which is a diamond-shaped ventilator. On the east elevation is a single 1/1 window and a pair of windows, while on the west elevation is a short single-light casement window, a doorway, and pair of 1/1 windows.

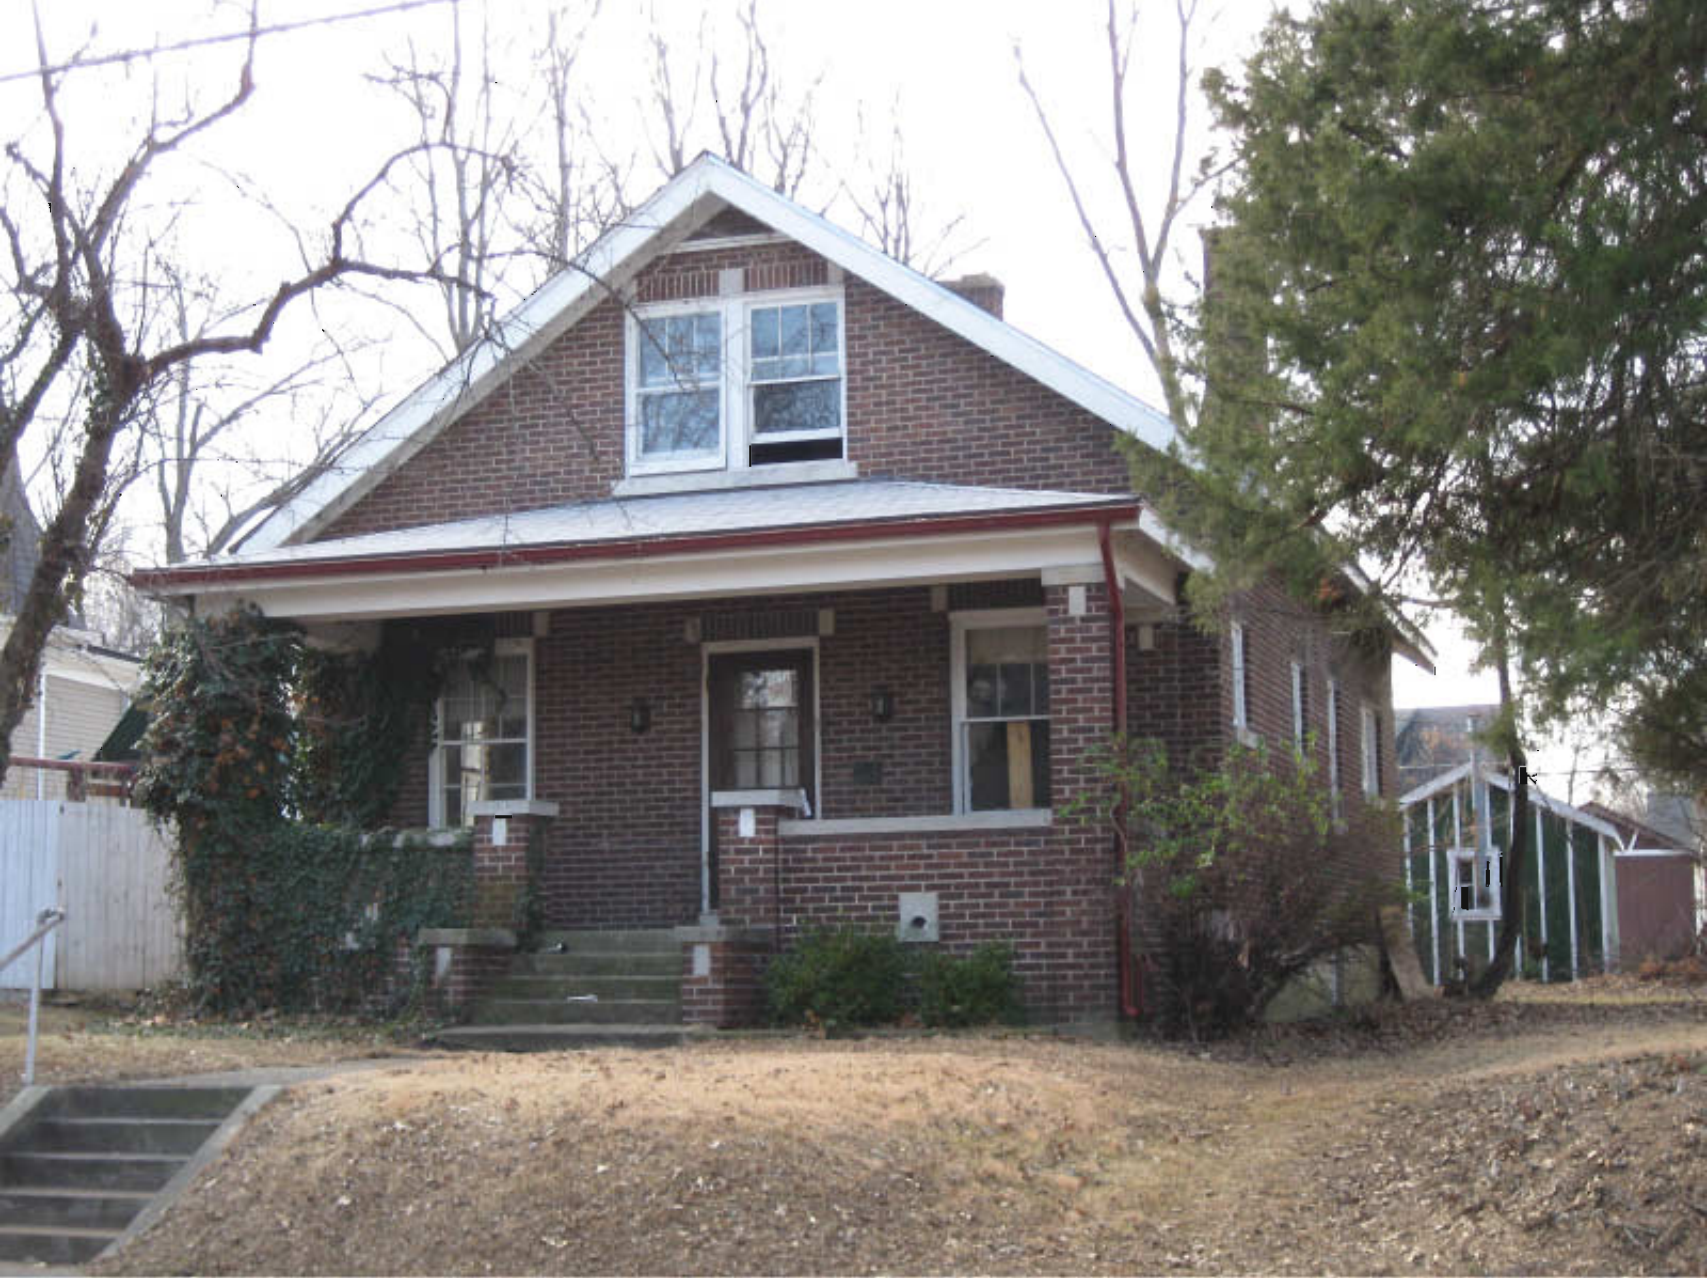
This one-and-one-half story, front-gabled, brick bungalow rests on a concrete foundation that is pierced by three-light basements windows topped by flat brick jack arches. The brick walls are laid in a running bond pattern and there are cast stone accents. The roof has exposed rafter tails in the eaves, and an interior brick chimney with concrete cap is on the east slope and an interior end chimney is on the west side. The center bay of the three-bay main façade has a glazed wood door with three vertical lights, and the wood storm door has four horizontal lights. To each side of the entrance is a 3/1 wood window, and the windows and doors on the main façade have cast stone sills and flat brick jack arches with cast stone blocks at each end. The door opens onto a one-story, ¾-width gallery with concrete deck; concrete stairway flanked by brick knee walls with concrete copings and plain cast stone ornaments on the front; brick pedestals at the top of the stair; and brick piers and pilasters supporting a hip roof. The pedestals and piers have concrete capitals and plain cast stone ornaments, and the plain brick railing has a concrete coping, concrete spouts on the front and diamond-shaped ornaments on the east and west railings. In the upper half story of the facade is a pair of 3/1 wood windows. On the west elevation is a small single-light casement window to each side of the interior chimney, and a 3/1 window and pair of short 3/1 windows are to the south. These window openings have cast stone sills and flat jack arches, but the jack arches do not have the cast stone end pieces like those of the façade. The east elevation has, from front to rear, a pair of 3/1 windows, a doorway at ground level, and a pair of short 3/1 windows. The doorway is protected by a shed awning supported by knee braces, and above the awning is another pair of 3/1 windows.
