ARCHITECTURAL/HISTORIC INVENTORY FORM

1. Survey No. SC-AS-009-001		2. Survey Name: St. Charles Survey Phase 3: Mid-Town and Commons Neighborhoods	
3. County: St. Charles		4. Address (Street No.) 128	Street (name) North Sixth Street
5. City: St. Charles	Vicinity: <input type="checkbox"/>	6. UTM:	
7. Township/Range/Section:		8. Historic name (if known): Meyer-Pieper House; The Meyerdorf	
9. Present/other name (if known):		10. Ownership: <input checked="" type="checkbox"/> Private <input type="checkbox"/> Public	
11a. Historic use (if known): Domestic/single dwelling		11b. Current use: Domestic/single dwelling

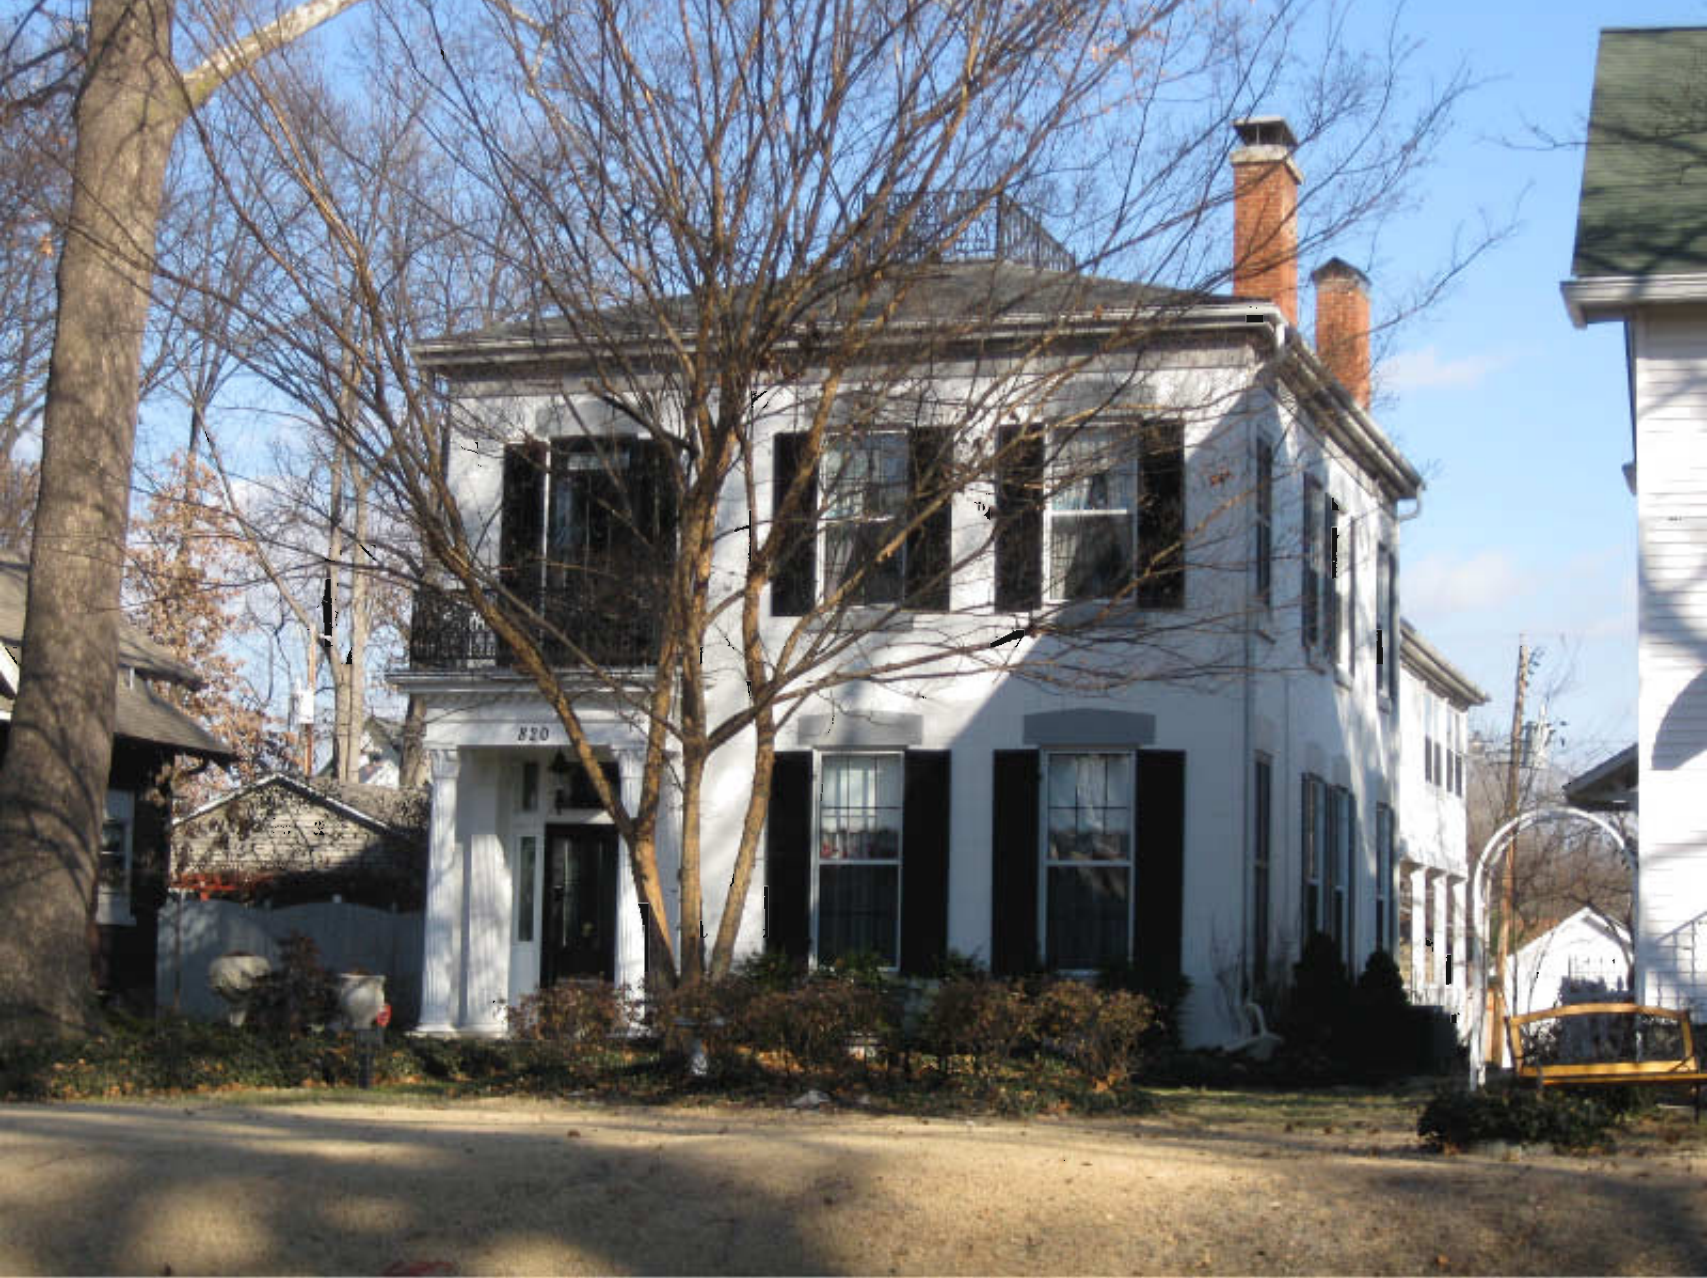
above the door and sidelights. The door opens onto a one-bay portico that has fluted Corinthian columns and pilasters supporting a flat roof trimmed with an entablature with denticulated frieze, and the roof, which forms a balcony, is enclosed with an ornate cast iron balustrade. To the right of the entrance are two 6/6 wood windows, and the windows on the main façade and east elevation have peaked stone lintels, stone lug sills and louvered wooden blinds. Opening onto the second floor balcony is a multi-light window that appears to be set above jib doors (a storm window and transom have been placed over the opening), and floor-length, louvered wood shutters frame the opening. To the right of the jib window are two 6/6 wood windows. There do not appear to be any openings on the west elevation, but on the east elevation are four 6/6 windows on each floor. A two-story, brick rear wing extends from the west half of the rear elevation, and the wing originally had a two-tiered porch on the east elevation, but the upper porch has been in-filled. The southernmost bay of the lower level of the gallery has been enclosed, but the remainder of the gallery has a wood deck, box columns with molded capitals, and a plain wood balustrade. The rear wall of the brick wing has two openings on each floor: on the first floor is a shuttered doorway and 6/6 window and on the second floor are two 6/6 windows. These openings have flat jack arches and wooden louvered blinds. In 2004 a one-story, two-car, side-gabled garage was attached to the northwest corner of the rear wing. The walls are clad with vinyl siding, and the overhead door is paneled and looks like carriage doors. Above the door are three five-light transoms, and to each side of the door is a detached box column.

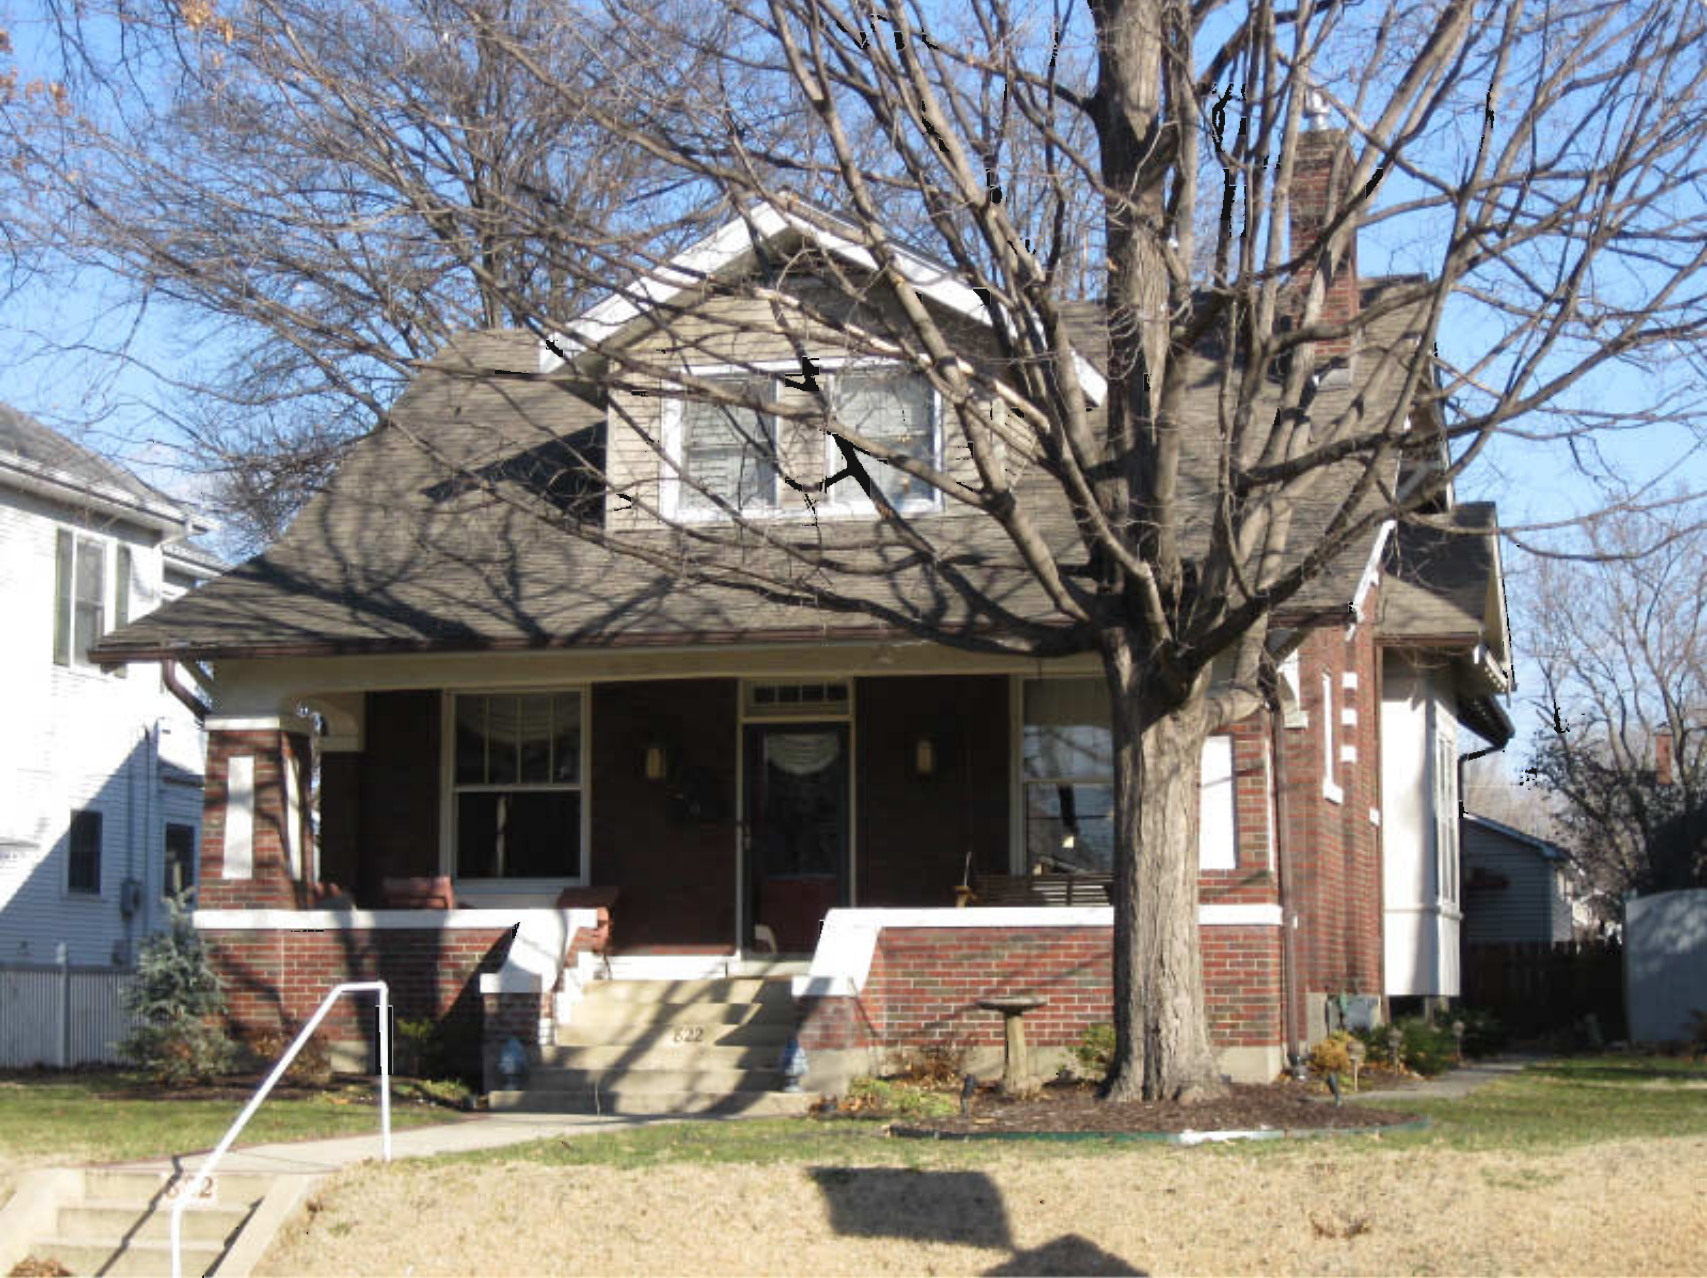
Facing south, this house is a one-and-one-half story, side-gabled, brick bungalow that has a one-story rear wing. The concrete foundation is pierced by three-light basement windows, and the red brick walls are laid in a running bond pattern. On the main façade the lower three courses are white glazed bricks, which form a baseboard for the porch. An exterior end brick chimney with cast stone accents is on the east elevation. The gable roof has wide overhanging eaves with exposed rafter tails and knee braces in the gable ends, and on the front slope is a gabled dormer with two 1/1 windows and vinyl-sided walls. A shed dormer with single window is on the west slope of the rear wing. The center bay of the three-bay main façade has a 2/3-glazed door with beveled glass, and above the door is a four-light transom. To each side of the doorway is a 4/1 wood window, and windows throughout the house have cast stone sills. A full-width gallery spans the façade and features a concrete stairway flanked by brick knee walls that have S-shaped concrete copings and white brick baseboards on the stair side, concrete deck, brick half-wall railings with concrete copings, battered brick piers with stucco panels, brick pilasters, and shed roof with Tudor-arched stucco frieze. From front to rear, the east elevation has small leaded glass windows to each side of the exterior end chimney; a box bay with stucco walls, a band of 3/1 wood windows, and a shed roof topped by a gable roof; and in the rear wing are two small 1/1 windows that apparently replace larger windows since they are surrounded by in-fill. In the upper half story is a 3/1 window. The west elevation has, from front to rear, a 3/1 window, a polygonal bay with shed roof and three 3/1 windows, and two windows (one is in the rear wing). In the upper half story is a pair of 3/1 windows.

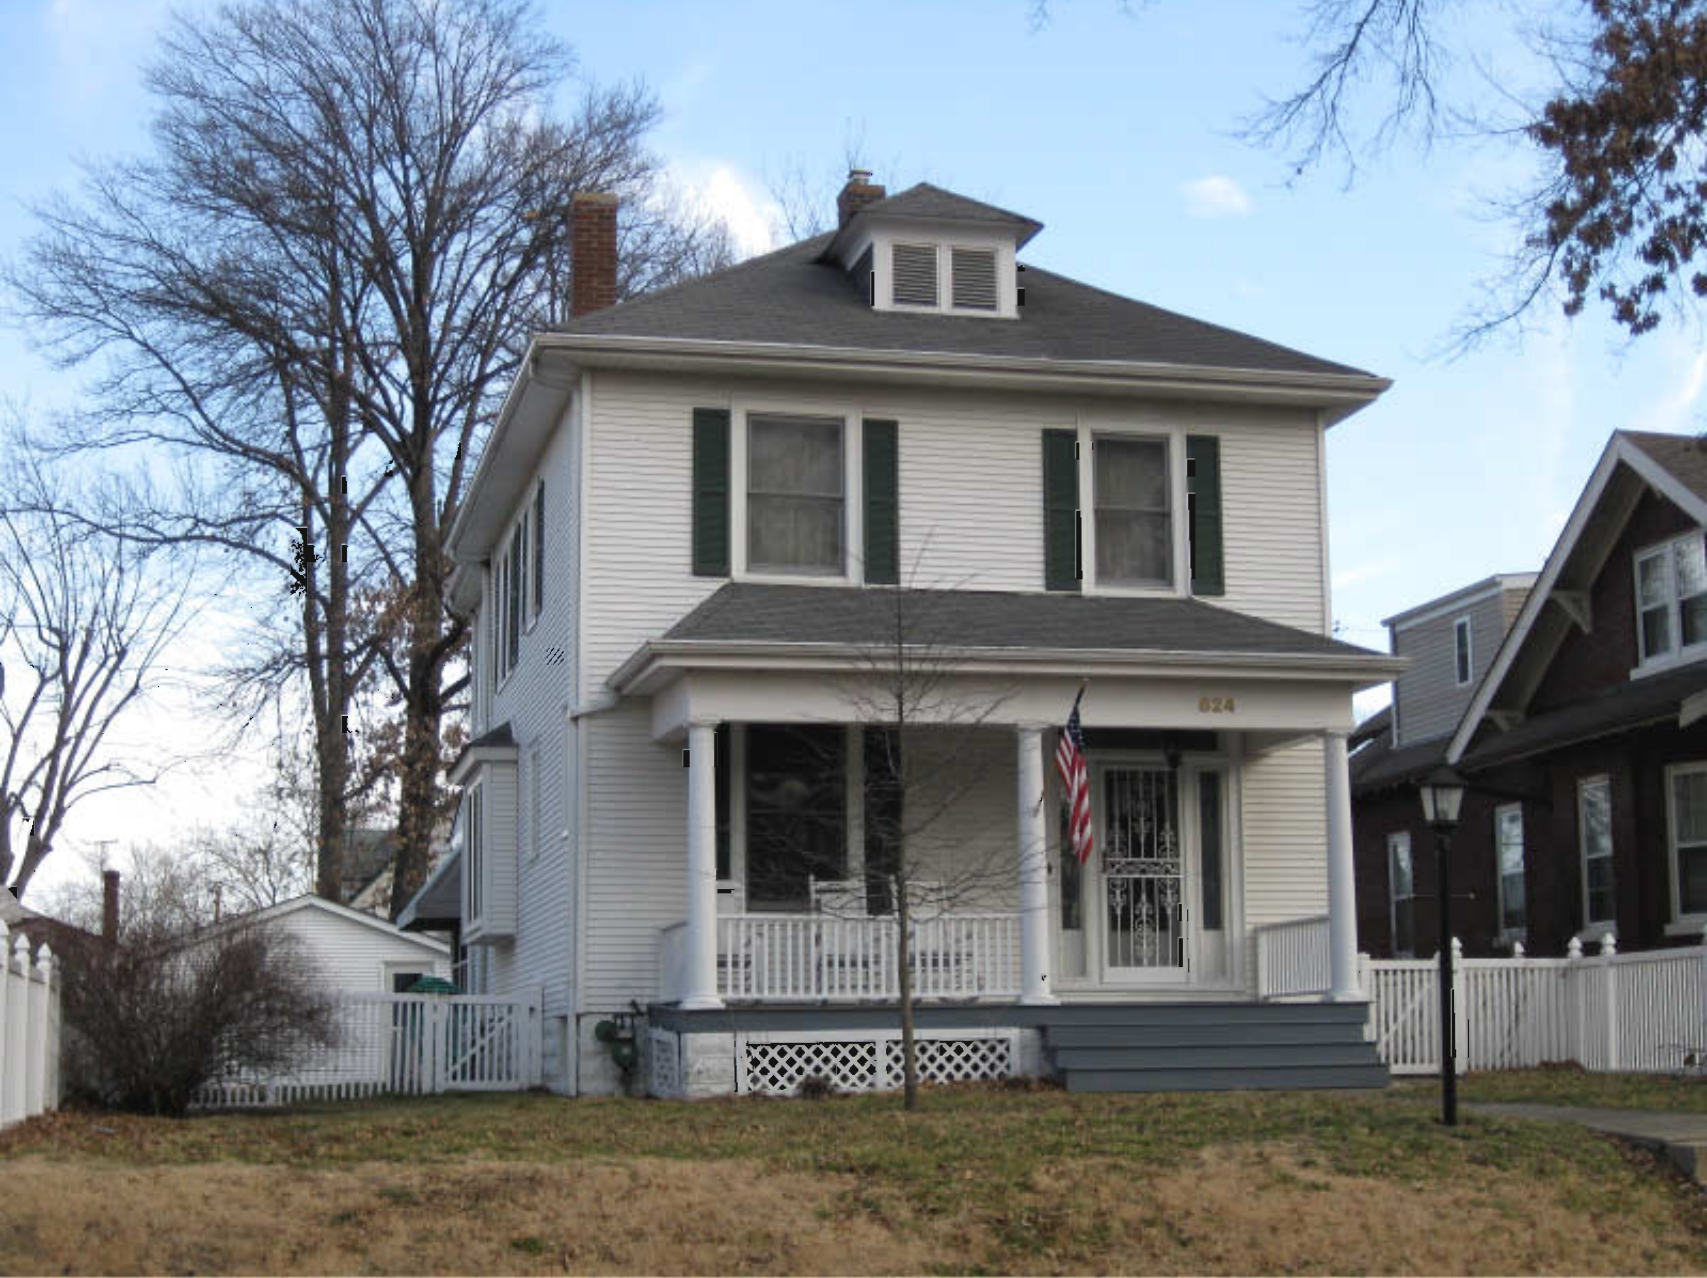
This two-story, frame, Colonial Revival style house rests on a rusticated concrete block foundation, has walls clad with vinyl, and is crowned by a high hip roof with wide overhanging eaves. A hipped dormer with paired ventilators rests on the front slope of the roof, while an interior end brick chimney pierces the west slope and another straddles the ridge. The two-bay main façade has an entrance in the east bay and a 1/1 window in the west. The entrance has a glazed wood door flanked by single-light sidelights, and a single-light transom spans the top of the door and sidelights. The 1/1 windows throughout the house appear to be replacements, but the house retains its original front door and stained and leaded glass windows. The door opens onto a one-story, ¾-width gallery that has rusticated concrete foundation piers in-filled with wooden lattice panels, a wide wooden stair and deck, plain wood balustrade, and Doric columns supporting a high hip roof. The second floor of the façade has two 1/1 windows. On the first floor of the west elevation, from front to rear, are two small leaded glass windows and a box bay with band of three 1/1 windows and hip roof, and the second floor has a 1/1 window and paired 1/1 windows. The west elevation of the two-story rear addition has a band of narrow 4/4 windows on both floors. On the east elevation is a small stained glass window, an entrance at ground level, and a 1/1 window, and above the metal awning of the entrance is a 1/1 window between floors, indicating that it overlooks a stairway. The second floor has two 1/1 windows. The house is being counted as contributing since it retains its front door, sidelights and transom; stained and leaded glass windows; and gallery with its original details.

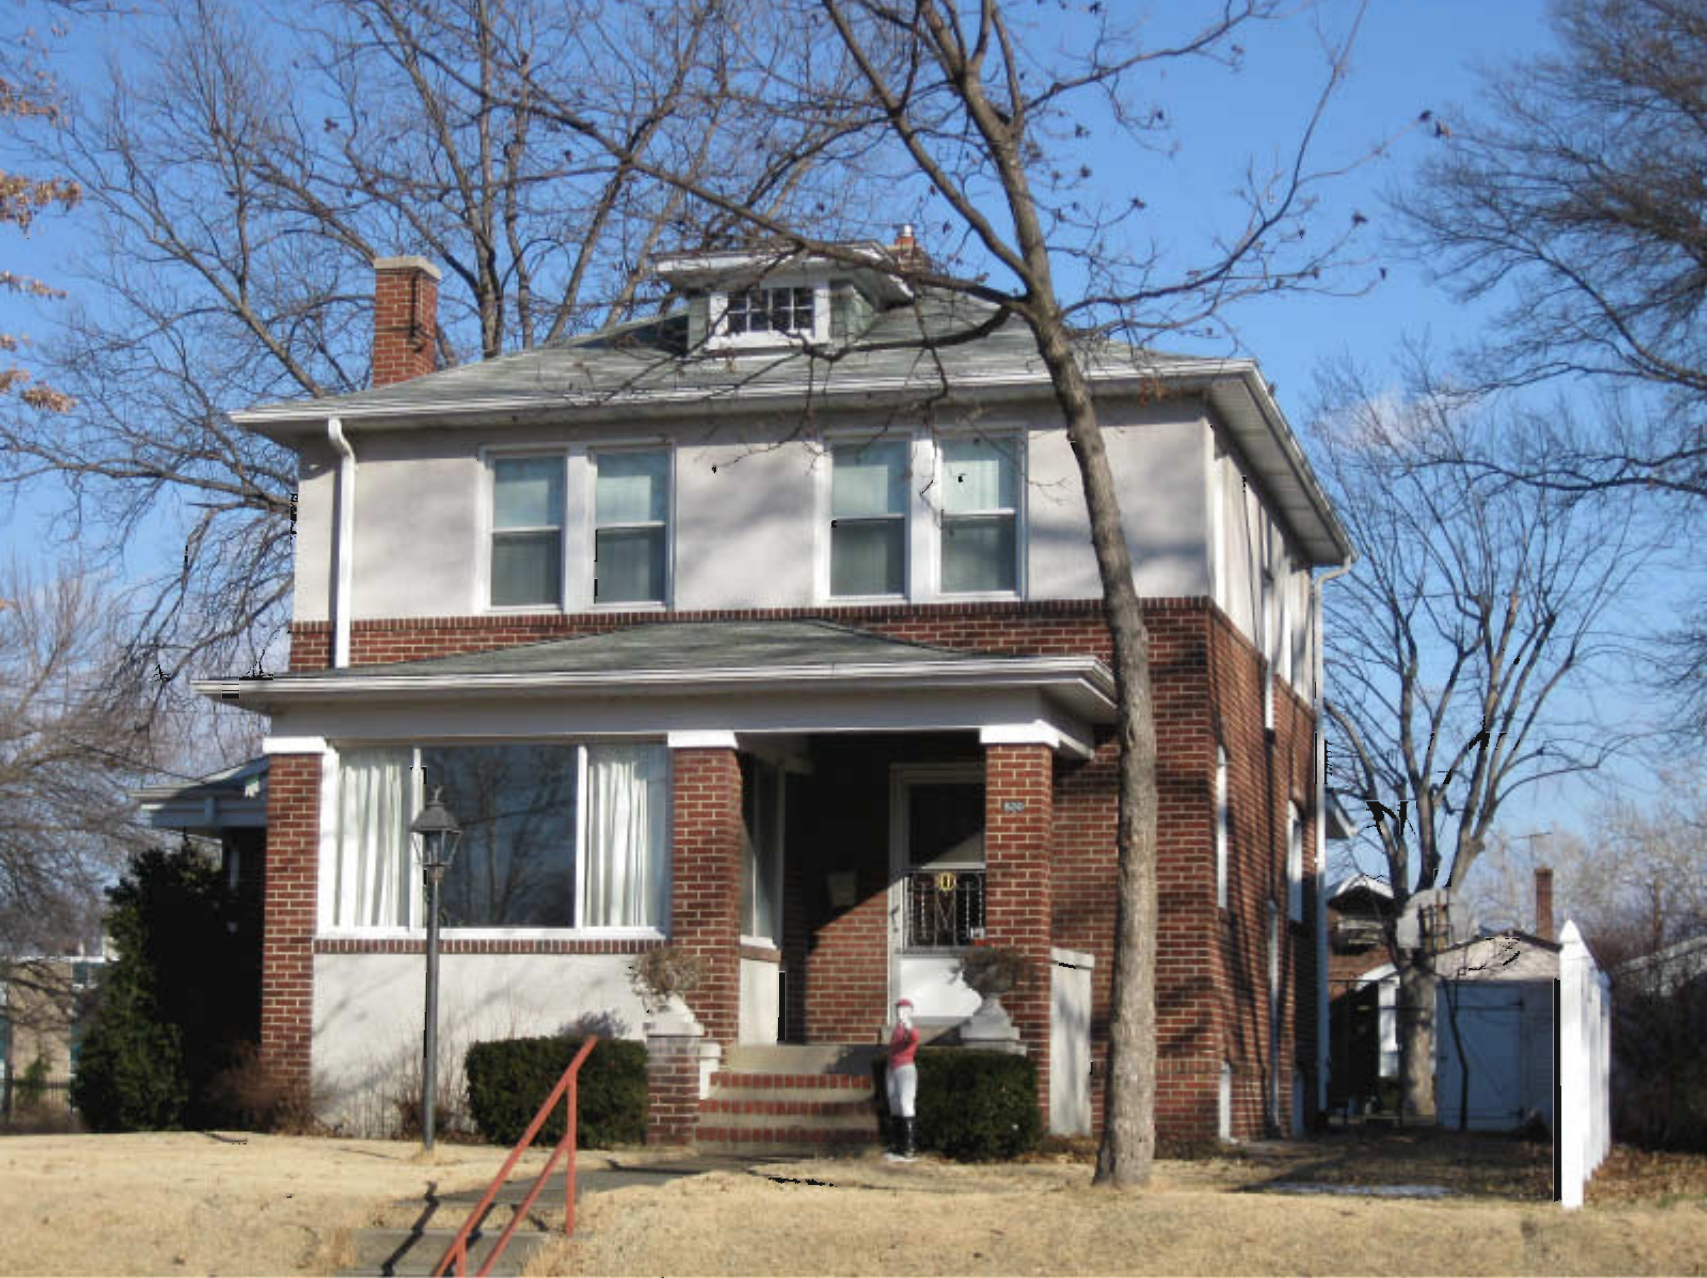
Located at the northeast corner of Monroe and Ninth Streets, this two-and-one-half story, masonry, American Foursquare house has a brick foundation with brick water table. The single-light basement windows are set within segmental-arched openings with radiating voussoirs and cast stone sills. The house is crowned by a pyramidal roof with wide overhanging eaves, and a hipped dormer with wide overhanging eaves, eight-light wood window, and walls clad with asphalt roofing shingles is on the front slope. An interior end chimney is on the west slope and an interior chimney is on the rear slope. The brick walls, which are laid in a running bond pattern, extend from the foundation to the sills of the second floor windows, and the walls above this level are finished with stucco. The entrance, which is located in the eastern bay of the two-bay main façade, is a Craftsman style, paneled wood door with eight small lights at the top, and the door is partially obscured by a screen door with metal grill. The door opens onto a one-story, ¾-width gallery, but the west bay is enclosed with glass, which apparently is either an original feature or early alteration since the 1929 and 1947 Sanborn maps show the west bay as enclosed. A circa 1940s-1950s photograph in the collection of the St. Charles County Historical Society shows that the porch was enclosed with what appears to be casement windows. The porch has a concrete stairway with brick pavers along the edge of each step, and the stairway is flanked by stucco knee walls with brick pedestals at the south end. Brick piers, which extend from the ground to the hip roof, have cast stone capitals and the railing is stucco. In the west bay is a three-light picture window set above a stucco half wall topped by bricks, and the side walls of the porch enclosure have two-light windows above matching half walls. Two pairs of 1/1 windows are in the second floor of the façade. On the first floor of the east elevation are three segmental-arched openings, which are from front to rear, a 1/1 window, door at ground level, and paired 1/1 windows. The first floor windows have brick sills and radiating voussoirs. The second floor features a 1/1 window and paired 1/1 windows, and between those two openings half way between the first and second floor is another window that apparently overlooks a stairway. On the first floor of the west elevation are paired leaded glass casement windows to each side of the exterior end chimney, and to the north is a one-story, hanging box bay with stucco walls, low hip roof, and band of three windows that have upper sashes with muntins set close to the top rail and the stiles but single-light lower sashes. On the second floor are three 1/1 windows. A one-story, brick wing with high stucco foundation and gable-on-hip roof extends from the north end of the west elevation. The 1929 and 1947 Sanborn maps show a shallow wing in this location, but it has been enlarged to the west and north, wrapping around part of the rear elevation. The basement level is a garage that is accessed from Ninth Street. The overhead door is a paneled-and-glazed wood door, and above this door is a band of three four-light (lights arranged horizontally), raw aluminum sash. Each side elevation of the addition also has a band of three

aluminum sash, and the rear elevation also has a door.

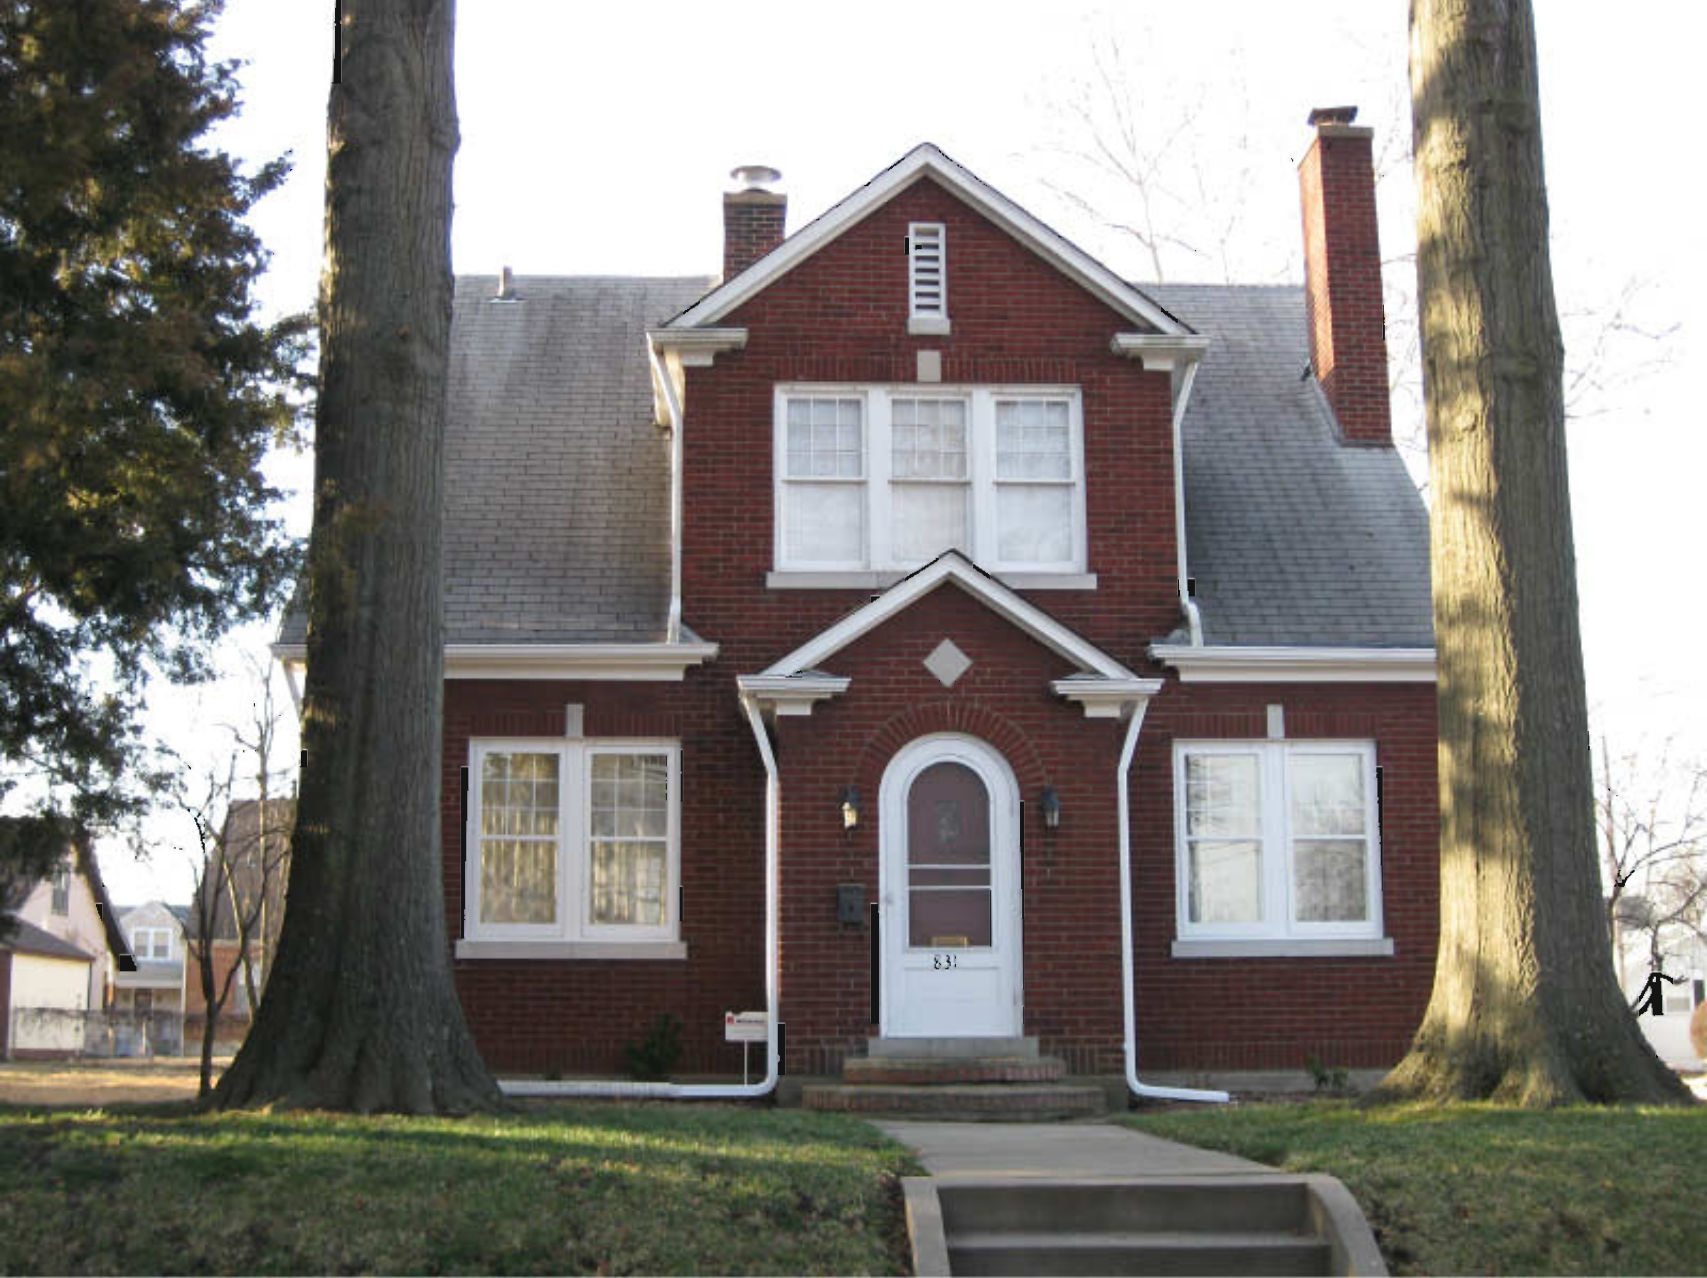
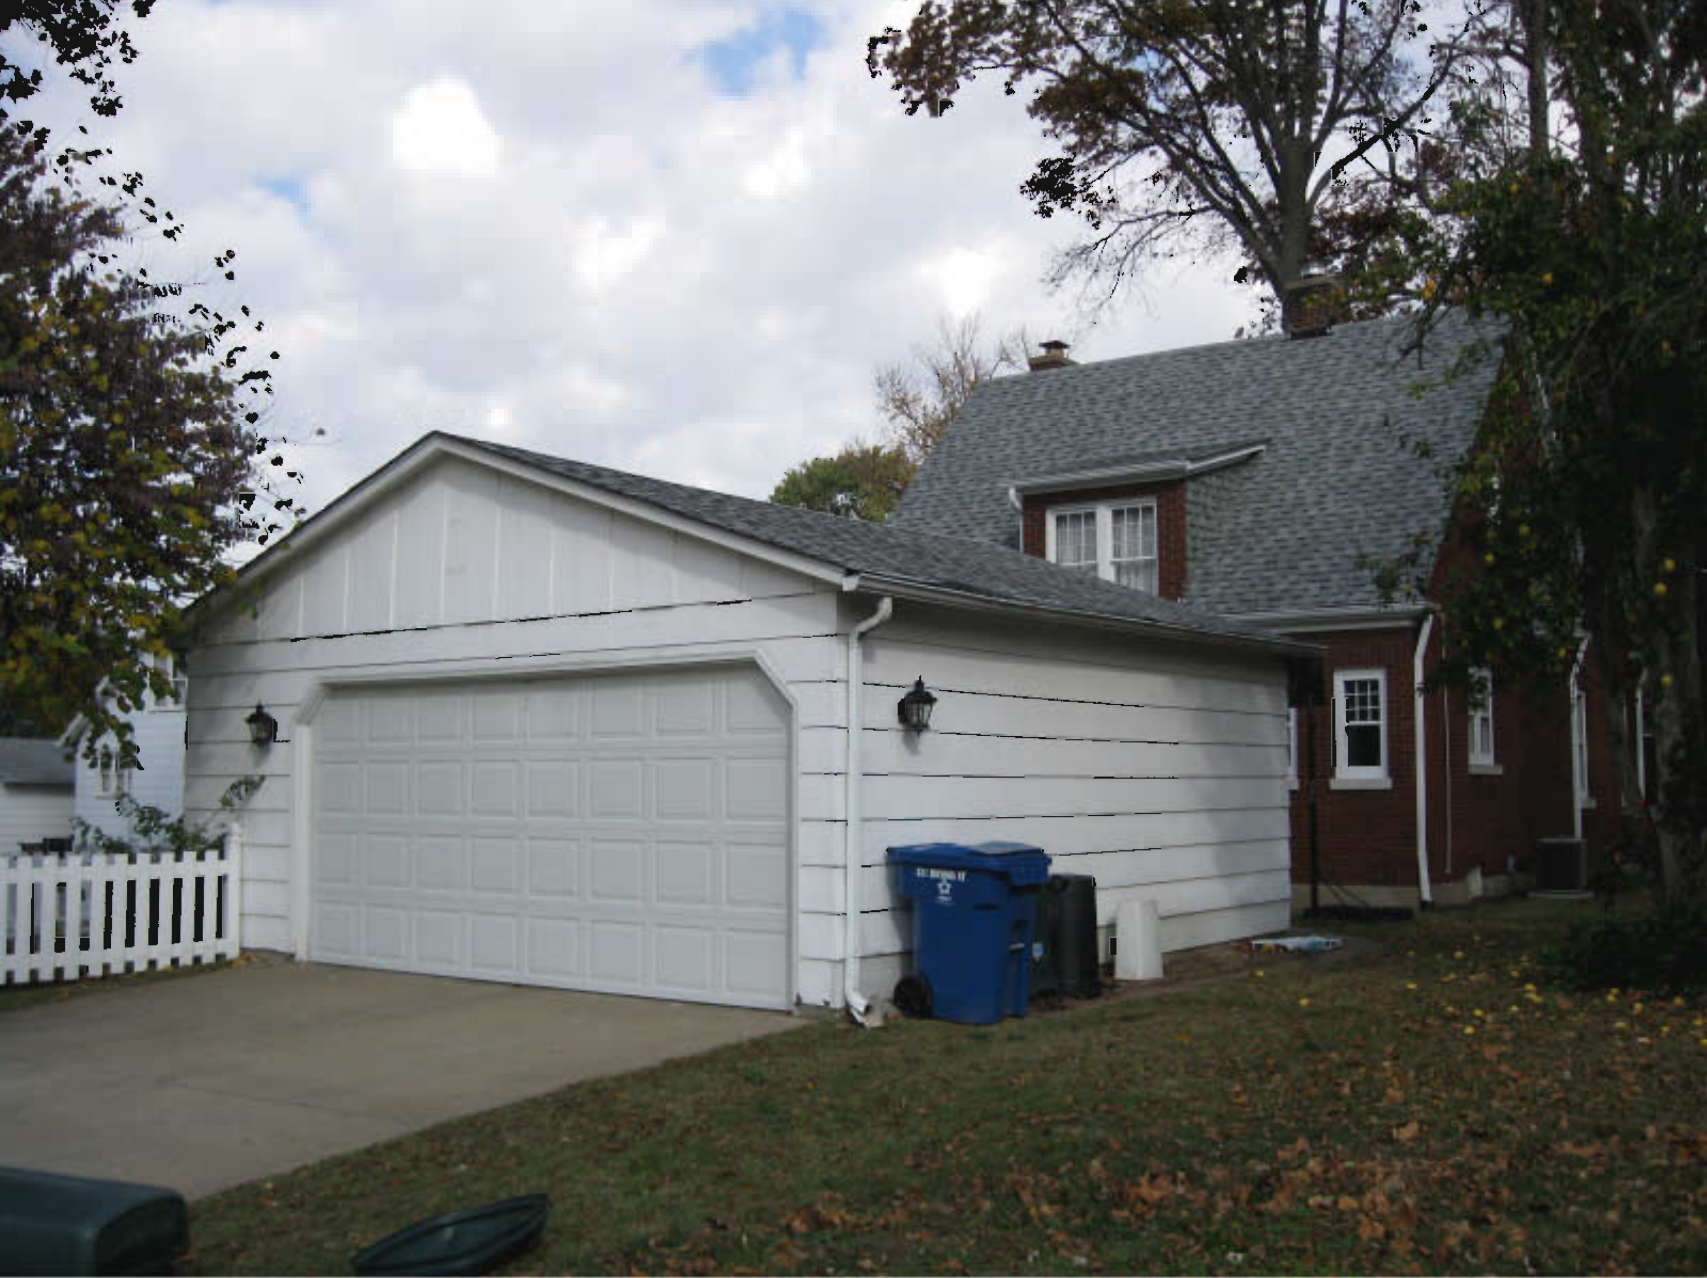
Situated on a tree-shaded corner lot, this one-and-one-half story, brick house with a steeply-pitched, side-gabled roof displays both Tudor Revival and Colonial Revival influences. The house has a concrete foundation and the textured brick walls are laid in a running bond pattern, except immediately above the foundation is a soldier course. The house is distinguished by its central, one-bay, projecting gabled entry wing and its large gabled wall dormer directly above. The main roof and the roofs of the dormer and entry wing have cornice returns, and there is a straddle ridge chimney and an exterior end chimney on the west side. The entrance is a round-arched opening with vertical board door having an opening filled with leaded glass in a diamond pattern, and the door has large iron hinges. The door is capped by radiating voussoirs, above which is a diamond-shaped, cast stone ornament. The door opens onto a semicircular stairway of concrete and brick. Each of the side walls of the projecting entry bay has a small casement window of diamond-patterned leaded glass. In the outer bays of the three-bay main façade is a pair of 9/1 wood windows and above the entrance is a wide brick wall dormer with band of three 9/1 wood windows, and all of these windows have cast stone sills and flat jack arches with cast stone keystones. A narrow rectangular ventilator with cast stone sill is in the gable ends of the house and dormer. On the first floor of the west elevation is a small leaded glass window to each side of the exterior end chimney, and to the south is a pair of 9/1 windows and another pair is in the upper half story. These windows also have cast stone sills and flat jack arches, but no keystones. On the east elevation, a one-story, gabled wing on the north end slightly projects from the remainder of the elevation and has two 9/1 windows. To the south is a pair of short 9/1 windows, and in the upper half story are two 6/1 windows.

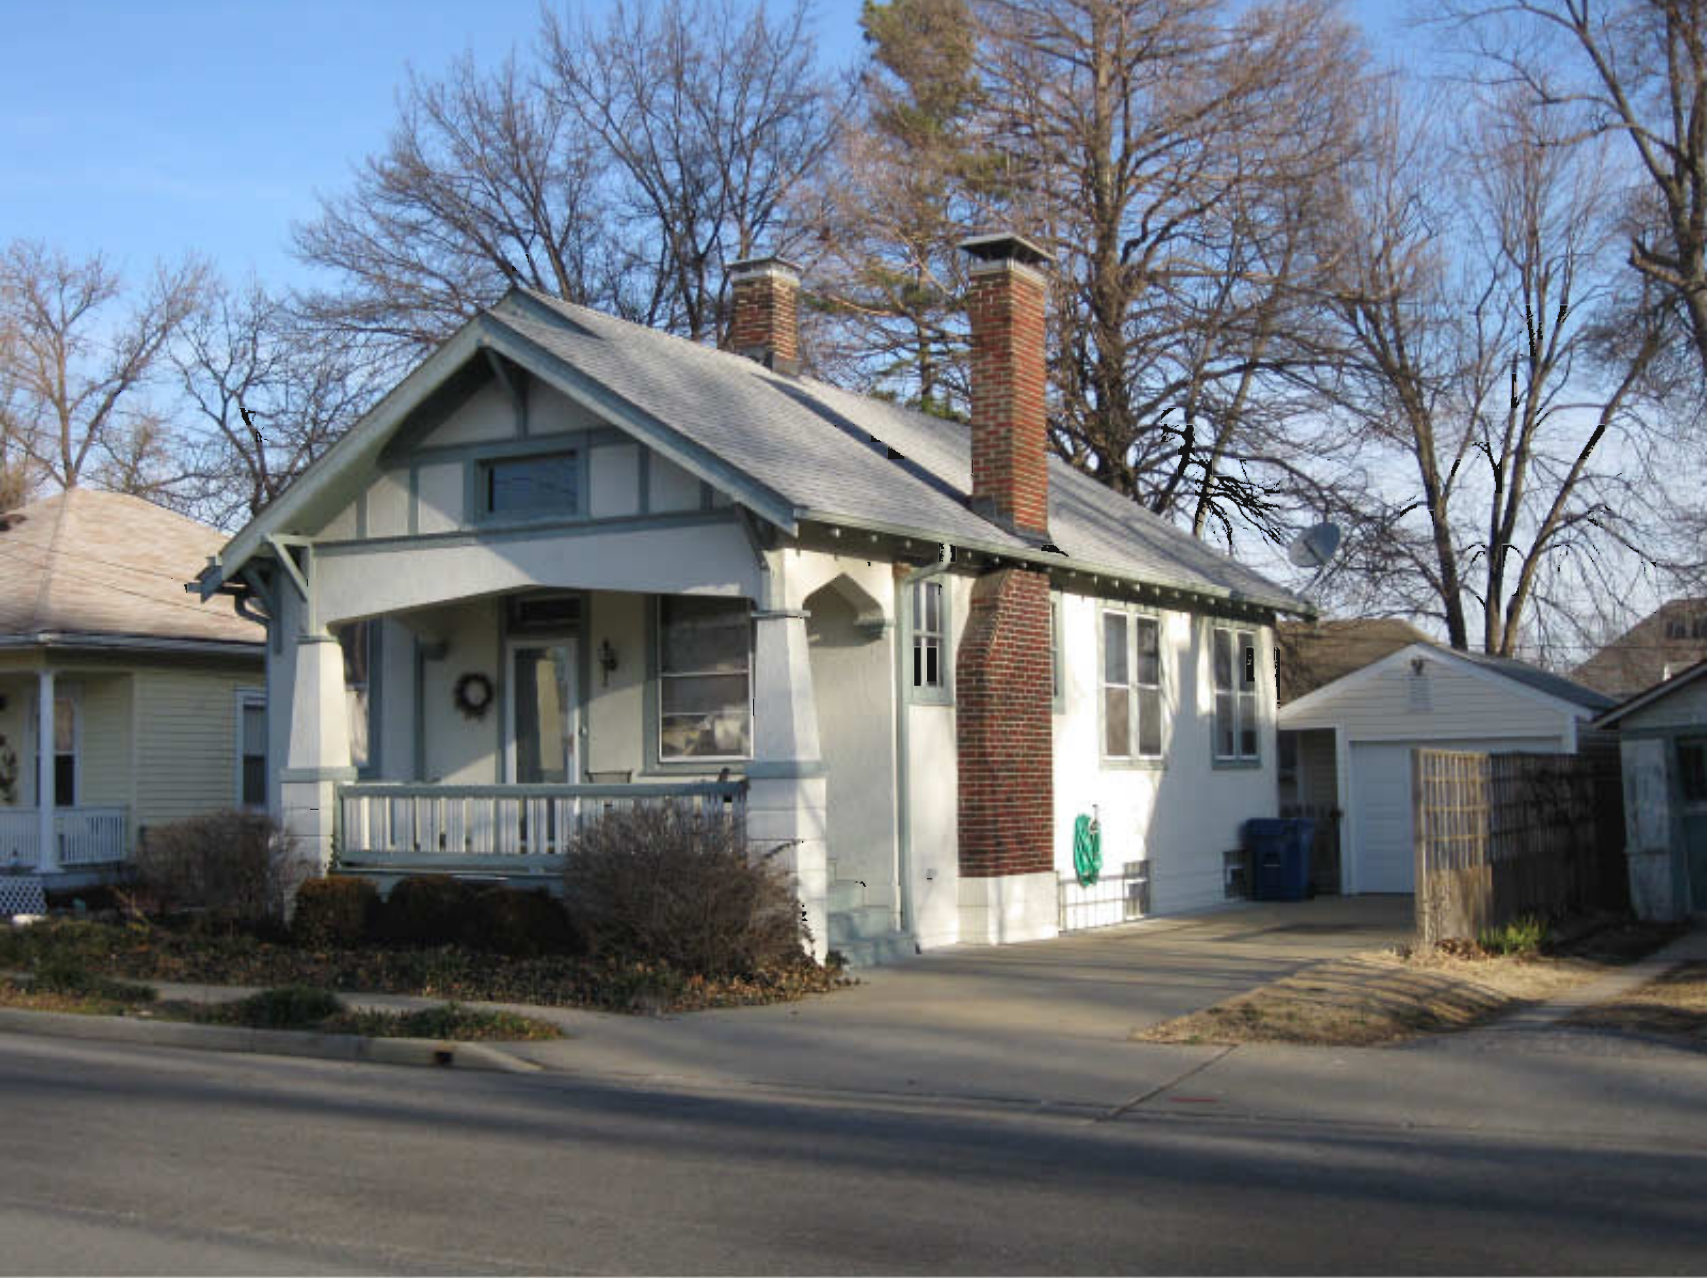
This one-story, front-gabled bungalow rests on a smooth, scored stucco foundation that has glass block basement windows, and the walls are finished with textured stucco. The front-gabled roof has exposed rafter tails in the wide overhanging eaves, and in the gable end are knee braces. A brick chimney straddles the ridge of the roof, and a brick exterior end chimney pierces the east slope. The main entrance is located in the center bay of the three-bay main façade, and to either side is a 1/1 window. The door appears to be a replacement with small leaded glass light, and above the door is a single-light transom. The house is distinguished by its gabled porch, which spans the eastern two bays and features decorative half-timbering, knee braces and a four-light window in the gable end. (Only the gable end of the porch has a window opening; there are none in the gable end of the house.) The porch has a wooden stair at the east side; wooden deck; smooth, scored stucco pedestals that extend to the ground and also support battered, textured box columns; wood balustrade with balusters arranged in groups of three; and a gable roof with Tudor-arched frieze. On the east elevation are paired casement windows to each side of the exterior end chimney and two pairs of 1/1 windows. The west elevation has a three-light, transom-type window and two pairs of 1/1 windows. The garage appears to be attached to the northeast corner of the house. The front-gabled, frame garage is finished with vinyl siding and the paneled metal overhead door is on the south elevation.

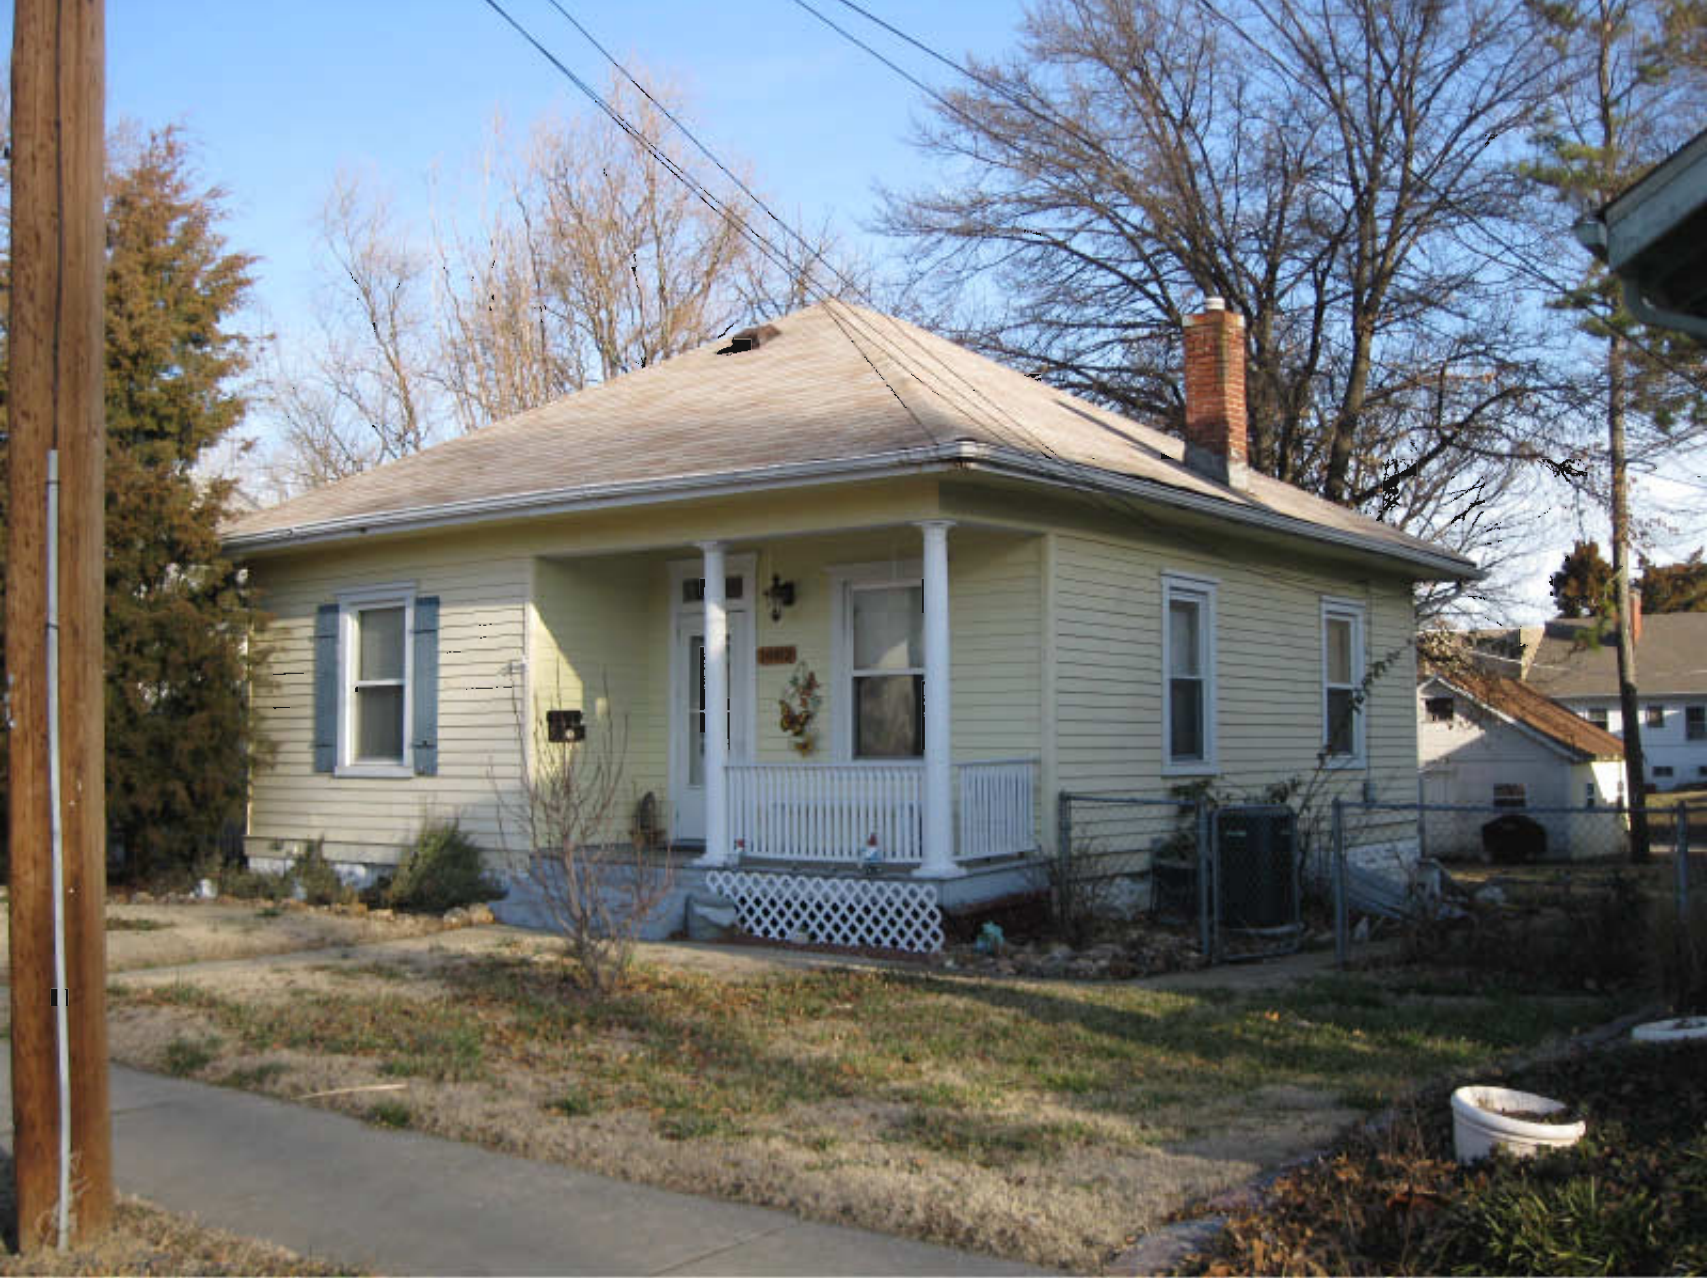
Facing south, this one-story, frame house rests on a rusticated concrete block foundation and the walls are finished with weatherboard siding. The pyramidal roof, which has wide overhanging eaves, is trimmed with a plain frieze and the east slope is pierced by an interior end brick chimney. The house's most distinguishing feature is its two-bay recessed porch at the southeast corner. It has a wooden deck and stairway, Tuscan columns, and a plain wood balustrade. The recessed porch gives the three-bay main façade an L-shape, and there is a 1/1 window in the western bay and the entrance and another 1/1 window in the recessed eastern two bays. Windows are replacements, and the western window has vertical-board shutters. The 2/3-glazed wood door has muntins near the edge of the glazing, and the door is topped by a single-light transom. Openings throughout the house have plain, slightly eared moldings. The east elevation has two window openings and a wooden bulkhead that provides access to the basement, while the west elevation has three 1/1 windows.
