ARCHITECTURAL/HISTORIC INVENTORY FORM

1. Survey No. SC-AS-009-001		2. Survey Name: St. Charles Survey Phase 3: Mid-Town and Commons Neighborhoods	
3. County: St. Charles		4. Address (Street No.) 128	Street (name) North Sixth Street
5. City: St. Charles	Vicinity: <input type="checkbox"/>	6. UTM:	
7. Township/Range/Section:		8. Historic name (if known): Meyer-Pieper House; The Meyerdorf	
9. Present/other name (if known):		10. Ownership: <input checked="" type="checkbox"/> Private <input type="checkbox"/> Public	
11a. Historic use (if known): Domestic/single dwelling		11b. Current use: Domestic/single dwelling

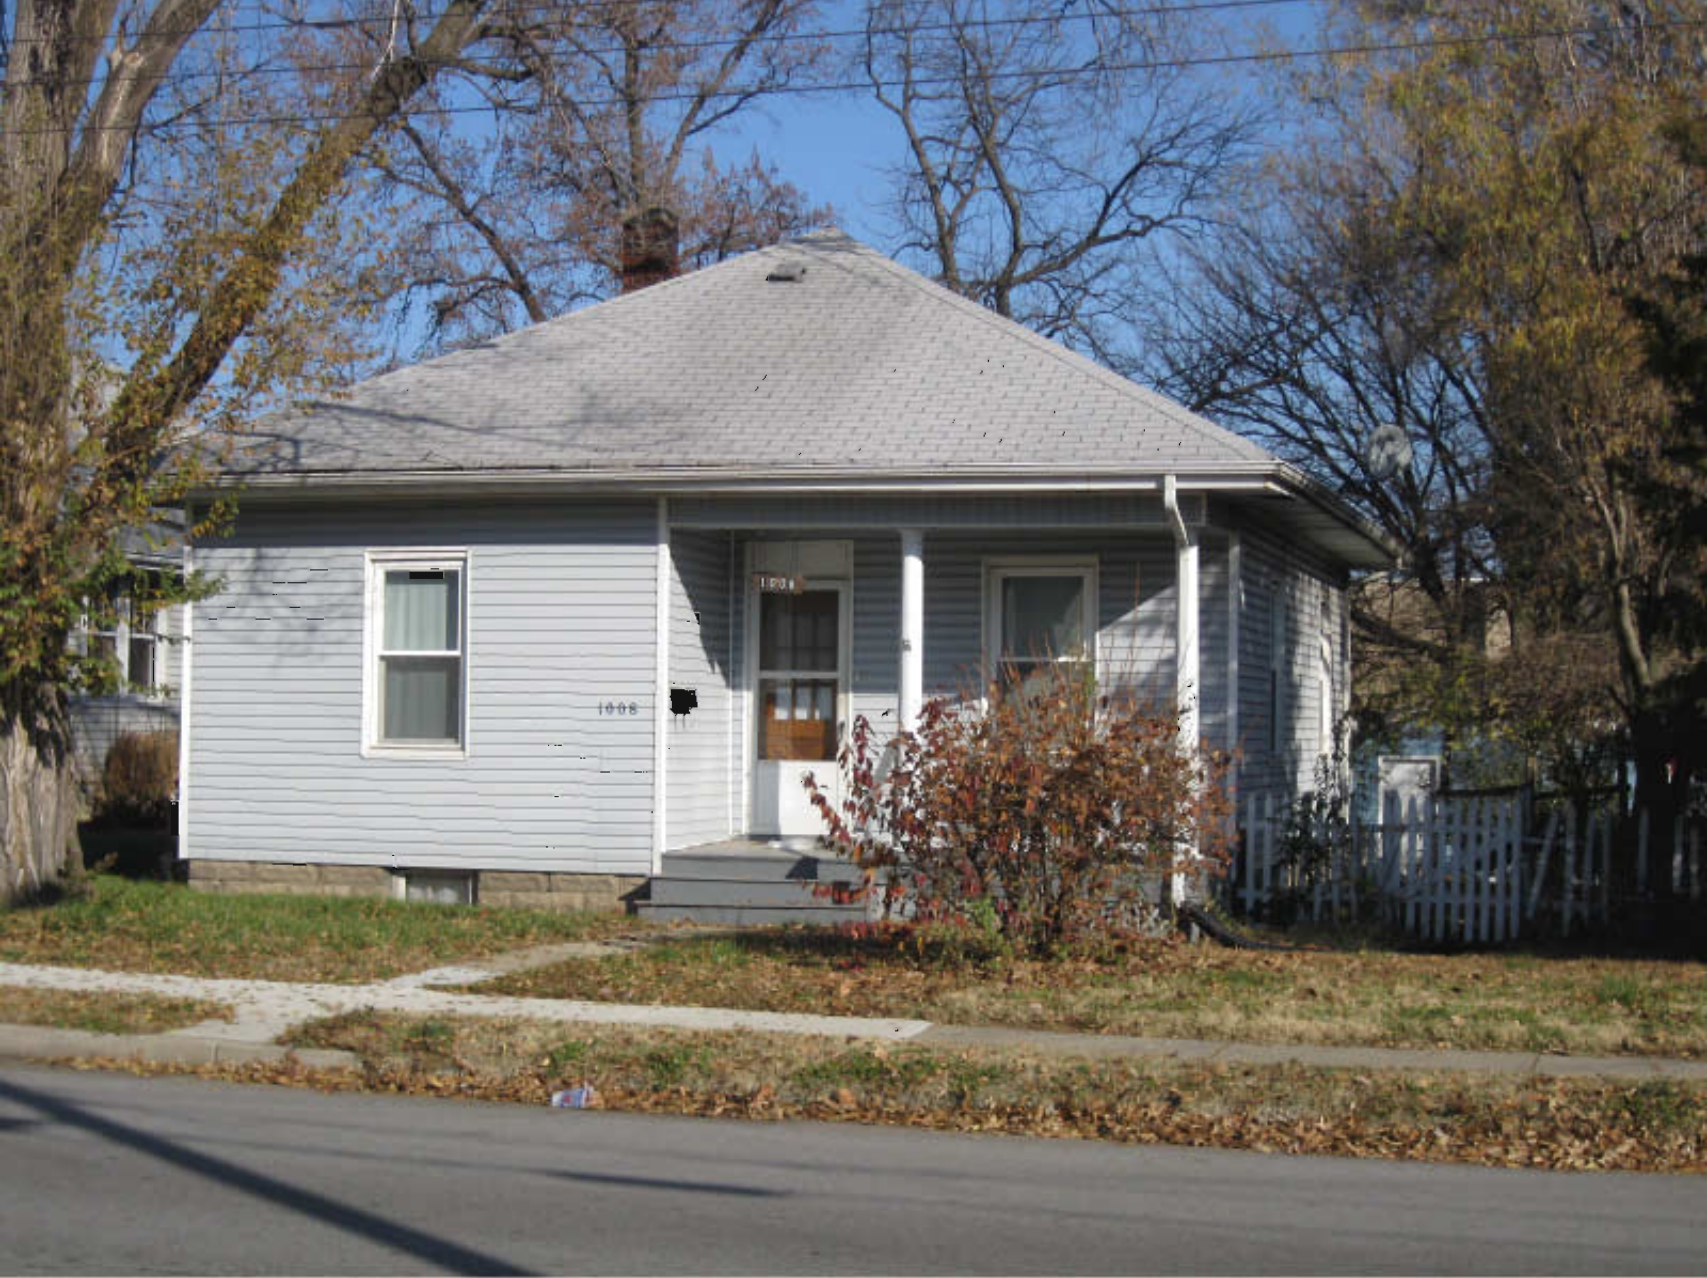
Nearly identical to the neighboring house at 1002 Monroe Street, this one-story, frame house is crowned by a pyramidal roof having wide overhanging eaves, and the west slope is pierced by an interior brick chimney. The rusticated concrete block foundation is pierced by single-light basement windows and the walls are finished with vinyl siding. The house's most distinguishing feature is its two-bay recessed porch at the southeast corner. It has a wooden deck and stairway, Tuscan columns, and a plain wood balustrade. The recessed porch gives the three-bay main façade an L-shape, and there is a 1/1 window in the western bay and the entrance and another 1/1 window in the recessed eastern two bays. The half-glazed wood door has nine lights and the transom has been enclosed. The windows appear to be replacement sash. The east elevation has two 1/1 windows and the west elevation has three. The house is noncontributing due to the installation of vinyl siding and replacement of the windows.

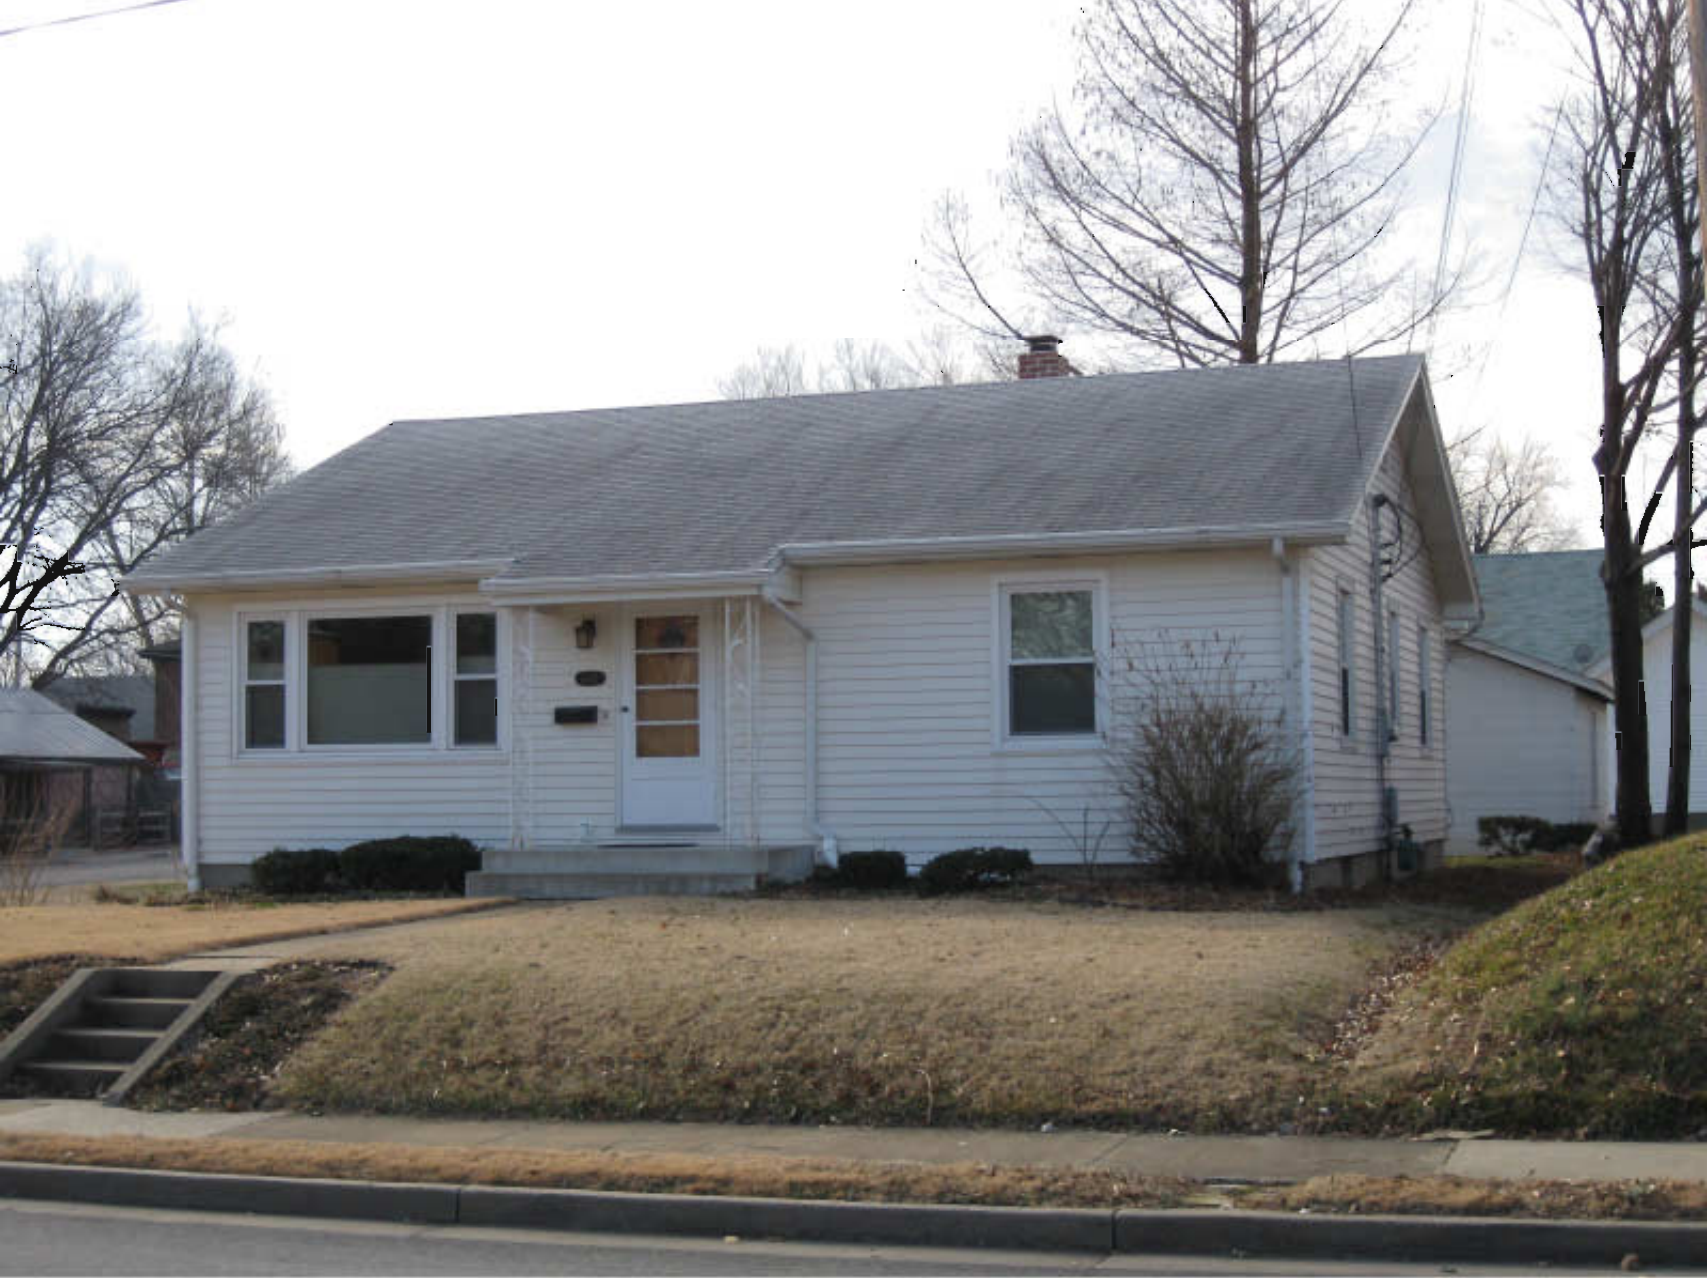
Built in 1954, this one-story, side-gabled, frame, Ranch style house rests on a concrete foundation and the walls have been clad in vinyl siding. An interior brick chimney pierces the rear slope of the low gabled roof. The three-bay main façade features, from east to west, a tripartite window composed of a large fixed window flanked by 1/1 windows, an un-paneled wood door with diamond-shaped light (and wood storm door with four horizontal lights), and a 1/1 window. The door opens onto a one-bay portico with concrete step and deck and wrought iron posts supporting the shed roof. The windows appear to be replacements. Each side elevation has three 1/1 windows. The house is noncontributing due to the installation of vinyl siding and replacement of the windows.

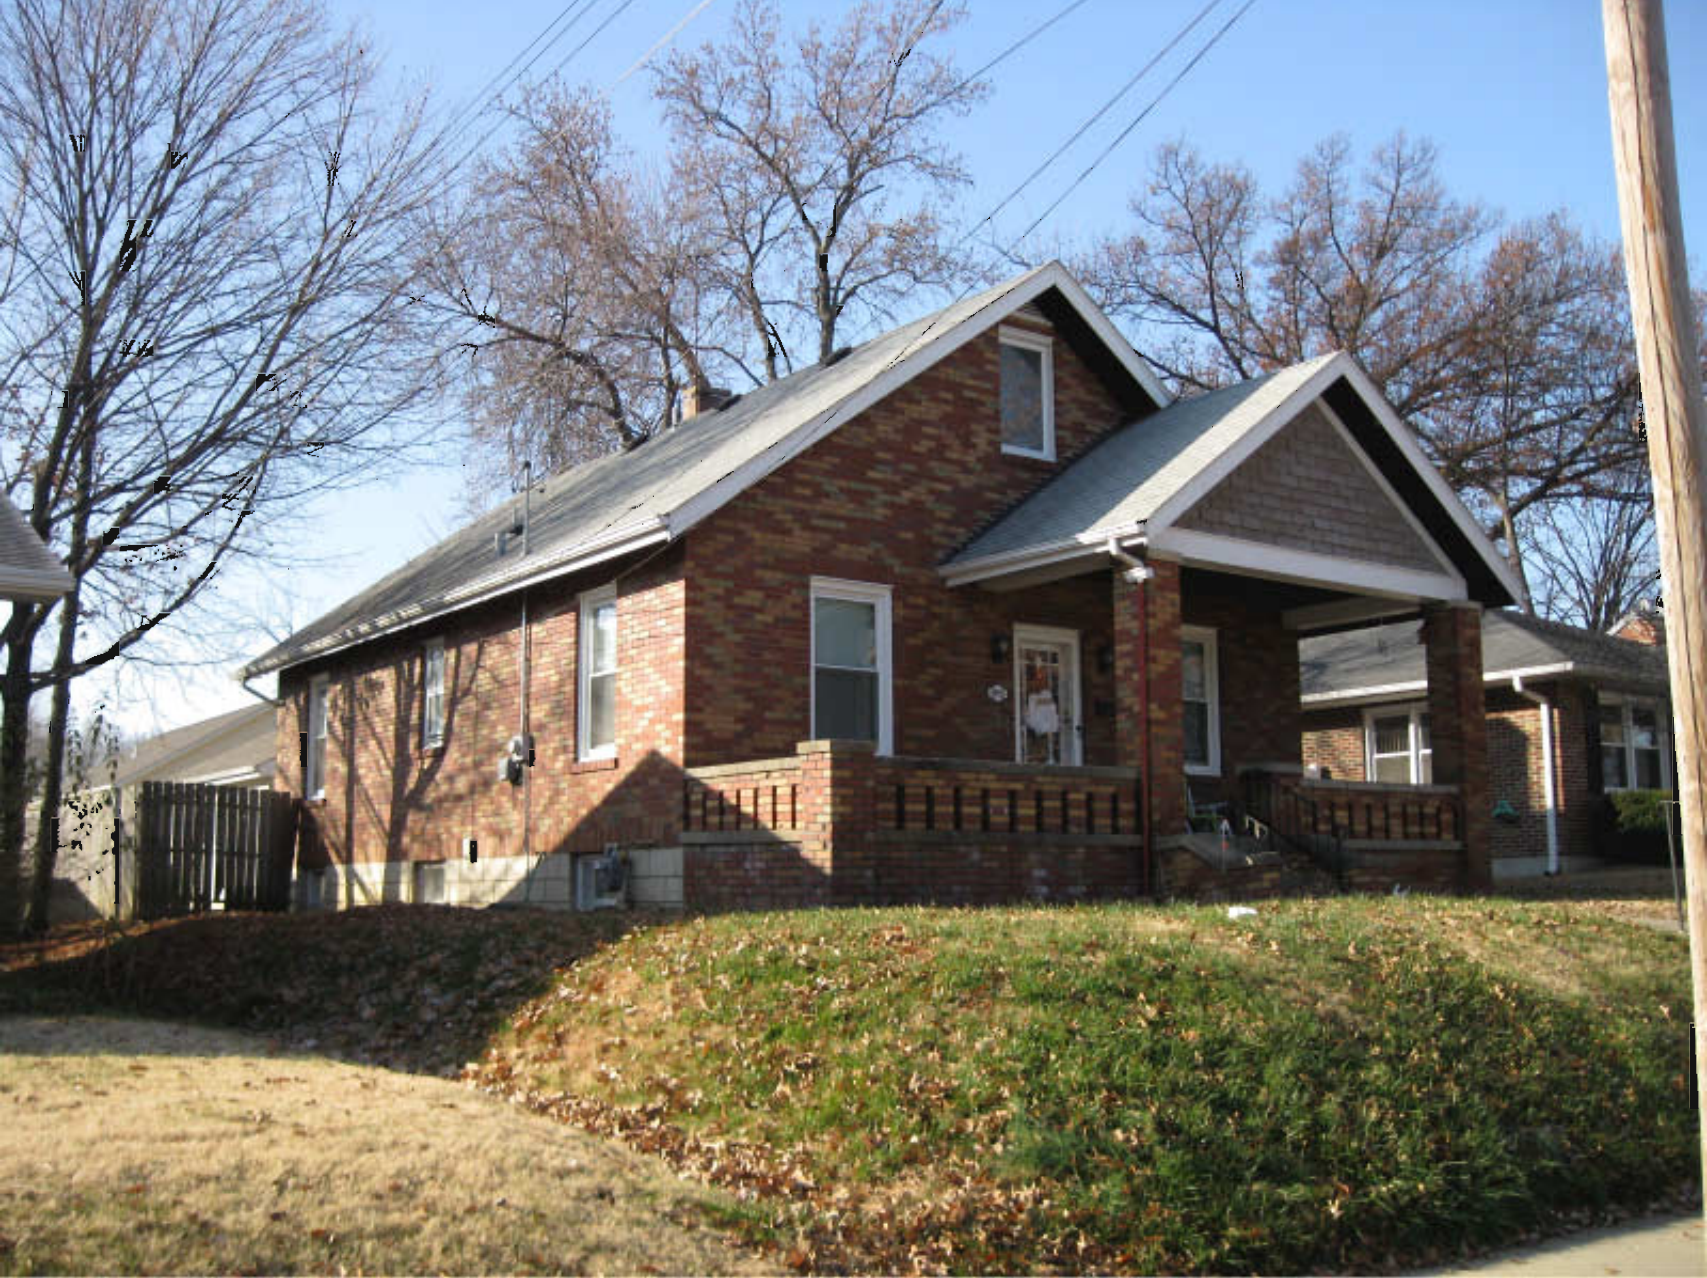
Facing north, this one-and-one-half story, front-gabled, brick bungalow rests on a scored concrete foundation pierced by glass block basement windows. The variegated brick is laid in a running bond pattern, but the first course above the foundation is a soldier course of Roman bricks. The gable roof has wide overhanging eaves and the west slope is pierced by an interior brick chimney. The three-bay main façade has a central glazed wood door (the muntins are arranged around the perimeter of the glass) flanked by 1/1 windows that appear to be replacements. The openings have brick sills and jack arches. The western two bays are protected by a gabled portico with concrete stairway flanked by brick knee walls, concrete deck, and brick piers supporting the gable roof. The porch deck extends the full width of the house, creating a terrace at the easternmost bay, and both the terrace and porch have pierced brick railings with concrete copings. The gable end of the porch is clad with asphalt shingles, and in the upper half story of the house is a single-light window. According to the City's address files, the attic was converted to living space in 2002. The west elevation has two short art glass windows at the north end and two pairs of 1/1 windows, with the pair nearer the rear of the house being shorter. Three 1/1 windows are on the east elevation, but the center one is shorter.

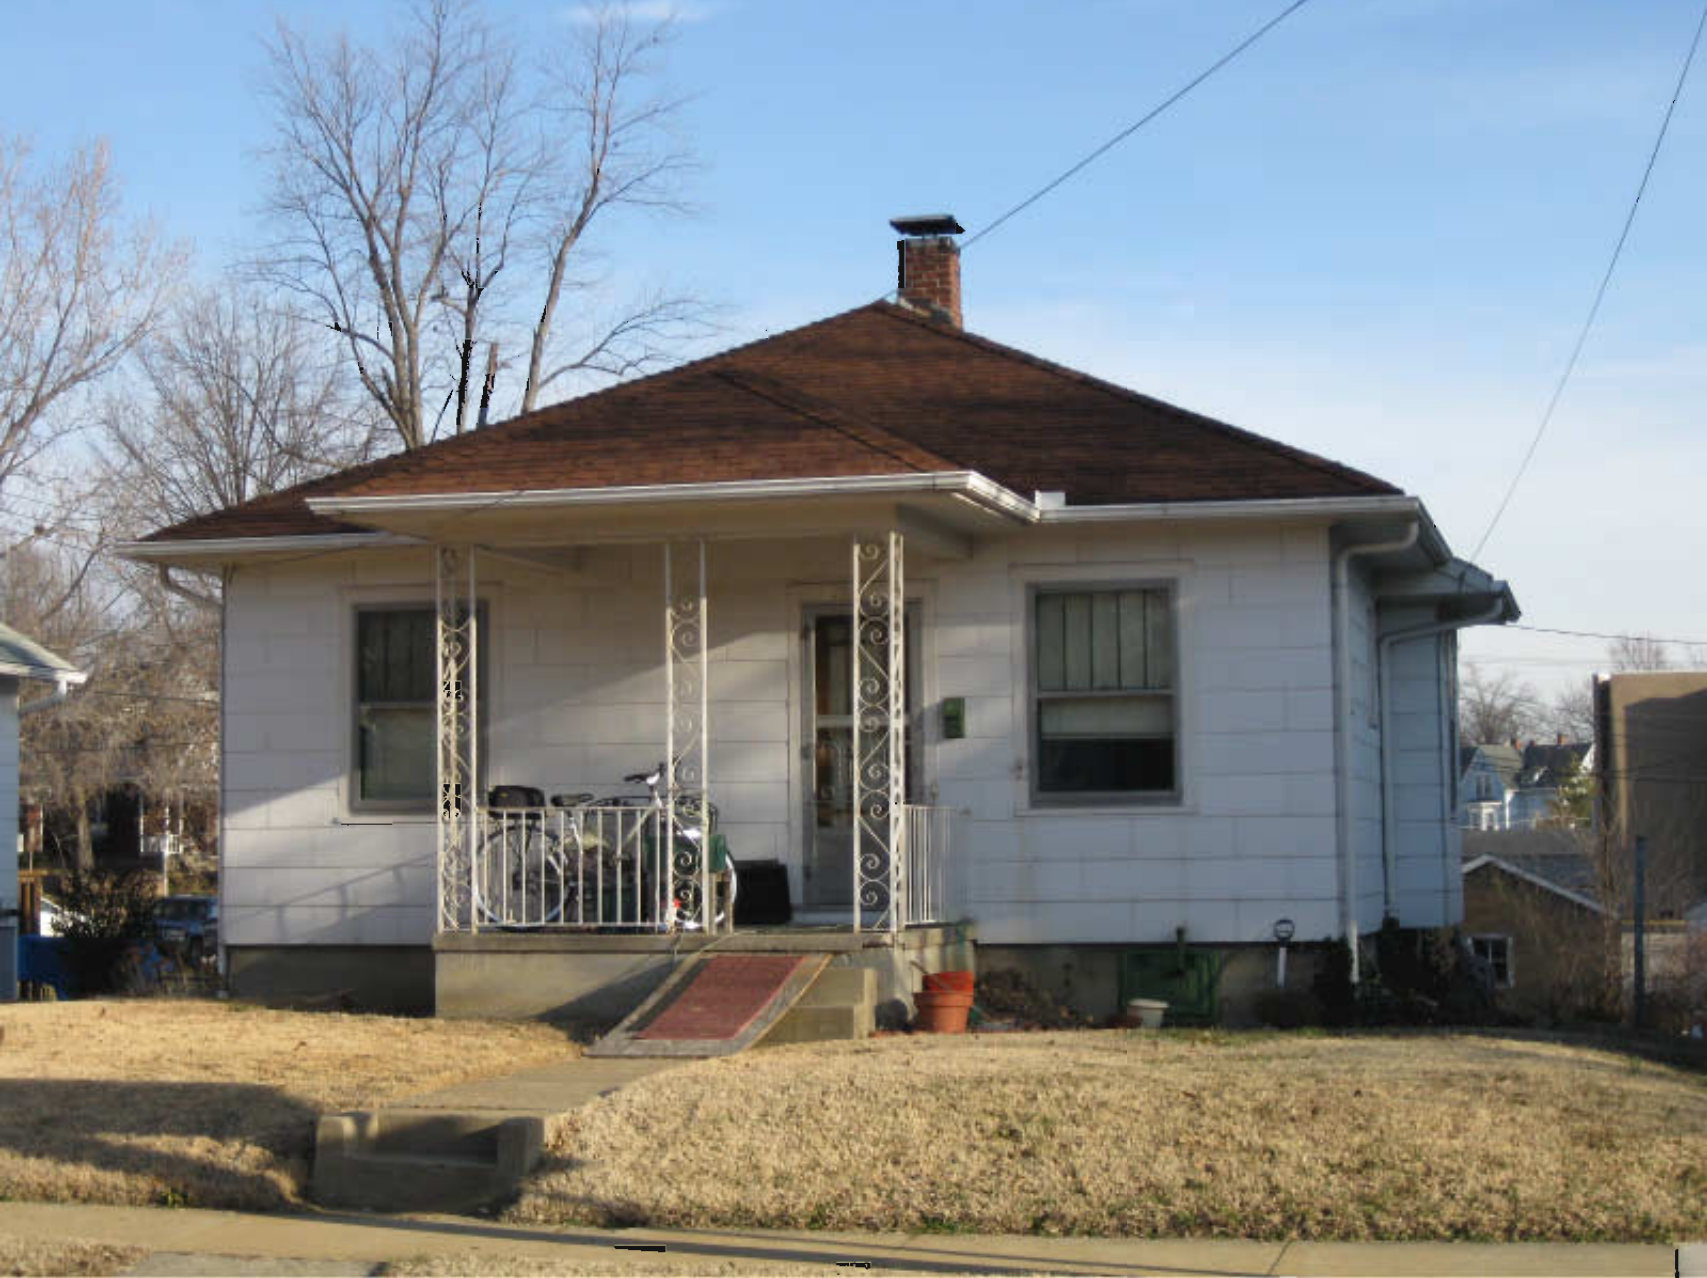
Situated on a slightly elevated lot, this one-story, frame house rests on a concrete foundation and the walls are finished with cement asbestos shingles that were probably added in the late 1940s or 1950s. The structure is crowned by a pyramidal roof with wide overhanging eaves, and the east slope is pierced by an interior brick chimney. The main façade has three bays, and in the center bay is a glazed wood door with muntins arranged near the perimeter of the glass. The door opens onto a one-bay portico featuring a concrete deck and stairway, plain iron railing, and wrought iron posts supporting a hip roof. To each side of the entrance is a 5/1 wood window. The west elevation features three 4/1 wood windows. The south end of the east elevation has two small art glass casement windows, and to the north is a hanging box bay with a window.

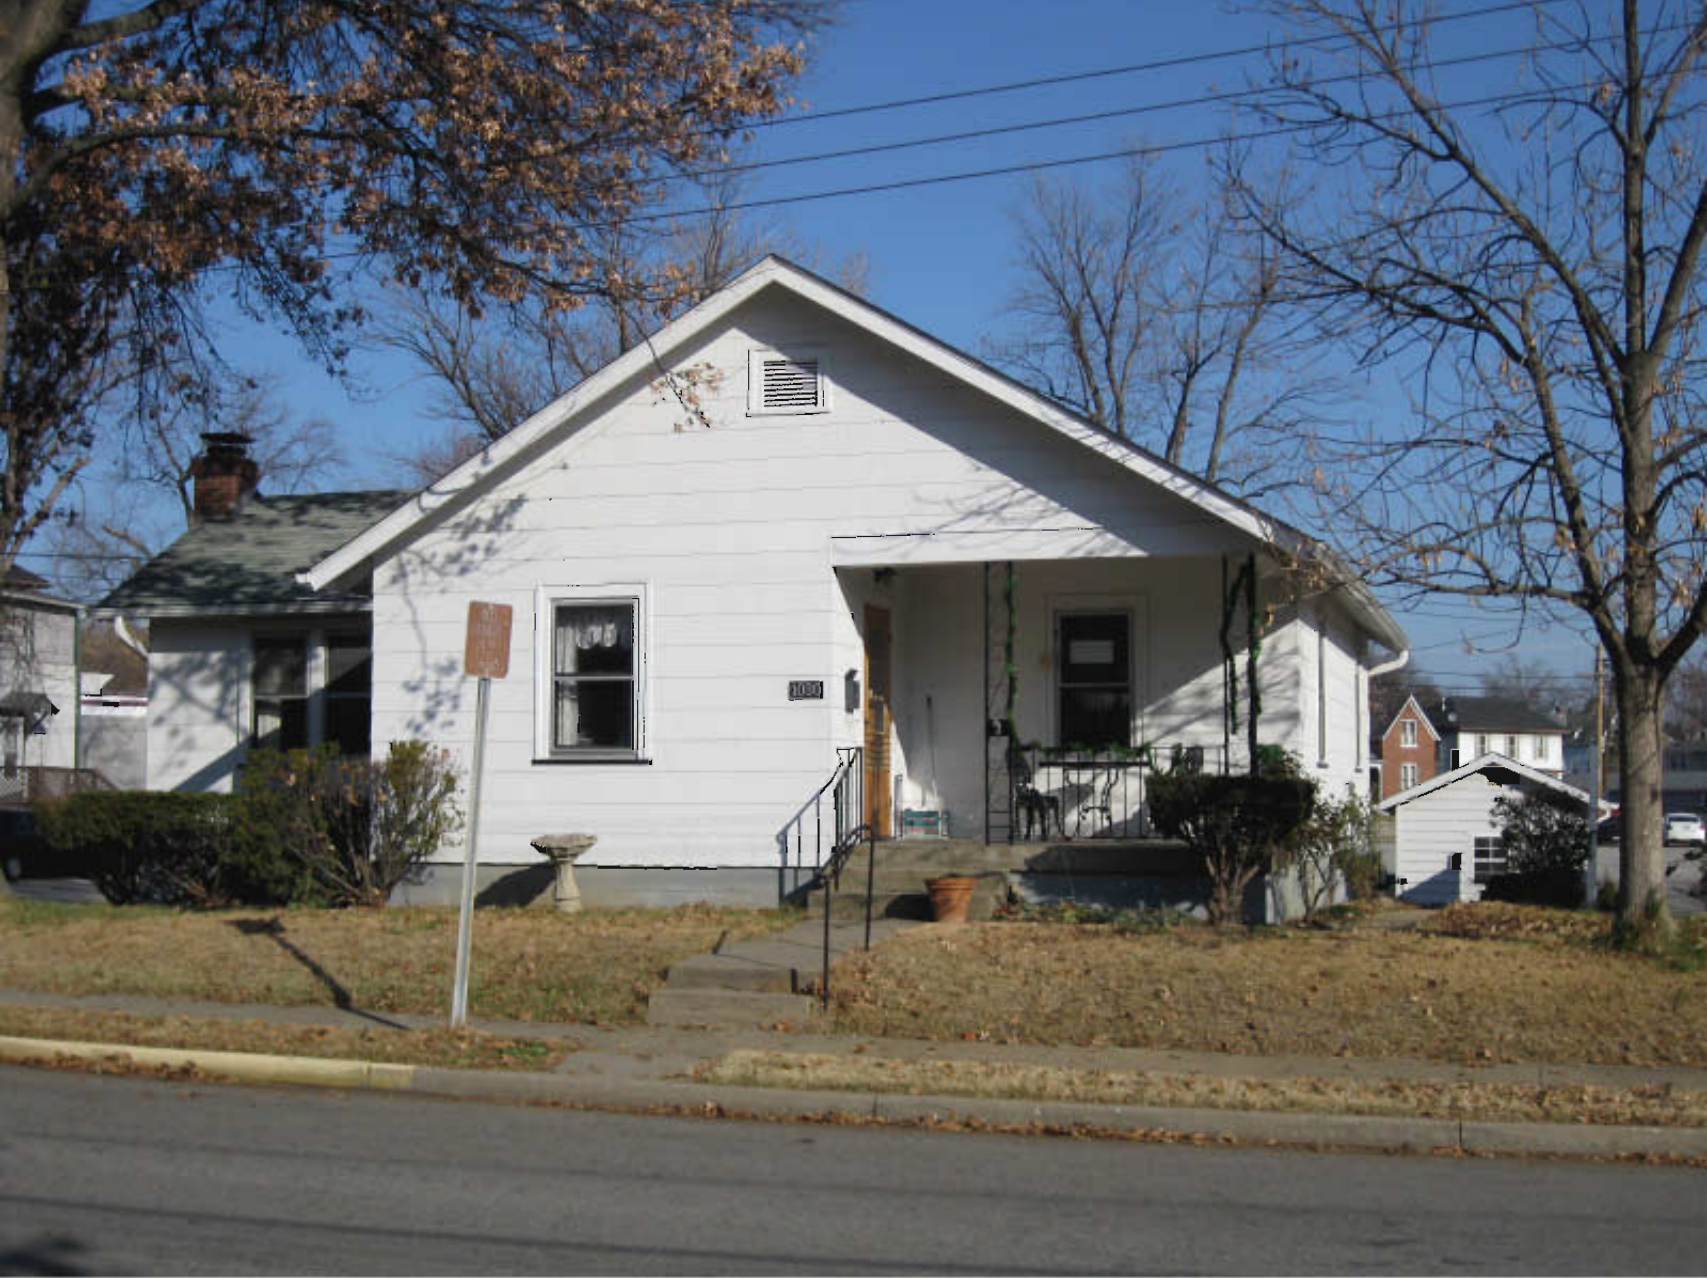
This house is a one-story, front-gabled, frame structure, and sometime after 1947 a side-gabled wing was added to the west elevation. The foundation is concrete and the walls are finished with cement asbestos shingles. The front-gabled roof has wide overhanging eaves and an interior brick chimney on the west slope, and the side-gabled addition has an exterior end chimney on the west elevation. A character-defining feature of the house is the one-bay recessed porch at the southeast corner. It has a concrete stair and deck, plain iron railing, and wrought iron posts. A photograph in the address file of the St. Charles County Historical Society showed the house historically had a battered box column. The two-bay main façade has two 1/1 windows, with the one in the east bay overlooking the recessed porch. The entrance, which is located on the east wall of the recessed porch, is a 1/3-glazed, paneled wood door with wood storm door having four horizontal lights over a single panel. The east elevation has two 1/1 windows while the west elevation has one. The side-gabled addition has a pair of 1/1 windows on the south elevation and no openings on the west.

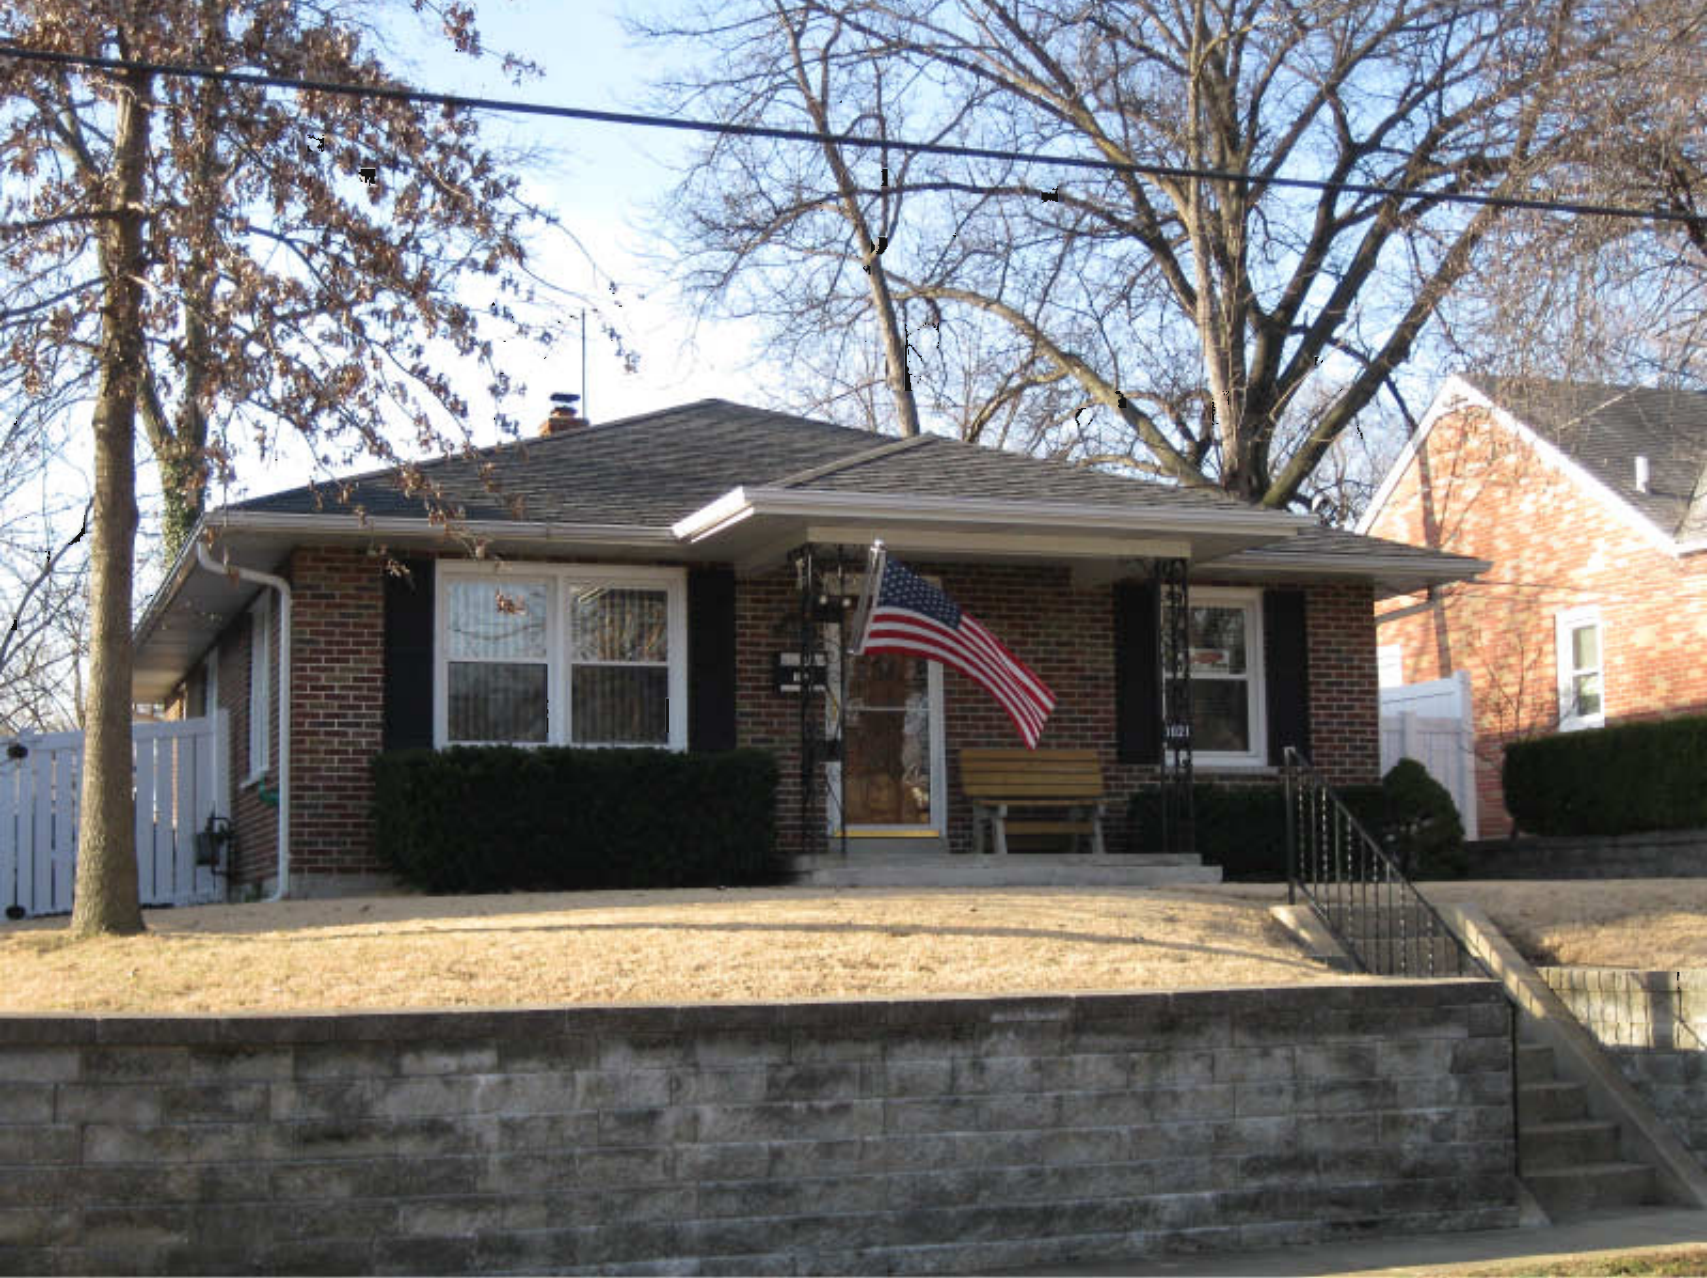
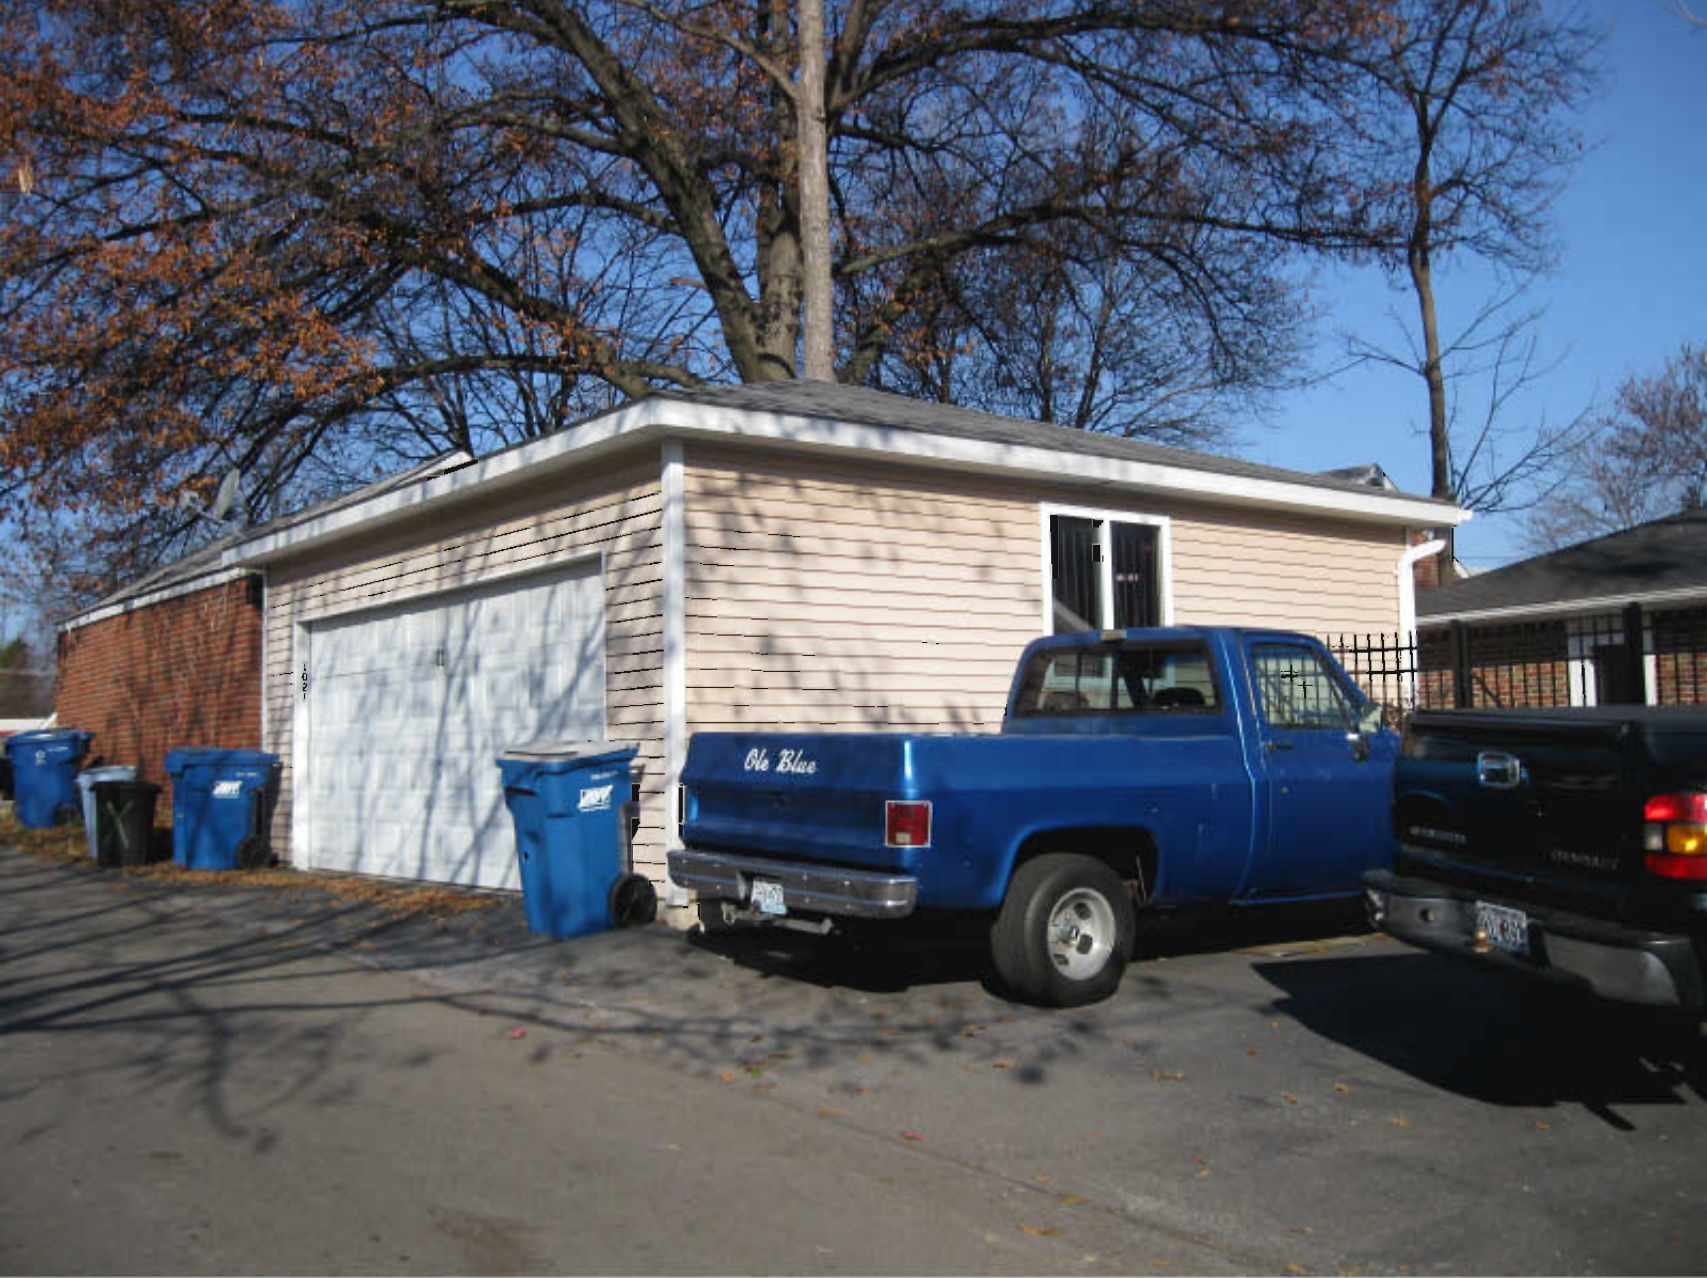
Located on an elevated lot, this one-story, brick house has a concrete foundation and pyramidal roof with wide overhanging eaves. An interior brick chimney pierces the east slope of the roof. In the center bay of the three-bay main façade is a multi-panel wood door with four small lights in one of the panels, and the door opens onto a one-bay portico with concrete deck and wrought iron railings supporting a hip roof. To the east of the entrance is a pair of 1/1 windows while to the west is a single 1/1 window. The windows have cast stone lug sills and vinyl louvered shutters. On the east elevation are two pairs of windows and a single window. A privacy fence obscures the view of the west elevation.

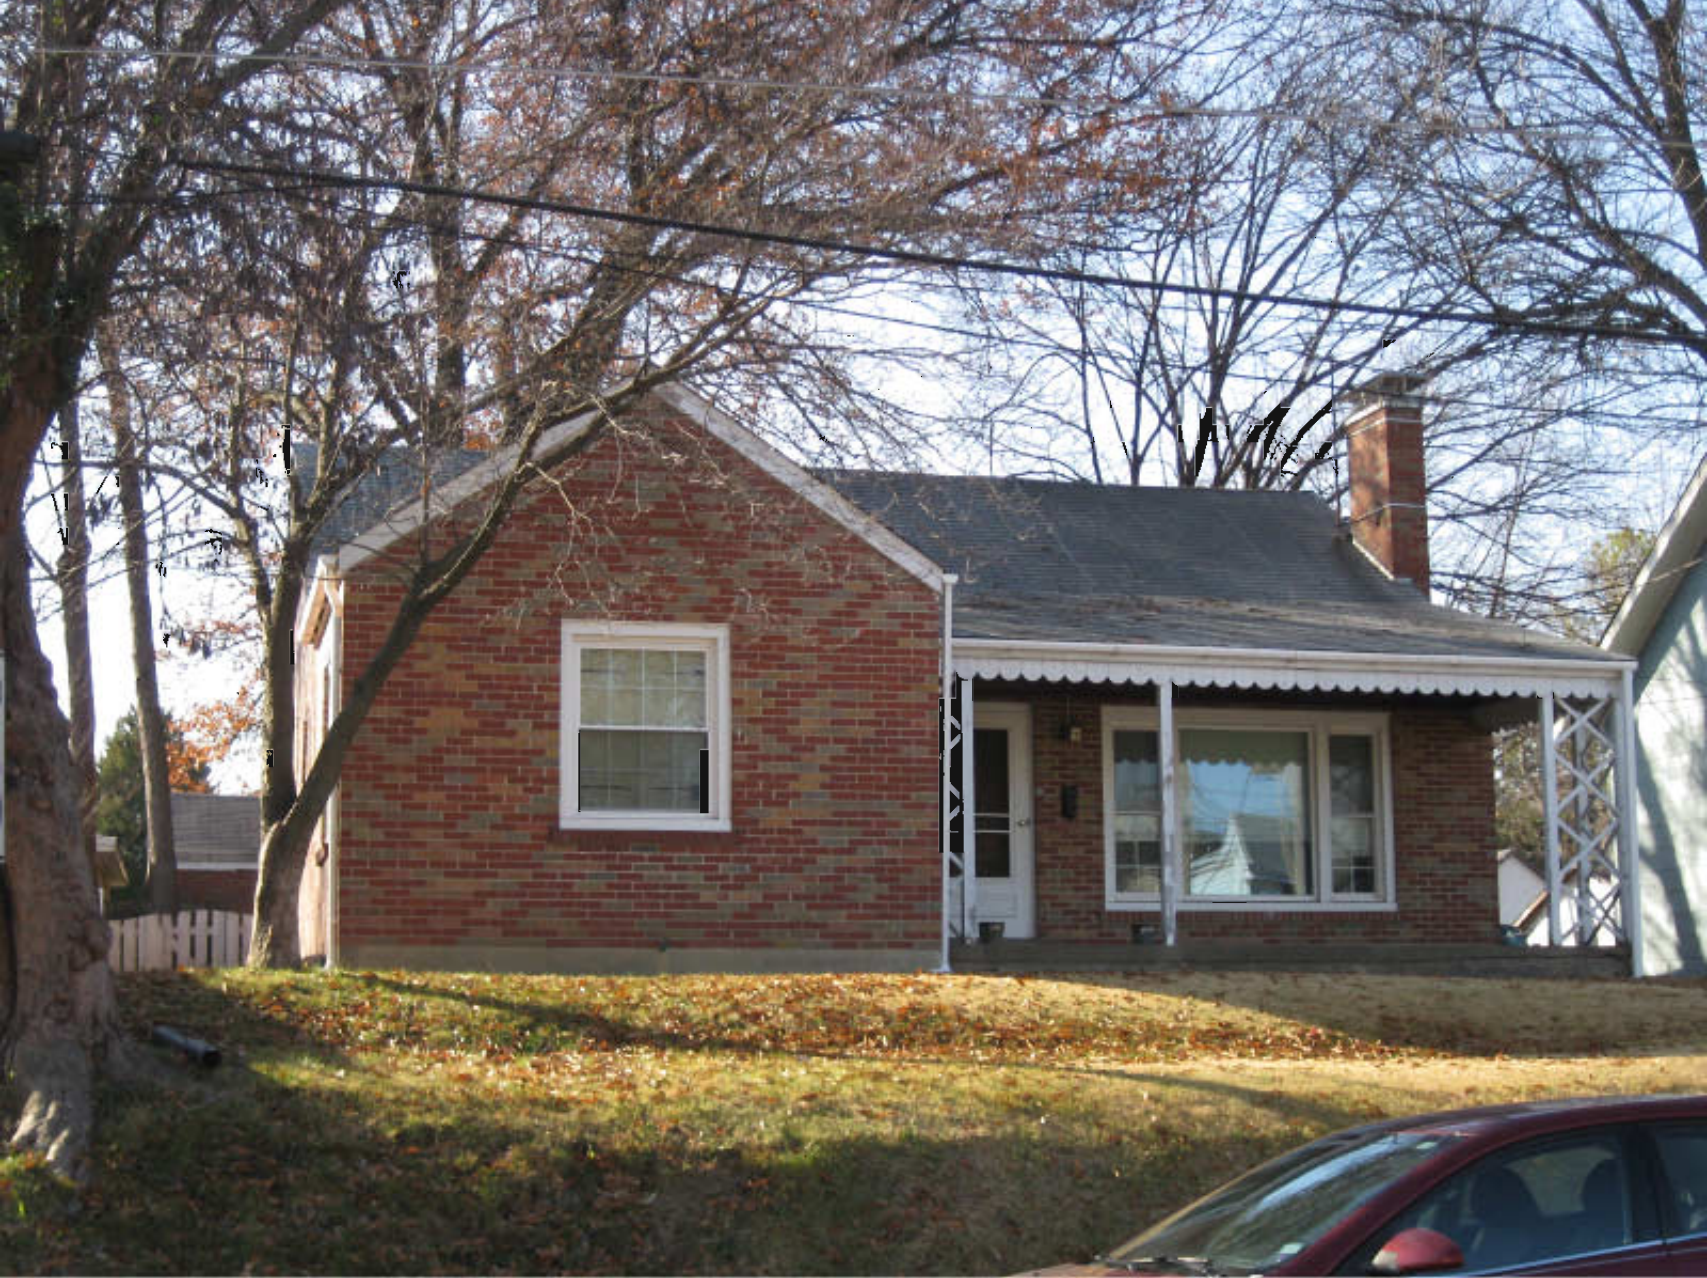
Built circa 1950, this one-story, brick house has a concrete foundation and the walls are finished with variegated bricks laid in a running bond pattern. The house is L-shaped, with a side-gabled roof intersected by a front-gabled wing that extends from the east end of the façade. The three-bay main façade has an 8/8 vinyl window in the east end, and to the west is a 6-panel wood door and a tripartite window composed of a central single-light picture window flanked by 4/4 windows. Windows throughout the house are replacement sash, and they have brick sills. A gallery spans the western two bays and features a concrete deck, plain posts that are in-filled with cross pieces, and a scalloped wood frieze. The west elevation has an exterior end brick chimney on the north end and two 6/6 windows, while the east elevation has three 6/6 windows.

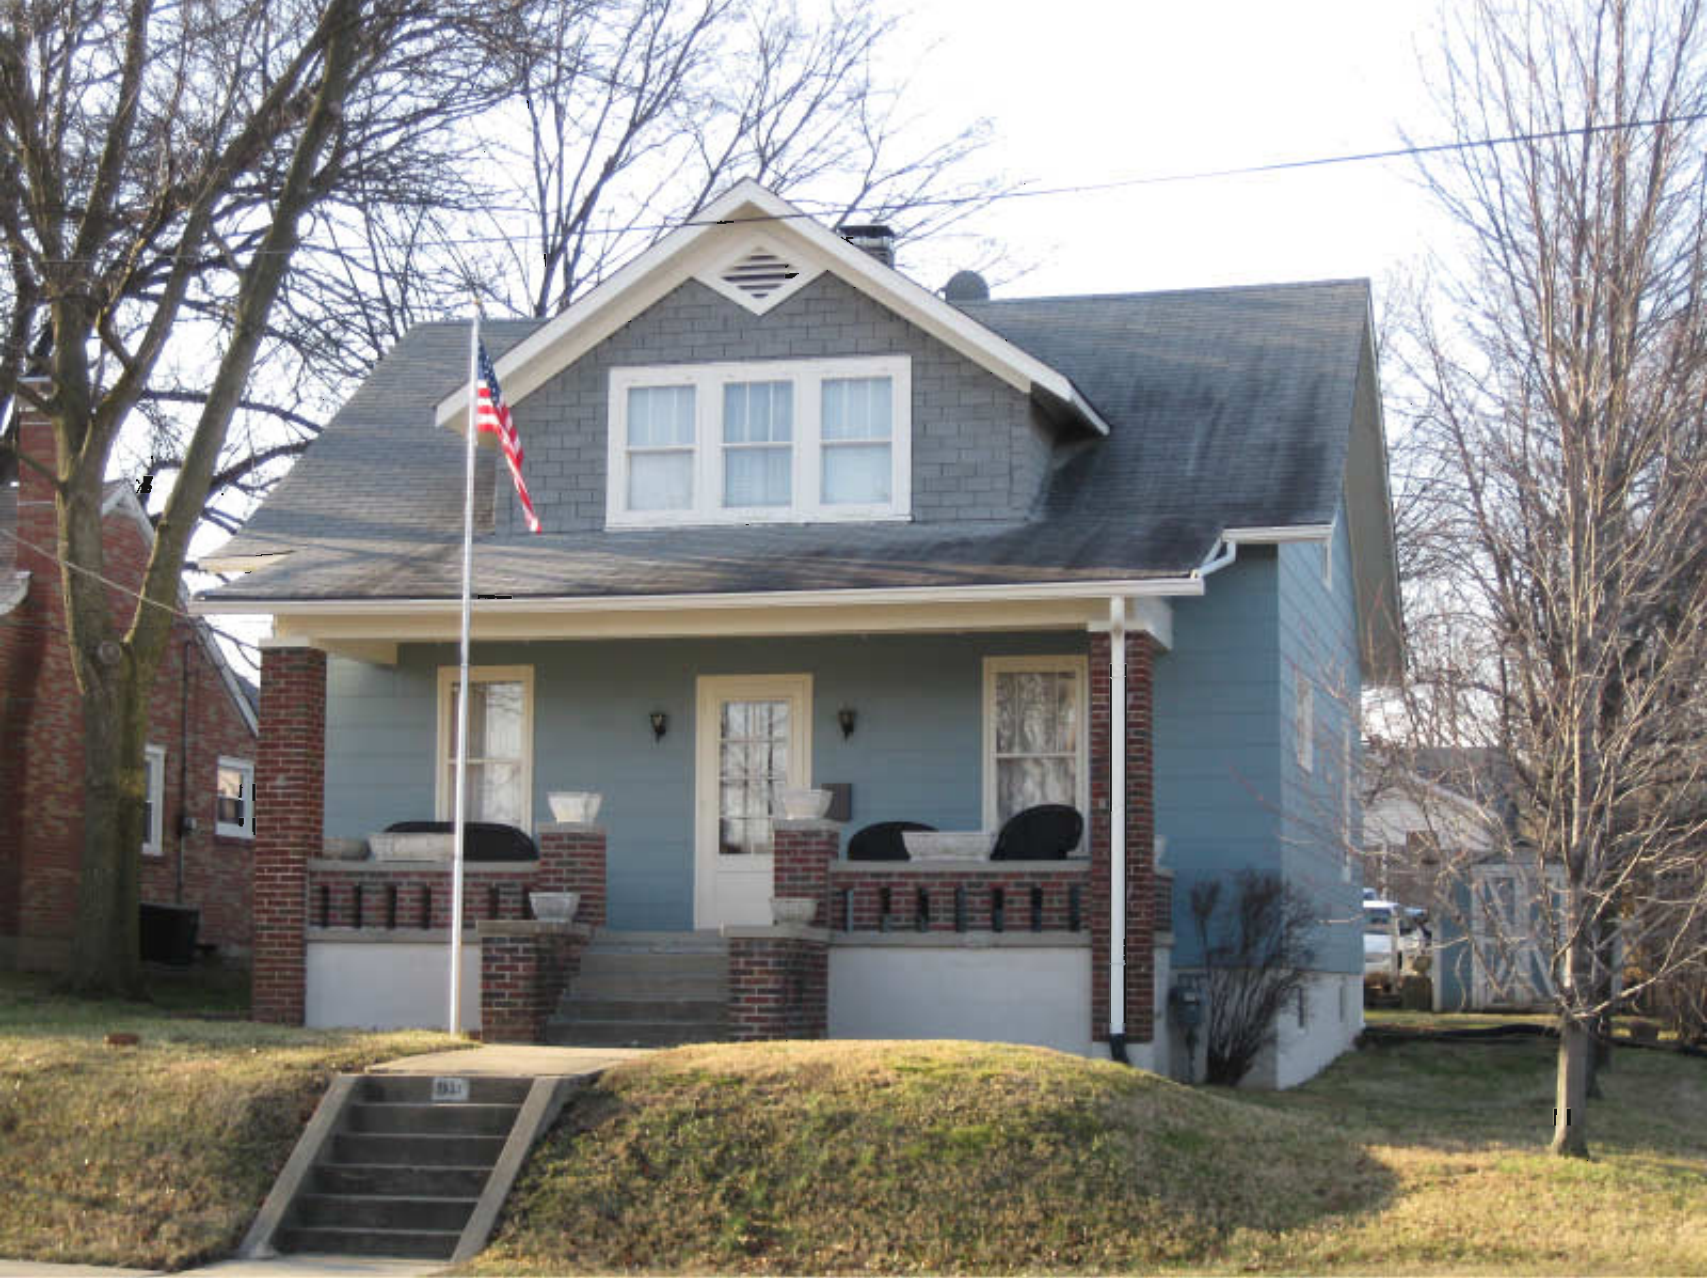
Built in 1927, this bungalow is a one-and-one-half story, side-gabled, frame structure that rests on a concrete foundation pierced by three-light wood basement windows. The walls are finished with cement asbestos shingles and the roof has wide overhanging eaves. An interior brick chimney is on the rear slope of the roof while on the front slope is a large gabled dormer with a group of three 3/1 wood windows and walls finished with asphalt roofing shingles. Above the windows is a diamond-shaped ventilator. The three-bay main façade features a central glazed wood door with three vertical lights, and to each side of the door is a 4/1 wood window. Spanning the three openings is a ¾-width gallery that has brick piers supporting a shed roof. A concrete stairway flanked by brick knee walls with concrete copings provides access to the gallery, and at the top of the stairway are two brick pedestals. The piers and pedestals extend to the ground, but the remainder of the foundation is concrete. A pierced brick balustrade encloses the gallery. The west elevation has a transom-type art glass window at the north end and a 4/1 wood window, and the upper half story also has a 4/1 window. The east elevation has a 4/1 window and pair of short windows on the first floor and a 4/1 window in the upper half story.
