ARCHITECTURAL/HISTORIC INVENTORY FORM

1. Survey No. SC-AS-009-001		2. Survey Name: St. Charles Survey Phase 3: Mid-Town and Commons Neighborhoods	
3. County: St. Charles		4. Address (Street No.) 128	Street (name) North Sixth Street
5. City: St. Charles	Vicinity: <input type="checkbox"/>	6. UTM:	
7. Township/Range/Section:		8. Historic name (if known): Meyer-Pieper House; The Meyerdorf	
9. Present/other name (if known):		10. Ownership: <input checked="" type="checkbox"/> Private <input type="checkbox"/> Public	
11a. Historic use (if known): Domestic/single dwelling		11b. Current use: Domestic/single dwelling

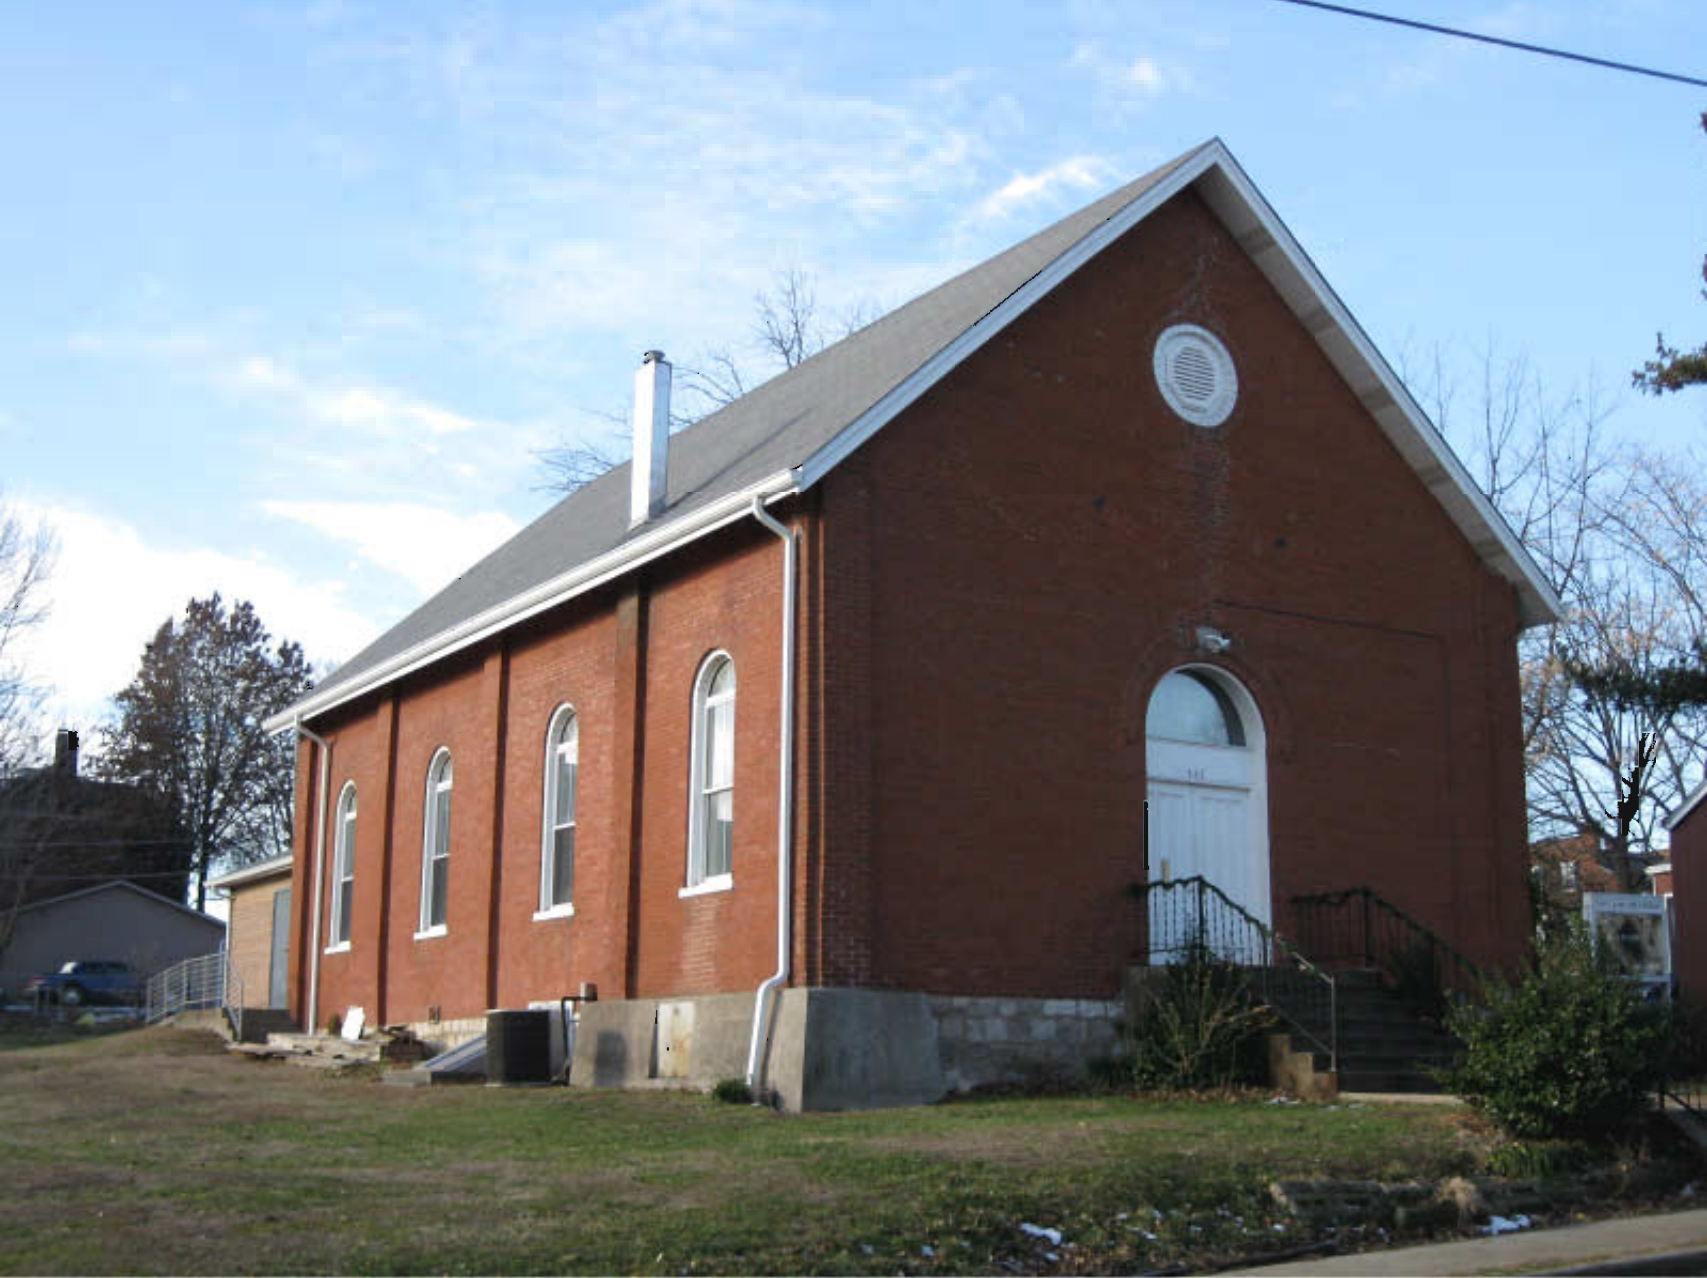
Built in 1872, St. John's AME Church is a brick, 1x4 bay building that rests on a coursed rock-faced stone foundation and is crowned by a high front-gabled roof. The doors and windows, which are set within round-arched openings, were replaced in the 1990s. The main façade features a pair of wood doors with three vertical panels, and above the doors is a stained glass fanlight topped by a brick hood mold. A historic photograph shows that the original doors had two panels, with the upper panel being arched, and the fanlight was in a rosette pattern. According to Warlene Reed, a church member, the fanlight was replaced around 2000. In the gable end is an octagonal ventilator set within a round opening, and this opening originally held a rosette window. The side elevations have four bays delineated by brick piers, and each bay holds a 2/2 window topped by a 4-light fanlight. The original windows were round-arched. A small brick, gabled addition is at the southeast corner of the building. It was constructed in 1979.

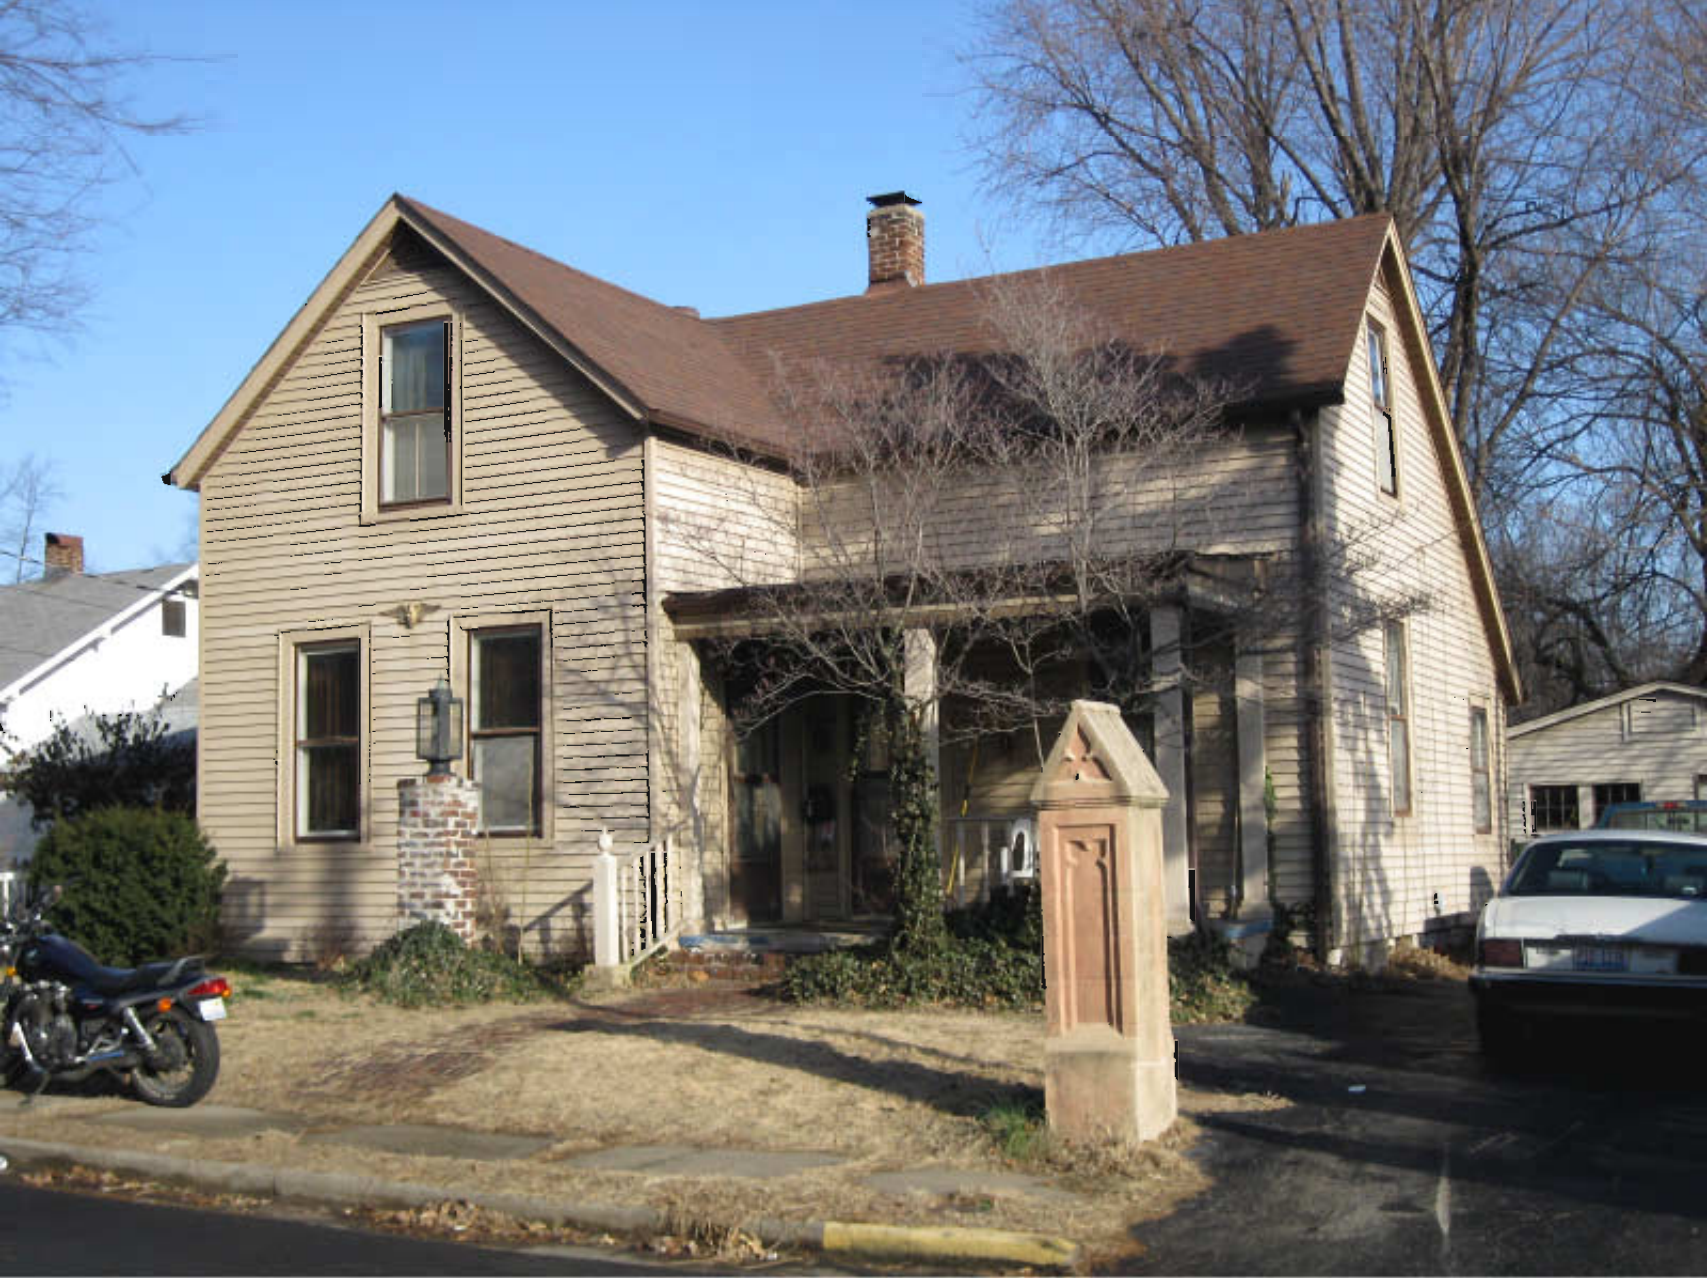
This one-and-one-half story, frame, gable-front-and-wing form structure has a coursed, rock-faced stone foundation and the walls have been clad with vinyl siding. A brick chimney straddles the ridge of the side-gabled portion of the roof. The house was originally T-shaped, but between 1917 and 1929 an addition was made to the northeast corner, giving the house its present L-shape. The first floor of the four-bay main façade has two 1/1 wood windows in the western two bays, which are in the front-gabled wing, and a half-glazed, paneled wood door and 1/1 window in the side-gabled wing. The door opens onto a two-bay gallery that spans the side-gabled wing, and the gallery has brick steps, concrete deck, a balustrade with turned balusters, and box columns and pilasters supporting a low shed roof. Another half-glazed wood door opens onto the porch from the east wall of the front-gabled wing. In the upper half story is a 1/1 wood window. The east elevation has two windows on the first floor and one in the upper half story.

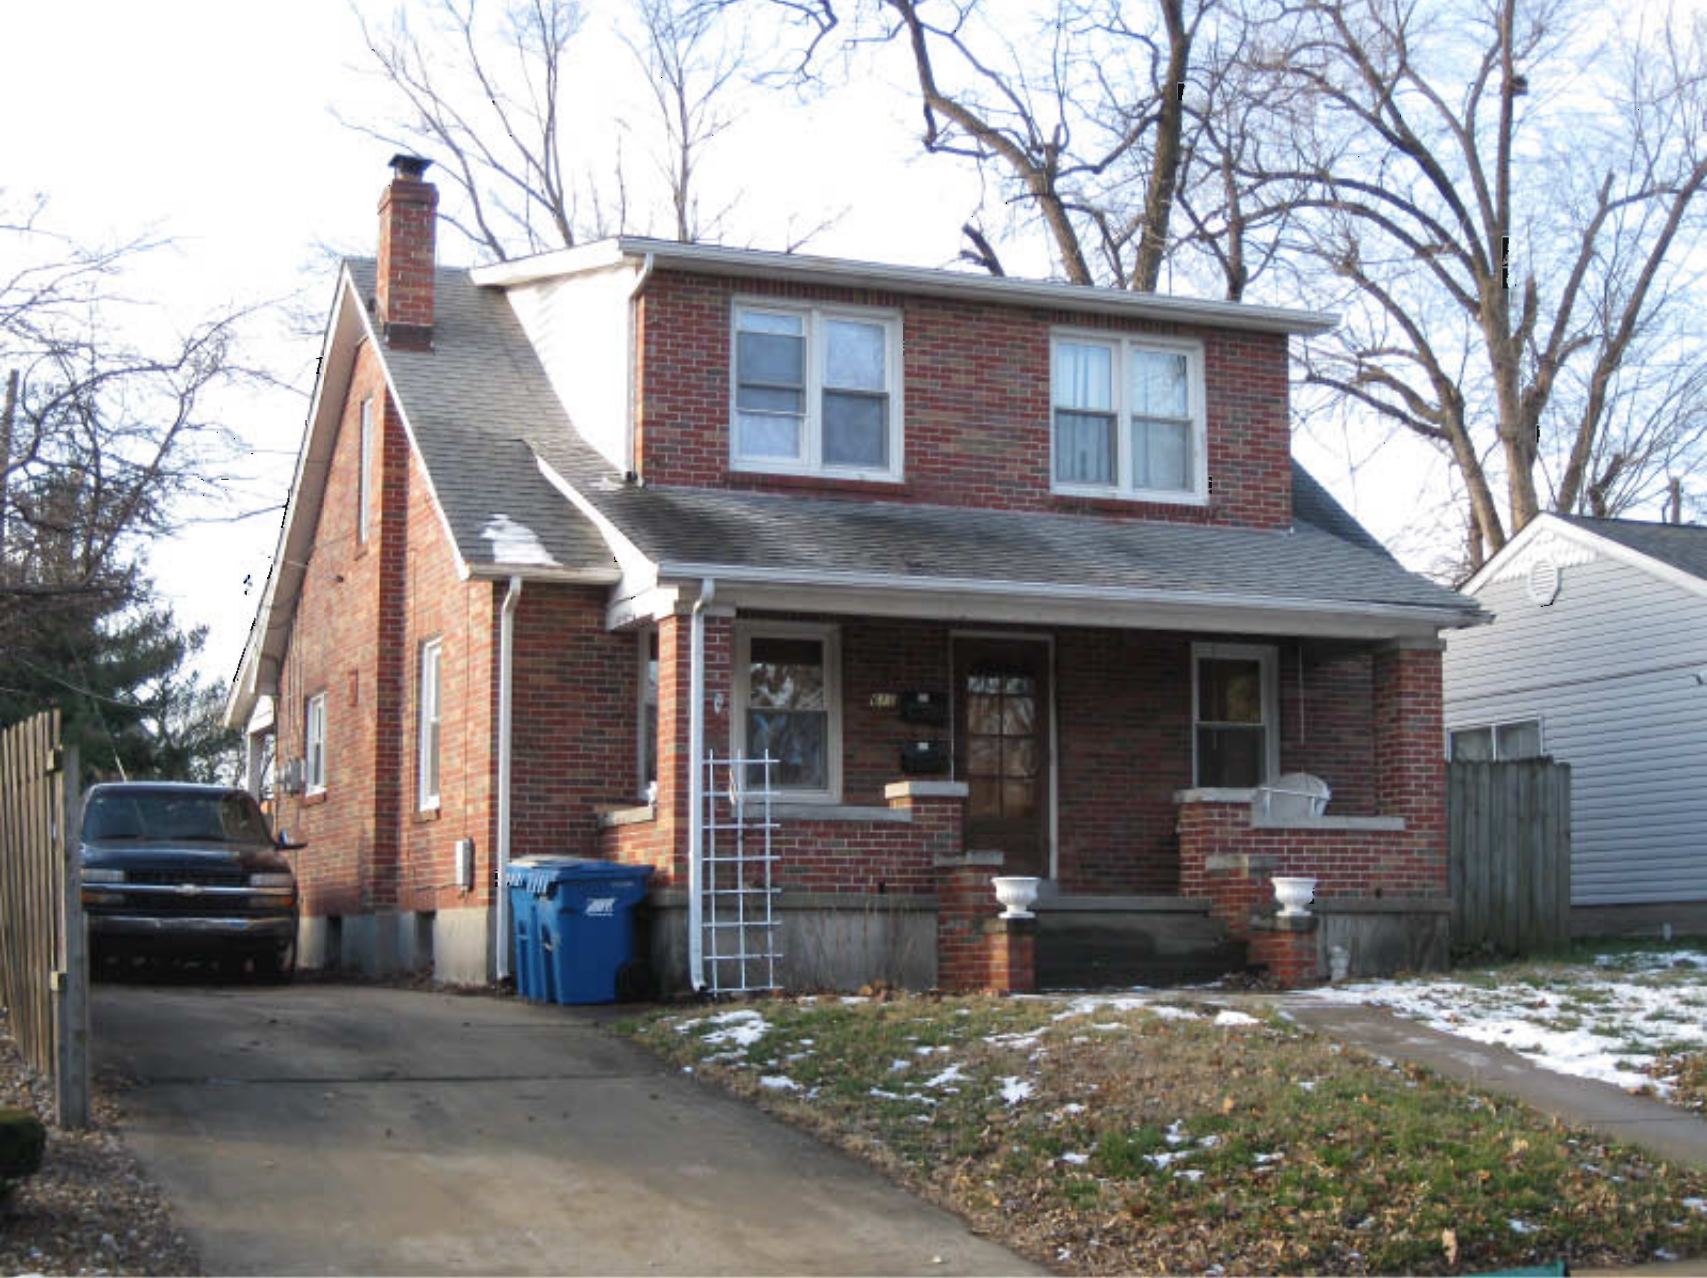
Facing north, this bungalow is a one-and-one-half story, brick building with concrete foundation and high side-gabled roof with wide overhanging eaves. A large shed-roof dormer rests on the front slope of the roof and features two pairs of 1/1 windows, a front wall clad with brick, and side walls finished with vinyl siding. An exterior end chimney with corbelled cap is on the east elevation. The house's variegated brick walls are laid in a running bond pattern, and a soldier course is directly above the foundation. The three-bay main façade has a central entrance that is a paneled-and-glazed door with an eight-light wood storm door. To the right of the entrance is a 1/1 window while to the left is a pair of 1/1 windows. Windows throughout the house appear to be replacements, and they have brick sills. The door opens onto a ¾-width gallery that has a concrete foundation and deck, concrete stairs flanked by stepped brick knee walls, and brick piers supporting a shed roof. At the top of the stairs are brick pedestals, and the porch railing is a brick knee wall with concrete coping. The west elevation has three 1/1 windows on the first floor and one in the upper half story, while the east elevation has a 1/1 window at the north end and a pair of short 1/1 windows at the south. Another 1/1 window is in the upper half story.

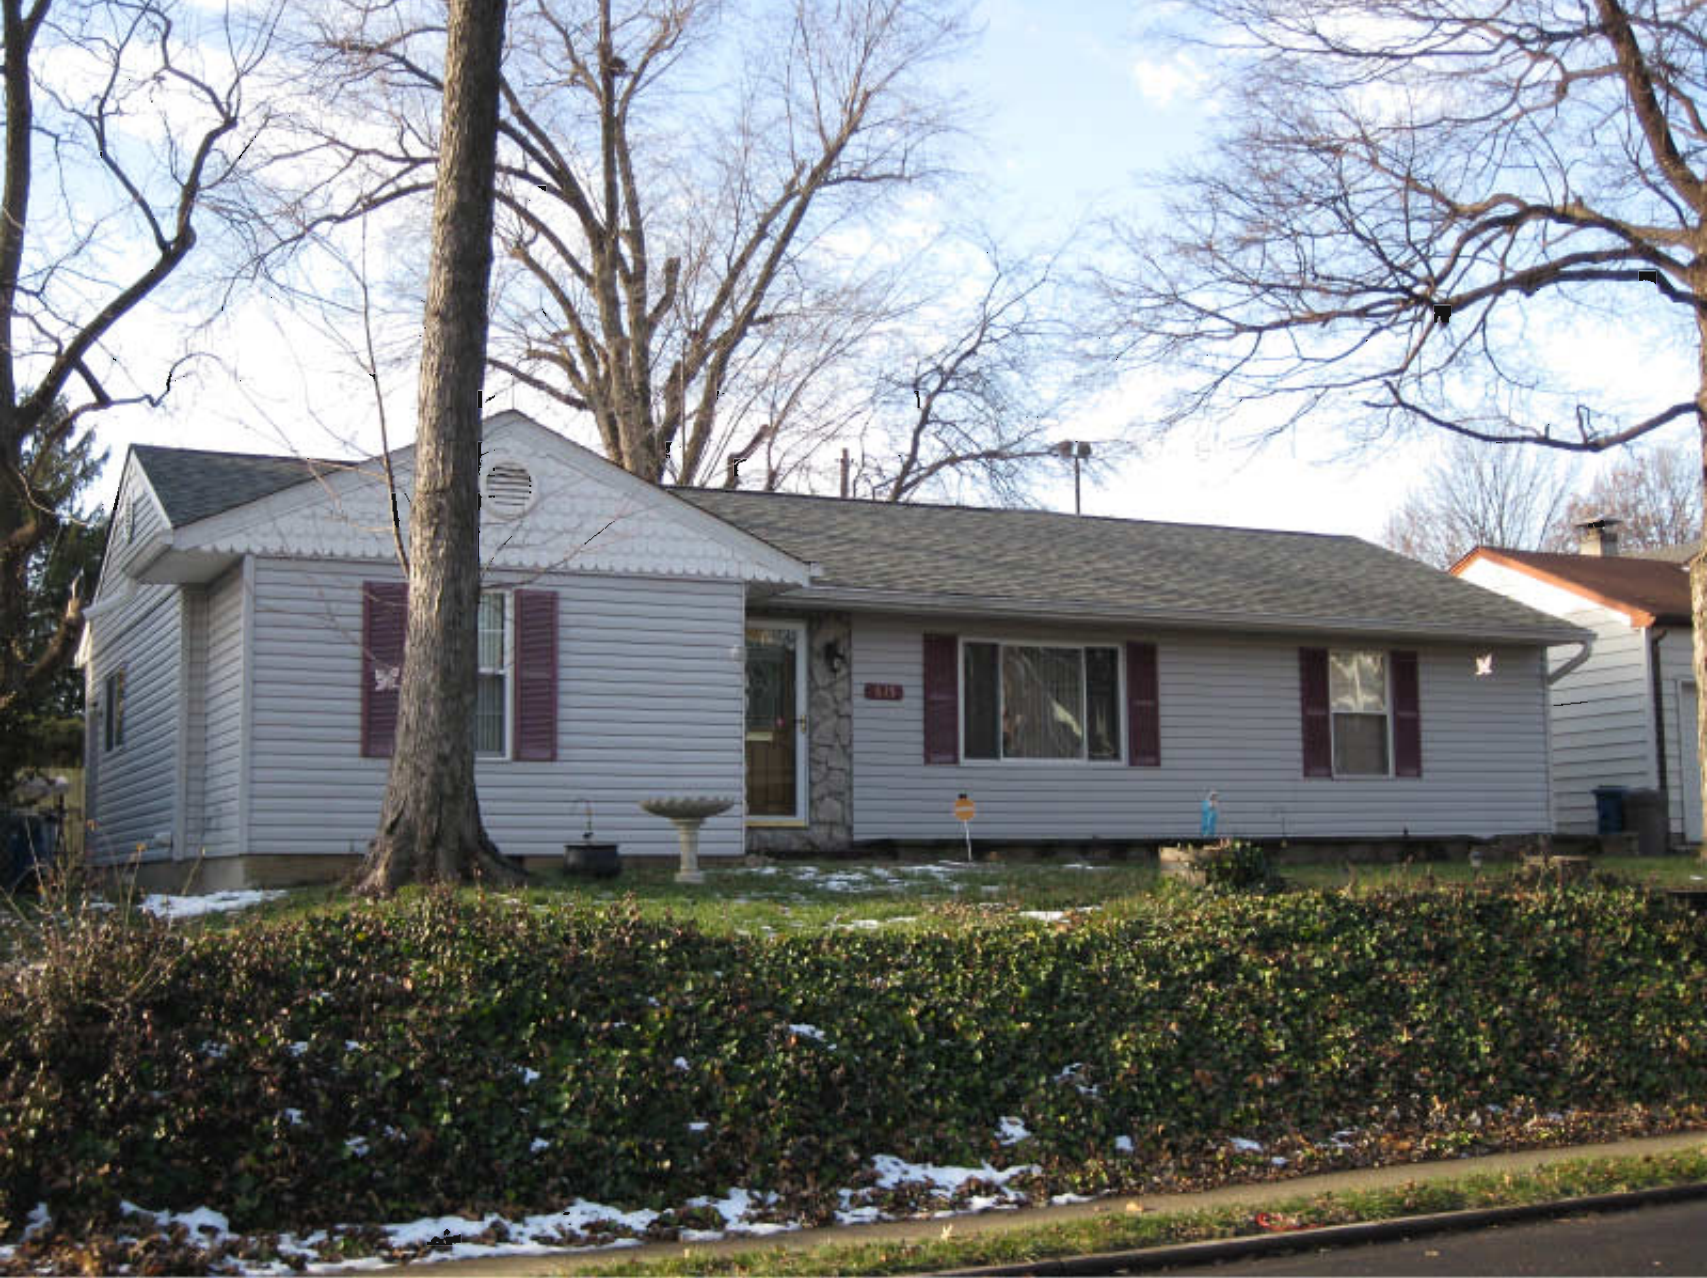
Situated on an elevated lot, this one-story, frame, Ranch style house has an irregular shape, with a side-gabled wing and a projecting front-gabled wing at the east end and a rear wing at the west end. The foundation is concrete and the walls are clad with Dutch lap vinyl siding, while the front gable end is finished with vinyl fish scale shingles. The area immediately around the entrance is clad with rubble stone. The main façade has four bays: in the front-gabled wing is a 6/6 window; to the west, in the side-gabled wing, is a half-glazed wood door with leaded glass light; a tripartite window with a wide, single-light fixed window flanked by narrow windows; and a 6/6 window. The windows are framed by vinyl louvered shutters. The door opens onto a one-bay concrete stoop. Although the house is more than 50 years old, it is noncontributing due to the installation of vinyl siding and shingles and replacement of the windows.

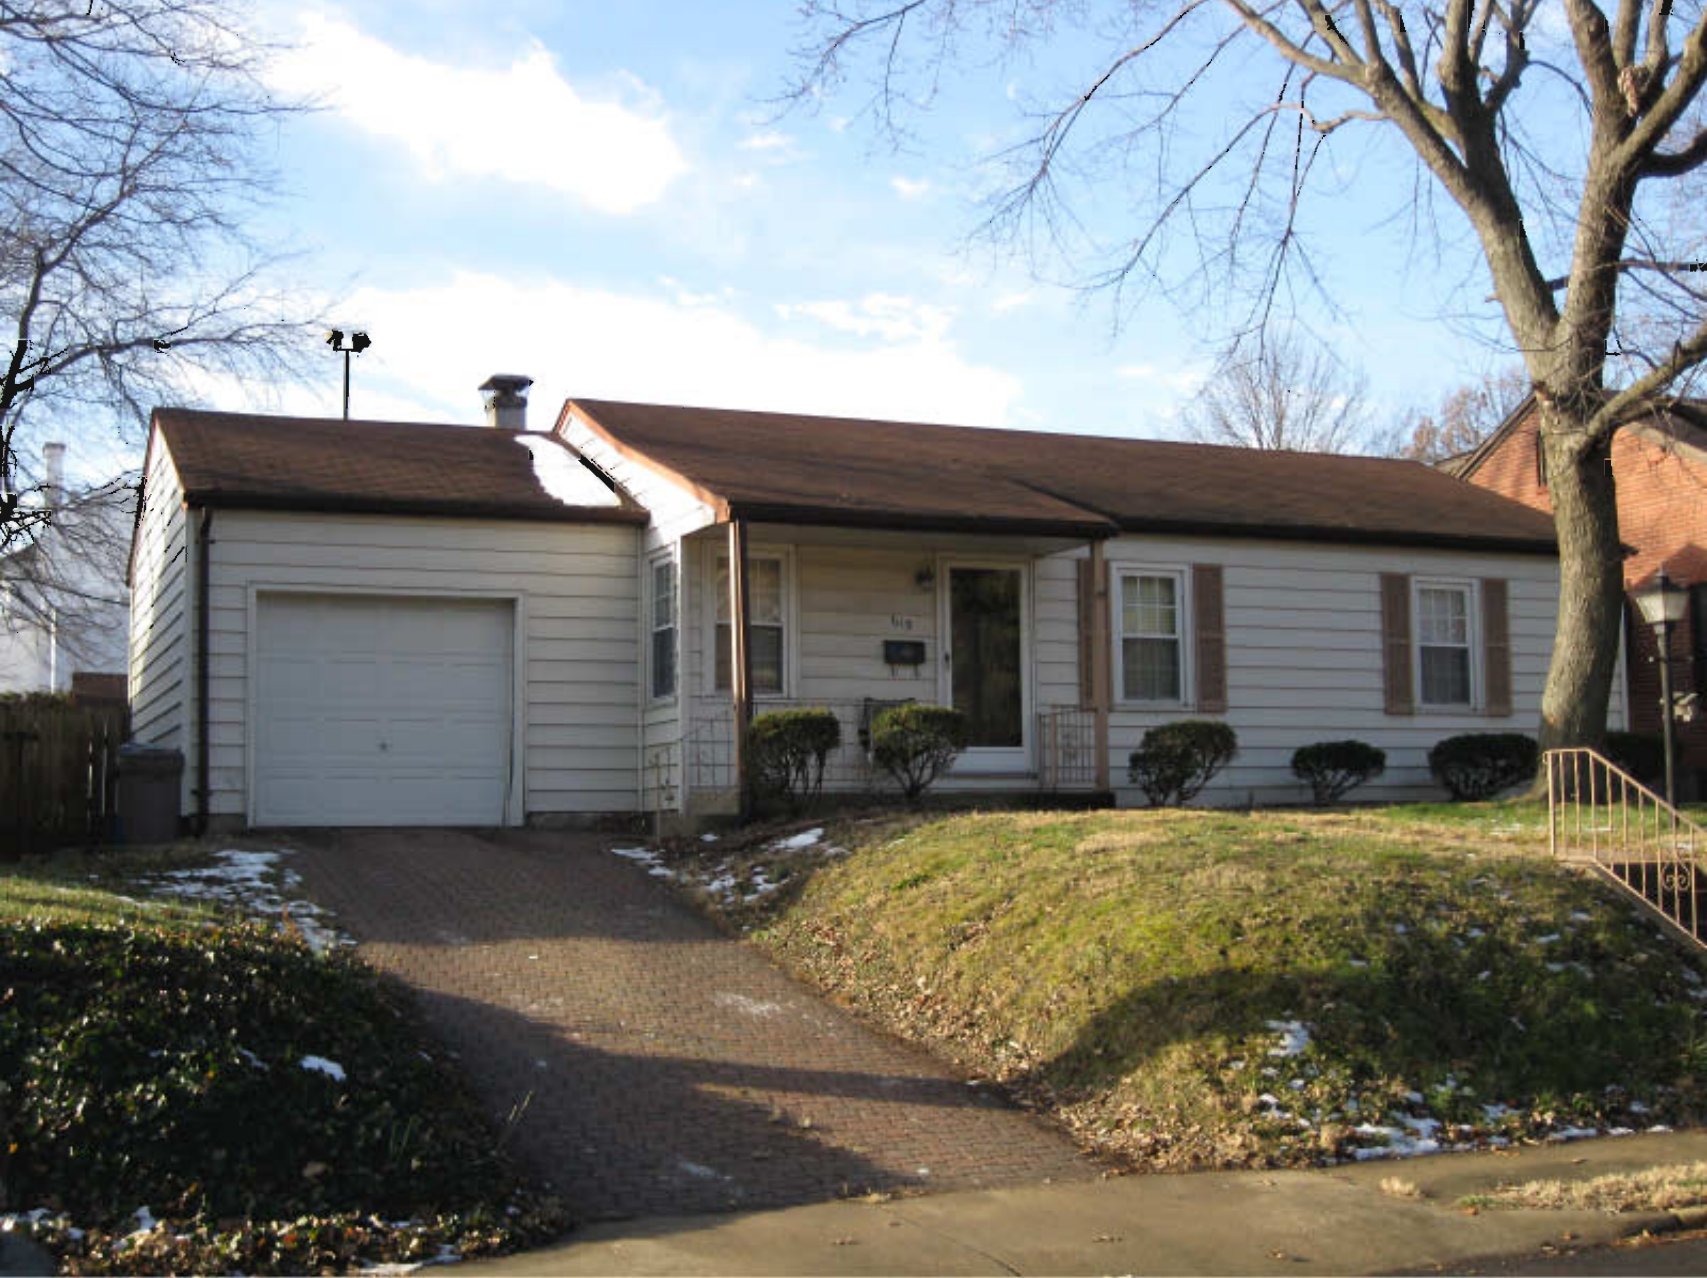
This one-story, frame, Ranch style house rests on a concrete foundation and has walls clad with vinyl siding. The rear slope of the low side-gabled roof is pierced by an interior chimney. The four-bay main façade has three 6/6 replacement windows, and in the second bay from the east is a paneled door that opens onto a shed-roofed porch. The porch spans the easternmost two bays and has a concrete deck, plain wood posts and a wrought iron railing. The porch can be accessed from the front (north) or by a stair on the east side which opens onto the driveway. The east elevation has a 6/6 window, and a one-car garage wing extends from the east end of the house. It has a slightly lower side-gabled roof than the house, a paneled metal overhead door on the north façade, and no openings on the east elevation. The three-bay west elevation of the house has a short window flanked by full-size windows. Although it is more than 50 years old, the house is noncontributing due to the installation of vinyl siding and replacement of the windows.

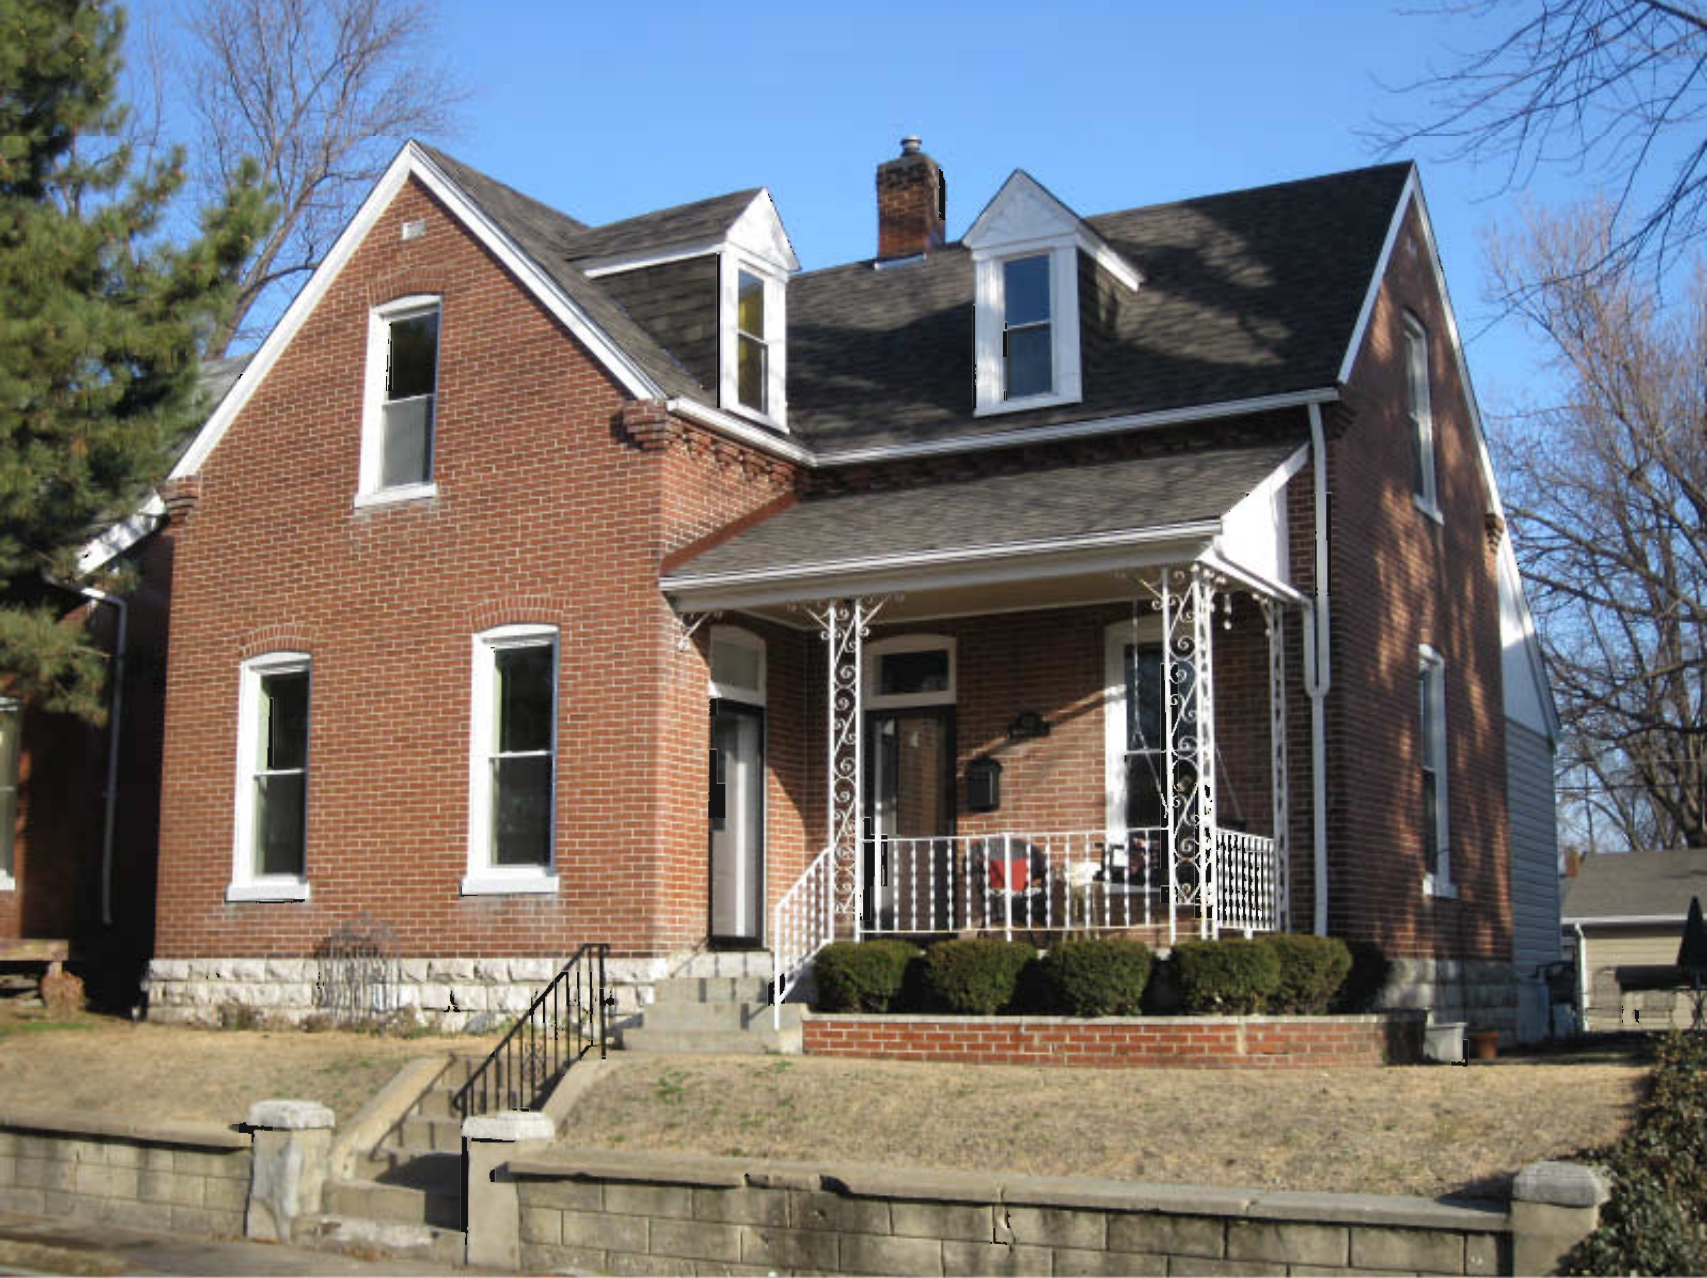
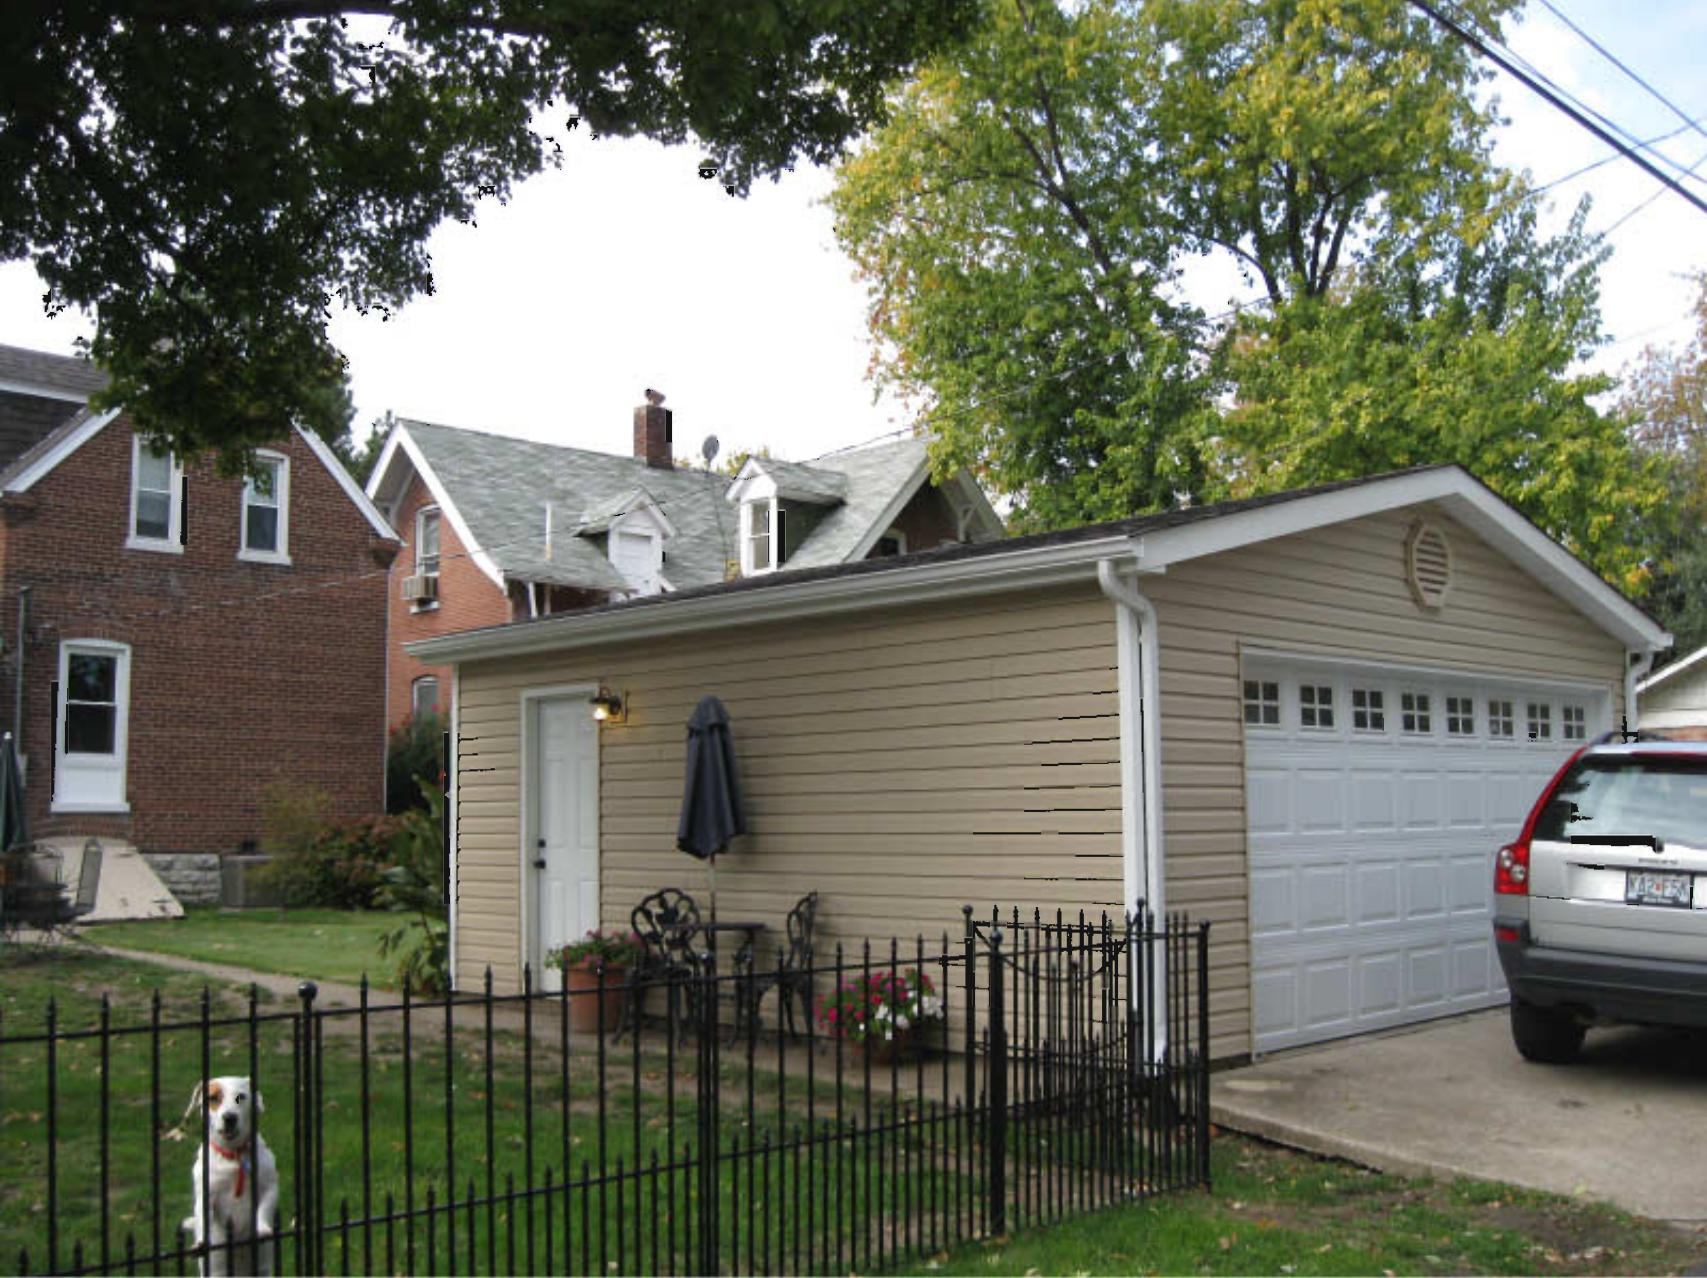
Situated on an elevated lot, this house is a one-and-one-half story, brick, gable-front-and-wing form structure that rests on a coursed rock-faced stone foundation. The shallow eave overhang is trimmed with an elaborate crenellated brick cornice that simulates the wooden brackets seen on many Italianate residences. A brick chimney straddles the ridge of the side-gabled roof, and gabled dormers are on the front slope of the side-gabled wing and on each slope of the front-gabled wing. Each gabled dormer has a 1/1 window flanked by fluted pilasters supporting a pediment, and in the tympanum is a sunburst ornament. A shed roof dormer has been added to the north end of the west slope of the front-gabled wing, and the dormer has a 1/1 window. The walls of the dormers are finished with asphalt roofing shingles. The brick walls of the house are laid in a running bond pattern on the main façade and a six-course common bond on the other elevations, and the windows and doors are set within low segmental-arched openings topped by a double row of radiating voussoirs. The first floor has two 1/1 windows in the front-gabled wing and a door and window in the side-gabled wing. Windows are replacement sashes and have painted wood sills. The half-glazed, wood paneled door, which is topped by a single-light transom, opens onto a two-bay gallery that has a concrete deck and stairway with four steps, wrought iron railing, and wrought iron posts supporting a shed roof. On the east wall of the projecting wing is a matching door that opens onto the gallery, and in the upper half story of the façade is a 1/1 window. The east elevation features a 1/1 window on both the first floor and upper half story, and the west elevation has two 1/1 windows. The house was originally T-shaped, but the rear porch has been enclosed, creating an L-shaped plan.

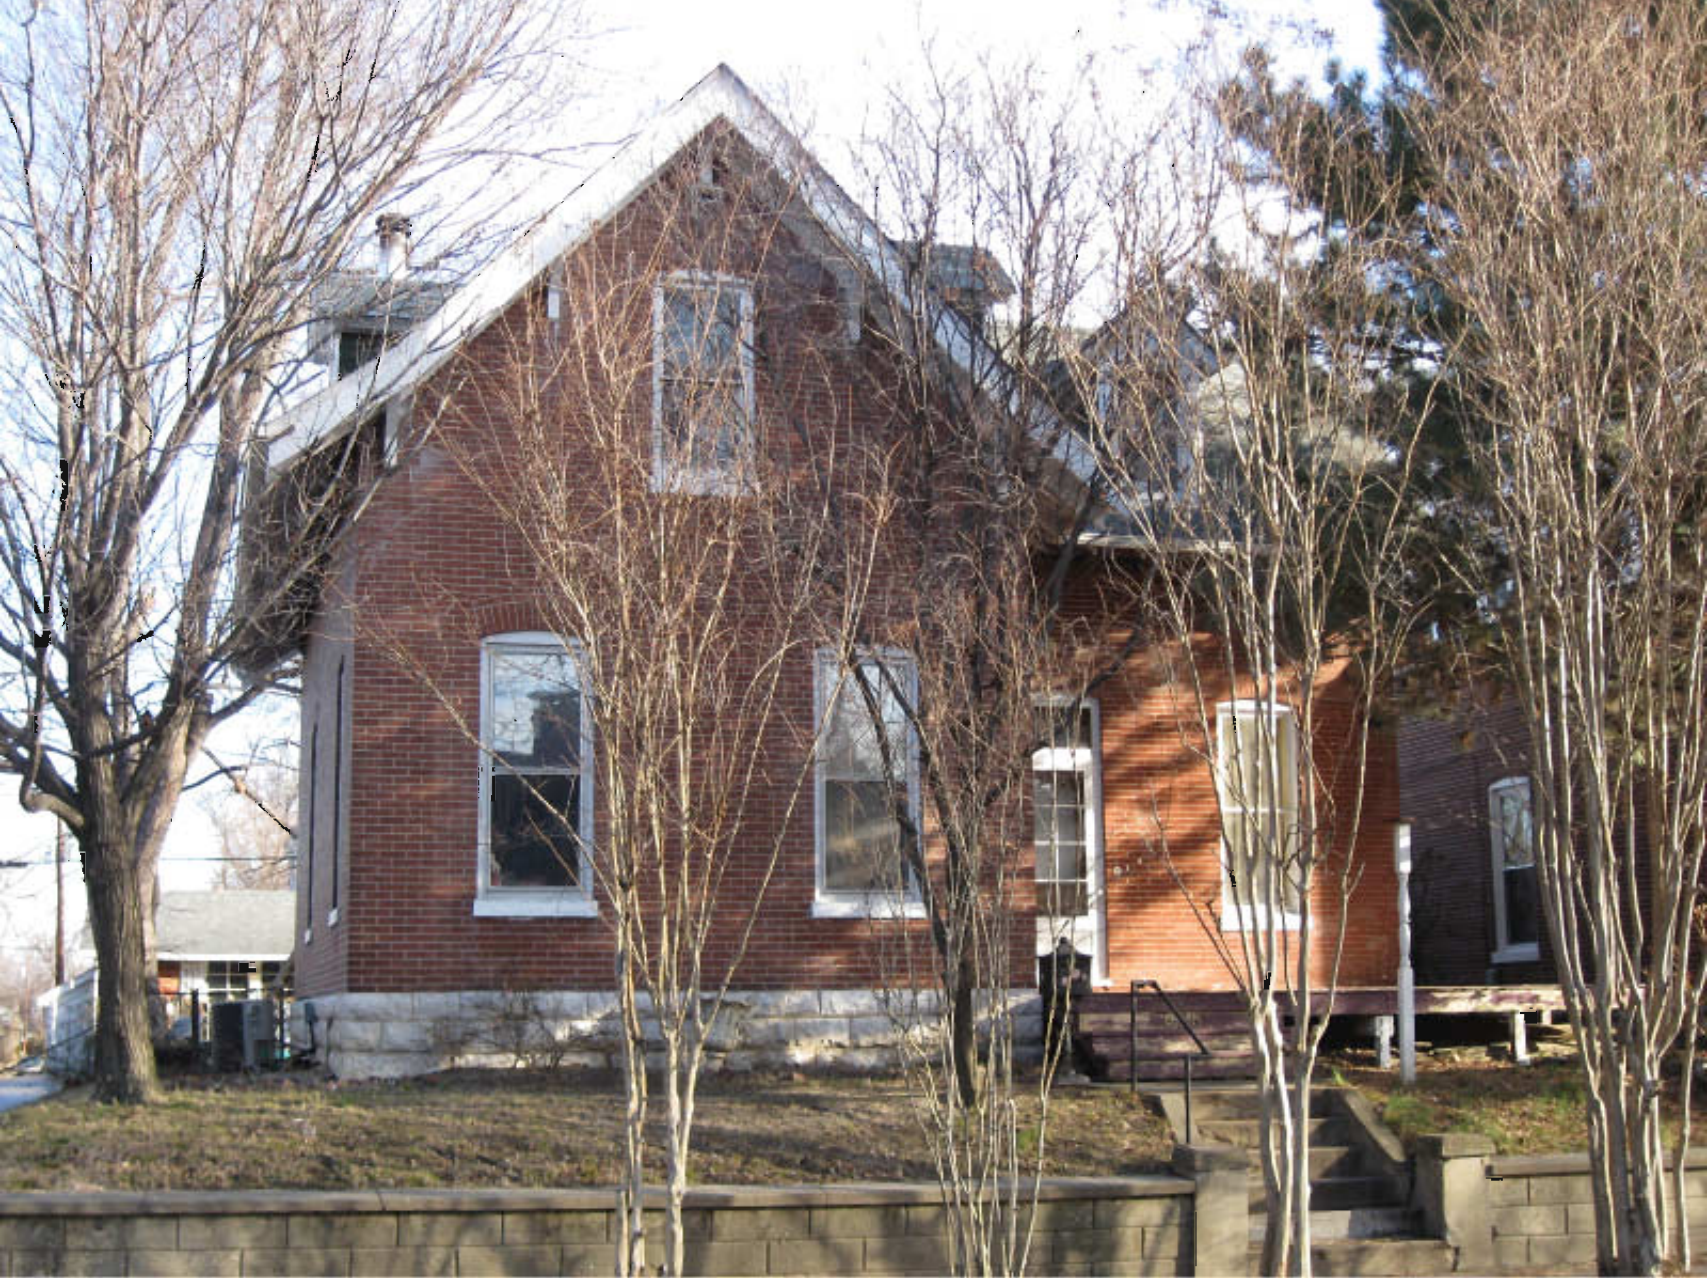
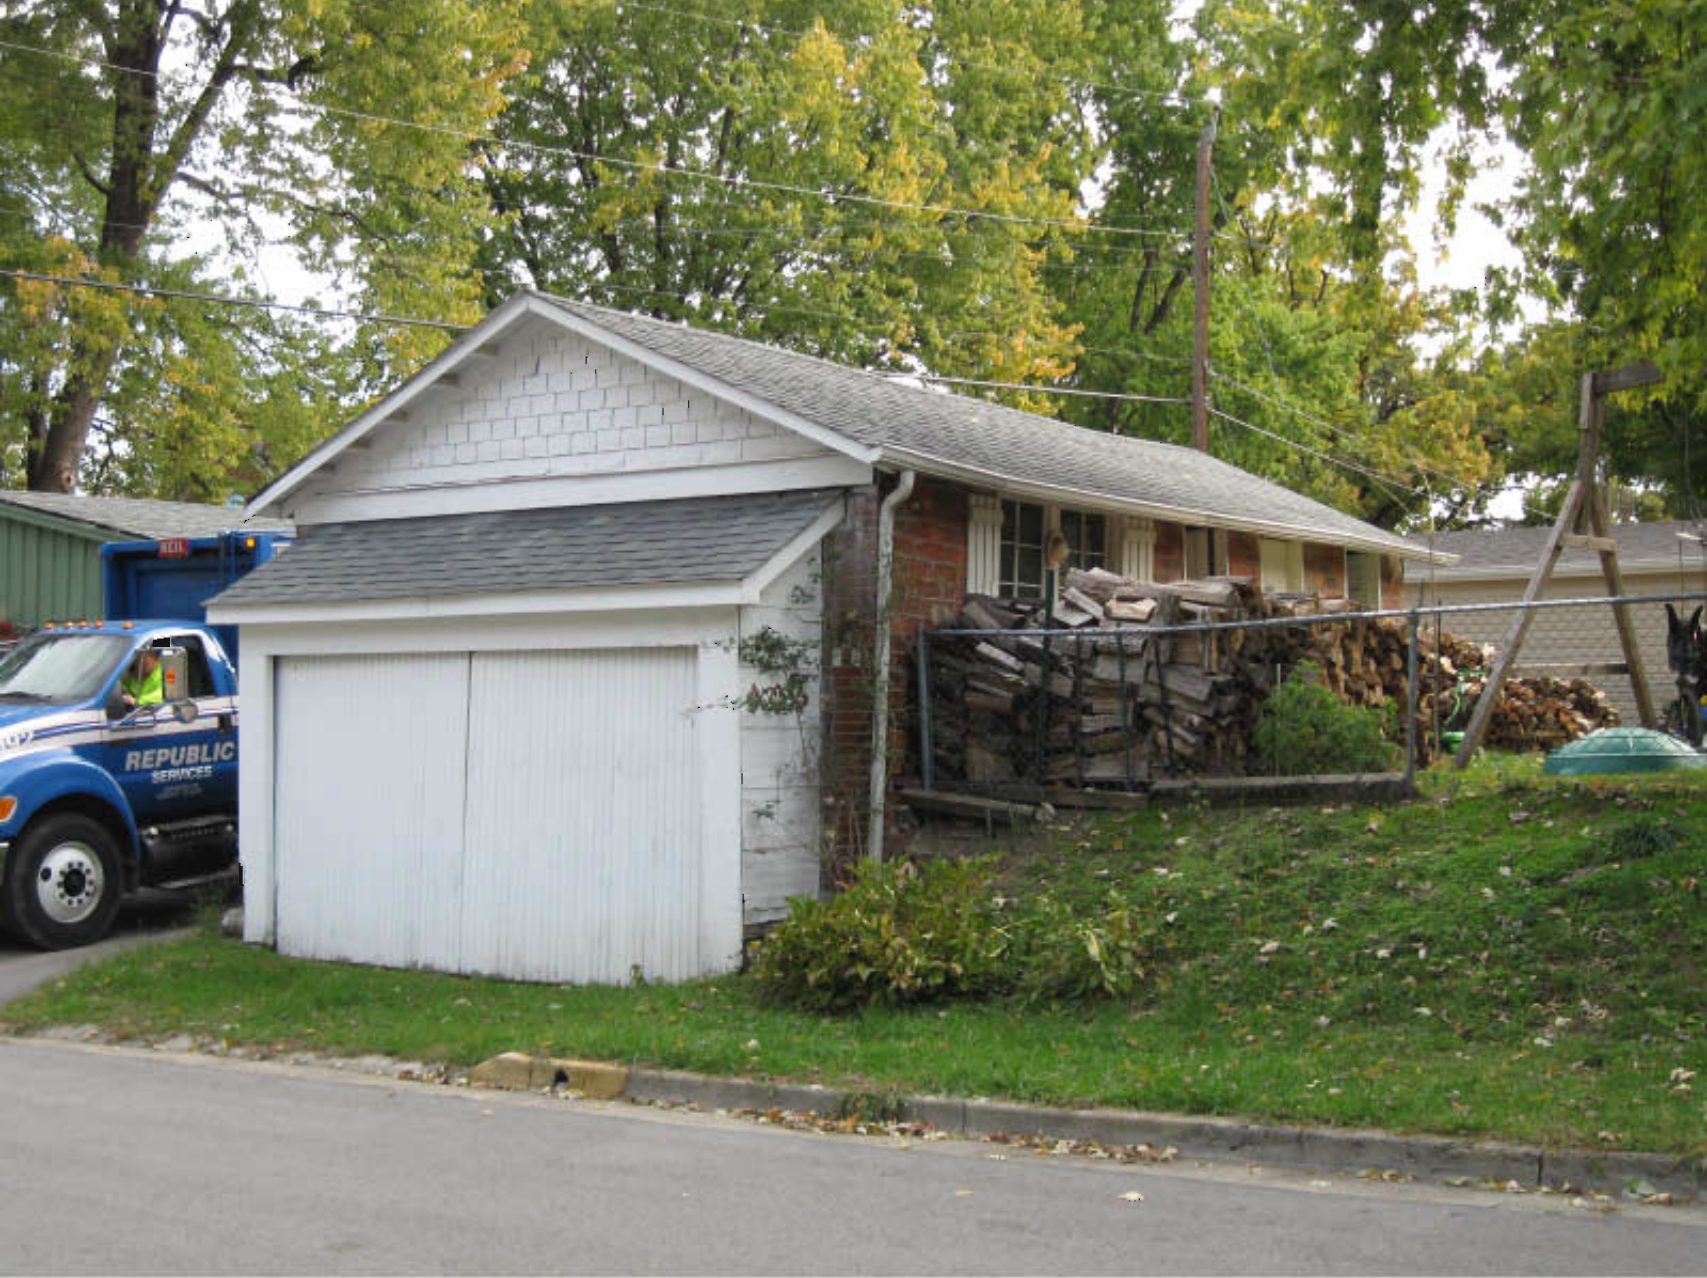
Located at the northeast corner of Washington and Seventh Streets, this house is a one-and-one-half story, brick, gable-front-and-wing form structure that rests on a coursed rock-faced stone foundation pierced by two-light basement windows. The brick walls are laid in a running bond pattern on the main façade, but the other elevations have walls in a six-course common bond, with every sixth course being Flemish bond. An elaborate crenellated brick cornice trims the roof, which appears to have been replaced in the 1920s because it has wide overhanging eaves with exposed rafter tails, and in the gable end are decorative knee braces. A brick chimney straddles the ridge of the side-gabled roof, and gabled dormers are on each slope of the roof. Each dormer has a 1/1 window flanked by fluted pilasters with plinth blocks and capitals, and there is a bullseye corner block in the middle of each pilaster. A triangular sawn ornament is in the gable end, and the dormers' walls are clad with roofing shingles. On the first floor of the main façade are two 1/1 windows in the front-gabled wing and a half-glazed wood door and 1/1 window in the side-gabled wing. The door is topped by a single-light transom, and an eight-light, paneled wood storm door topped by a three-light transom protects the doorway. The windows and doors are set within low segmental-arched openings topped by radiating voussoirs. Those of the windows are formed with a soldier course topped by a header course, while the voussoirs of the doors have two rows of headers. The door opens onto a porch deck, and physical evidence shows that at one time the deck had been covered by a roof. On the east wall of the projecting wing is a matching door that opens onto the gallery deck, and in the upper half story of the façade is a 1/1 window. The east elevation features a 1/1 window on both the first floor and upper half story. The

west elevation has two openings: the one on the south end is a 1/1 window while the one on the north is a 2/2 window. The house was originally T-shaped, but the rear porch has been enclosed, giving the house its present L-shape.
