2009-HUD-0012
Habitat True Vine Project
New Infil Housing
Kansas City, Jackson County

ARCHITECTURAL/HISTORIC INVENTORY FORM

Survey No.: E-HTV-0001		Survey Name(s): Habitat True Vine 106 Survey	
County: Jackson	City: Kansas City <input type="checkbox"/> Vicinity	Zip Code 64127	
Address: 3015 E 24th		Ter	Ownership: <input checked="" type="checkbox"/> Private <input type="checkbox"/> Public
Historic Name:		Present Name:	
UTM: Zone: 15 E: 366190 N: 4326952	Township/Range/Section: Twn: 49 Rng: 10 Sec: 33		
Historic Use (if known): single family dwelling		Current Use: single family dwelling	
Legal Descrip: West 30 Feet of Lots 1 & 2 Block 7, Lafayette Place

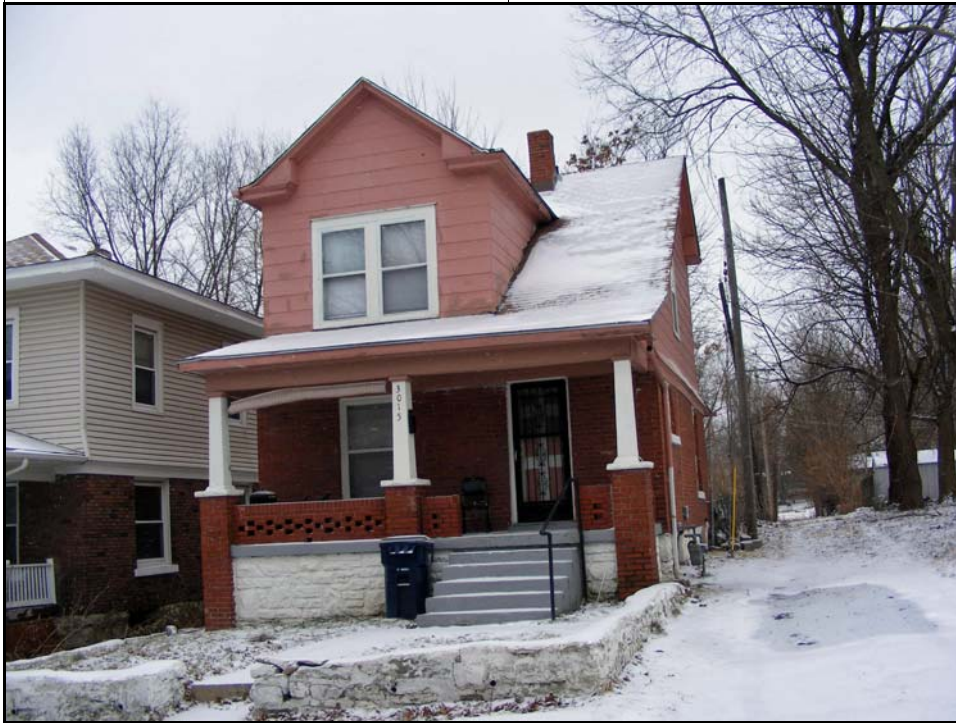
Address: 3015 E 24th

Property Category: Building	Chimney Placement:	Outbuildings (list, describe on continuation sheet:)
Arch. Style and/or Vernacular Type: Craftsman	central on ridge line	
Plan shape: rectangular	Structural: frame	Changes <input type="checkbox"/> Additions Date(s): <input type="checkbox"/> Alteration Date(s): <input type="checkbox"/> Moved Date(s): <input type="checkbox"/> Other Date(s): Endangered By:
No. of Stories: 1 1/2	Exterior Cladding: brick and asbestos shingle	
No. of Bays (1st story): 2	Foundation Material: limestone	
Roof Type: side gable	Basement Type: Full	
Roof Material: composition shingle	Front Porch Type: full width, shed roof, tapered columns	
	Acreage (rural):	
	Visible from Public Rd <input checked="" type="checkbox"/>

A short painted stone retaining wall surrounds the front yard.

The house features a large gable dormer with coupled double hung windows asymmetrical placed on the front façade. The front porch has a shed roof with tapered wood post on brick bases. There is a low brick wall surrounding the porch.

This is an interesting vernacular type, but is not designed by an architect and would not be individually eligible. Given the number of demolitions in the area, it would not be eligible for listing as part of a district.

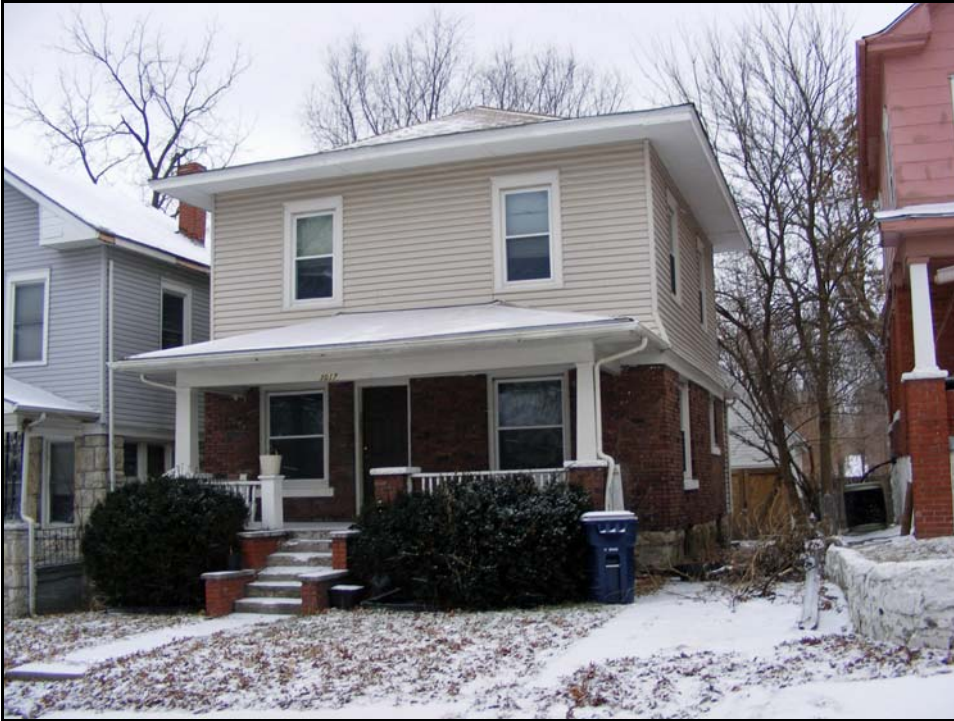
Address: 3017 E 24th

Property Category: Building	Chimney Placement:	Outbuildings (list, describe on continuation sheet:)
Arch. Style and/or Vernacular Type: Kansas City Shirtwaist	Structural: frame	
Plan shape: rectangular	Exterior Cladding: brick/vinyl lap siding	Changes <input type="checkbox"/> Additions Date(s): <input type="checkbox"/> Alteration Date(s): <input type="checkbox"/> Moved Date(s): <input type="checkbox"/> Other Date(s): Endangered By:
No. of Stories: 2	Foundation Material: limestone	
No. of Bays (1st story): 3	Basement Type: full	
Roof Type: hipped	Front Porch Type: full width, hipped roof, wood/brick posts	
Roof Material: composition shingle	Acreage (rural):	
	Visible from Public Rd <input checked="" type="checkbox"/>

This KC Shirtwaist features 1/1 double hung vinyl windows, a full width front porch with a hipped roof and taper wood posts on brick bases and a wood railing.

This is a common Kansas City Shirtwaist local vernacular that would not be individually eligible for listing. Given the number of demolitions in the area, it would not be eligible for listing as part of a district.

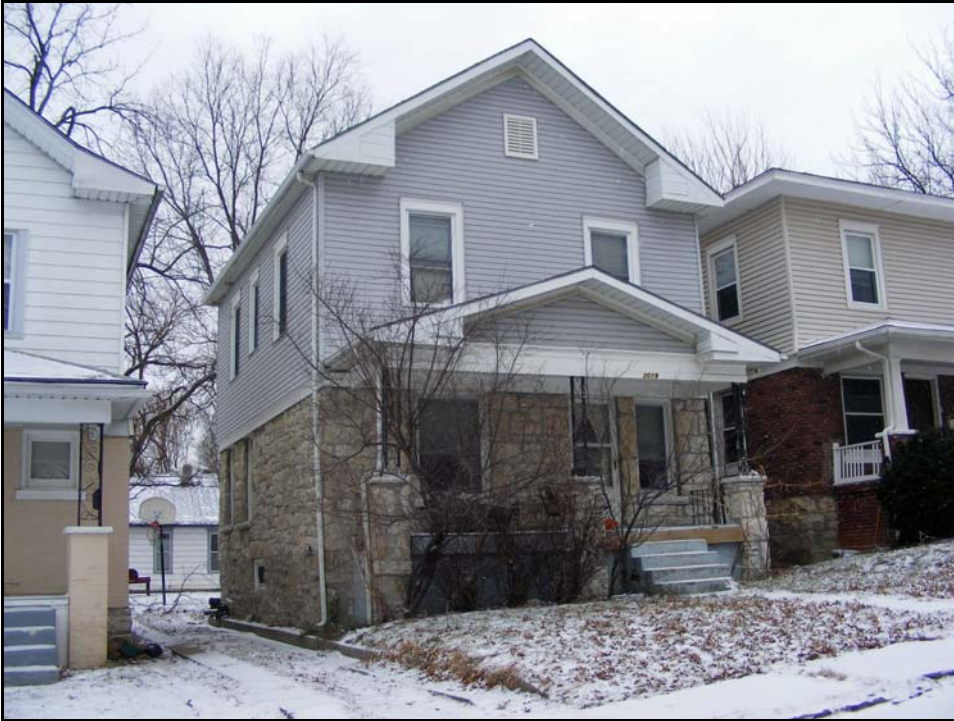
Address: 3019 E 24th

Property Category: Building	Chimney Placement:	Outbuildings (list, describe on continuation sheet:)
Arch. Style and/or Vernacular Type: Kansas City Shirtwaist	Structural: frame	
Plan shape: rectangular	Exterior Cladding: stone/vinyl lap siding	Changes <input type="checkbox"/> Additions Date(s): <input type="checkbox"/> Alteration Date(s): <input type="checkbox"/> Moved Date(s): <input type="checkbox"/> Other Date(s): Endangered By:
No. of Stories: 2	Foundation Material: limestone	
No. of Bays (1st story): 3	Basement Type: full	
Roof Type: gable	Front Porch Type: full width, gable roof, wood/brick posts	
Roof Material: composition shingle	Acreage (rural):	
	Visible from Public Rd <input checked="" type="checkbox"/>

This KC Shirtwaist features 1/1 double hung wood windows, a full width front porch with a gable roof and metal post on brick bases and a metal railing.

This is a common Kansas City Shirtwaist local vernacular that would not be individually eligible for listing. Given the number of demolitions in the area, it would not be eligible for listing as part of a district.

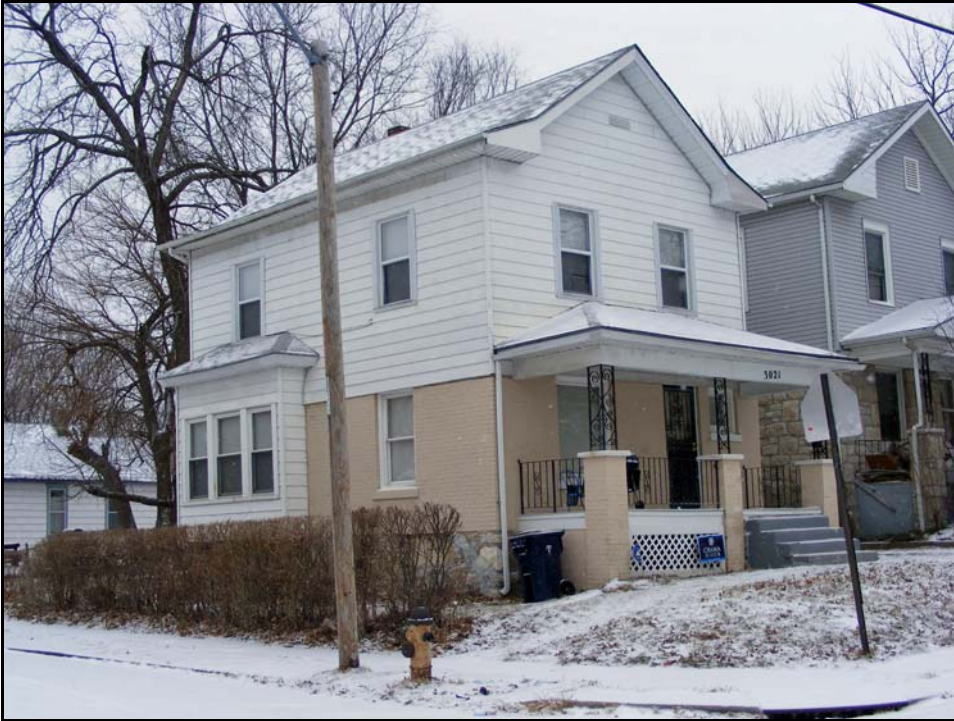
Address: 3021 E 24th

Property Category: Building	Chimney Placement:	Outbuildings (list, describe on continuation sheet:)
Arch. Style and/or Vernacular Type: Kansas City Shirtwaist	Structural: frame	
Plan shape: rectangular	Exterior Cladding: brick/vinyl lap siding	Changes <input type="checkbox"/> Additions Date(s): <input type="checkbox"/> Alteration Date(s): <input type="checkbox"/> Moved Date(s): <input type="checkbox"/> Other Date(s): Endangered By:
No. of Stories: 2	Foundation Material: limestone	
No. of Bays (1st story): 3	Basement Type: full	
Roof Type: gable	Front Porch Type: full width, hipped roof, metal/brick posts	
Roof Material: composition shingle	Acreage (rural):	
	Visible from Public Rd <input checked="" type="checkbox"/>

This KC Shirtwaist features 1/1 double hung wood windows, a full width front porch with a hipped roof and metal post on brick bases and a metal railing.

This is a common Kansas City Shirtwaist local vernacular that would not be individually eligible for listing. Given the number of demolitions in the area, it would not be eligible for listing as part of a district.

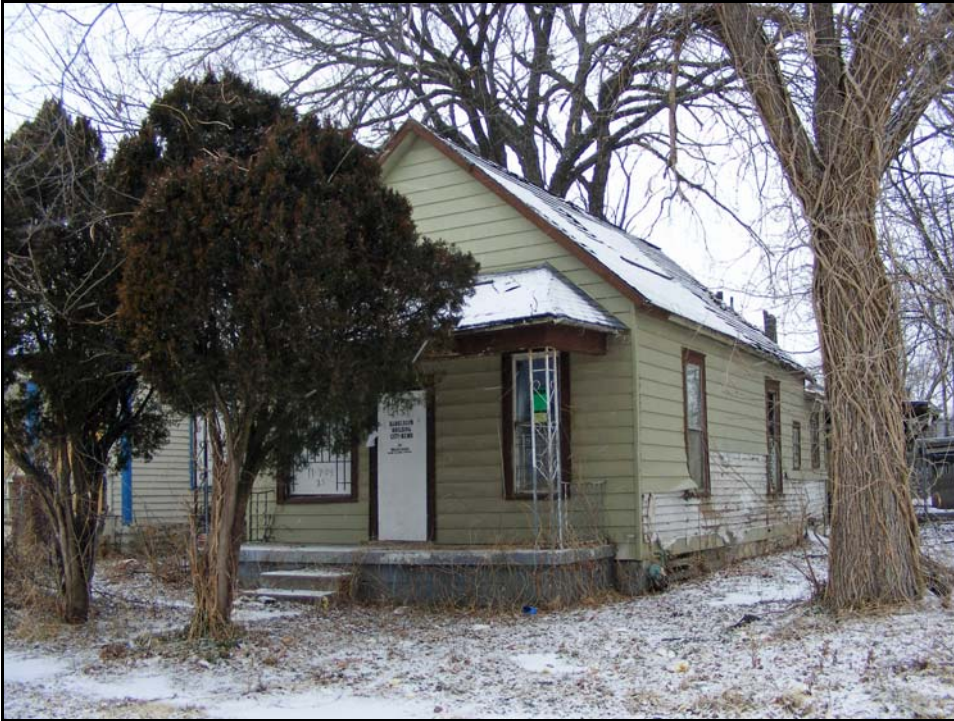
Address: 3004 E 25th

Property Category: Building	Chimney Placement:	Outbuildings (list, describe on continuation sheet:)
Arch. Style and/or Vernacular Type:	Structural: frame	
Plan shape: rectangular	Exterior Cladding: vinyl lap siding	Changes <input type="checkbox"/> Additions Date(s): <input type="checkbox"/> Alteration Date(s): <input type="checkbox"/> Moved Date(s): <input type="checkbox"/> Other Date(s): Endangered By:
No. of Stories: 1 1/2	Foundation Material: limestone	
No. of Bays (1st story): 3	Basement Type: unknown	
Roof Type: gable	Front Porch Type: full width, hipped roof, metal posts	
Roof Material: composition shingle	Acreage (rural):	
	Visible from Public Rd <input checked="" type="checkbox"/>

The house has 1/1 double hung wood windows with aluminum storms. The front porch is concrete with nonoriginal metal post supporting the hipped roof. The front door is currently boarded.

This is a common bungalow style in Kansas city and would not be individually eligible. Given the number of demolitions in the area, it would not be eligible for listing as part of a district.

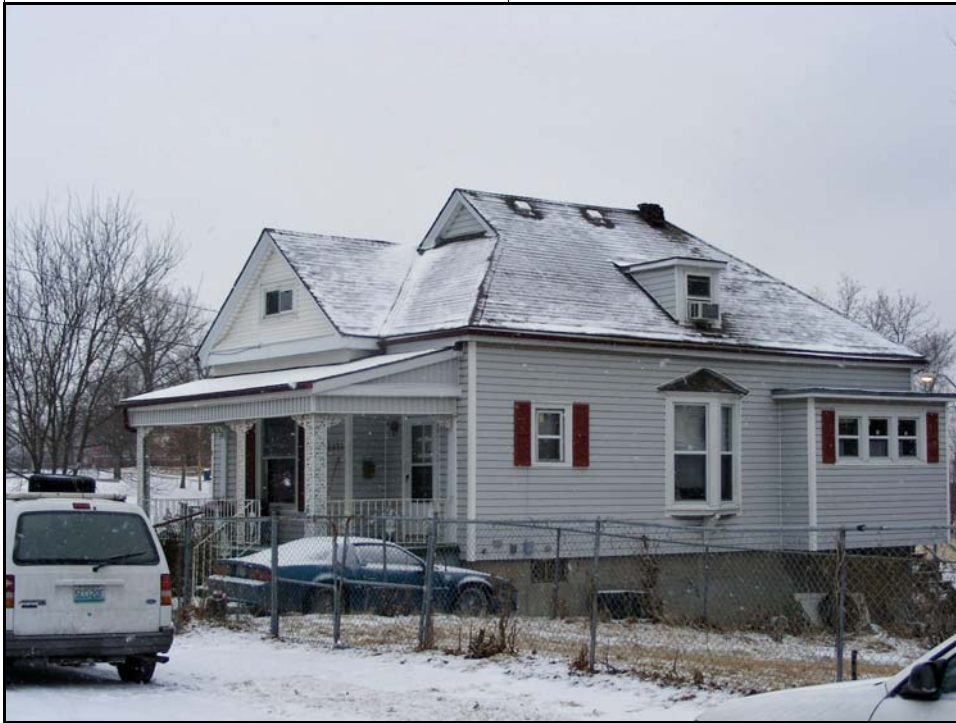
Address: 2437

Property Category: Building	Chimney Placement:	Outbuildings (list, describe on continuation sheet:)
Arch. Style and/or Vernacular Type: Queen Anne	center on ridge	
Plan shape: rectangular	Structural: frame	Changes <input type="checkbox"/> Additions Date(s): <input type="checkbox"/> Alteration Date(s): <input type="checkbox"/> Moved Date(s): 1953 <input type="checkbox"/> Other Date(s): Endangered By:
No. of Stories: 1 1/2	Exterior Cladding: vinyl lap siding	
No. of Bays (1st story): 2	Foundation Material: poured concrete	
Roof Type: gable-on-hip	Basement Type: full	
Roof Material: composition	Front Porch Type: full width, shed, metal posts	
	Acreage (rural):	
	Visible from Public Rd <input checked="" type="checkbox"/>

chain link fence surrounds the property

1/1 double hung vinyl windows

This house was moved from 2423 Agnes in 1953 by A.P. Concard to make way for the Booker T. Washington School.

Due to the fact that it has been moved and the windows and siding are nonoriginal, it would not be eligible for listing.

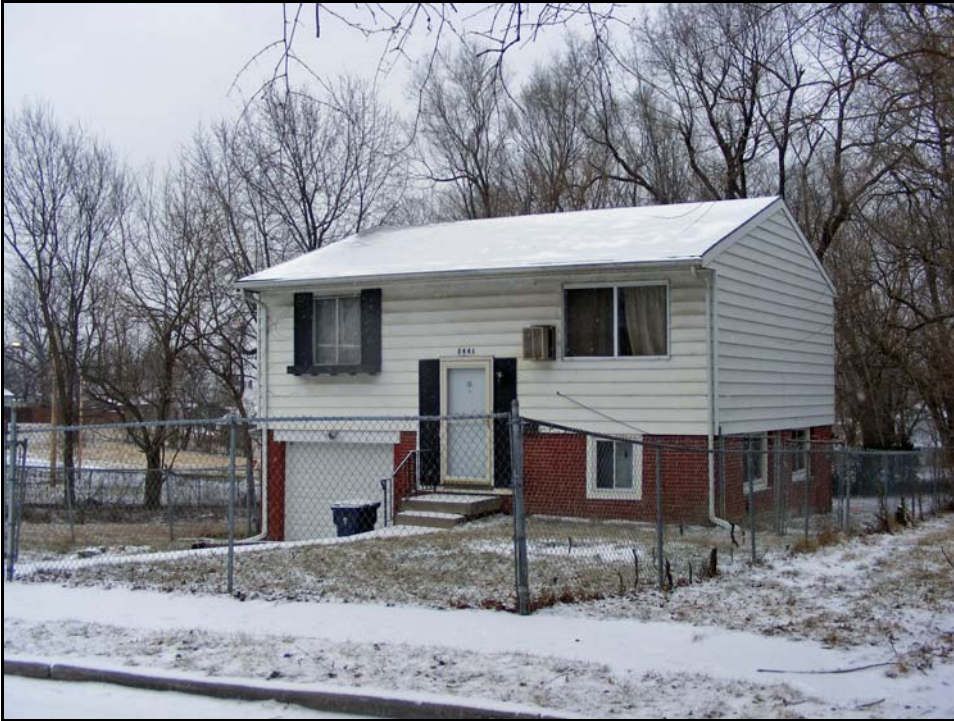
Address: 2441

Property Category: Building	Chimney Placement:	Outbuildings (list, describe on continuation sheet:)
Arch. Style and/or Vernacular Type: raised ranch	Structural: frame	
Plan shape: rectangular	Exterior Cladding: vinyl lap siding/brick	Changes <input type="checkbox"/> Additions Date(s): <input type="checkbox"/> Alteration Date(s): <input type="checkbox"/> Moved Date(s): <input type="checkbox"/> Other Date(s): Endangered By:
No. of Stories: 1	Foundation Material: poured concrete	
No. of Bays (1st story): 3	Basement Type: full	
Roof Type: side gable	Front Porch Type: stoop	
Roof Material: composition shingle	Acreage (rural):	
	Visible from Public Rd <input checked="" type="checkbox"/>

A chain link fence surround the parcel.

The house has vinyl slider windows, a metal replacement front door and an overhead garage door.

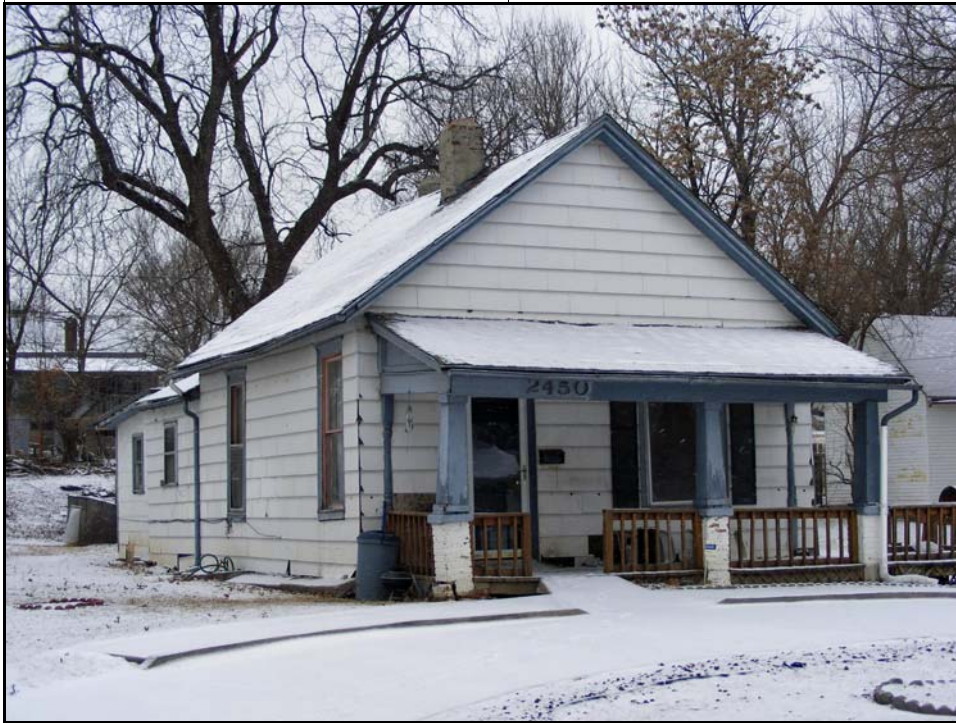
Property Category: Building	Chimney Placement:	Outbuildings (list, describe on continuation sheet:)
Arch. Style and/or Vernacular Type: cottage	center ridgeline	
Plan shape: rectangular	Structural: frame	Changes <input type="checkbox"/> Additions Date(s): <input type="checkbox"/> Alteration Date(s): <input type="checkbox"/> Moved Date(s): <input type="checkbox"/> Other Date(s): Endangered By:
No. of Stories: 1	Exterior Cladding: asbestos shingle	
No. of Bays (1st story): 2	Foundation Material: stone	
Roof Type: end gable	Basement Type: full	
Roof Material: composition shingle	Front Porch Type: full width, taper columns on brick bases	
	Acreage (rural):	
	Visible from Public Rd <input checked="" type="checkbox"/>

The 1 1/2 story cottage has 1/1 double hung windows, asbestos shingle siding, and a gable roof with composition shingles. The front porch has a shed roof supported by tapered wood columns on brick bases.

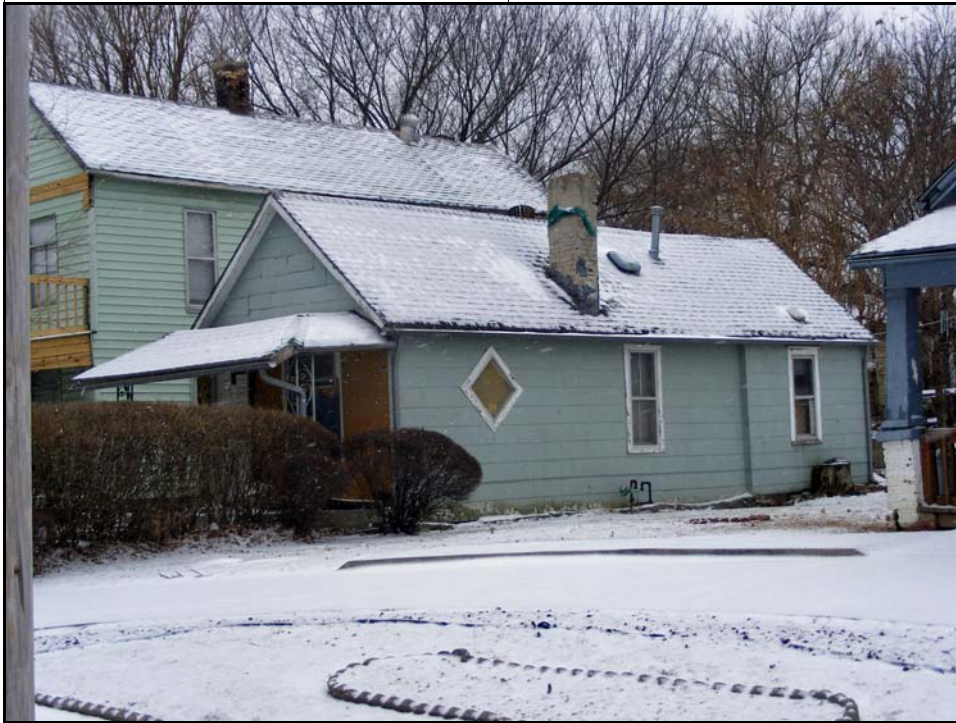
Property Category: Building	Chimney Placement:	Outbuildings (list, describe on continuation sheet:)
Arch. Style and/or Vernacular Type:	Brick, north wall, mid	
	Structural: frame	
Plan shape: rectangular	Exterior Cladding:	
No. of Stories: 1 1/2	asbestos shingle	
No. of Bays (1st story): 2	Foundation Material: limestone	Changes <input type="checkbox"/> Additions Date(s): <input type="checkbox"/> Alteration Date(s): <input type="checkbox"/> Moved Date(s): <input type="checkbox"/> Other Date(s): Endangered By:
Roof Type:	Basement Type: unknown	
gable	Front Porch Type:	
	front, full width, hipped roof, metal posts	
Roof Material:	Acreage (rural):	
composition shingle	Visible from Public Rd <input checked="" type="checkbox"/>

The 1 1/2 story cottage has 1/1 double hung windows, asbestos shingle siding, and a gable roof with composition shingles. The front porch has a hipped roof supported by metal posts.

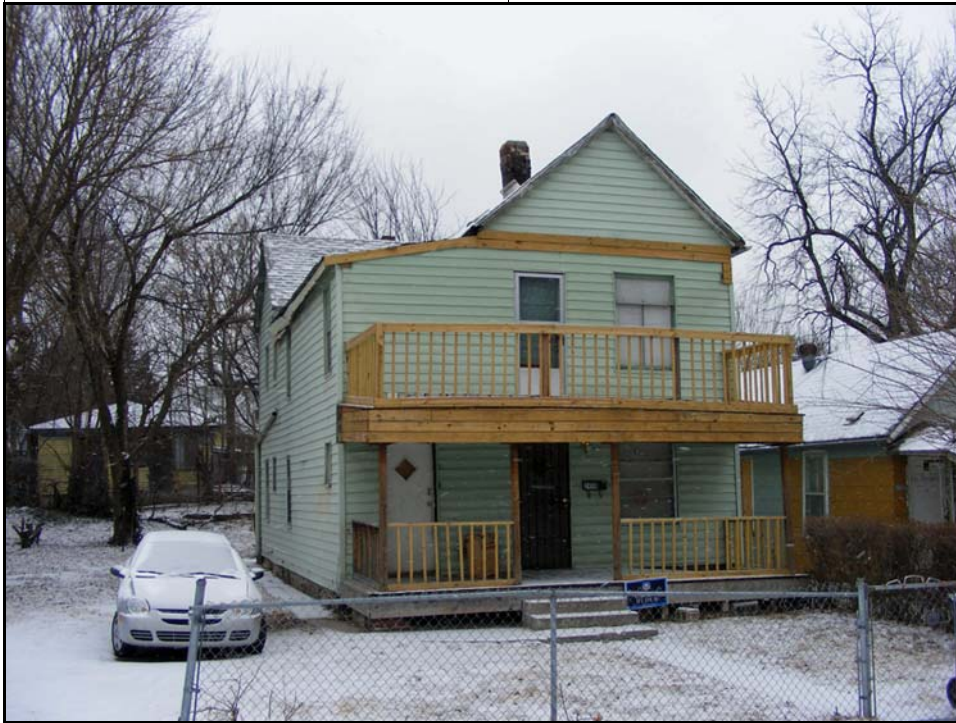
Property Category: Building	Chimney Placement:	Outbuildings (list, describe on continuation sheet:)
Arch. Style and/or Vernacular Type: Folk Victorian	brick/ center ridge	
Plan shape: rectangular	Structural: frame	Changes <input type="checkbox"/> Additions Date(s): Story, 1925-40 <input type="checkbox"/> Alteration Date(s): <input type="checkbox"/> Moved Date(s): <input type="checkbox"/> Other Date(s): Endangered By:
No. of Stories: 2	Exterior Cladding: vinyl lap siding	
No. of Bays (1st story): 3	Foundation Material: limestone	
Roof Type: cross gable/shed	Basement Type: unknown	
Roof Material: composition shingle	Front Porch Type: 2 story, full width, nonoriginal	
	Acreage (rural):	
	Visible from Public Rd <input checked="" type="checkbox"/>

There is a driveway on the south side and a chain link fence in the front yard.

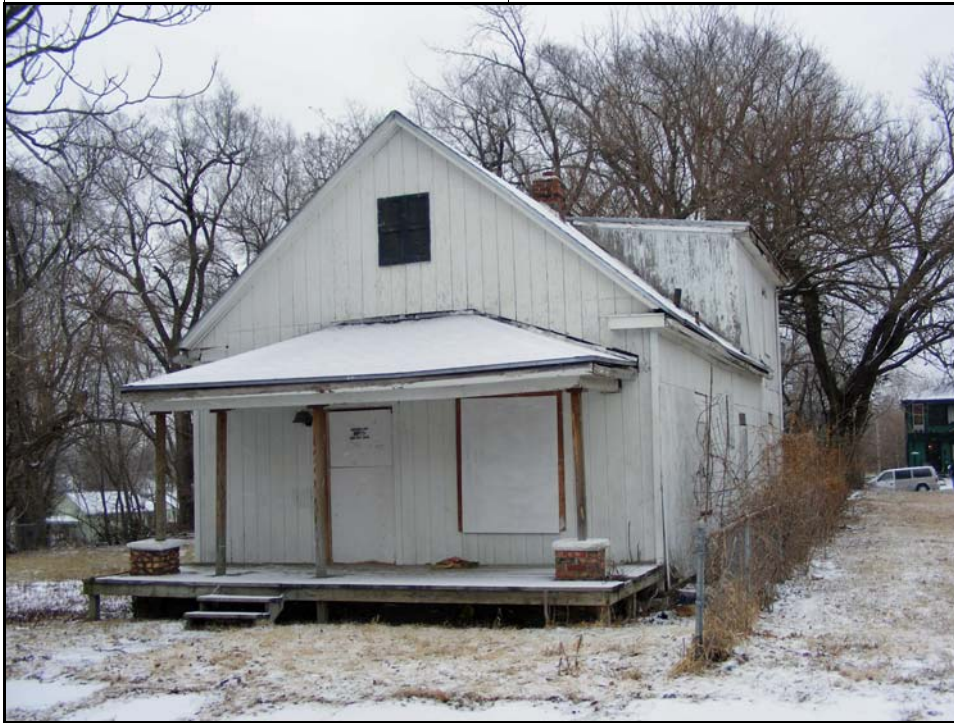
Property Category: Building	Chimney Placement:	Outbuildings (list, describe on continuation sheet:)
Arch. Style and/or Vernacular Type: bungalow	center ridge, brick	
	Structural: frame	
Plan shape: rectangular	Exterior Cladding:	
No. of Stories: 1 1/2	scored plywood	
No. of Bays (1st story): 2	Foundation Material: limestone	Changes <input type="checkbox"/> Additions Date(s): <input type="checkbox"/> Alteration Date(s): 1959 <input type="checkbox"/> Moved Date(s): <input type="checkbox"/> Other Date(s): Endangered By:
Roof Type: gable	Basement Type: unknown	
Roof Material: composition shingle	Front Porch Type: full width, hipped roof, wood posts	
	Acreage (rural):	
	Visible from Public Rd <input checked="" type="checkbox"/>

chain link fence on south side of parcel

This 1/2 story bungalow has had numerous alterations and is in poor physical condition. A second story dormer was added in 1959.

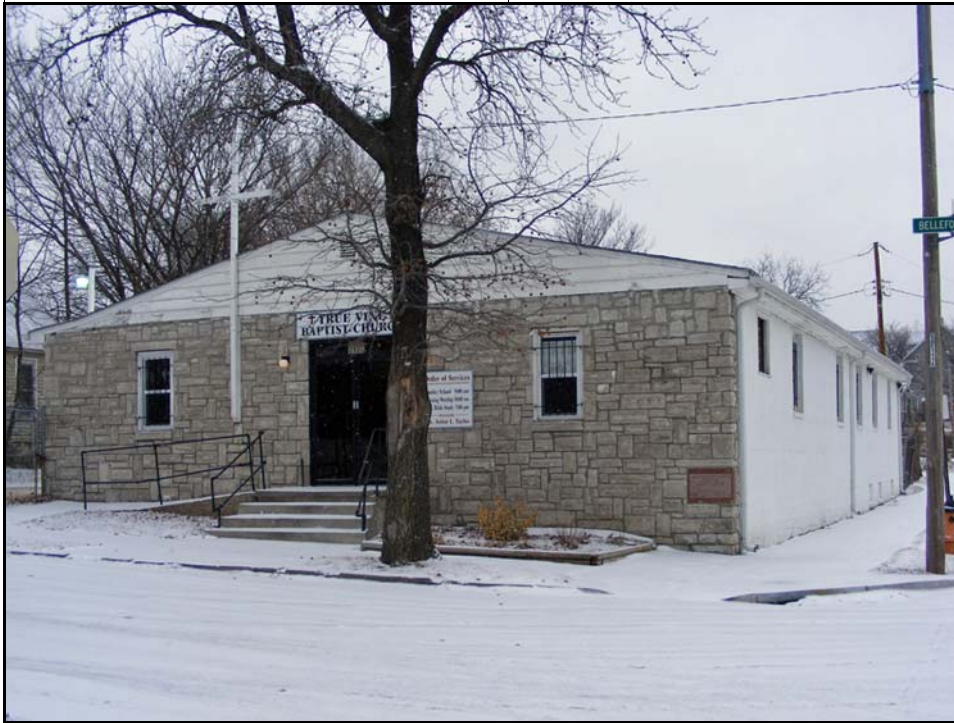
Property Category: Building	Chimney Placement:	Outbuildings (list, describe on continuation sheet:)
Arch. Style and/or Vernacular Type: Modern	n/a	
Plan shape: rectangular	Structural: masonry: concrete block	Changes <input type="checkbox"/> Additions Date(s): <input type="checkbox"/> Alteration Date(s): <input type="checkbox"/> Moved Date(s): <input type="checkbox"/> Other Date(s): Endangered By:
No. of Stories: 1	Exterior Cladding: stone on front (west) façade	
No. of Bays (1st story): 3	Foundation Material: concrete	
Roof Type: gable	Basement Type: unknown	
Roof Material: composition shingle	Front Porch Type: stoop	
	Acreage (rural):	
	Visible from Public Rd <input checked="" type="checkbox"/>

There are 1/1 double hung windows on the west north and south facades. The steps leading up to the church are concrete with metal pipe railings.

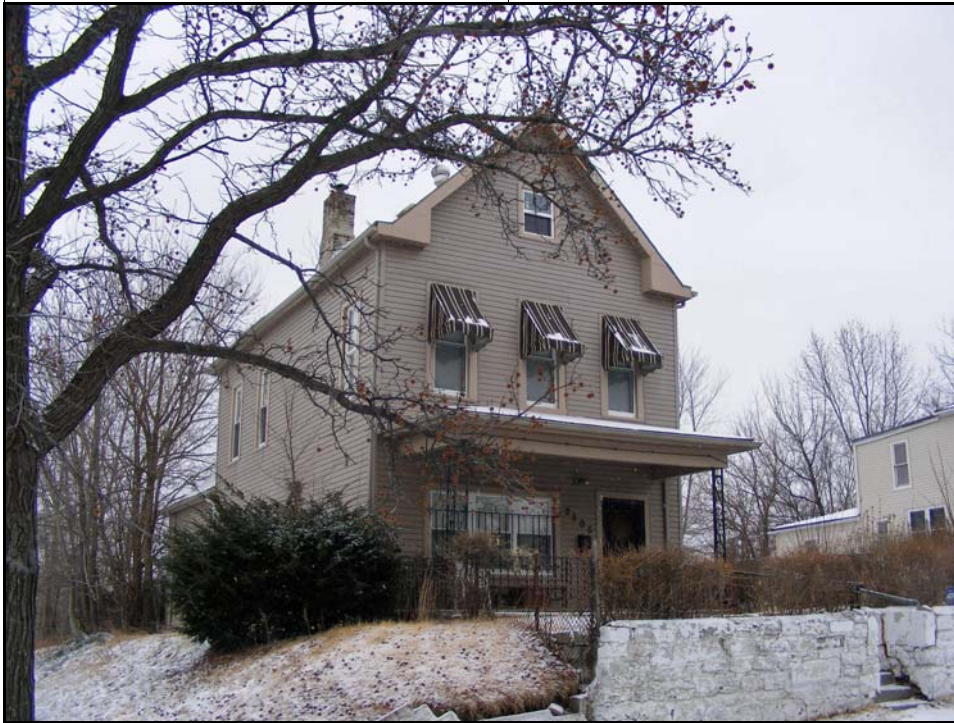
Property Category: Building	Chimney Placement:	Outbuildings (list, describe on continuation sheet:) 1
Arch. Style and/or Vernacular Type: American Foursquare	central on ridgeline Structural: frame	
Plan shape: rectangular	Exterior Cladding: vinyl lap siding	Changes <input type="checkbox"/> Additions Date(s): <input type="checkbox"/> Alteration Date(s): <input type="checkbox"/> Moved Date(s): <input type="checkbox"/> Other Date(s): Endangered By:
No. of Stories: 2 1/2	Foundation Material: limestone	
No. of Bays (1st story): 2	Basement Type: unknown	
Roof Type: gable	Front Porch Type: full width, hipped roof, metal posts	
Roof Material: composition shingle	Acreage (rural):	
	Visible from Public Rd <input checked="" type="checkbox"/>

There is an underground garage on the east side of the parcel that faces Walrond. A painted limestone retaining wall faces the west side of the parcel.

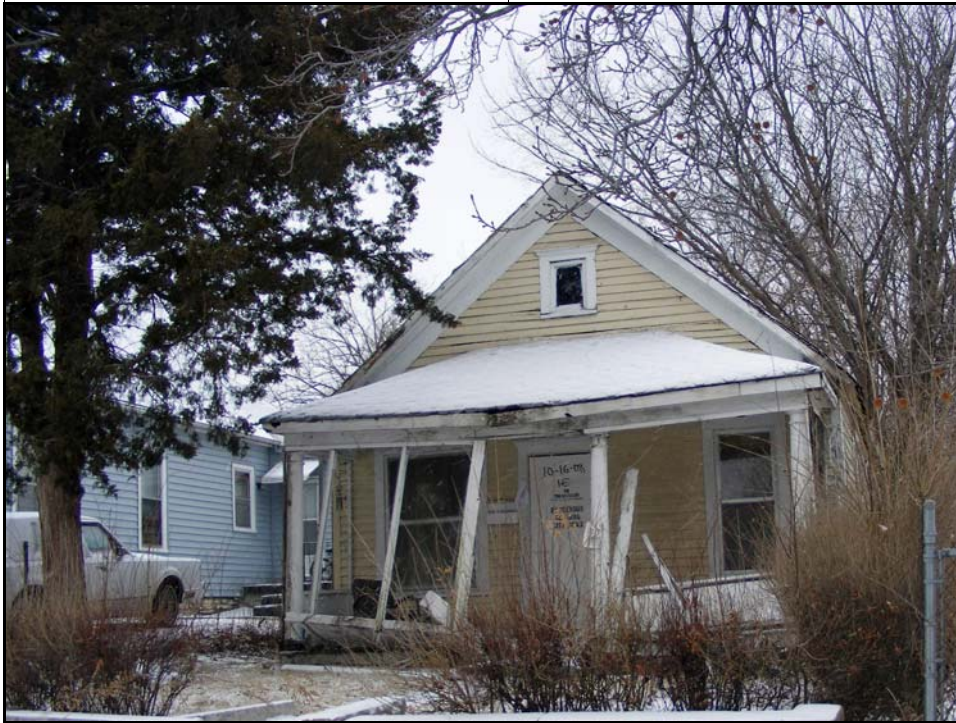
Property Category: Building	Chimney Placement:	Outbuildings (list, describe on continuation sheet:)
Arch. Style and/or Vernacular Type: bungalow	center/ridge line	
Plan shape: rectangular	Structural: frame	
No. of Stories: 1 1/2	Exterior Cladding: wood lap siding	
No. of Bays (1st story): 3	Foundation Material: limestone	Changes <input type="checkbox"/> Additions Date(s): <input type="checkbox"/> Alteration Date(s): <input type="checkbox"/> Moved Date(s): <input type="checkbox"/> Other Date(s): Endangered By:
Roof Type: gable	Basement Type: unknown	
Roof Material: composition shingle	Front Porch Type: full width, hipped roof, wood posts	
	Acreage (rural):	
	Visible from Public Rd <input checked="" type="checkbox"/>

The 1 1/2 story bungalow has 1/1 double hung windows on the front porch. The front door is currently boarded. The front porch has Doric columns in poor condition.

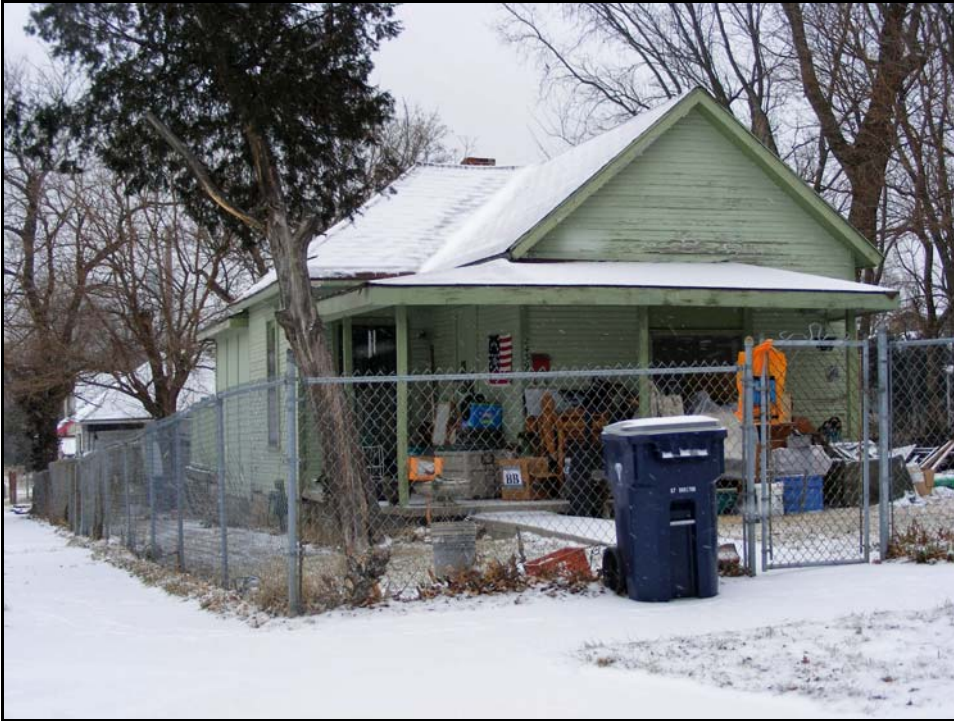
Property Category: Building	Chimney Placement:	Outbuildings (list, describe on continuation sheet:)
Arch. Style and/or Vernacular Type: Folk Victorian	center ridge brick chimney	
Plan shape: L-shaped	Structural: frame	Changes <input type="checkbox"/> Additions Date(s): <input type="checkbox"/> Alteration Date(s): <input type="checkbox"/> Moved Date(s): <input type="checkbox"/> Other Date(s): Endangered By:
No. of Stories: 1	Exterior Cladding: wood lap siding	
No. of Bays (1st story): 2	Foundation Material: limestone	
Roof Type: hipped/gable	Basement Type: unknown	
Roof Material: composition shingle	Front Porch Type: wrap around, hipped roof	
	Acreage (rural):	
	Visible from Public Rd <input checked="" type="checkbox"/>

A chain link fence surrounds the property

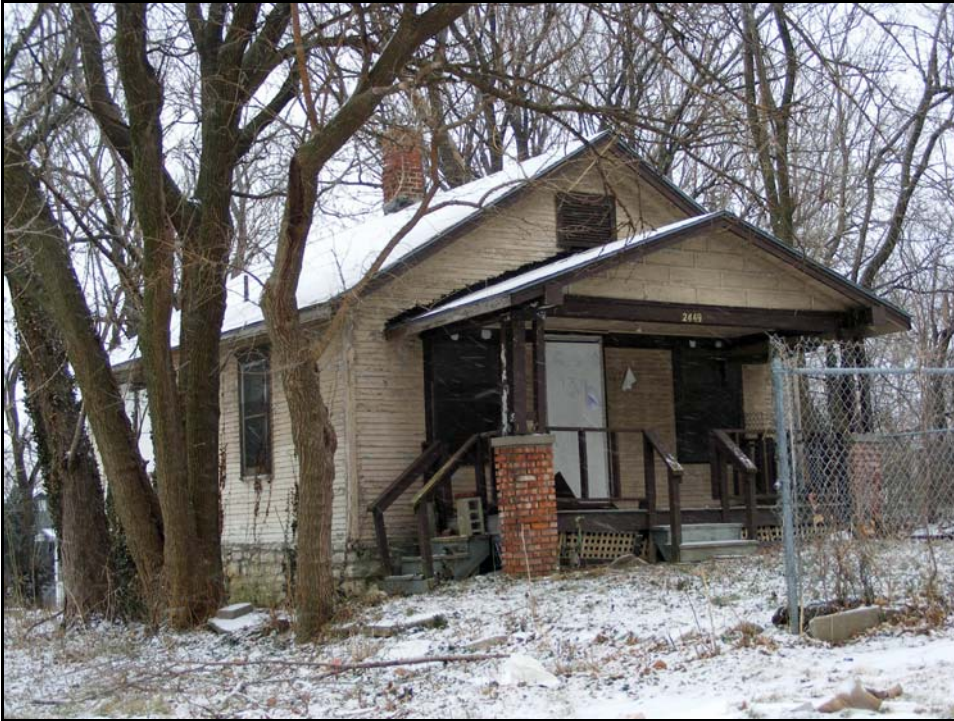
Property Category: Building	Chimney Placement:	Outbuildings (list, describe on continuation sheet:)
Arch. Style and/or Vernacular Type: bungalow	center ridge	
Plan shape: rectangular	Structural: frame	
No. of Stories: 1	Exterior Cladding: wood lap siding	
No. of Bays (1st story): 3	Foundation Material: limestone	Changes <input type="checkbox"/> Additions Date(s): <input type="checkbox"/> Alteration Date(s): <input type="checkbox"/> Moved Date(s): <input type="checkbox"/> Other Date(s): Endangered By:
Roof Type: gable	Basement Type: unknown	
Roof Material: composition shingle	Front Porch Type: full width, gable roof, wood post on brick	
	Acreage (rural):	
	Visible from Public Rd <input checked="" type="checkbox"/>

There is a chain link fence on the west and south sides of the lot.

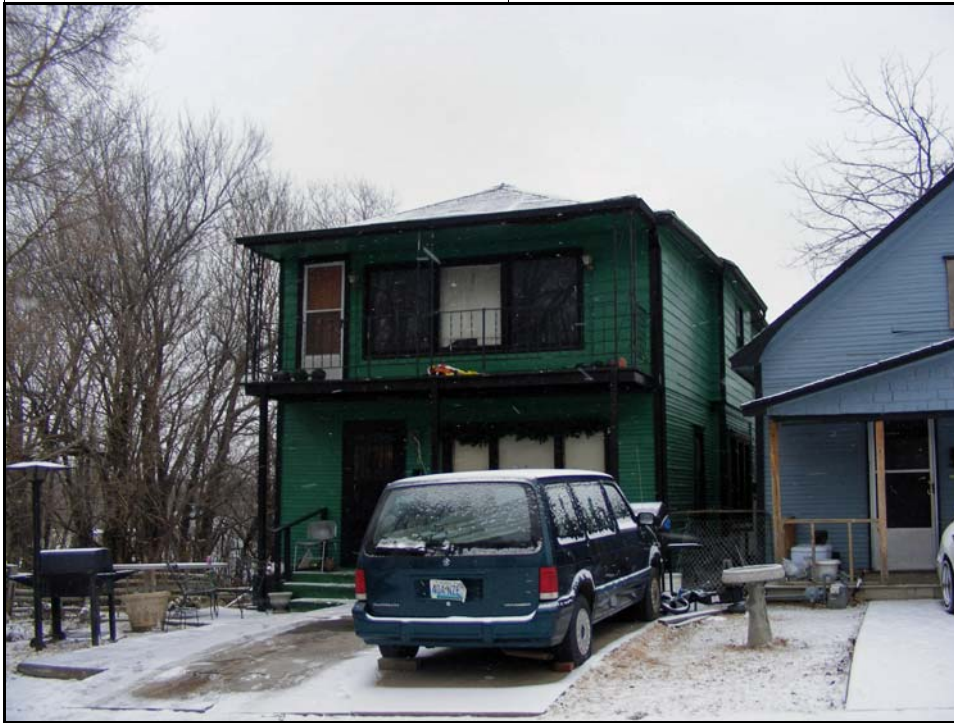
Property Category: Building	Chimney Placement:	Outbuildings (list, describe on continuation sheet:)
Arch. Style and/or Vernacular Type:	Structural: frame	
Plan shape: rectangular	Exterior Cladding: wood lap siding/asbestos shingle	Changes <input type="checkbox"/> Additions Date(s): <input type="checkbox"/> Alteration Date(s): <input type="checkbox"/> Moved Date(s): <input type="checkbox"/> Other Date(s): Endangered By:
No. of Stories: 2	Foundation Material: limestone	
No. of Bays (1st story): 2	Basement Type: unknown	
Roof Type: hipped	Front Porch Type: 2 story, full width, flat roof	
Roof Material: composition shingle	Acreage (rural):	
	Visible from Public Rd <input checked="" type="checkbox"/>

This house has been altered by the addition of a second story and a two story porch. The original house was 1 1/2 stories with a gable roof.

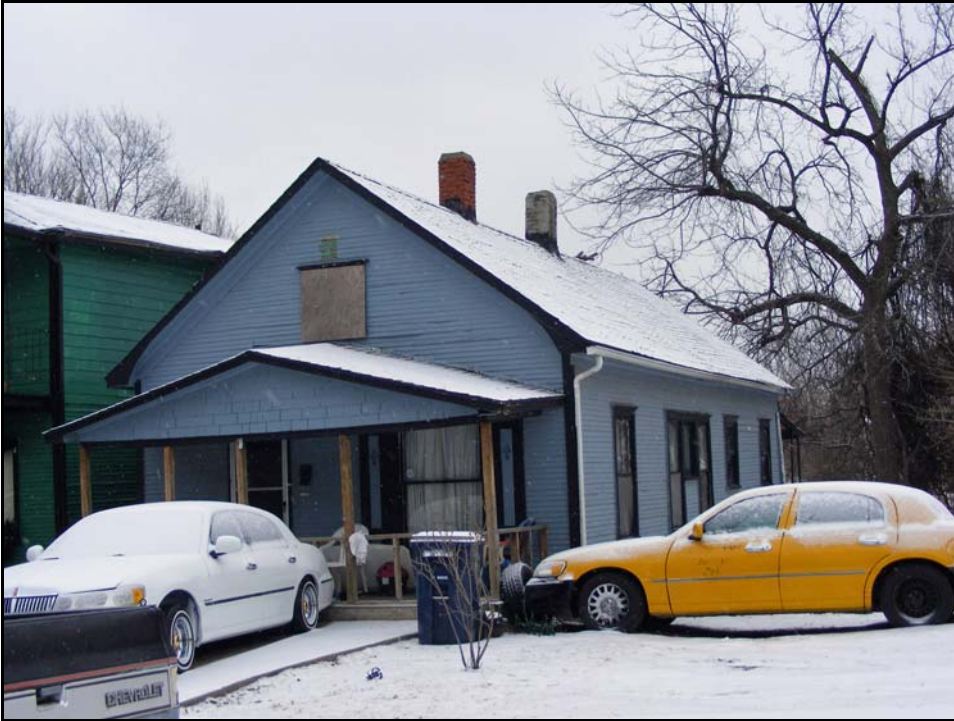
Property Category: Building	Chimney Placement:	Outbuildings (list, describe on continuation sheet:) n/a
Arch. Style and/or Vernacular Type:	2 on central ridgeline	
	Structural: frame	
Plan shape: rectangular	Exterior Cladding:	
No. of Stories: 1 1/2	wood lap siding	
No. of Bays (1st story): 2	Foundation Material: stone	Changes <input type="checkbox"/> Additions Date(s): <input type="checkbox"/> Alteration Date(s): <input type="checkbox"/> Moved Date(s): <input type="checkbox"/> Other Date(s): Endangered By:
Roof Type:	Basement Type: full	
end gable	Front Porch Type:	
	front, full width, gable roof, wood posts	
Roof Material:	Acreage (rural):	
composition shingle	Visible from Public Rd <input checked="" type="checkbox"/>

Original Address 2455 Walrond; Arsene C. Brosseau was a employ of Dierks Lumber Co.

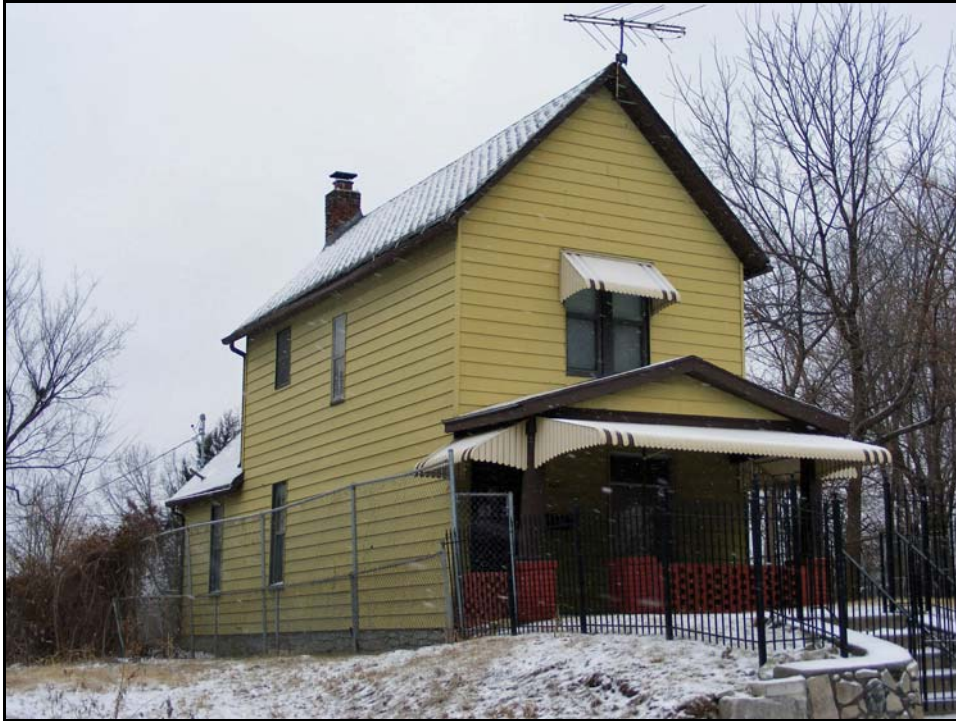
Property Category: Building	Chimney Placement:	Outbuildings (list, describe on continuation sheet:) 1 in rear facing Walrond
Arch. Style and/or Vernacular Type: Folk Victorian	1: east end gable Structural: frame	
Plan shape: rectangular	Exterior Cladding: vinyl lap siding	Changes <input type="checkbox"/> Additions Date(s): <input type="checkbox"/> Alteration Date(s): <input type="checkbox"/> Moved Date(s): <input type="checkbox"/> Other Date(s): Endangered By:
No. of Stories: 2	Foundation Material: stone	
No. of Bays (1st story): 2	Basement Type: full	
Roof Type: end gable	Front Porch Type: front, full width, gable roof	
Roof Material: composition shingle	Acreage (rural):	
	Visible from Public Rd <input checked="" type="checkbox"/>

There is a six foot black picket fence in the front yard and chain link in the side yard.

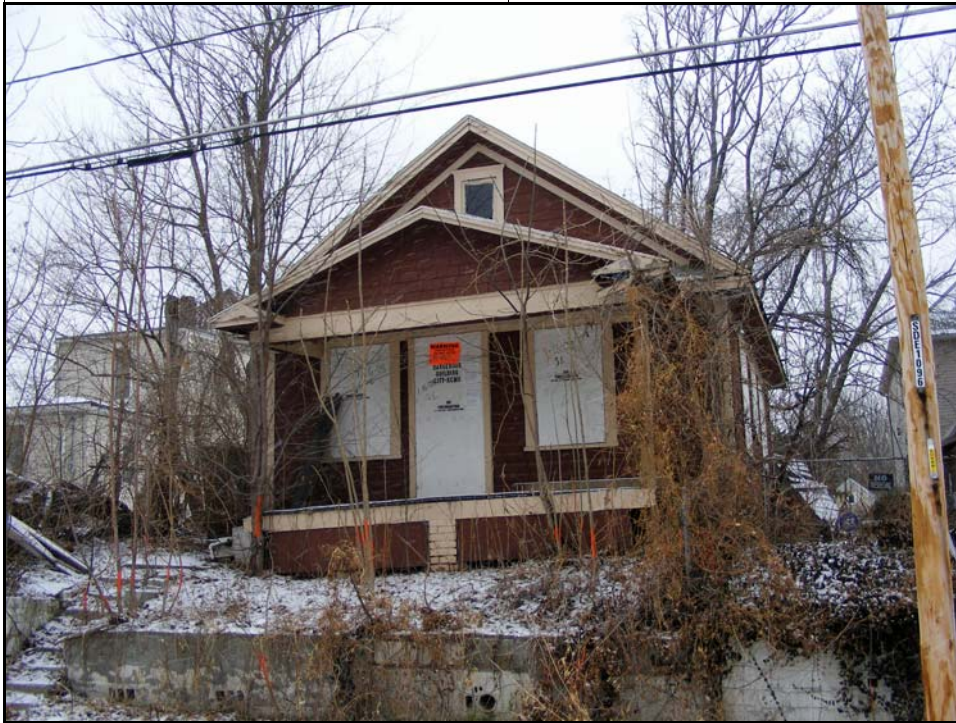
Property Category: Building	Chimney Placement:	Outbuildings (list, describe on continuation sheet:)
Arch. Style and/or Vernacular Type: bungalow	center	
Plan shape: rectangular	Structural: frame	Changes <input type="checkbox"/> Additions Date(s): <input type="checkbox"/> Alteration Date(s): <input type="checkbox"/> Moved Date(s): <input type="checkbox"/> Other Date(s): Endangered By:
No. of Stories: 1 1/2	Exterior Cladding: wood lap siding	
No. of Bays (1st story): 2	Foundation Material: stone	
Roof Type: end gable	Basement Type: full	
Roof Material: composition shingle	Front Porch Type: front, full width, gable roof	
	Acreage (rural):	
	Visible from Public Rd <input checked="" type="checkbox"/>

The is a concrete block retaining wall along the west side of the parcel.
