Land-Use and Building Survey Inventory Form

SURVEY NO. BU-AS-005-LUBC-018		
TOTAL SCORE OF OVERALL INTERIOR BUILDING CONDITION:		LOCATION: L1 – 1 ST FLOOR; L2- 2 ND FLOOR; L3 -3 RD FLOOR
12- EXCELLENT	6-8 – FAIR	0-4 - DILAPIDATED
9-11 – GOOD	1-3 - POOR

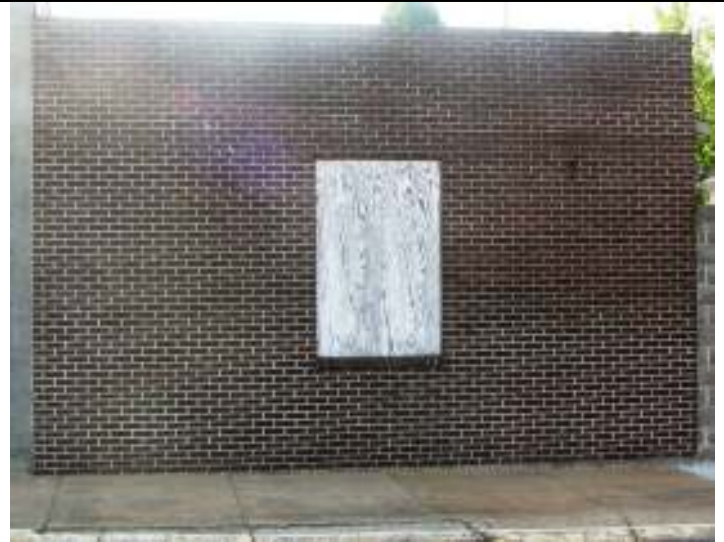
Façade – false front, showing boarded up window opening and no egress.

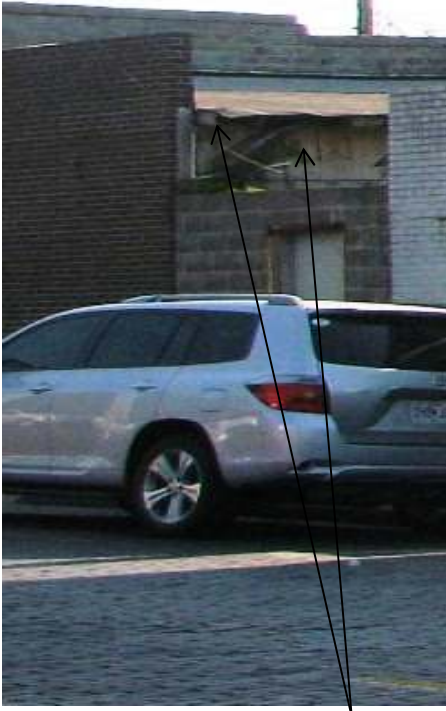
South elevation, showing the deterioration of the expose roof rafters and wall surface

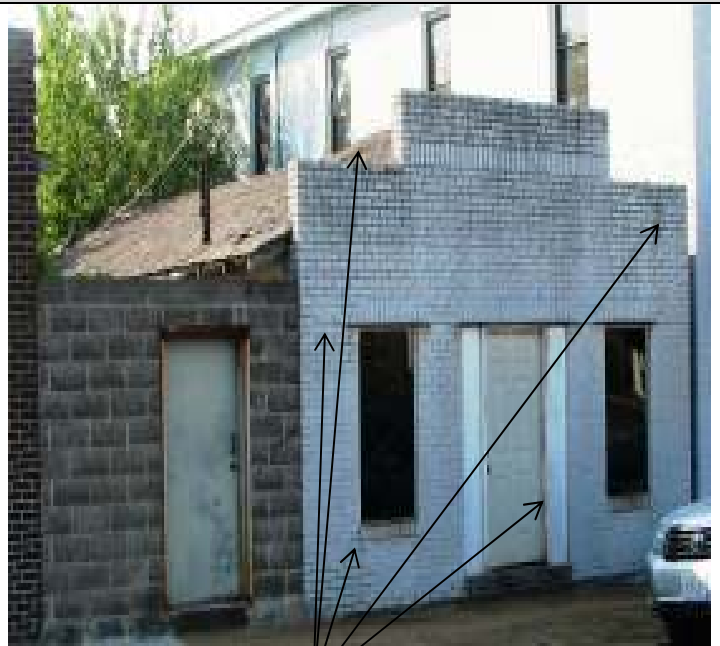
Façade (west) and north elevation, showing worn roof, deteriorated rafters, missing mortar, cracked brick, and weather door surround

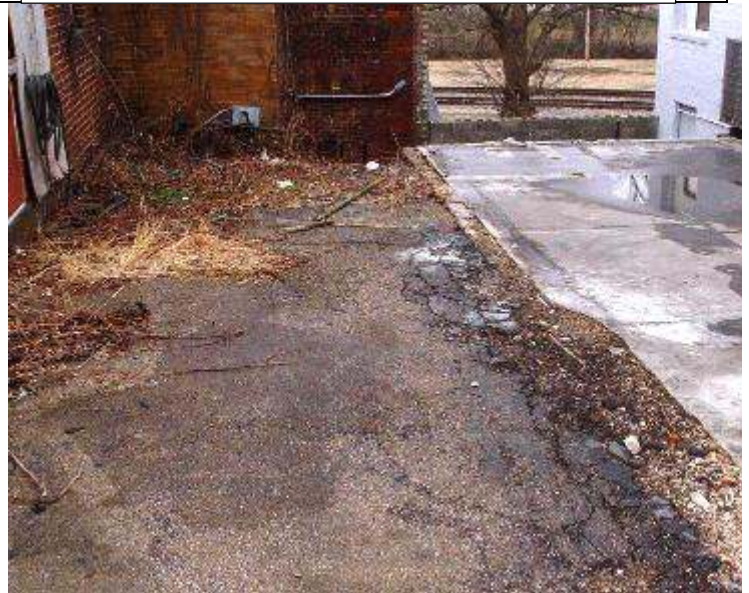
Showing the foundation and lot where building once stood

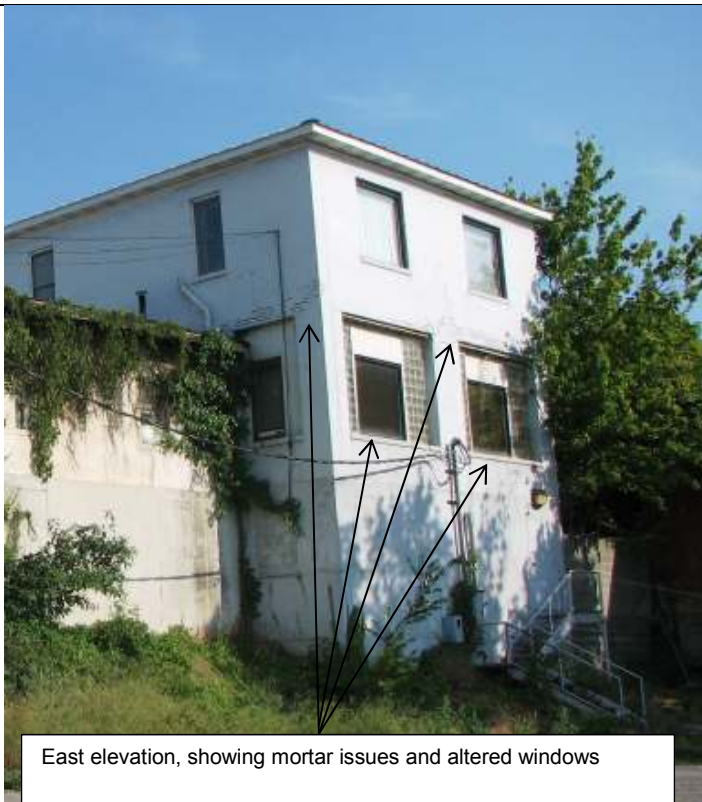
This two-story brick building fronts S. 2nd Street to the west.
 The east and south elevations of the building has some deterioration of mortar. The windows on the east elevation have been altered. The lower level of the east and south elevation exhibits signs of bricked in window openings.
 There is some vegetation growing up on the exterior wall surface of the south elevation.
 Interior of the building on the second floor has mold growing and the wall paper is coming loose and hanging down in some spots.

East elevation, showing mortar issues and altered windows

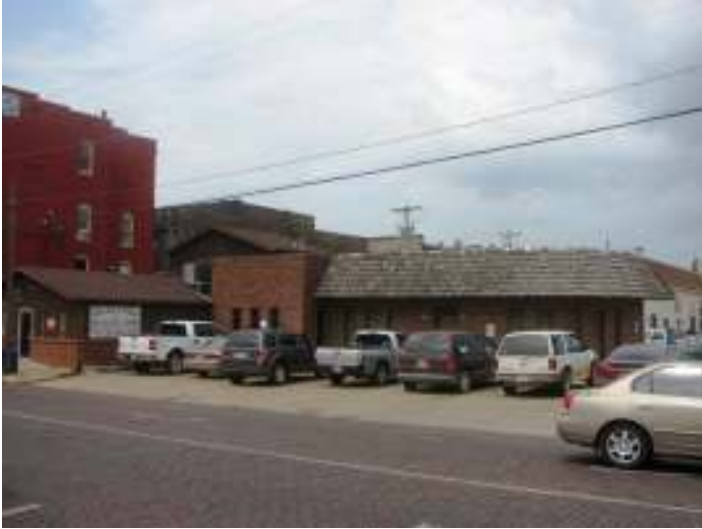
Showing façade and parking

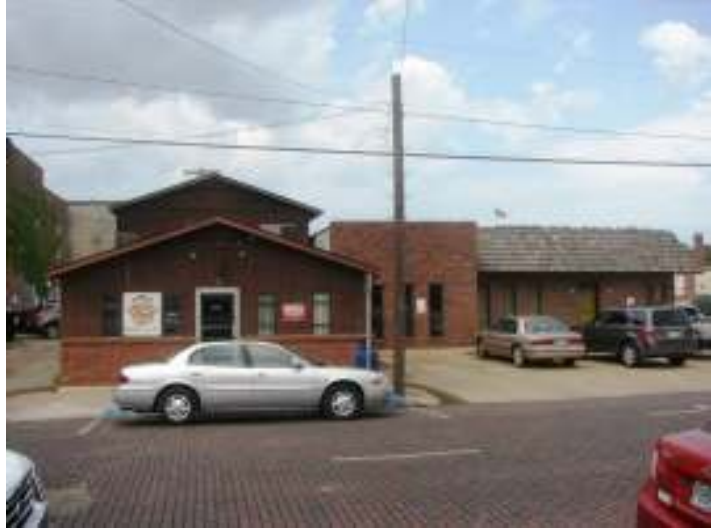
Overall the building looks well maintained. Located on the façade of the Ca. 1950 building is an area of missing mortar around the windows.

Showing facade

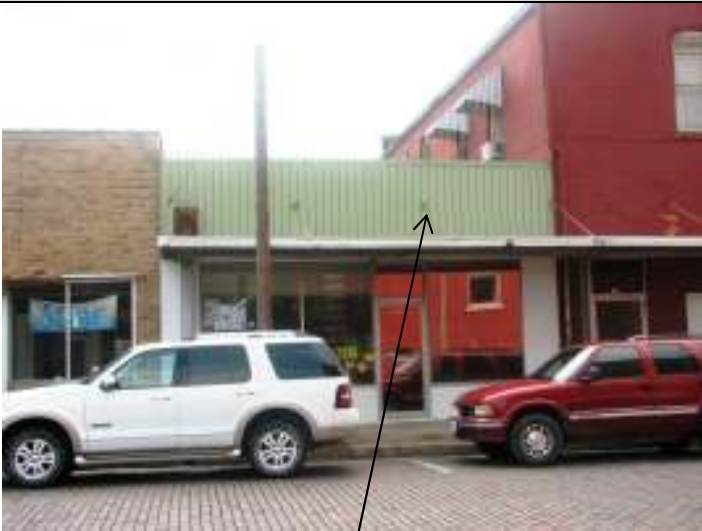
The awning supports shows signs of weathering. Overall, the building appeared maintained, but the interior ceiling did have signs of water damage.

Façade (west), showing weathered supports

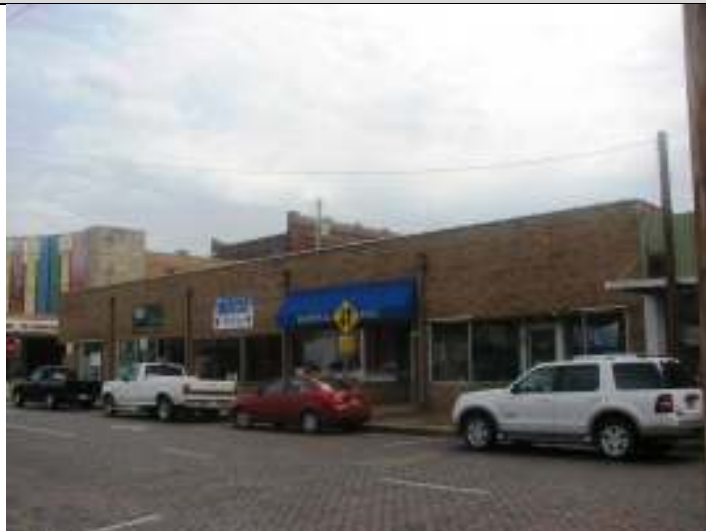
Façade (west)

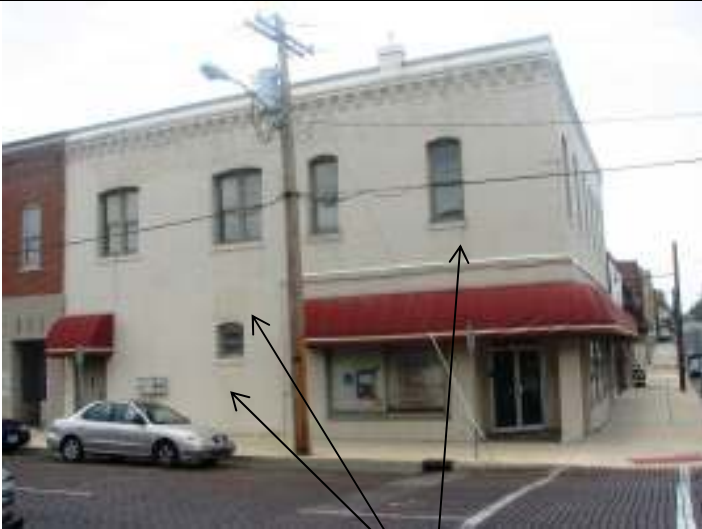
Façade (east), showing weathered stucco

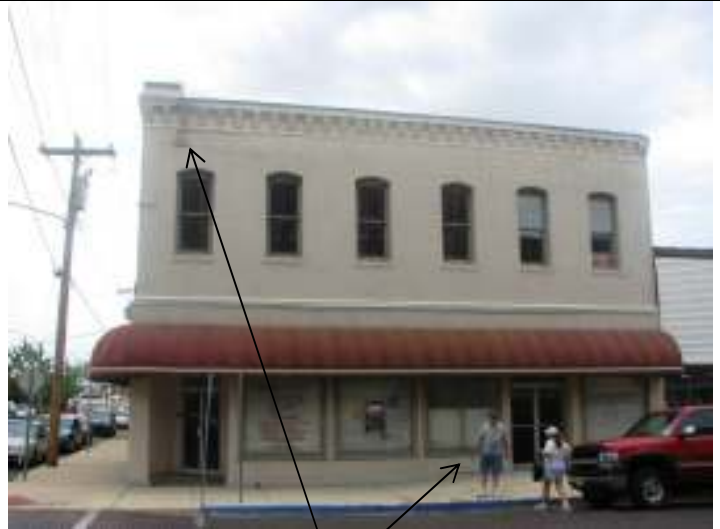
North elevation, showing weathered stucco

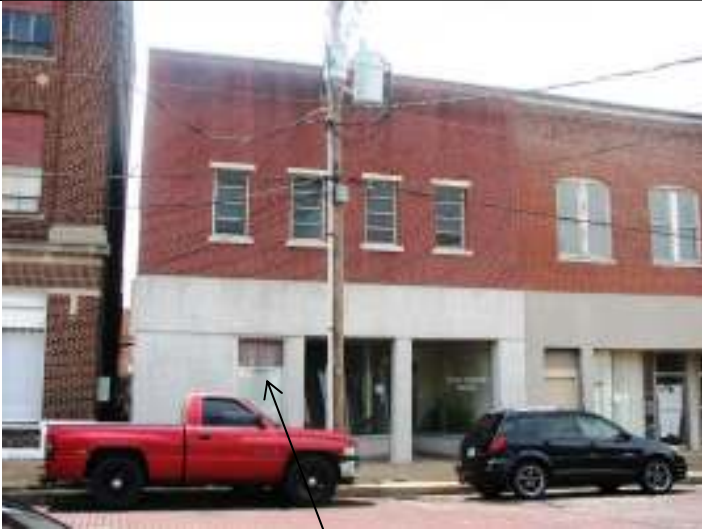
Façade (east), showing infilled window opening

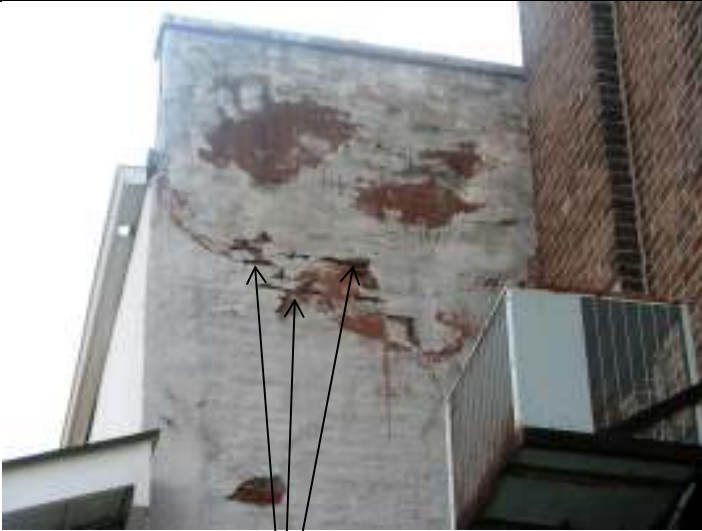
South elevation, missing mortar

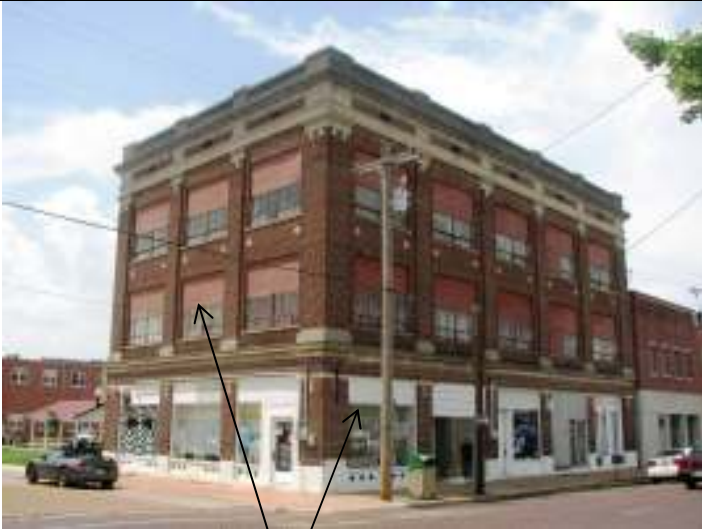
Façade (east) and south elevation, showing boarded up windows

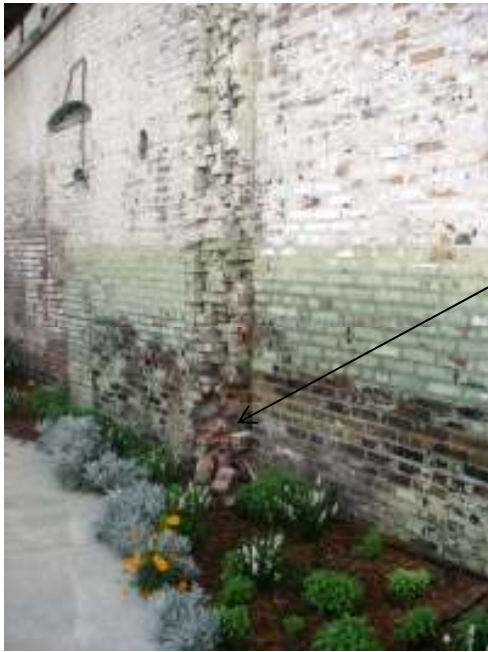
West elevation, showing
fallen and loose bricks

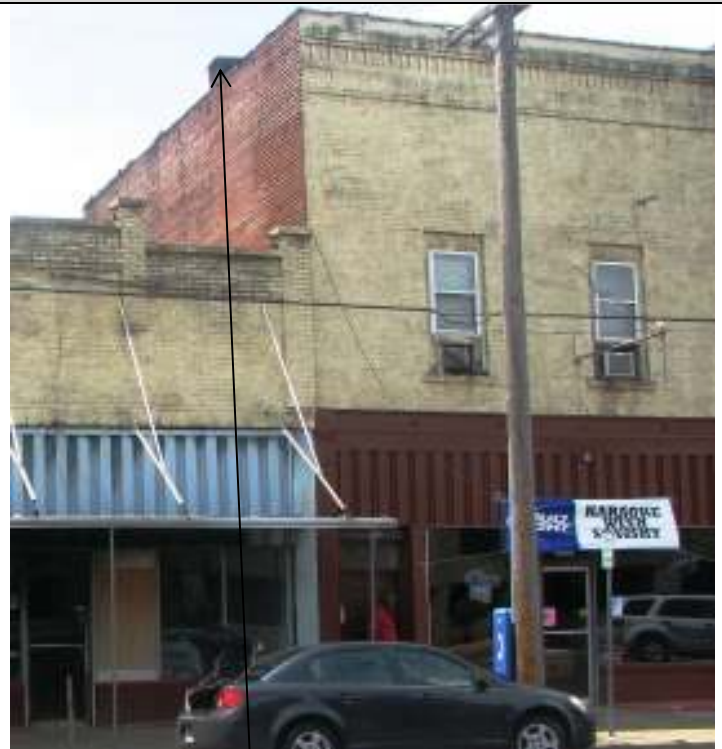
North and west elevation, showing missing mortar, missing window, infilled window, repair of brick with concrete and missing brick

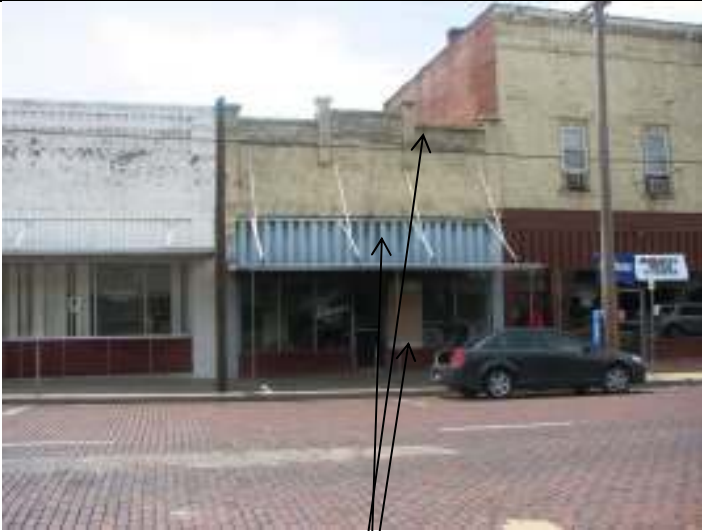
Façade (east), showing smoke damage on brick wall surface and awning, and missing store front window

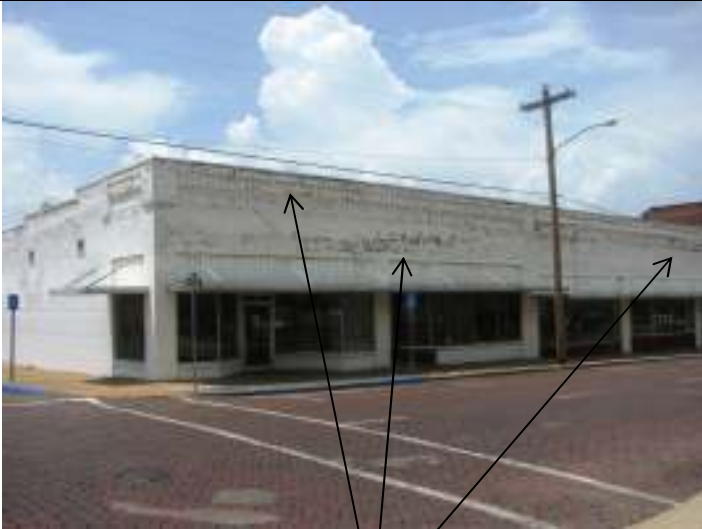
Façade (east) and south elevation, showing peeling paint and mortar issues

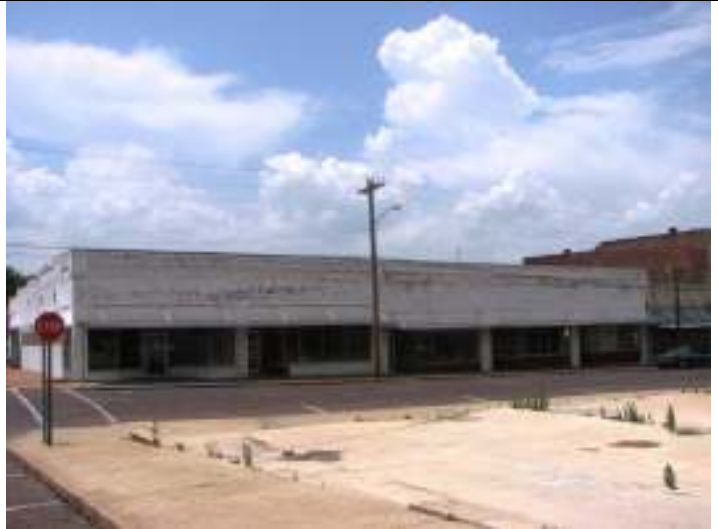
Façade (east)

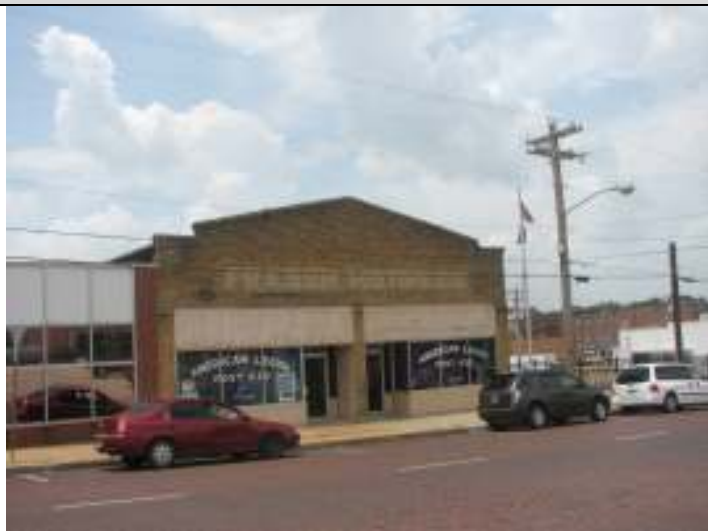
Façade (east)

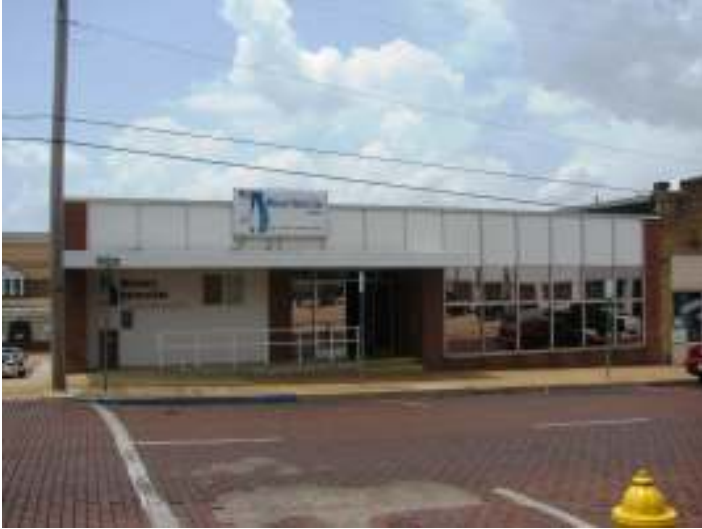
Façade (east)

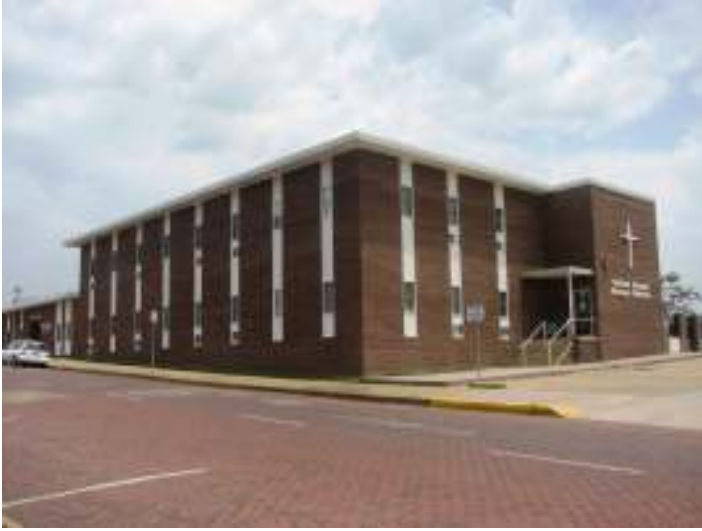
Façade (west) and south elevation

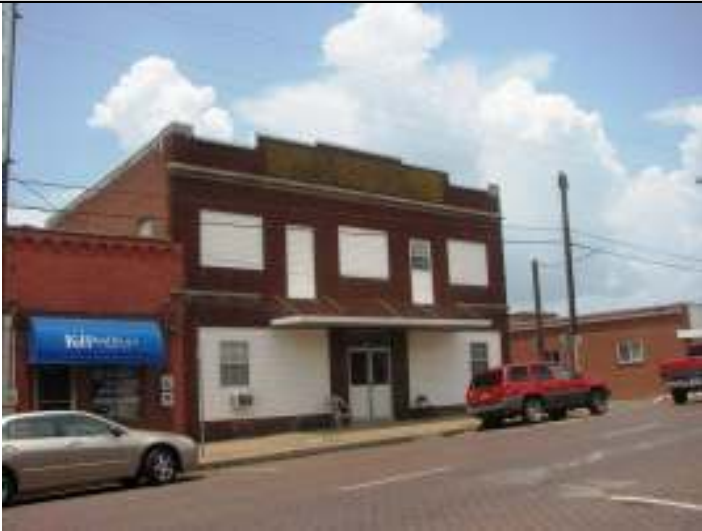
Façade (east)

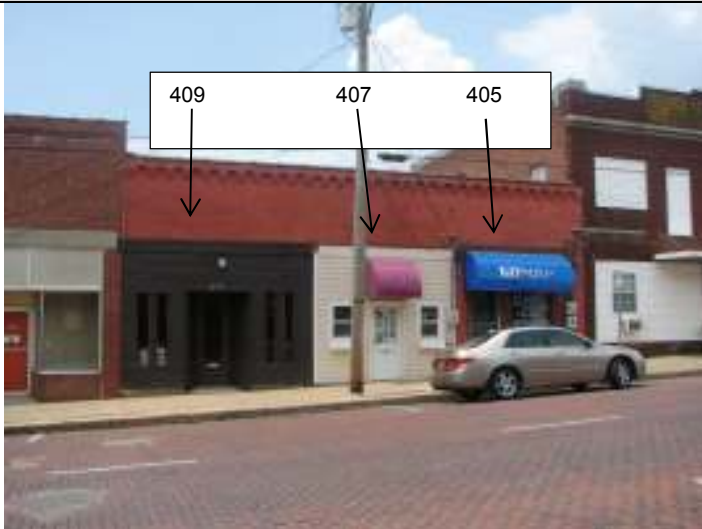
Façade (east), showing the different addresses

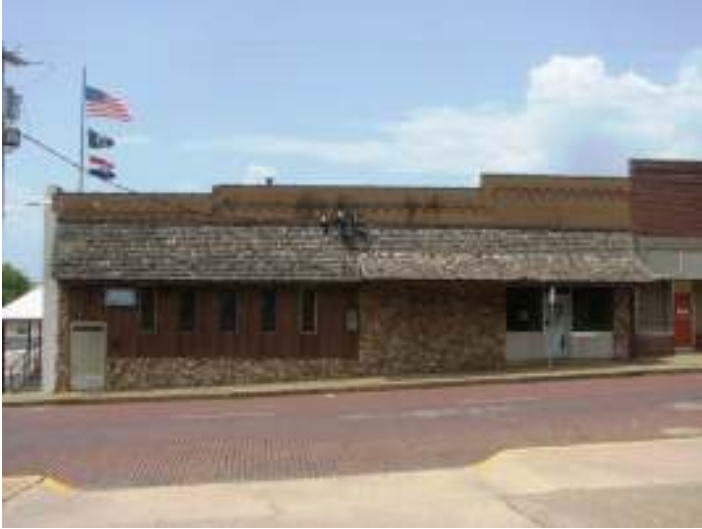
Façade (east

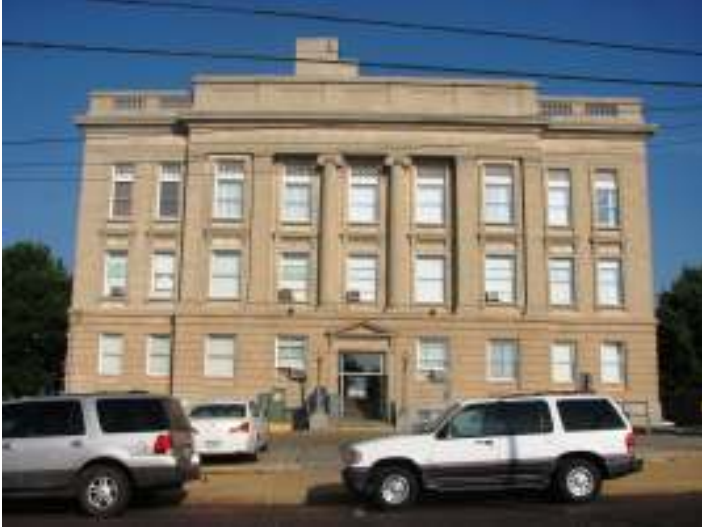
East elevation

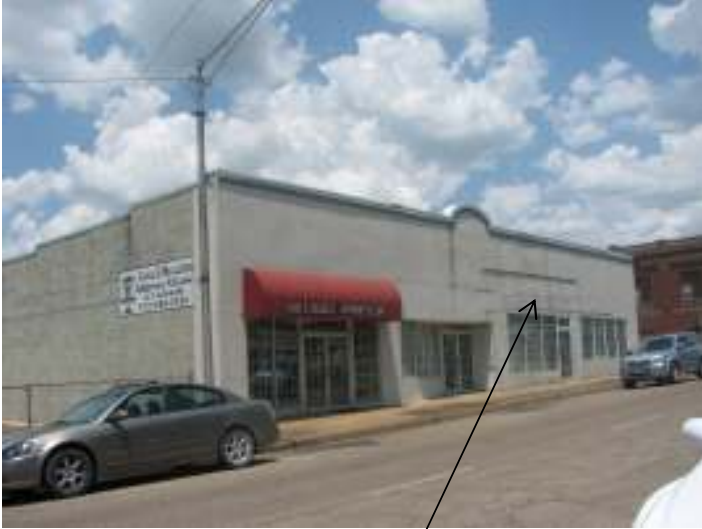
Façade (east), showing missing awning cover

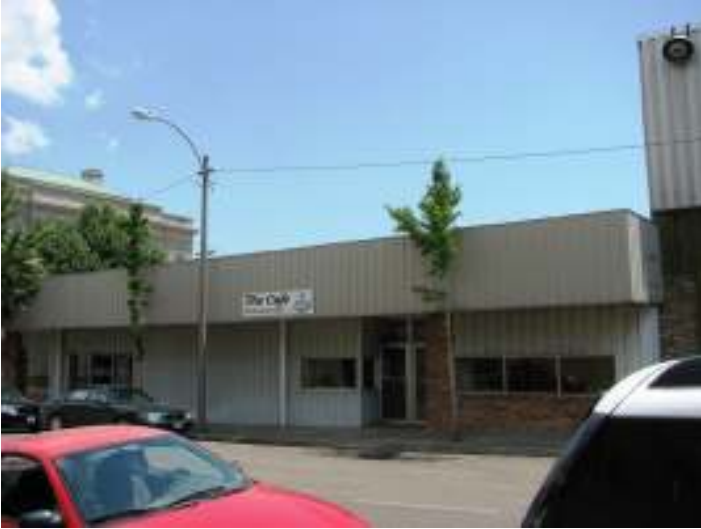
Façade (west) showing weathered metal siding

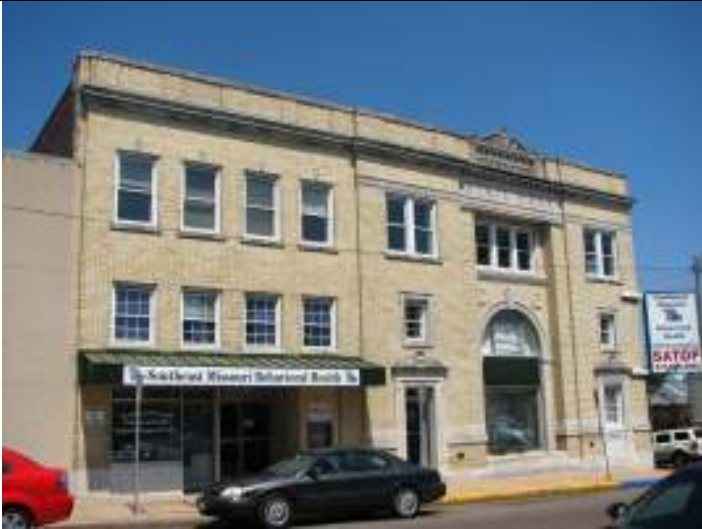
Façade (east), showing maintained building

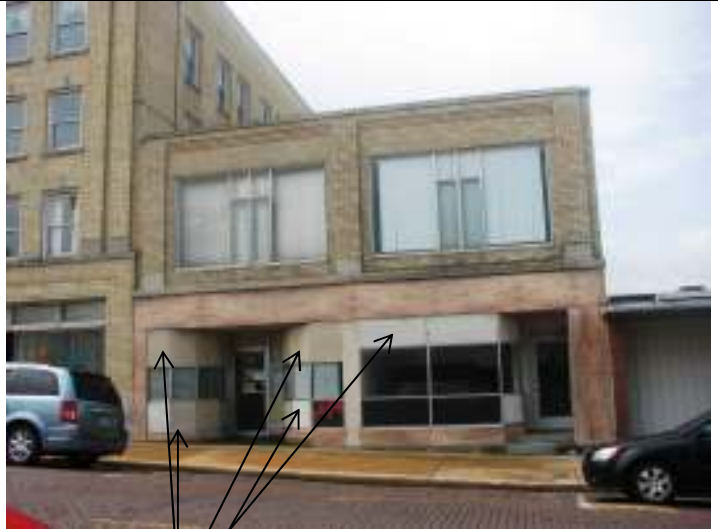
North elevation, showing the address of 332 Vine Street, and boarded up windows

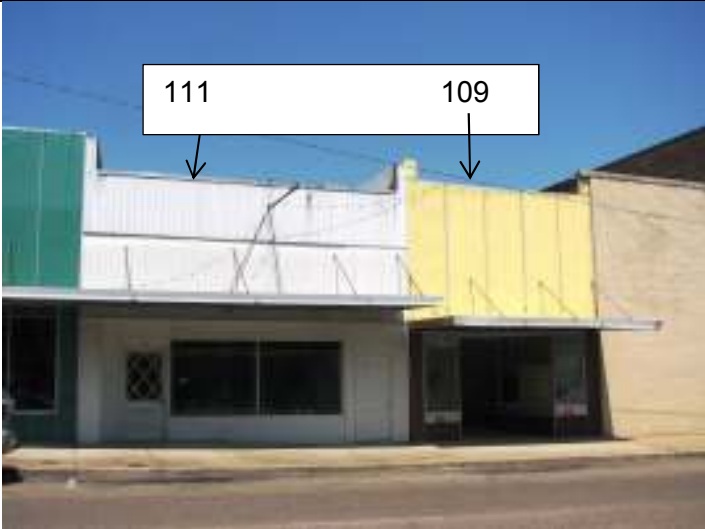
Façade (east)

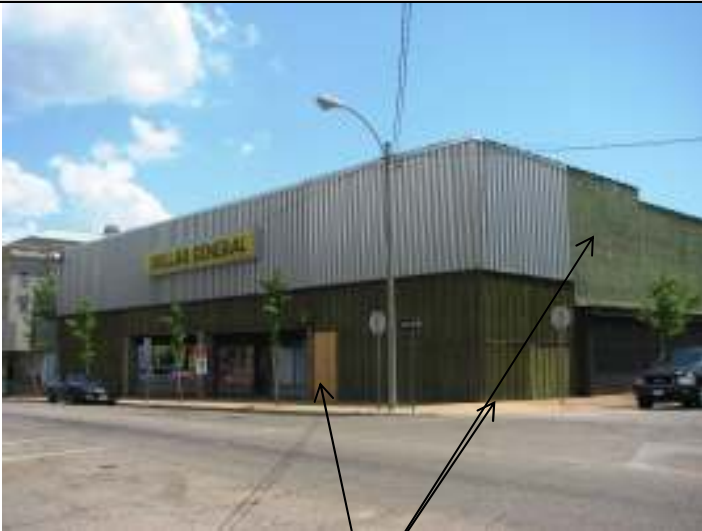
Façade (west) and south elevation, showing missing storefront window, deteriorated wood siding, and peeling paint

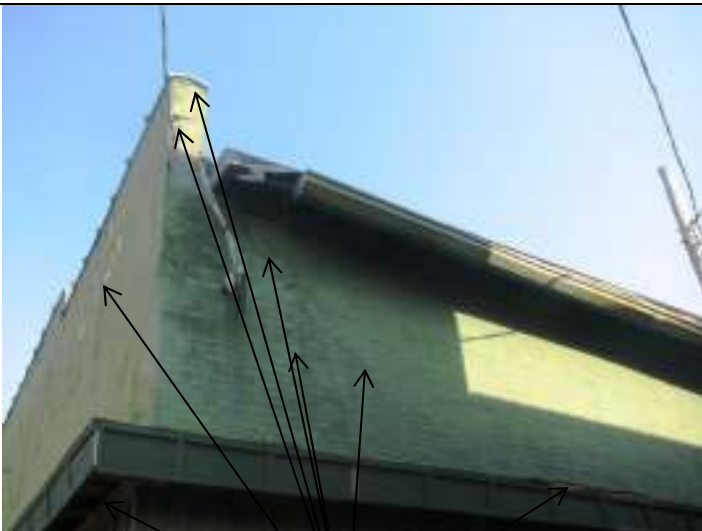
Southeast corner showing cracked brick wall surface, partial missing brick, bent coping, missing trim, deteriorated trim and peeling paint

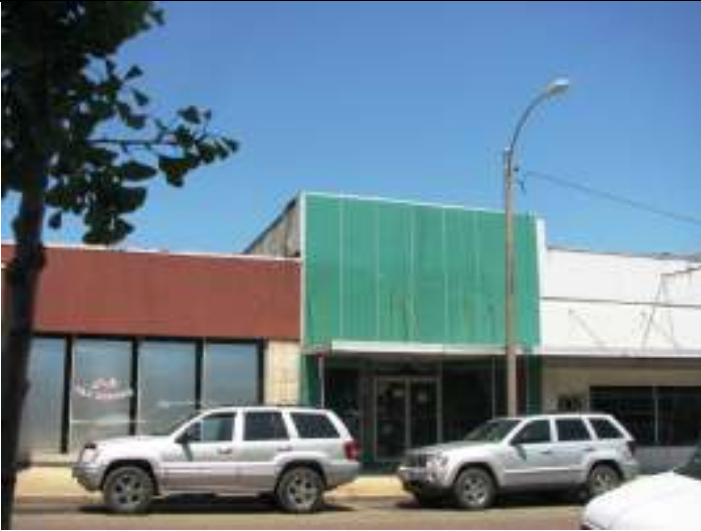
A few of the porcelain enamel panels are loose; marked as “other” in building condition box.

Façade (east) , some of the porcelain enamel panels are loose

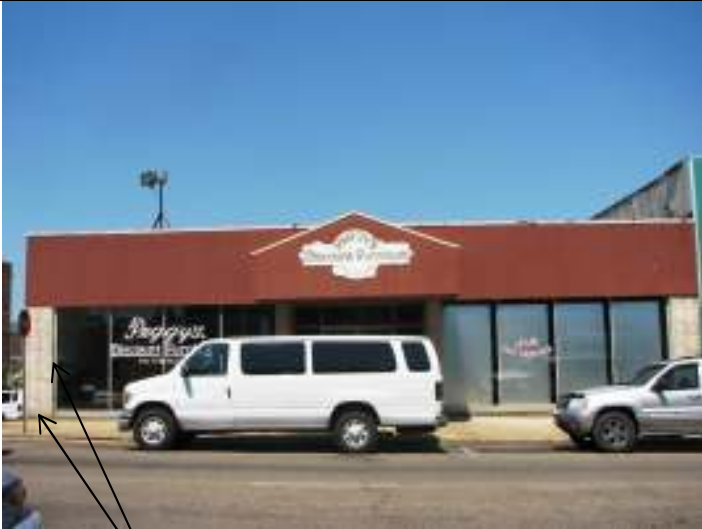
Façade, showing chip bricks, cracked foundation, and weathered sign.

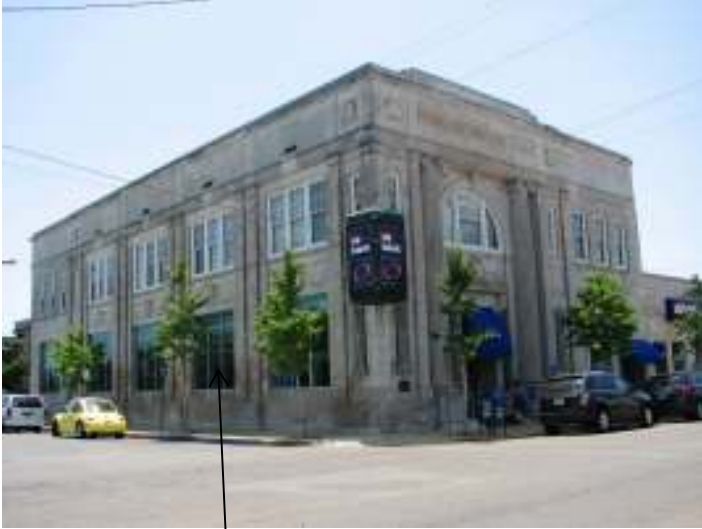
Façade (west) and north elevation, showing location of small hole in window

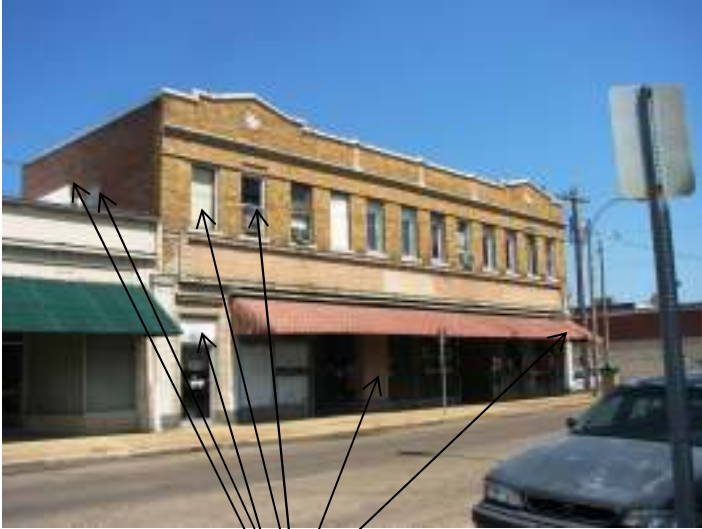
Façade (east) and south elevation showing bent awning, boarded up windows, missing windows

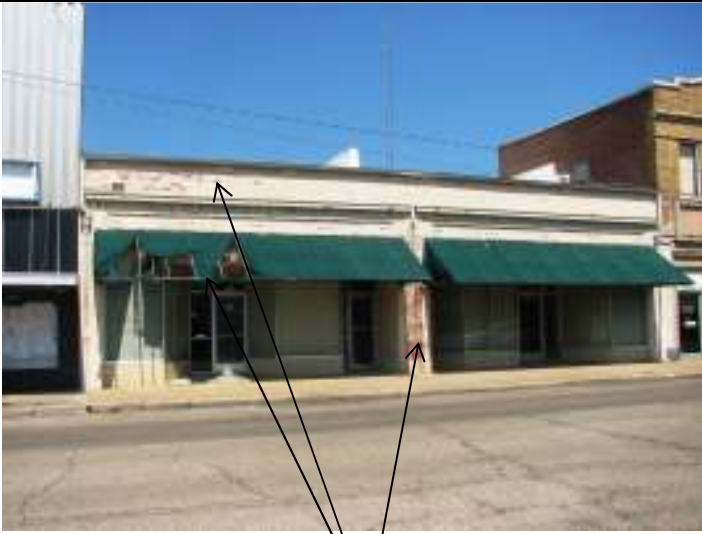
Façade (east), showing peeling paint, torn awning cover

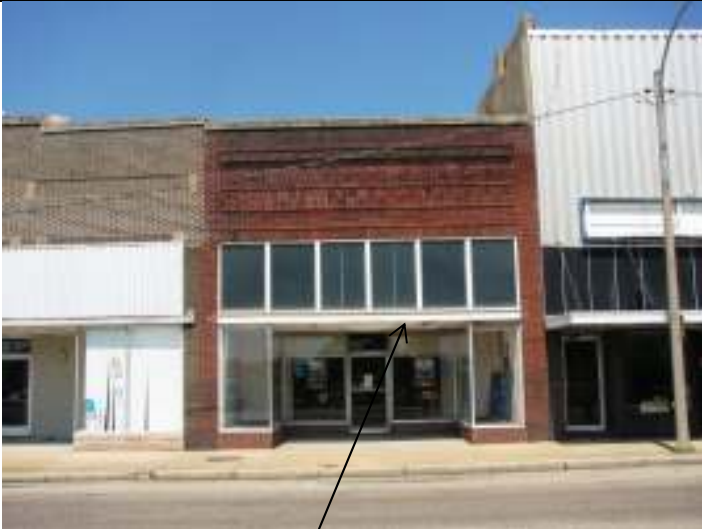
The ceiling in the entrance has peeling paint; marked as “other” in building condition box.

Façade (east), showing peeling paint

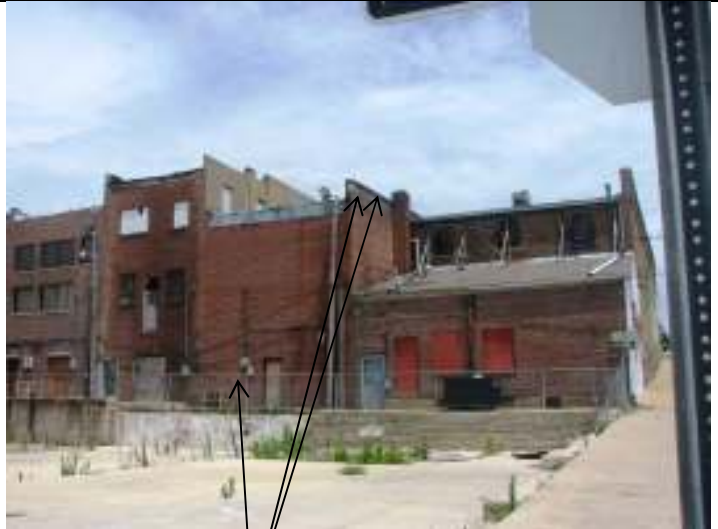
The parapet at the rear of the building appears to be leaning and brick work needs repair; marked as “other” in building condition box. It looks like there has been some repair work done in the past. West elevation has graffiti; marked as “other” in building condition box.

West and south elevation, showing leaning parapet wall, brick work issues, and graffiti

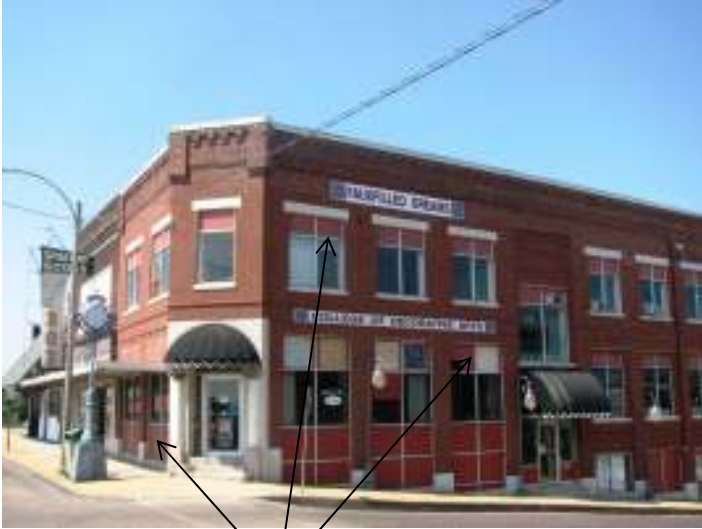
Façade (east) and north elevation, showing covered over windows

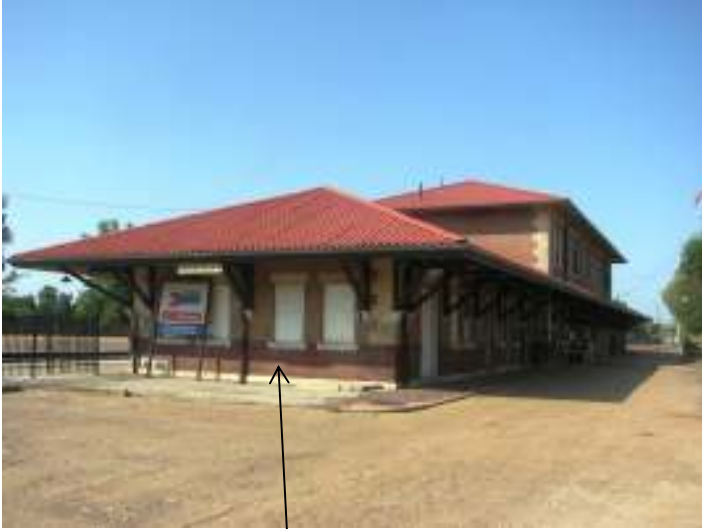
North elevation, showing boarded up windows

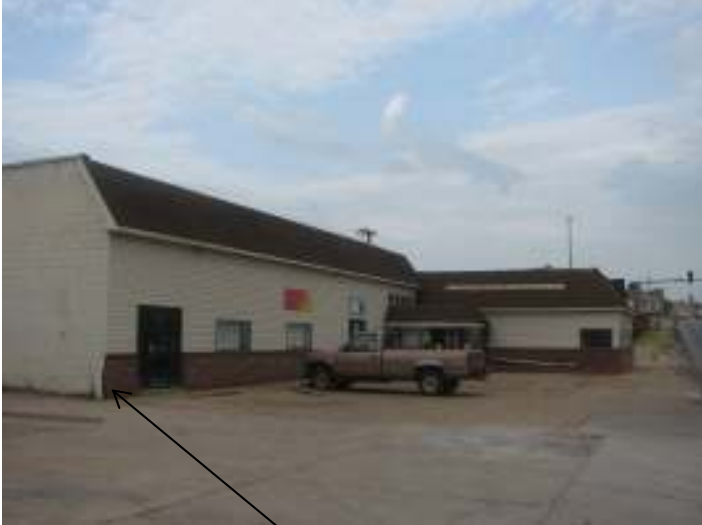
The main entrance to the building has missing wood trim in door surround creating a hole on either side of the door frame. A brick coping for landscaping (façade or north elevation), is located between the building and the parking lot. Coping has loose and fallen bricks (noted under landscaping element in table). Located on the northeast corner of the building is a damaged downspout.

Façade and east elevation; showing damaged downspout

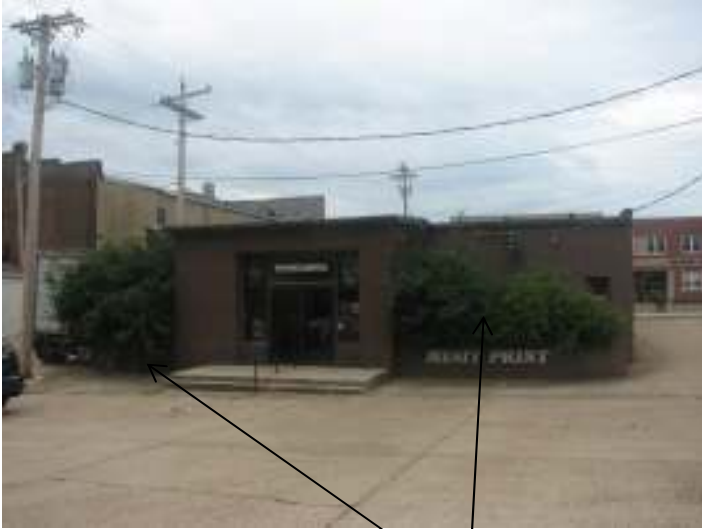
Façade (north), showing overgrown shrubs

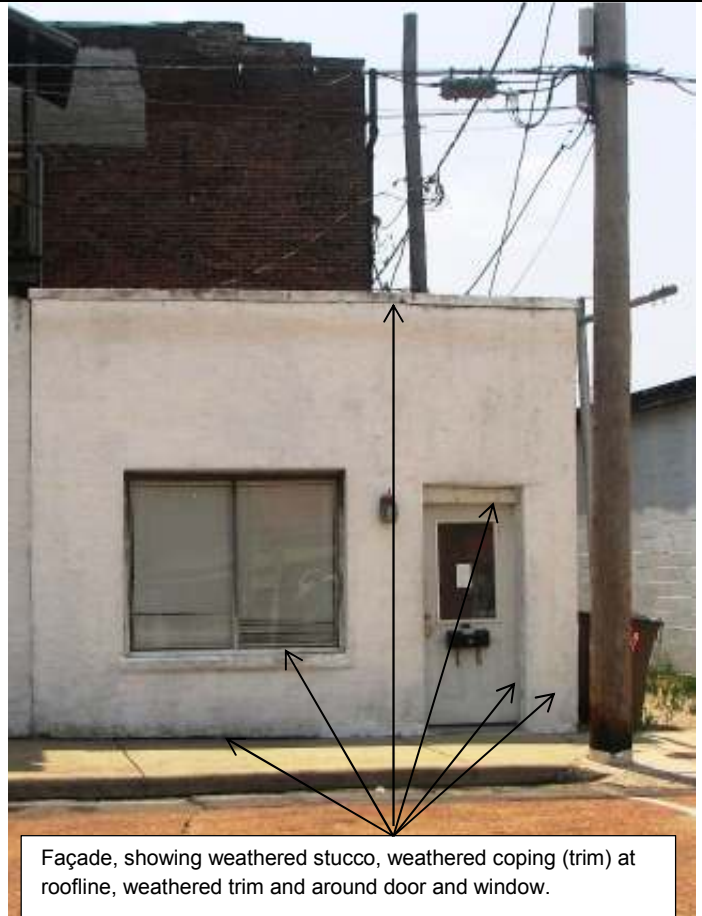
Façade, showing weathered stucco, weathered coping (trim) at roofline, weathered trim and around door and window.

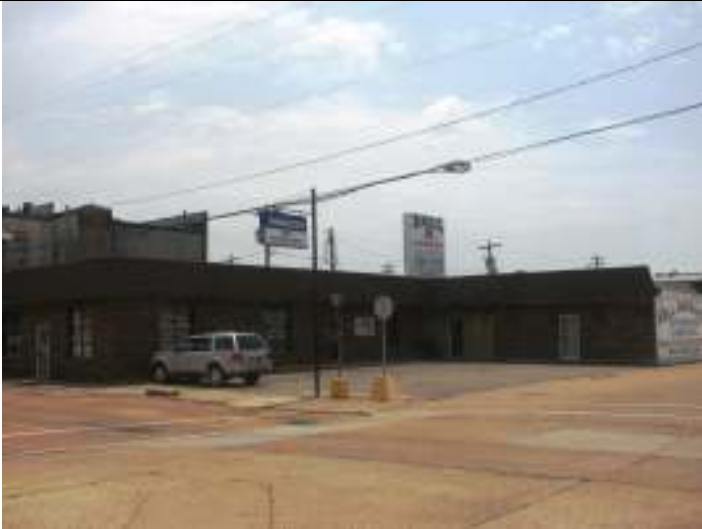
Façade (north and west elevation, showing off street parking)

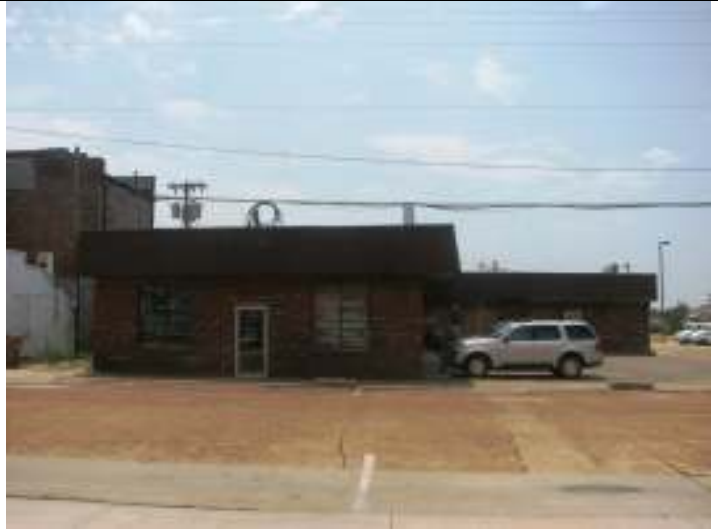
Façade (north)

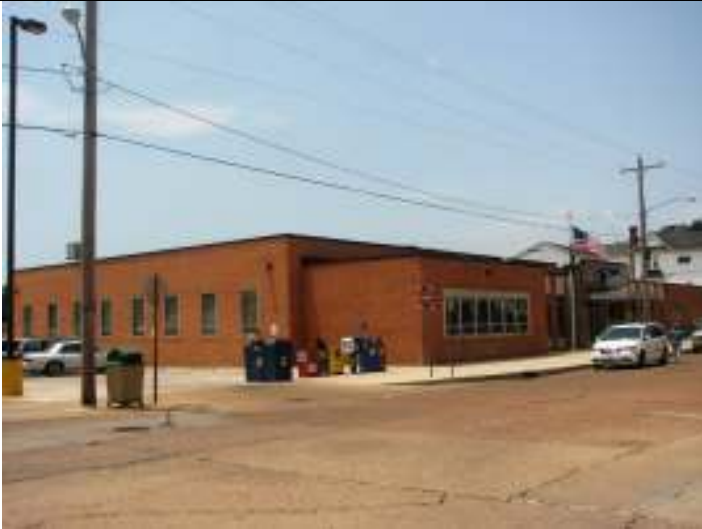
Overall the building appears to be in good to excellent condition. Building has had some previous re-pointing of the brick on the east elevation. Roof condition is unknown and was given a score of 2. If roof is in good to excellent condition, the overall rating for the building could be higher.

Façade (north) and east elevation

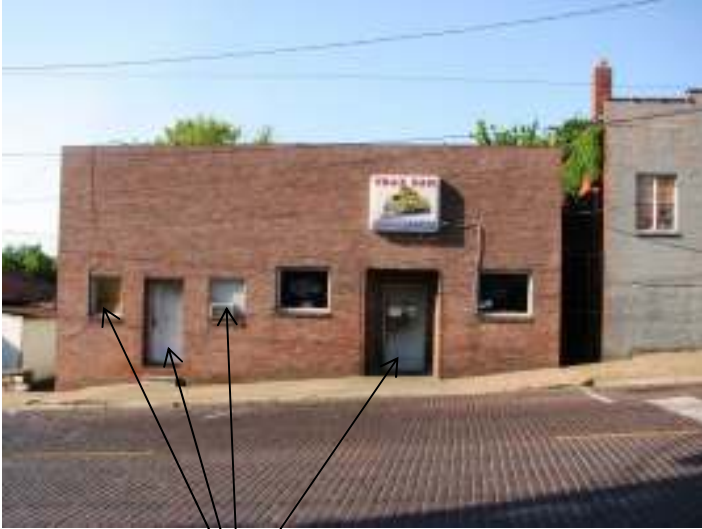
Façade (north), showing boarded up windows, and worn entrance doors.

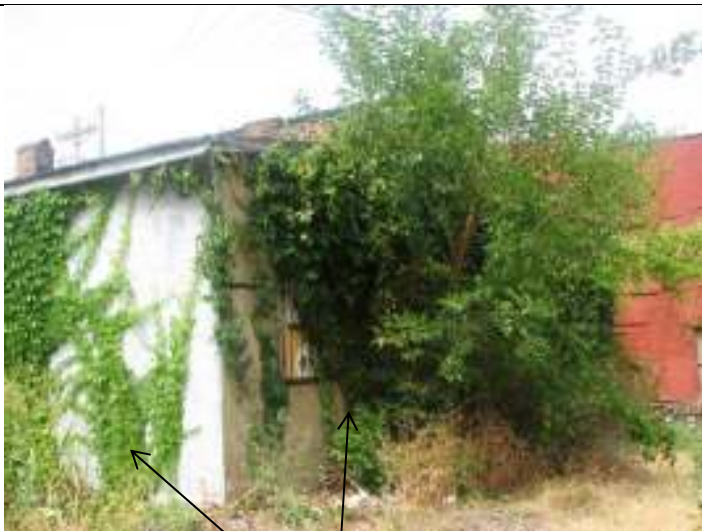
North and east elevation, showing over grown vegetation on building

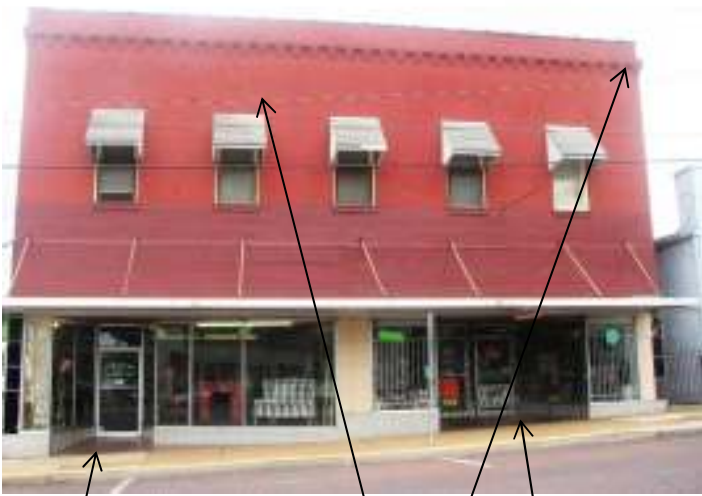
West elevation and façade, showing some peeling painting and spalling of brick

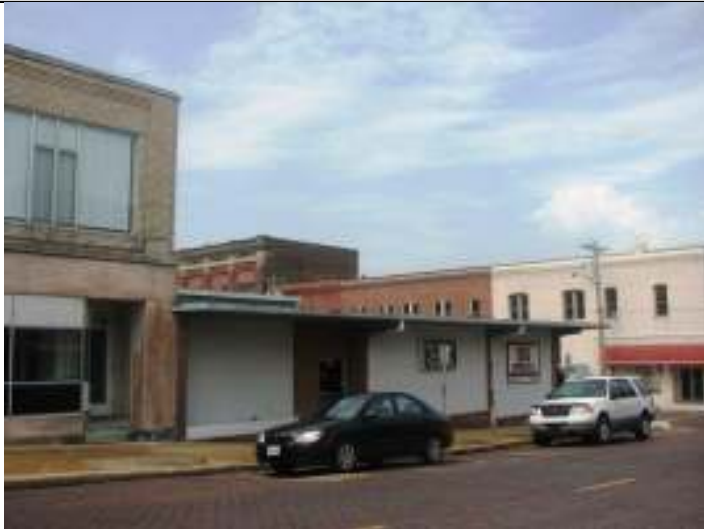
North elevation

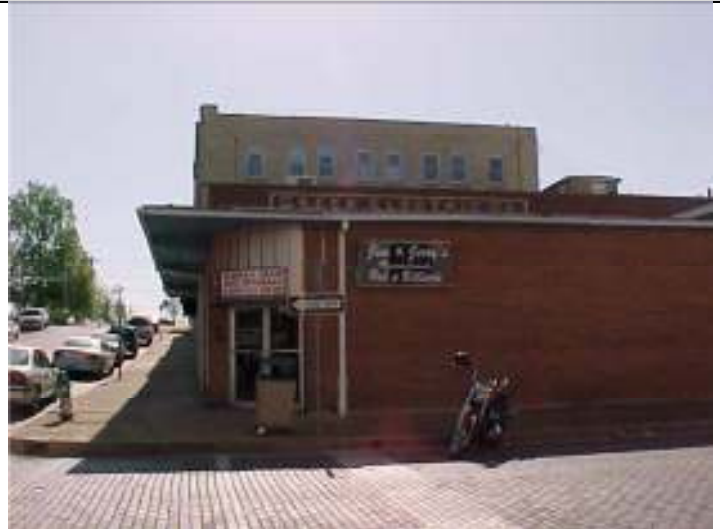
West elevation

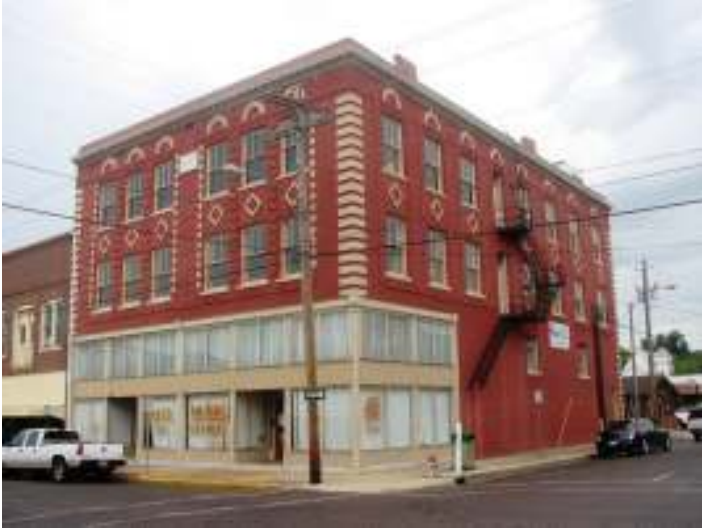
Façade (south) and east elevation

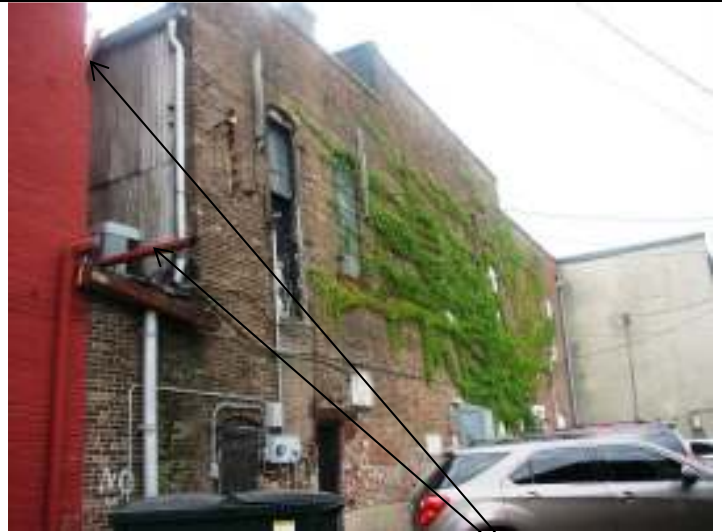
Rear (north) elevation – showing the west corner and disconnected downspout. Building is the red building in the photograph

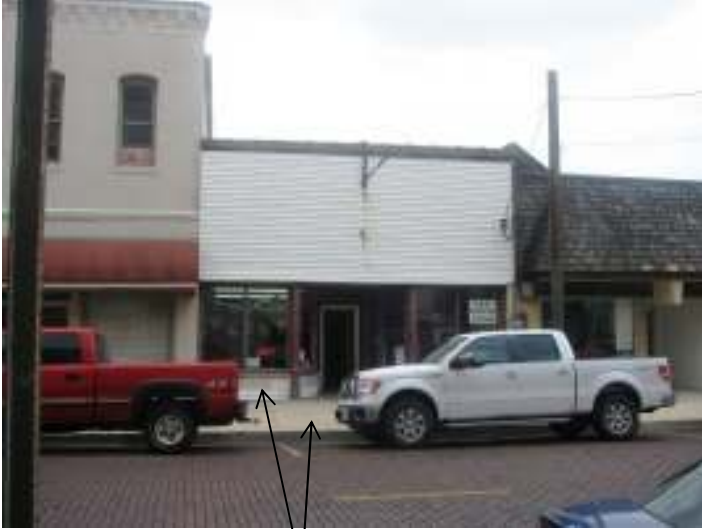
Façade (north), showing missing vinyl siding panel
