Land-Use and Building Survey Inventory Form

SURVEY NO. BU-AS-005-LUBC-018		
TOTAL SCORE OF OVERALL INTERIOR BUILDING CONDITION:		LOCATION: L1 – 1 ST FLOOR; L2- 2 ND FLOOR; L3 -3 RD FLOOR
12- EXCELLENT	6-8 – FAIR	0-4 - DILAPIDATED
9-11 – GOOD	1-3 - POOR

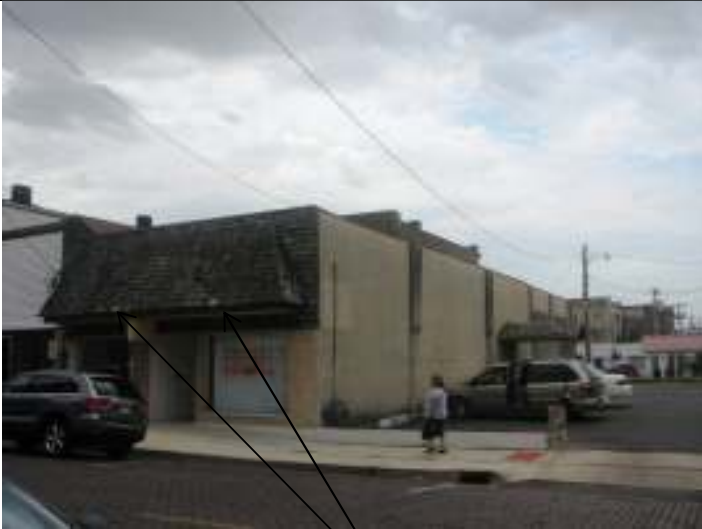
The wood shingle porch roof on the west elevation exhibits some deterioration; as well as the wood shingle roof over the storefront located on the facade. Located at the southwest corner are the remains of a wall from another building (see photo below) and the wall has loose bricks and fallen bricks.

Facade (north), showing missing wood shingles

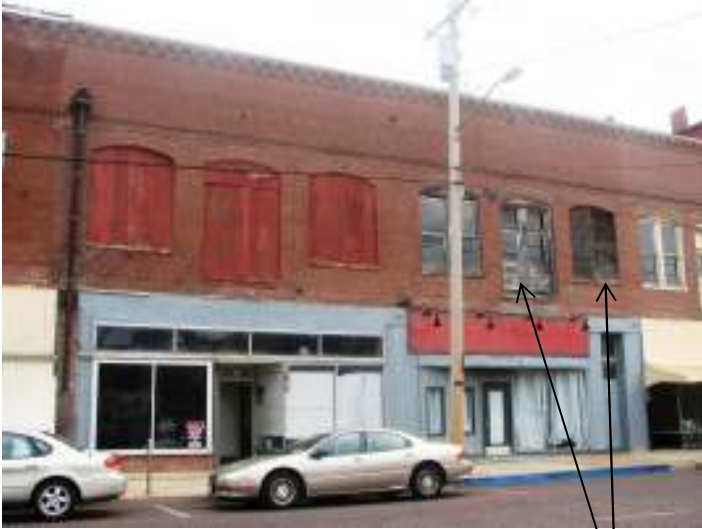
Façade (south) – showing boarded windows, deteriorated windows and doors

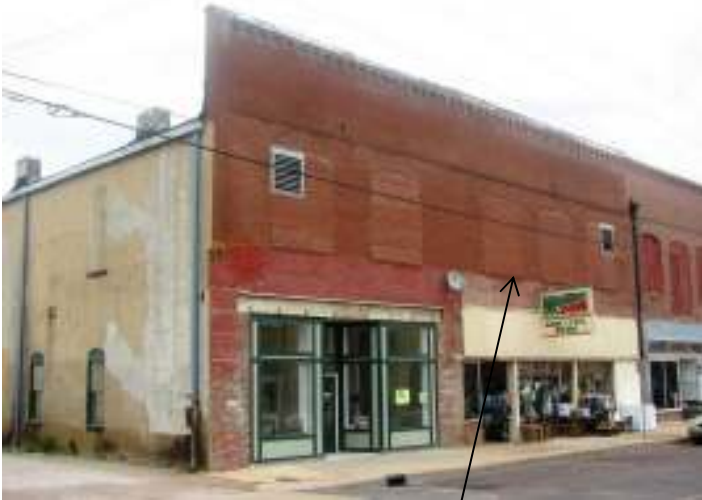
Façade (south) – 413 is second storefront from corner. Showing brick infilled windows

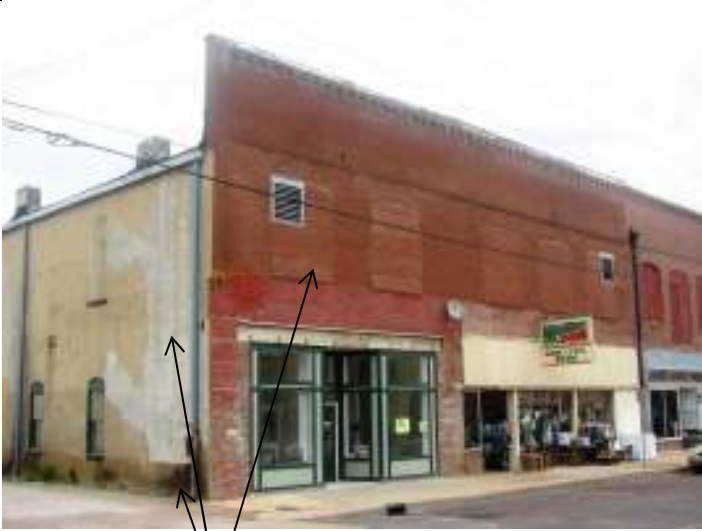
Façade (south) and west elevations – 415 is storefront on the left (end) – showing brick infilled windows, and deteriorated stucco. Water damage on lower section of west elevation
