City of St. Louis Cultural Resources Office

Holly Hills Neighborhood Survey

Lynn Josse and NiNi Harris
3/1/2010

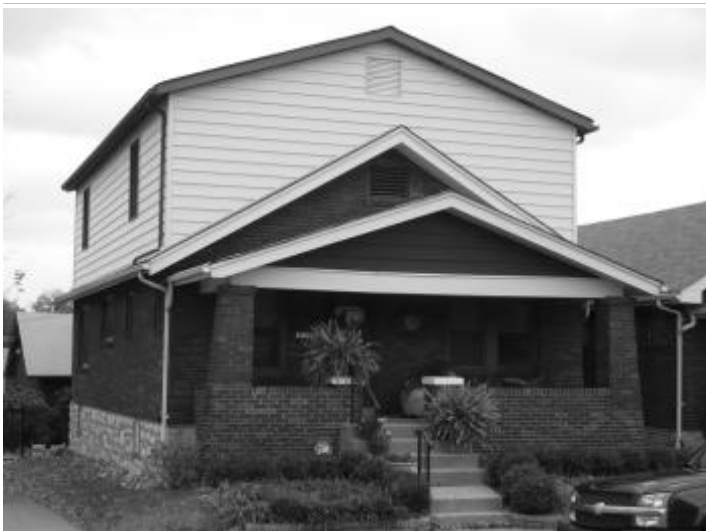
Added second story.

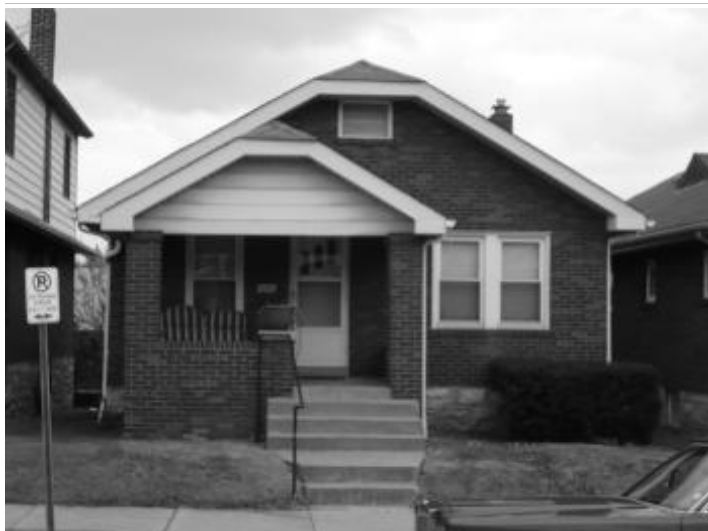
Modern siding used at porch's gable end and eaves. Replacement windows.

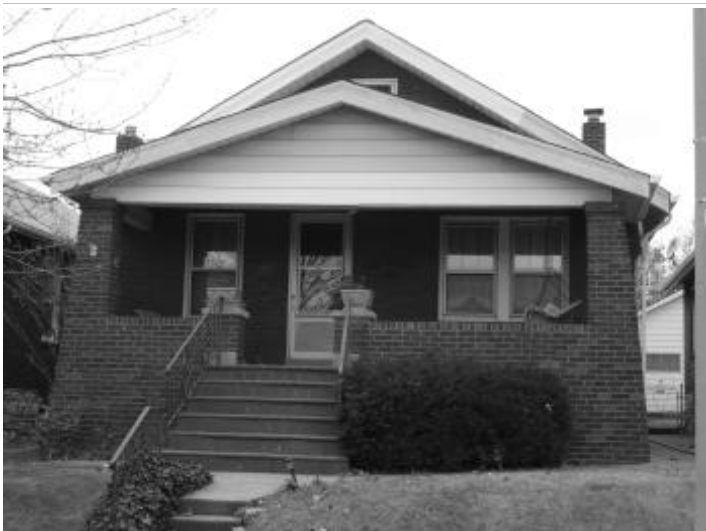
14*14 addition permitted to owner Doehler in 1946. Siding at porch gable end. Horizontal modern siding at porch gable end.

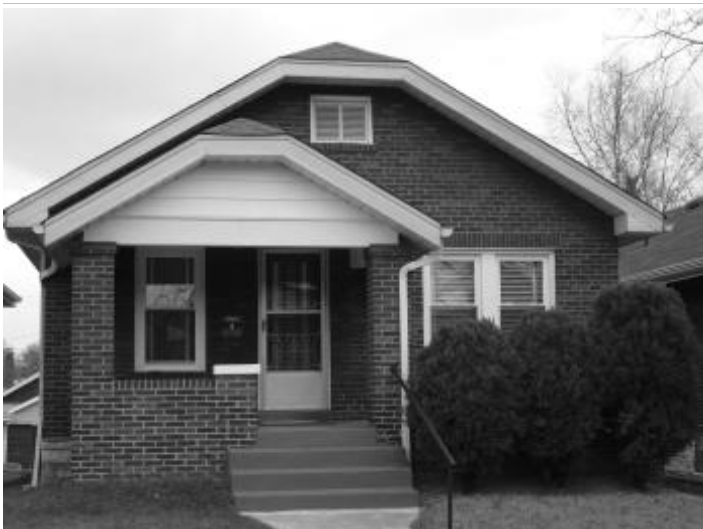
Modern siding used at porch's gable end and eaves. Replacement windows.

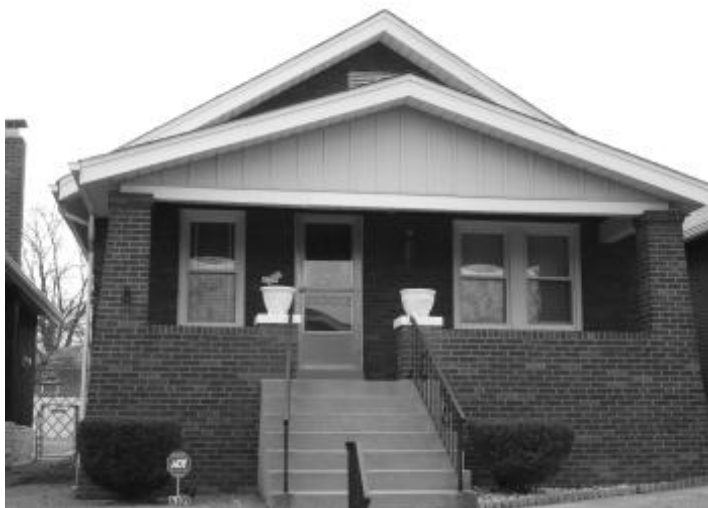
Vertical metal siding at porch's gable end. Replacement windows.

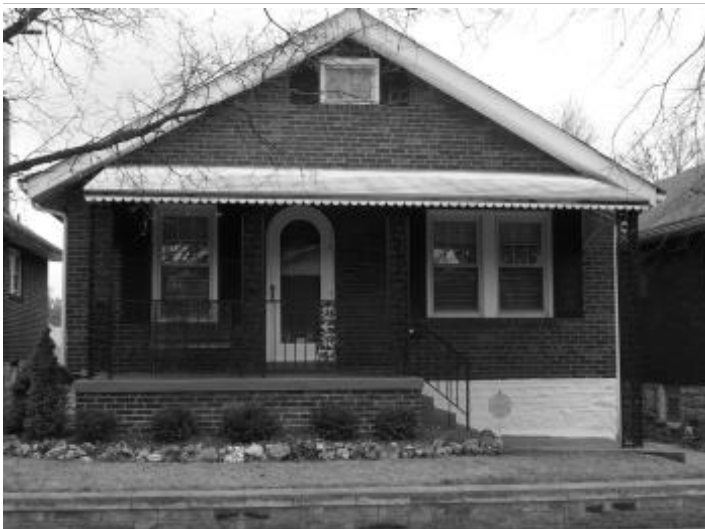
Replacement windows.

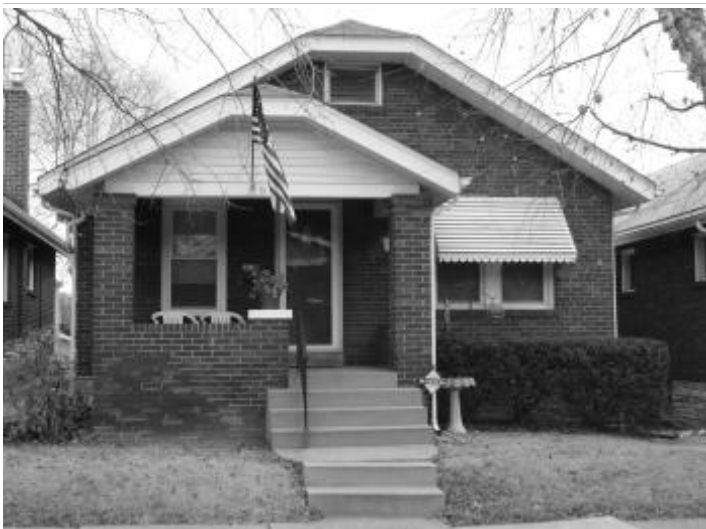
Replacement windows. Awning at right windows. Horizontal modern siding at porch gable end.

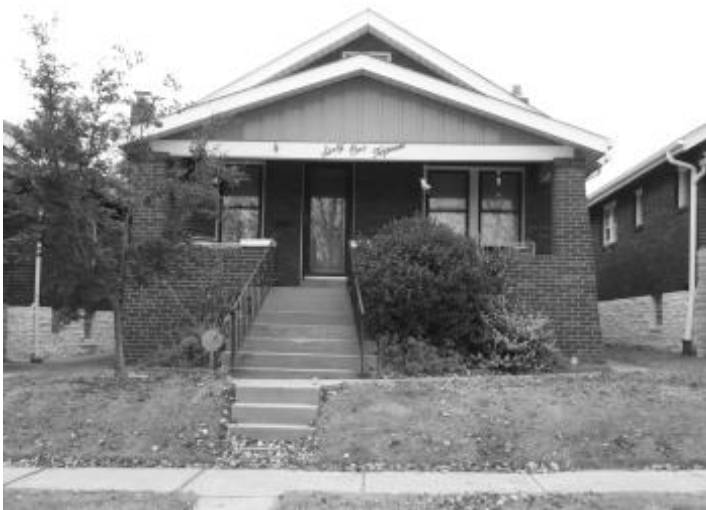
1-story addition 3/9/1949 to owner Cashel, \$1500. Vertical metal siding in porch gable end; replacement door.

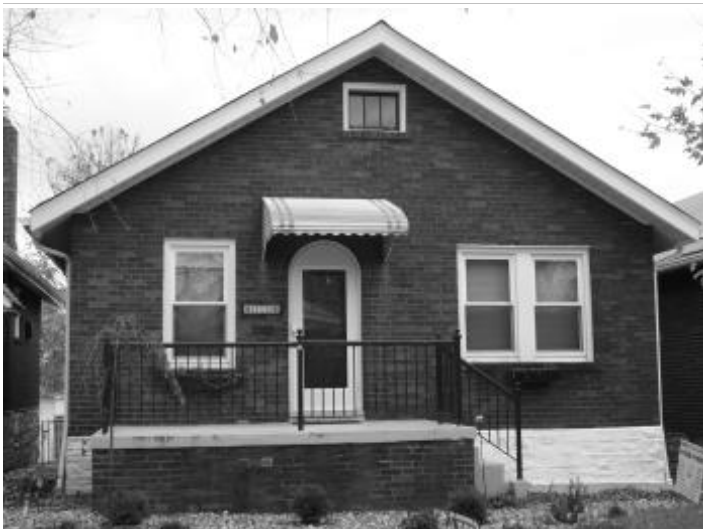
Replacement windows.

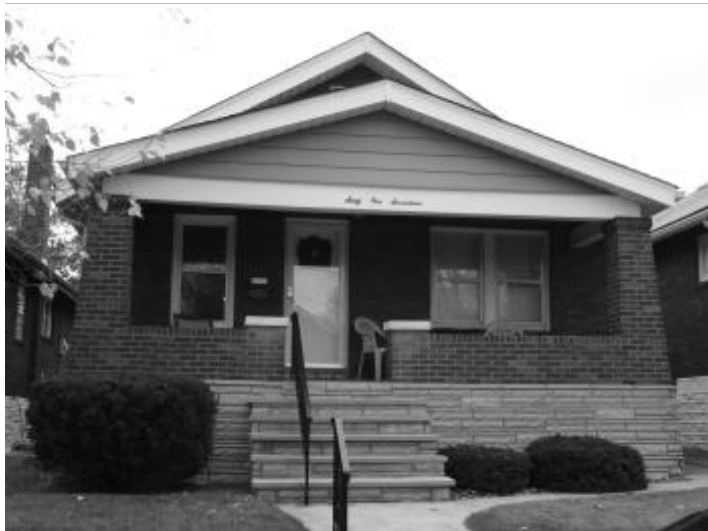
imitation stone veneer applied to base at façade. Siding over all porch and eave wood trim.

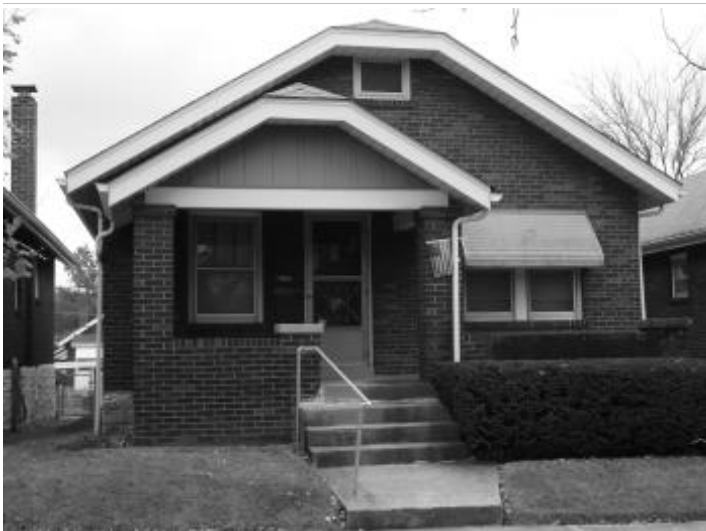
Modern vertical siding on porch gable end. Fiberglass awning, right.

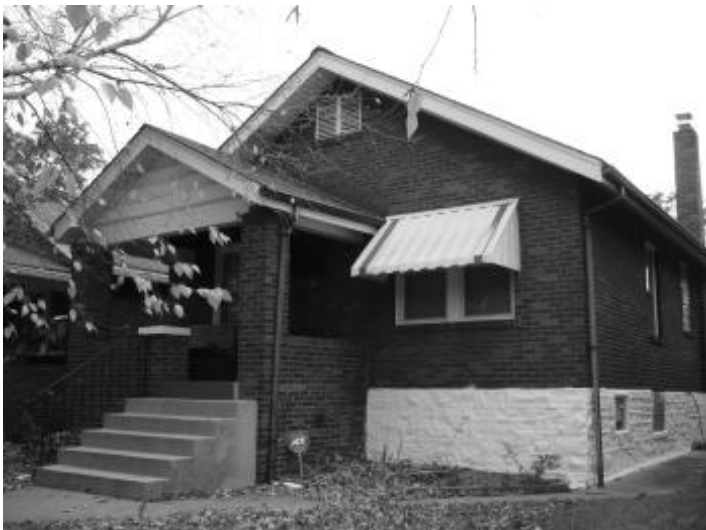
To the right, the paired windows are under a metal awning. All three façade windows are replacements, and all of the wood trim is covered with siding.

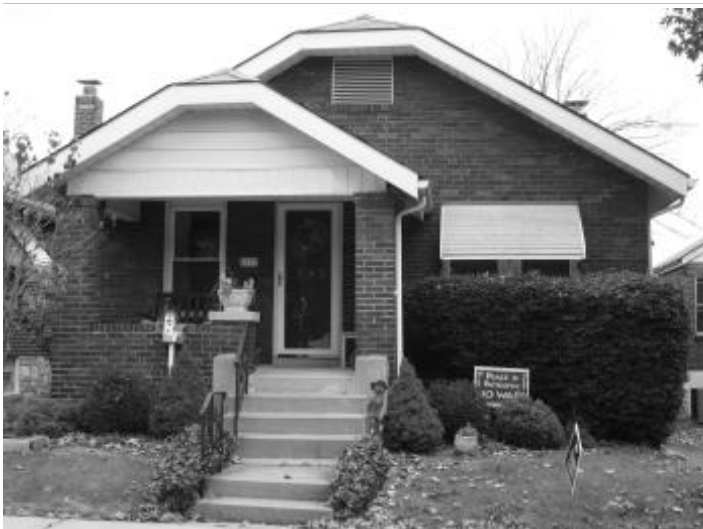
Modern horizontal siding on porch gable end. Fiberglass awning, right. Replacement windows.

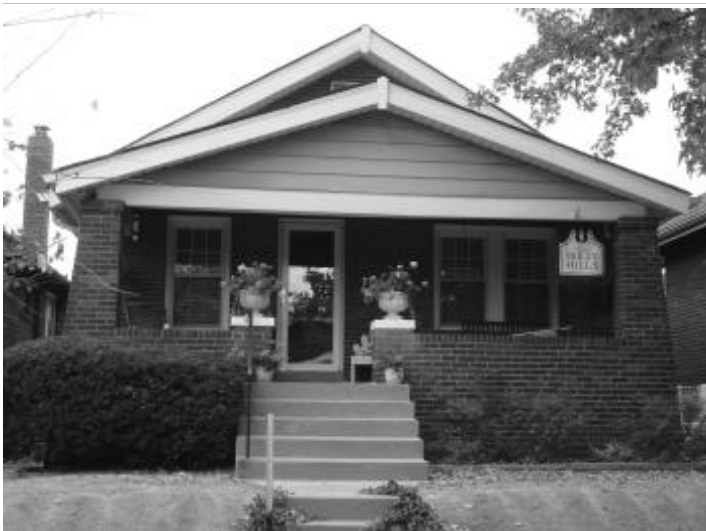
Replacement windows; wood trim sided; horizontal siding in porch gable end.

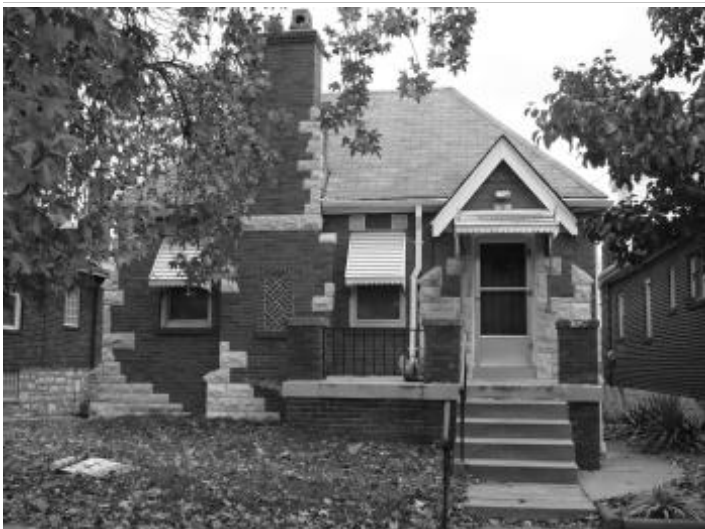
\$1500 addition 9/21/1949 to owner Gergs. Awnings added at façade windows and door.

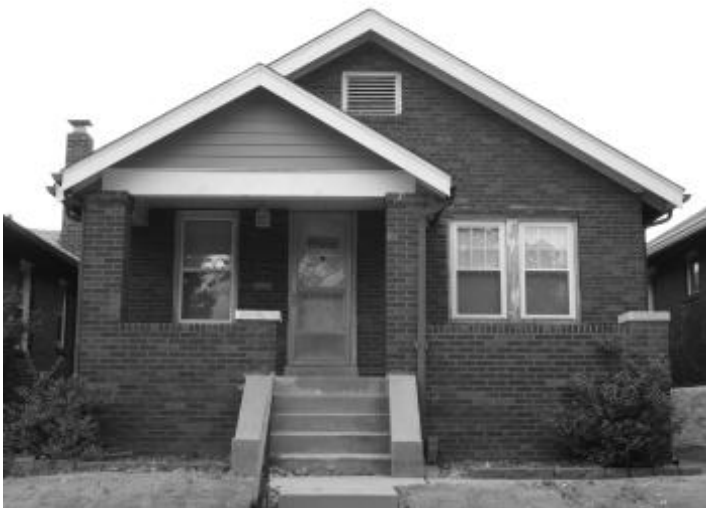
Front door and windows are replaced. Vinyl in porch gable end.

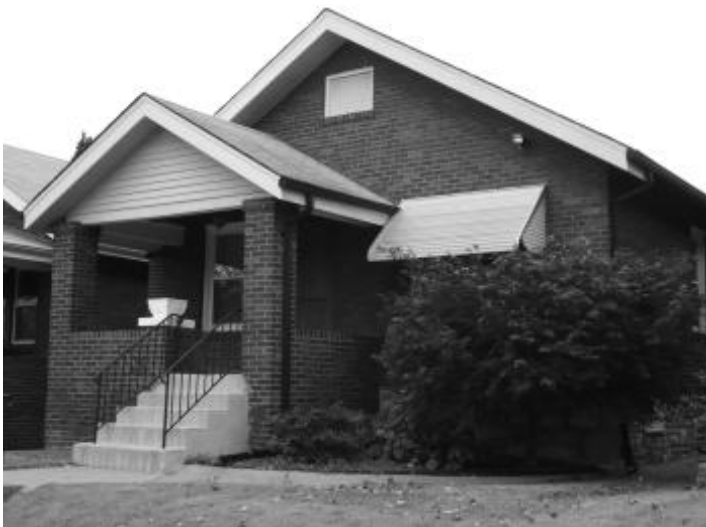
Front door and windows are replaced. Vinyl in porch gable end. Awning at window pair, right.

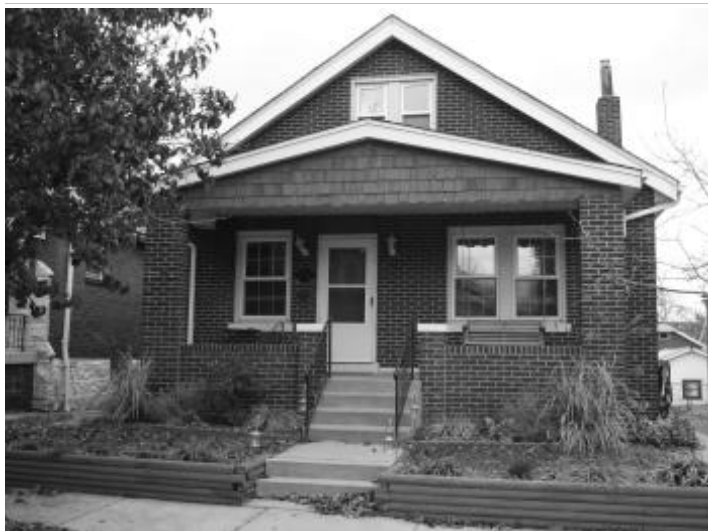
Full façade windows replacement.

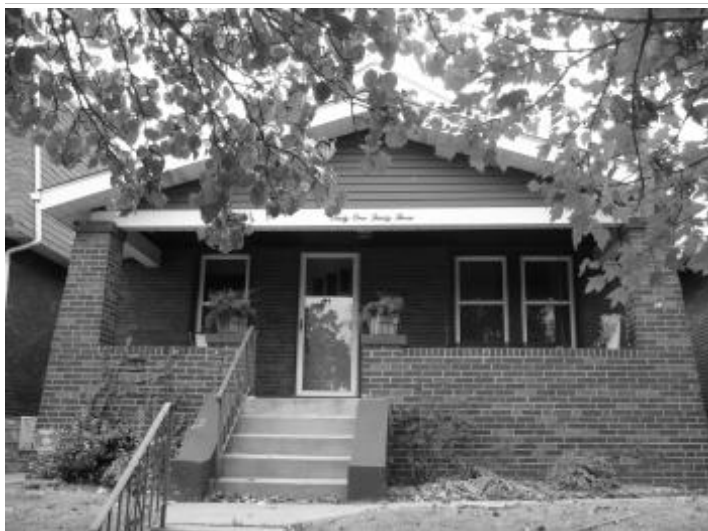
replacement vinyl windows; vinyl siding at porch gable end and over wood trim.

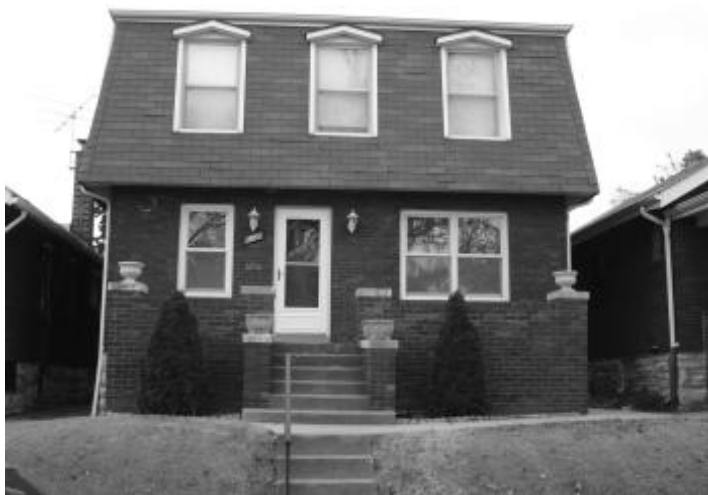
New windows.

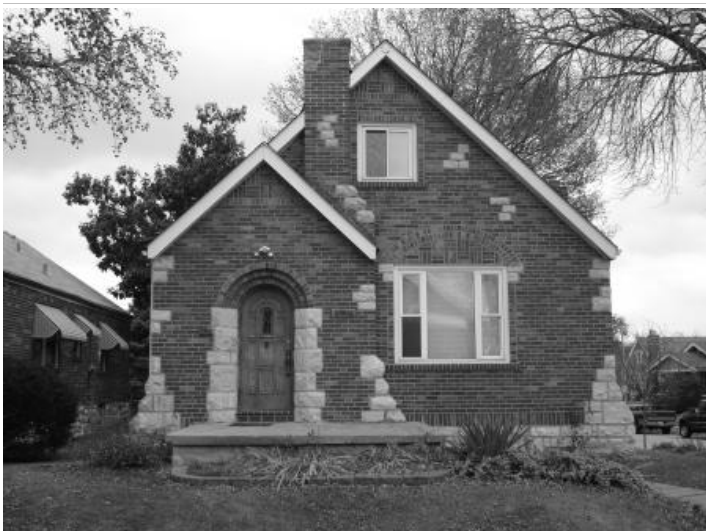
Replacement windows at façade.

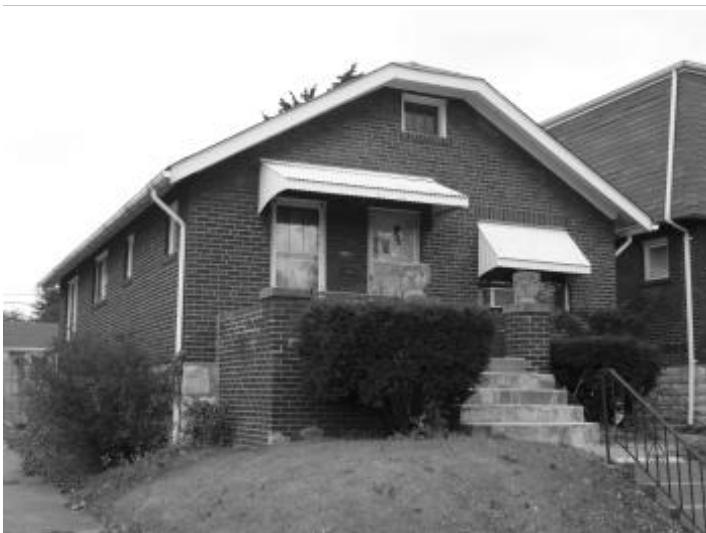
Porch roof replaced with metal awning; second metal awning over window pair, right.

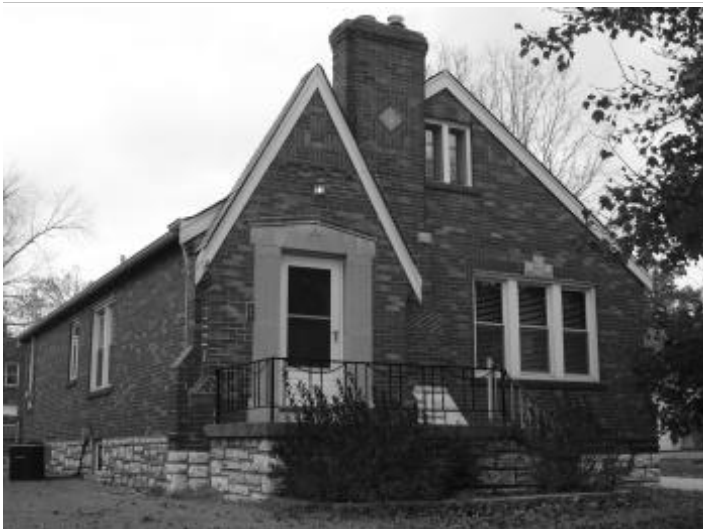
Replacement triple set of 1/1 windows. Skylight in north slope of roof.

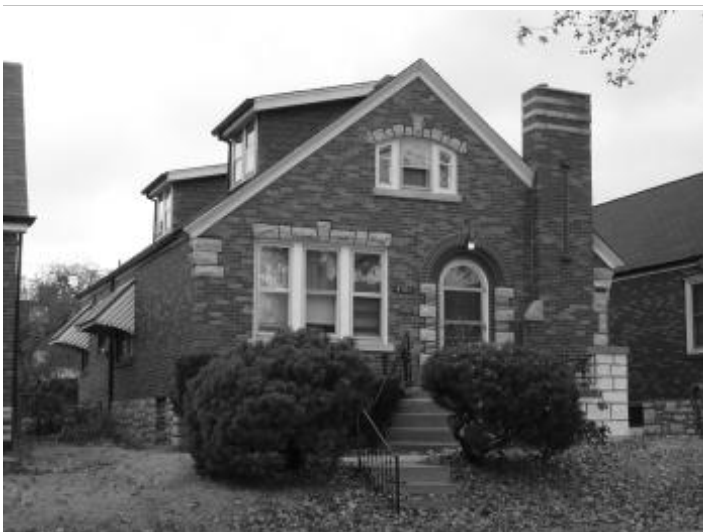
Trim wrapped at eaves.

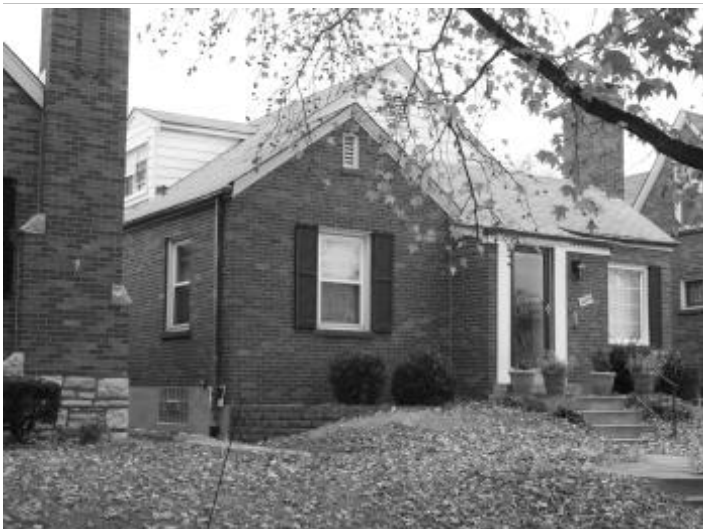
Replacement windows. Horizontal modern siding in front gable end (above lower side gabled roof).

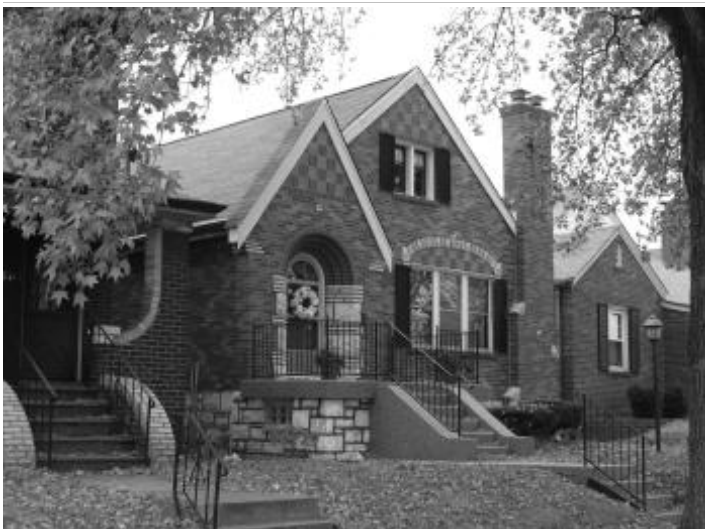
Shutters added. Some trim wrapped.

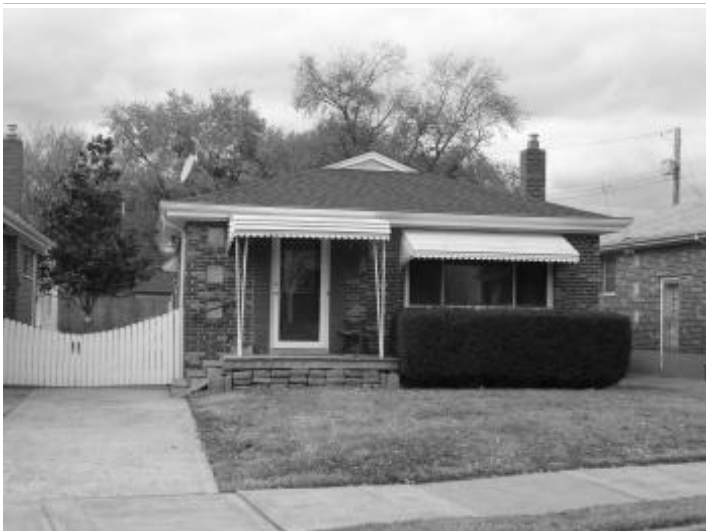
The front door and the wide window set to the right are replacements; metal are under metal awnings.

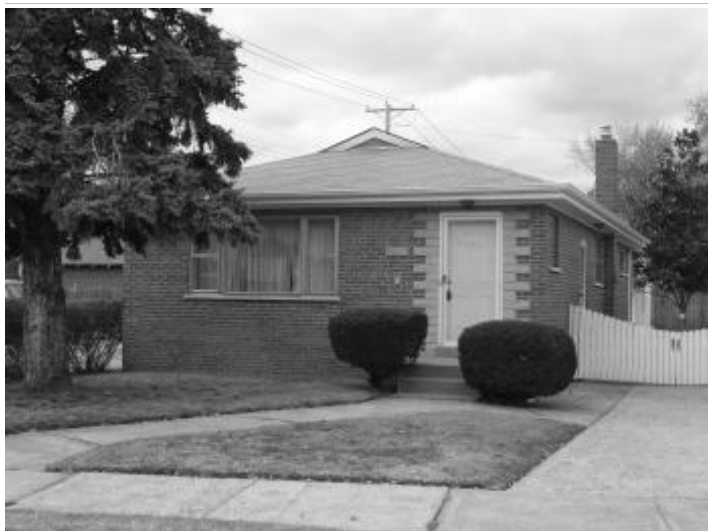
Replacement door and picture window.

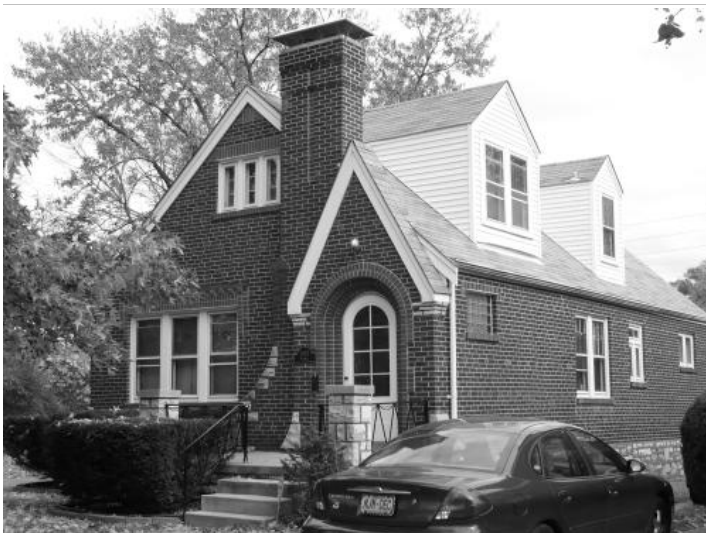
Vinyl over wood trim. Dormers (south elevation) are added.

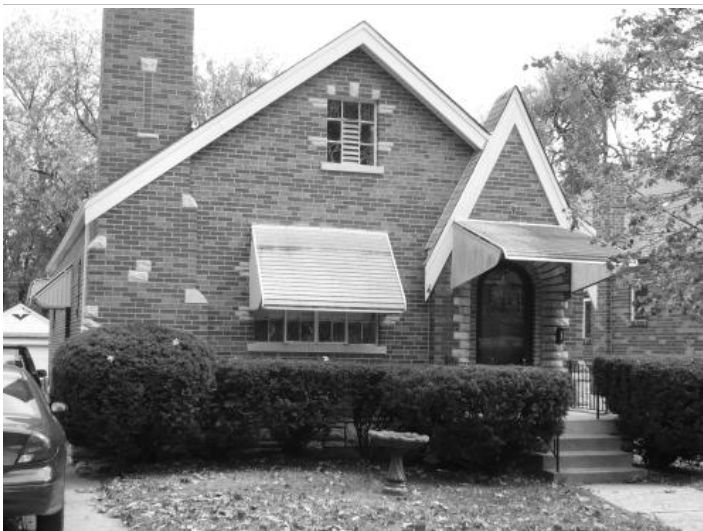
Vinyl over wood trim.

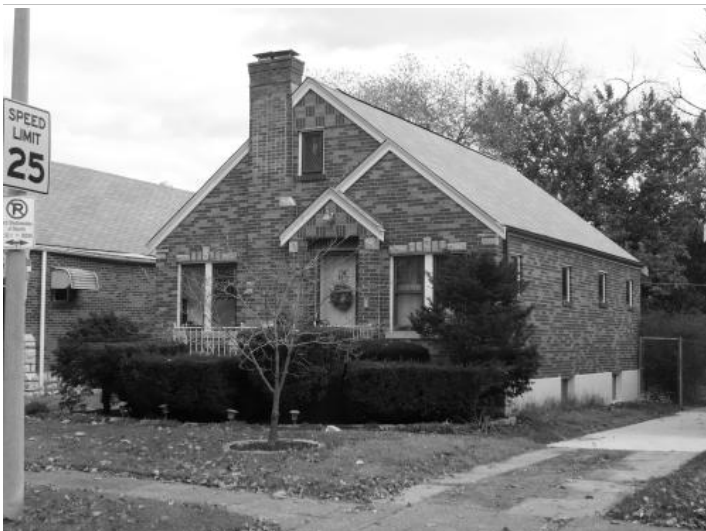
Vinyl over wood trim.

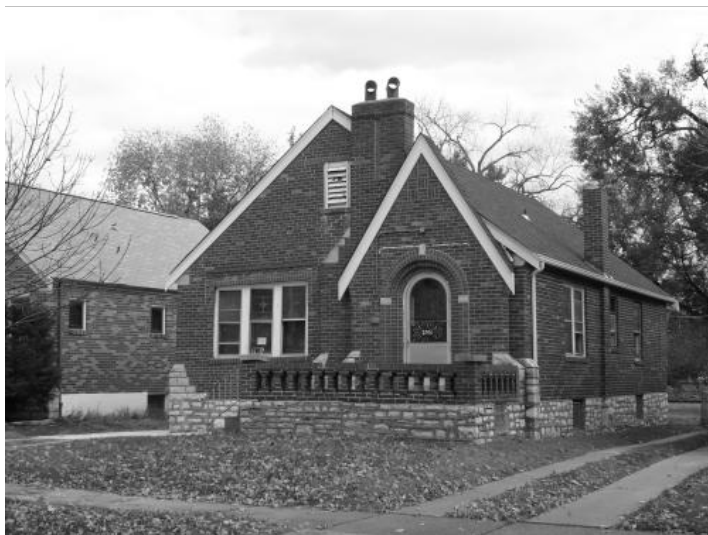
Vinyl over wood trim.

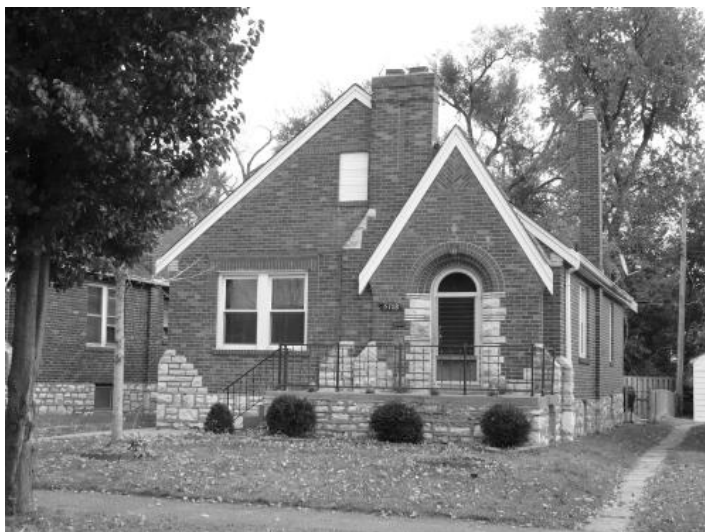
Vinyl over wood trim. Replacement windows.

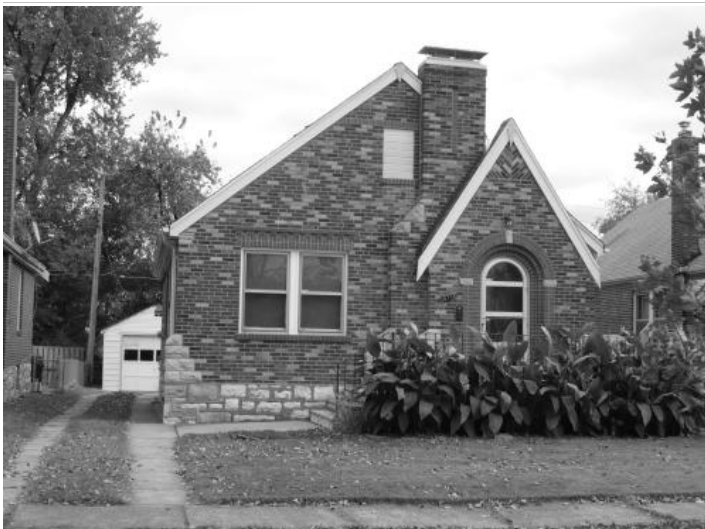
The attic window is covered. Imitation stone veneer at porch base.

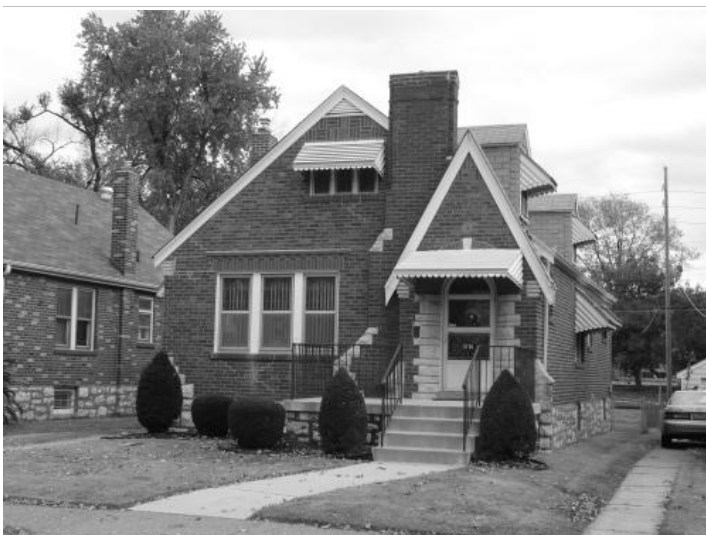
Metal awnings at front door and attic window. Aluminum sheaths wood trim.

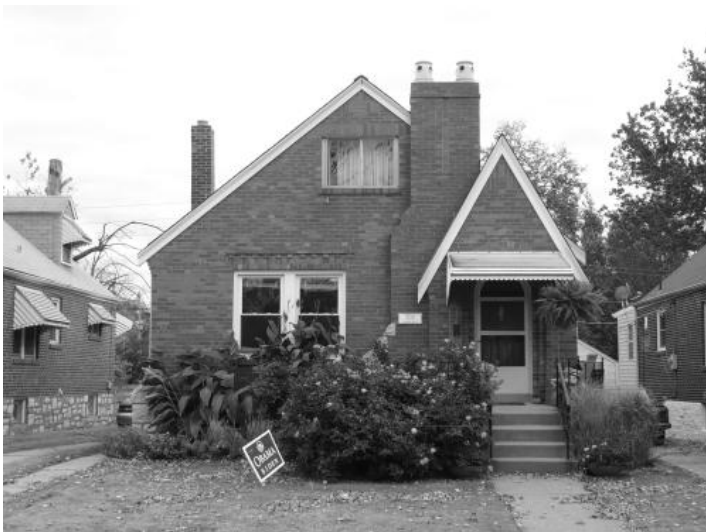
Windows are vinyl replacements.

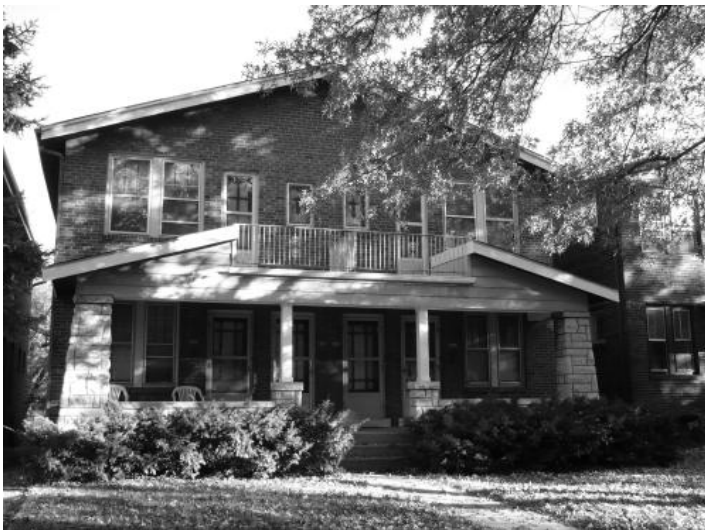
Porch gable end covered with later modern horizontal siding.

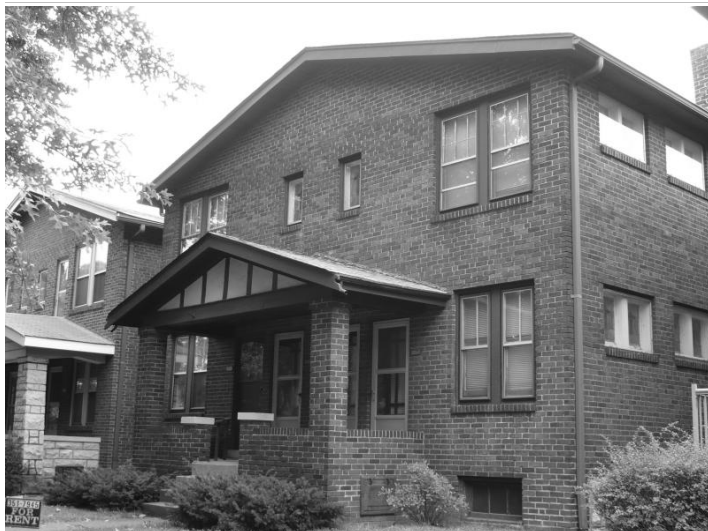
Screen/storm doors and windows are only notable alteration.

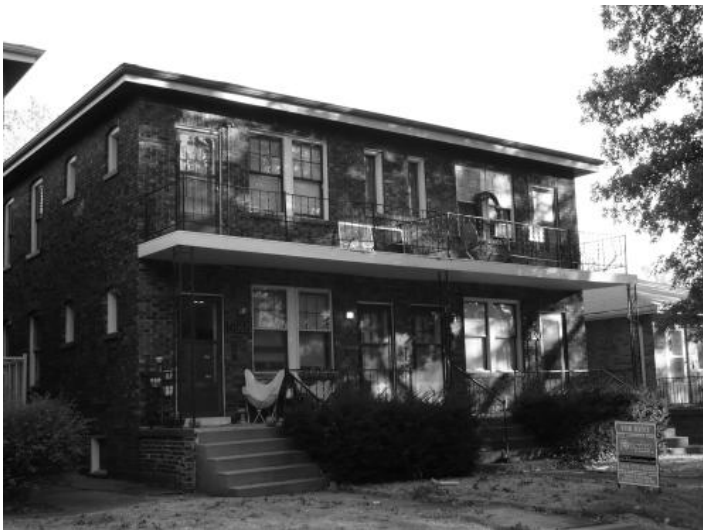
The balcony appears to be a replacement. Pair of replacement windows at first story right bay.

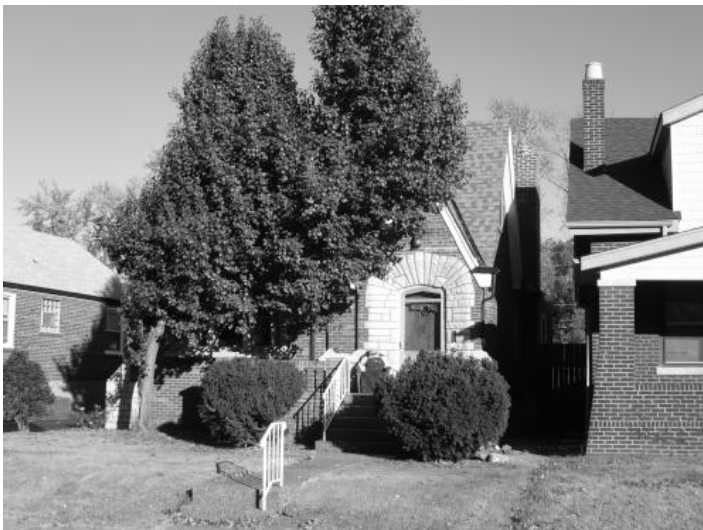
Some wood trim wrapped (vergeboard)

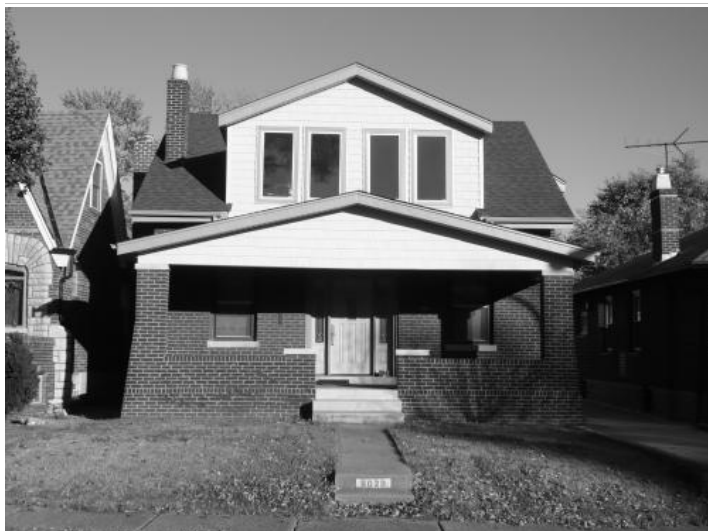
This simple dark red brick bungalow has a side gabled roof and a broad full width gabled front porch. The gable end and the gabled dormer above it are sided with a modern siding. The front door and its sidelights, center, are replacements. To either side are 1/1 windows.

The four gable windows are modern single-panes. Some wood trim wrapped.

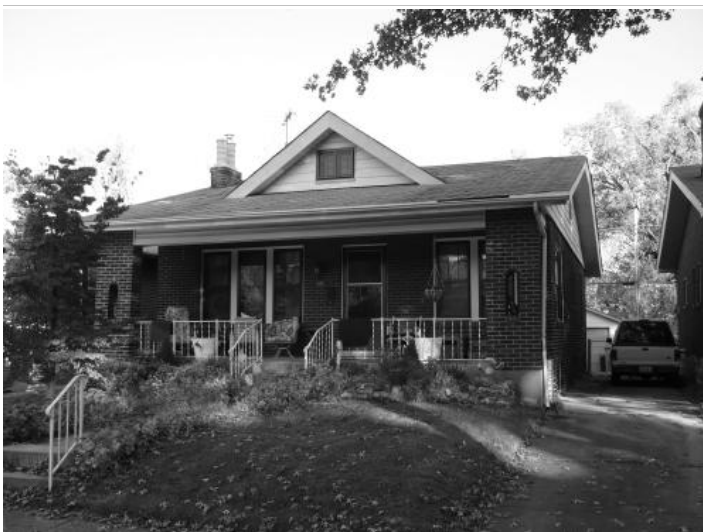
Some wood trim is wrapped; modern siding at dormer.

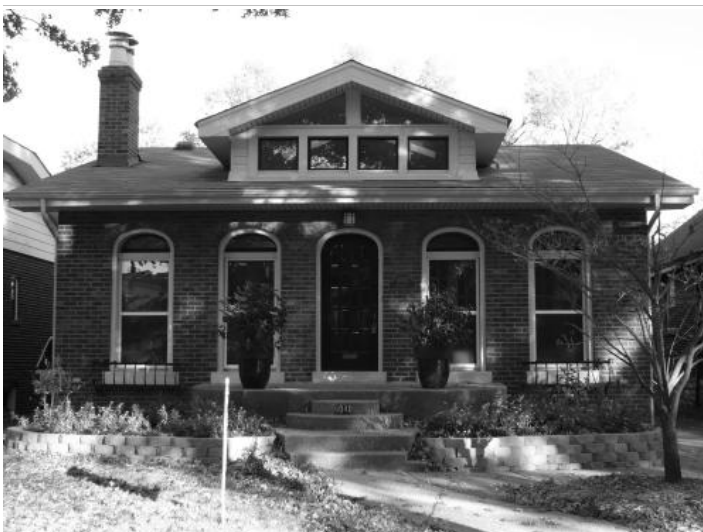
Replacement windows in dormer; gable end opened with two additional triangular windows.

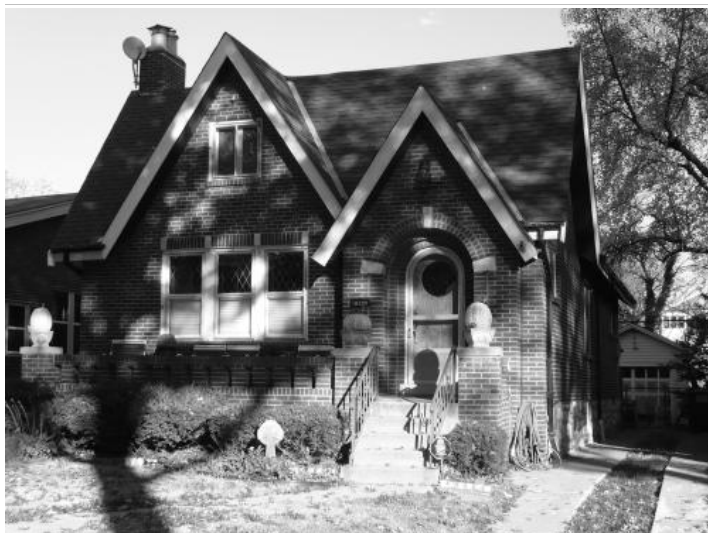
Some trim (vergeboard) wrapped with siding.

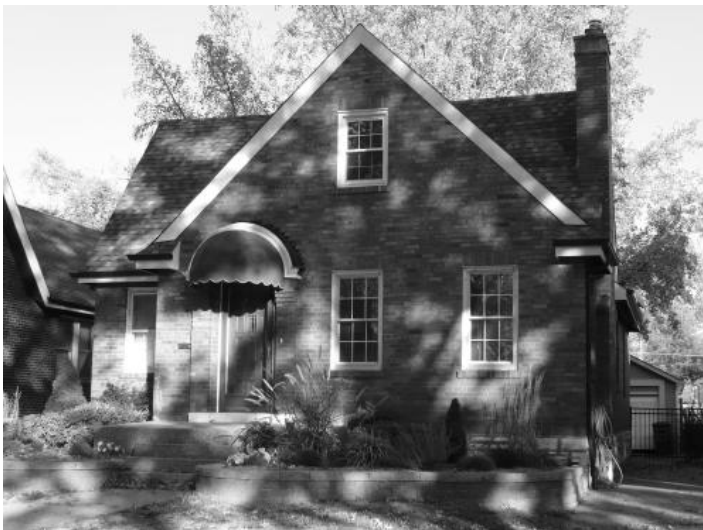
Replacement window in gable end; vergeboard covered with vinyl wrap.

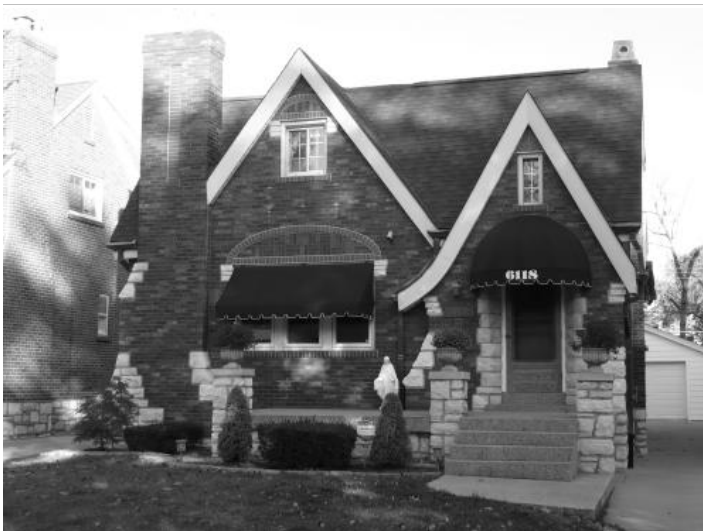
Façade windows are replacements.

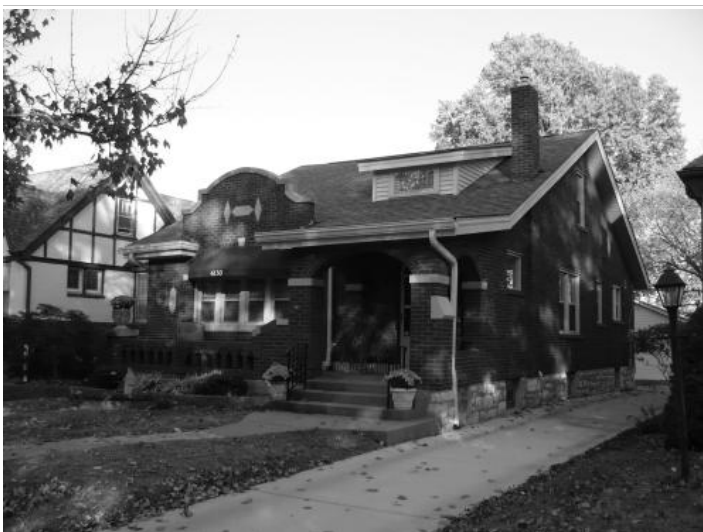
Replacement windows

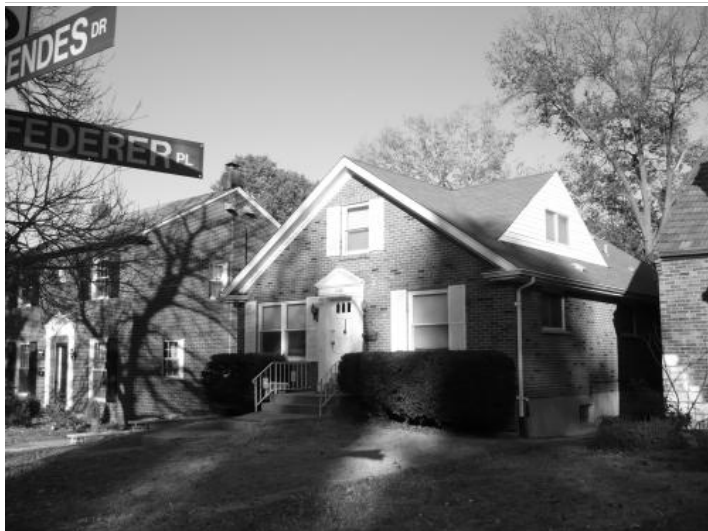
façade window replacement as above. (noncontributing due to recent date.)

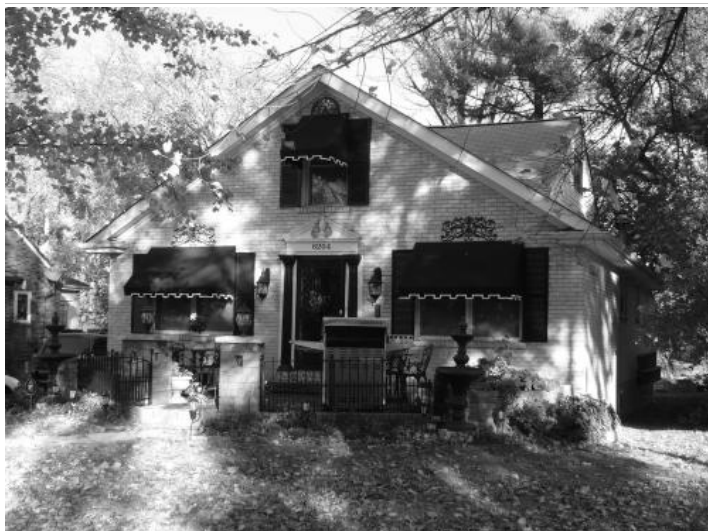
Replacement windows, applied decorative surround at centered front door. Noncontributing for the purposes of the survey due to date.

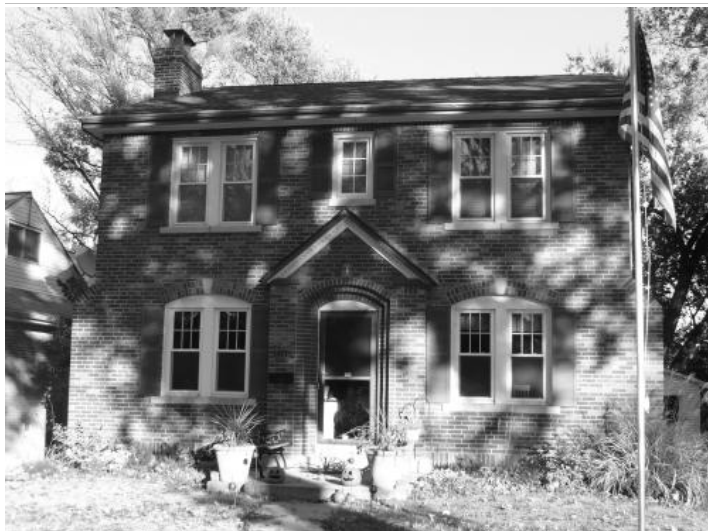
Replacement door and windows.

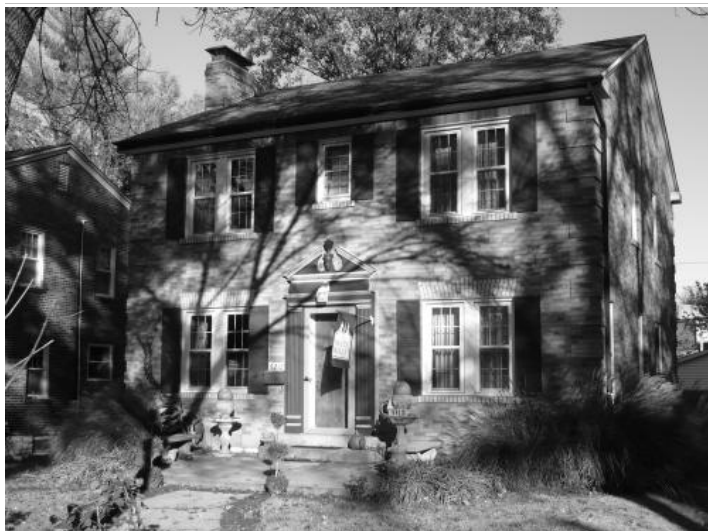
Replacement windows.

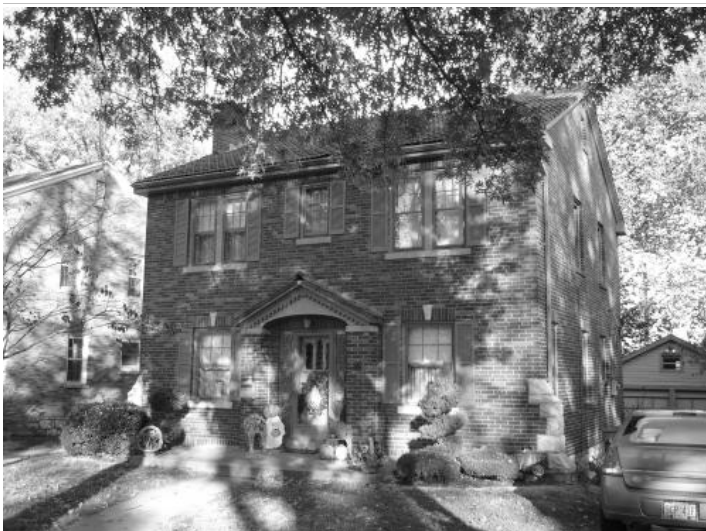
Sidelights covered; inoperable shutters added.

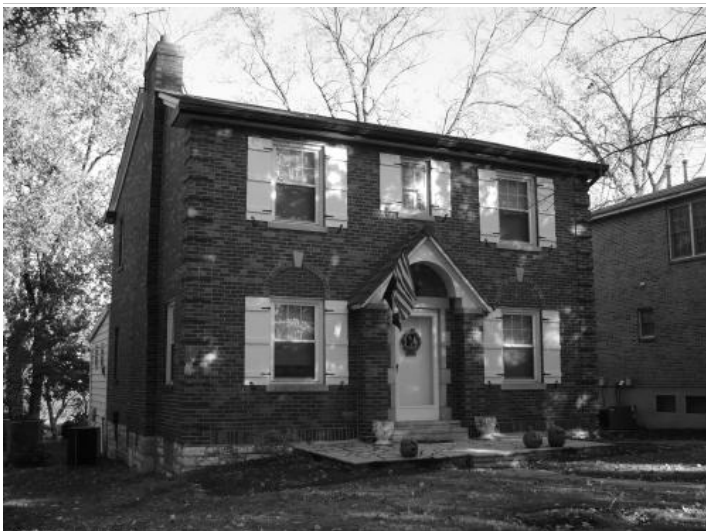
Replacement windows at outer bays, both stories.

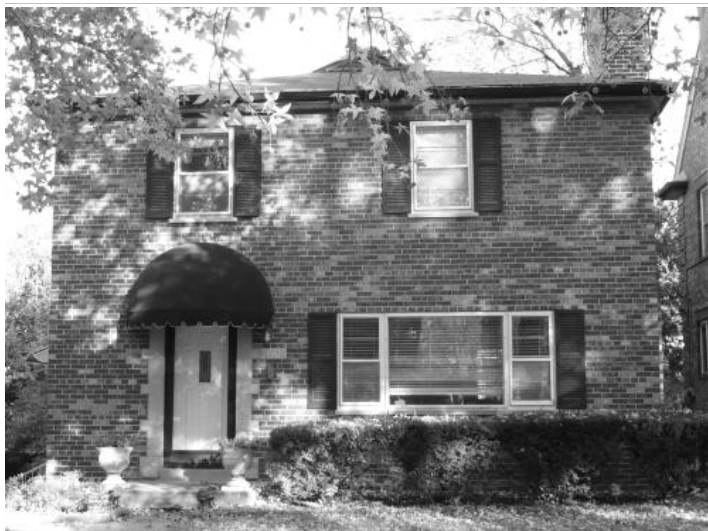
Replacement door; canvas awning over door.

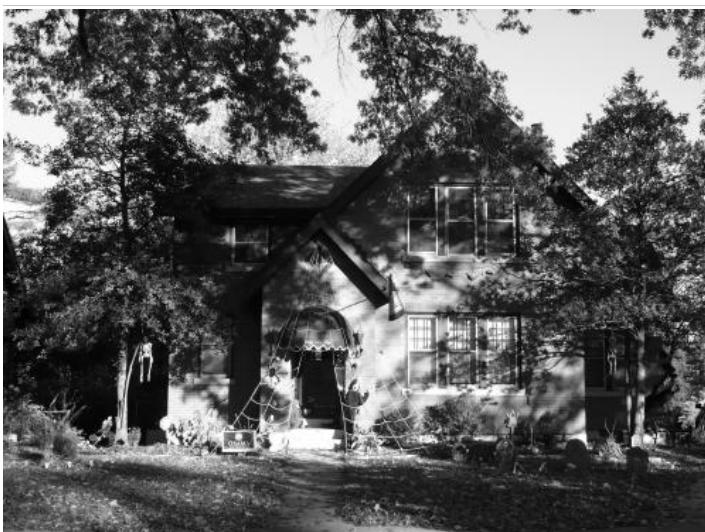
Vergeboard wrapped in siding.

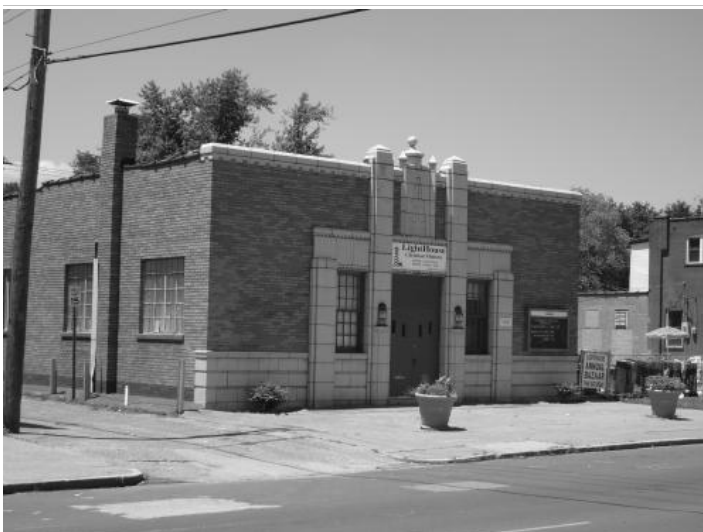
Doors and transom replaced.

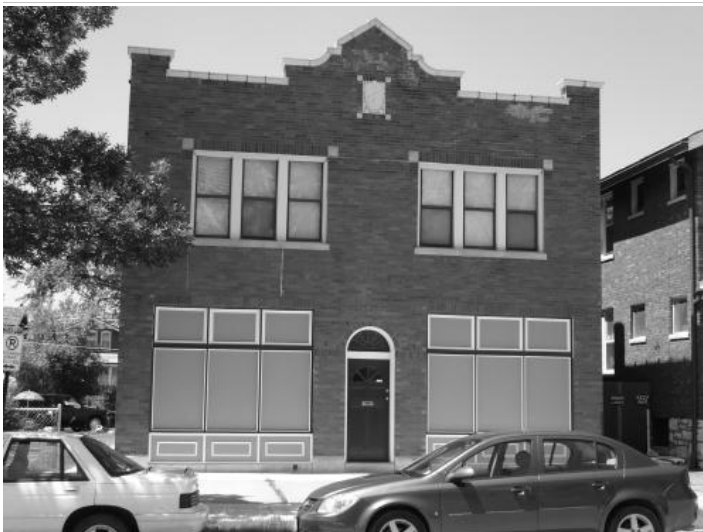
The storefronts are presently divided into three wood-paneled sections, with painted windows, bulkheads and transoms. Replacement windows at second story.

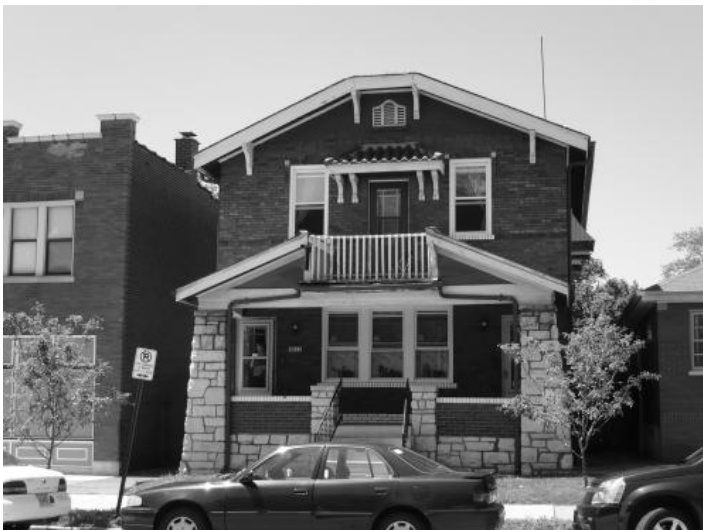
Replacement windows, replacement wood railing on balcony; siding covers stucco on front of porch.

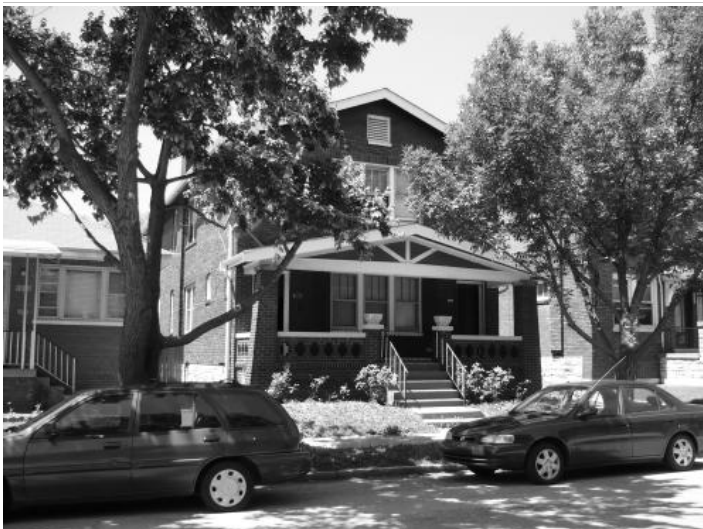
Front doors are replaced, and faux shutters added.
