City of St. Louis Cultural Resources Office

Holly Hills Neighborhood Survey

Lynn Josse and NiNi Harris
3/1/2010

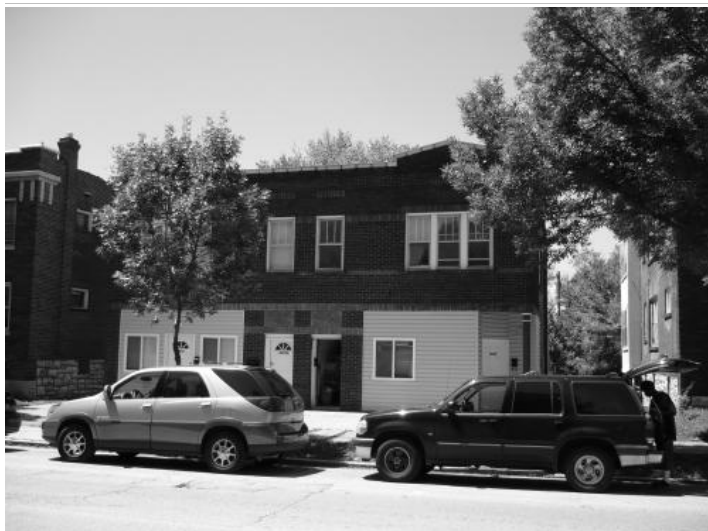
The storefront openings are filled in with siding and new doors.

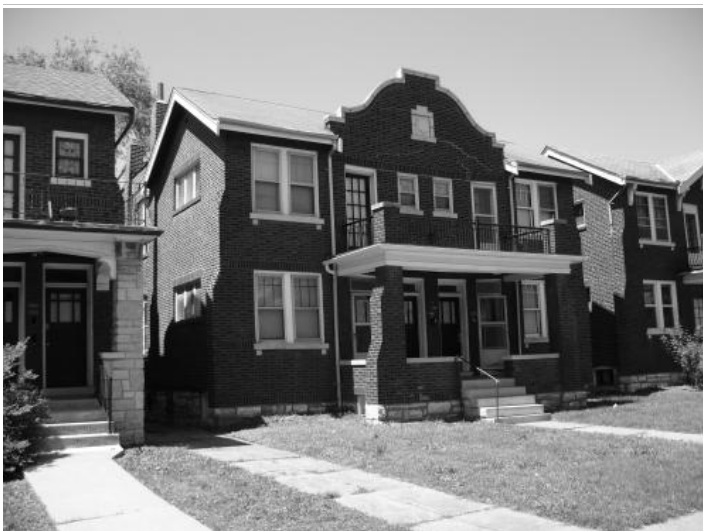
Replacement windows.

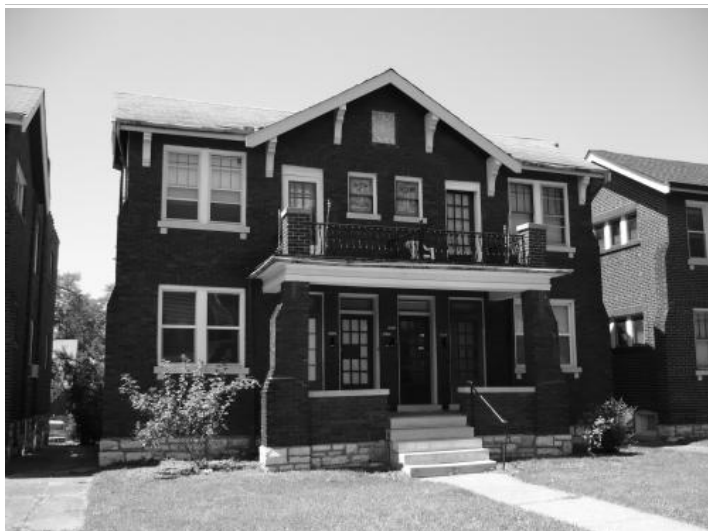
Replacement windows

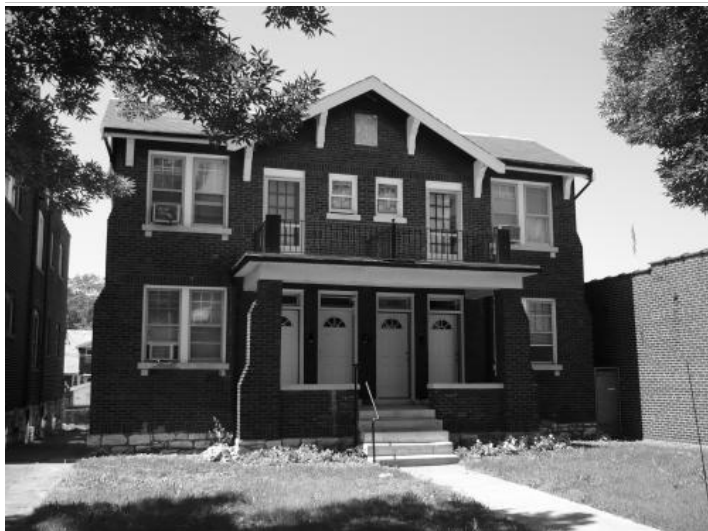
The four front doors have been replaced with a more contemporary style (although the two balcony doors are original)

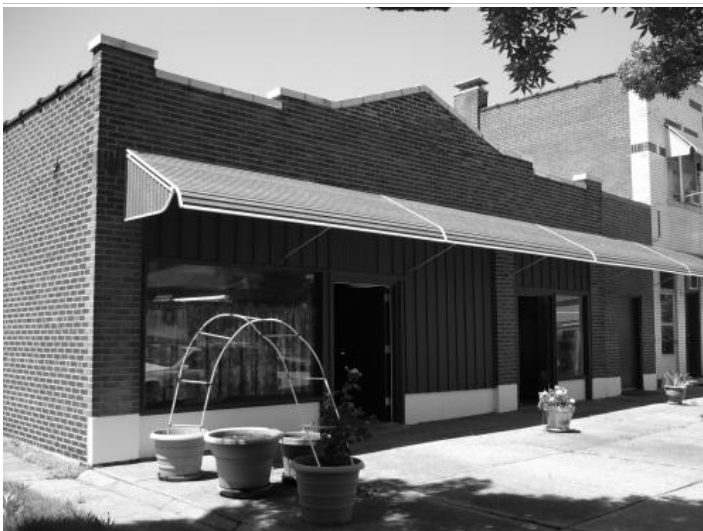
Storefronts are filled in with new windows, doors and paneling. The fiberglass awning continues to the building to the west.

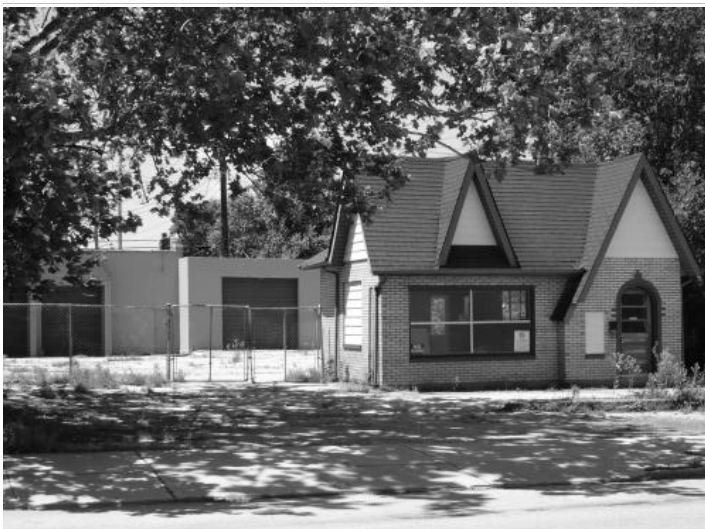
Aluminum covers gable ends, fills in small façade window; replacement door and large window.

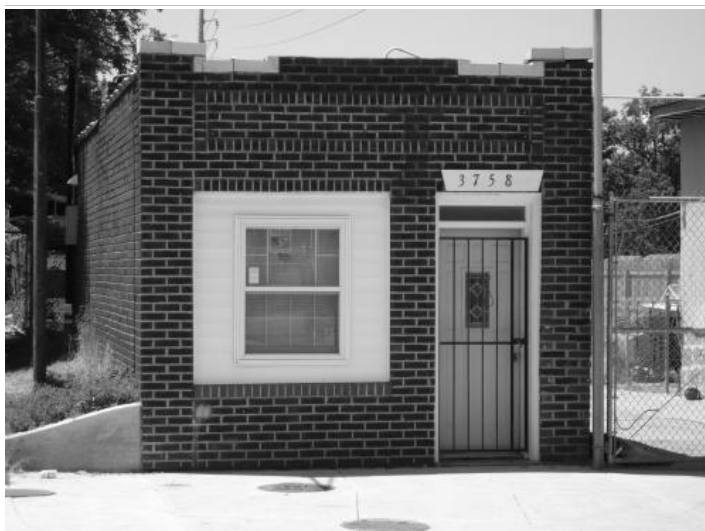
Office building was constructed after 1916; its red brick walls extend all the way to the ground (no other foundation material is visible). Replacement door, window, transom; center step of parapet wall shortened with the removal of terra cotta coping. 2 or 3 buildings on site. Small office is a brick parapet roof building. "Concrete warehouse" adjacent to railroad track. Occupy as lumber yard - 10/21/1964 - no building permits. Nothing on site in 1916; the two front buildings are in place on the 1938 map. (Ruprecht Building materials) Rear address, a tank storage for sand, in 3752 1/2

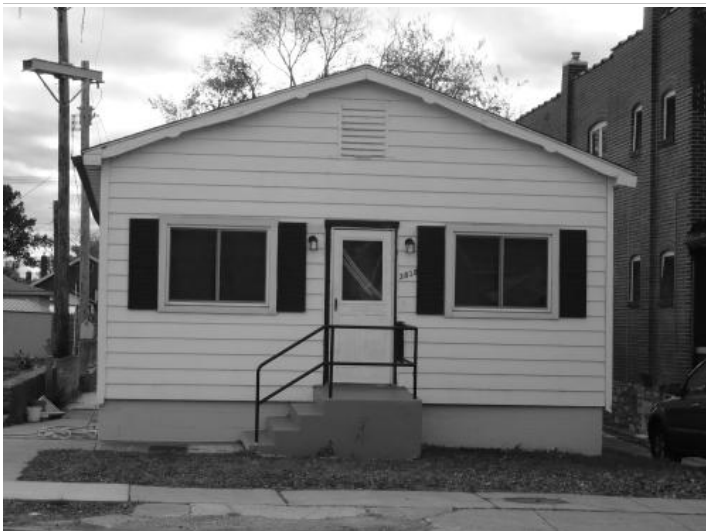
Almost no original material is visible; this house is believed to be the same one on the 1938 Sanborn map but it's hard to tell from the outside.

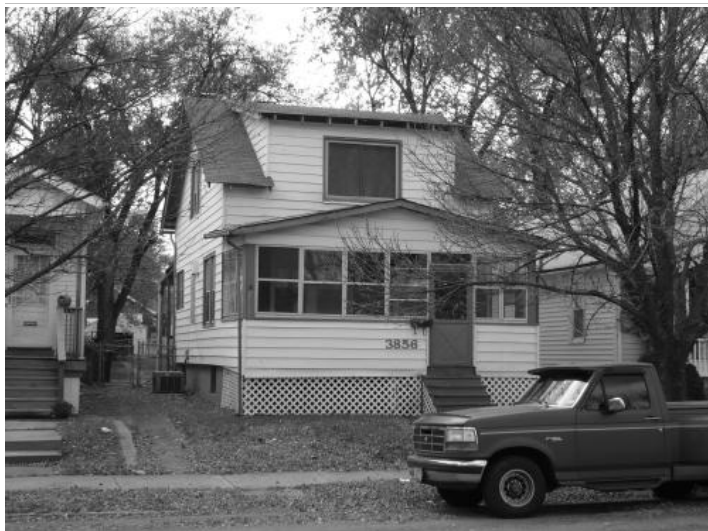
Replacement windows in dormer

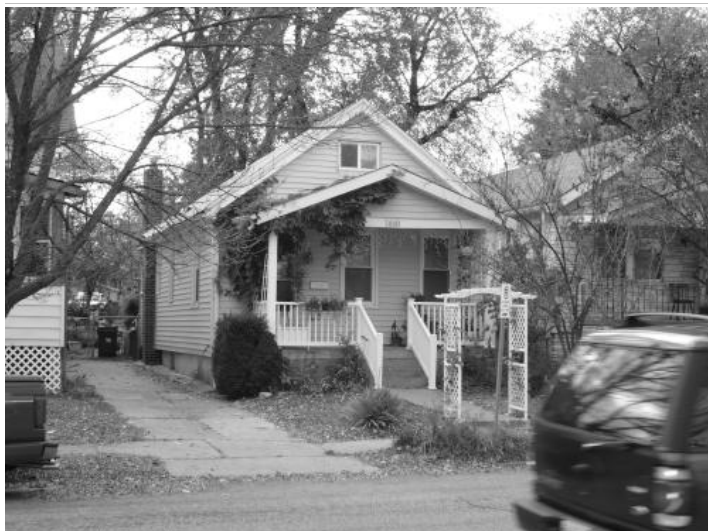
There is a single small horizontal slider window in the gable end. The siding is modern vinyl, and the window trim is obscured by it.

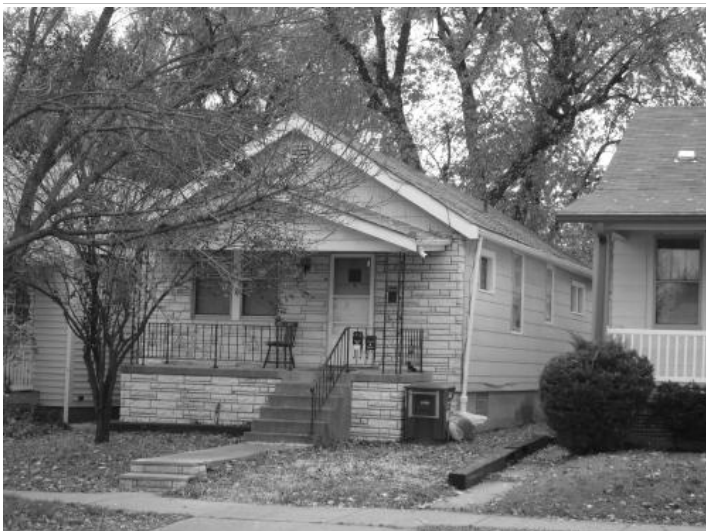
Replacement door, railings, piers

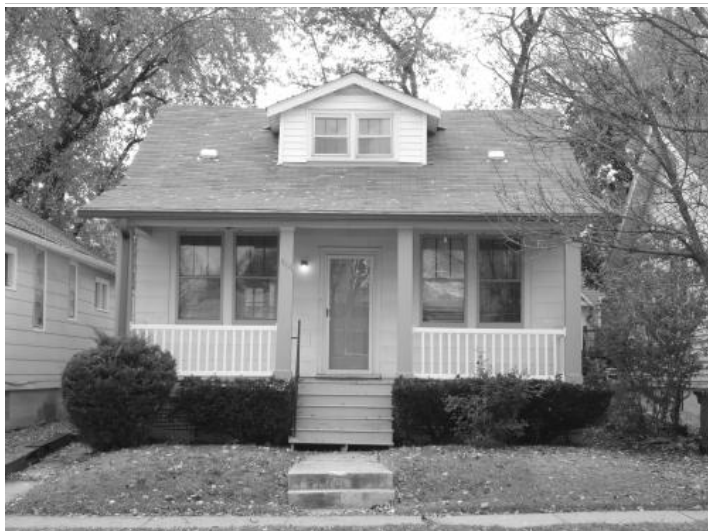
Replacement door and railings.

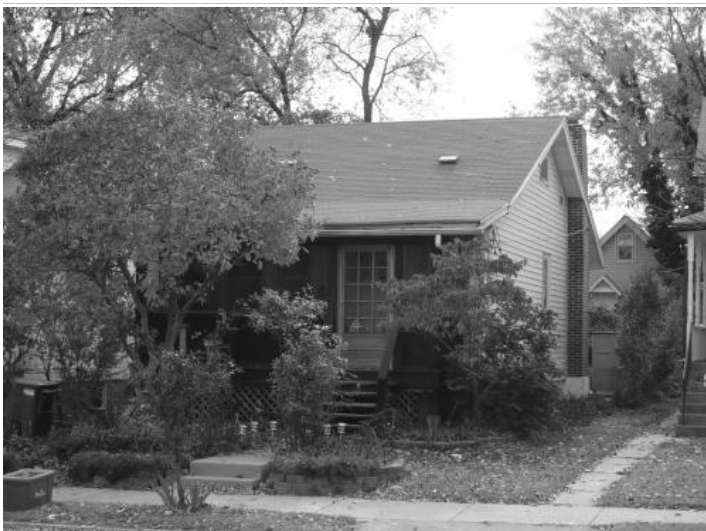
Porch is screened in

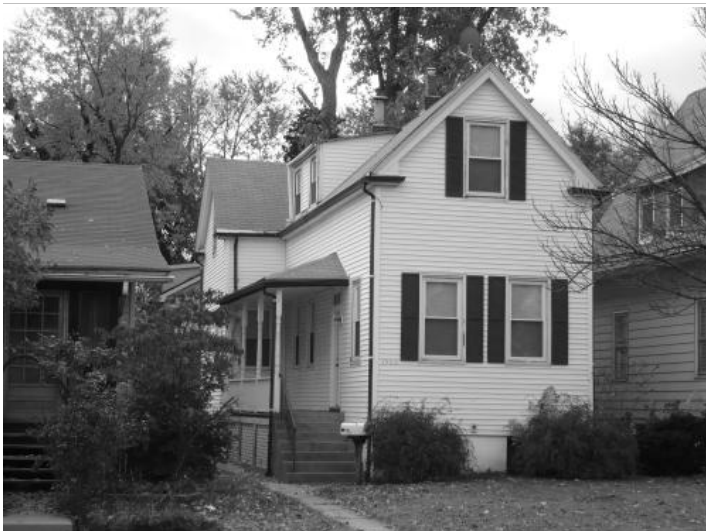
Front door and windows are replaced. Added shutters.

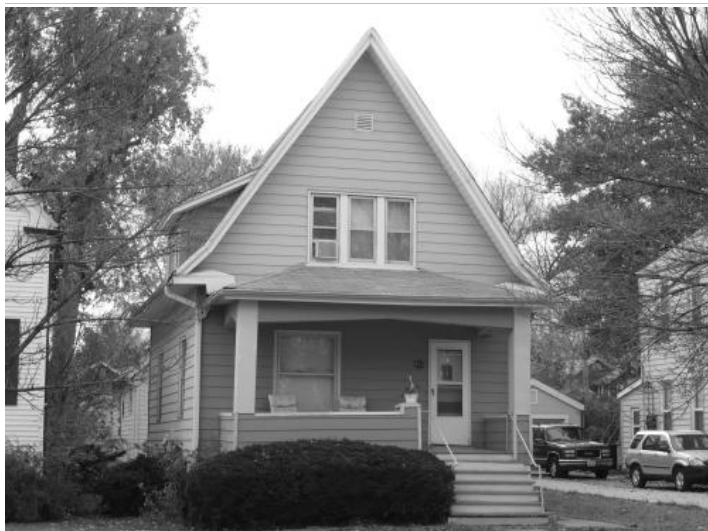
Fully sided eaves and porch; window trim hidden under façade siding; replacement front door.

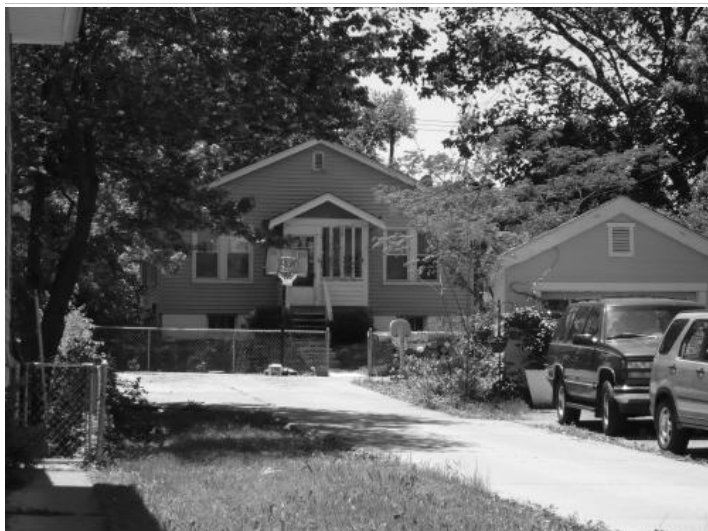
Replacement windows.

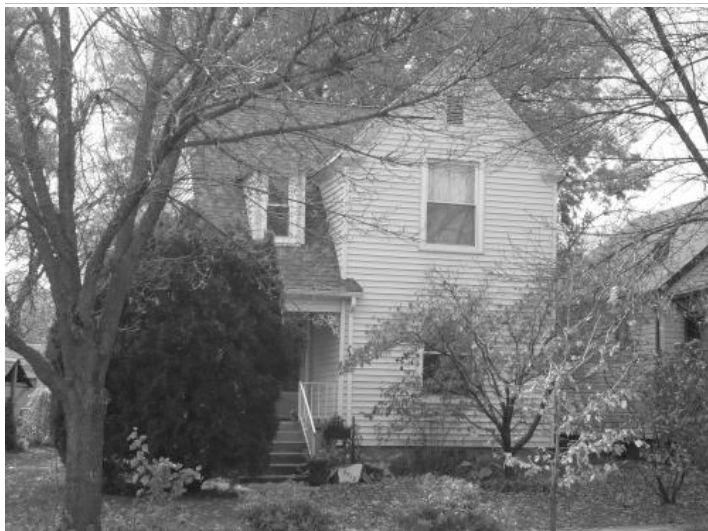
While the windows are replacements, the proportions are maintained.

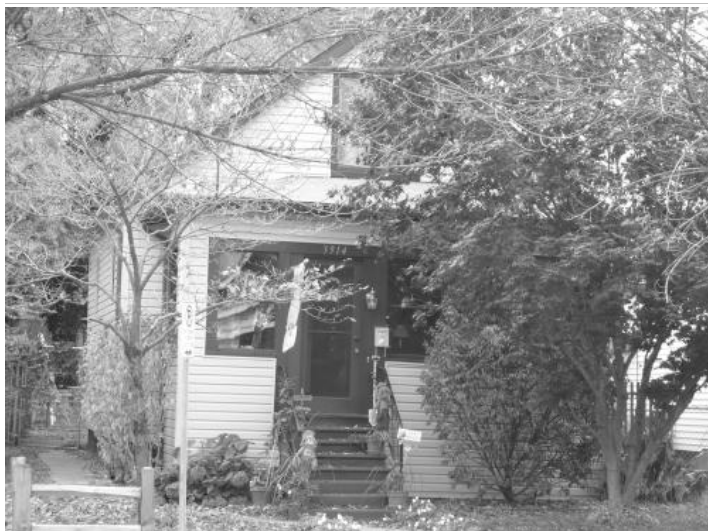
Replacement window in attic.

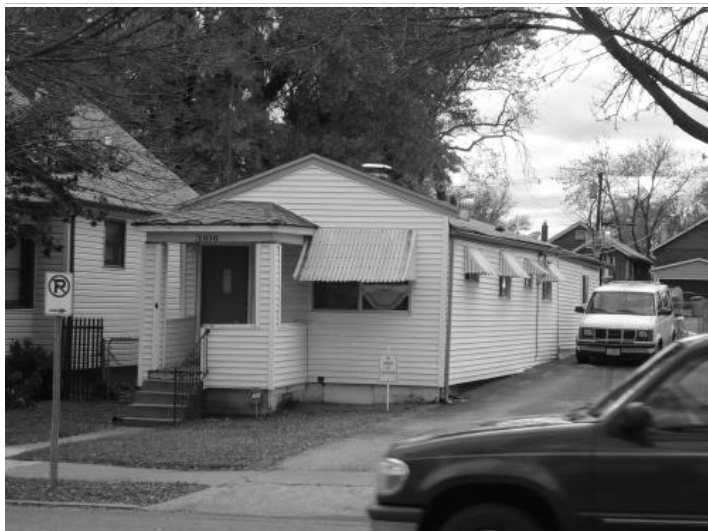
Replacement windows under awnings. Replacement front door.

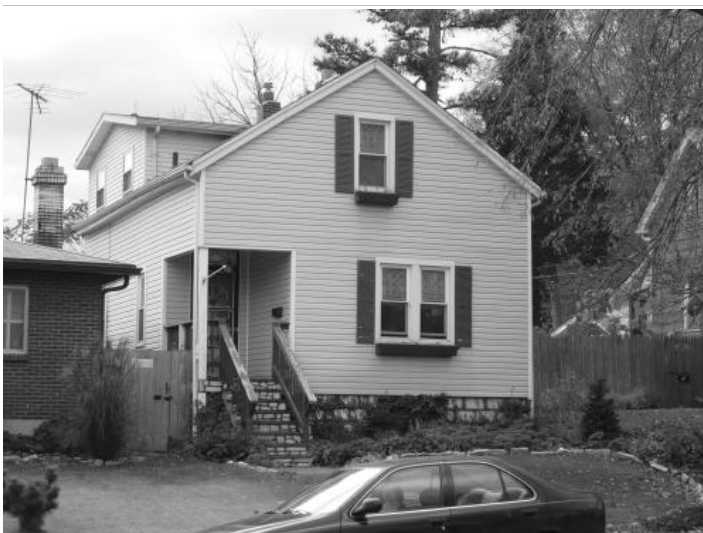
Replacement windows, door, railings. Shutters added.

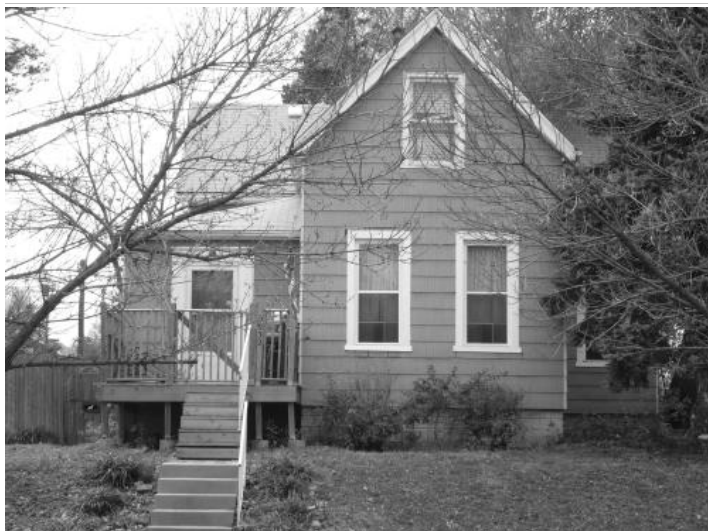
Replacement windows.

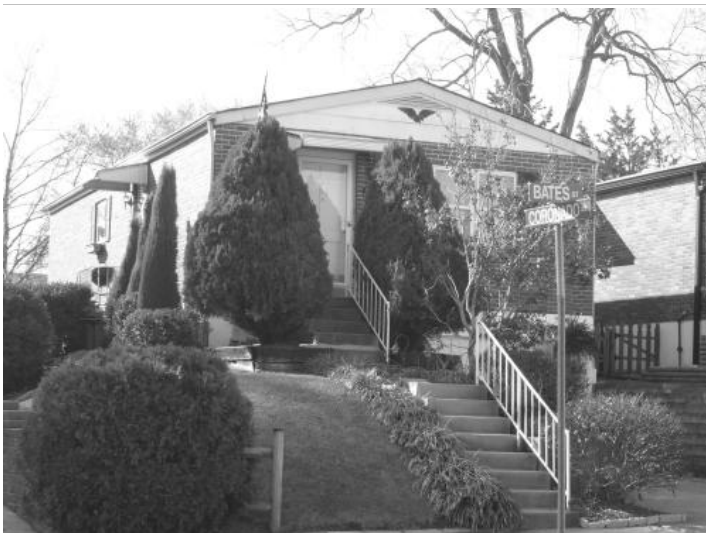
This 1977 house retains most of its original features; some trim wrapped with aluminum.

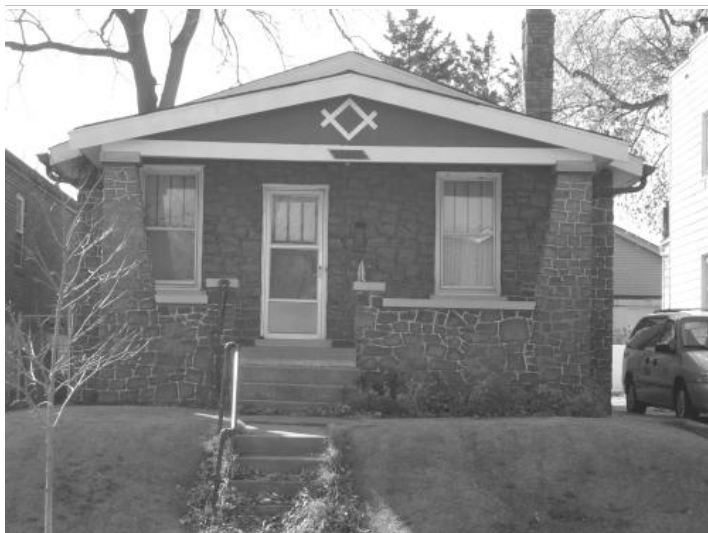
Aluminum wraps some wood trim elements.

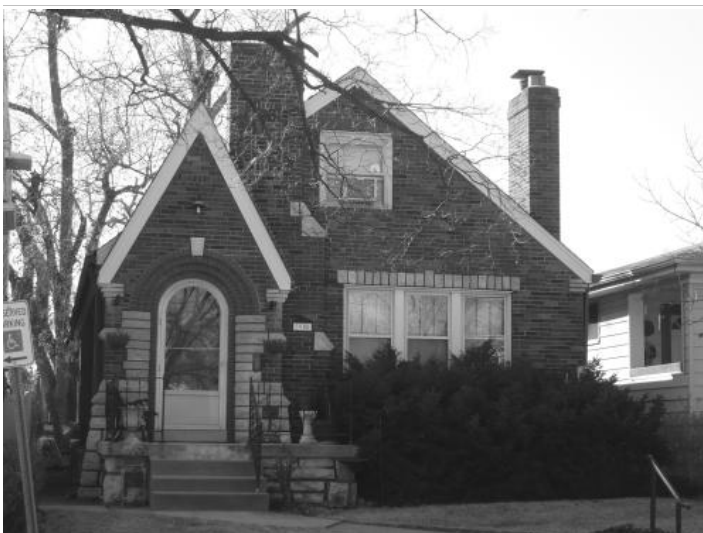
Replacement window in gable end.

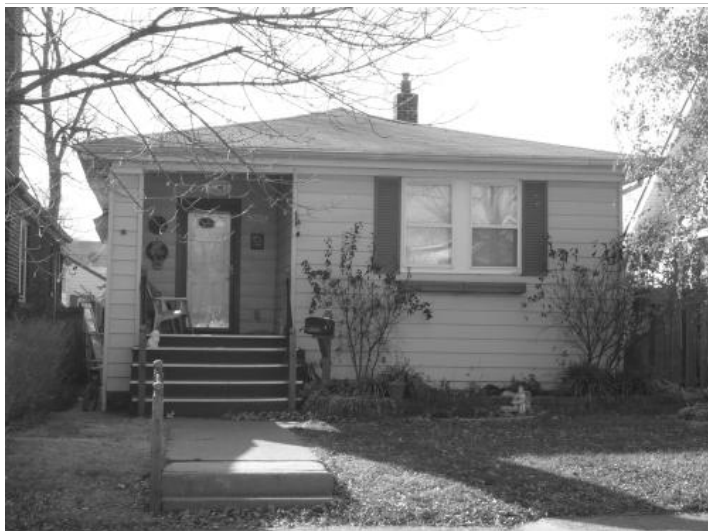
This simple hip-roofed frame house has replacement doors and windows, and no original material visible.

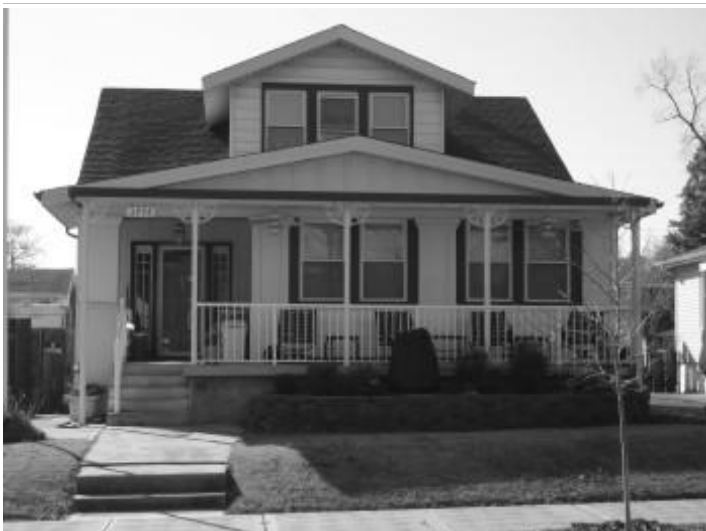
All windows are replacements, aluminum covers wood trim. Front porch is new, in front of original recessed porch.

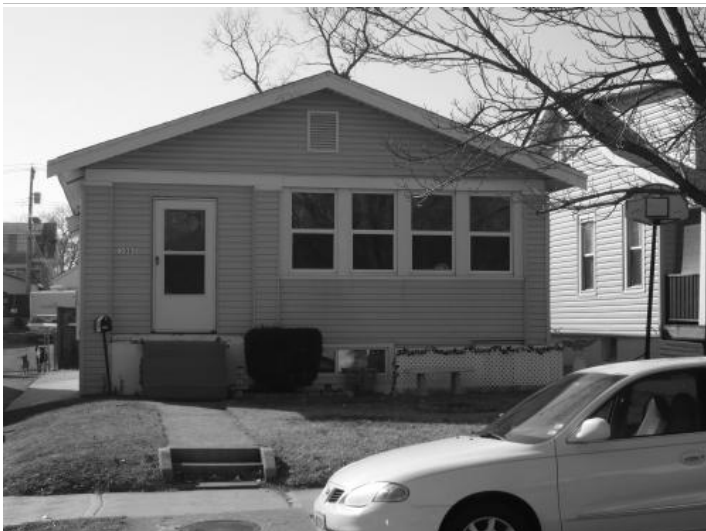
Filled in porch; replacement door and windows; fully sided.

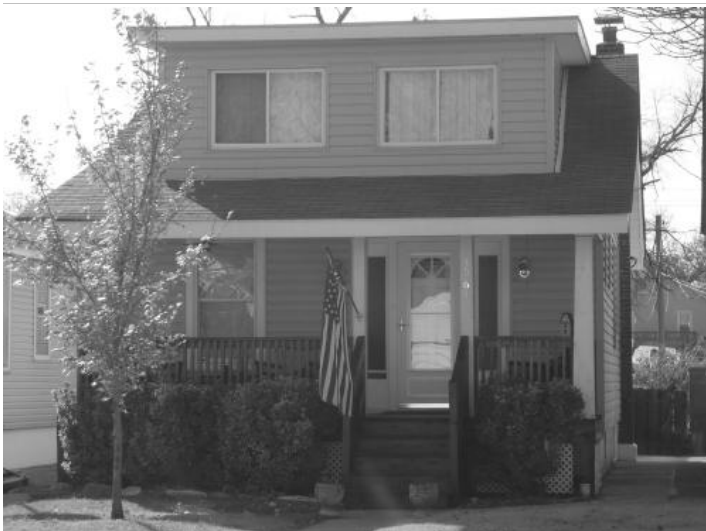
Vinyl covers walls, eaves, vergeboard. Door and windows are replacements, are are porch railings.

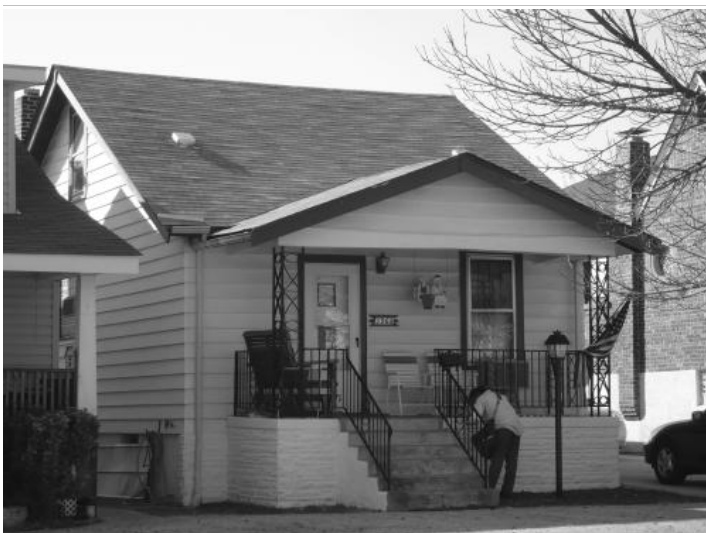
Replacement door. Metal railings and supports at porch.

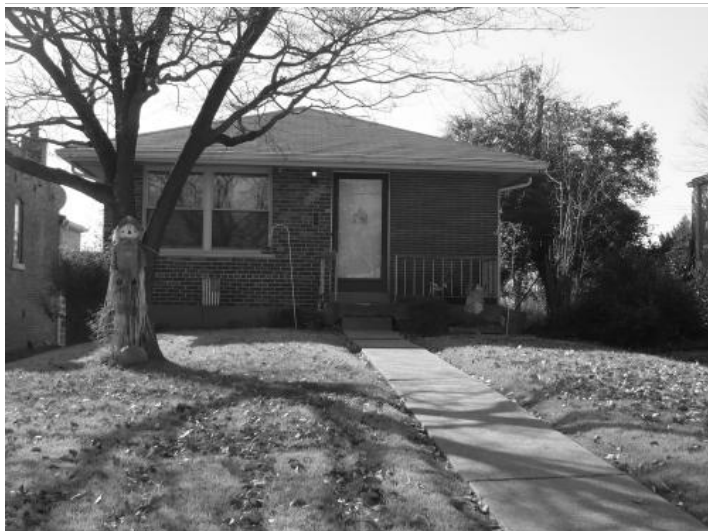
Door and windows are replaced.

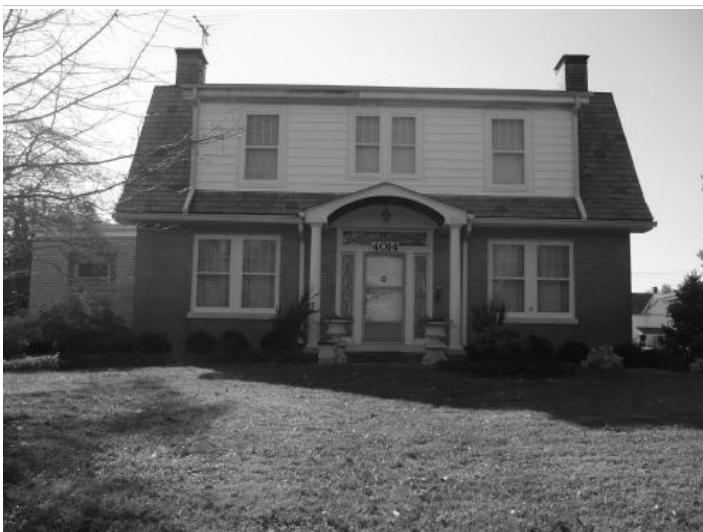
Dormer and eaves sided with aluminum. Modern 1-story addition set back at left (east) elevation.

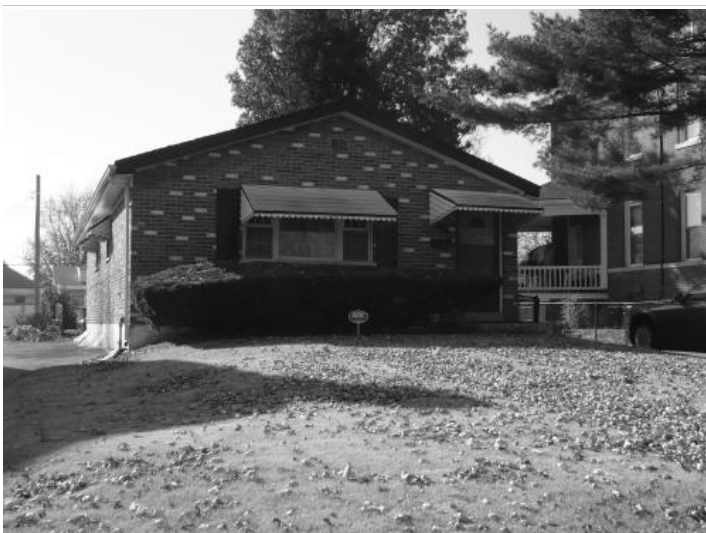
Replacement door and windows.

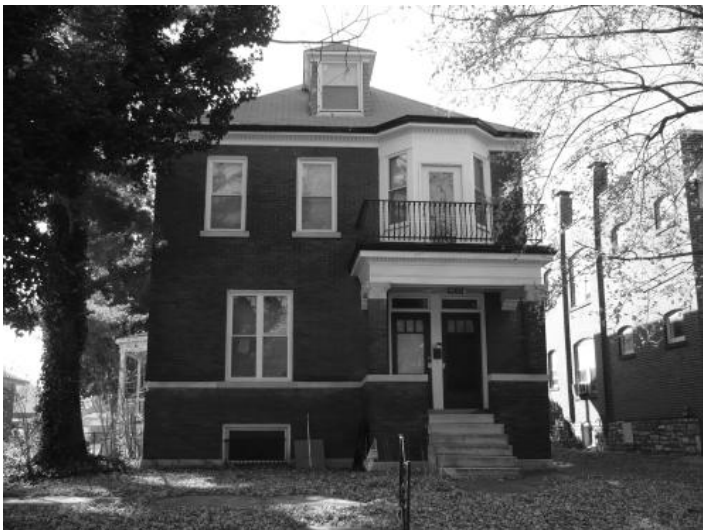
All façade windows are replacements, as is the balcony door.

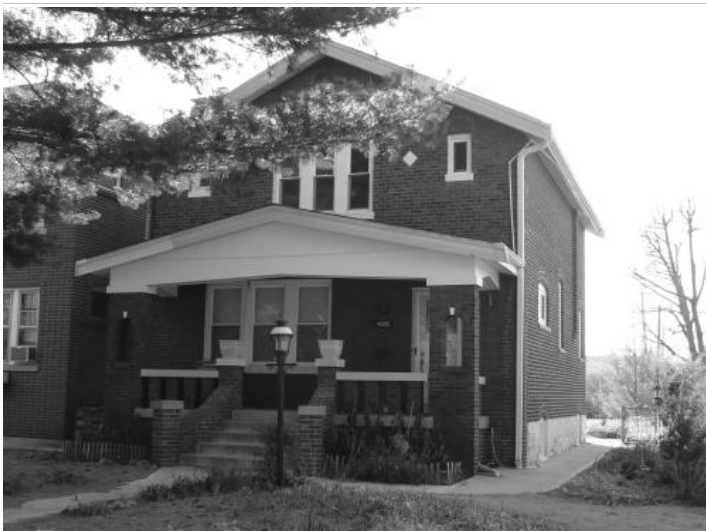
Double-hung façade windows replaced with vinyl. Roof brackets soffitted, and some other wood trim wrapped.

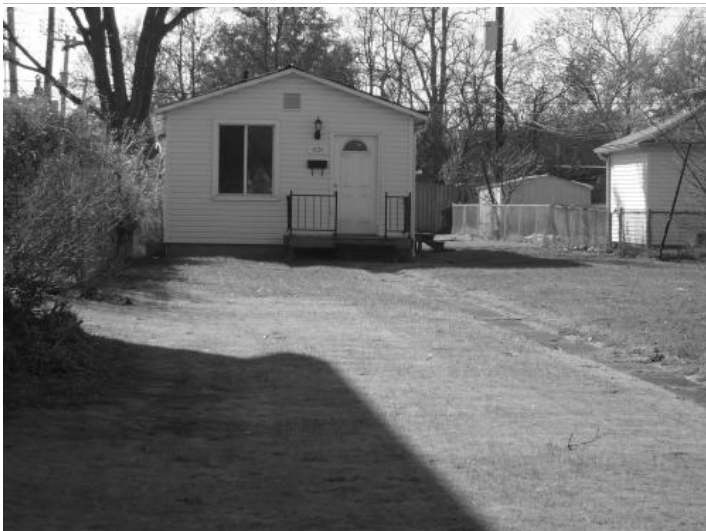
Replacement door and windows. Vinyl covers walls, vergeboard and eaves.

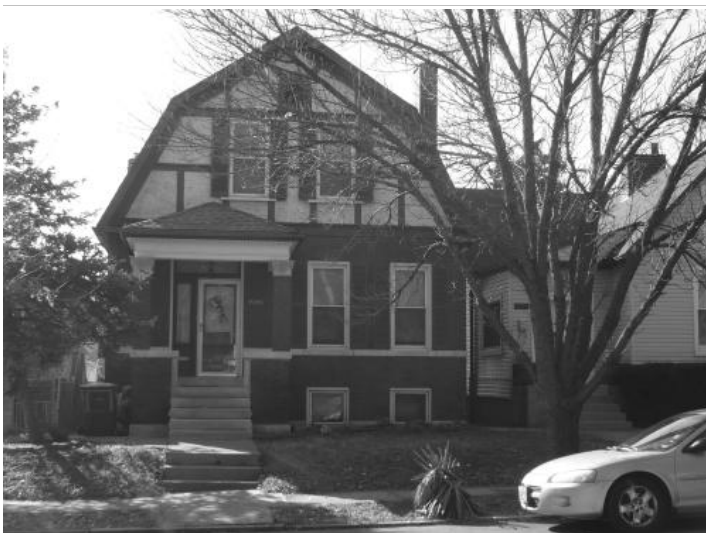
Replacement windows have added imitation shutters.

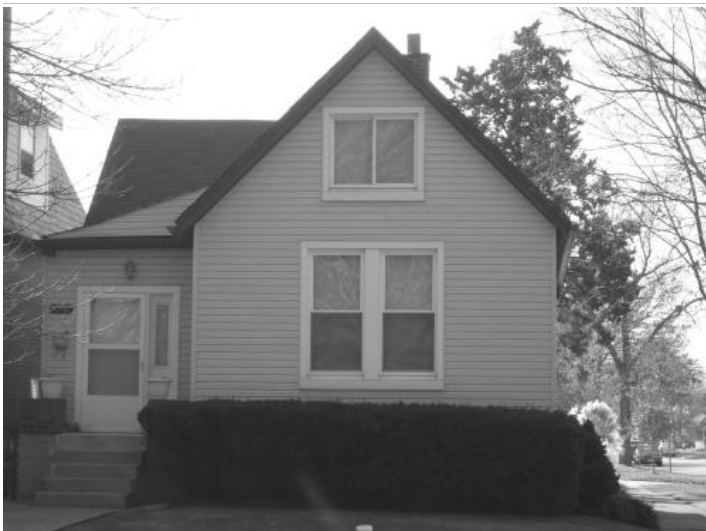
Windows are replacements with wrapped trim; the gable end window is a contemporary vinyl slider set. Replacement front door.

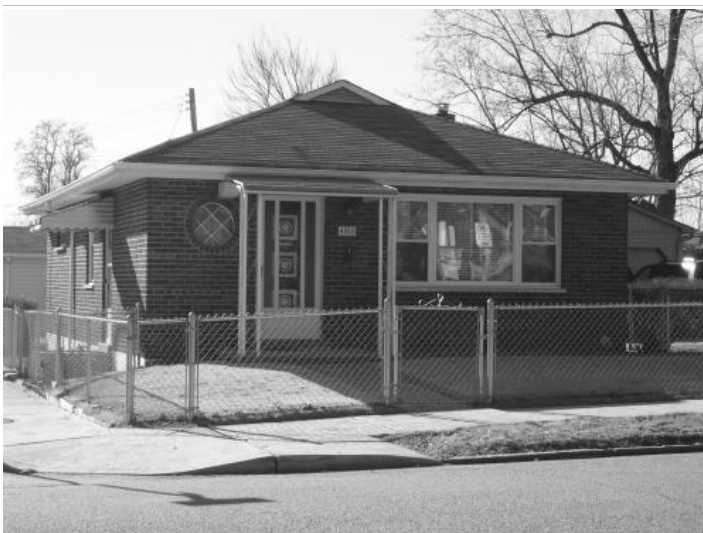
Other windows are replaced.

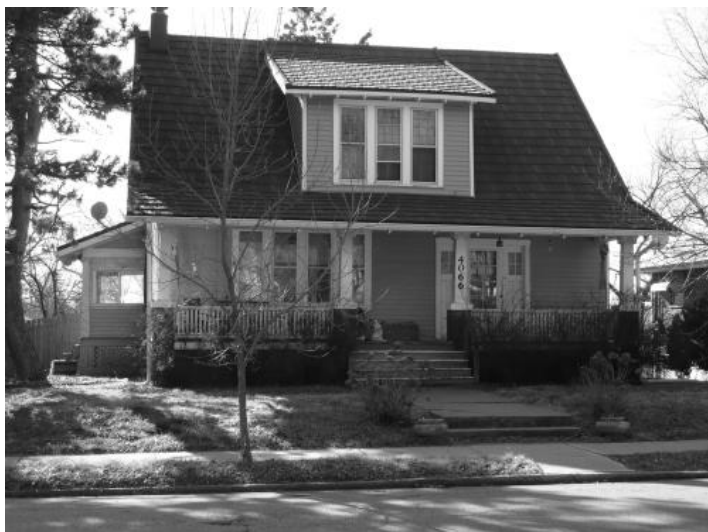
The siding does not substantially detract from the integrity of the house because it approximates the original, and it does not obscure original trim.

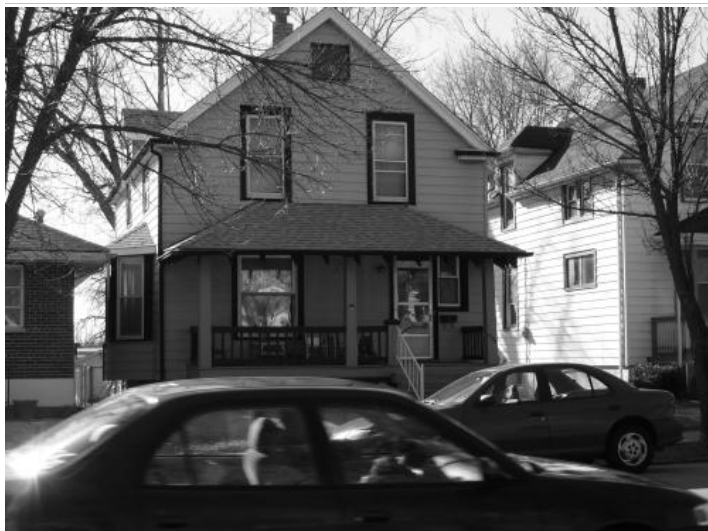
First floor windows and door are replacements, their trim covered by the siding.

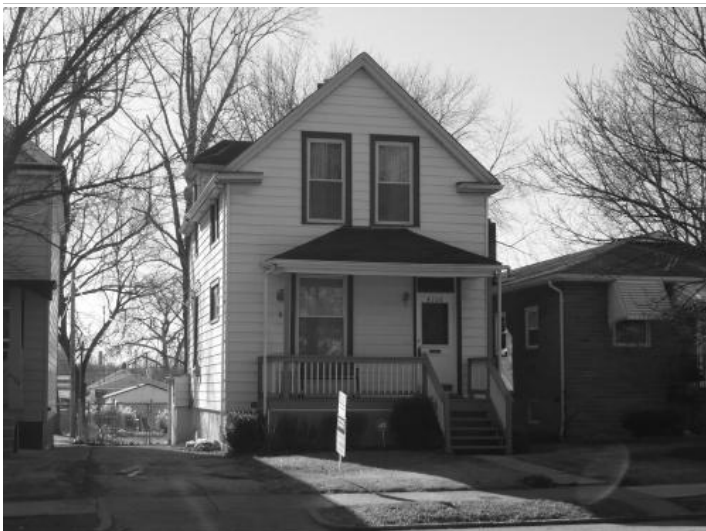
Windows are replacements, their trim covered by the siding. Replacement porch.

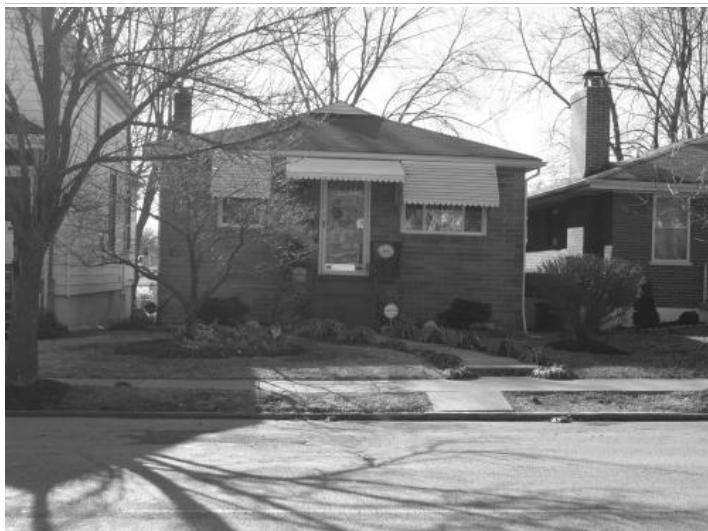
Front door and windows are replacements.

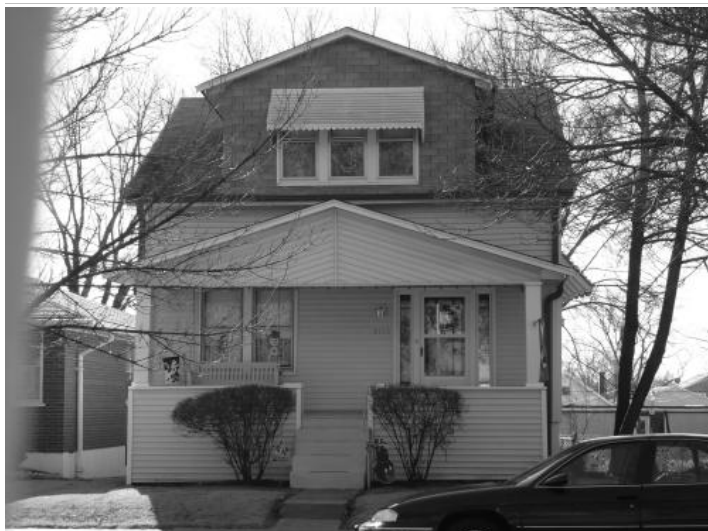
Dormer (now covered with asphalt shingles) is probably an addition to the original 1909 house. Vinyl siding obscures window trim.

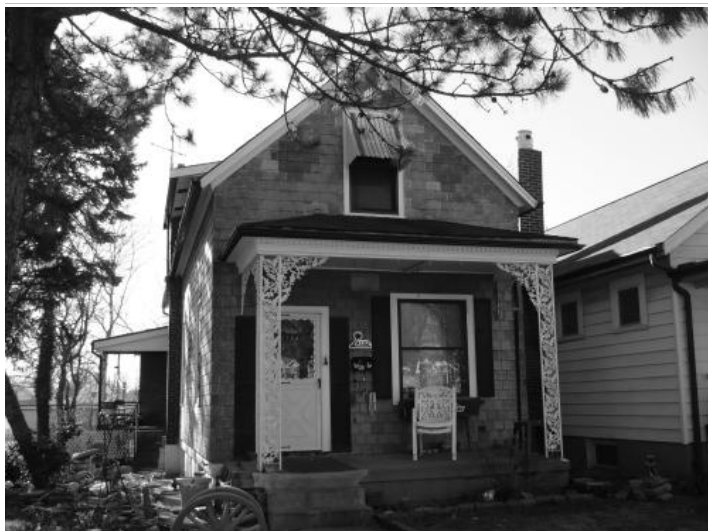
Shutters added, and porch posts replaced.

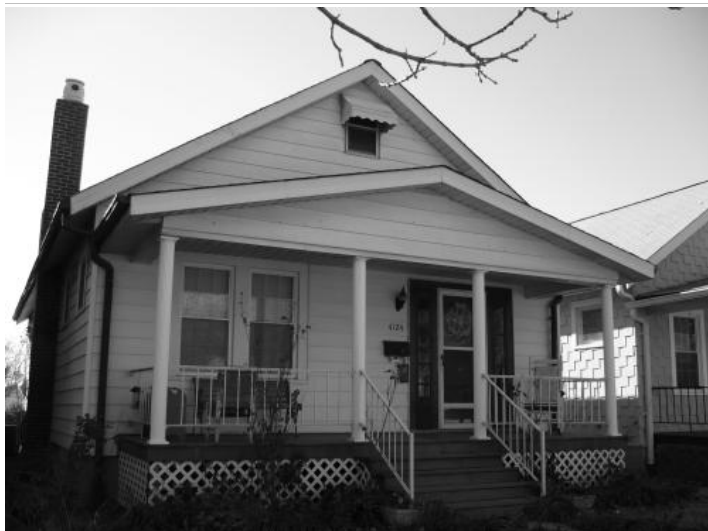
Replacement piers and railings at porch; replacement windows with their frames obscured by siding.

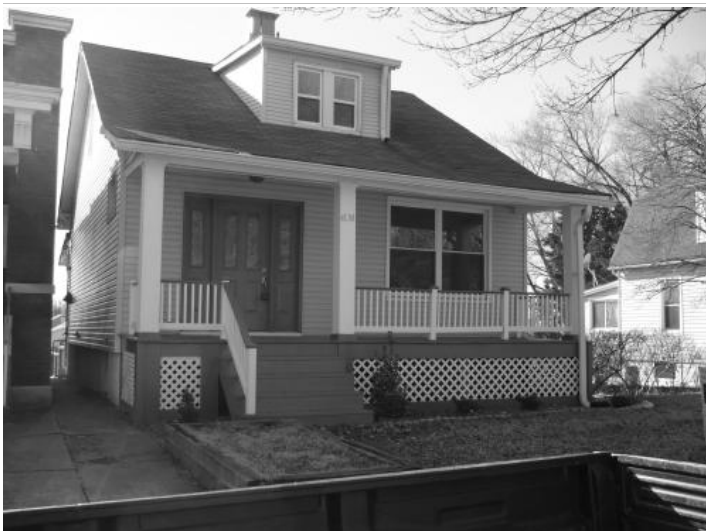
Replacement door, sidelights and windows.

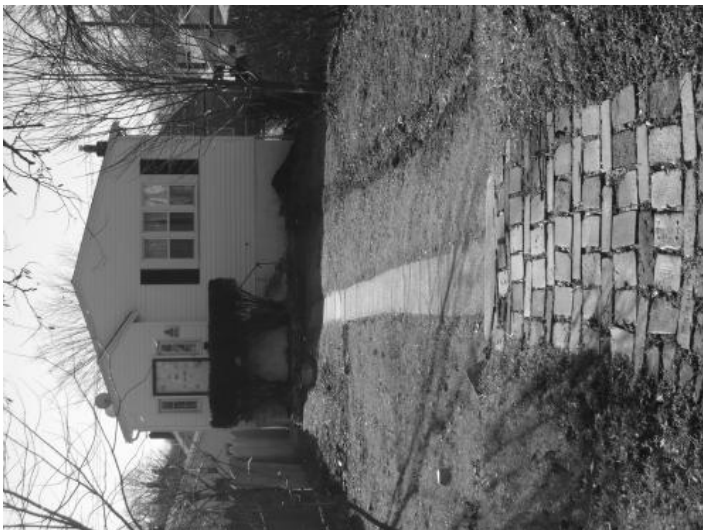
From the street, everything appears to be replaced or covered with vinyl.

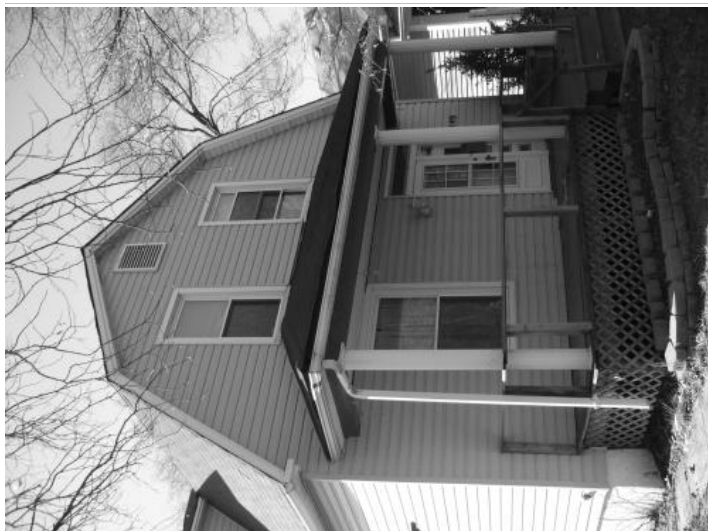
Replacement windows (original trim covered); replacement piers and railing at hipped porch.

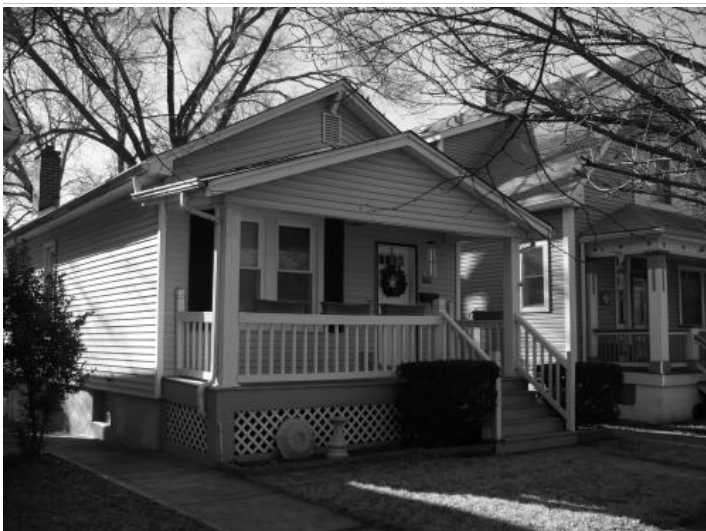
Replacement door, windows, railings, piers.

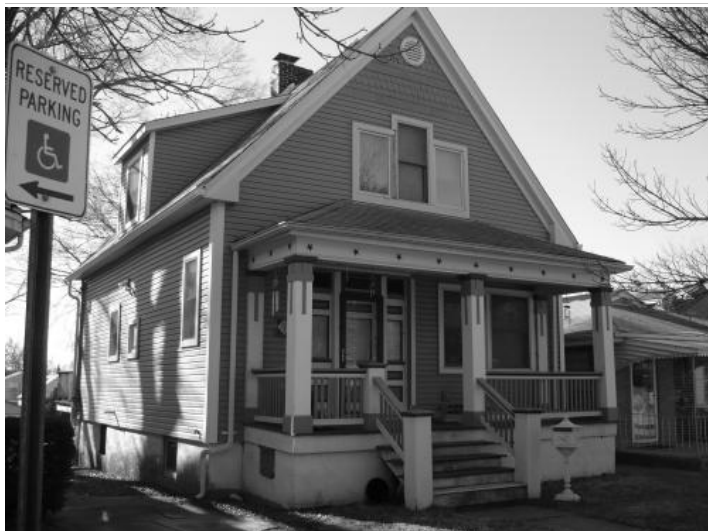
Replacement windows ; siding covers original trim.

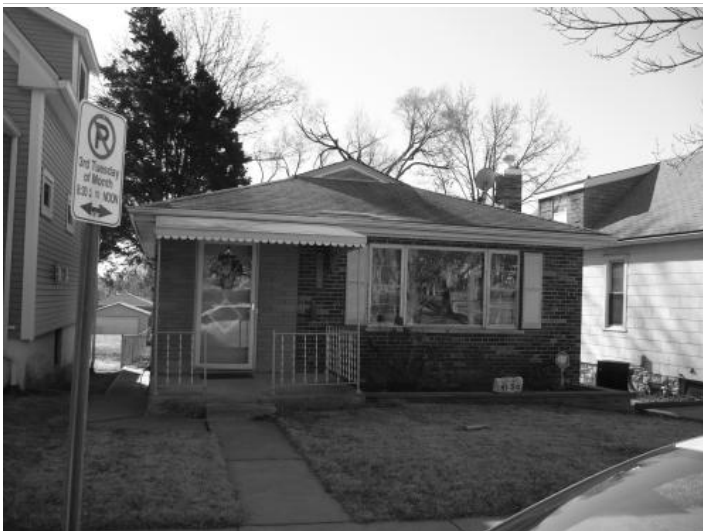
porch awning added. Shutters added.

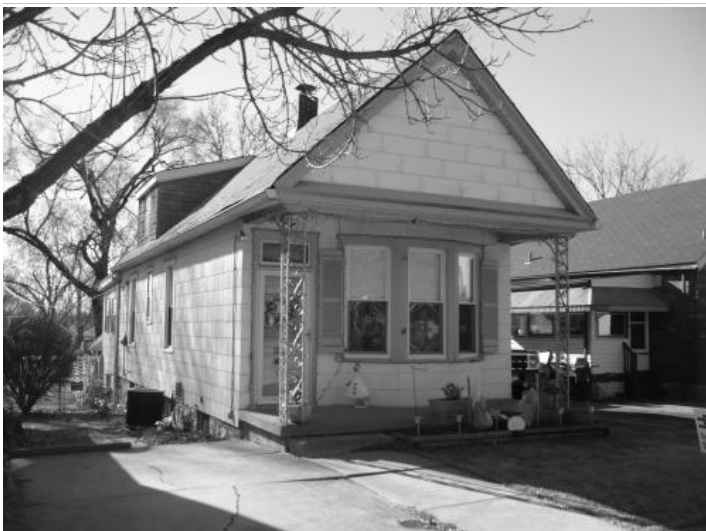
Replacement window. Porch piers replaced with metal (base is concrete).

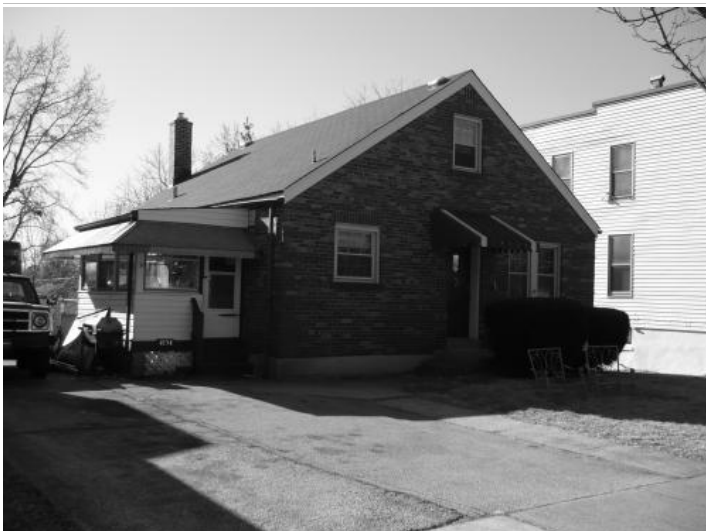
Windows are replacements; metal awning over front door (early but not original) ; vinyl and fiberglass added over side porch.

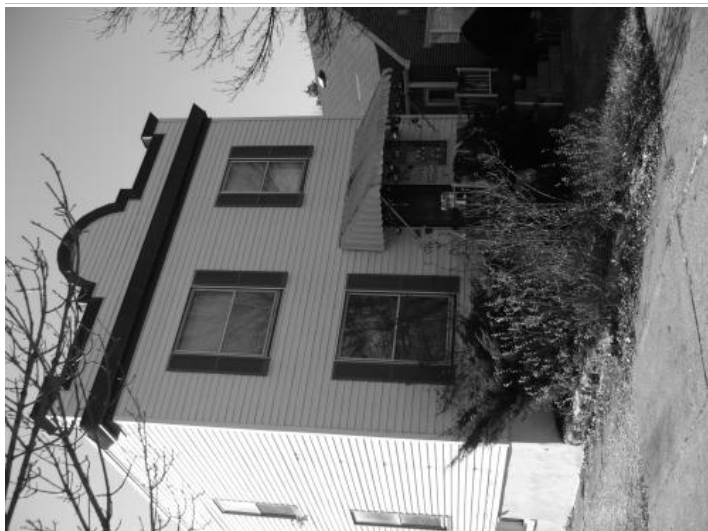
Most historic elements are sided over, including window trim, cornice, coping. Railings and awning at porch are incompatible replacements

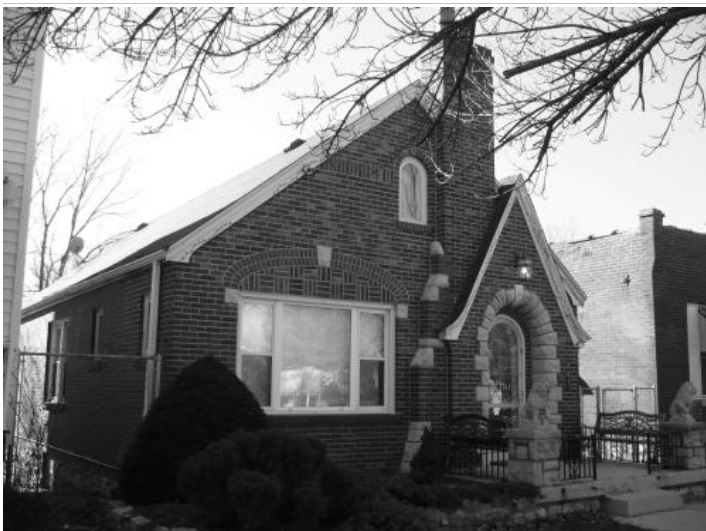
Facade window replacement.

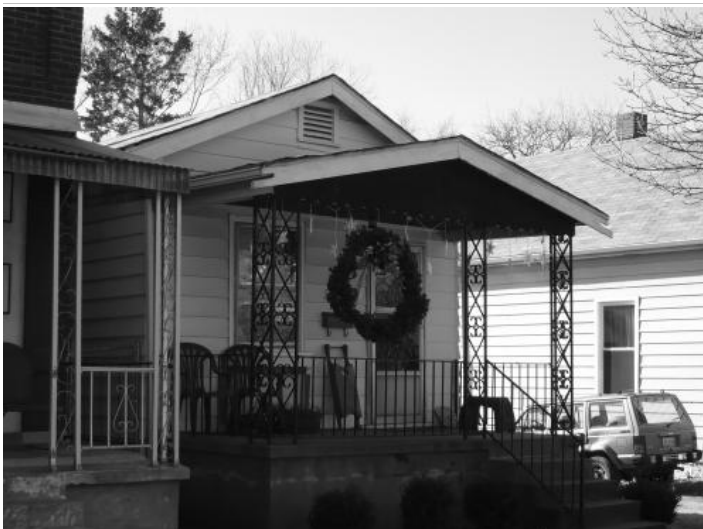
Gable end of porch covered; replacement front door; replacement metal trellis-style porch supports .

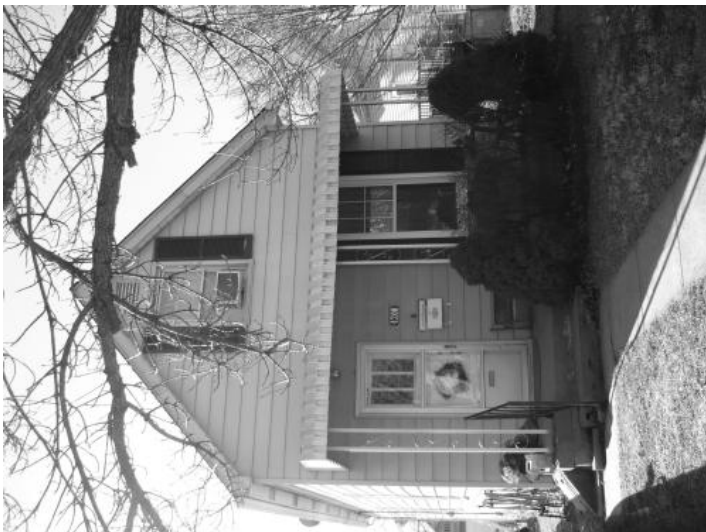
Replacement windows and no historic window trim; metal awning instead of original front porch; shutters added. Virtually none of the historic exterior surface is visible.

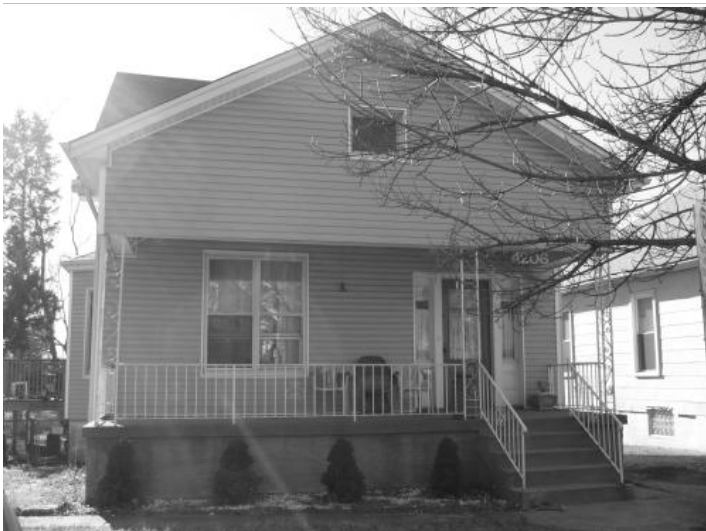
Replacement windows.
