City of St. Louis Cultural Resources Office

Holly Hills Neighborhood Survey

Lynn Josse and NiNi Harris
3/1/2010

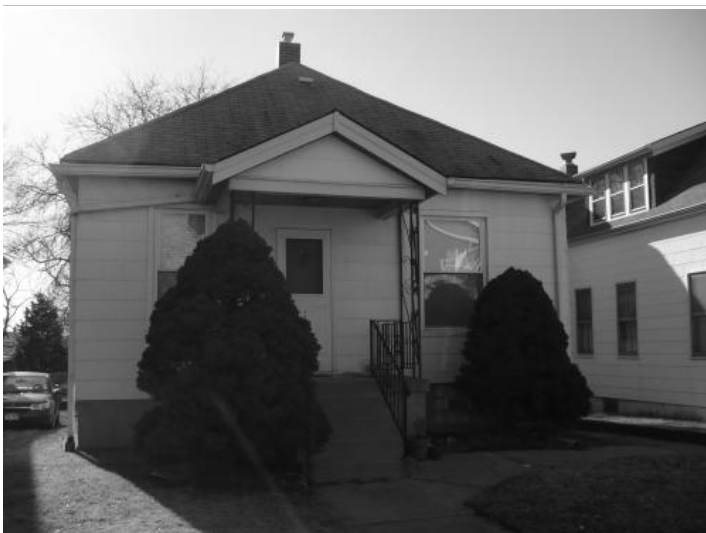
\$1300 addition, 1957, is not visible from street. Windows, doors, porch elements replaced, and most everything else sided.

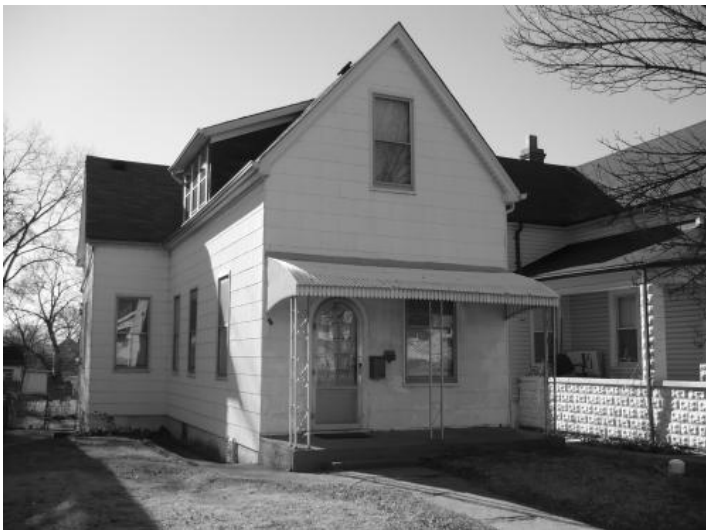
The front porch, one step above grade, is a concrete slab with a metal awning on aluminum supports. Original wood window frames are covered by the siding, although the door frame is exposed.

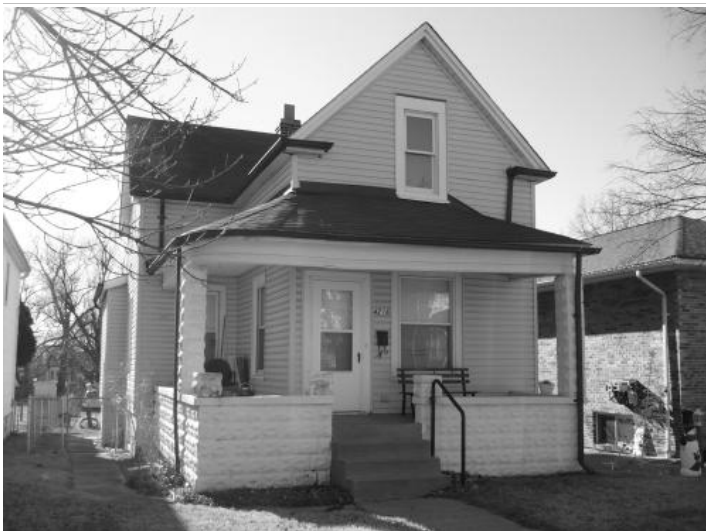
Doors and windows are replaced. Vinyl covers walls and eaves.

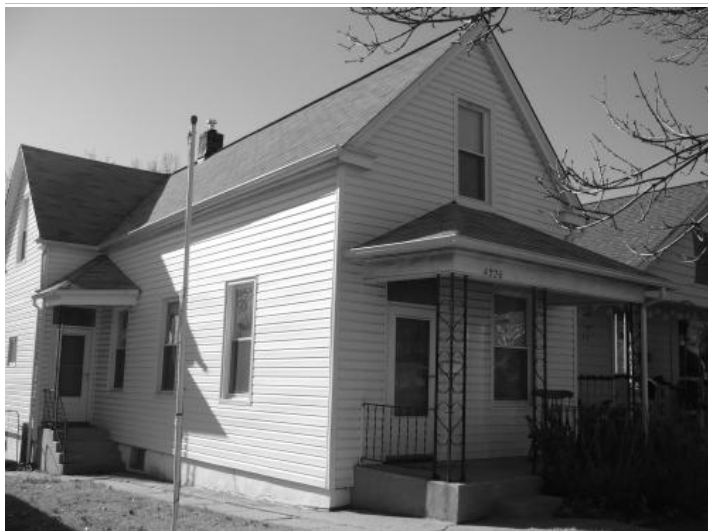
Vinyl covers most original wall and trim (except porch soffits, eaves, and ceiling). Replacement windows and porch base/supports.

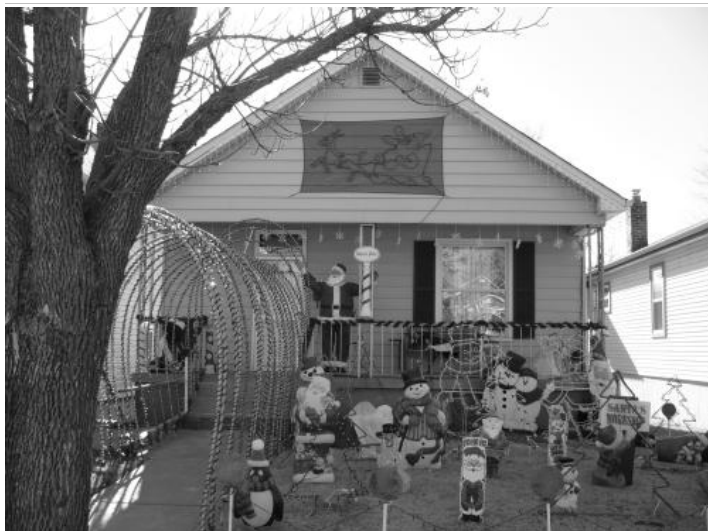
Most surfaces are covered with siding. Front door and window are replacements.

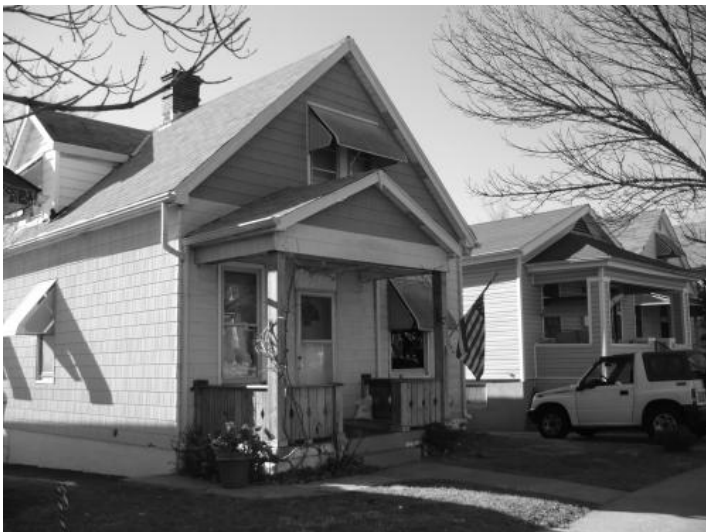
In addition to the exterior wall surface, the front door is not original. The transom is covered. Fiberglass awnings are added. Some original porch trim is present but the posts and rails are replaced.

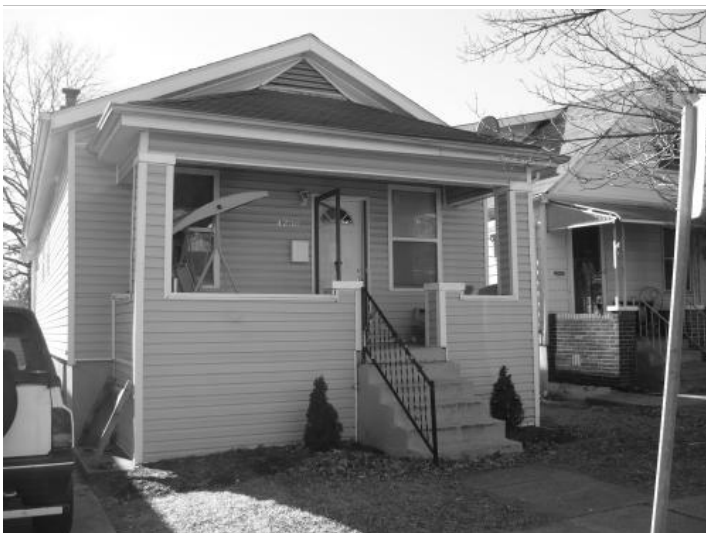
Most surfaces armored with vinyl. Front door and windows replaced.

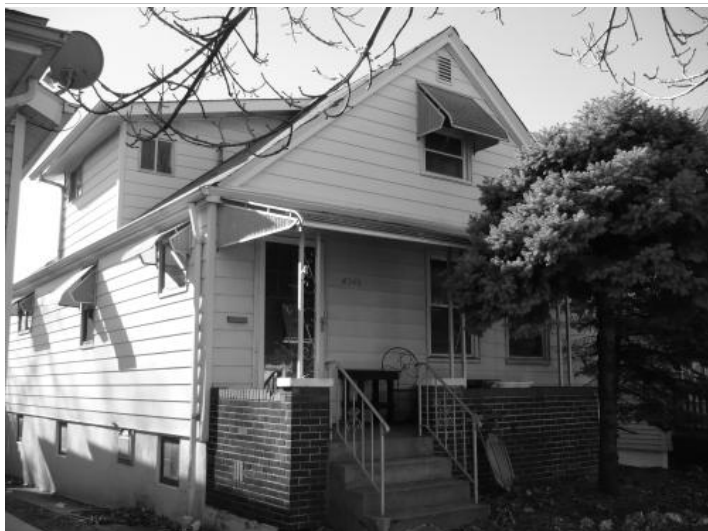
Replacement windows; window trim obscured by siding. Fiberglass awnings. Metal supports for awning. No visible original siding.

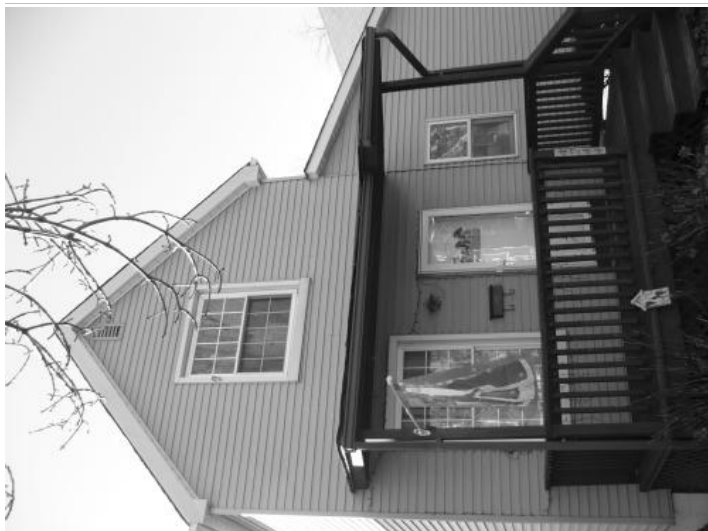
No original material is visible at the front elevation after siding and door/window replacement.

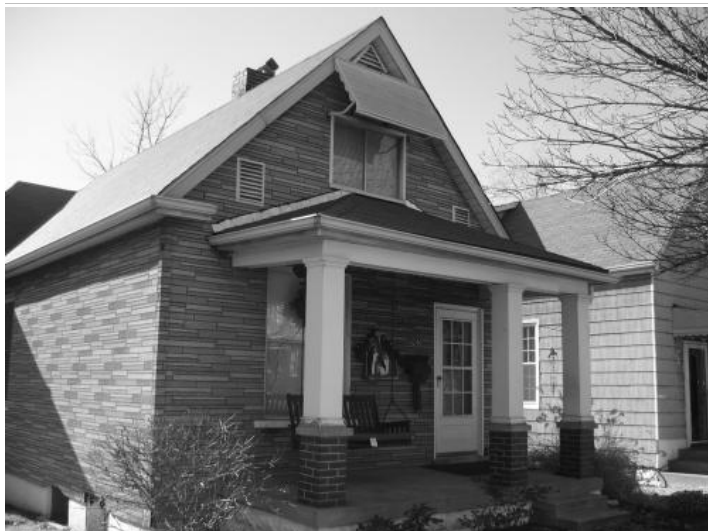
Asphalt siding (possibly historic in its own right) ; replacement windows and door.

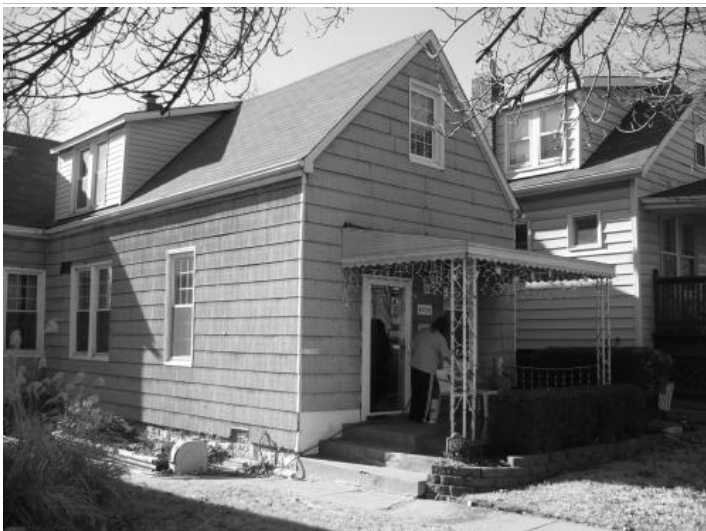
Replacement door, windows; porch is a metal awning on trellis-style metal supports.

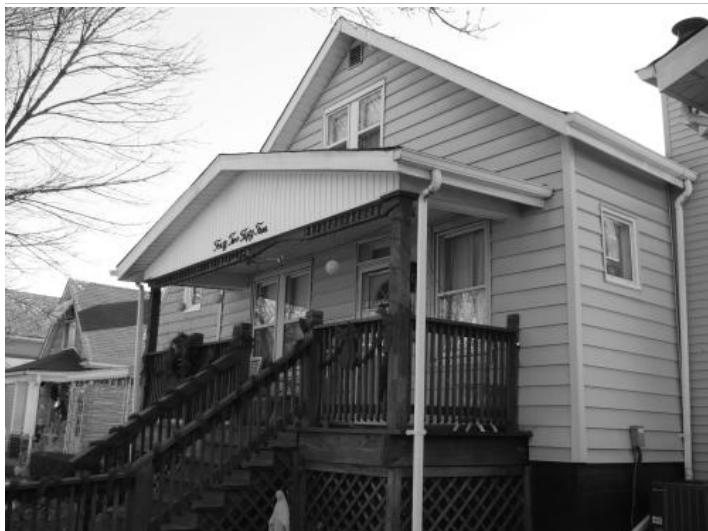
Front door and windows are replacements lacking original trim. Vinyl covers walls, porch gable end, soffits, eaves.

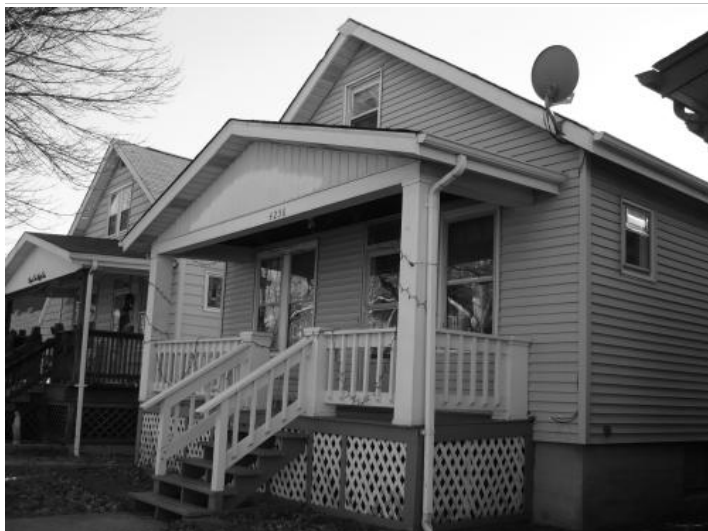
Siding covers walls, soffits, eaves; replacement wood porch railings; replacement attic window.

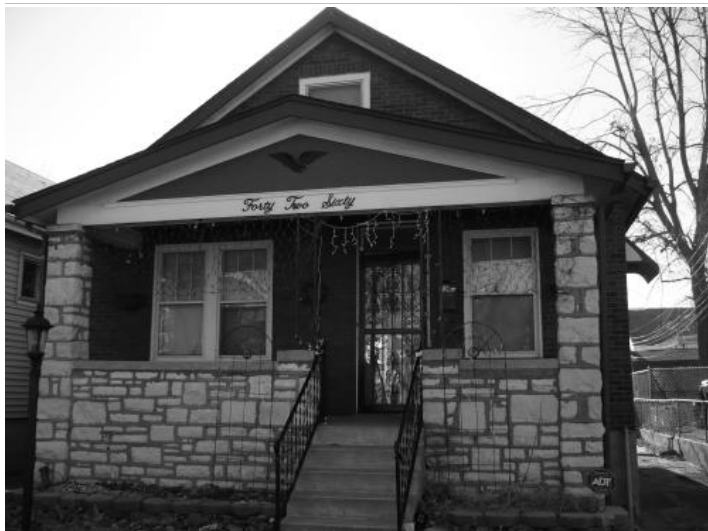
Metal supports brace the porch roof; replacement attic window.

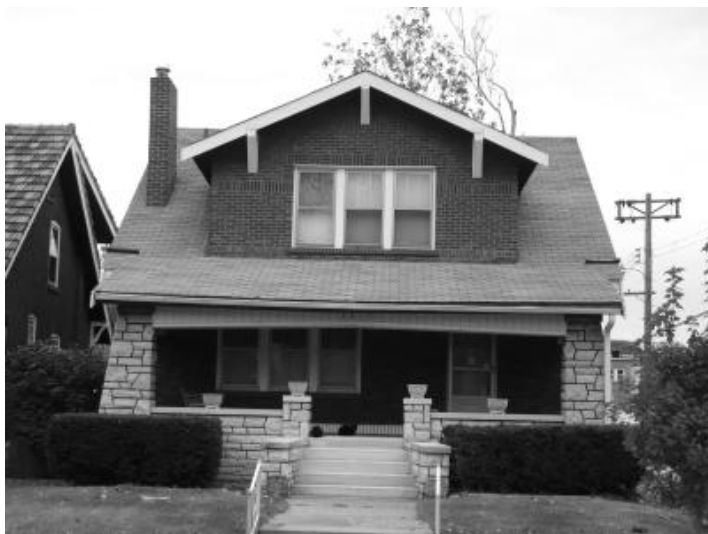
aluminum siding at soffits and brackets.

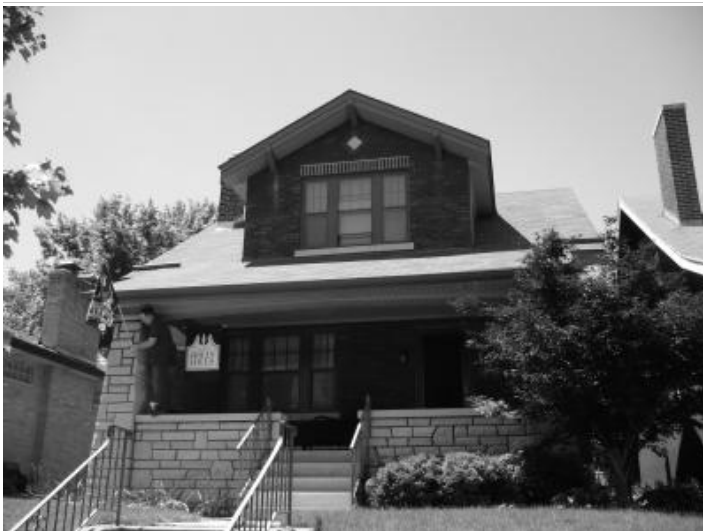
The façade windows are vinyl replacements. The front door is a replacement. Soffits, eaves and brackets sheathed with vinyl.

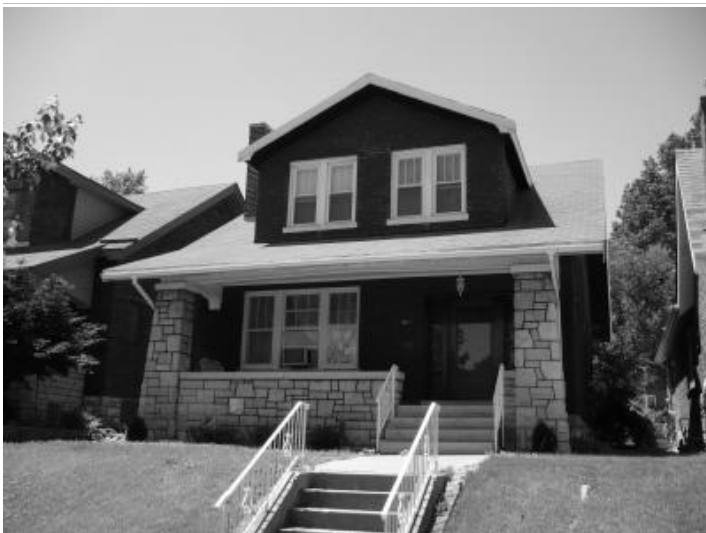
Replacement windows at dormer.

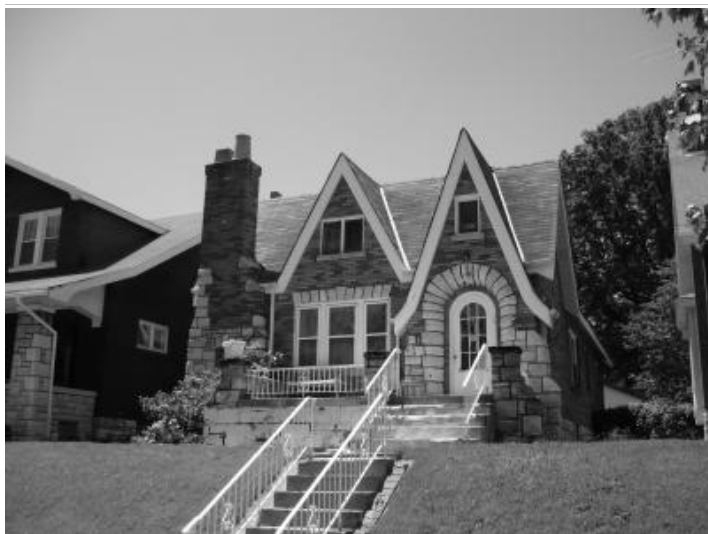
wood trim is sheathed with vinyl.

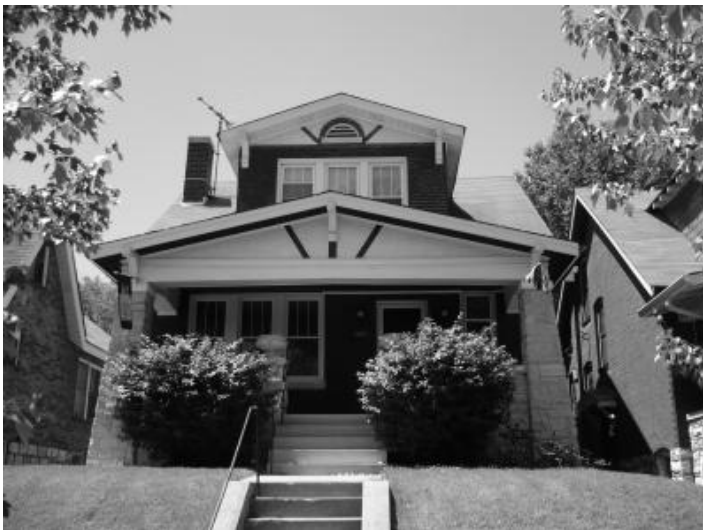
Dormer eaves are vinyl-covered.

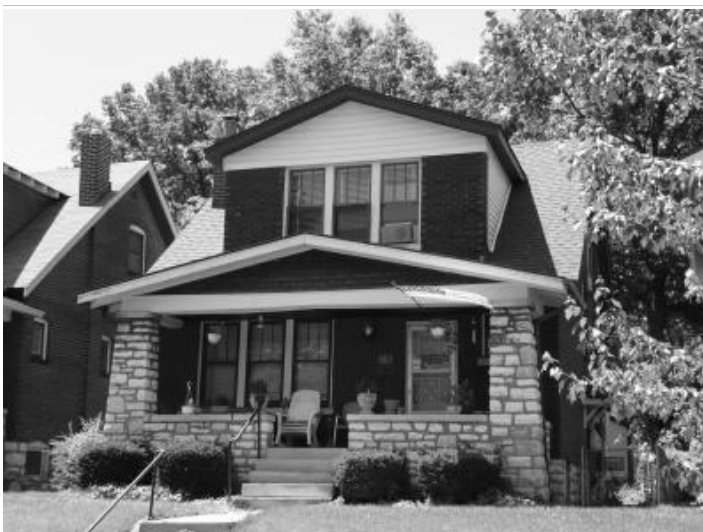
Dormer's gable end and side elevations are covered with siding.

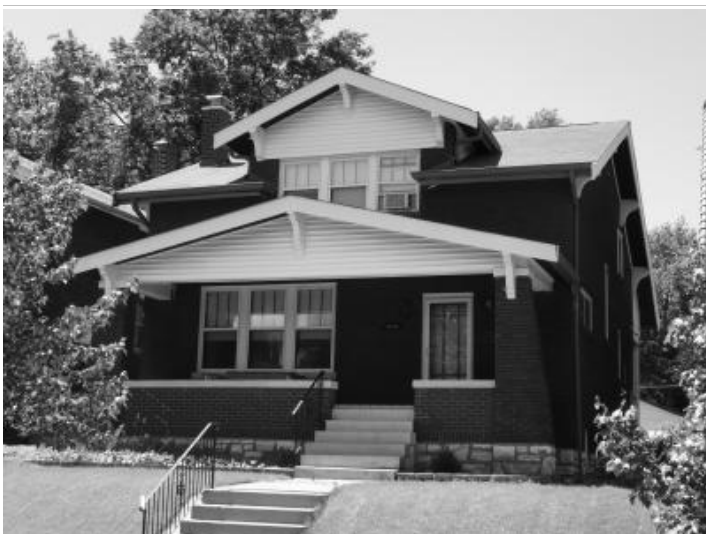
Vinyl siding at gable ends.

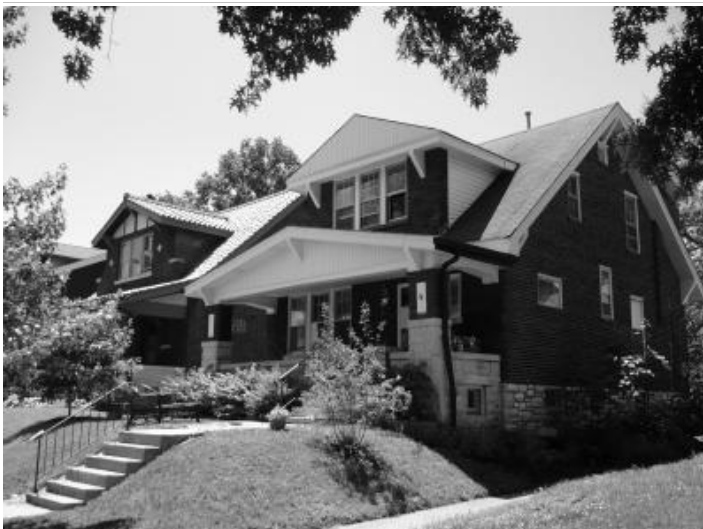
Soffits and eaves are vinyl covered.

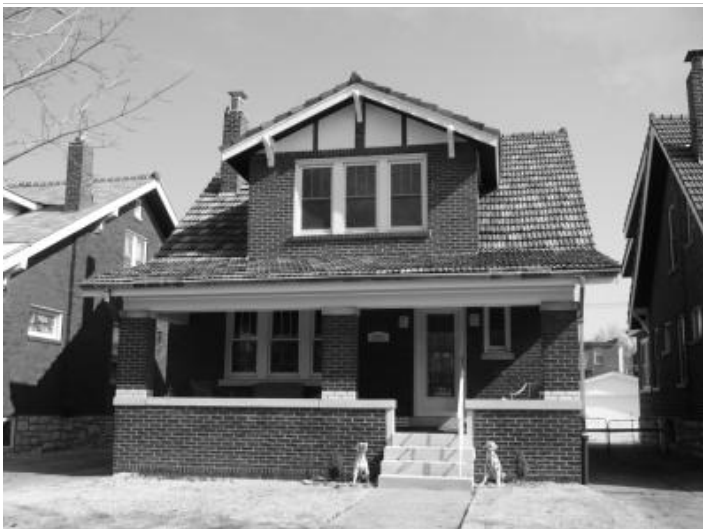
All windows are replacements.

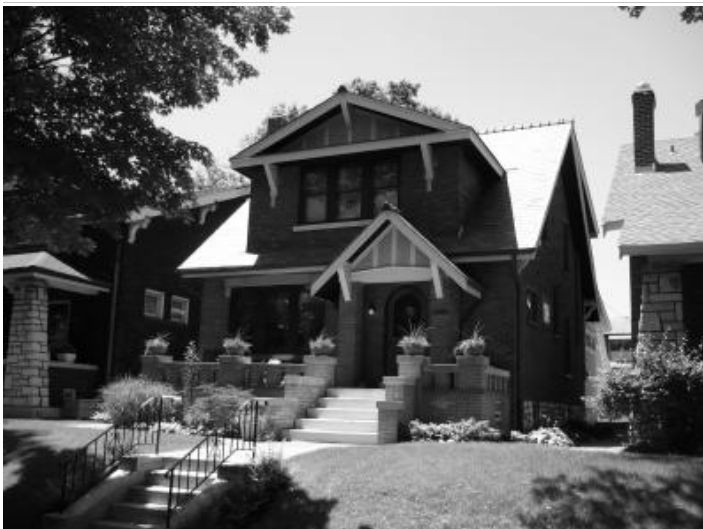
The two brackets at the door and three at the dormer are encased in vinyl.

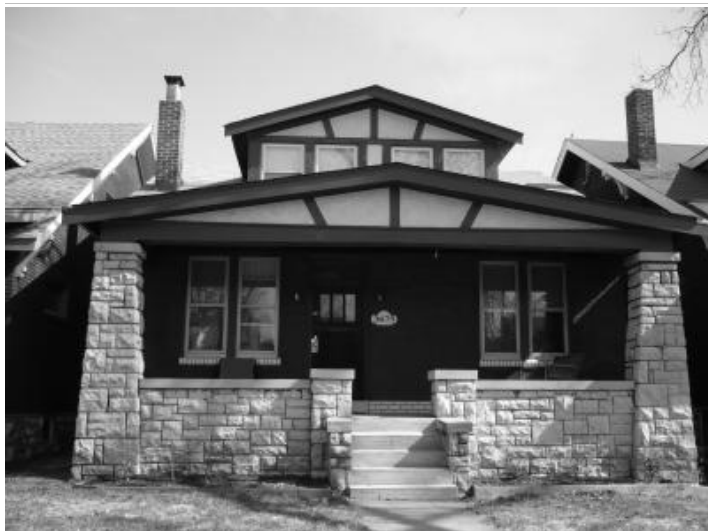
replacement windows at dormer.

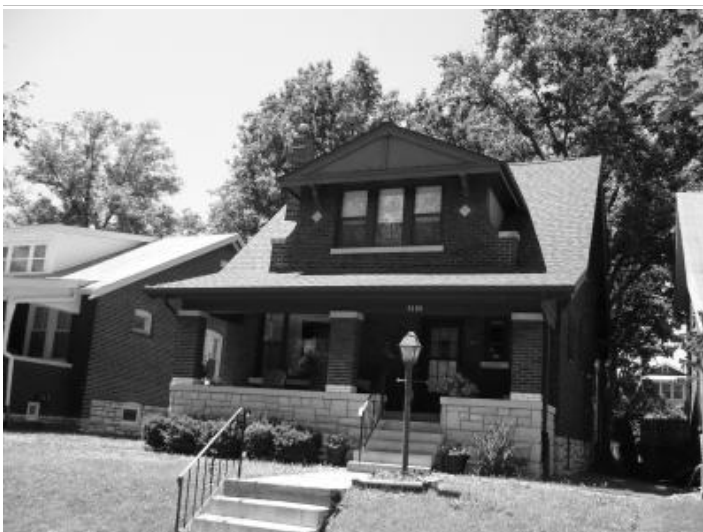
Front door is a replacement.

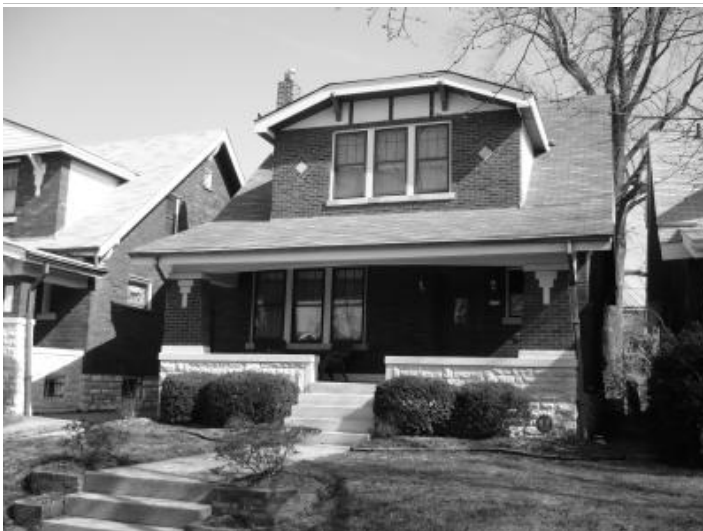
Replacement front door and side window

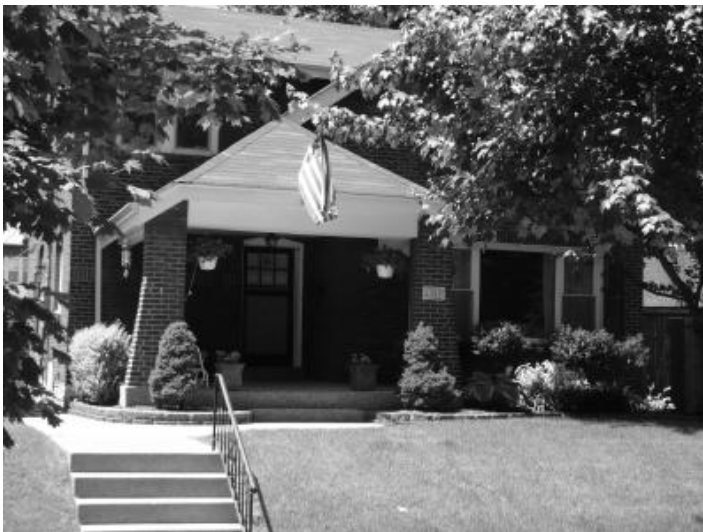
Façade windows have been replaced with vinyl. Eaves and vergeboard covered with vinyl

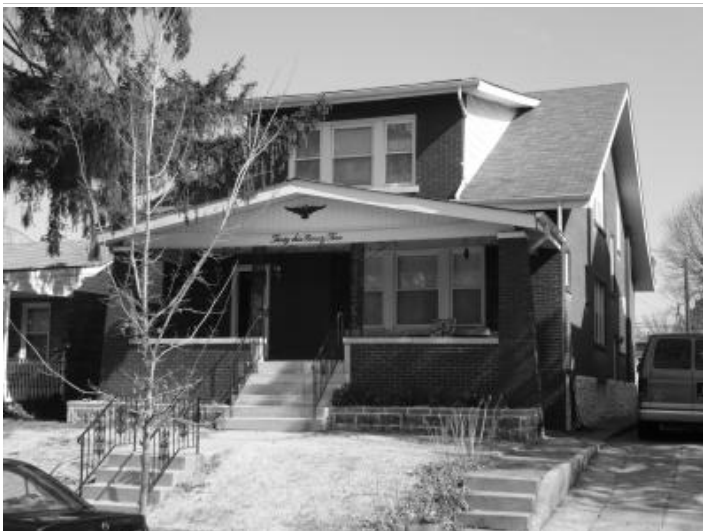
Window replacement at façade

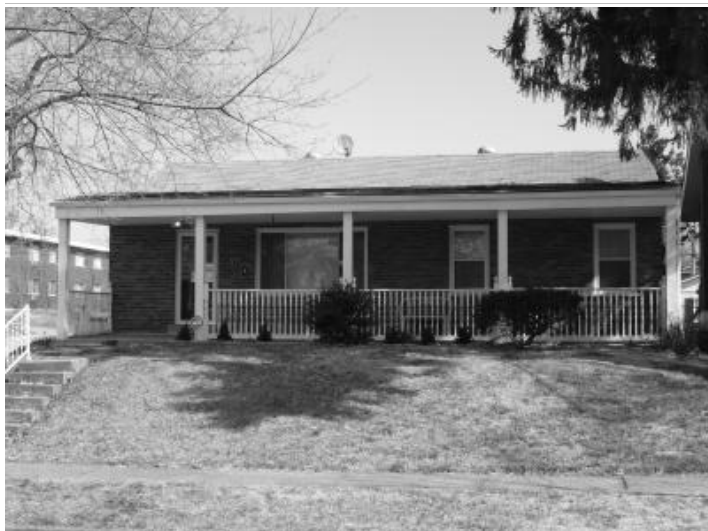
Facade windows are replacements, and porch has a lot of vinyl.

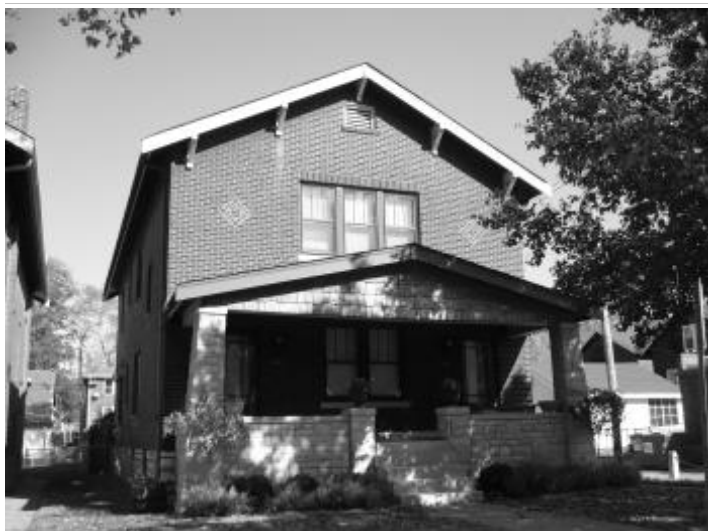
Siding at porch's gable end.

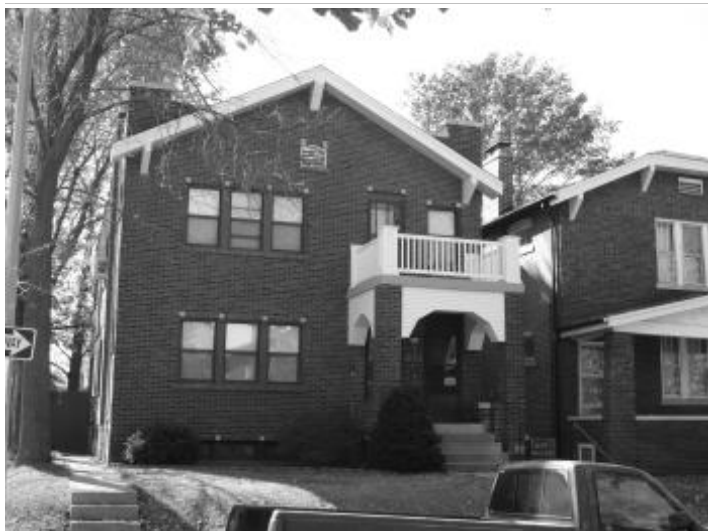
Replacement doors and windows. Soffits and gable and brackets covered with siding.

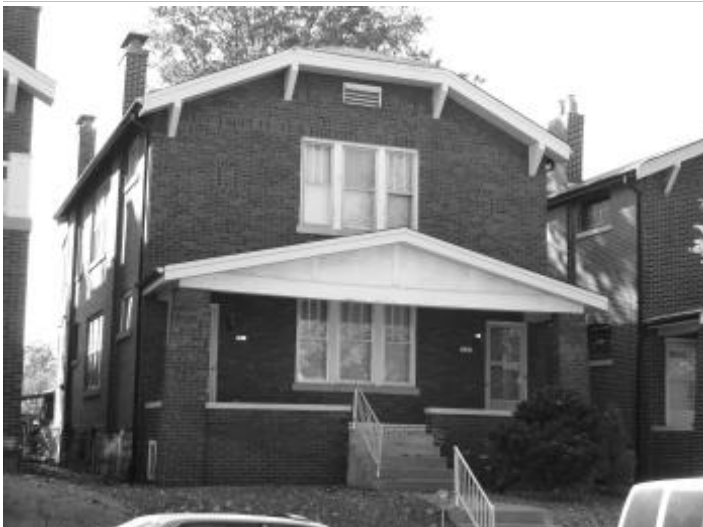
Front doors are replacements. Brackets and eaves of main roof are encased in siding.

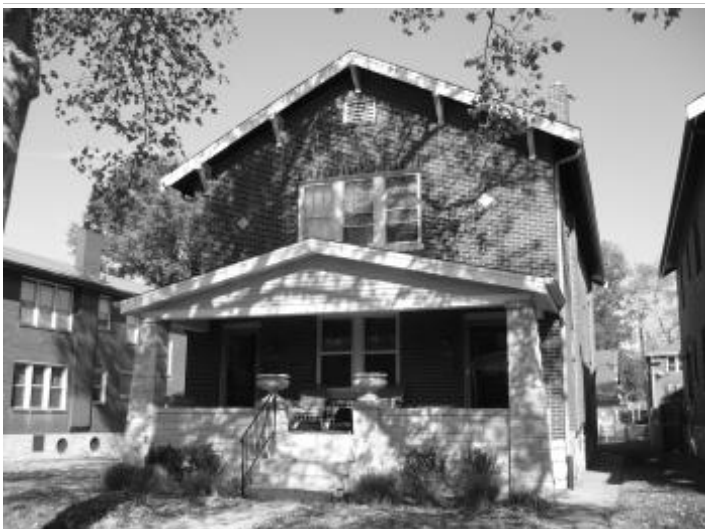
Siding at porch's gable end.

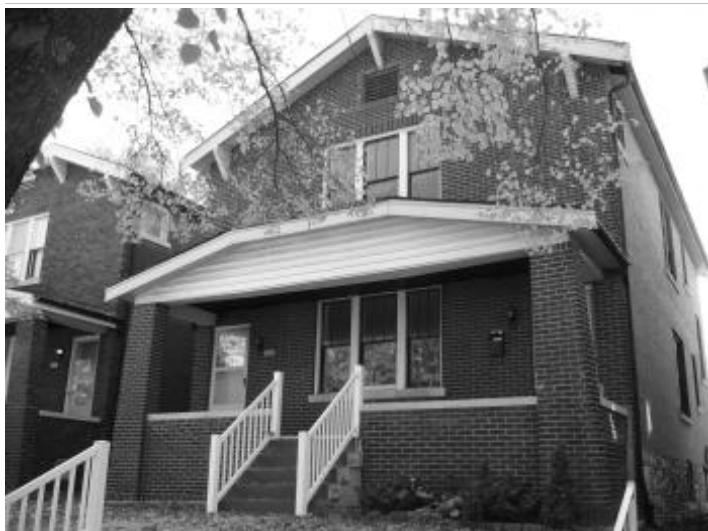
Doors and windows are replacements; brackets/eaves/porch gable end all sided over.

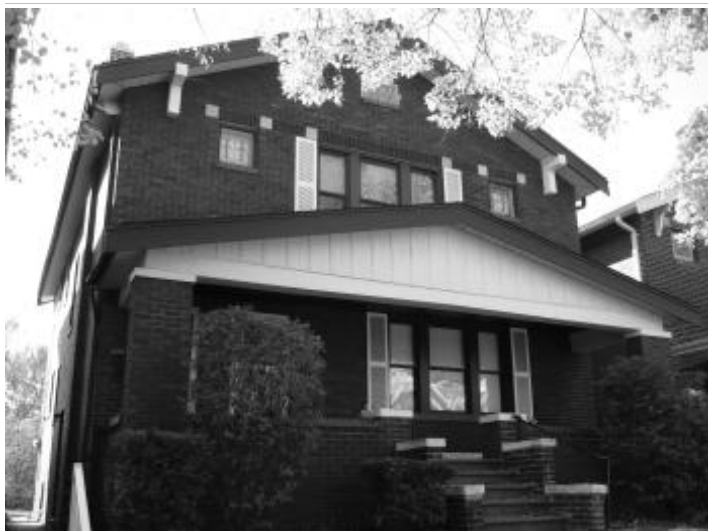
Replacement windows. Porch soffits/eaves/gable end covered in vinyl. Eaves and brackets at main roof also vinyl. Faux shutters added.

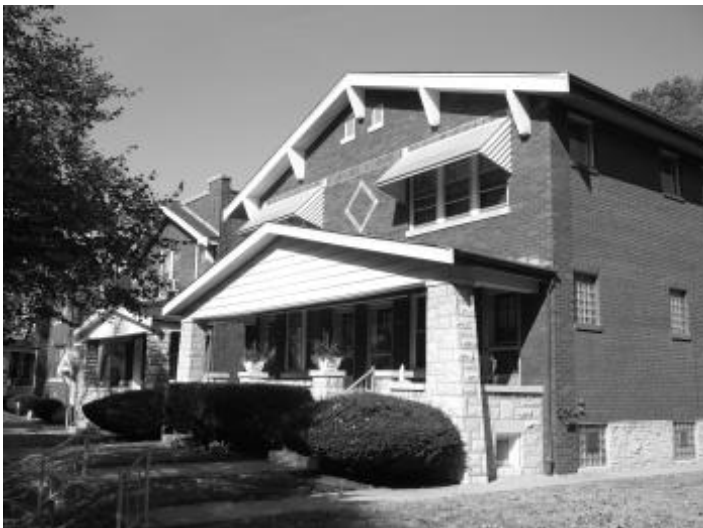
One pair of windows at the first story is replaced. Gable end and eaves of porch encased in aluminum siding. Eaves and the 5 brackets at main roof also.

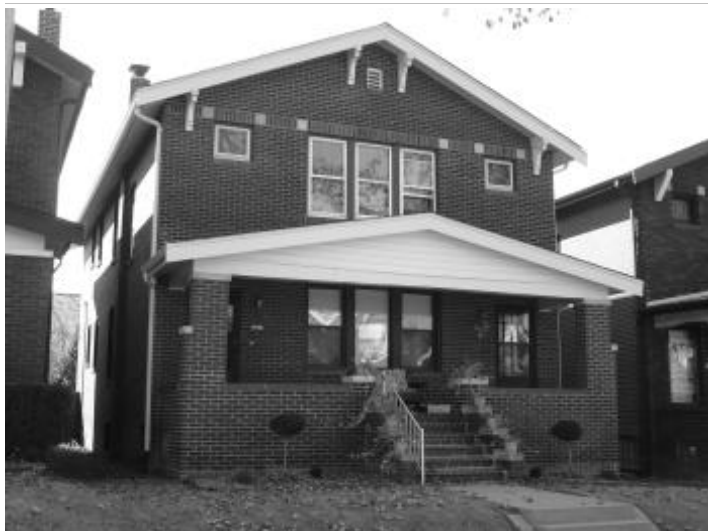
This front gabled two-family building has a full-width front porch on brick piers. Front doors are original, as are the small art glass windows and 3/1 windows at the second story. Brick is the only material visible at the foundation. Four wood brackets support the main eaves,

First story windows are replacements. Gable end at porch is covered with vinyl.

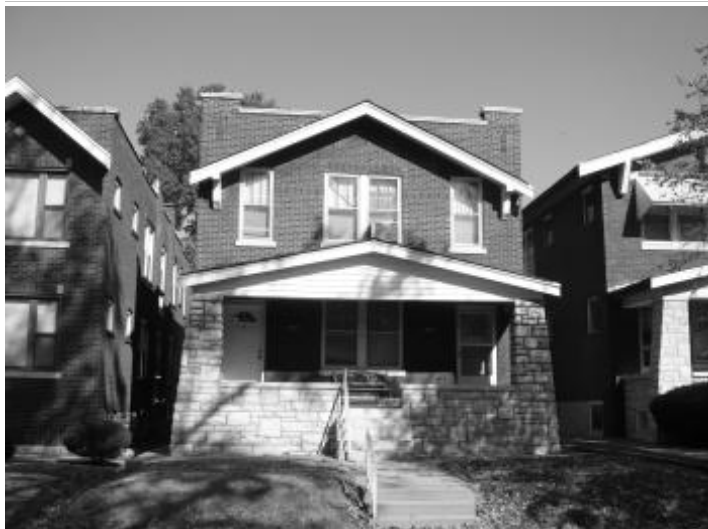
Gable end and eaves of porch and applied gable above 2nd story encased in aluminum siding. Replacement front doors.

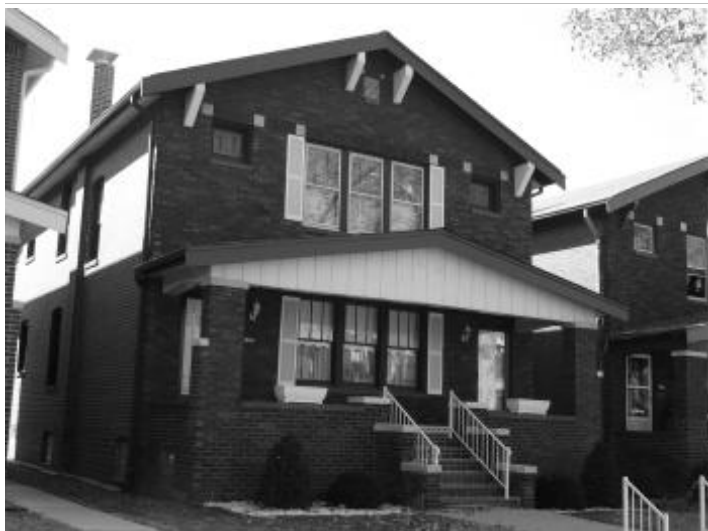
This front gabled two-family building has a full-width front porch on brick piers. Front doors are original, as are the small art glass windows and 3/1 windows at the both stories. Brick is the only material visible at the foundation.

Siding covers porch gable end and four brackets at main roof. Shutters added at windows.

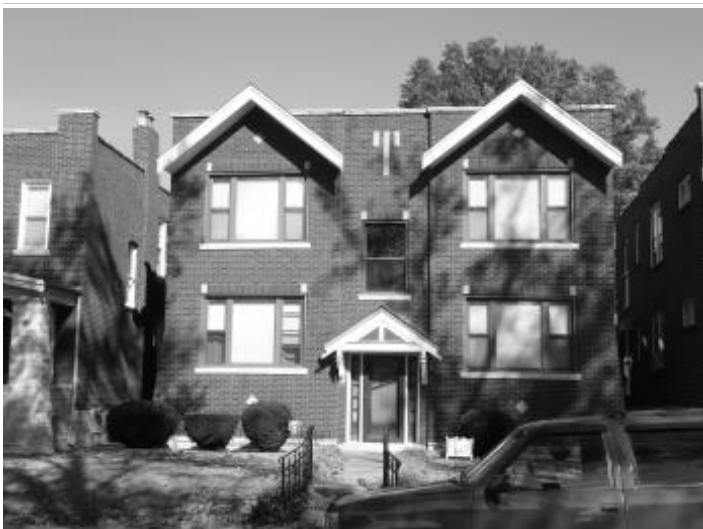
Replacement windows.

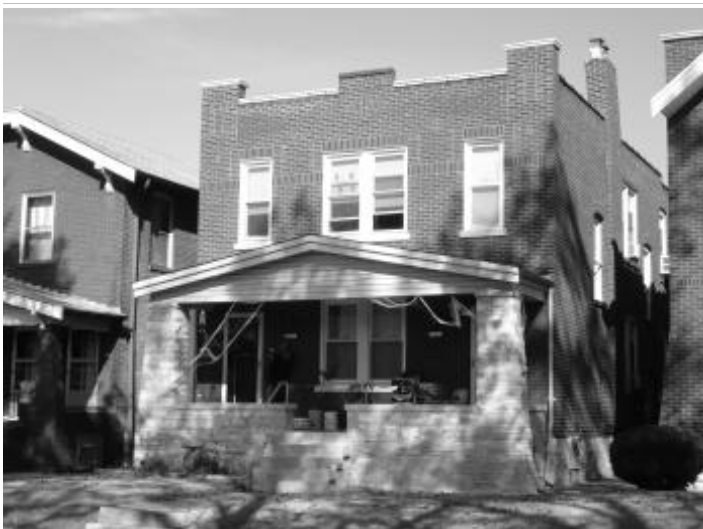
Facade windows are replacements. At the front porch, gable end and eaves and soffit all clad in siding.

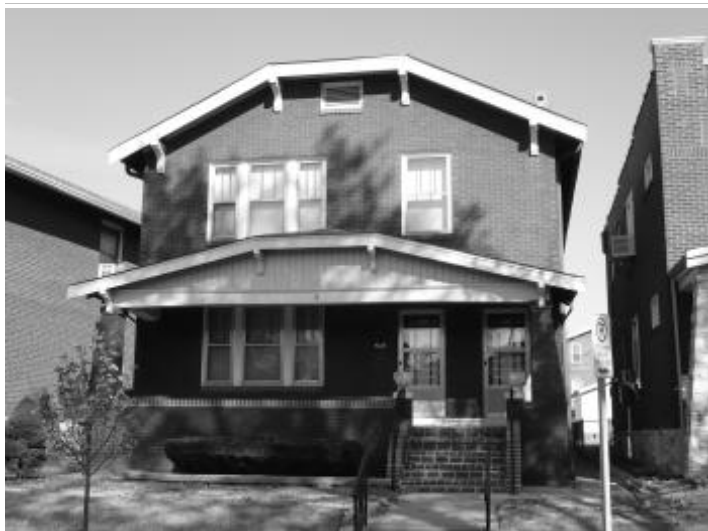
Brackets and porch's gable end all sided over.

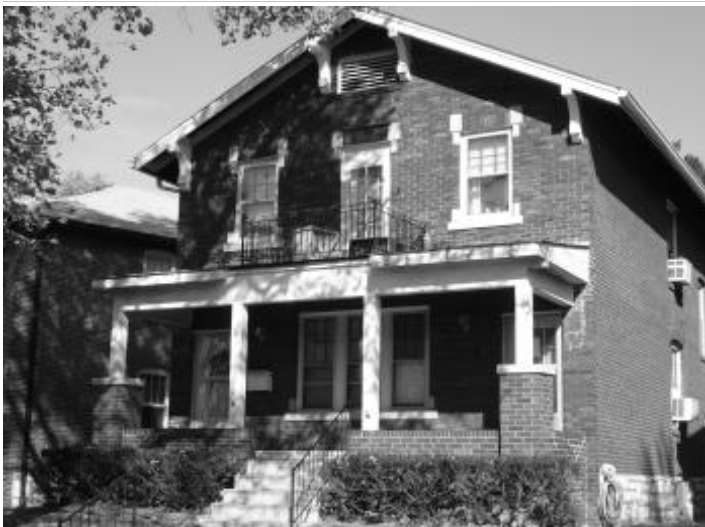
Porch supports are replacement wood. Four brackets at front eaves are covered with vinyl.

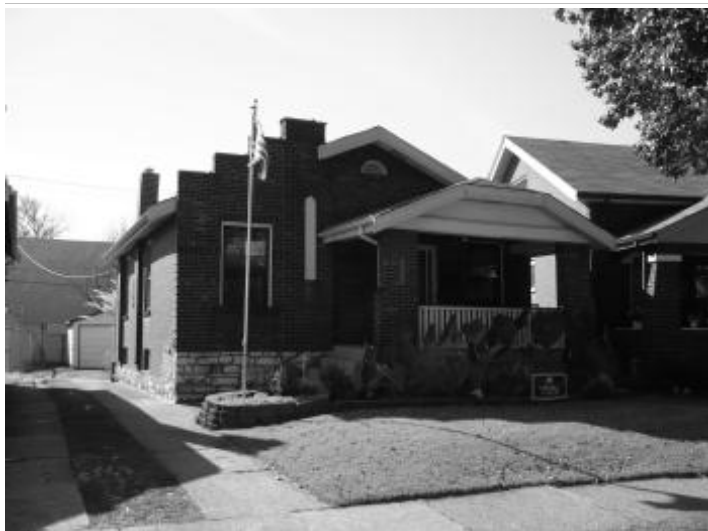
Door and windows are replacements. Siding at porch covers eaves, gable end, soffits.

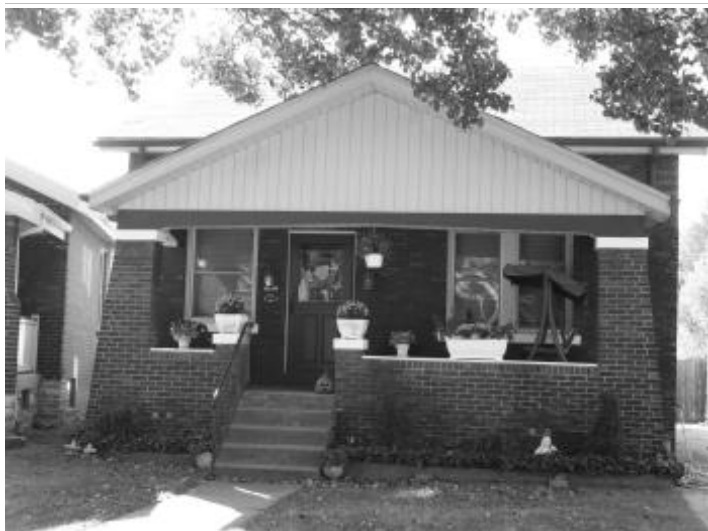
Side gabled building has a full width gabled porch on battered brick piers. Brick is the only material visible at foundation.

Front door and windows are replacements. Siding over porch gable end.

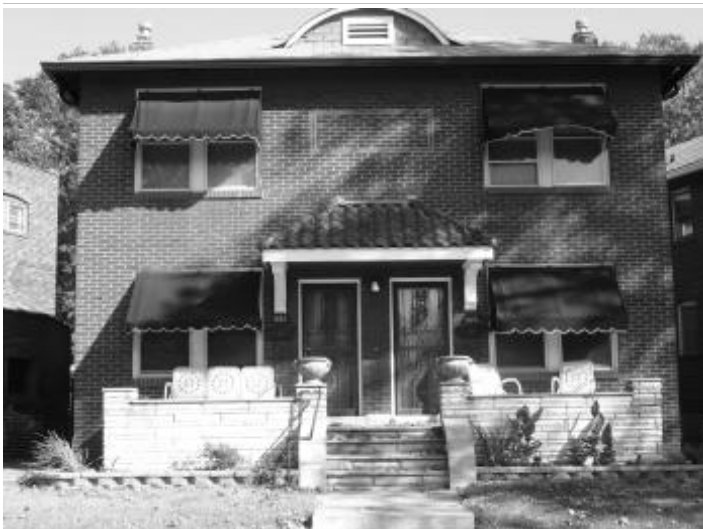
Fabric awning; imitation stone veneer at porch walls.

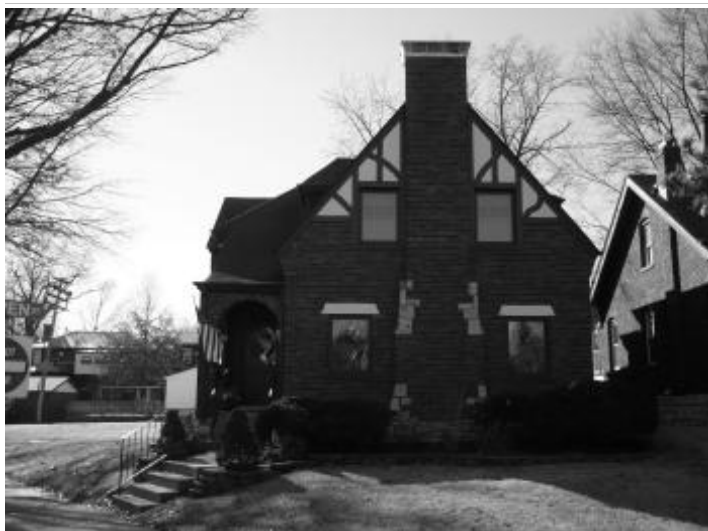
\$2800 addition 5/23/1956 to owner Ahrenhoerster - this appears to be a sunroom addition. Window replacement.

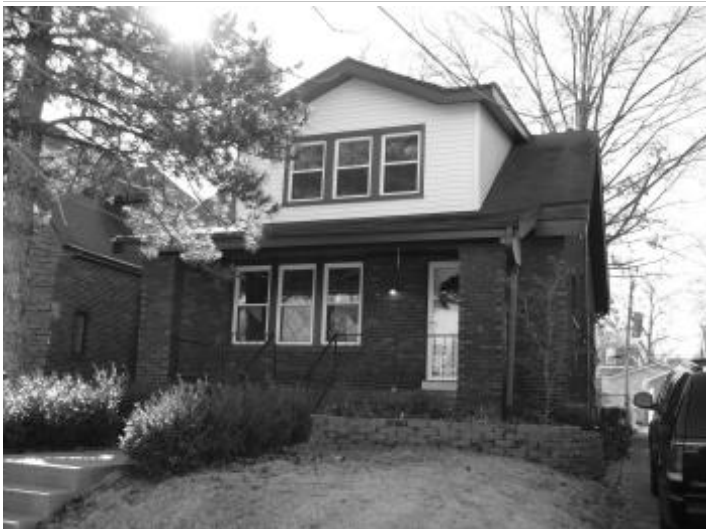
Replacement windows; dormer, eaves covered with modern siding.

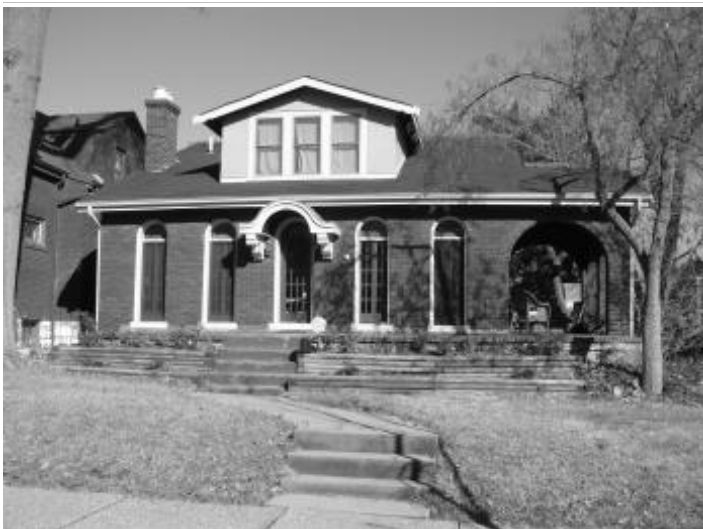
Replacement dormer windows.

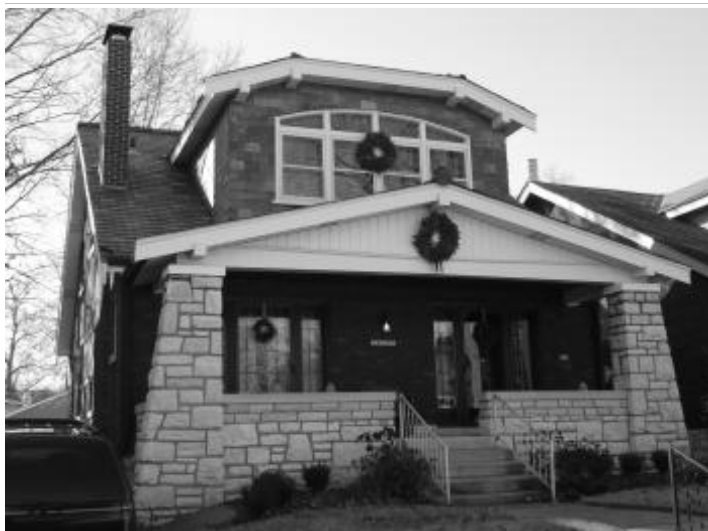
The porch's gable end and wood trim is covered with siding.

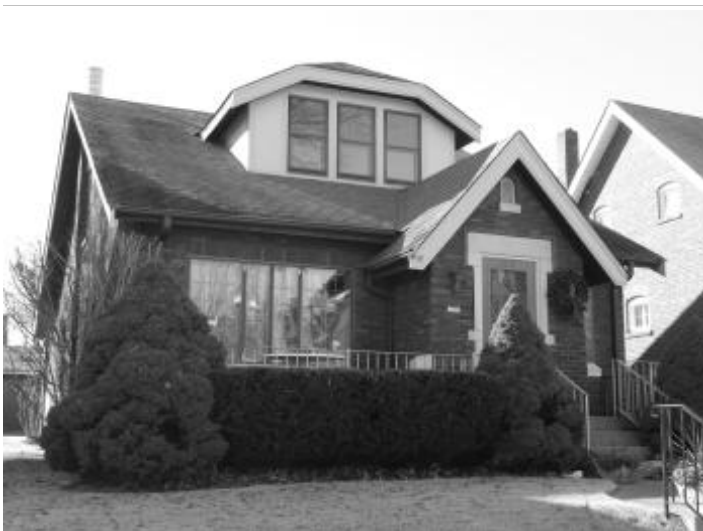
Replacement window in dormer.

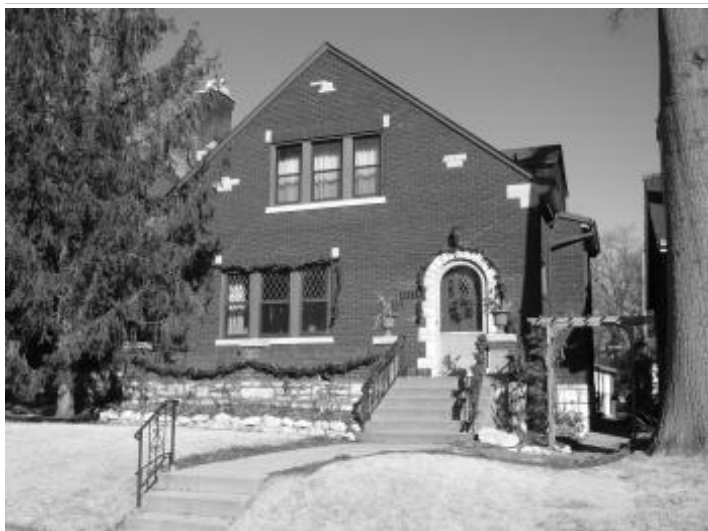
At the second story, centered, is a triple set of replacement windows.

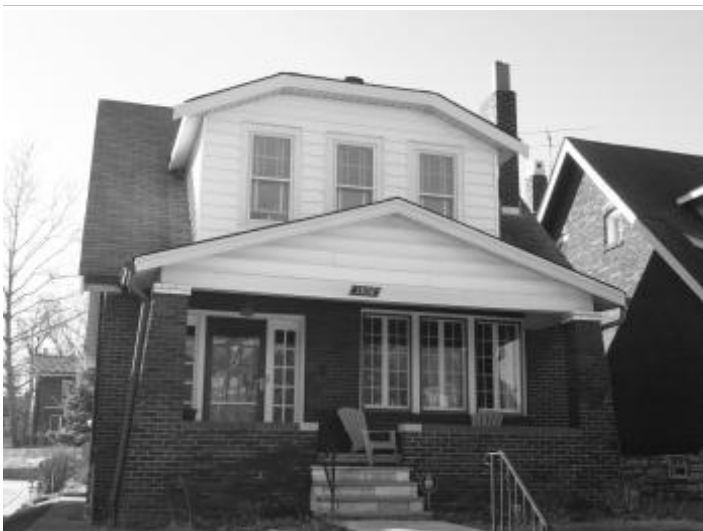
Some wood trim (eaves) covered with siding.

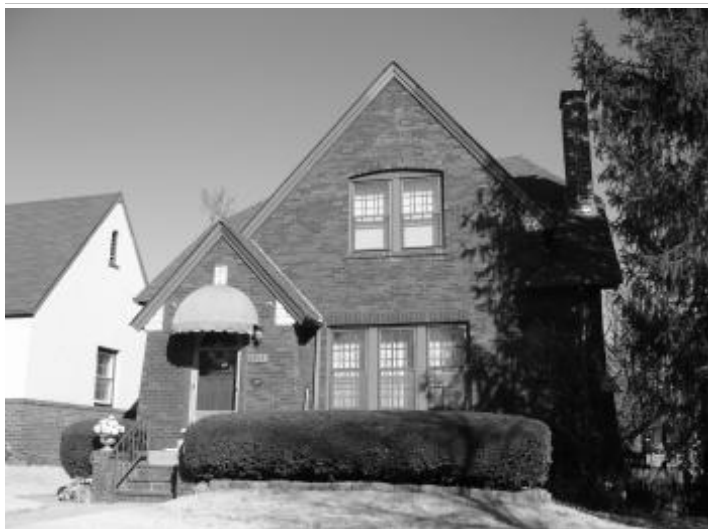
Some wood trim wrapped. Fabric awning over door.

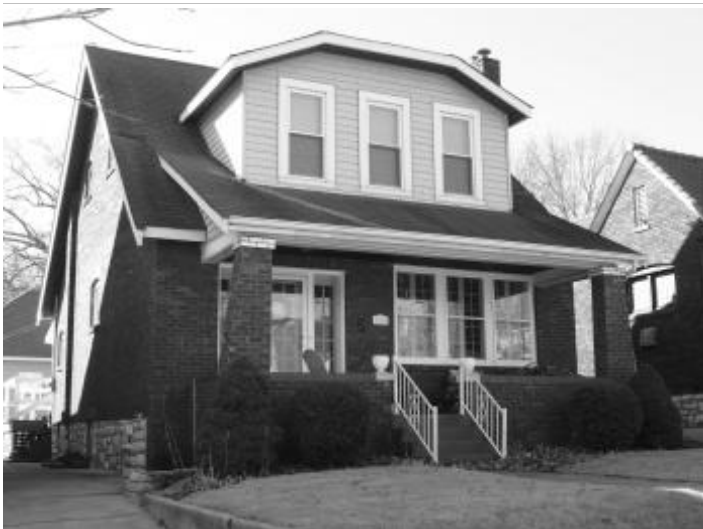
The dormer is fully sided with modern horizontal siding, and has 3 replacement windows.

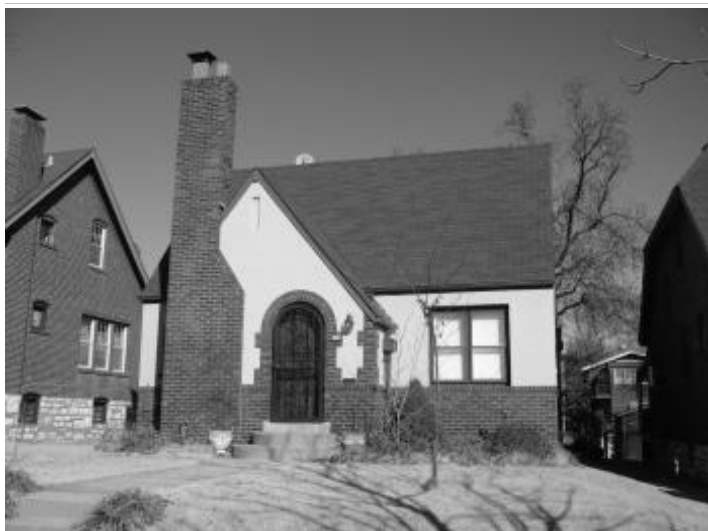
Replacement window pair at right bay.

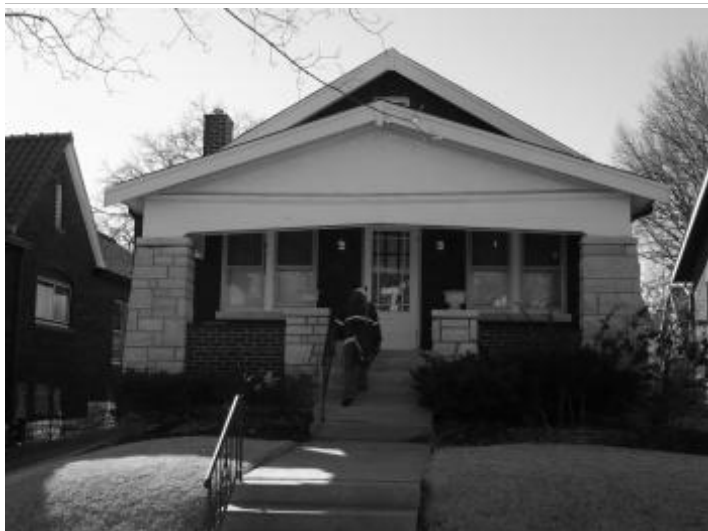
Some wood trim covered with aluminum siding.
