City of St. Louis Cultural Resources Office

Holly Hills Neighborhood Survey

Lynn Josse and NiNi Harris
3/1/2010

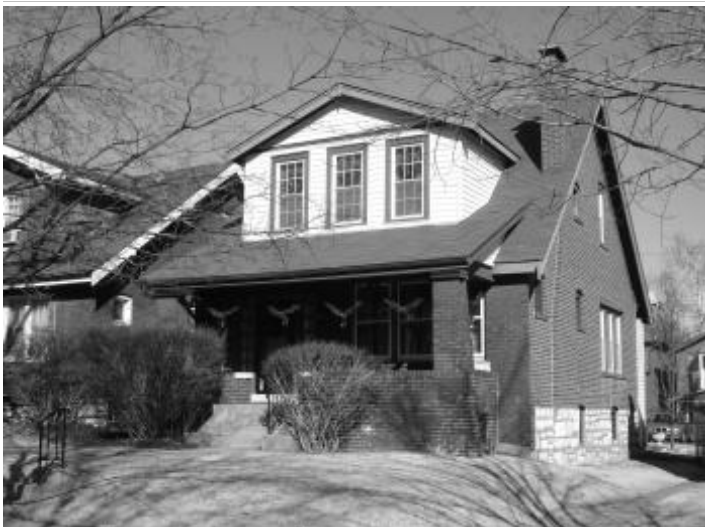
Replacement windows in sided dormer.

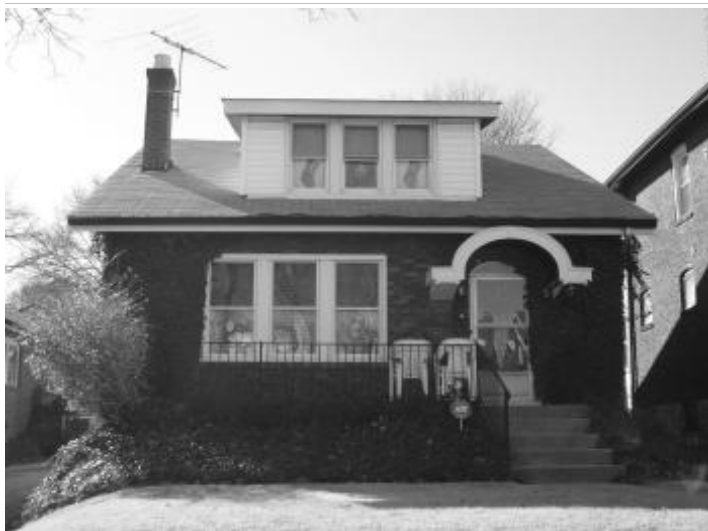
Replacement windows. Modern horizontal siding covers dormer walls and eaves.

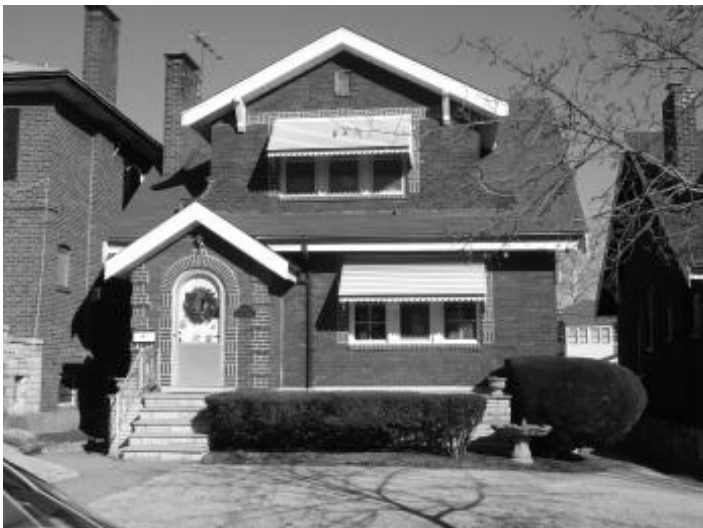
Vergeboards/brackets wrapped; metal awnings at windows; façade windows replaced, steps/porch im. stone veneered(although this house and next door at 3829 are nearly identical, permits are a year apart with different builders... recheck at nomination phase)

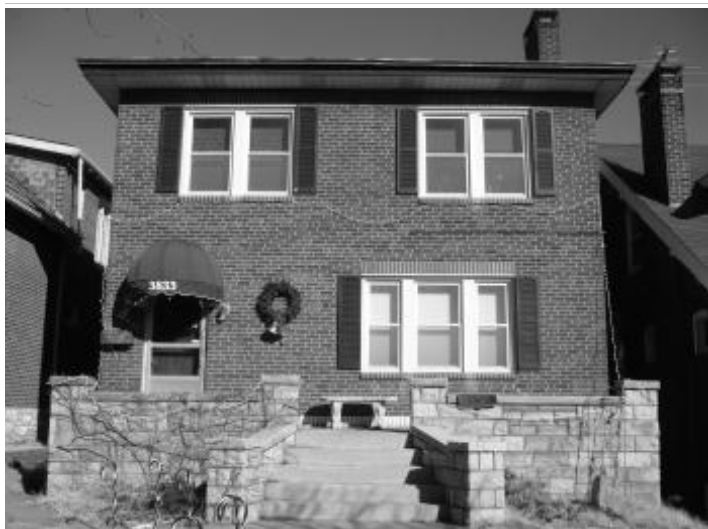
Replacement windows with fake shutters.

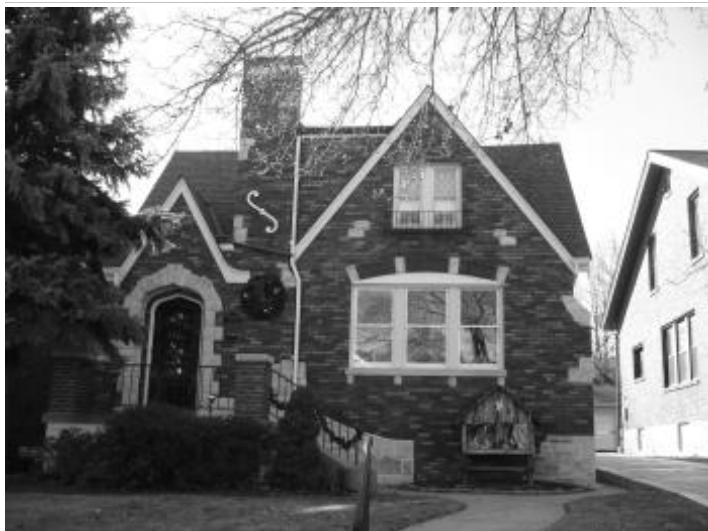
Some wood trim is wrapped (subtle).

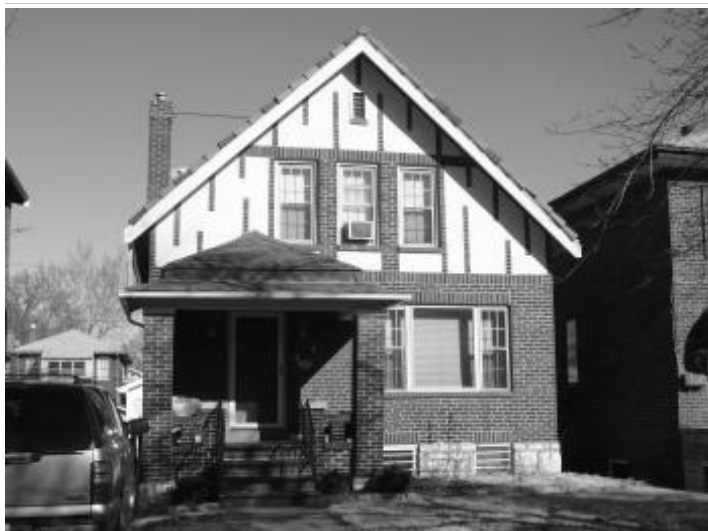
Replacement windows.

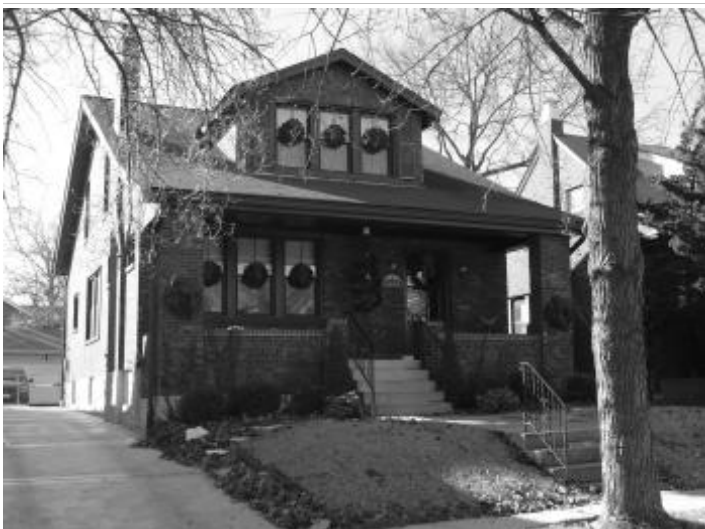
Replacement windows; some wood elements are wrapped with siding.

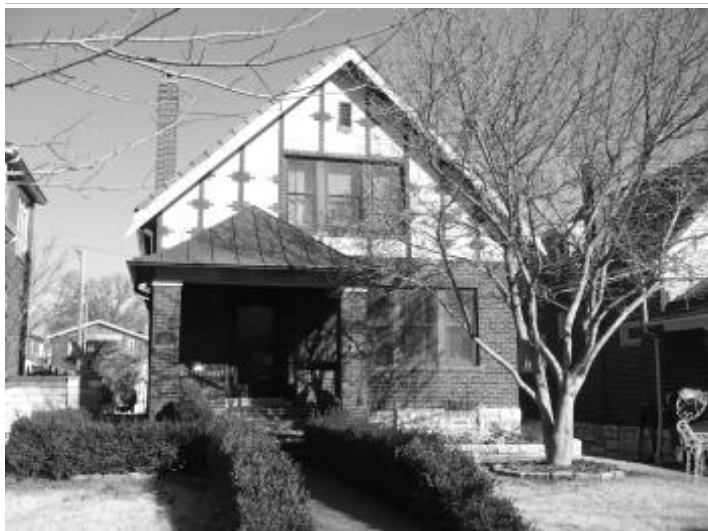
Replacement windows.

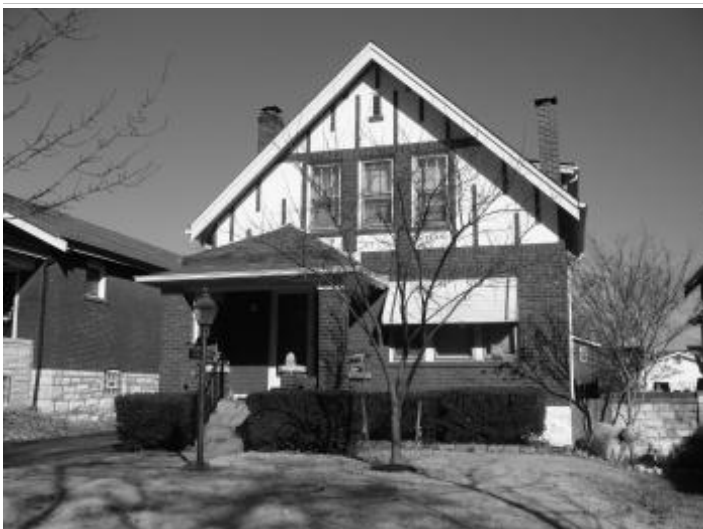
Some wood trim wrapped. Replacement front door.

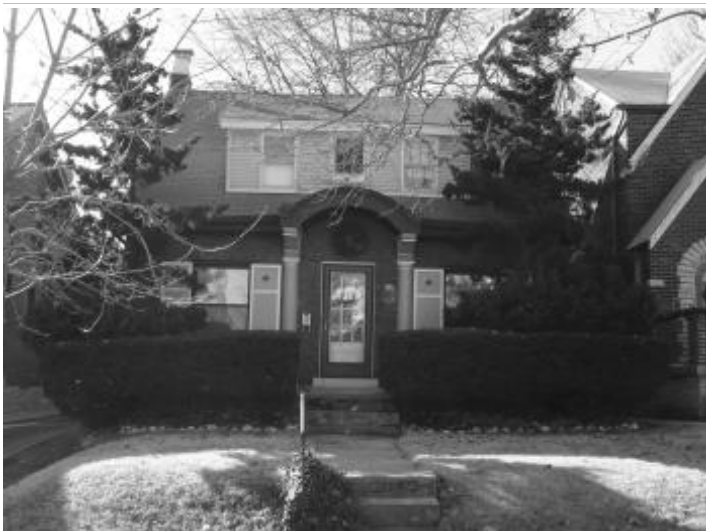
The two first story windows are replacements; dormer sided with horizontal vinyl.

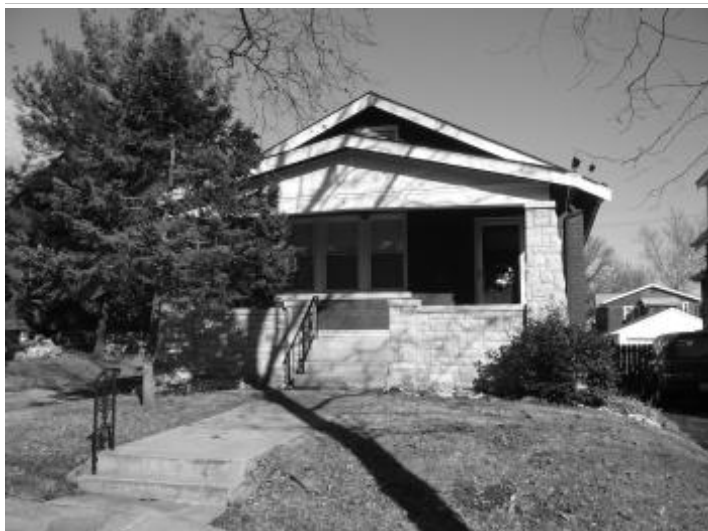
Replacement windows; some wood trim wrapped.

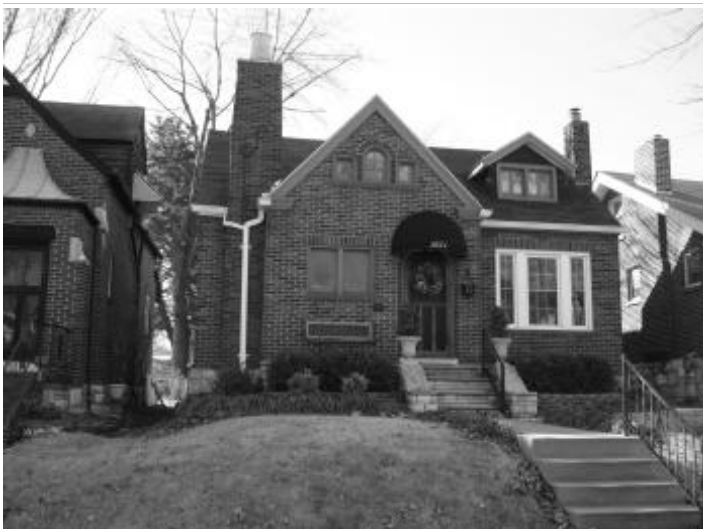
First story window set (right side of façade) is a vinyl replacement.

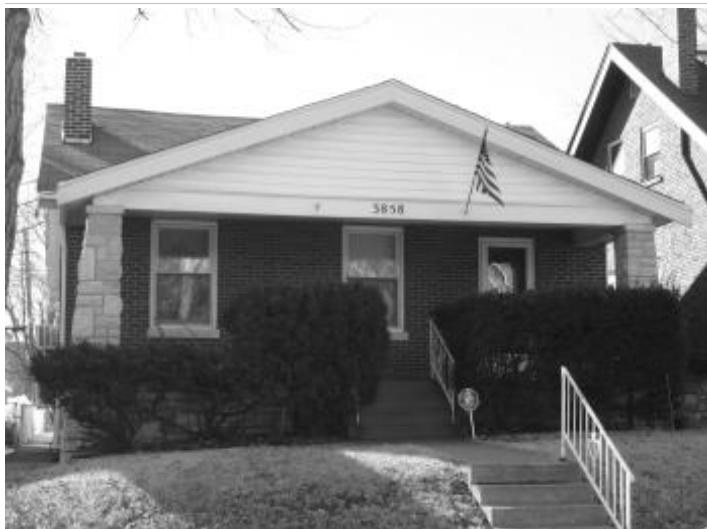
Replacement windows. Aluminum siding covers porch gable end.

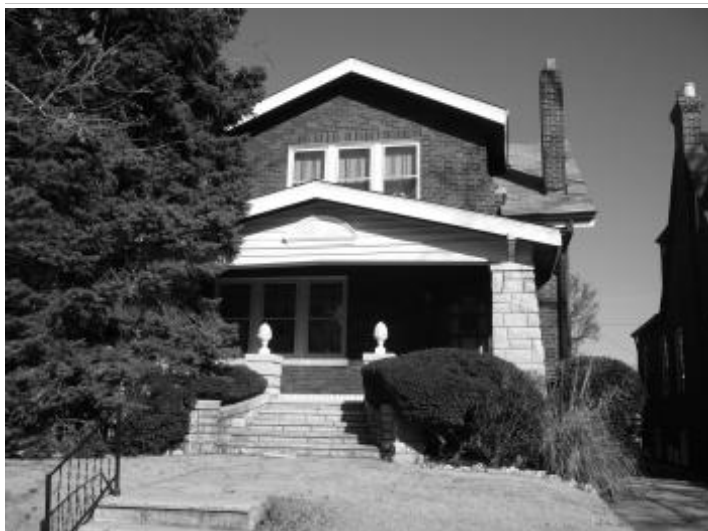
Some wood trim wrapped. Aluminum siding in porch's gable end.

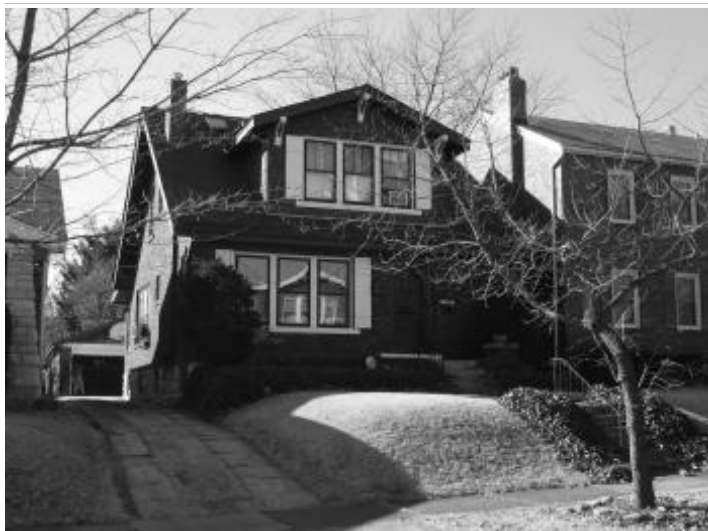
Aluminum siding on sides of dormer.

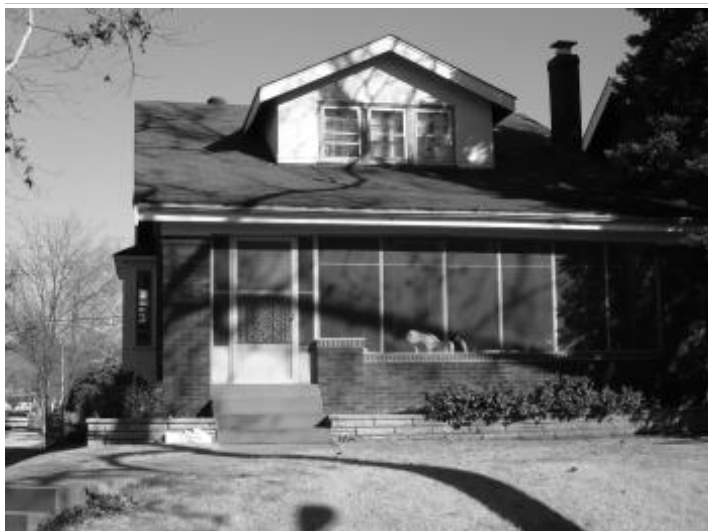
Porch enclosed with aluminum screens.

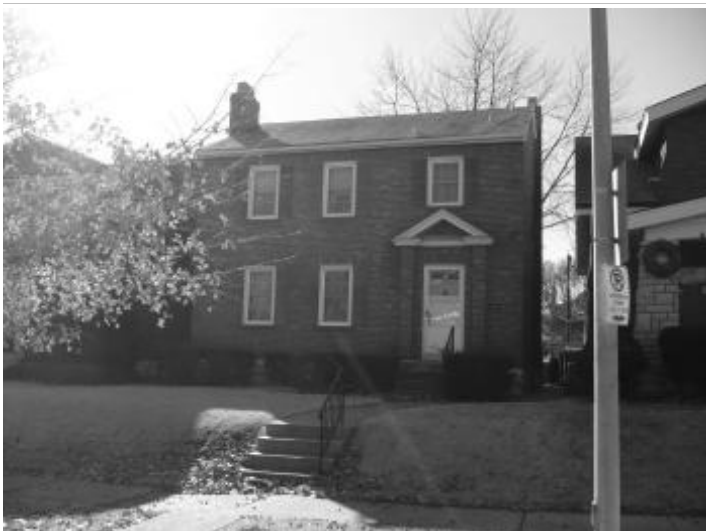
The five façade windows are replacements.

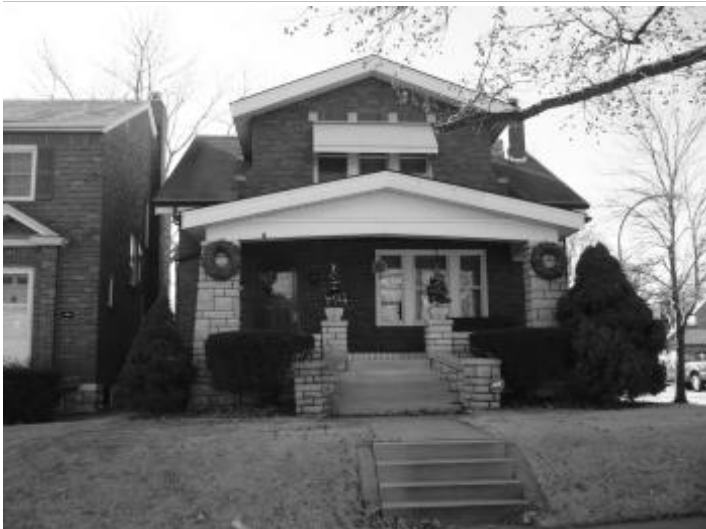
Replacement windows; metal awning at dormer, much of the wood trim is wrapped in siding.

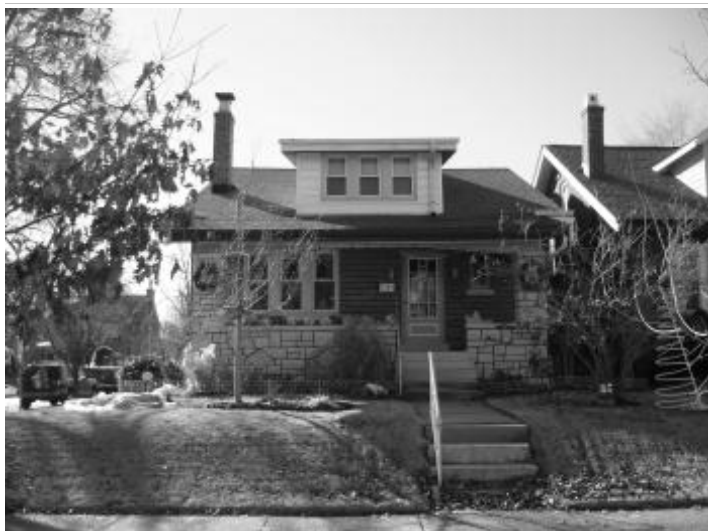
Replacement windows.

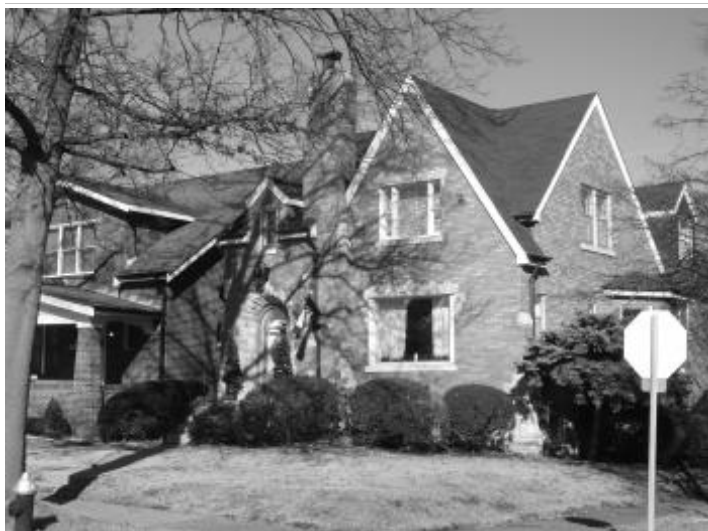
Wide 1st floor right window is a replacement. Some wood trim is wrapped with aluminum.

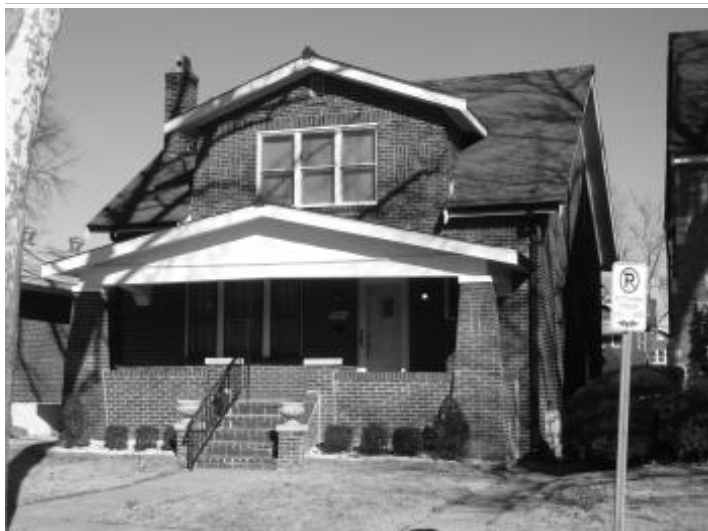
Replacement windows at dormer.

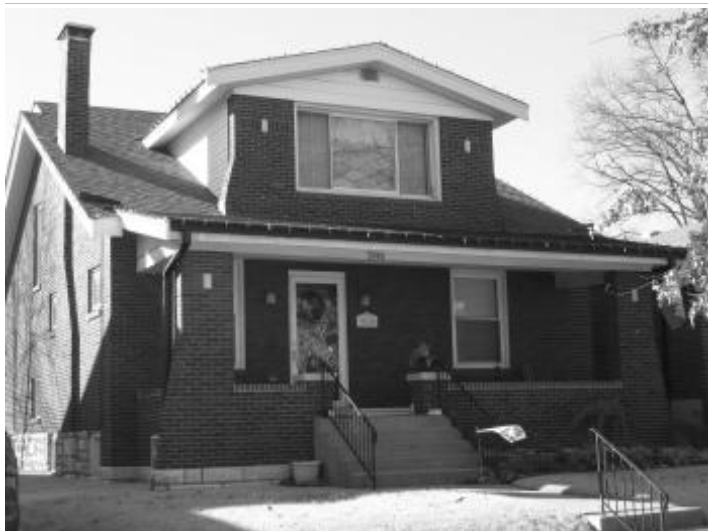
All windows are replacements.

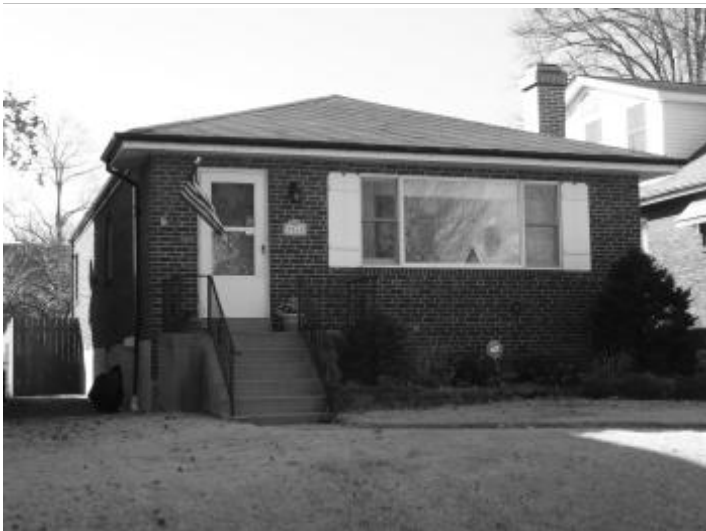
The façade windows, right, are a replacement set in a single wide opening.

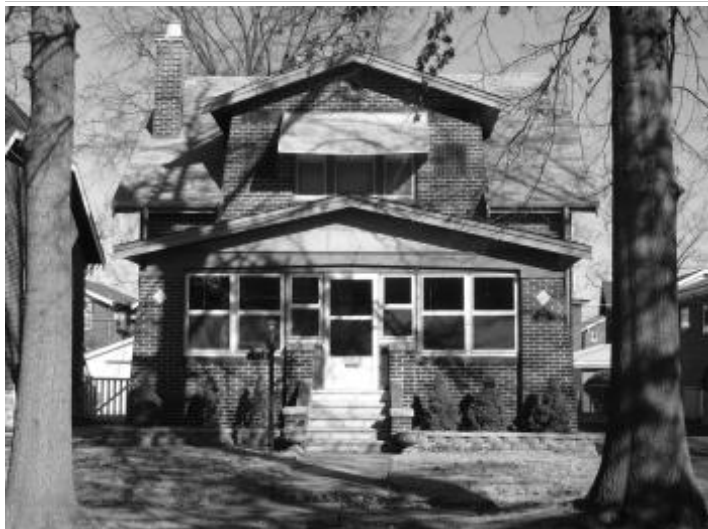
The front porch is enclosed with screen and storm windows; fiberglass awning added at dormer windows.

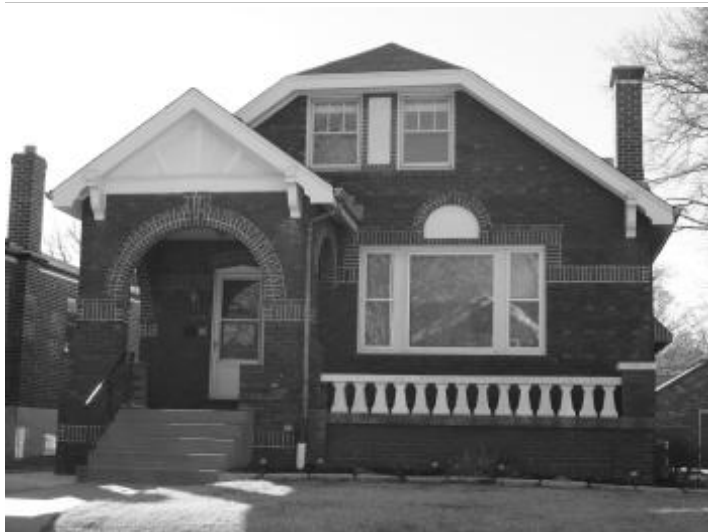
The front window set, right, would have originally had a Palladian feel, with a stucco blind arch over the center where the middle window would have been. A wider fixed pane now centers the opening.

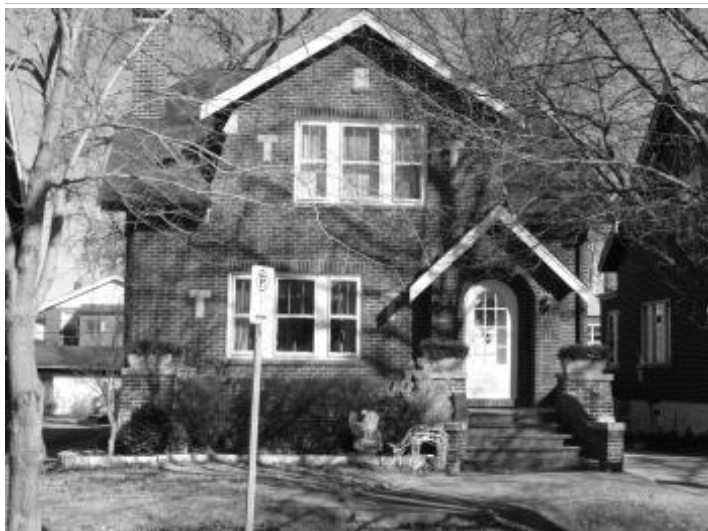
Aluminum wrap at vergeboards.

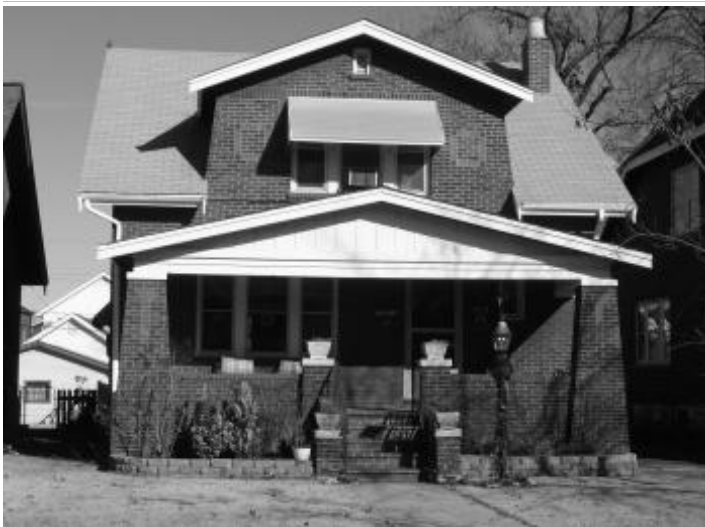
The porch gable end is sided with wood. Replacement windows in dormer under fiberglass awning.

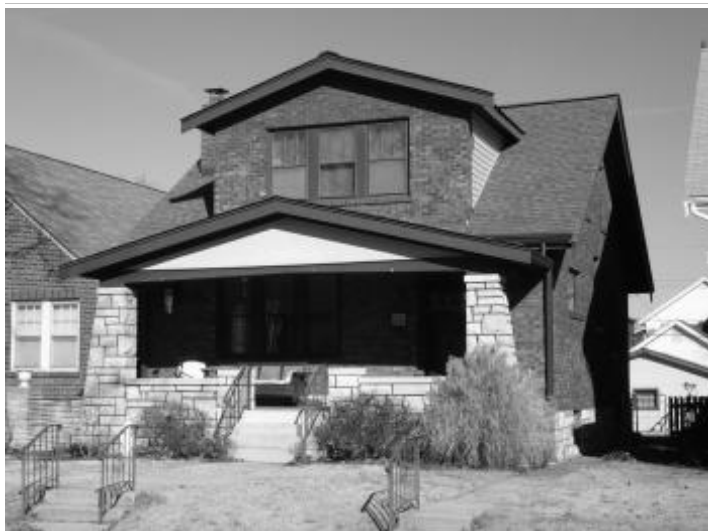
Aluminum wrap covers vergeboards.

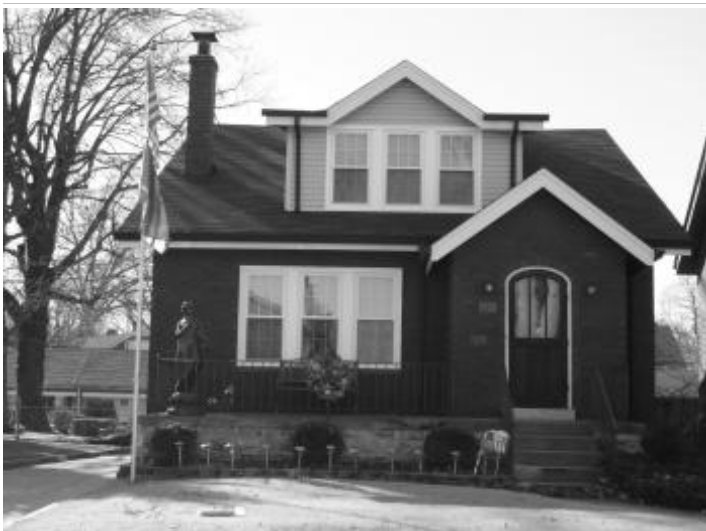
Replacement windows at both stories.

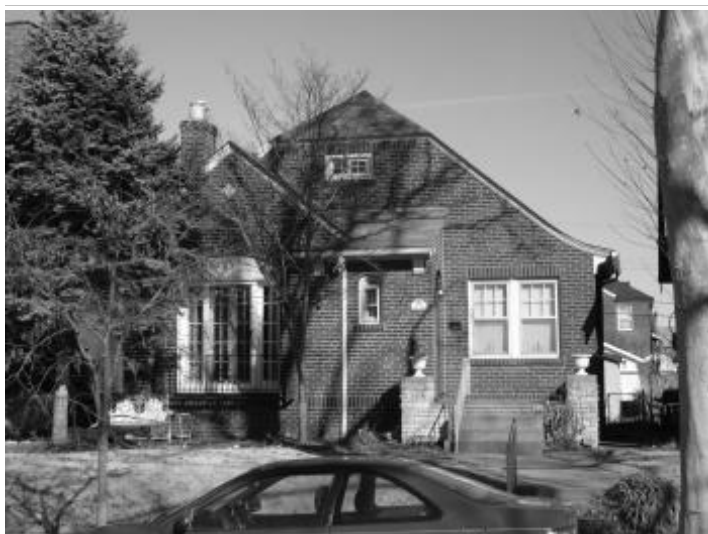
Imitation stone veneer at porch.

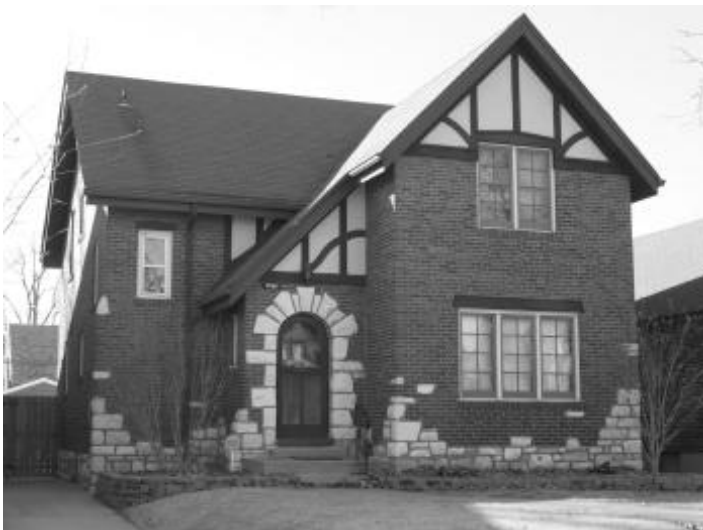
Some wood trim wrapped with siding.

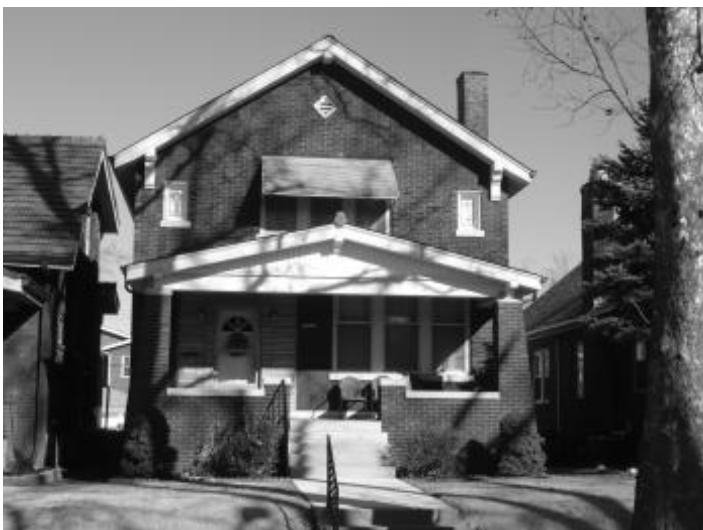
Replacement door, left, in imitation stone veneer surround. Façade windows are replacements; the second story center set is covered is a fiberglass awning. Some wood trim scrapped with aluminum.

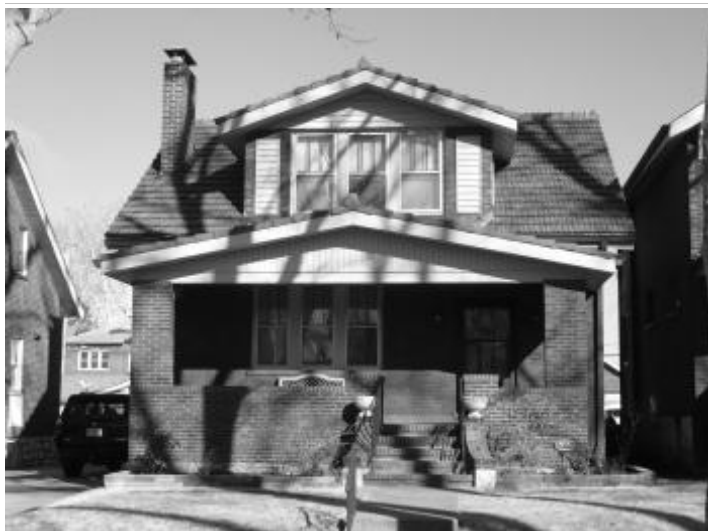
Modern siding replaces stucco at porch and dormer gable ends and dormer panels.

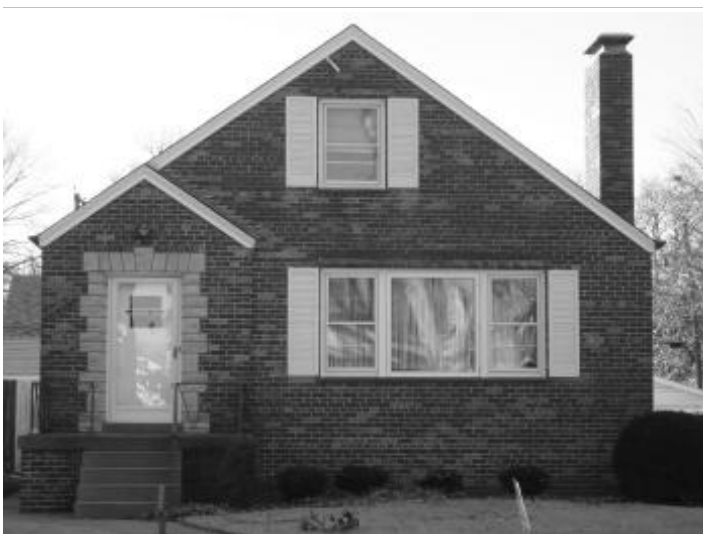
Shutters added and some wood trim wrapped.

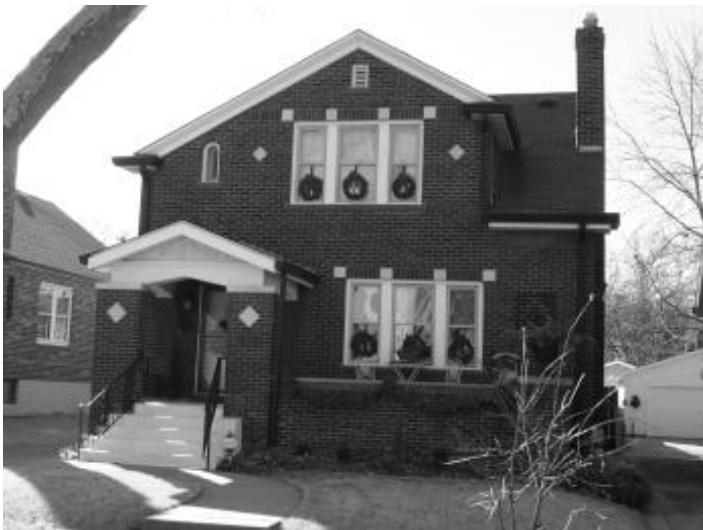
Replacement windows. Much wood trim is wrapped with aluminum.

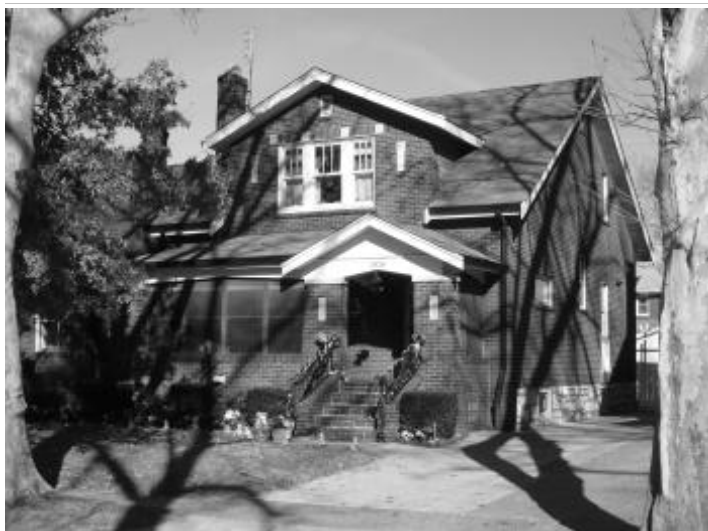
Replacement windows; original wood trim wrapped with aluminum.

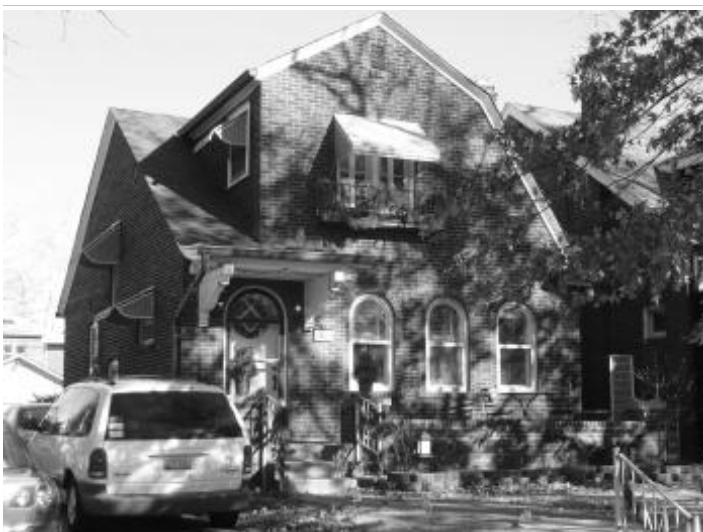
fiberglass awnings added at side and second story windows.

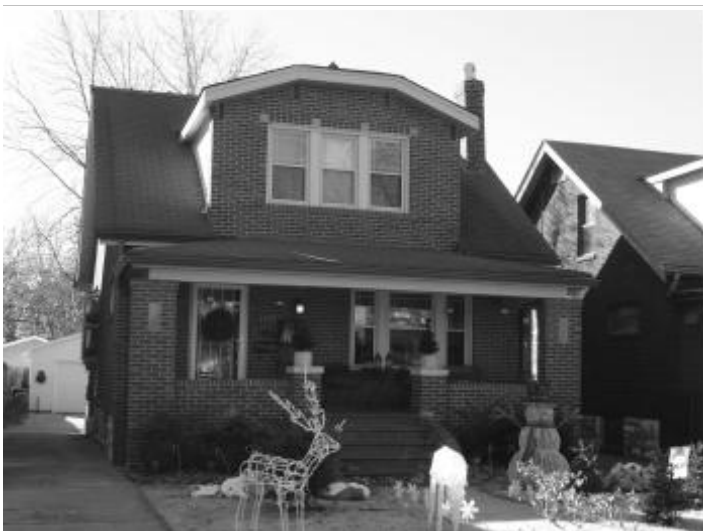
Replacement door and windows.

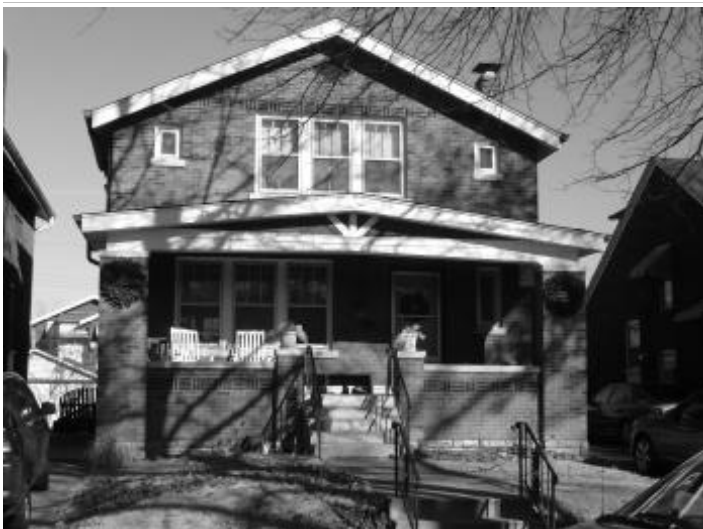
Some wood trim wrapped with aluminum.

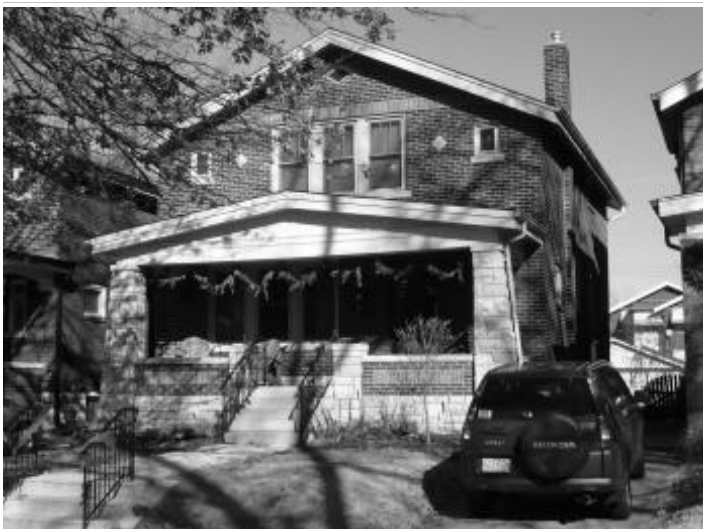
Some wood trim wrapped with aluminum. Replacement (imitation 3/1s) are in triple sets at both stories.

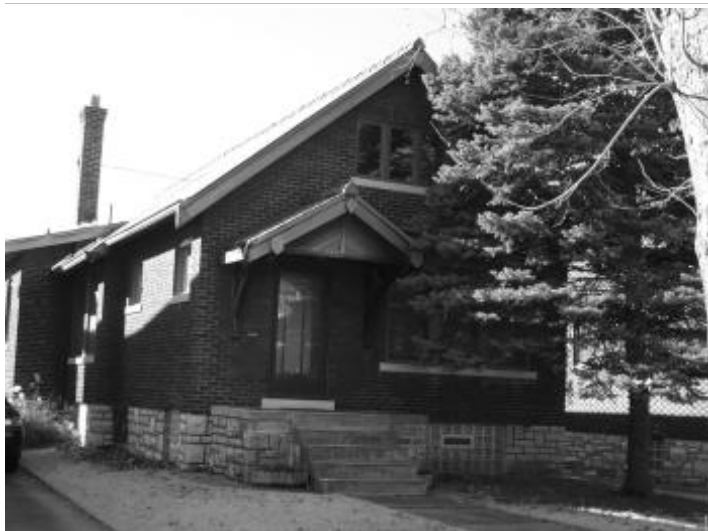
Replacement windows, vergeboards.

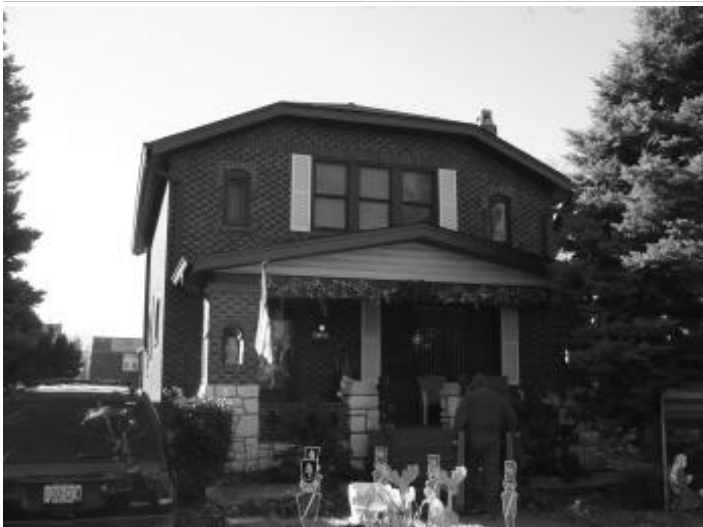
Replacement windows with inoperable added shutters. Aluminum siding. Covers porch gable end.

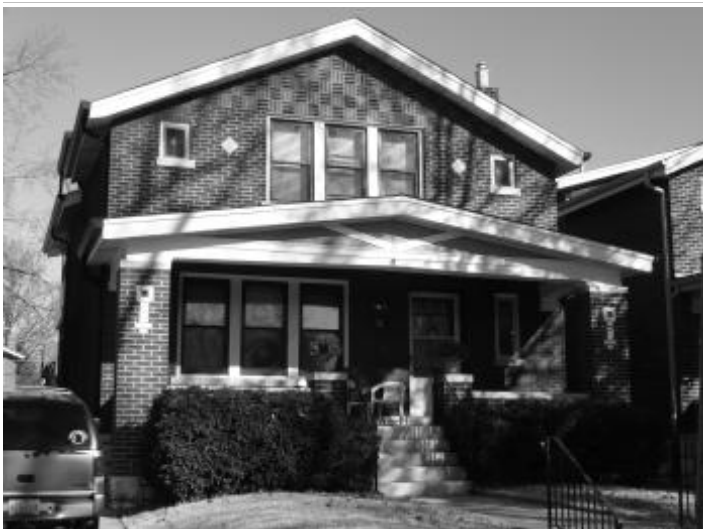
Triple sets of replacement windows at both stories. Some wood trim wrapped with aluminum.

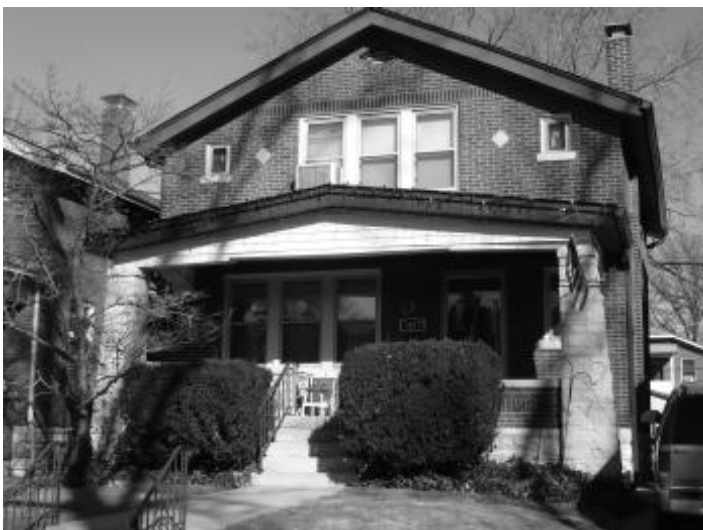
Triple sets of replacement windows at both stories. Some wood trim wrapped with aluminum. The porch's gable end is filled with modern horizontal siding.

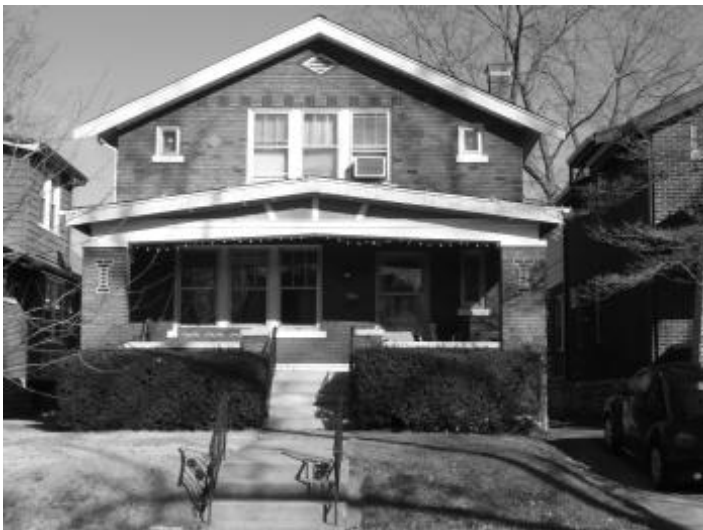
Some wood trim wrapped with aluminum.

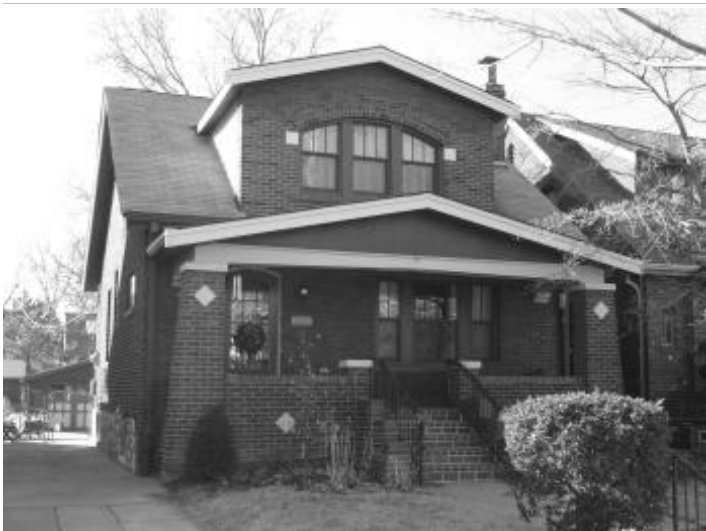
Windows appear to be compatible modern replacements.

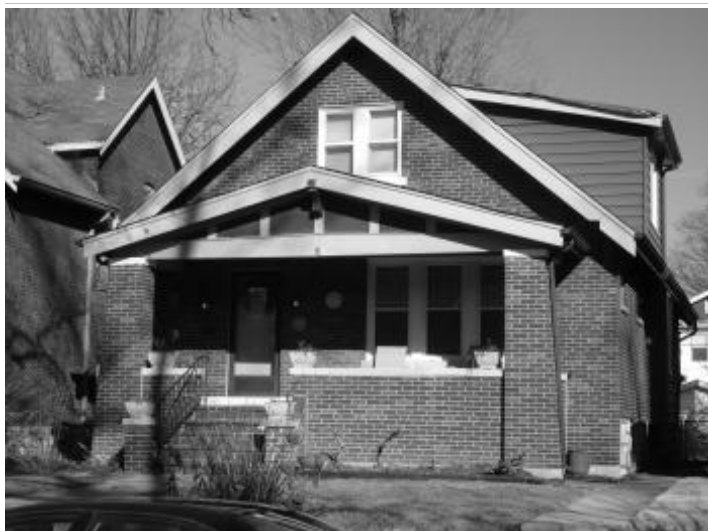
Replacement door and façade windows. Some wood trim wrapped with aluminum.

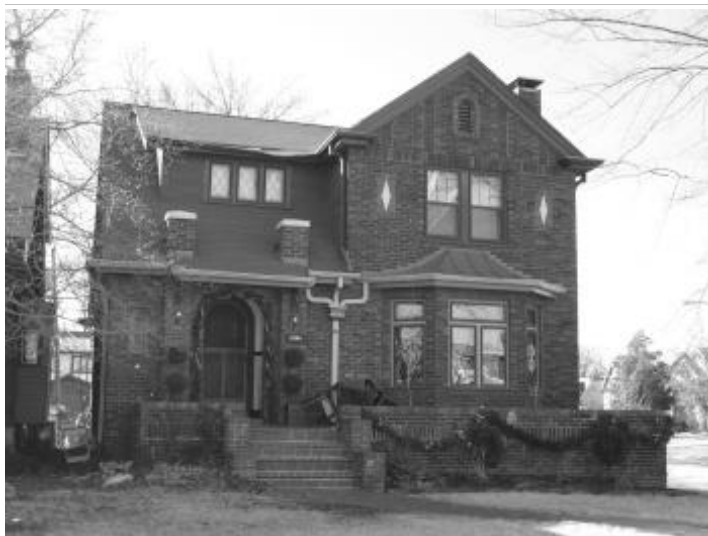
The right side of the façade has a front gable above the second story. The left bay is side gabled with a low shed dormer that is attached to the cross gable at its right side. The round arched front door (original with wood screen) is at the left bay, recessed in a round-arched opening between two pilasters which rise through the roof and are capped with stone. A small arched casement is to the left of the front door. The three casements at the shed dormer also have leaded diamond-paned glass. At the right bay is a bay window with flared metal hip roof. The gable end features soldier and stacked courses, recalling the stickwork in stucco gable ends. All façade windows are original. Rear second story balcony filled in to become sunroom.

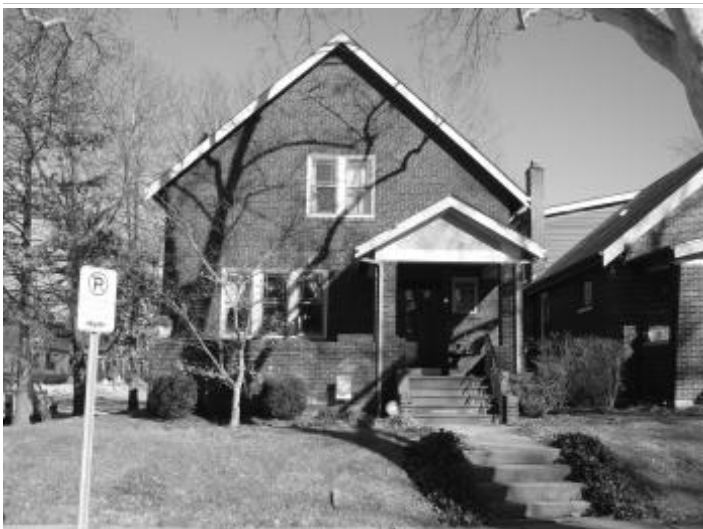
At the left side of the façade is a triple set of vinyl replacement windows; a pair is in the gable end.

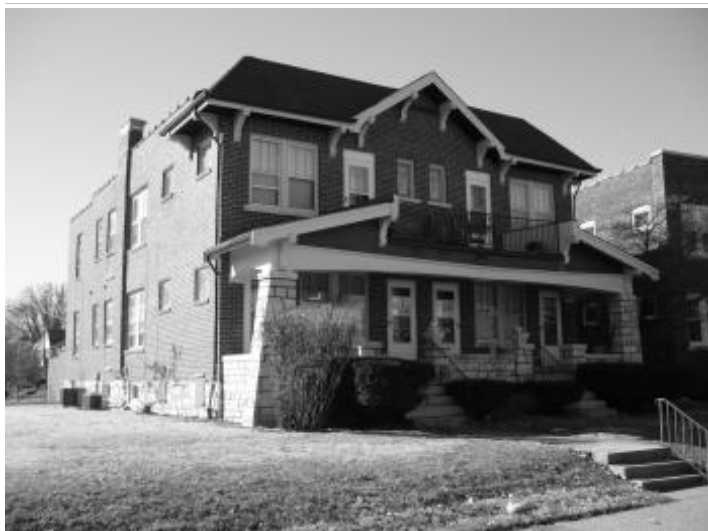
Balcony door openings partially filled in in front of doors for smaller storm doors.

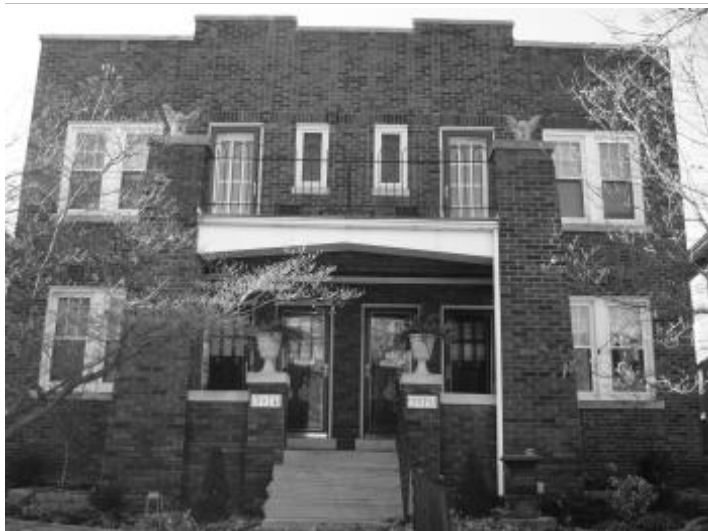
At the outer bays are pairs of vinyl replacement windows.

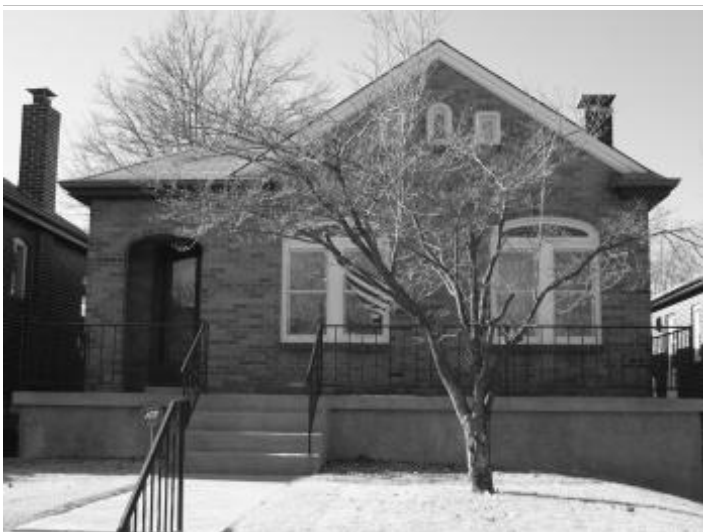
Some wood trim (vergeboard) wrapped with siding.

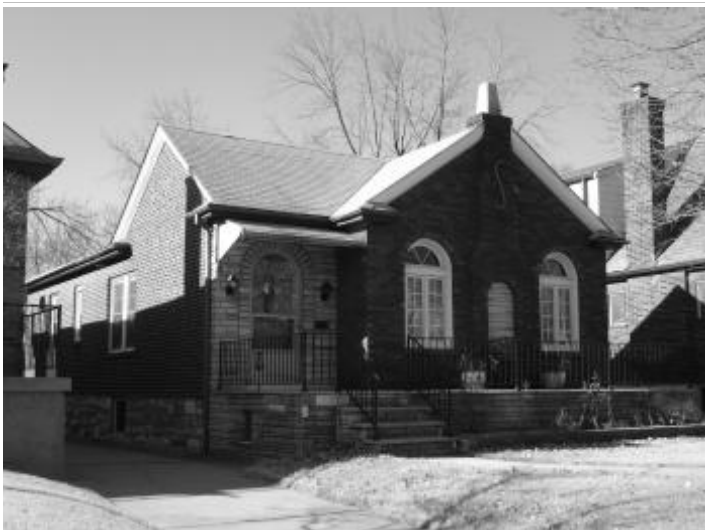
Imitation stone veneer also covers the porch base and is used in the arched niche in the chimney wall. Front windows are replacements (except for fanlights)

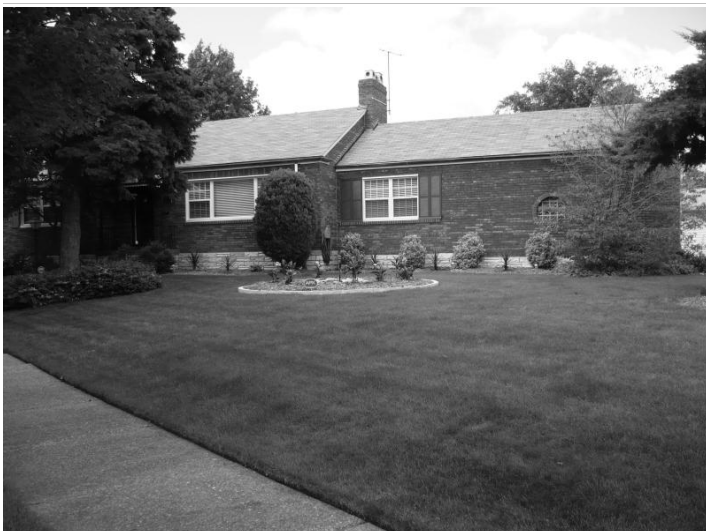
Window are replacements. Gable end at left side of Bowen elevation is clad with modern horizontal siding. Vinyl shutters added.

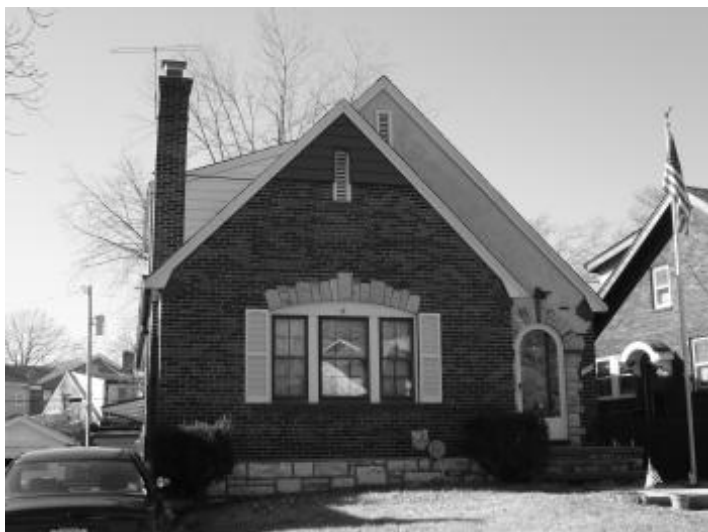
Some wood trim wrapped with siding; inoperable shutters added.

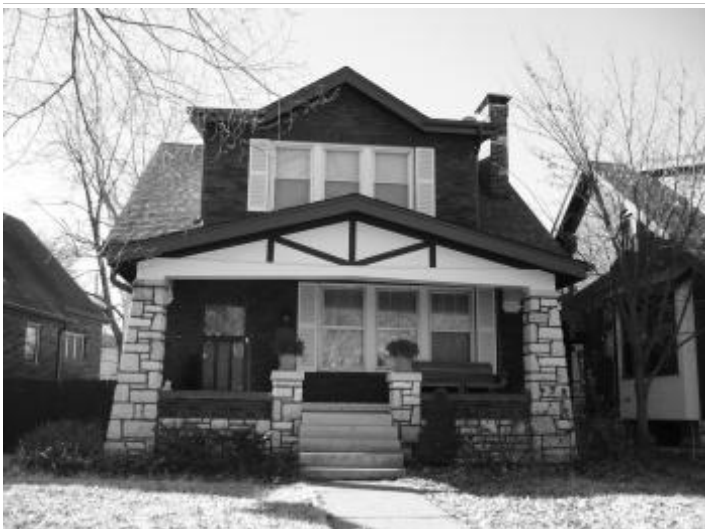
dormer windows are replacements. Inoperable shutters added. Some trim wrapped.

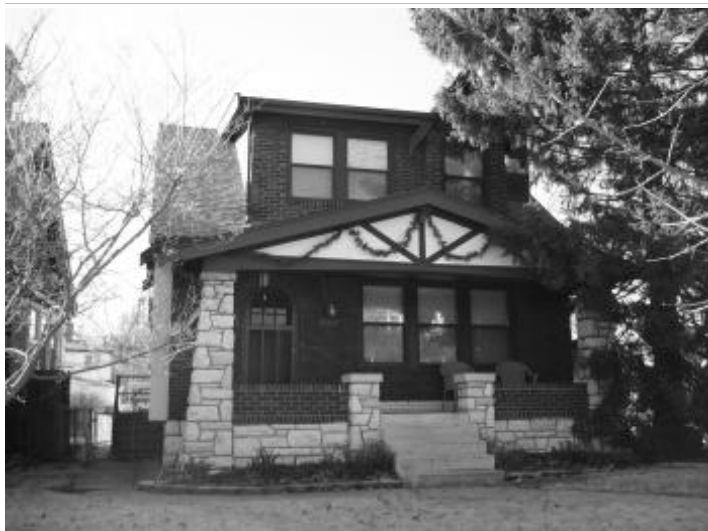
Replacement façade windows.

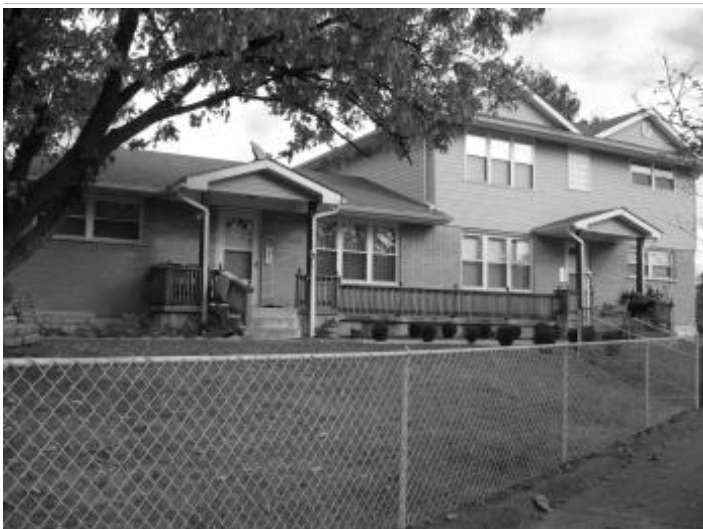
Full second story frame addition on 4065 side is added.
