City of St. Louis Cultural Resources Office

Holly Hills Neighborhood Survey

Lynn Josse and NiNi Harris
3/1/2010

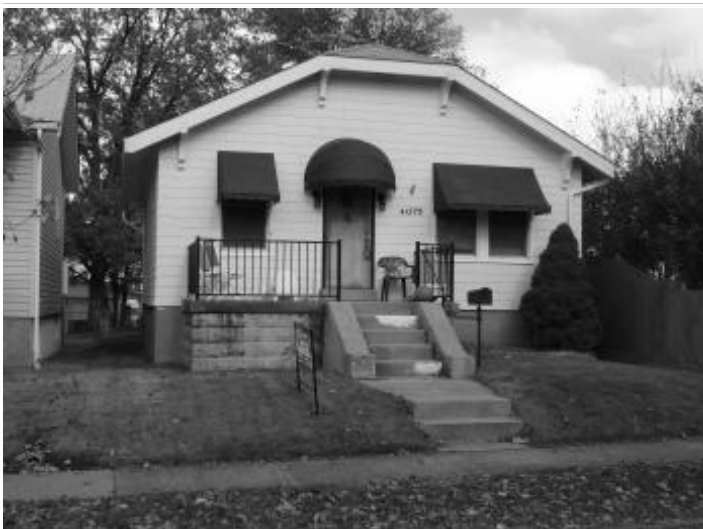
Awnings added over windows and replacement front door.

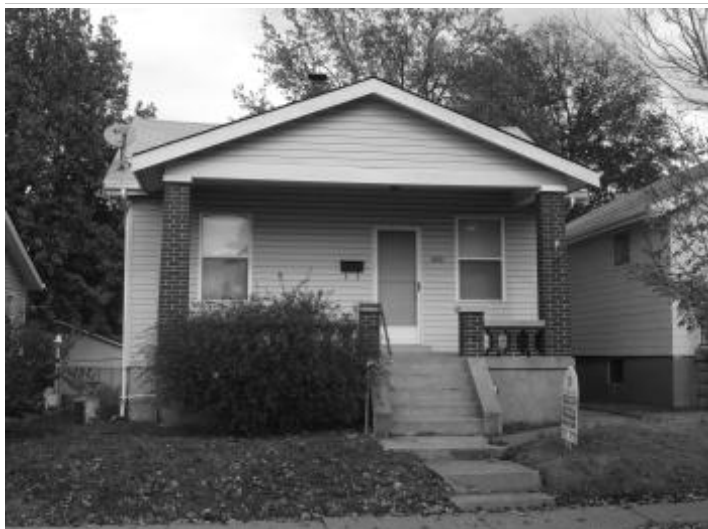
Replacement front door. Window trim not visible.

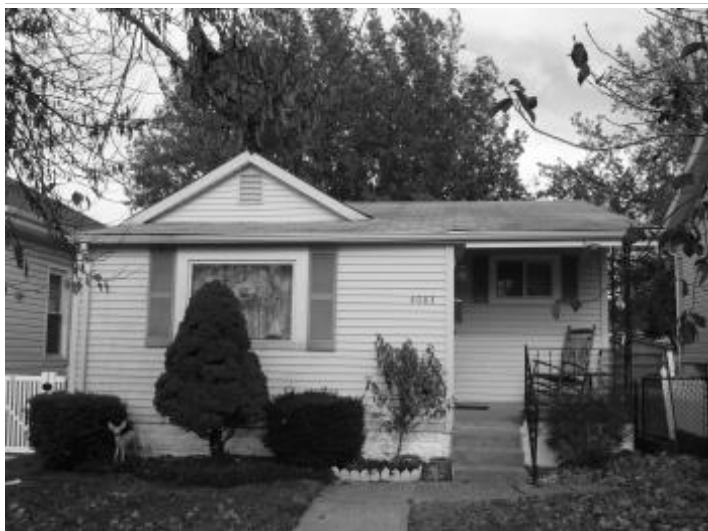
Front addition appears to be filled in porch with historic door but vinyl windows.

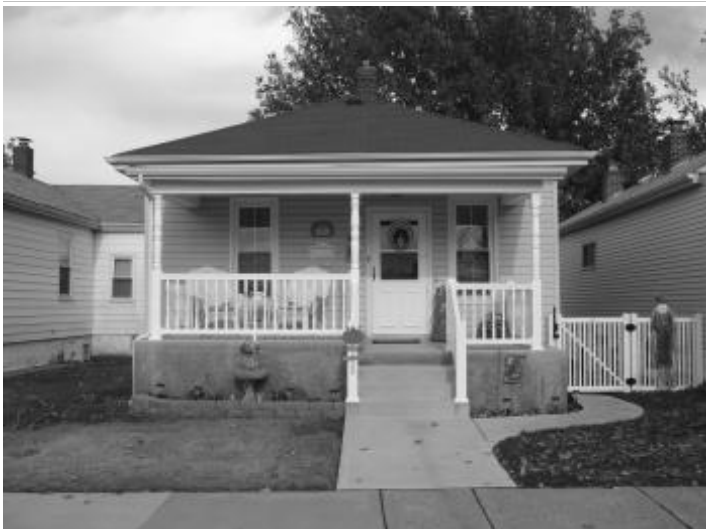
Front porch has new concrete base, new rails and imitation turned posts - replacement windows and door.

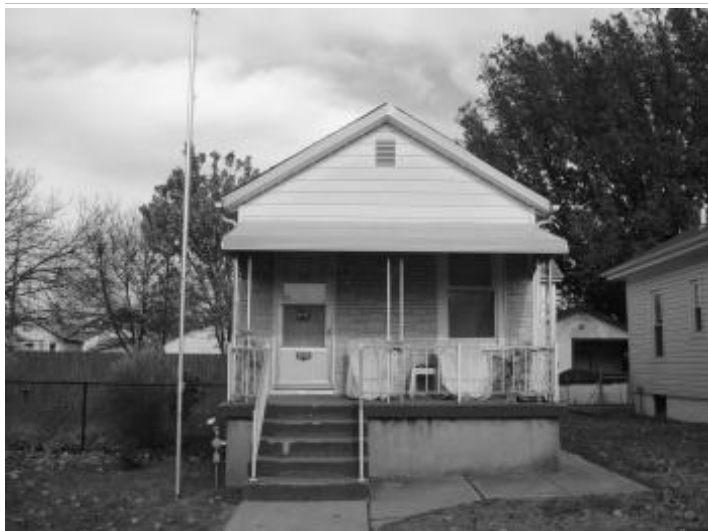
Replacement windows/doors. Below the porch awning, the façade is covered with imitation stone veneer.

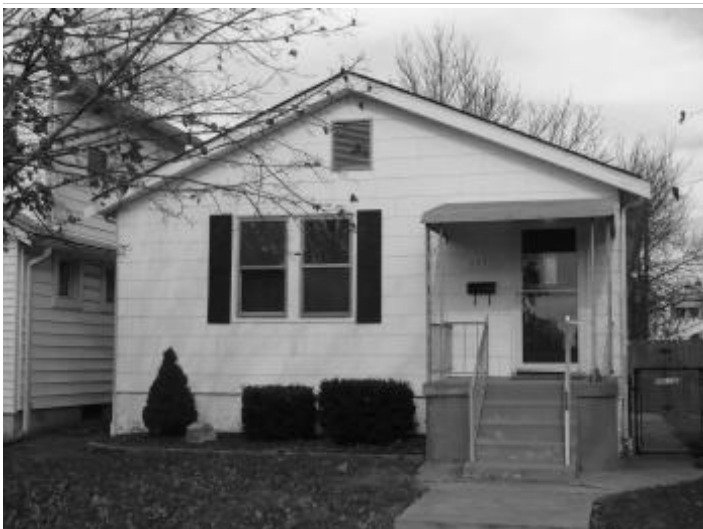
concrete porch has fiberglass awning on metal supports. Replacement door. Added shutters.

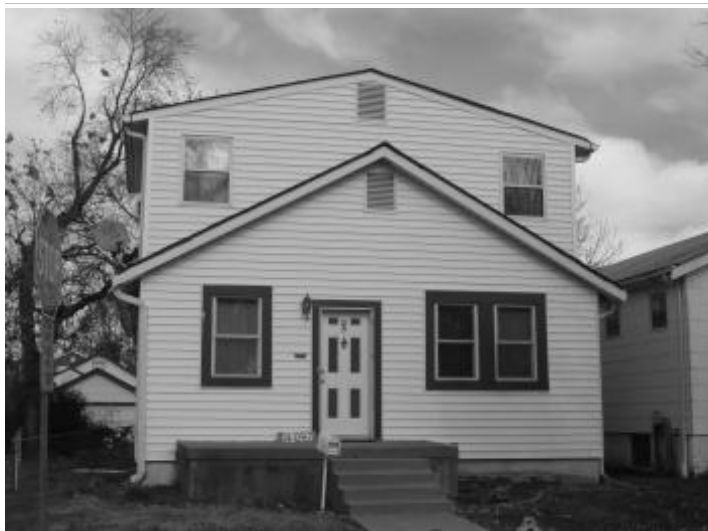
Second story added. Replacement front door and windows.

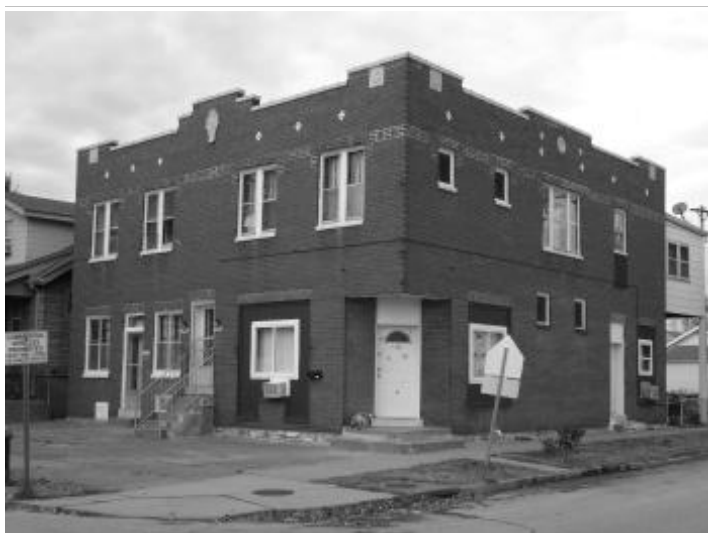
Windows filled as above.

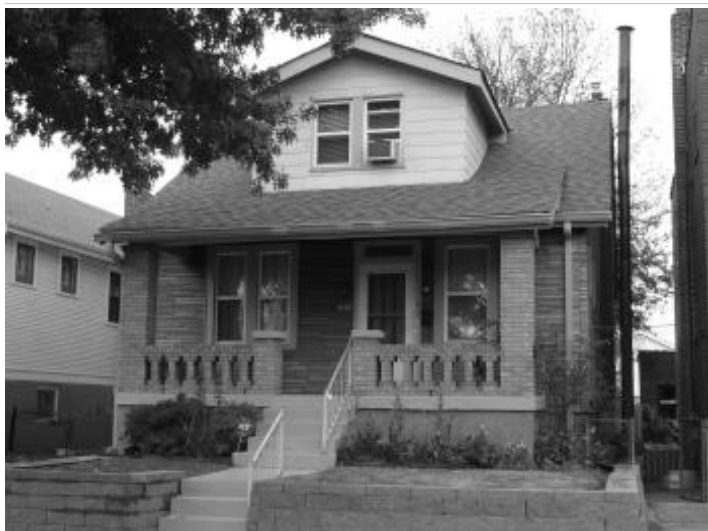
Replacement windows.

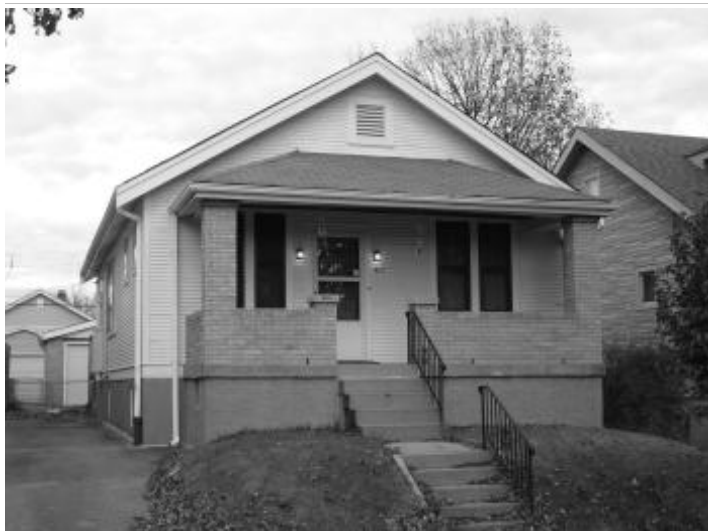
The front door is a replacement.

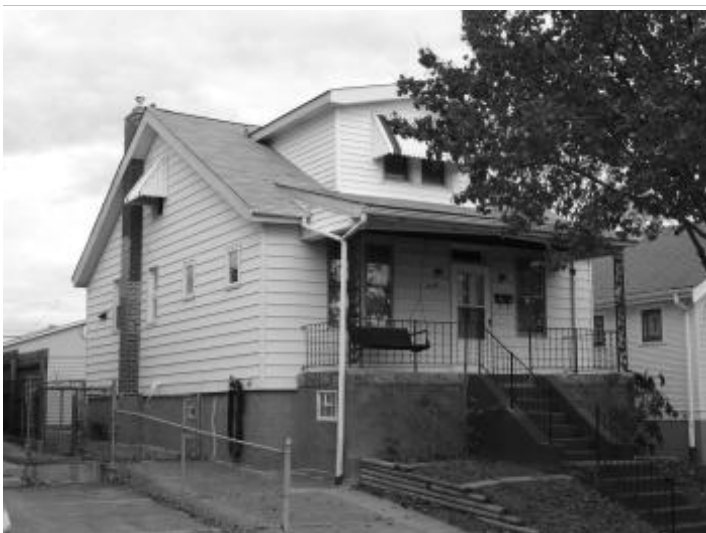
Replacement front door; metal porch supports.

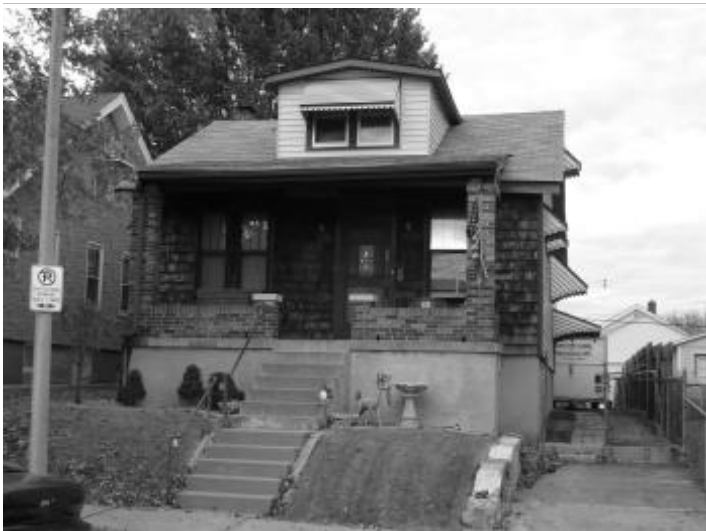
The façade is dark stained wood shingle. Side elevations are vinyl siding. Replacement front door. Metal awnings added at dormer and sides.

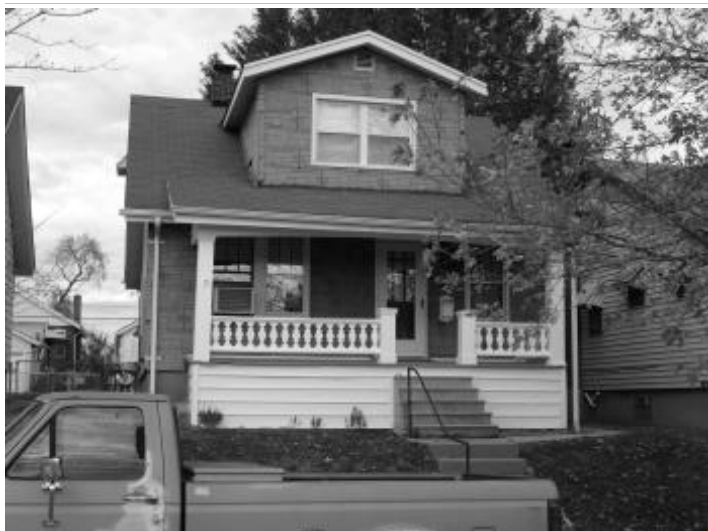
Imitation stone siding makes the building noncontributing. Replacement windows at dormer.

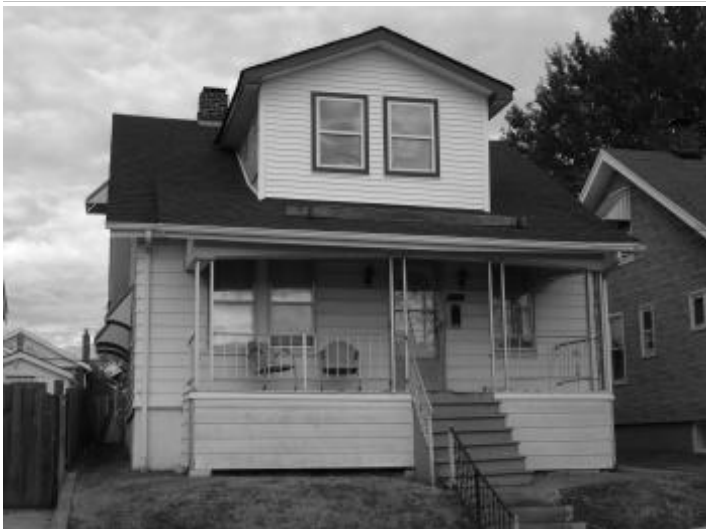
Replacement windows at dormer. No wood visible anywhere on façade. Replacement door. Replacement porch supports.

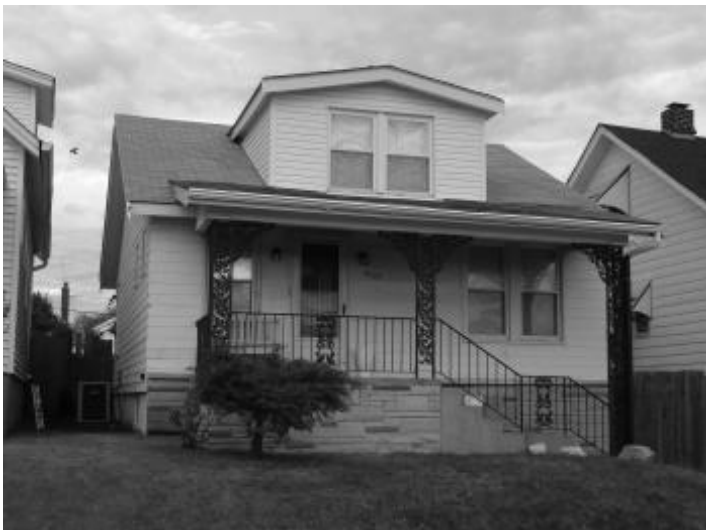
The porch roof is intact, but the right half of its base is scooped away for a side stair. Porch surface only takes about half of the roofed area. Imitation stone veneer covers the porch and facade base. Repl. Windows.

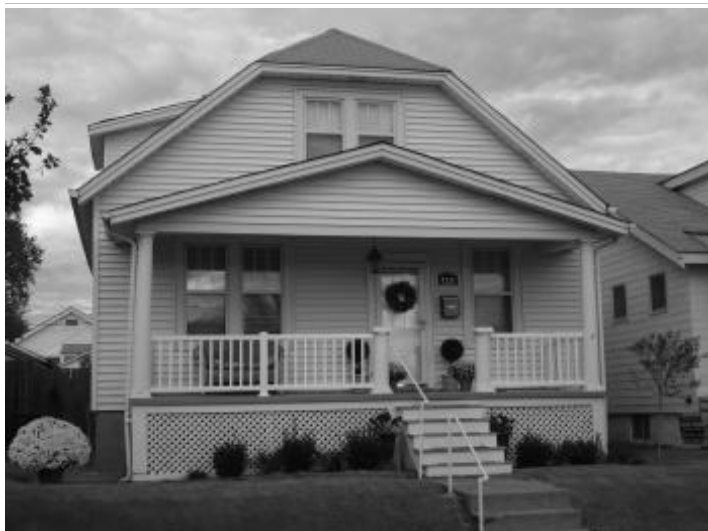
Replacement front door.

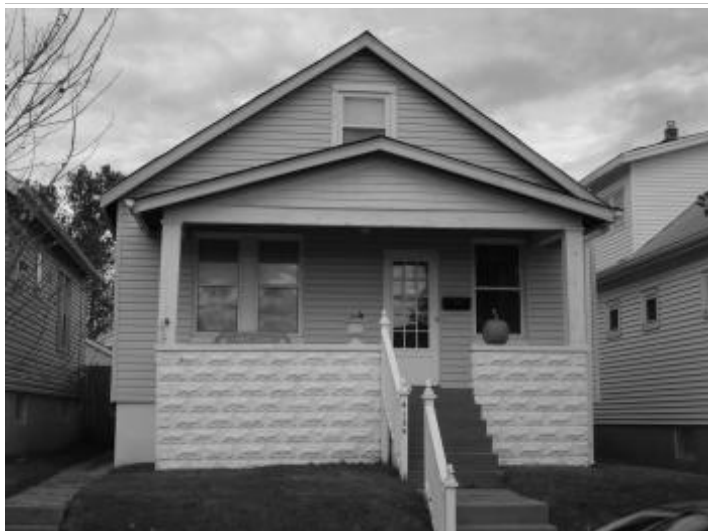
Replacement windows.

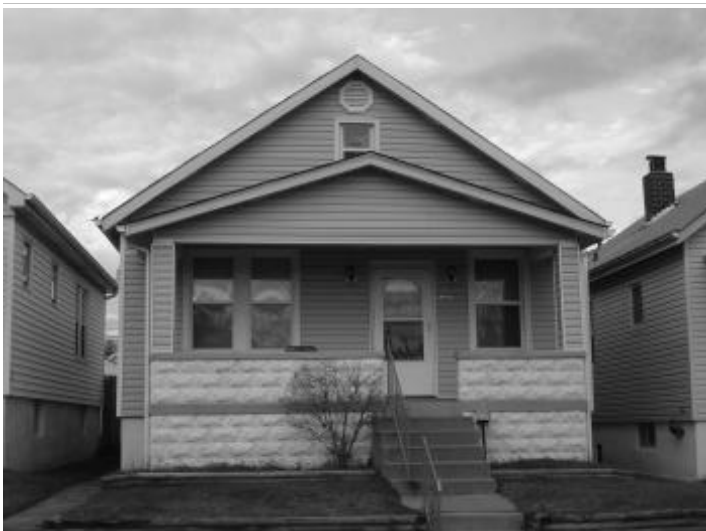
Replacement windows and door.

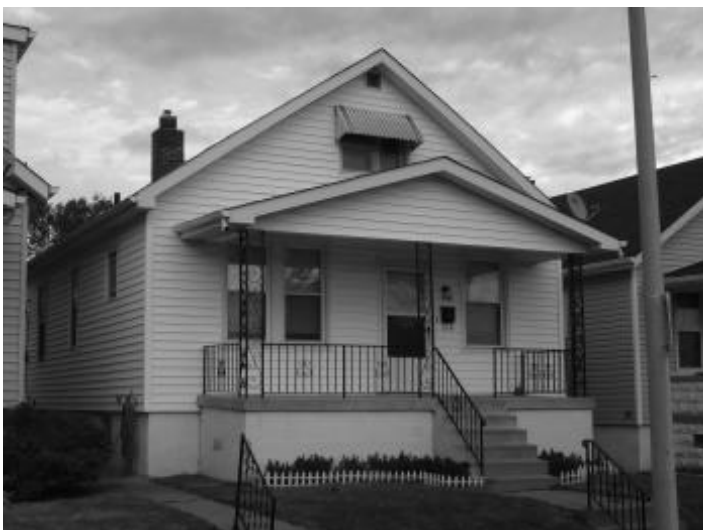
The porch base is concrete; three metal supports hold up the porch roof. Replacement windows, doors and porch piers. Metal awning added at attic.

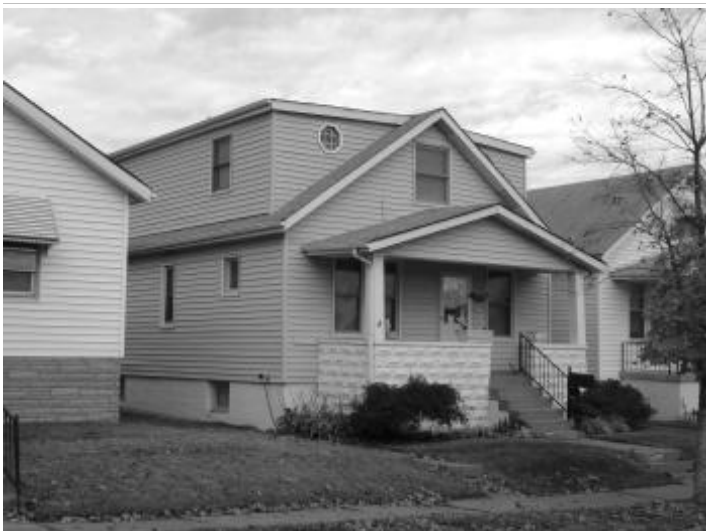
Large dormer additions add a full second story and obscure the original lines of the house. Replacement door and windows.

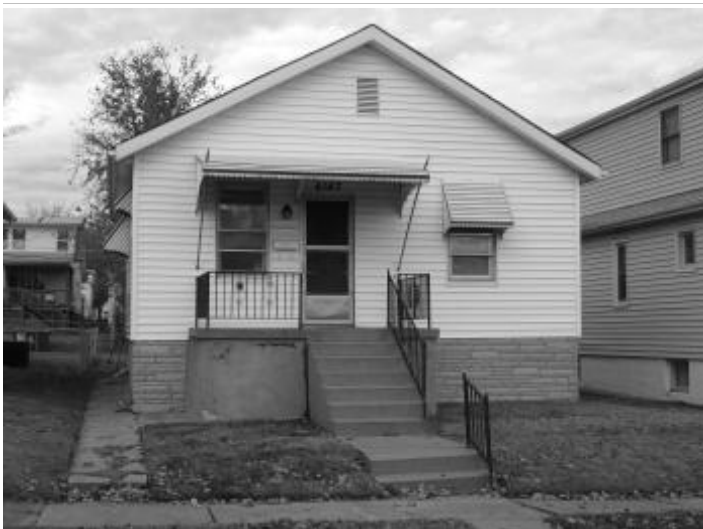
Replacement door and windows. Imitation stone veneer covers base of façade. Exterior chimney cut off at roofline.

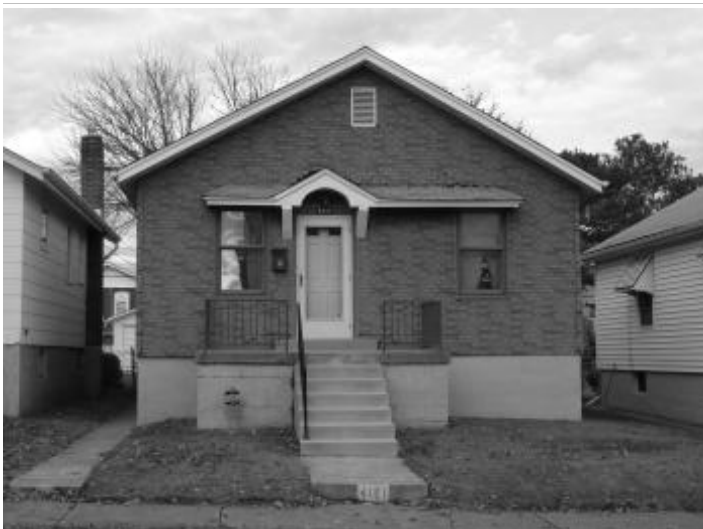
This house is sided with imitation brick. Replacement door and windows.

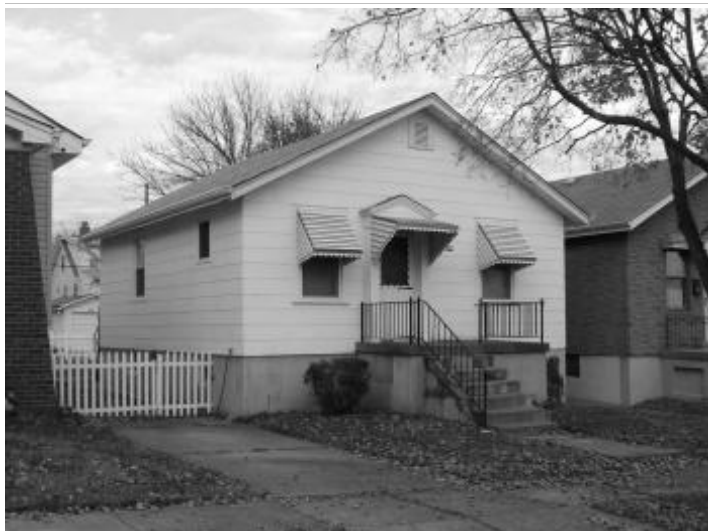
Replacement windows, metal awnings. Wavy asbestos shingle siding.

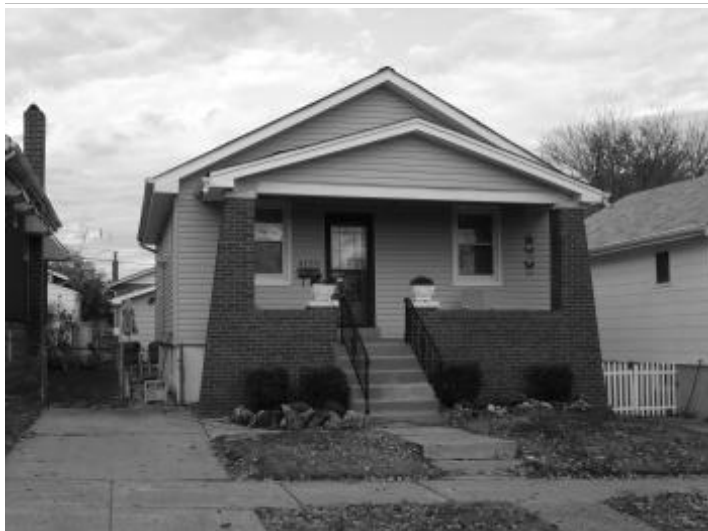
No wood visible other than front door.

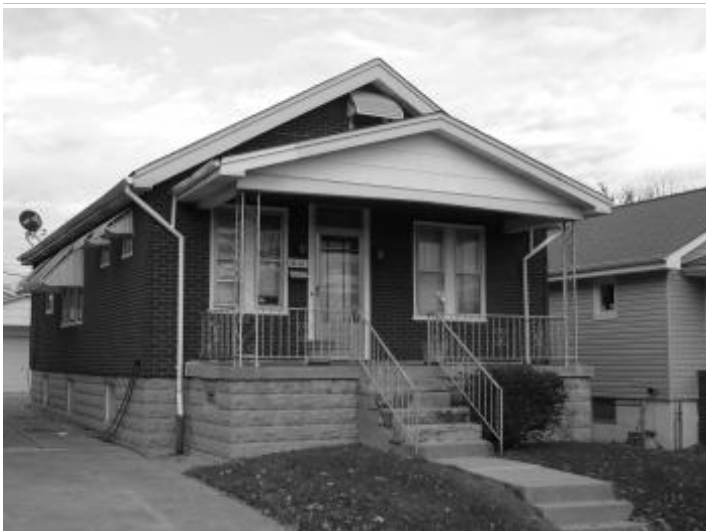
The gabled porch's piers have been replaced by metal trellis-style supports.

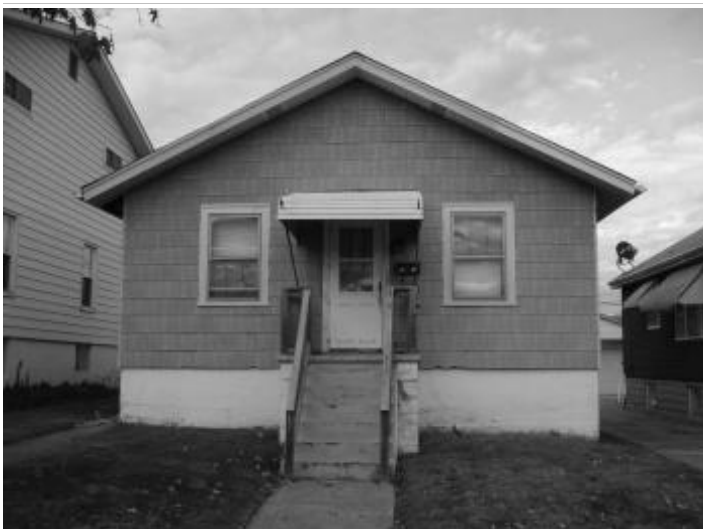
\$900 concrete block porch 1959. Awning over front door.

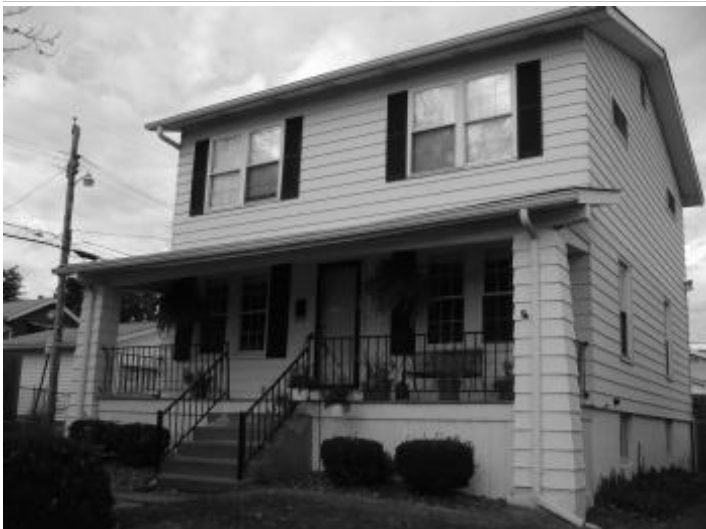
Replacement door and vinyl windows with imitation shutters. Porch elements fully sided.

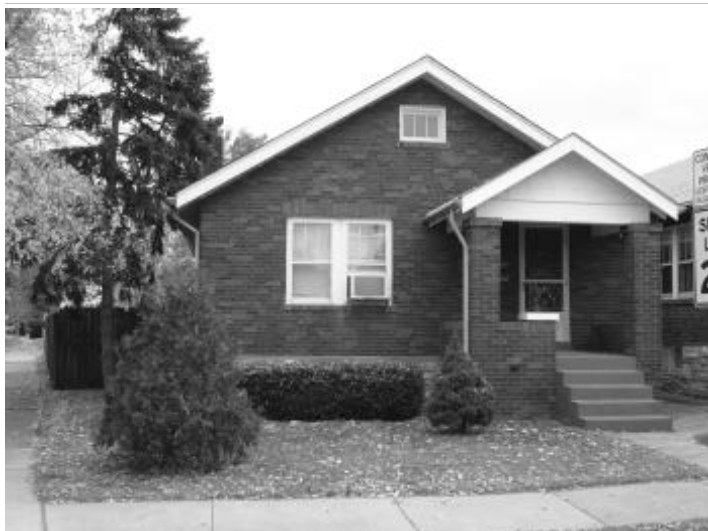
Shingled gabled end at porch.

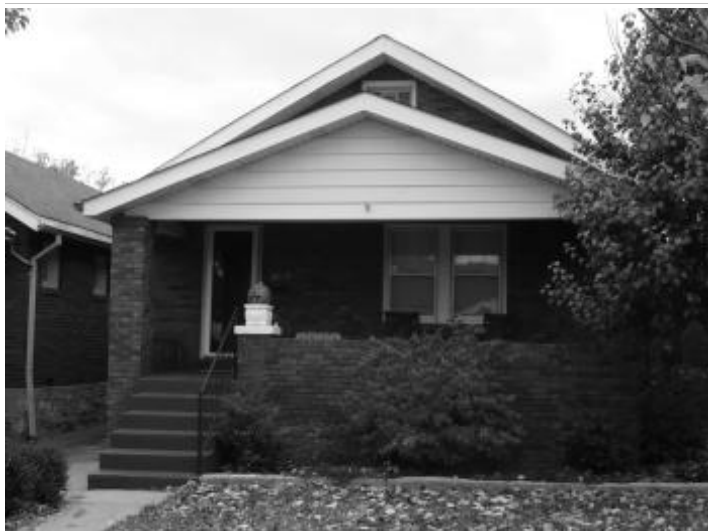
Siding in gable end and at porch vergeboard and eaves.

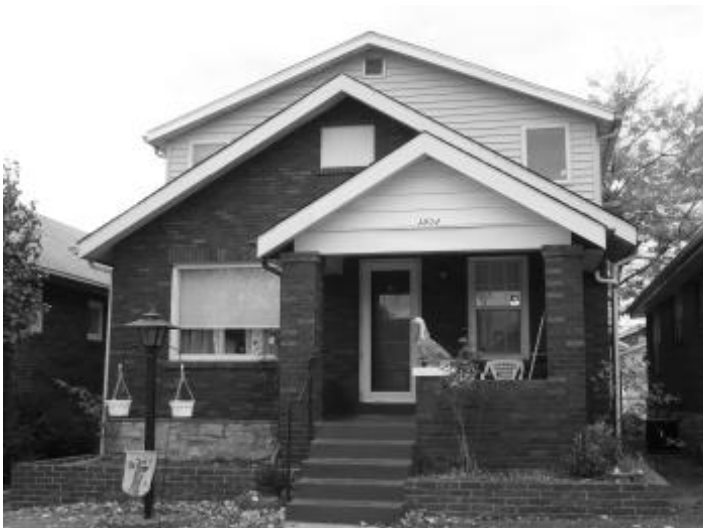
A gabled second floor has been added, fairly well set back from the original roofline. Windows are replaced. Porch's gable end, verge boards, eaves covered with siding.

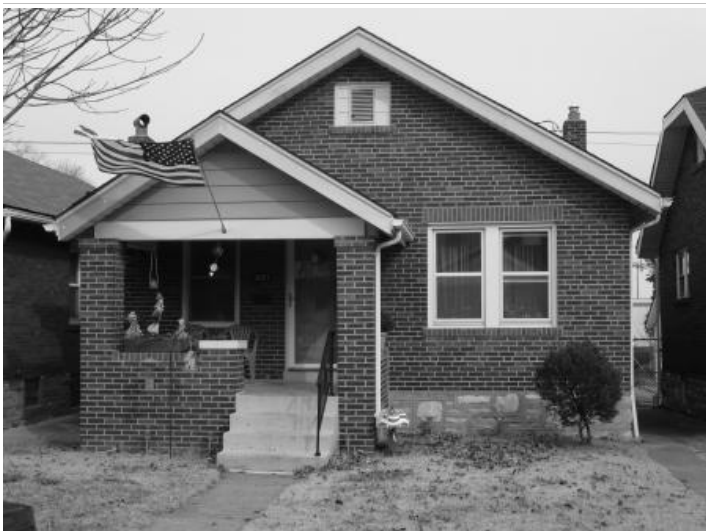
Replacement door and windows ; siding at porch gable end and eaves.

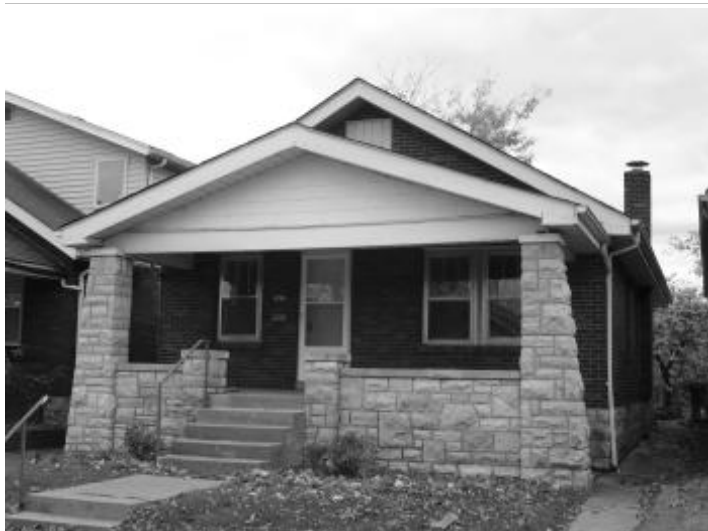
Front door is a replacement.

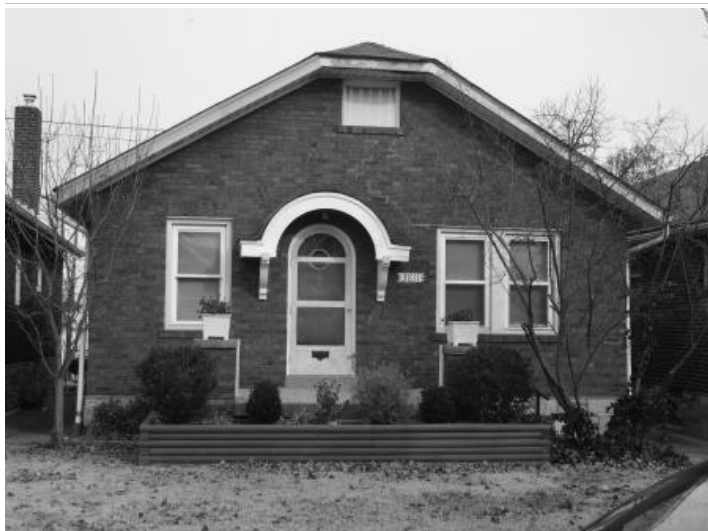
Left of the door is a single 1/1 vinyl window; a pair of the same is to the right.

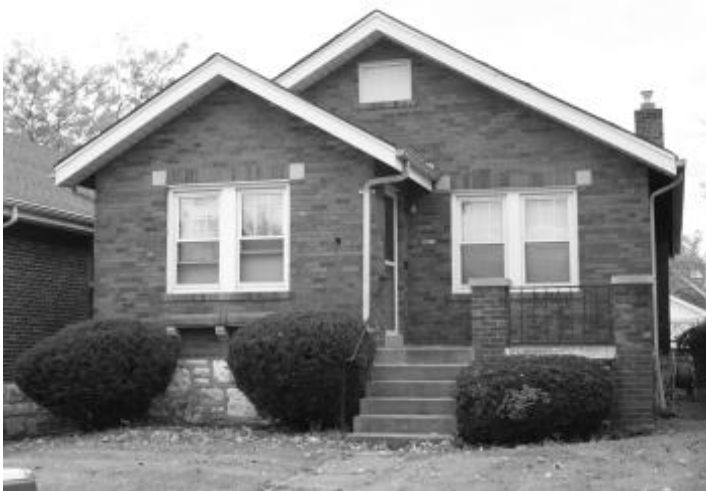
Replacement windows. Aluminum covers eaves and vergeboards.

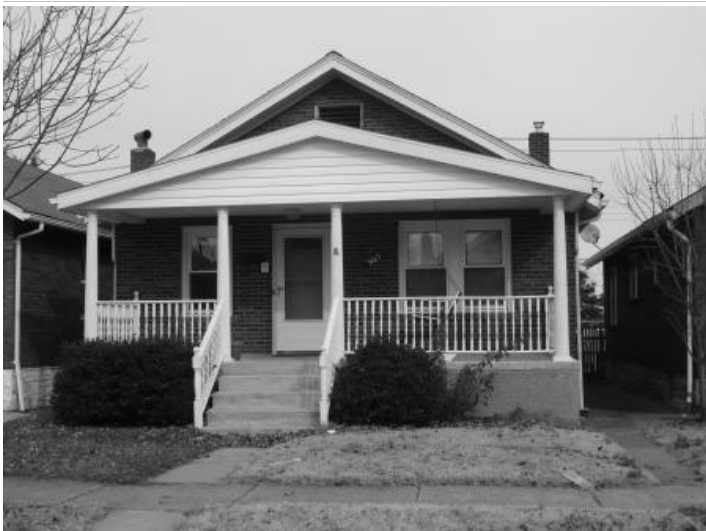
The front door and windows are replaced, and the gabled porch appears to be added.

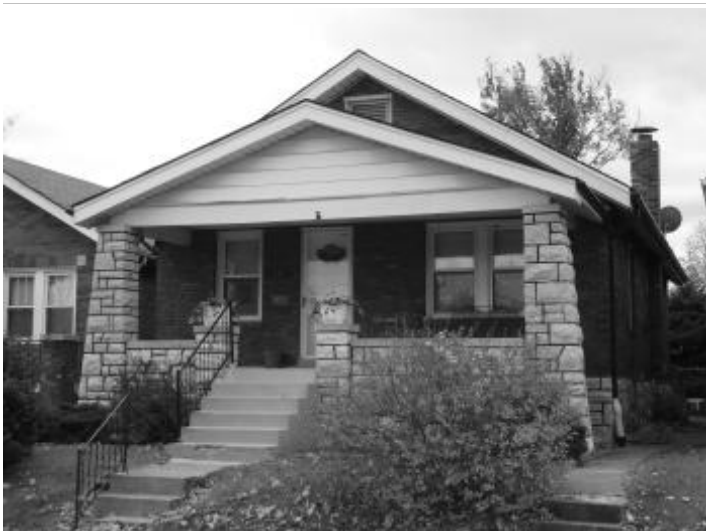
The porch's gable end is sided. Replacement front door and windows.

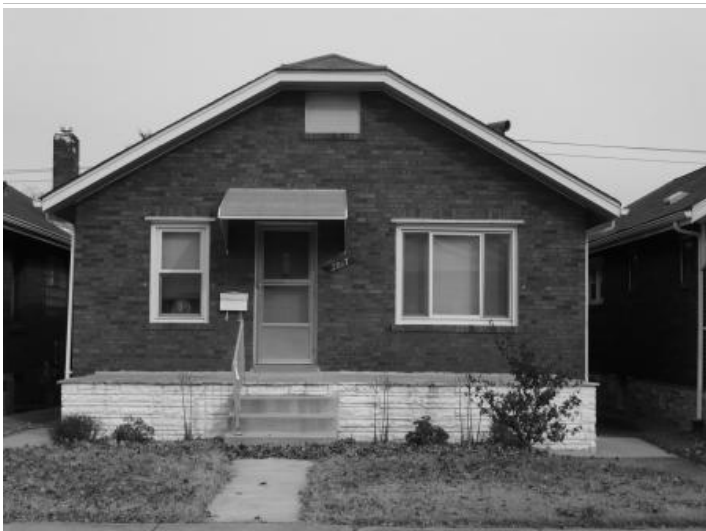
The unroofed full-width concrete front porch has imitation stone veneer covering. Awning at front door. Replacement front door and windows.

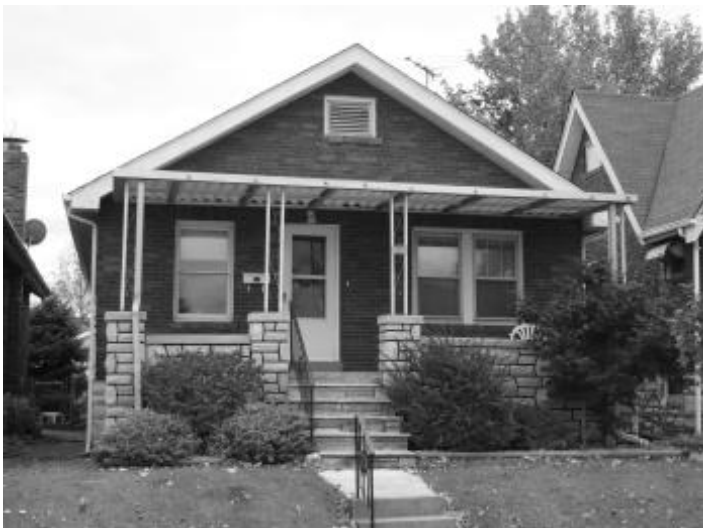
The full-width porch has 4 limestone bases under trellis-style metal supports hold up a fiberglass awning. It appears that this replaced a hood over the door. The front door and one of the façade windows have been replaced.

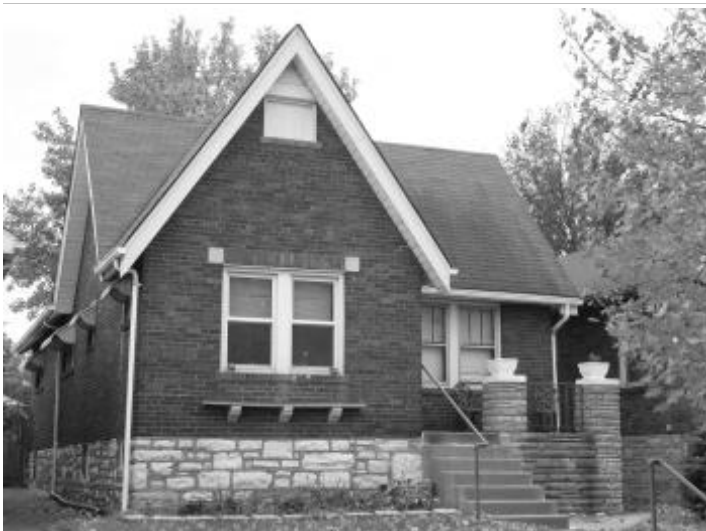
Imitation stone veneer covers the porch base, and the window pair at the left bay is a vinyl replacement.

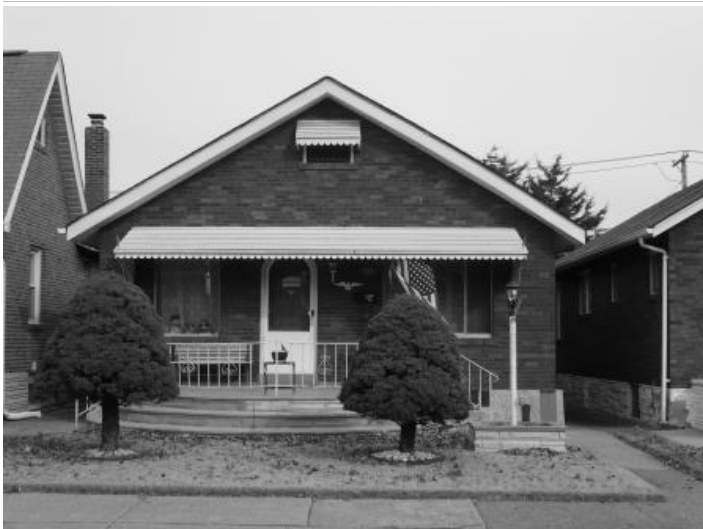
The façade was modernized in c. 1950s with new windows, metal awning, semicircular porch with 3 concentric steps.

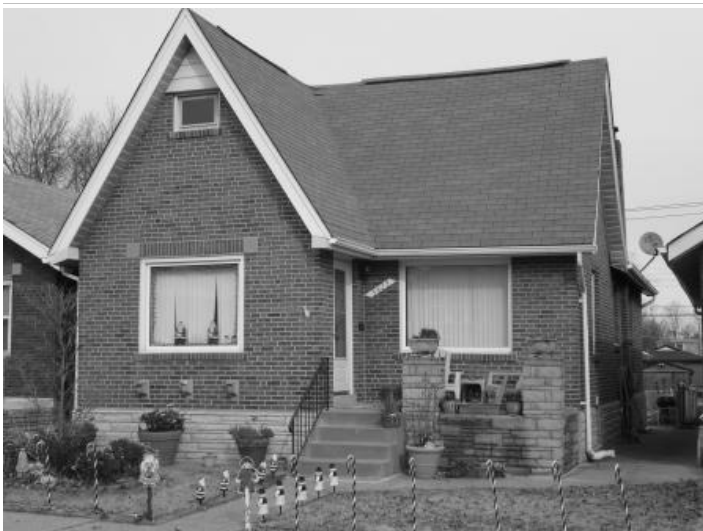
The foundation (presumably stone) is covered with imitation stone veneer. The front door and windows are replacements.

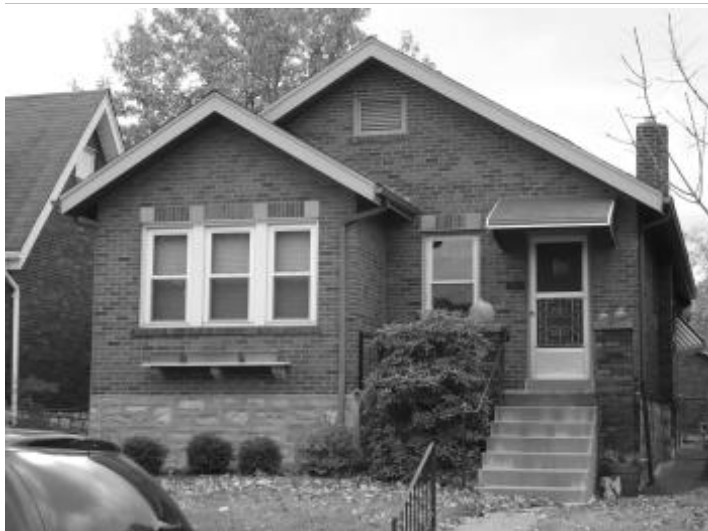
Replacement windows.

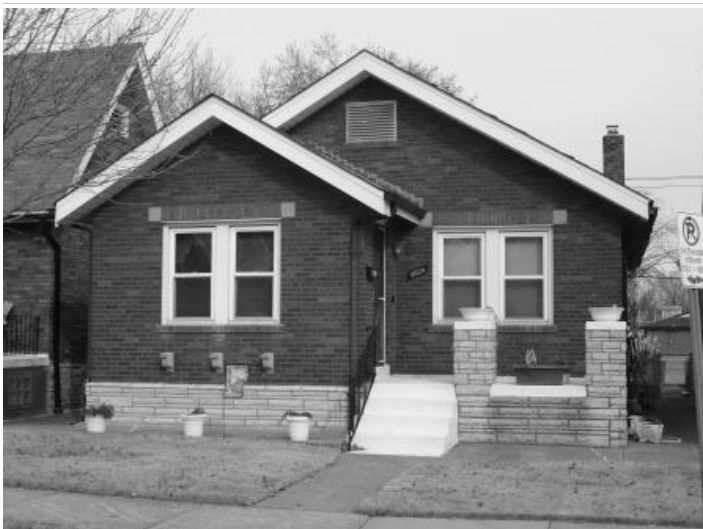
The foundation (presumably stone) is covered with imitation stone veneer. The windows are replacements.

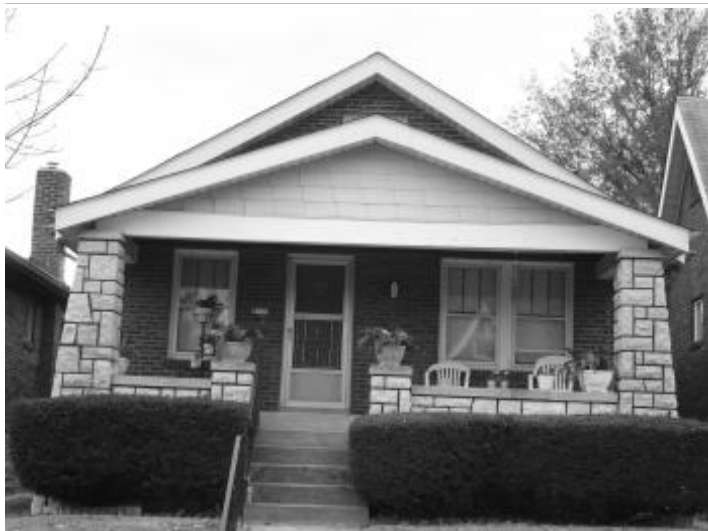
Siding covers eaves and vergeboards

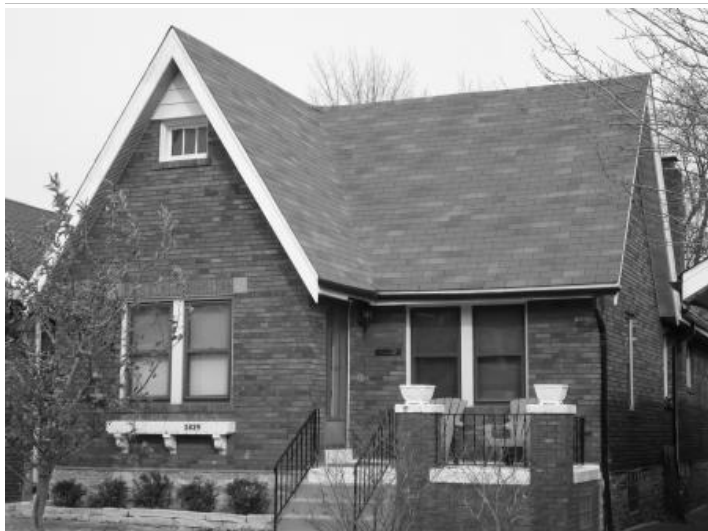
Windows are replacements.

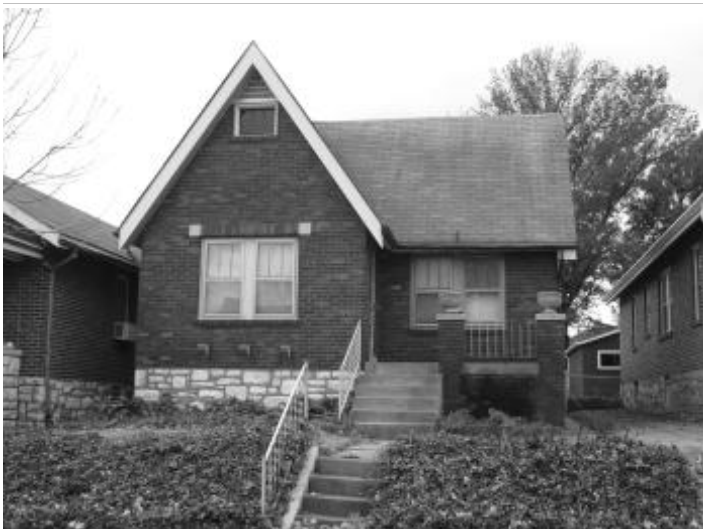
This variegated brick building has a steep front gable, left, meeting a side gabled section, right. The front door is original. Planter box is missing from the three concrete brackets below window pair, left. Most original features are intact (door, 3/1 windows, attic vent lantern)

Aluminum over vergeboard and eaves.

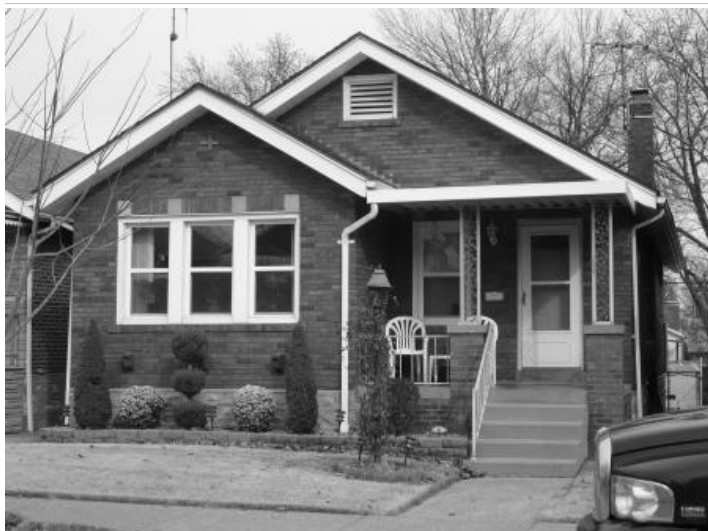
Replacement front door and windows; metal porch roof added.

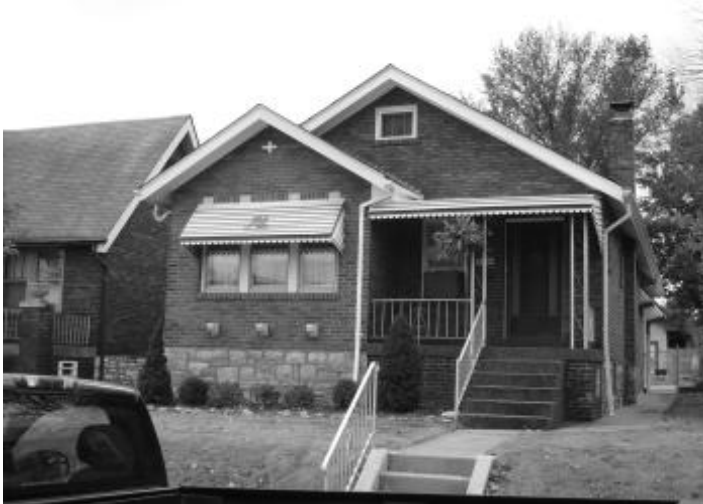
Metal awnings added at porch (supported by metal railings and trellis-style uprights) and triple window set.

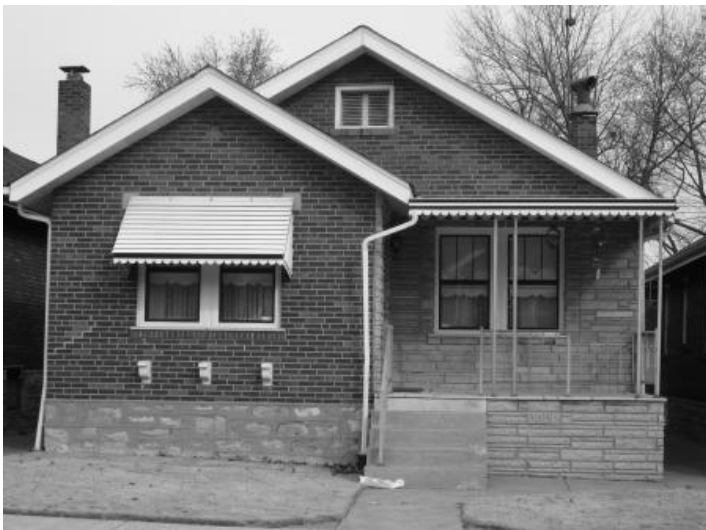
Imitation stone veneer covers foundation and porch wall at right bay; Metal awnings added over window pair, left, and porch (supported on trellis-style supports), right.

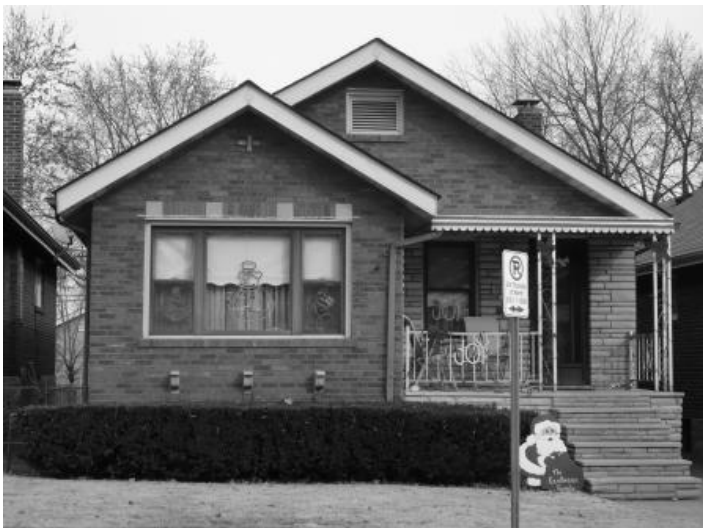
Imitation stone veneer covers foundation and porch wall at right bay; Metal awning added over porch (on trellis-style supports), right. Windows and front door are replacements.

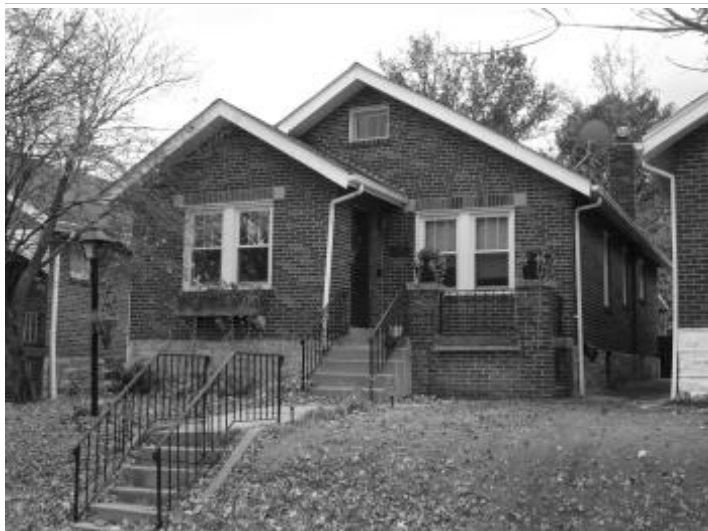
window frames are sided, as are vergeboard and eaves.

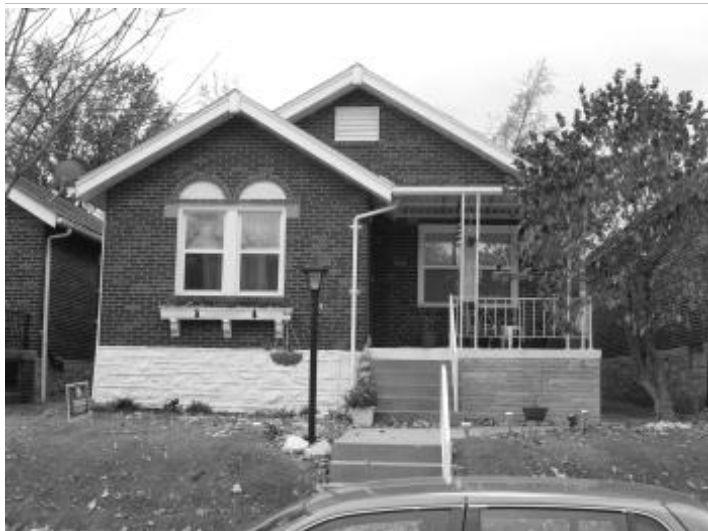
Replacement windows, gable vent. Fiberglass awning at porch supported on metal uprights. Imitation stone veneer covers porch base.

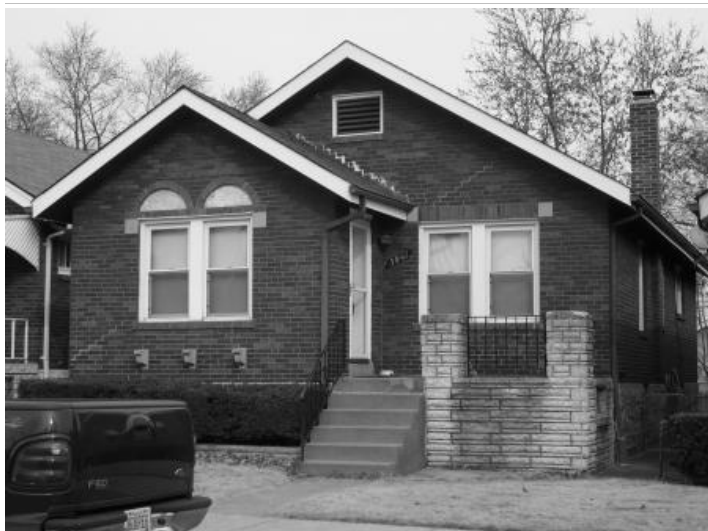
Imitation stone veneer covers porch base and piers. Replacement windows.

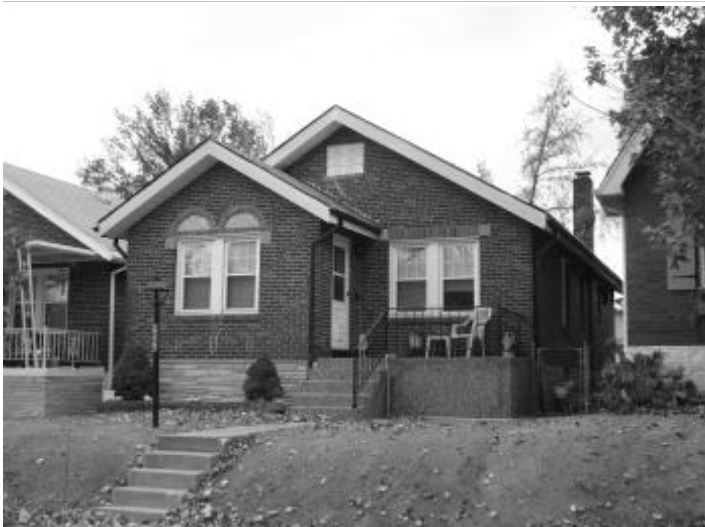
Replacement window. Imitation stone veneer added to façade foundation.

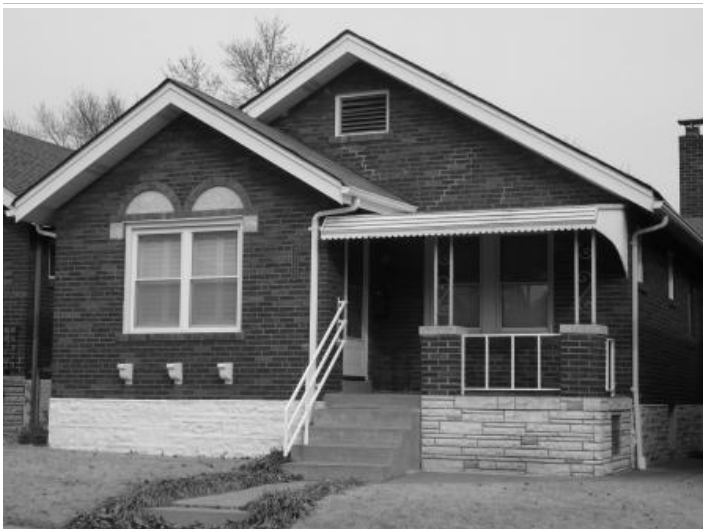
Imitation stone veneer covers porch base, and a metal awning roof has been added. Replacement windows and door.

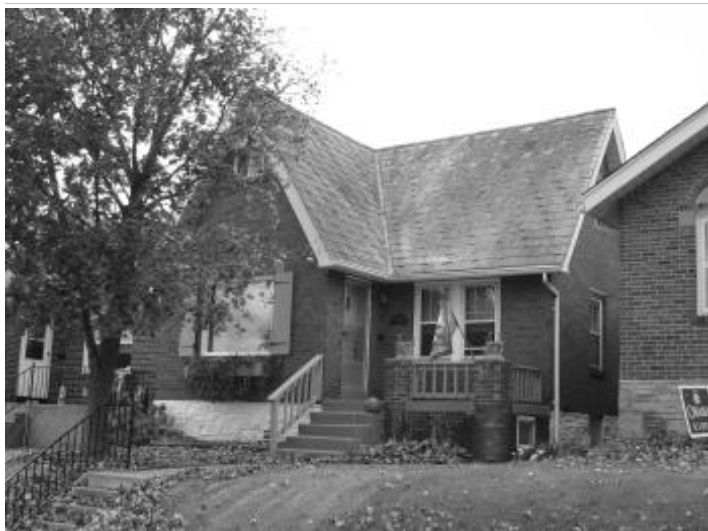
Picture window has replaced window pair, left. Shutters added.

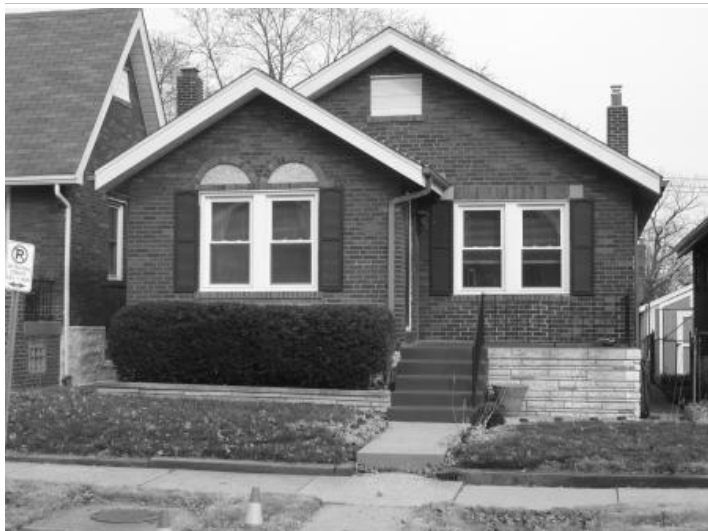
Imitation stone veneer covers porch base Replacement windows. Shutters added.

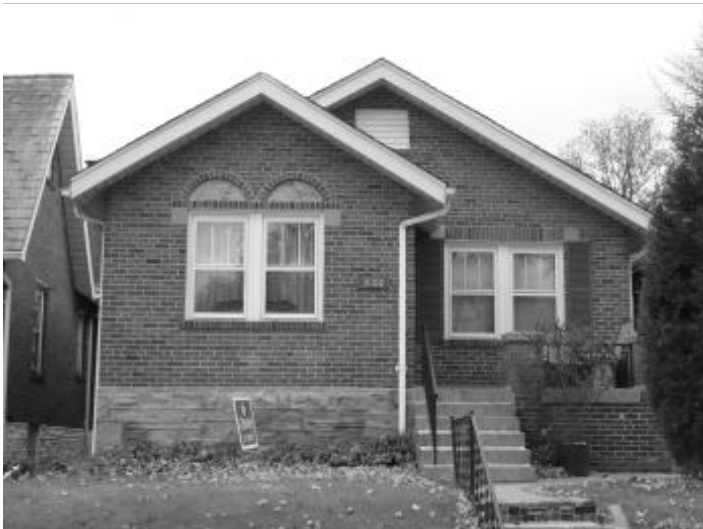
Aluminum covers eaves and vergeboard; attic vent covered.
