City of St. Louis Cultural Resources Office

Holly Hills Neighborhood Survey

Lynn Josse and NiNi Harris
3/1/2010

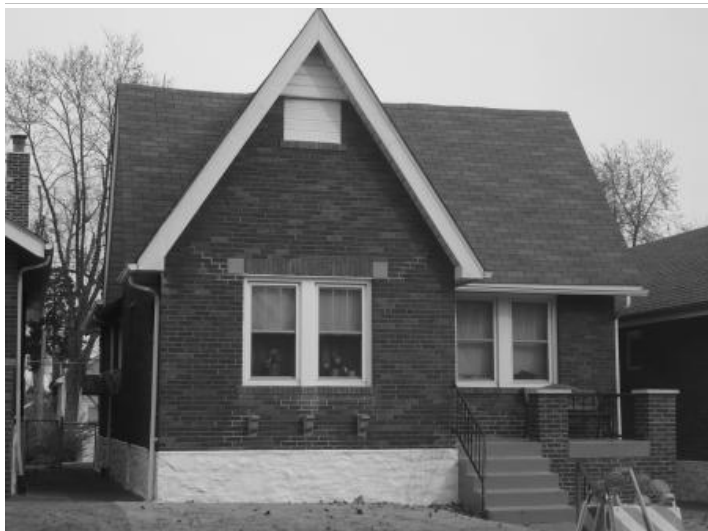
Replacement windows; vinyl covers some wood elements.

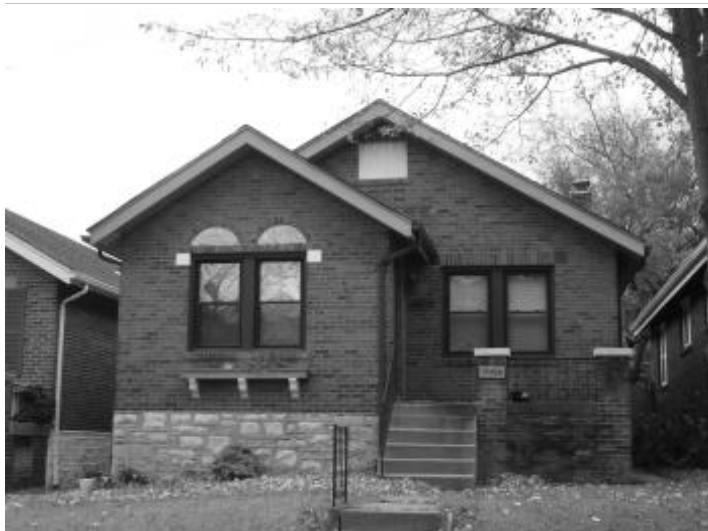
Aluminum covers eaves and vergeboard; replacement windows.

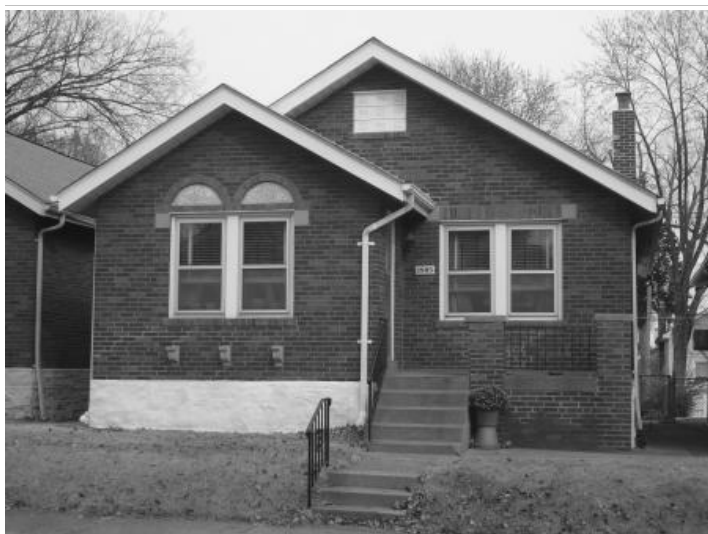
vinyl covers some wood elements.

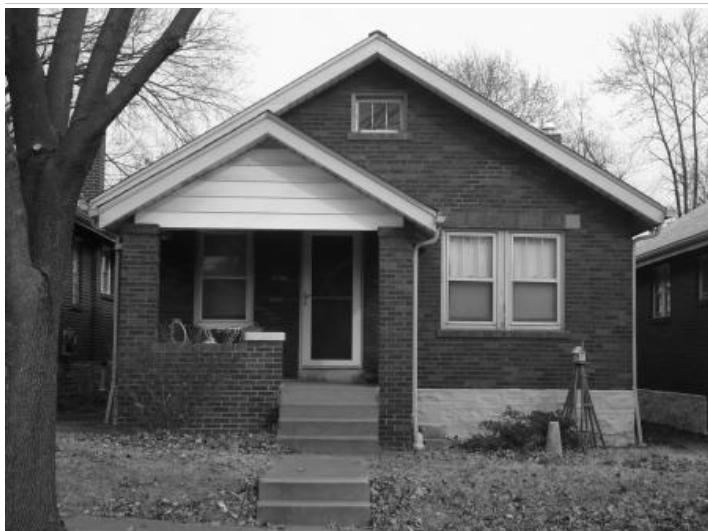
vinyl covers some wood elements.

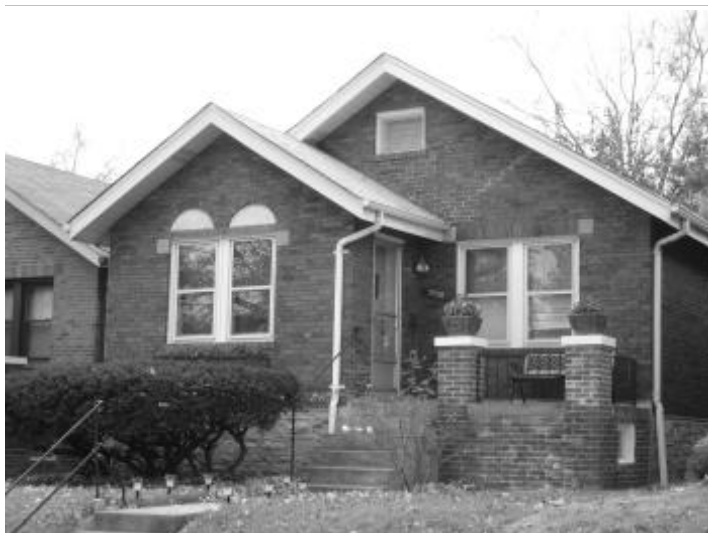
Aluminum covers eaves and vergeboard.

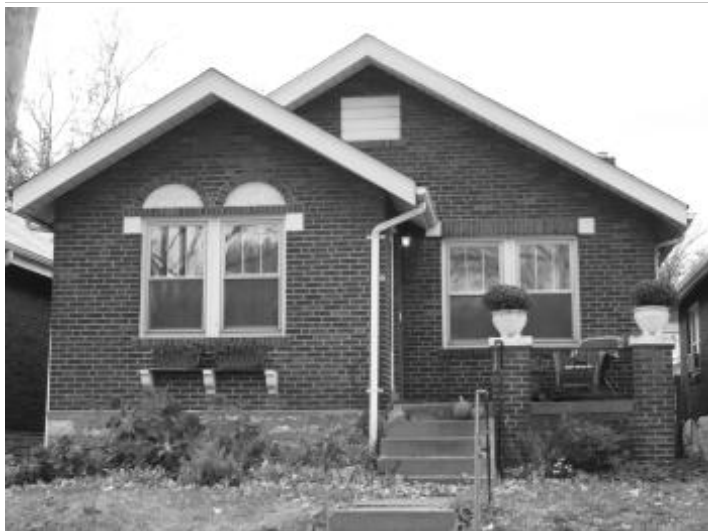
Aluminum covers eaves and vergeboard. Replacement front door.

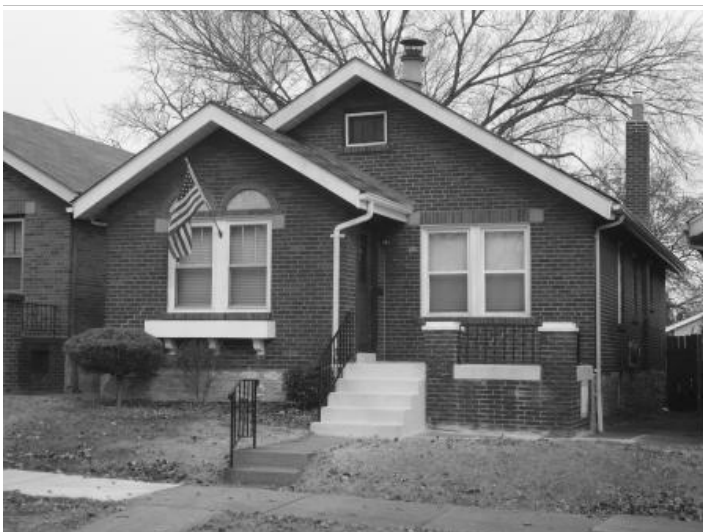
vinyl covers some wood elements. Two replacement vinyl windows at façade. New imitation slate roof.

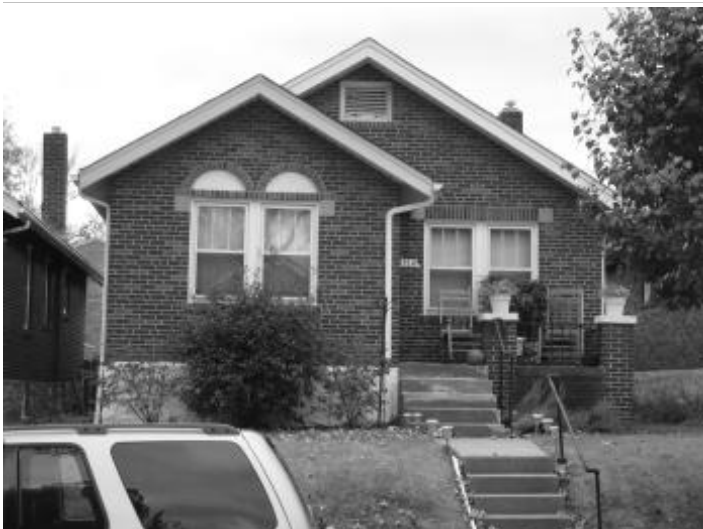
Aluminum covers eaves and vergeboard.

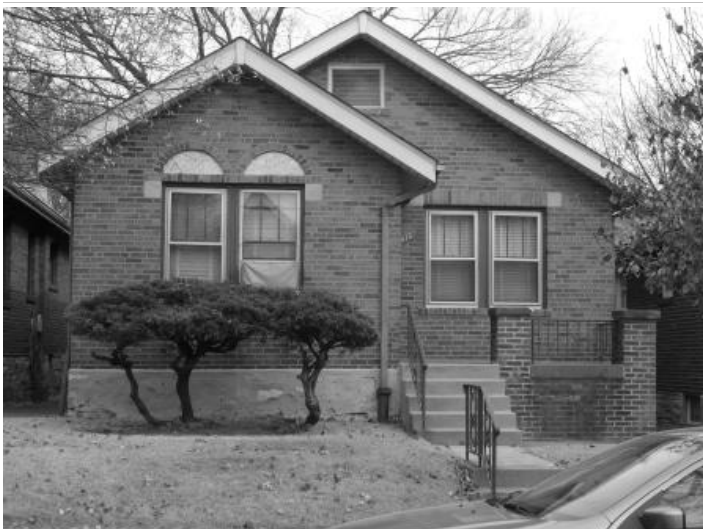
vinyl covers some wood elements.

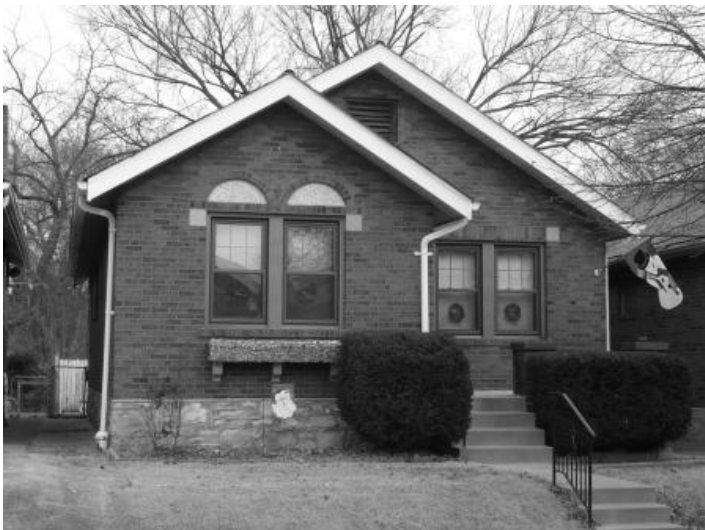
Both pairs of windows at the façade are vinyl replacements, and the door is replaced. Some wood elements (eaves and vergeboard) are sided.

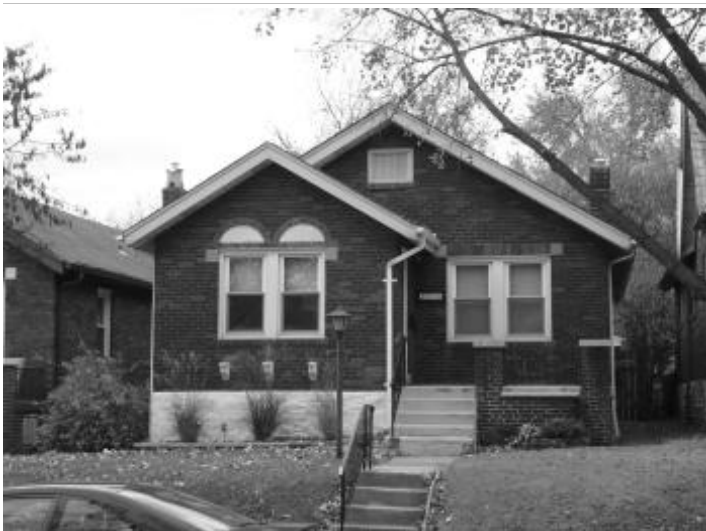
both pairs of façade windows are replacements.

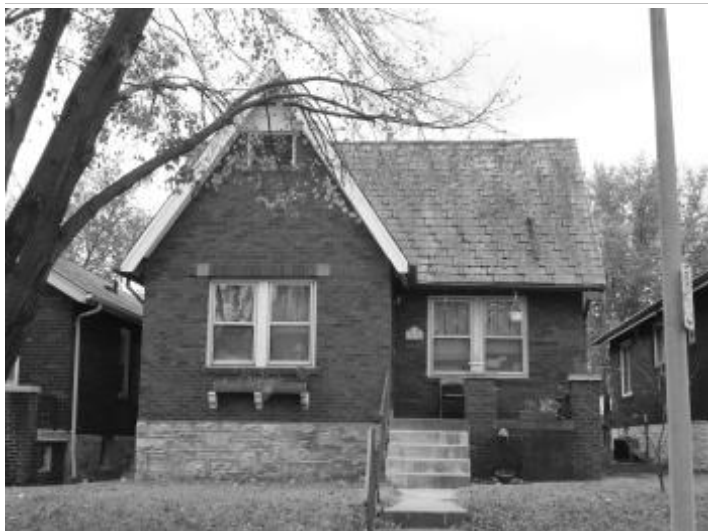
Vergeboard is covered with siding.

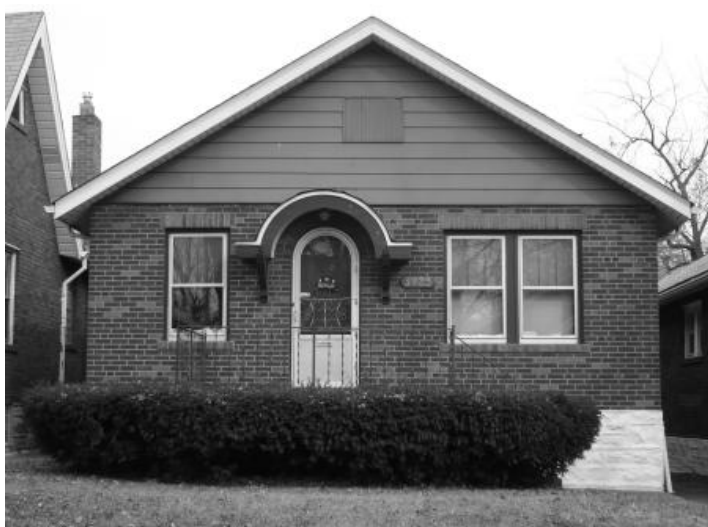
Some wood elements (eaves and vent) are sided. The gable end is covered with horizontal siding.

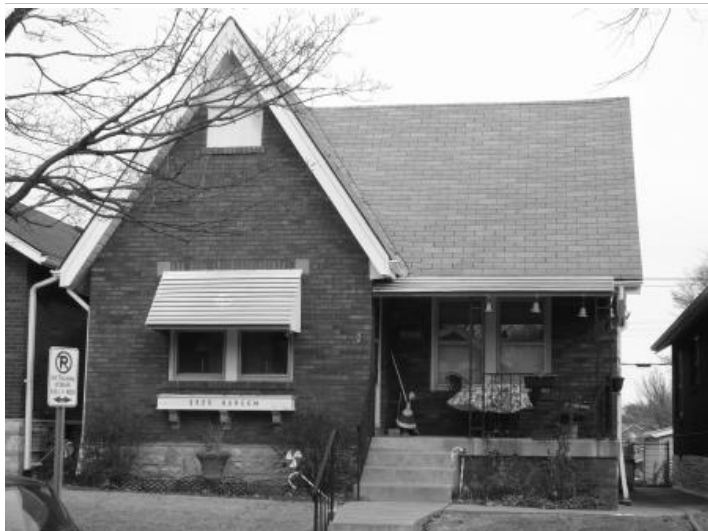
Some wood elements (eaves and vergeboard) are sided. Metal awning at left windows.

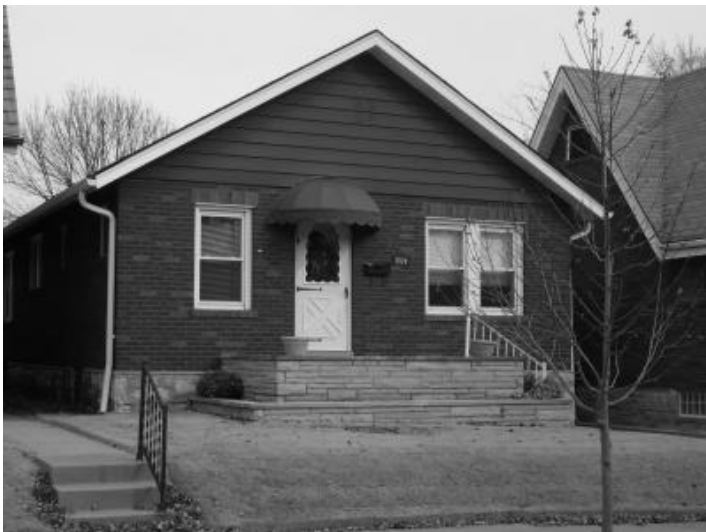
Fabric awning likely replaces original wood hood. Facade windows are vinyl replacements (paired at the right and a single window at the left). Modern horizontal siding in gable end.

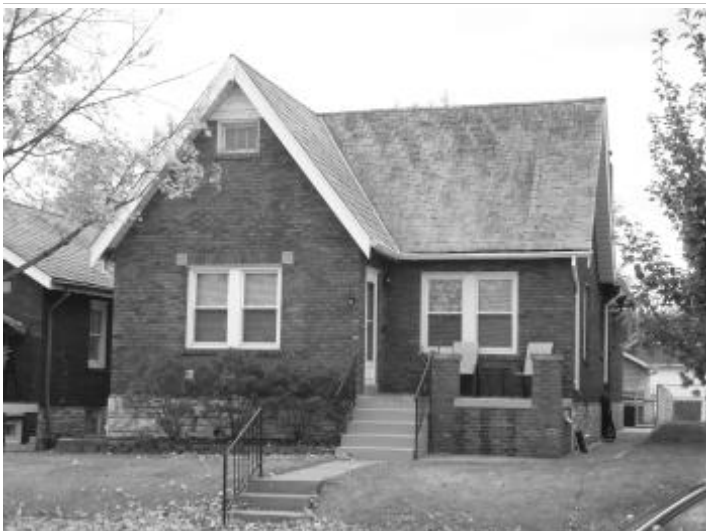
Replacement windows.

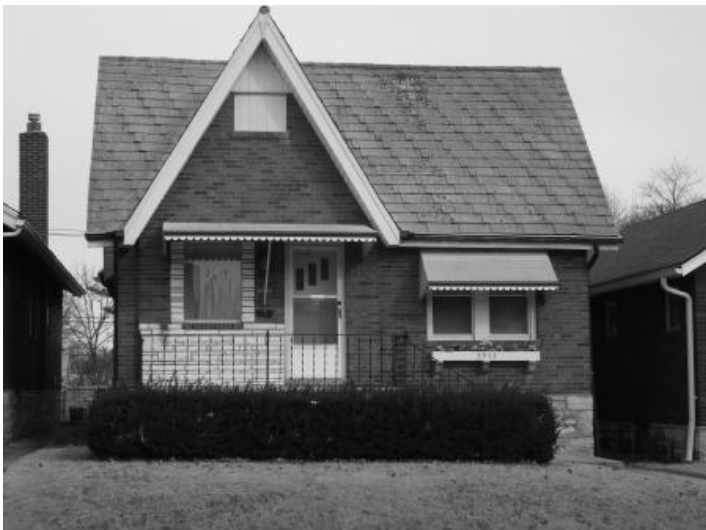
Replacement door, window, attic vent. Fiberglass awning over door. Imitation stone veneer applied around window and porch base, and below left window to the left of the front door.

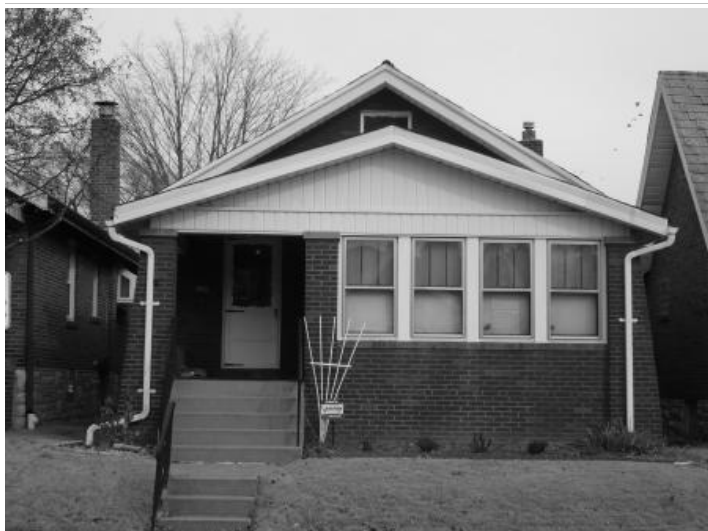
Front door is a replacement; vinyl covers some wood elements (eaves) and porch's gable end.

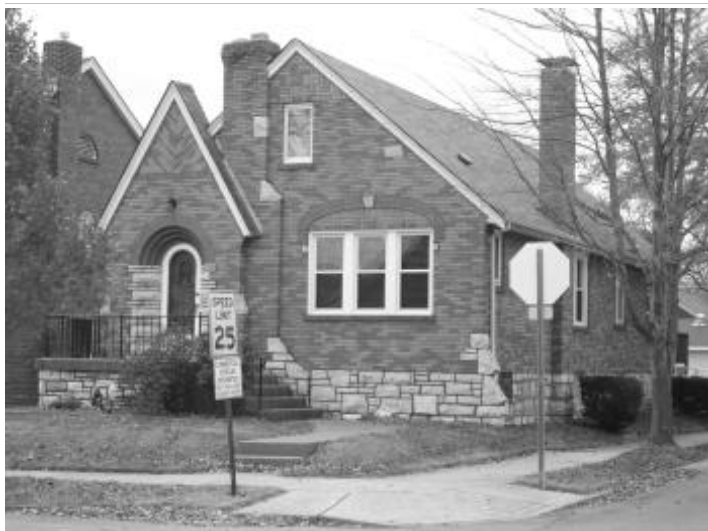
Replacement windows

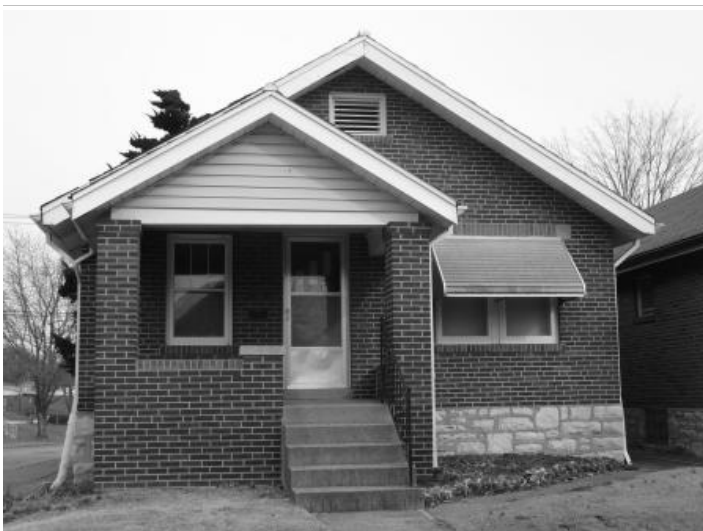
Front door is a replacement; vinyl covers some wood elements (eaves); fiberglass awning over right window pair.

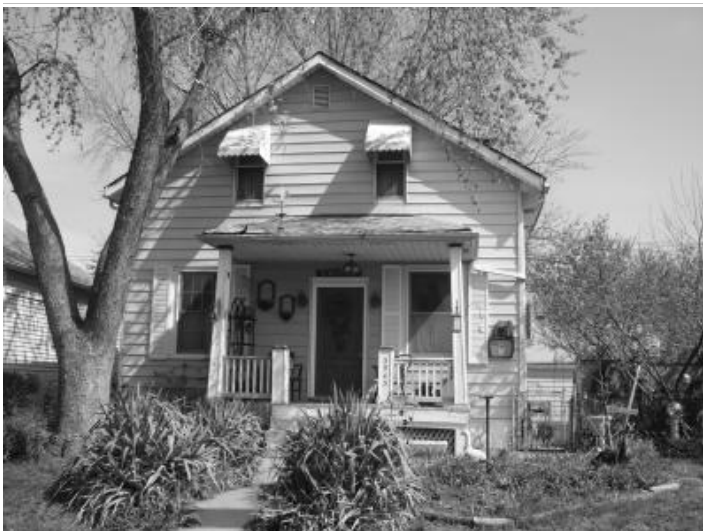
Front door and windows at first story are replacements; their frames are covered by siding.

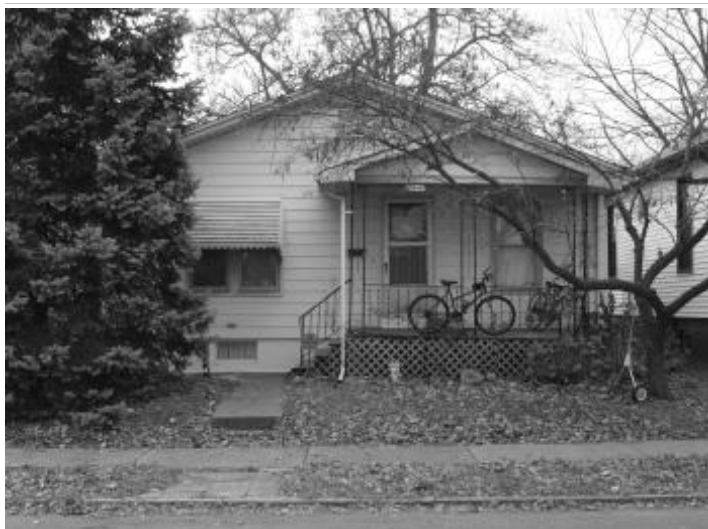
The windows are modern replacements, and all original wood trim is all covered by siding or wrap.

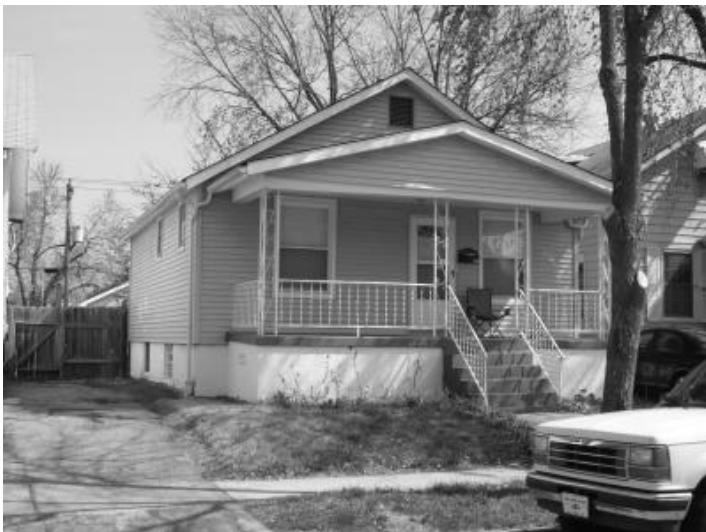
Porch piers replaced by metal trellis-style supports. Vinyl covers porch gable end and eaves. Replacement door and windows (with frames covered).

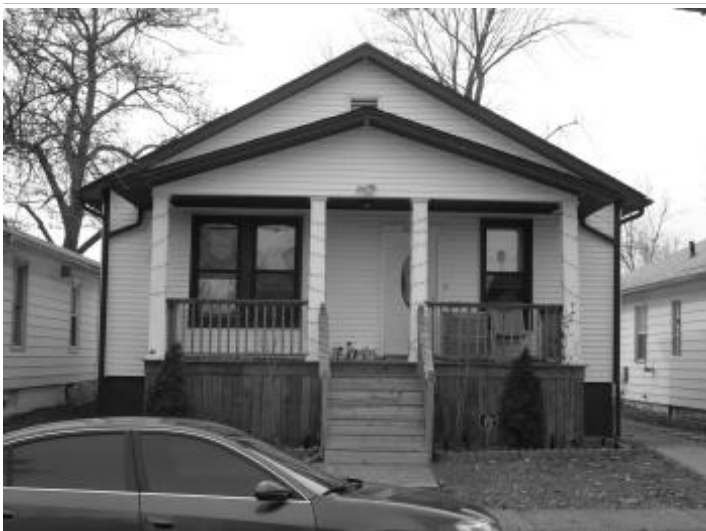
Replacement door and windows; wood trim covered by siding or wrapped.

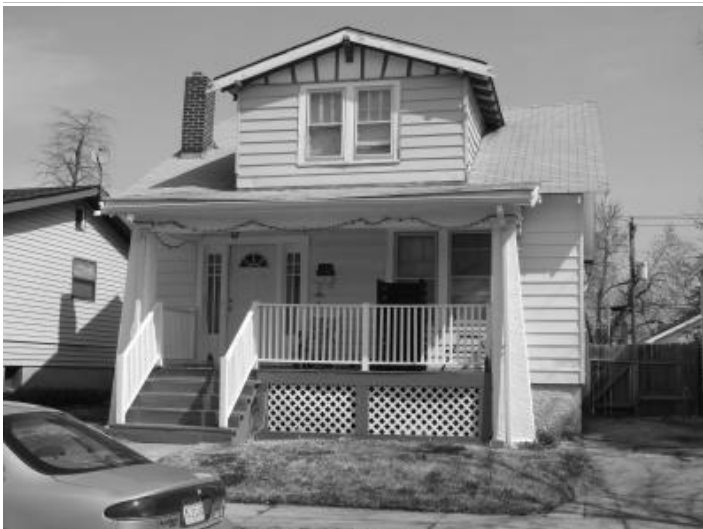
The front door is a replacement.

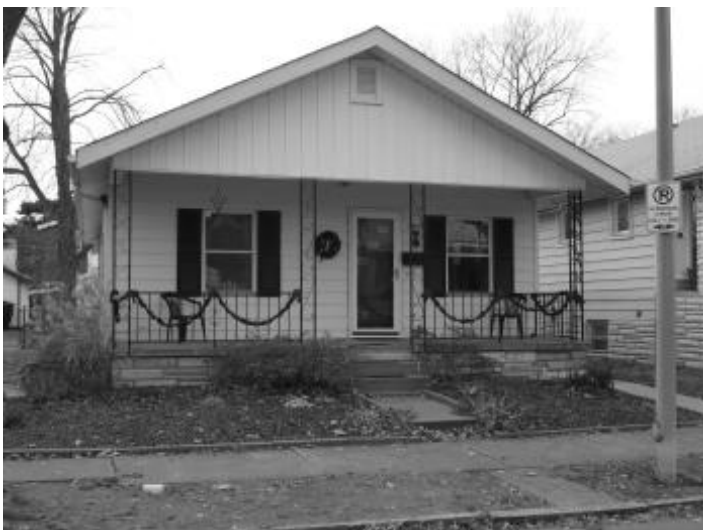
the front door is a midcentury replacement, windows are modern, shutters have been added, and original trim is either sided over or wrapped. Foundation is covered with imitation stone veneer, and porch posts replaced with metal supports

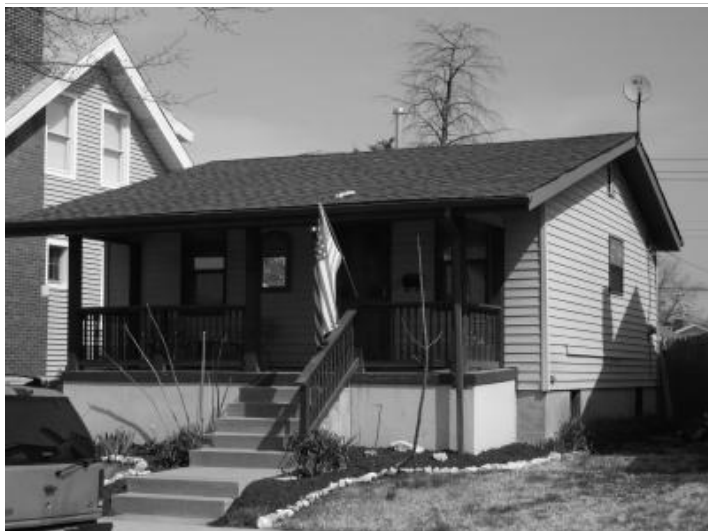
Replacement door, windows (frames covered).

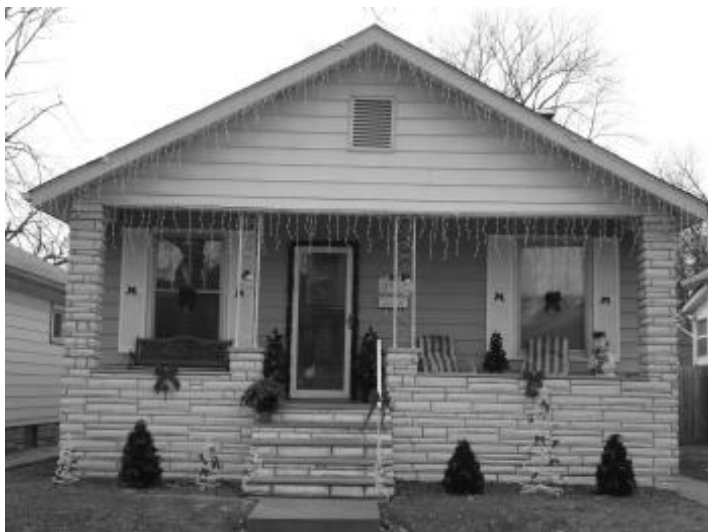
the front door is a replacement, shutters have been added, and original trim is either sided over or wrapped. Foundation/porch covered with imitation stone veneer (over concrete, visible in areas) and porch posts replaced with metal supports

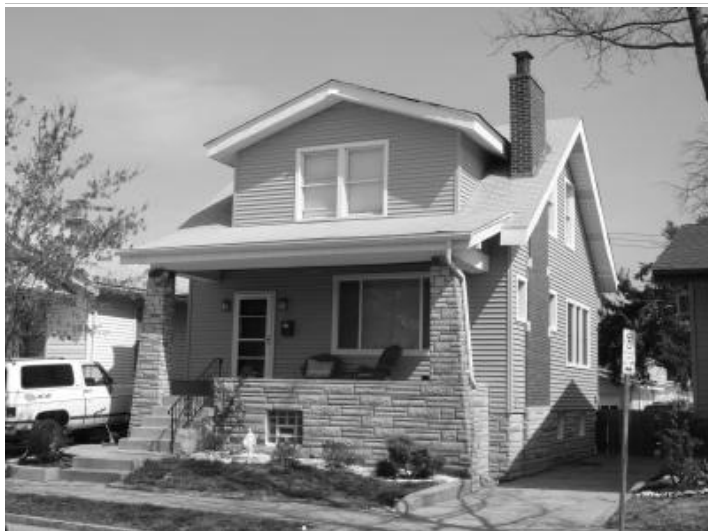
The front porch is clad with imitation stone veneer. Replacement front door; replacement windows, including large picture window at first story.

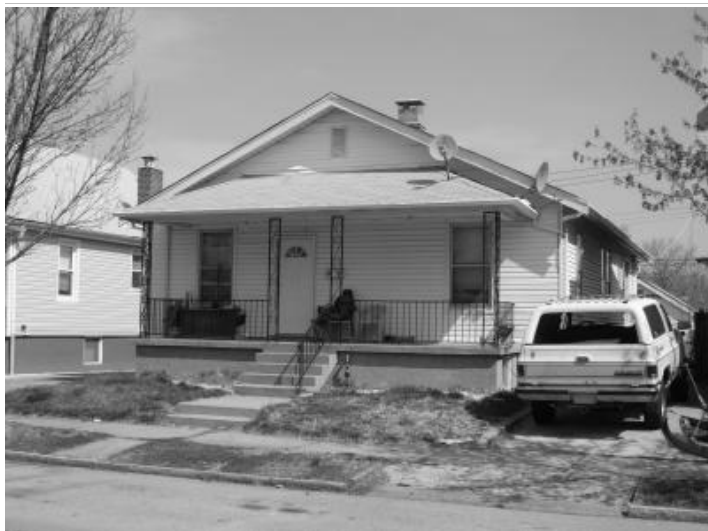
The four porch supports and railings are metal replacements. Replacement door and windows.

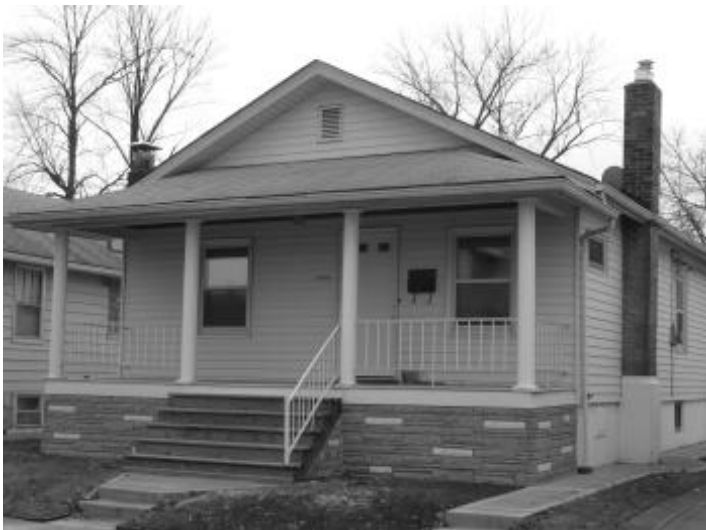
the front door is a replacement, windows are modern, and original trim is either sided over or wrapped. Porch base is concrete and posts replaced with metal supports

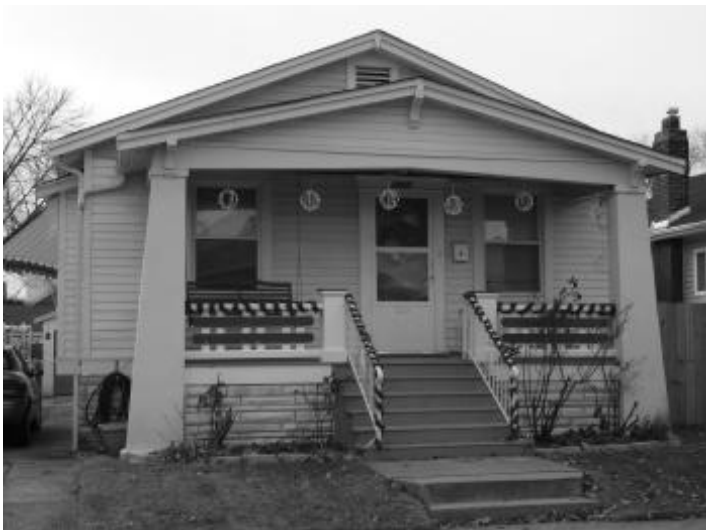
the front door is a replacement, windows are modern, and original trim is either sided over or wrapped. Porch base is concrete and posts replaced with metal supports. Imitation stone veneer over porch base and foundation.

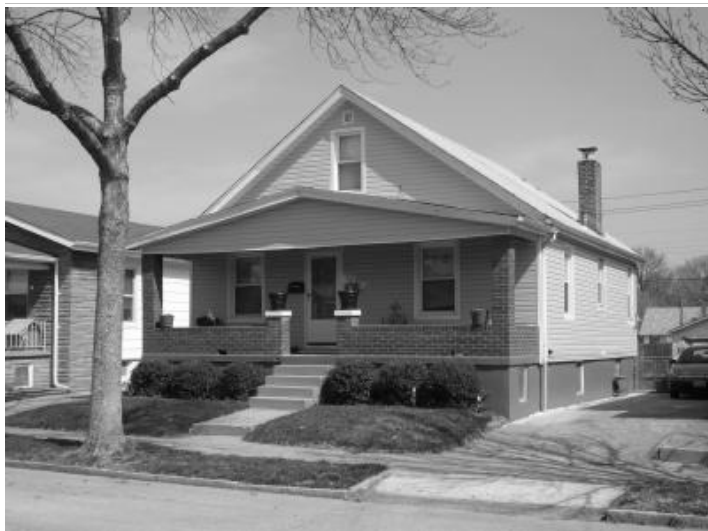
Replacement windows.

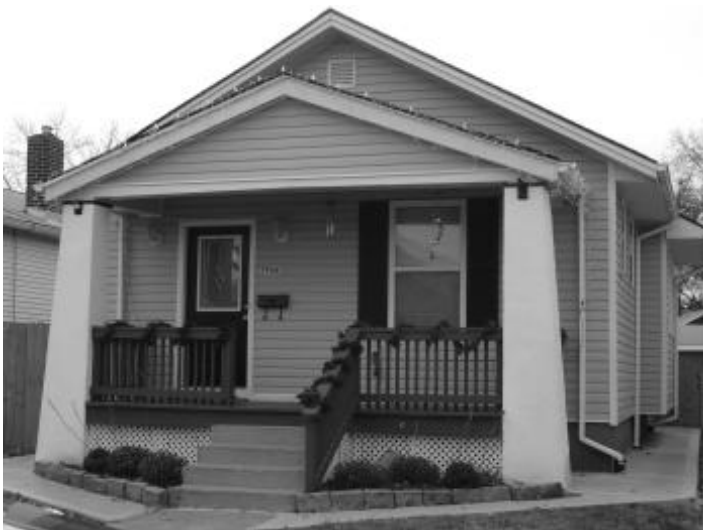
the front door is a replacement, façade window is modern, and original trim is either sided over or wrapped. Wood porch is rebuilt with unpainted (or brown painted) lumber. Inoperable shutters added at façade window.

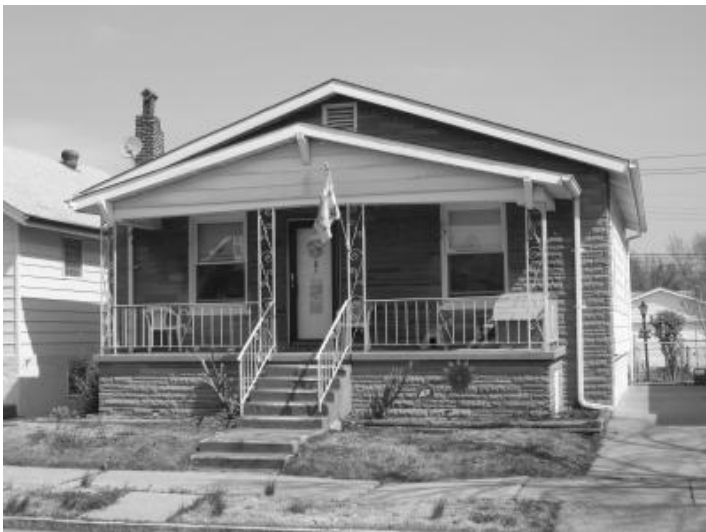
The facade is covered with imitation stone veneer. The porch's gable end retains three brackets, soffited. Porch posts are replaced with metal supports. Side elevations are horizontal wood siding. The front door is non-historic. Repl. Windows.

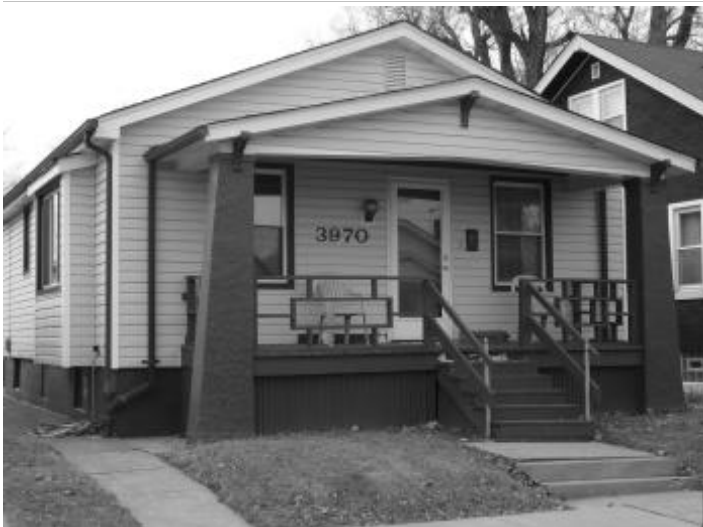
the front door is a replacement, façade windows are modern, and most original trim is either sided over or wrapped.

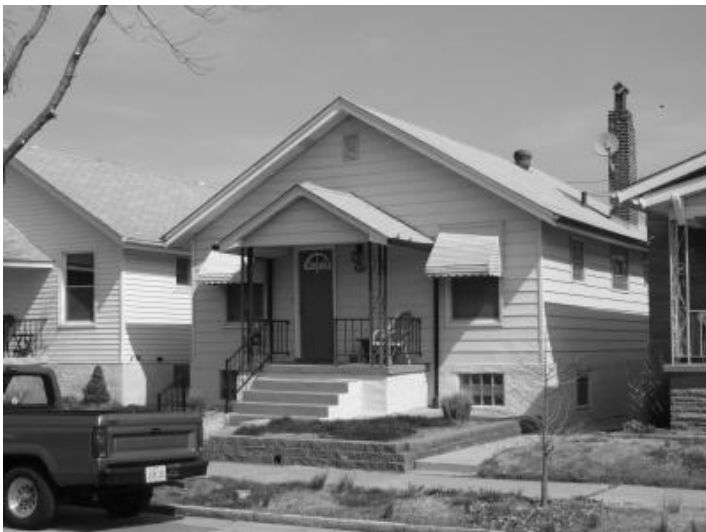
The front door is non-historic. Metal porch supports are replacements. Awnings are at windows at façade. Replacement windows. Gable end of porch is sided.

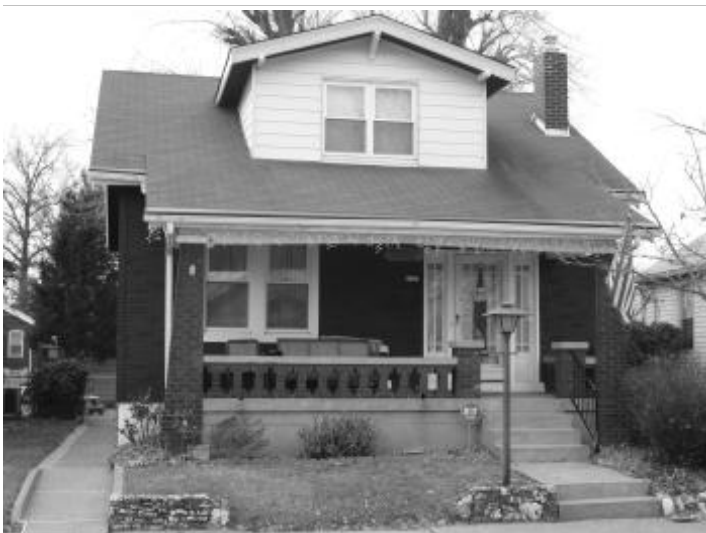
Replacement windows.

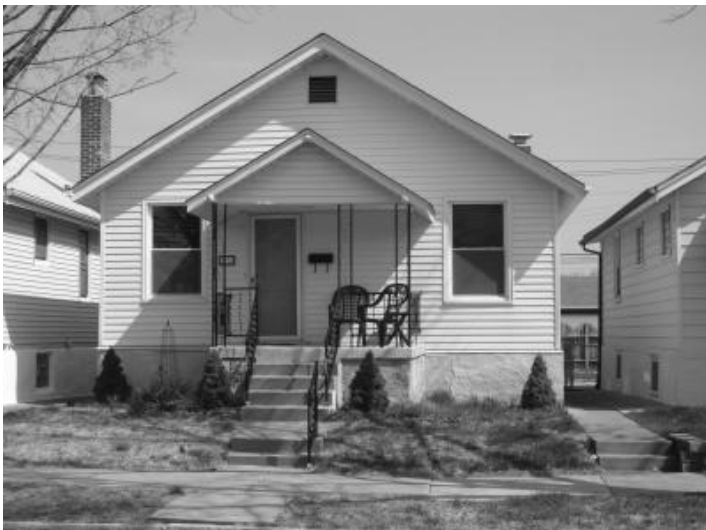
The front door is non-historic. Metal porch supports are replacements. The two façade windows are replacements. Gable end of porch and eaves are covered with siding.

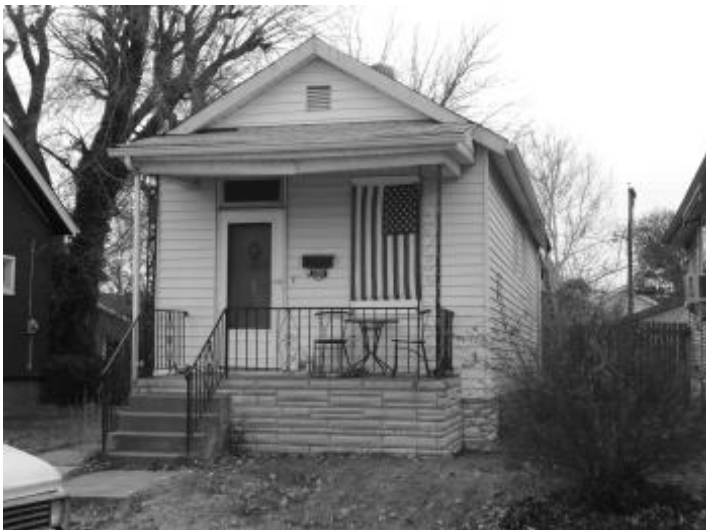
The foundation and concrete porch base are covered with imitation stone veneer. No original material visible (doors, windows, porch posts replaced, trim sided over or wrapped).

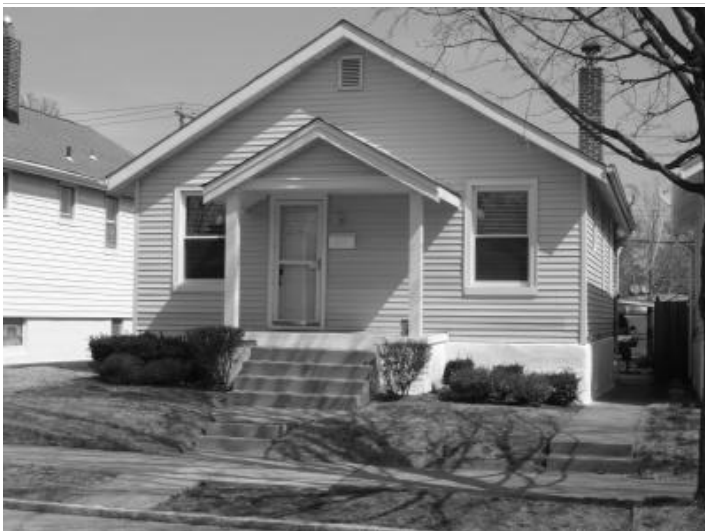
The front door is non-historic. The two façade windows are replacements. Gable end of porch, eaves, porch piers covered in siding.

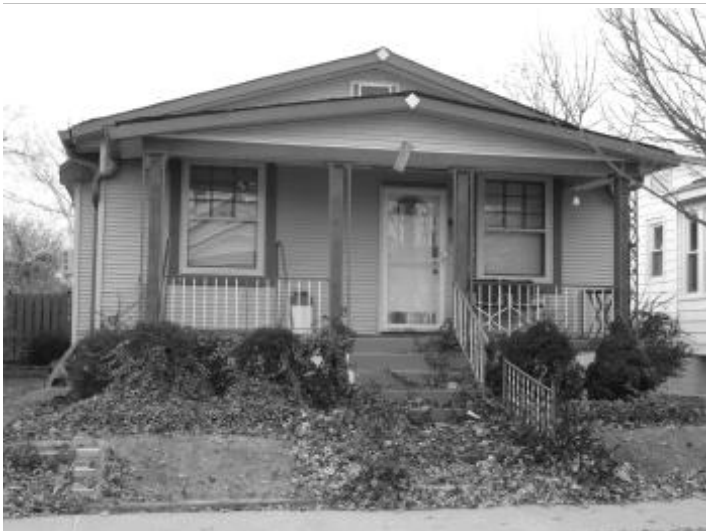
doors, and porch posts replaced, trim sided over or wrapped.

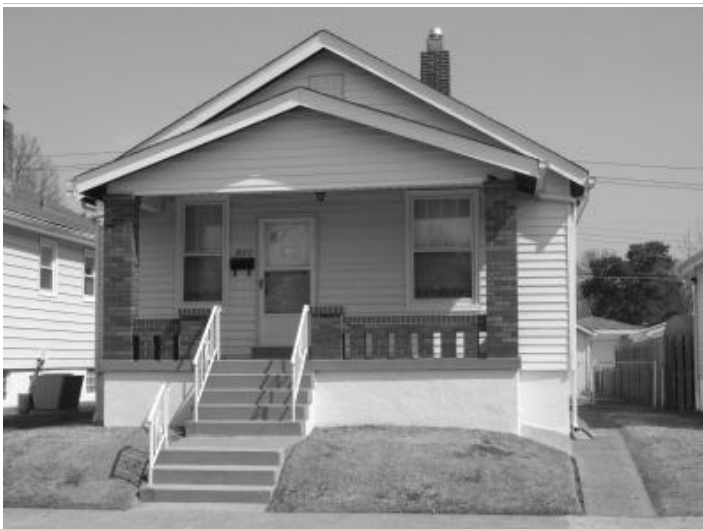
The front door is a replacement, possibly contemporary with the brick porch. Gable end of porch and vergeboard are replacements.

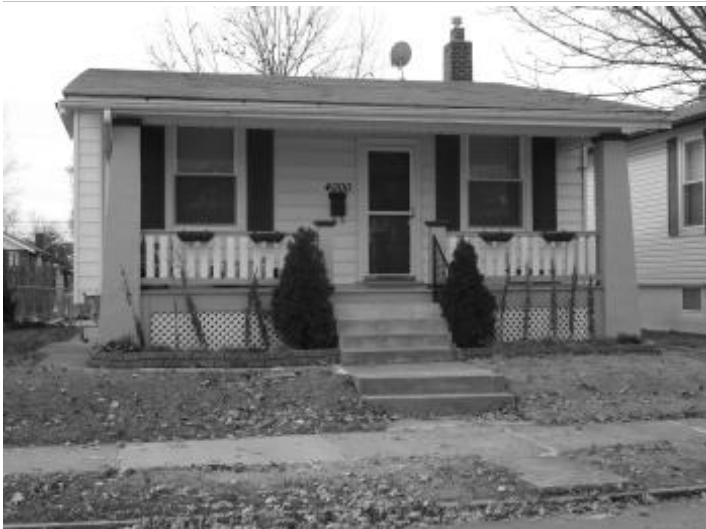
Door and façade windows are replacements; trim is obscured under siding or wrap; inoperable shutters added.

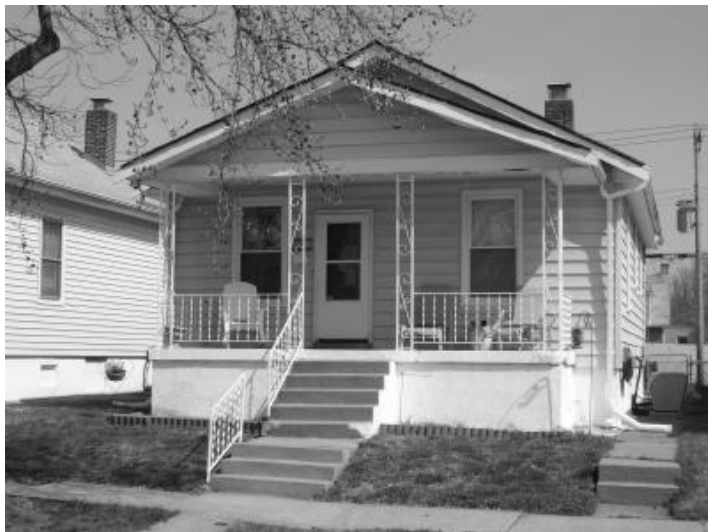
Door and windows are covered; window trim wrapped but shows original dimensions. Porch supports and railings are metal replacements on concrete base. Vergeboards, eaves and gable end of porch are all covered with siding.

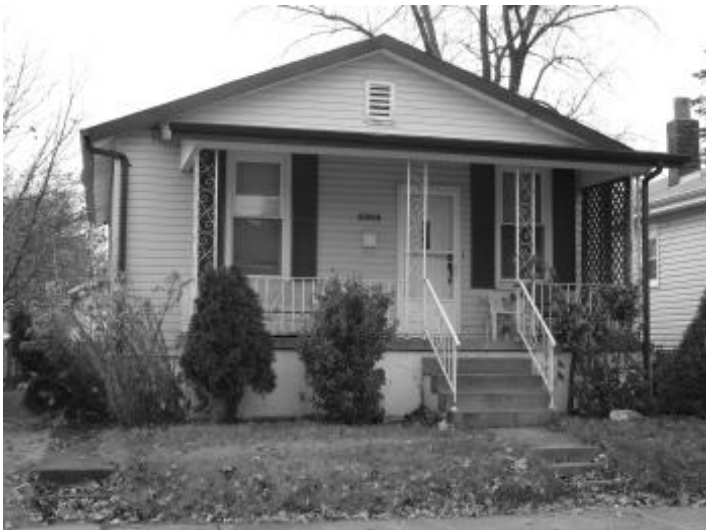
Door and façade windows are replaced; original trim sided over or wrapped; porch has concrete base with metal rails and supports; shutters added

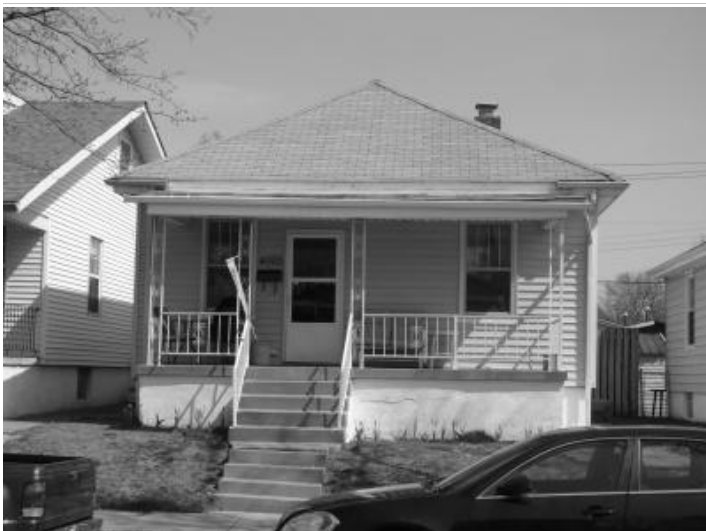
The concrete porch base has metal supports instead of original piers. Replacement door and sided eaves.

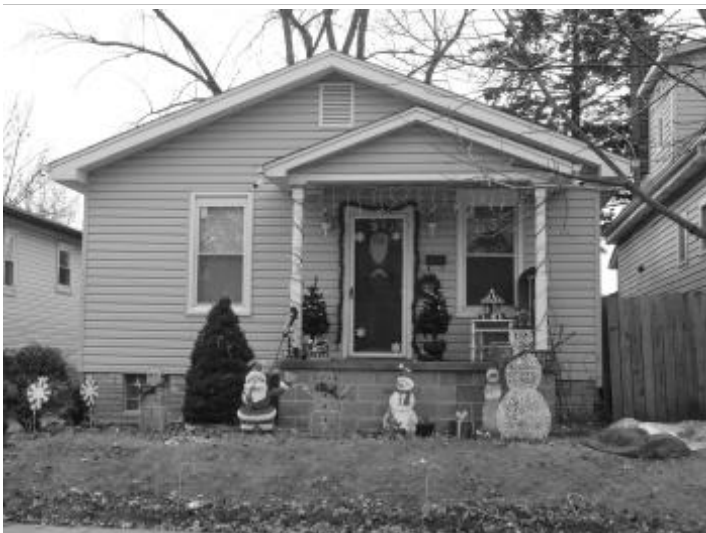
this front gabled house has a gabled porch at the right bay. No historic materials are visible at the facade. The foundation is clad with imitation stone veneer, and the porch has a concrete block base.

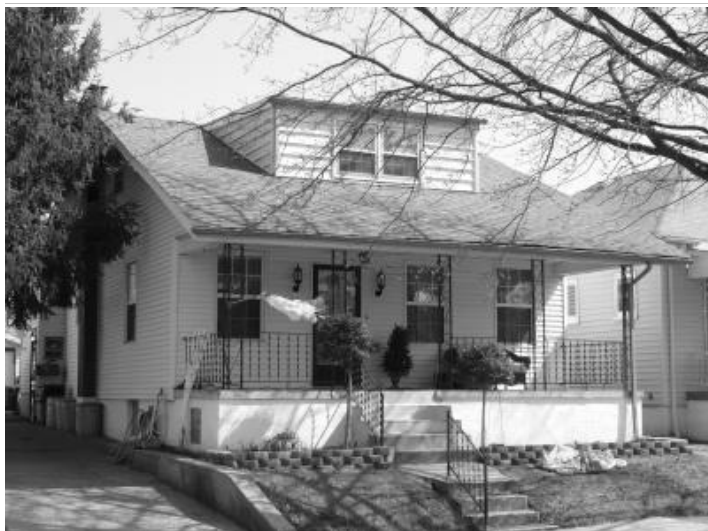
The concrete porch base has metal supports. The windows at first floor are replacements.

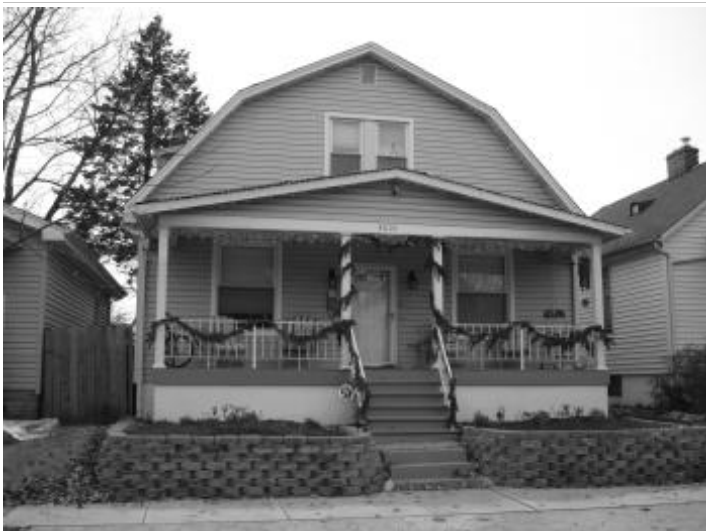
The open end of the gambrel roof faces the street; there is a full-width gabled porch with wood steps and replacement piers. No original materials are visible at the façade.

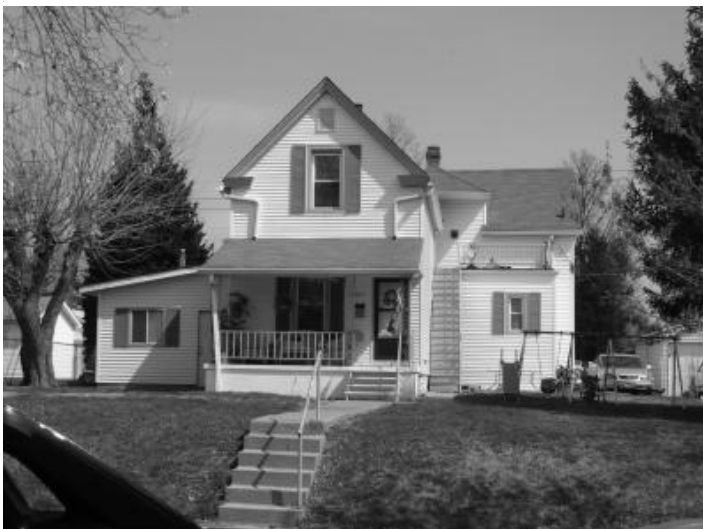
Not original material is visible except for part of the original foundation and a chimney. Siding, doors, windows, shutters, are relatively new. The wing facing Burgen may be a historic (Victorian-era) addition.

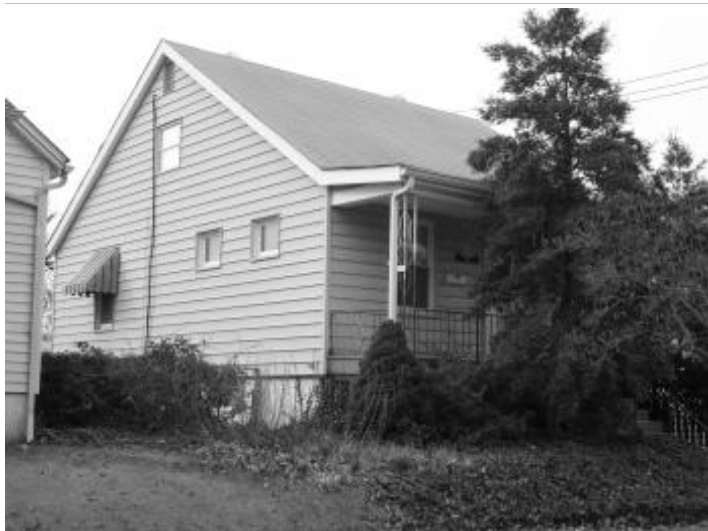
Replacement doors and windows; porch elements replaced; original wood trim sided over or wrapped.

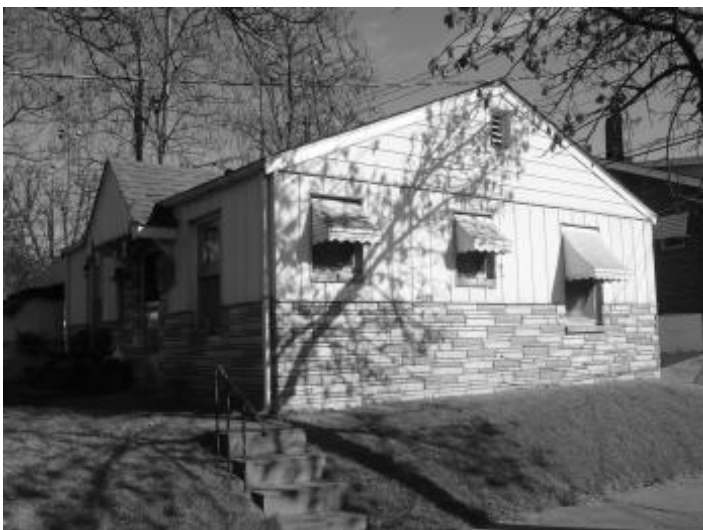
alter frame dwelling 5/22/1946 \$2000 to owner Flori. Imitation stone veneer at lower half of exterior walls; aluminum siding above. Metal awnings over windows.

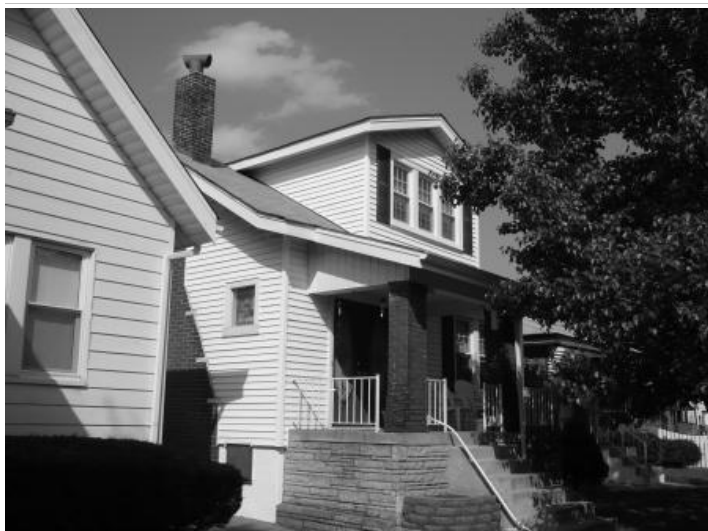
Siding, replacement windows, false shutters

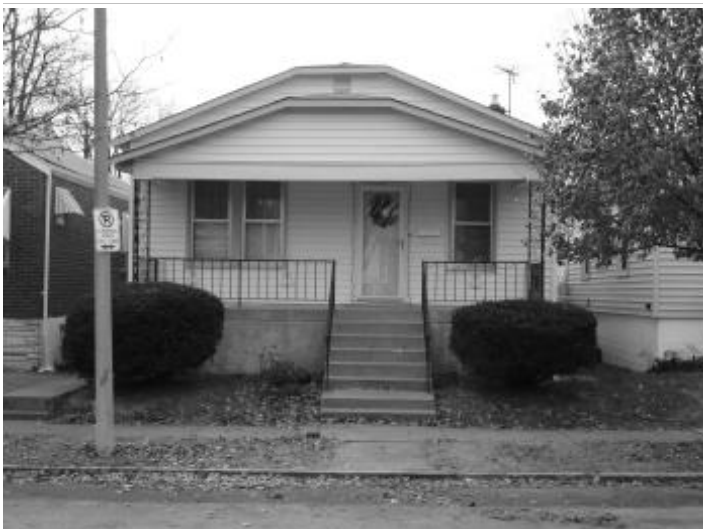
Replacement front door; front porch base, rail, piers replaced; wood trim at windows covered by siding.

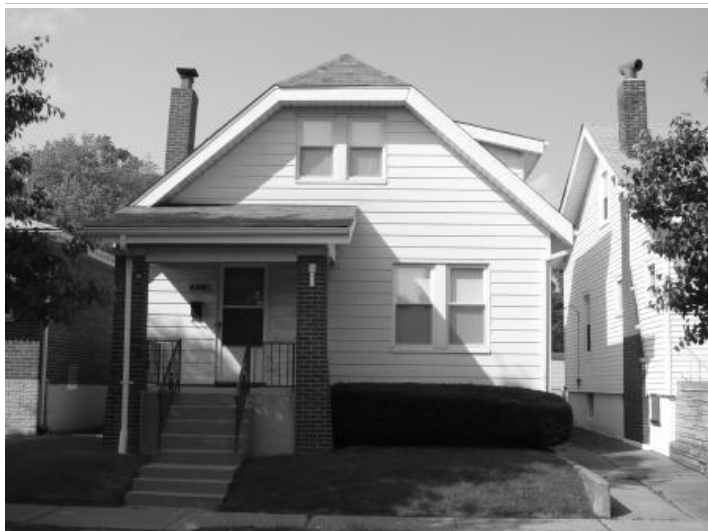
Aluminum siding, replacement windows.

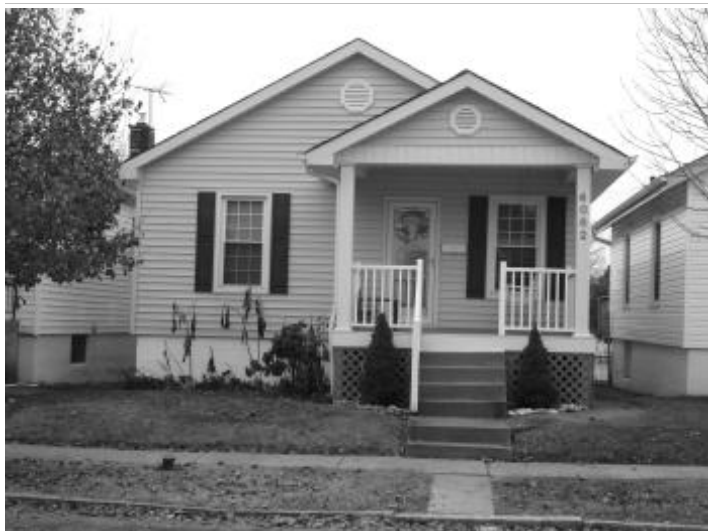
No historic material visible.
