City of St. Louis Cultural Resources Office

Holly Hills Neighborhood Survey

Lynn Josse and NiNi Harris
3/1/2010

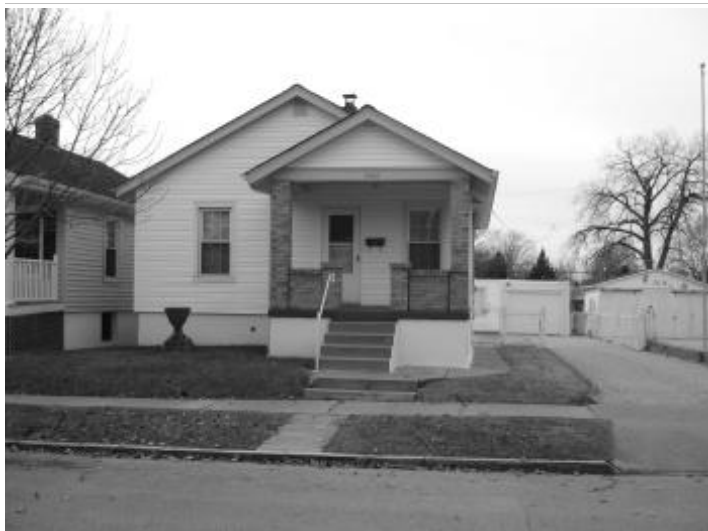
Windows are replaced.

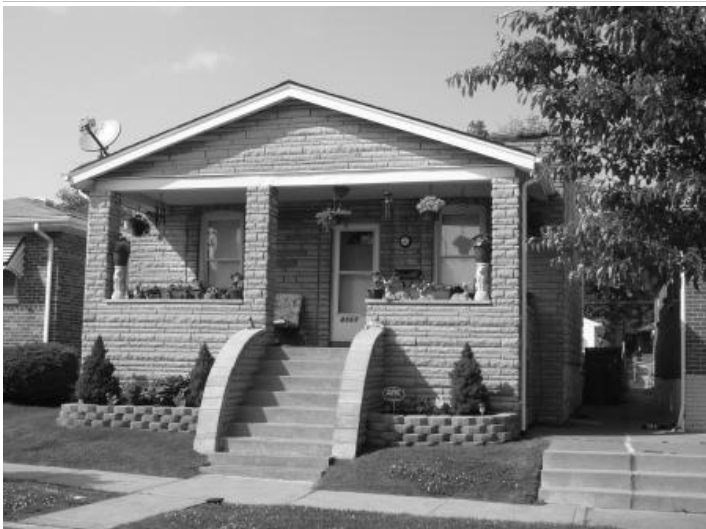
Full-width front gabled porch and walls clad with imitation stone veneer. Replacement window and doors.

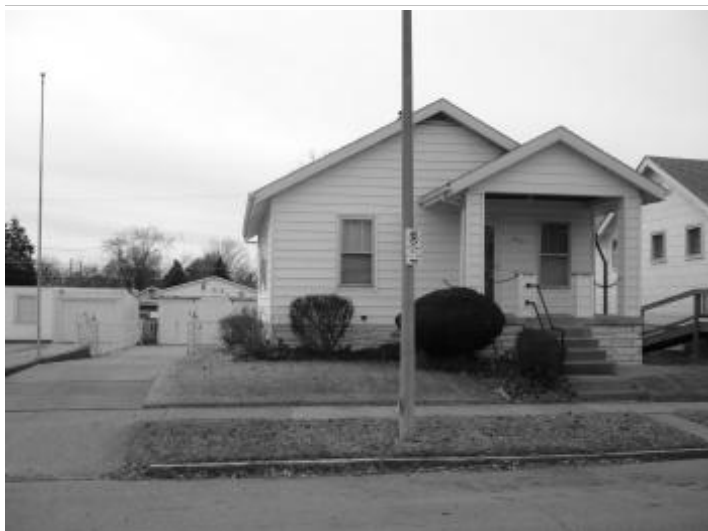
Replacement front door

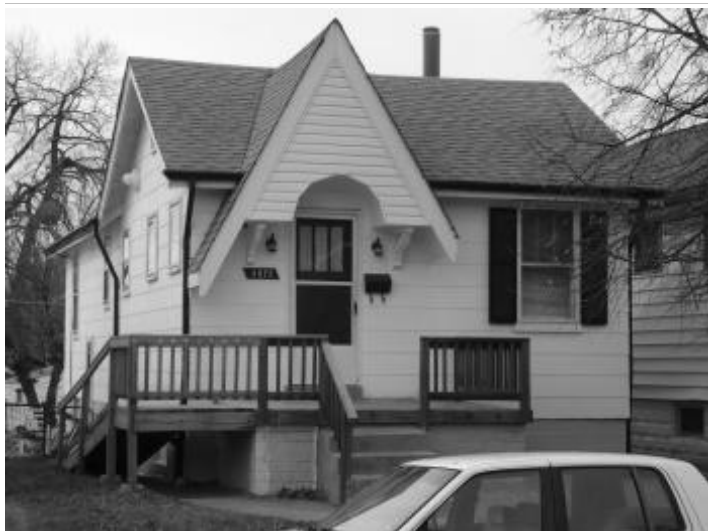
Porch is replaced by a wood deck; asbestos siding.

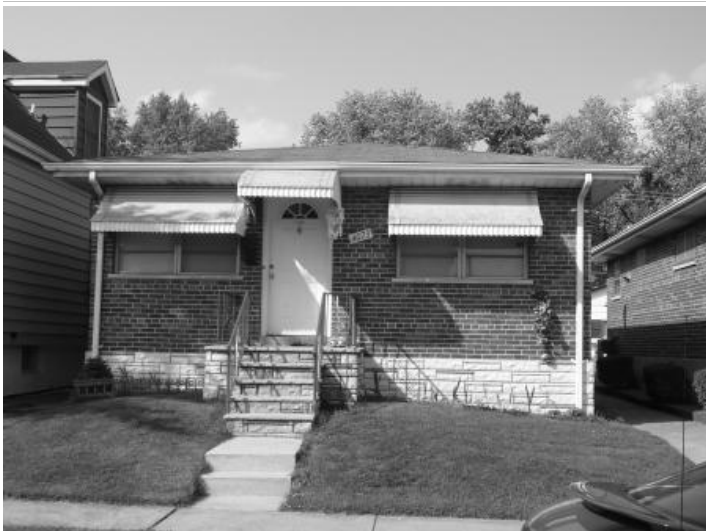
replacement door

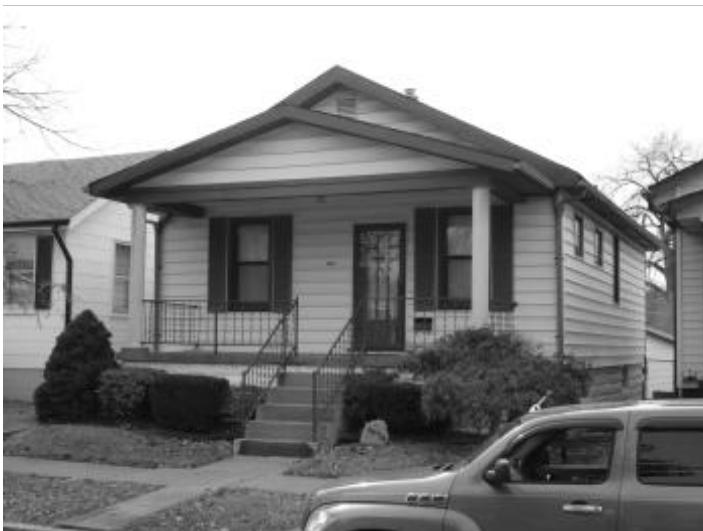
Porch piers are replaced. Windows are replaced.

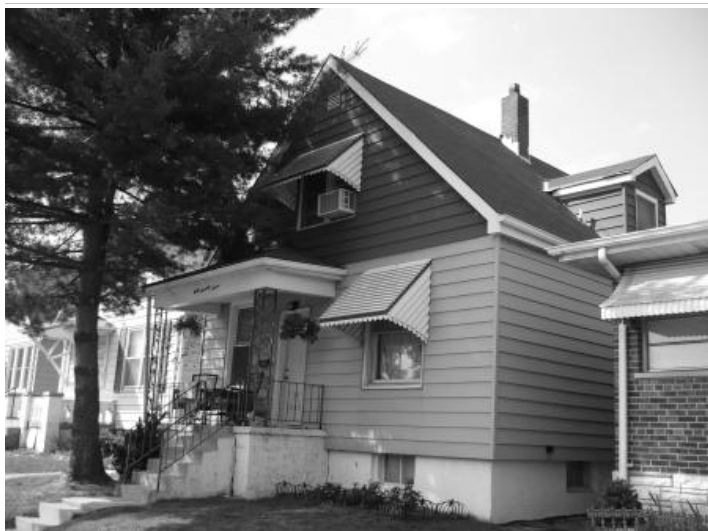
Replacement window, door, siding, porch base and piers. Metal awnings.

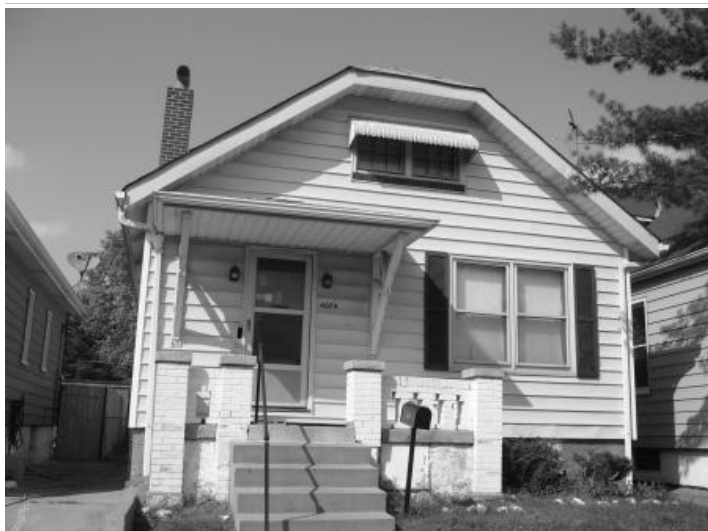
Replacement front door; siding covers window trim at first floor.

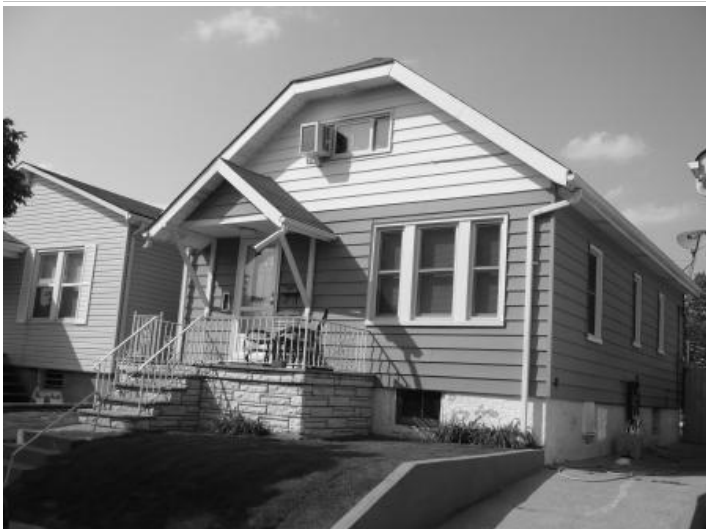
Siding covers window trim. Replacement windows. Imitation stone veneer at foundation (façade only)

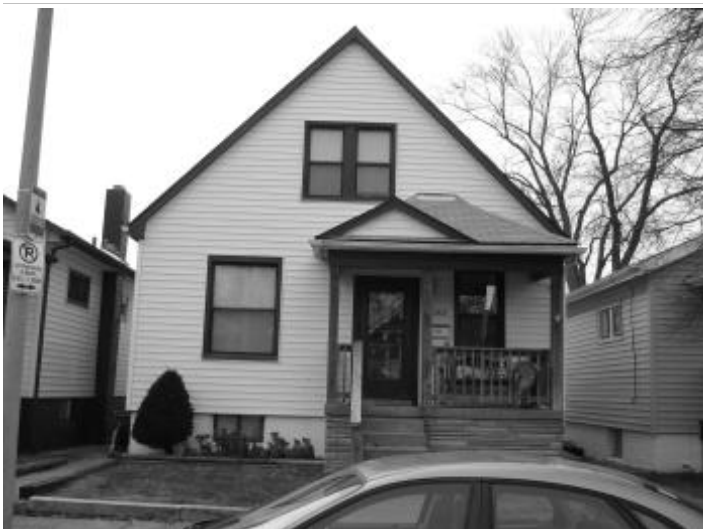
Porch base rebuilt with imitation stone veneer, dimensional lumber rail and supports. Window trim wrapped under siding.

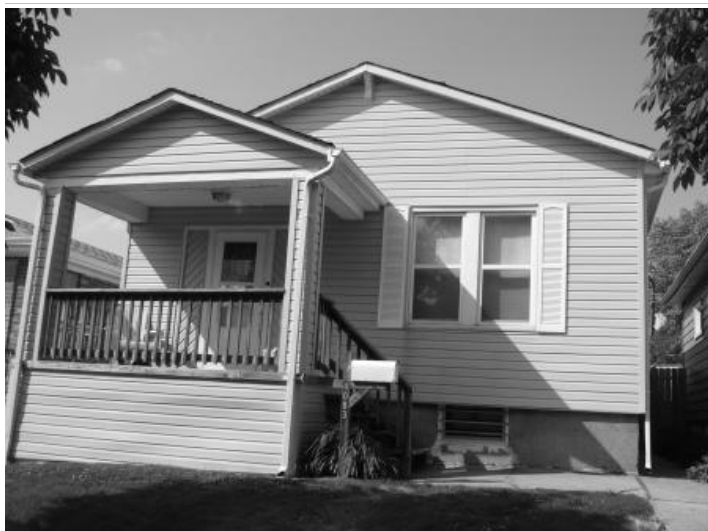
Siding covers porch, walls, window trim, sidelights.. Façade windows replaced.

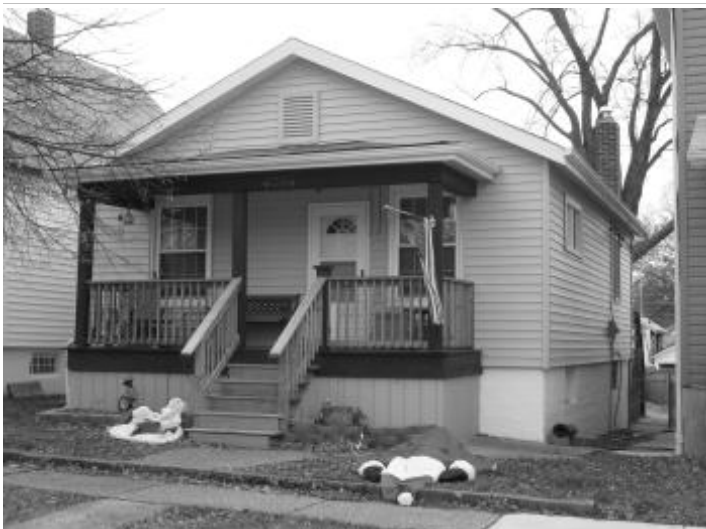
Windows and doors are replaced, as is the porch base and supports.

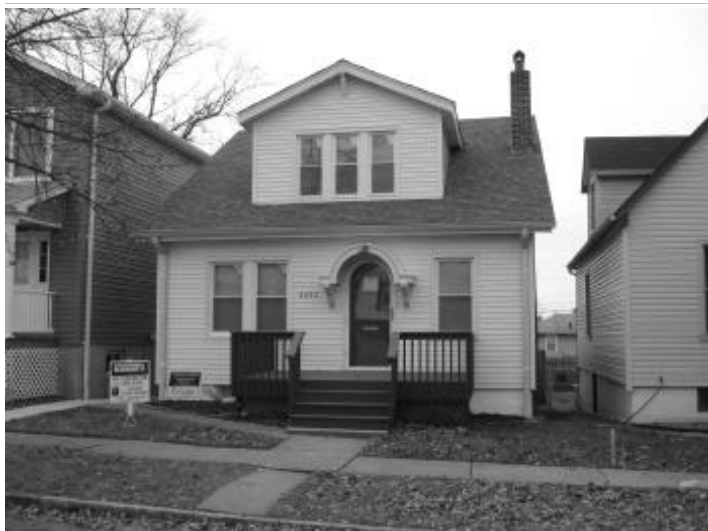
Windows are replaced but window trim remains.

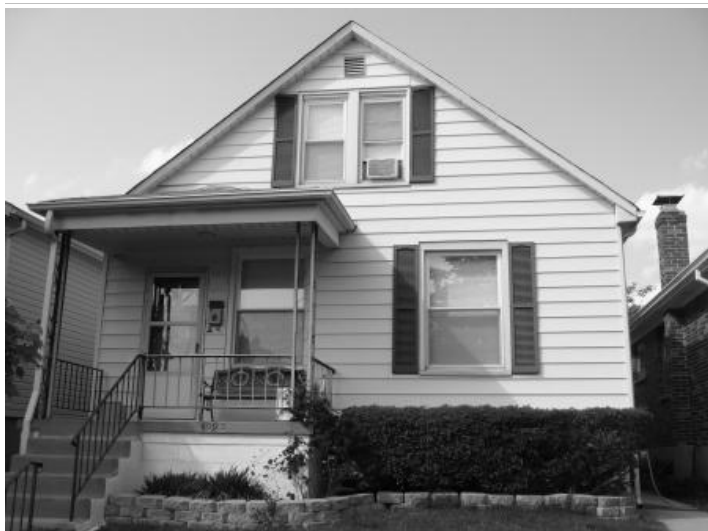
Replacement windows, door; siding.

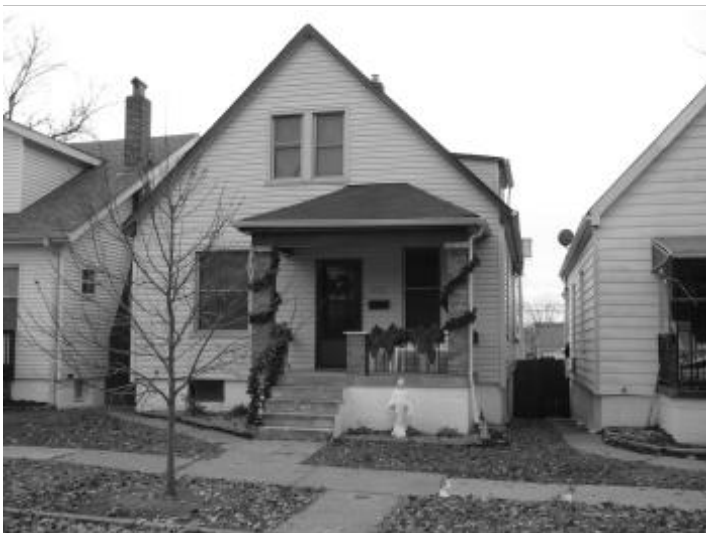
Windows are modern replacements; siding covers original window trim.

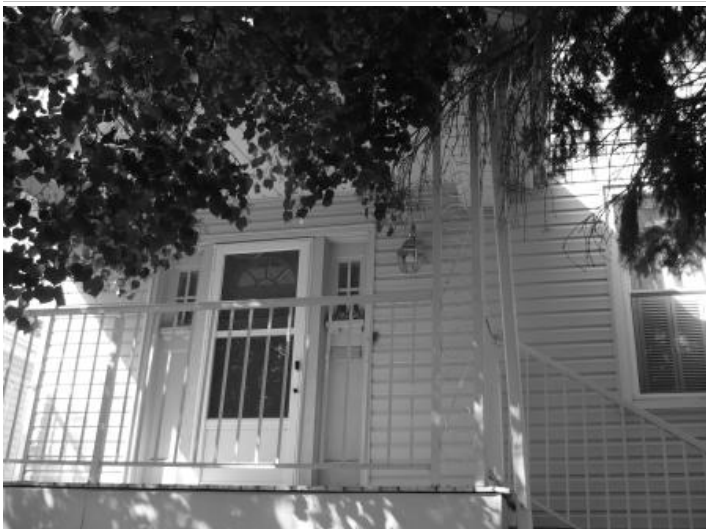
Replacement windows, piers, railings.

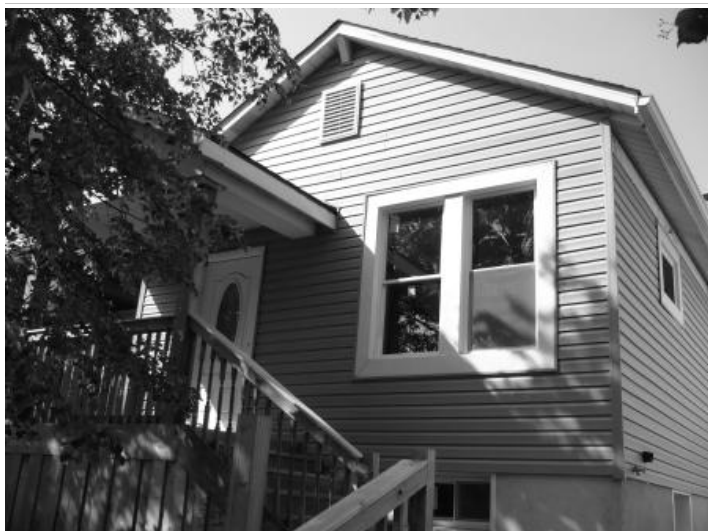
Replacement windows, piers, railings.

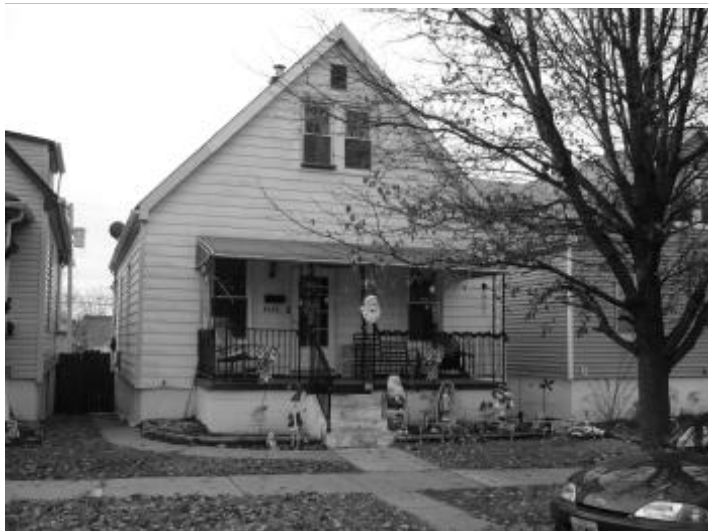
Windows are modern replacements; siding covers original window trim.

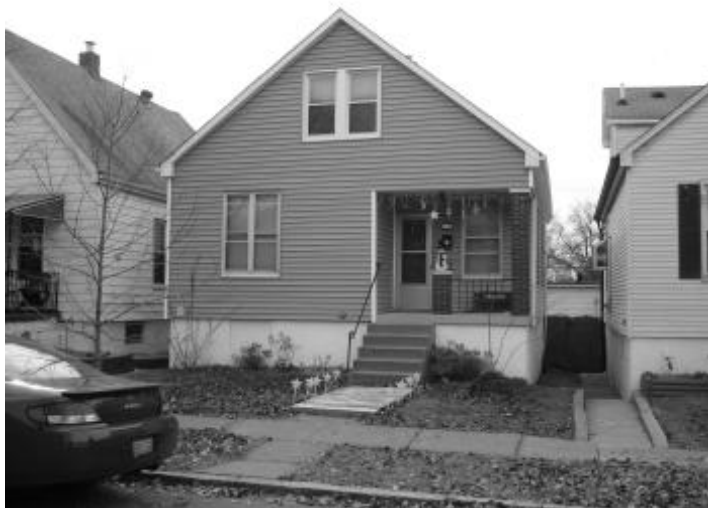
Replacement front door.

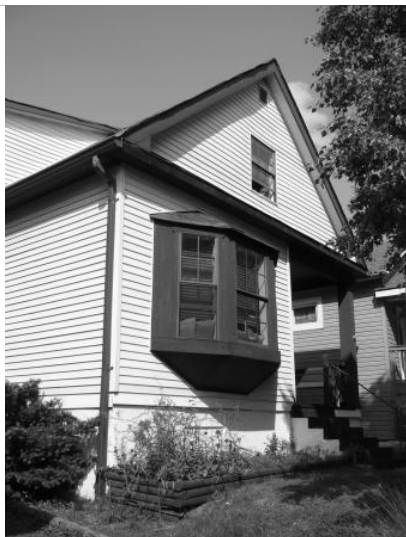
Replacement windows and covered window trim. Replacement wood railings and corner pier at porch.

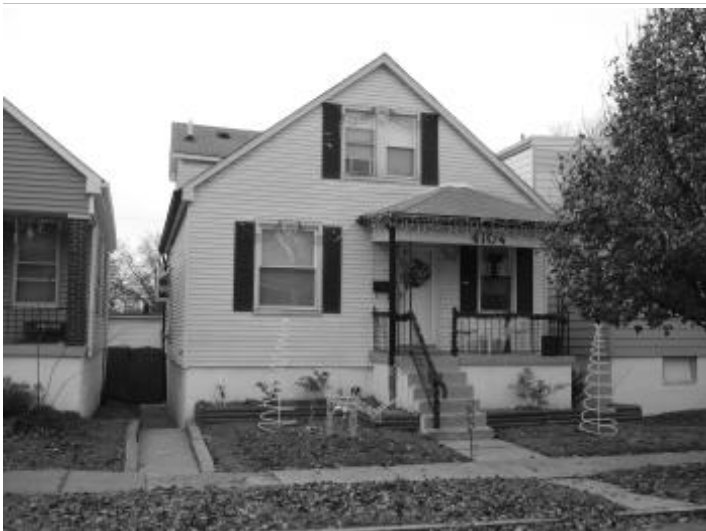
no permit found. This front gabled house has a hipped porch at the right.

Virtually no original material visible on façade.

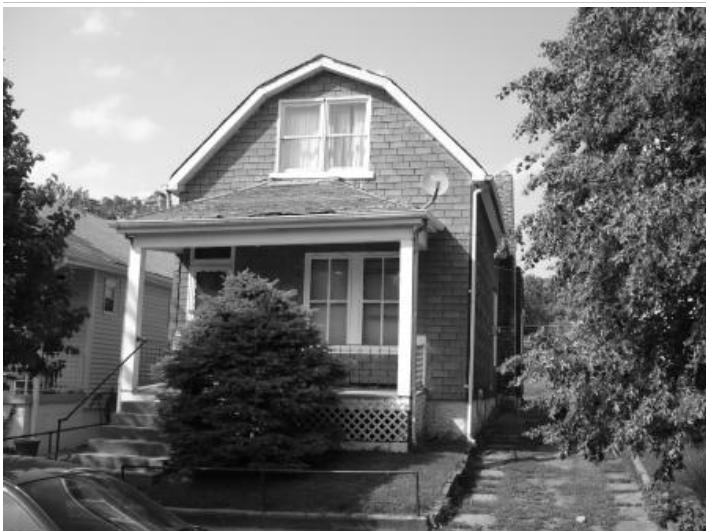
This gambrel-fronted house has a wood hipped front porch, just short of full width, on replacement posts. Door and transom, windows and storm windows all appear original.

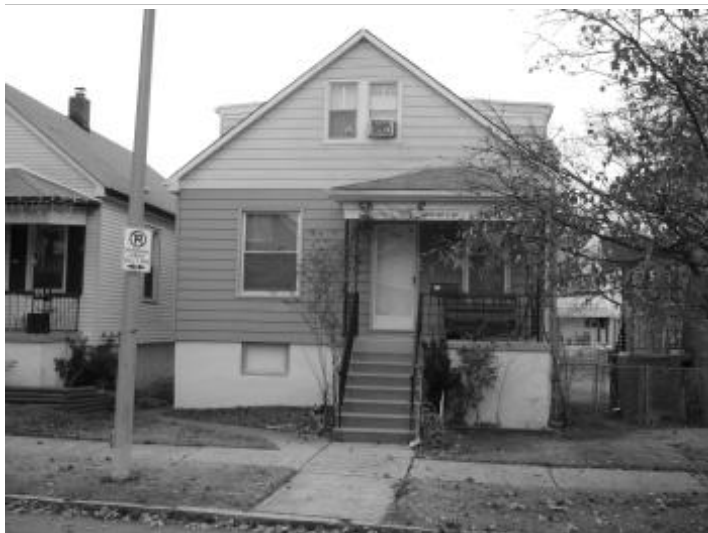
This front gabled house has a hipped porch at the right. Paired 2/2s in gable end are about the only original thing at the façade.

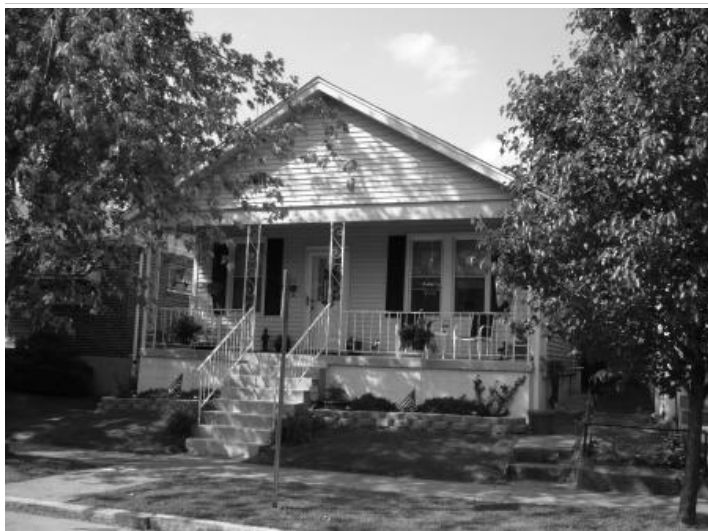
Porch piers replaced with metal trellis-style supports. Replacement windows and false shutters.

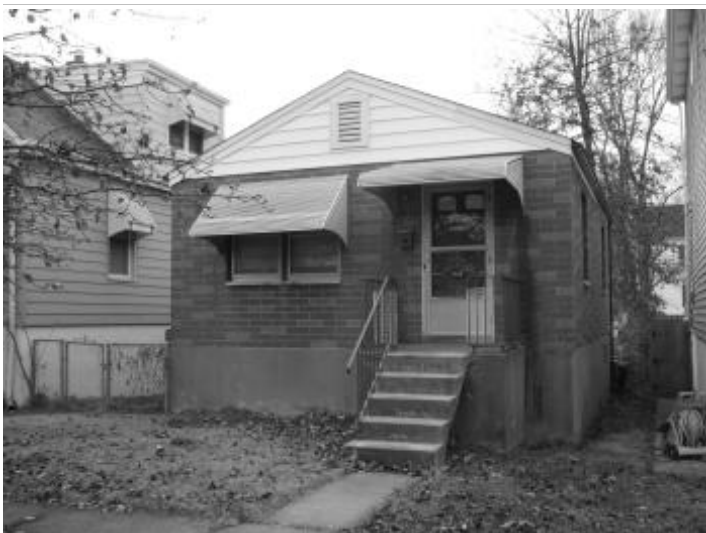
This front gabled house has a concrete brick exterior. Door and window have awnings. Building permit not found.

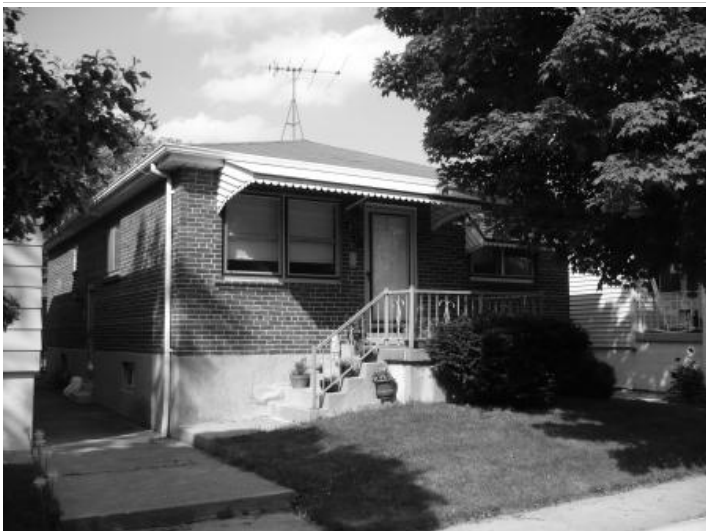
This lot is still vacant in 1950 (per Sanborn map); house is here in 1963. Original metal windows and railings intact.

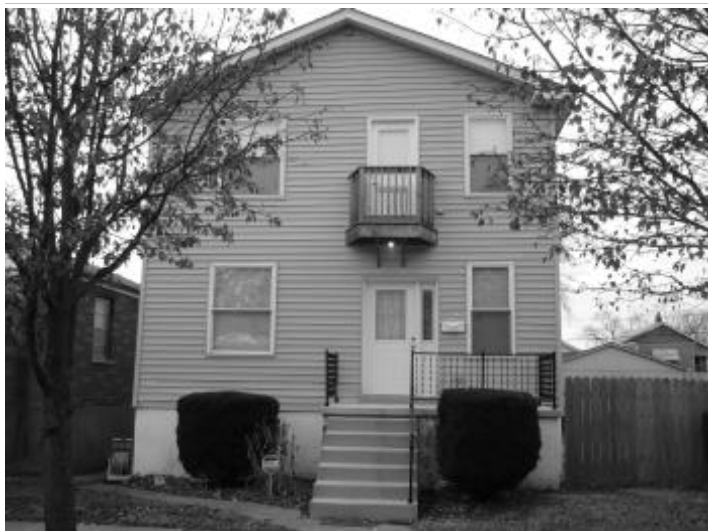
Front gabled house seems to be a typical single story 1910 frame house with a full second story added. No original materials visible other than foundation.

1999 permit for addition of second story.

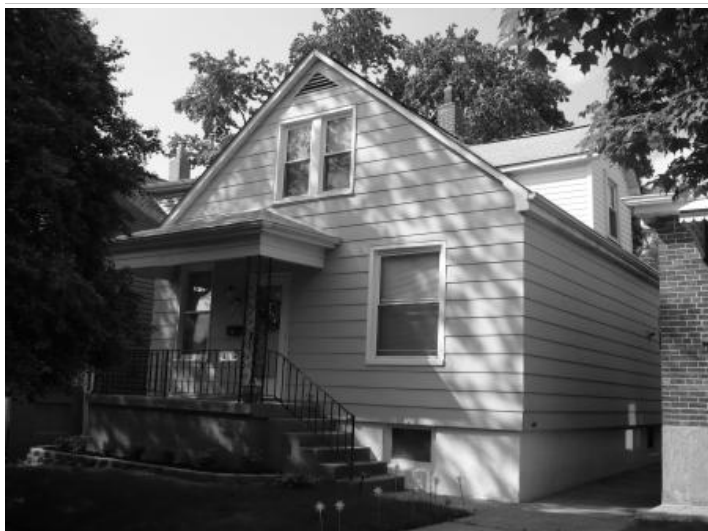
Replacement windows, door, and porch base and rails.

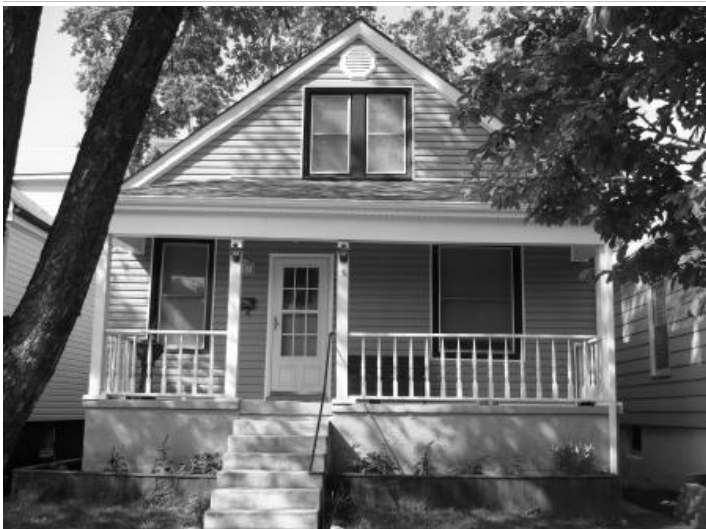
Replacement front door and porch base/rails

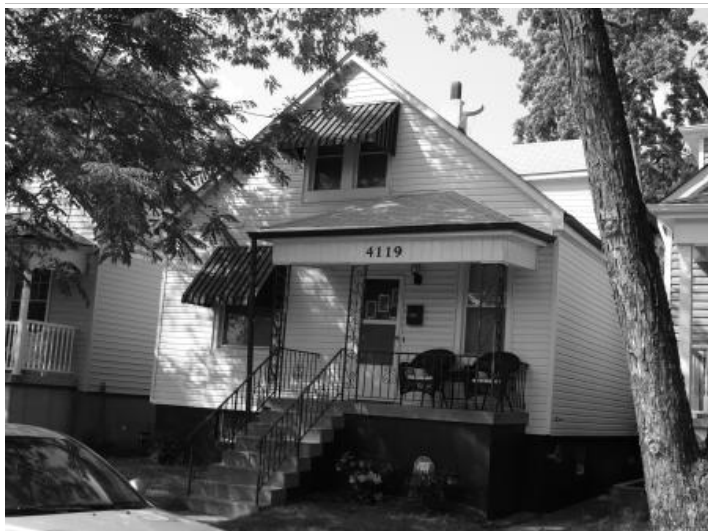
Porch base is concrete; porch uprights are metal replacements. Replacement windows and covered window trim. Replacement front door.

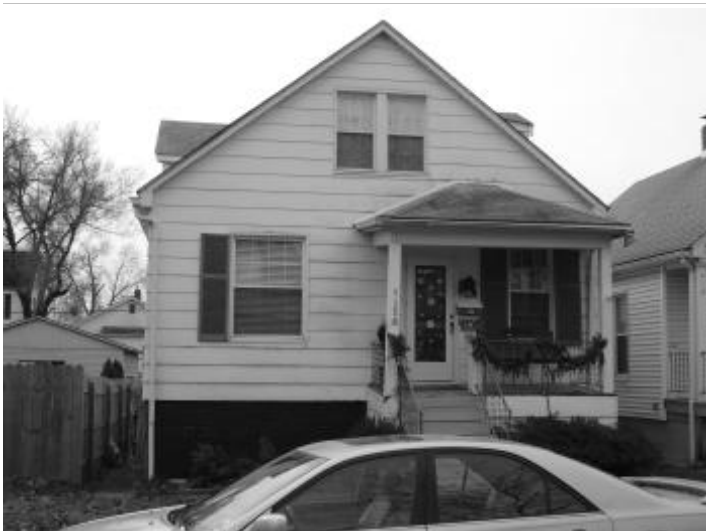
New windows, siding, new door.

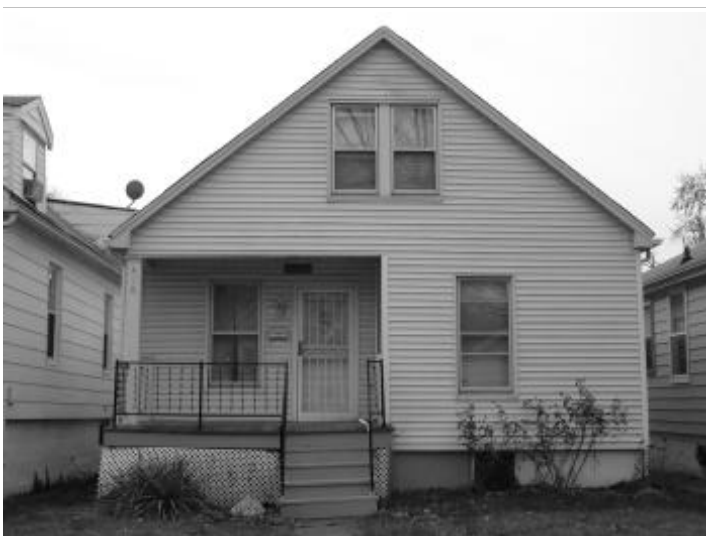
Front gabled house has a recessed corner porch, original 1/1 windows and an original front door.

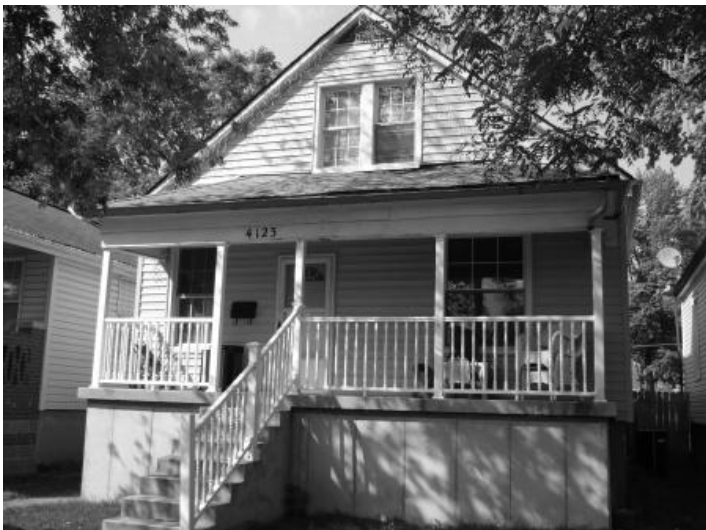
Porch base is concrete; porch uprights and rails are modern replacements. Replacement windows and covered window trim. Replacement front door.

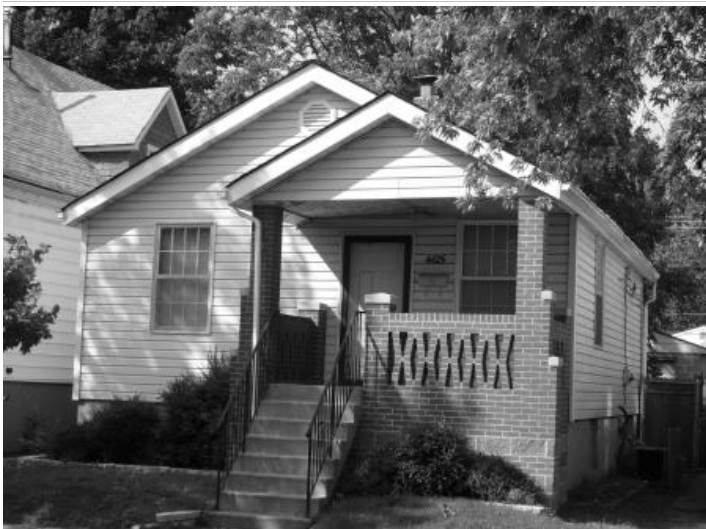
Replacement windows and covered window trim. Replacement front door.

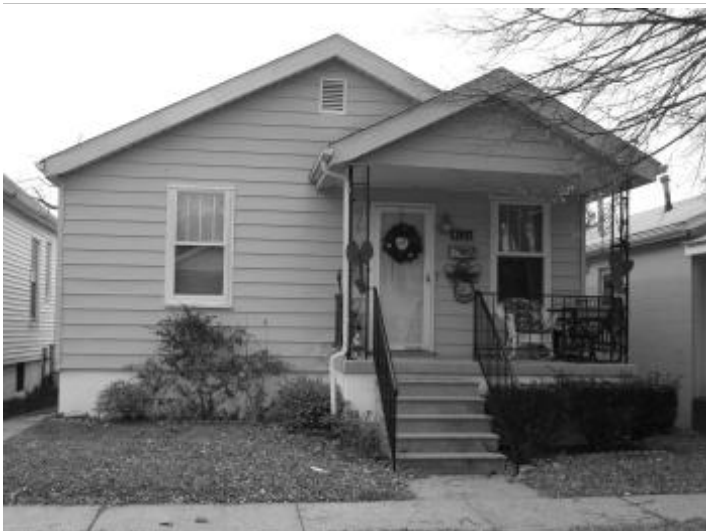
New front door. Original trim is not visible under siding.

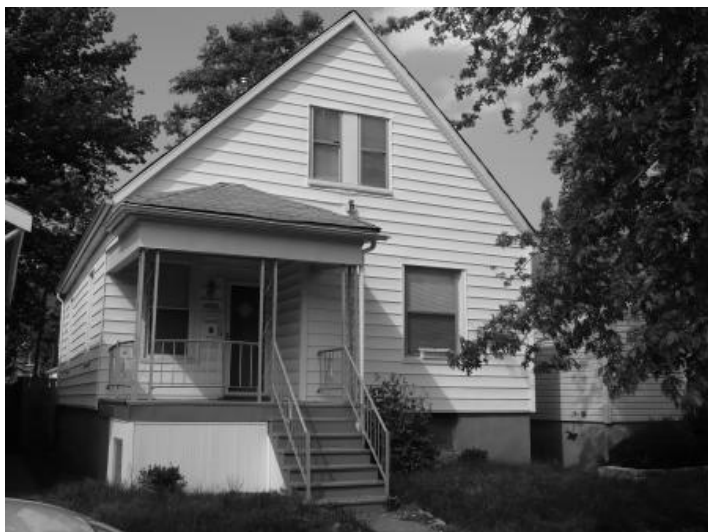
Replacement windows and covered window trim. Replacement front door. Replaced porch base (now concrete) and railings and piers (now metal).

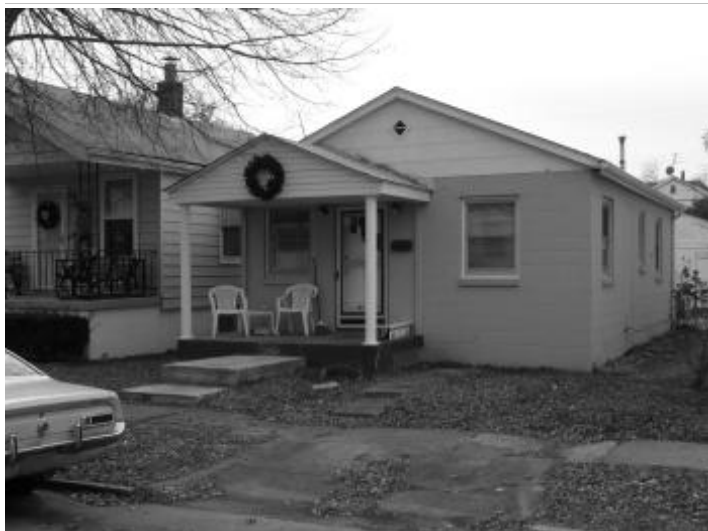
Porch columns are added

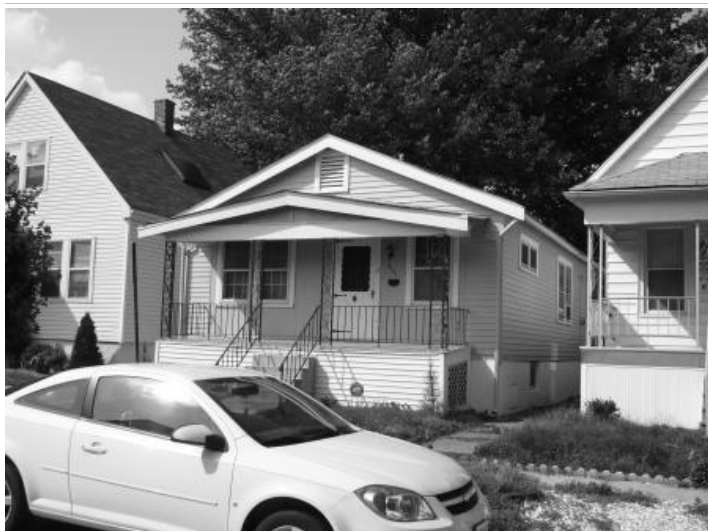
Siding appears to be mixed original wood and replacement wood composite. Front gabled house has a gabled front porch. There's one original 3/1 façade window and the porch's gable end retains its stucco finish.

One replacement window. Replacement front door. Replaced porch base (now concrete) and railings and piers (now metal).

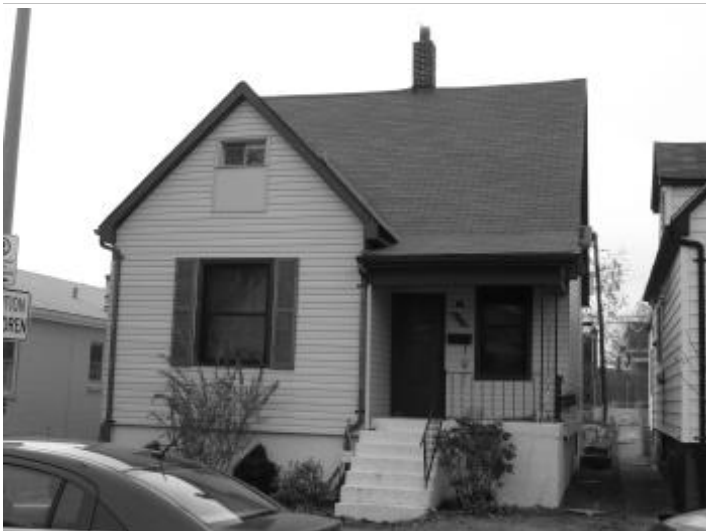
New doors, windows, siding.

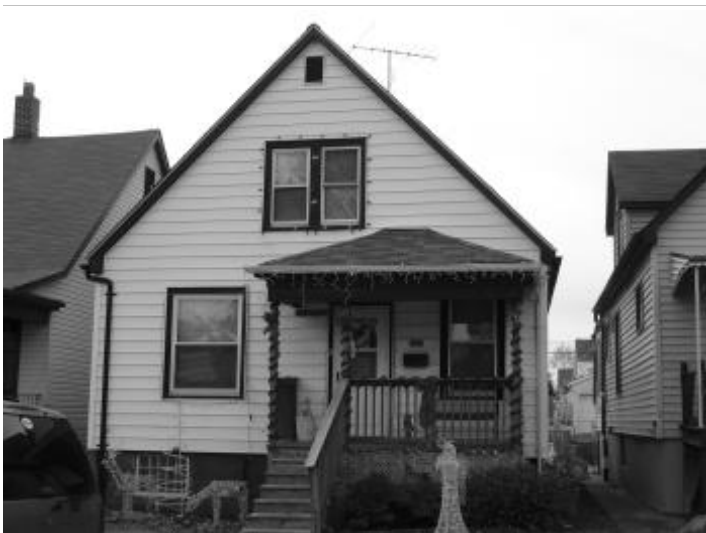
New windows, door, porch base and piers.

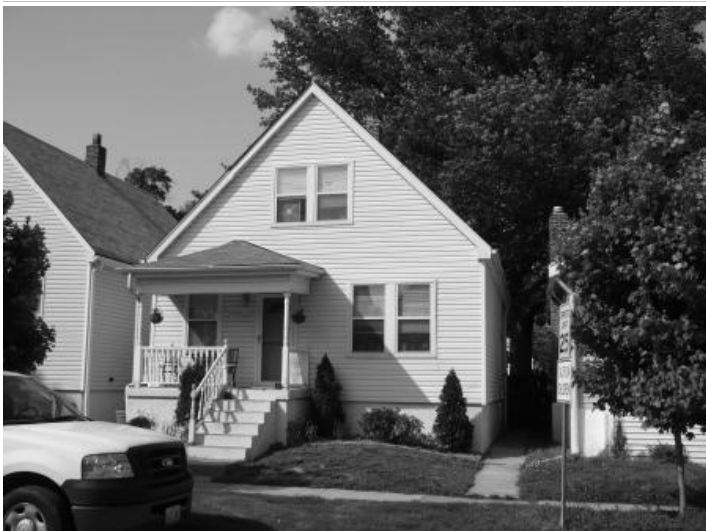
Replacement front door and façade windows. Replaced porch base (now concrete) and railings and piers.

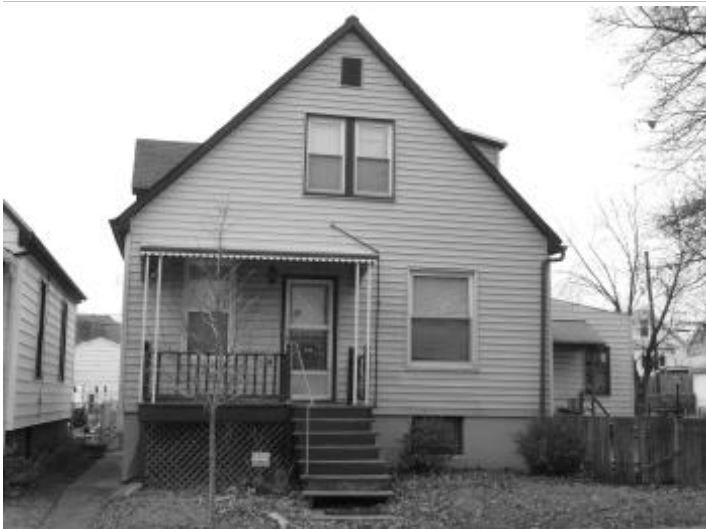
Replacement windows.

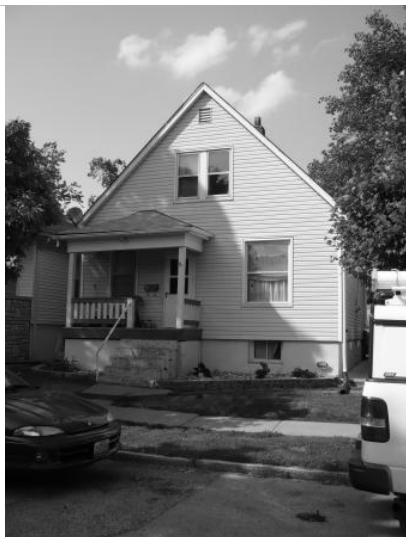
Replacement front door and façade windows. Replaced porch base (now concrete) and railings and piers.

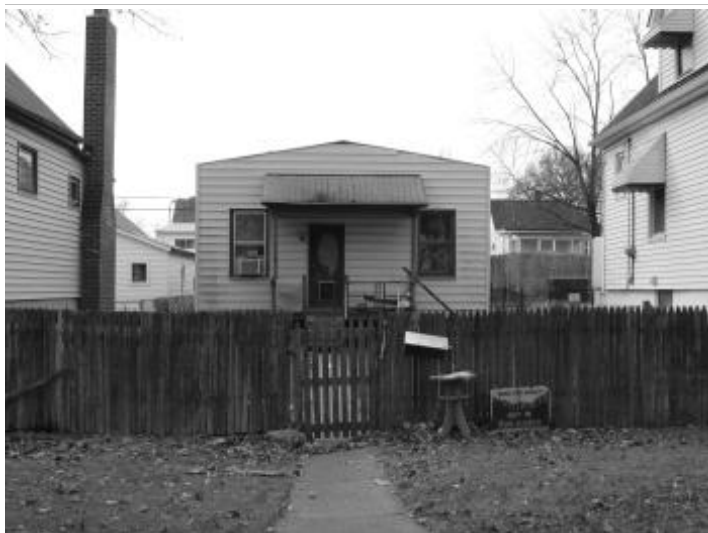
This is on the 1916 Sanborn map (shallow dwelling towards rear of lot). The small house is at the rear of the lot with a shallow gable roof and no eaves. Concrete block foundation, wood 3/1s and wood basement windows. Front door appears original.

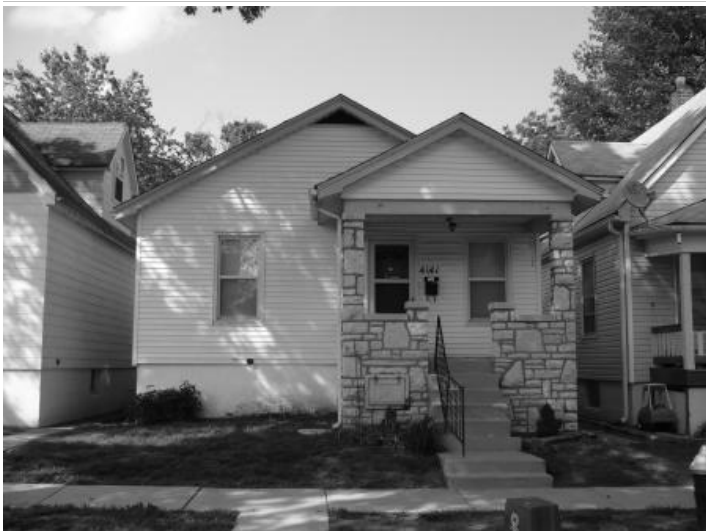
The front door is a replacement, and original window trim is covered by the siding

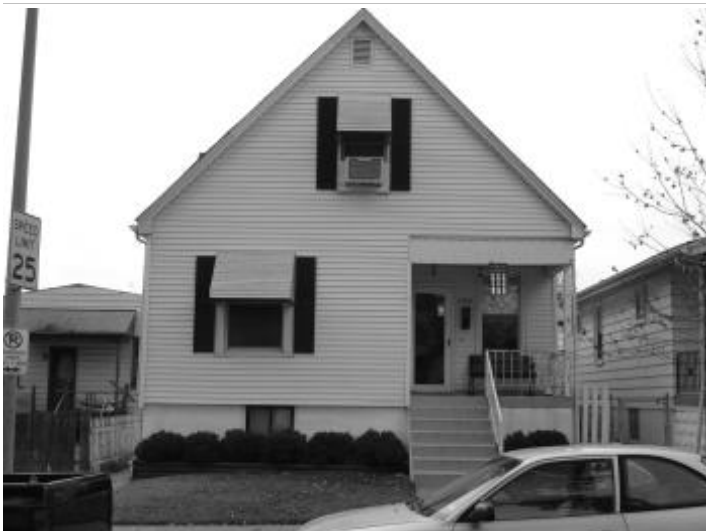
Replacement windows, metal awnings.

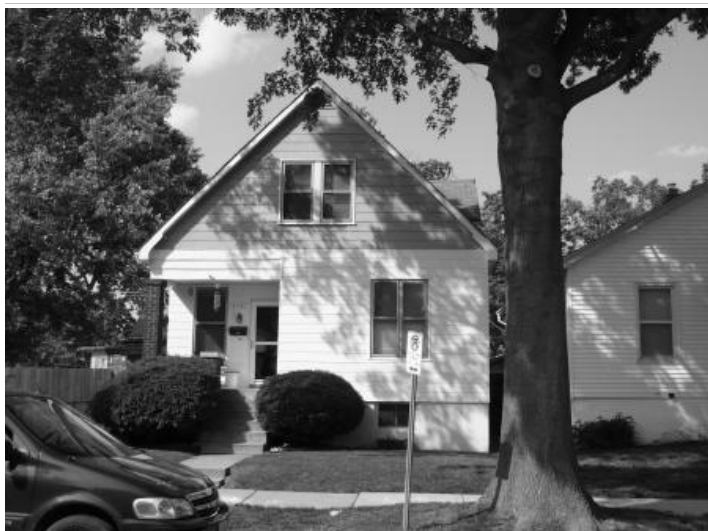
Replacement front door

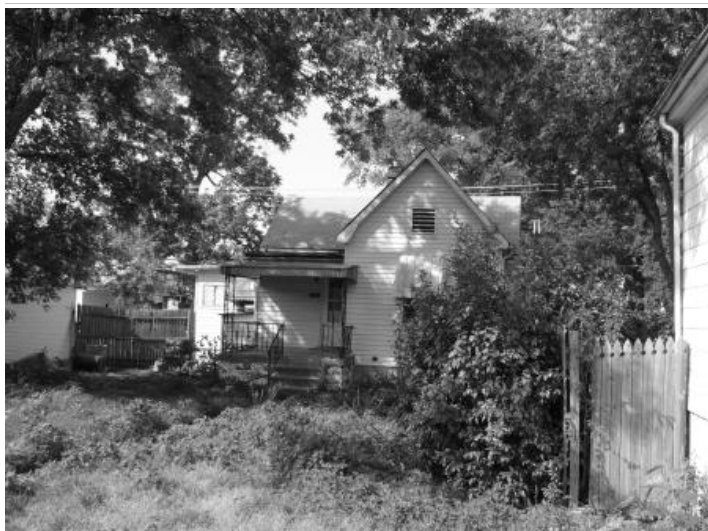
Front door and porch railings and posts appear to be replacements.

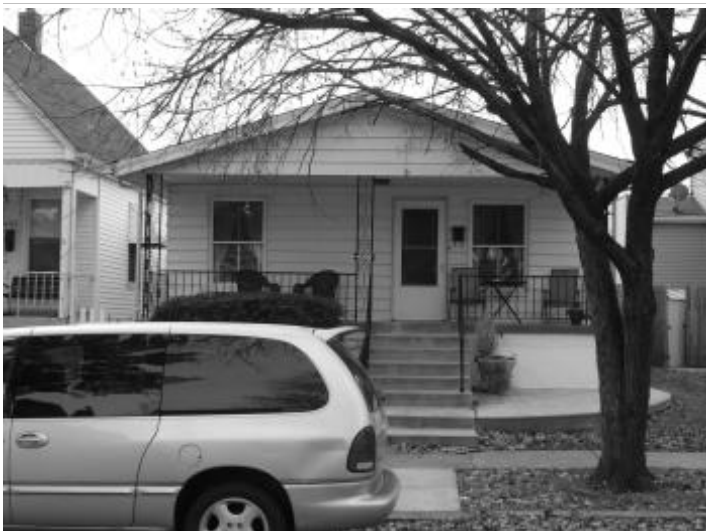
Porch has a concrete base and metal supports

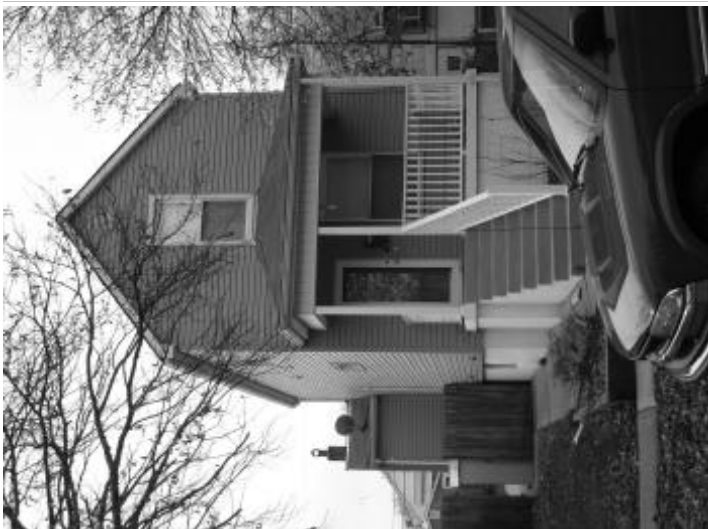
New windows and door.

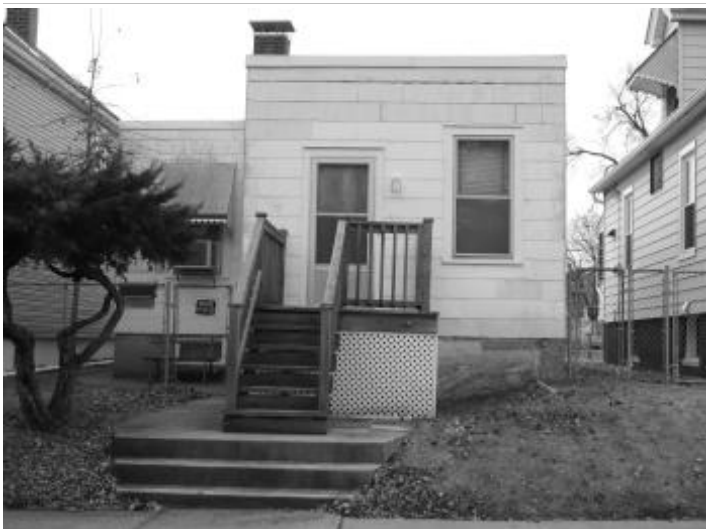
New door; asbestos siding; deck-style front porch.

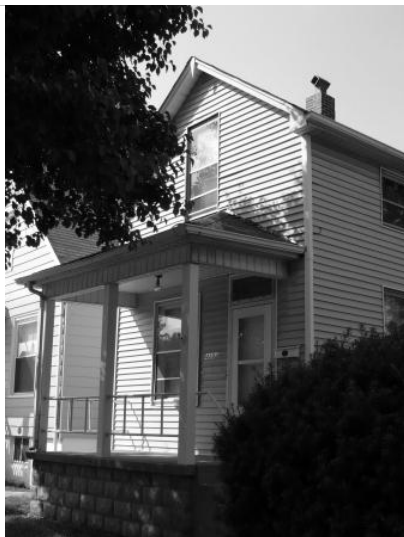
Replacement windows, with original trim covered by siding. Replacement porch rail

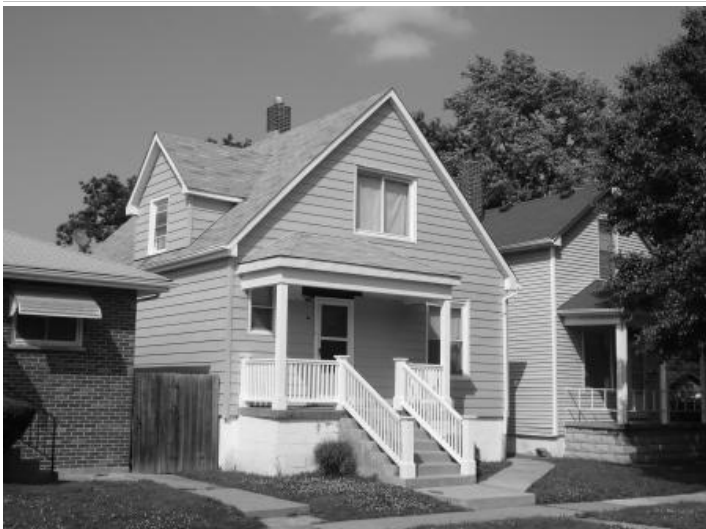
Replacement windows, window trim covered, replacement door, replacement porch base and posts

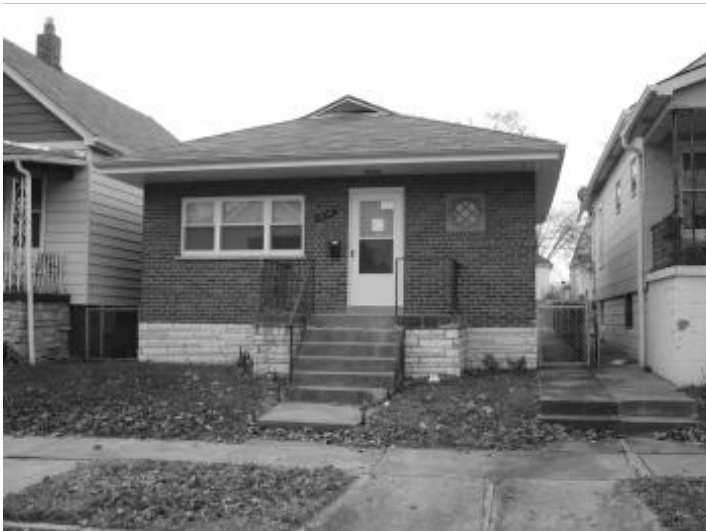
Original metal windows are replaced

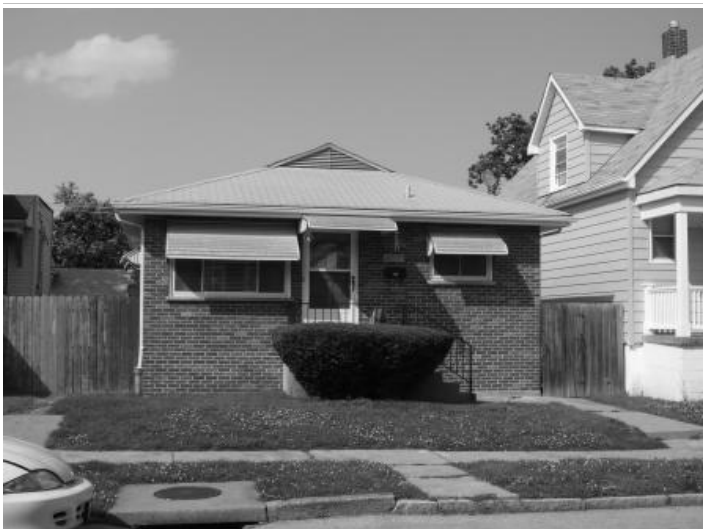
Windows and front door are replaced

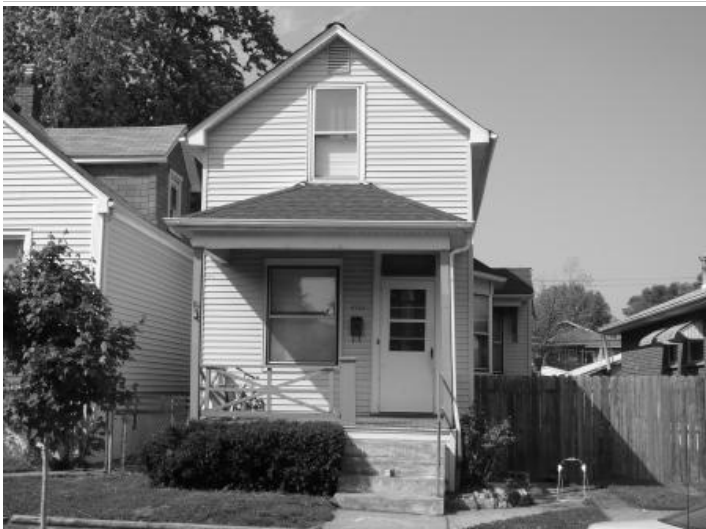
Siding obscures the window trim, and porch is altered

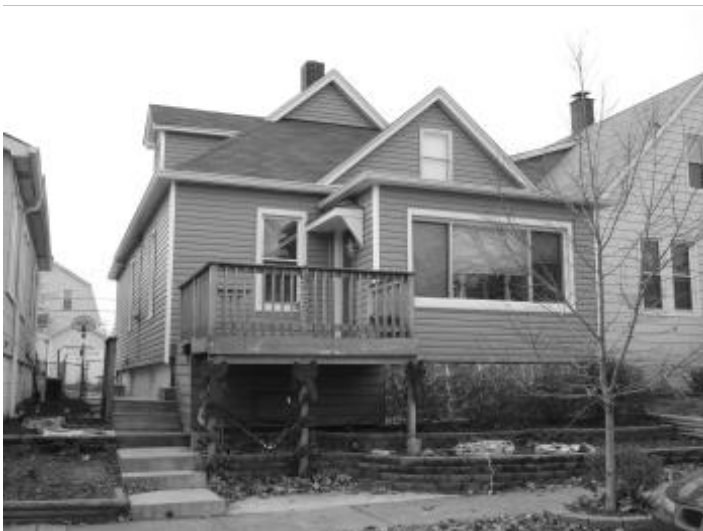
New doors and windows, siding, front addition, new porch.

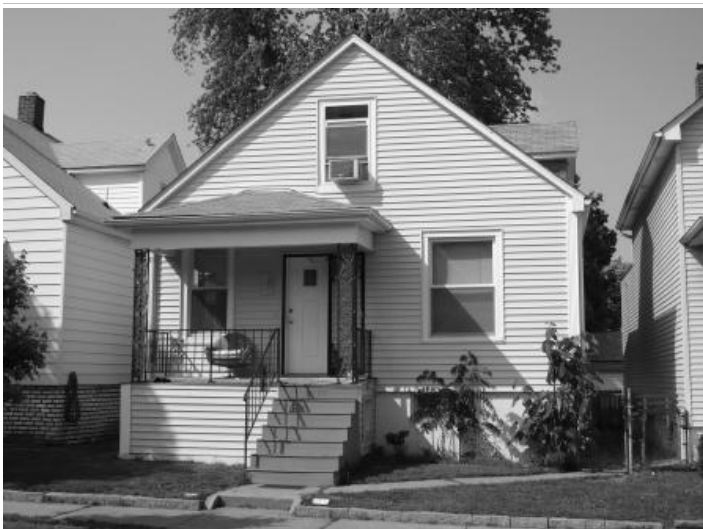
Replacement front door. Concrete porch base with metal trellis-style supports. Replacement windows.

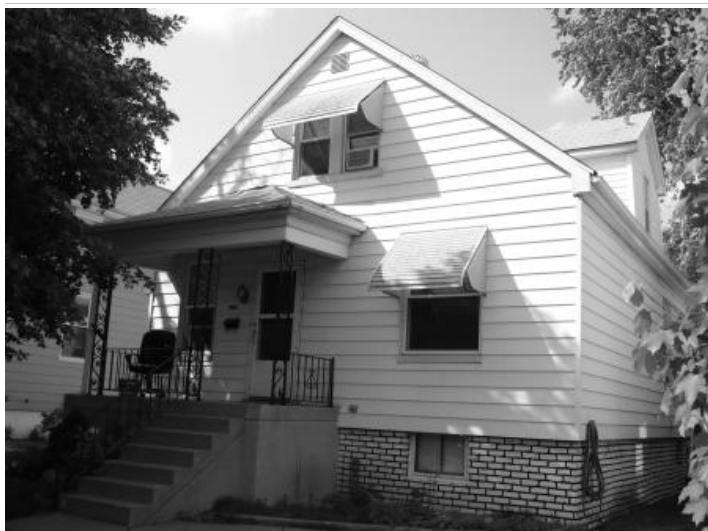
This house has a front gabled roof and side dormers; visible foundation is concrete imitation brick.

New door, windows, and siding; fiberglass awning
