City of St. Louis Cultural Resources Office

Holly Hills Neighborhood Survey

Lynn Josse and NiNi Harris
3/1/2010

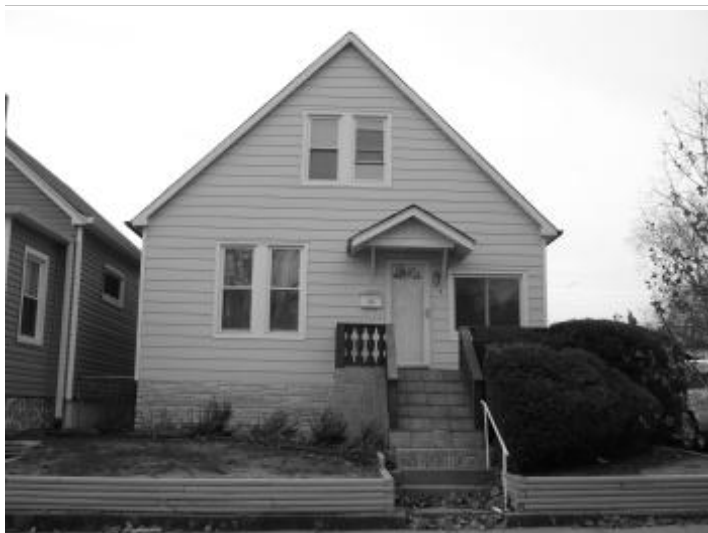
new windows, siding, porch, door

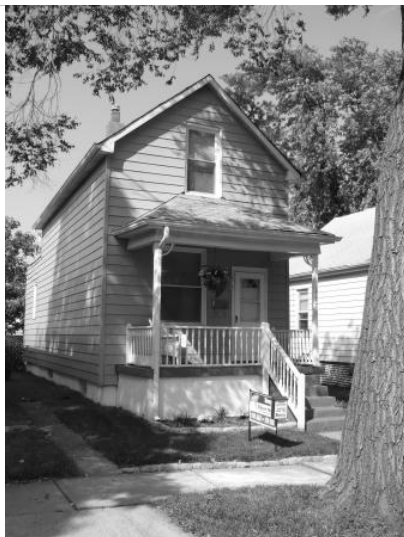
Front door and windows are new.

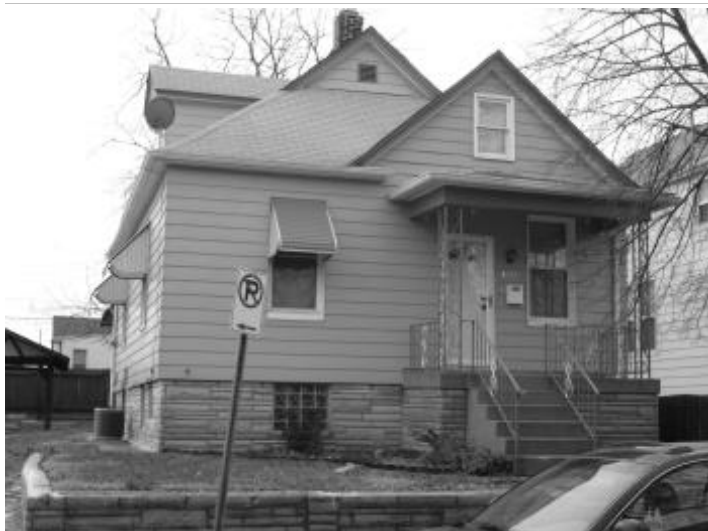
This house is a very good example of midcentury remodeling, with blue siding and salmon imitation stone veneer at the foundation and retaining wall, fiberglass awnings, pink metal supports at the porch.

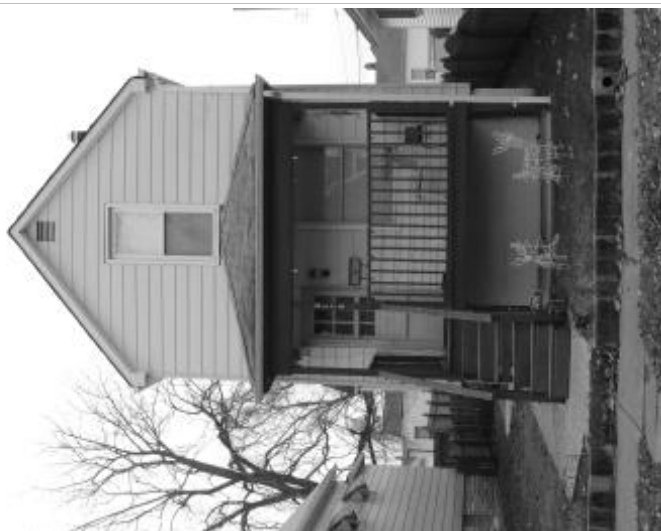
Replacement windows.

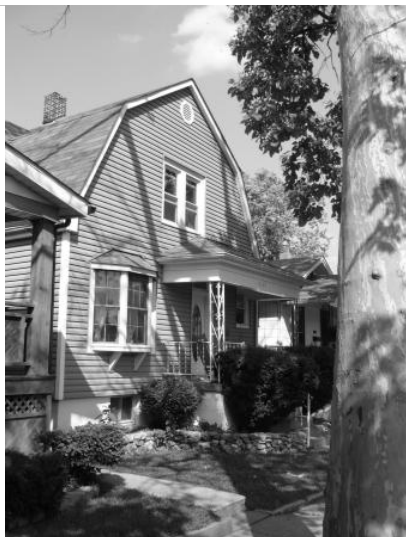
This house is on the 1916 Sanborn map (1 1/2 sty frame dwelling). The narrow gambrel end faces the street. Permit not found.

Doors, windows replaced; CMU porch base with metal supports. Pop out bay window left side of façade.

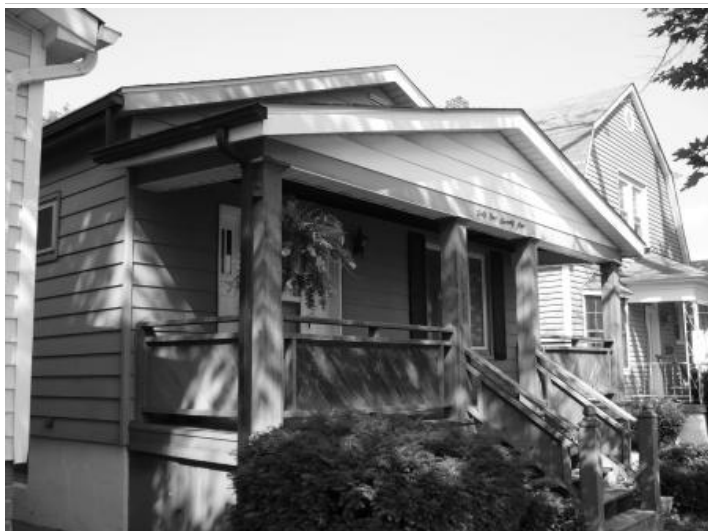
replacement windows, right.

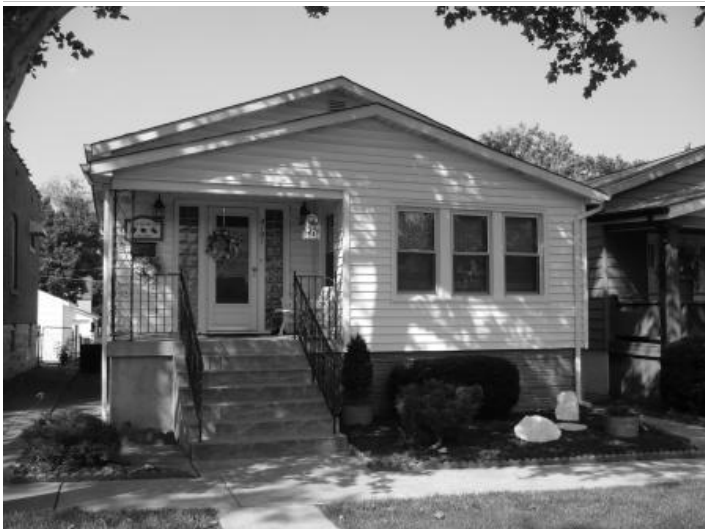
Right half of front porch filled in , new vinyl windows there. New front door with glass block sidelights. Imitation stone veneer is at foundation

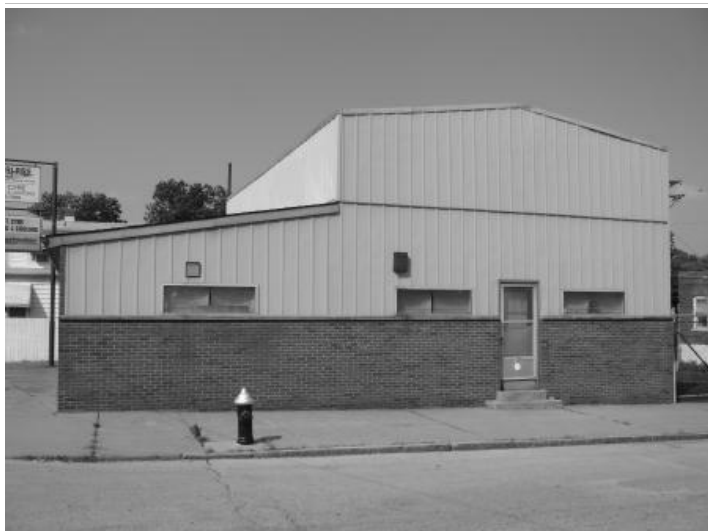
A western shed addition and complete re-cladding with brick veneer and metal siding renders the original building unrecognizable.

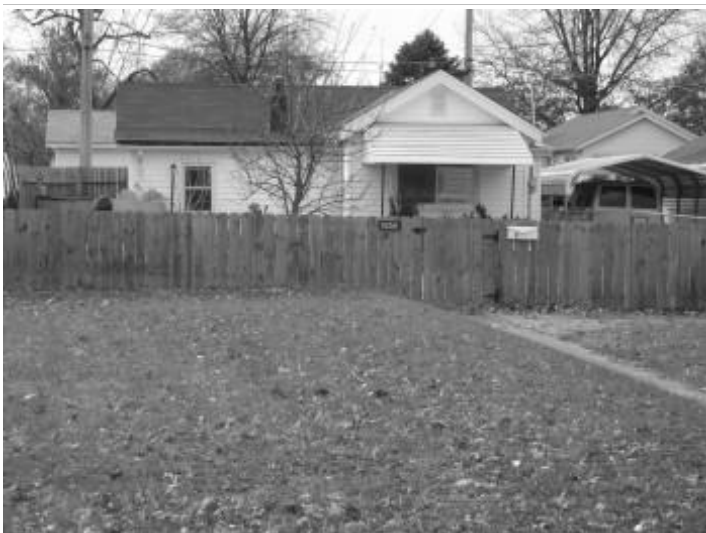
The rear section of this building is side gabled brick painted white. The front additions are frame. The front sections of the house are sided with aluminum. Replacement windows and door.

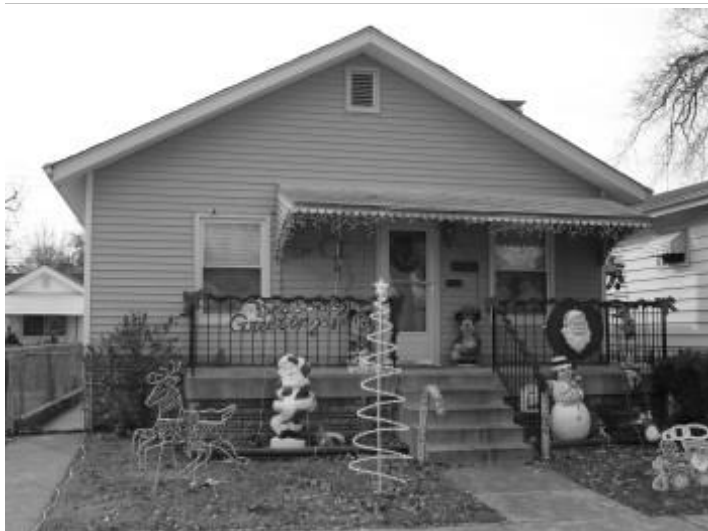
This front gabled house has a metal awning over the porch at the right bay (the base of the wood porch is almost full-width). Foundation and porch base are clad with imitation stone veneer.

Replacement front door and windows; wood trim wrapped.

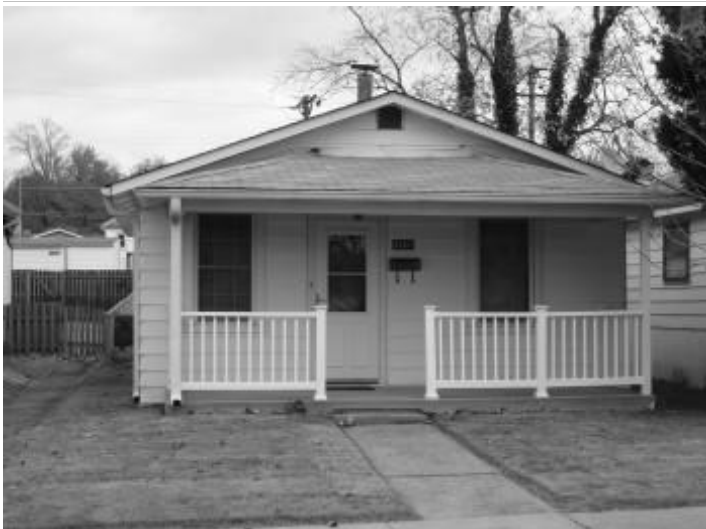
The front door and two windows at the façade are not historic; not is the porch structure.

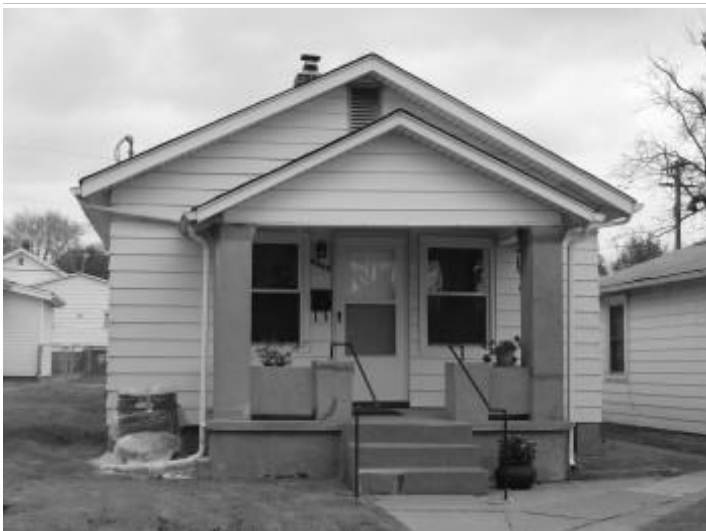
The door and two windows are replacements, and the piers are stuccoed or concrete.

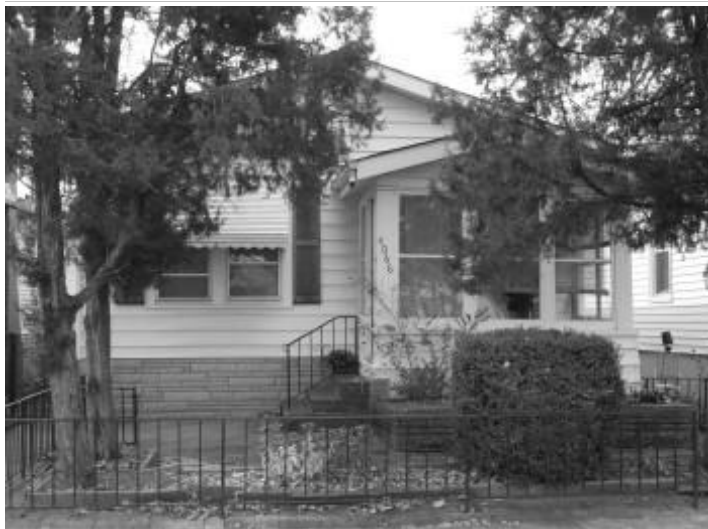
Replacement window at left bay under metal awning and flanked by inoperable shutters.

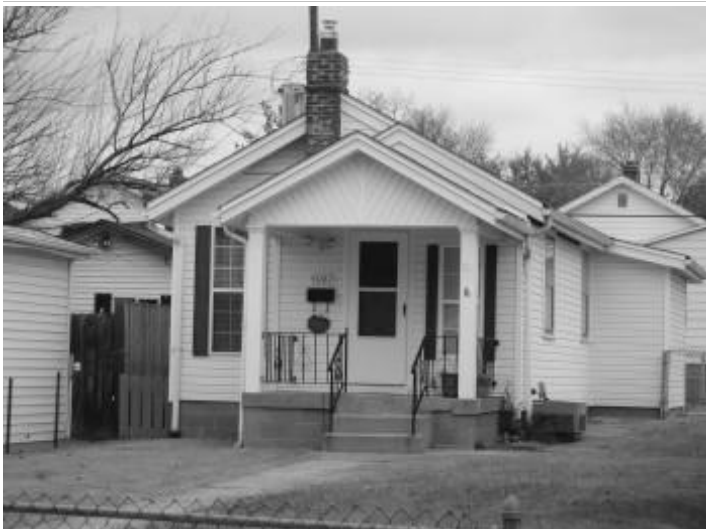
The front door and windows are replacements. Absurdly narrow shutters have been added at the front windows.

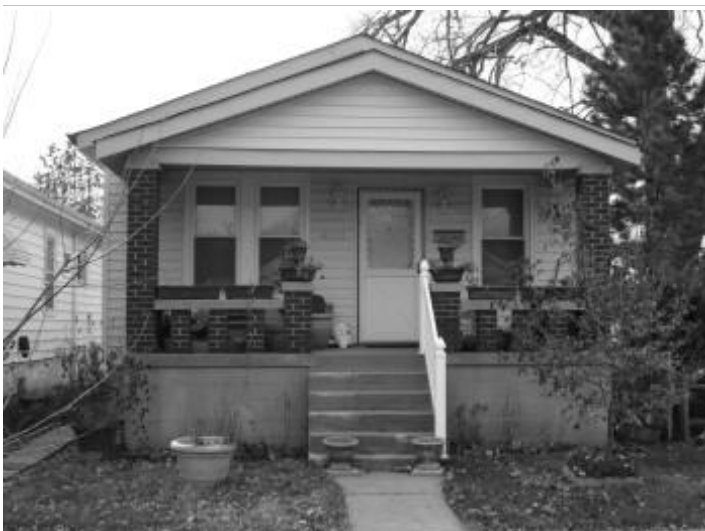
Replacement doo rand windows. Wood trim wrapped.

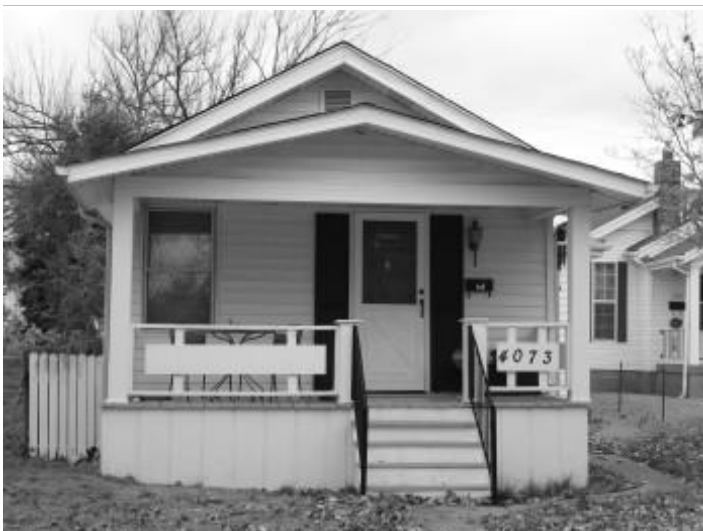
This front gabled house has a gabled front porch which is the full width of the façade. The porch has a concrete base and replacement wood posts.

The front door and window are replacements; no wood trim is visible under siding.

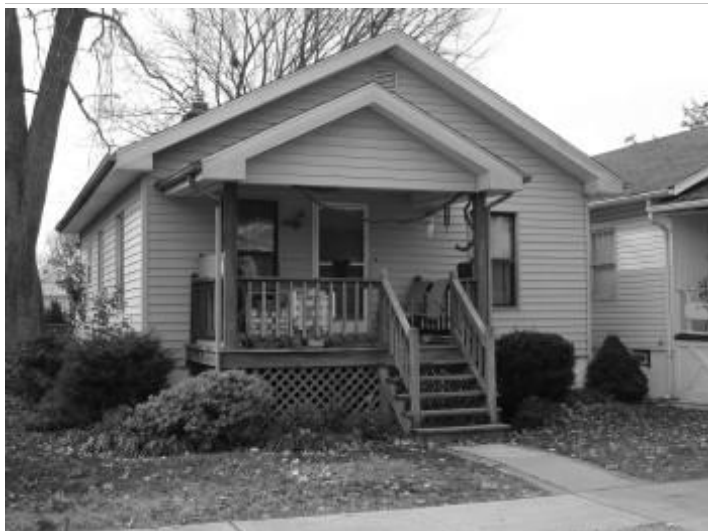
Frame porch structure is rebuilt with unpainted wood, including base, rails, and posts. Replacement door and windows.

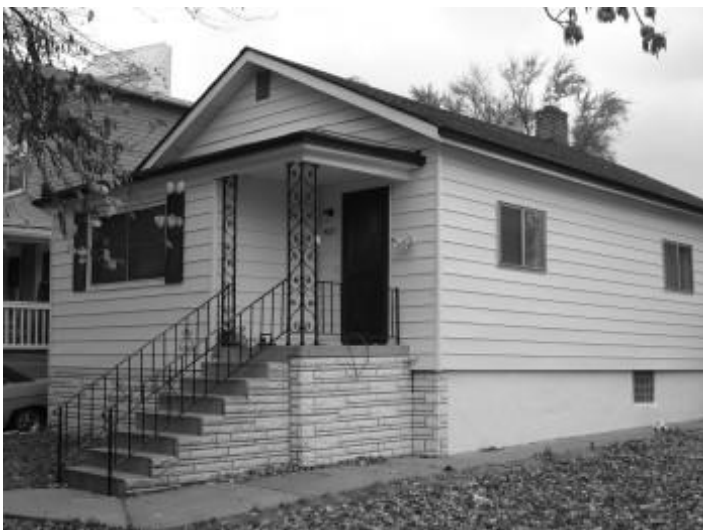
The left side of the full-width porch has been enclosed. The concrete porch base is faced with imitation stone veneer. Fenestration altered; window openings are horizontally oriented. Replacement front door.

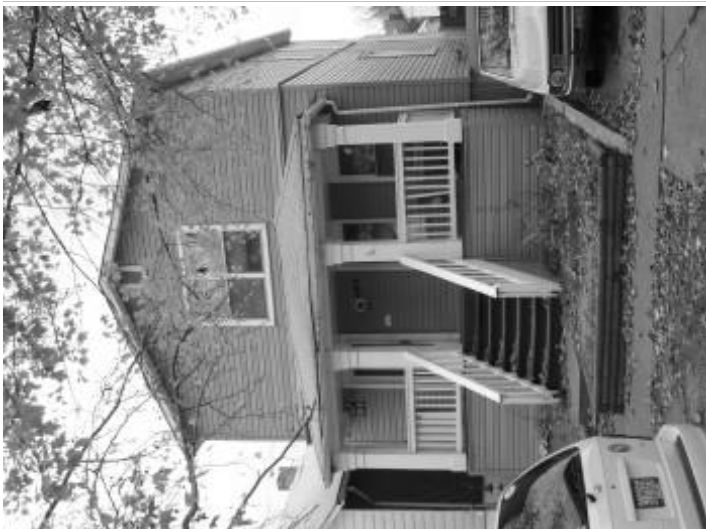
In 1950 this was still a single story building; second story addition is probably fairly recent.

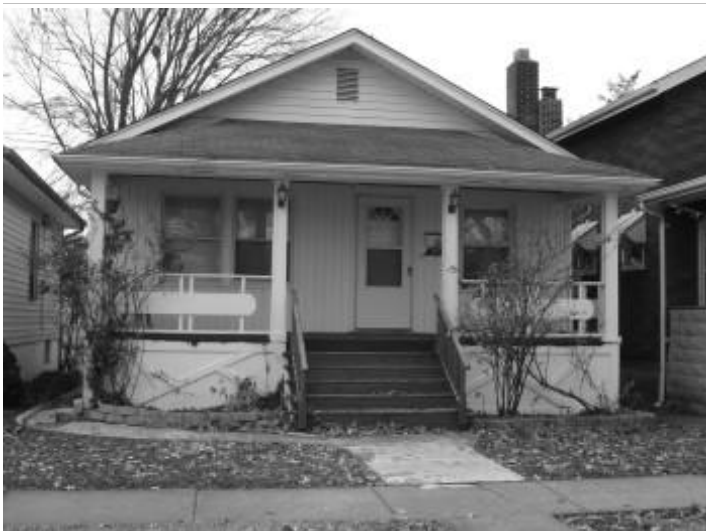
Replacement windows and doors; original trim wrapped.

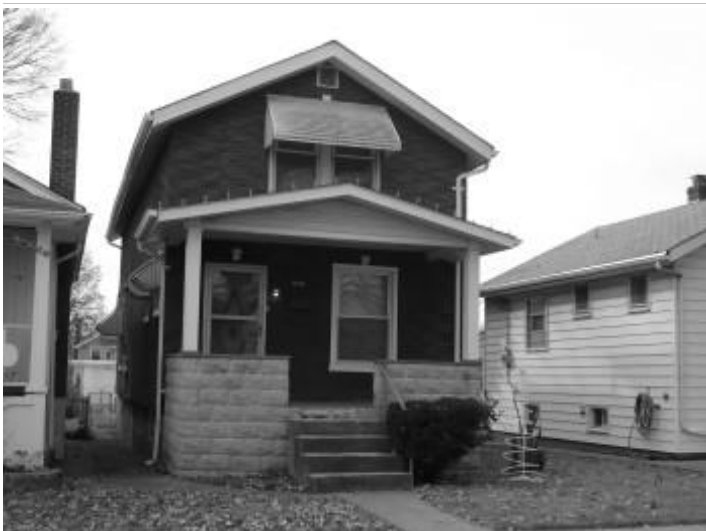
This front gabled house has a full-width gabled porch with a cast stone base and walls, and two replacement columns.

Replacement door and windows; metal awning at second story.

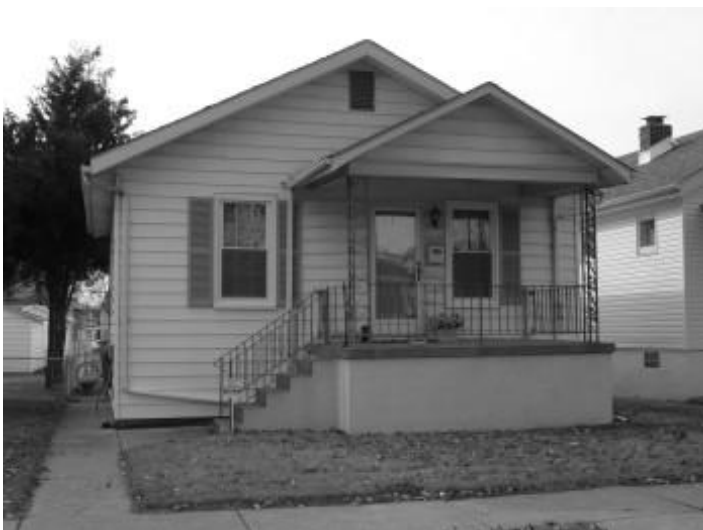
Replacement door and windows with original trim wrapped. Shutters added at façade windows. Trellis-style metal supports at concrete-based porch.

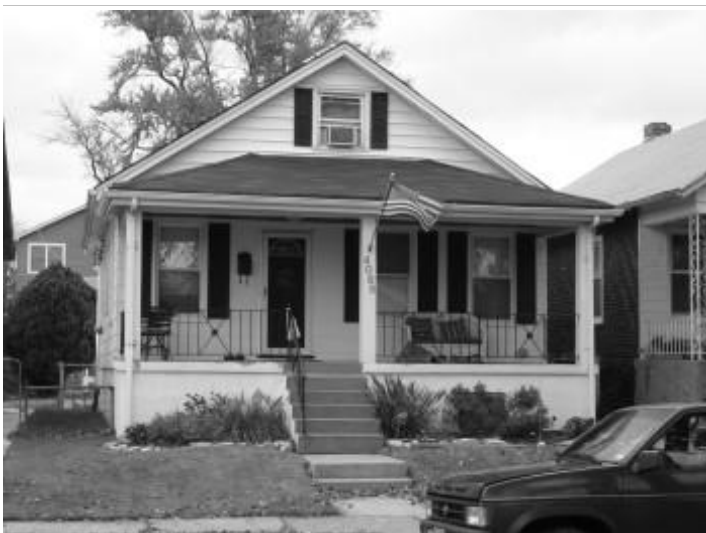
The front door is a new-style replacement. Shutters added. Replacement windows.

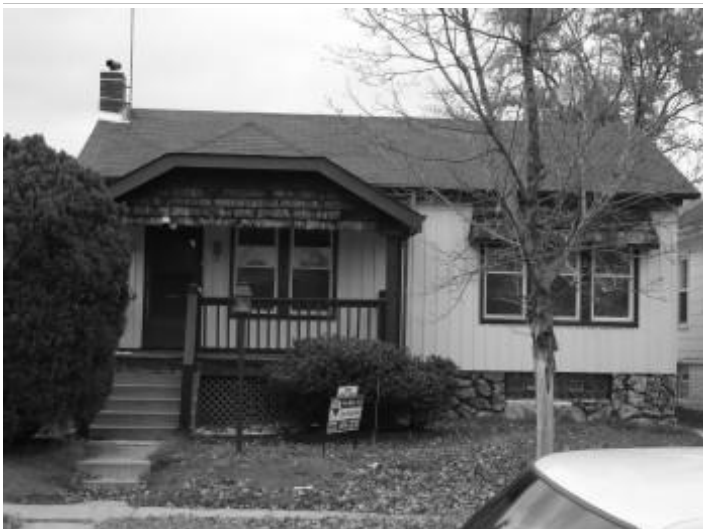
Door and windows are replacements; vertical metal siding; brown stones applied to exterior of foundation.

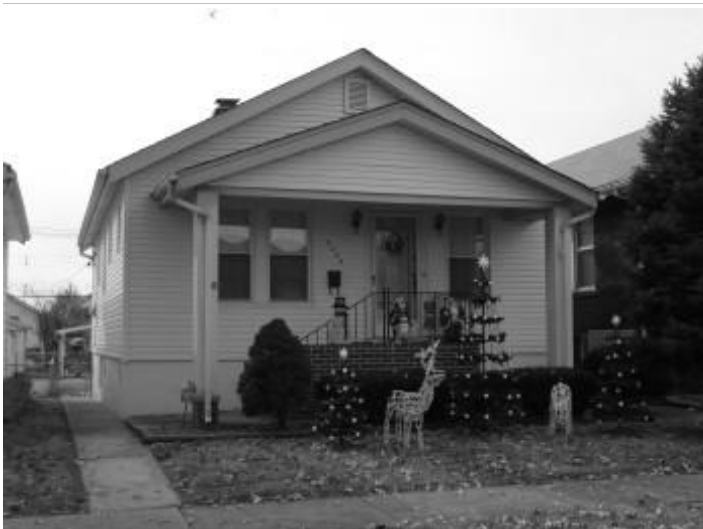
Replacement windows; wood trim wrapped. The porch base is a brick replacement which only covers about half the footprint of the original.

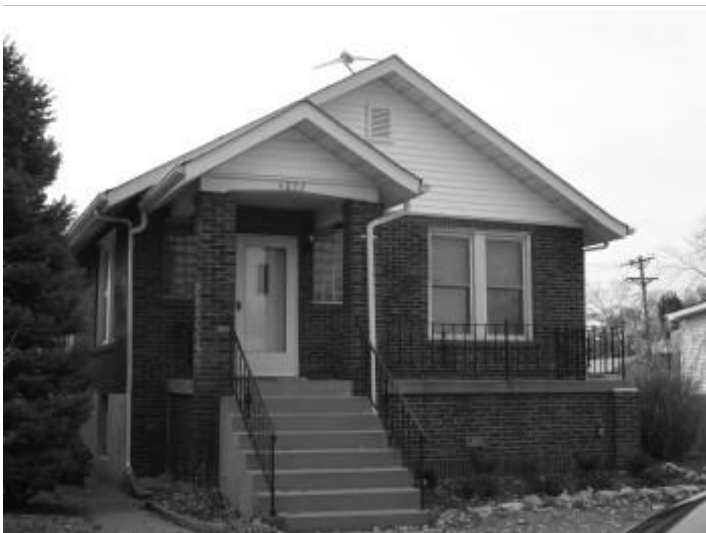
Replacement door and windows. Gable ends are vinyl clad.

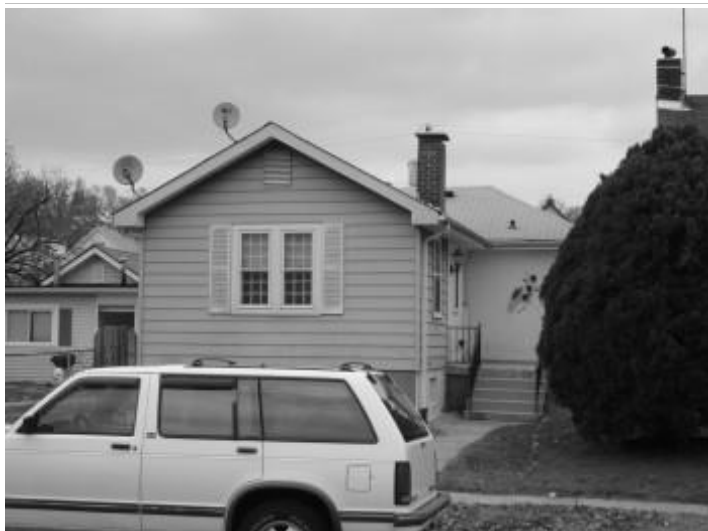
Shutters added; trim wrapped or hidden; concrete porch area has unknown vertical siding.

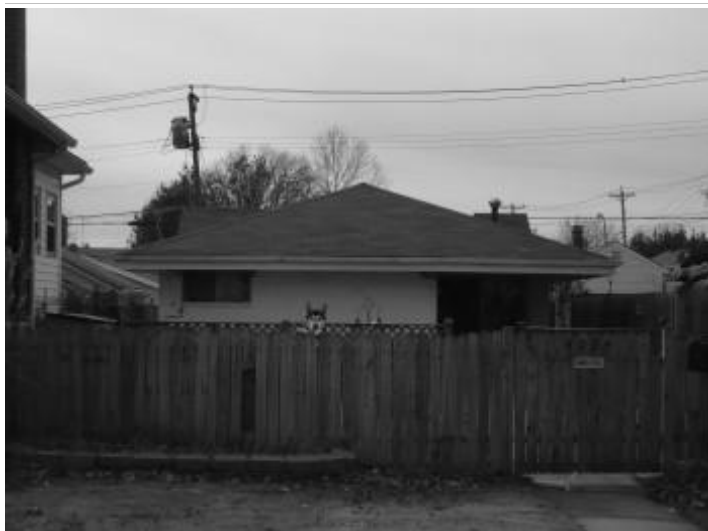
Porch windows appear to be non-original.

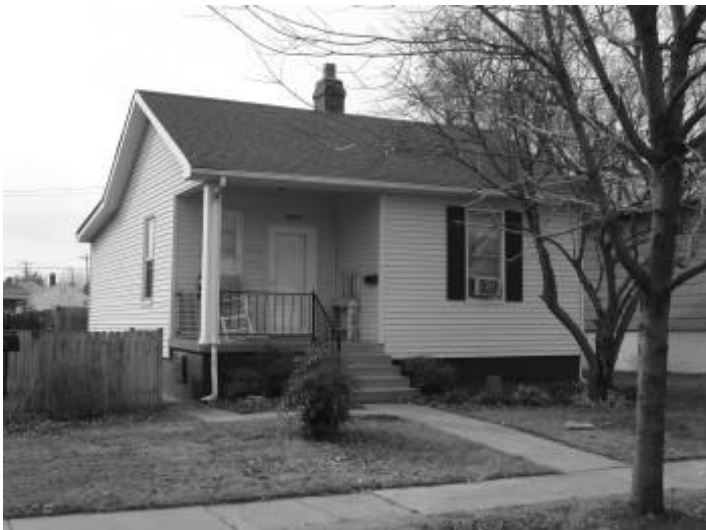
Replacement door. Eaves and porch post at corner are vinyl clad. Inoperable shutters added at right façade window. Original window trim covered.

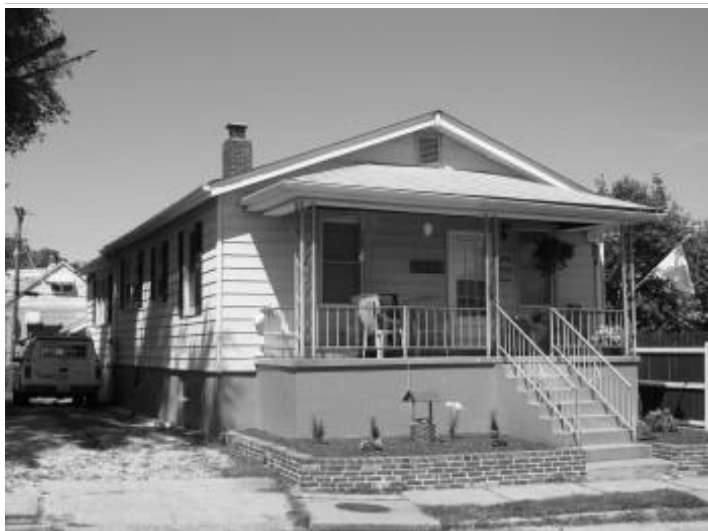
the porch has 3 metal trellis-style supports on a concrete block base. Front door and windows are replacements.

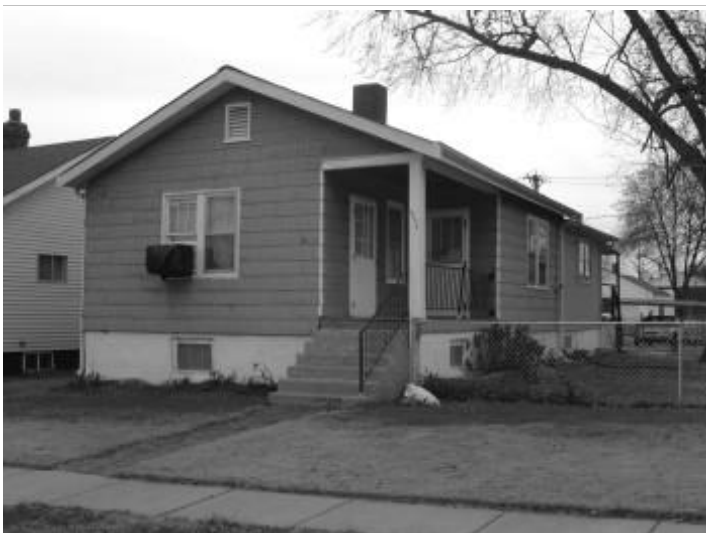
Some wood trim is wrapped.

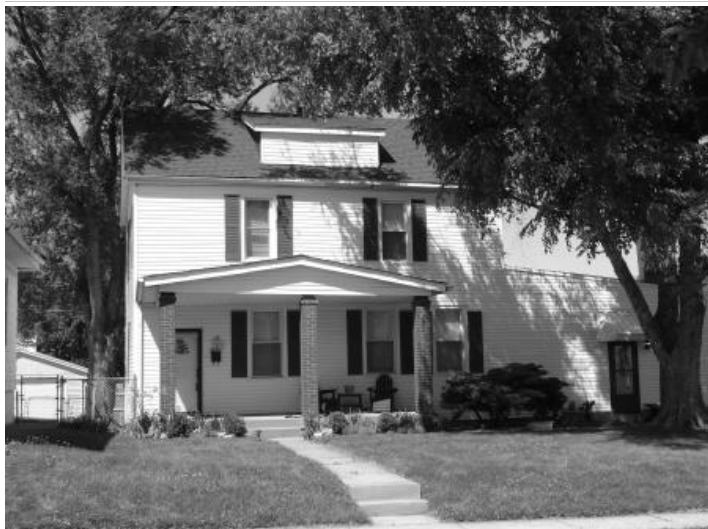
Replacement windows and door; shed dormer sided over

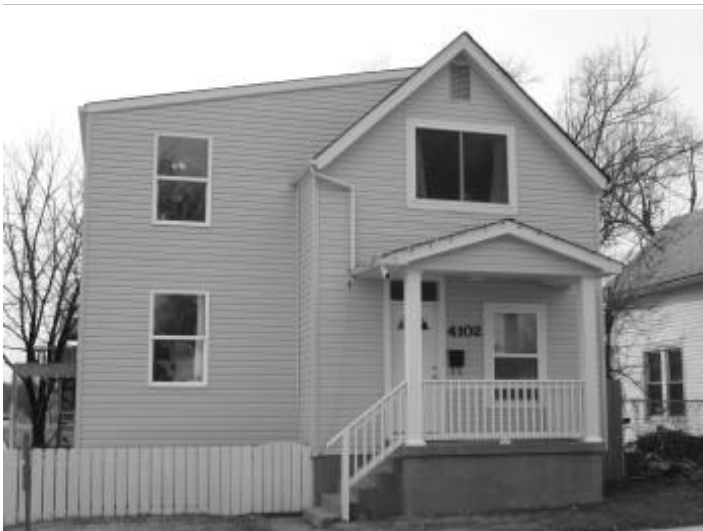
This building was originally a single-bay house, but a huge 2-story shed addition at the right elevation alters the appearance of the façade. No original materials are visible on the exterior of the house (with the exception of the front door's transom).

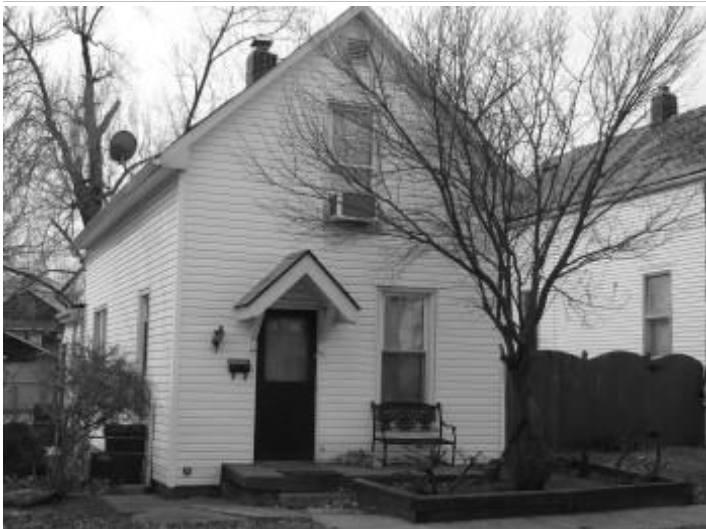
The front door and windows are replacements, and any original trim is covered or wrapped.

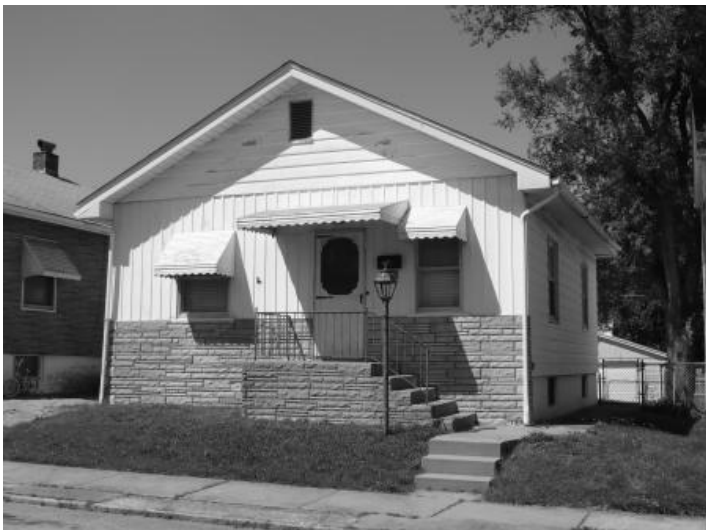
The front door, just to the right of center, is a replacement. Metal awnings cover all three façade openings. The base of the façade (below the window sill level) is covered with imitation stone veneer.

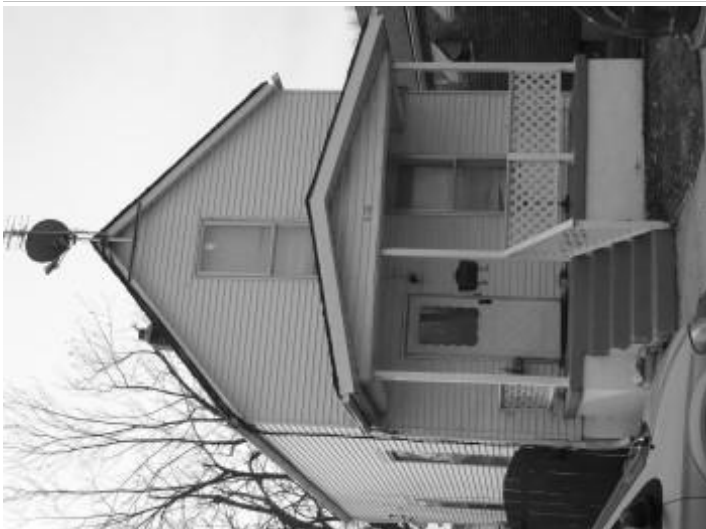
The front door and windows are replacements, and any original trim is covered or wrapped.

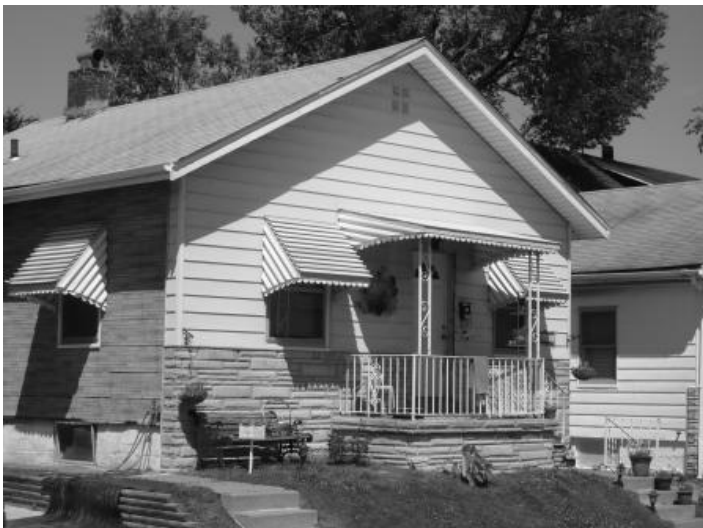
Front door, just right of center, is replaced. Metal awnings cover all three façade openings. The base of the façade (below window sills) is covered with imitation stone veneer, with vinyl siding above. Side elevations are covered w/ asphalt shingle.

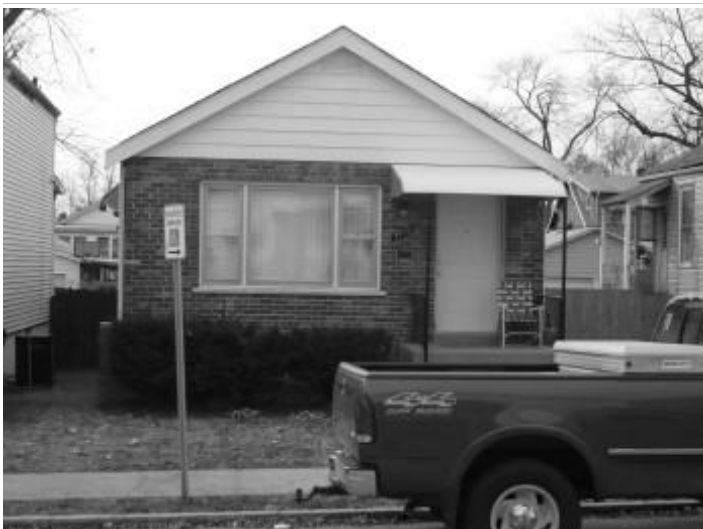
The front door is a replacement. Over it, the fiberglass awning is supported on two metal posts.

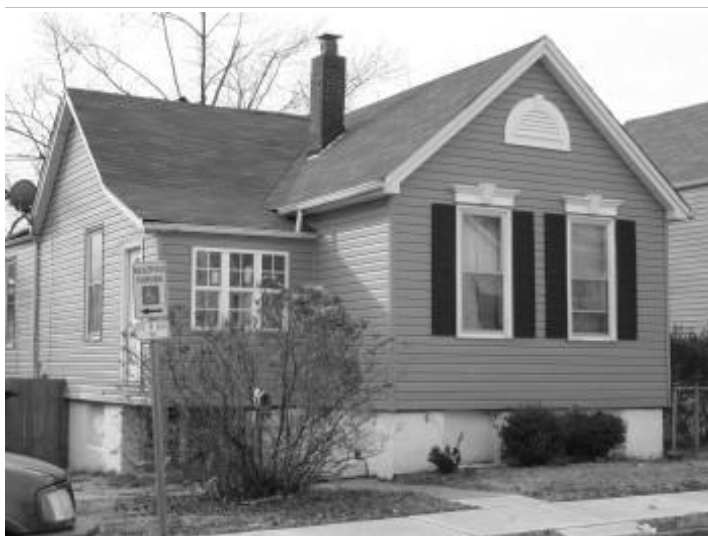
New window hoods and shutters.

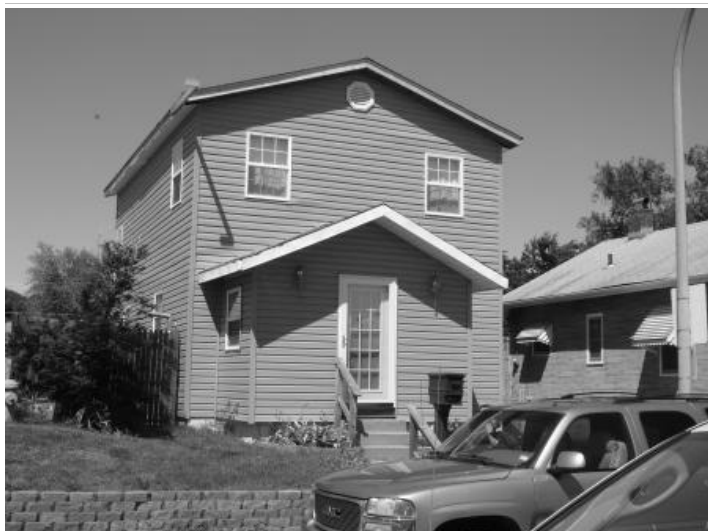
Second story added sometime after 1963. Gabled front porch enclosed. No real relation to historic building underneath.

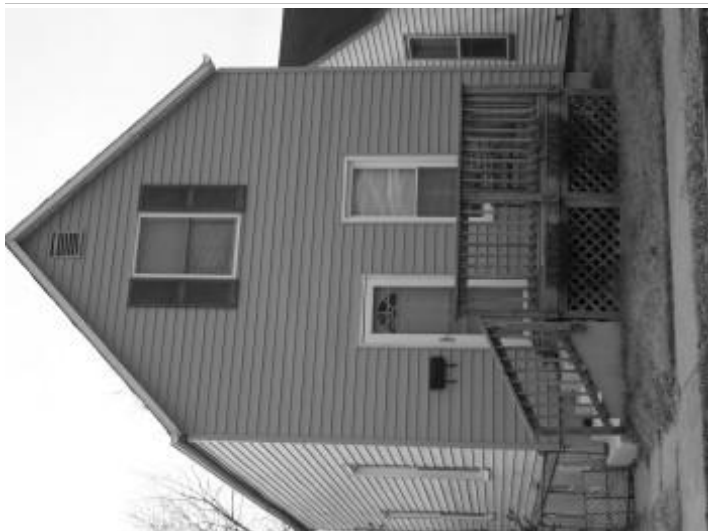
Replacement front door and windows.

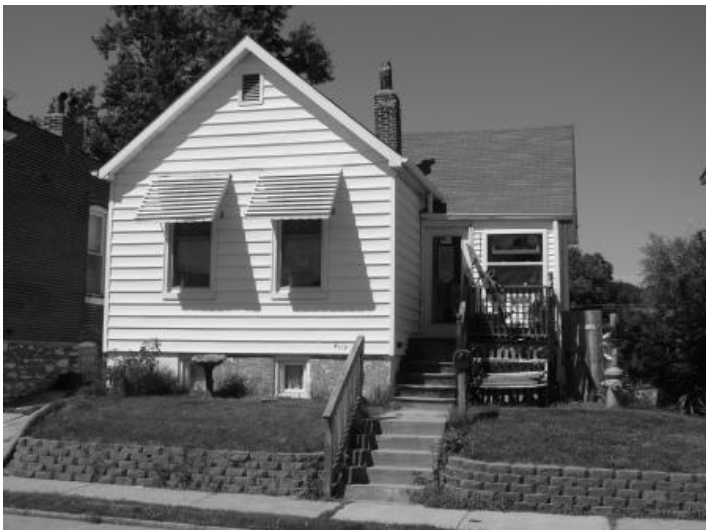
new deck-style porch in front of original (vinyl-sided, enclosed) porch. New door and replacement windows. Awnings at 2 façade windows at left bay.

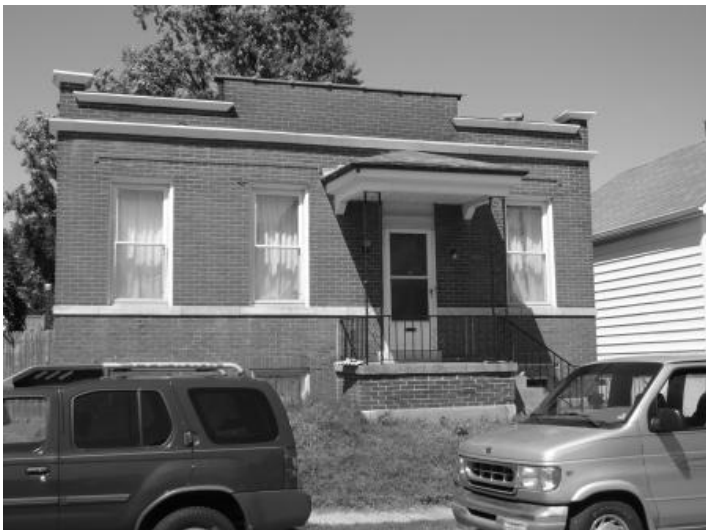
Door and windows replaced, porch posts replaced with metal trellis-style supports; cornice covered, center step of parapet copped with newer clay tile; the rest of parapet coping, and front door transom, covered or replaced with modern siding material.

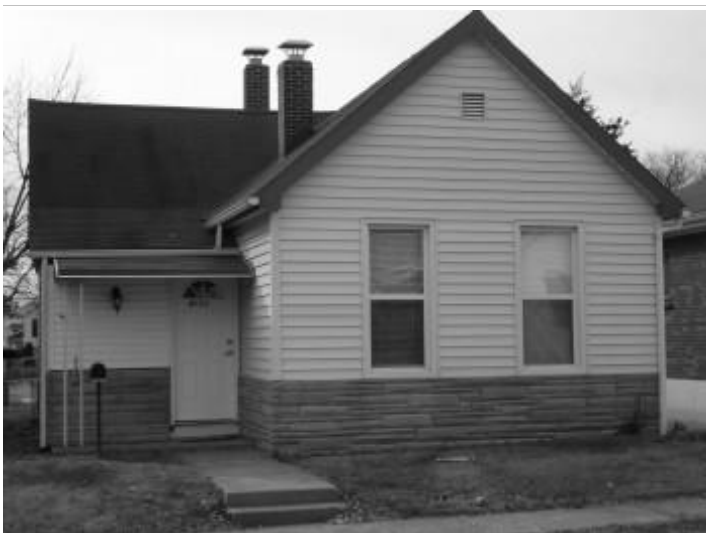
Replacement front door and windows. imitation stone veneer at base of façade.

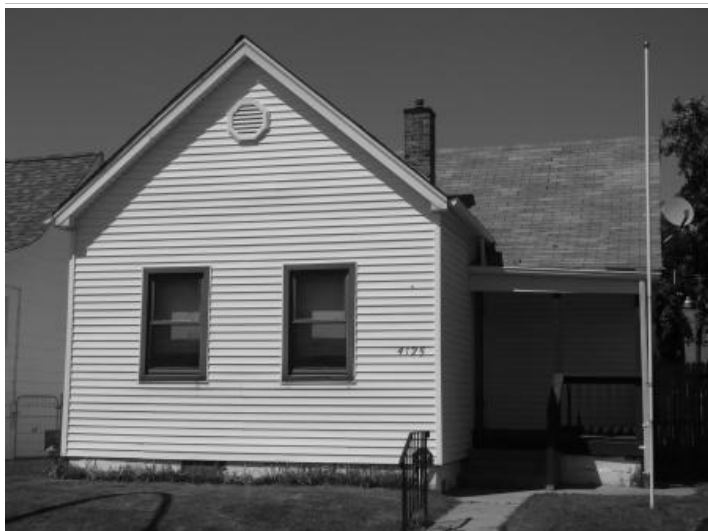
Porch materials replaced; replacement windows;

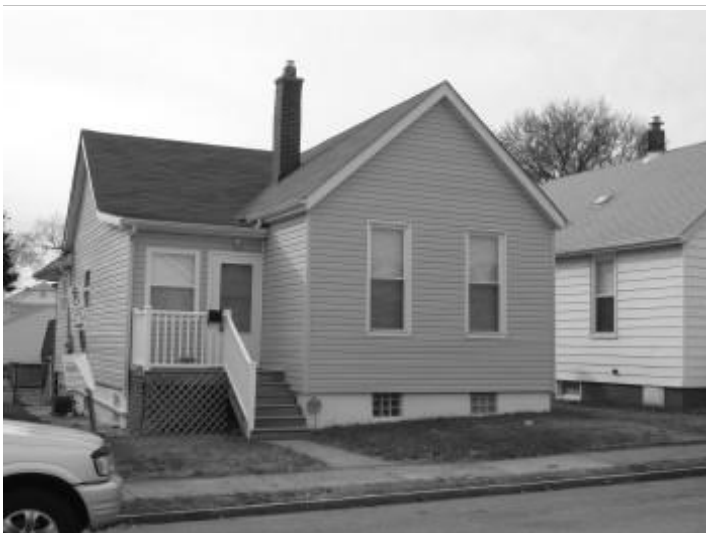
Windows and door are replacement; no wood trim is visible under siding and wrap.

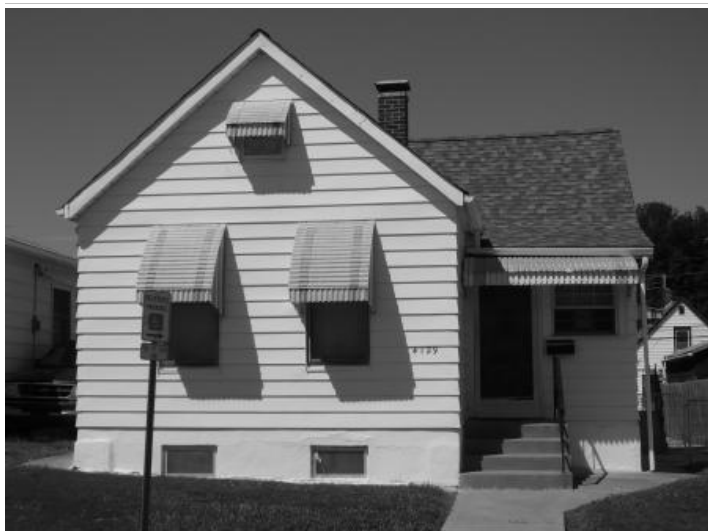
New door and window at right bay. Metal and fiberglass awnings. Window trim covered with siding.

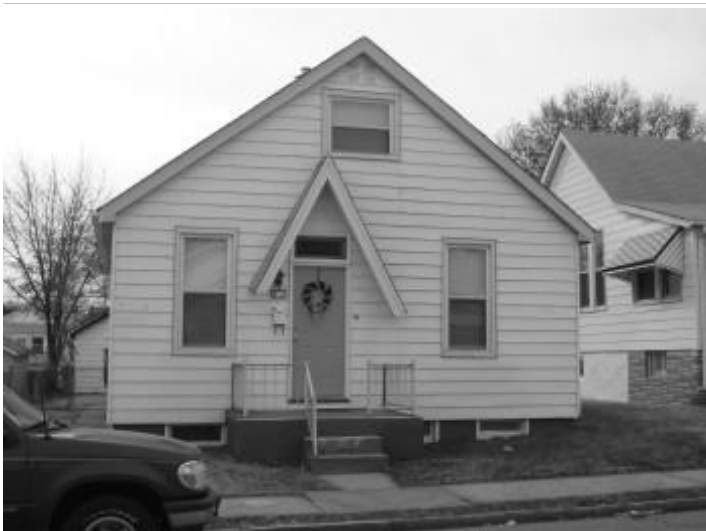
Replacement front door and windows.

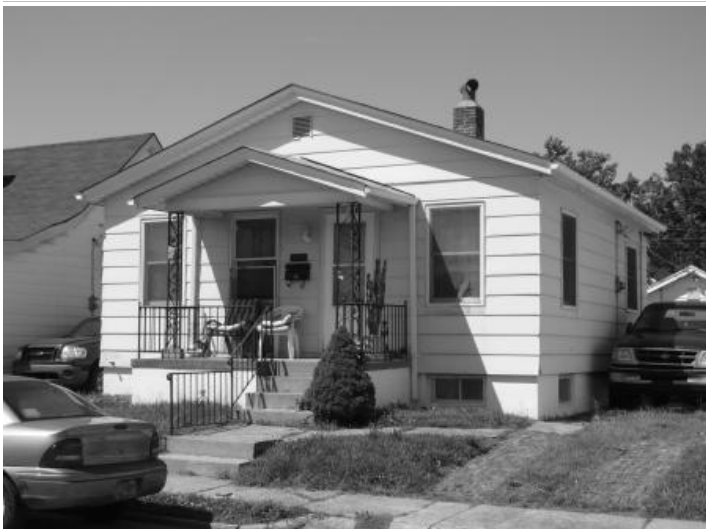
Concrete porch base and trellis-style metal supports. Front door and three façade windows are replacements.

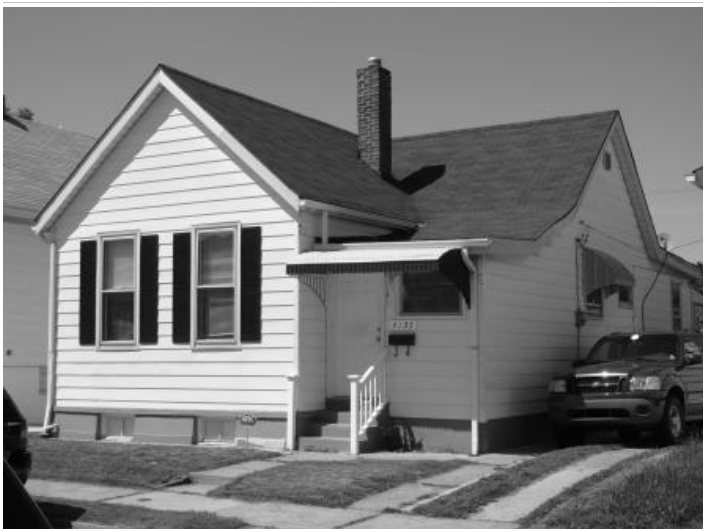
12*24 addition was permitted in 1929. Window trim/wood detailing obscured by application of siding. Fiberglass awning at (new) porch.

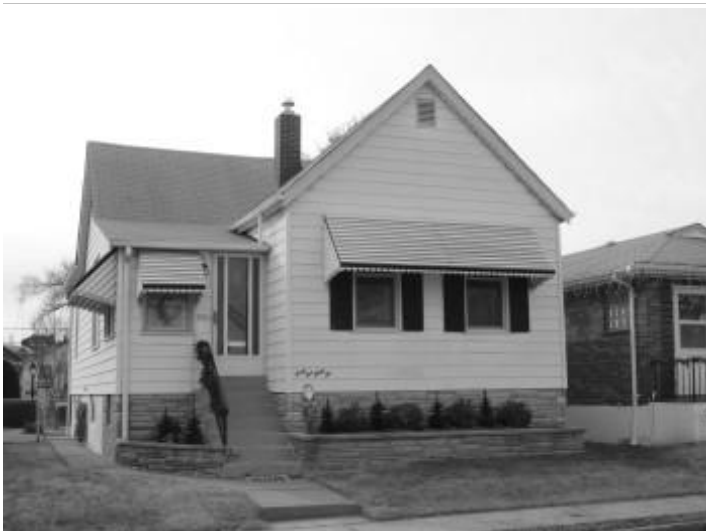
Awnings and shutters added. No original wood trim visible under siding and wrap.

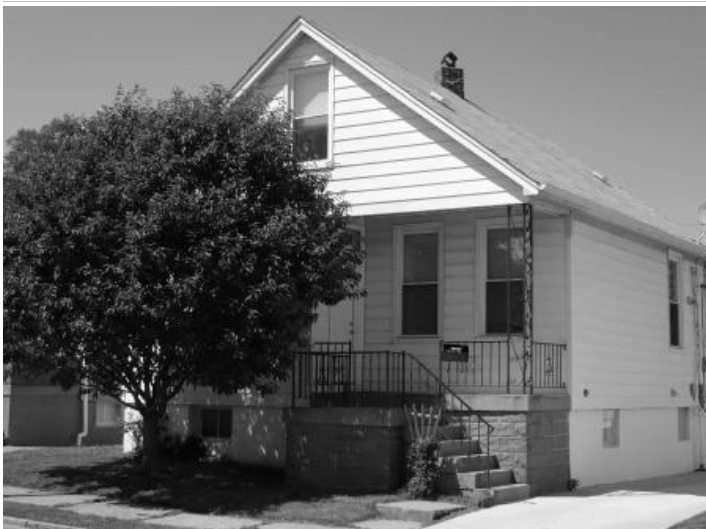
Replacement windows and doors. Trellis-style porch post

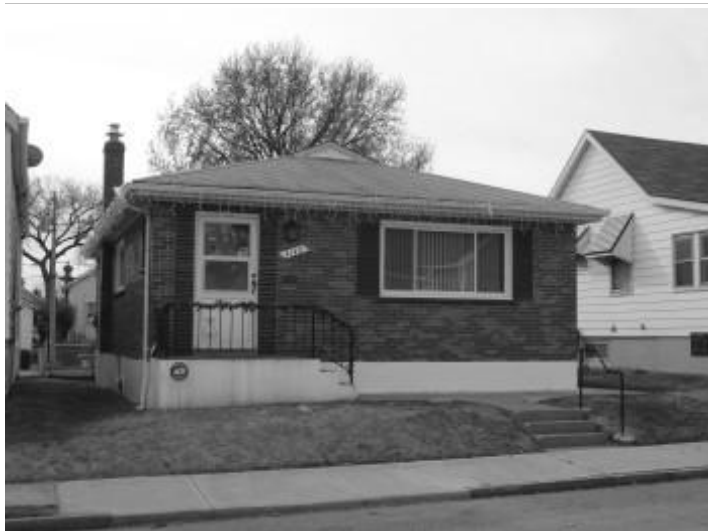
Replacement windows.

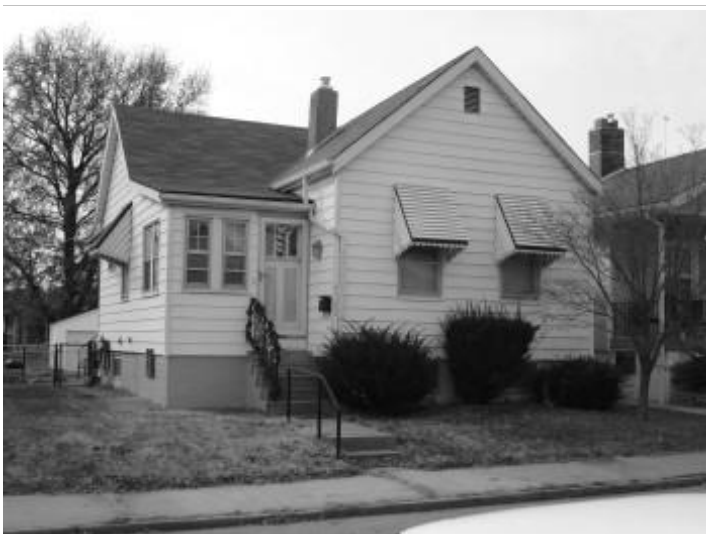
Metal awnings added at right bay and side elevation. None of the original wood trim is visible under siding and wrap.

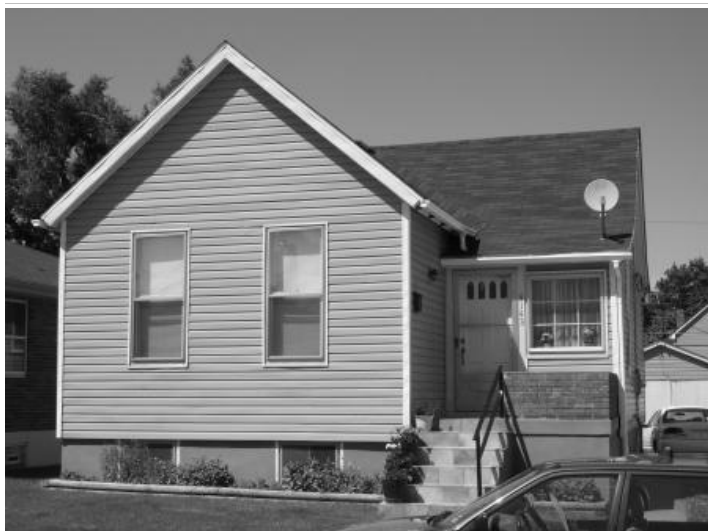
Replacement front door; most original wood trim covered by siding.

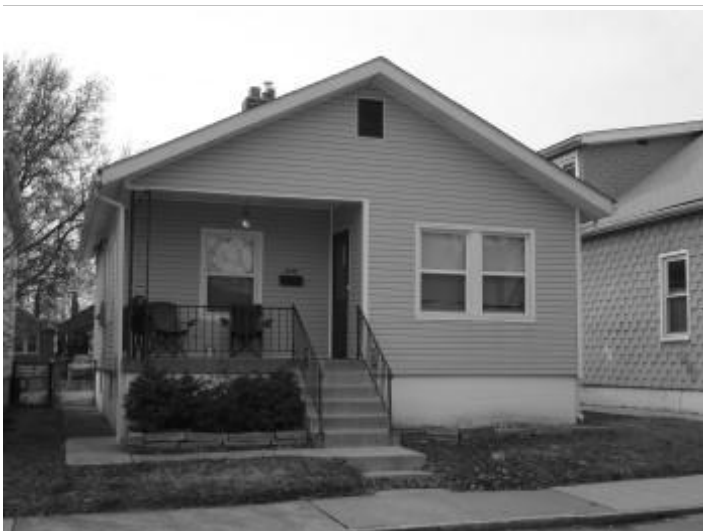
Replacement windows; no visible intact wood trim.

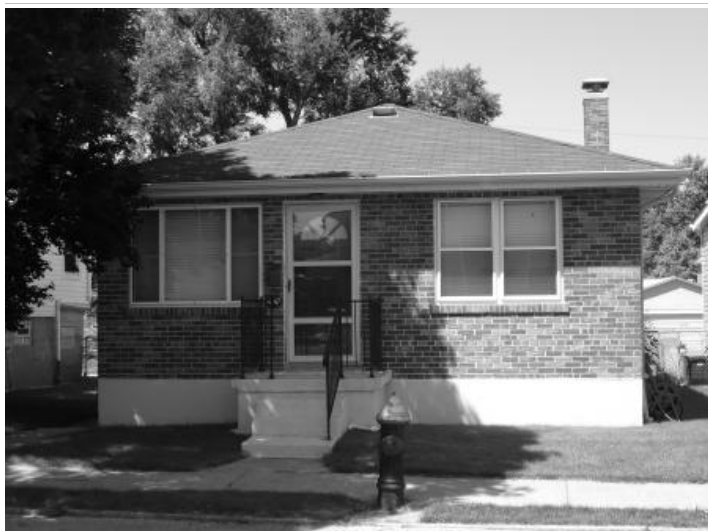
Replacement front door.

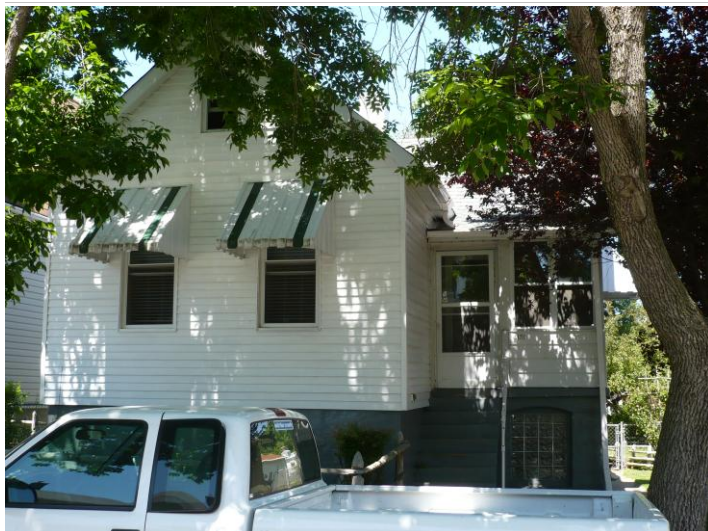
Replacement windows; original wood trim covered.
