City of St. Louis Cultural Resources Office

Holly Hills Neighborhood Survey

Lynn Josse and NiNi Harris
3/1/2010

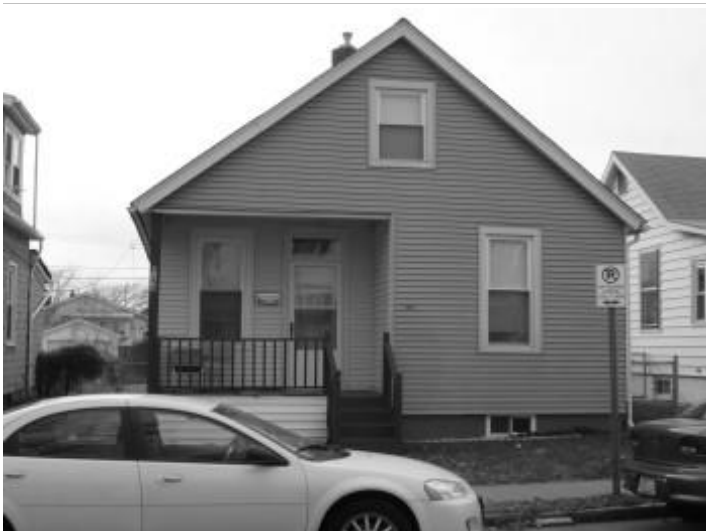
The windows are porch corner pier are replacements. It appears that a second front door has been filled in.

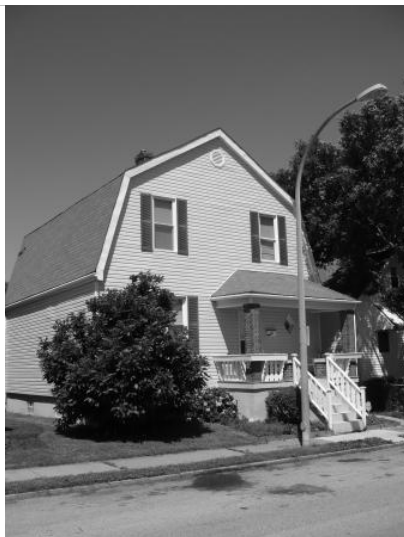
Siding covers most of the wood trim, and façade sash windows and front door have been replaced.

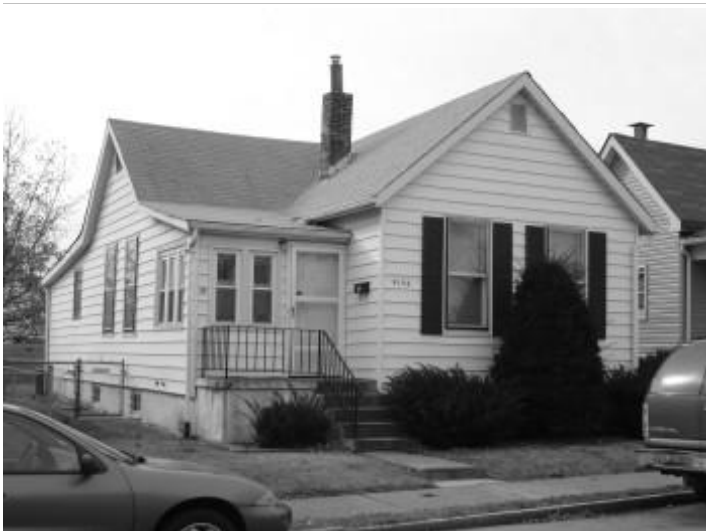
Door and windows are replacements. Wood trim is not visible under siding and wrap. Concrete front porch. Shutters added.

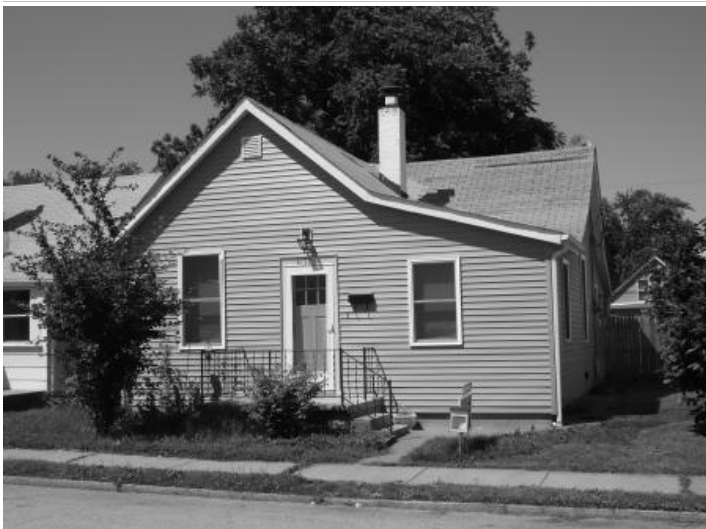
Replacement windows; most wood trim obscured by siding.

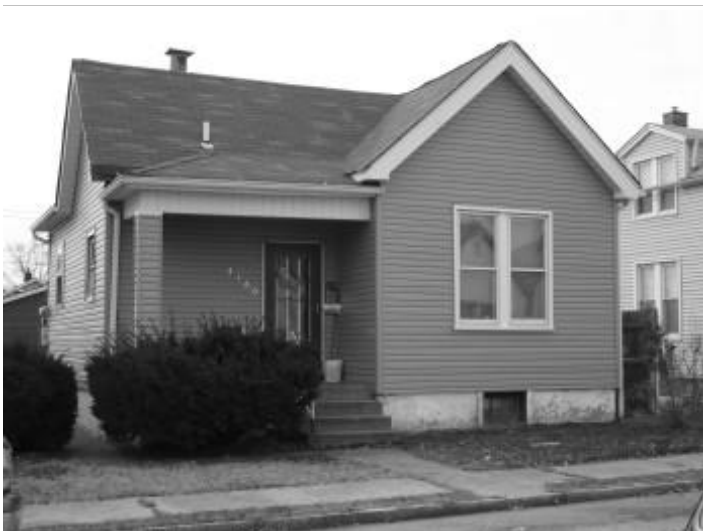
New door; wood siding is covered with siding and / or wrap.

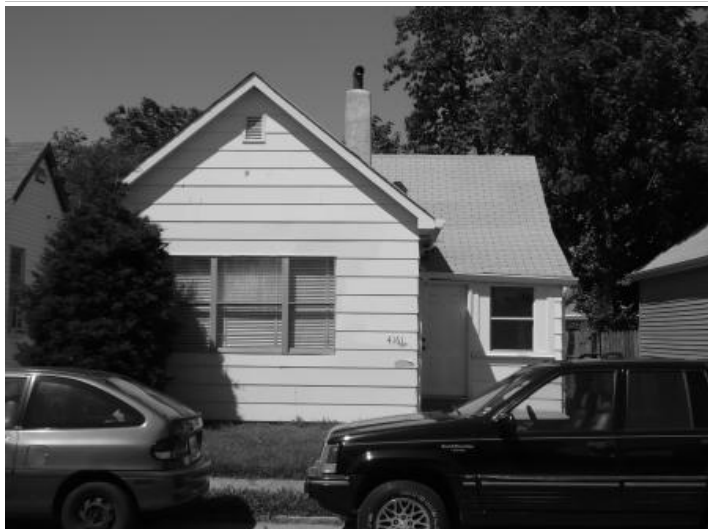
Replacement windows and door; left bay window openings altered to picture-window size.

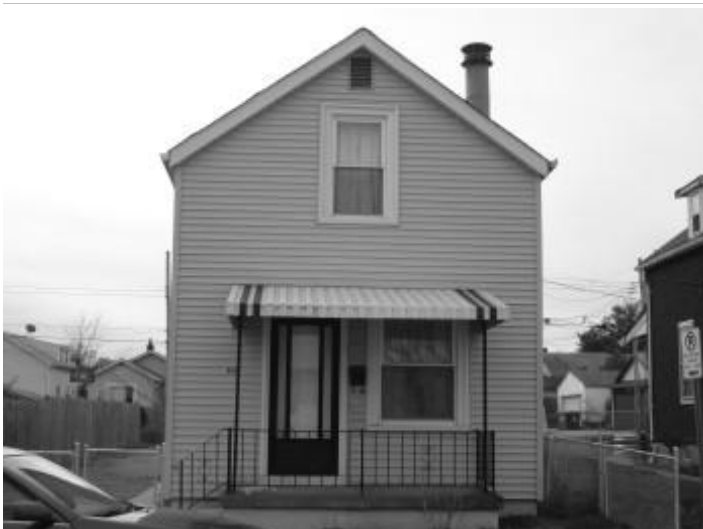
Concrete base porch with metal awning; replacement door and windows; no wood trim visible under siding and/or wrap.

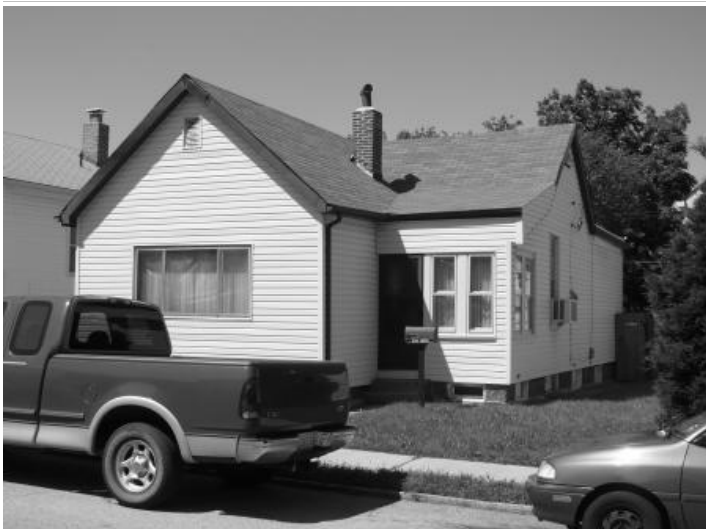
Replacement door; left bay window openings altered to picture-window size. Wood trim covered with siding.

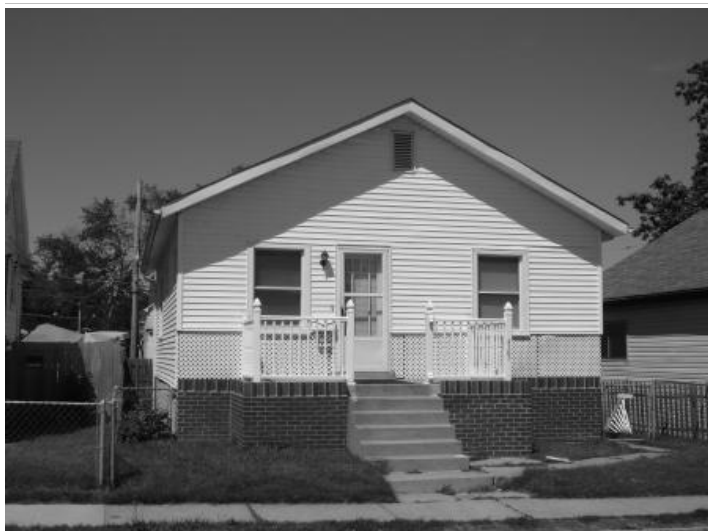
Vinyl windows.

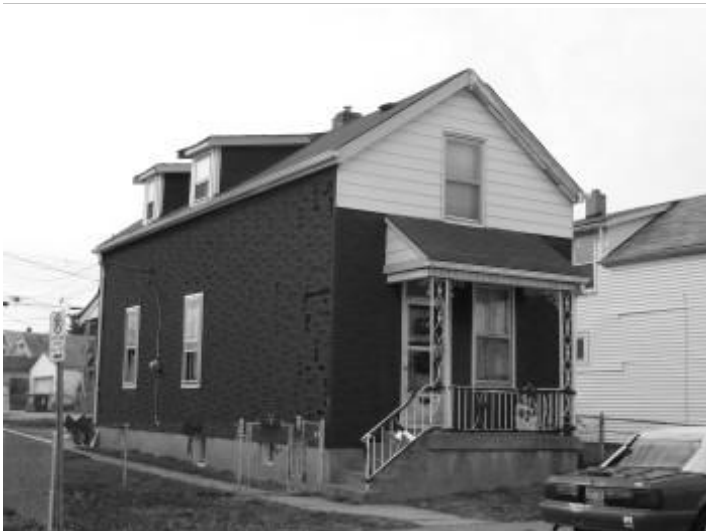
Porch structure replaced with concrete base and metal trellis-style supports. Asphalt siding at façade imitates brick.

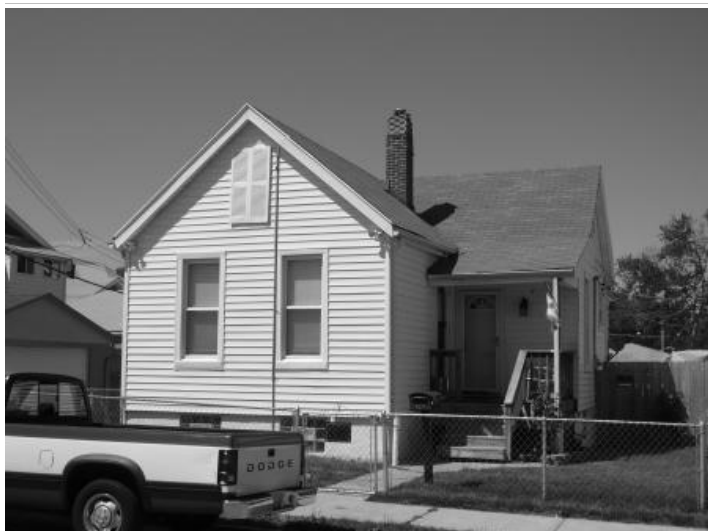
This single story house has a projecting left gabled bay which intersects with the side-gabled volume behind. This is one of the only examples which has not had its corner porch enclosed. Two doors lead from the porch into the house; the left door (facing east) is original; the right door, which faces the street, is a replacement.

17*22 addition in 1927. Attic vent is covered with louvered shutters. New windows.

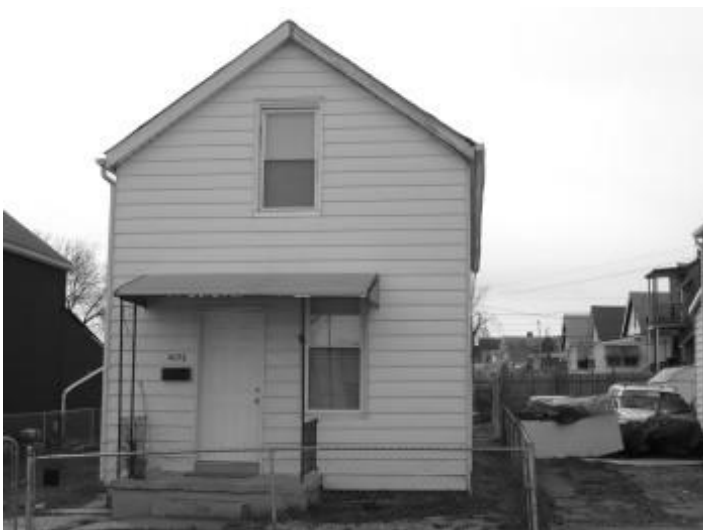
Porch structure replaced with concrete base and metal trellis-style supports holding up awning roof. Replacement front door and windows. Façade has aluminum siding; vinyl siding is at the side elevations.

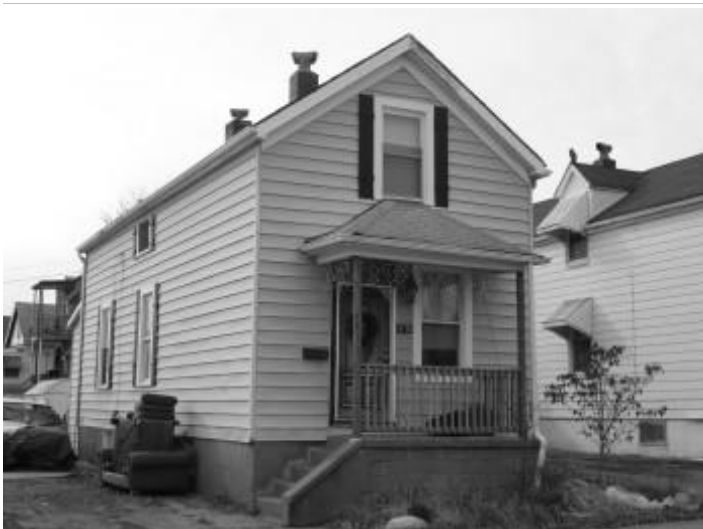
Porch structure replaced with concrete base and wood post supports. Front door and windows are replacements.

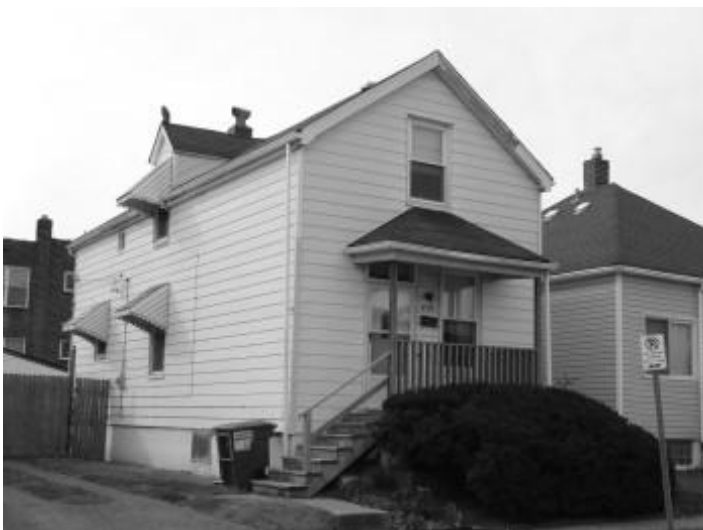
Porch structure replaced with concrete base and wood post supports. The replacement door retains original transom; windows are replacements.

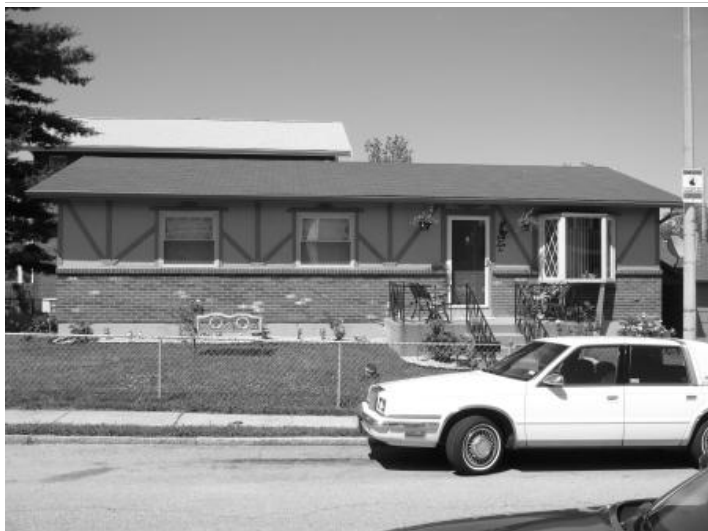
This 1977 house is clad with stucco and imitation half-timber over a brick-veneered base. Flush door and new (1990s - 2000s) windows.

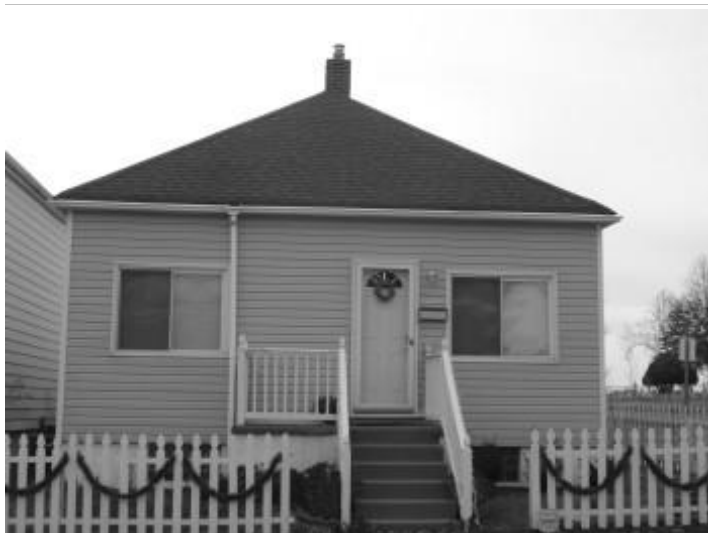
This hip-roofed house has no visible historic features; the front door is new, porch is new, siding is new and fenestration altered for horizontal window openings.

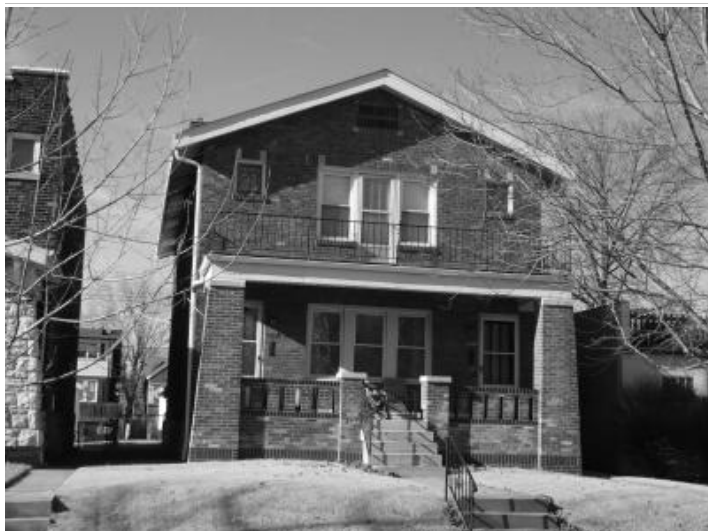
The triple set of windows at the first floor, and windows flanking the second story balcony door, are replacements.

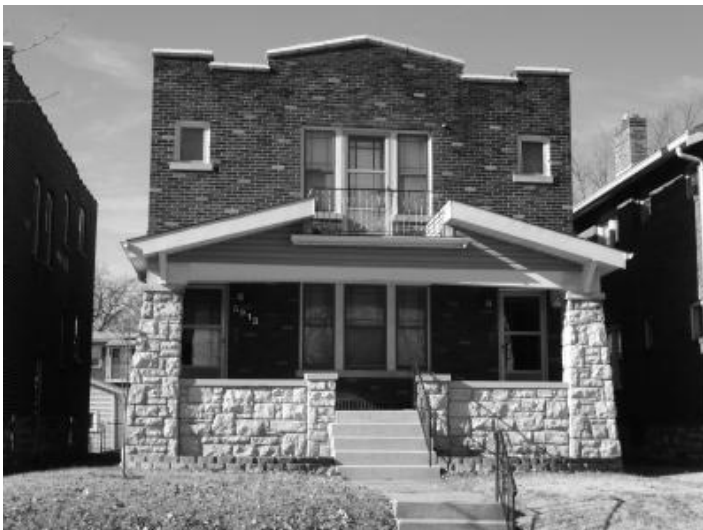
This two-family building has a brown variegated striated brick exterior. The full-width brick porch has a gable roof, broken in the center for an inset balcony. The two front doors are at opposite ends of the façade. The front doors, and the art glass windows above them at the second story are original. The triple set of windows at the first floor, and windows flanking the second story balcony door, are original multilight windows with large center panes surrounded by 8 smaller ones (this pattern is repeated at the doors as well). The front parapet wall retains original terra cotta coping.

Vinyl siding at the porch gable end.

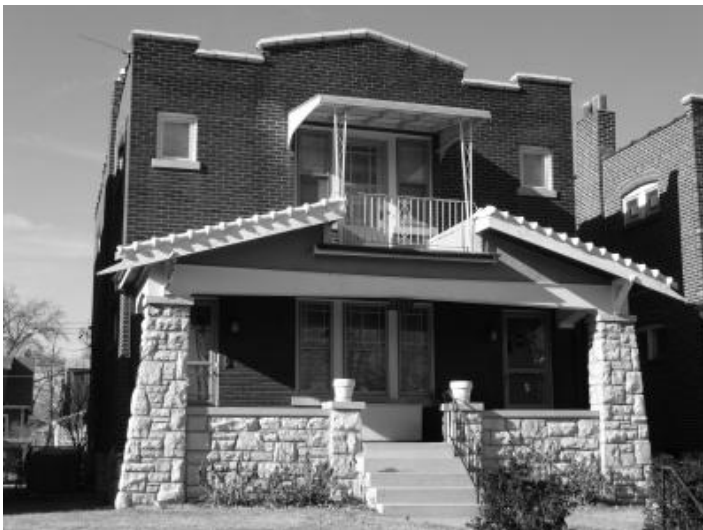
This two-family building has a variegated striated brick exterior. The full-width brick porch has a gable roof, broken in the center for an inset balcony. The two front doors (replacements) are at opposite ends of the façade. The art glass windows above them at the second story are original. The triple set of windows at the first floor, and windows flanking the second story balcony door, are original multilight windows with large center panes surrounded by 8 smaller ones (this pattern is repeated at the balcony door as well). The front parapet wall retains original terra cotta coping. The porch gable end retains original stucco.

Front doors replaced, and metal awning on poles over balcony.

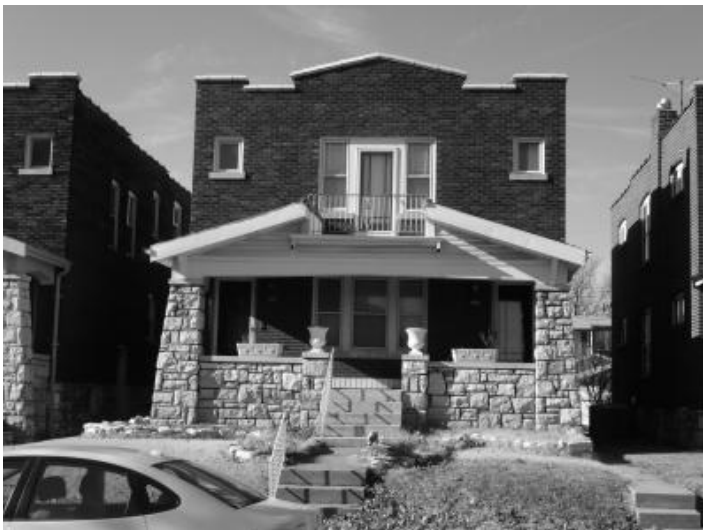
This two-family building has a brown variegated striated brick exterior. The full-width brick porch has a gable roof, broken in the center for an inset balcony. The two front doors are at opposite ends of the façade. The front doors, and the art glass windows above them at the second story are original. The triple set of windows at the first floor, and windows flanking the second story balcony door, are original multilight windows with large center panes surrounded by 8 smaller ones (this pattern is repeated at the doors as well). The front parapet wall retains original terra cotta coping.

Siding at porch gable end.

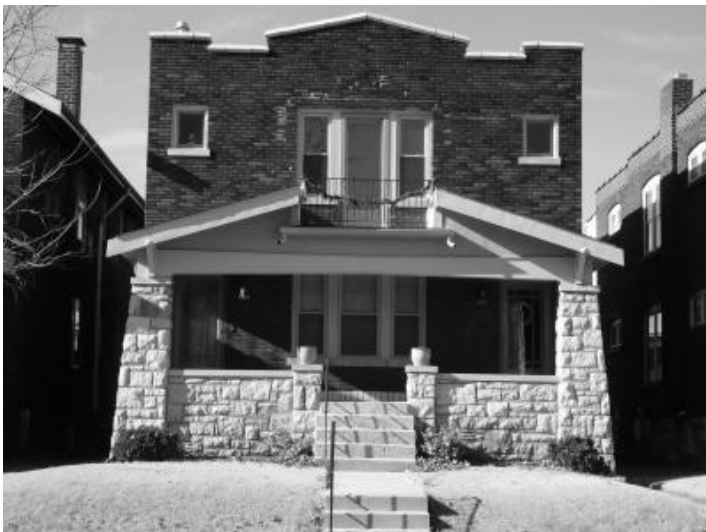
This two-family building has a variegated striated brick exterior. The full-width brick limestone porch has a gable roof, broken in the center for an inset balcony. The two front doors (both original) are at opposite ends of the façade. The front parapet wall retains original terra cotta coping. The porch gable end retains original stucco.

The triple set of windows at the first floor, and windows flanking the second story balcony door, are replacements. The balcony door is a replacement.

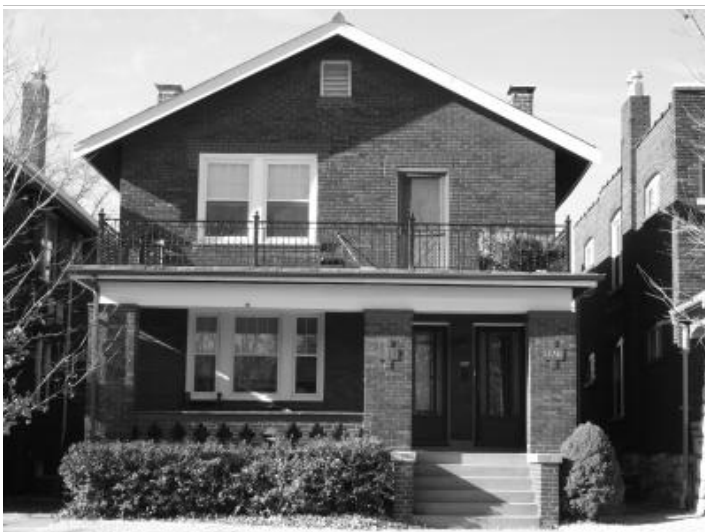
The windows at both stories of the left bay are replacements.

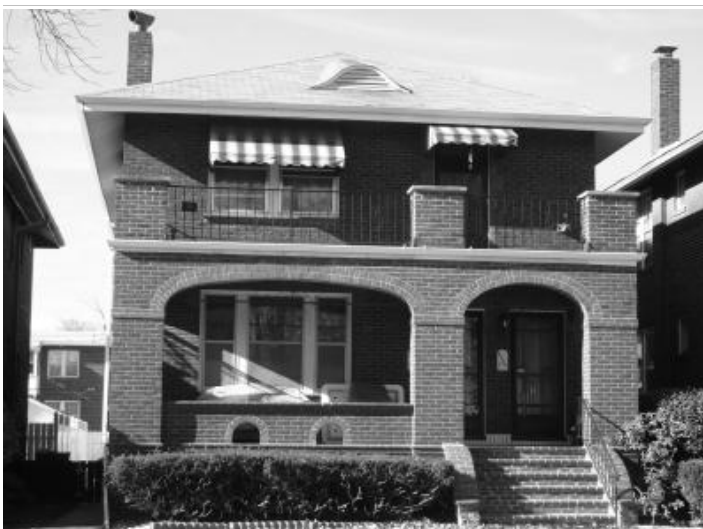
Fabric awnings at second story.

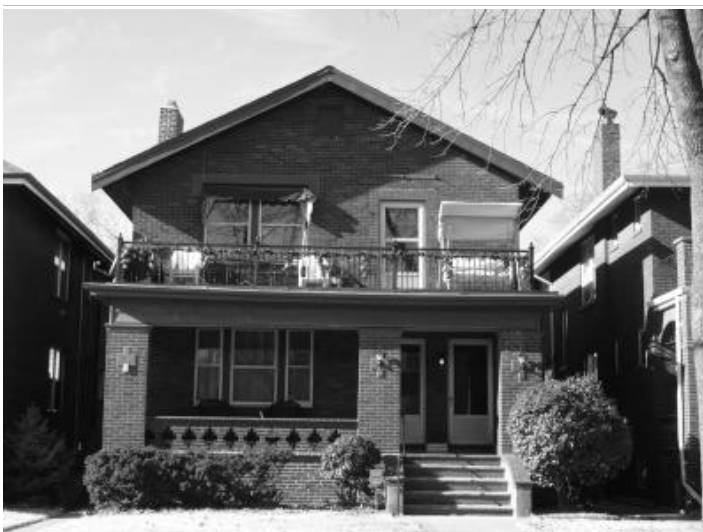
Fabric awning added at second story windows

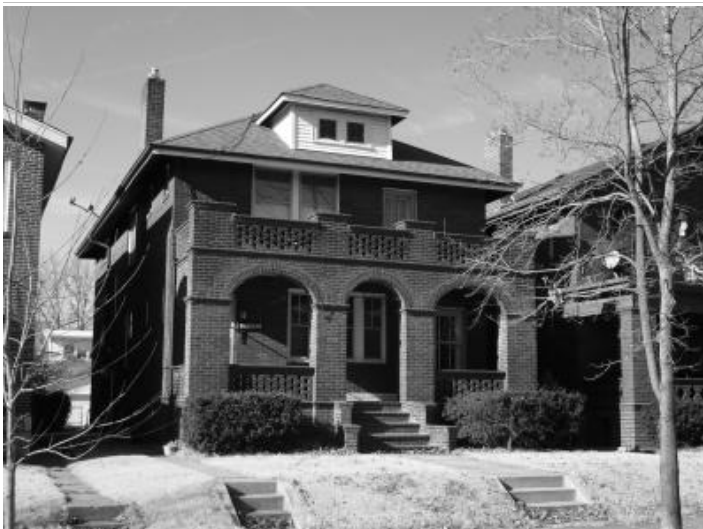
Vinyl siding at hipped dormer.

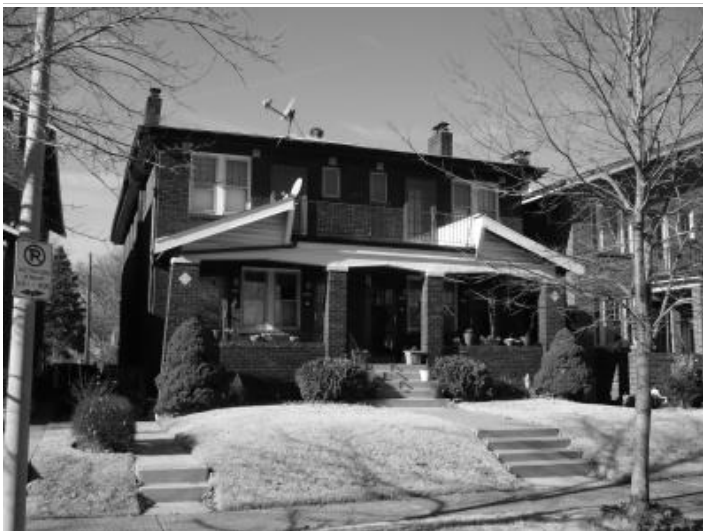
This four-family building has a dark striated brick façade and red brick sides. The full-width porch has a gable roof, broken for an inset balcony at the center two bays. Original 3/1 windows, art glass windows (at the center of the second story) and doors are all intact.

Modern horizontal siding at porch's gable end.

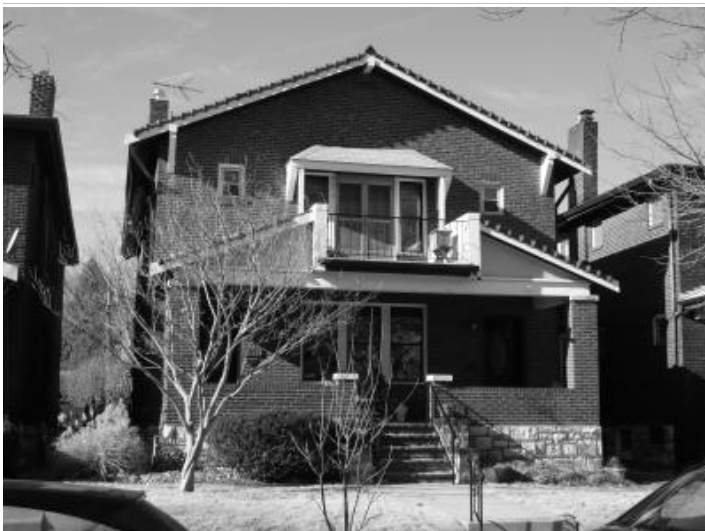
This front gabled building has a variegated striated brick façade and red brick sides. The full-width porch has a gable roof, broken for an inset balcony at the center. Original French doors are intact at the balcony, and art glass windows are at the outer ends of the second story. Both porch and main roof retain green ceramic coping tile along the front edges.

The first story doors are modern replacements, as are the windows. The three brackets at the main roof are sheathed with siding.

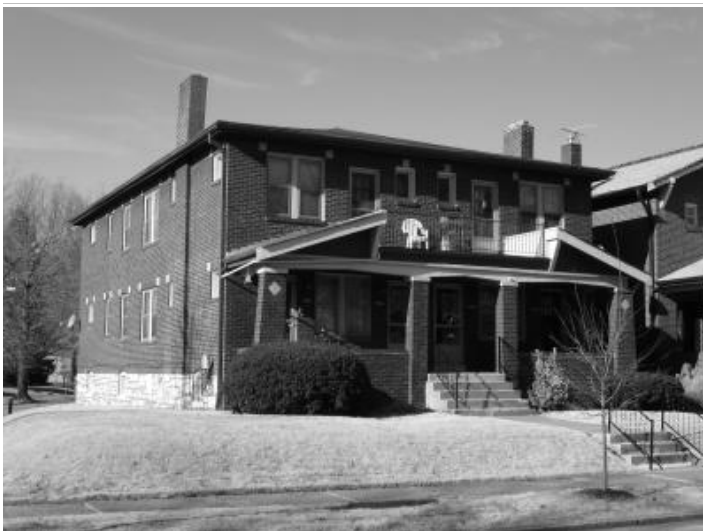
This four-family building has a rough-textured variegated brick façade and side elevation. The full-width brick porch has a gable roof, broken for an inset balcony at the center two bays. Original 3/1 windows, art glass windows (at the center of the second story) and doors are all intact. The porch gable end is stuccoed.

Sided vergeboard and brackets at gable end.

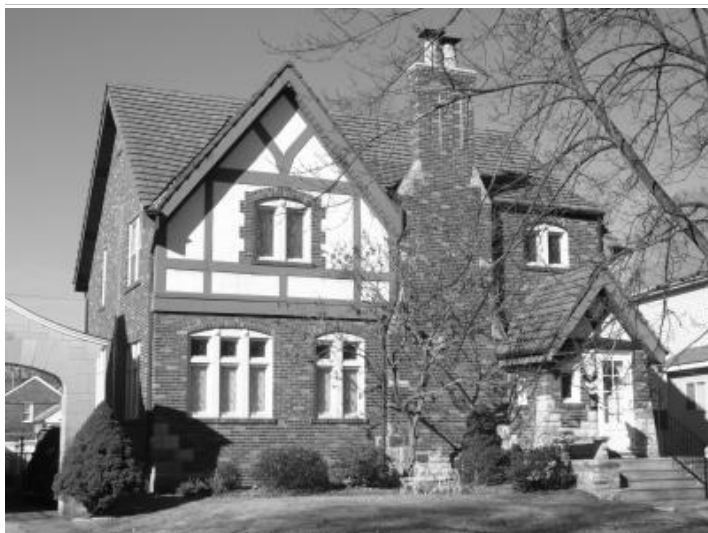
Much of the wood trim is wrapped with siding.

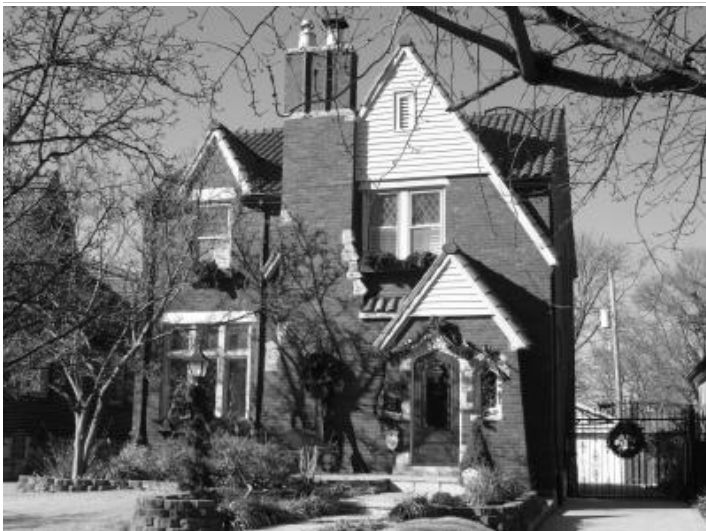
Modern horizontal siding in the three gable ends.

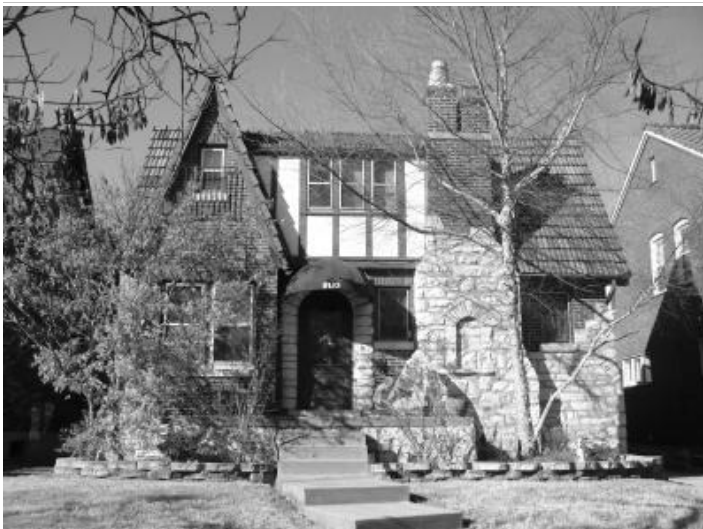
This Romantic Revival house is a single story at the façade, with a steep pitched gable at the left bay, a prominent stone and brick exterior chimney on the right side of the house, and a stuccoed shed dormer running between the two. The front door near the center of the first story is the original round-arched with wood storm door. First floor windows are original, s is the window in the gable end. Dormer windows are replacements. The roof is red French tile with some green tiles scattered in.

Some wood trim wrapped

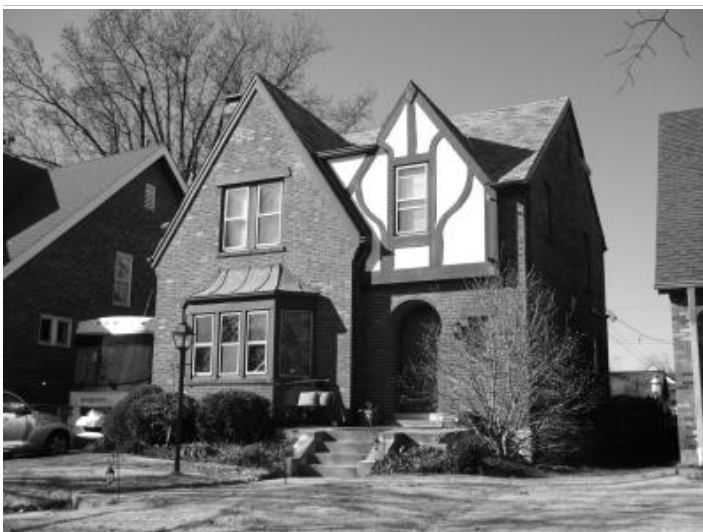
Some wood trim wrapped with siding.

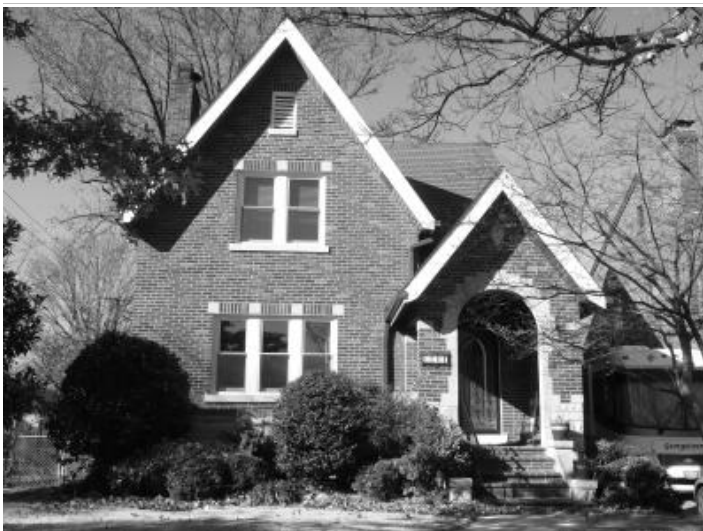
Façade windows are replacements, and some trim is wrapped.

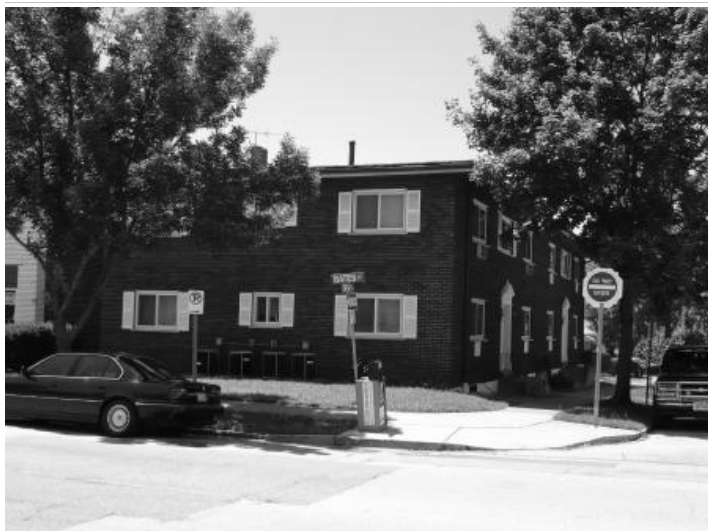
Date of construction is 1962 per assessor's database. The dark brick building retains original doors but has replacement windows; most of the original wood (inoperable) shutters have been replaced.

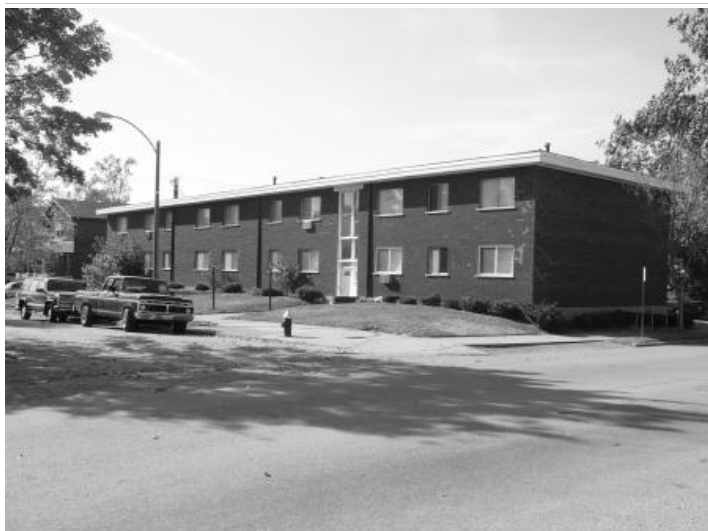
Replacement door; sidelight and transom filled in.

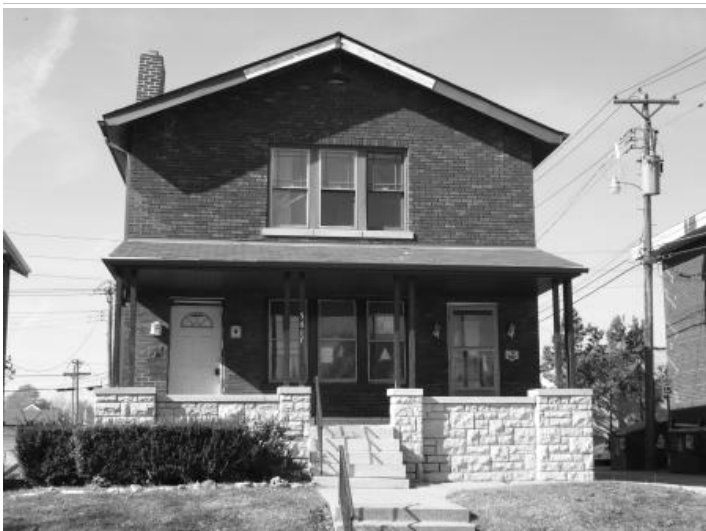
This variegated brick two-family has a front gabled roof. The full-width limestone porch has an added shed roof which replaces the original hoods.

Doors and windows are replacements.

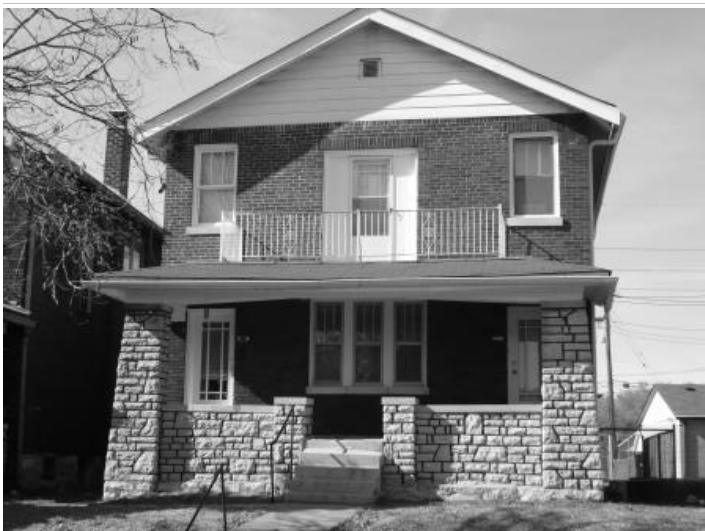
The balcony door's sidelights are covered. Gable end and eaves of main roof are sided.

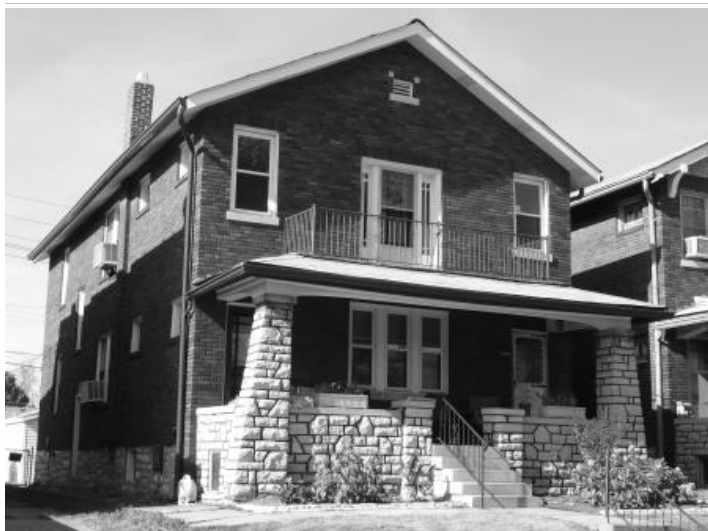
Replacement façade windows.

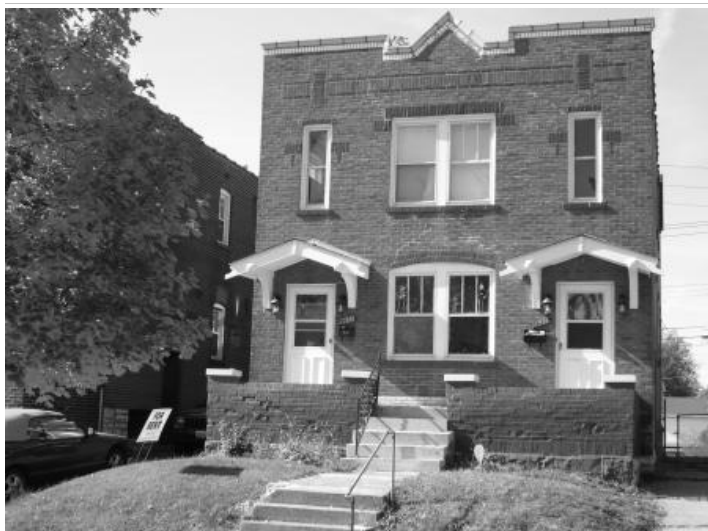
Replacement windows. Painted porch brick.

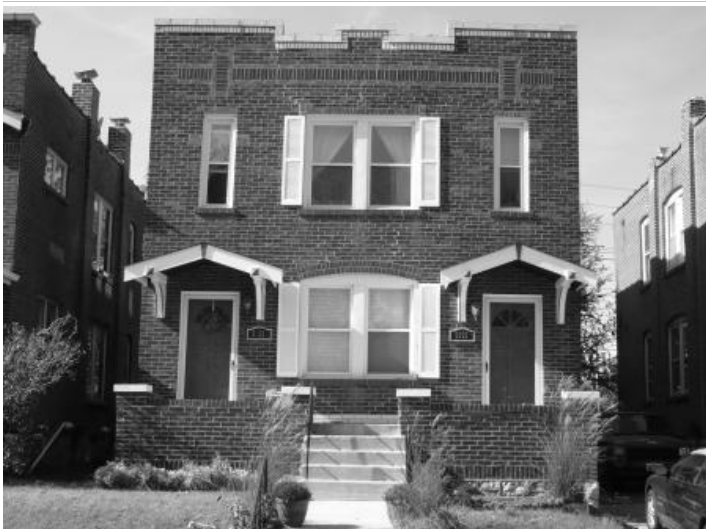
Replacement doors and windows.

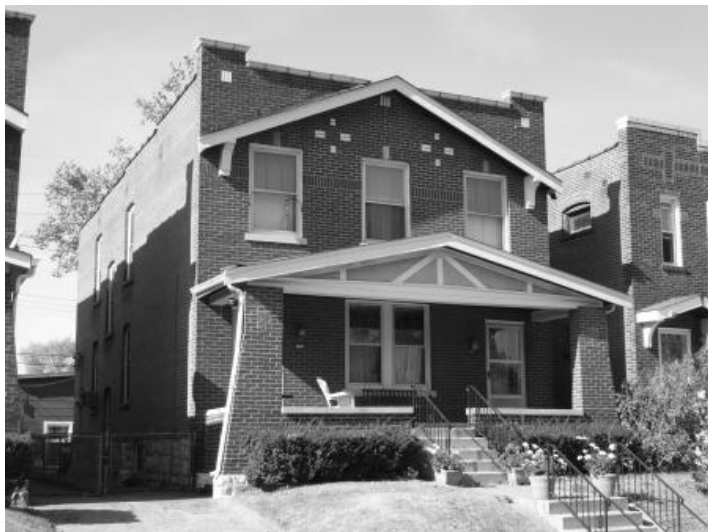
Some wood trim covered with siding, including brackets.

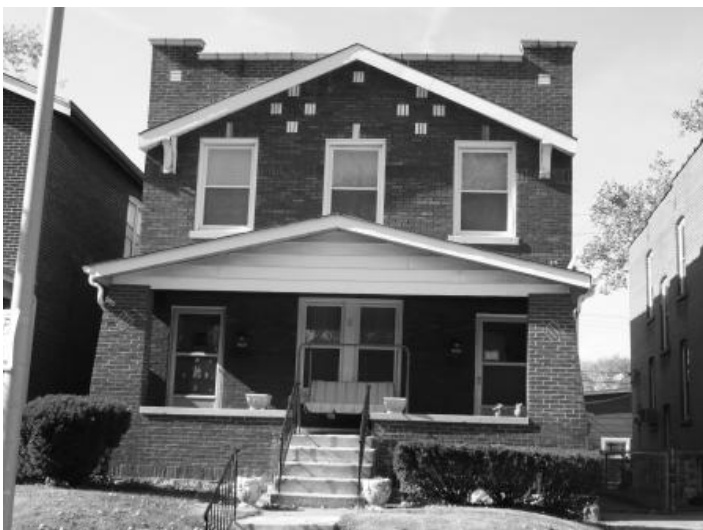
Some wood trim covered with siding, including brackets. The porch gable end has modern horizontal siding. The two front doors at opposite ends of the porch are replacements. The first floor's center window pair and the three second story windows are re

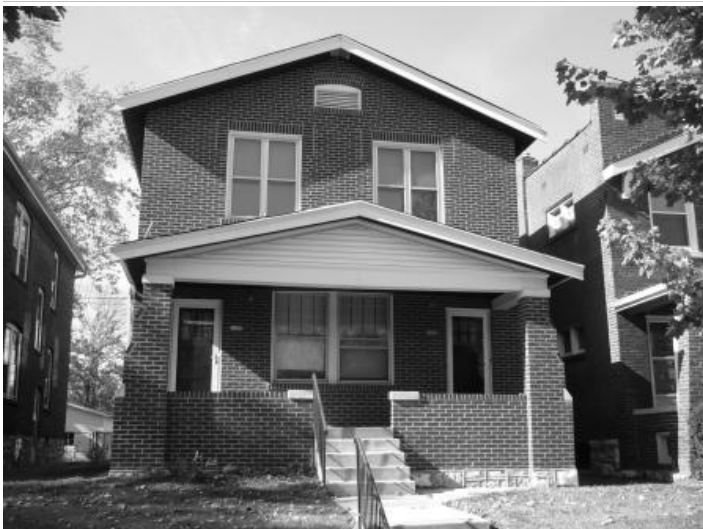
Aluminum covers gable end and vergeboards.

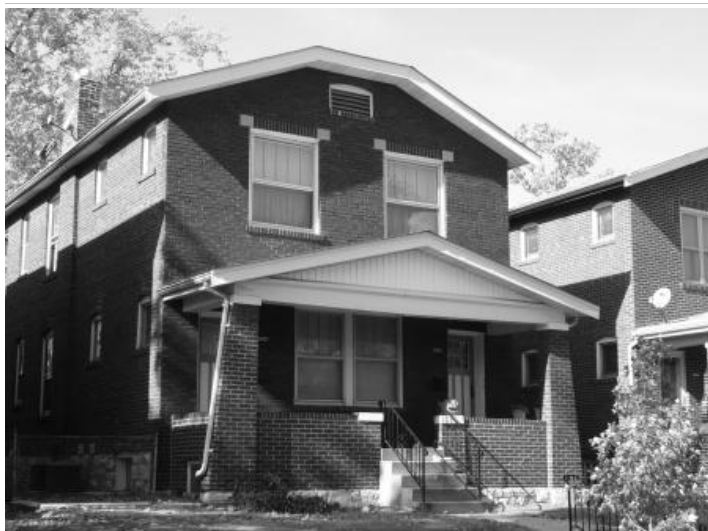
Aluminum covers porch gable end and much of the façade's wood trim.

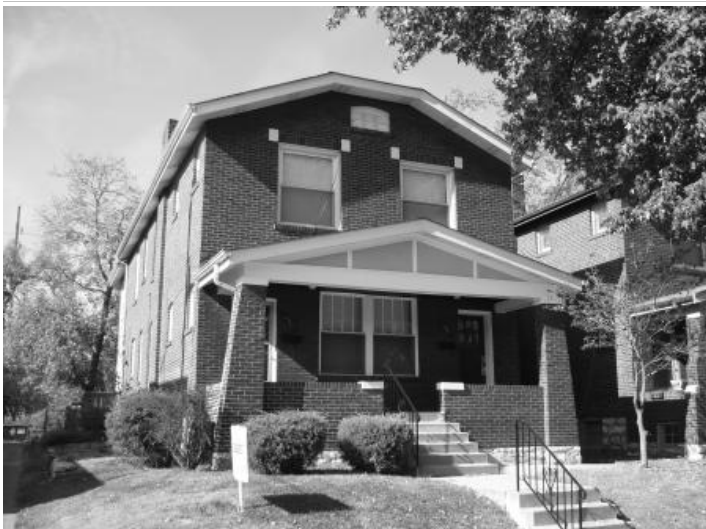
Second floor windows are replaced. Some wood trim covered with siding.

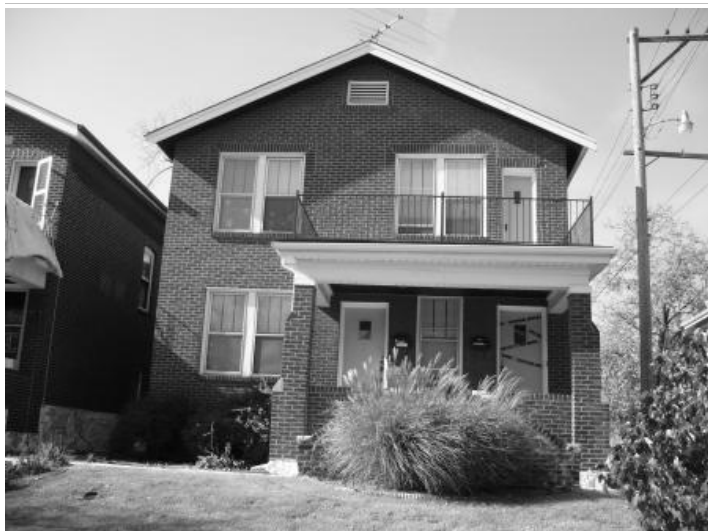
Much wood trim (widow frames, vergeboard, porch eaves) covered/soffitted.

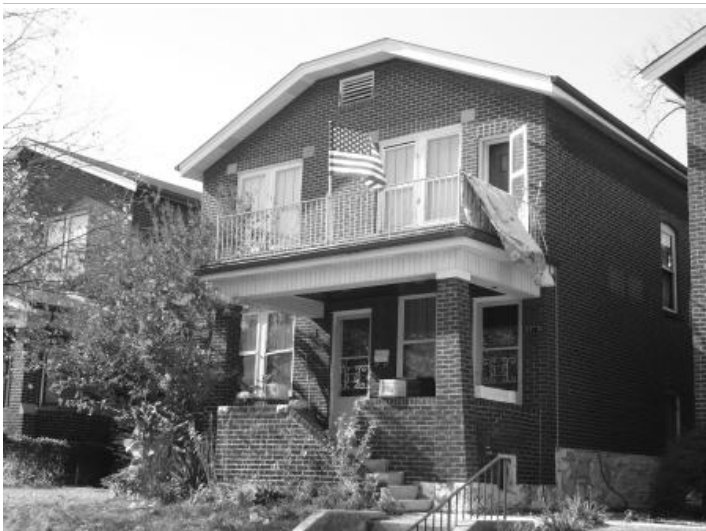
vergeboards and eaves are covered with siding.

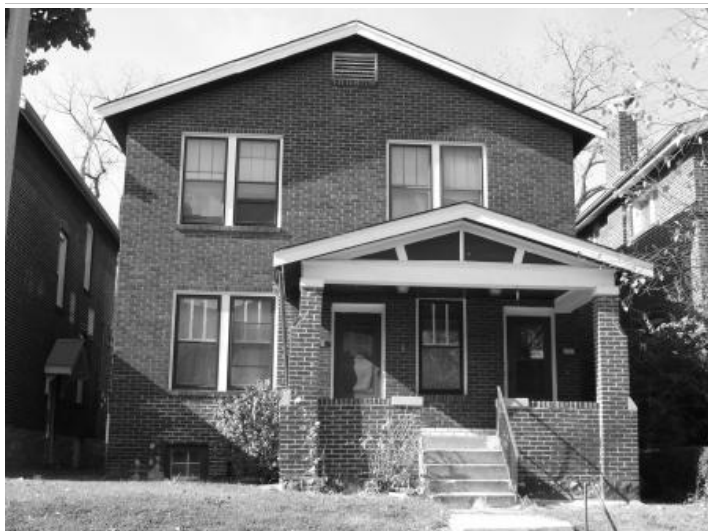
main roof's vergeboard covered with siding.

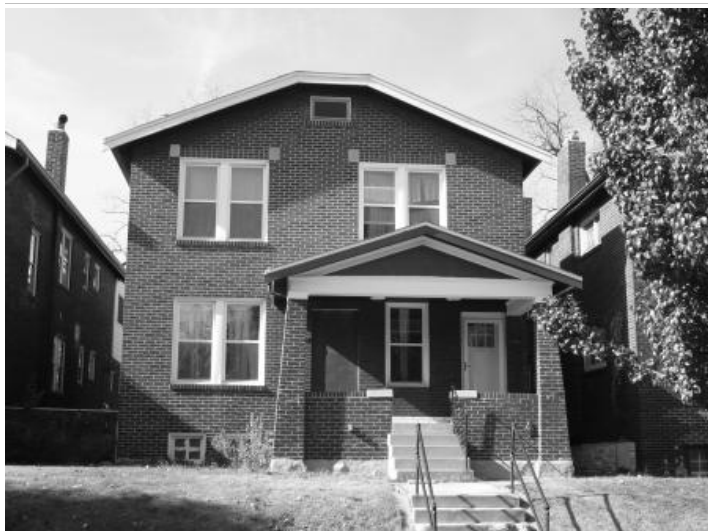
Left front door is boarded and all façade windows are replacements.

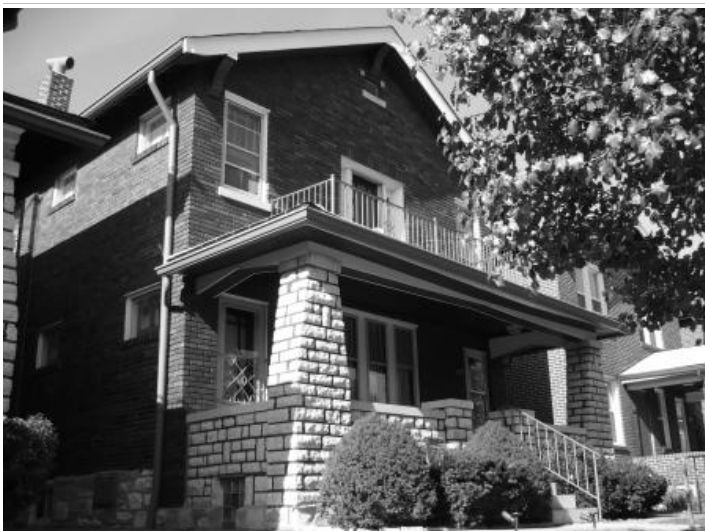
Some wood tri is wrapped.

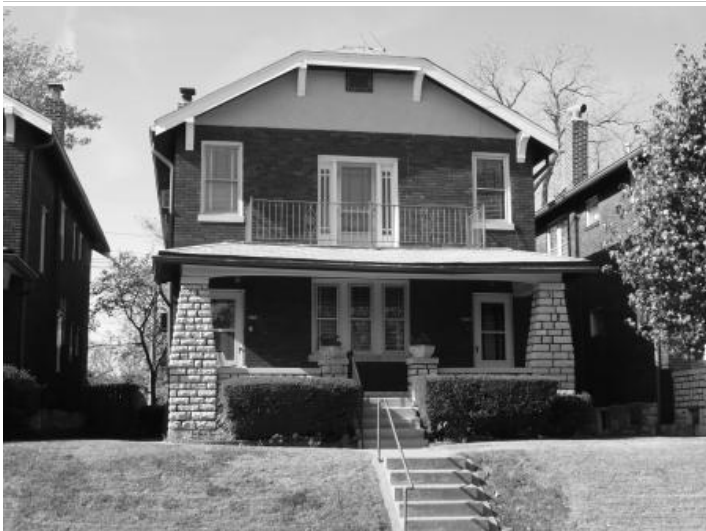
Some wood elements are wrapped in siding, including the four brackets and vergeboards at the main roof.

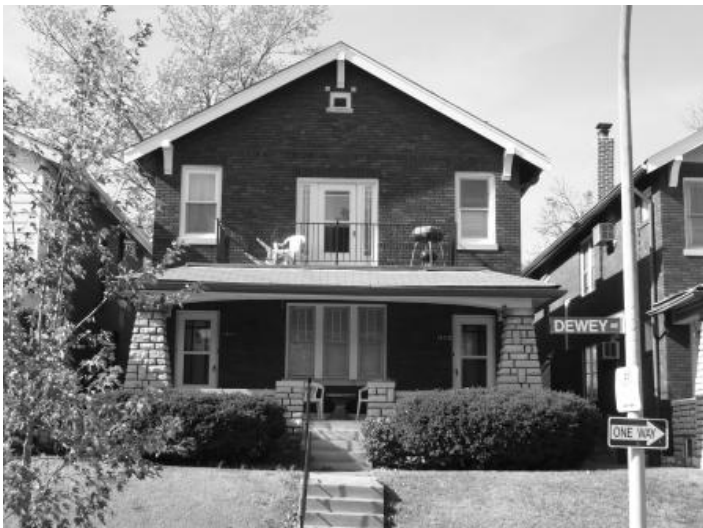
Some wood elements are wrapped in siding, including the three brackets and vergeboards at the main roof. Second floor windows are replaced

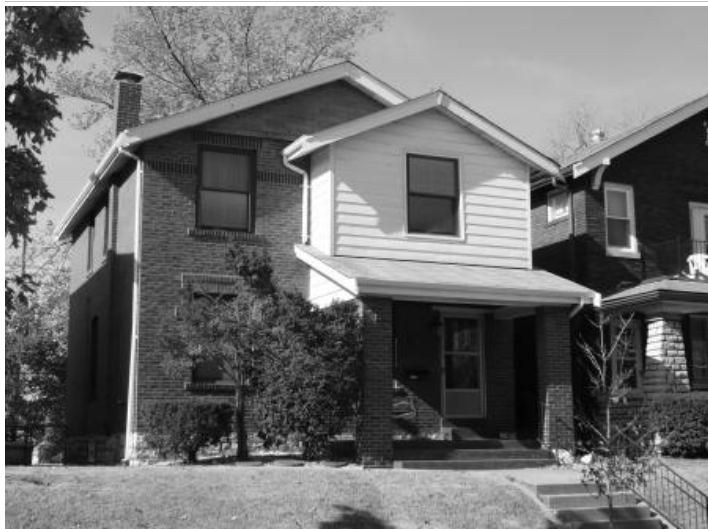
Projecting bay over porch, right, covered with siding. Replacement windows. Much of wood trim, included vergeboards, are wrapped.

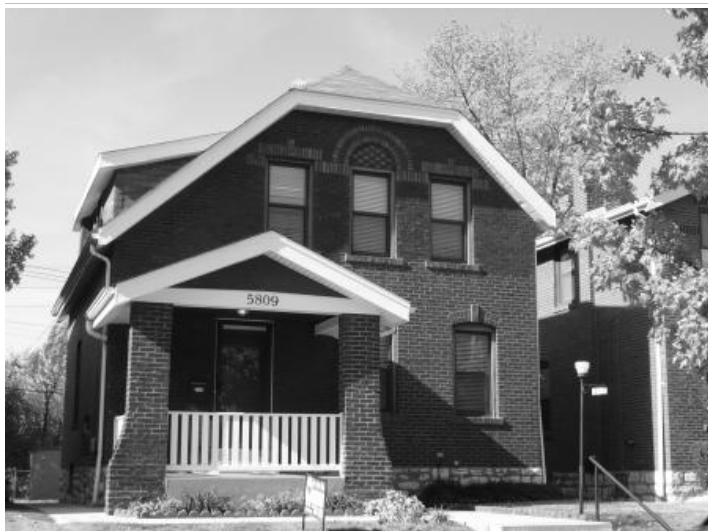
Replacement windows; some wood trim is wrapped with siding.

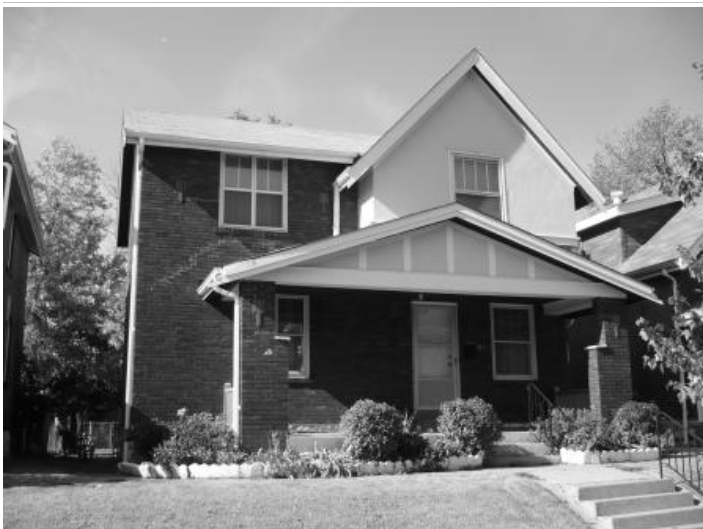
Replacement door.
