City of St. Louis Cultural Resources Office

Holly Hills Neighborhood Survey

Lynn Josse and NiNi Harris
3/1/2010

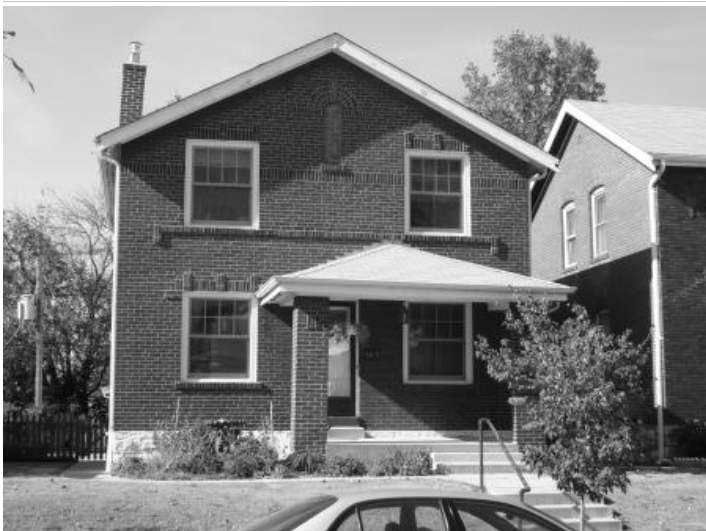
Replacement windows; most wood trim is wrapped.

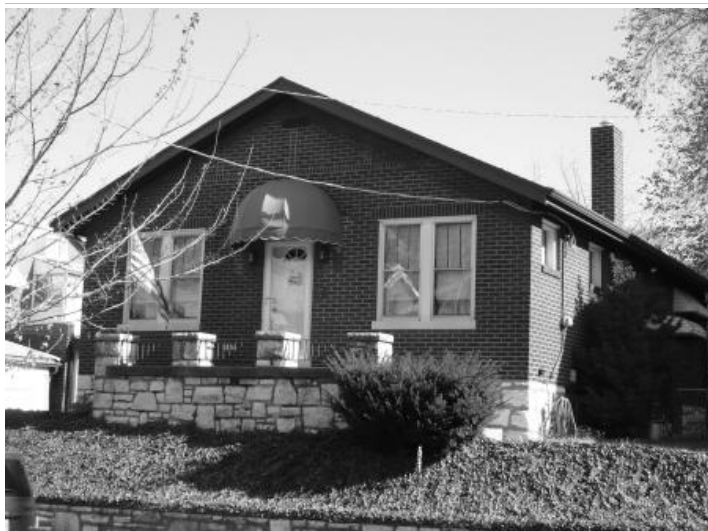
Replacement door sheltered by canvas awning. Some wood trim wrapped in siding.

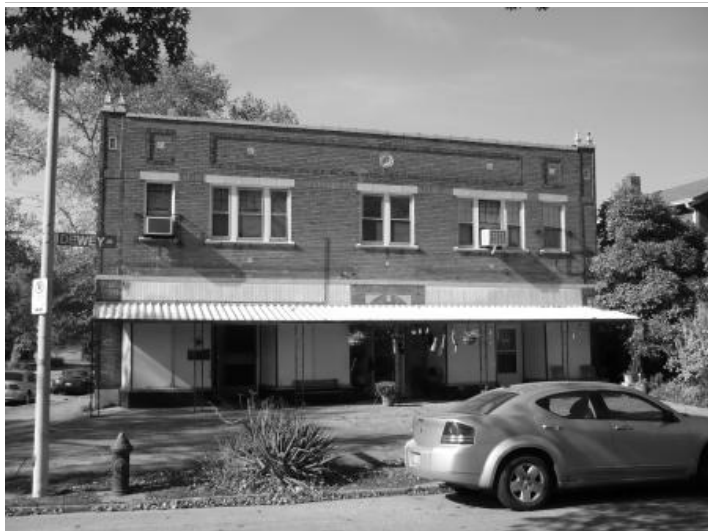
A full-width metal awning separates the storefronts from the covered transoms.

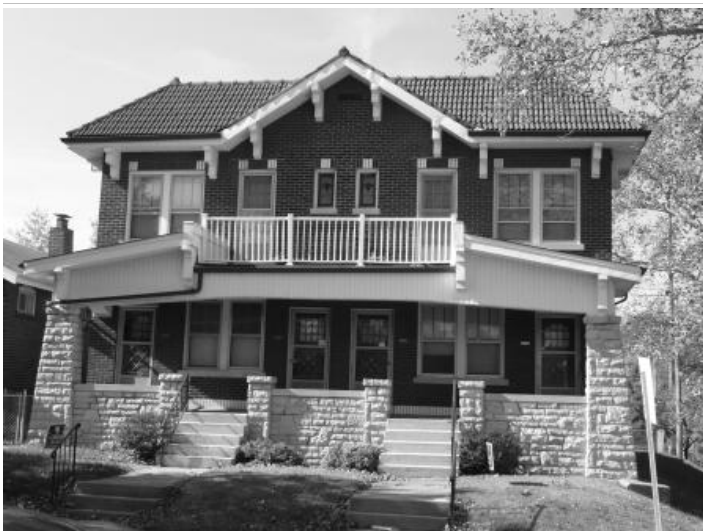
Porch brackets/eaves gable end are covered with siding.

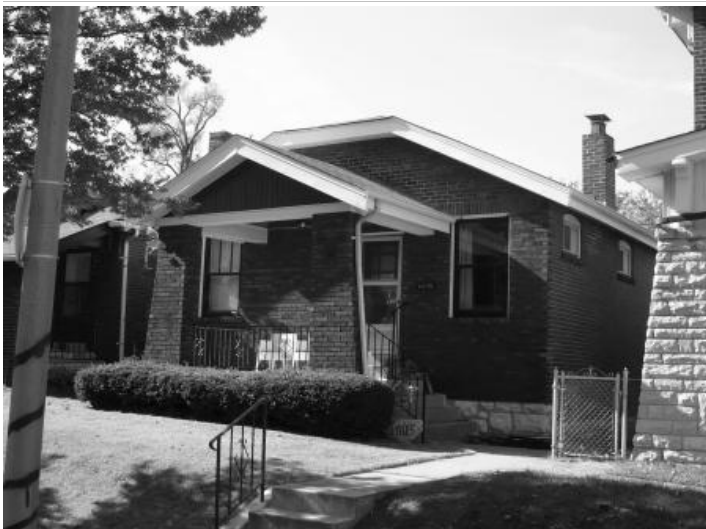
Eaves, soffit and gable end of porch are encased in vinyl.

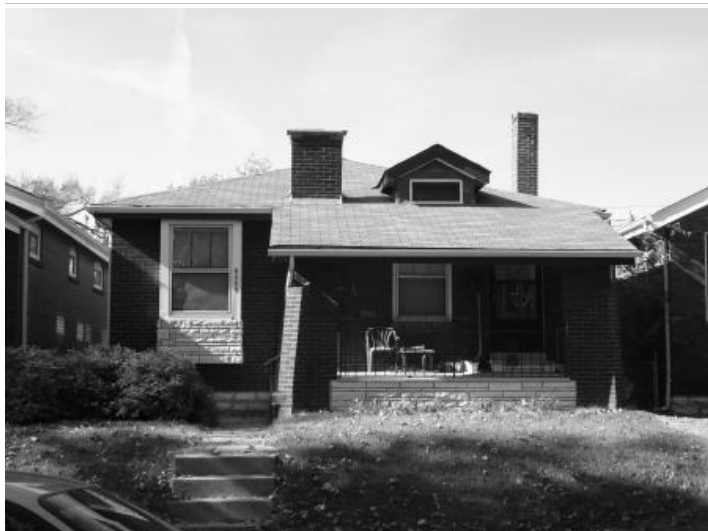
Imitation stone veneer at porch and under left window.

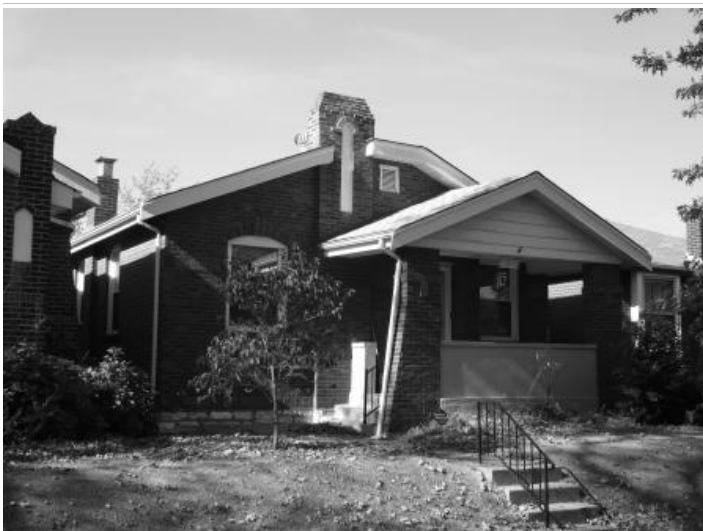
Replacement window, porch wall; gable end of porch and related wood trim sided with aluminum.

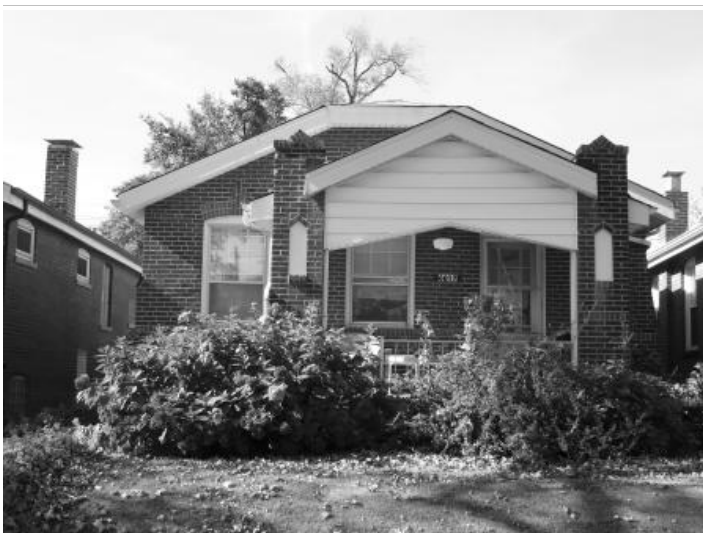
Gable end , soffits / eaves are encased in vinyl.

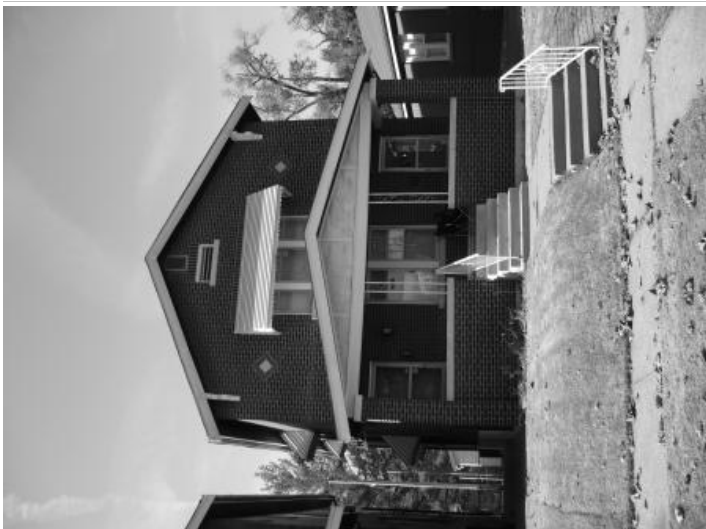
Replacement doors. Added metal supports for porch roof. Metal awning over second story windows.

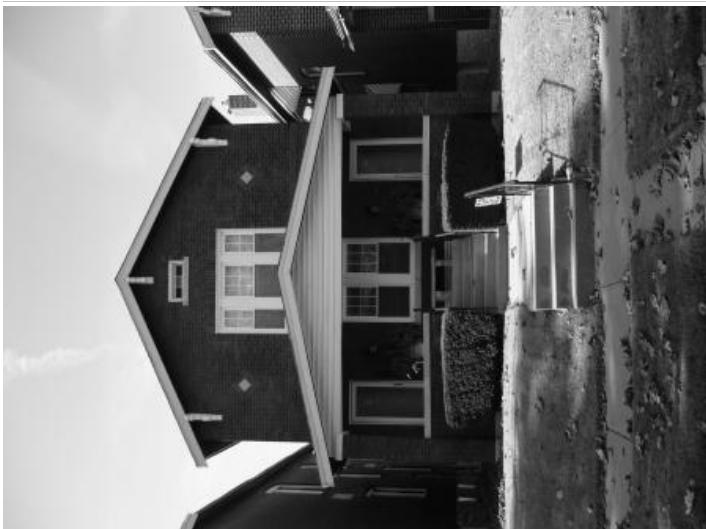
The porch gable end is sided with aluminum, and façade doors and windows are modern replacements.

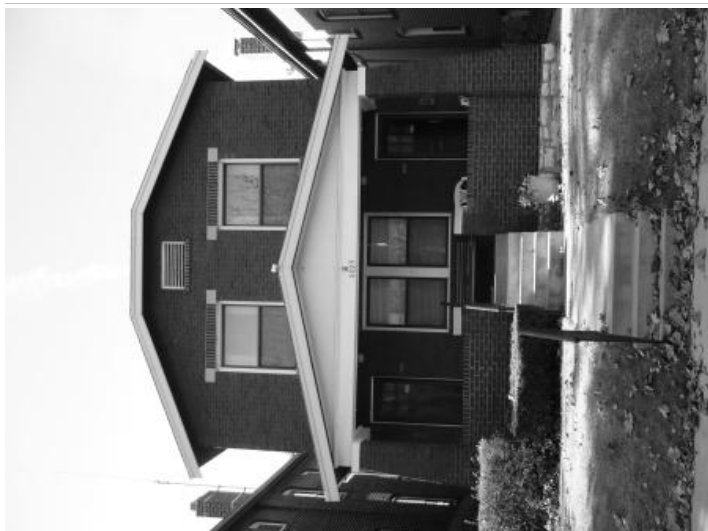
Replacement windows. Gable end covered with wood.

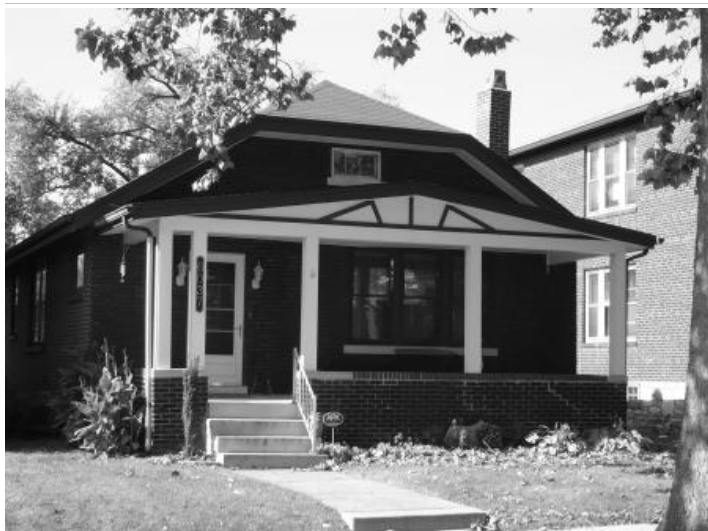
Porch roof and supports are new. Replacement windows and doors.

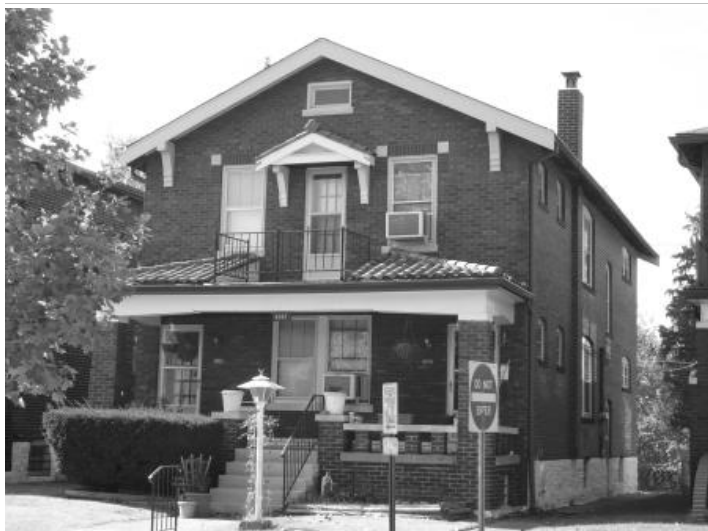
Brackets at main roof are clad in aluminum.

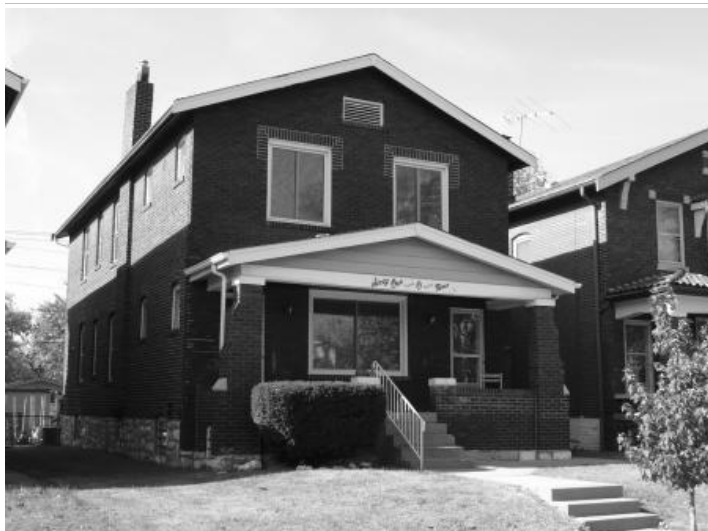
Porch gable end and eaves are encased in siding, Both front doors and all façade windows are replacements.

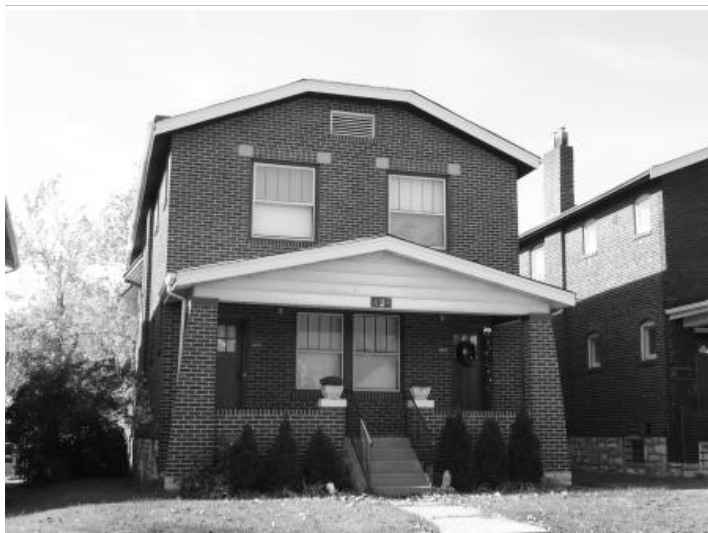
Porch eaves, soffit and gable end all covered with siding

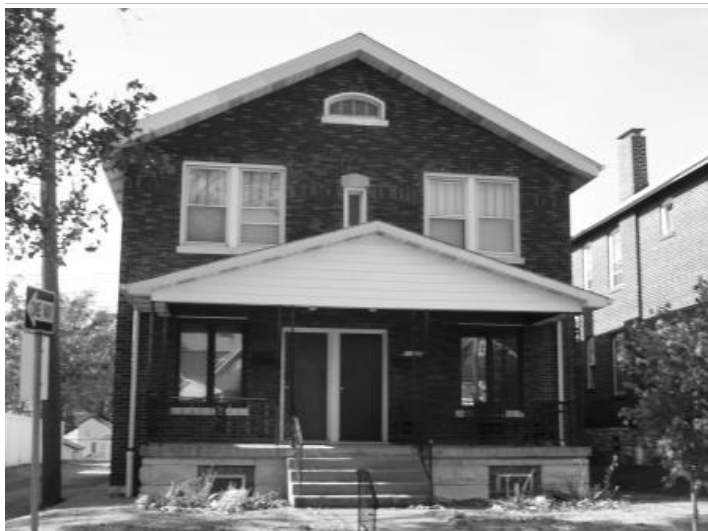
Replacement doors and first story windows. Front porch rebuilt; its gable end is covered with siding, now supported on metal piers.

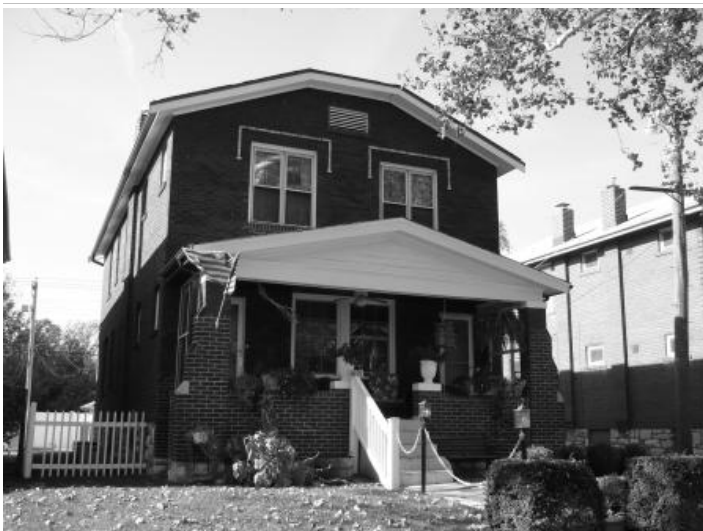
Replacement doors and first story window. Brick labels at 2nd story highlighted with white paint. Windows added at sides of porch.

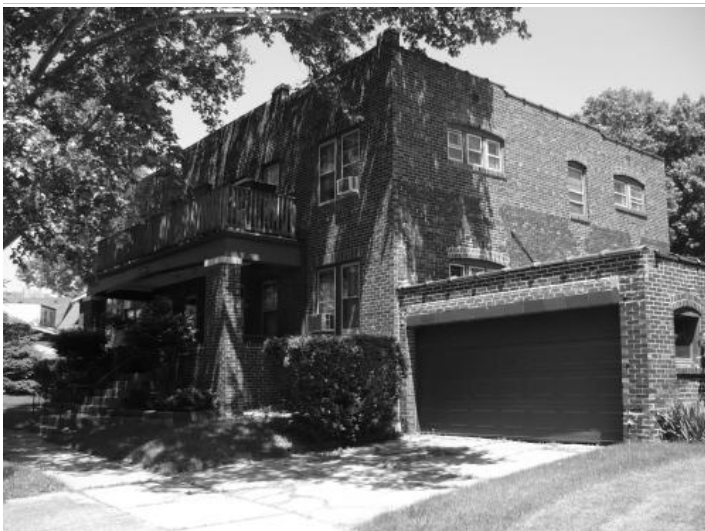
Replacement wood balcony railing. Attached garages to either side.

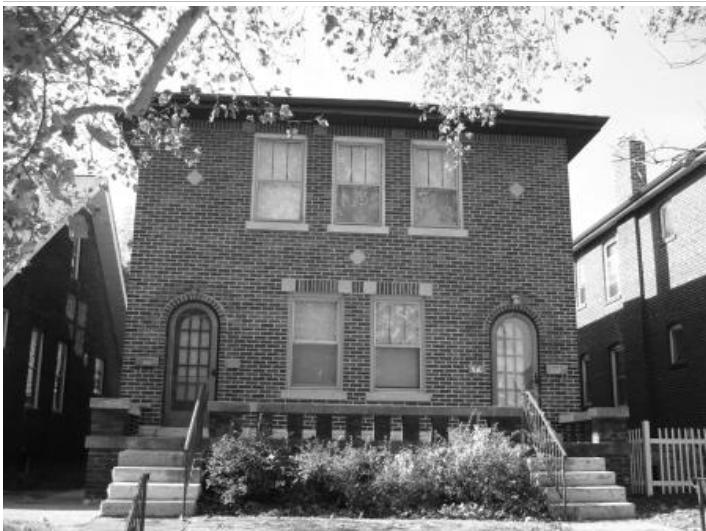
One replacement window at first story.

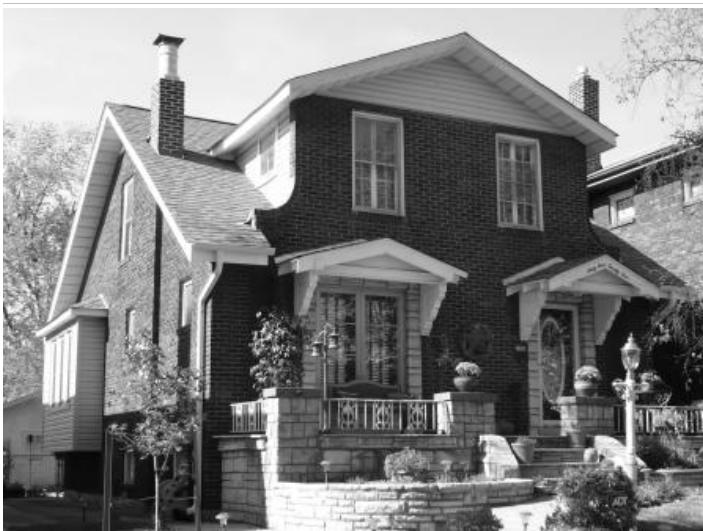
Imitation stone veneer framing first story openings and walls of porch. Gable end covered with aluminum siding. Metal railing c. 1960s.

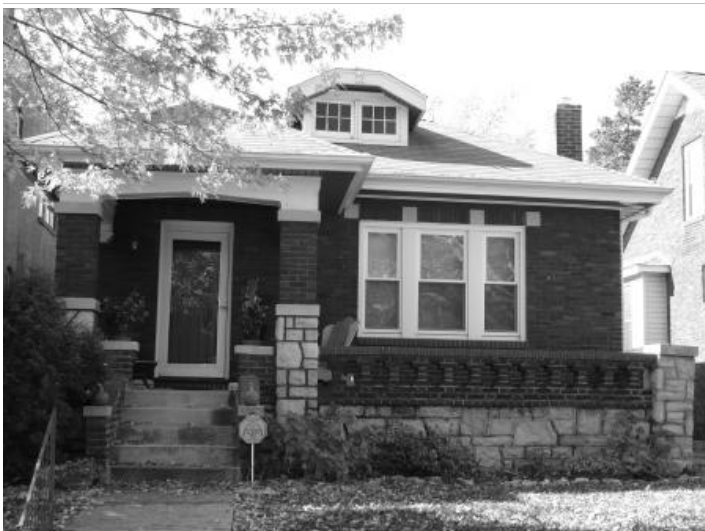
Replacement windows on first story.

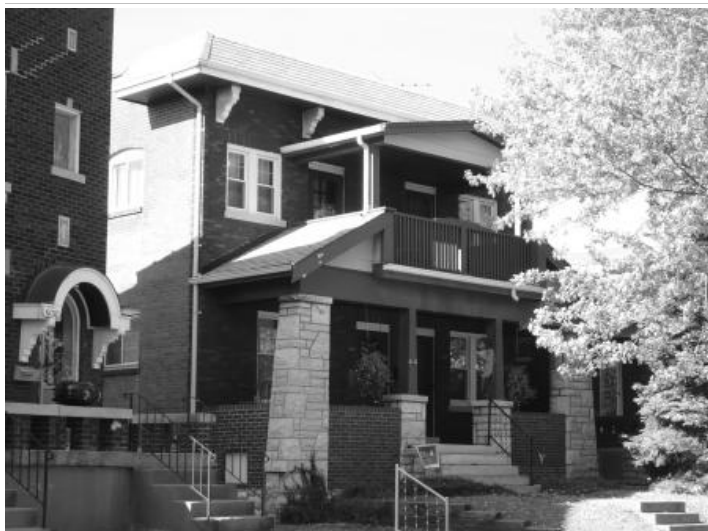
First story doors are replacements, as are windows. Gabled roof added over balcony.

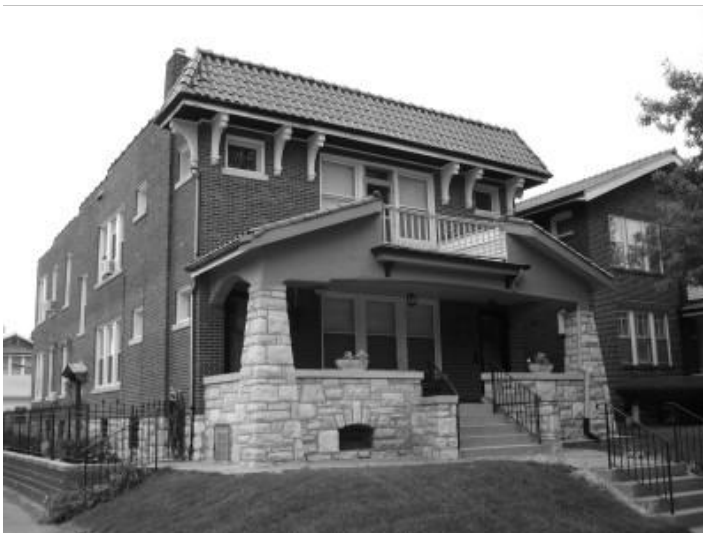
Replacement windows.

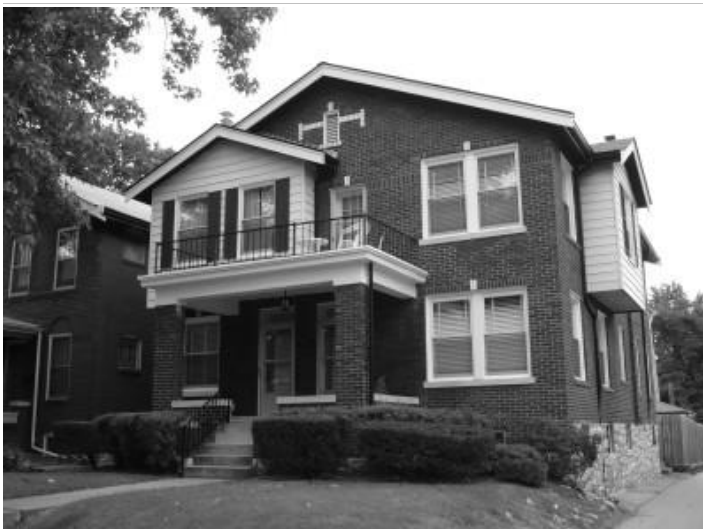
Façade windows are all replacements; added shutters; siding at bay.

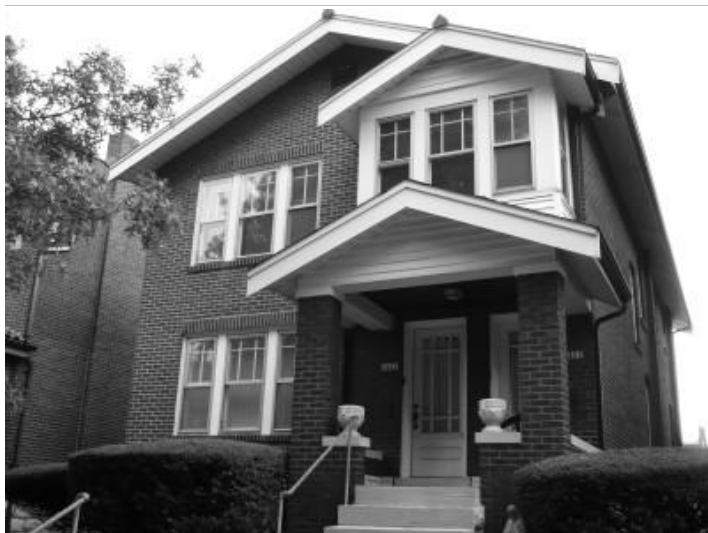
Siding is over the gable ends of the porch and bay and over some wood trim.

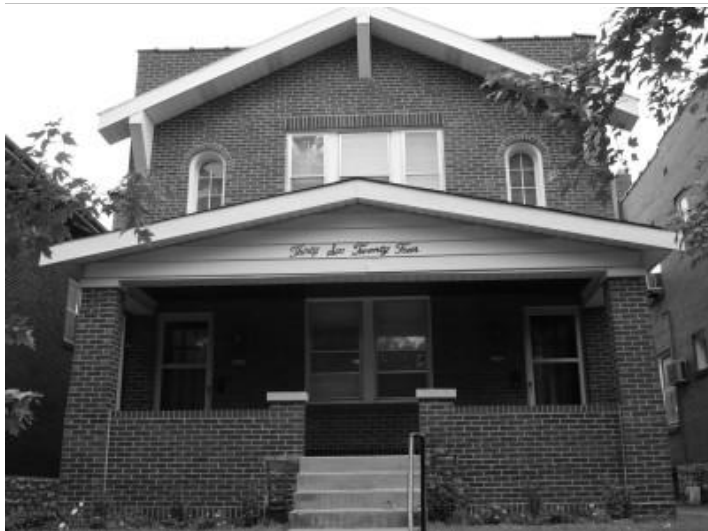
Eaves and brackets are sheathed in siding. Gabled end of porch is sided.

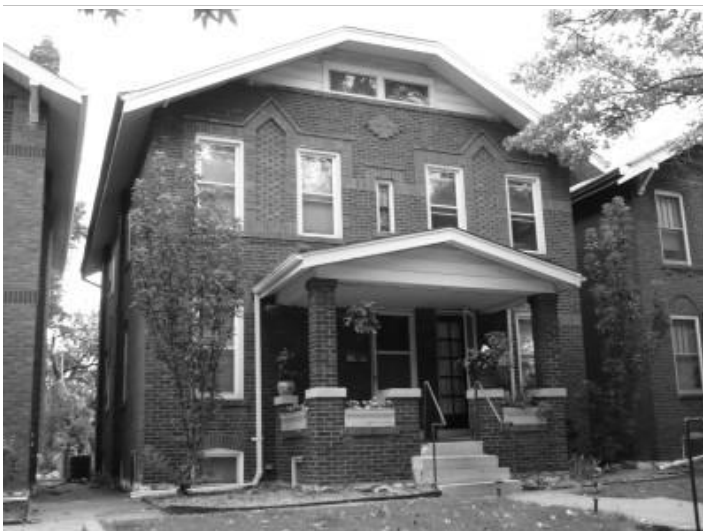
Replacement windows. Eaves, ceiling, gable ends are sided.

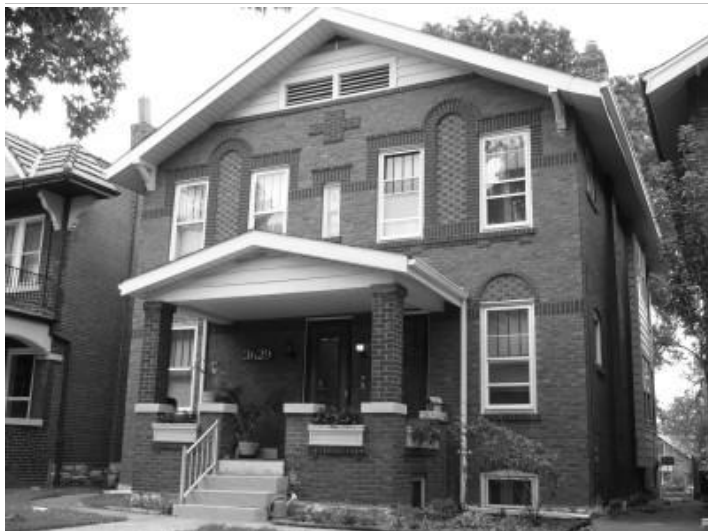
Replacement doors; vinyl-encased eaves, gable ends, soffits, brackets.

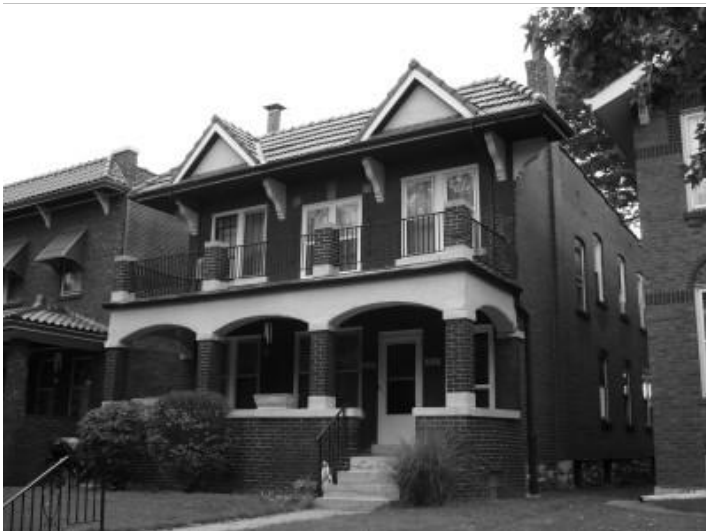
Replacement windows at façade.

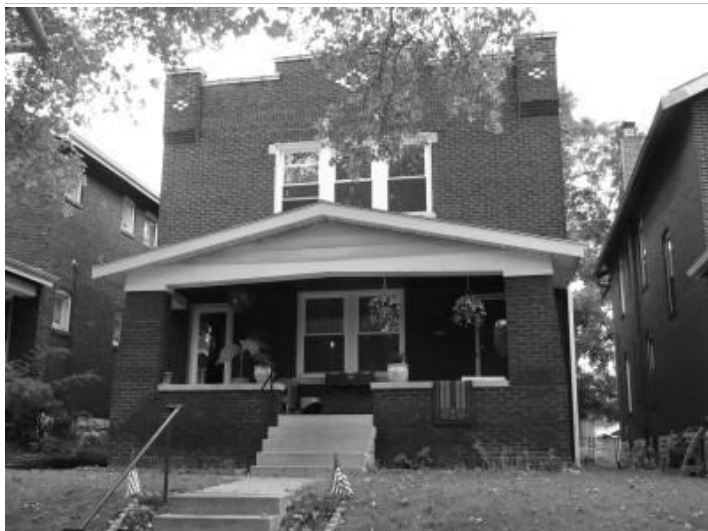
Doors and windows replaced; porch's gable end, eaves and vergeboard covered with siding.

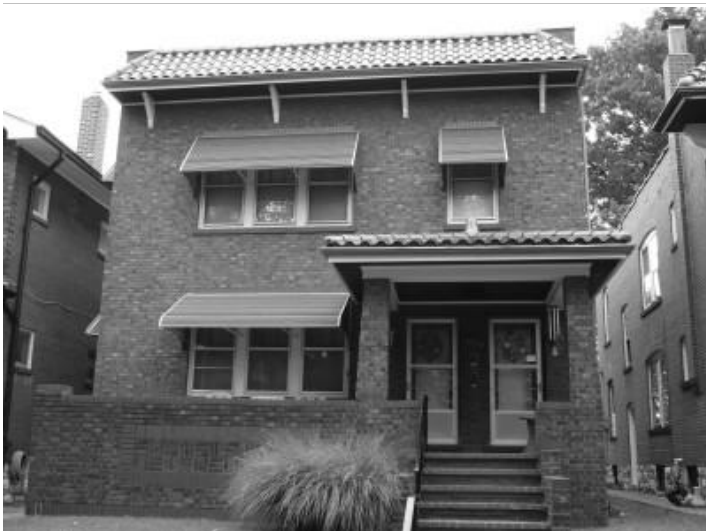
Fiberglass awnings at all façade windows.

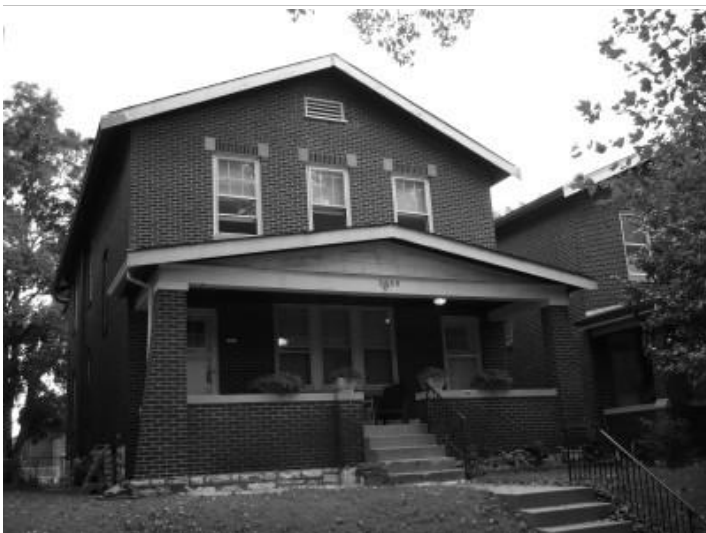
Replacement doors.

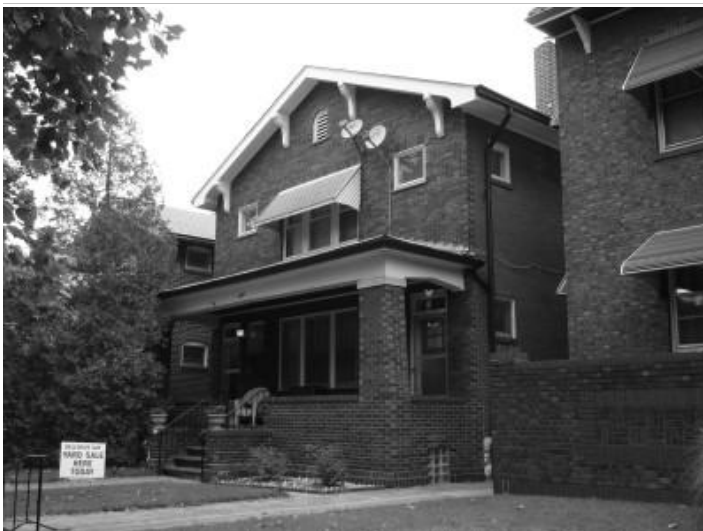
Metal awning at 2nd story windows.

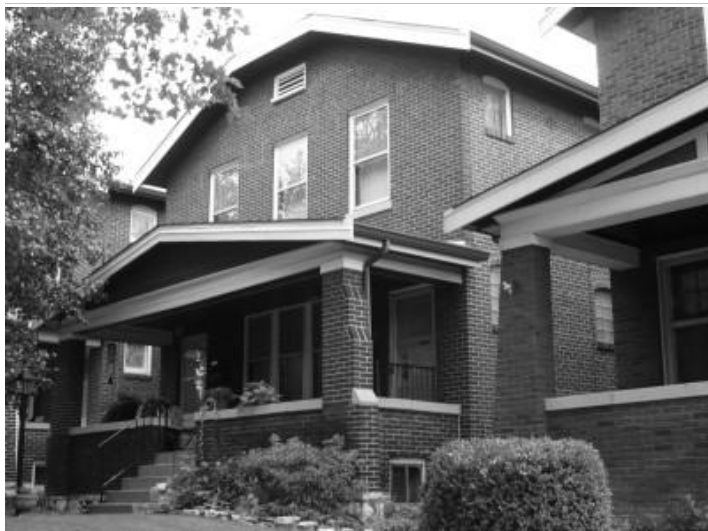
Some siding over wood trim, including window frames, vergeboards, gable end of porch.

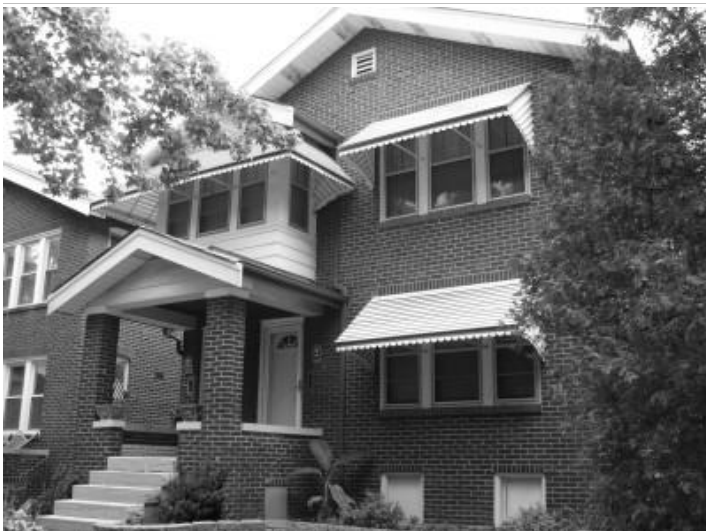
Siding at eaves, gable ends, soffits and frame bay (over porch). Replacement front doors.

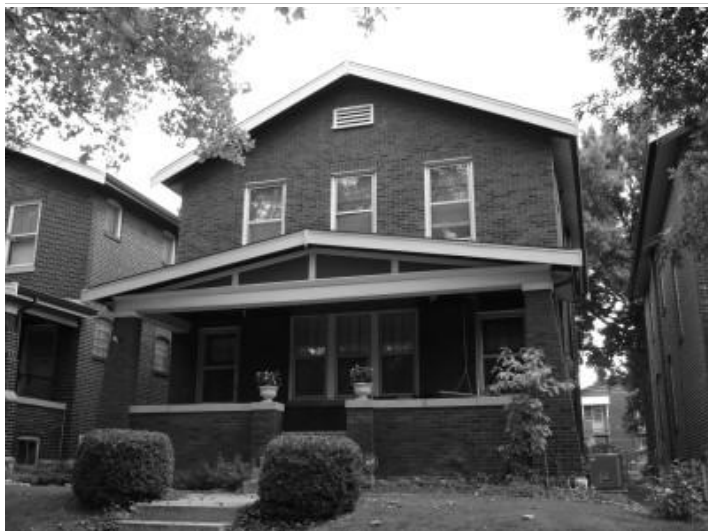
Vergeboards, window frames, and even the imitation half-timber at porch gable end are covered with aluminum.

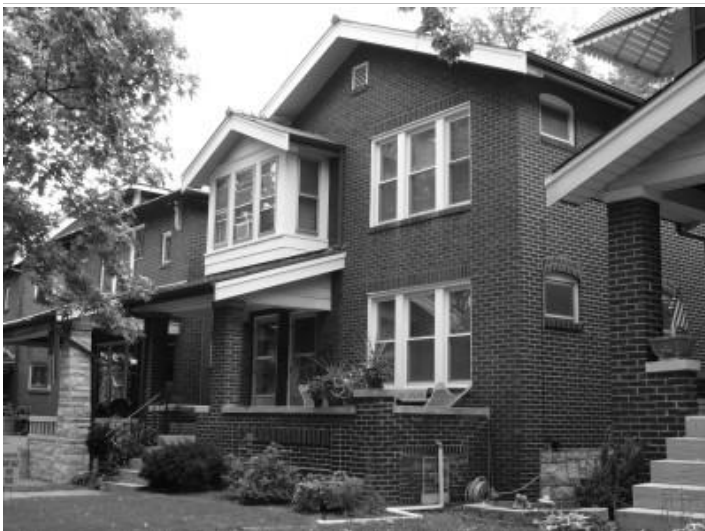
All other façade windows are replaced, as are the front doors. Sided eaves and soffits.

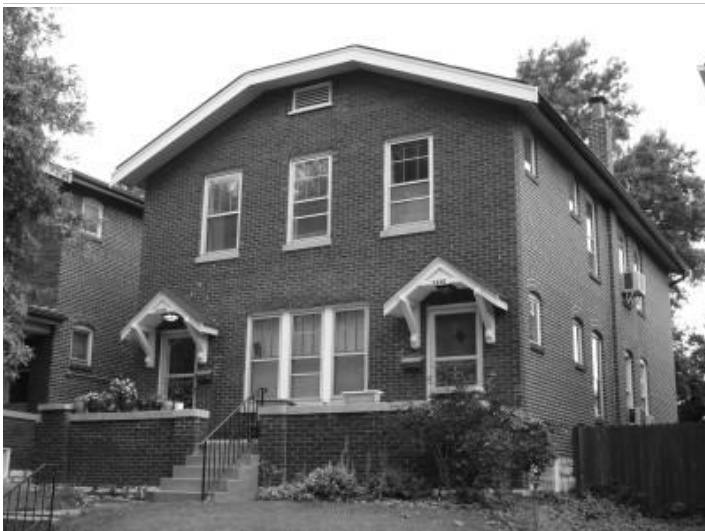
The two front doors are replacements. Some wood trim is covered with aluminum.

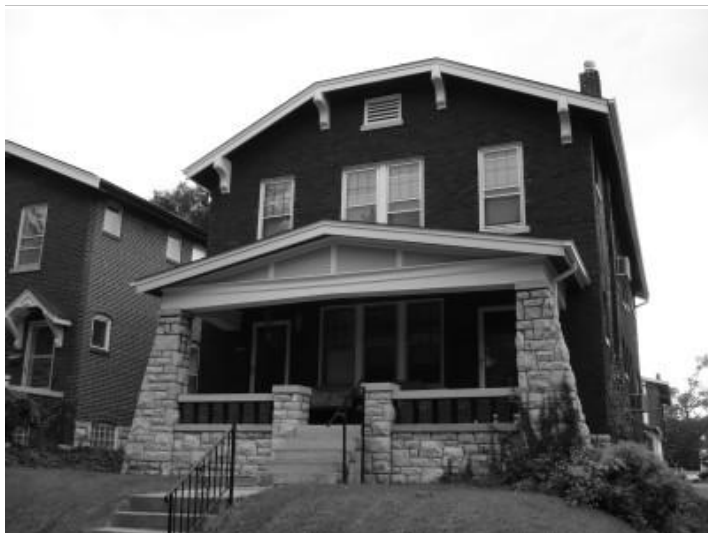
Vergeboards are covered with aluminum, but otherwise the exterior is very intact.

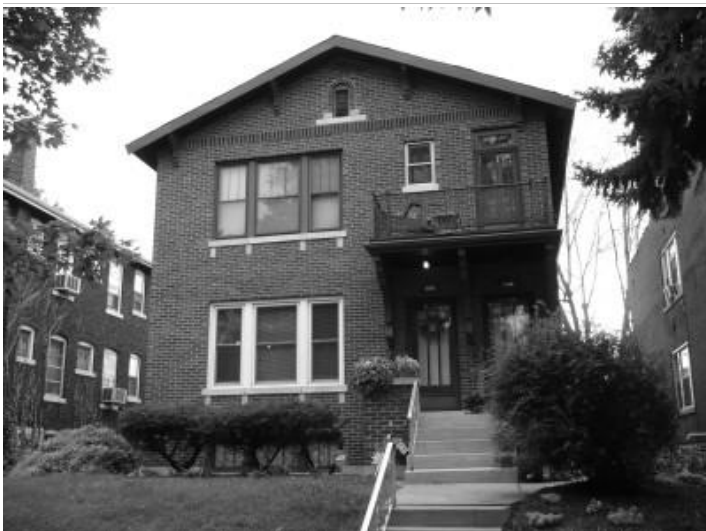
The lower story has replacement windows.

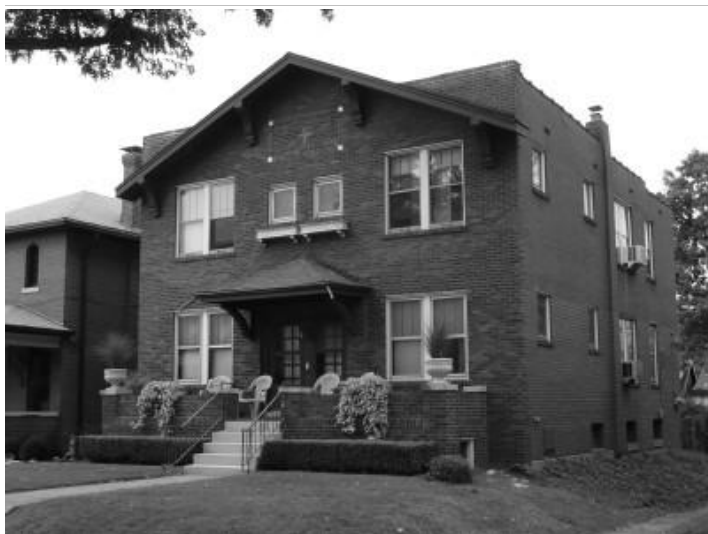
The foundation appears stuccoed; the red brick side walls descend past the coal chutes and windows to a low foundation course.

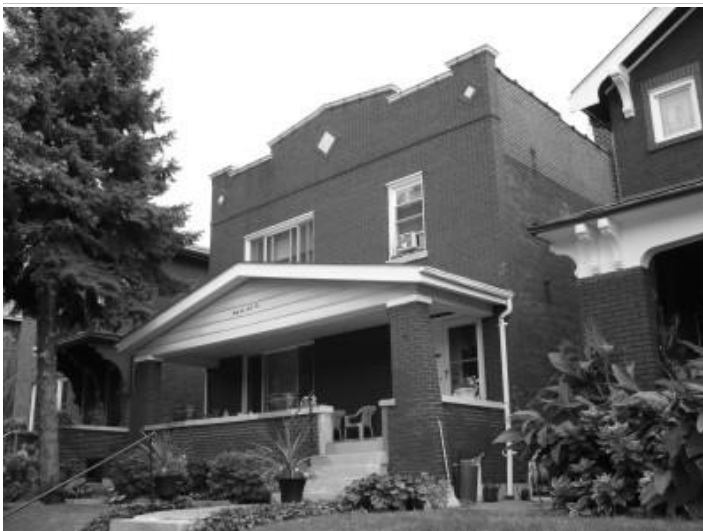
There's siding over the gable end at the porch, eaves, and vergeboard. Façade windows and doors are replacements.

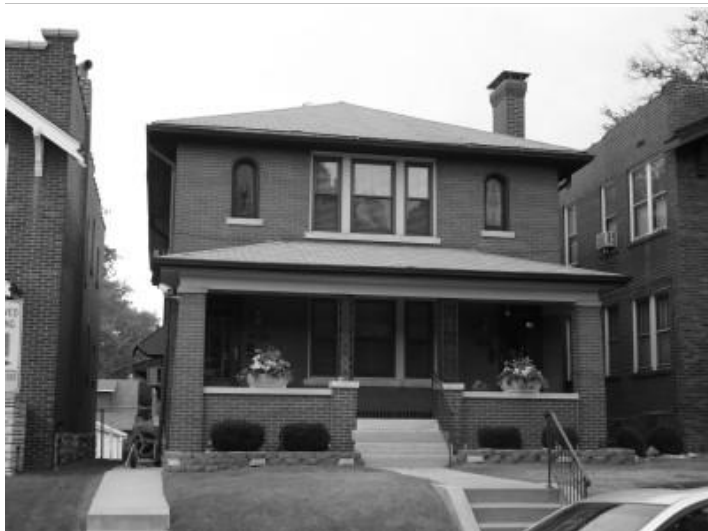
Sash windows are modern replacements. Two metal trellis-style supports supplement the brick piers at the porch.

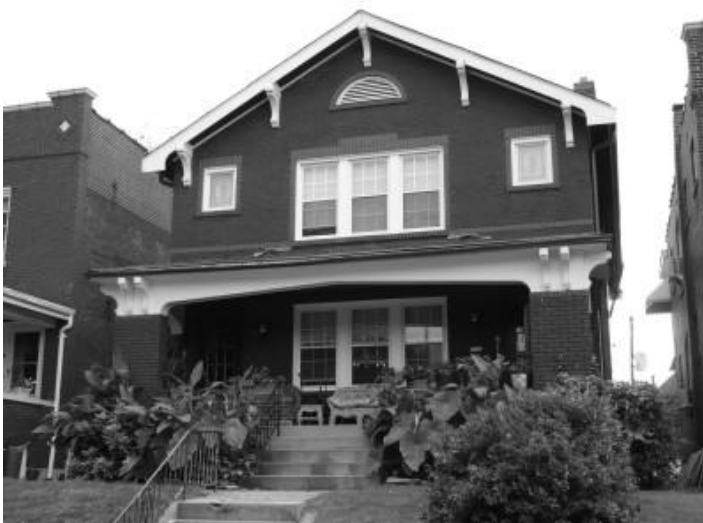
The triple sets of window at the center of both bays are replacements.

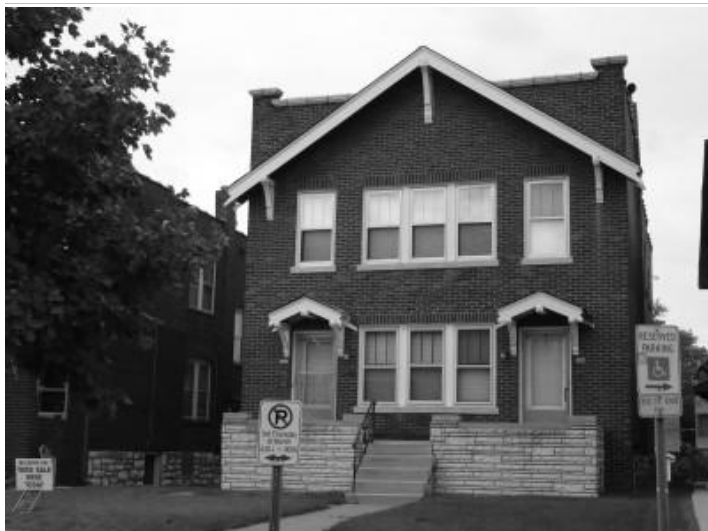
Imitation stone veneer covers porch base.

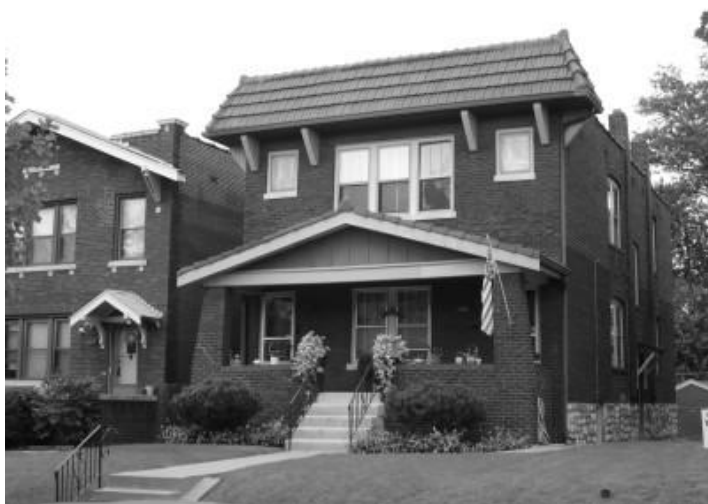
Vinyl encases the eaves, soffits, gable end, and brackets

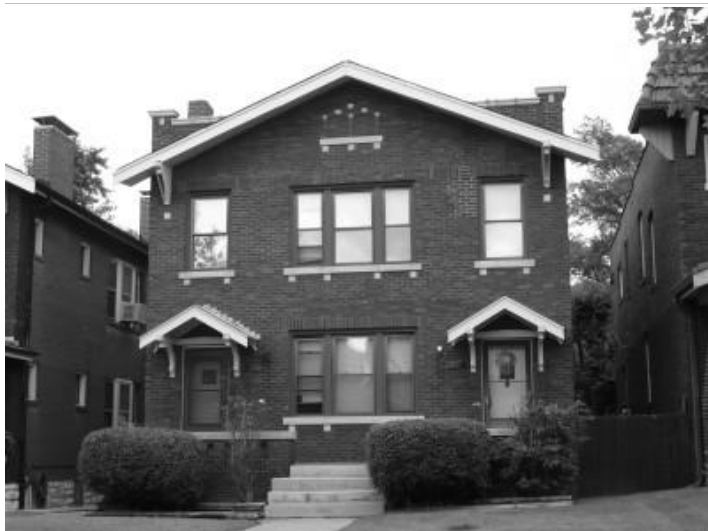
All doors and windows are replacements.

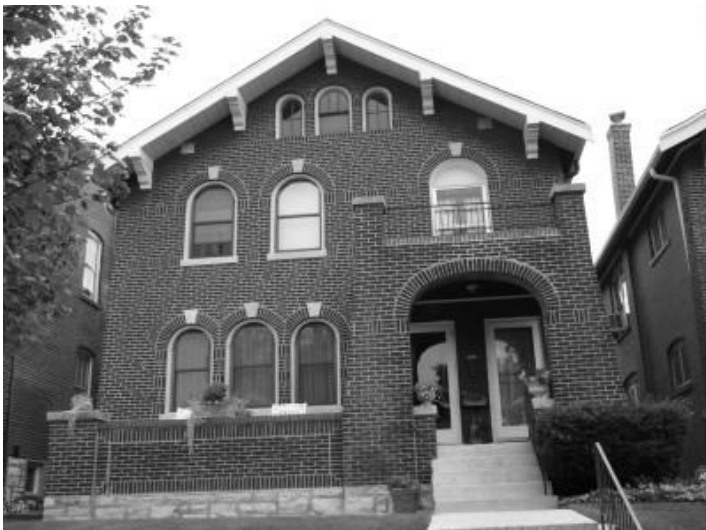
Round arch over balcony doors is filled in, and the five main façade windows are replaced. Brackets, eaves and windows frames covered with aluminum.

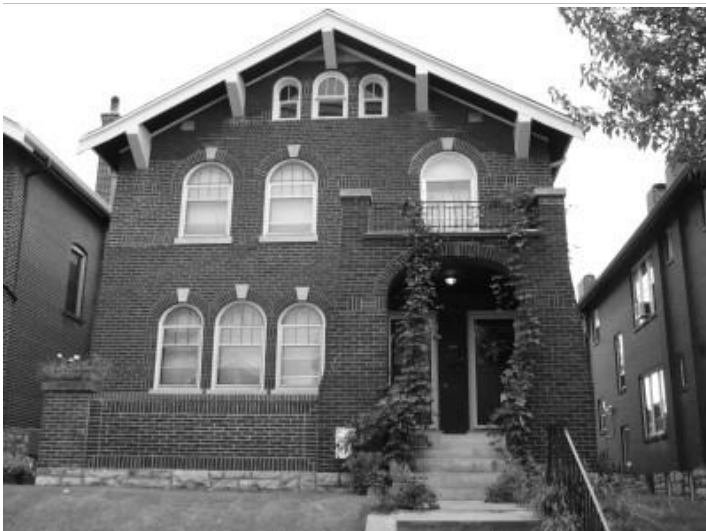
The eaves are supported by five wood brackets, now soffitted.

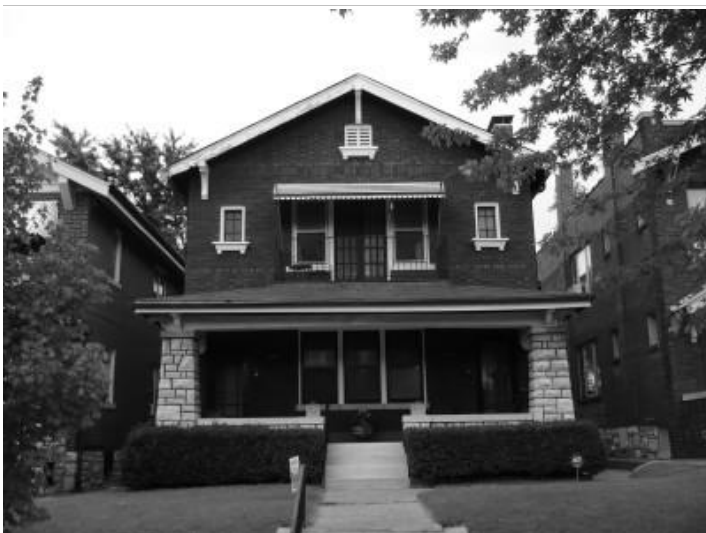
A metal awning at the balcony is added

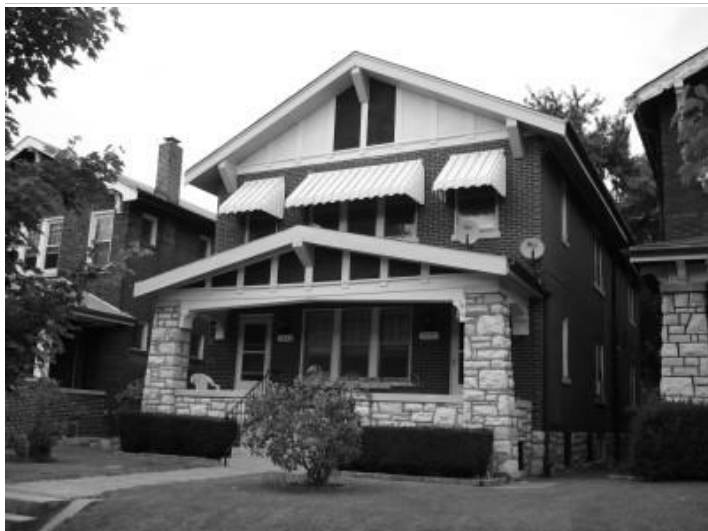
Eaves and brackets are encase in siding. Metal awnings are at the 2nd story windows.

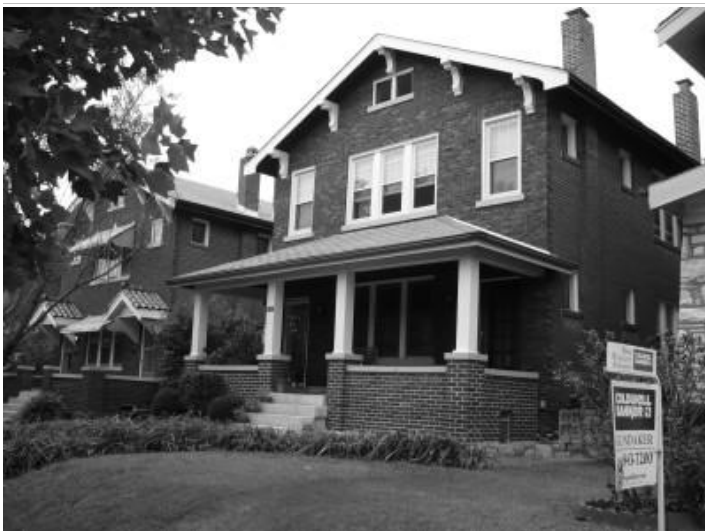
Replacement windows

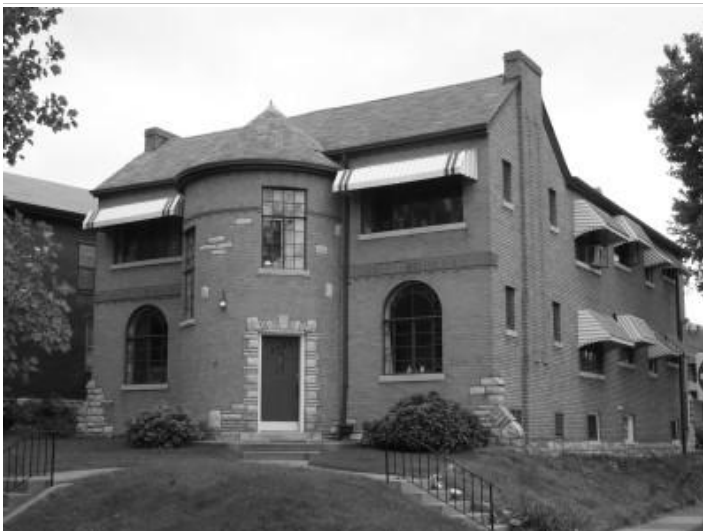
Metal awnings at west elevation and upper façade windows.

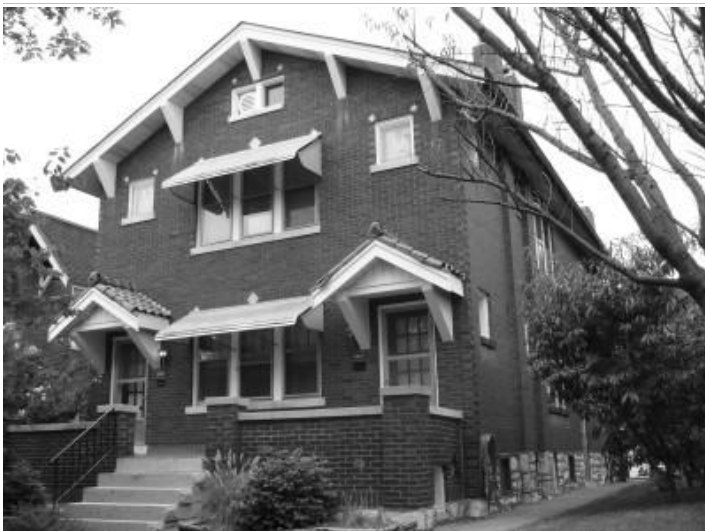
Fiberglass awnings added over two center window sets; five brackets at roof and eaves are encased in vinyl.

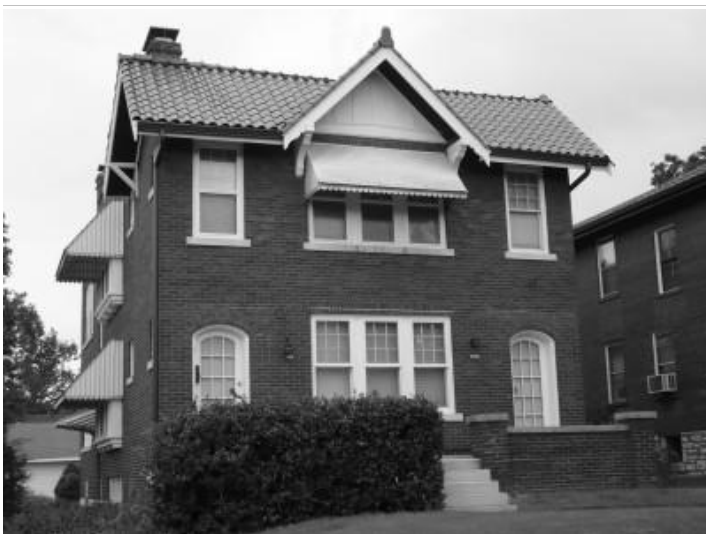
awning at 2nd story center window set. It appears that there may have been hoods over the two front doors.

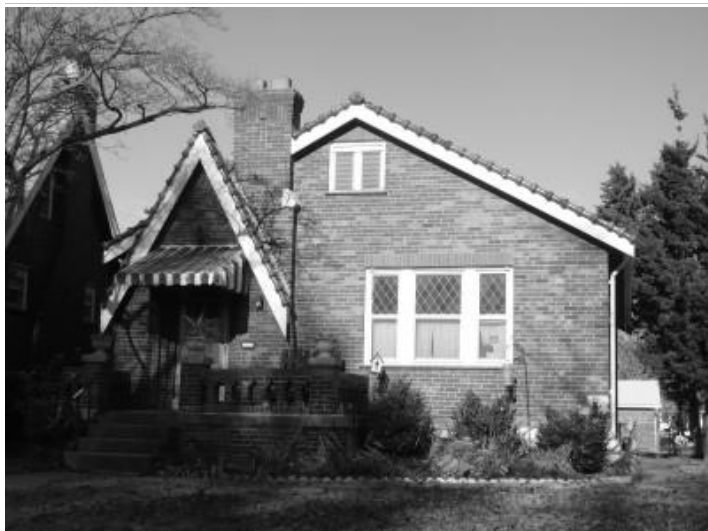
vinyl over vergeboard; replaced attic window; metal awning over door.

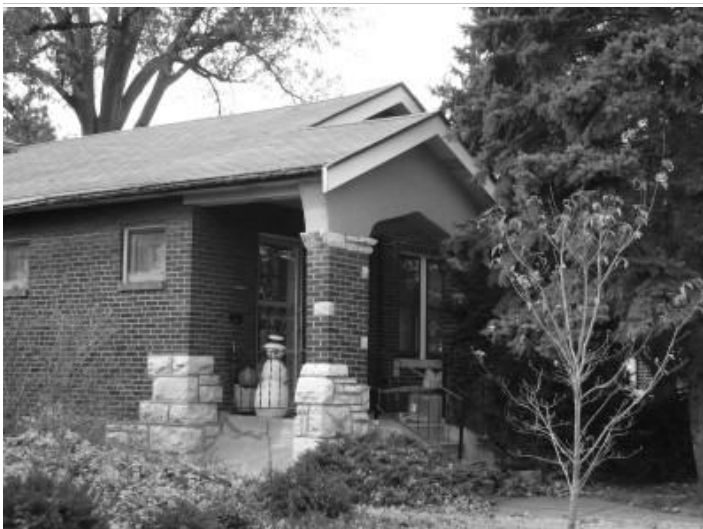
Replacement windows

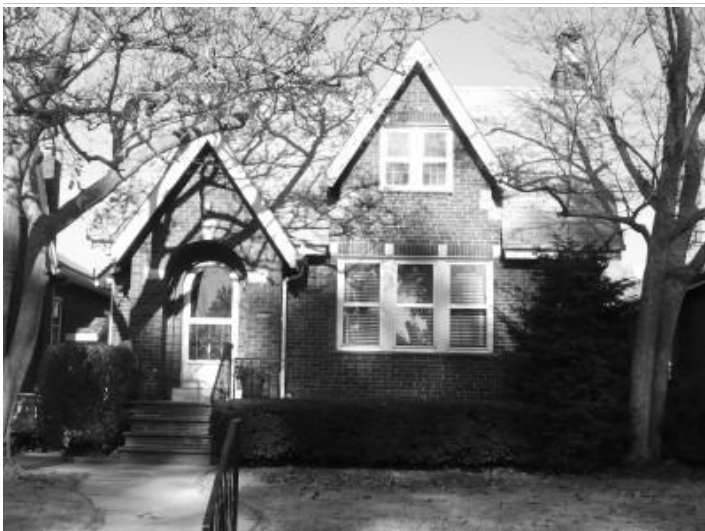
Siding over vergeboard.

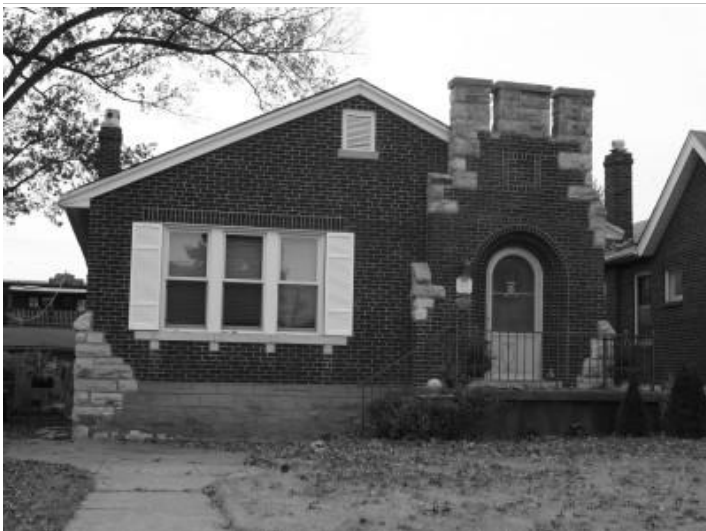
Triple set of windows, left, is a replacement with faux shutters that would not cover much of the window area if closed.
