City of St. Louis Cultural Resources Office

Holly Hills Neighborhood Survey

Lynn Josse and NiNi Harris
3/1/2010

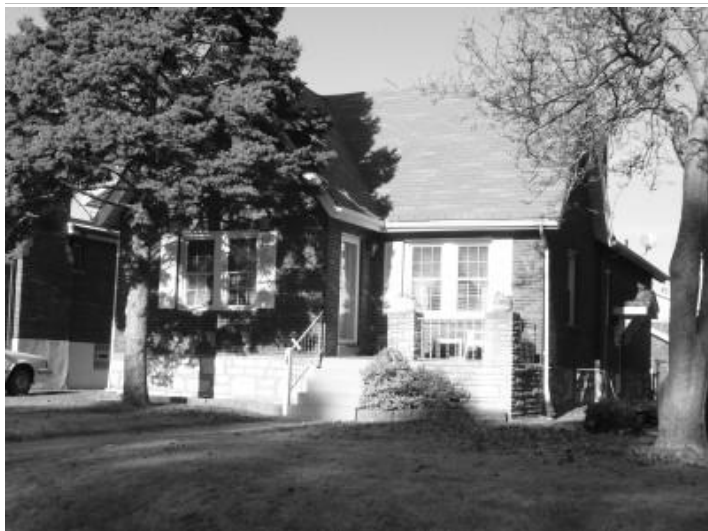
Replacement door, window; shutters added; imitation stone veneer covers porch base; aluminum over vergeboard/eaves.

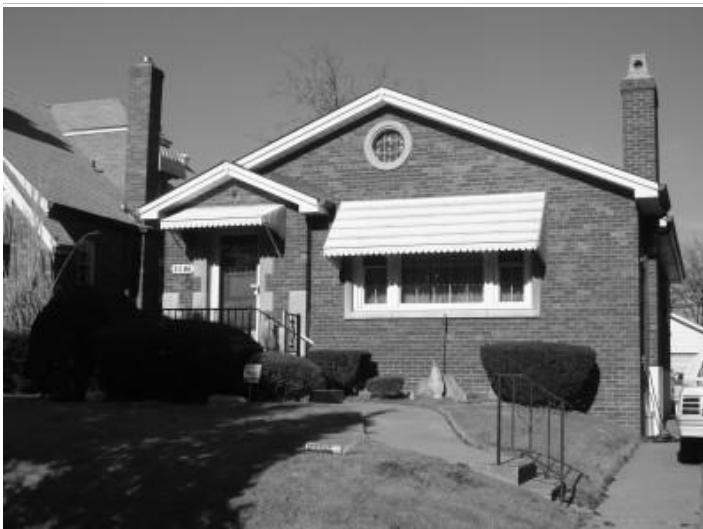
Replacement window; aluminum sheathed vergeboard and eaves.

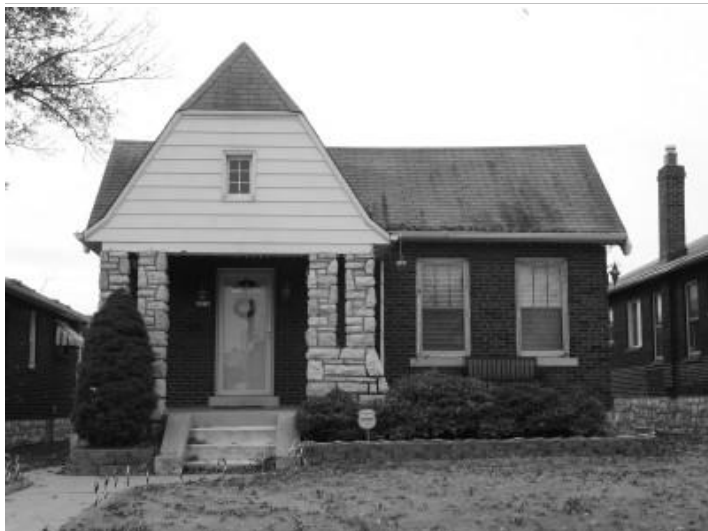
Replacement front door; siding at gable end, vergeboard and eaves

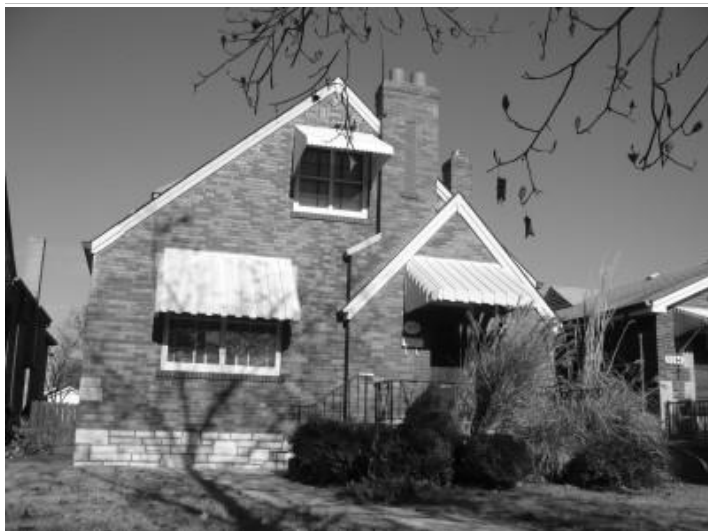
Metal awnings over windows and door. Siding over vergeboard.

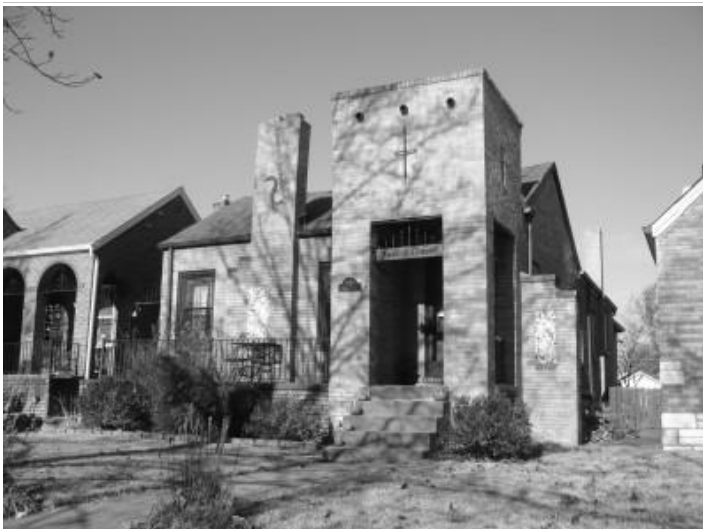
\$2200 addition to owners berring 4/8/1952, must be at rear of house. Window frames have some protective siding on them.

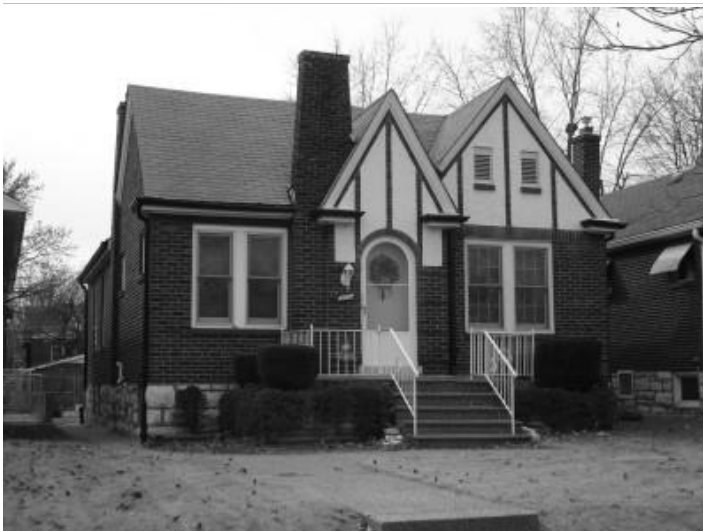
One of the façade's window pairs is a replacement.

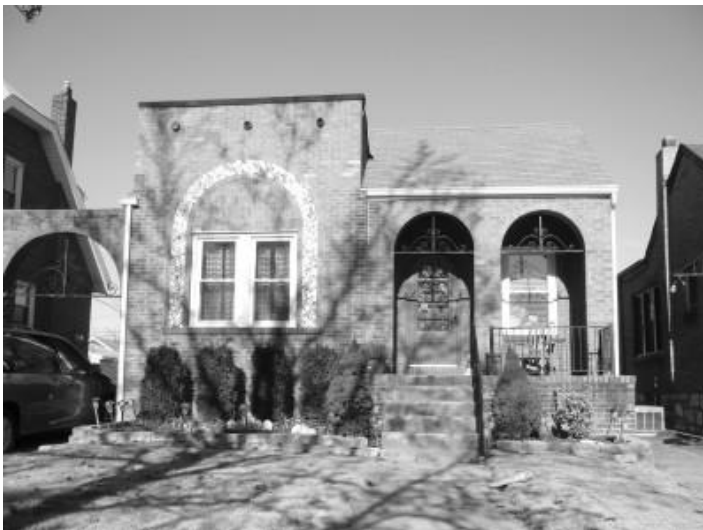
Replacement windows.

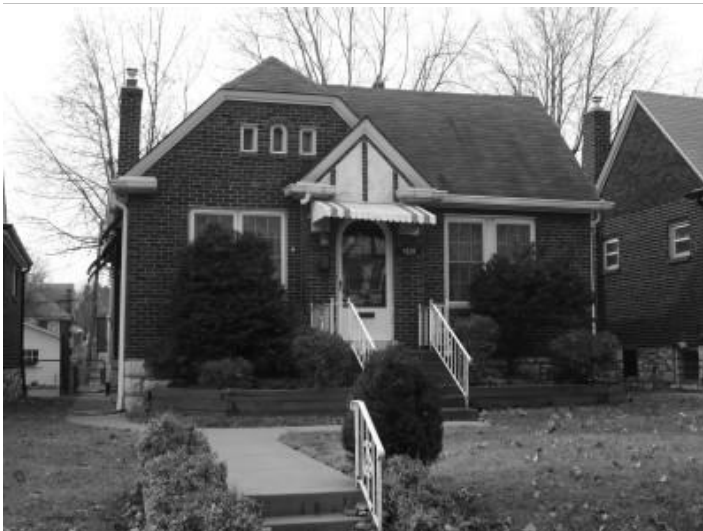
Windows are vinyl replacements. Metal awning over front door. Siding covers some window trim, vergeboards and eaves.

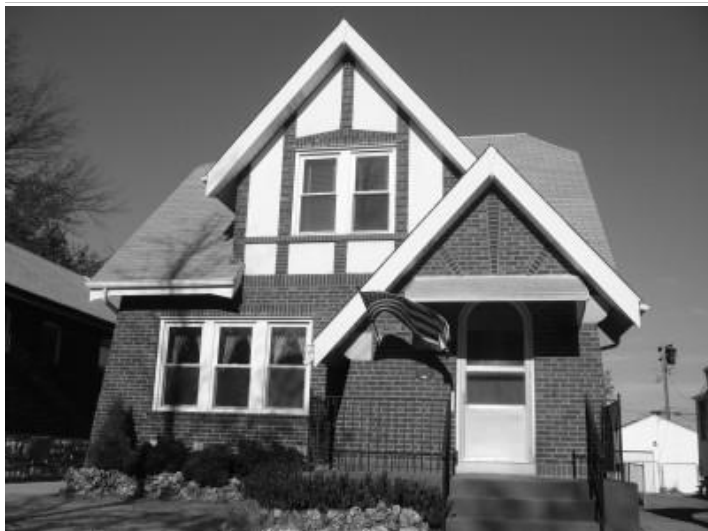
Replacement windows, fiberglass awning, some wood trim obscured by protective vinyl siding.

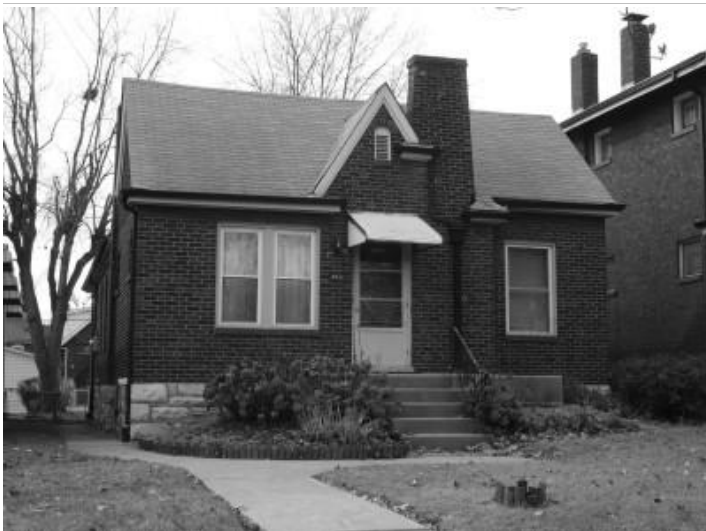
Replacement widows; fiberglass awning over door; aluminum covers vergeboard, eaves, window frames.

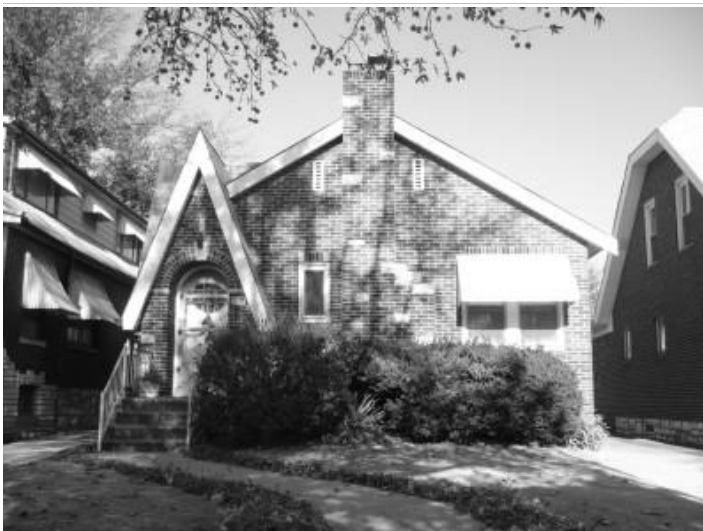
Alterations are minor, including a fiberglass awning over façade windows and aluminum sheathing at the vergeboard and eaves.

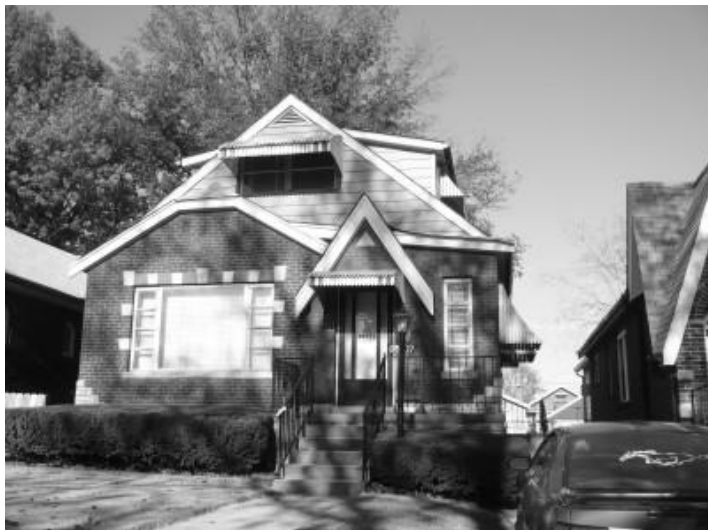
\$5000 alteration 3/63/1956 - appears to be for the addition of a full second story that built up from a complex roofline into a simple front gable with shed dormers on either side. Depending on period of significance, this building may be NC

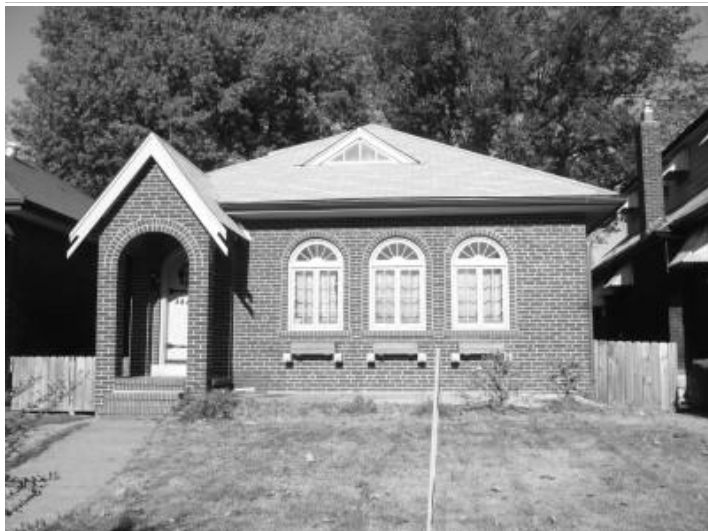
Shed dormer at back of left side appears added.

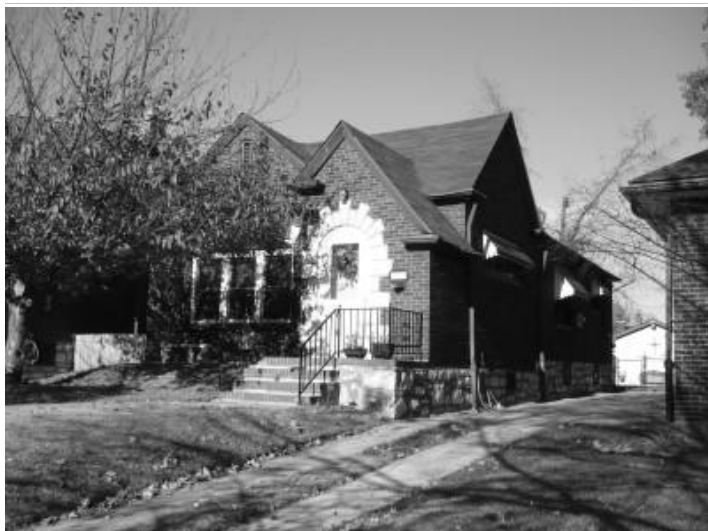
aluminum covers vergeboard.

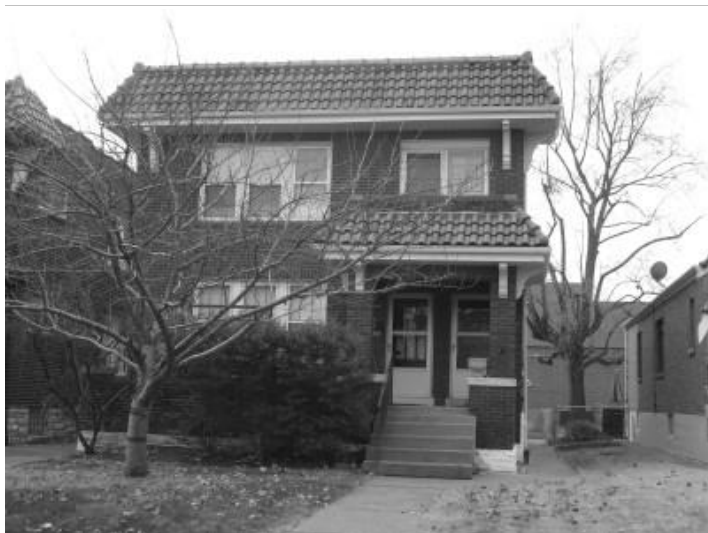
aluminum covers eaves and brackets on main roof and porch.

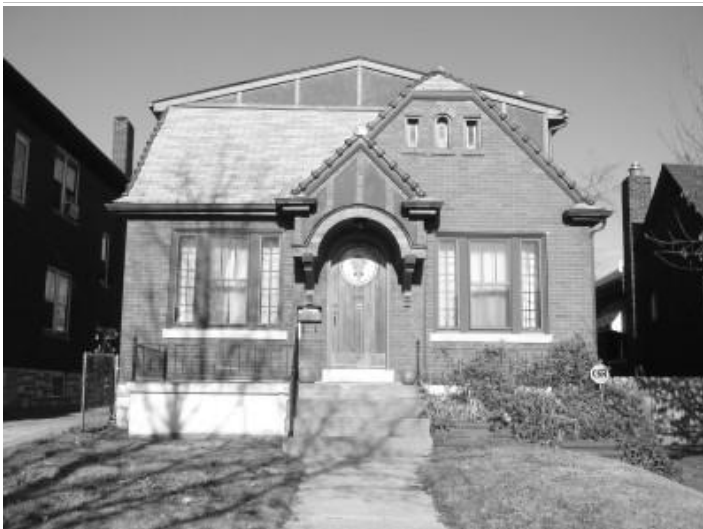
Beyond the ridge of the front volume's side-gabled roof, a second story is added.

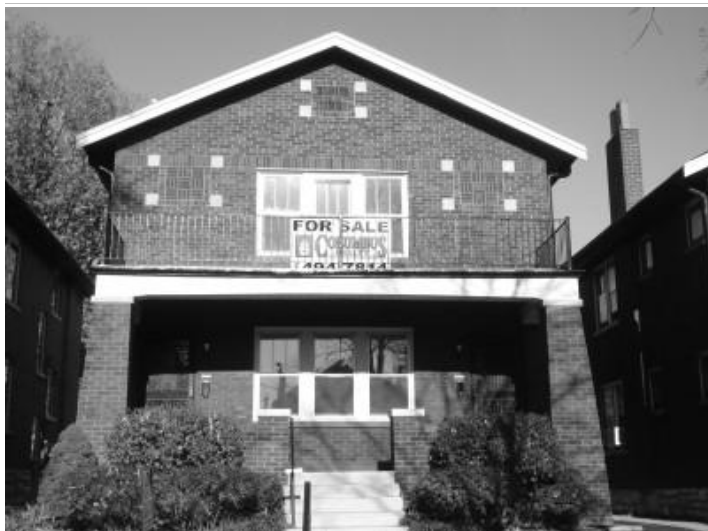
Aluminum sheaths the vergeboard, window frames

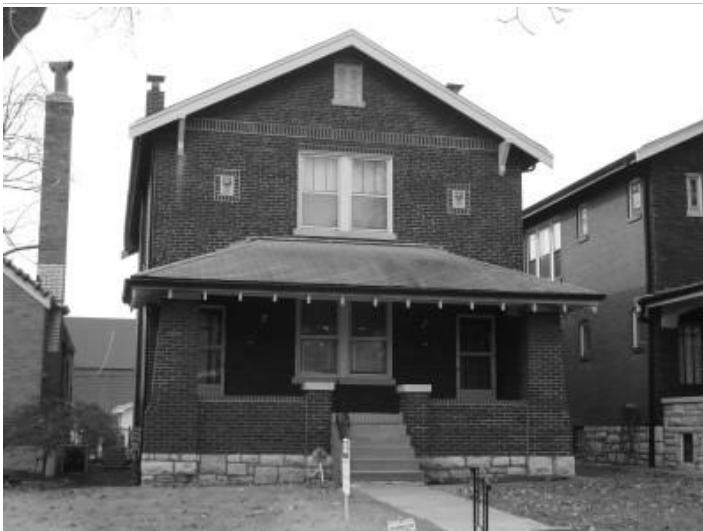
Siding over front gable's vergeboard and brackets.

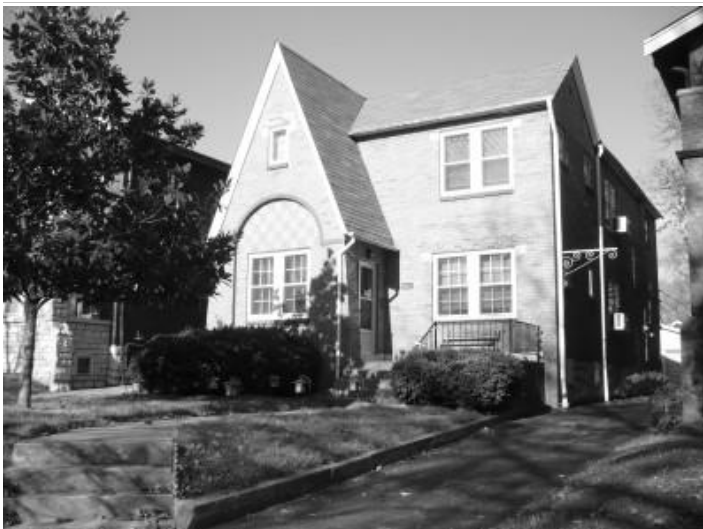
Some wood trim has aluminum cover

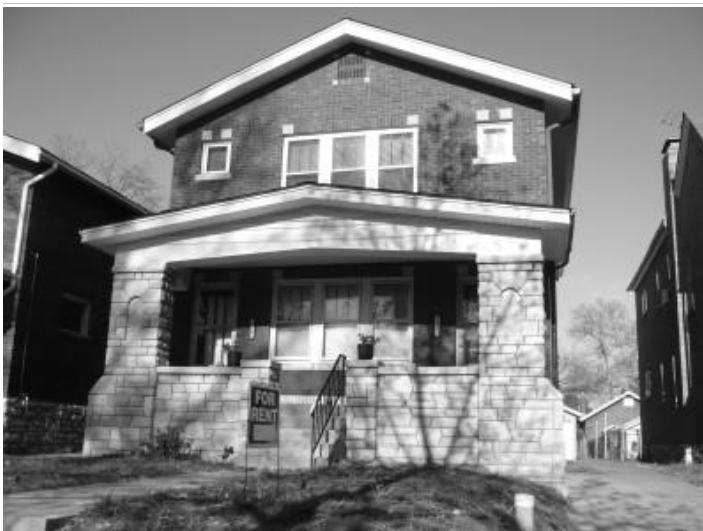
Aluminum siding covers porch gable end, vergeboard, eaves.

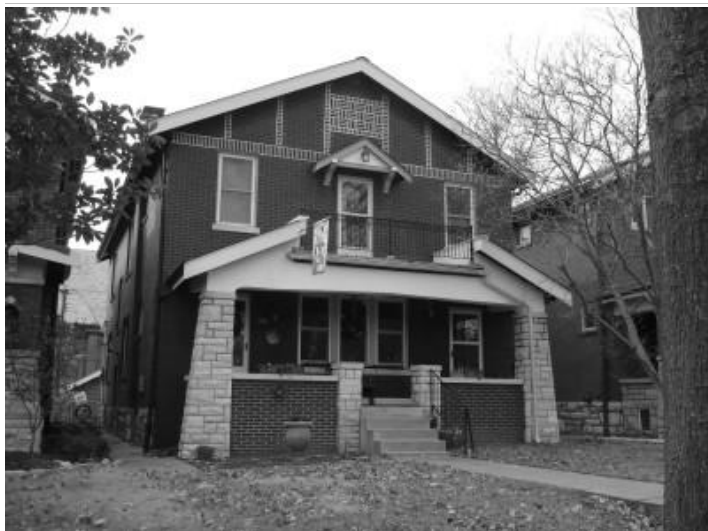
Replacement windows; aluminum siding over porch vergeboard and main roof.

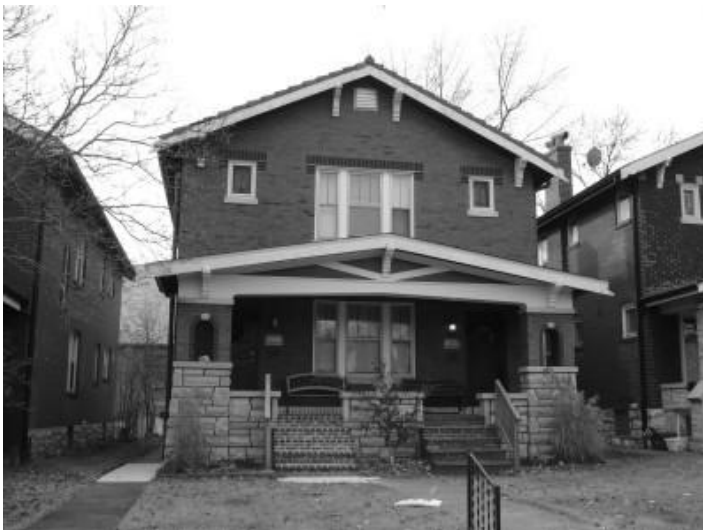
Replacement doors.

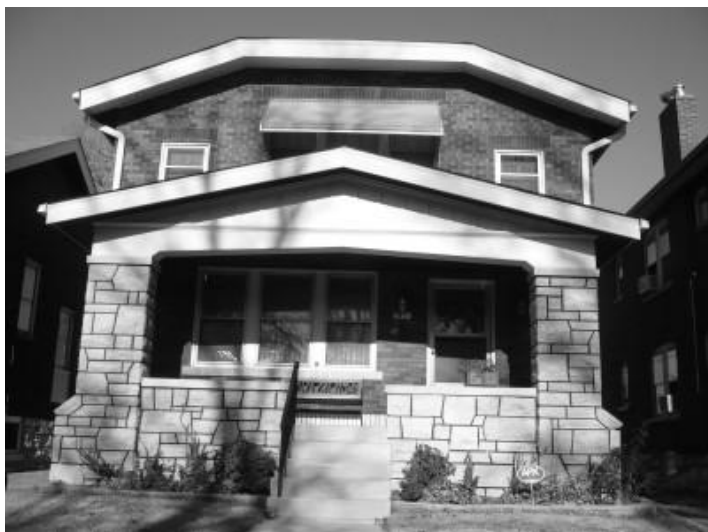
Replacement door at right side of first story. Siding over porch gable end and some wood trim. Fiberglass awning over 2nd story center set of windows.

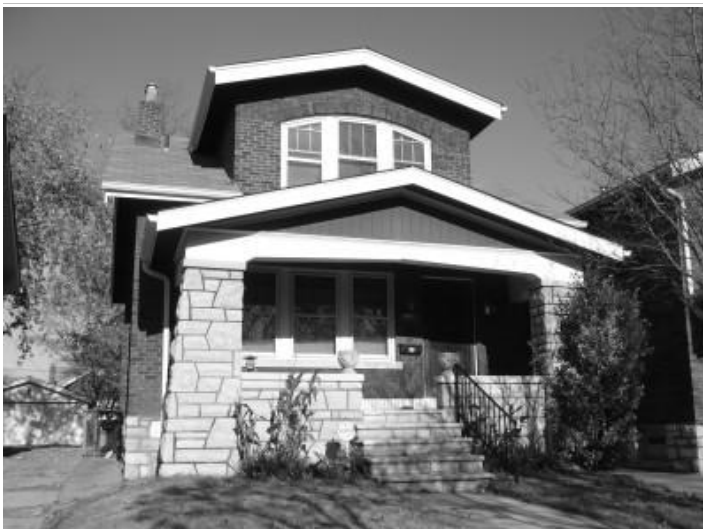
Replacement door. Vertical aluminum siding on porch's gable end.

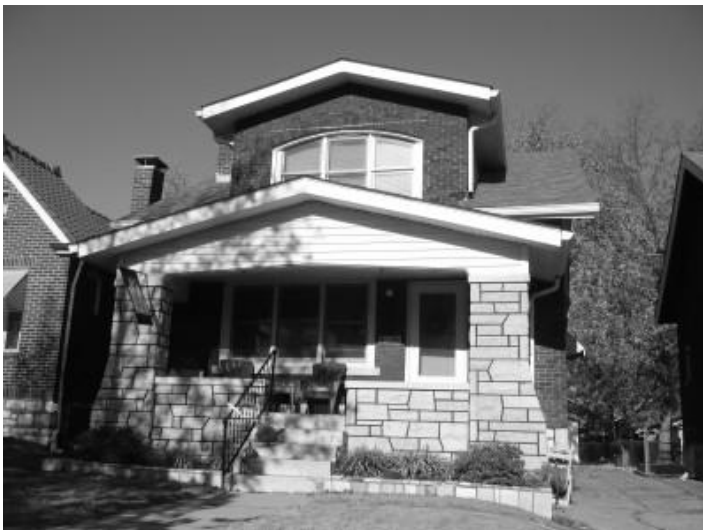
Door at right side of first story is a replacement; both triple sets of windows (left side of first story and in dormer) are replacement; gable end of porch sided.

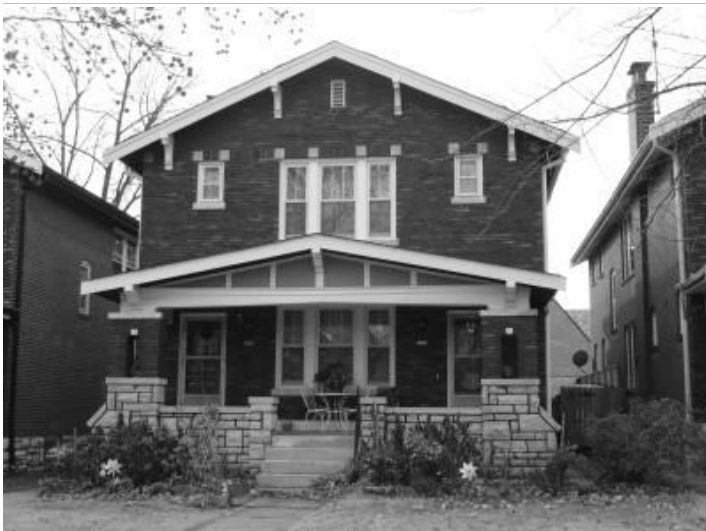
Replacement windows; brackets and vergeboards covered with siding.

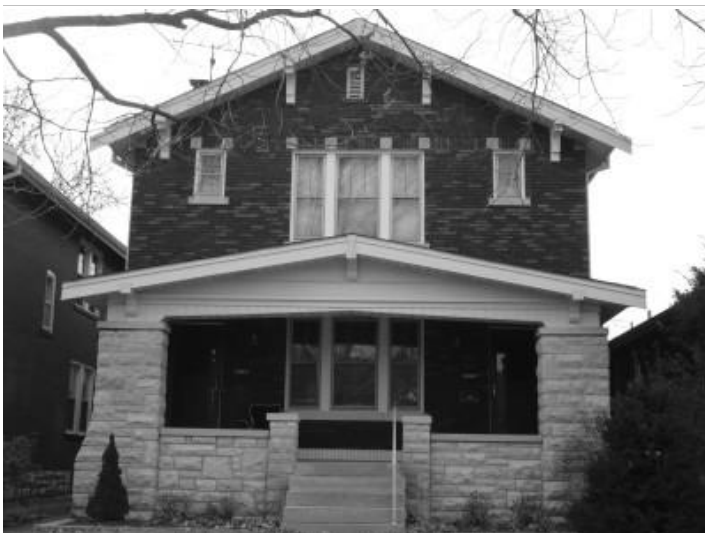
Porch gable end, brackets and vergeboards covered with siding.

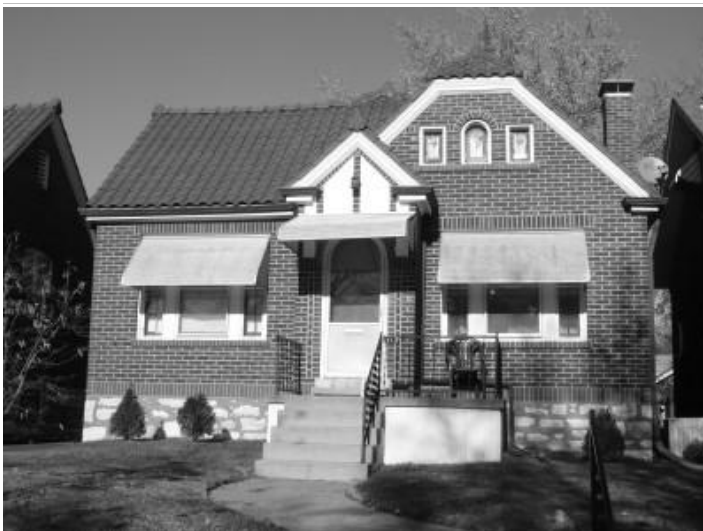
Fiberglass awnings over window and door.

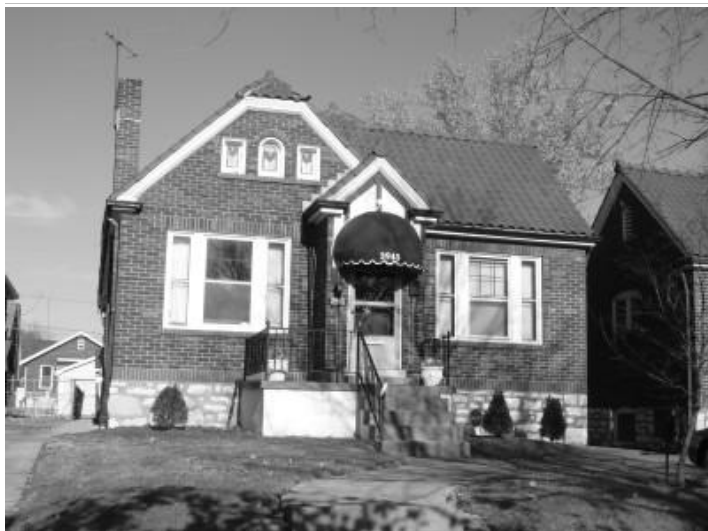
Fabric awning over front door.

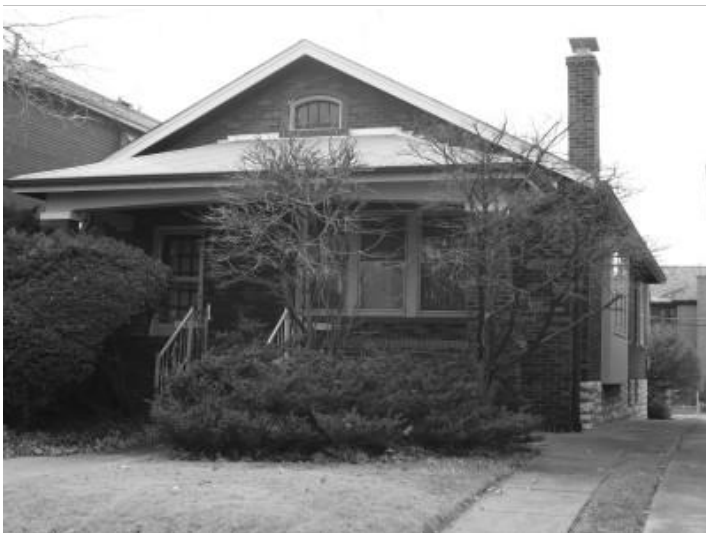
Aluminum covers vergeboard.

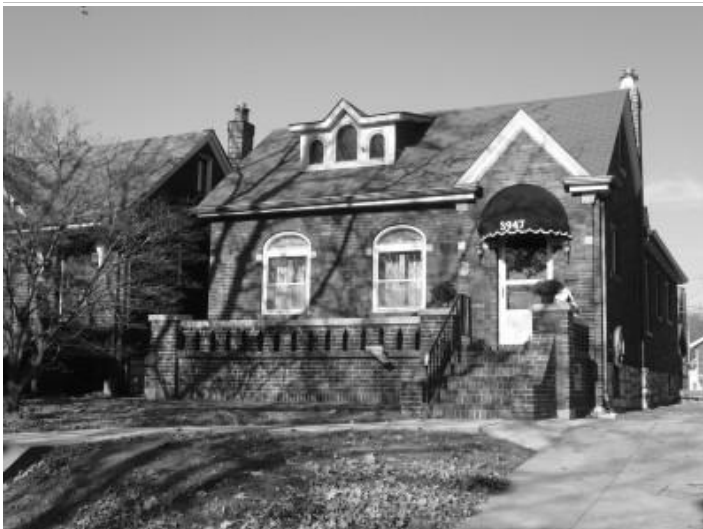
A fabric awning is over the door, and modern siding is used at the front of the dormer and vergeboards and eaves.

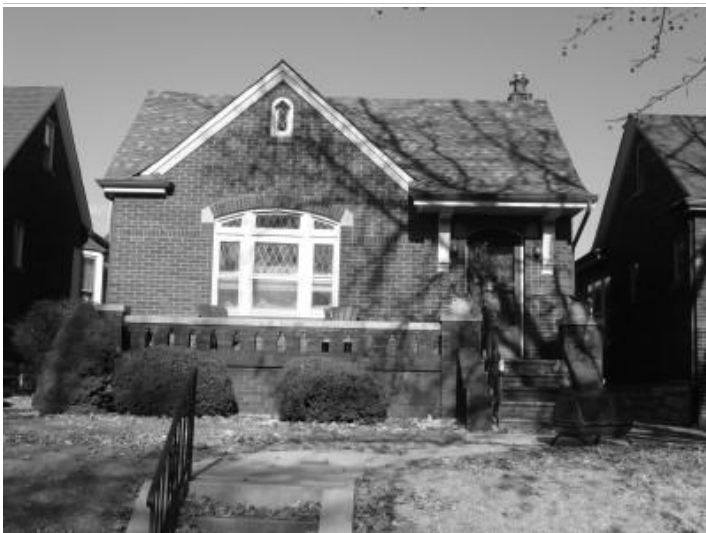
Modern siding over vergeboard and some window trim.

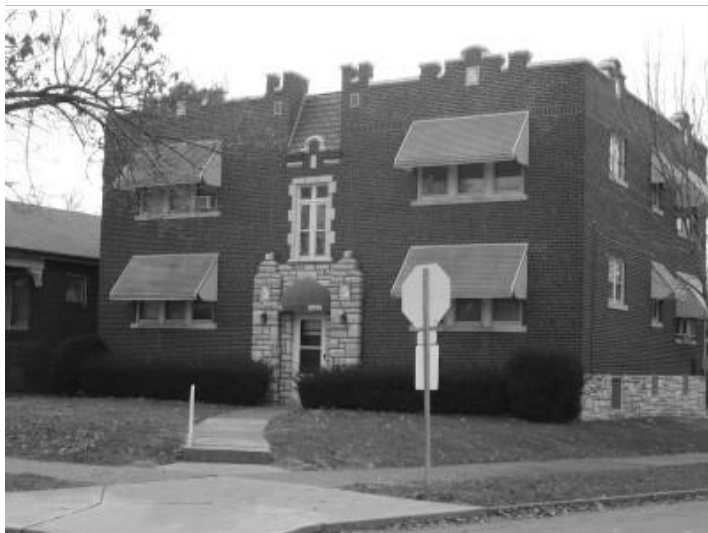
Awnings added over windows and door.

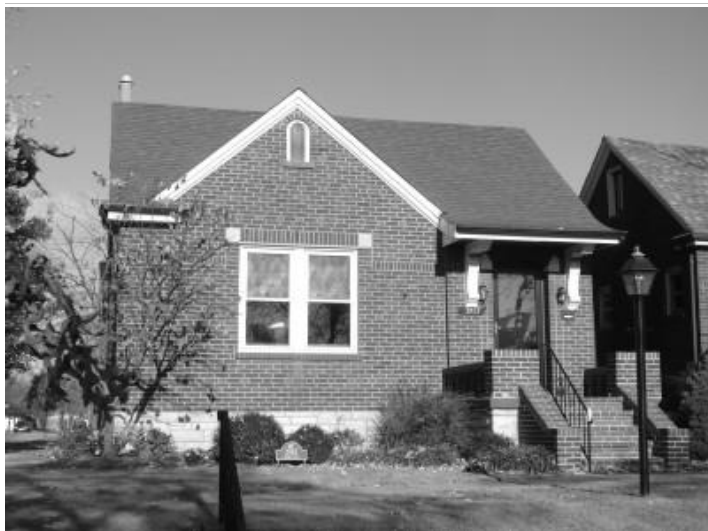
Modern siding over vergeboard and some window trim.

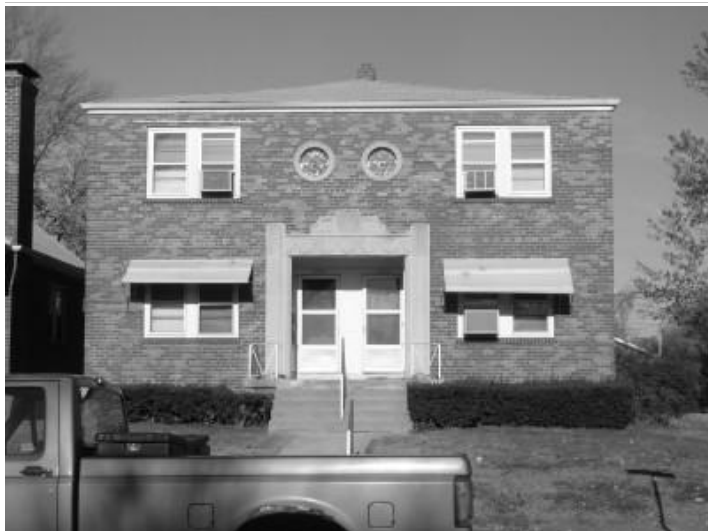
Awnings added over first story windows.

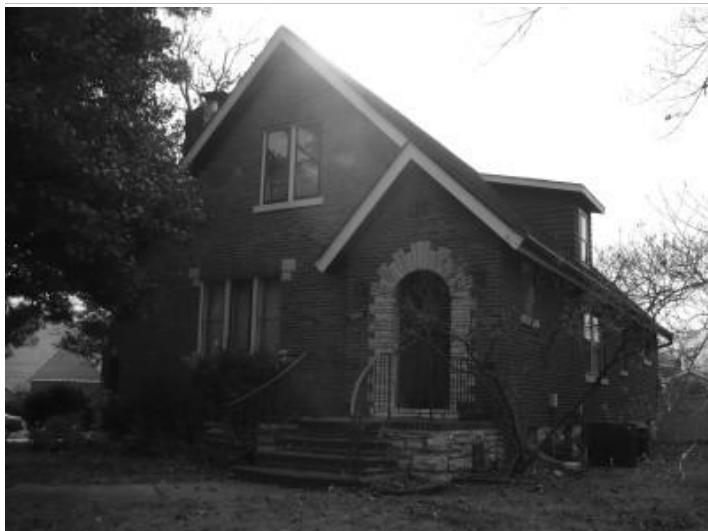
Replacement windows in front gable end.

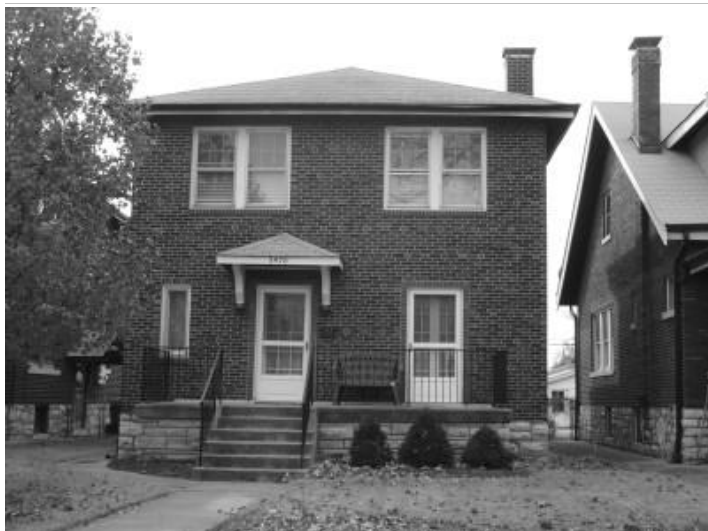
Base of porch is covered with imitation stone veneer.

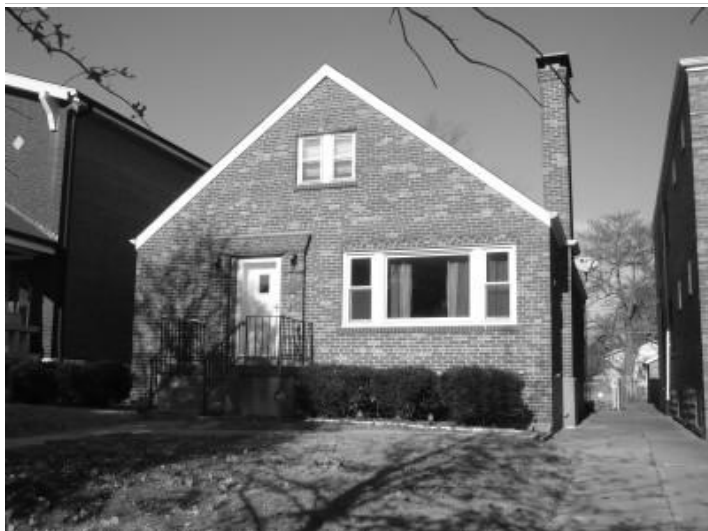
Windows are modern replacements.

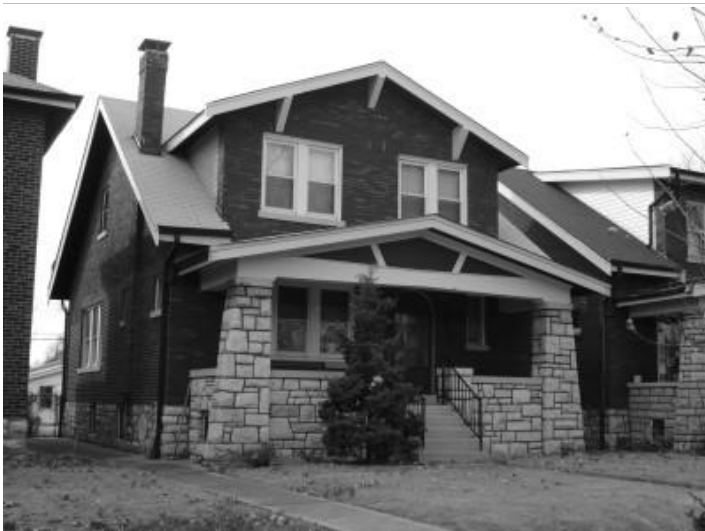
Replacement windows. Much wood trim wrapped.

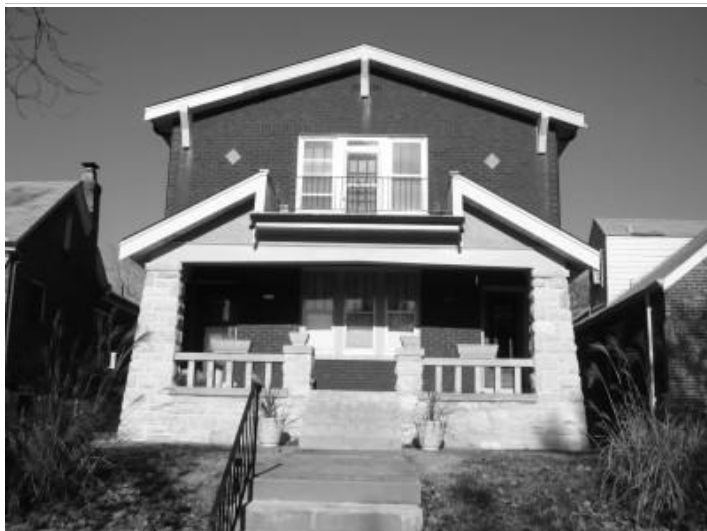
Wood details, including 3 brackets at main roof's eaves, wrapped in siding.

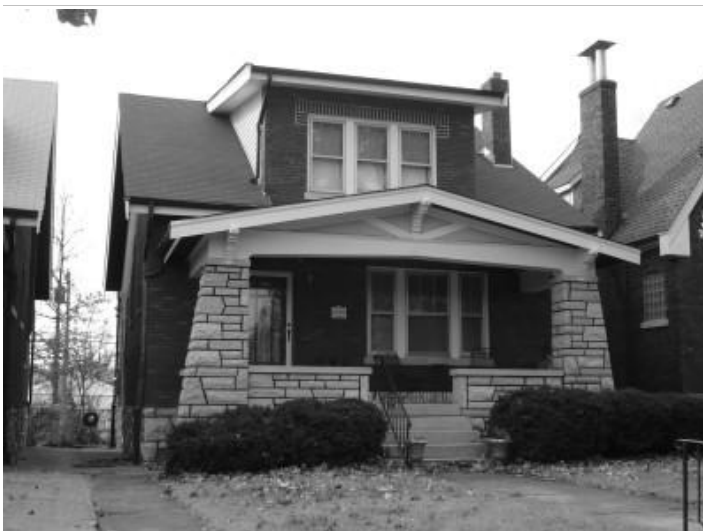
Some trim is wrapped.

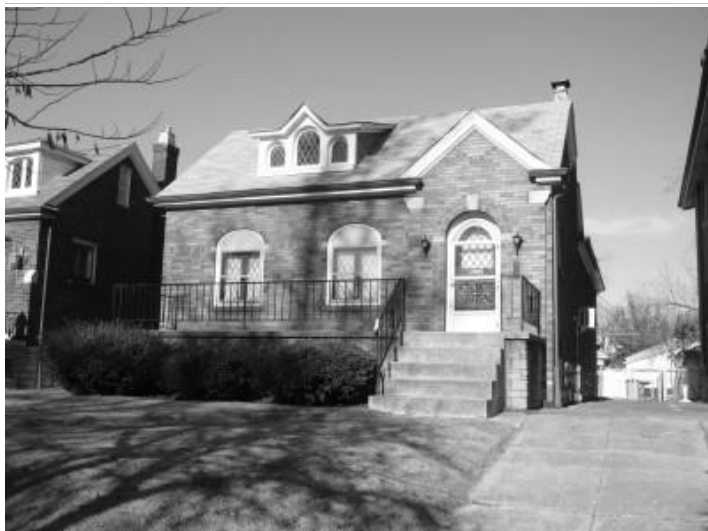
The transoms of the first story casement pairs are covered with siding. Imitation stone veneer at base of porch.

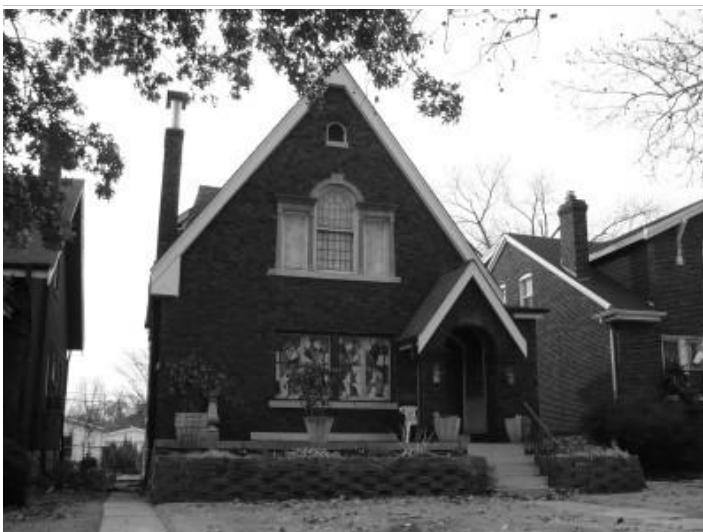
Much trim wrapped.

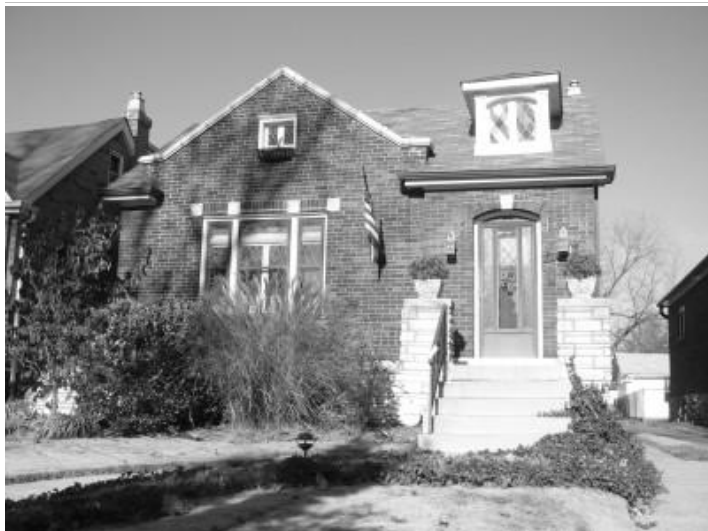
Imitation stone veneer at porch. Siding wraps much wood trim.

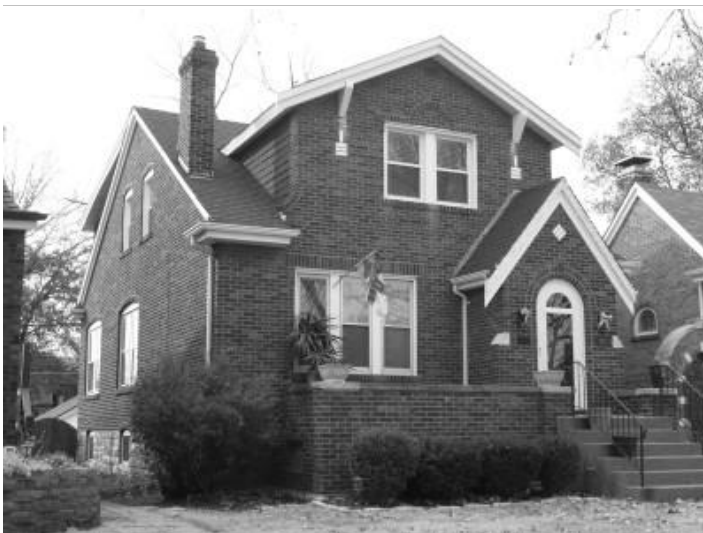
Pair of replacement windows in dormer. Most wood trim wrapped.

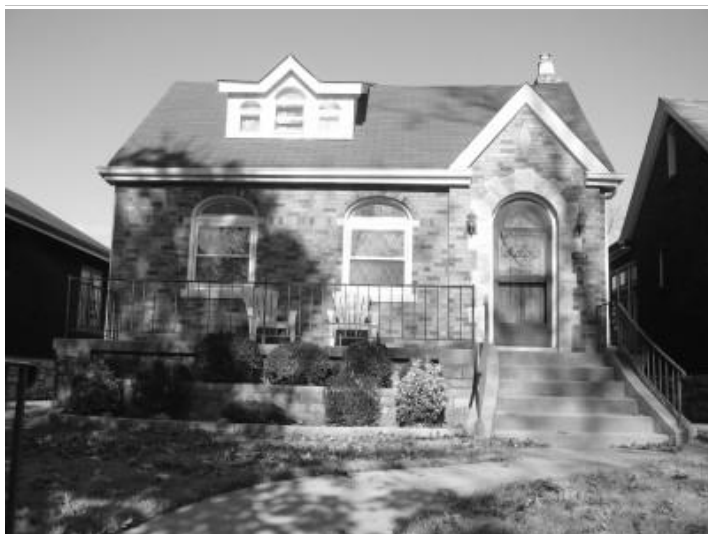
Imitation stone veneer at porch. Siding wraps much wood trim.

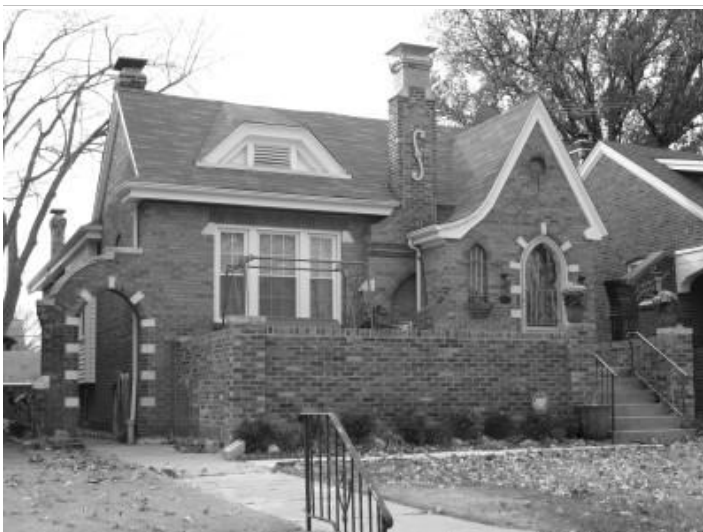
Replacement windows at left bay. Wood trim wrapped.

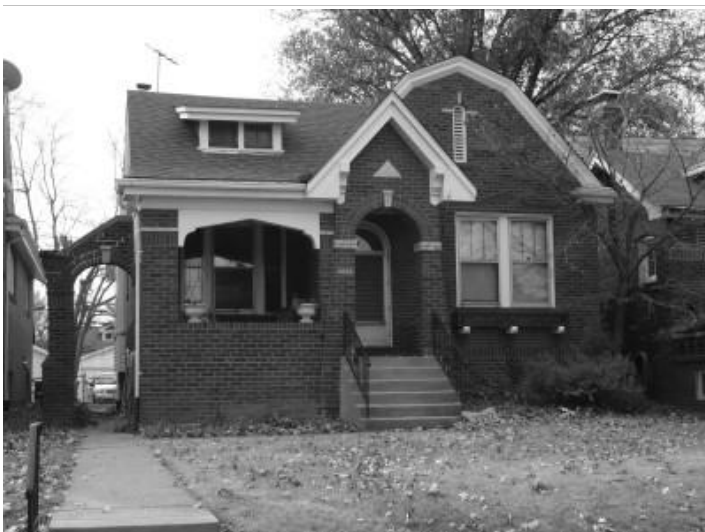
Wood trim wrapped, including porch brackets.

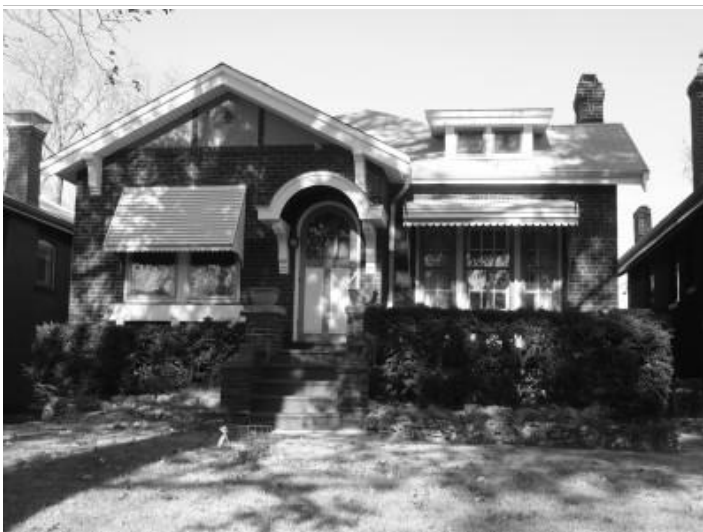
Metal awning at left bay's window pair; some siding over eaves and vergeboard.

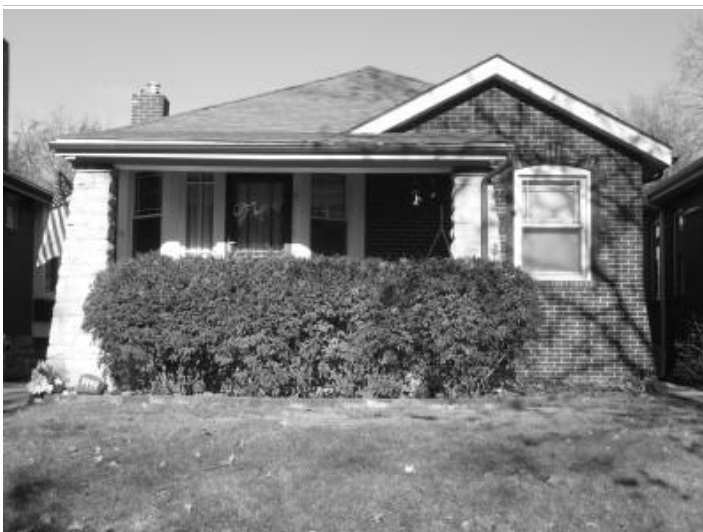
Replacement windows. Much of the wood trim is wrapped.

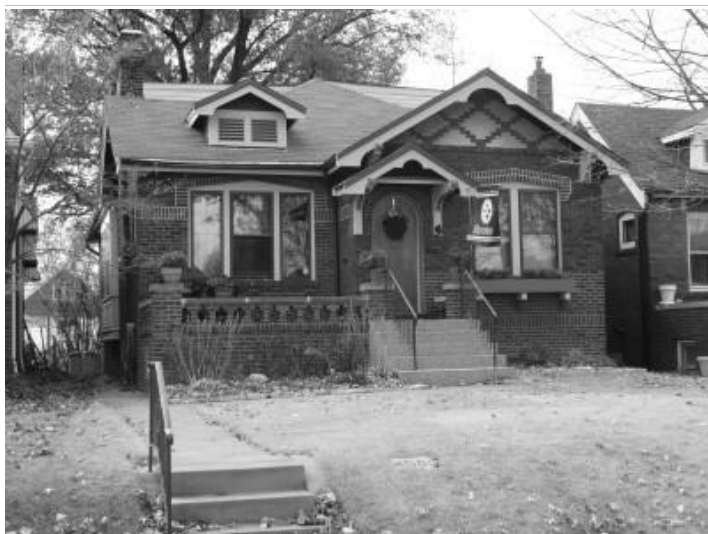
Side dormers expand rear wing.

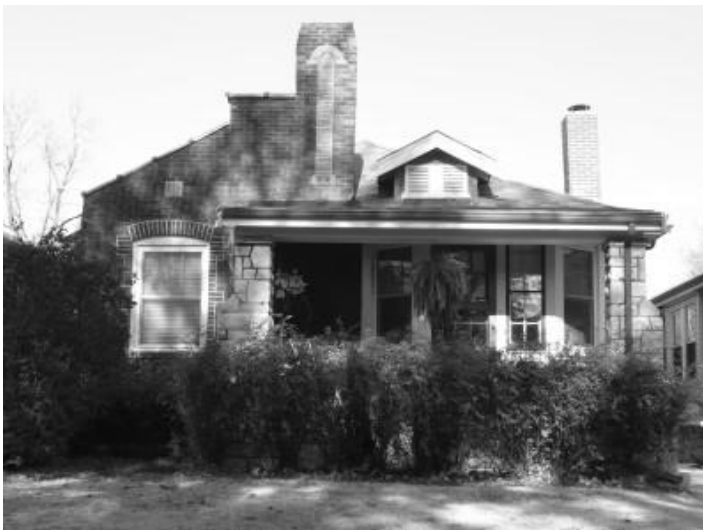
Replacement windows.

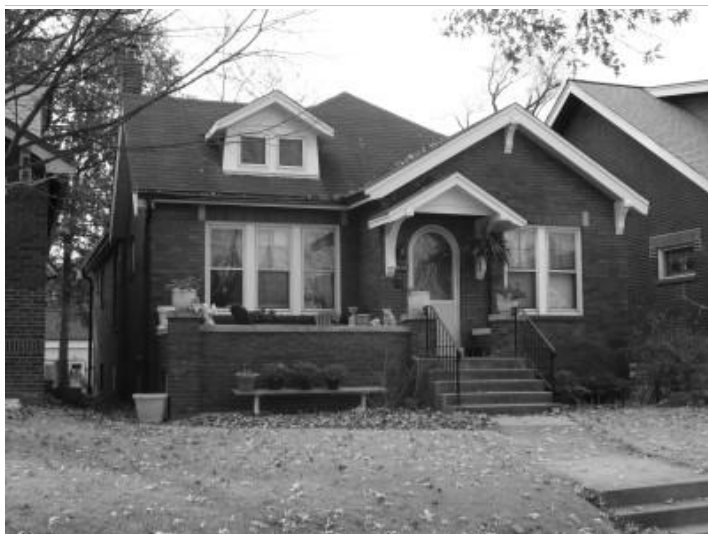
Some wood trim (vergeboard and eaves) wrapped.

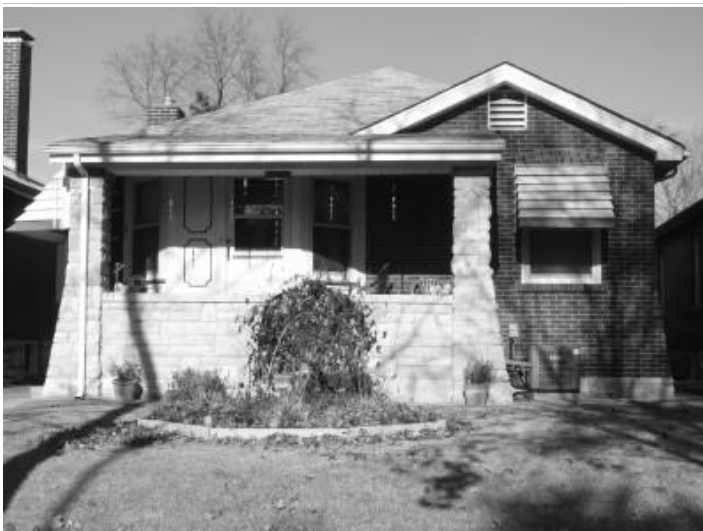
Sidelights are covered and windows are replaced. Metal awnings added over windows, and much wood trim is covered with siding.

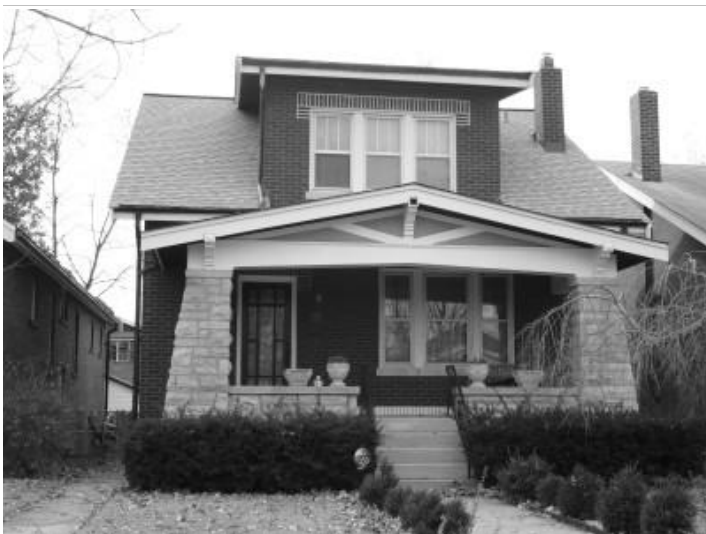
Some wood trim (vergeboard) wrapped.

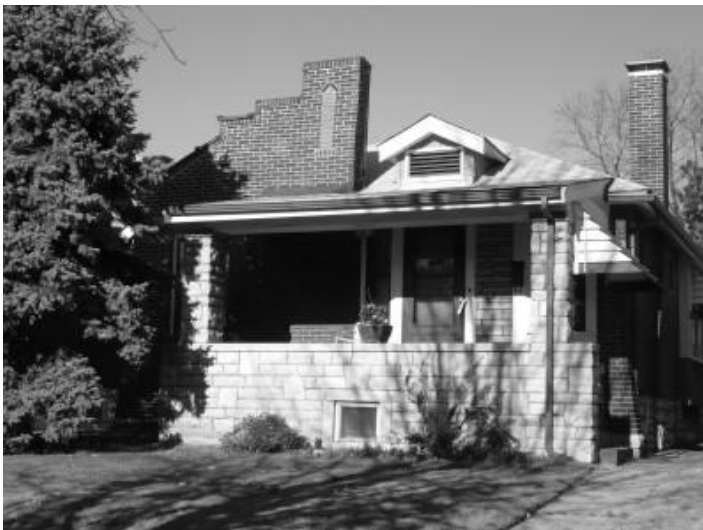
Front door is a replacement; the bay front next to it is covered with imitation stone veneer.

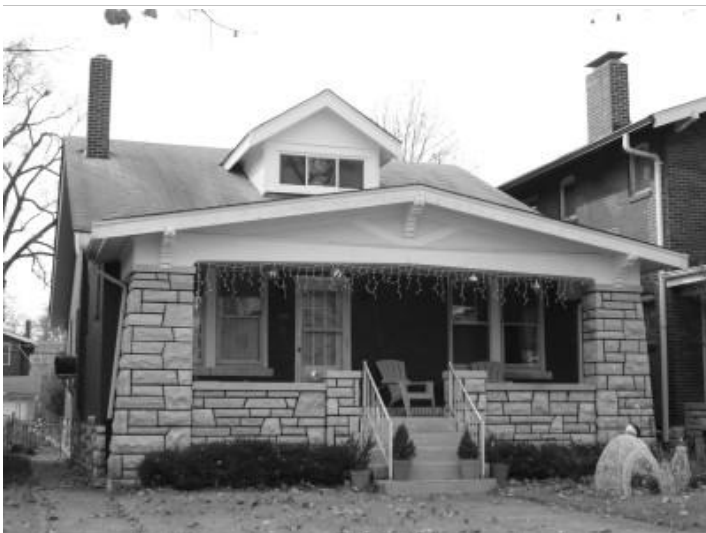
Replacement windows in dormer.

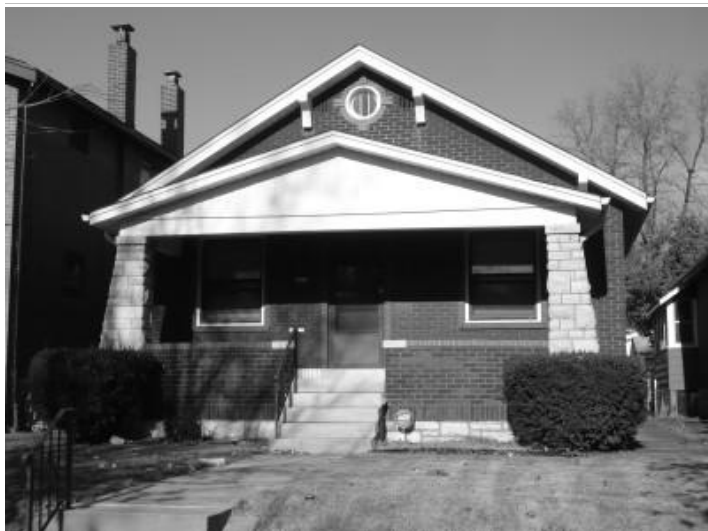
Replacement door and windows; aluminum siding over wood trim.

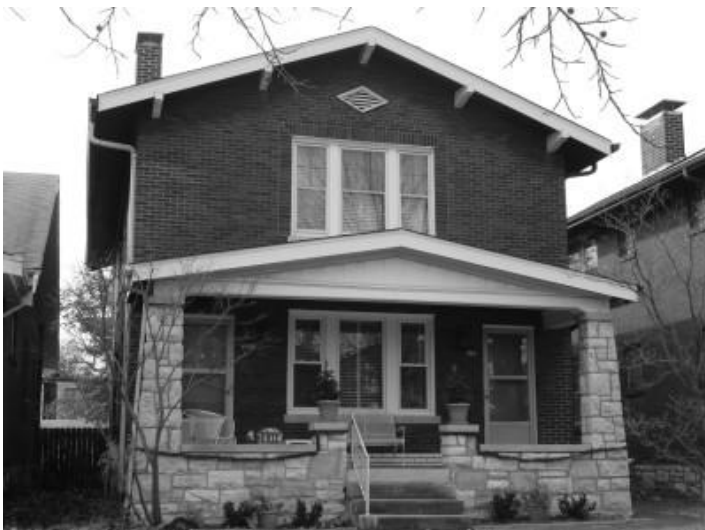
The two front doors and the triple window set between them are all replacements. Aluminum covers vergeboards, brackets at main eaves, and porch gable end.
