City of St. Louis Cultural Resources Office

Holly Hills Neighborhood Survey

Lynn Josse and NiNi Harris
3/1/2010

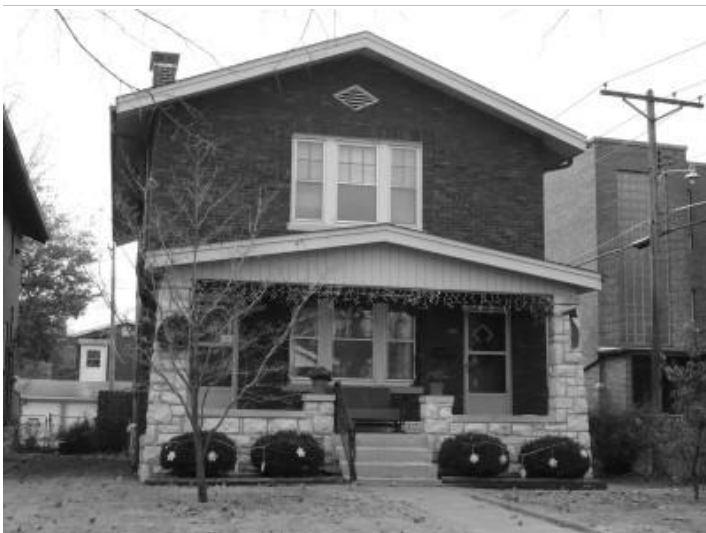
The two front doors are replacements. Aluminum covers vergeboards and porch gable end.

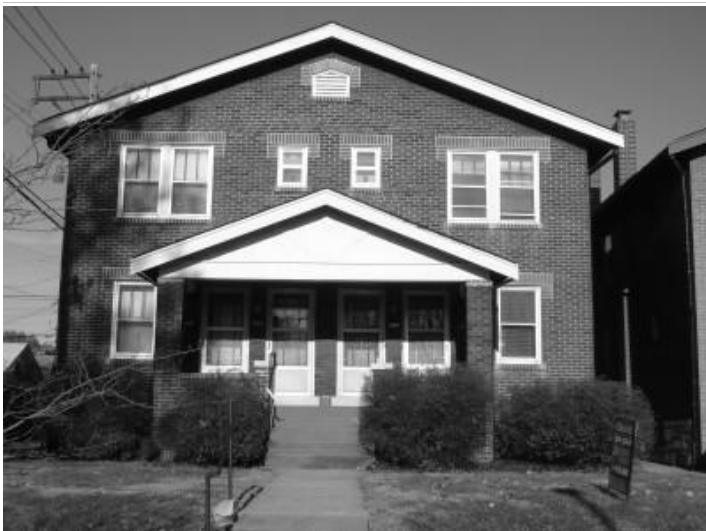
Some wood trim covered with siding.

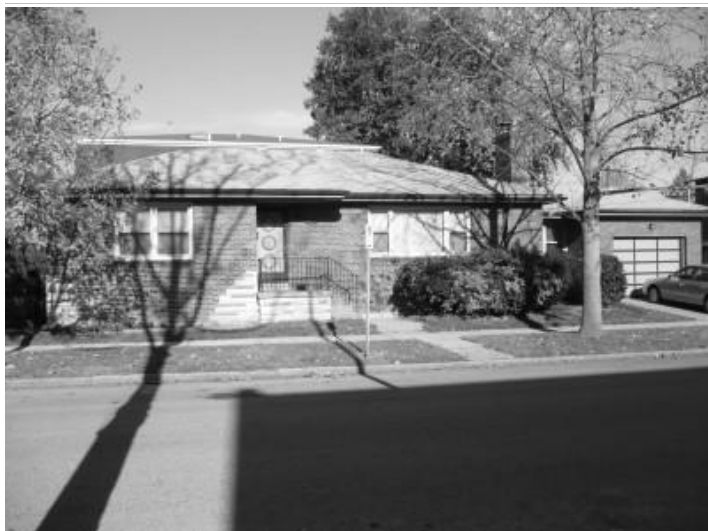
Windows are replaced.

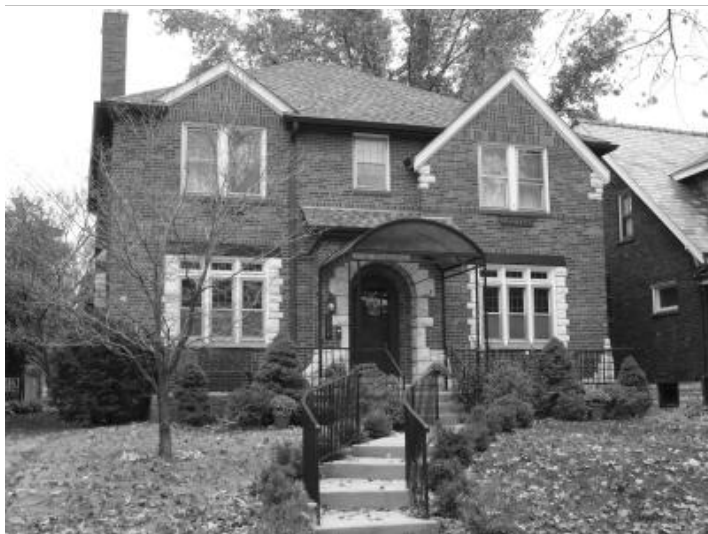
Some wood trim wrapper in aluminum; metal and glass arched awning on poles at front door.

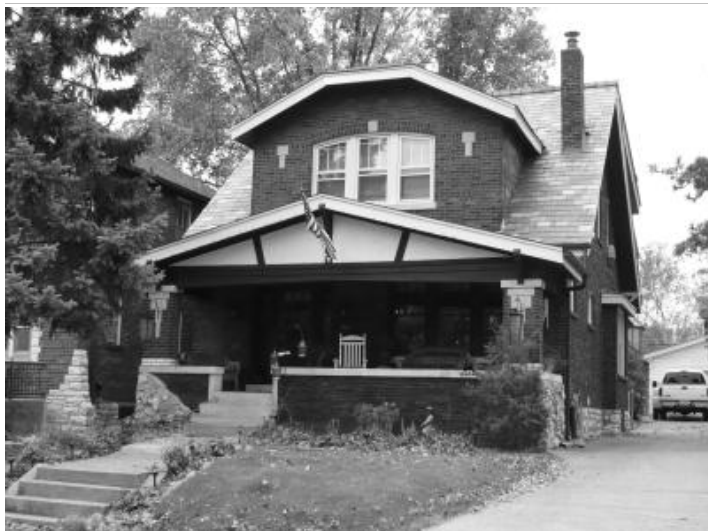
imitation stone applied to porch sides.

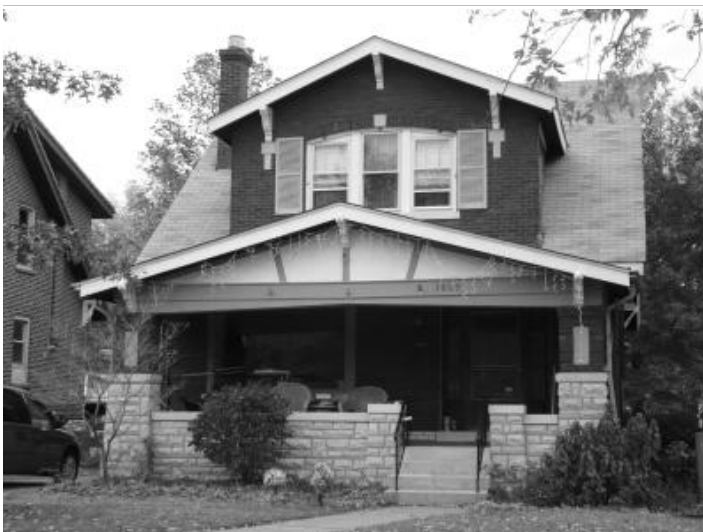
Picture window replaces original window set at first floor. Shutters added to façade windows.

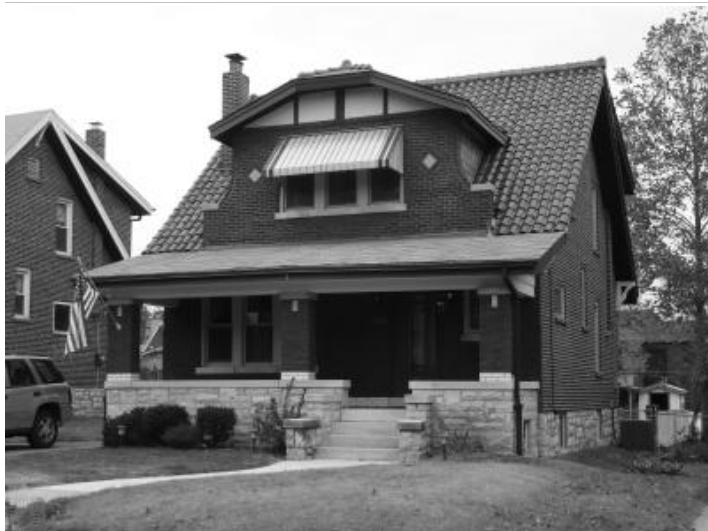
Replacement windows at façade; metal awning at dormer.

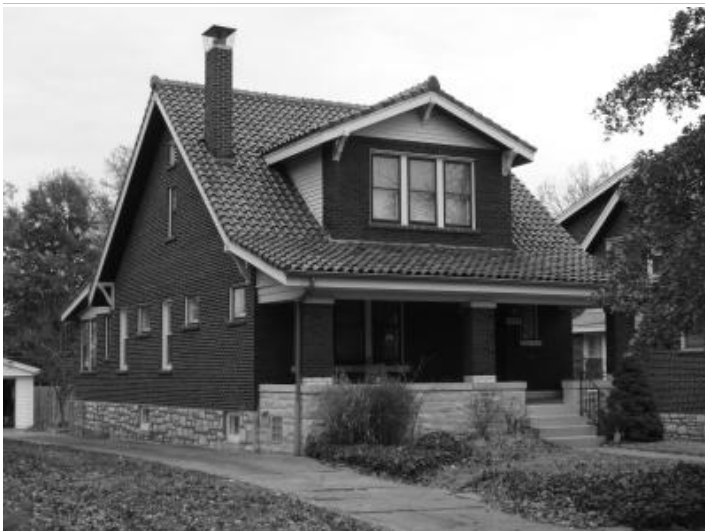
Modern horizontal siding is used at the sides of the porch and dormer, and over the dormer's gable end.

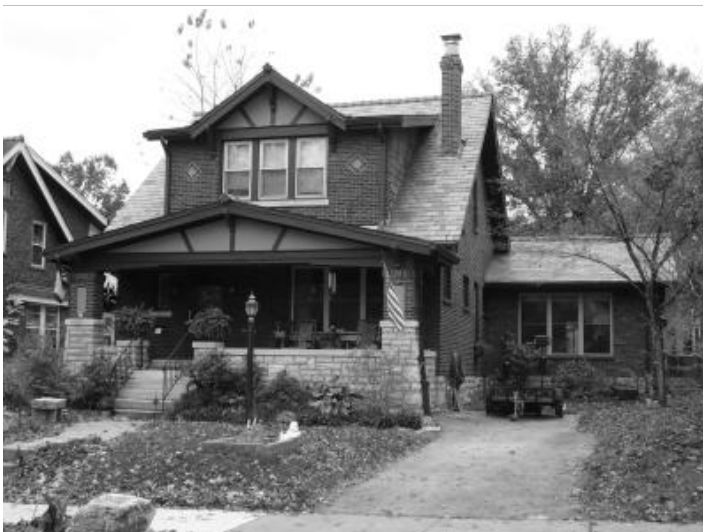
room added at rear of right (west) elevation (post-1963). The front door and all façade double-hung windows are replacements.

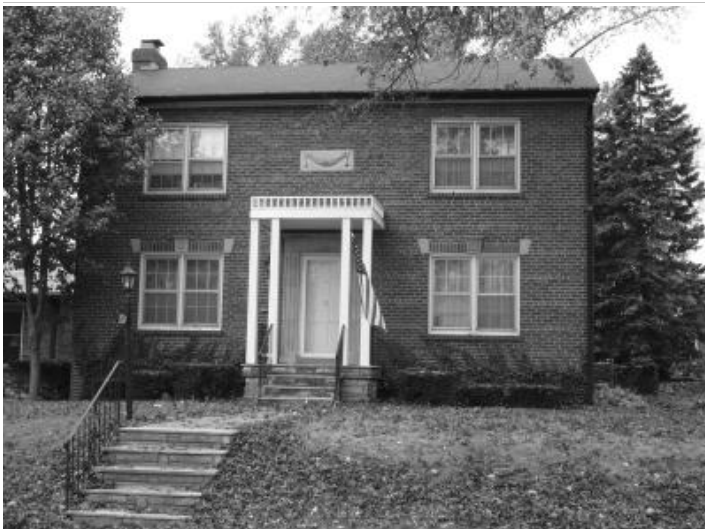
The wood porch (a very simple flat-roofed porch with two square posts at either side) is fully wrapped (and may not be original)

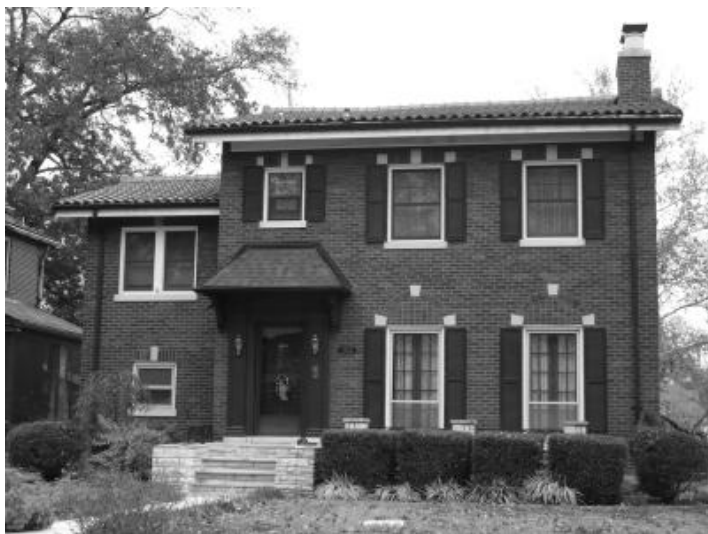
Shutters added; unroofed porch faced with imitation stone veneer. Windows are hard to make out.

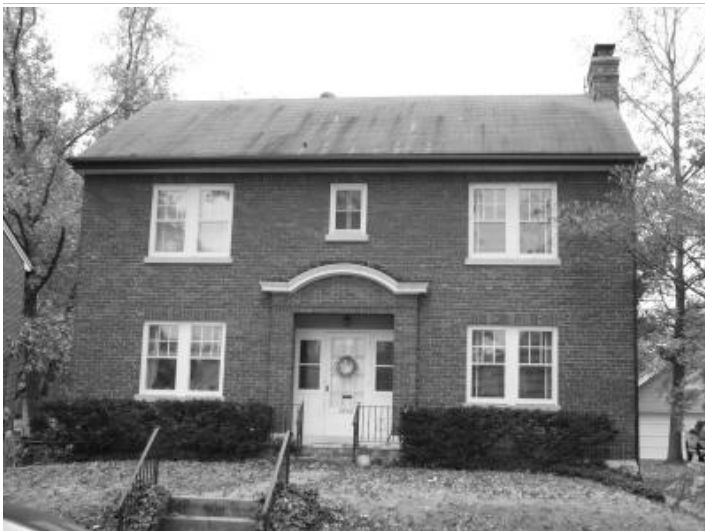
Aluminum replaces original eave material.

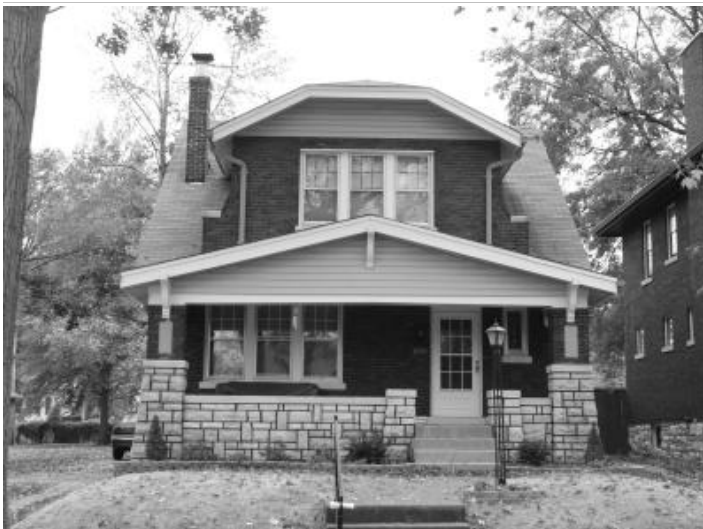
Both the dormer and porch gable ends are aluminum sided.

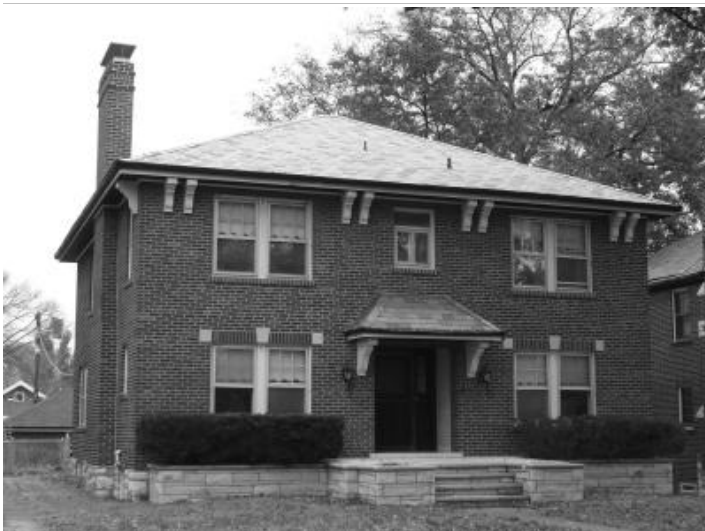
Canvass awnings added at façade windows. Imitation stone veneer covers porch base, steps, and planters.

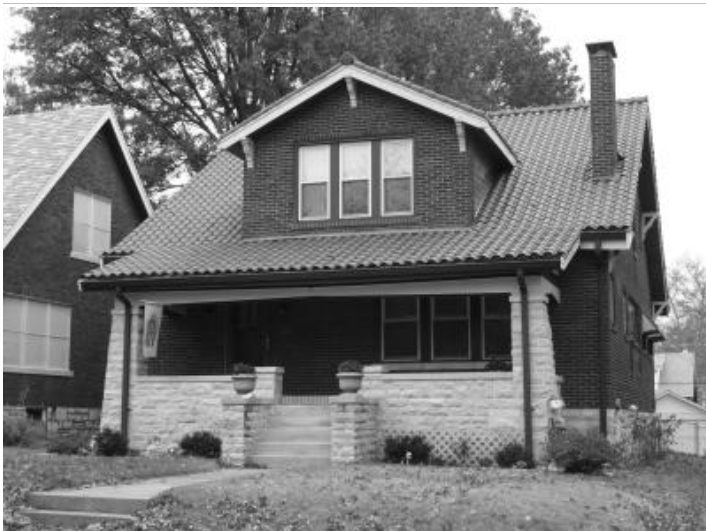
Windows at façade are replacements.

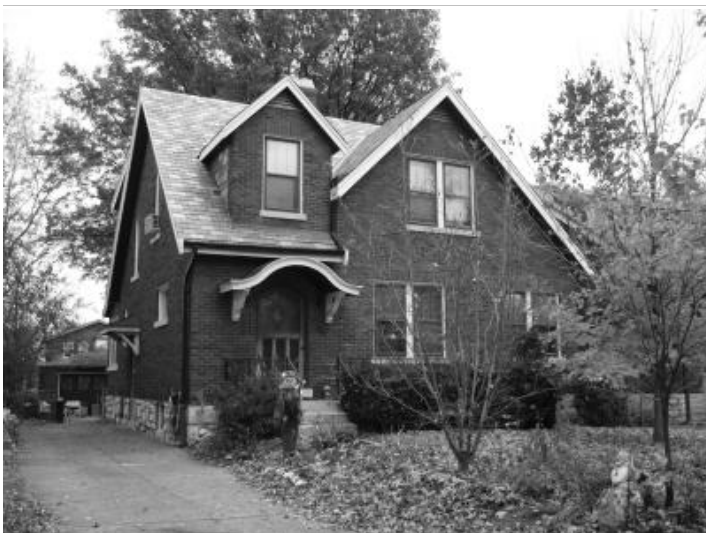
Some wood trim is wrapped.

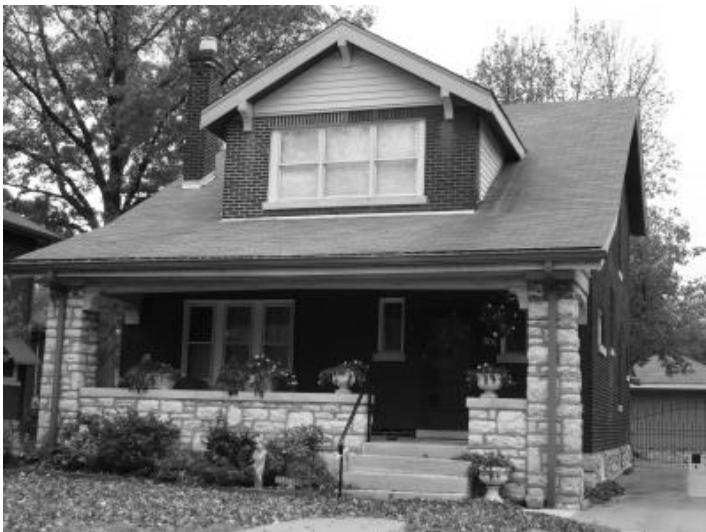
The front door is a replacement. The three dormer windows are replaced. Aluminum siding covers the dormer's gable end and wraps its 3 brackets.

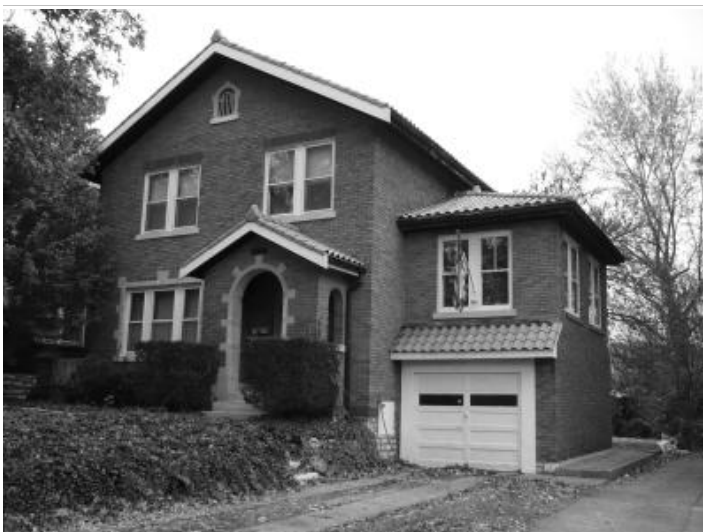
Vergeboards covers with wrap.

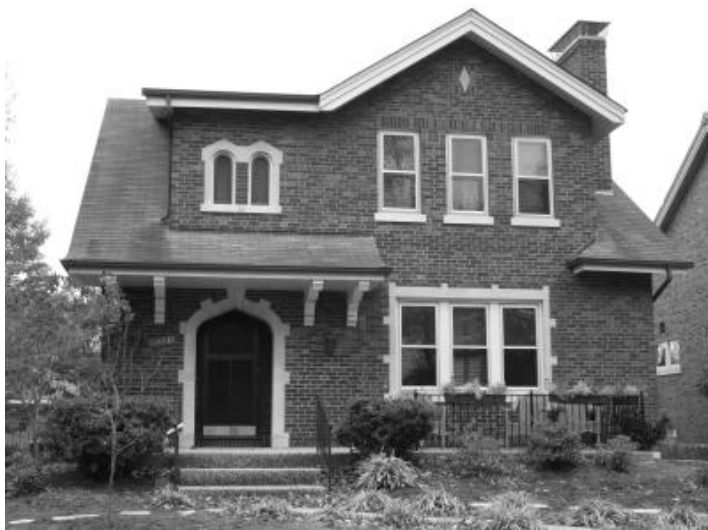
Right bay windows at both stories are replacements. Some wood trim wrapped with siding.

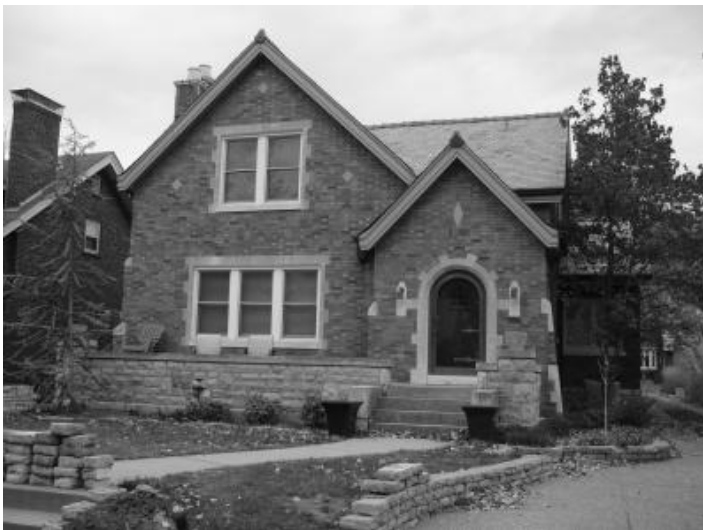
Façade windows are replacements

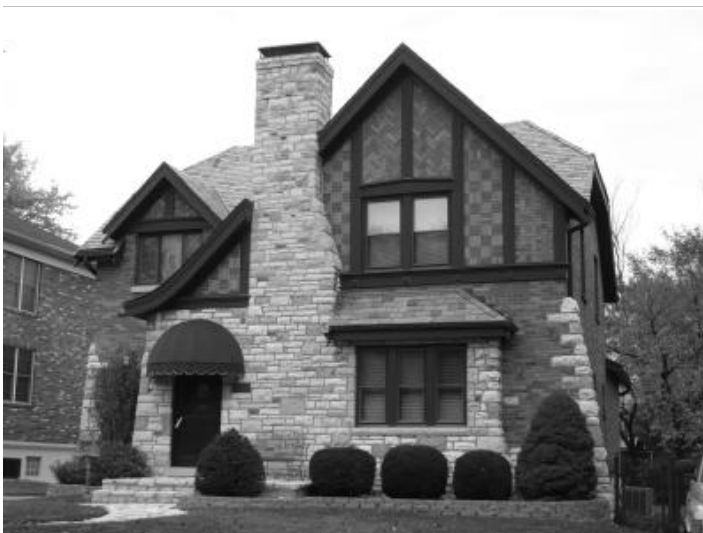
Canvas awning over door; wood trim very carefully sheathed in aluminum.

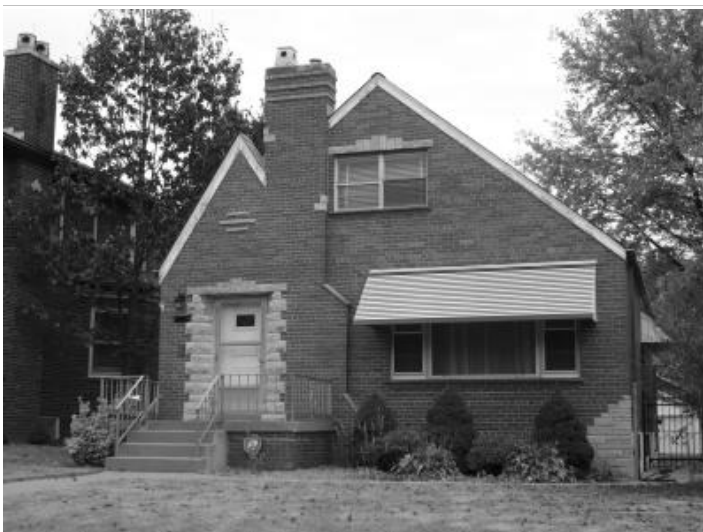
Metal awning over picture window.

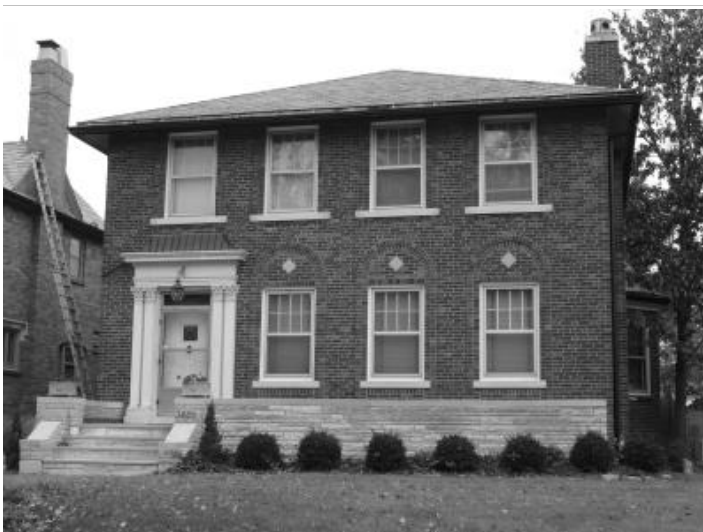
Porch covered with imitation stone veneer.

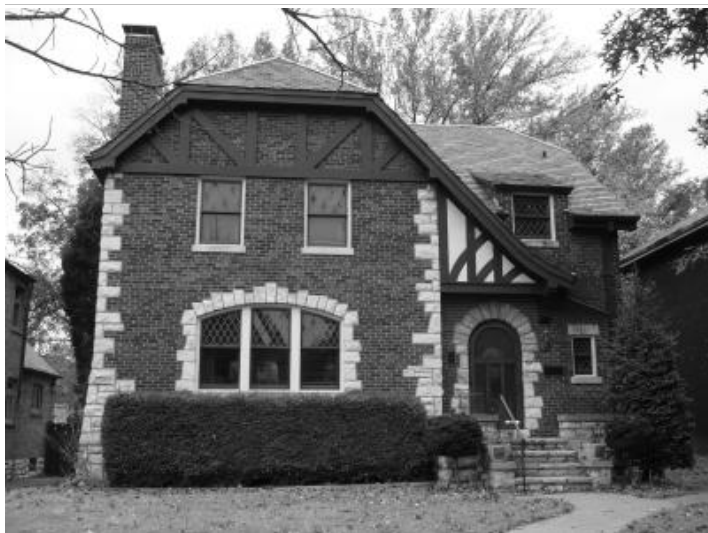
Some wood trim is wrapped.

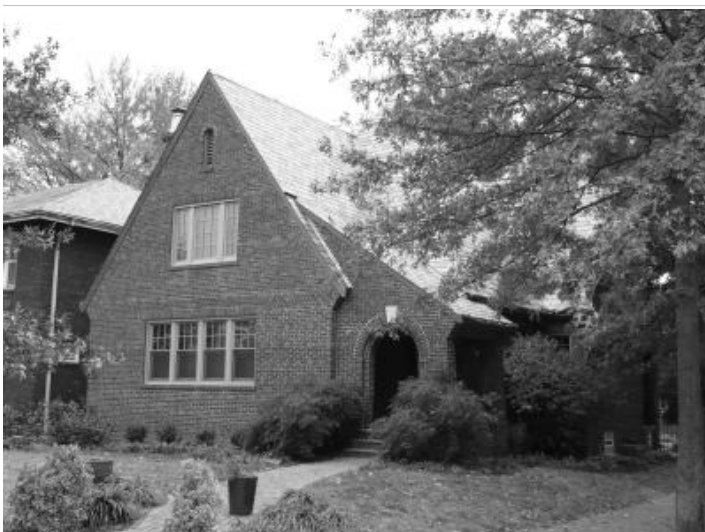
New wood windows: four connected 6/1s at first floor of gable end, and multilight window set at 2nd.

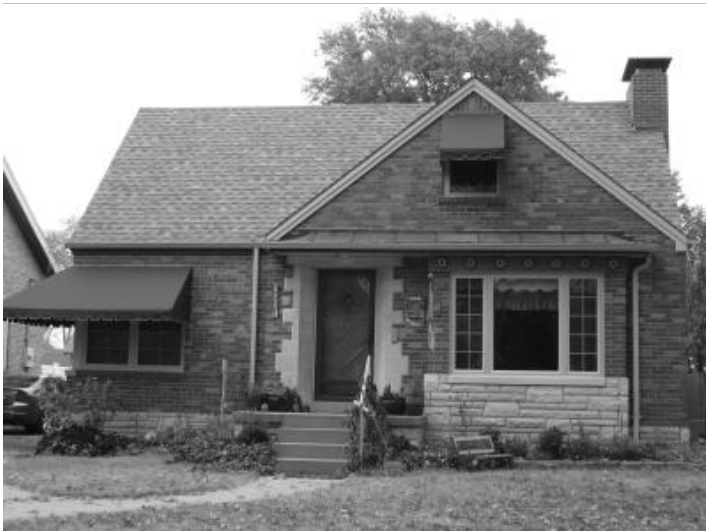
Fabric awnings.

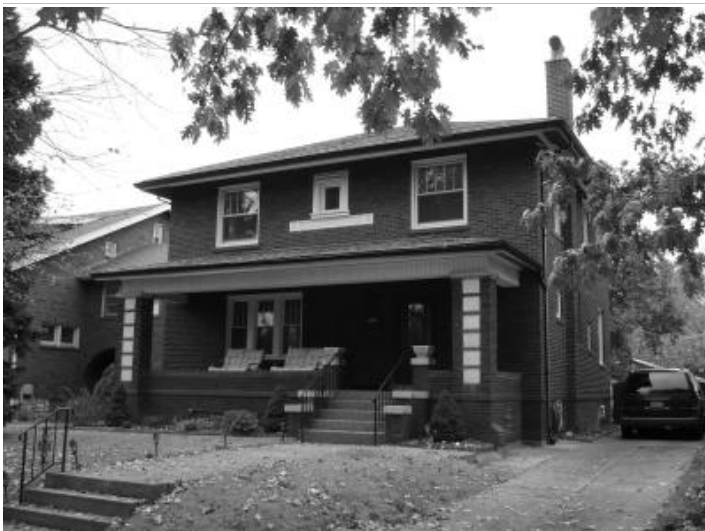
Replacement windows. Vinyl soffit at porch.

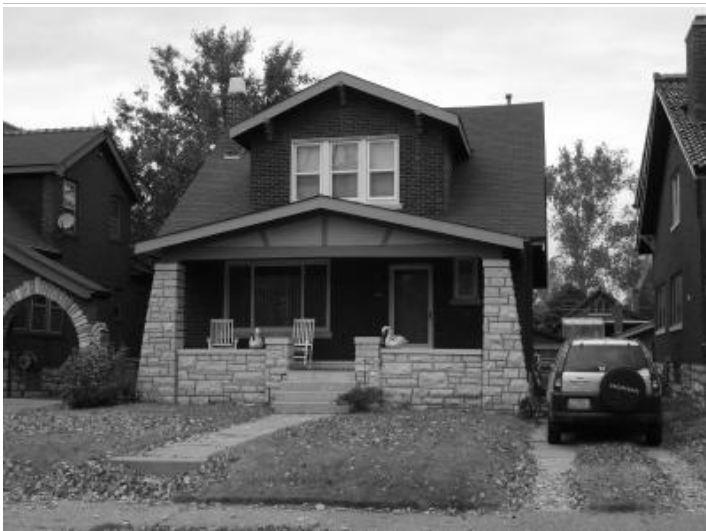
\$500 addition by owner HC Lake in 9/1/1932, must be at the rear. The façade windows appear to be replacements, as does the front door.

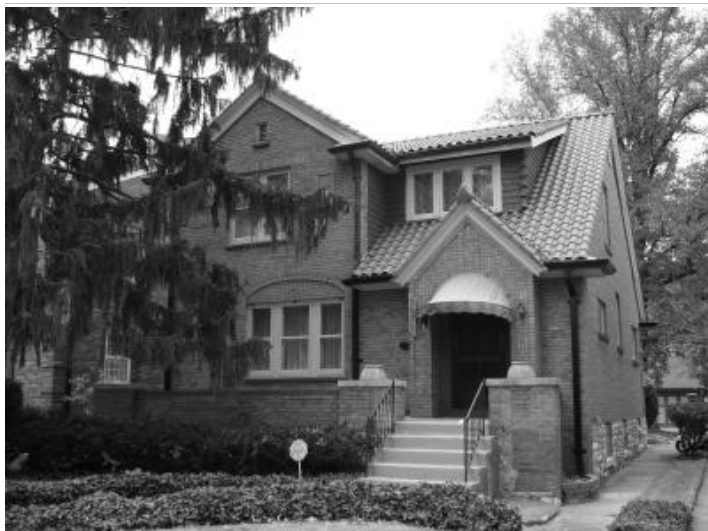
fabric awning.

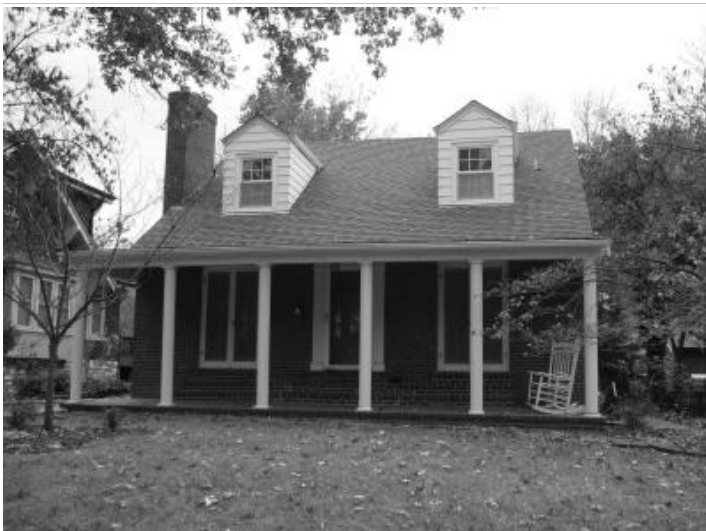
frame front porch structure permitted in 1976.

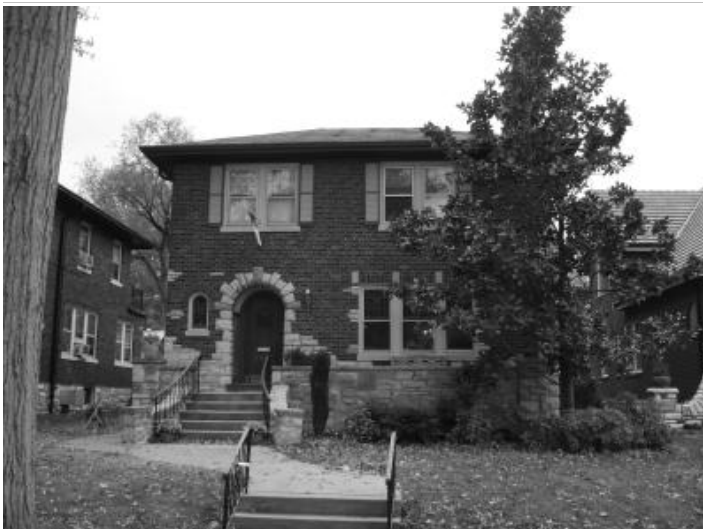
Shutters added

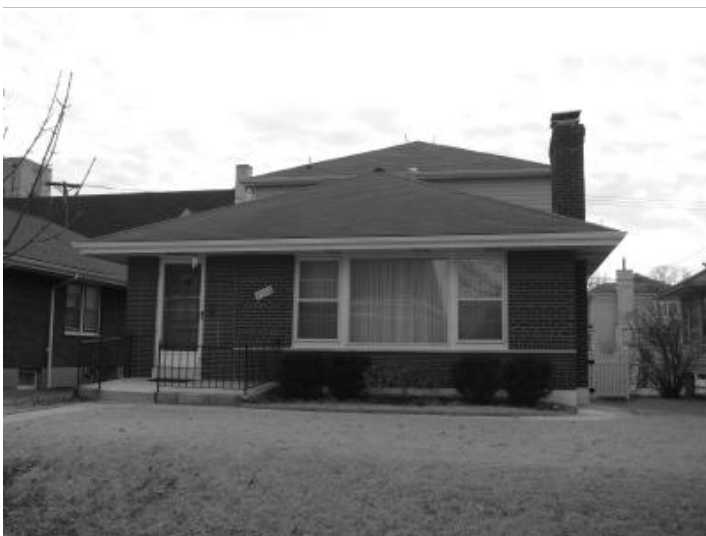
This red brick building is noncontributing because of the large hipped second story addition at the rear of the house.

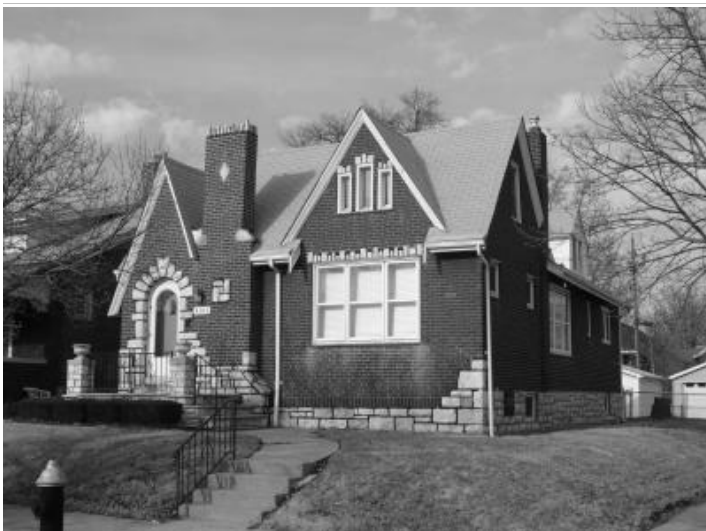
Triple set of replacement windows at right bay. Some wood trim is wrapped with aluminum.

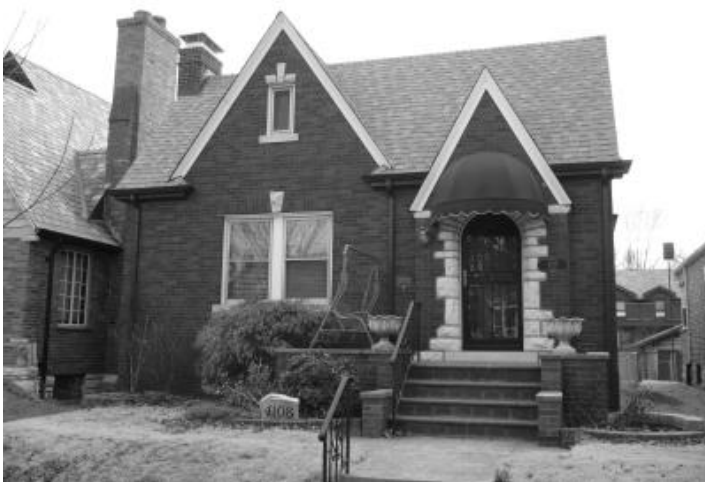
Some wood trim wrapped with siding; canvas awning over front door.

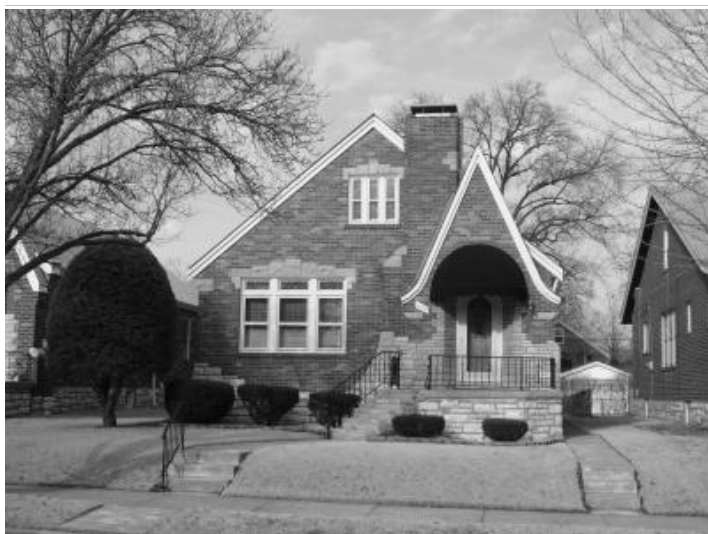
Some wood trim wrapped with siding.

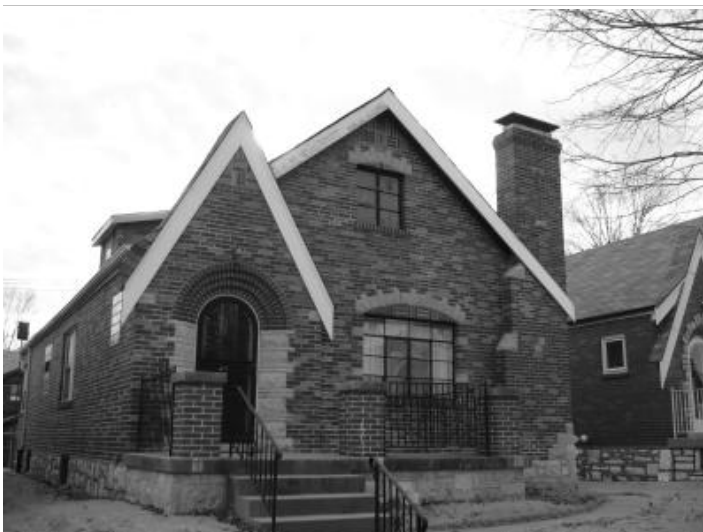
Some trim wrapped in siding. Small shed dormers at side elevations appear to be added.

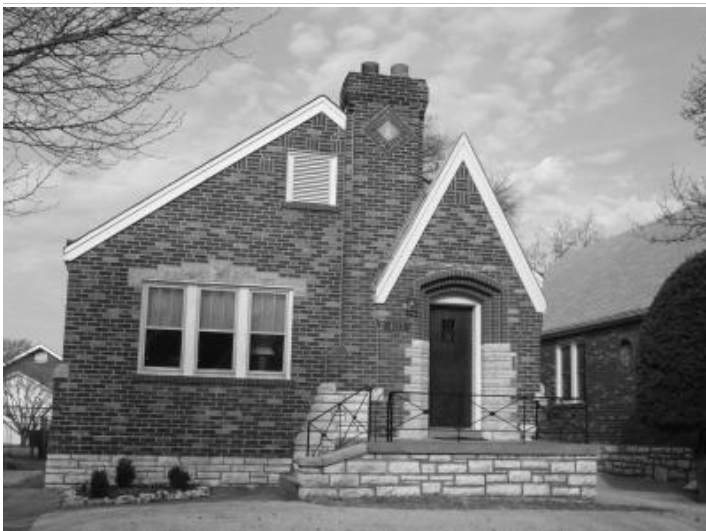
Some wood trim wrapped with siding.

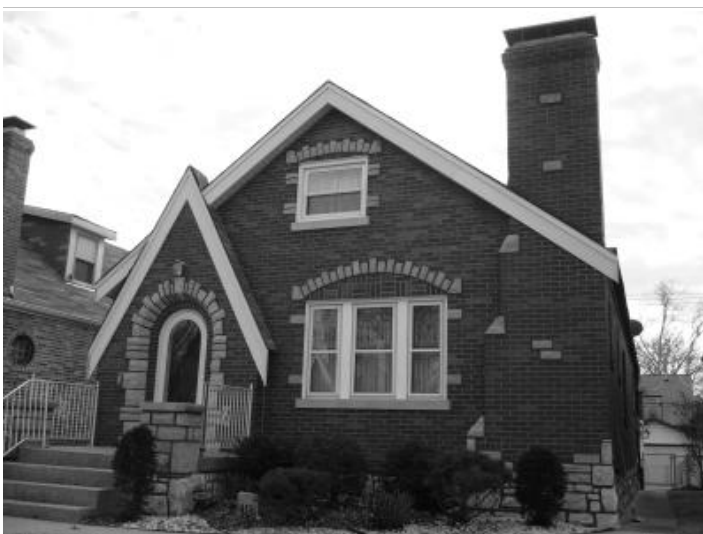
Replacement window in gable end; some wood trim wrapped with siding.

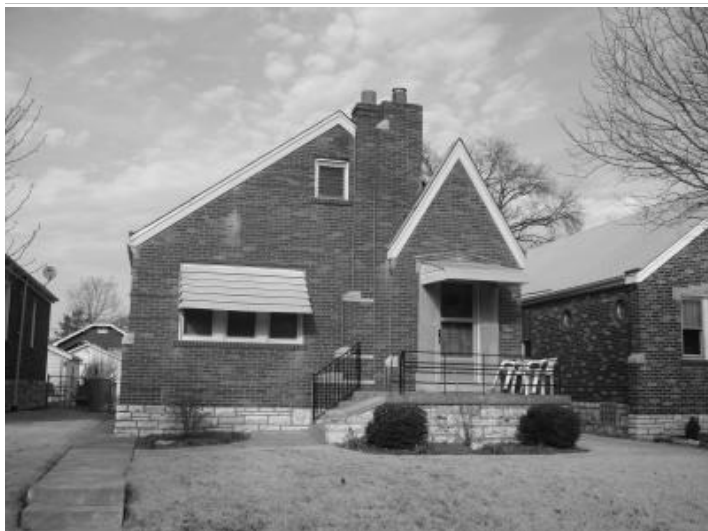
Some wood trim wrapped with siding. awnings at replacement window set (left) and front door.

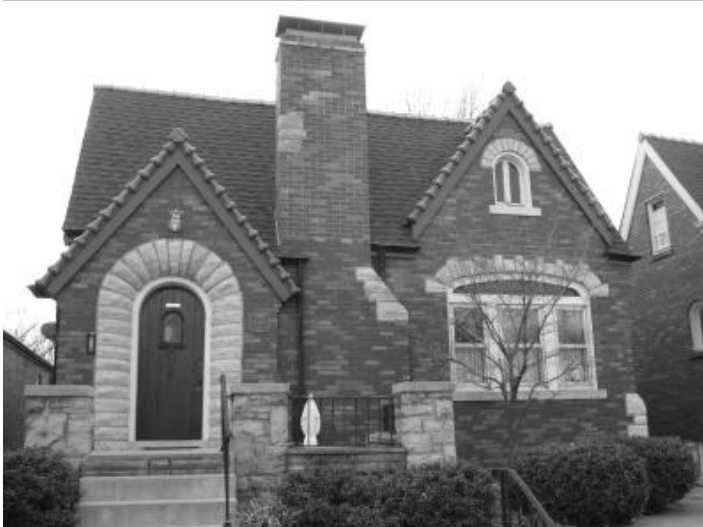
Some wood trim wrapped in siding

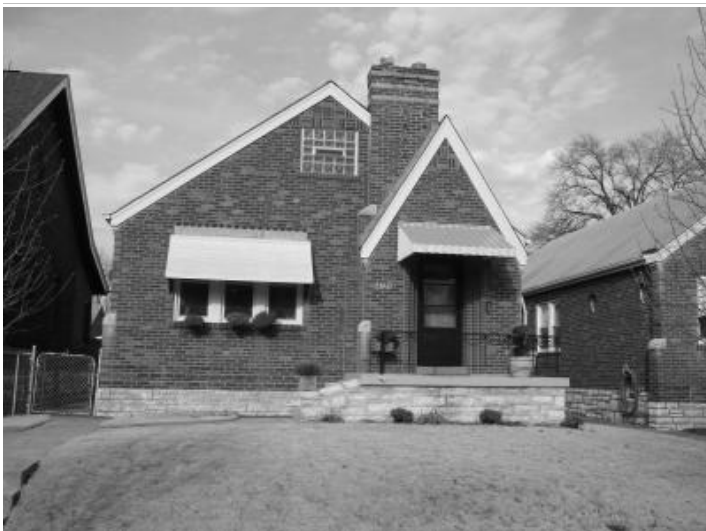
awnings at window set and front door. Replacement façade windows.

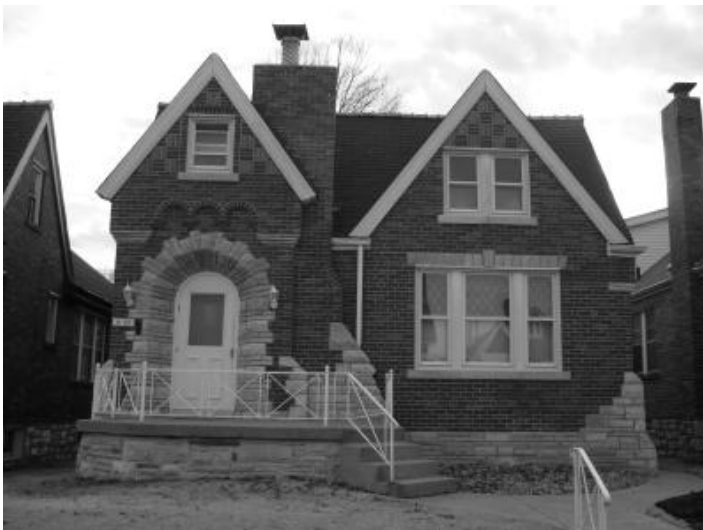
Some wood trim wrapped in siding

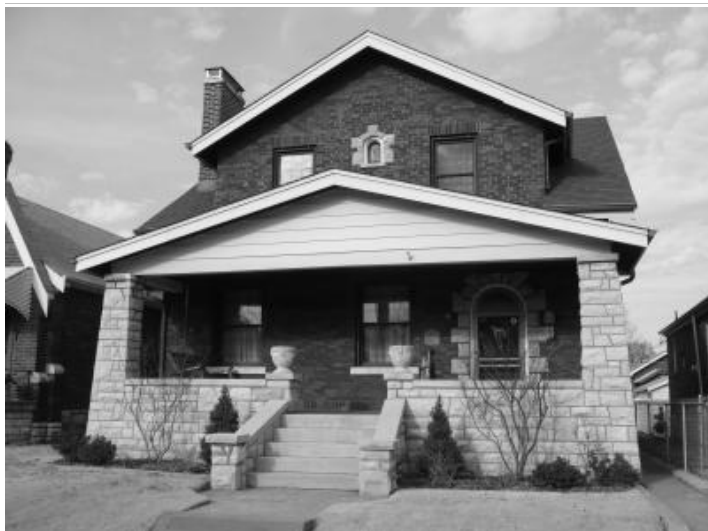
Replacement façade windows.

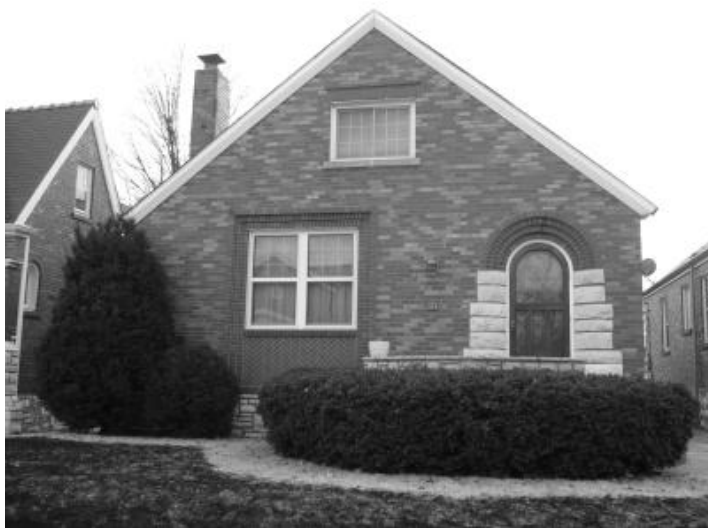
Façade windows are vinyl replacements.

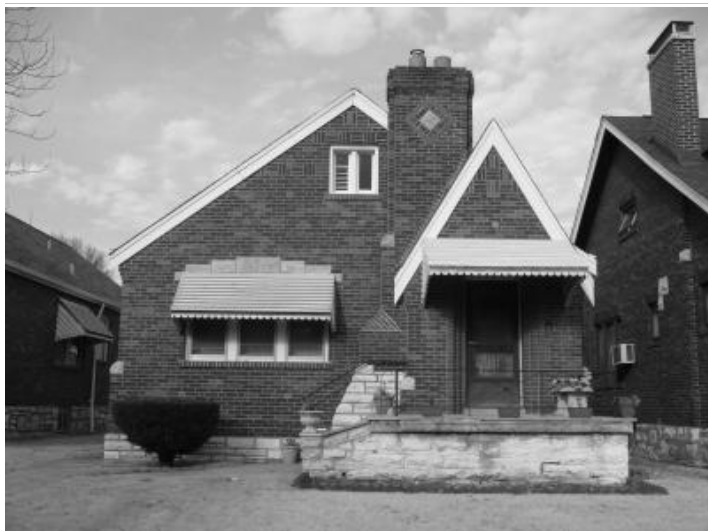
awnings at window set and front door.

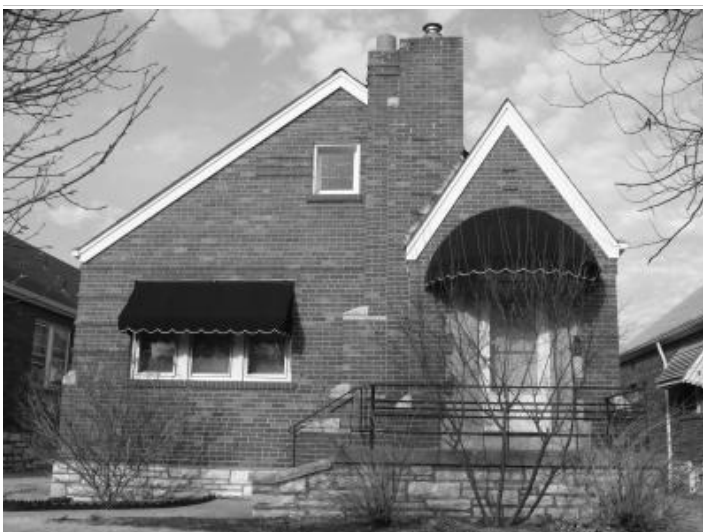
Fabric awnings at window set and front door.

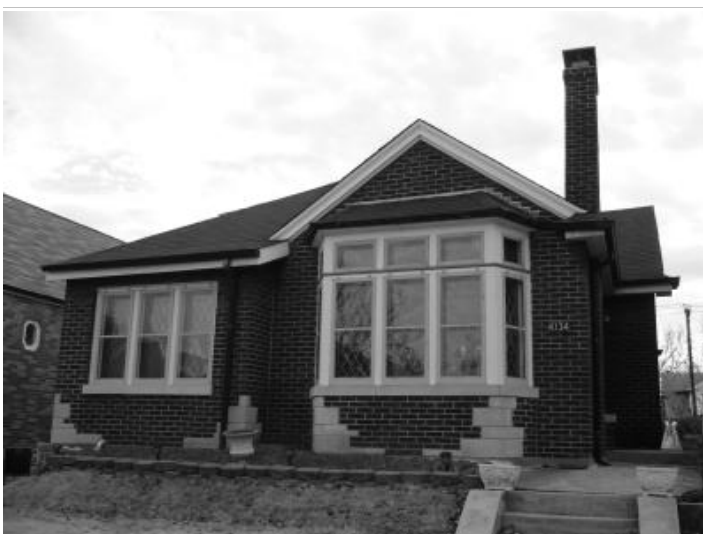
Some wood trim wrapped with siding.

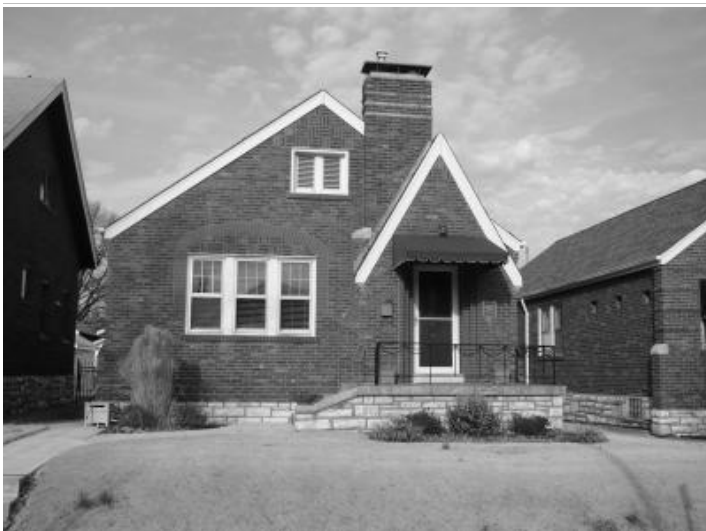
Replacement front door under fabric awning, right.

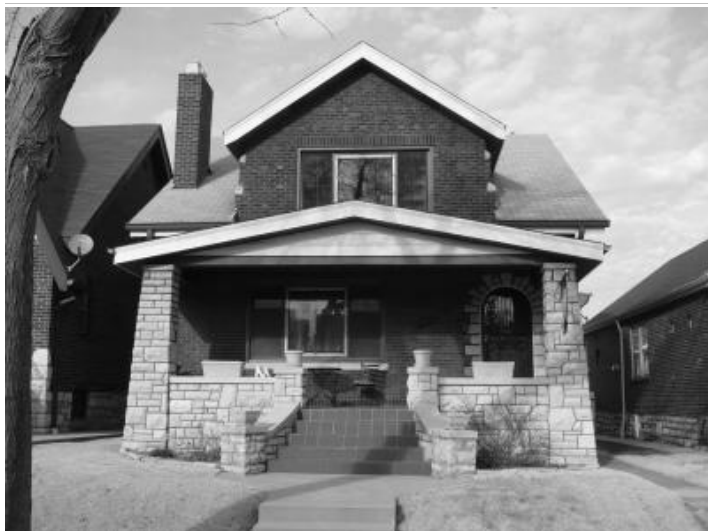
Replacement windows at façade.

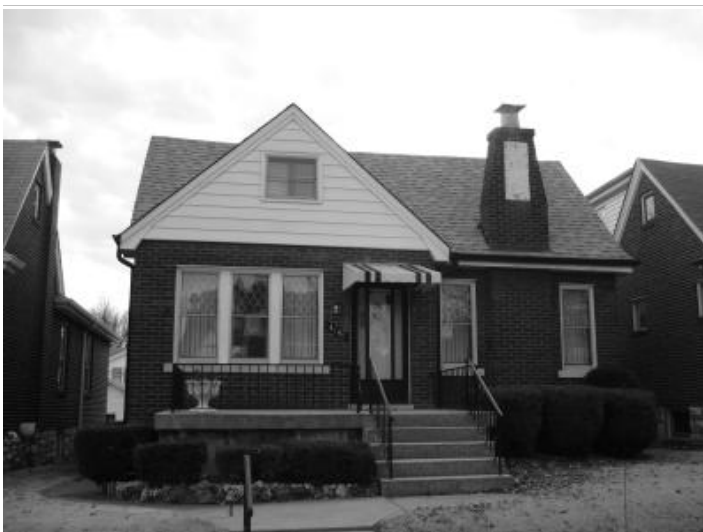
Siding at gable end, vergeboards and eaves. Metal awning added over front door.

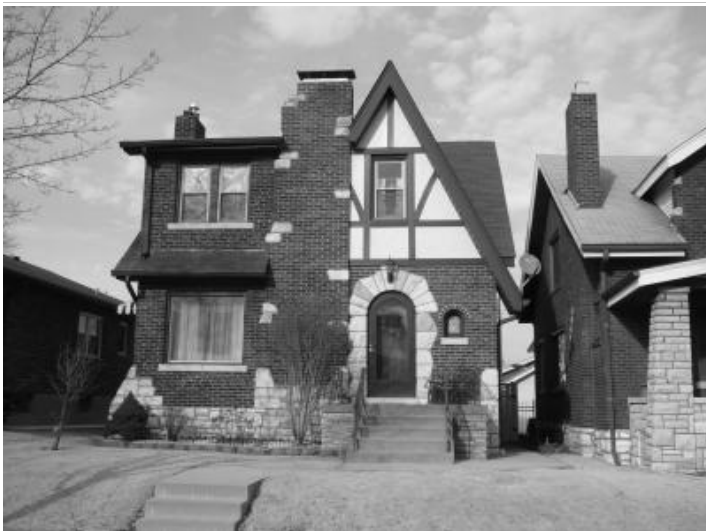
Left bay windows are replacements, as is the window at the second story of the right bay.

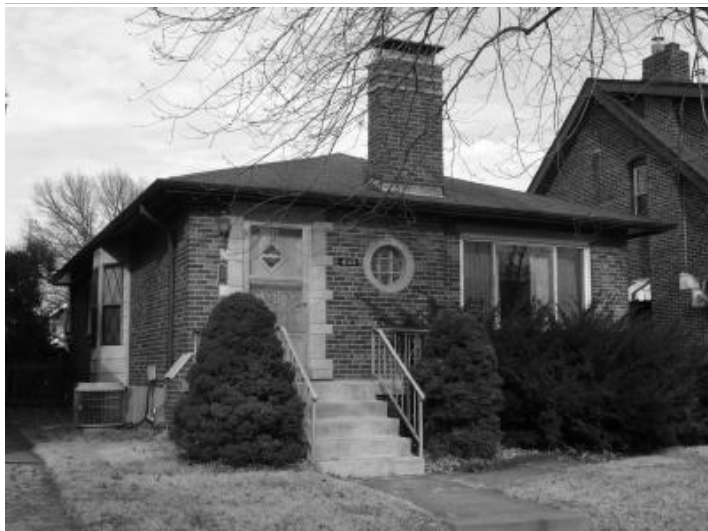
Right bay has a replacement picture window.

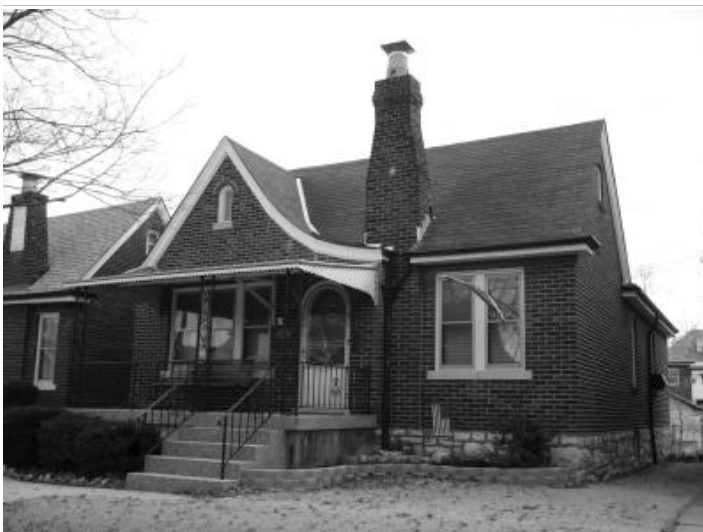
The concrete porch has a metal awning roof on metal trellis-style supports. Some wood trim is wrapped with siding.

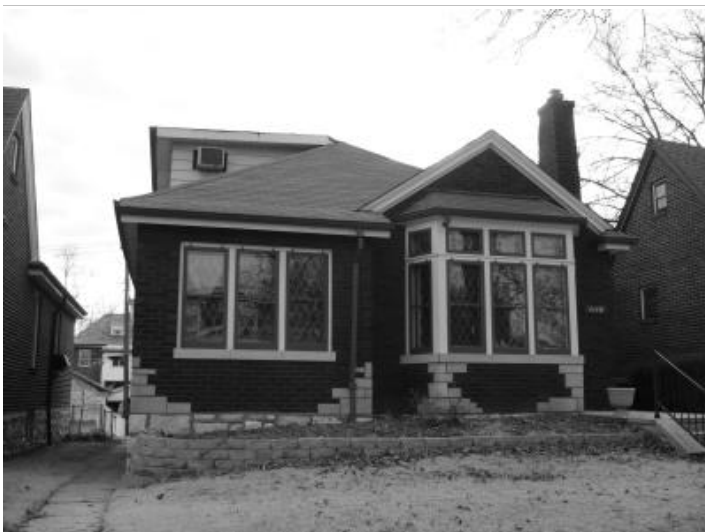
Pop-up dormer adds second story living space at rear of house, well back from façade.

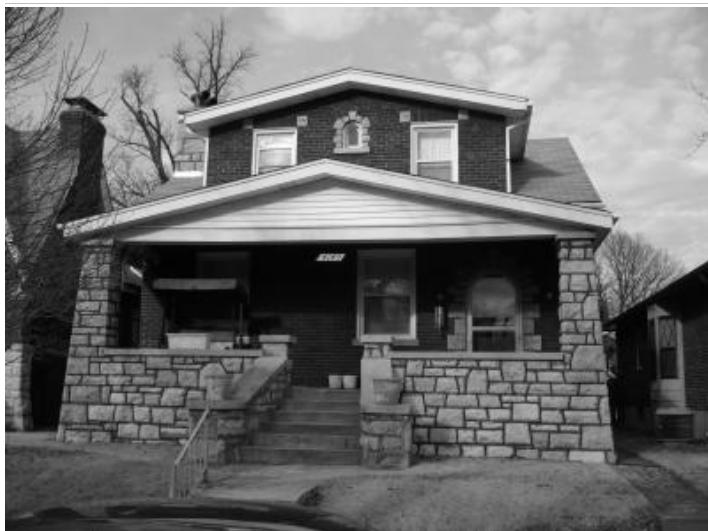
Facade window replacement. Porch gable end covered with modern horizontal siding.

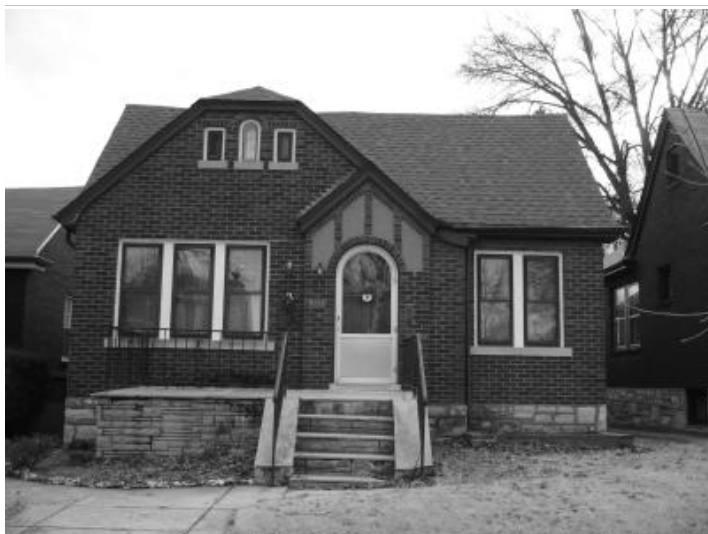
Porch base covered with imitation stone veneer.

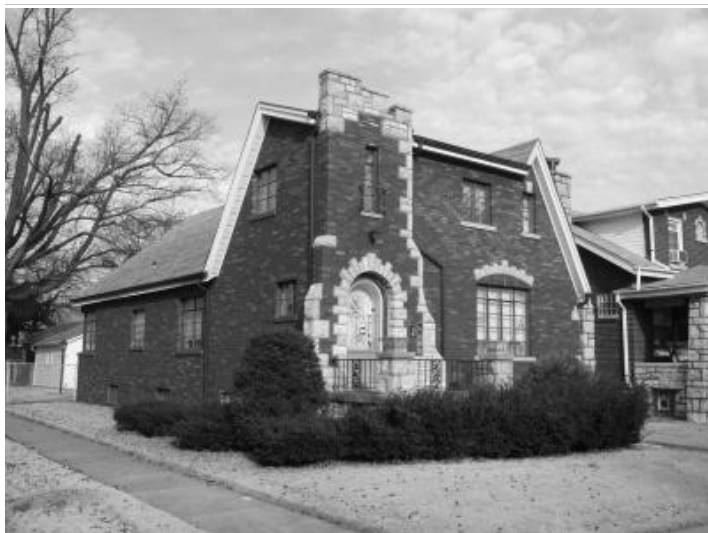
Some wood trim is wrapped with aluminum.

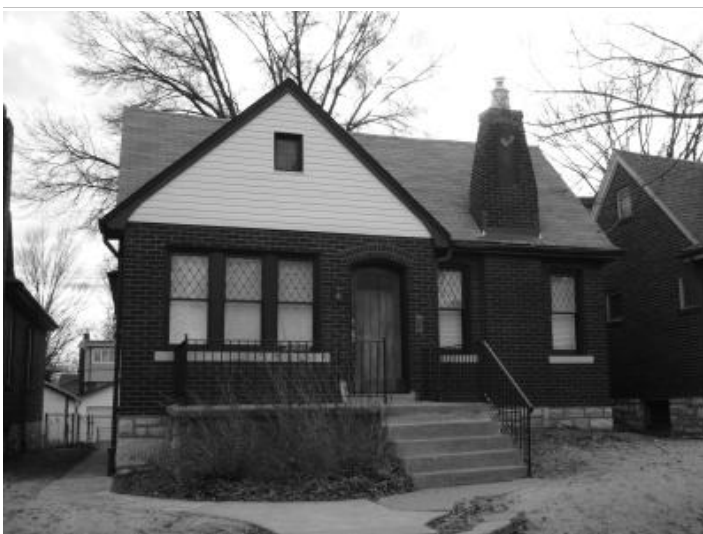
Modern horizontal siding in front gable end.

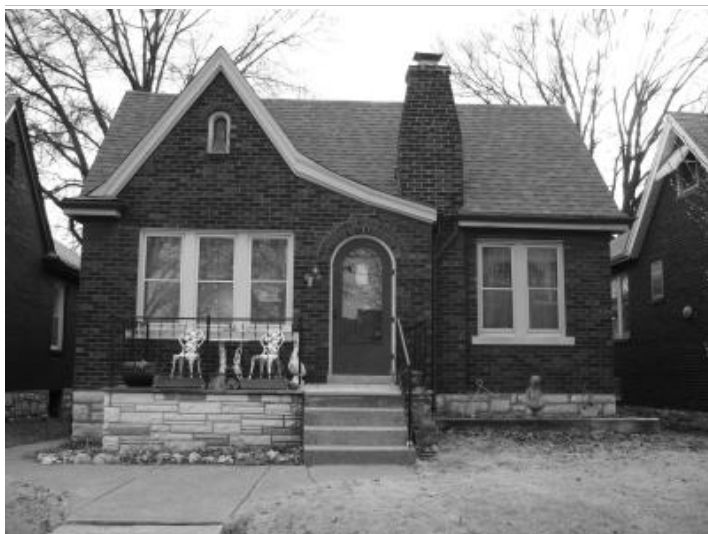
Some wood trim pieces wrapped with aluminum siding.
