City of St. Louis Cultural Resources Office

Holly Hills Neighborhood Survey

Lynn Josse and NiNi Harris
3/1/2010

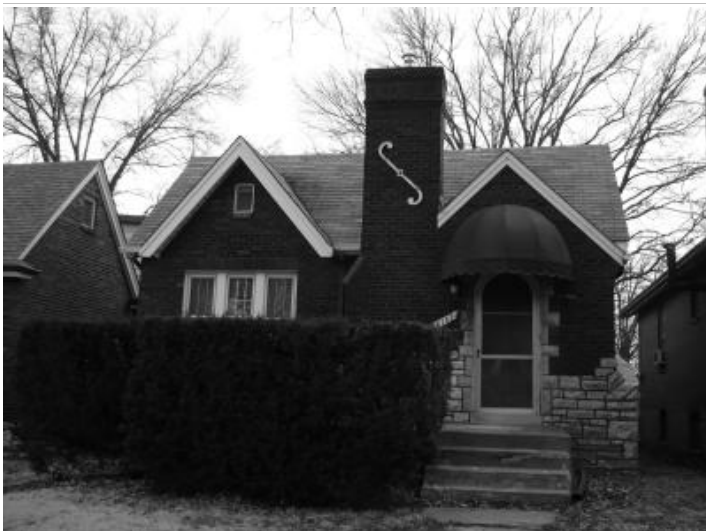
Some wood trim wrapped with aluminum; fabric awning over door.

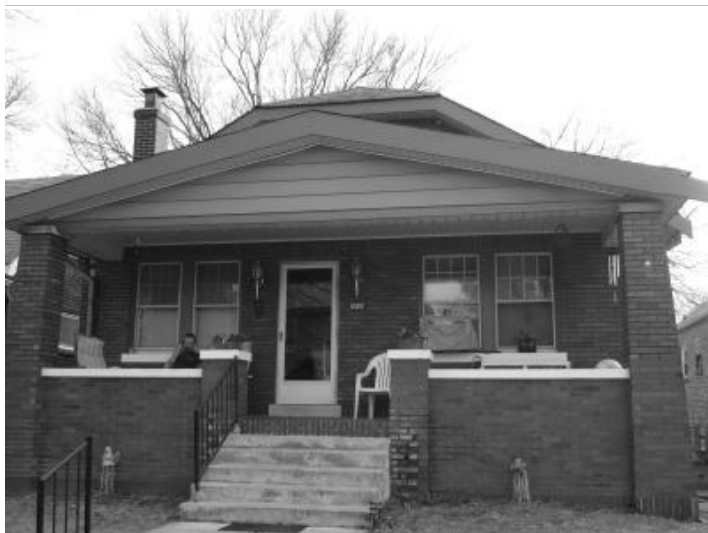
Modern horizontal siding over porch gable end; aluminum/vinyl wraps some wood trim.

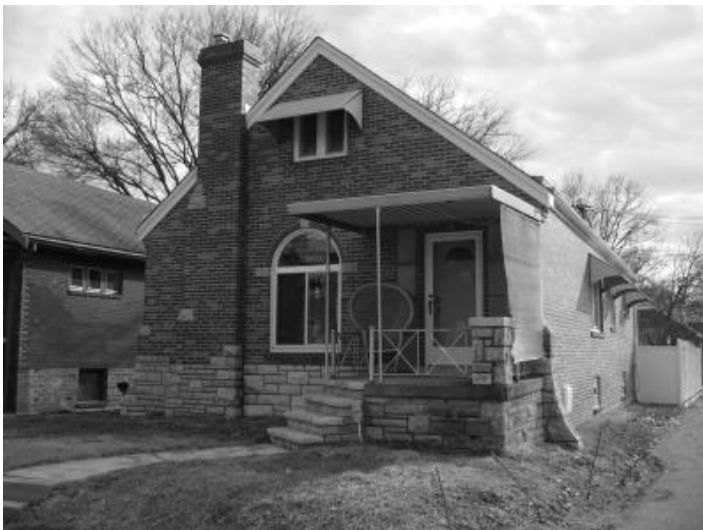
Door and center arched window replaced.

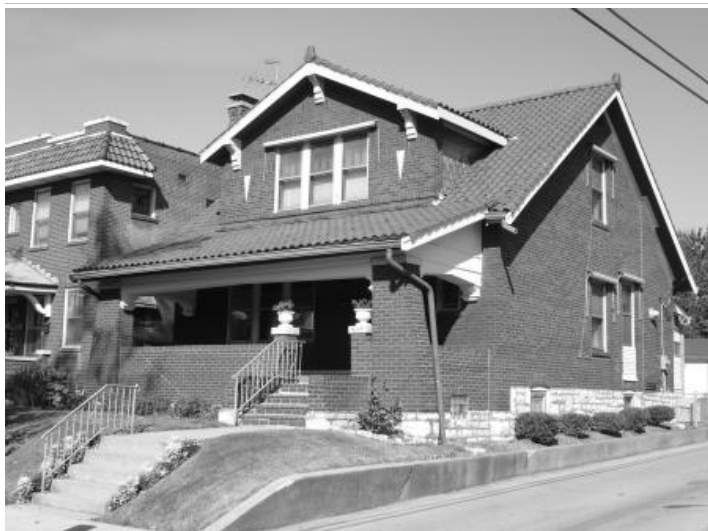
Eaves and 3 brackets at dormer are encased in vinyl

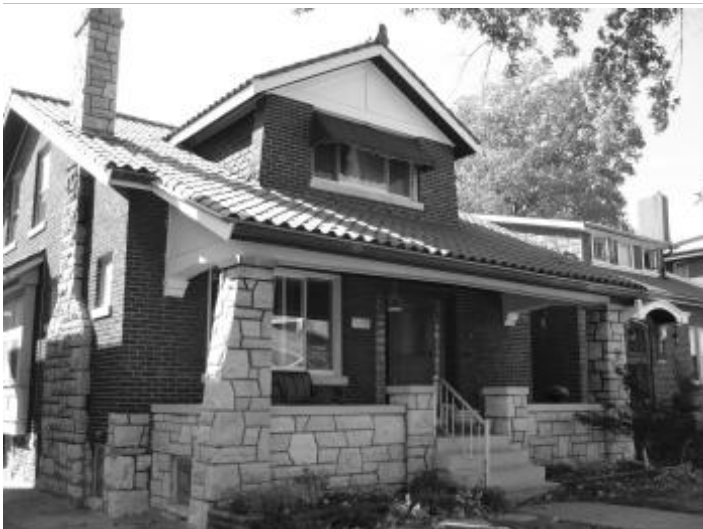
Windows are replacements, and sidelights are filled in with glass block.

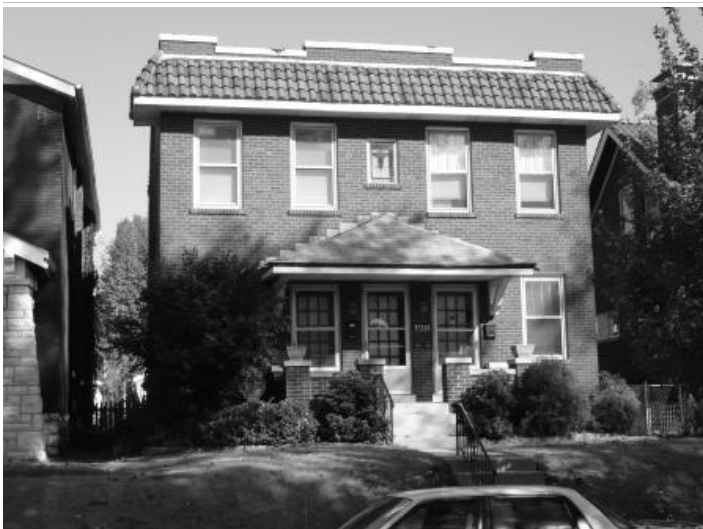
Two façade windows are replacements; eaves and brackets are sheathed with siding.

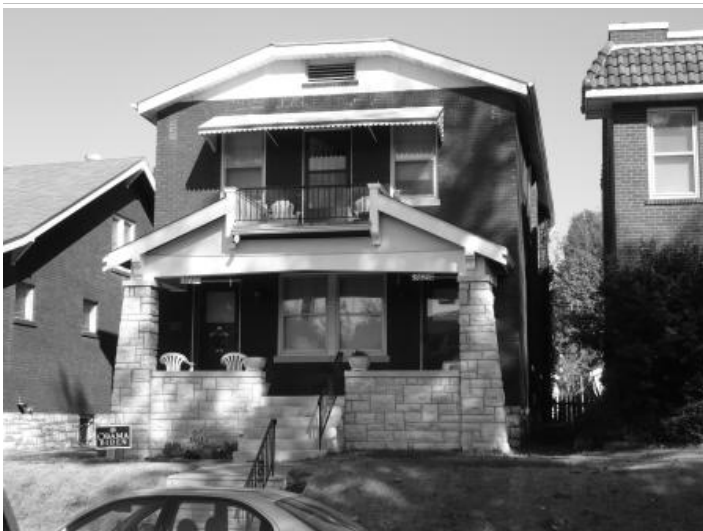
This red brick building has a full-width limestone porch, its gable roof broken by an inset balcony. Doors and 3/1 windows are original.

Metal awning at second story.

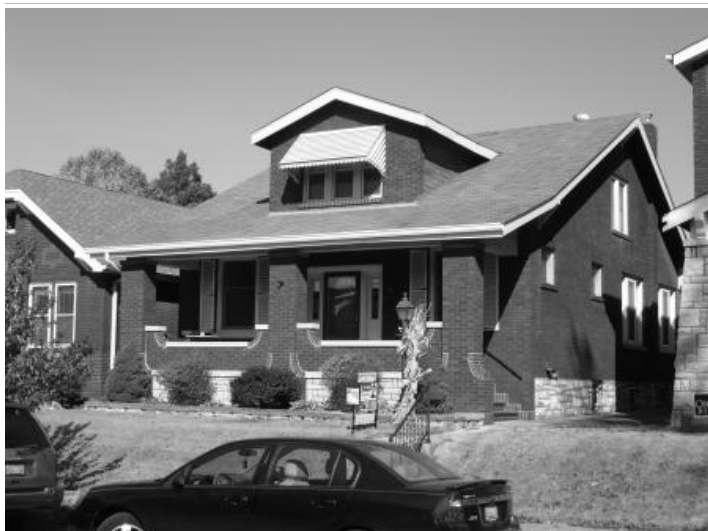
Doors and windows are replaced, shutters and awnings added, siding over brackets.

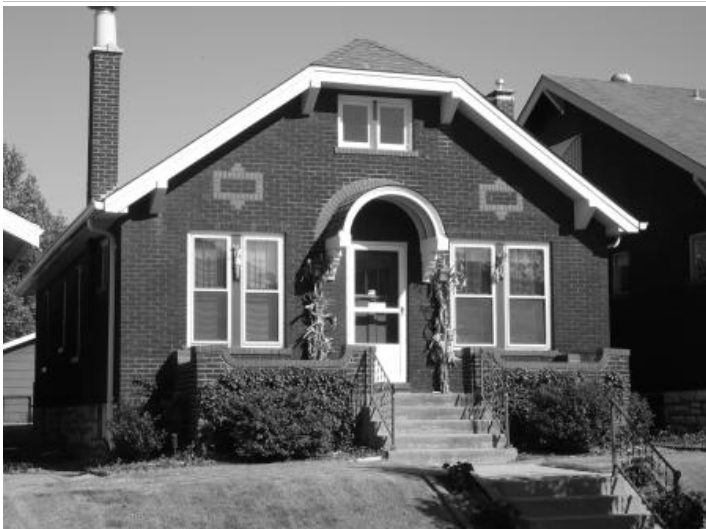
Eaves and brackets are in siding.

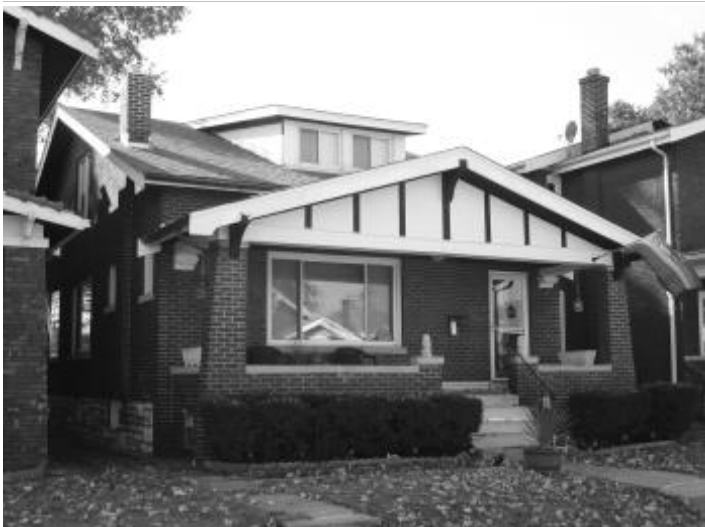
Windows at left side of façade replaced by modern arrangement.

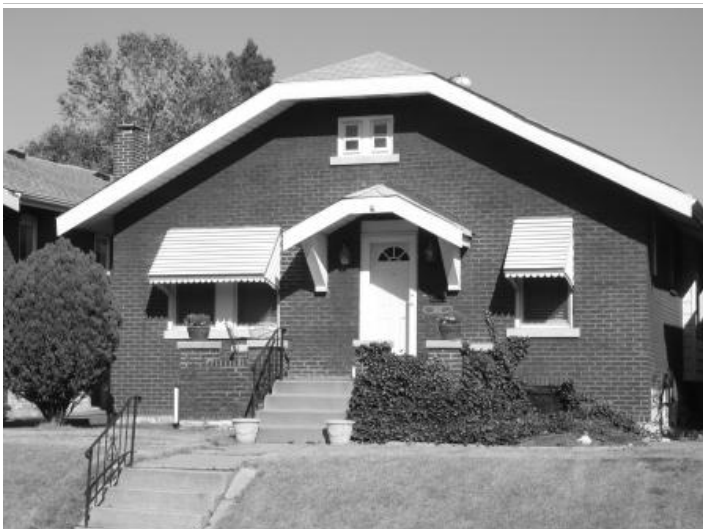
Door and windows are replaced. Hood and brackets, eaves encased in siding; metal awnings over windows.

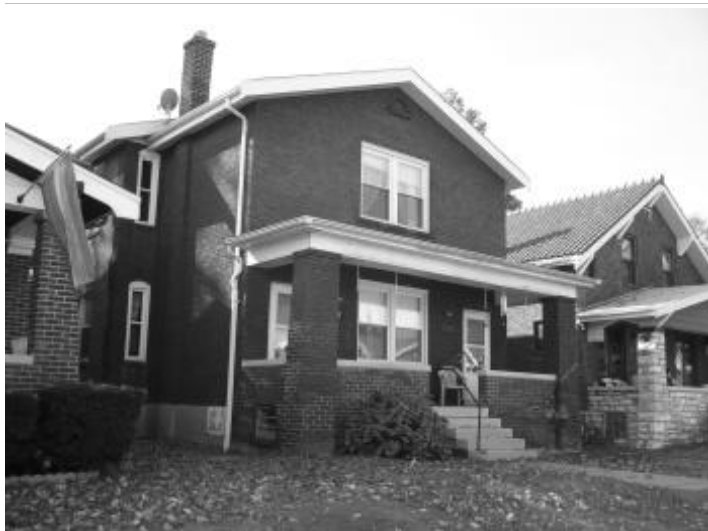
windows are replacements, and aluminum trim covers eaves and soffits.

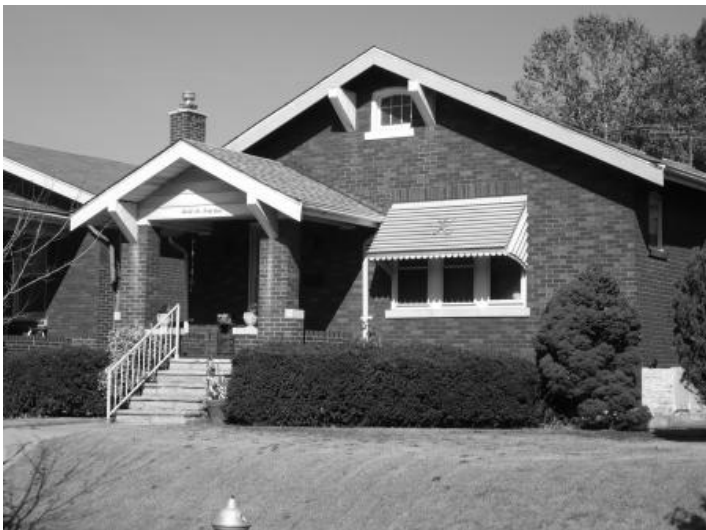
Most wood elements are wrapped/covered in siding (aluminum) including porch gable end, eaves, soffits, pair of brackets. Metal awning over windows.

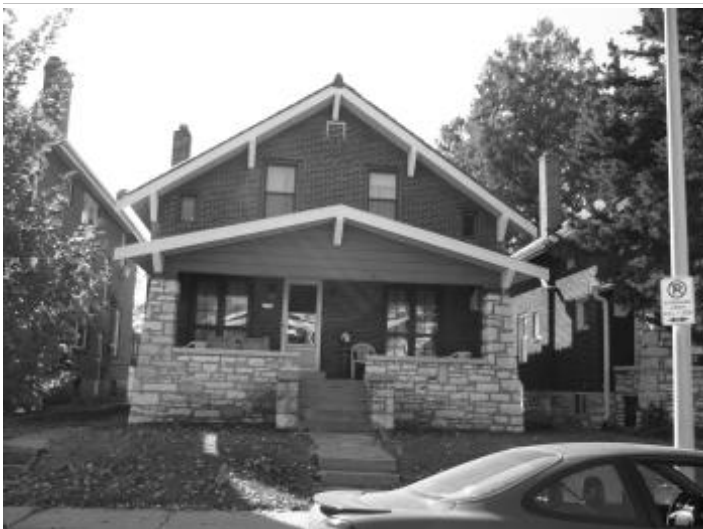
Second story windows are replacement 1/1s; siding over porch gable end, eaves and brackets.

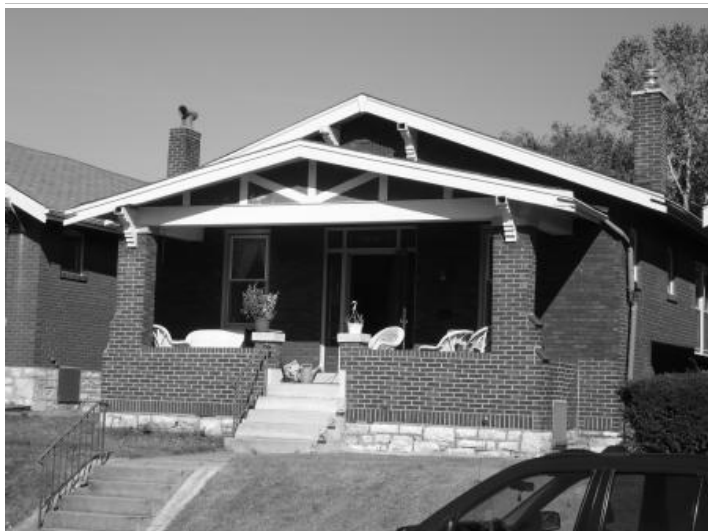
Replacement windows

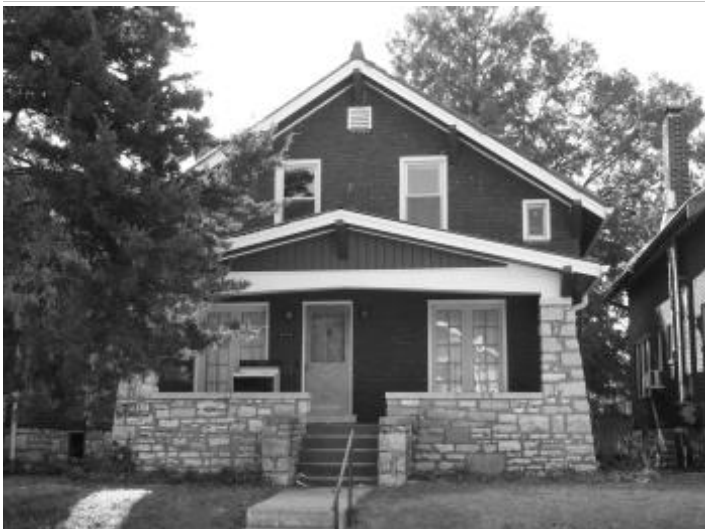
Replacement front door and second story sash windows. Aluminum siding over eaves, brackets, soffits, porch gable end.

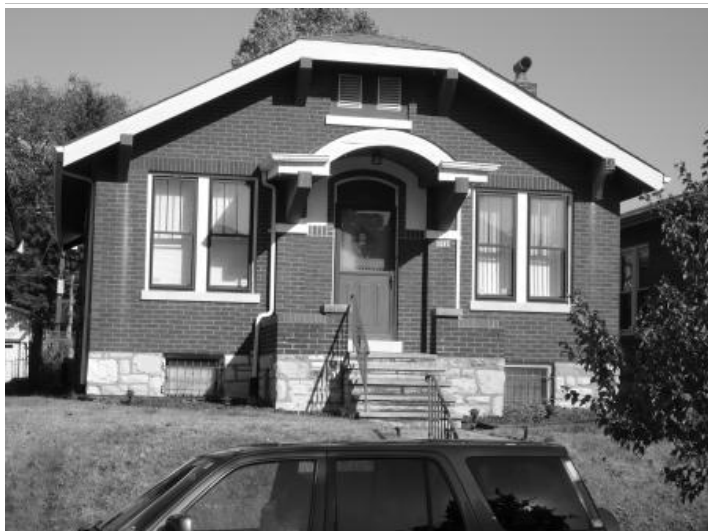
Replacement front door. Vinyl encases eaves and brackets of hood and main roof.

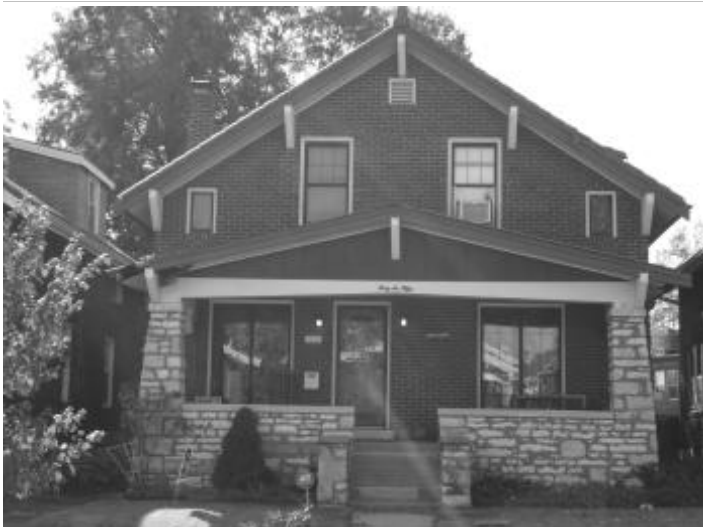
Replacement front door and second story sash windows. Aluminum siding over eaves, brackets, soffits, porch gable end.

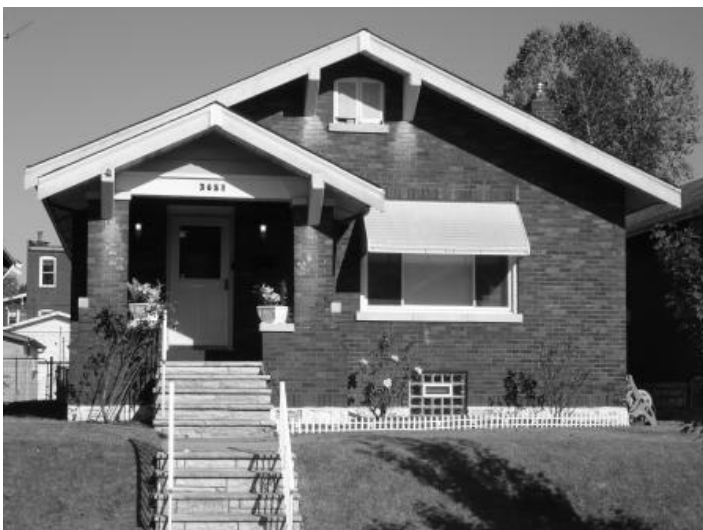
Front door and windows have been replaced. Eaves, porch gable end and brackets encased in aluminum. Fiberglass awning over windows, right.

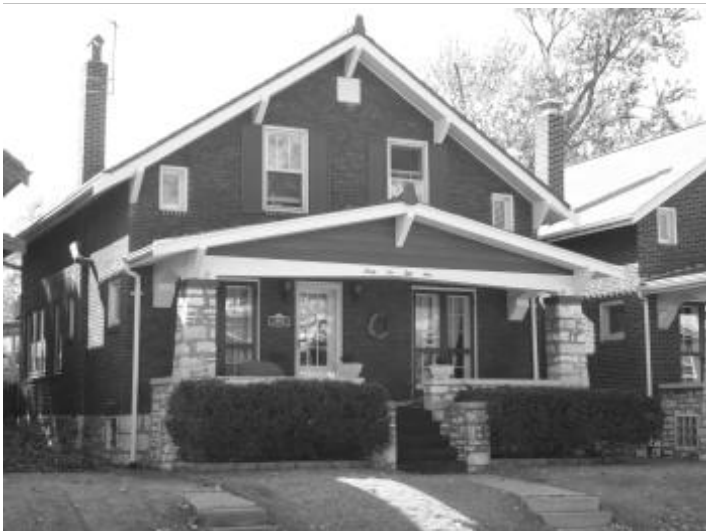
Aluminum siding over eaves, brackets, soffits, porch gable end.

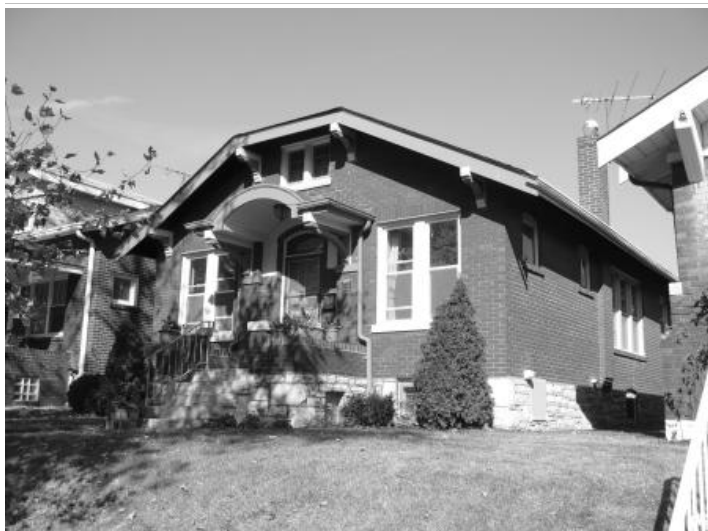
replacement windows

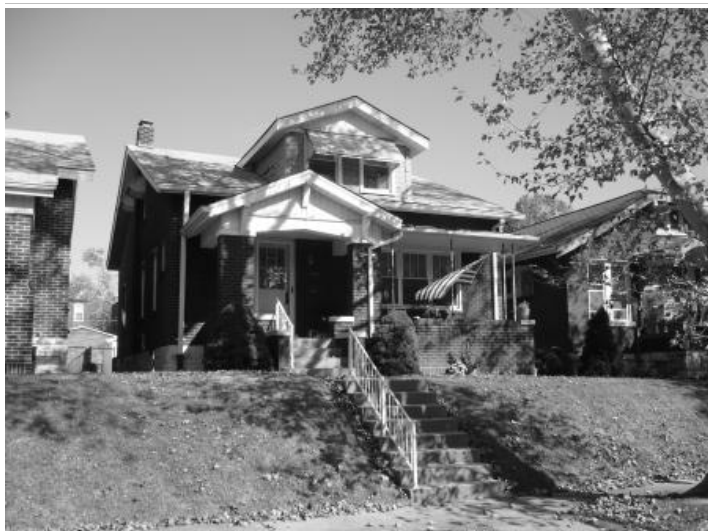
Windows are replacements. Metal awning roof added over porch, right. Siding over eaves, brackets, and gable end.

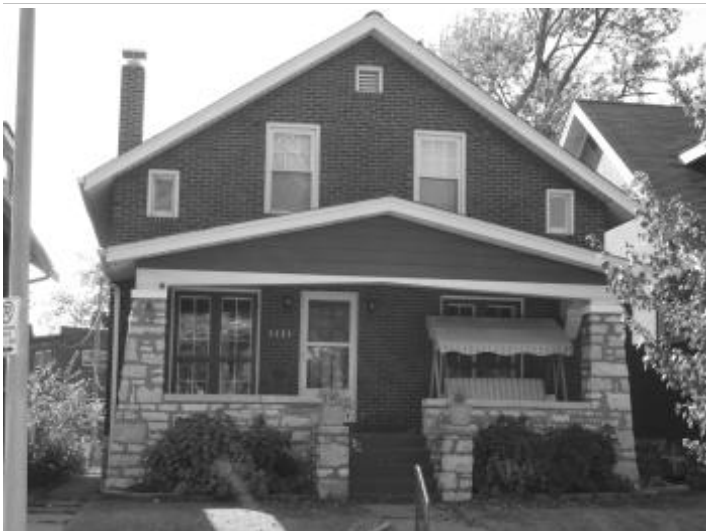
Aluminum siding over eaves, soffits, porch gable end. Replacement sash windows at second story.

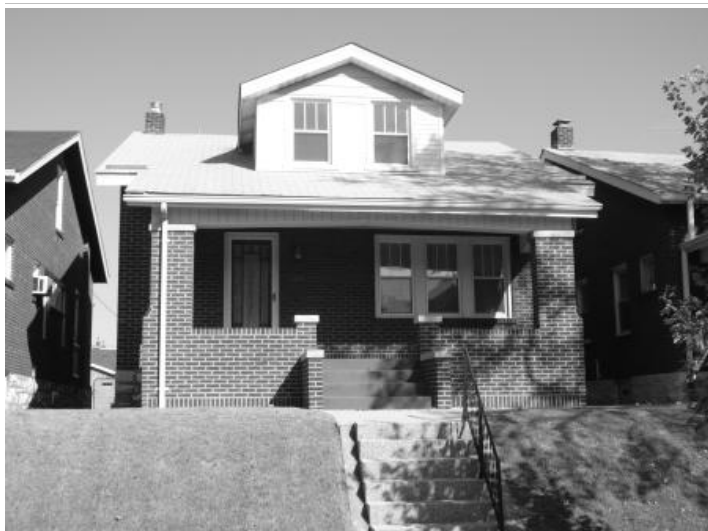
Windows are replaced. Modern siding used at dormer, gable end, eaves, soffits,

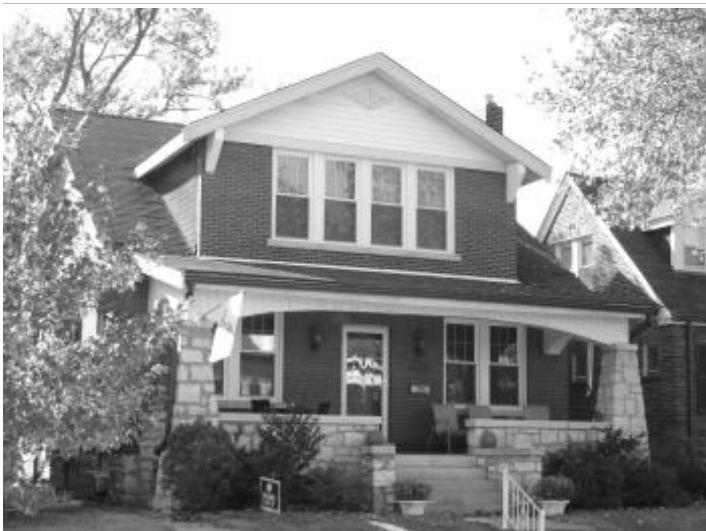
Front door and windows are replacements. Siding covers brackets and gable end of dormer, and eaves and soffits of porch.

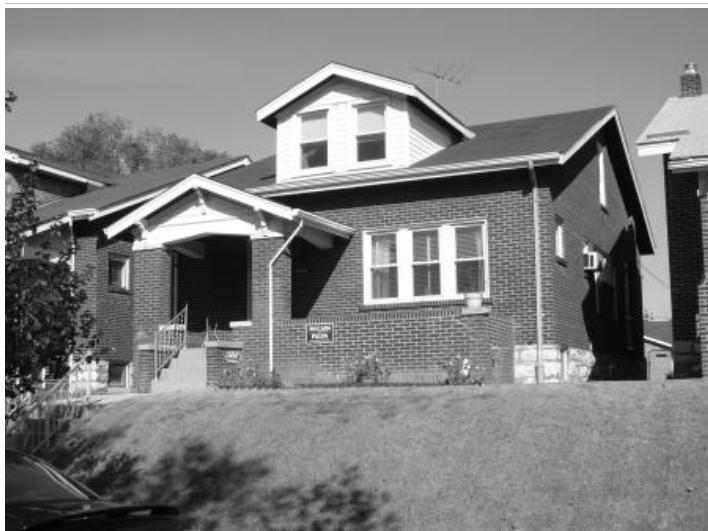
Replacement windows. Siding at gable ends is modern (aluminum or vinyl)

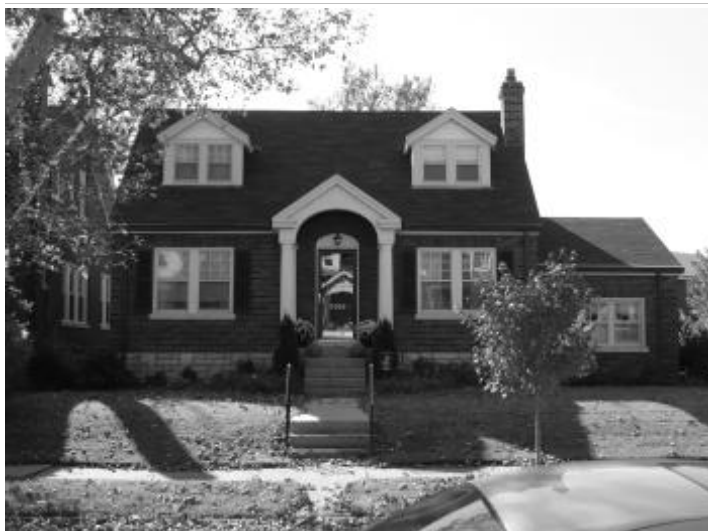
1966 dormer addition (\$2600). Replacement front door and windows at right wing.

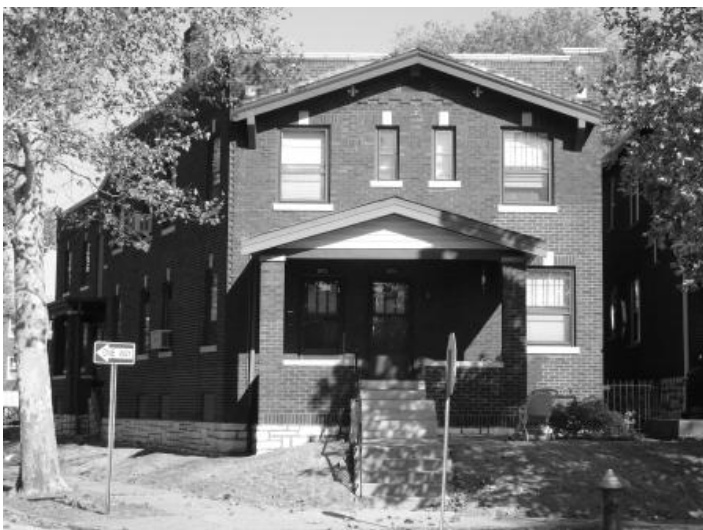
This six-family building has two front doors facing Fillmore and four at Dewey. The exterior is variegated red and black brick with enameled white brick highlights. Doors are original. Half of the windows facing the two streets are original 3/1 and 1/1s, half are replacements.

Vinyl covers gable end, eaves, ceiling. Faux gable end on Fillmore. Half of the windows are replaced, and two balcony doors at the Dewey elevation are filled in with vinyl.

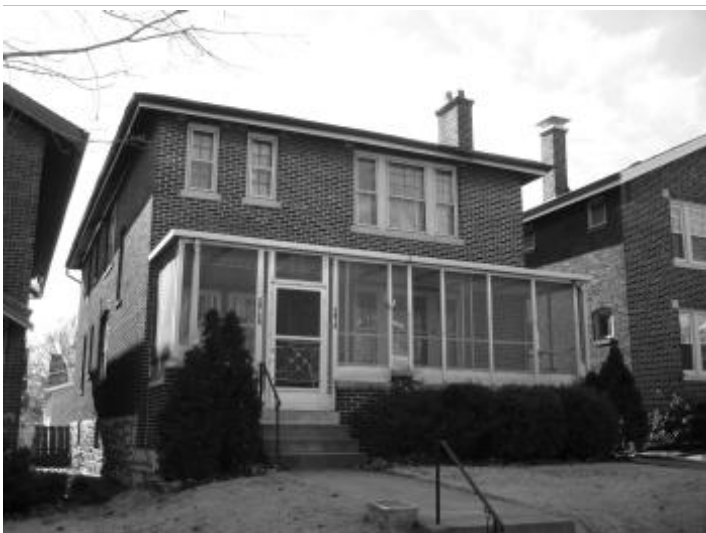
Porch is enclosed with metal system including metal roof. (Low porch walls are intact)

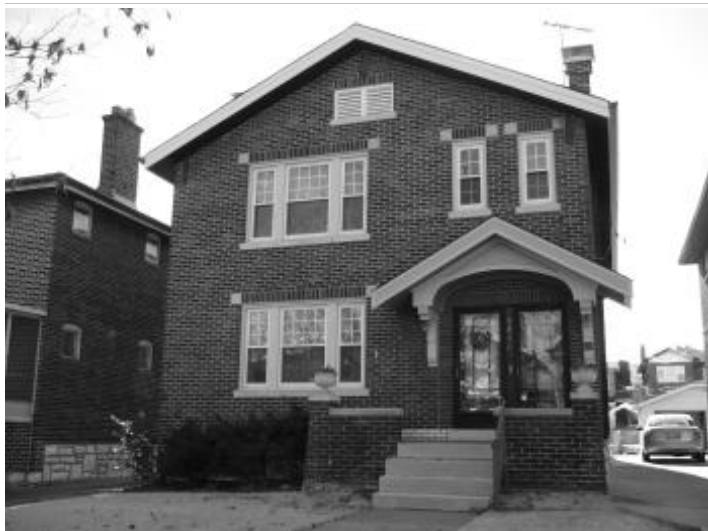
The two small windows above the front doors and the sets at both stories of the left bay are vinyl replacements.

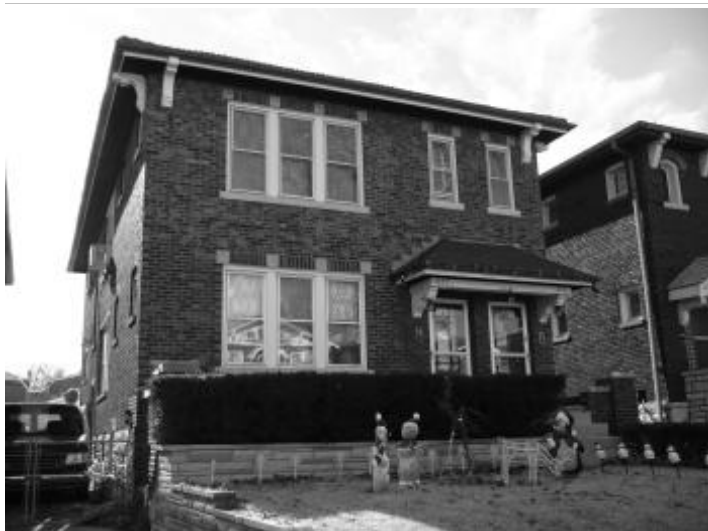
imitation stone veneer is used to form a planter across the full width of the front porch.

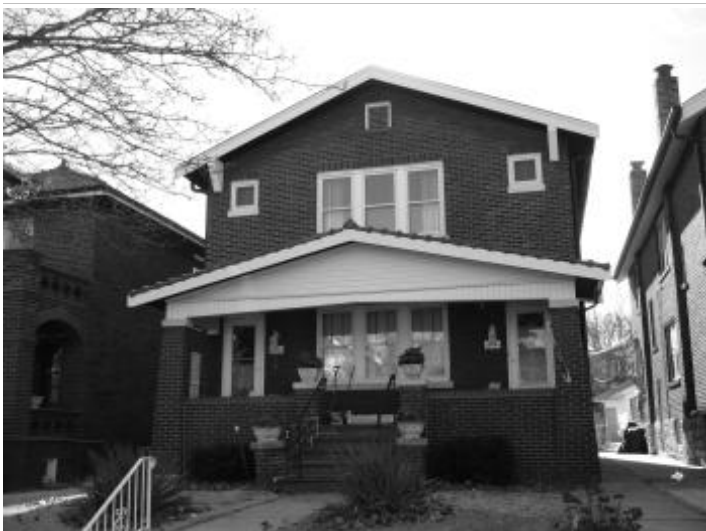
Replacement doors; vinyl siding in porch gable end.

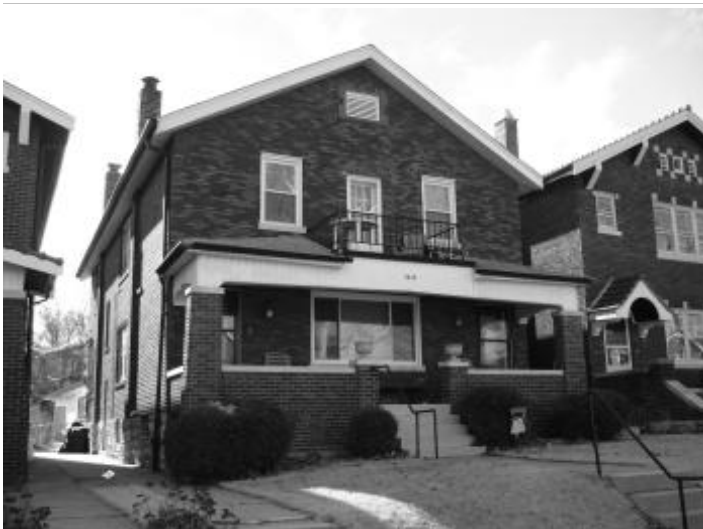
Replacement vinyl windows, including track window at first story.

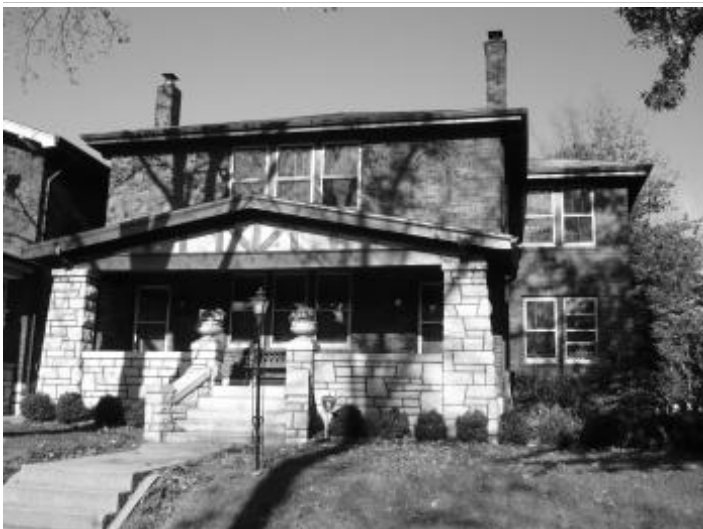
Front doors replaced.

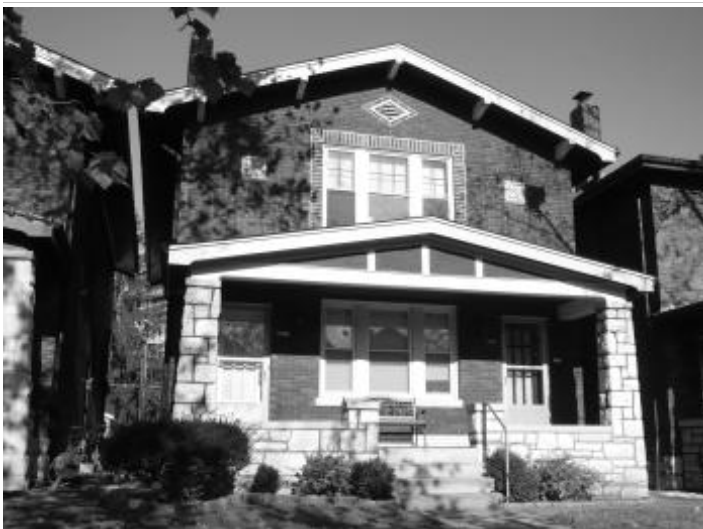
First floor window set replaced with vinyl windows. Some wood trim (including brackets) clad.

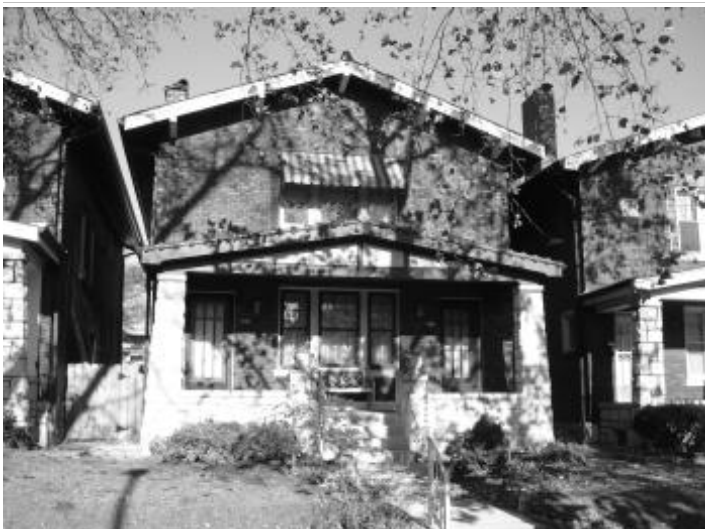
Some wood trim (including brackets) is wrapped. Fabric awning over second story windows.

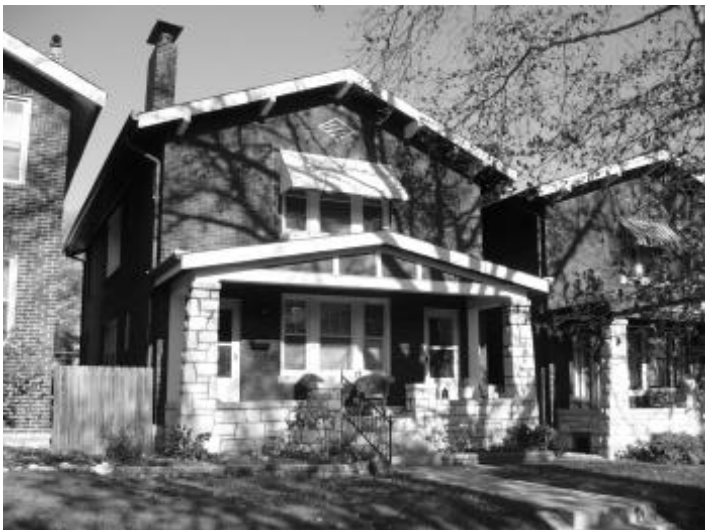
Some wood trim (including brackets) is wrapped. Metal awning over second story windows. Centering both stories is a triple set of replacement vinyl windows.

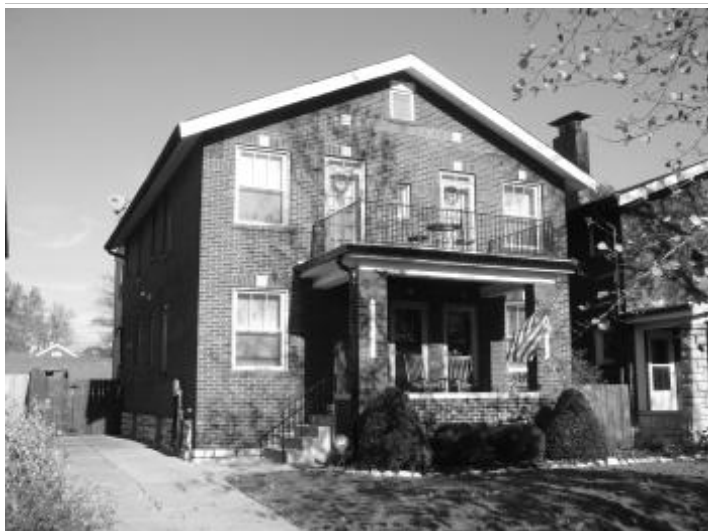
Replacement windows; Some wood trim is wrapped in siding.

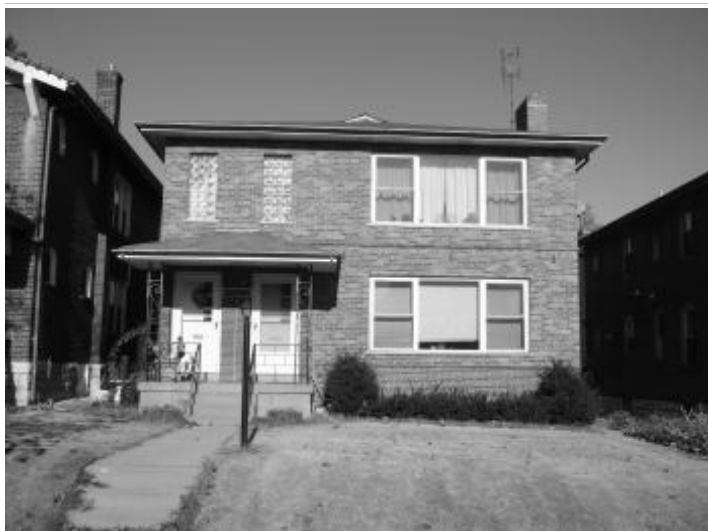
Wide window openings at the right bay bear vinyl replacement windows.

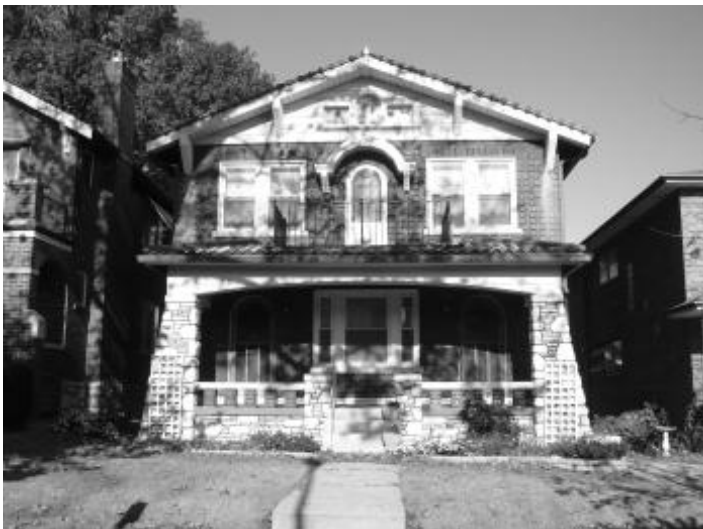
This front gabled building has a green ceramic tile roof. The full-width porch has a hipped tile roof with an inset center balcony. The porch is limestone with battered piers. At either end of the first story and the center of the second are original round-arched doors. Vinyl windows replace all original at façade; wood trim wrapped including balcony's round-arched hoods, brackets at eaves and hood, gable end.

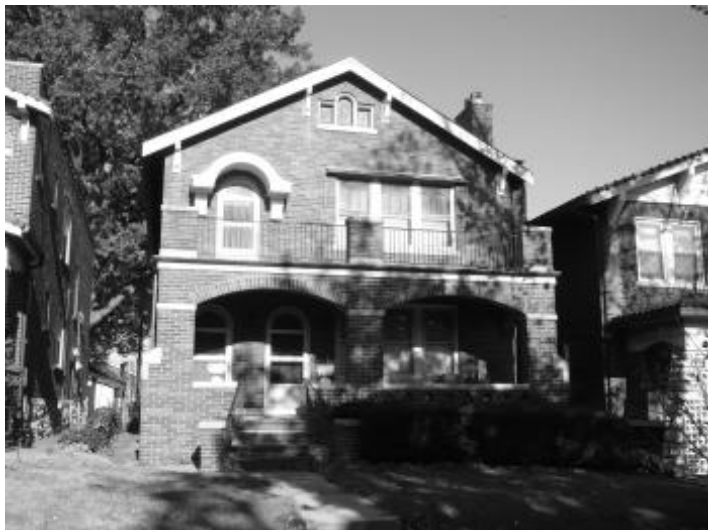
The round-arched hood over the balcony door and brackets at both the hood and front eaves are wrapped with siding. Retractable awning at second story windows.

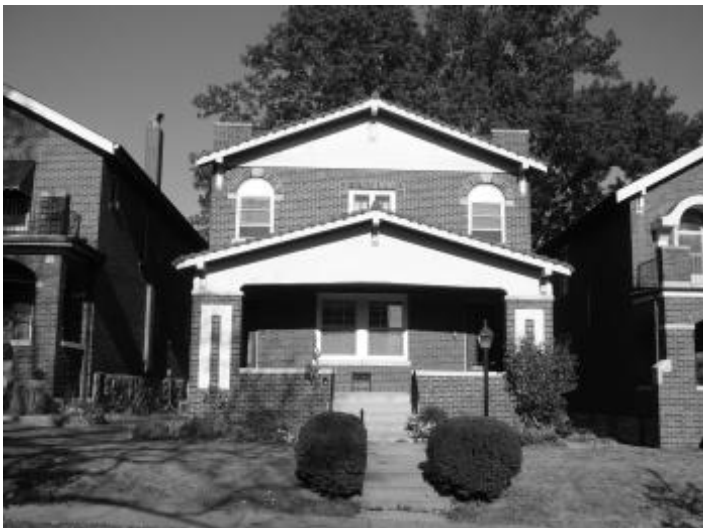
Center window set at first story is vinyl. At the second story it appears that the arched windows at the outer bay are intact but the tympanum is covered by a wood insert to accommodate conventional storm windows.

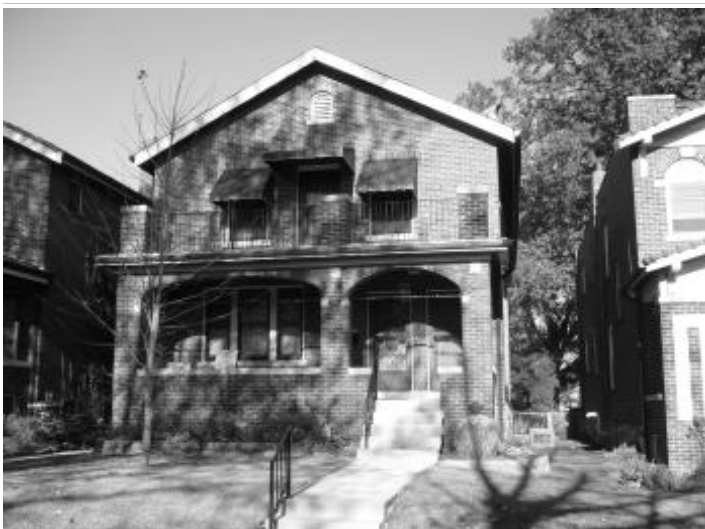
Metal awnings added at second story.

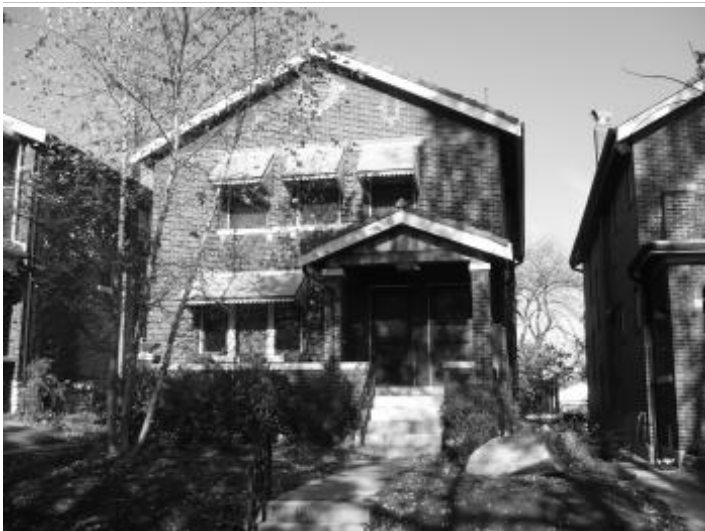
Metal awnings added at all façade windows.

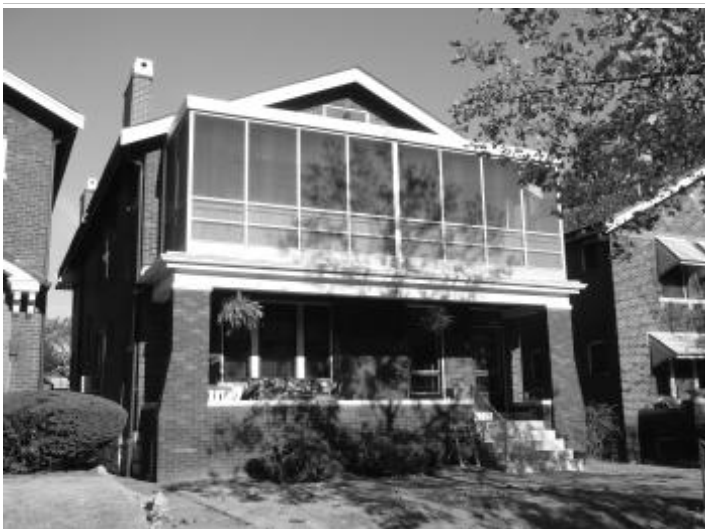
Metal-framed enclosure of second story balcony obscures second story.

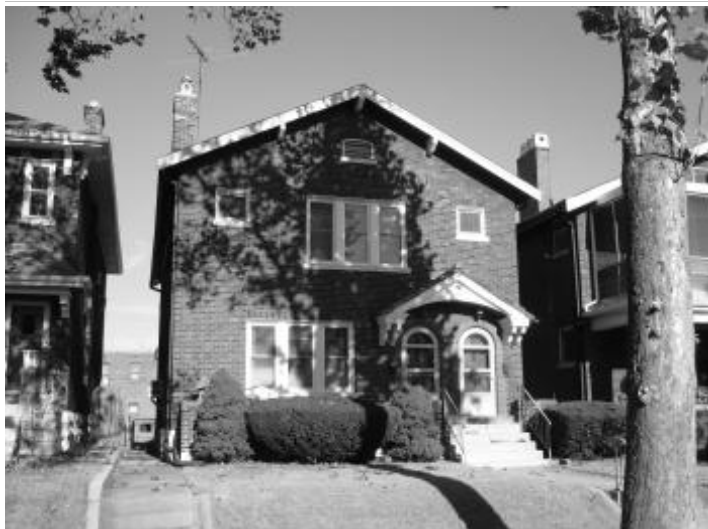
Vinyl replacement windows at both stories of façade. Some wood trim (including 5 brackets at front eaves) wrapped in siding.

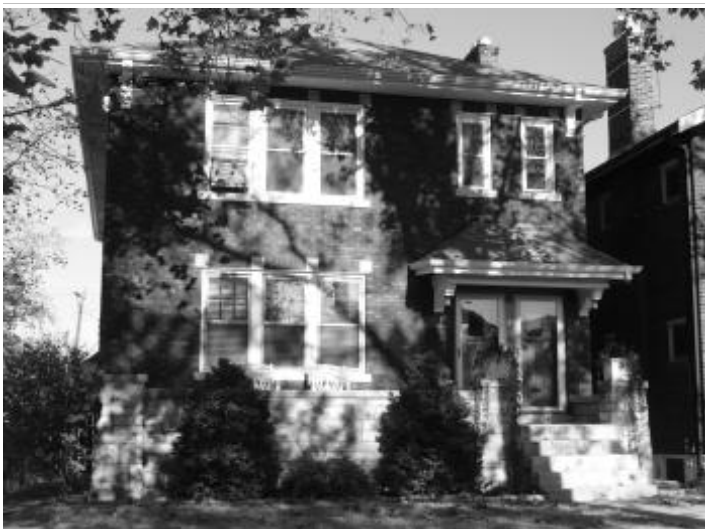
Vinyl windows at second story.

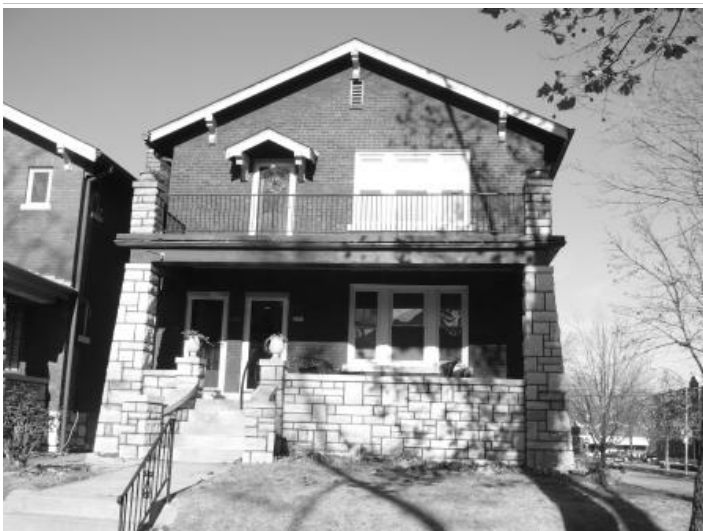
Window replacement at right bay, both stories

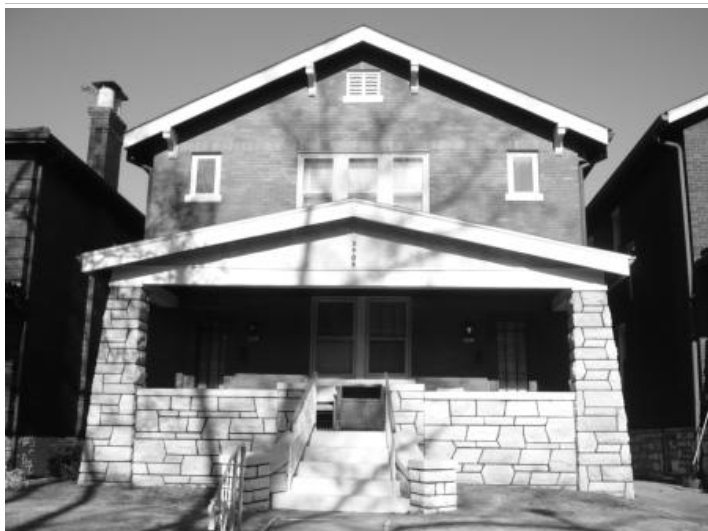
Replacement windows at second story. Some wood trim wrapped with aluminum.

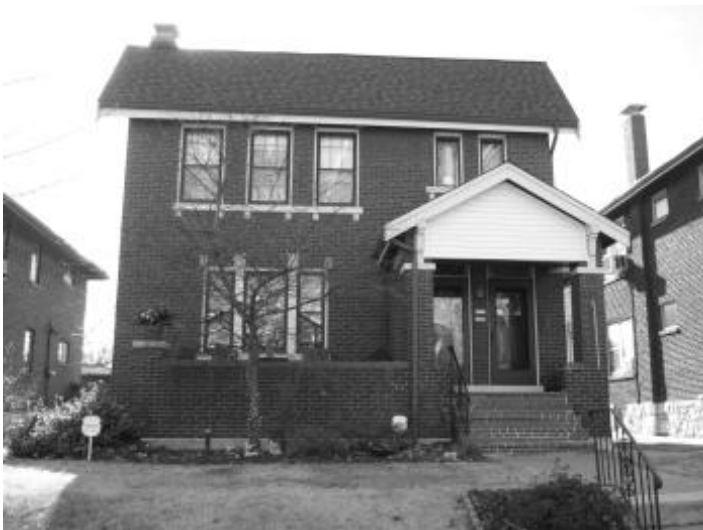
Some original trim wrapped with siding.

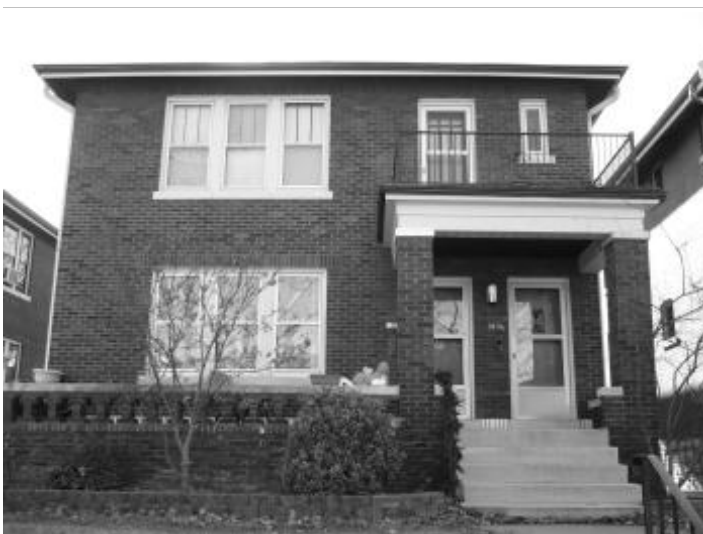
Some original trim wrapped with siding.

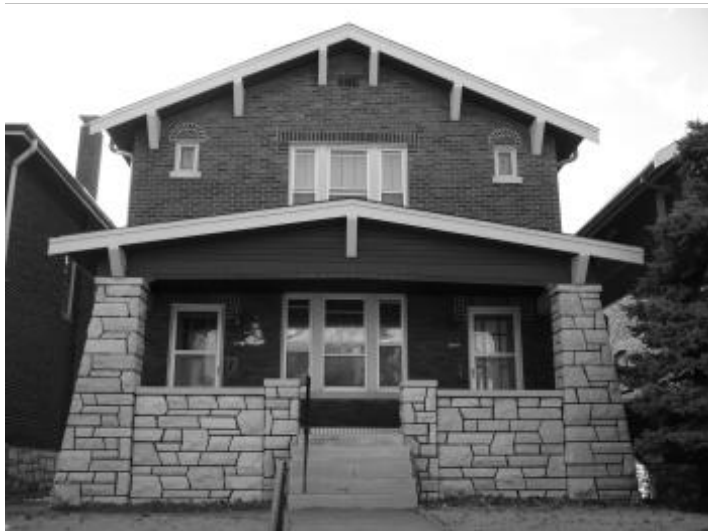
Some original trim wrapped with siding.

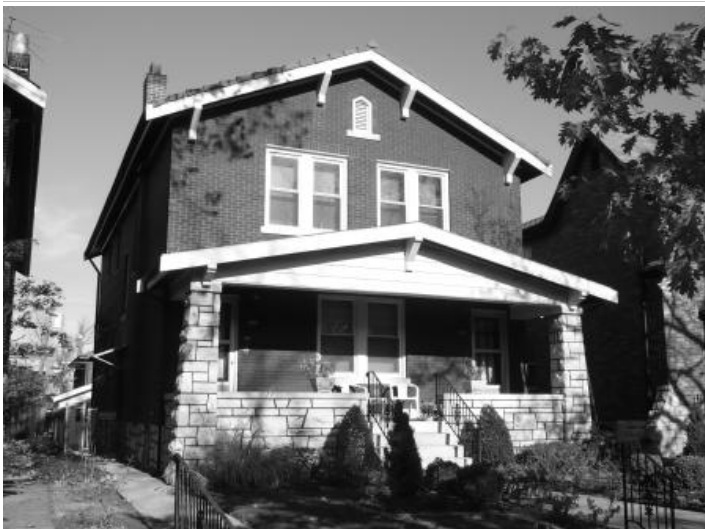
Both the porch roof and main eaves are supported on wood brackets, now soffitted. Full window replacement at façade.

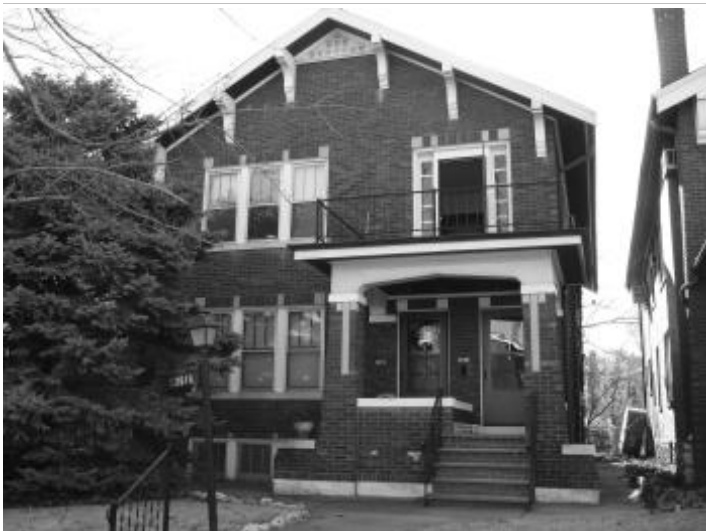
Some original trim wrapped with siding.

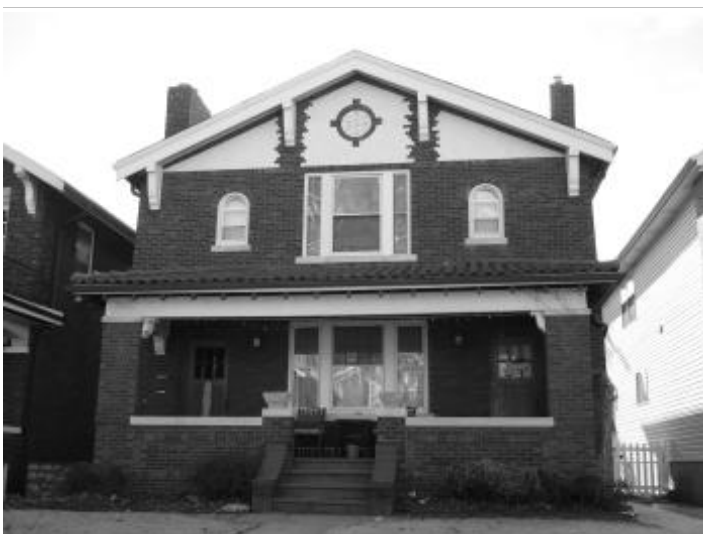
Some original trim wrapped with siding.

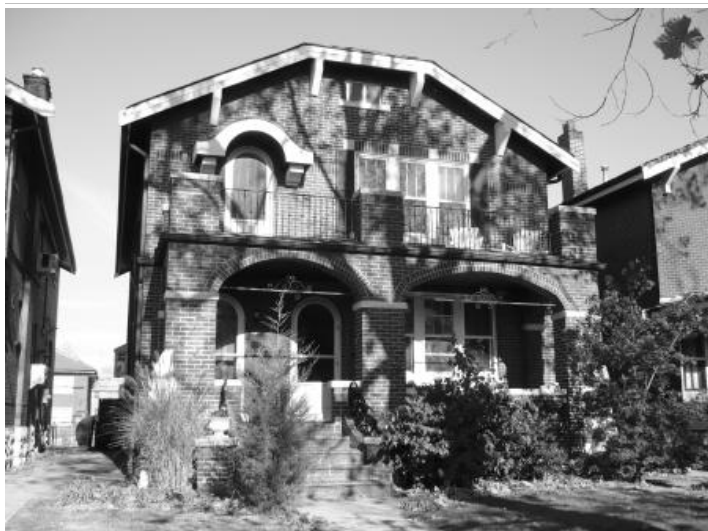
Some wood trim wrapped with aluminum.

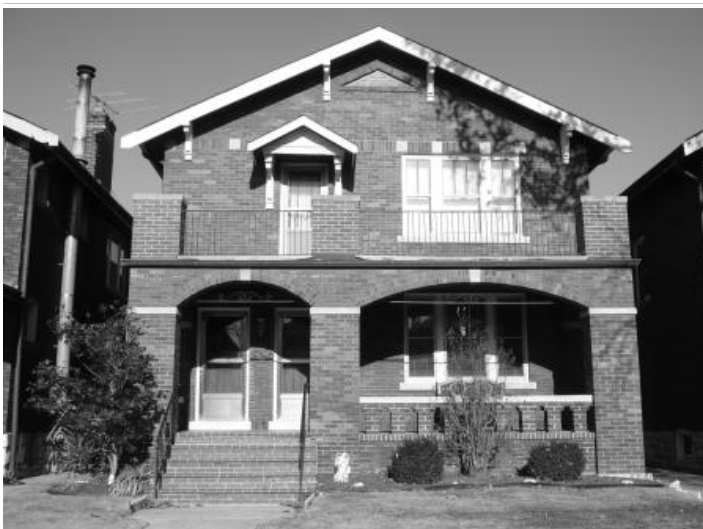
Some wood trim wrapped with aluminum.

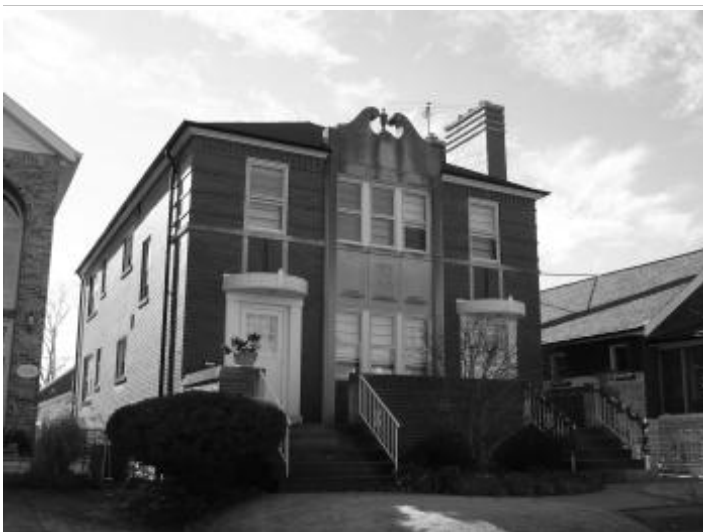
Some original trim wrapped with siding.
