City of St. Louis Cultural Resources Office

Holly Hills Neighborhood Survey

Lynn Josse and NiNi Harris
3/1/2010

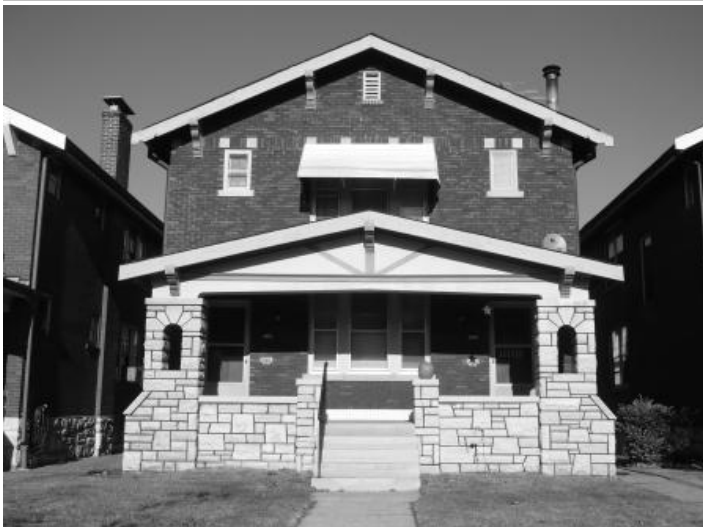
Metal awning covers 2nd story windows.

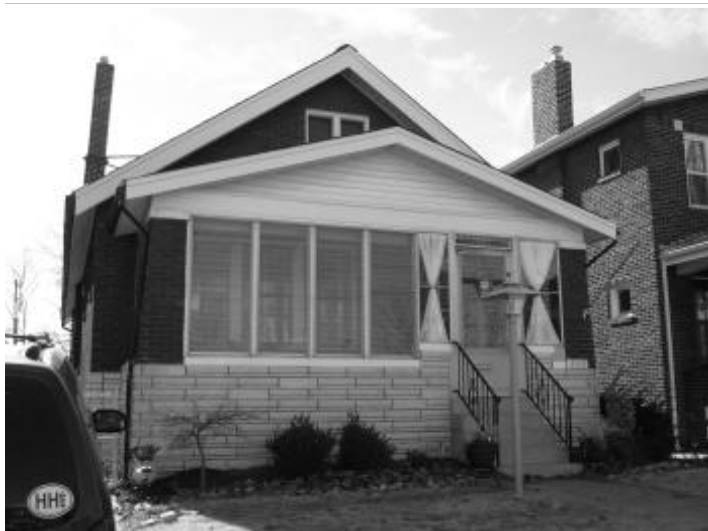
Some original trim wrapped with siding. Porch now enclosed with louvered windows. Porch's gable end covered with modern horizontal siding.

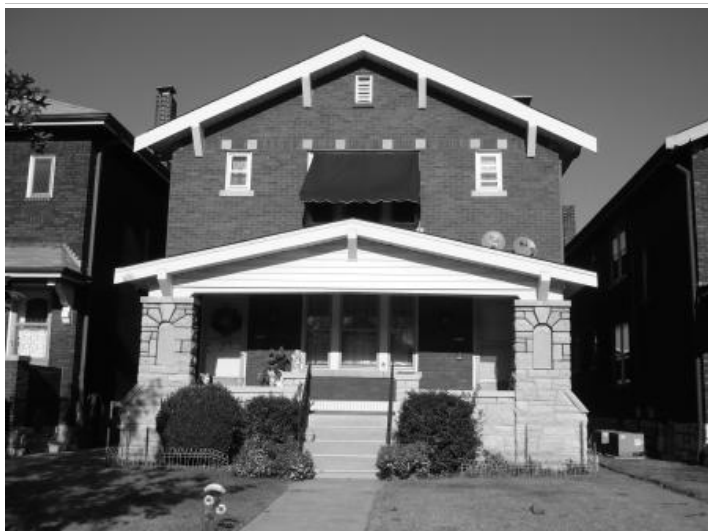
The two front doors at opposite end of the façade are not original. Brackets soffitted; modern horizontal siding covers porch gable end.

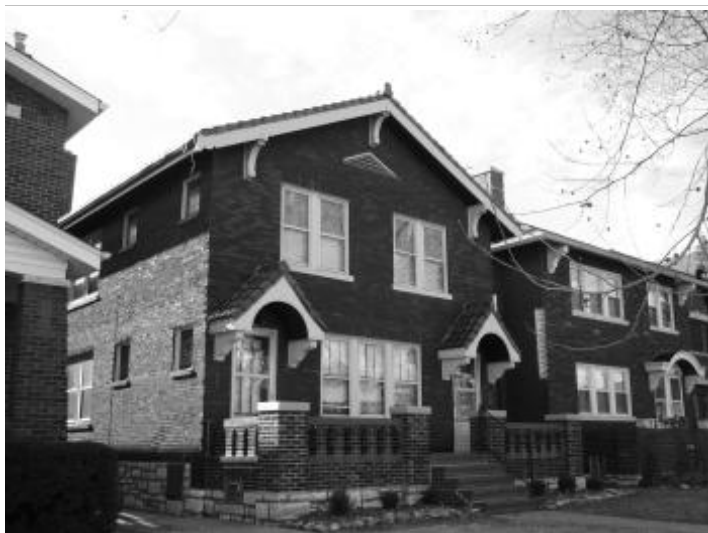
13*13 addition in 1938

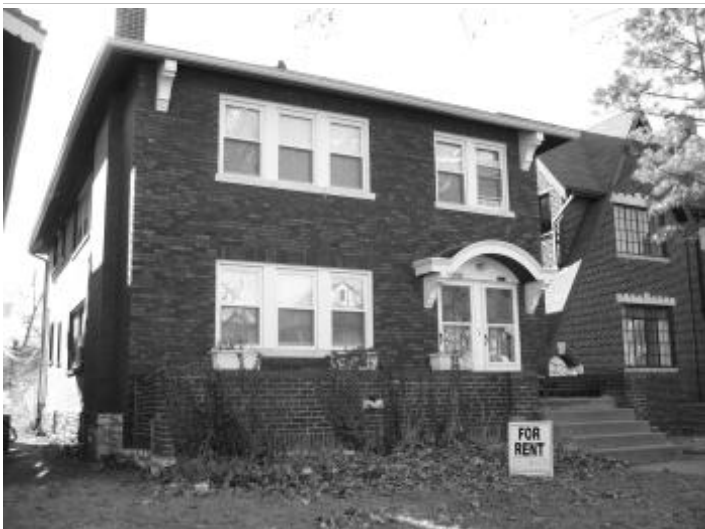
full window replacement at façade.

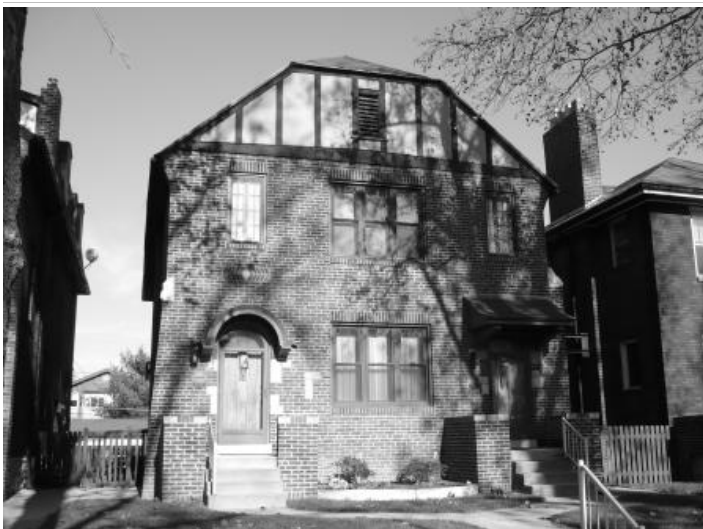
Centered at both stories is a triple set of replacement windows.

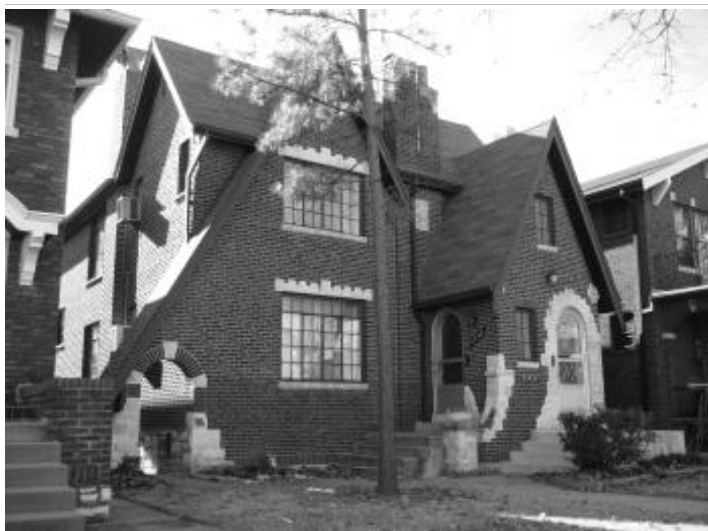
Wood vergeboards are wrapped with siding.

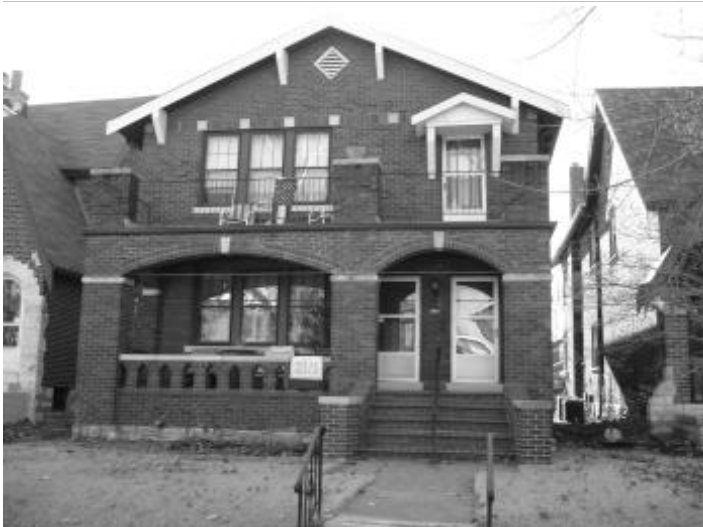
Four eave brackets, eaves, and bracketed hood at balcony, all wrapped in siding.

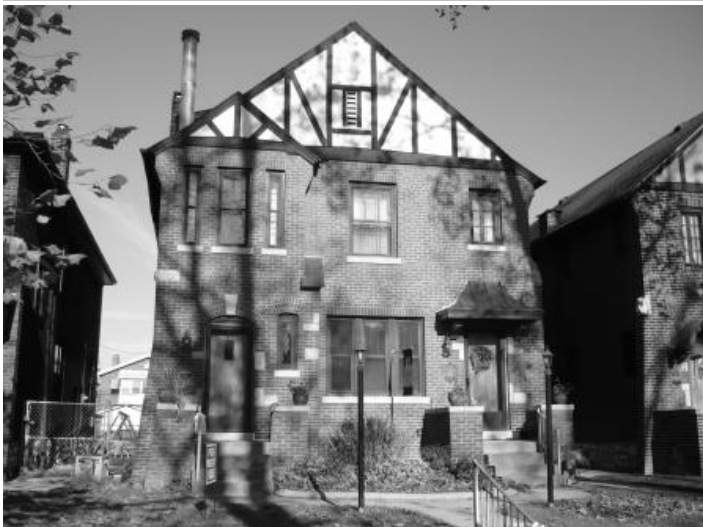
3rd floor dormers added at side elevations.

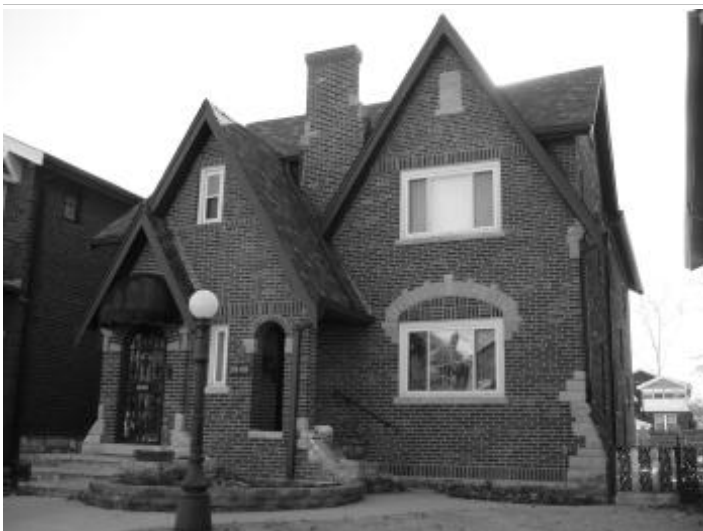
Façade windows are replacements. Attic window or vent filled in with stone or concrete.

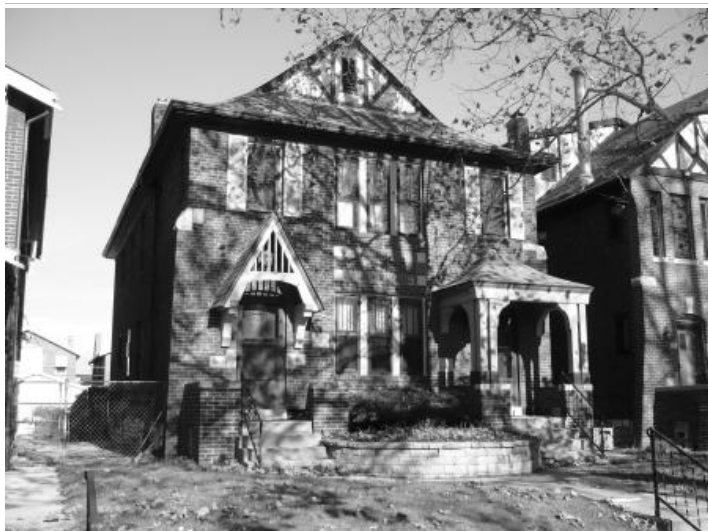
Inoperable shutters added at second story.

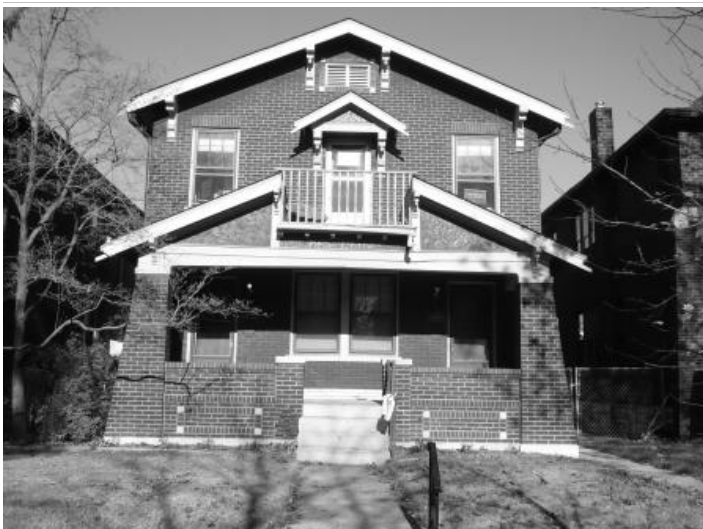
Replacement front doors.

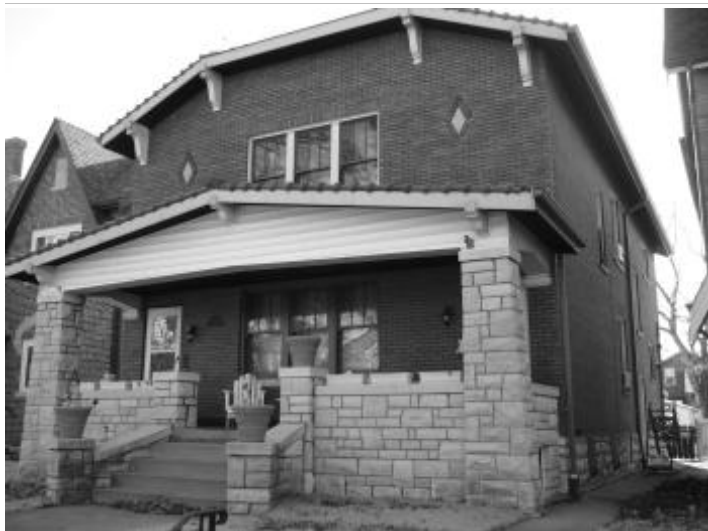
Some wood trim wrapped with siding.

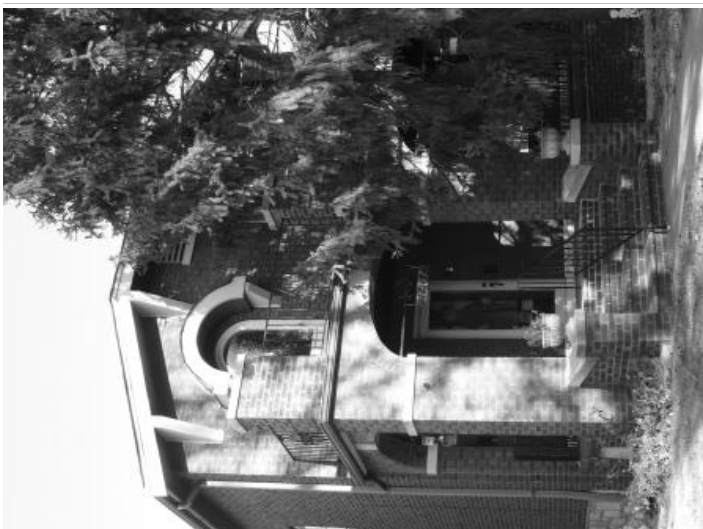
Some wood trim wrapped with aluminum, including façade brackets, hood, eaves.

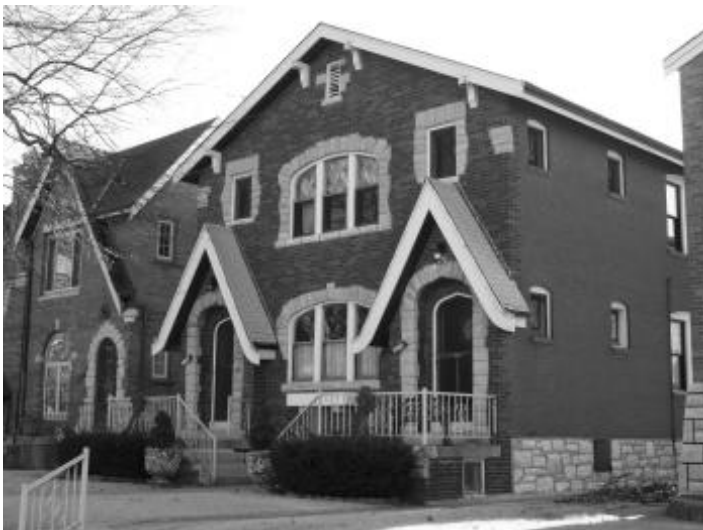
Some wood trim (vergeboard, window frames) is covered with aluminum.

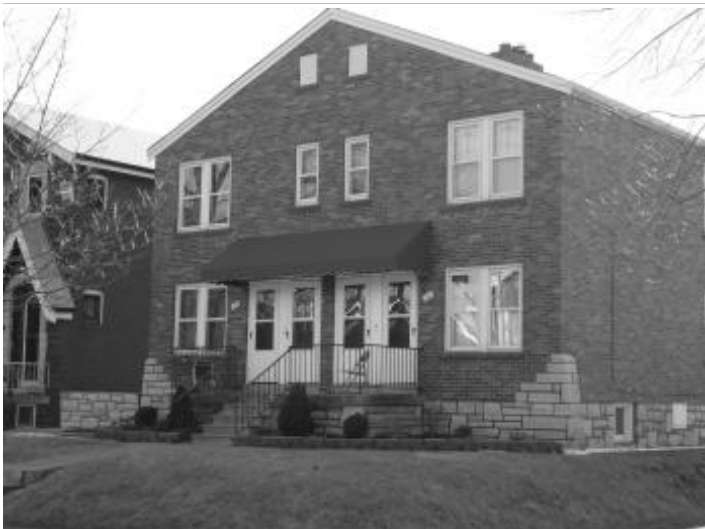
Attic vents covered. Canvas awning over door.

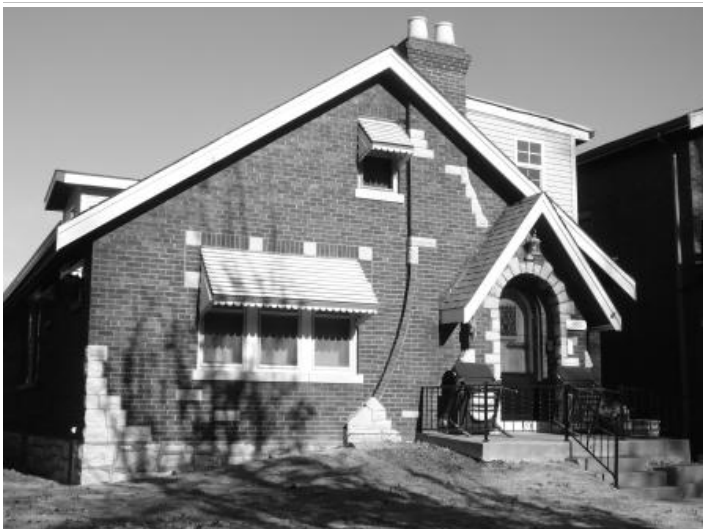
Large shed dormer at right elevation; some wood trim wrapped with aluminum.

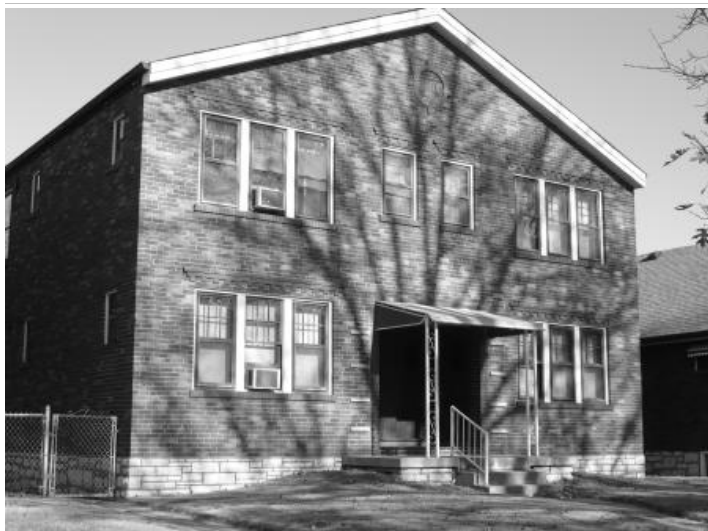
Metal awning on trellis supports at front stoop. Vinyl covers some original wood elements.

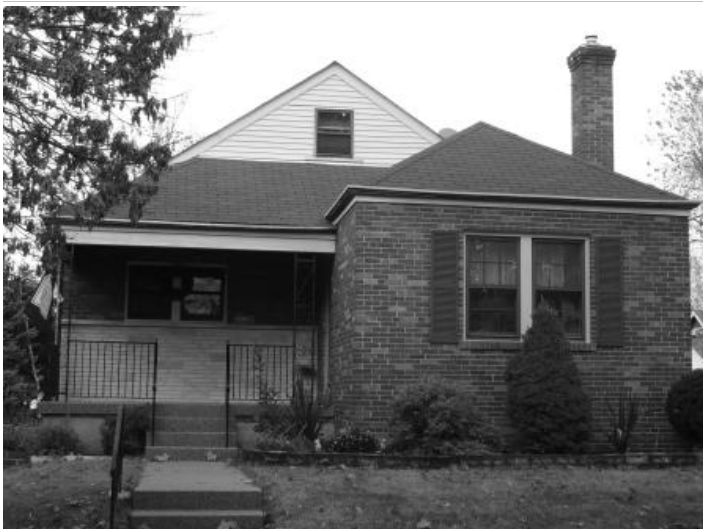
Some windows are not original. The house appears to have been remodeled in the 1960s or so.

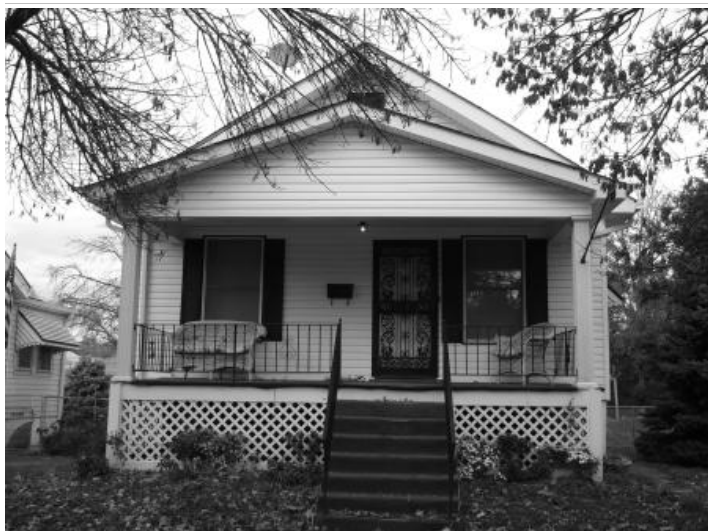
New door; metal awnings.

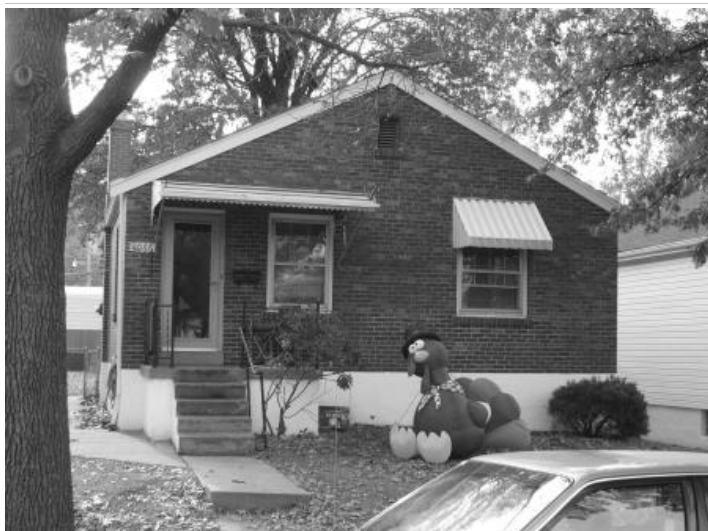
Replacement front door

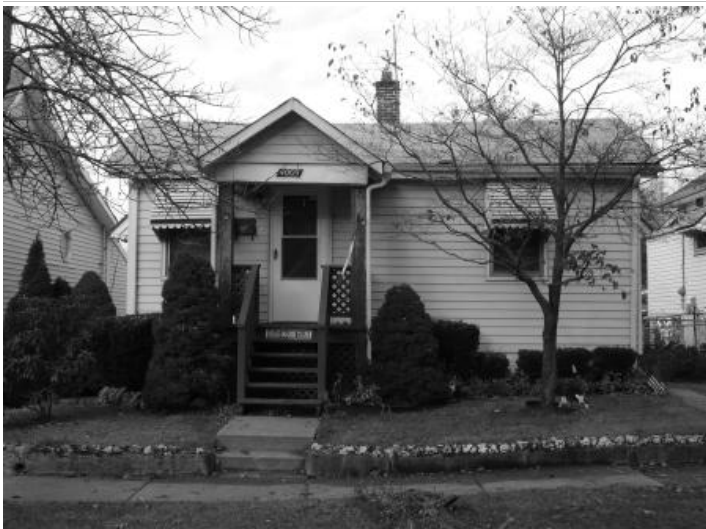
New wood porch base, new door, metal awnings.

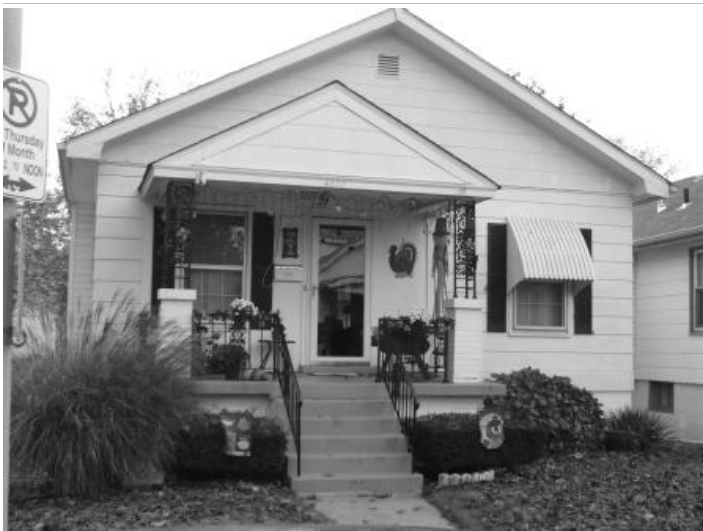
Pressed wood siding; asbestos shingle in gable ends. New doors.

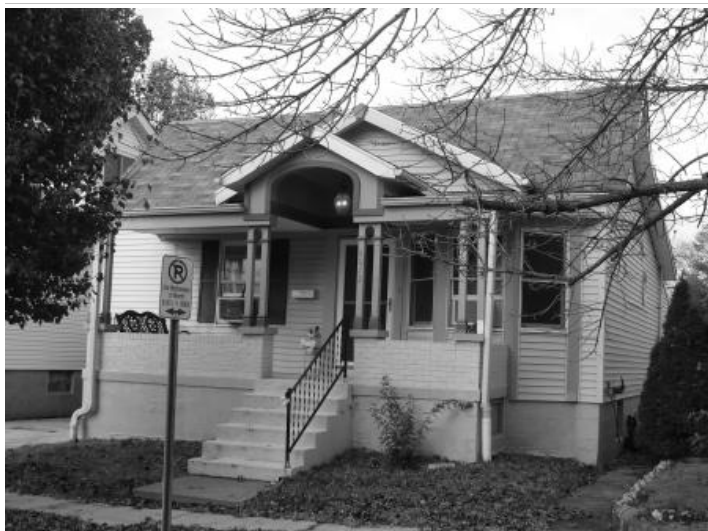
New door. Windows look like wood replacements.

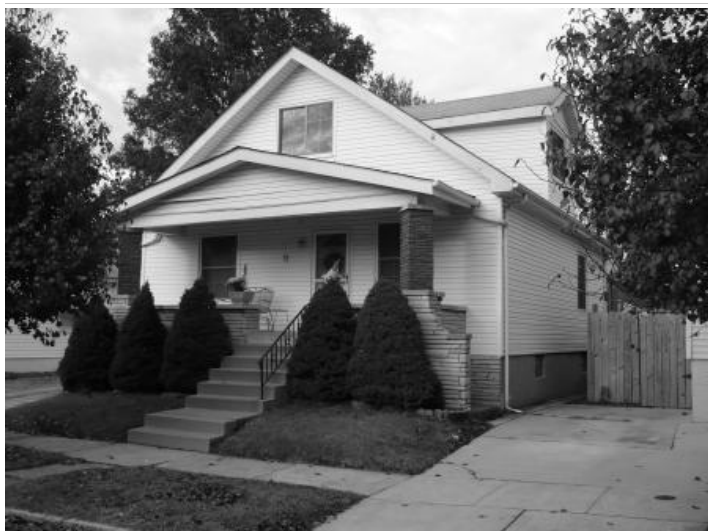
Imitation stone veneer porch has off-axis columns. Replacement door and windows.

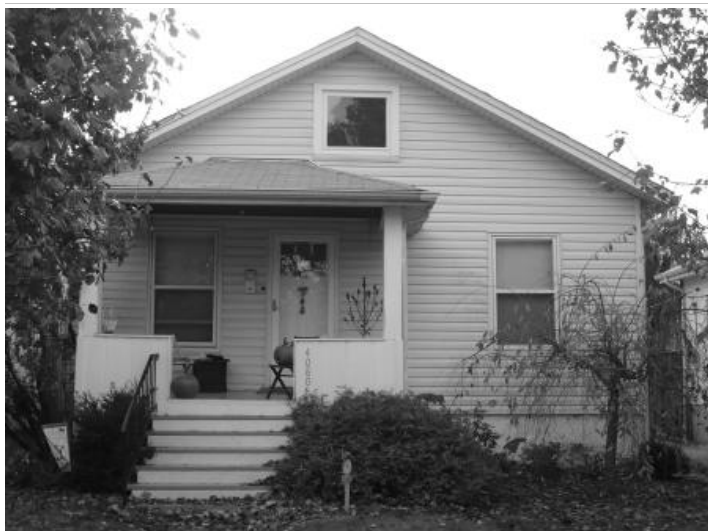
Windows replaced.

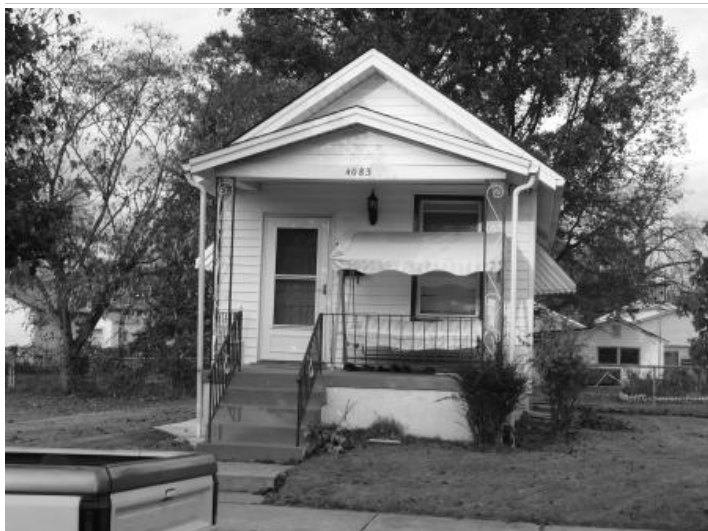
Replacement door and windows

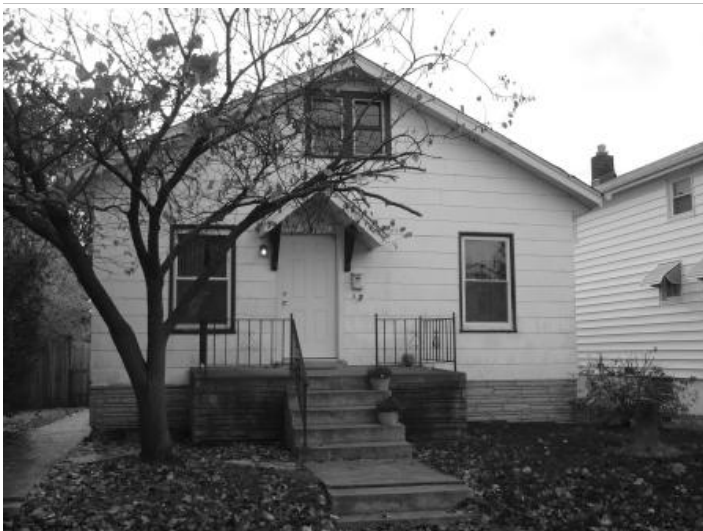
Door and façade windows are replacements.

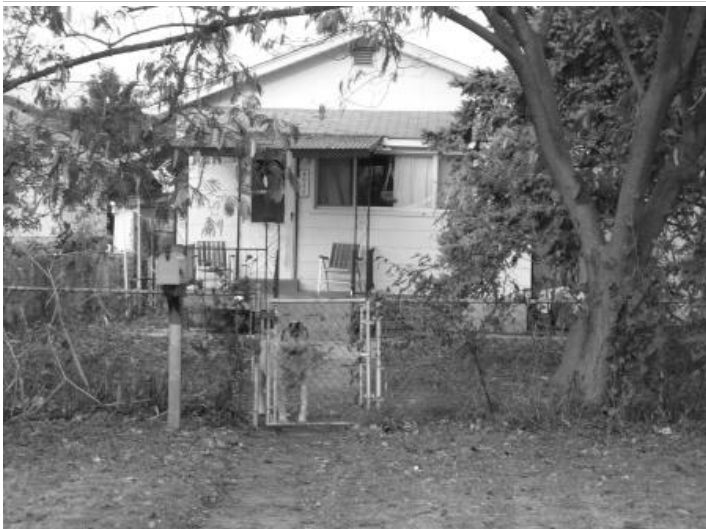
Filled in shed porch across front.

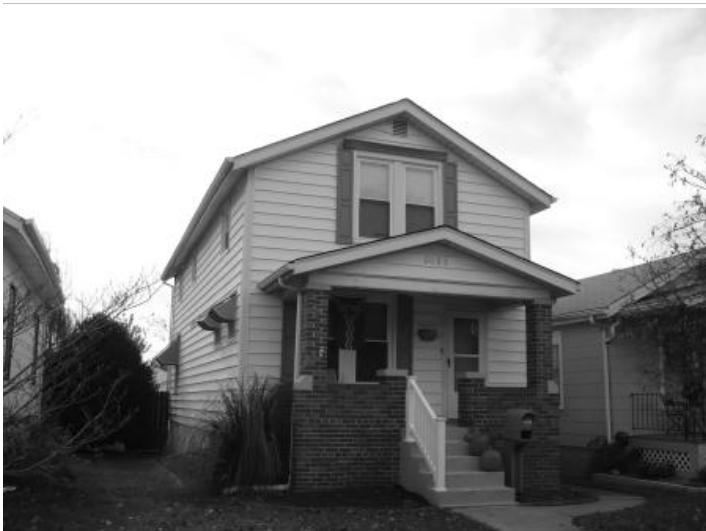
Front door and windows replaced.

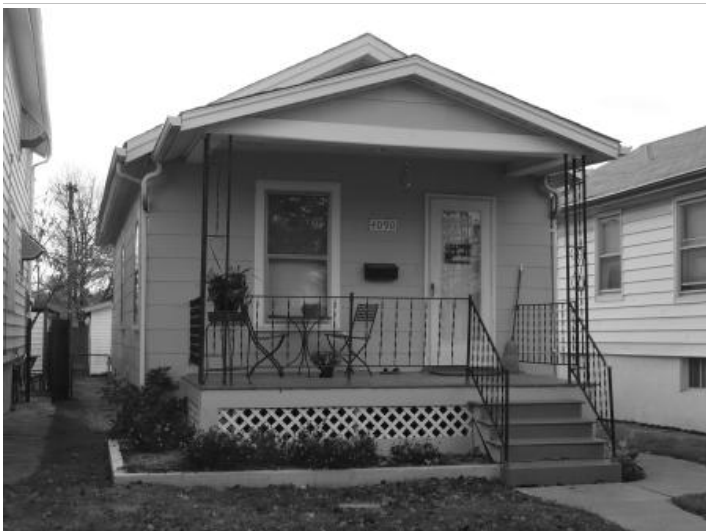
Replacement front door

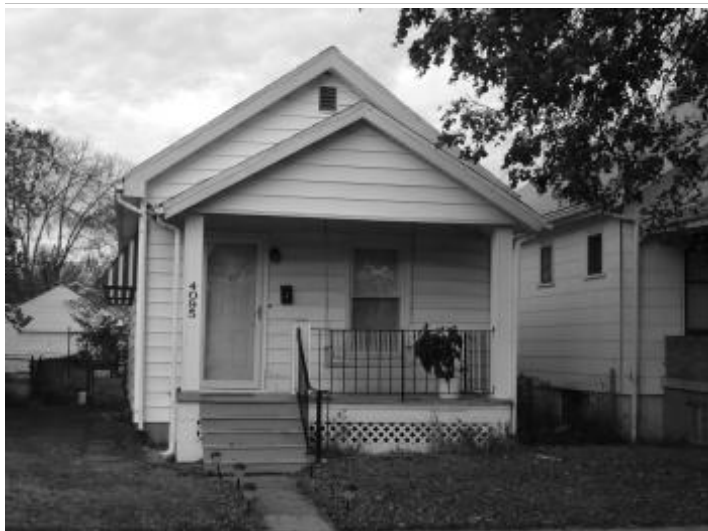
New front door.

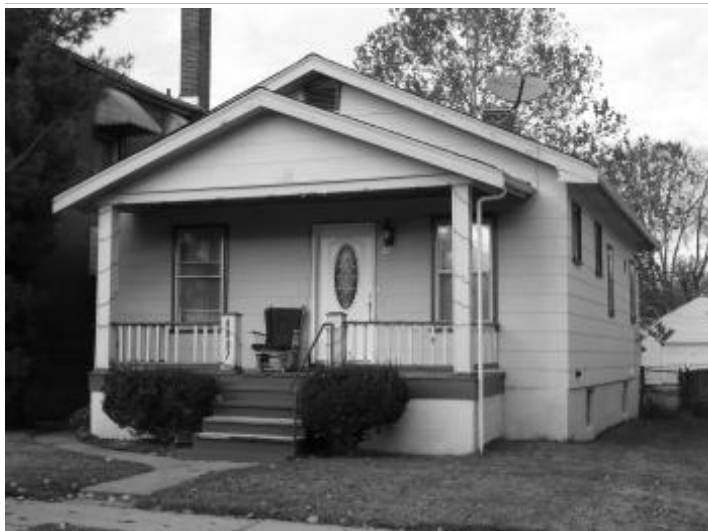
The replacement doors and windows retain original window trim.

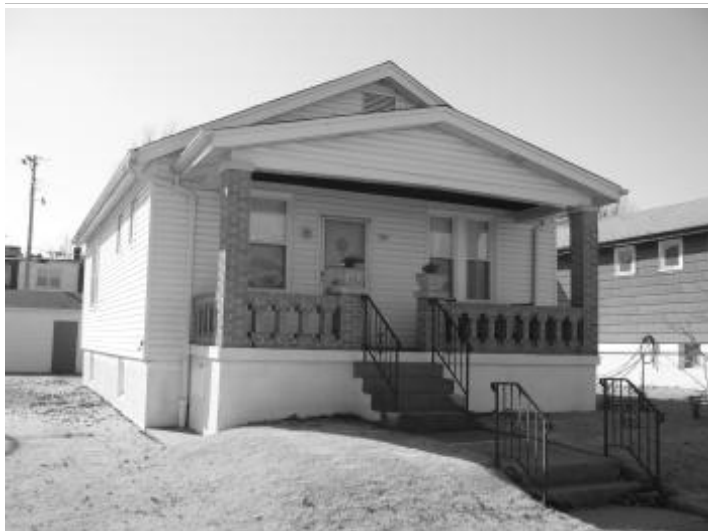
Replacement door; no original wood trim visible under siding

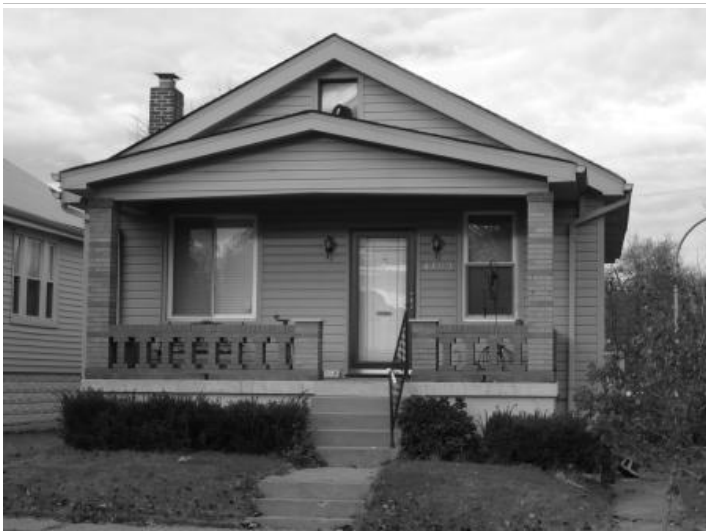
Full window replacement, new front door. \$1200 addition, 1957

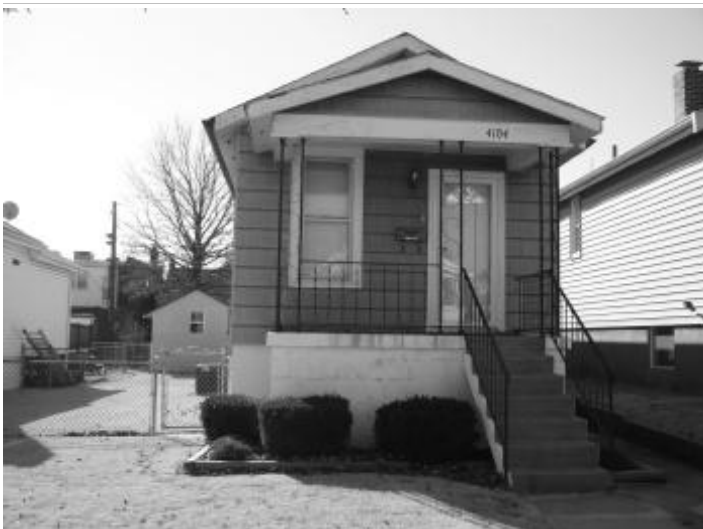
Replacement front door; replacement porch posts (metal trellis-style).

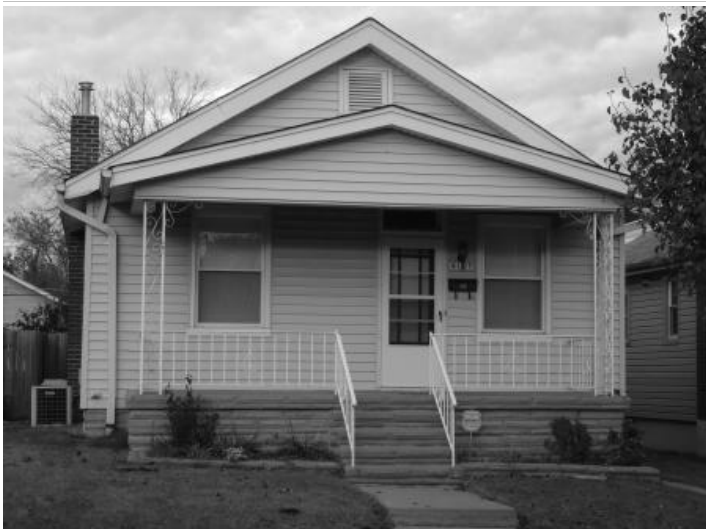
Windows are new replacements.

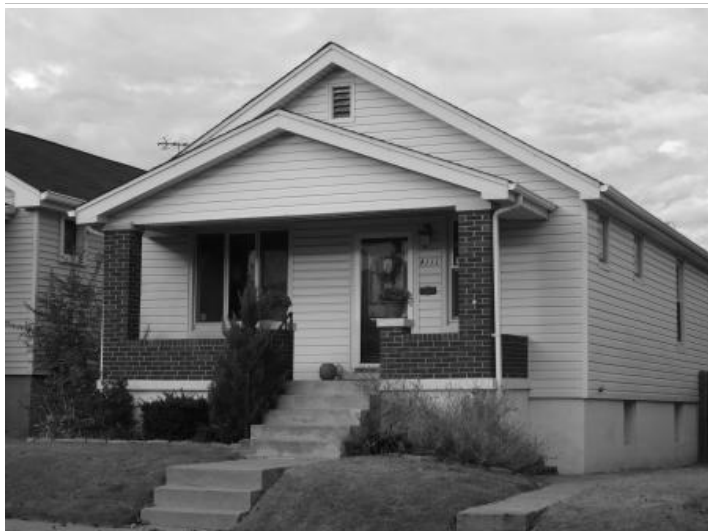
Replacement front door and windows.

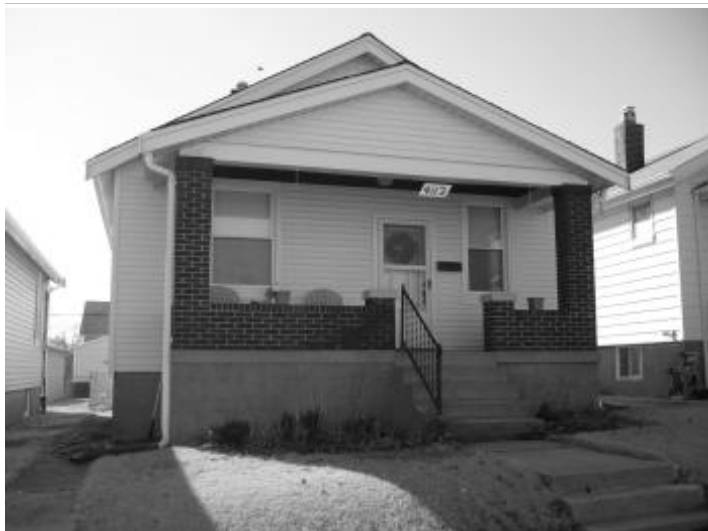
This front gabled house has a centered front porch which is just short of full width. Its gable roof is supported on red brick piers. Scored concrete foundation and porch base. Original front door.

Replacement windows.

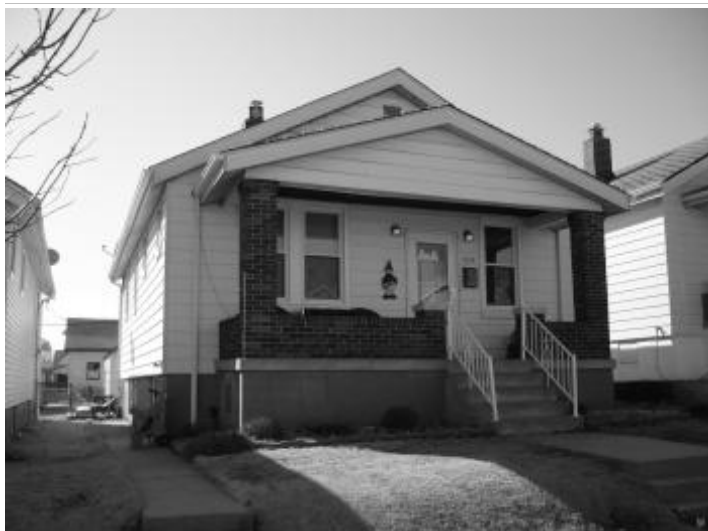
This front gabled house has a centered front porch which is just short of full width. Its gable roof is supported on red brick piers. Scored concrete foundation and porch base. Original front door.

Replacement windows.

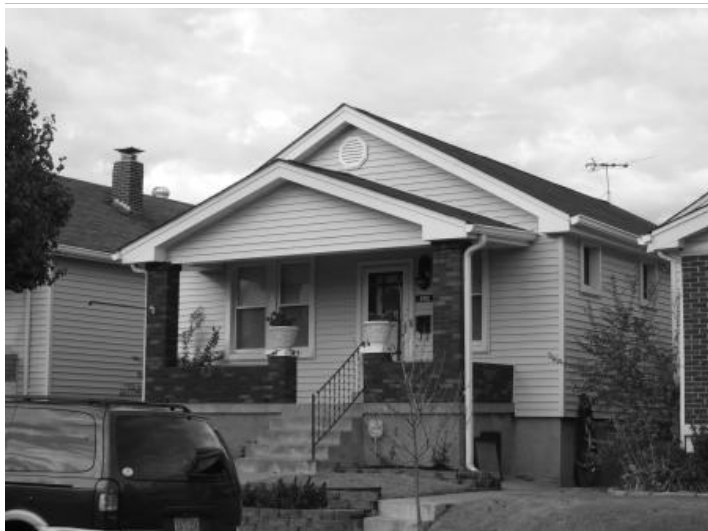
replacement windows.

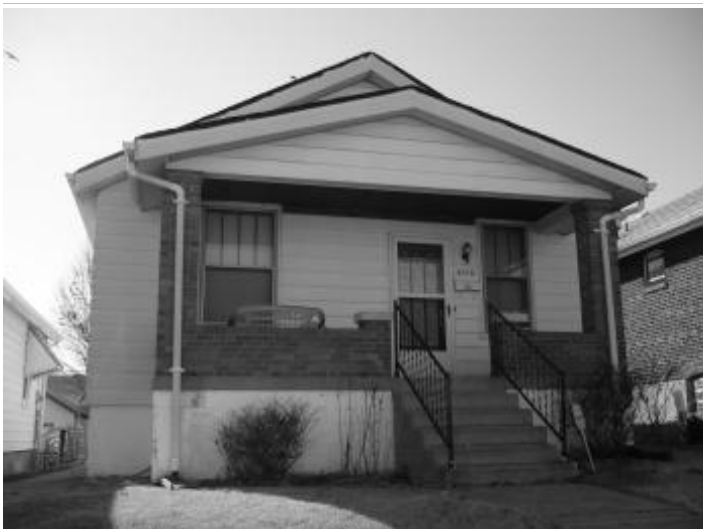
This front gabled house has a centered front porch which is just short of full width. Its gable roof is supported on orangish-tan brick piers. Scored concrete foundation and porch base. Original front door.

Convincing replacement 3/1 windows

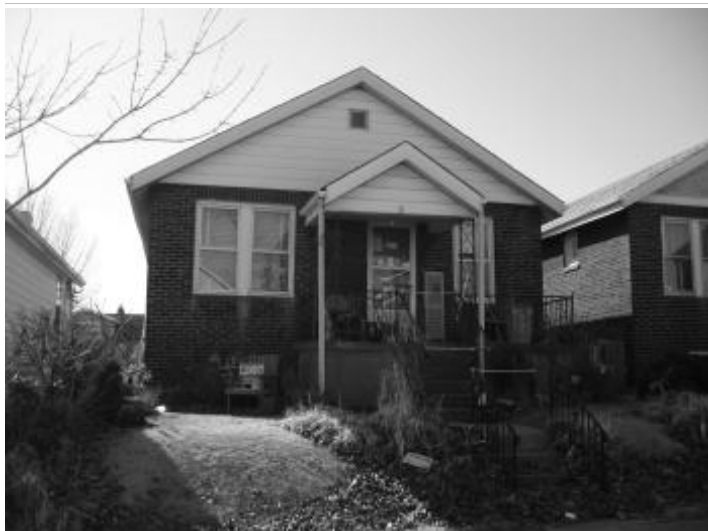
Replacement door; trellis-style metal porch posts; vinyl-covered gable ends

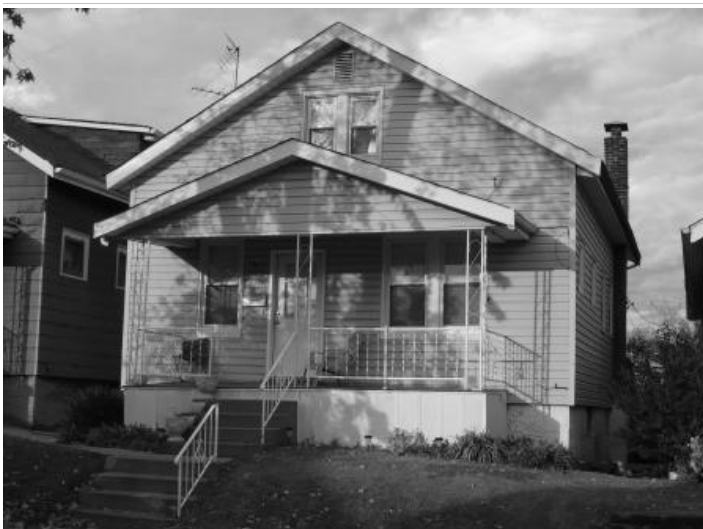
Replacement front door and façade windows.

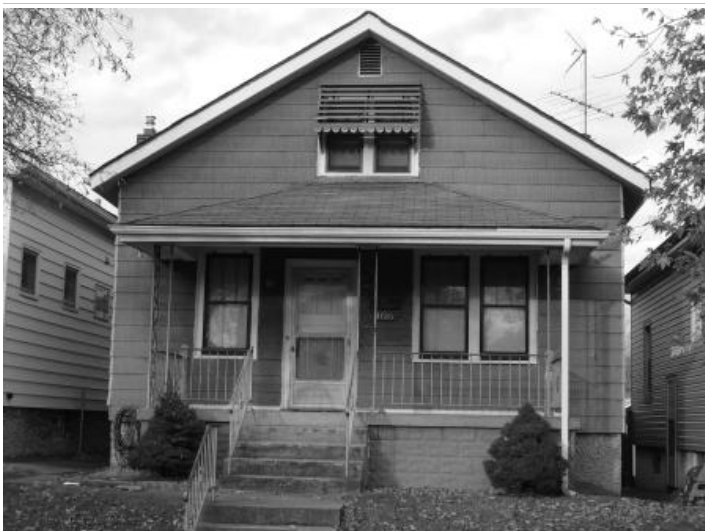
Asbestos shingle siding.

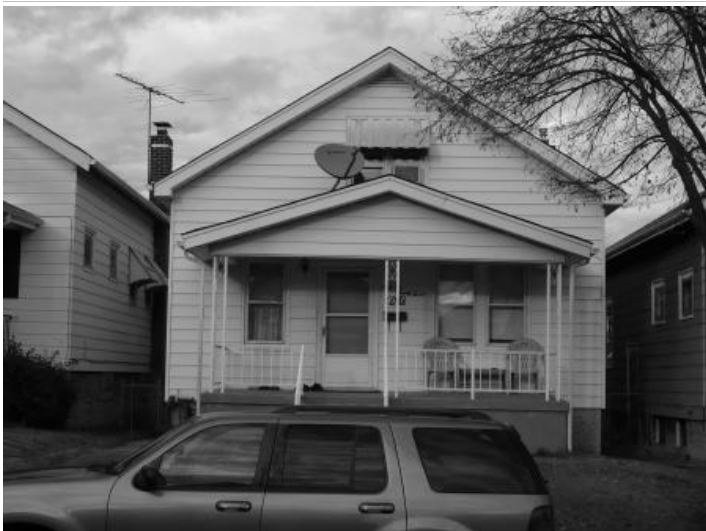
Replacement door.

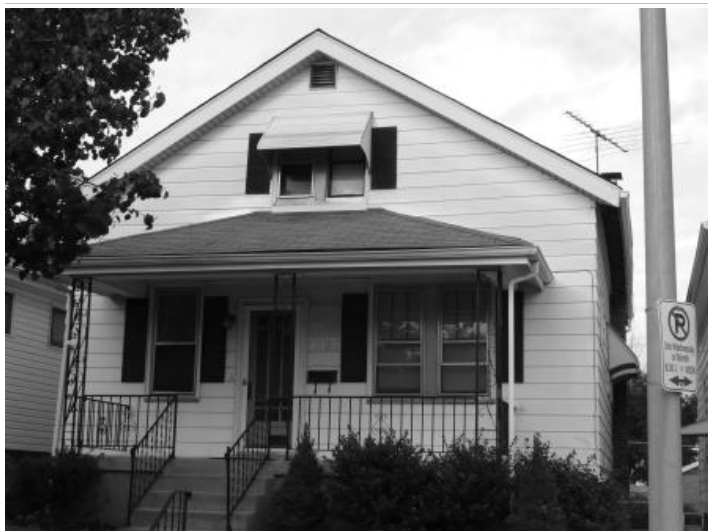
Metal porch supports; non-functional applied shutters.

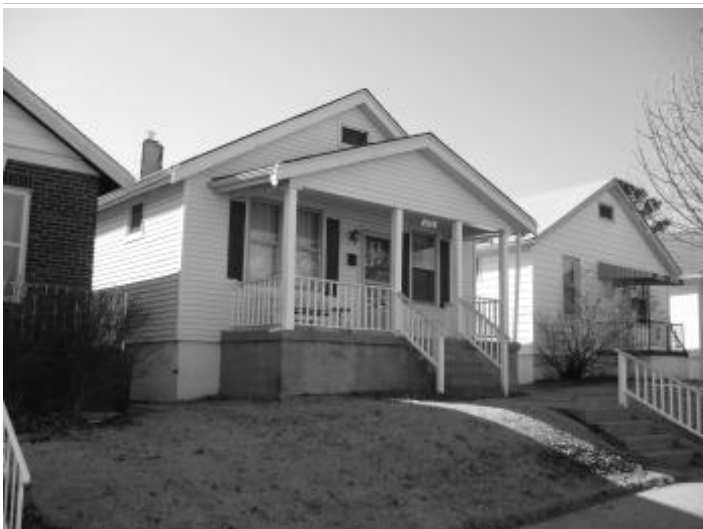
This front gabled house has a centered front porch which is just short of full width. Its gable roof is supported on four full-height replacement posts on a concrete slab porch base. The original Craftsman-era front door is flanked by a pair of 3/1 windows, let, and a single 3/1 on the right.

Shutters added; original wood trim covered with siding.

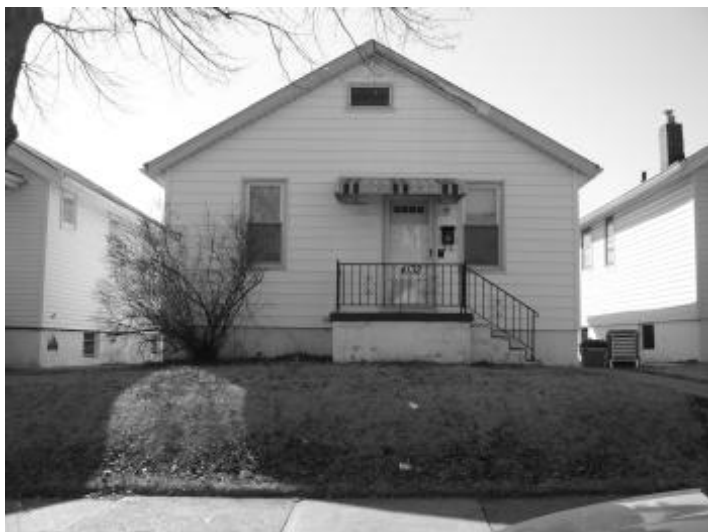
The front door is a replacement. Wood trim is covered with siding except for one section of the vergeboard where the siding has fallen off. Original porch removed.

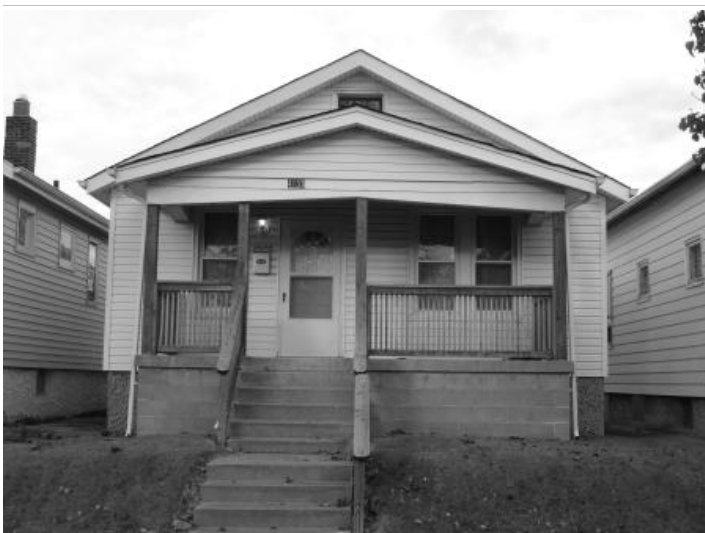
Replacement windows and door; new wood porch supports on CMU base.

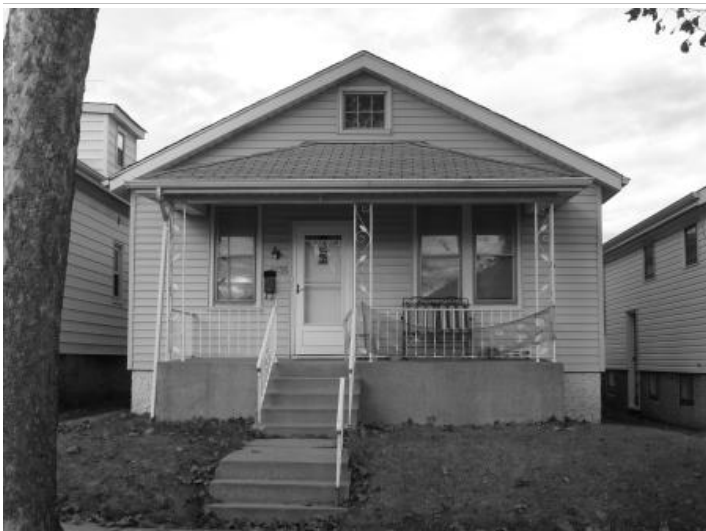
Replacement front door; metal supports at porch.

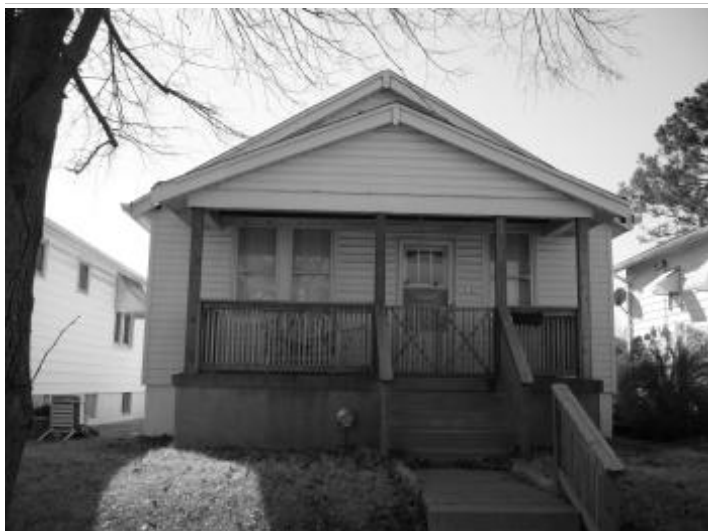
This front gabled house has a centered front porch which is just short of full width. Its gable roof is supported on four unpainted replacement wood posts. The original Craftsman-era front door is just right of center, with a pair of 3/1 windows to the left and a single 3/1 window to the right. The windows retain their original storm windows.

Although sided, the vergeboards retain center post and window trim is not bad.

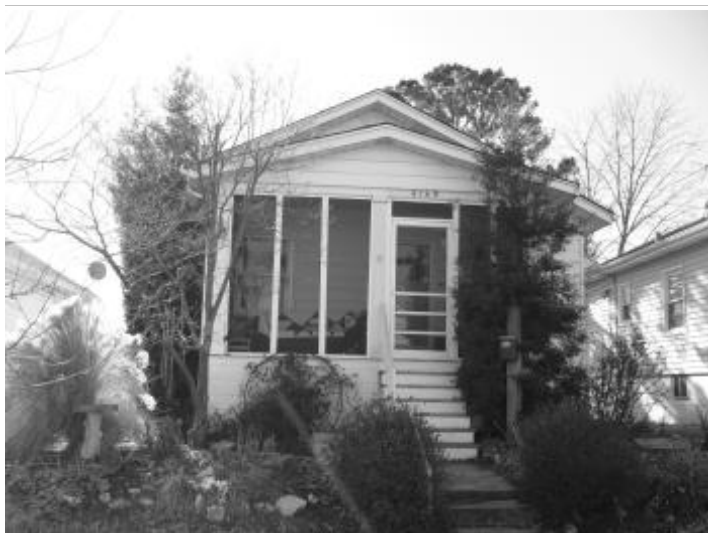
Wood trim obscured by siding.

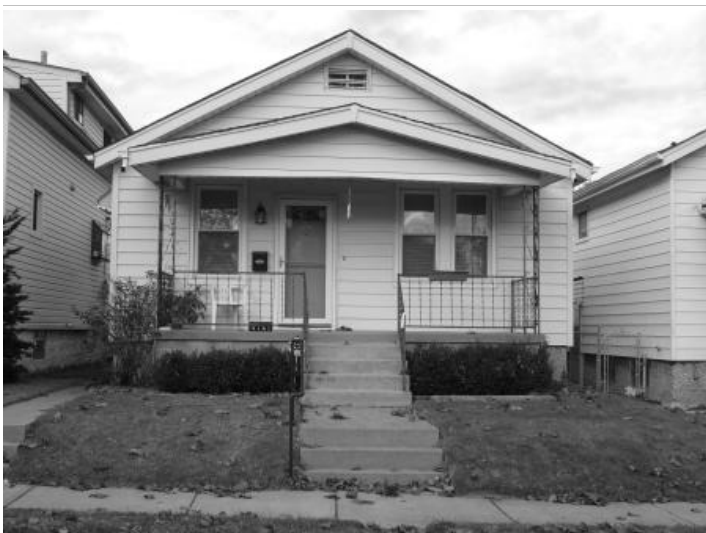
Replacement front door.

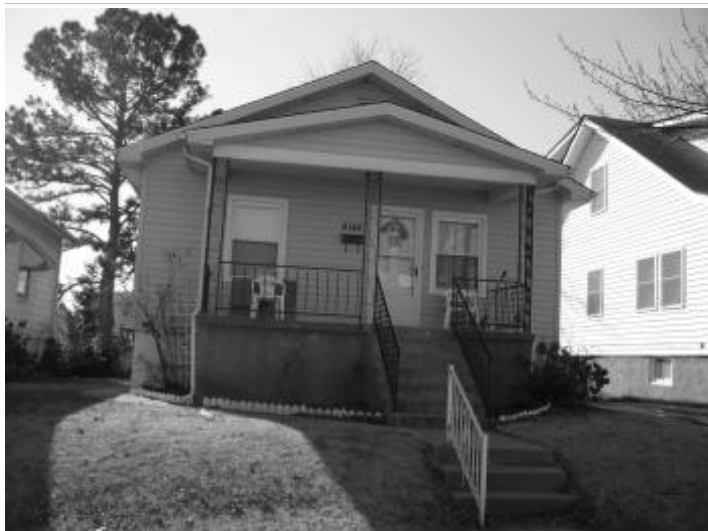
This front gabled house has a centered front porch which is just short of full width. Its gable roof is supported on 3 full-height replacement metal trellis-style supports.

Replacement door and windows

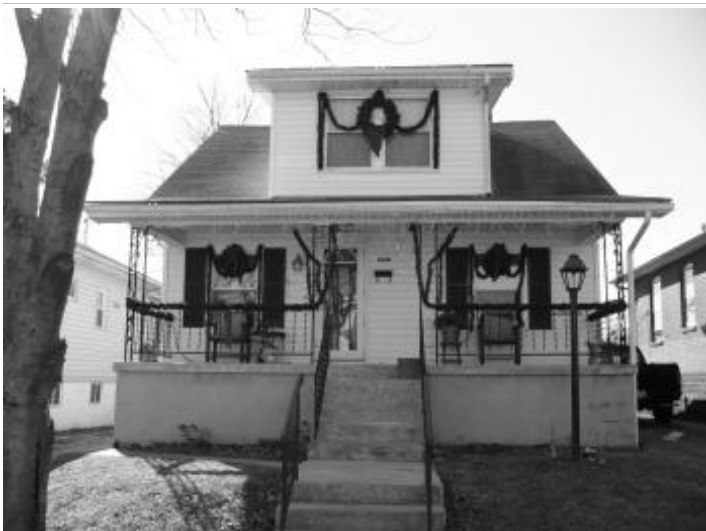
This side gable house has a full-width porch on a concrete base; it is sheltered under a lower-pitched extension of the main roof, supported on 4 replacement metal trellis-style supports. A shed dormer faces the street.

Replacement front door and windows.

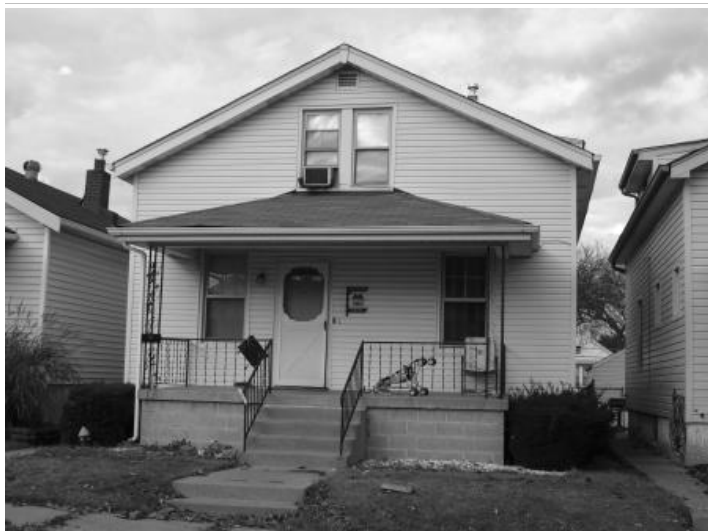
Replacement door and windows.

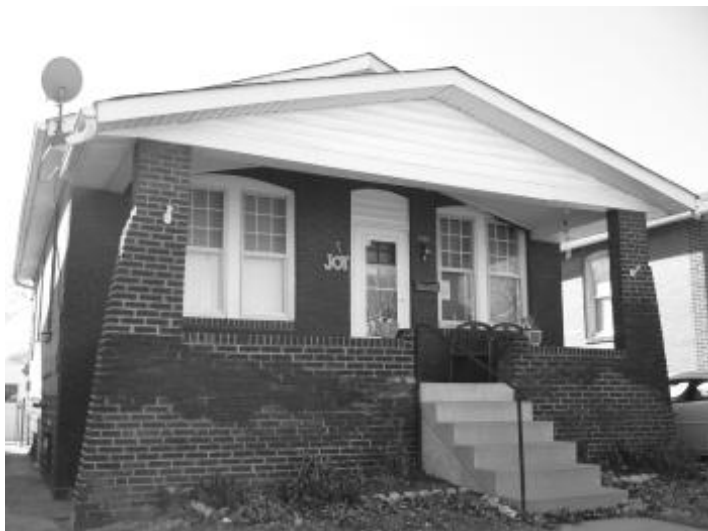
The three houses at 4150-4160 Fillmore are unusual - a 19th-century form, with an almost centered transomed door and paired windows under segmental arches, but with façade brick and porch detailing that is no earlier than the late teens. This front gabled brick house has a brick porch with battered brick piers and a gabled roof. Pairs of original 9/1 windows to the left and right of the front door share segmental arched openings and brick sills. The façade and porch are a striated red brick, while the sides are a common red brick. The foundation is oversized engineer brick. (Building permits for this block prior to 1925 are missing.)

The front door's transom is covered. The porch looks like an addition (its interior gabled ceiling covers part of the window opening), but it is the same brick as the façade.
