City of St. Louis Cultural Resources Office

Holly Hills Neighborhood Survey

Lynn Josse and NiNi Harris
3/1/2010

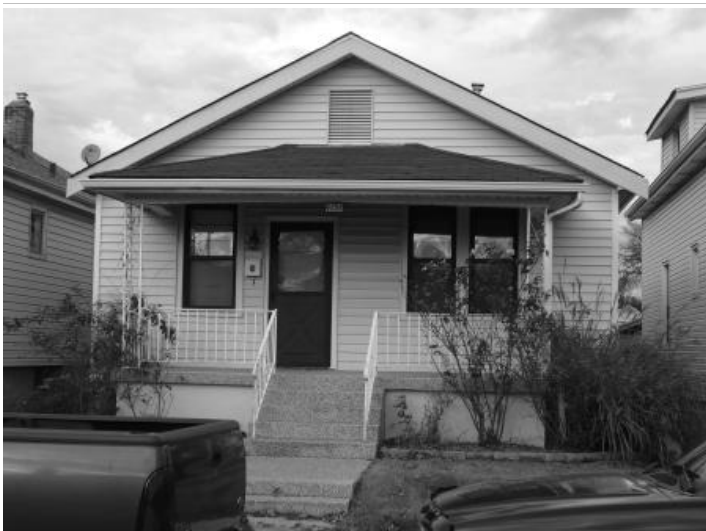
Replacement door and windows.

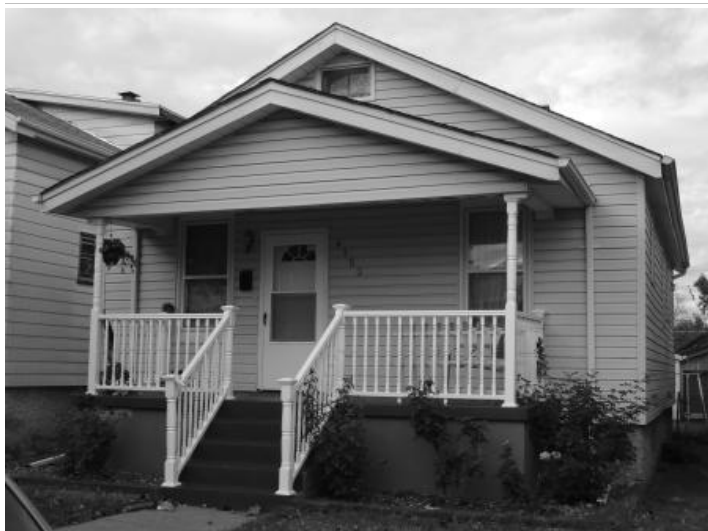
Replacement front door.

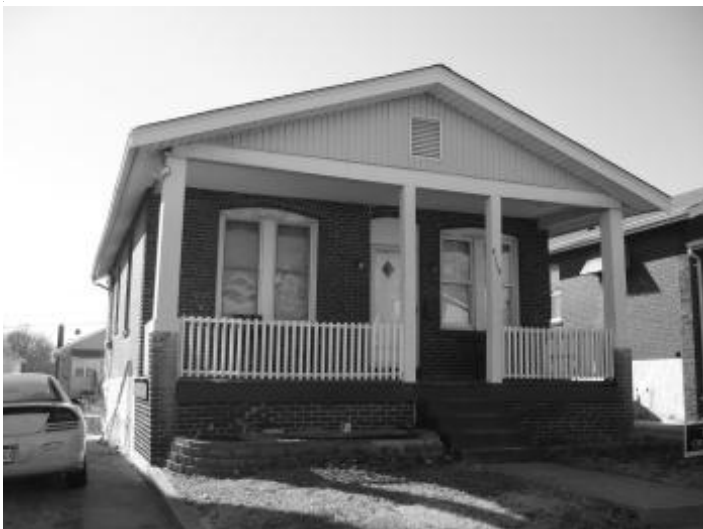
The three houses at 4150-4160 Fillmore are unusual - a 19th-century form, with an almost centered transomed door and paired windows under segmental arches, but with façade brick that is no earlier than the late teens. This front gabled brick house has a full width porch under the gabled roof. Pairs of windows to the left and right of the front door share segmental arched openings and brick sills. The façade and porch are a striated red brick, while the sides are a common red brick. The foundation is oversized engineer brick. (Building permits for this block prior to 1925 are missing.)

The front door's transom is covered and the door is a replacement. Windows are replaced. The foundation is parged but some of the brick underneath is visible.

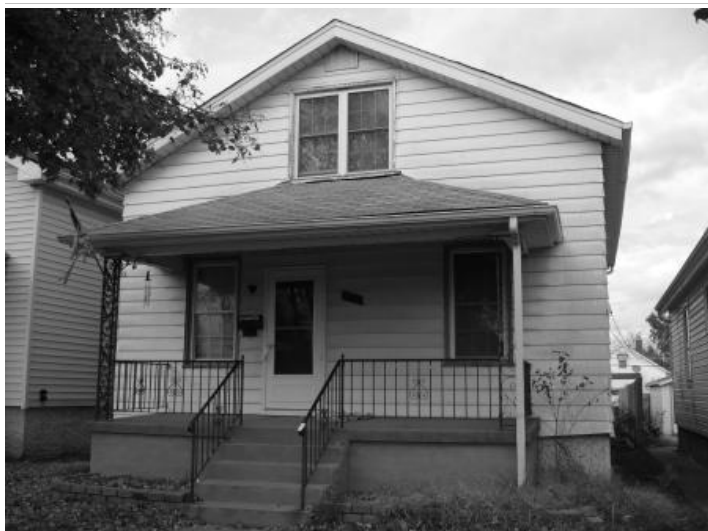
Metal porch piers. Façade windows replaced.

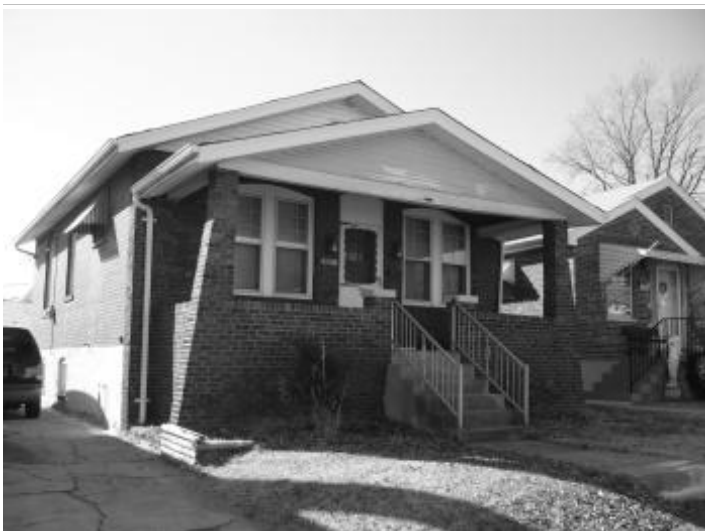
The front door's transom is covered

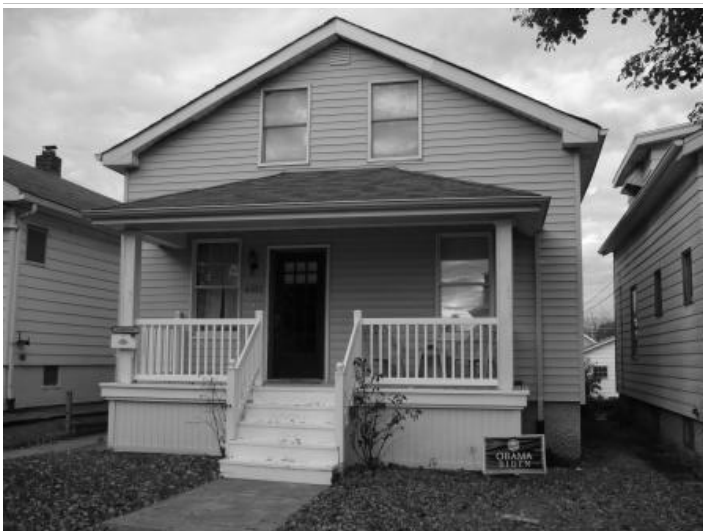
Vinyl windows and siding.

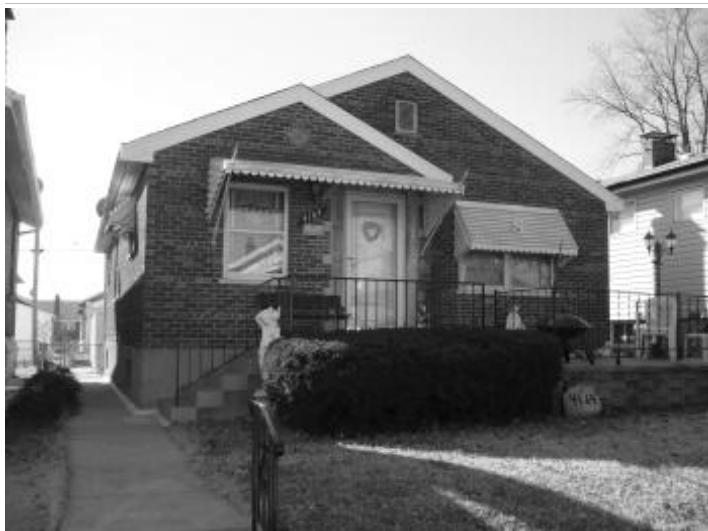
Front door is a replacement.

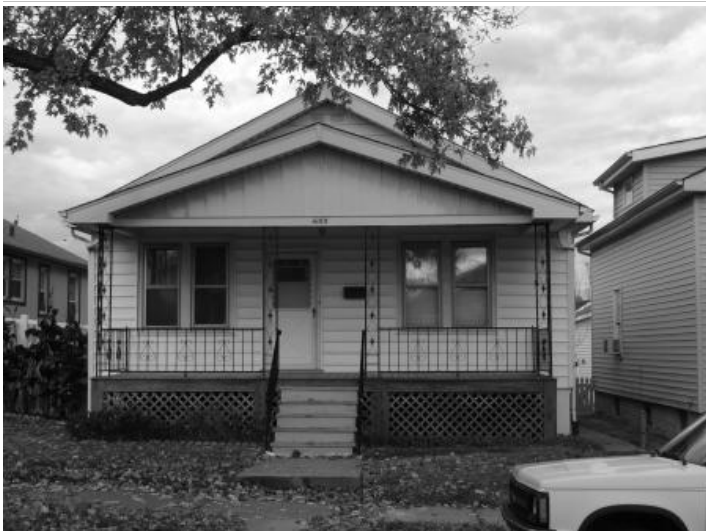
Little historic material visible.

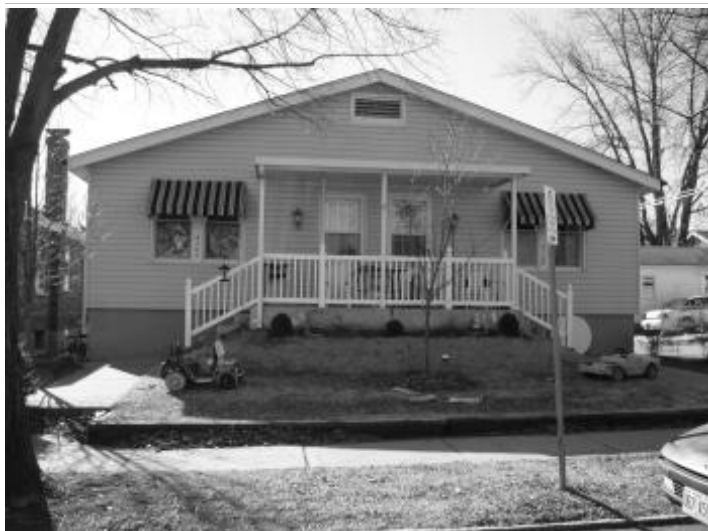
Replacement windows paired at outer bays under fabric awnings. Concrete front porch has fairly new posts and low-pitched shed roof.

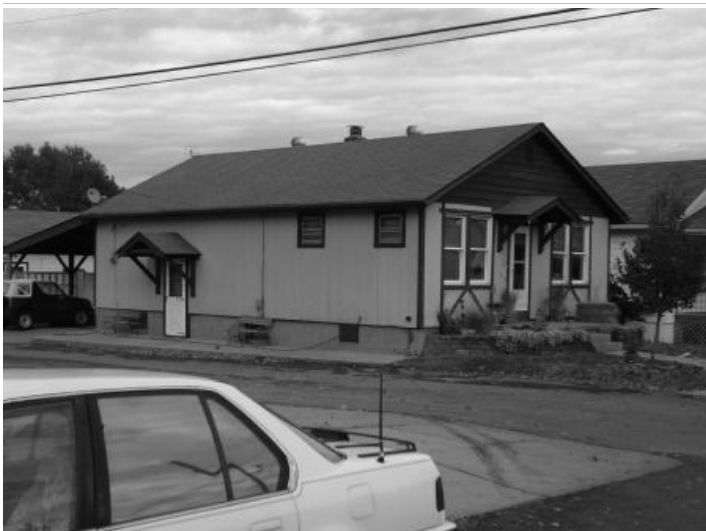
Pressed wood siding.

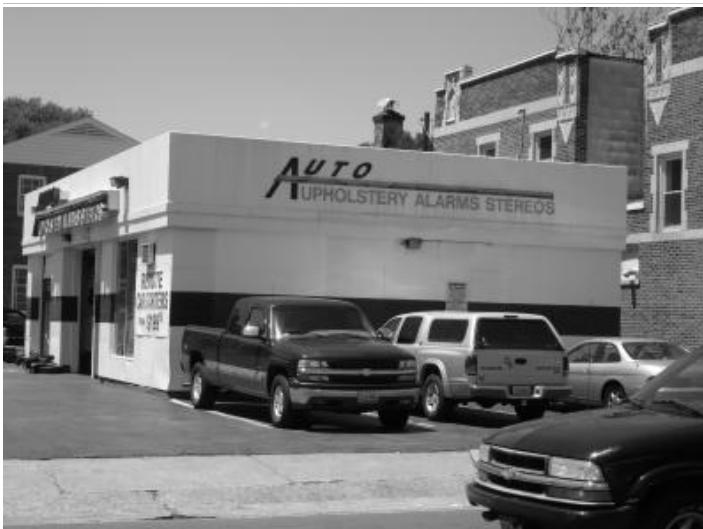
1950 alteration/addition

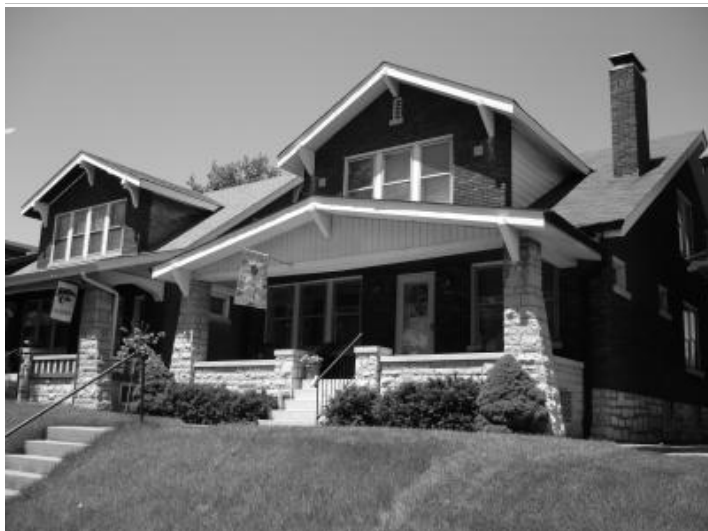
Gable end, soffits, eaves and brackets supporting porch roof and gable roof all encased in vinyl.

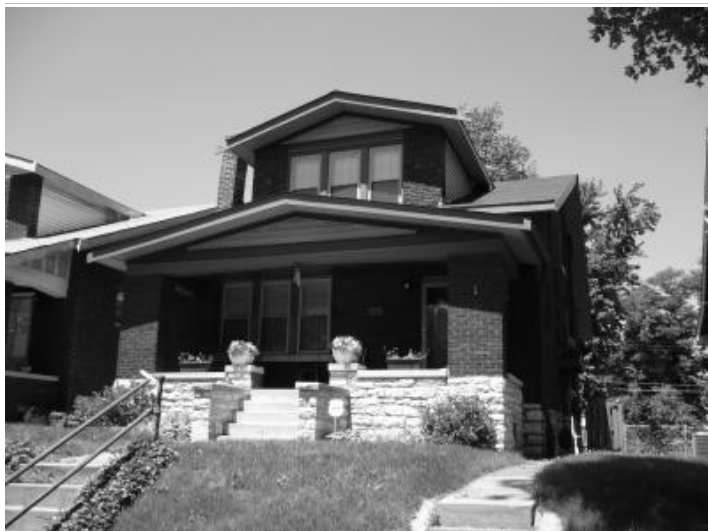
Triple set of windows at first floor and the three at dormer are replacements.

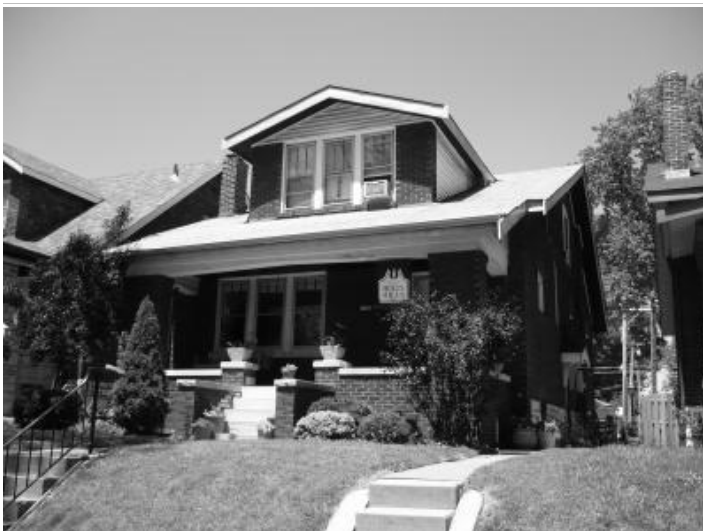
Replacement front door at right; siding at gable end of dormer and first floor eaves.

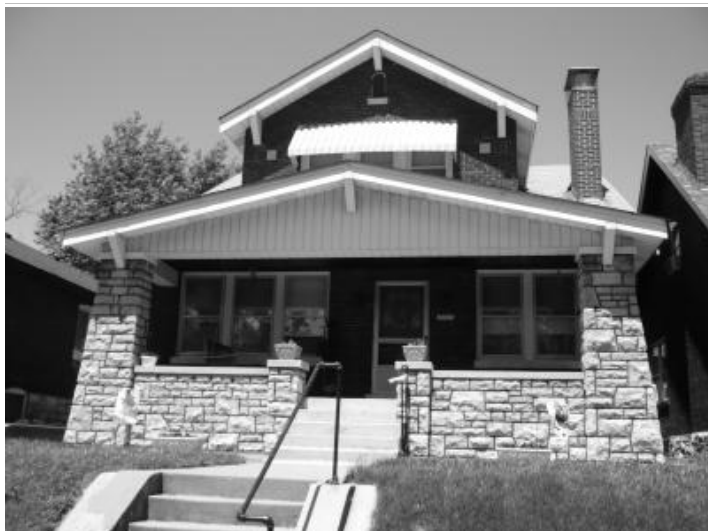
replacement windows at dormer under metal awning.

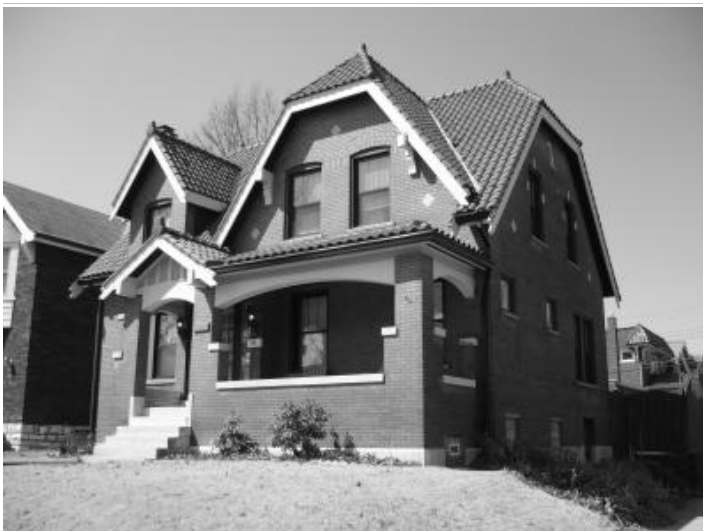
Replacement windows.

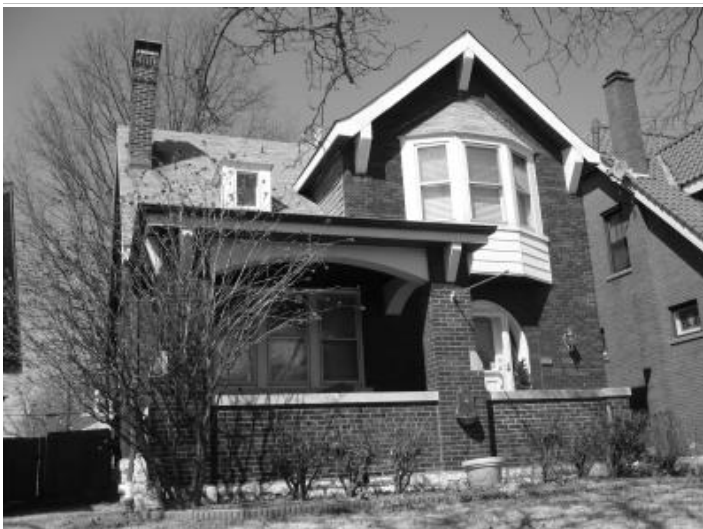
Vinyl or aluminum siding/soffiting at bay window (2nd floor), brackets.

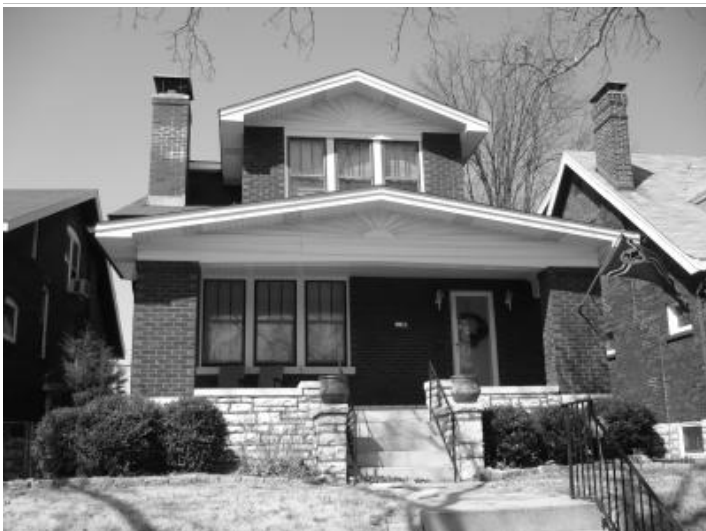
Front door is replaced, and gable ends are sided over.

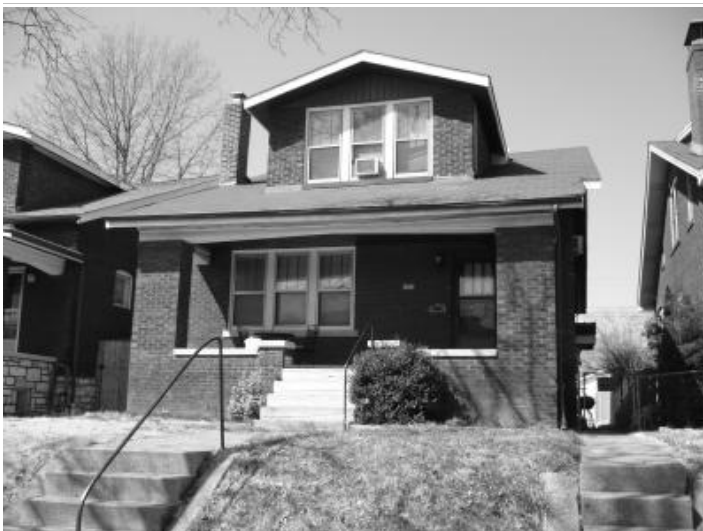
Siding covers gable end at dormer and soffits.

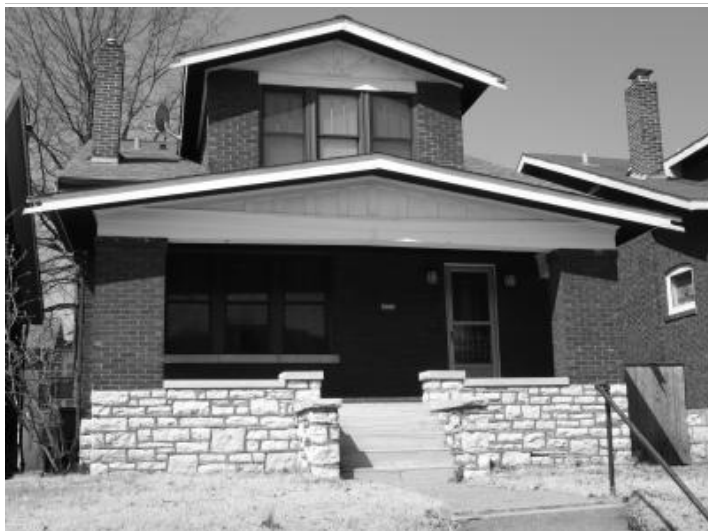
Replacement windows at first floor

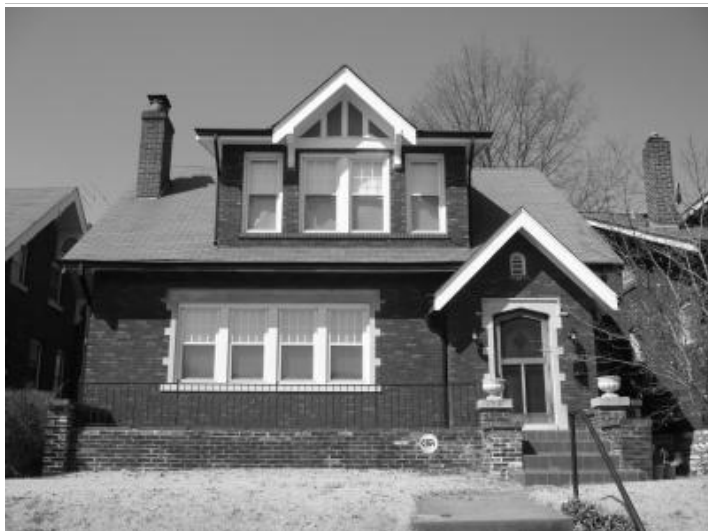
Replacement windows.

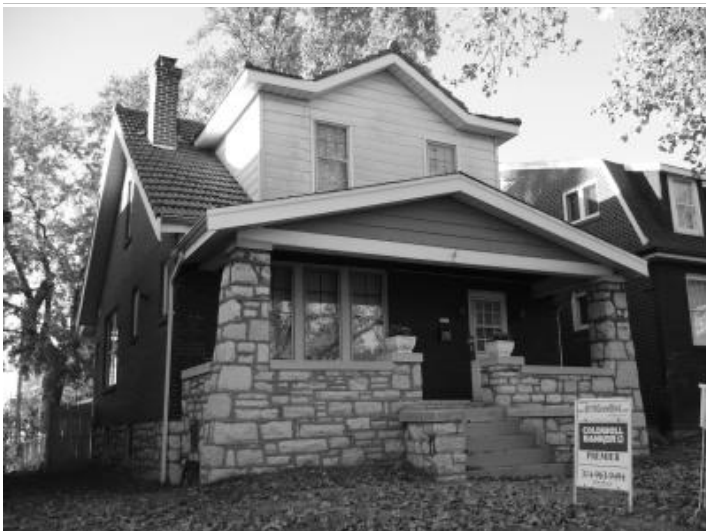
Gable ends, dormer, eaves/soffits sided.

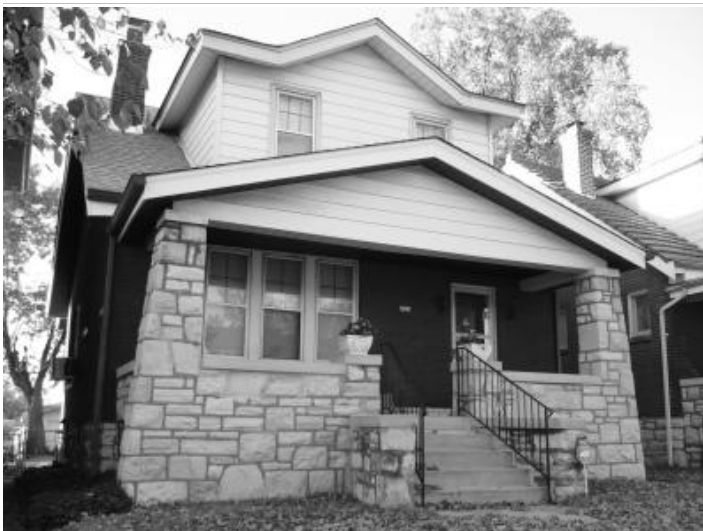
Gable ends, dormer, eaves/soffits sided.

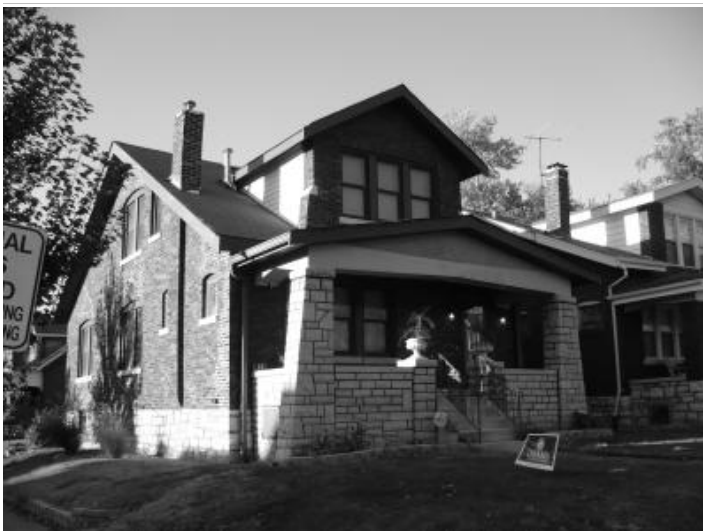
Replacement door and windows.

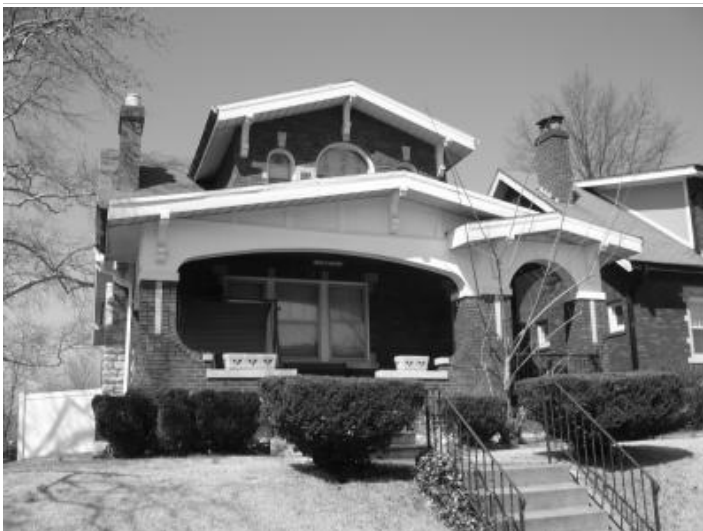
Soffits sided.

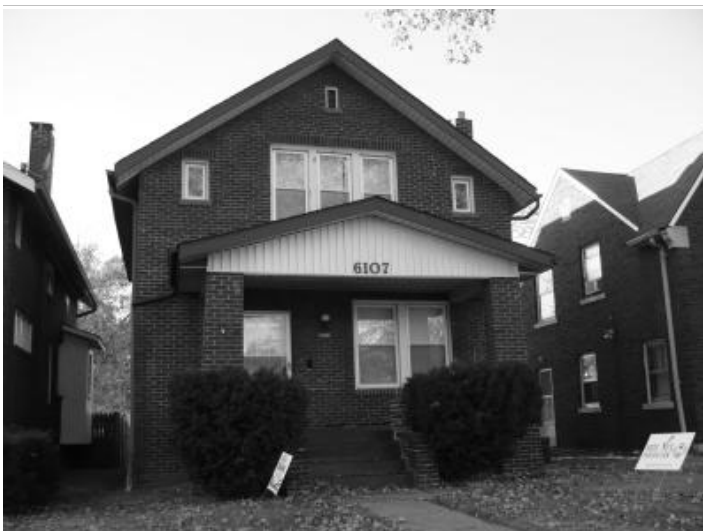
Replacement windows. Gable end is covered with siding (as are soffits, eaves).

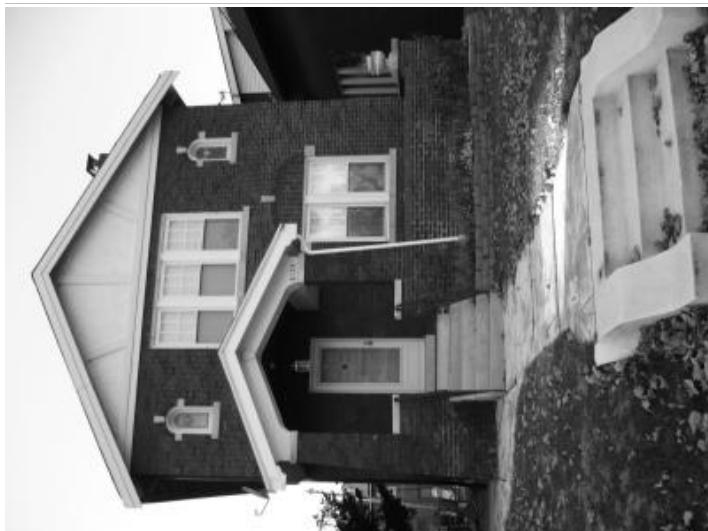
Replacement door and windows.

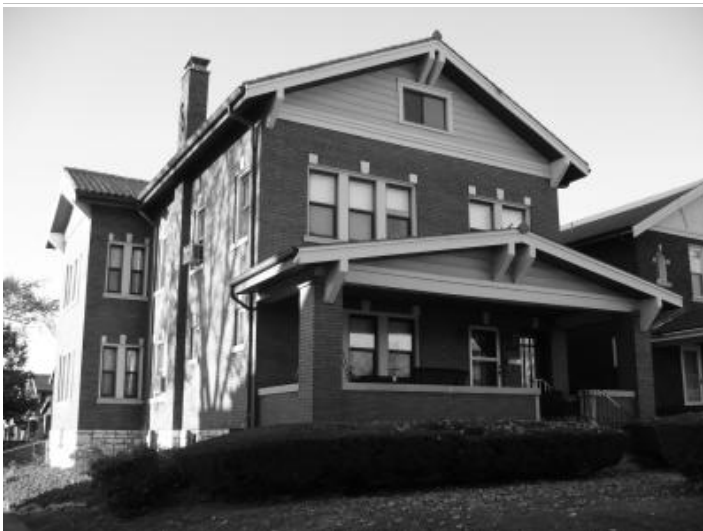
Windows are modern replacement. Gable ends, brackets, eaves, soffits all sided.

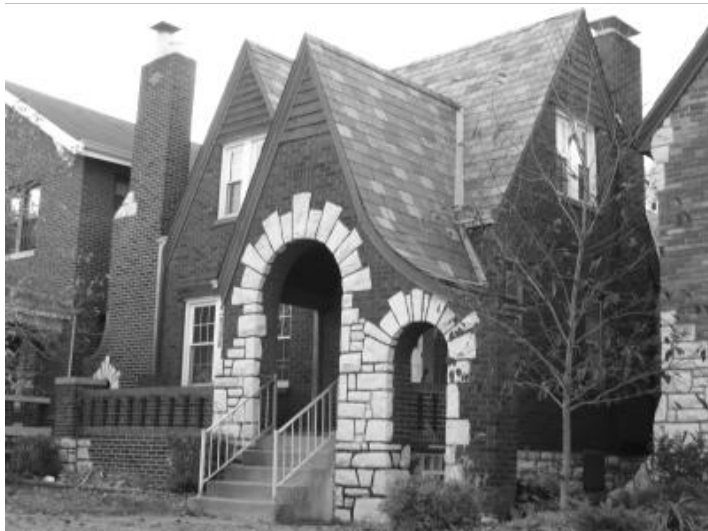
Windows are replacements.

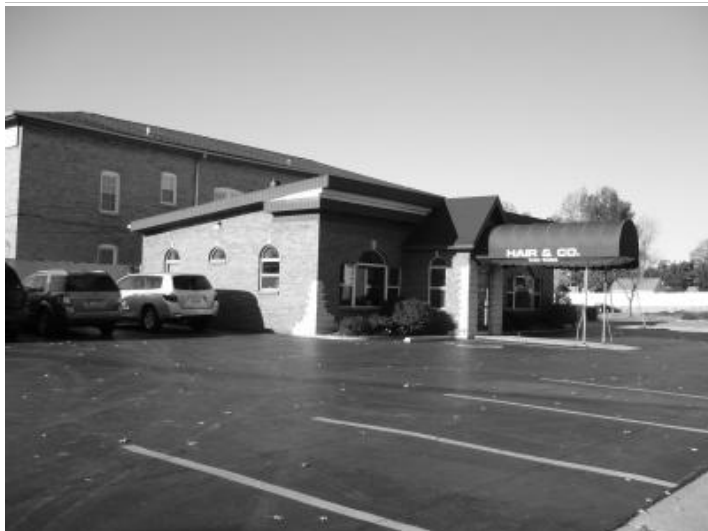
This is a former filling station, dramatically altered to become a hair salon.

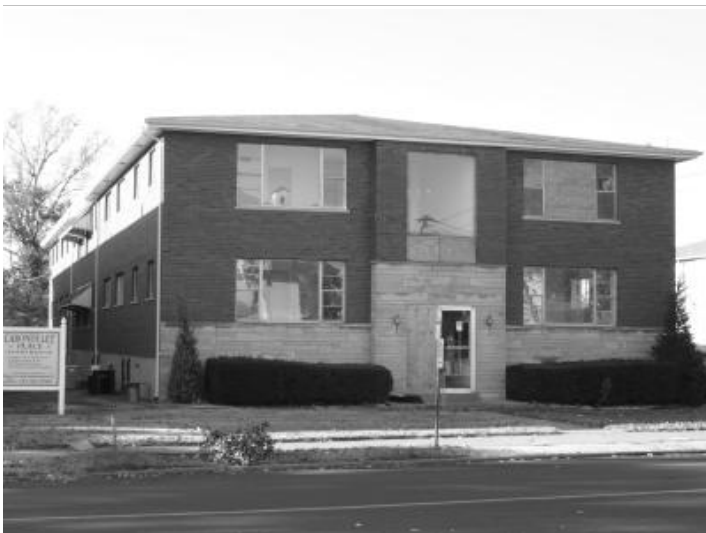
Partially boarded

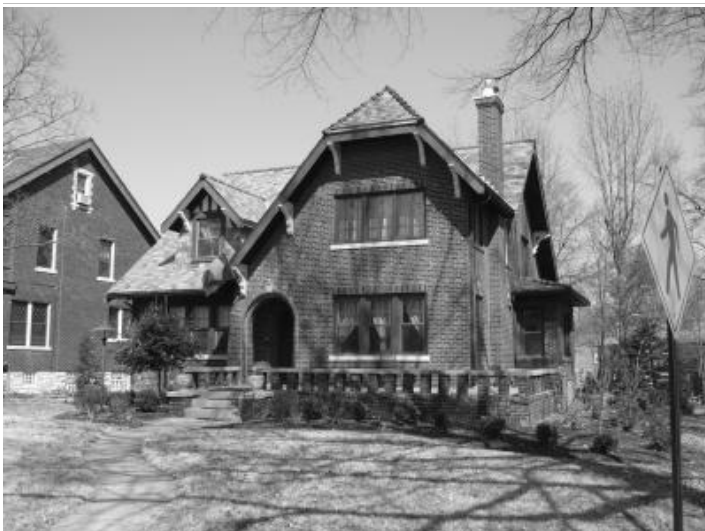
replacement windows at first story.

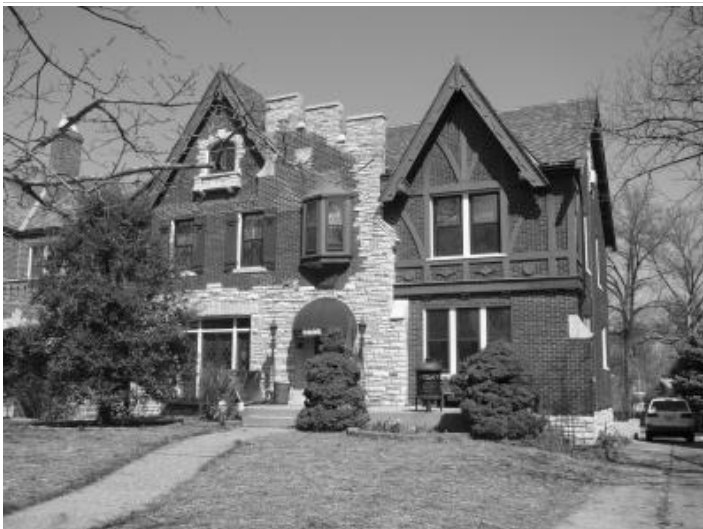
Second story windows are replacements.

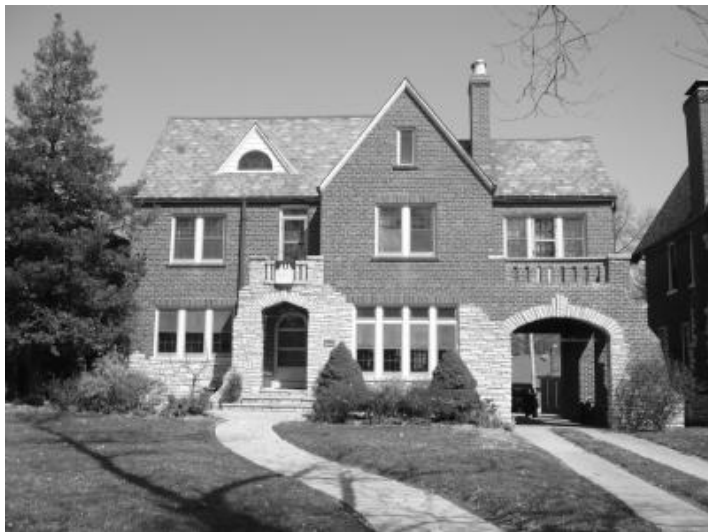
The only obvious alteration is the siding at the dormer.

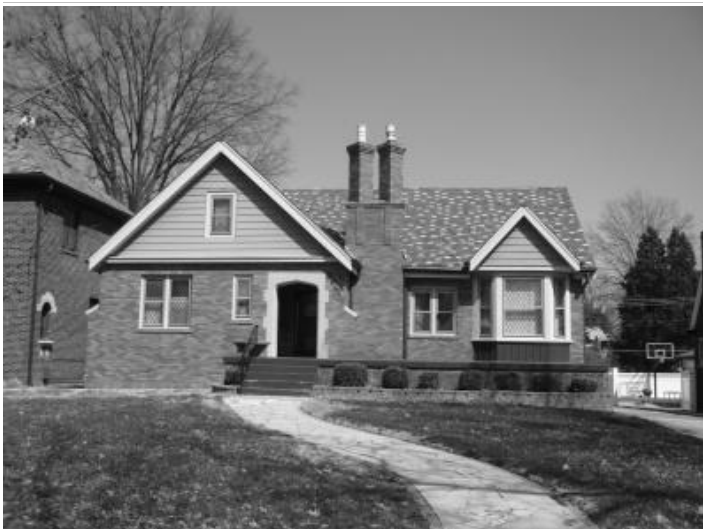
Aluminum siding at both front gable ends.

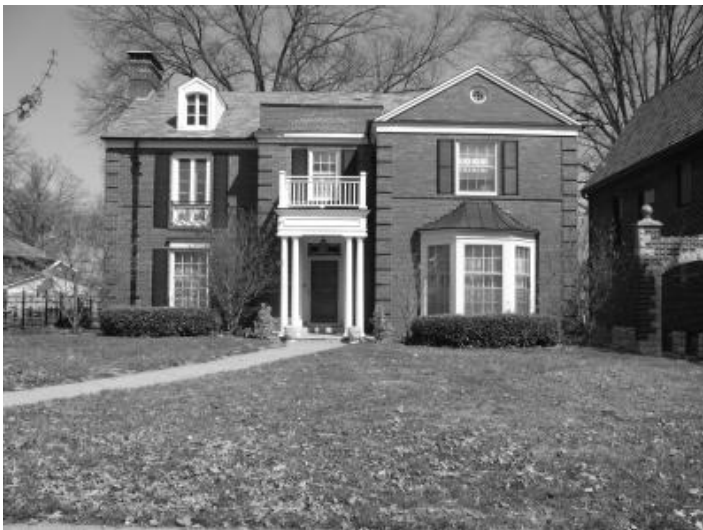
Some wood trim wrapped in siding.

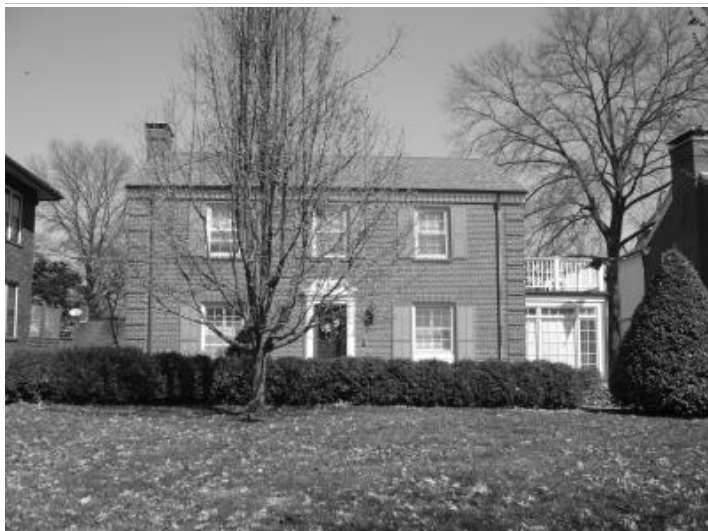
Part of architrave appears replaced.

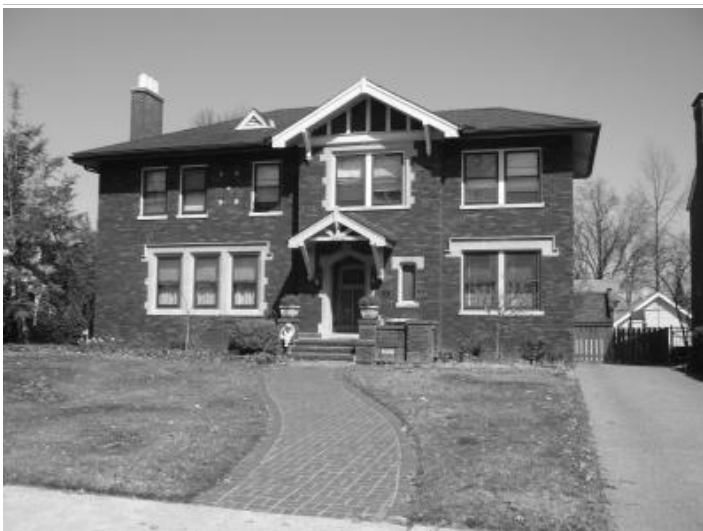
most façade windows are replacements; some wood trim wrapped in siding.

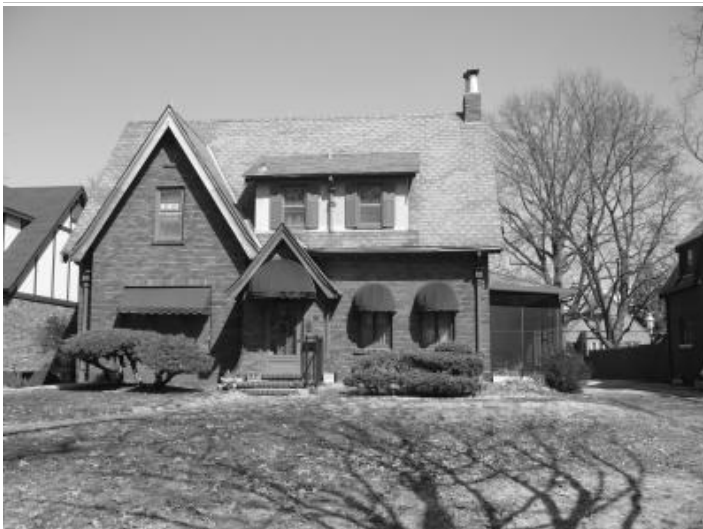
Some wood trim covered with siding; canvas awnings at first floor windows; Screened porch added at right elevation.

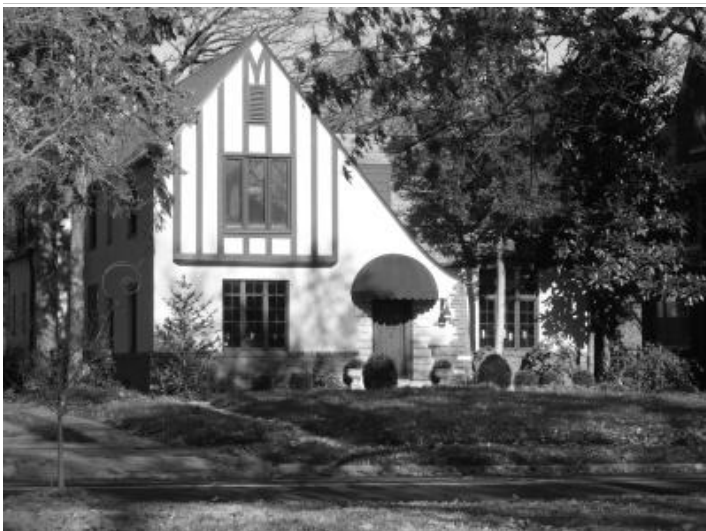
second floor windows are replacements. Fabric awning over the door.

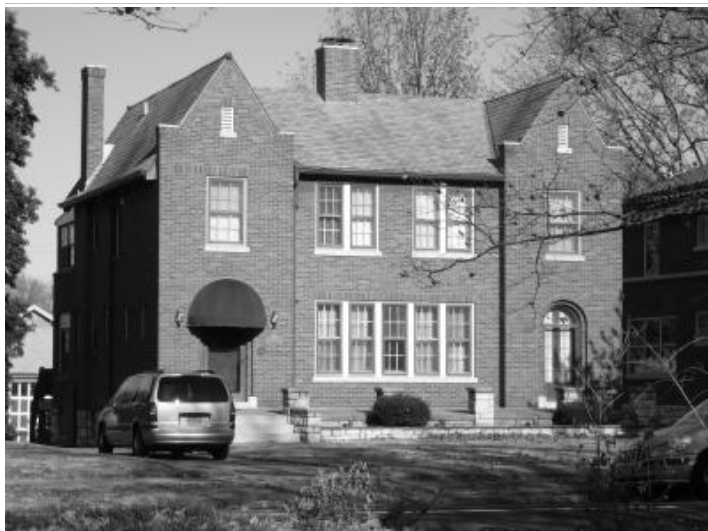
Fabric awning over front door.

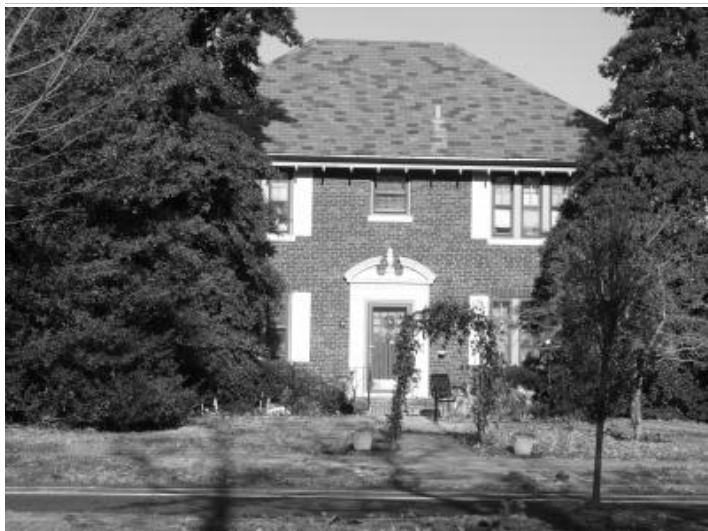
applied shutters

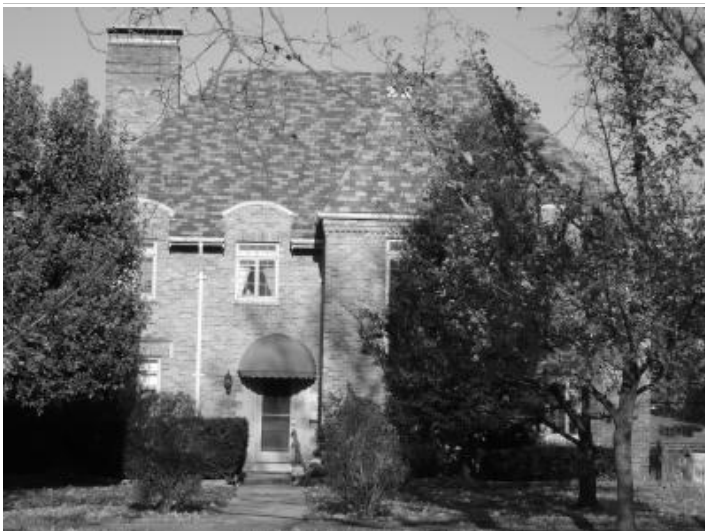
Fabric awnings.

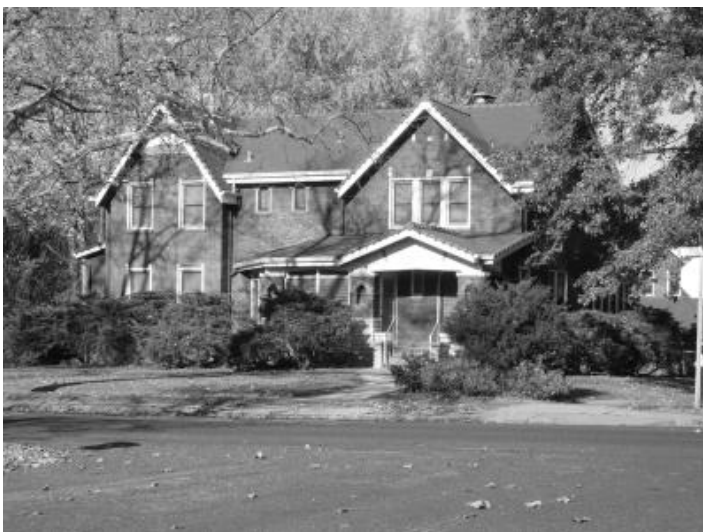
Replacement façade windows; some wood trim wrapped.

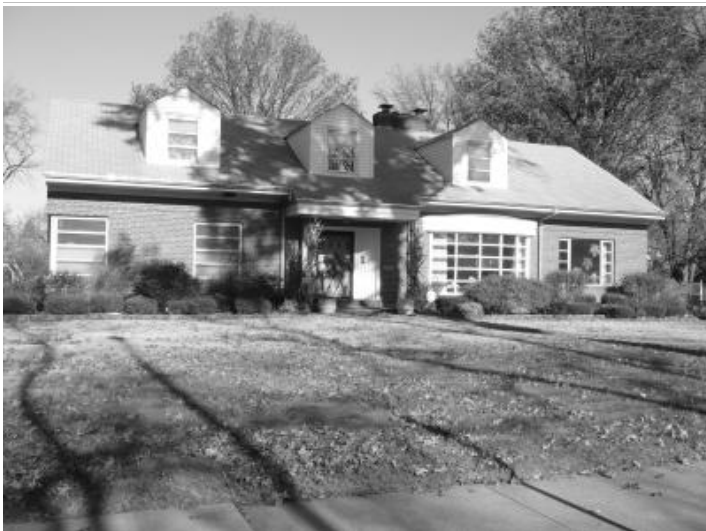
Some trim is wrapped; dormers sided.

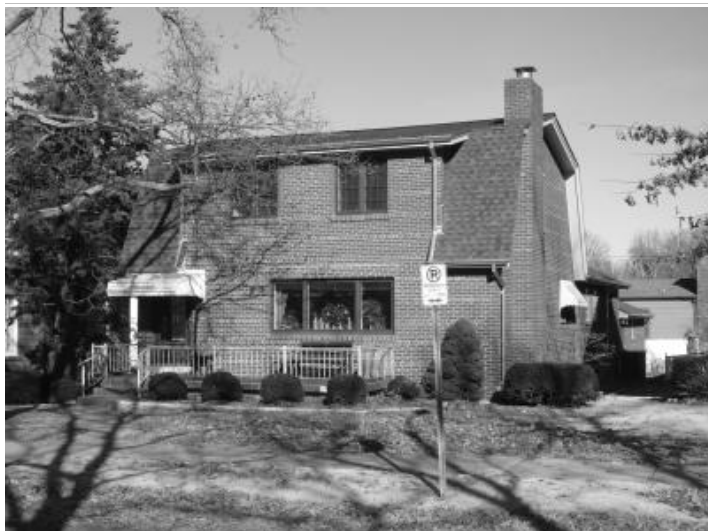
Metal awning at door, left. Replacement door; replacement fixed window at first story.

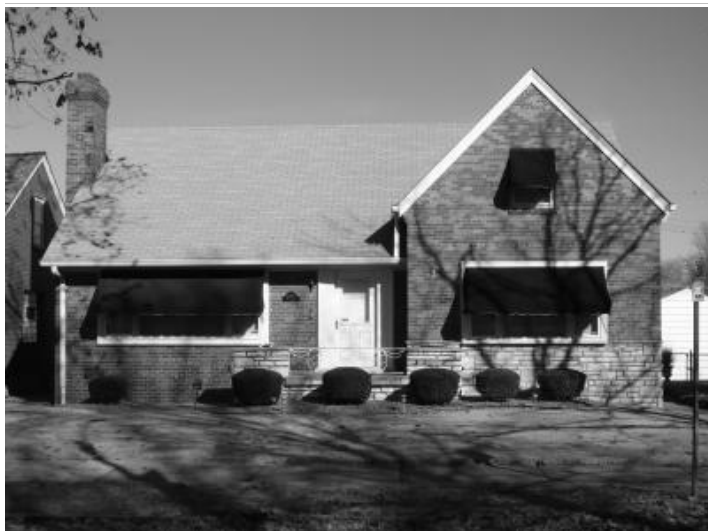
Replacement windows. Fabric awnings.

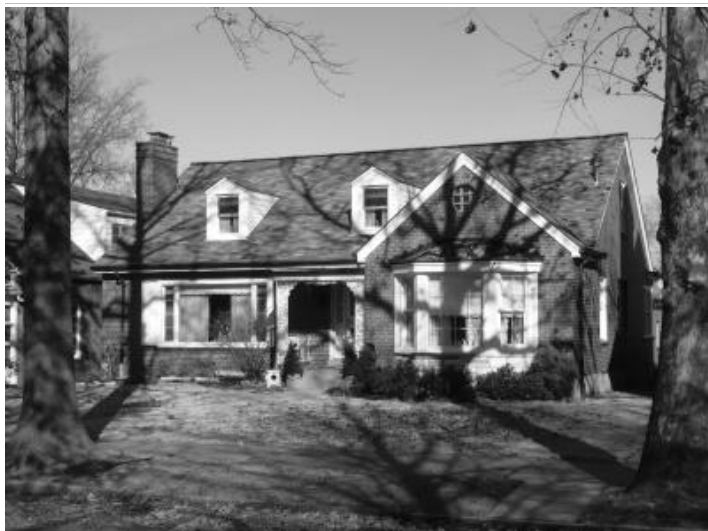
Replacement windows

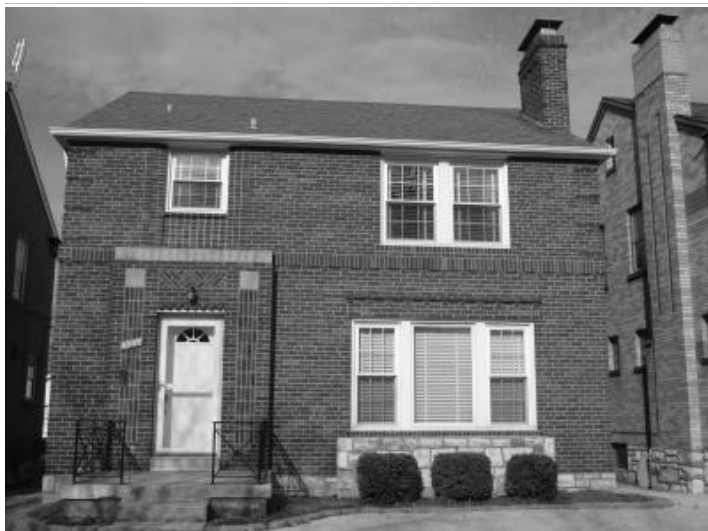
\$1100 brick addition to owner Louis Schulty. Doors and windows have been replaced.

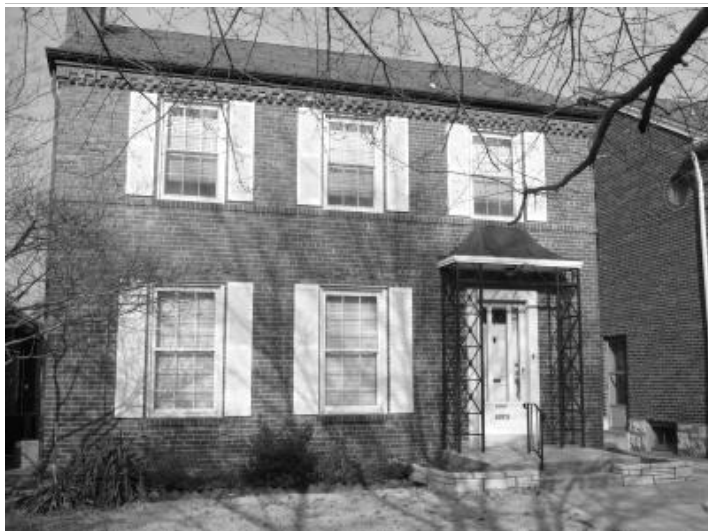
Replacement windows. Shutters added.

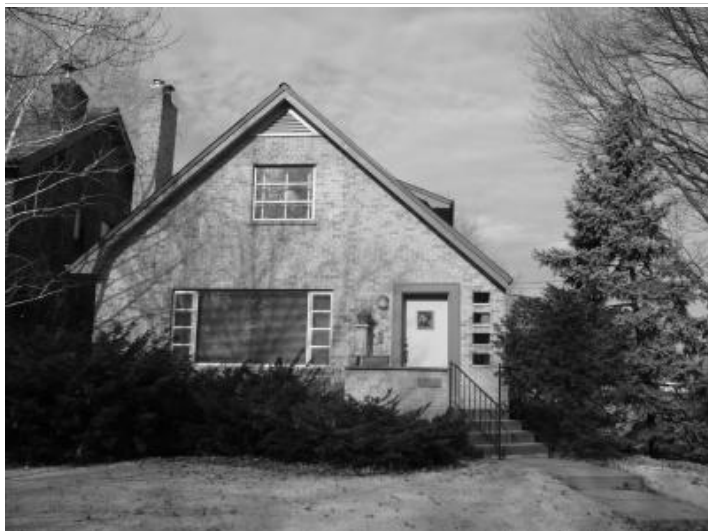
Some wood trim wrapped in siding at eaves.

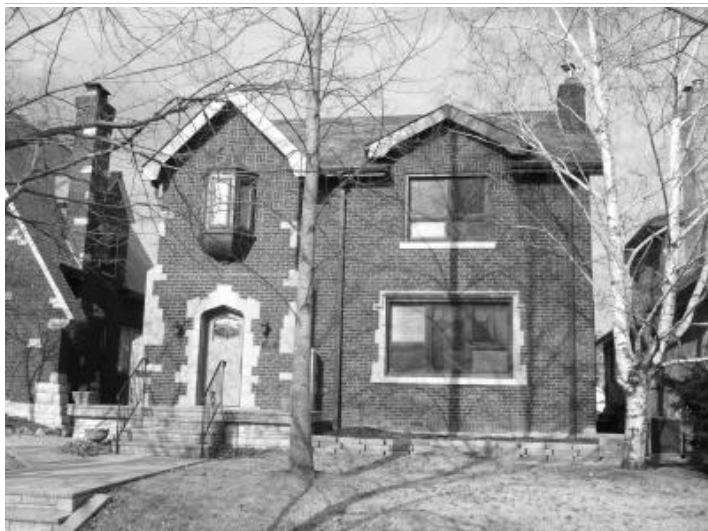
Replacement windows.

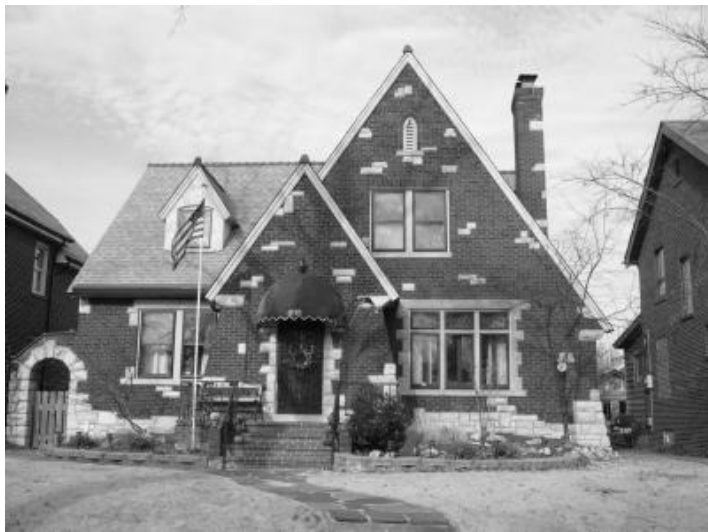
Some wood trim sided.

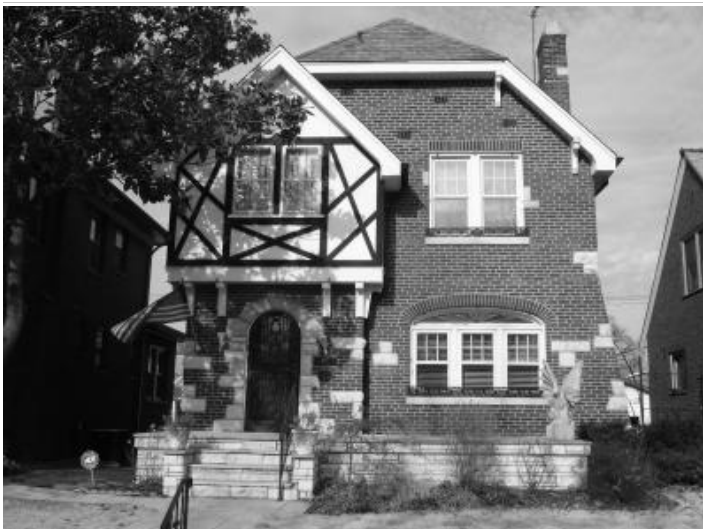
Right bay windows at second story are replacements. Porch base covered with imitation stone veneer. Some wood trim covered with siding.

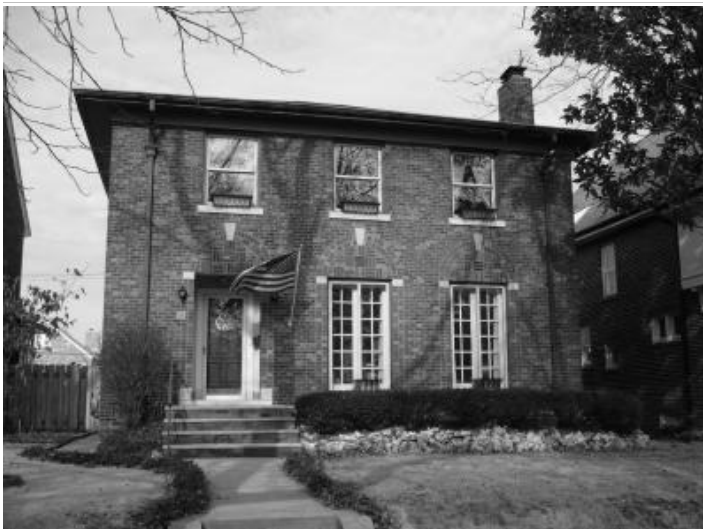
Replacement door and second story windows.

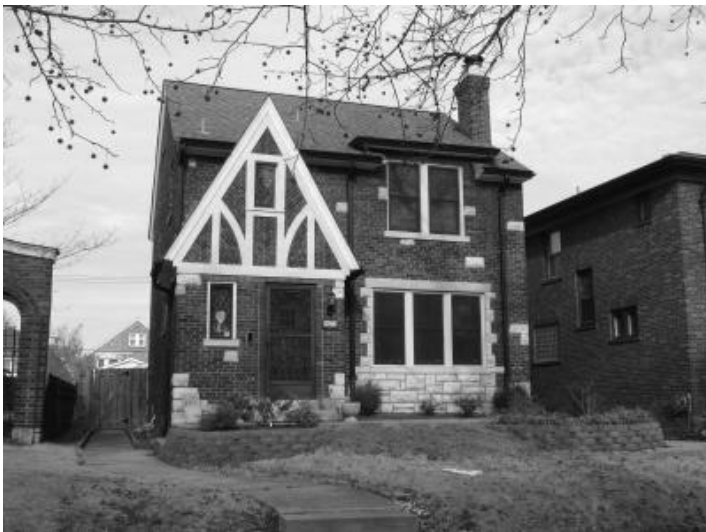
The right bay windows are replacements.

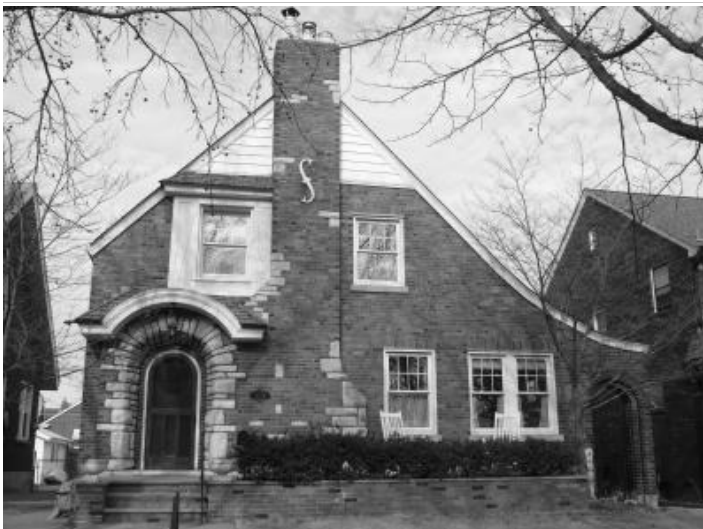
All façade windows are replacements; some wood trim covered with siding.

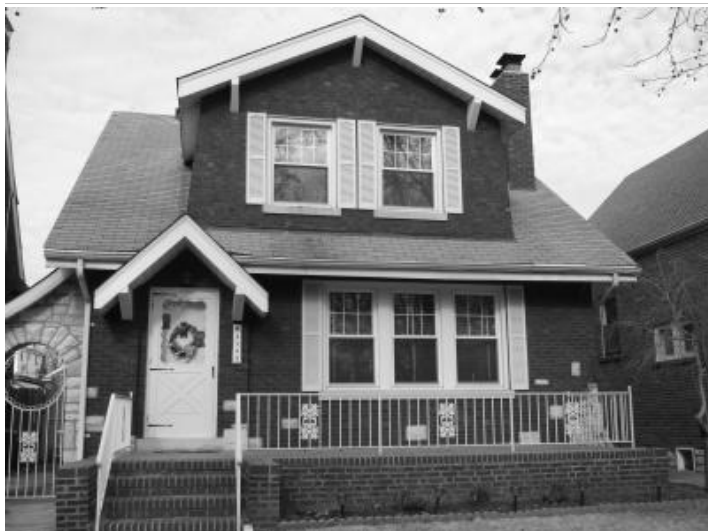
All façade windows are replacements with non-functional shutters added. Some wood trim is soffitted/sided.

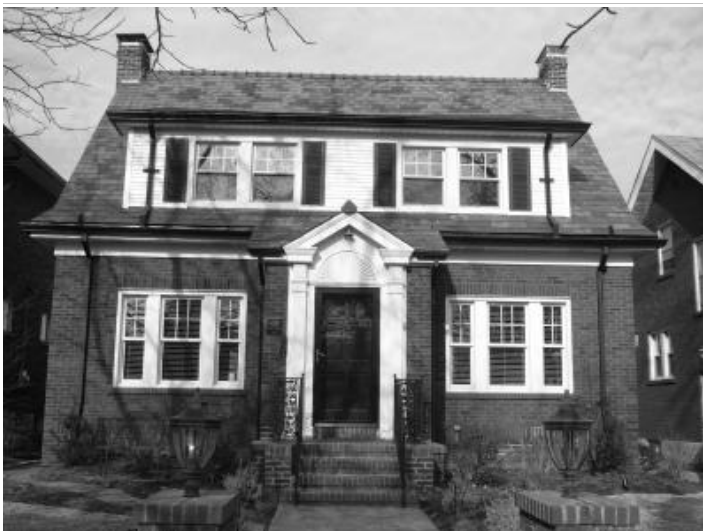
Replacement front door; replacement façade windows.
