City of St. Louis Cultural Resources Office

Holly Hills Neighborhood Survey

Lynn Josse and NiNi Harris
3/1/2010

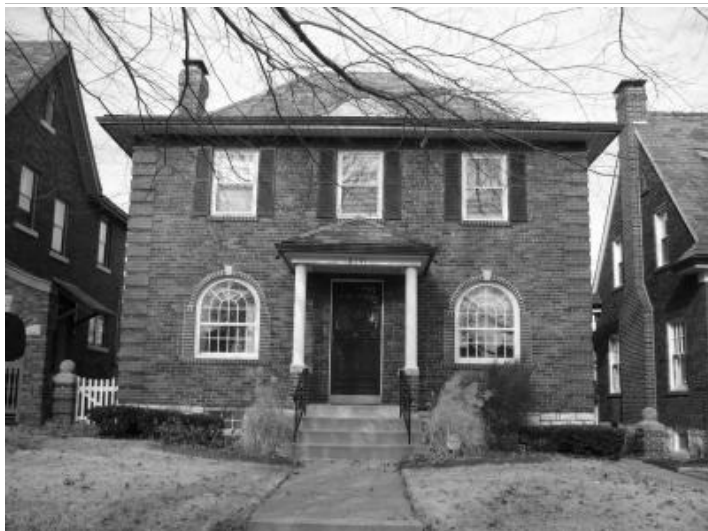
Hipped porch roof is on replacement metal columns. Some wood trim sided with vinyl. Vinyl shutters.

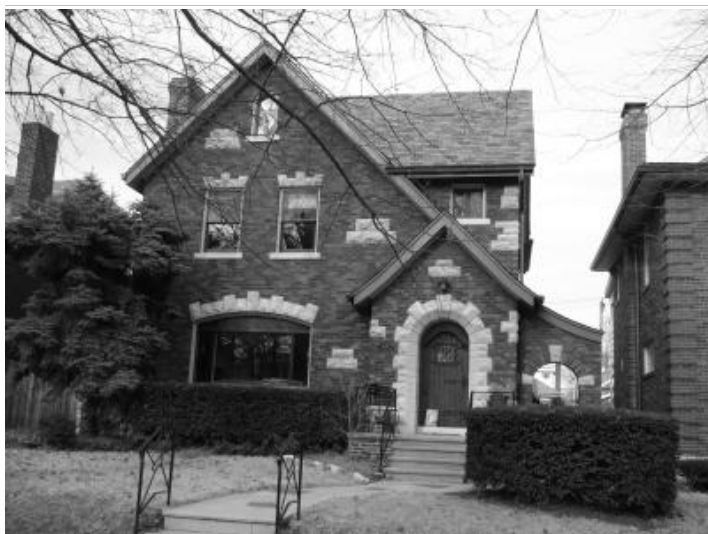
Large fixed pane window at left bay is modern.

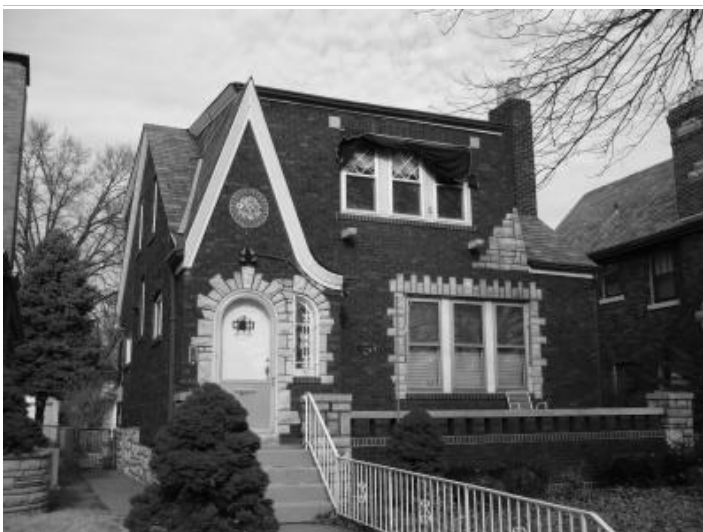
Replacement windows is dormer. Some siding over wood trim.

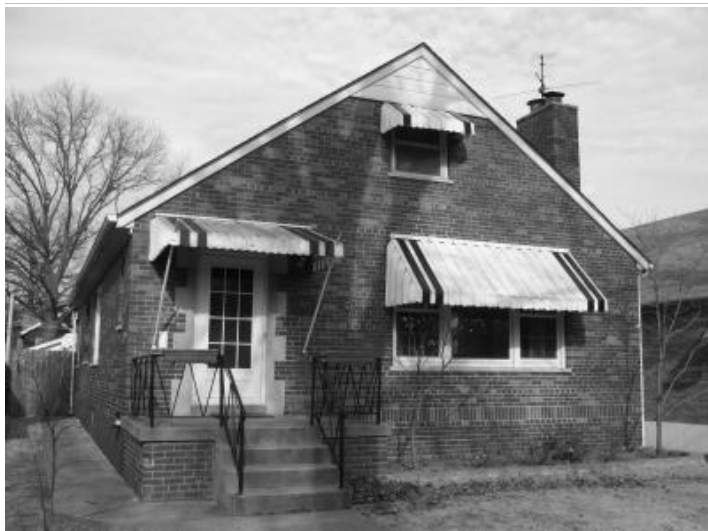
Replacement picture window.

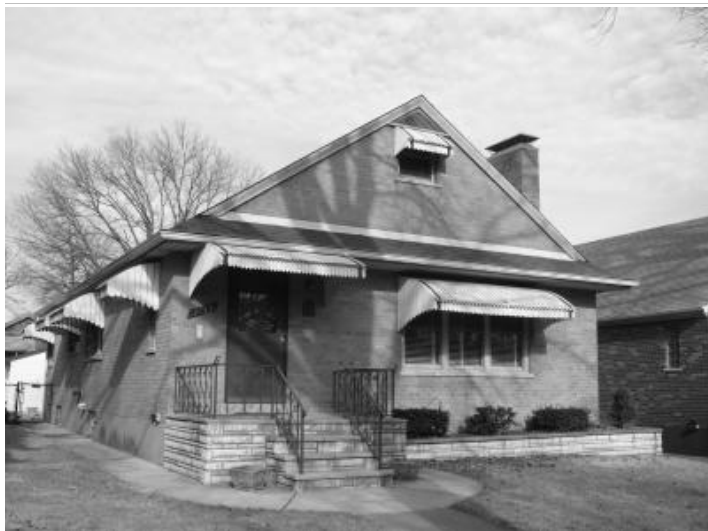
Replacement windows.

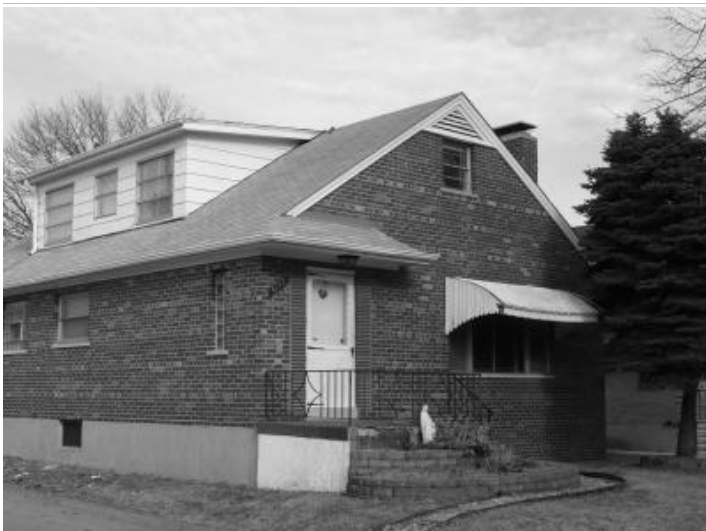
Dormer added in 1959, per permit.

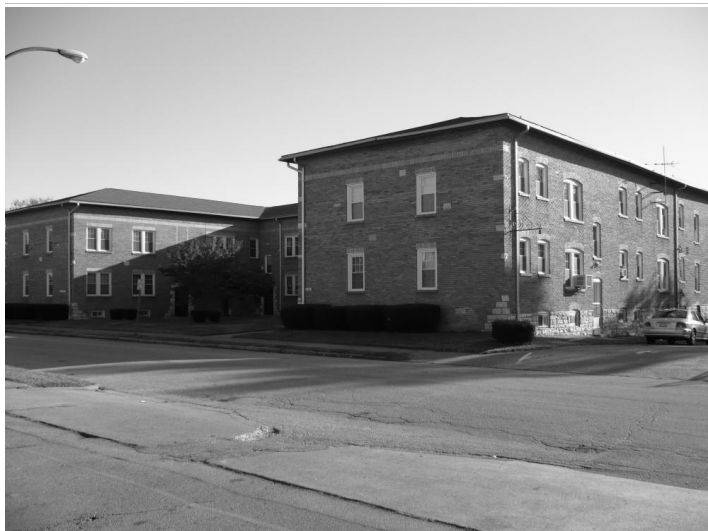
Replacement windows.

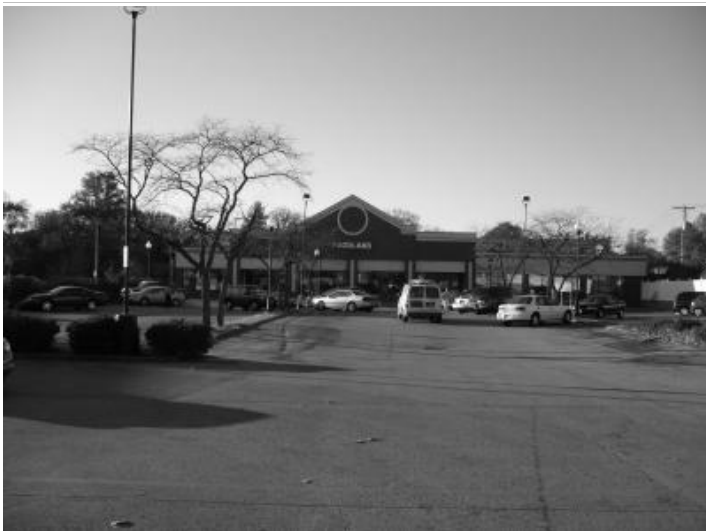
This grocery store is a former bus barn; its façade has been completely altered to a typical false-parapet stucco modern grocery store. Alternate address: 6155 S. Grand

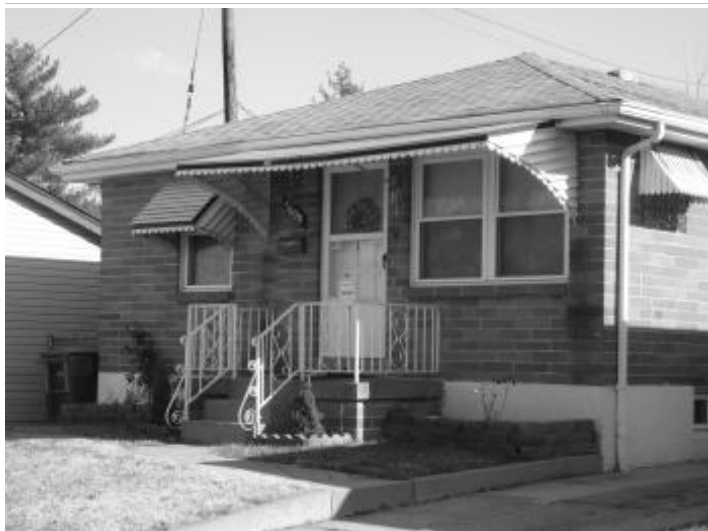
Replacement door and windows.

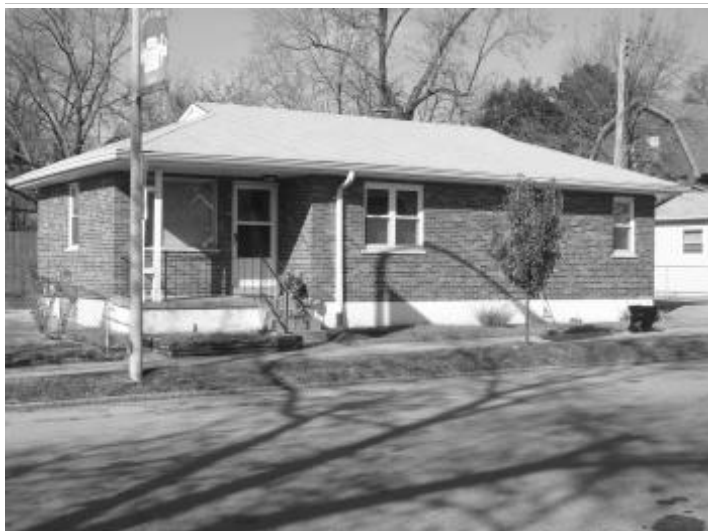
Replacement door and windows.

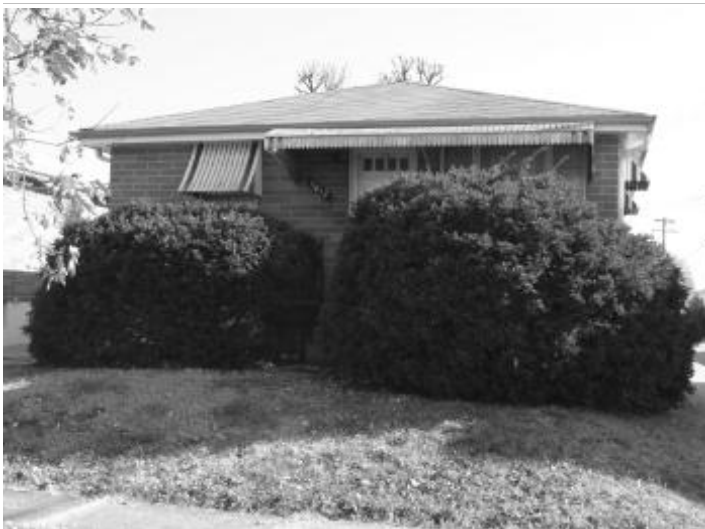
Replacement door.

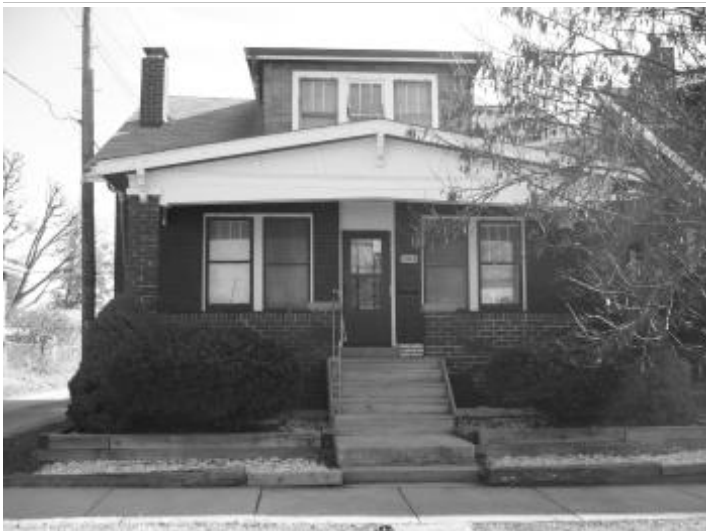
Transom over door is covered. Dormer is asphalt shingled.

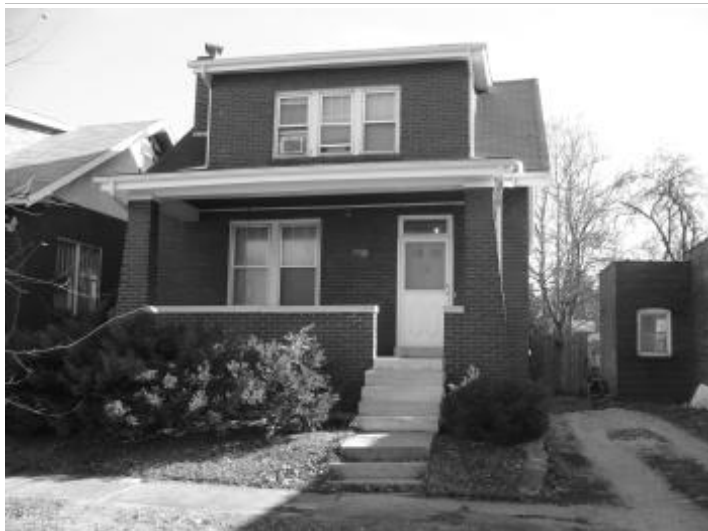
Replacement front door. Some wood trim wrapped.

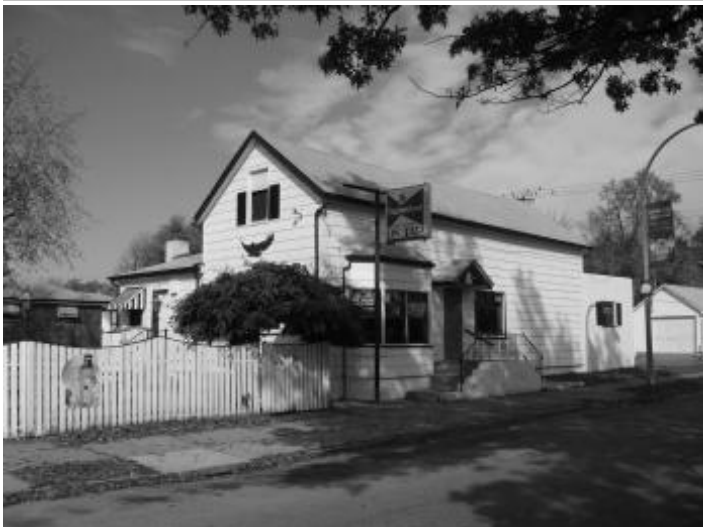
A \$2000 addition permitted in 1955 is likely the concrete block room to the north. Bay window faces Leona. Replacement windows.

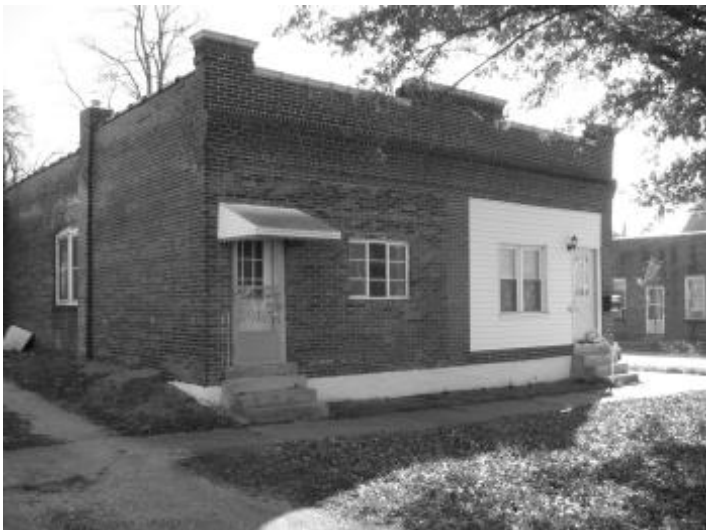
Left storefront filled with brick, possibly during historic period. Right with vinyl siding and a new door and windows. Contributing status uncertain.

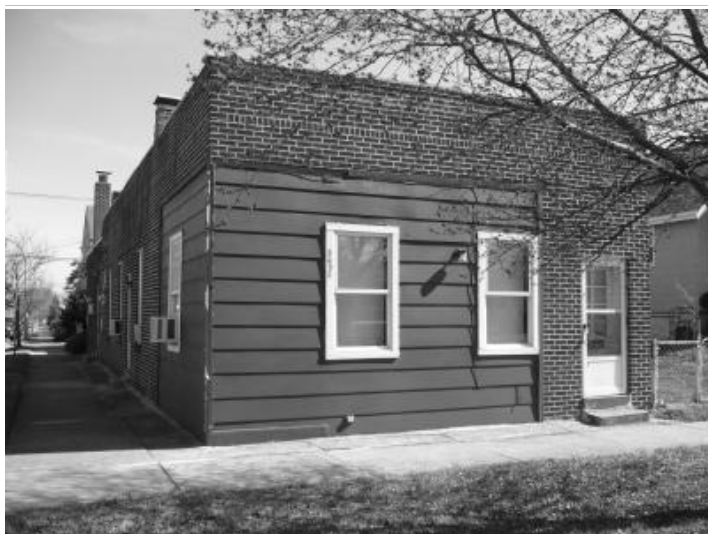
Corner storefront filled in with wood siding and new windows.

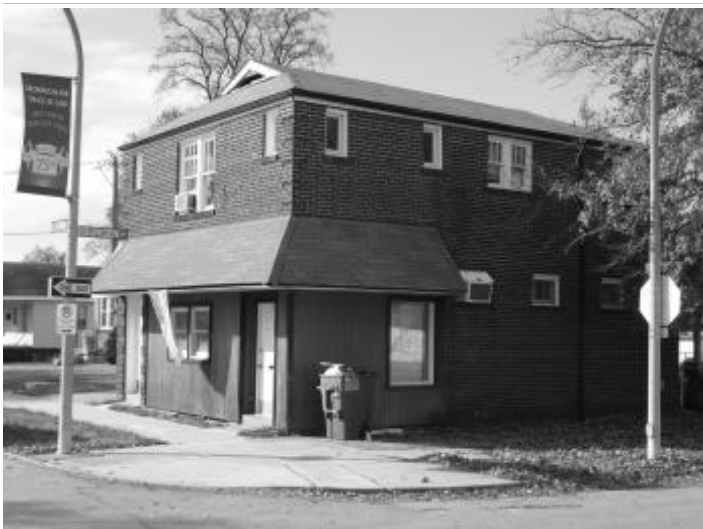
This dark red brick building has a gablet roof, which is very unusual for this early date (possibly a replacement of the original). The red brick forms suggestions of quoins at the corners.

First story storefront is filled in with wood or pressed wood siding and modern windows.

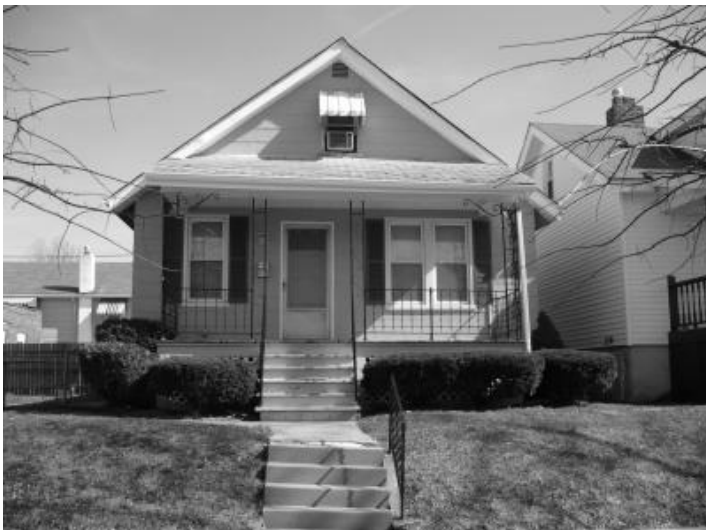
Replacement door and 1st story window; window/door trim covered with siding; porch base and metal supports are not historic; shutters added; metal awning at second story.

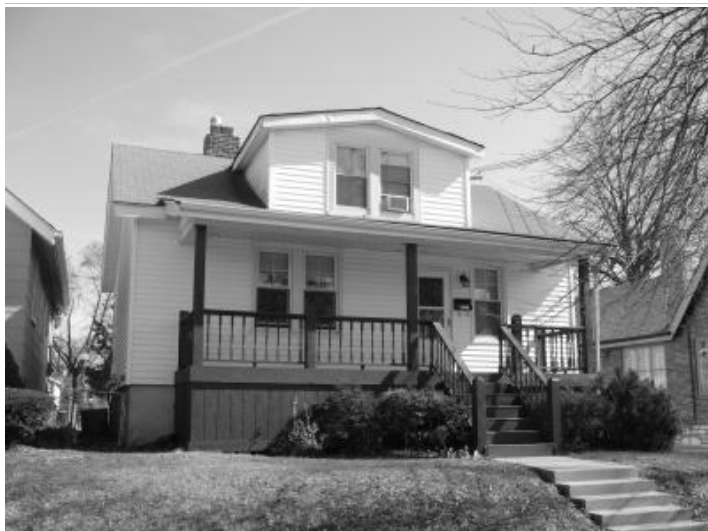
Replacement door, front windows, porch structure; vergeboard, eaves, window trim sided or wrapped.

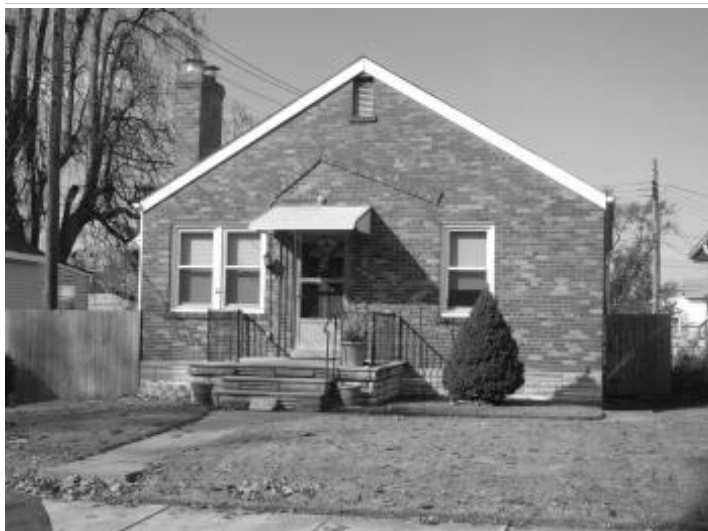
Vinyl windows replaced originals.

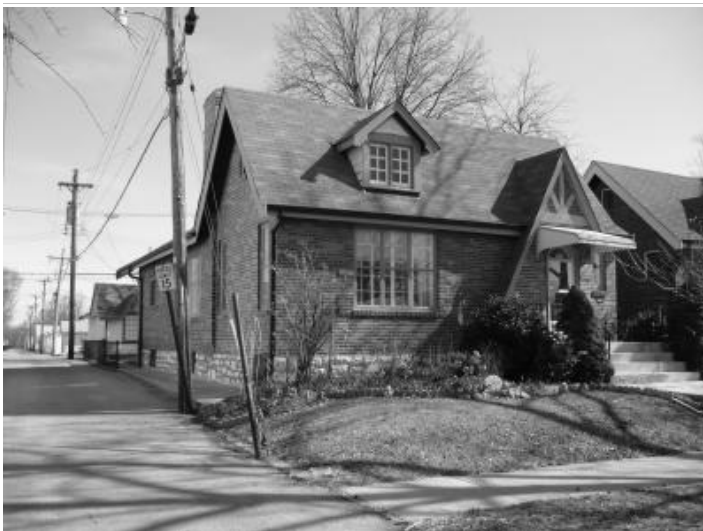
metal awning over front door.

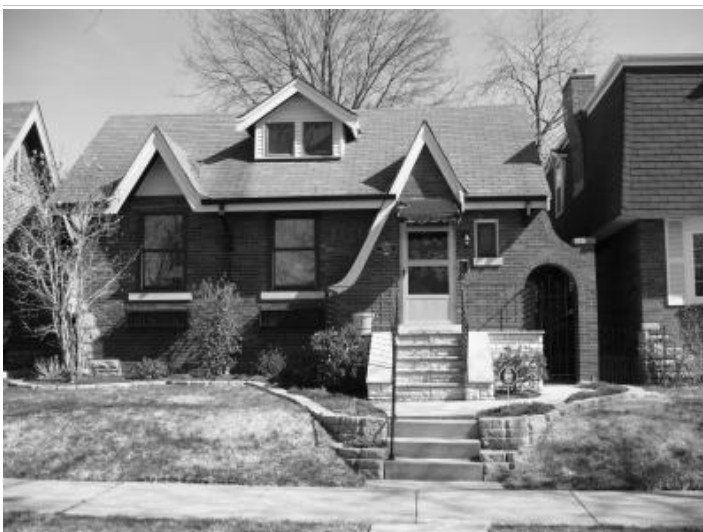
Siding at dormer, wrap at most wood trim; imitation stone veneer at porch base.

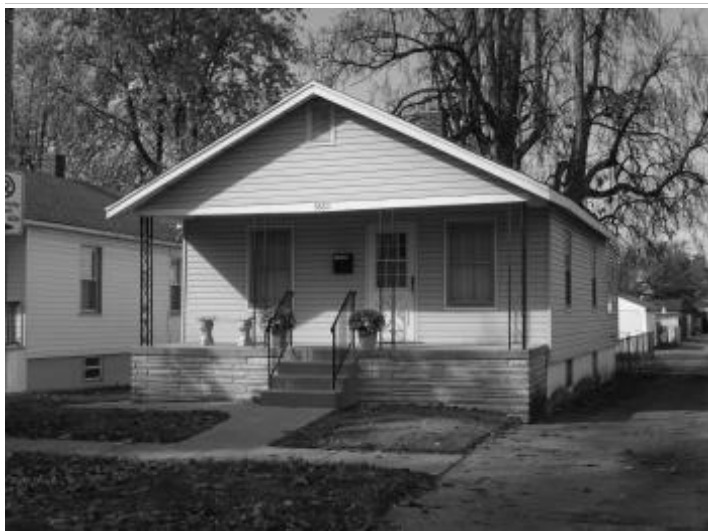
Porch base is clad in imitation stone veneer; doors and windows are replacements.

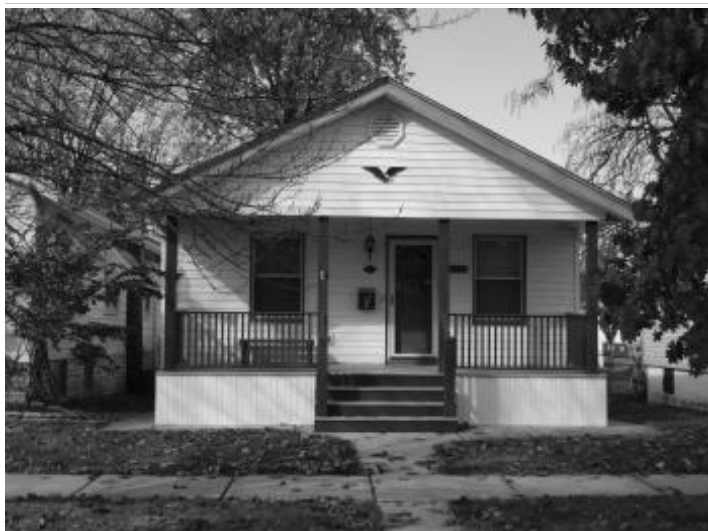
Porch is rebuilt in wood; vinyl-sided gable end; doors is a replacement.

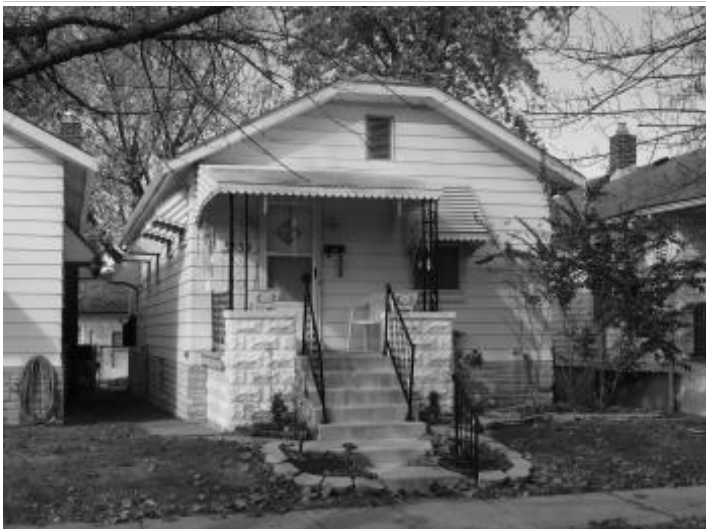
Imitation stone veneer covers base of house. Front door is replaced. Metal awning at window, right.

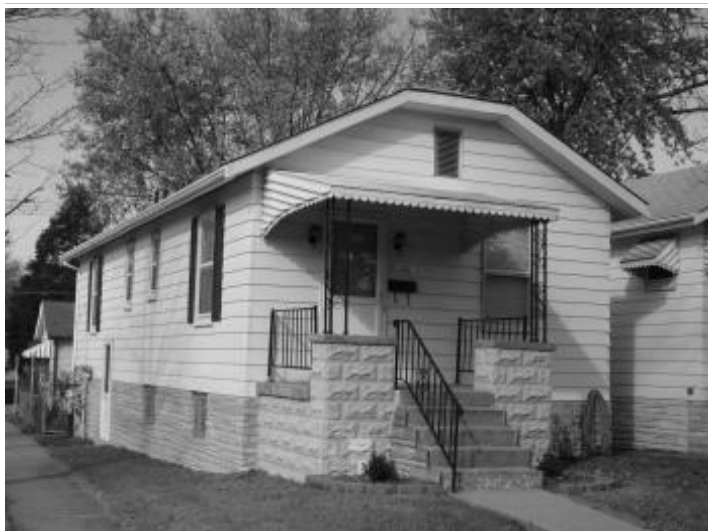
Imitation stone veneer covers base of house. Front and window are replacements.

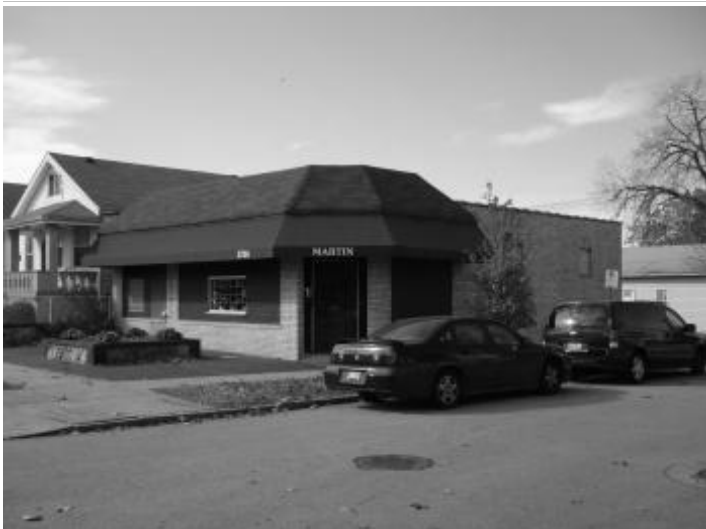
The original store windows are filled in. Awning at façade wrapping around corner.

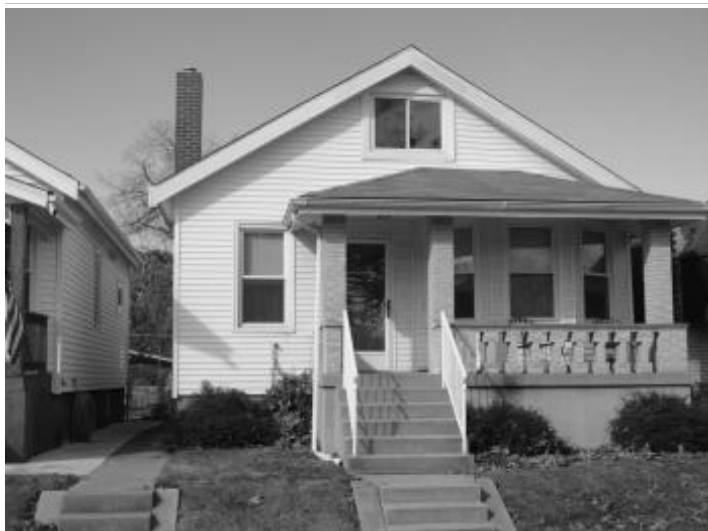
Replacement door, windows; aluminum wraps vergeboard & eaves.

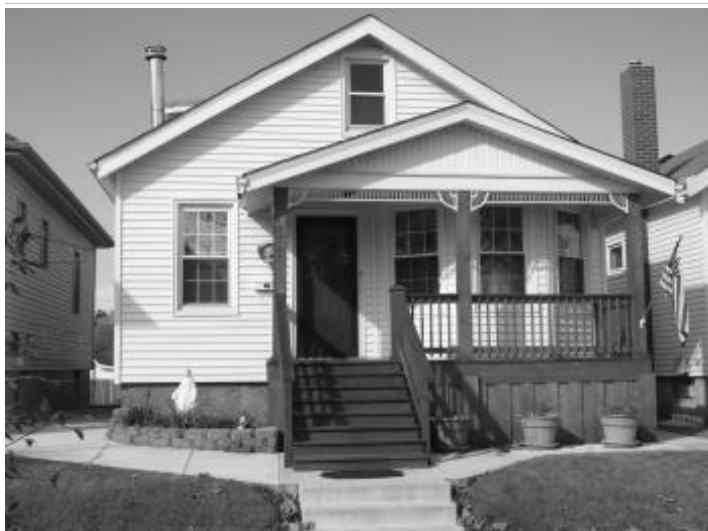
Replacement door, windows; aluminum wraps vergeboard & eaves. The porch has unpainted wood posts and rail on a concrete base.

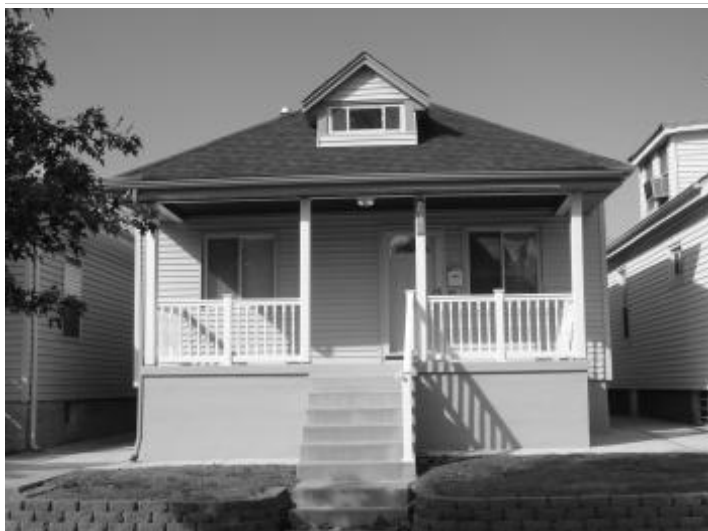
Replacement door; façade windows replaced with sliding track windows. Porch railings and supports are replacements.

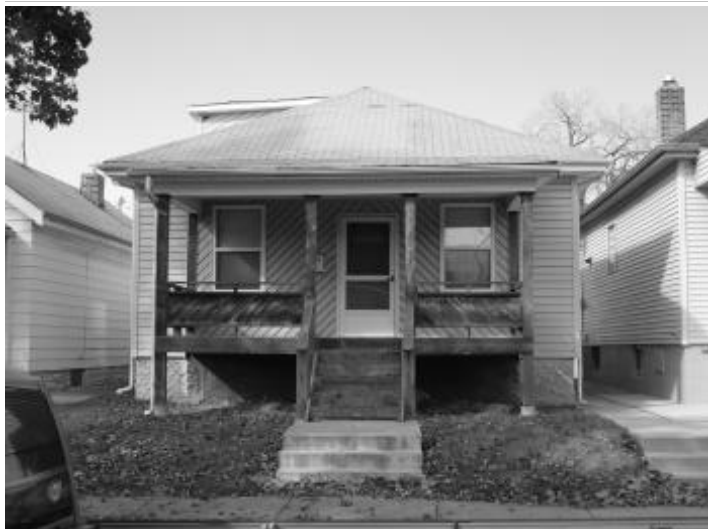
The center of the facade (at the hipped porch) has diagonally applied vinyl siding. Replacement door and windows; unpainted wood porch.

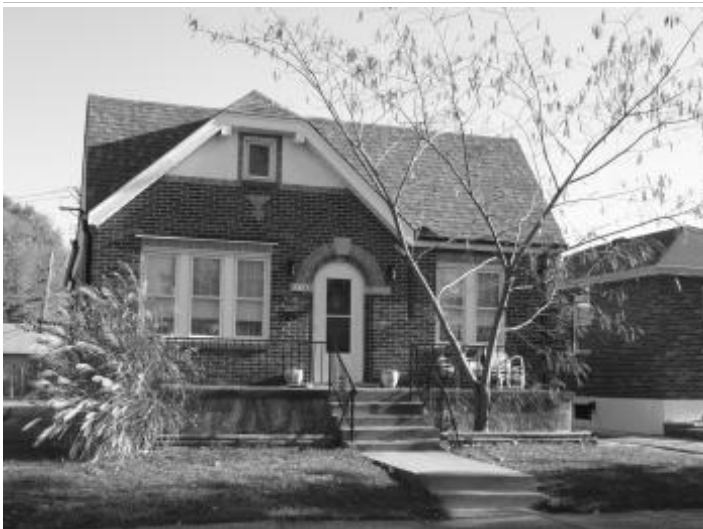
Wood trim wrapped/covered.

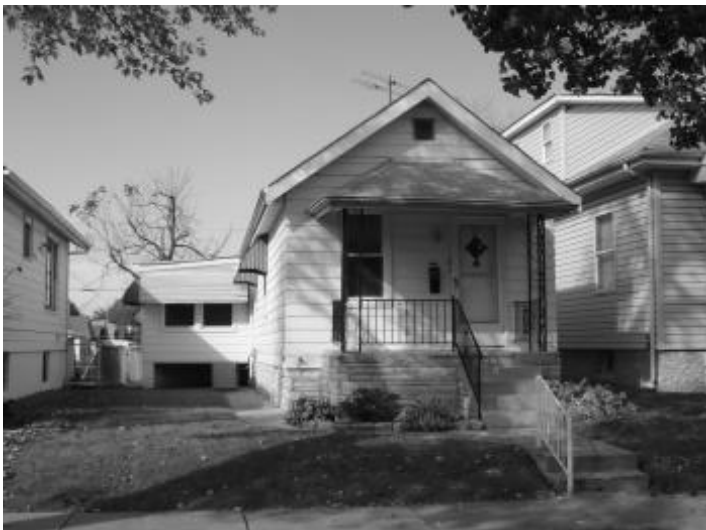
Replacement door, window, siding, porch rails and supports. Foundation and porch base are imitation stone veneer. Rear wing with shed roof to left

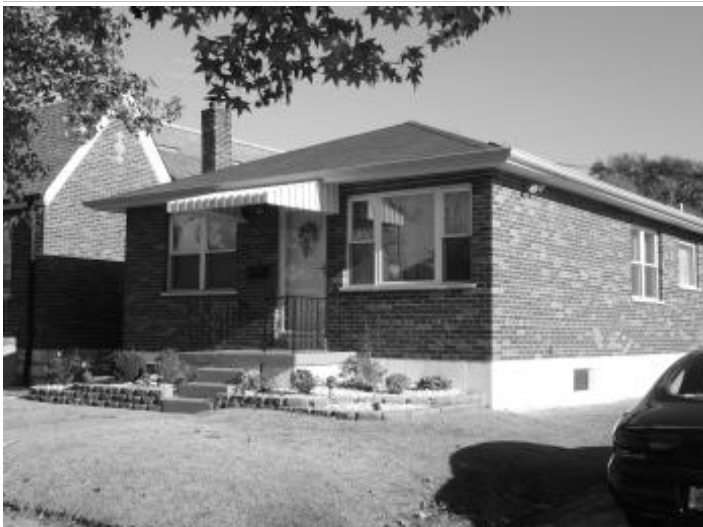
Door and windows appear to be replaced.

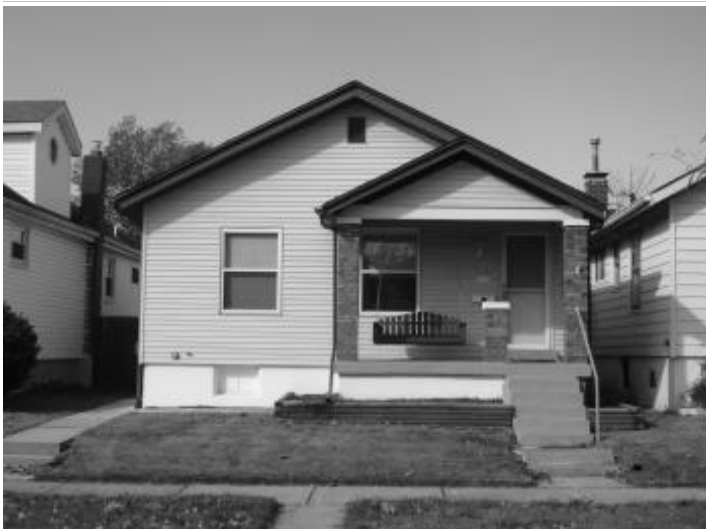
Replacement door and windows. Wood trim clad in aluminum.

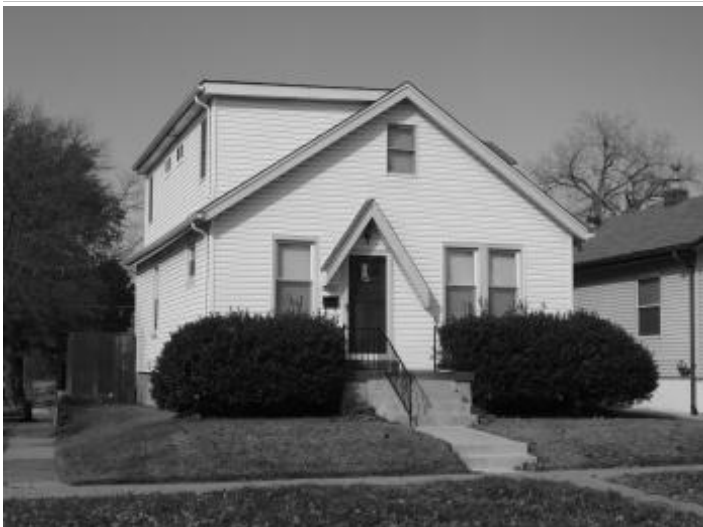
A large shed dormer at the left elevation is not original. Replacement windows. Original wood trim obscured by wrap and siding.

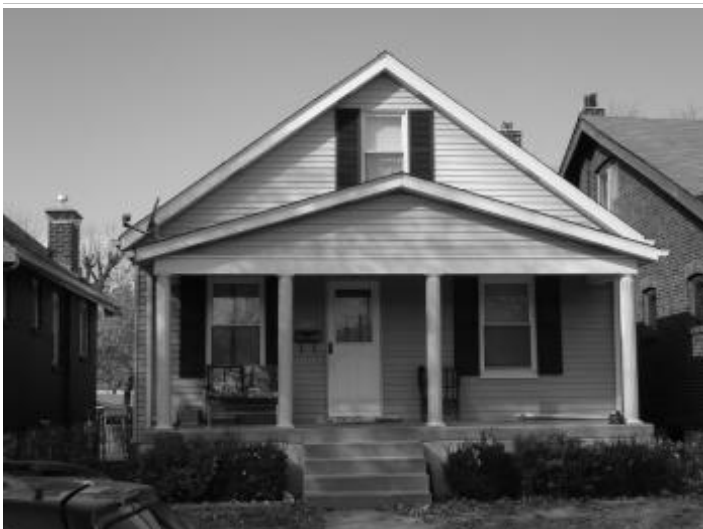
Base of gable-front porch is concrete, and columns are replacements. Front gable roof. Original front door. Permit not found.

Replacement windows with no original trim showing.

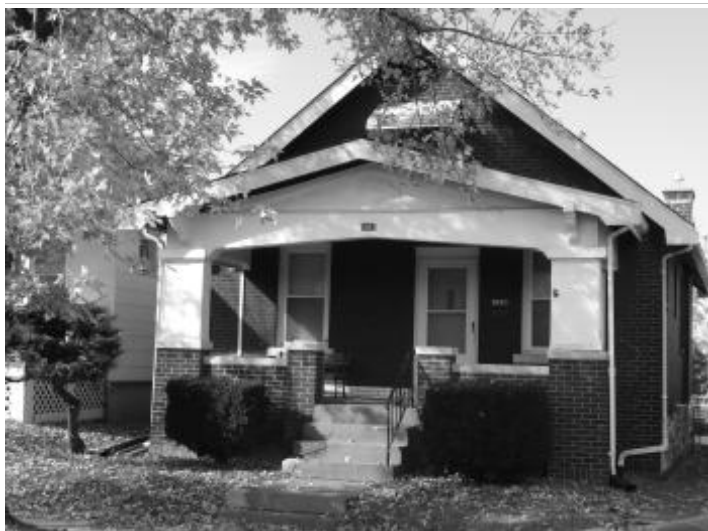
Replacement door and windows at façade.

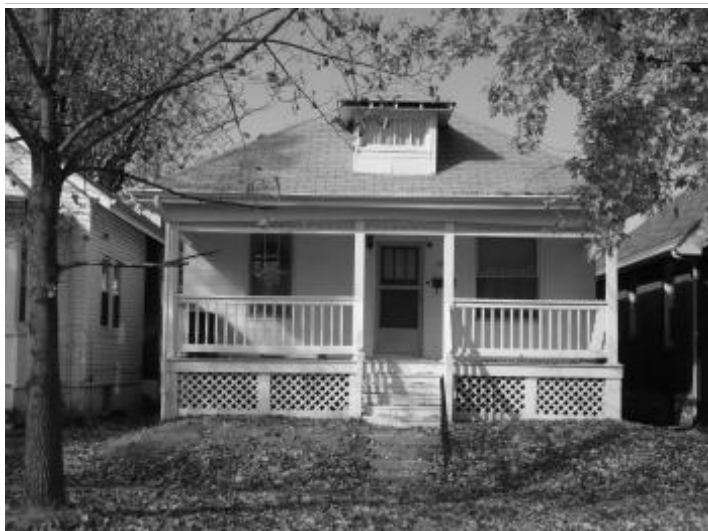
Porch rails are added.

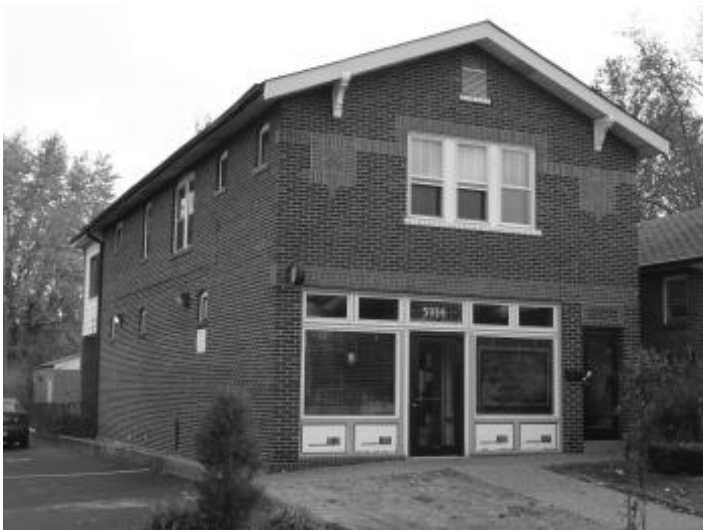
Vinyl soffit and eaves

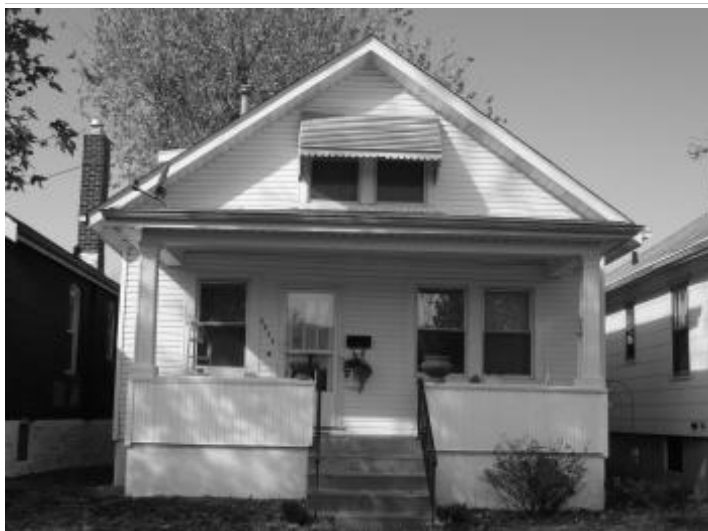
windows are replaced.

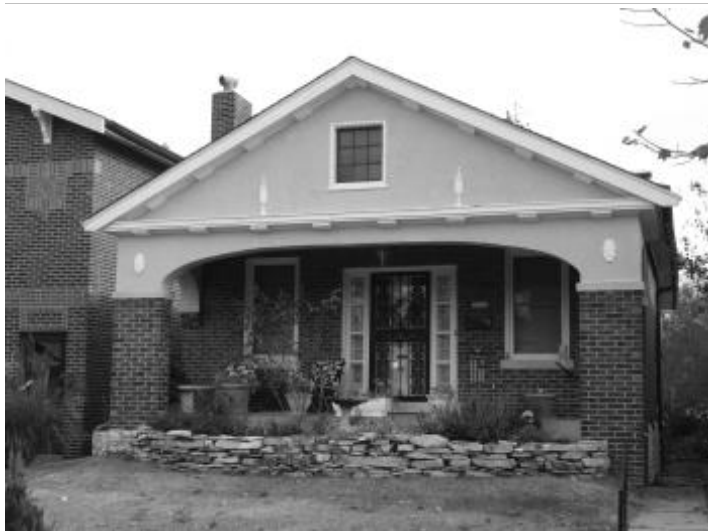
The façade's two windows and front door are replacements.

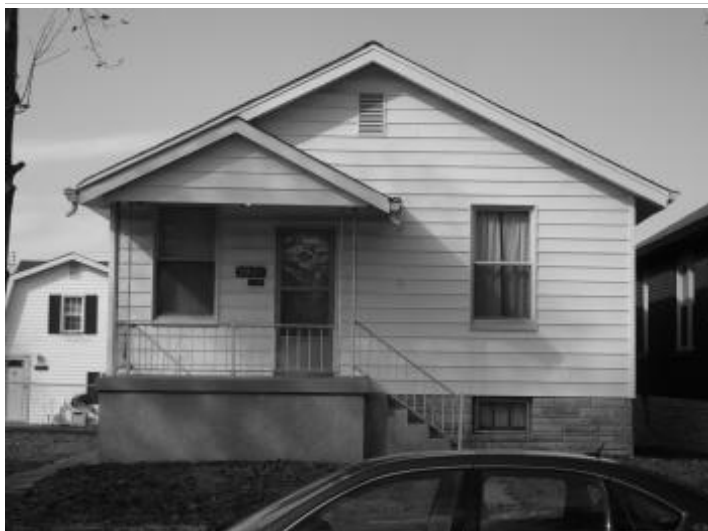
Replacement front door and windows.

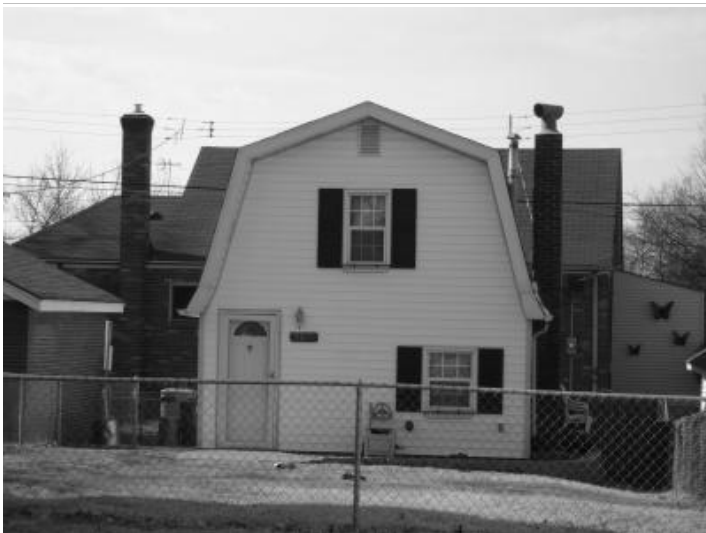
Door and windows are replaced.

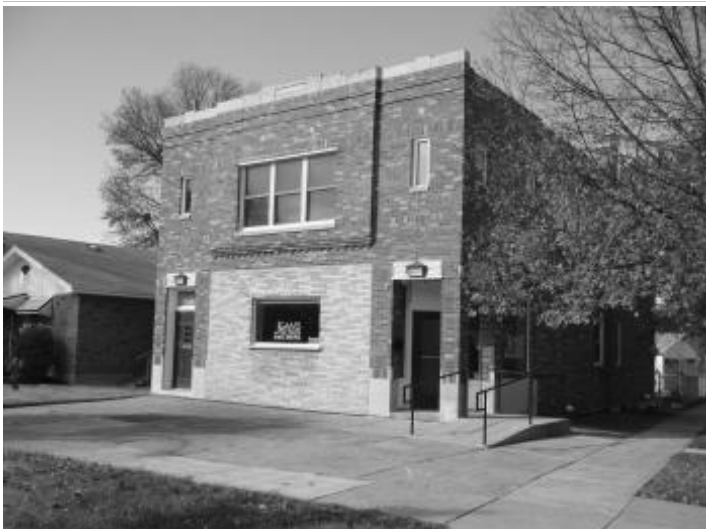
Storefront window infilled with imitation stone veneer and small window. Vinyl replacement windows.

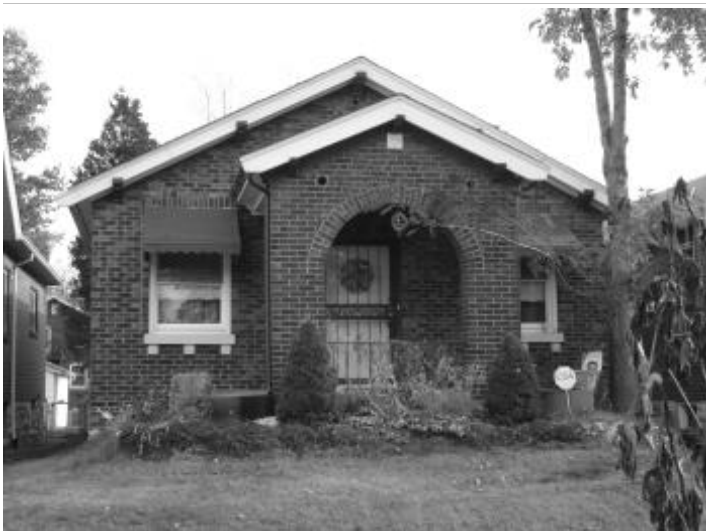
Windows and front door are replaced.

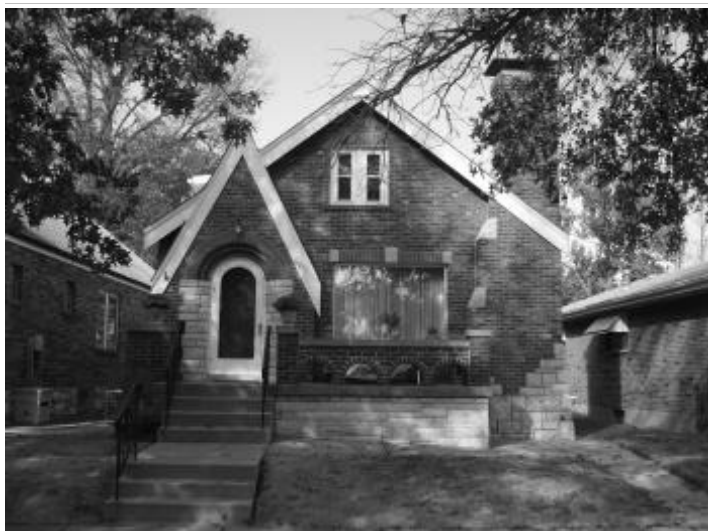
Façade windows are replacements. Dormer on south side added (or possibly expanded) 1973.

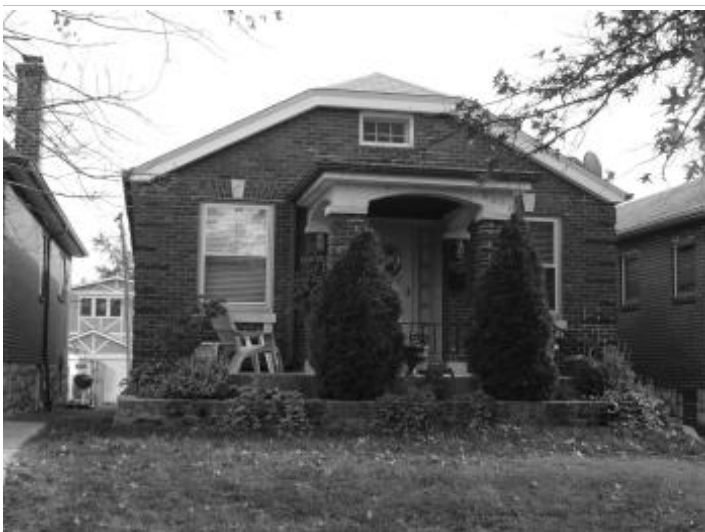
Replacement front door.

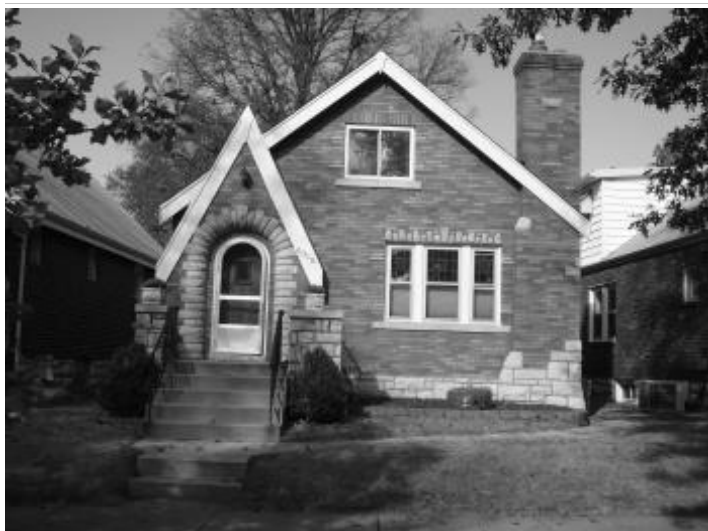
Replacement slider window in gable end.

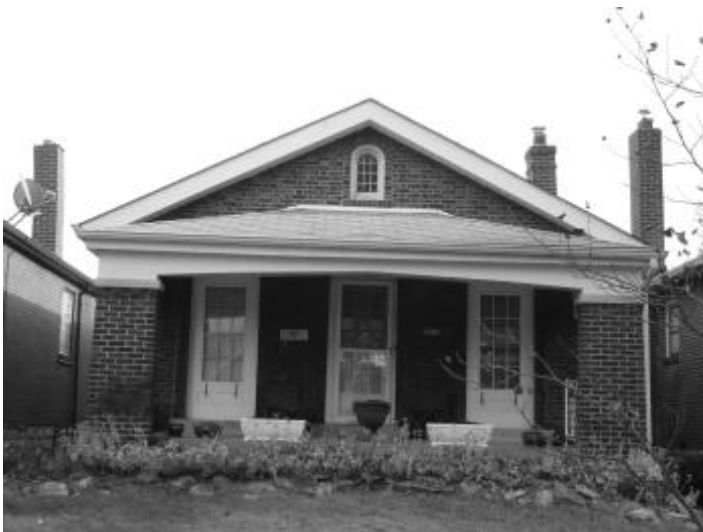
Vinyl over eaves, soffit, vergeboard.

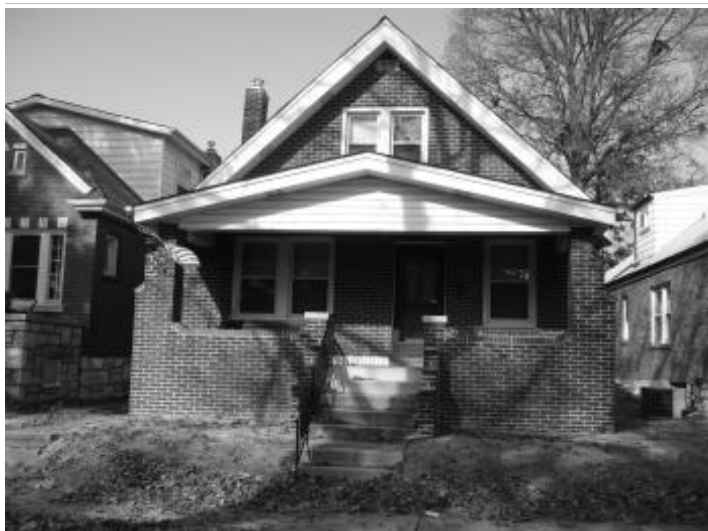
Front door and windows are replaced.

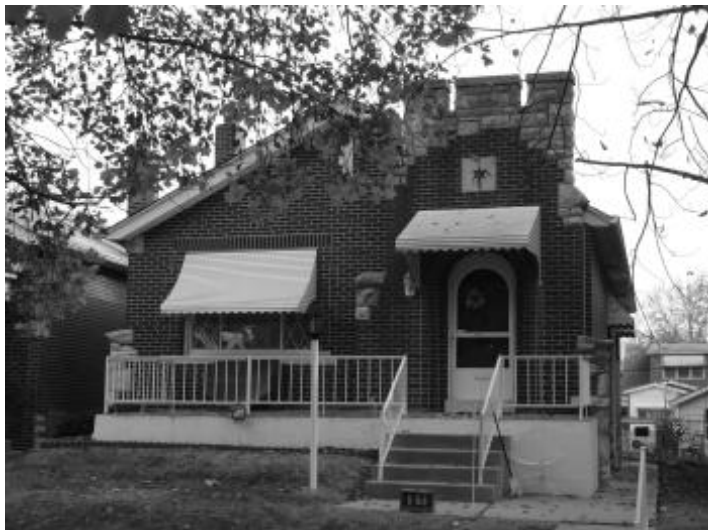
Replacement window (picture window) under awning; awning at front door; soffited eaves; replacement attic vent.

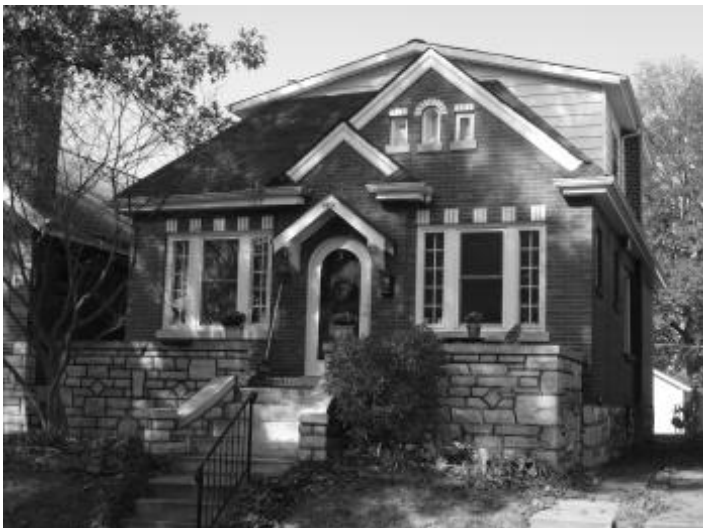
pop-up dormer at rear of house adds second story (1975), but this is not prominent when viewed from the street. The center section of the tripartite windows L and R of door has been replaced with vinyl 1/1s, but the outer sections are orig. casements

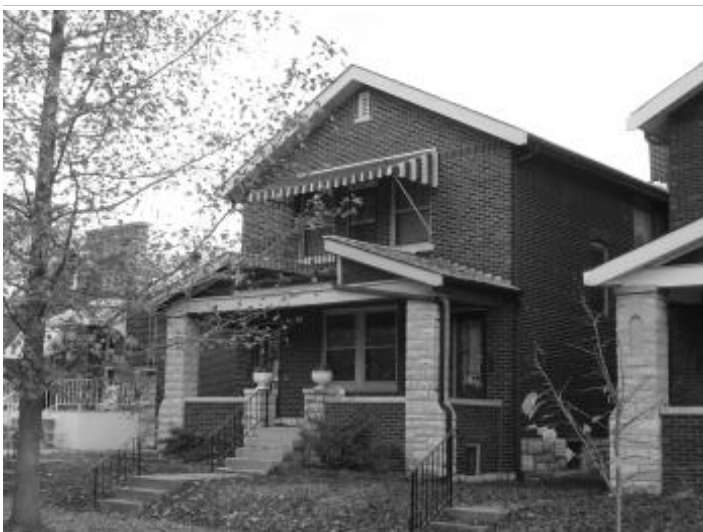
Metal awning at balcony.

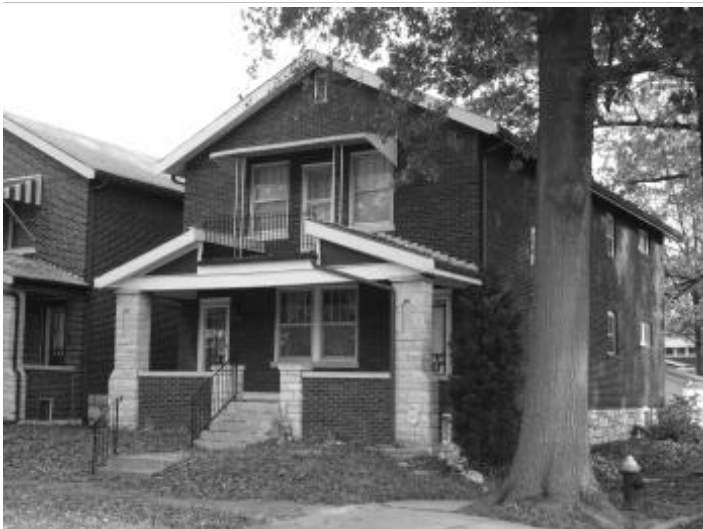
Metal awning at balcony.

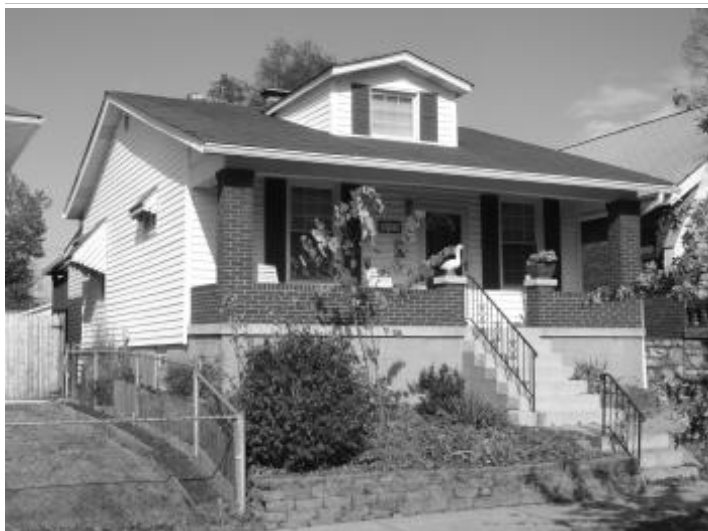
Replacement windows and front door; trim covered by horizontal siding and vinyl shutters.

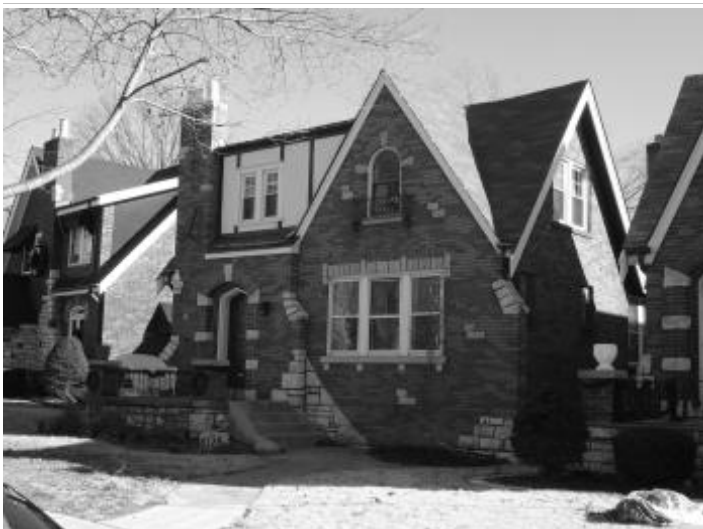
New windows at the dormer.

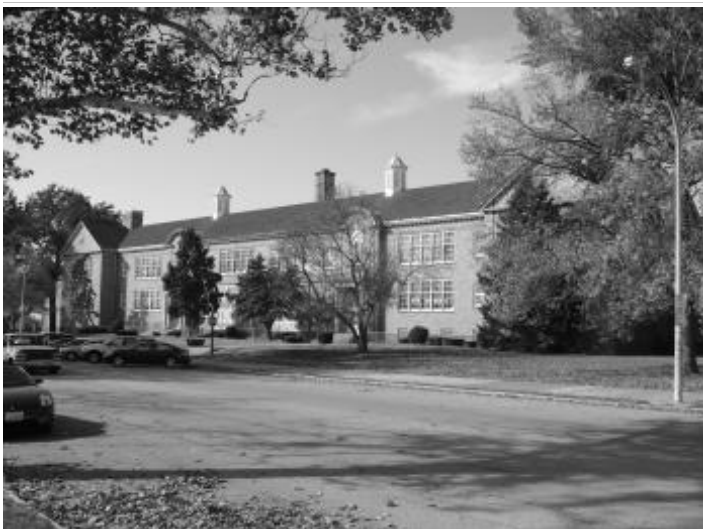
Gym addition to the south respects style and materials of buildings.
