City of St. Louis Cultural Resources Office

Holly Hills Neighborhood Survey

Lynn Josse and NiNi Harris
3/1/2010

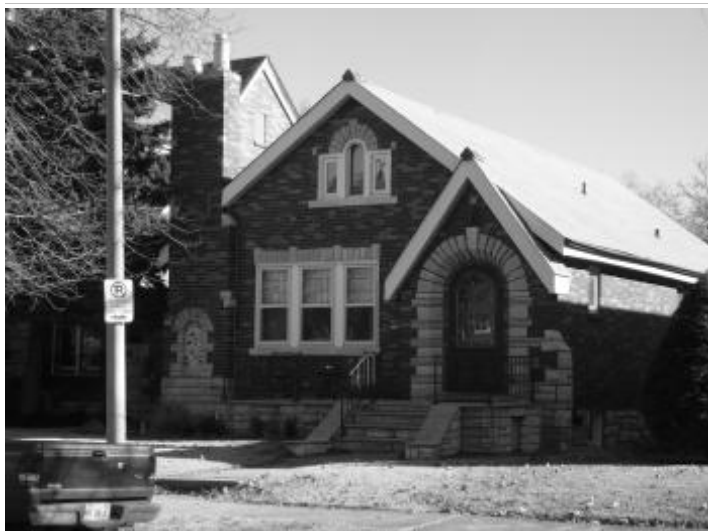
Replacement windows at Palladian arrangement in gable end.

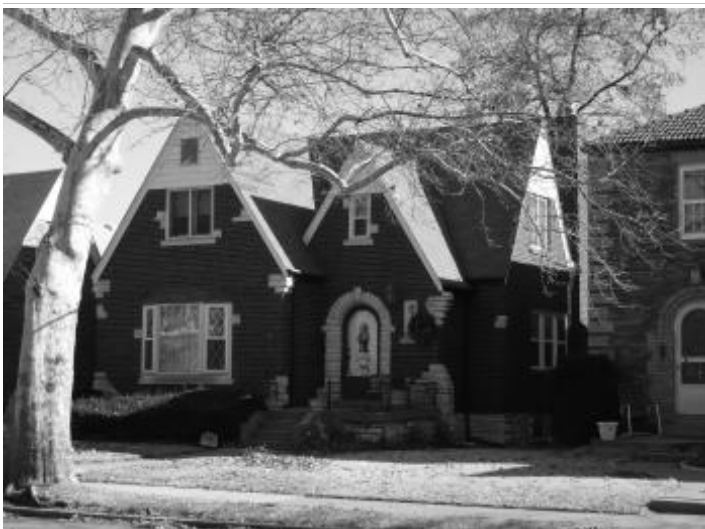
Oriel window, left, likely added in existing frame (windows are modern at least)

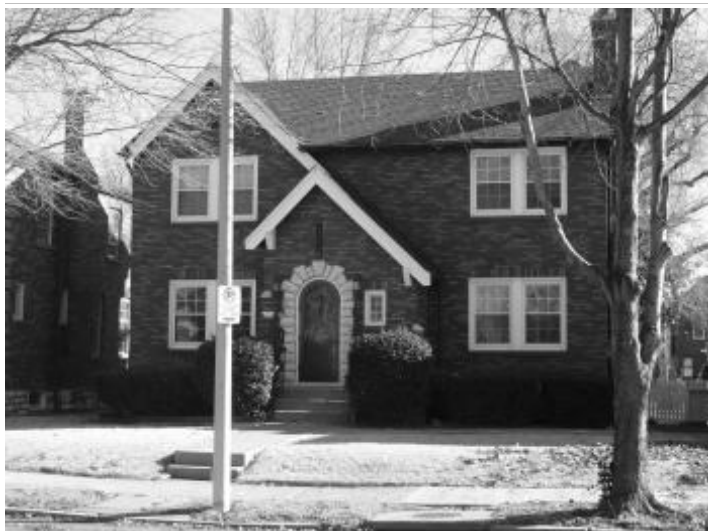
replacement windows.

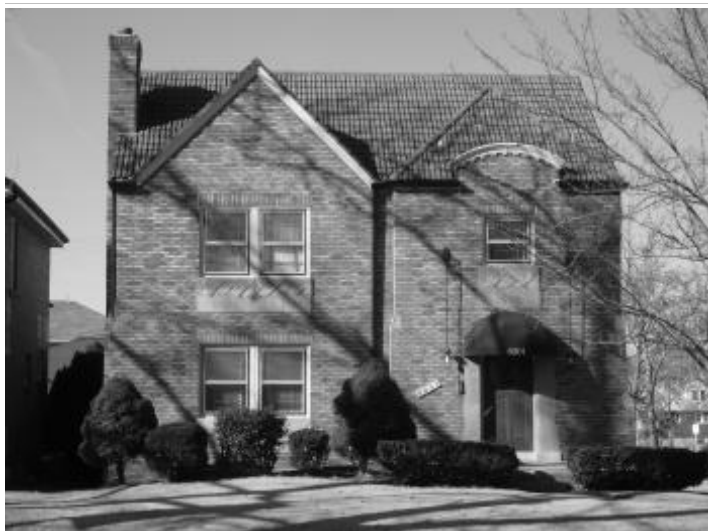
Fabric awning at front door.

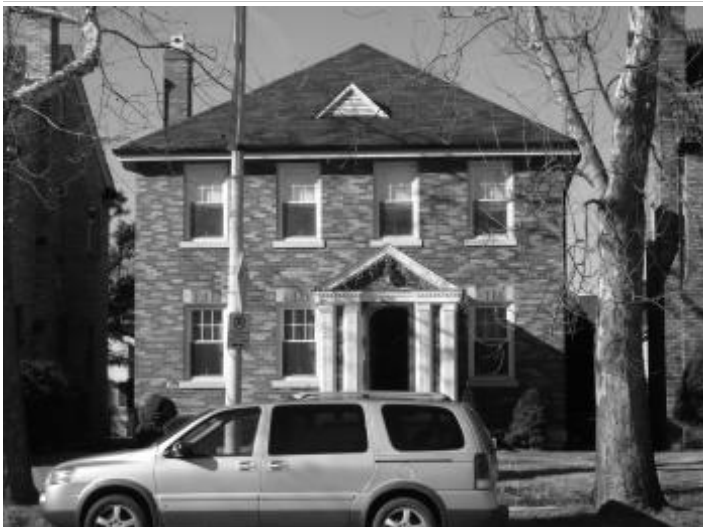
Windows are replaced with vinyl.

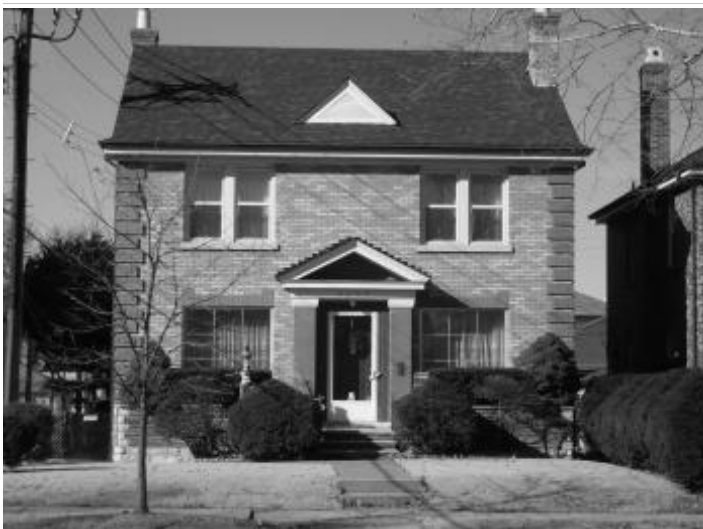
Replacement picture windows at first story.

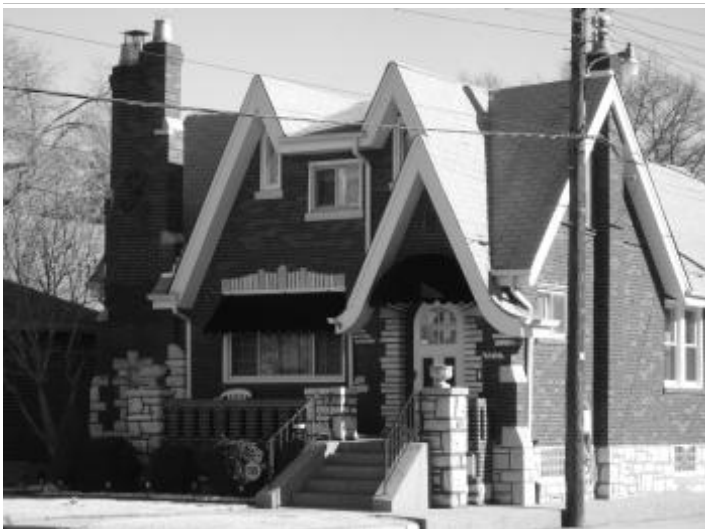
First story windows replaced.

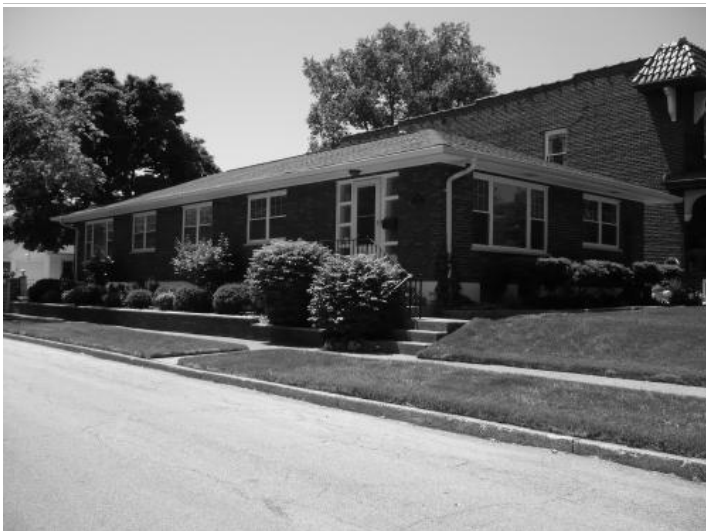
Replacement windows. Replacement door on side porch.

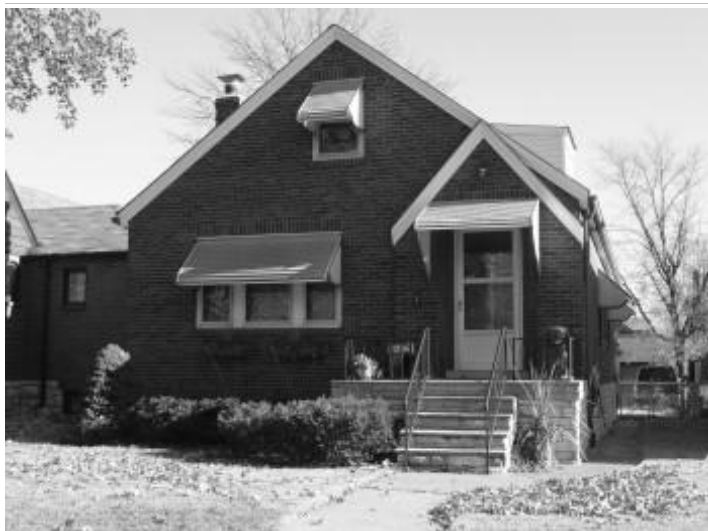
This simple house has a colorful velvet-textured variegated brick exterior. The front door is original. Two shed dormers at the right elevation appear to be added. At the façade the foundation is covered with brick; at the side elevations it is covered with imitation stone veneer.

Three fiberglass awnings added at façade.

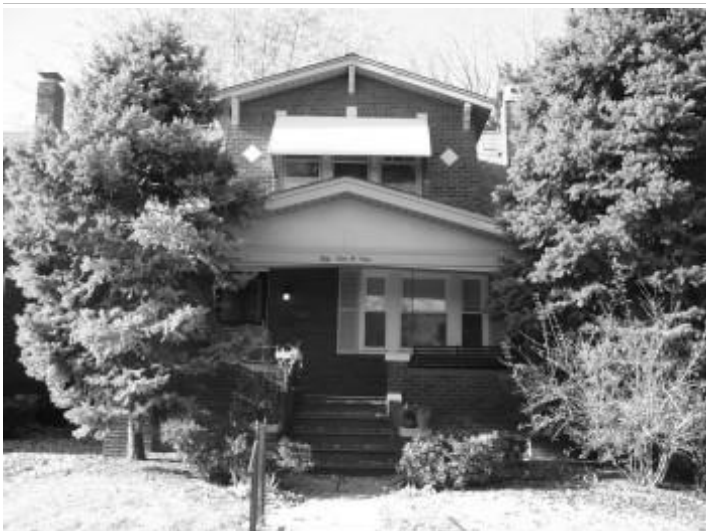
At the first story the door and windows are modern replacements. Faux shutters are added at the first story. Metal awning added at dormer.

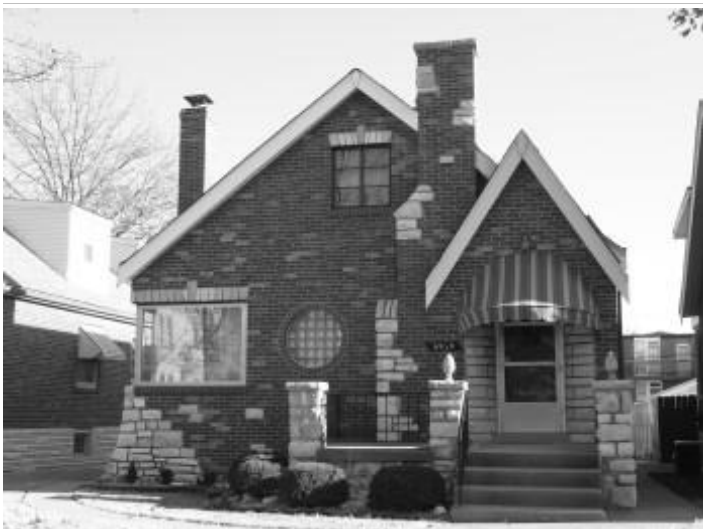
Fabric awning at front door.

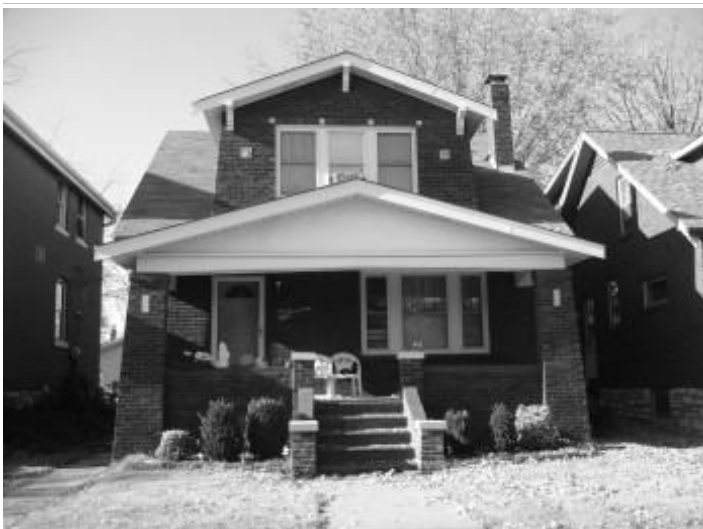
At the first story the door is a modern replacement. Dormer windows are also modern replacements.

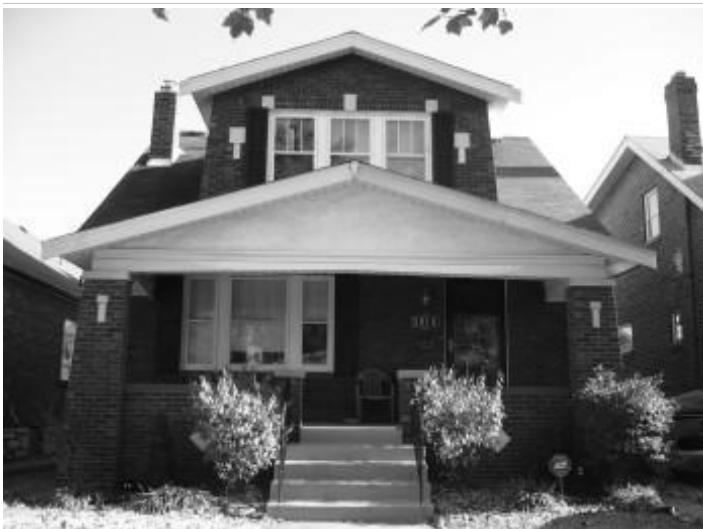
Modern horizontal siding at sides of dormer. Shutters added at windows.

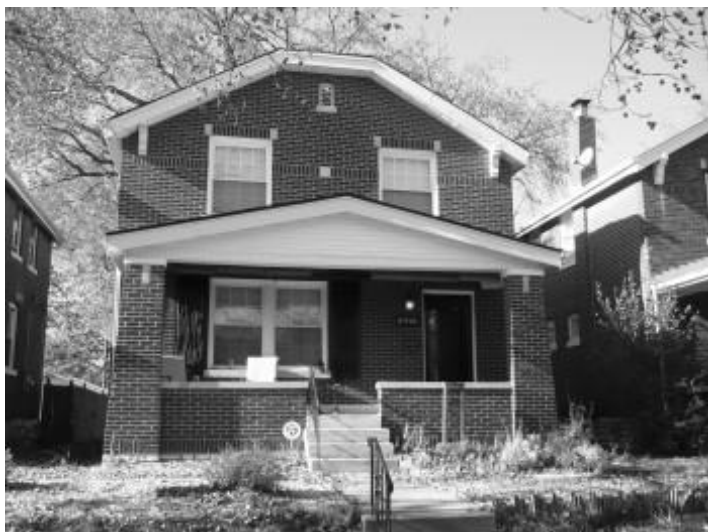
The front door, right, and all façade windows are modern replacements. Faux shutters added at the first story. The porch's gable end is covered with modern horizontal siding.

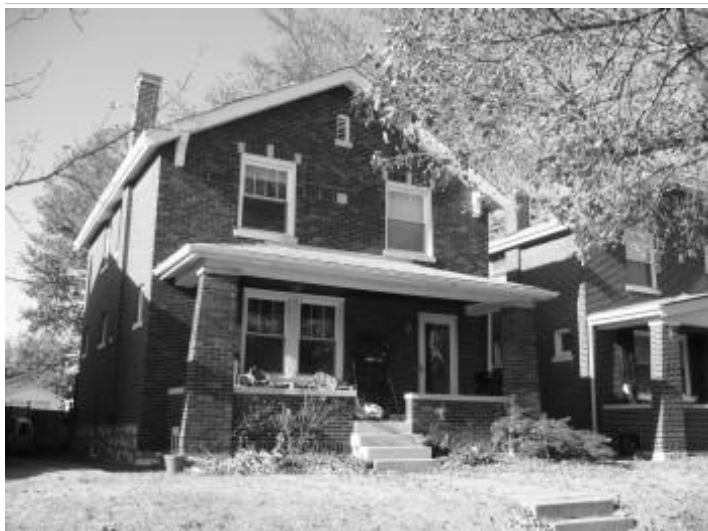
Front door, right, is a replacement.

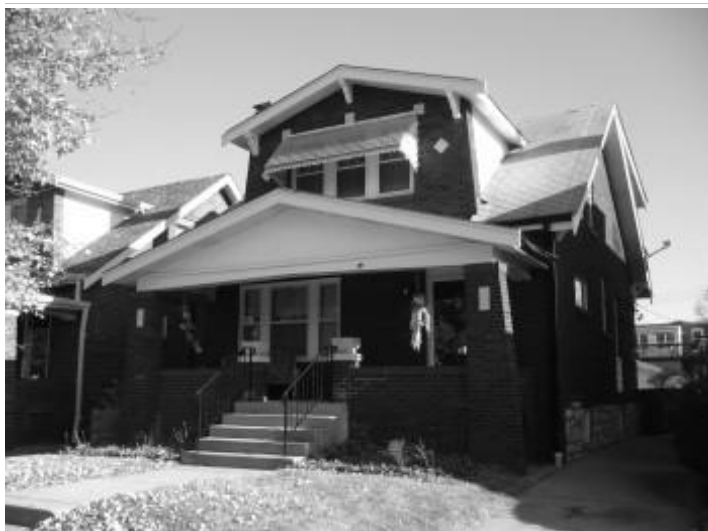
A metal awning shades the dormer windows. Modern horizontal siding is at the sides of the dormer.

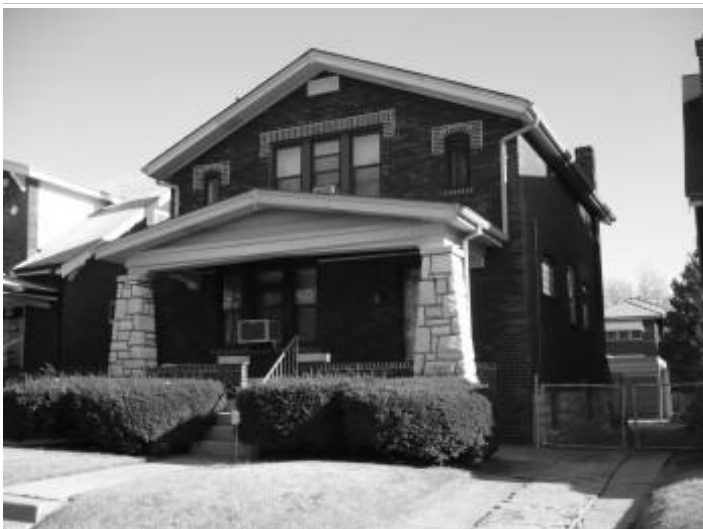
Modern horizontal siding in porch's gable end; modern door and windows at façade.

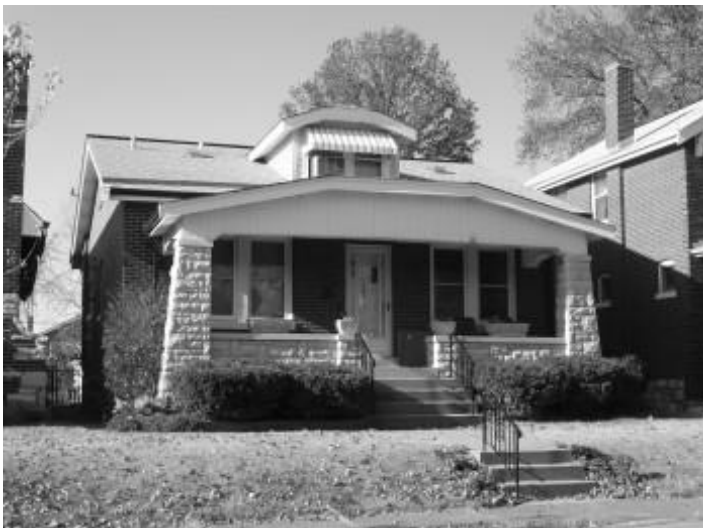
The jerkinhead dormer is covered with modern horizontal siding, as is the porch's gable end. Windows and doors are contemporary replacements.

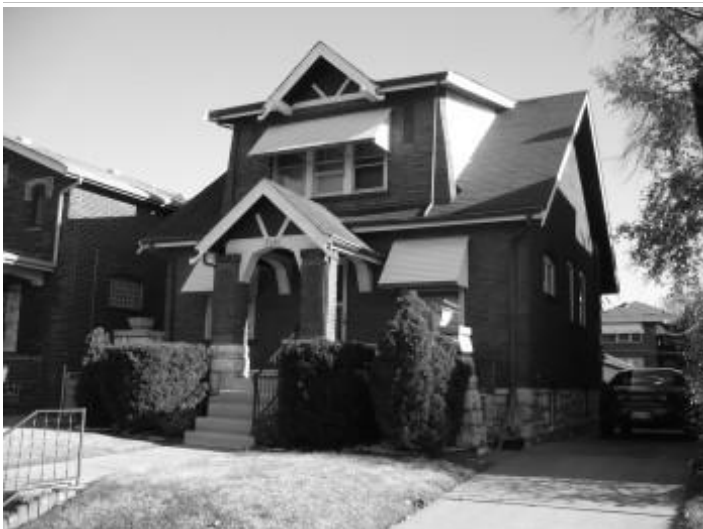
Metal awnings at all façade windows.

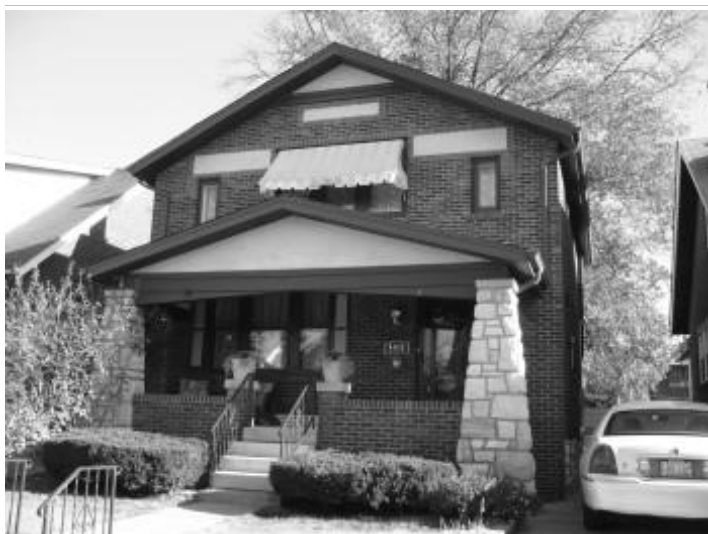
Porch's gable end appears to have a plywood base. Fabric awning shades second story windows.

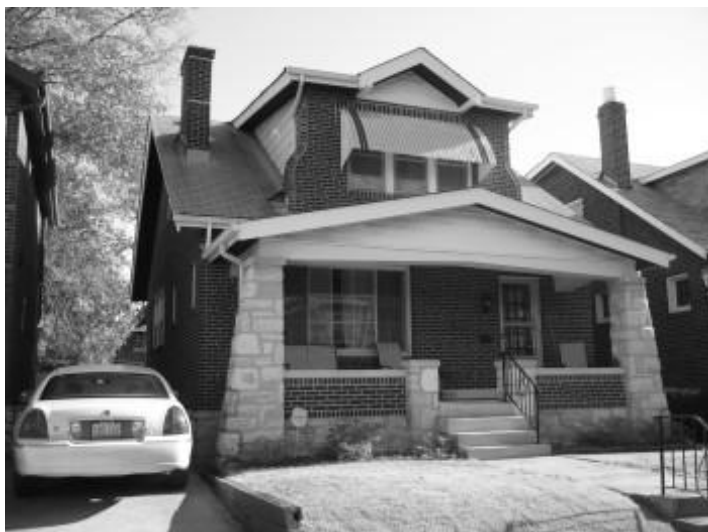
First story windows are replacements; metal awning at second story. Both the porch and dormer gables are filled with modern imitation shingle siding.

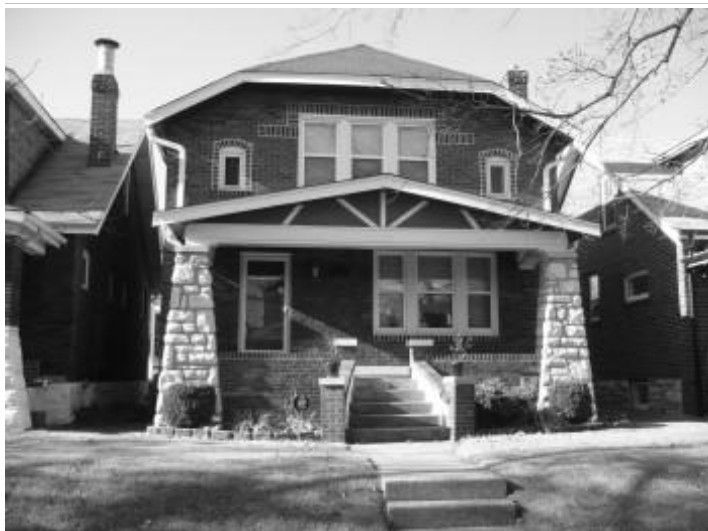
Windows are replaced except for two small arched openings at the second story which appear to retain art glass. replacement door.

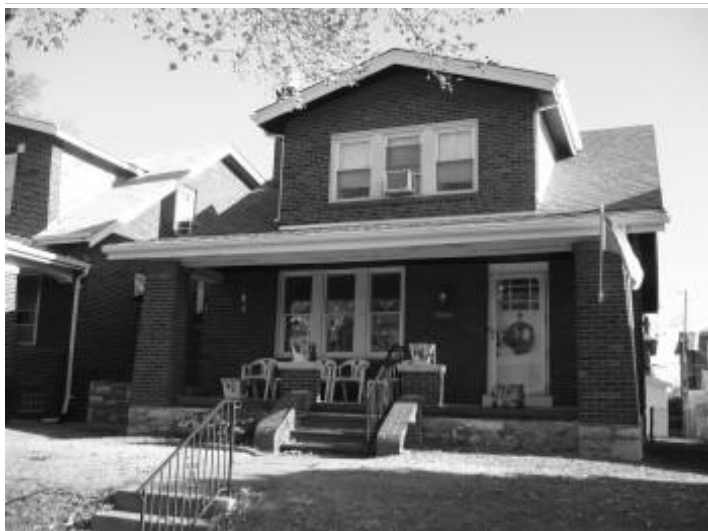
Façade windows are modern replacements.

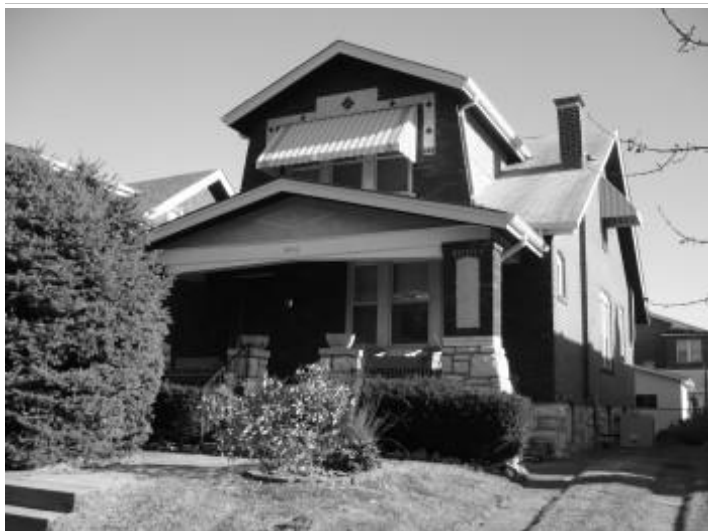
Windows are replacements, and a metal awning is at the dormer.

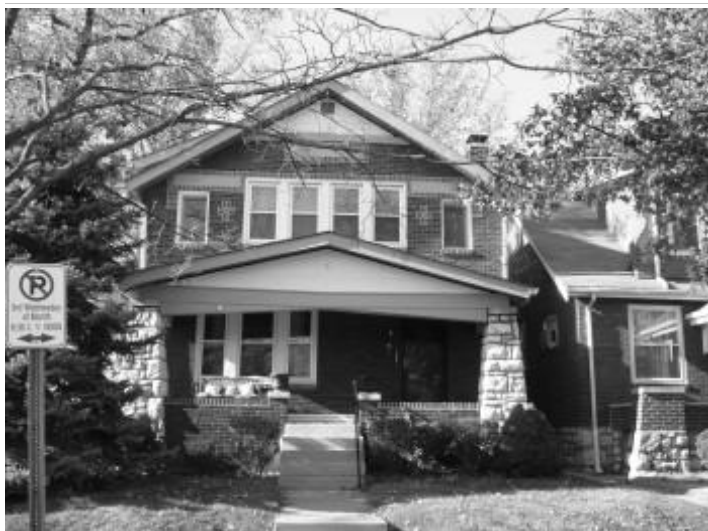
Full window replacement except for upper left art glass window. Stucco panels at second story now parged over; both gable ends shingled.

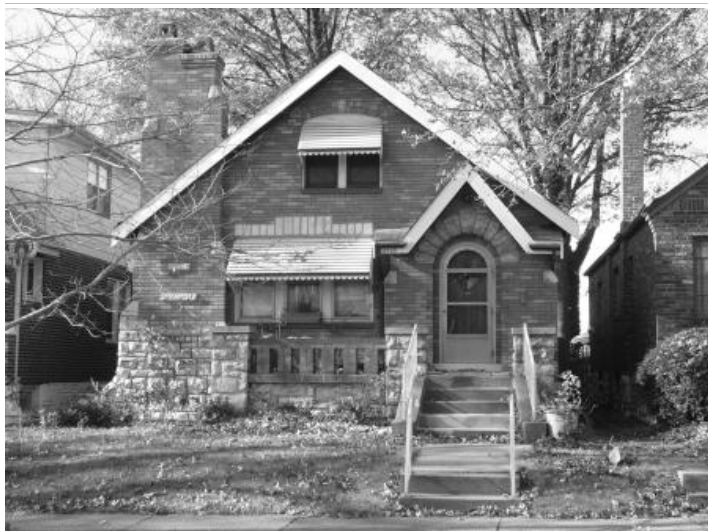
Awnings added. Lost turnbuckle at prominent front chimney.

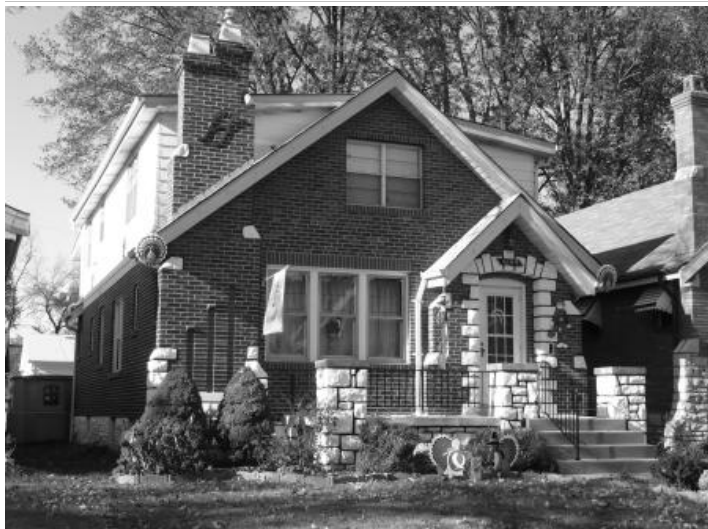
\$5000 fire repair, 1963, may have included the shed dormers at both side elevations and the window pair in gable end.. Limestone is painted.

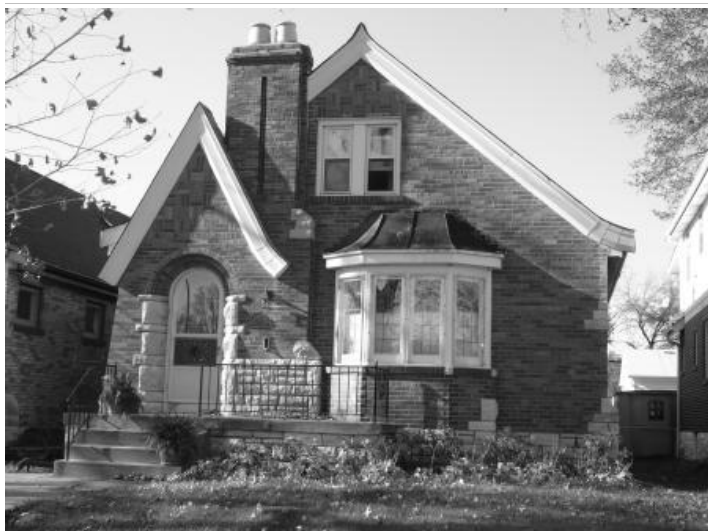
Gable end windows are replacements

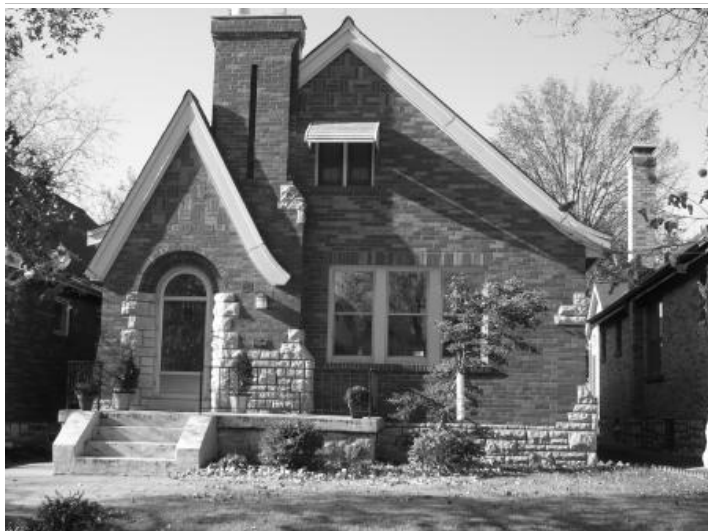
Fiberglass awning at gable end.

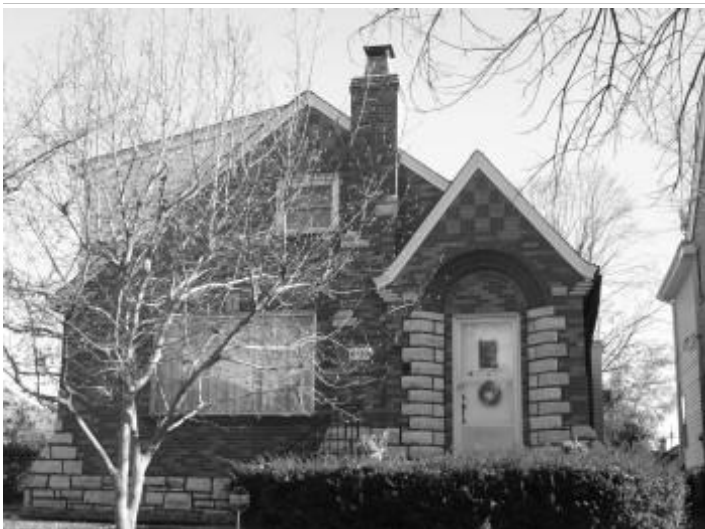
Large dormer added 1962, rear shed addition. Replacement picture window, left.

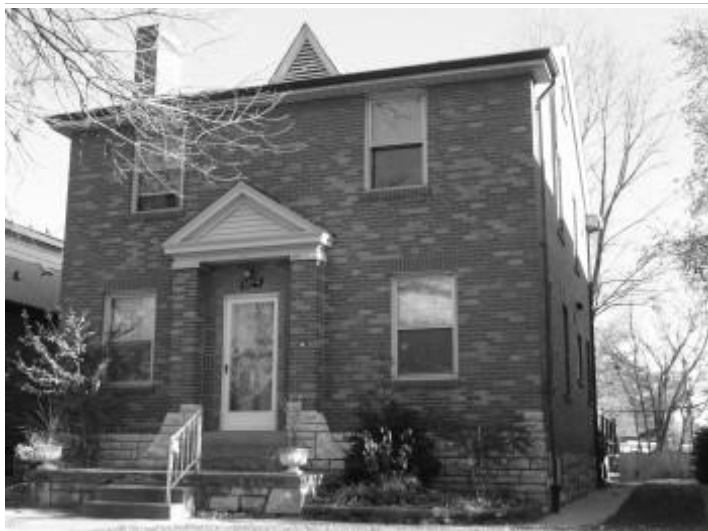
Siding on pediment.

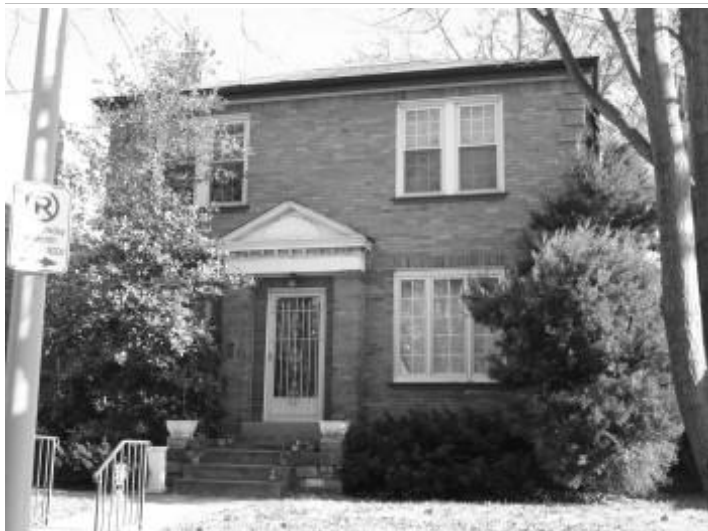
Replacement windows

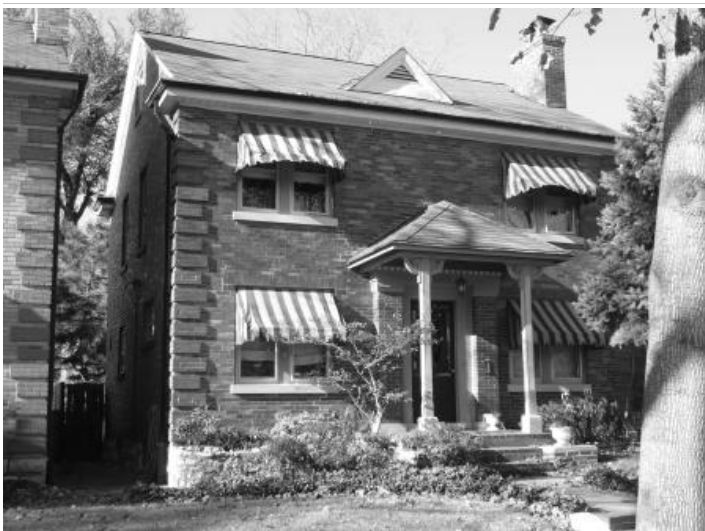
Added hipped pseudo-Victorian porch structure on original stoop. Fabric awnings.

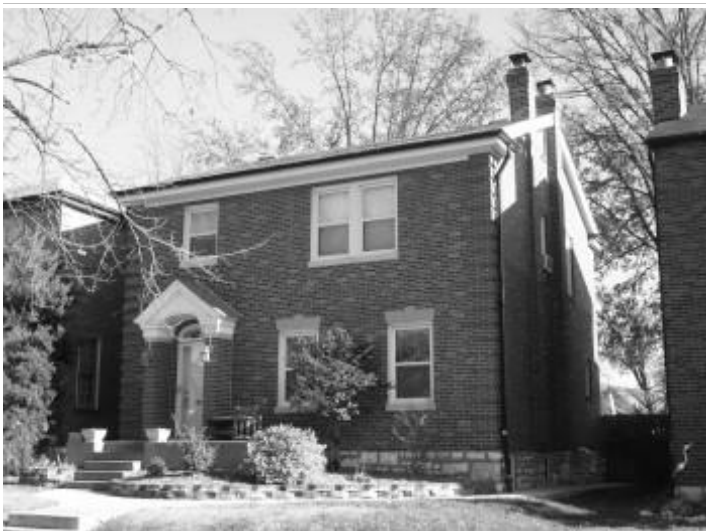
Replacement windows

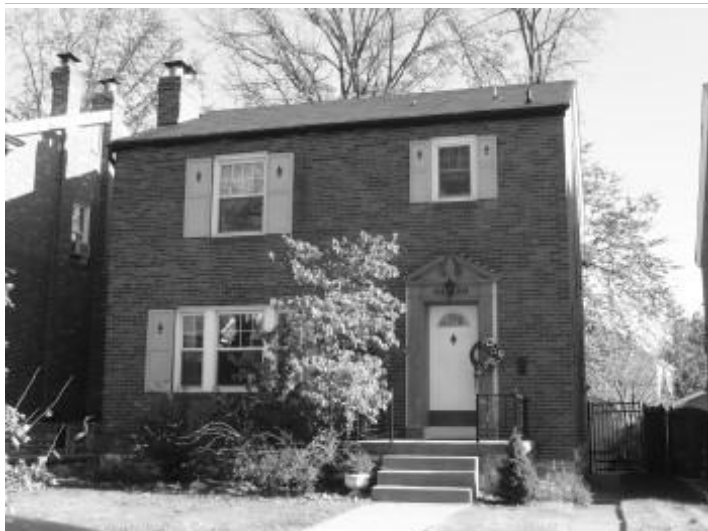
Door and windows replaced.

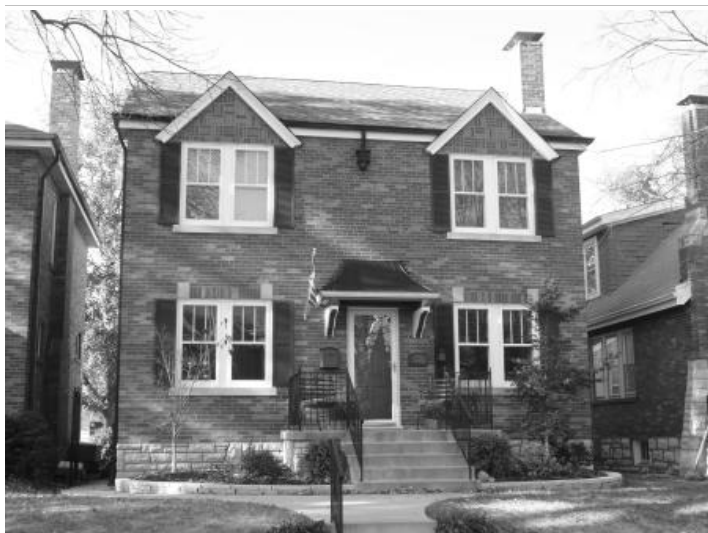
Shutters added.

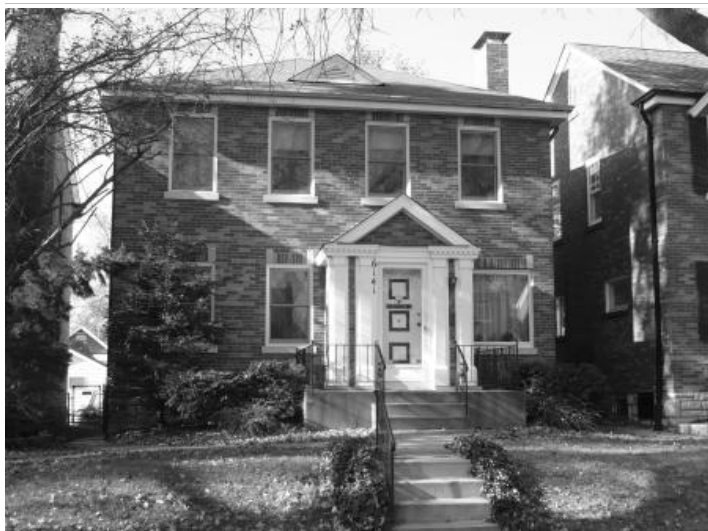
1950s-style front door. Lower right window looks like a fixed pane replacmee3nt.

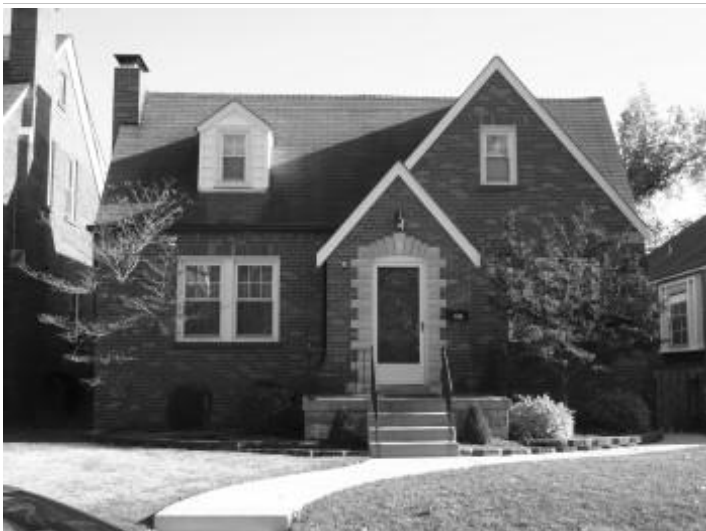
Replacement windows and door.

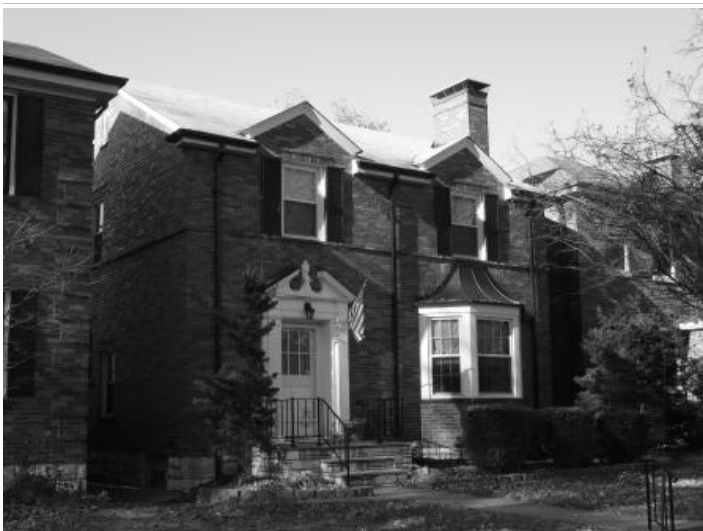
All façade windows are modern replacements

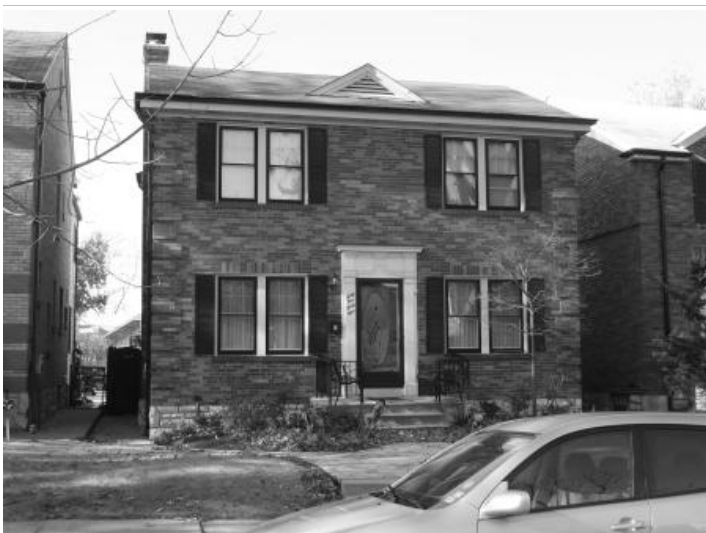
Replacement front door. Added shutters at windows.

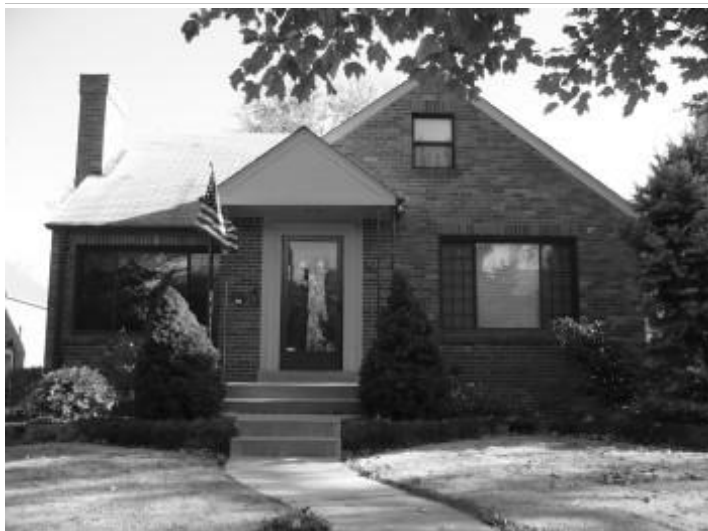
Replacement windows

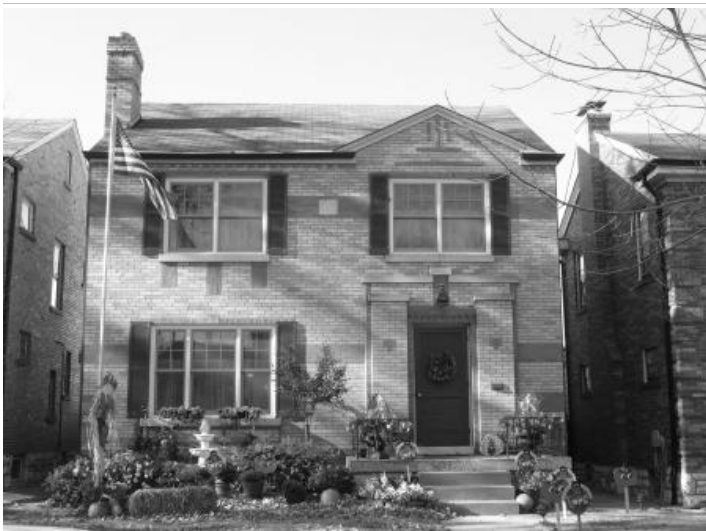
Added shutters at façade windows.

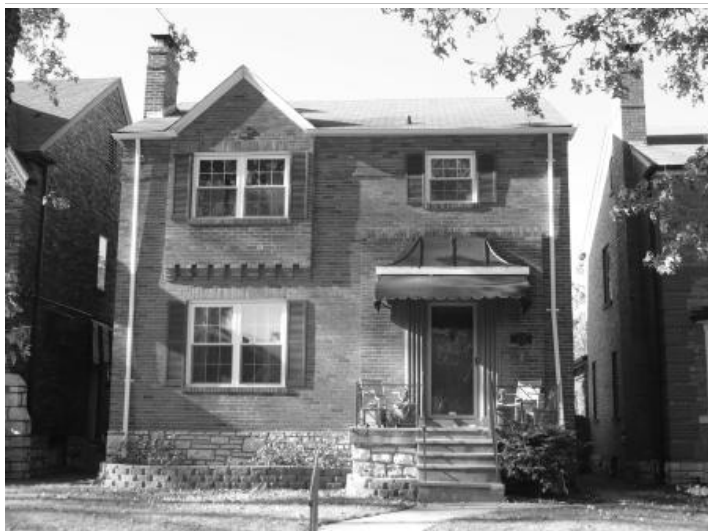
Replacement windows

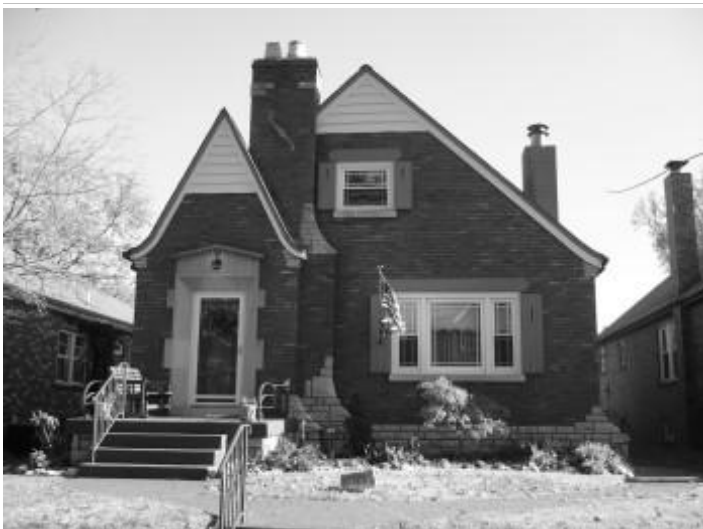
Window replacement.

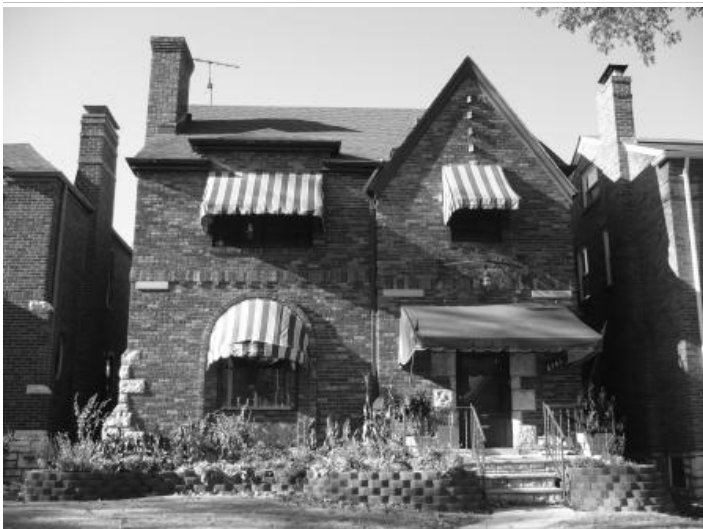
fabric awnings

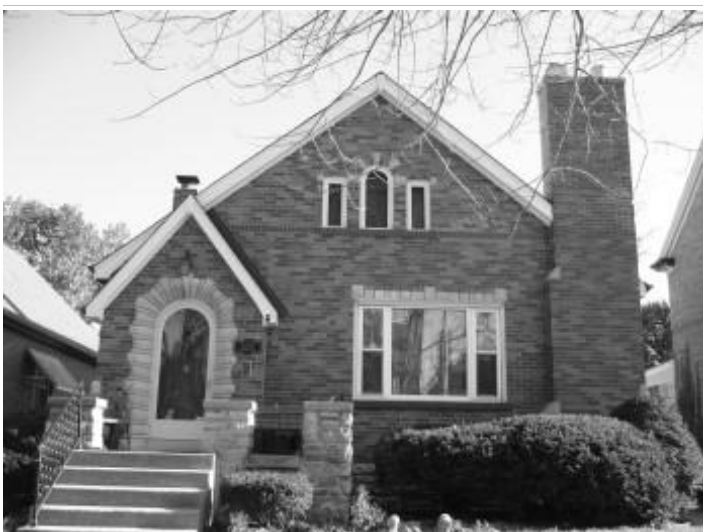
This variegated brick front-gabled house has a secondary projecting gabled bay, left, featuring a round arched door opening defined by a quoined limestone surround with a curved reveal. A broad front chimney projects at the right side of the façade. The round-arched original front door is intact. Original attic windows are set in a Palladian arrangement. Brick is the only material visible at the side elevations' foundation.

Replacement window, right.

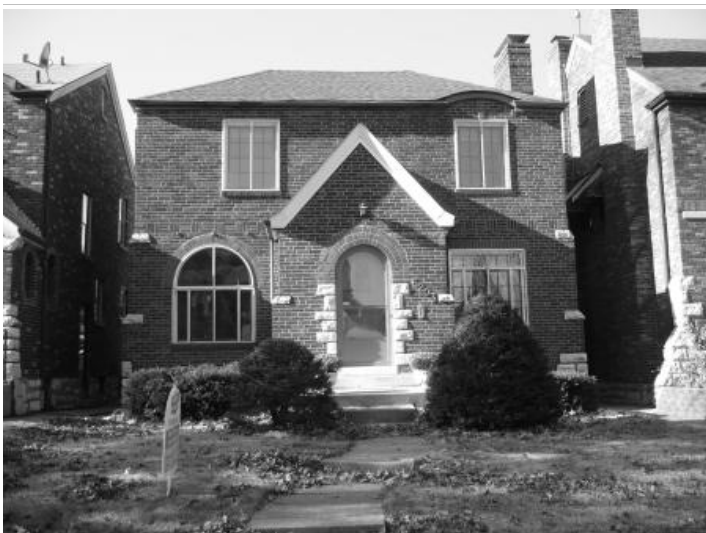
This house has a variegated brick exterior. A single story projecting bay, center, houses the original round-arched door. Windows are original. Slight segmental arch wall dormer, right. Red brick archivolt / lintels at first story. Limestone trim at door, edges of façade.

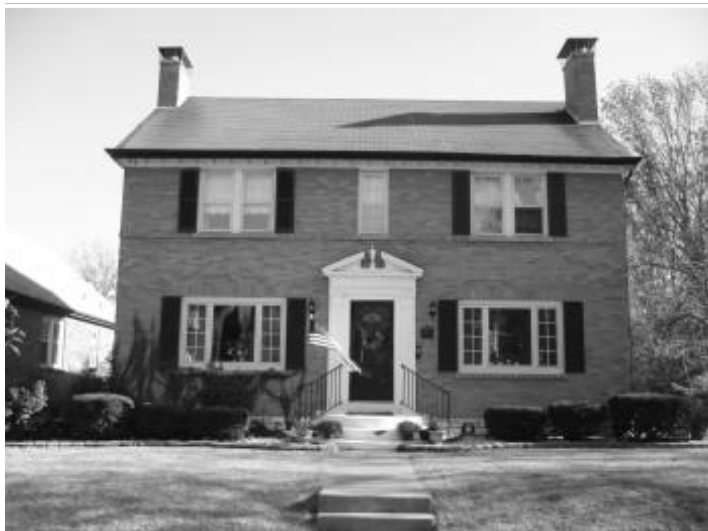
This symmetrical side gabled blonde brick house has a centered front door in a wood architrave with a broken pediment. Modillioned eaves. Original windows at the second story.

Replacement windows at the first story.

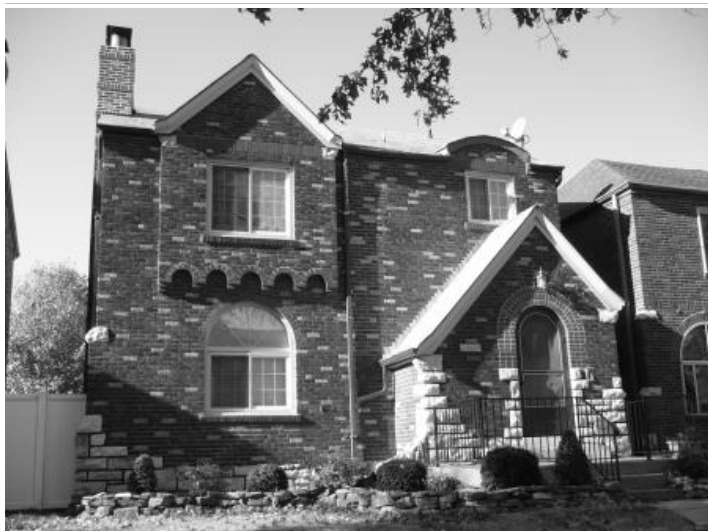
Replacement windows.

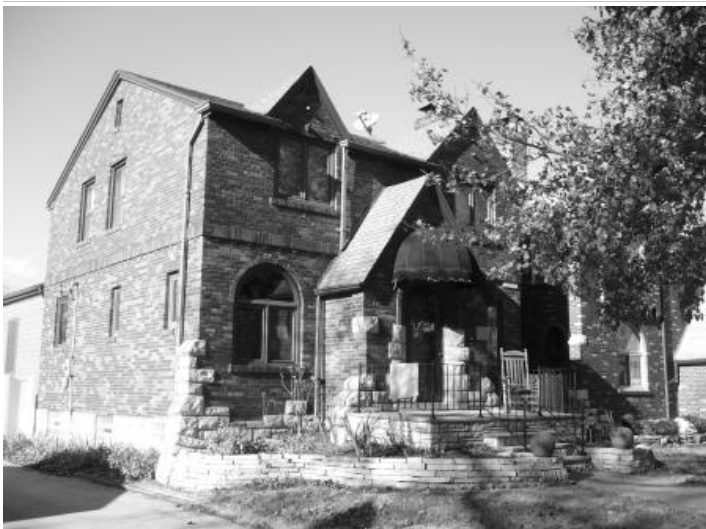
Replacement windows. Fabric awning at front door.

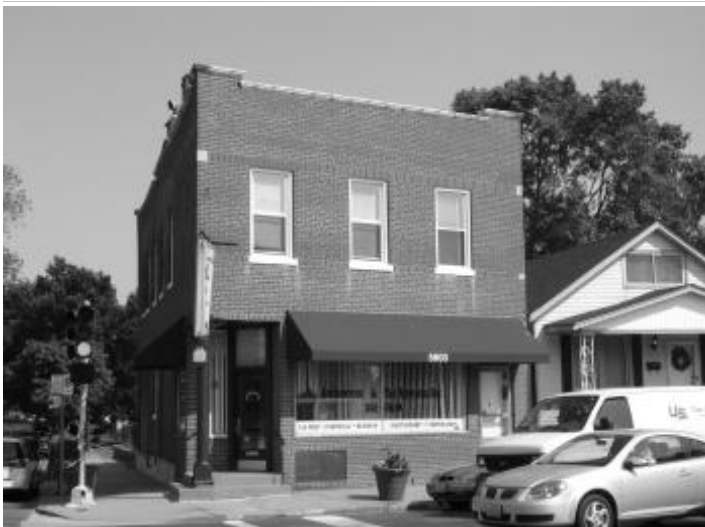
Vinyl replacement windows; Aluminum windows and brick infill at storefront. Replacement door to upstairs unit.

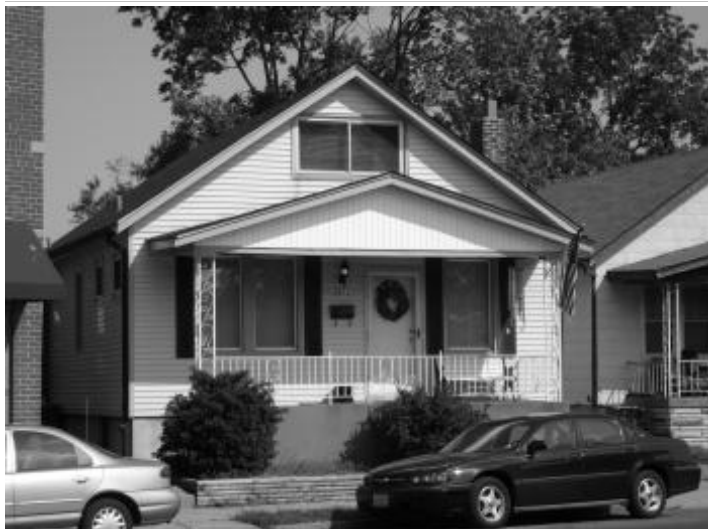
Replacement front door and fixed pane windows. Metal porch supports on concrete base.

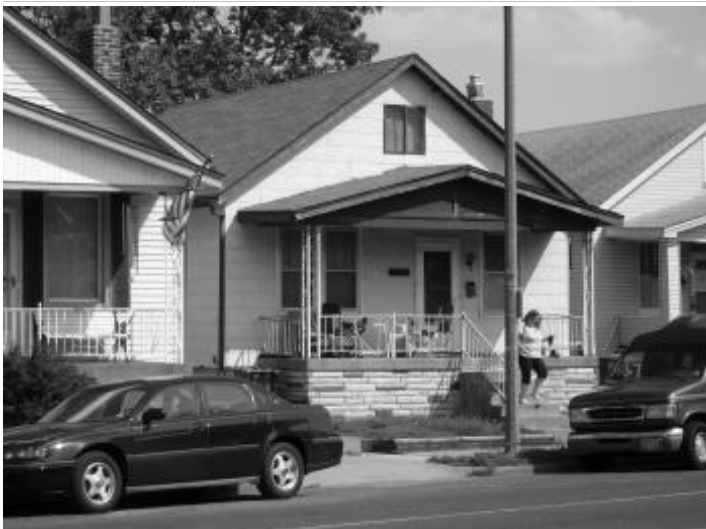
This front gabled house has a gabled front porch which is almost the full width of the façade. Original 3/1 windows at façade. Wood trim at porch and eaves is unusually intact, though not in good condition.

Metal porch supports. Imitation stone veneer covers porch foundation. Replacement front door.

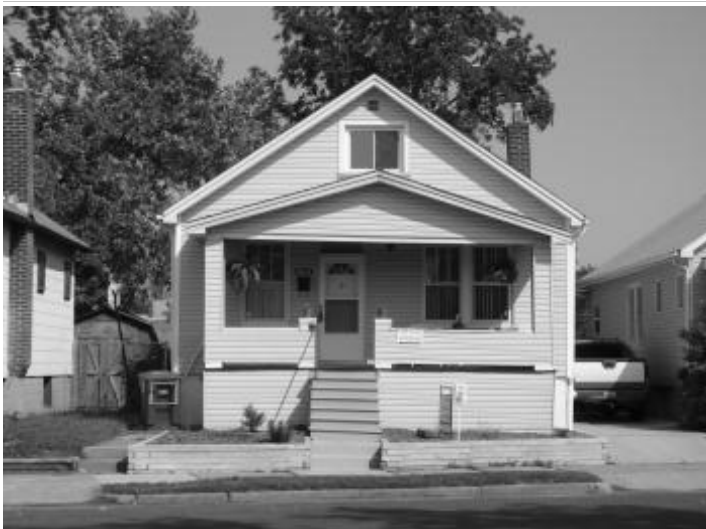
Replacement front door. Sided porch. Vinyl window in gable end.

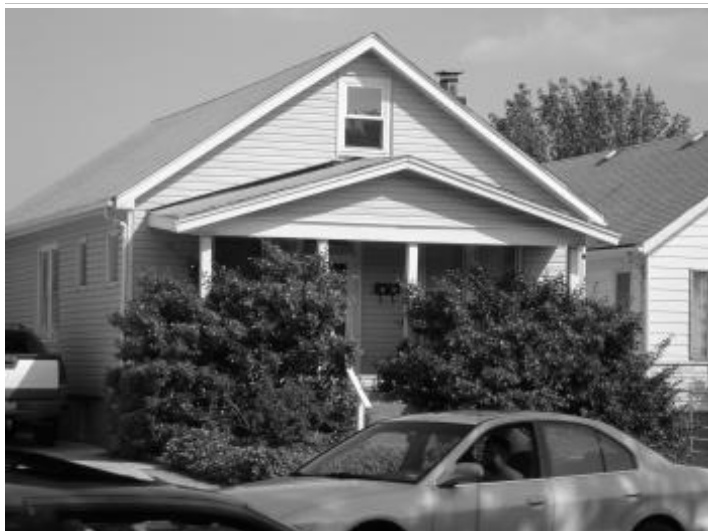
Replacement front door. Vinyl window in gable end.

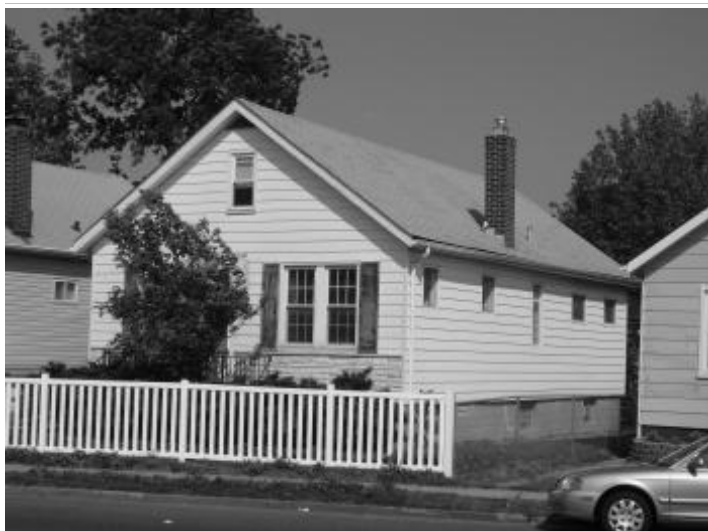
Windows and doors have been replaced. Imitation stone veneer base at façade.

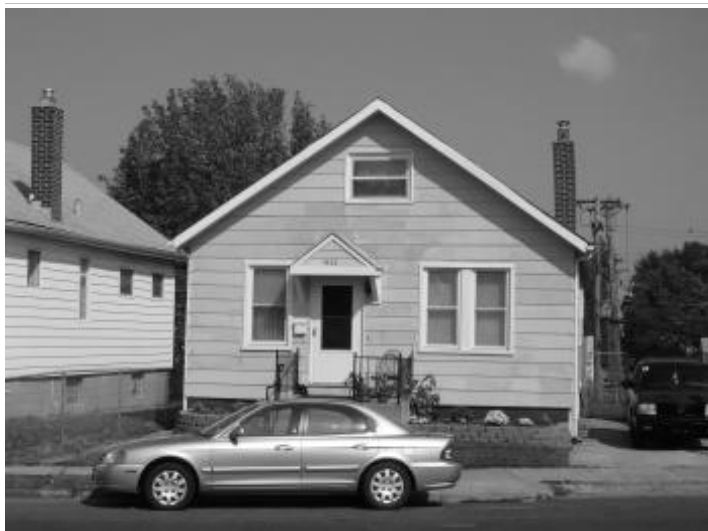
Windows and doors have been replaced.

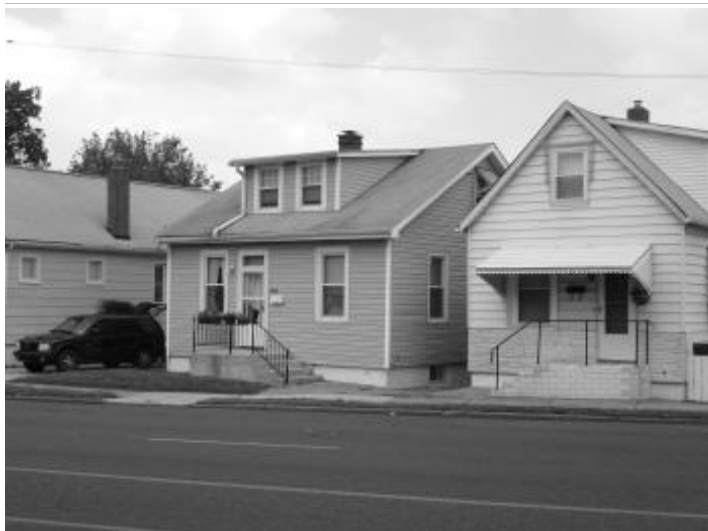
Windows have been replaced.
