City of St. Louis Cultural Resources Office

Holly Hills Neighborhood Survey

Lynn Josse and NiNi Harris
3/1/2010

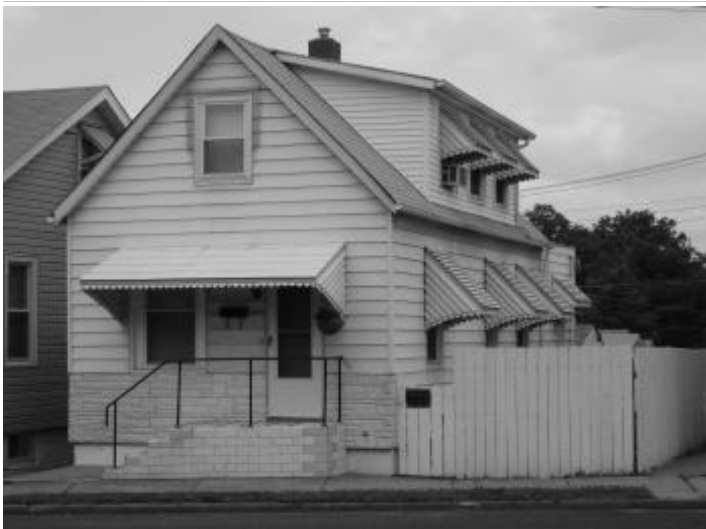
porch and metal awning; imitation stone veneer at base of façade. New windows and door.

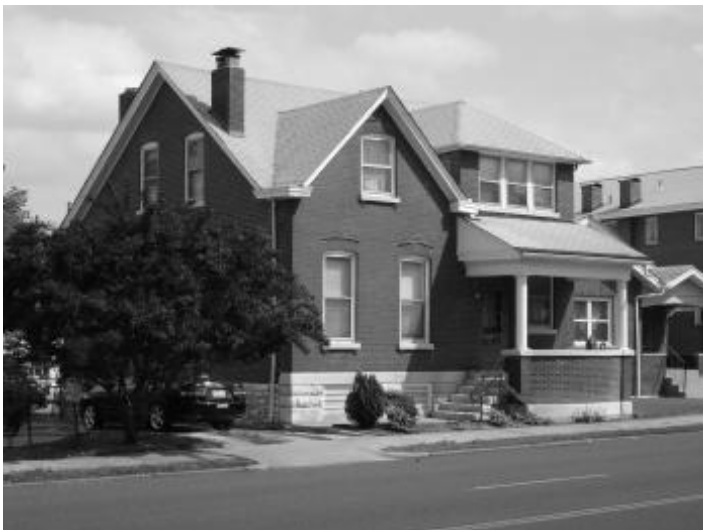
Porch columns are modern replacements.

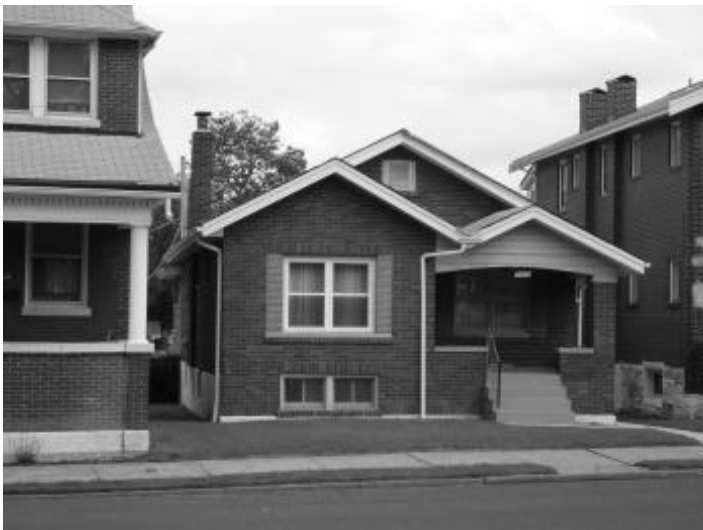
This front-gabled bungaloid house has a lower projecting gabled bay, left, and a gabled brick porch, right. The surface is variegated tan and brown brick. Modern-era detailing has been added, perhaps as part of the 1956 alterations. The front door is at the right side of the left bay; it has glass block sidelights. The window set at the right bay is a set of four wood sash hinged windows with red Roman bricks or tiles to either side. The front windows at the left bay are a replacement pair with a similar Roman brick treatment to either side.

\$1,200 addition to brick dwelling to owner Alles, 1956

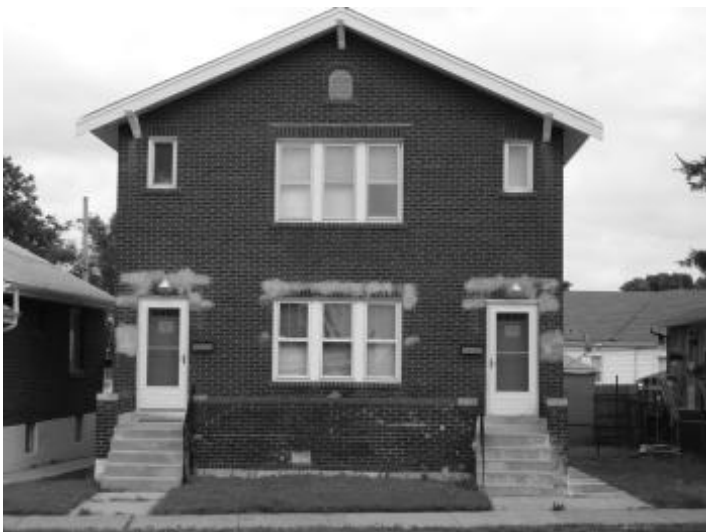
White paint around the doors and first story windows and at the front porch alters the appearance of the building. Replacement front doors. Three brackets at front eaves are soffitted.

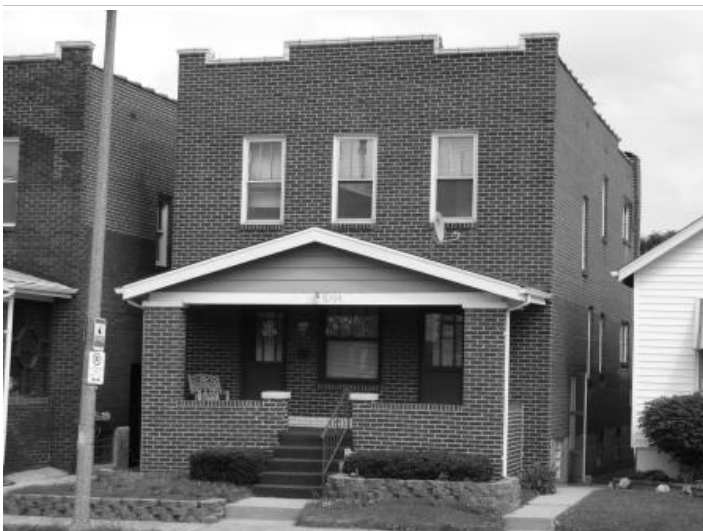
applied gable removed at upper façade.

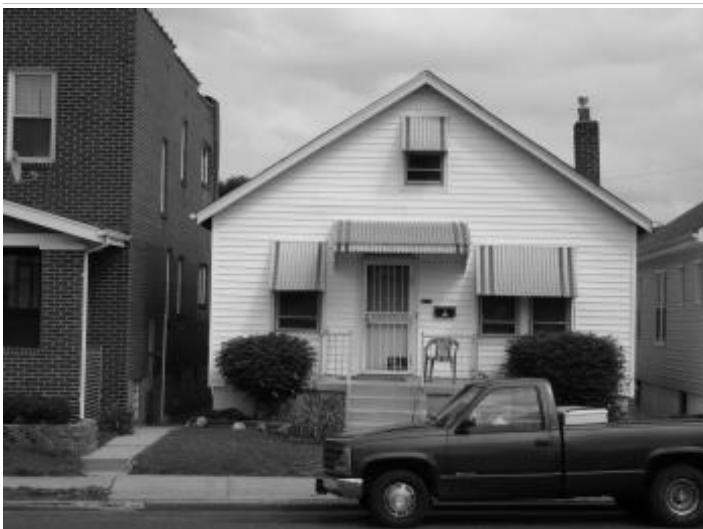
This front gabled house was constructed after the original bldg. on this site was moved to 4167 Wilmington (around the corner). The front door is just left of center; a single window is to its left and a pair at the right. The 3/1 attic window is original. This house replaces the one around the corner on Wilmington moved in 1925.

Replacement door; metal awnings at all façade openings; concrete porch.

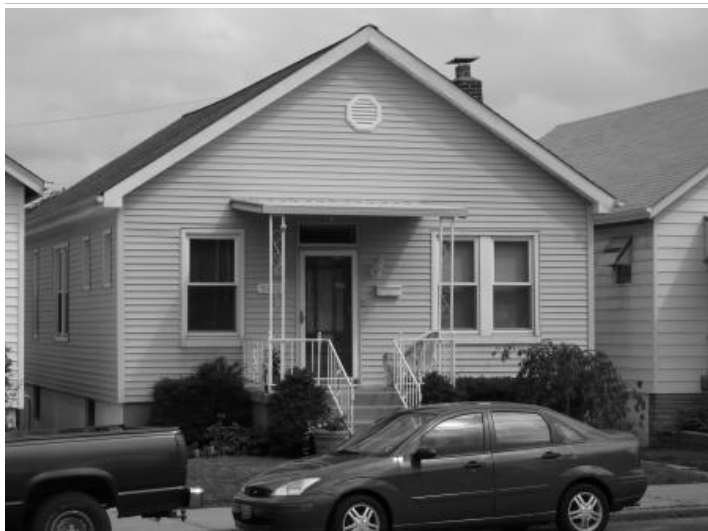
Replacement windows. Awning-style roof at concrete porch.

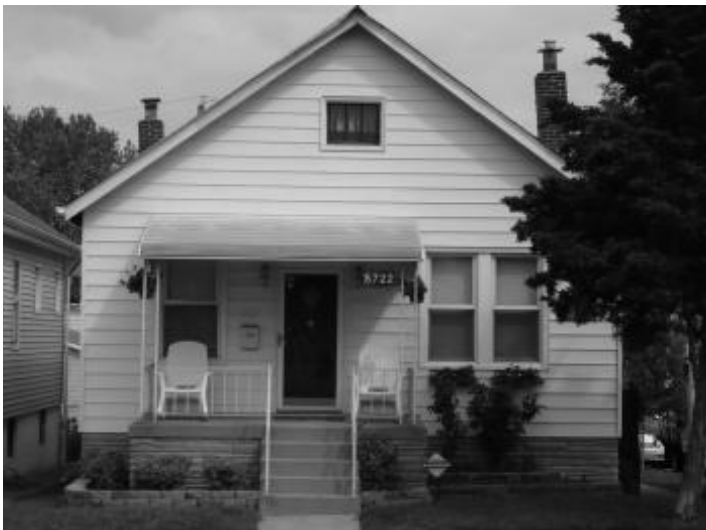
Replacement front door; metal awning roof held up by trellis-style metal supports at concrete porch, left. Awning covers door and left window. Imitation stone veneer covers foundation at façade. Replacement façade windows.

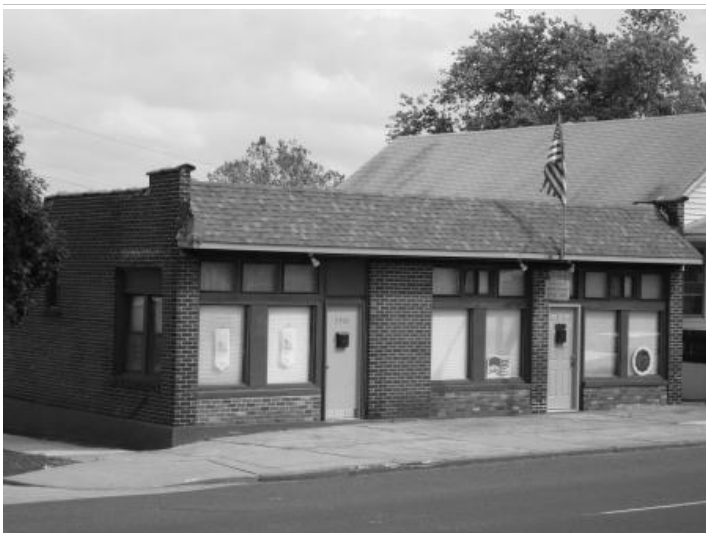
The three storefronts are reconfigured - brick bulkheads are below wood-framed storefront windows and transom lights.

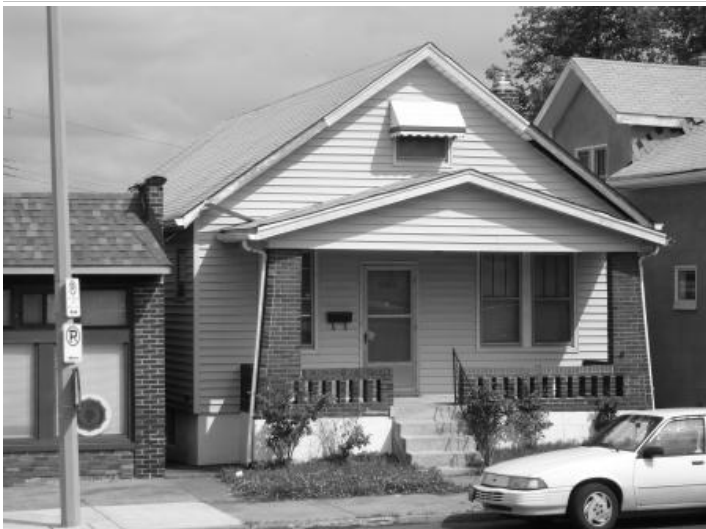
Brick porch may be historic addition (on concrete block base); new door; vinyl siding covers original window trim.

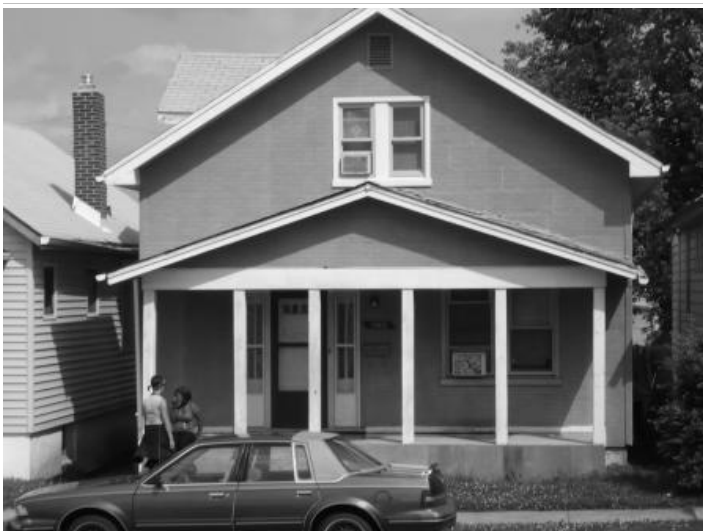
Door and windows at façade are replacements

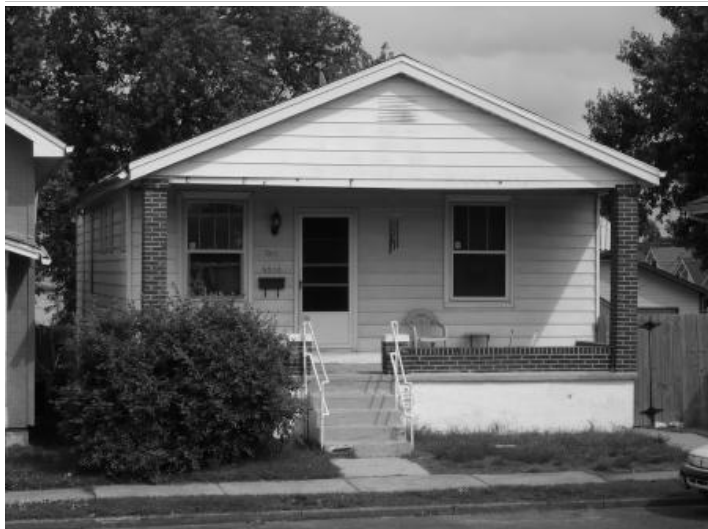
Replacement front door. Original trim not visible.

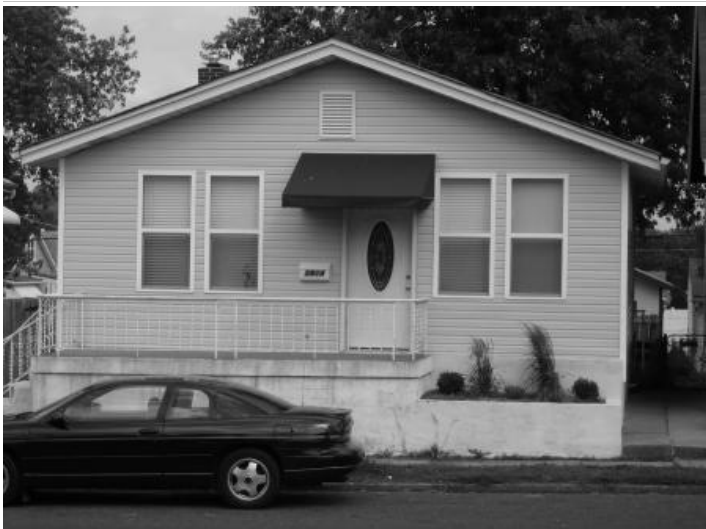
Replacement door and windows at façade. No historic materials visible.

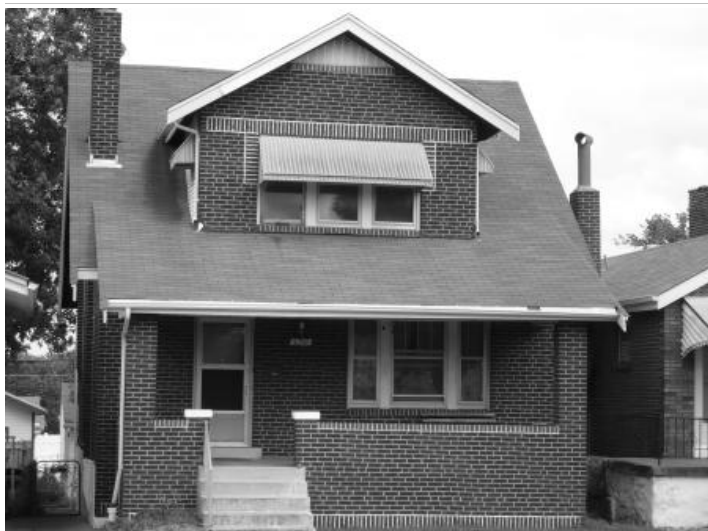
Limestone foundation visible under concrete parging. Side gabled roof; shed roofed brick porch. The façade windows are original. (3/1s except for center window of first story, which is a 4/1).

Replacement front door.

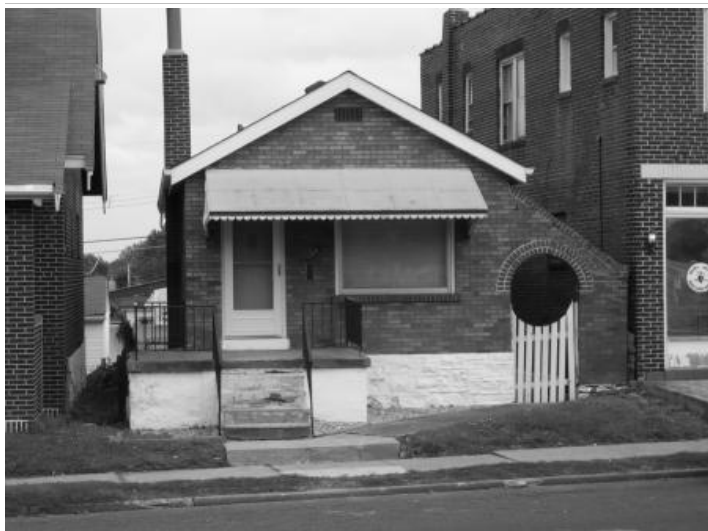
awning appears to be a 1950s addition.

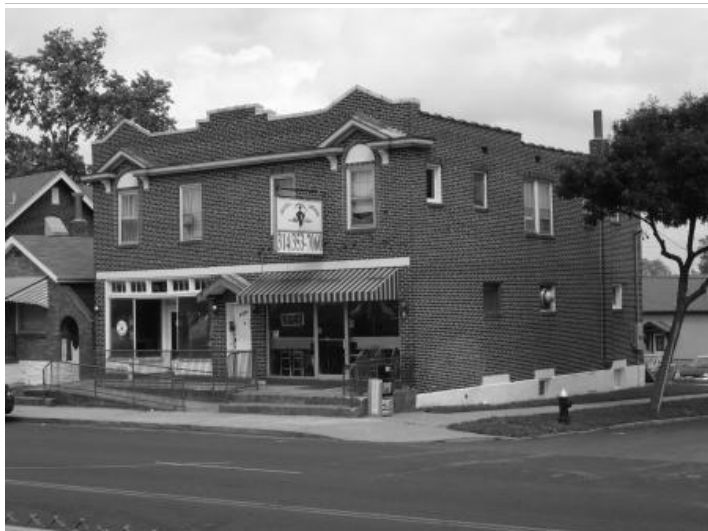
The left storefront is intact, with a recessed entrance between storefront windows, all under a transom course. Gable hood over center door. Metal cornice; terra cotta coping. 3/1 windows at second story facing Morgan Ford. Stone foundation partially visible under parging.

Right storefront replaced with more contemporary storefront windows; center door to upstairs units is modern replacement.

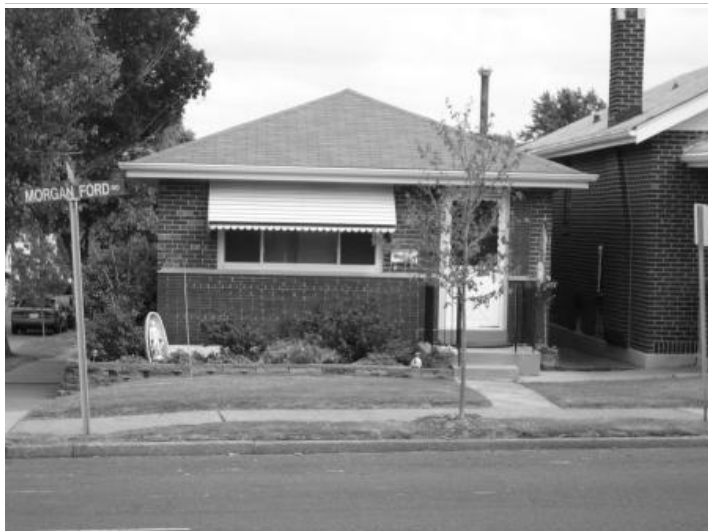
Replacement door and windows.

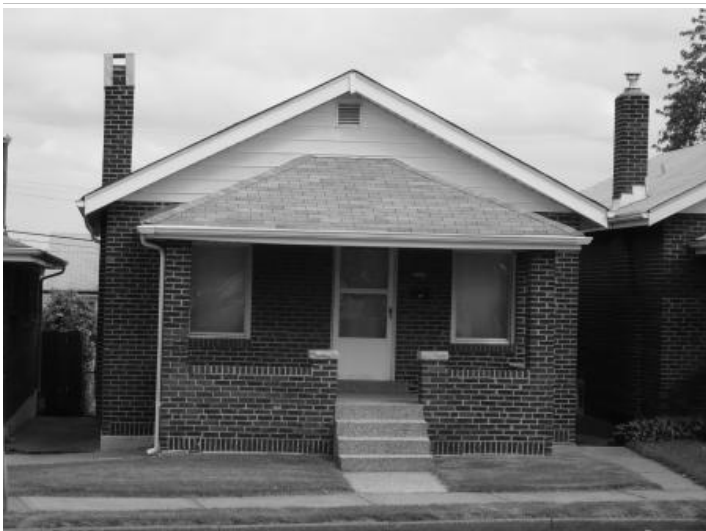
Door is a replacement; façade windows replaced with fixed panes.

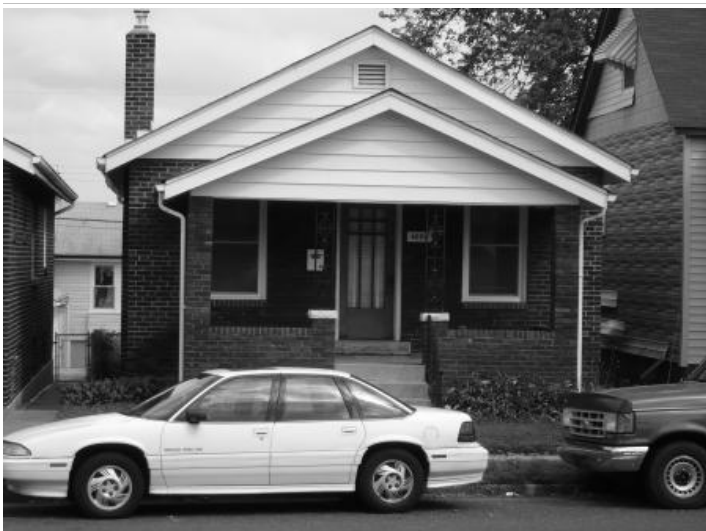
Two additional trellis-style metal supports at the porch support the gable roof.

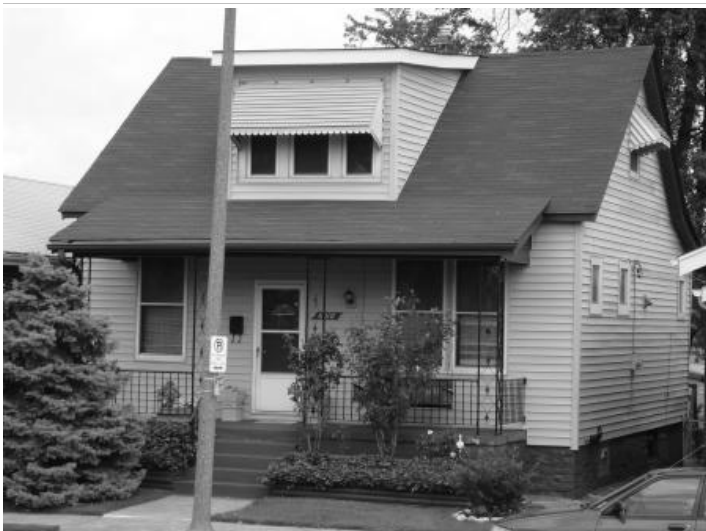
Replacement door. Stone foundation is lightly parged (or heavily painted). Original wood trim sided over.

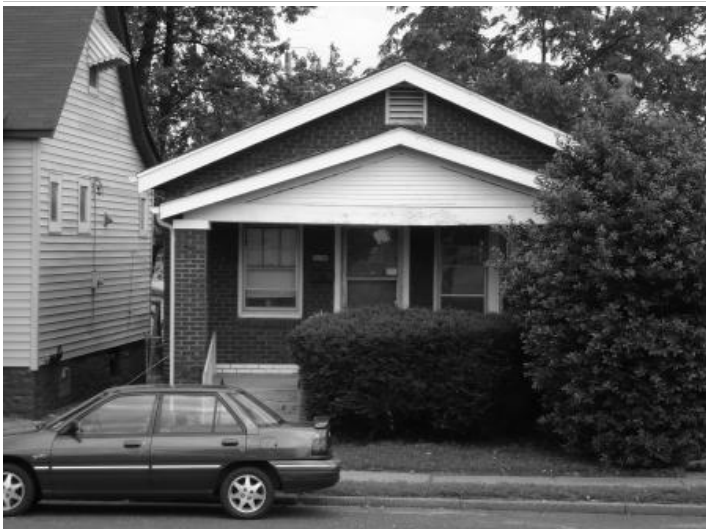
Replacement front door.

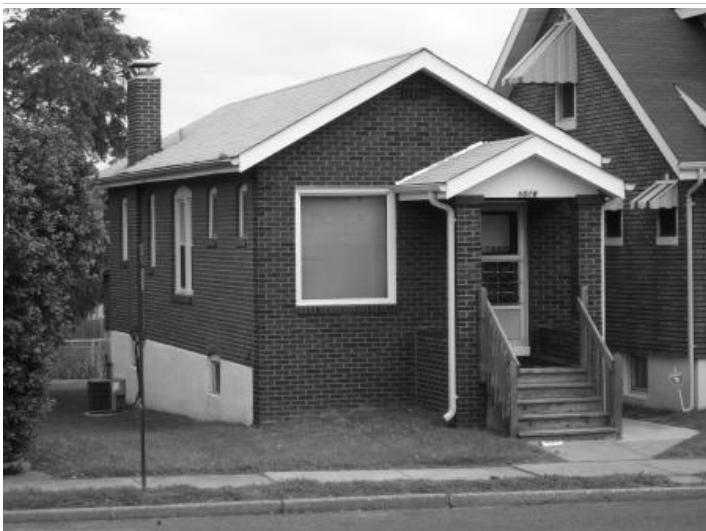
Front window, left, replaced fixed pane picture window.

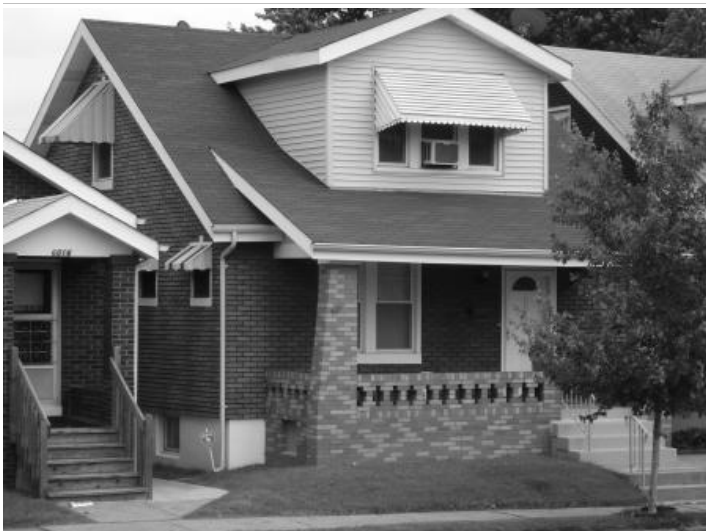
Replacement door and windows; vinyl siding and metal awning at dormer.

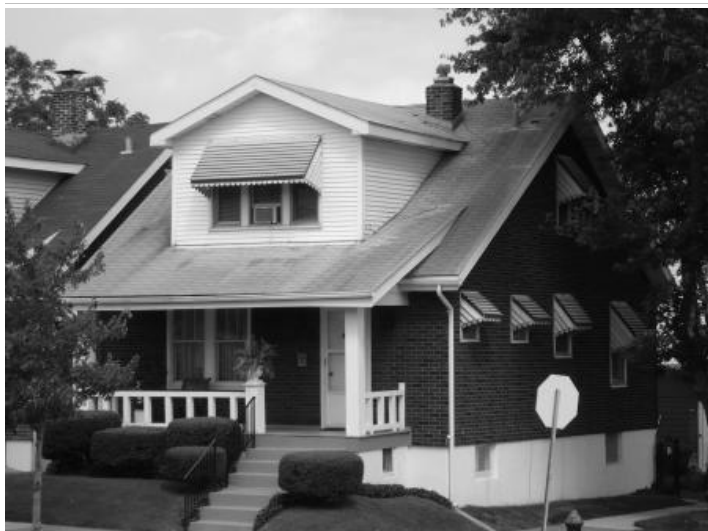
Replacement door; vinyl siding and metal awning at dormer (awning at all south-facing windows as well).

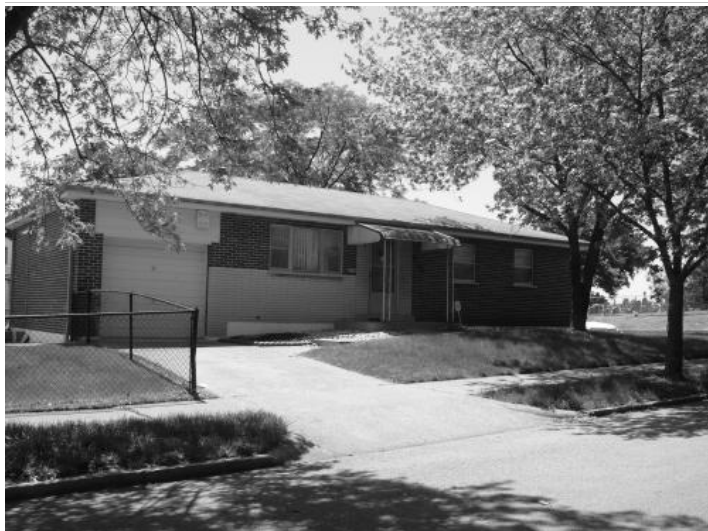
Replacement door.

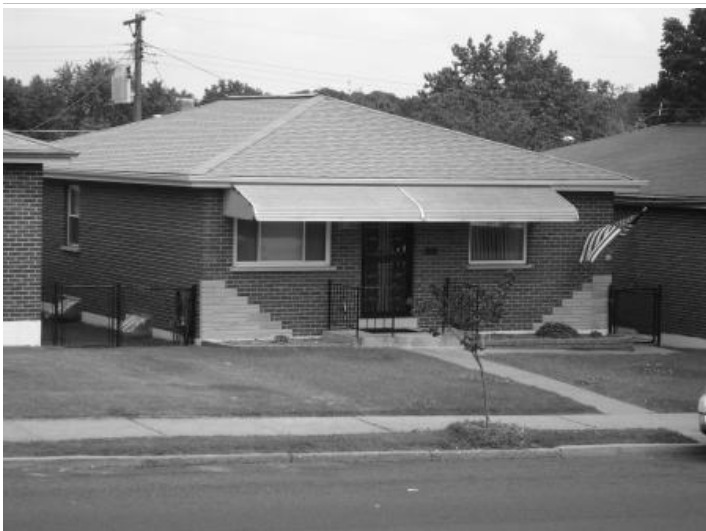
replacement door.

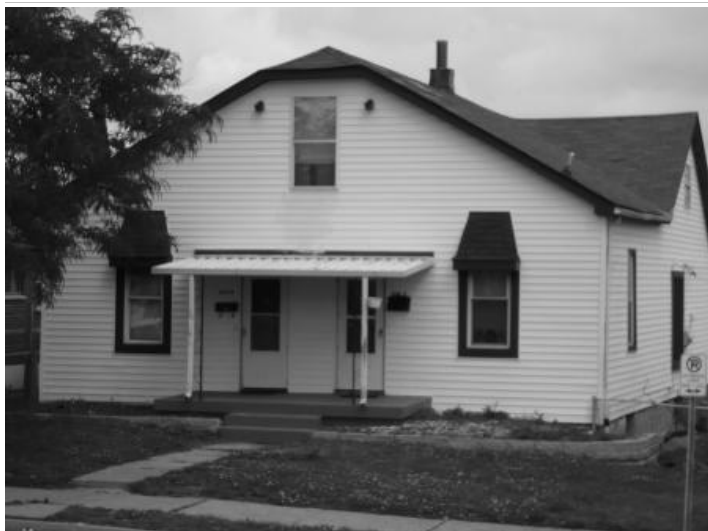
The front of this wide duplex is a hipped gable. No original features visible. The assessor's database gives the 1889 date, which is consistent with known buildings on the Lillienkamp farmstead.

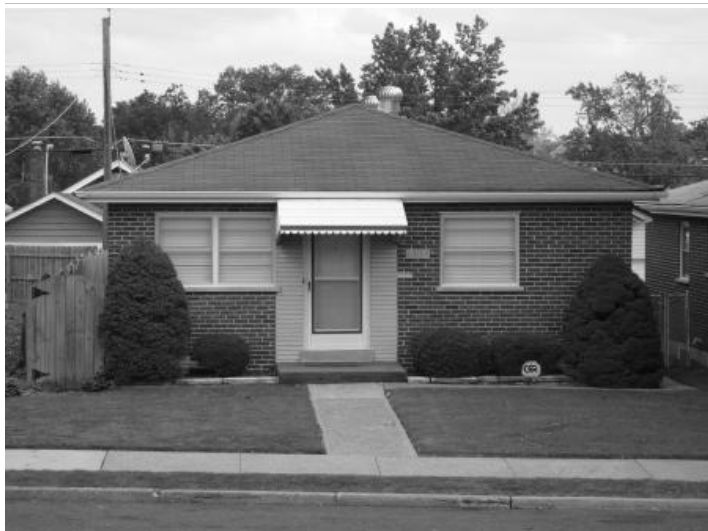
Replacement door.

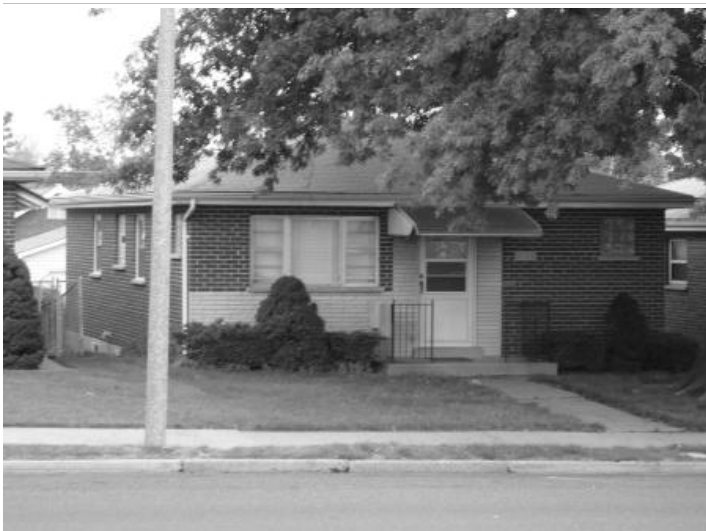
Replacement door.

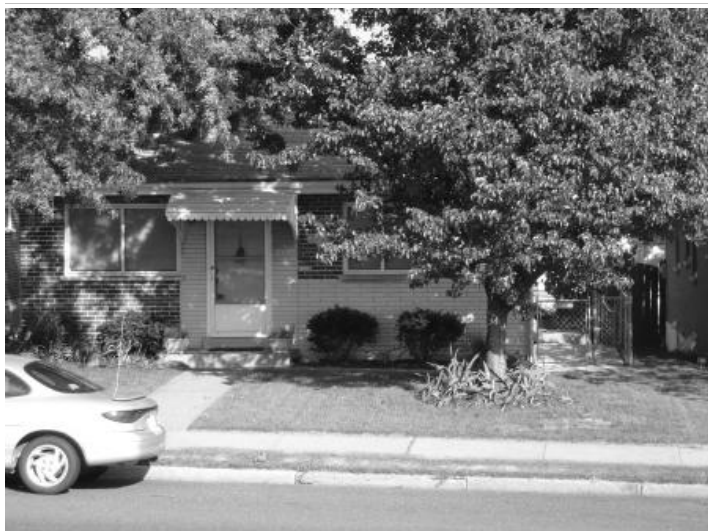
Replacement door and windows.

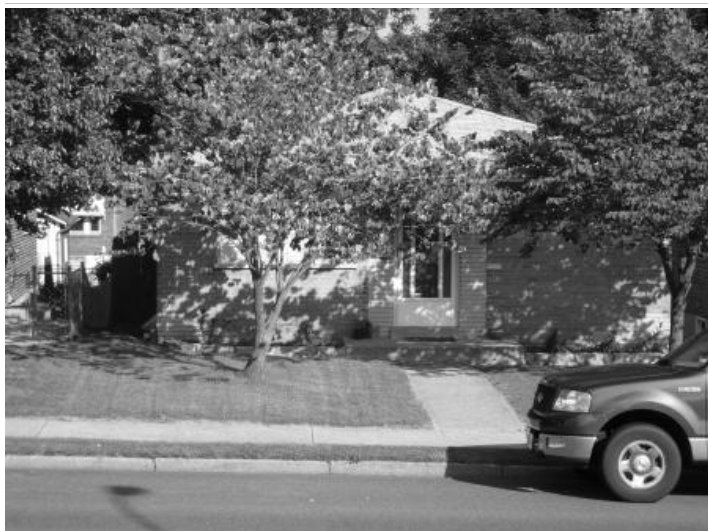
Replacement door.

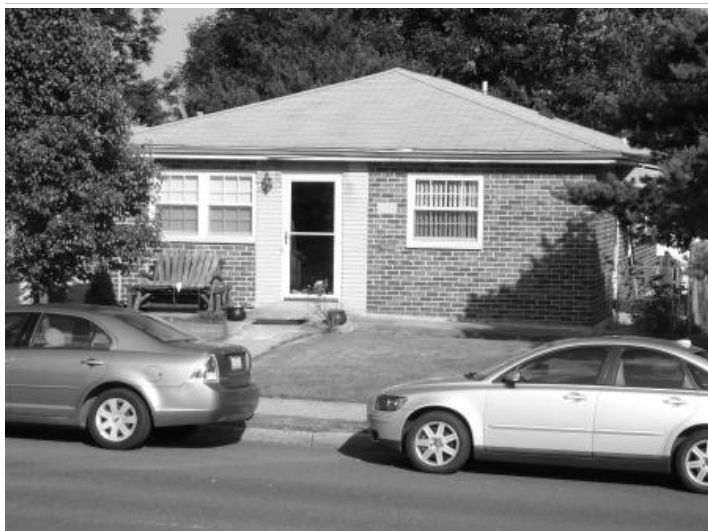
Vinyl replacement windows.

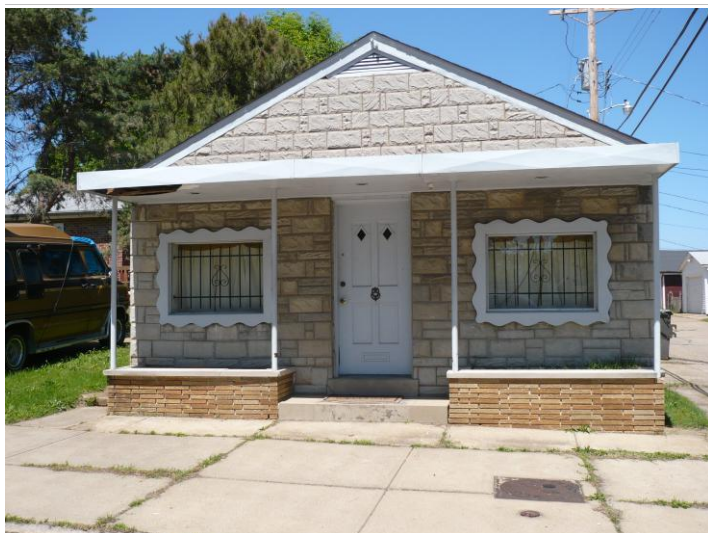
This gable-fronted building facing Rosa is listed as a shop on c. 1960s Sanborn maps. The exterior is clad with imitation stone veneer. The flush wood vergeboard is intact. Some original 2/2 horizontal-paned windows are intact.

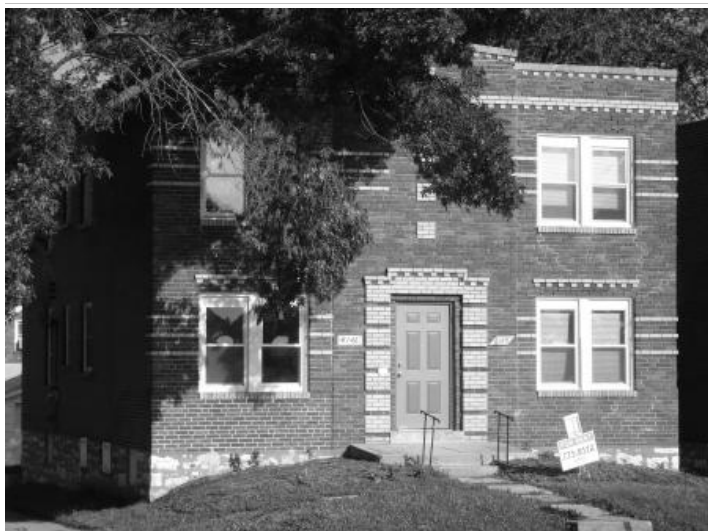
Replacement door, windows.

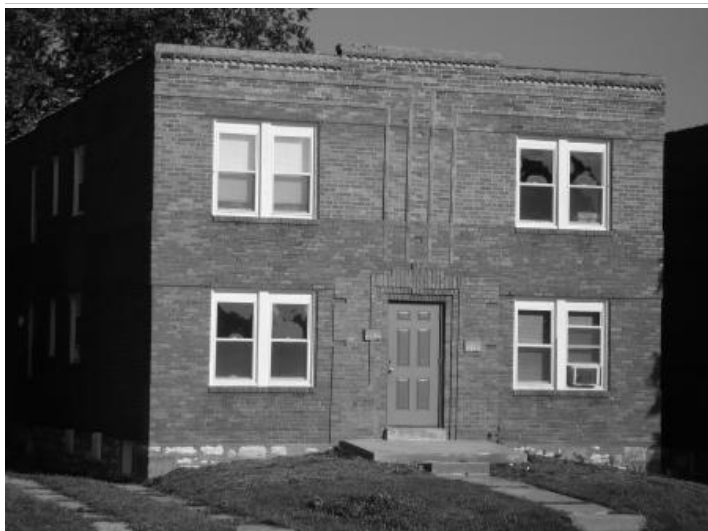
Replacement door, windows.

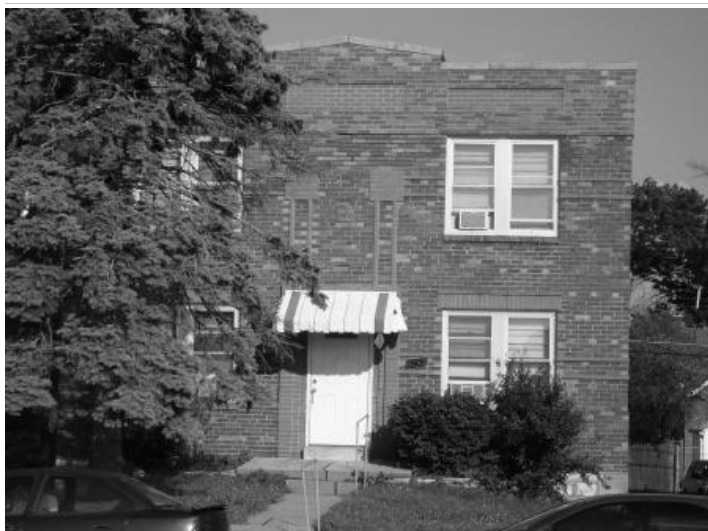
Replacement door. Metal awning over front door.

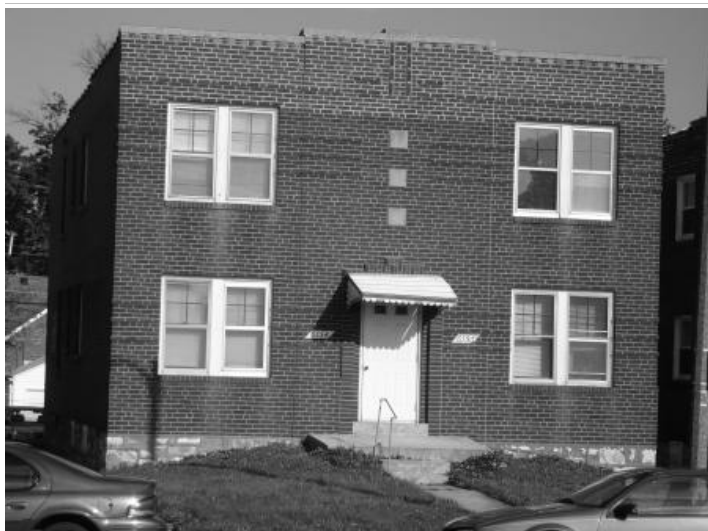
Replacement door. Metal awning over front door.

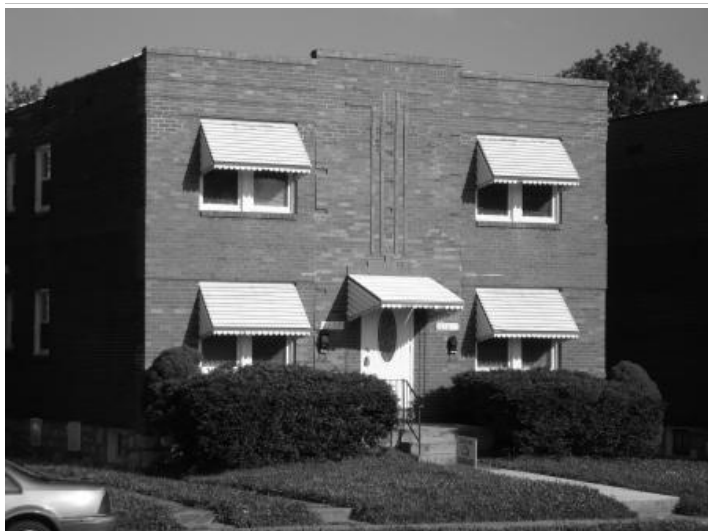
Replacement door and windows. Awnings at façade openings.

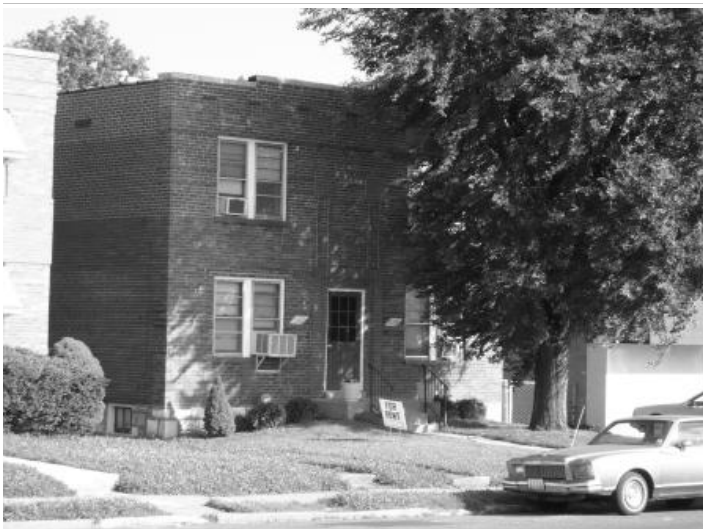
New front door.

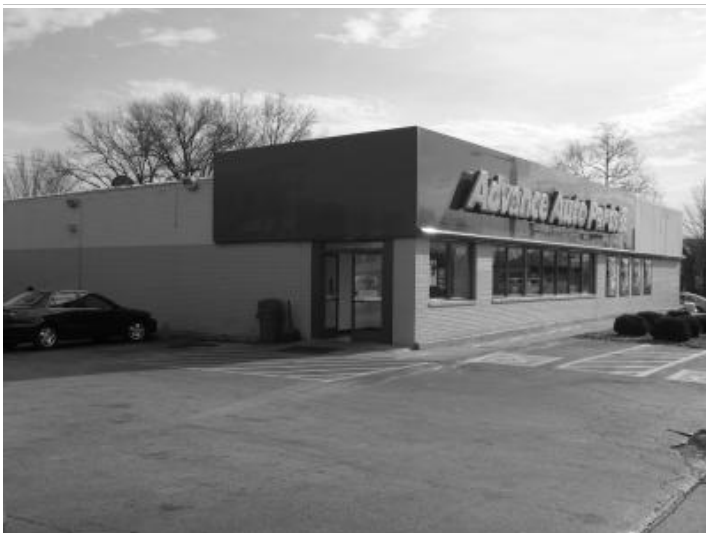
This painted brick-veneered commercial building no longer possesses integrity due to the large red siding/sign across the front.

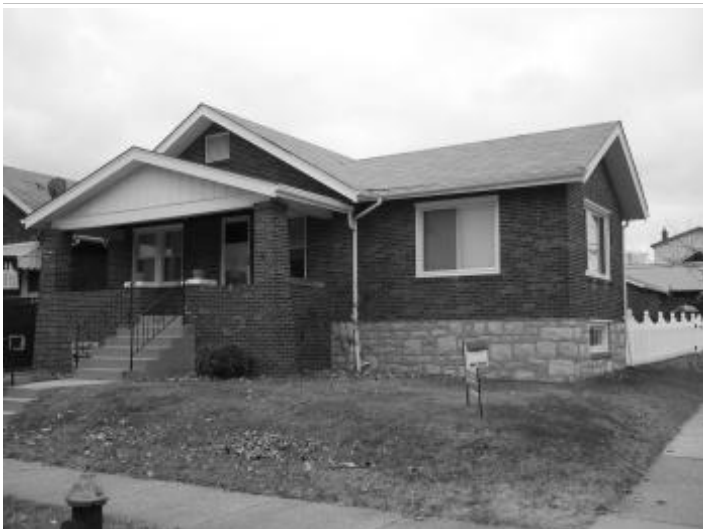
Modern windows at right bay.

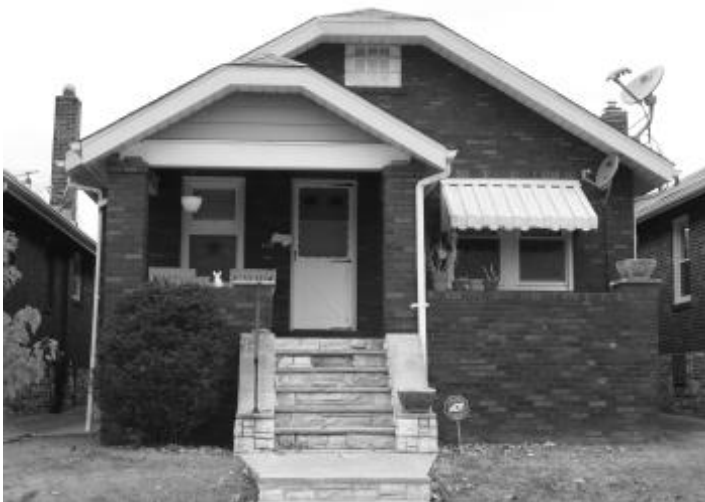
Porch gable end is filled in with modern horizontal siding. Replacement windows and door.

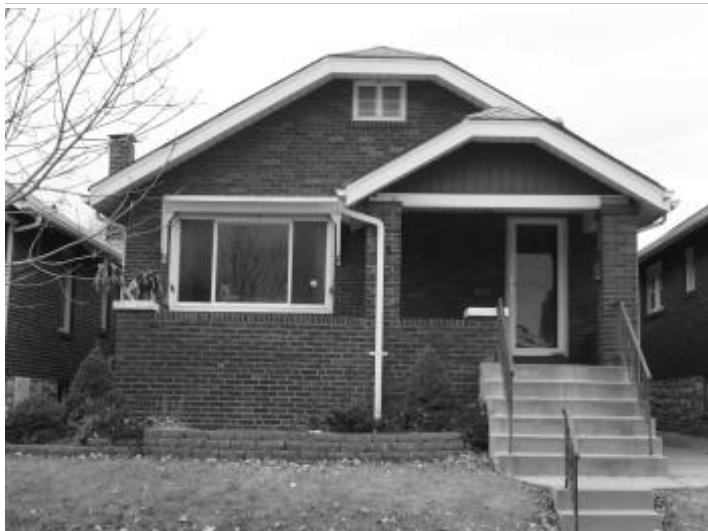
Porch gable end is filled in with modern vertical siding. Replacement windows. Left windows have retractable awning.

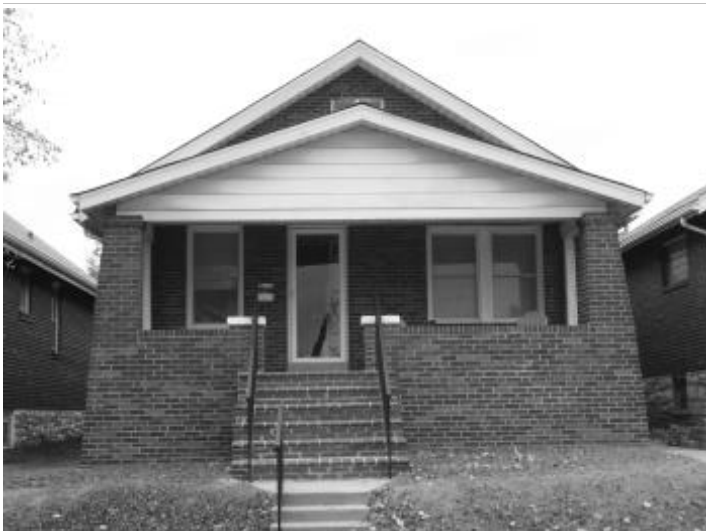
The porch's gable roof is faced with modern horizontal siding. Replacement front door and windows.

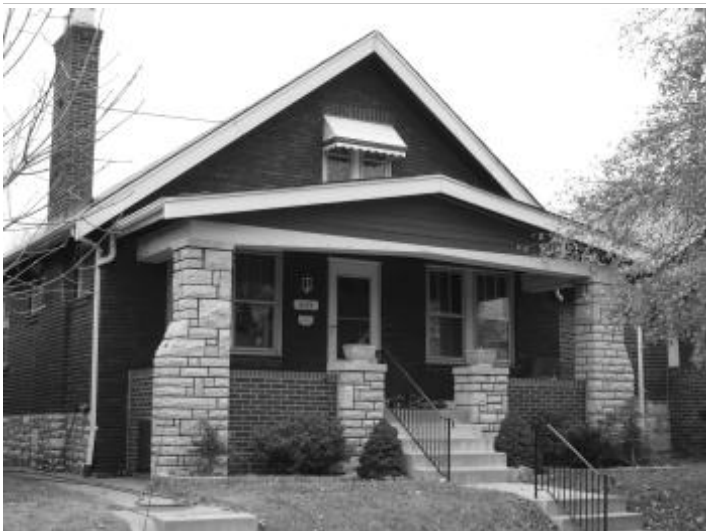
The porch's gable roof is faced with modern horizontal siding. Metal awning at small attic window pair in gable end.

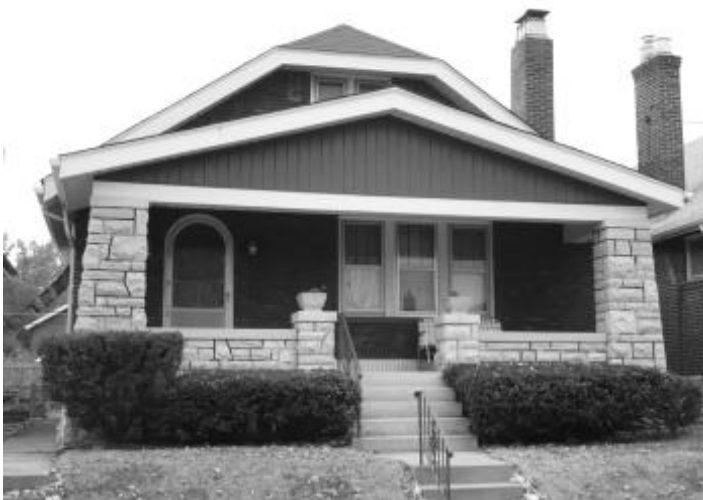
The porch's gable roof is faced with modern vertical siding. Brackets removed at main eaves.

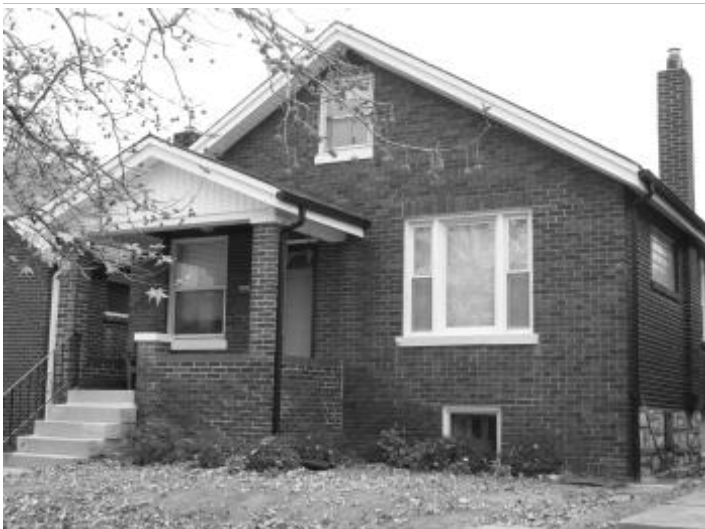
Door and window replacement at façade. Porch gable end filled with modern vertical siding.

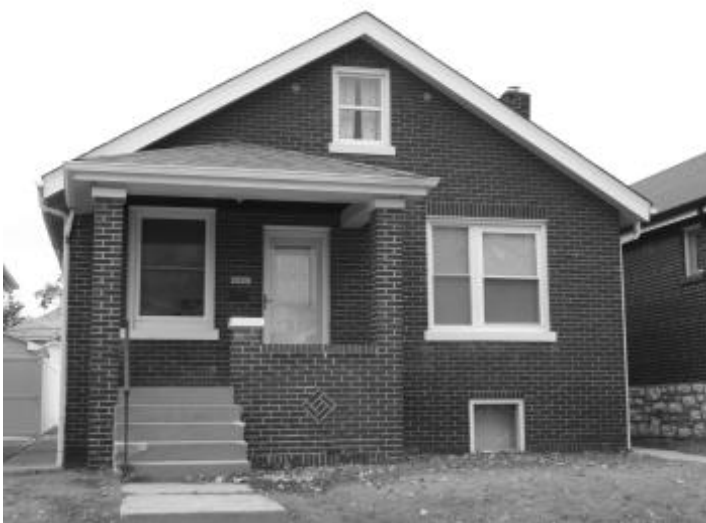
Door and window replacement at façade.

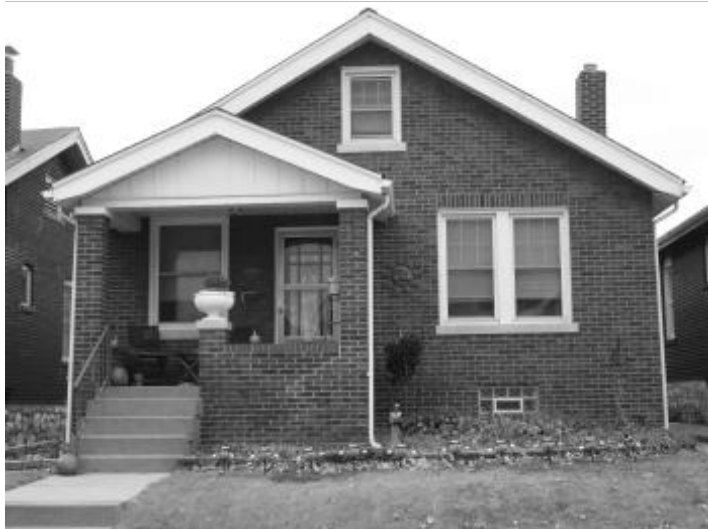
Window replacement at façade. Porch gable end filled with modern vertical siding.

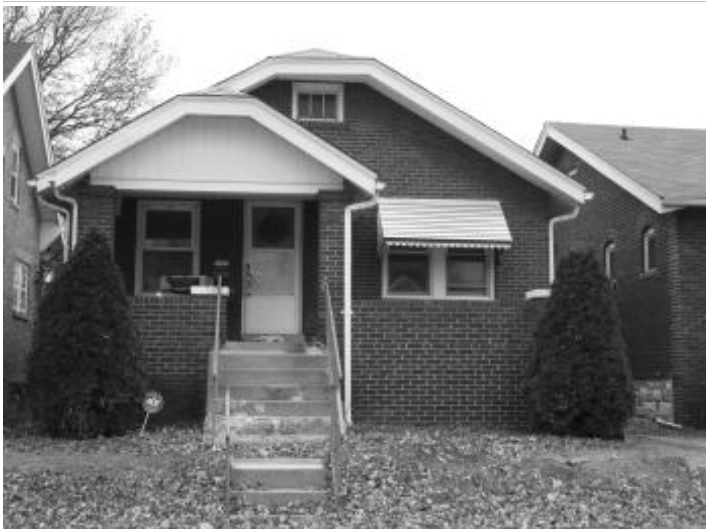
Windows are replaced except for 3-pane attic window. Metal awning over right window pair.

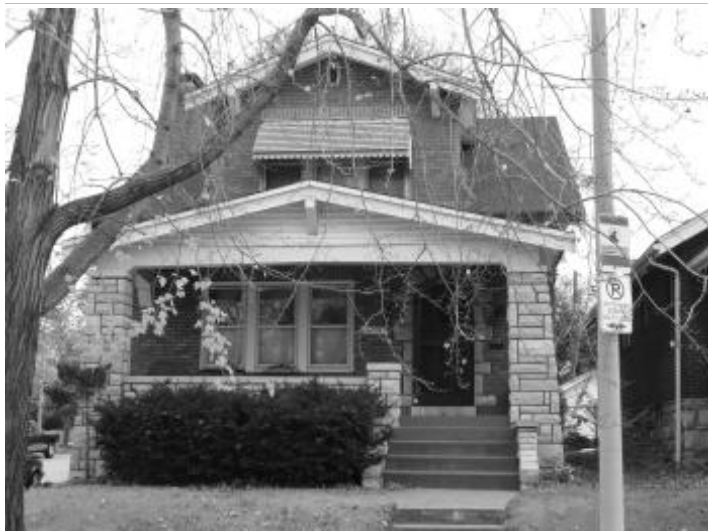
Replacement windows; modern horizontal siding in porch gable end; brackets soffitted in siding; awning over dormer windows.

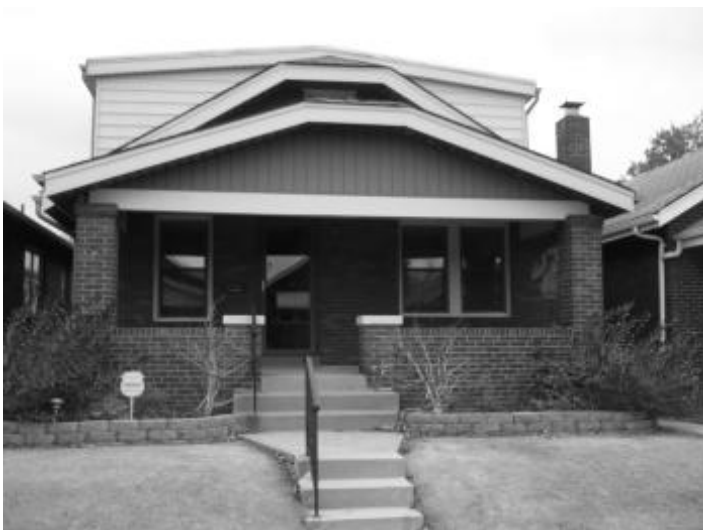
Second floor added in the form of shallow gabled pop-up behind original roofline. Front door and windows are not original. Siding at porch gable end.

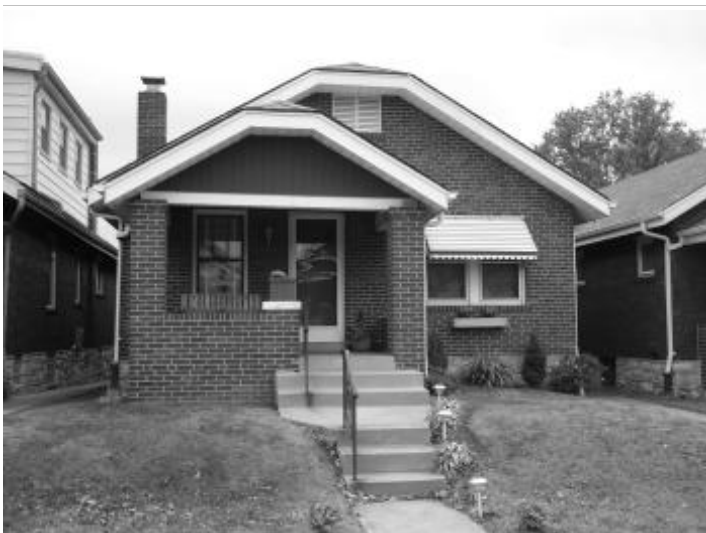
Replacement front door. Metal awning over paired windows, right.

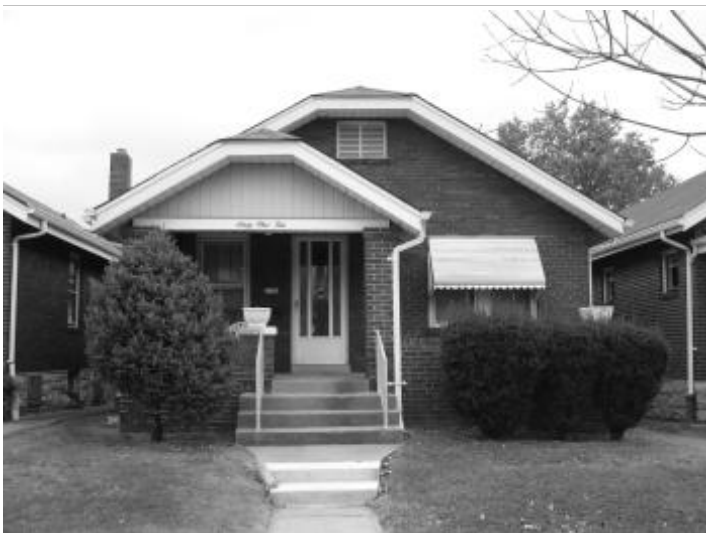
Replacement front door. Metal awning over paired windows, right.

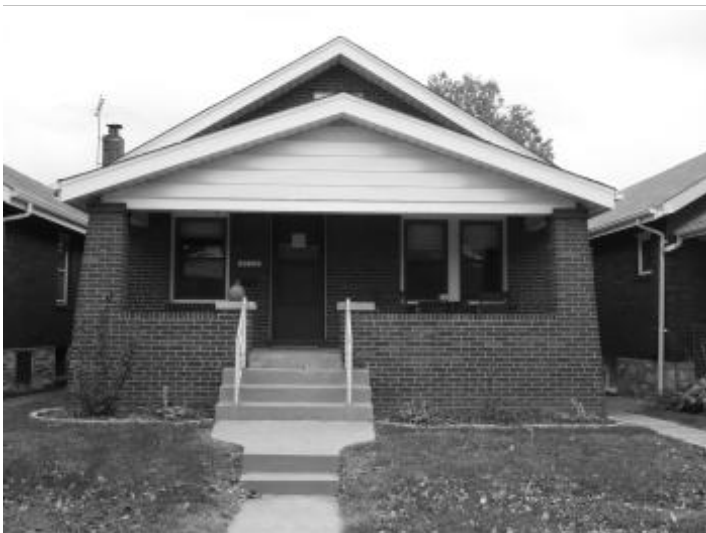
Replacement windows; siding at porch gable end.

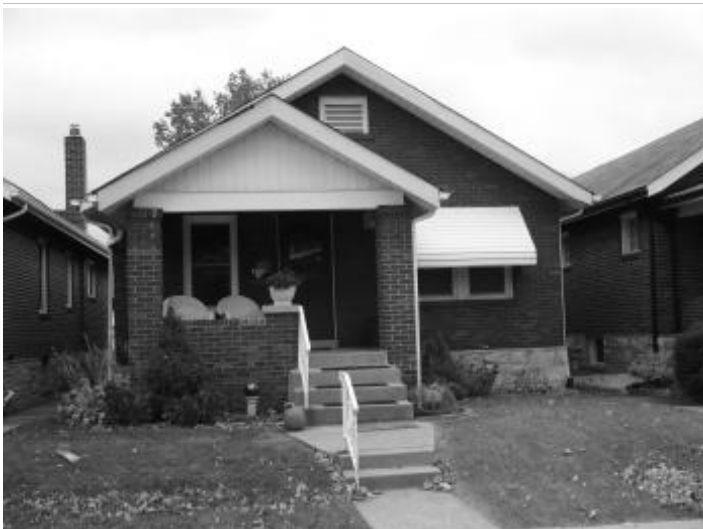
Replacement window at left (can't see pair at right); metal awning over right windows; siding at porch gable end.

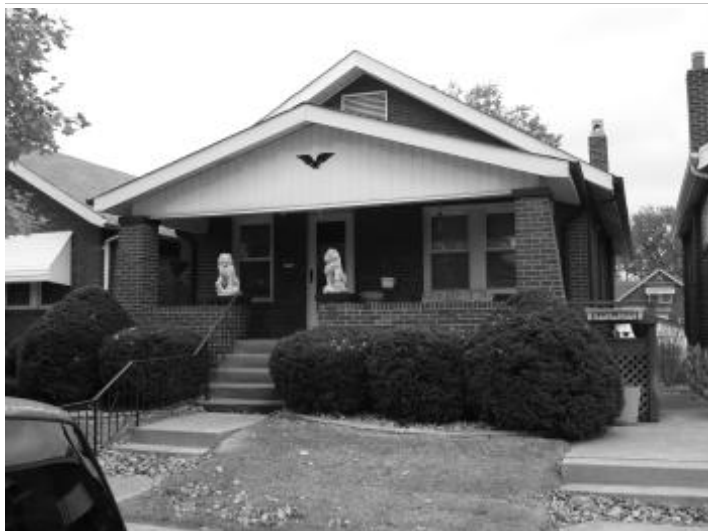
Replacement windows; siding at porch gable end.
