City of St. Louis Cultural Resources Office

Holly Hills Neighborhood Survey

Lynn Josse and NiNi Harris
3/1/2010

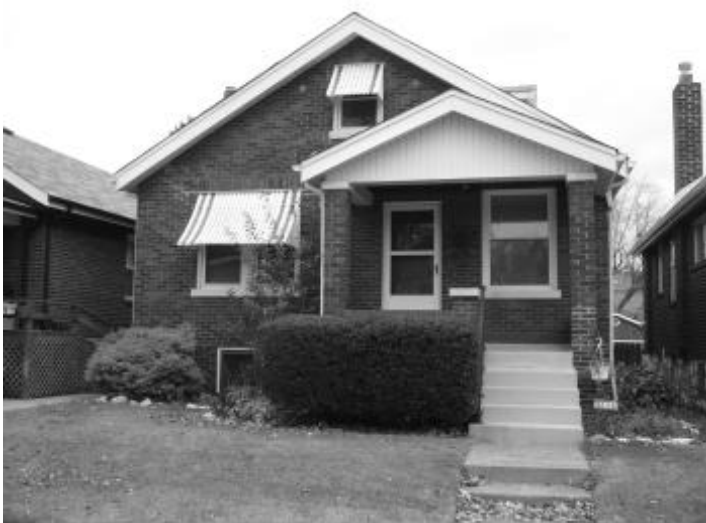
Replacement door and windows; siding at porch gable end. Metal awning over paired windows, left.

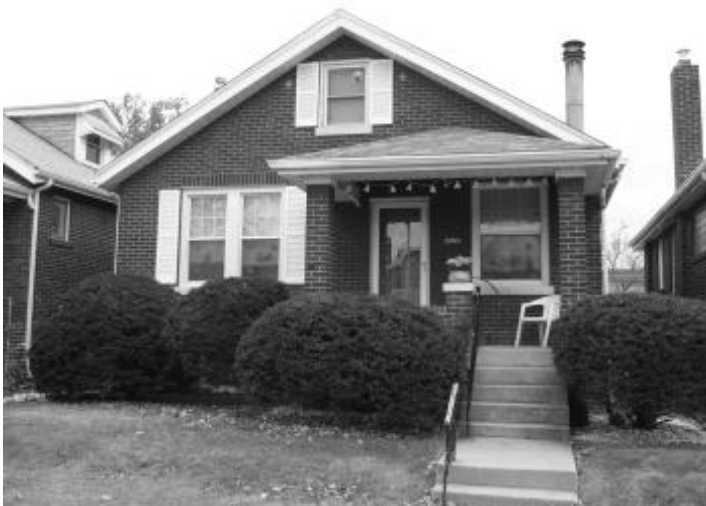
Replacement door and windows; shutters added

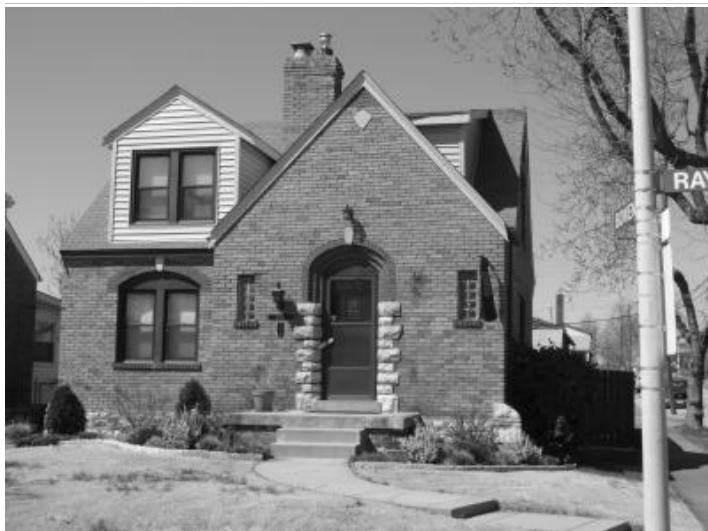
Window replacement; siding at dormer.

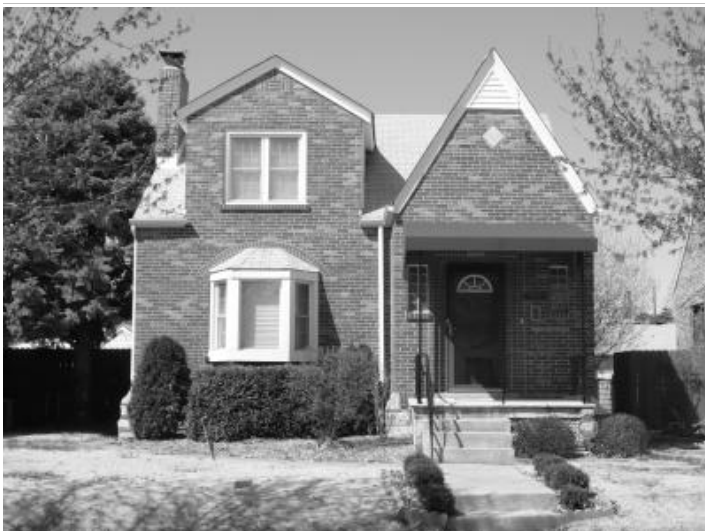
Oriel window, left, added in original opening. Dormer window replaced. Front door replaced.

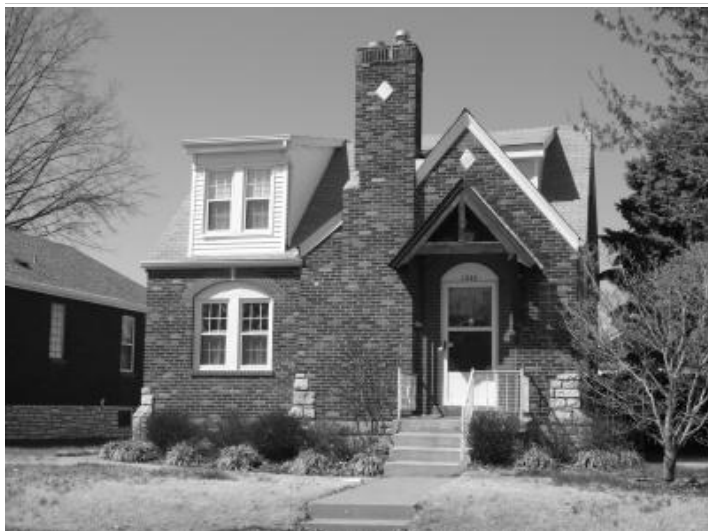
Full window replacement. Front door is replaced. Siding at dormer.

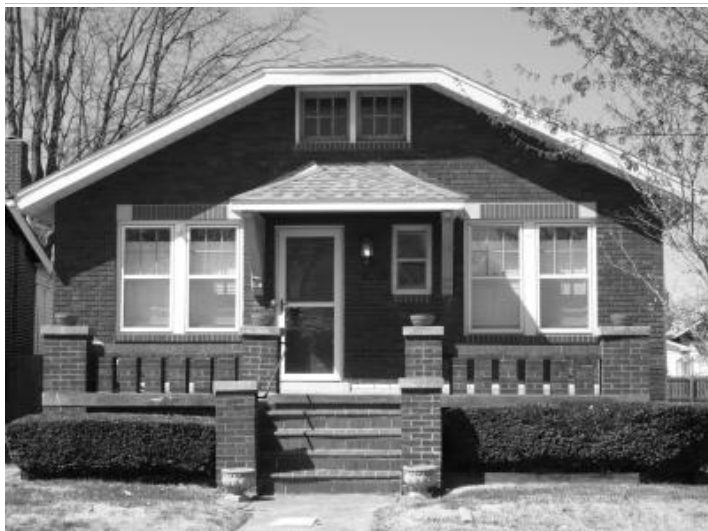
Front door is a replacement.

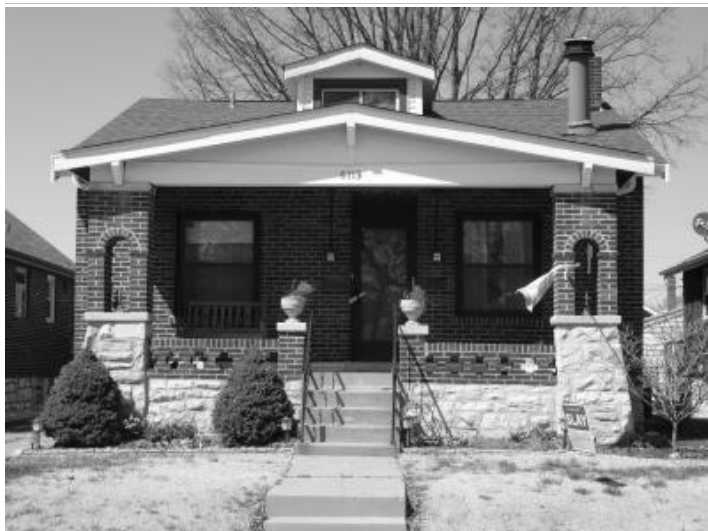
Windows are replacement.

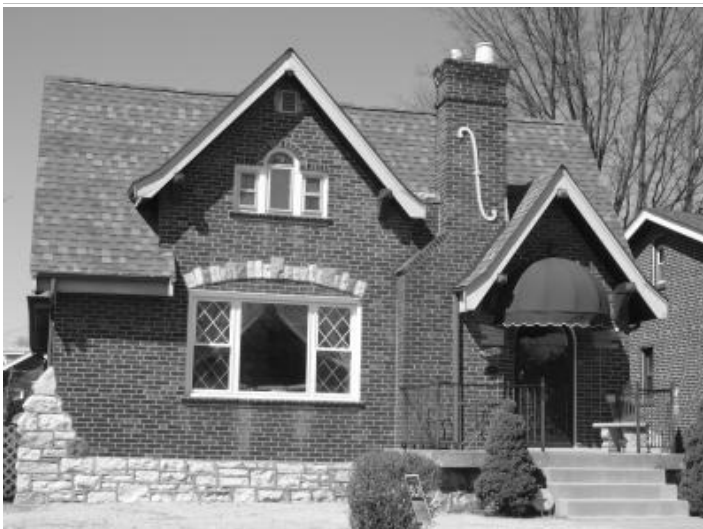
replacement windows at first story.

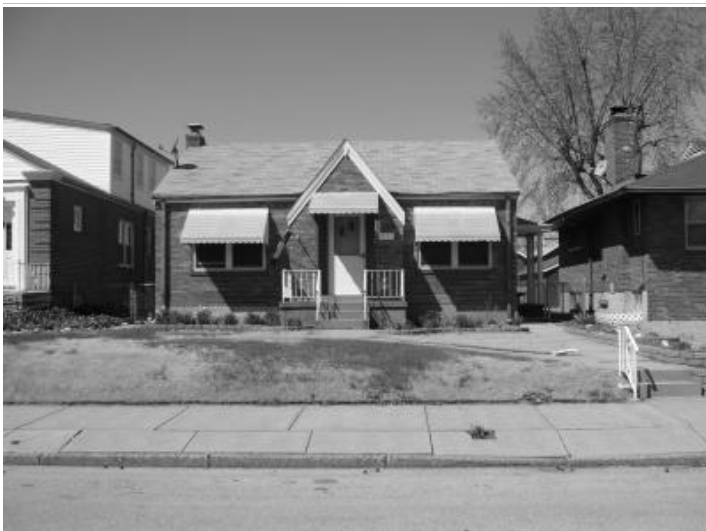
Replacement windows under metal awnings.

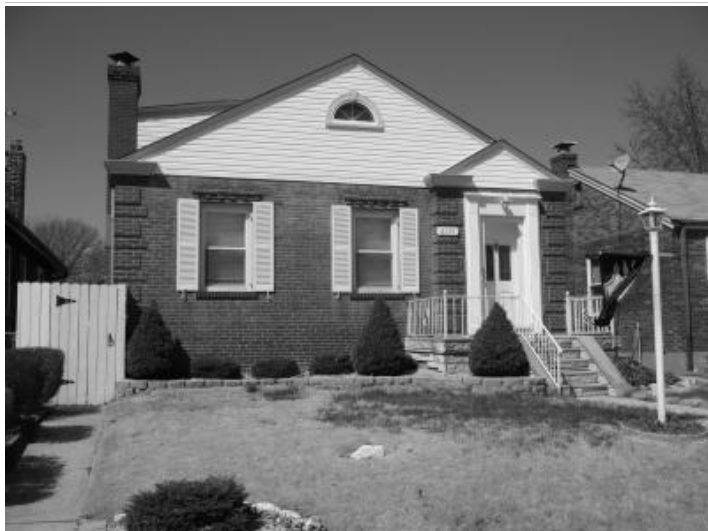
Siding at gable ends.

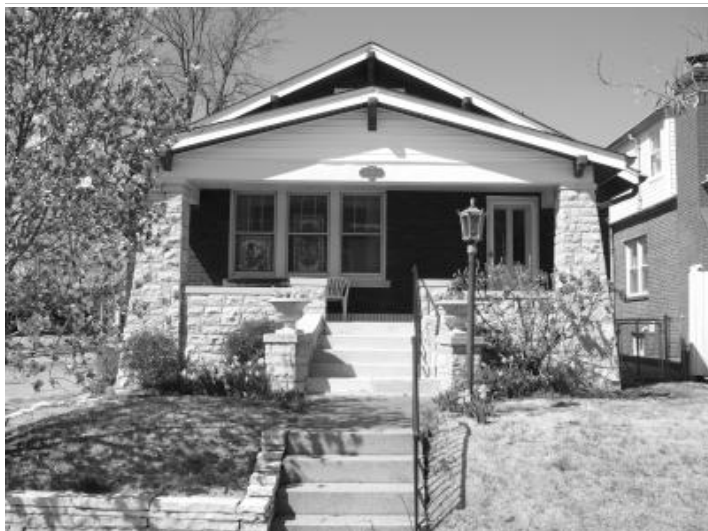
Replacement front door. Siding at porch gable end.

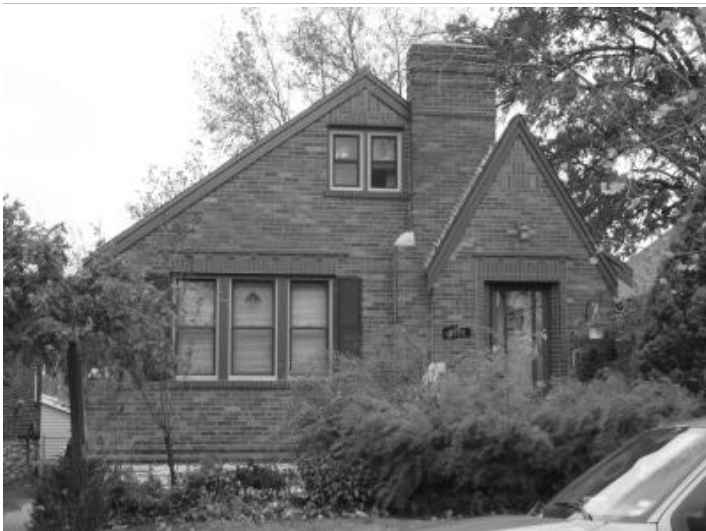
Replacement façade windows

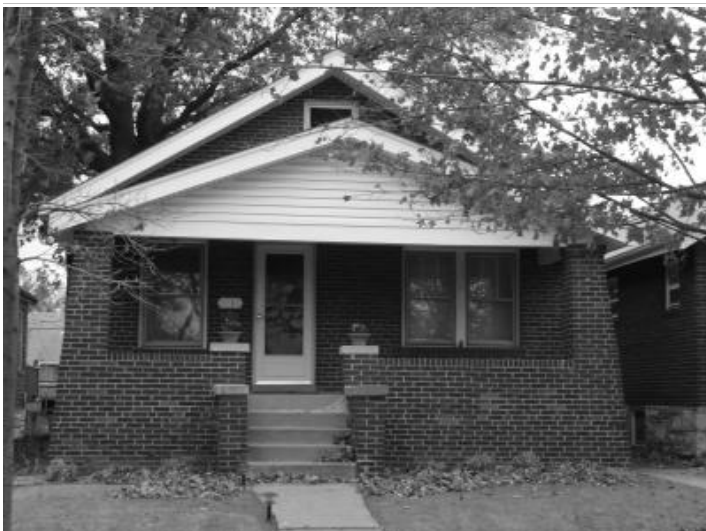
Eaves and gable end are soffited.

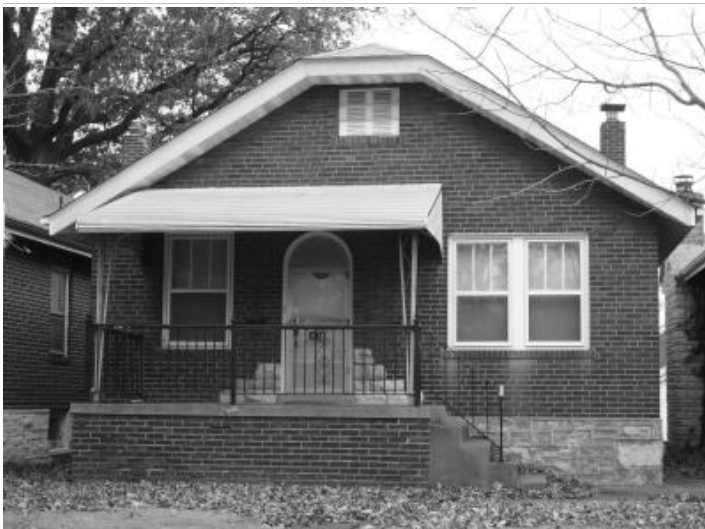
Eaves and gable end are soffited. The front porch, at the left side of the façade, has a full metal awning.

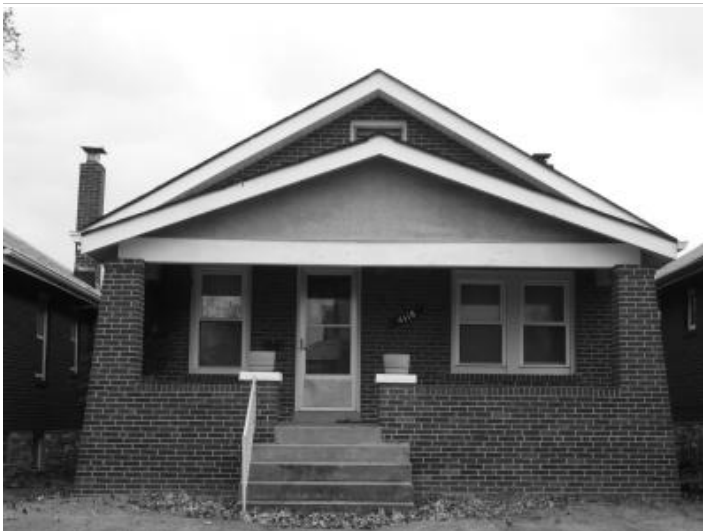
Replacement windows and soffitted eaves.

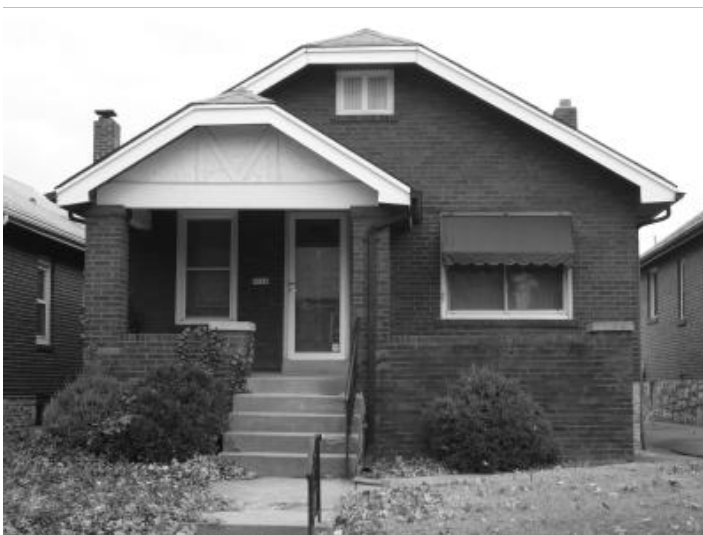
Replacement door and windows; fabric awning over right windows.

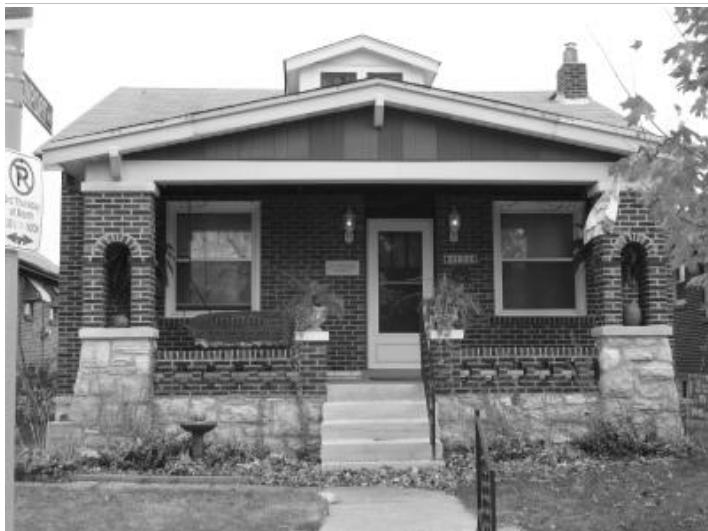
Façade windows are replaced. Wood trim is wrapped, and the porch's gable end is covered with modern vertical siding.

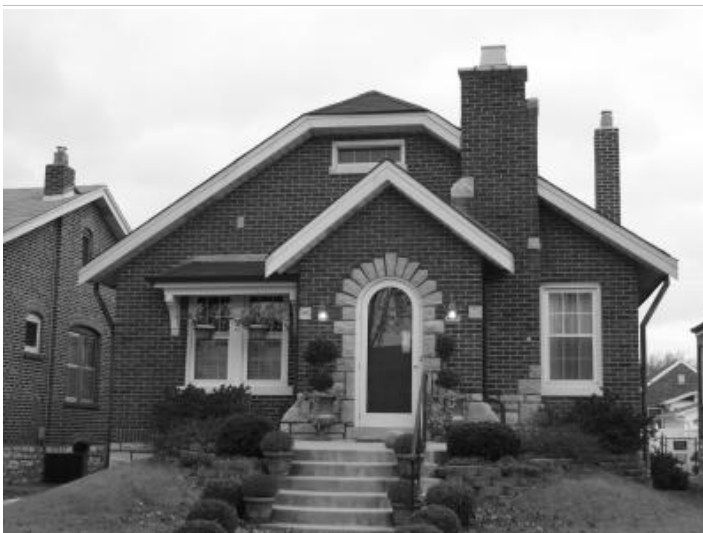
Replacement façade windows.

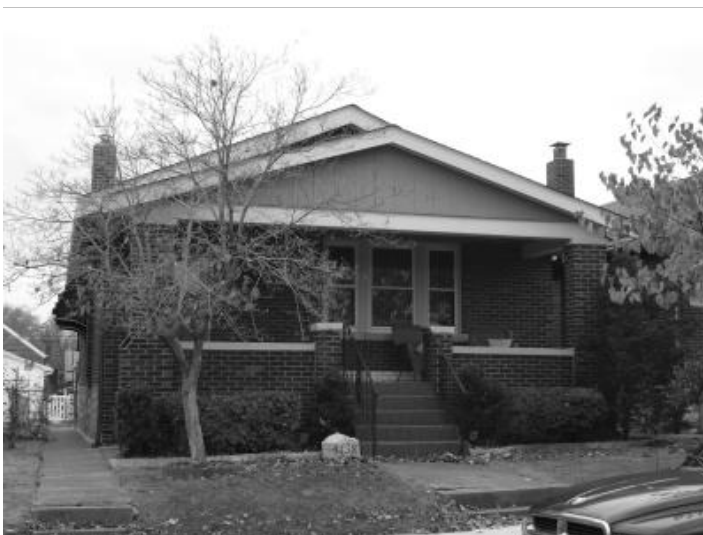
Vertical modern siding in porch gable end. Much wood trim is wrapped.

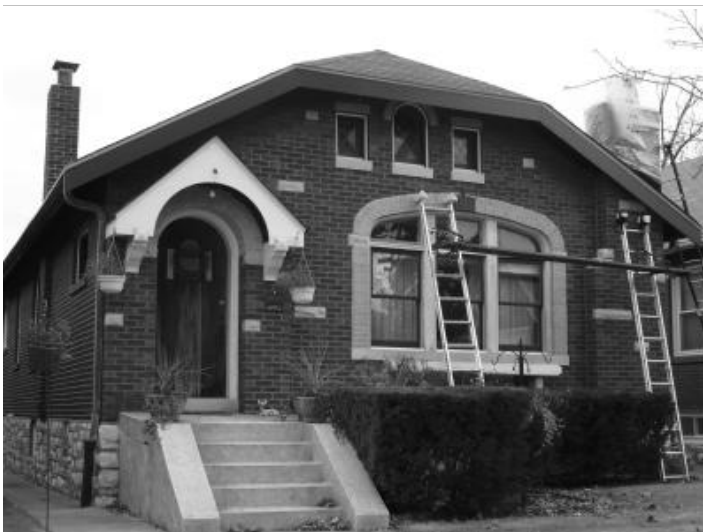
Triple set of windows is a replacement.

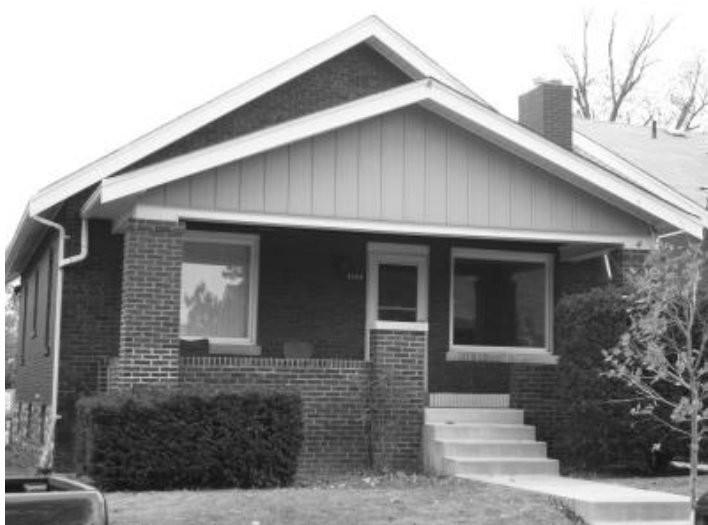
Porch gable end filled with vertical modern siding. Former window pairs have been replaced with single large fixed pane windows.

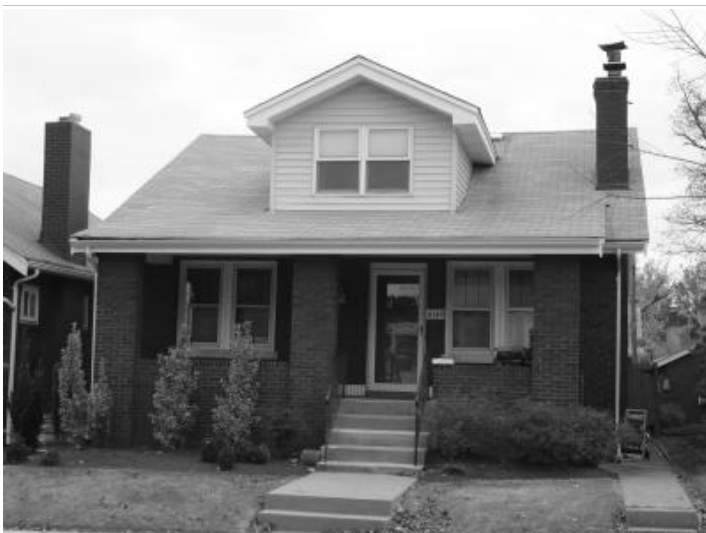
The gabled dormer has modern horizontal siding and replacement windows.

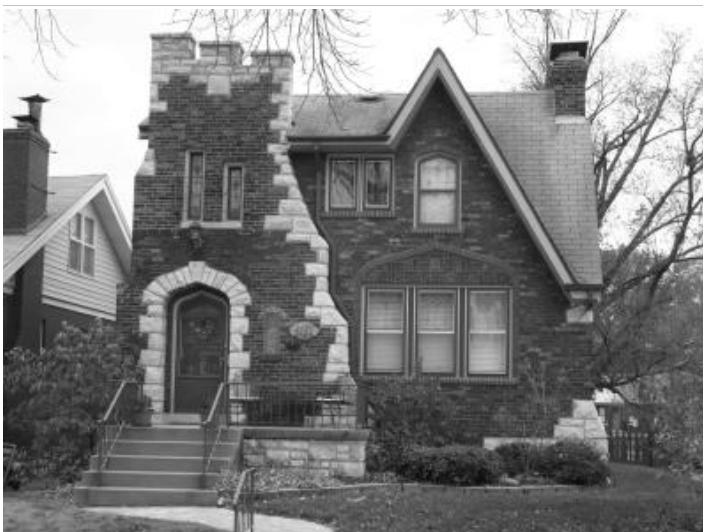
Eaves are wrapped with aluminum.

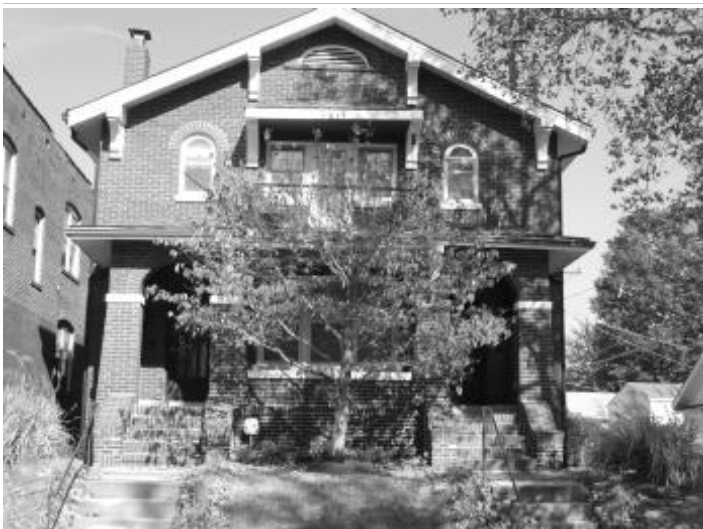
replacement windows.

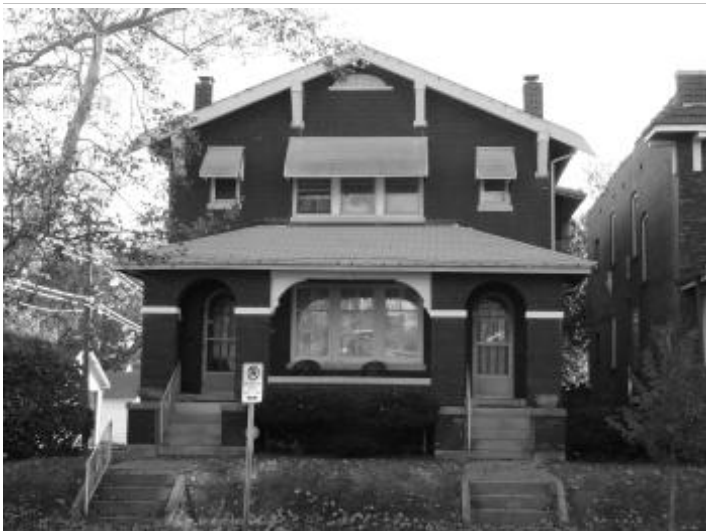
awnings added; brackets and eaves soffitted.

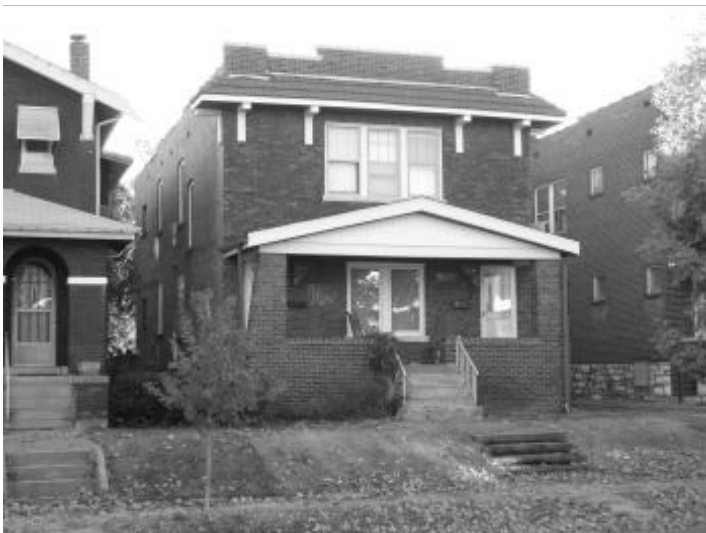
One replacement front door; gable end and brackets are sided.

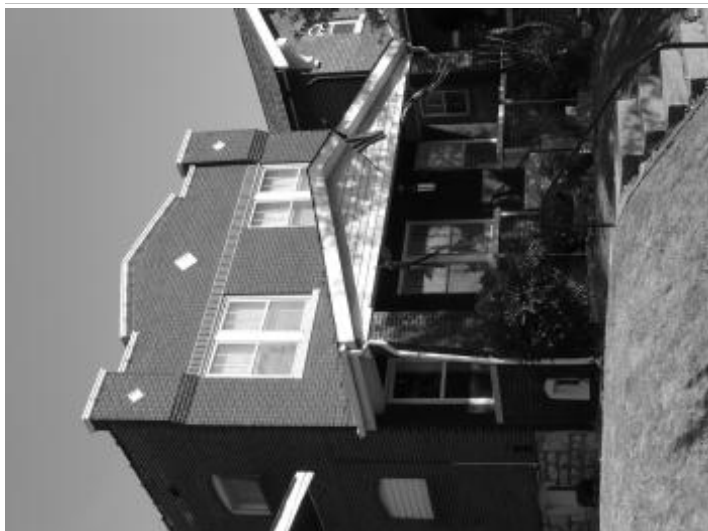
Replacement front doors.

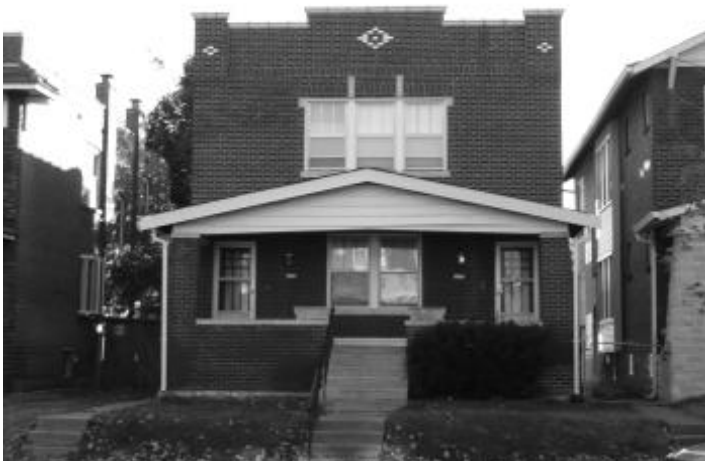
Porch's gable end is sided.

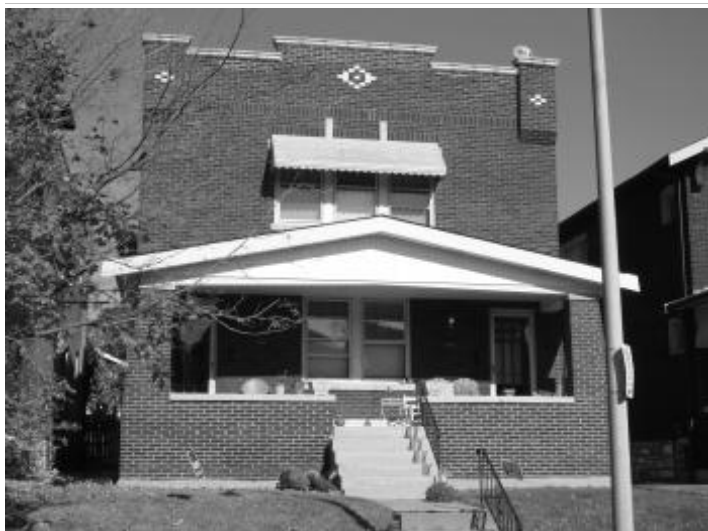
Vinyl soffit at front porch; awning at second story

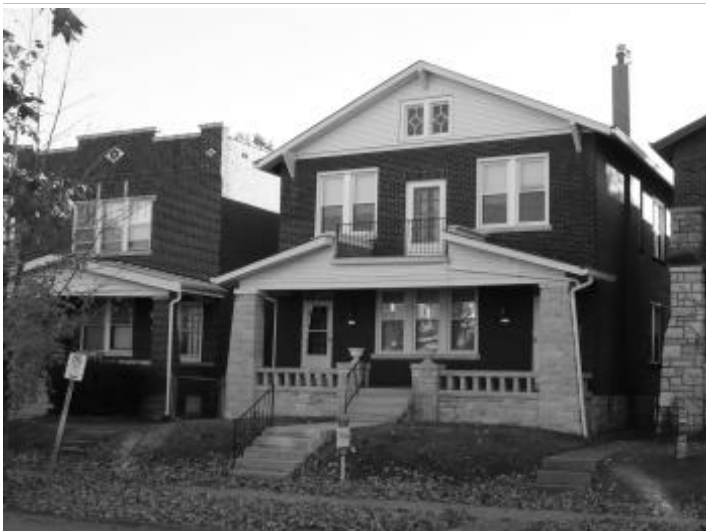
Replacement windows. Eaves, gable ends, brackets all sided.

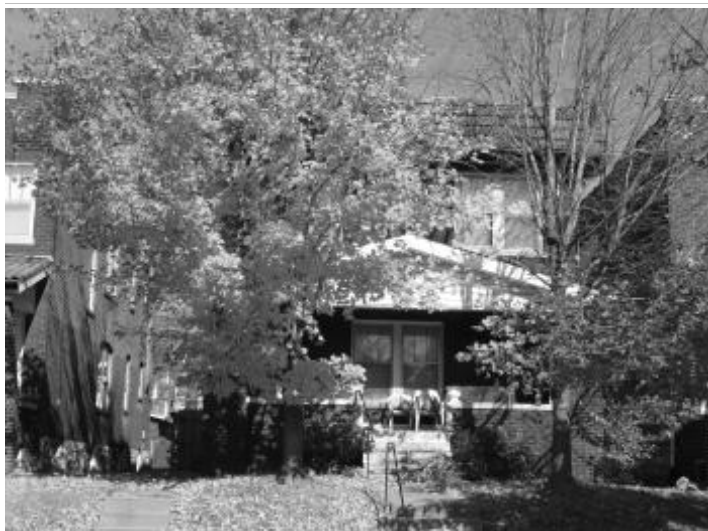
Second story windows are replacements; vinyl covers gable end soffits and eaves.

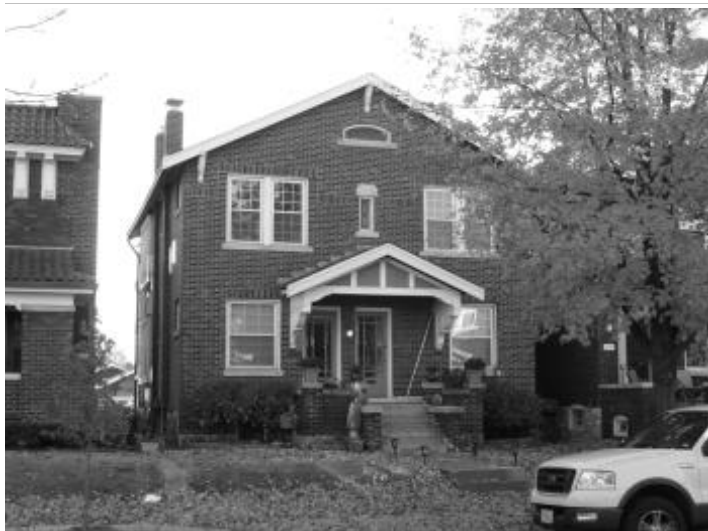
Replacement windows.

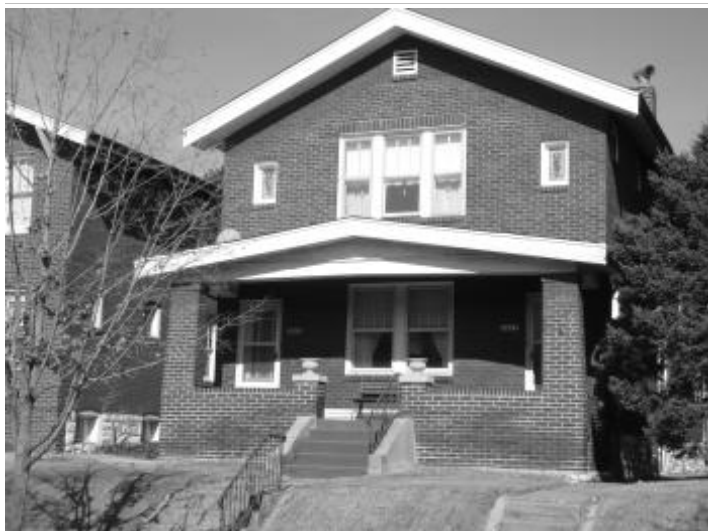
One front door is replaced.

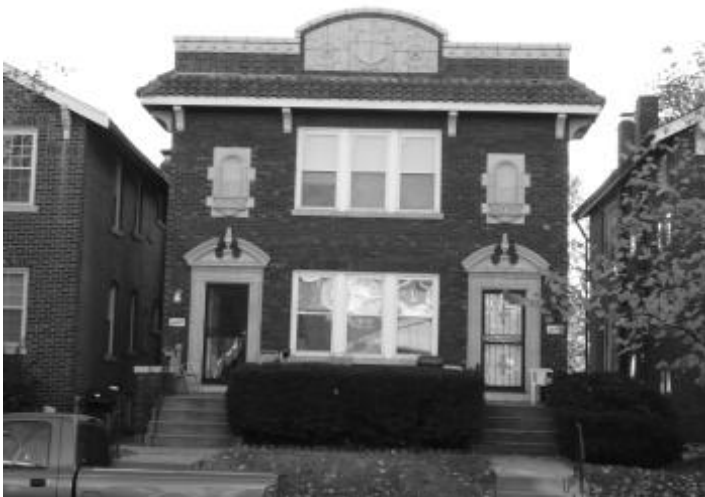
The two front doors and both triple sets of windows have been replaced.

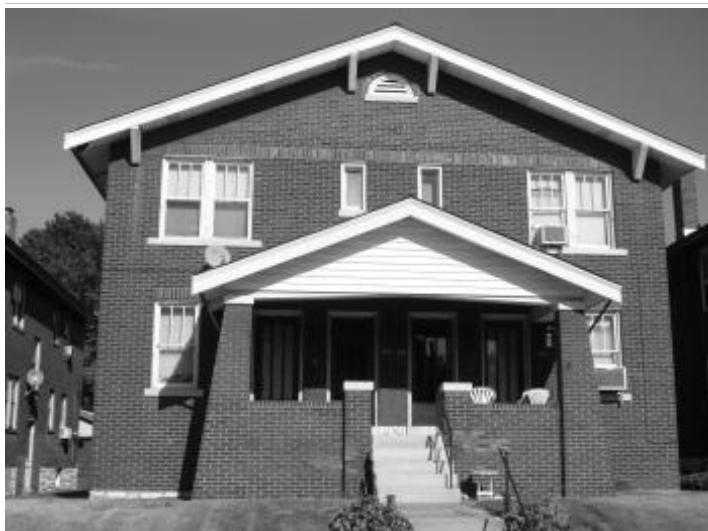
Porch gable end and eaves are clad with vinyl. Second story's center windows are replacements.

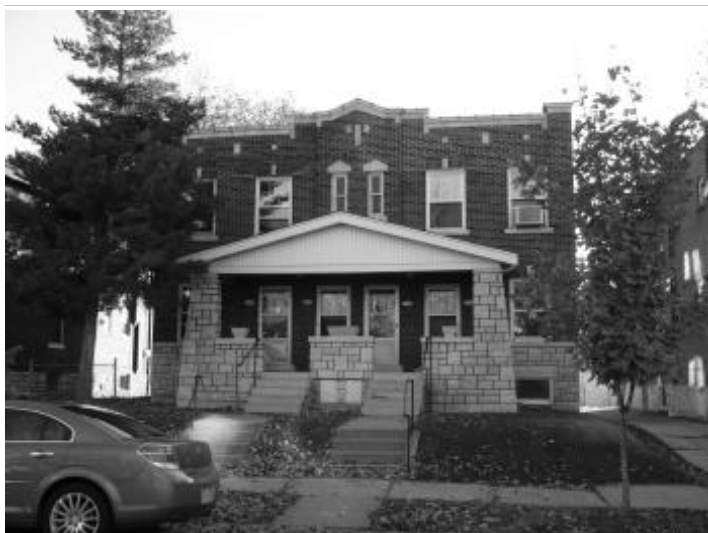
Siding is used at the porch over the gabled end and soffits.

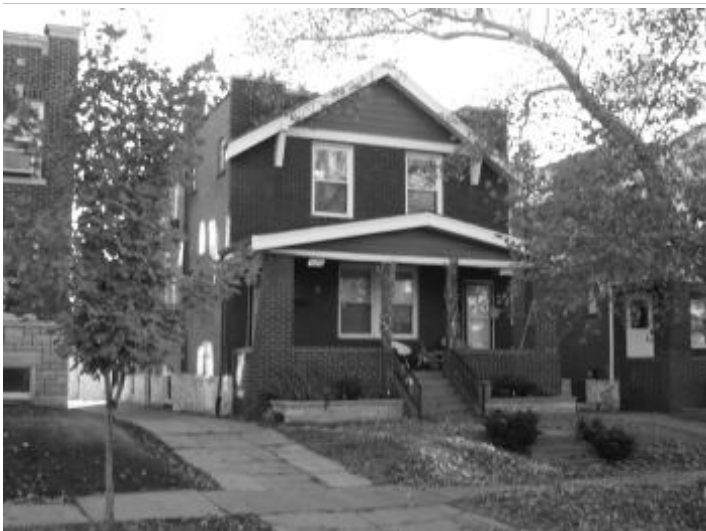
Doors and windows replaced; gable ends sided over; two metal supports added at porch

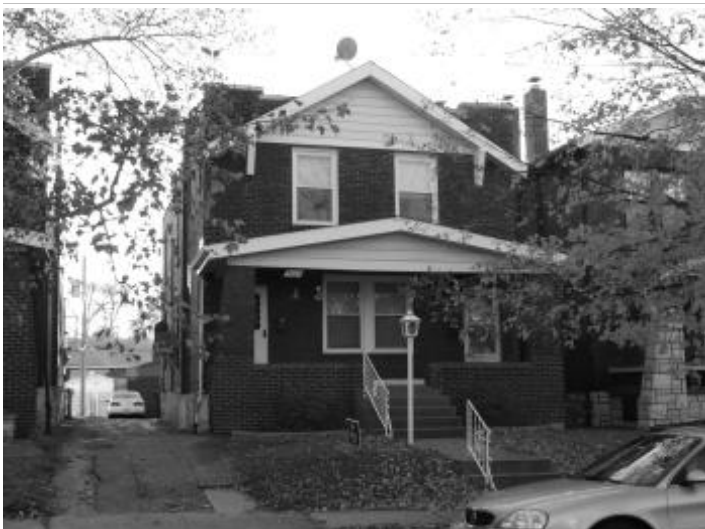
windows replaced; gable ends sided over; two betel supports added at porch

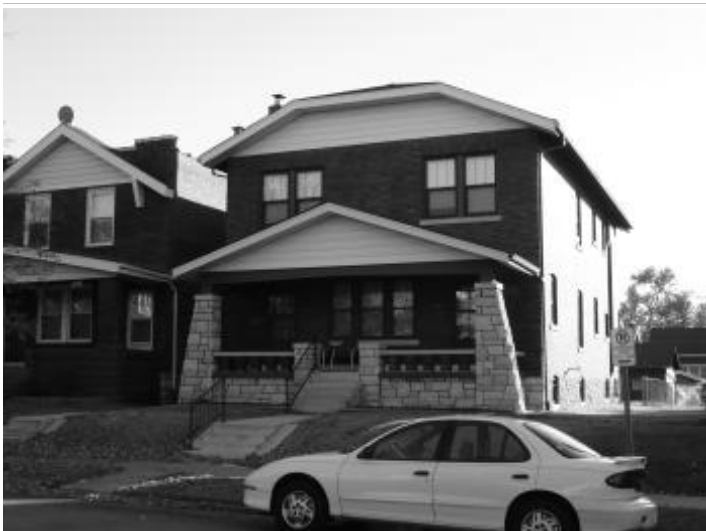
Eaves, soffits and gable ends encased in vinyl siding.

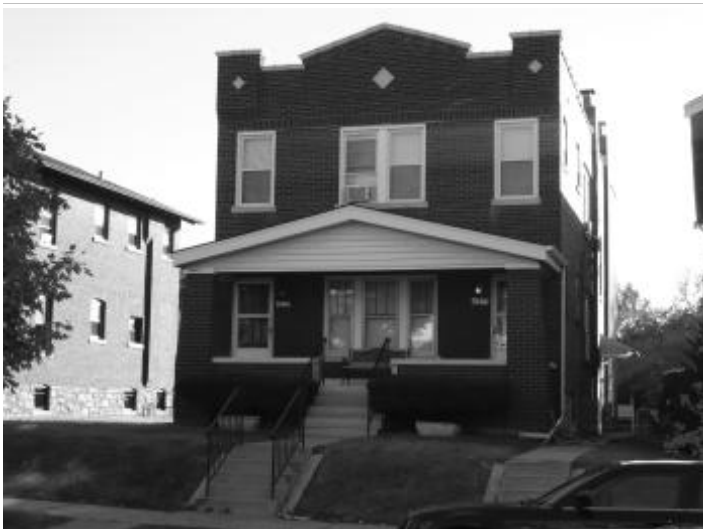
Second story windows are replacements. Porch eaves, soffits and gable end are encased in aluminum.

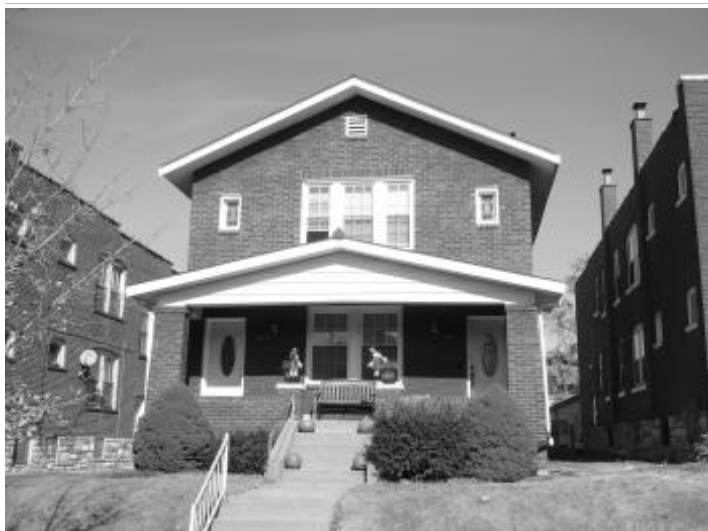
Two replacement front doors; replacement windows.

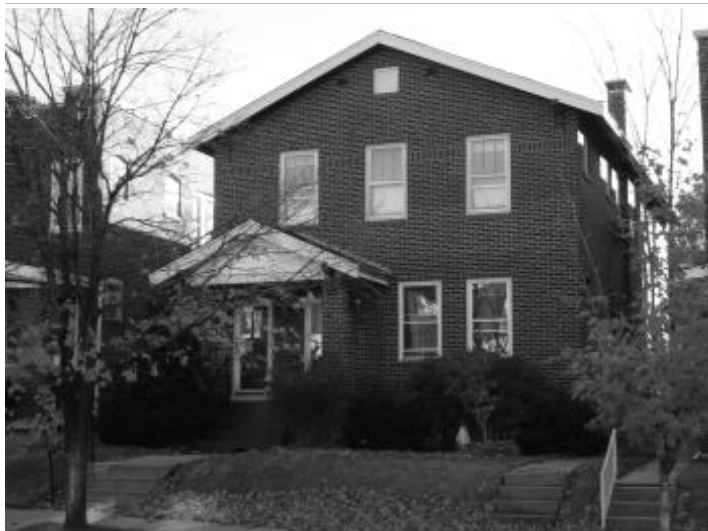
Porch eaves and gable end are sided with aluminum.

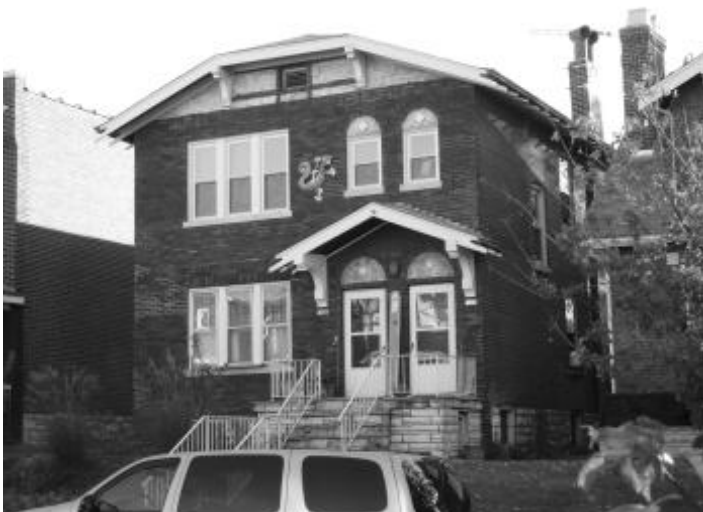
Second floor windows are replacements

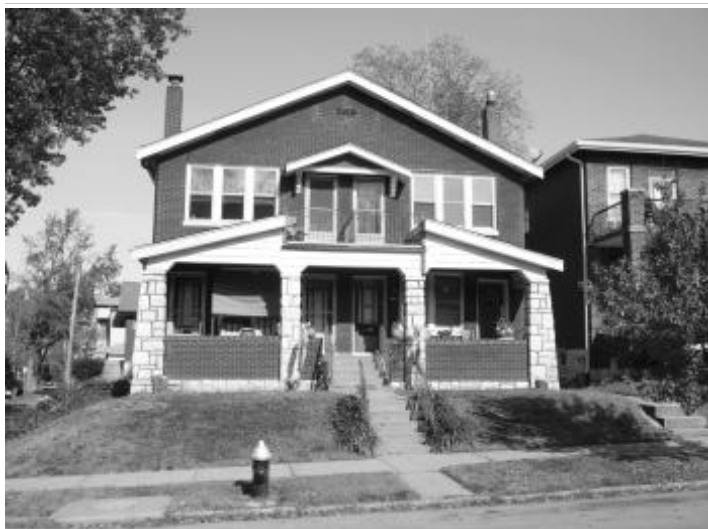
Replacement set of windows at second story of right bay; aluminum covers much wood trim including gable end of porch.

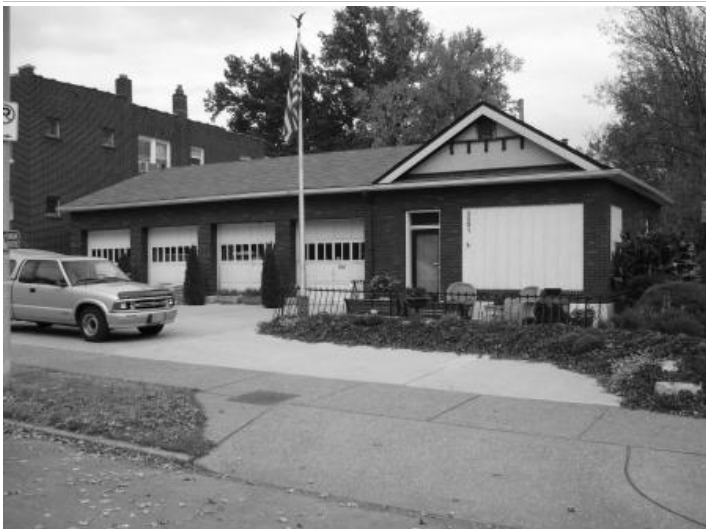
Large office bay window filled in with paneling.

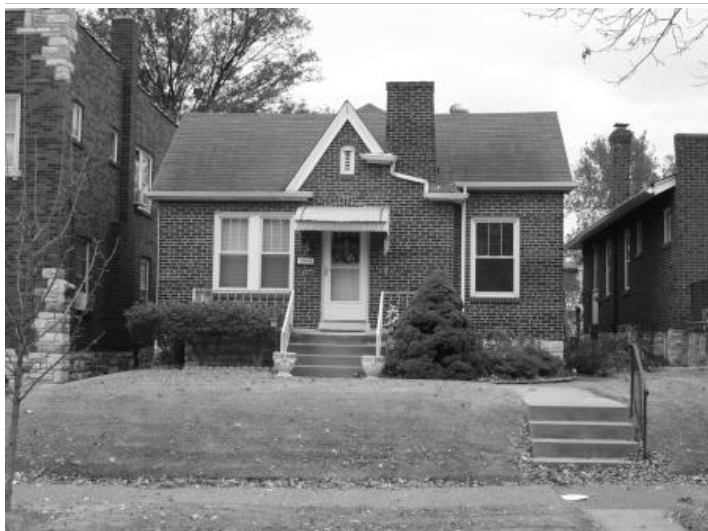
Metal awning; vinyl windows at façade.

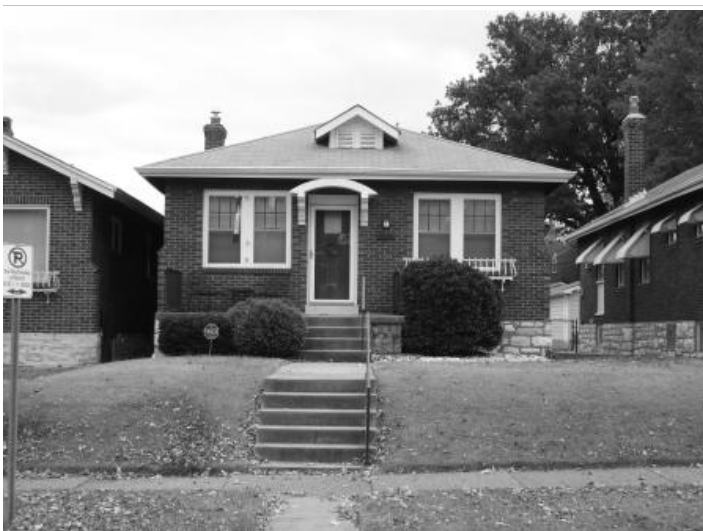
some wood trim wrapped.

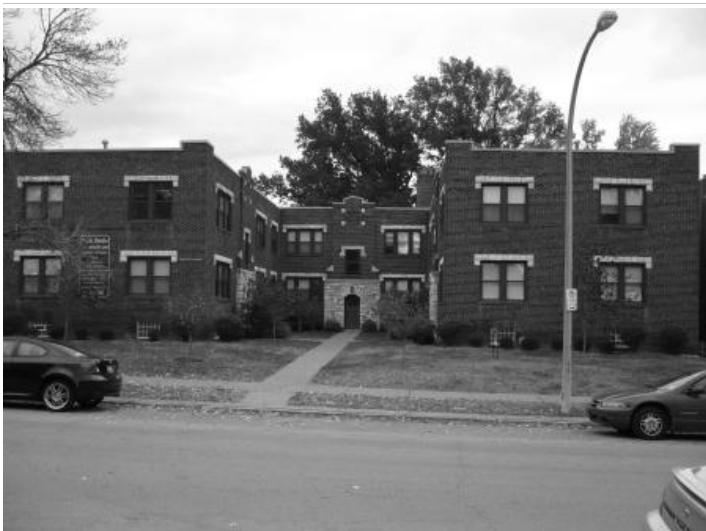
All façade windows are replacements.

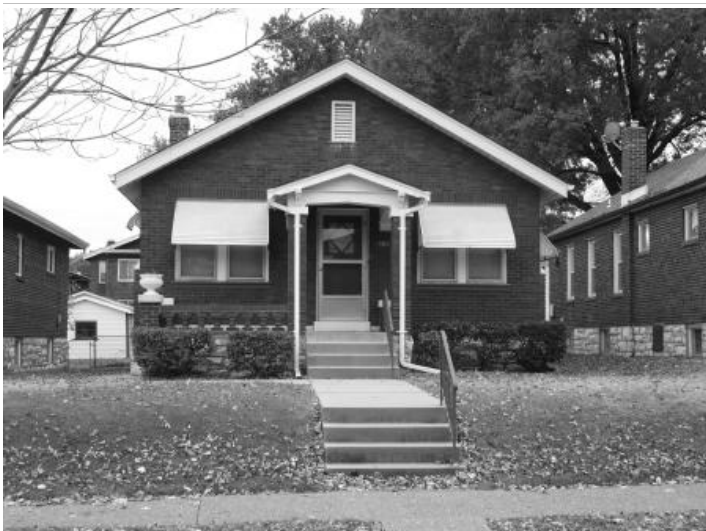
Some wood trim wrapped in siding; awnings at façade windows.

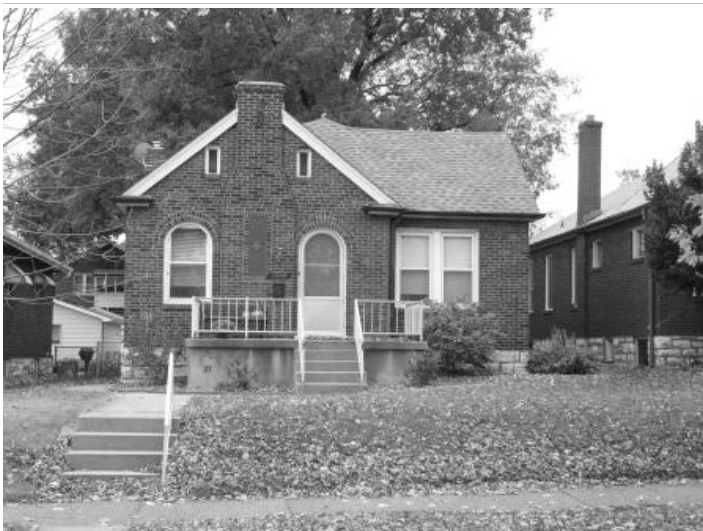
Facade window replacement.

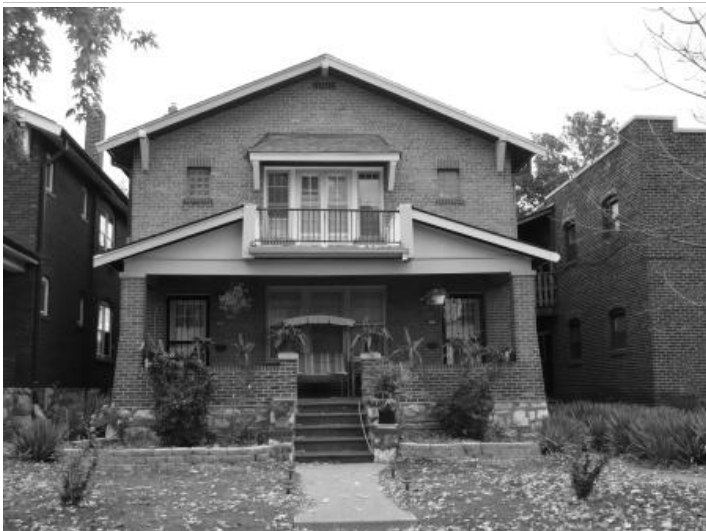
The small outer windows at the second story are filled in with glass block. Some wood trim wrapped.

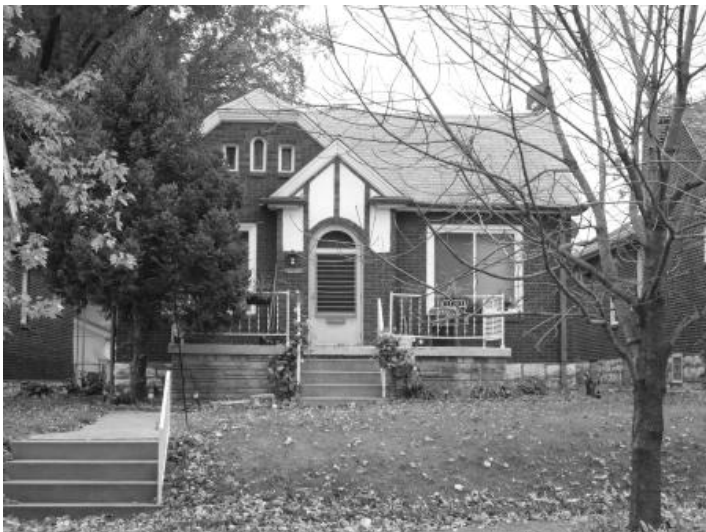
First story window replacement.

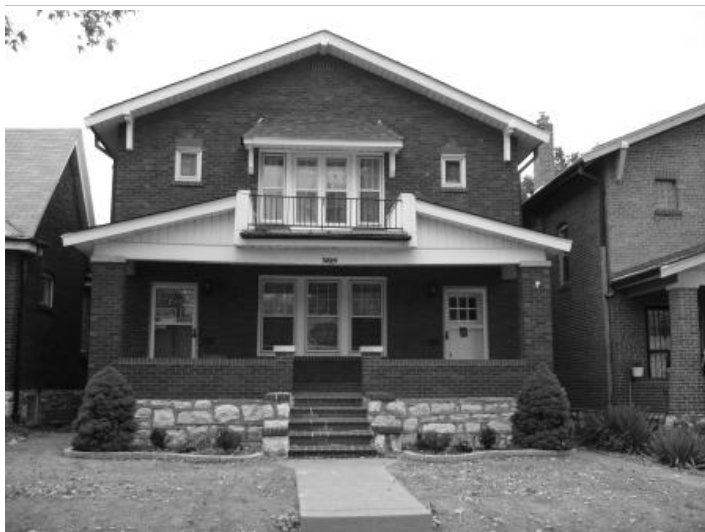
Most wood trim is wrapped, and modern vertical siding is in gable end.

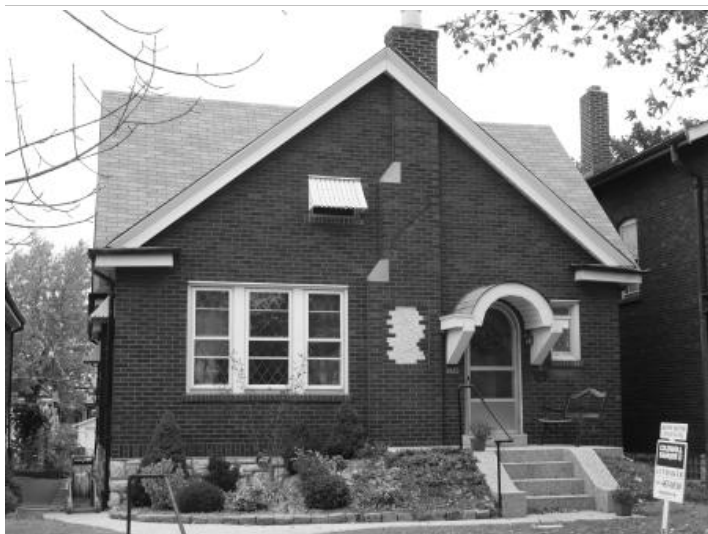
Aluminum wraps most wood trim. Metal awning over attic window.

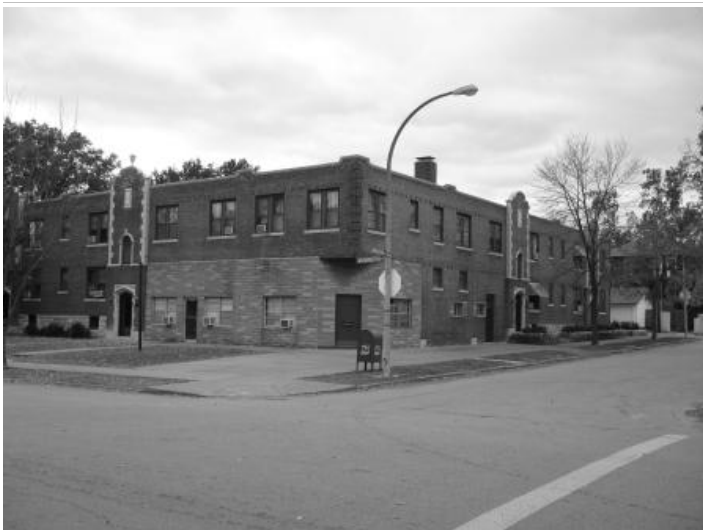
Corner storefront is filled in (2 bays along Wilmington and one along Livingston) with imitation stone veneer exterior, metal windows and 2 modern doors (including at cutaway corner facing intersection).

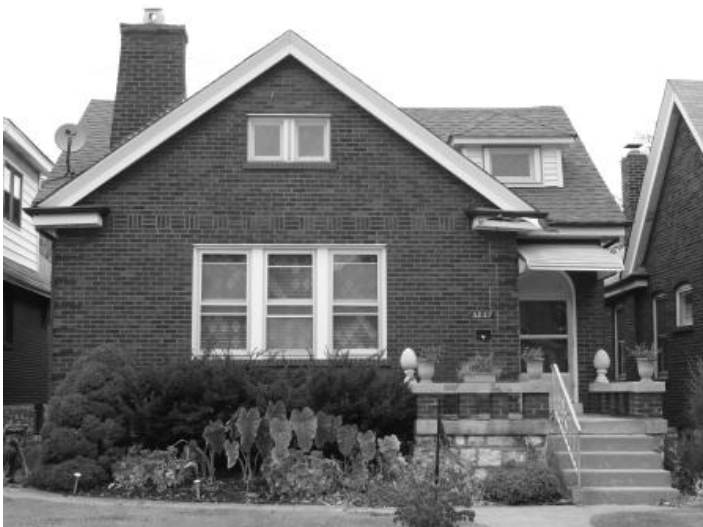
Aluminum wraps most wood trim. Fiberglass awning over door.

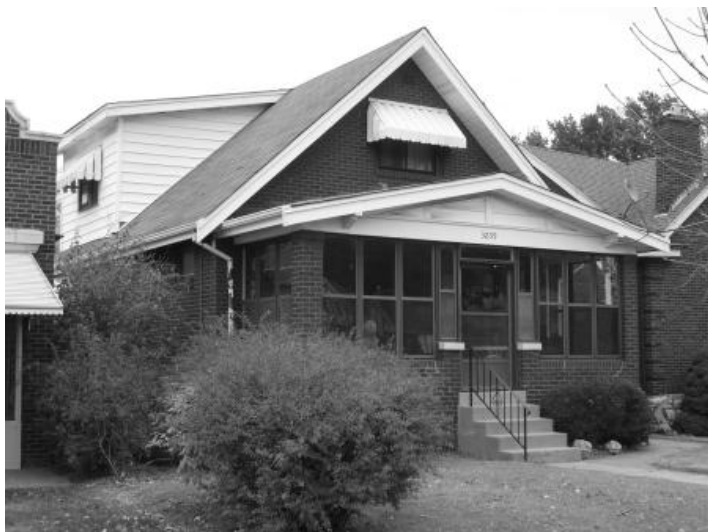
Front porch has been screened in, making it difficult to assess original windows and doors. A metal awning is over the gable end window. Side dormers may be added.

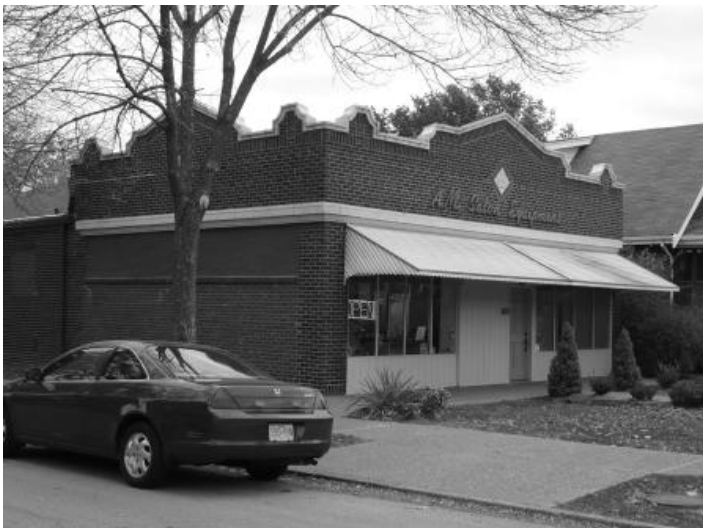
Replacement door and shop windows on front, sheltered by metal awning. The side storefront is filled in with red brick (likely the \$1600 alteration permitted in 1946) and a stuccoed panel filling in where a window strip likely had been.

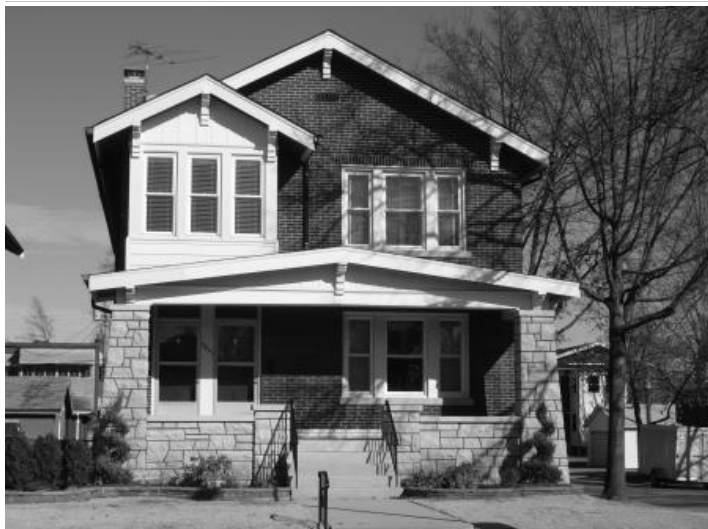
Front doors (at the left bay) and all façade windows are replacements. Most wood trim covered with siding.
