City of St. Louis Cultural Resources Office

Holly Hills Neighborhood Survey

Lynn Josse and NiNi Harris
3/1/2010

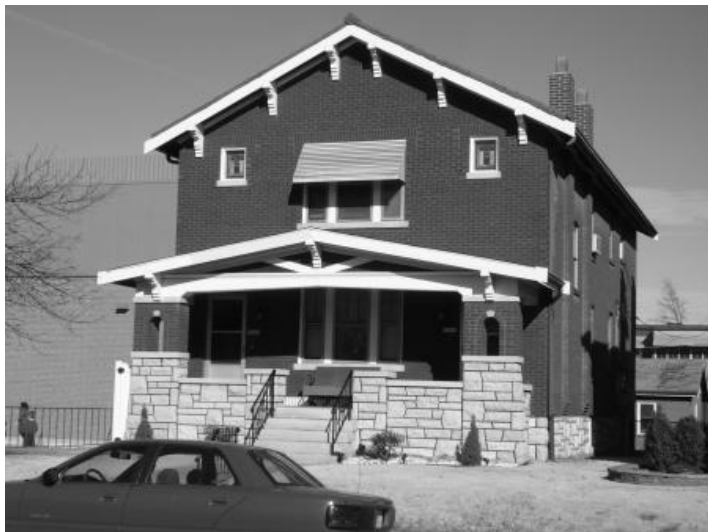
Some wood trim faced with siding.

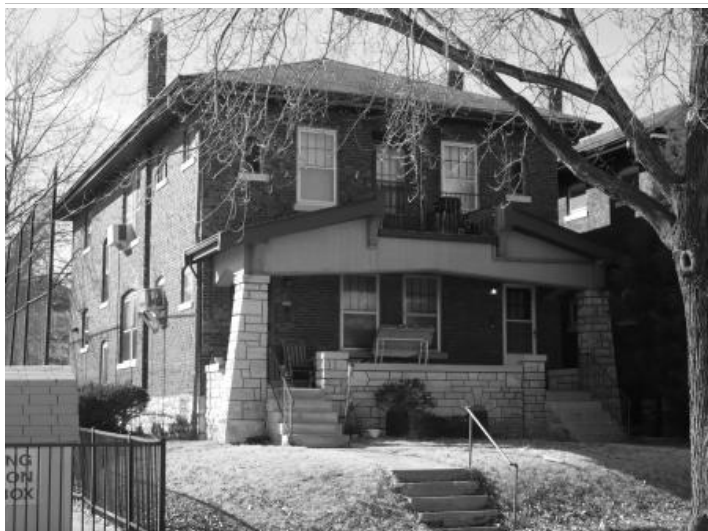
pressed wood siding over porch gable end

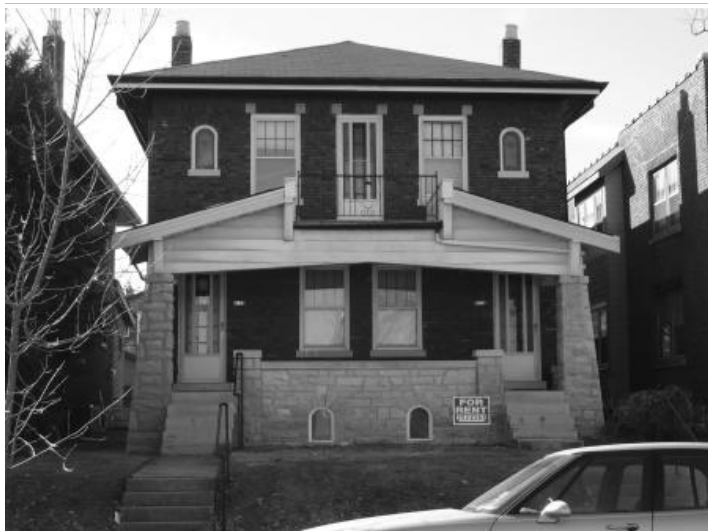
synthetic siding over porch's gable end/brackets

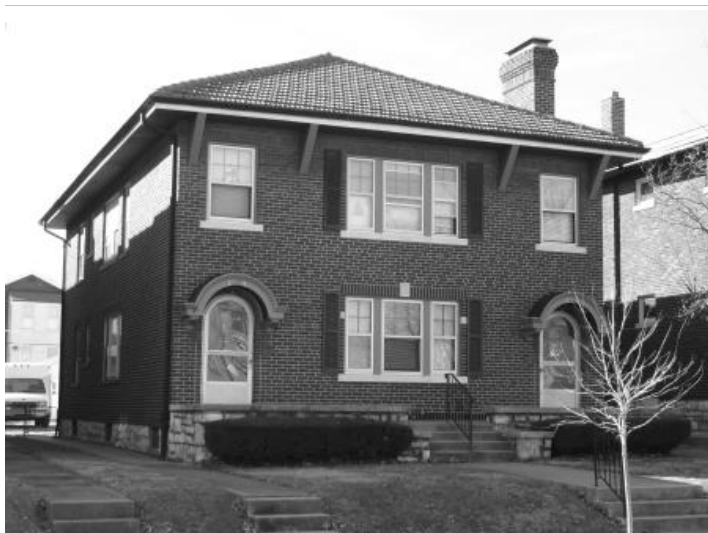
Plastic shutters added. Brackets and eaves covered with siding.

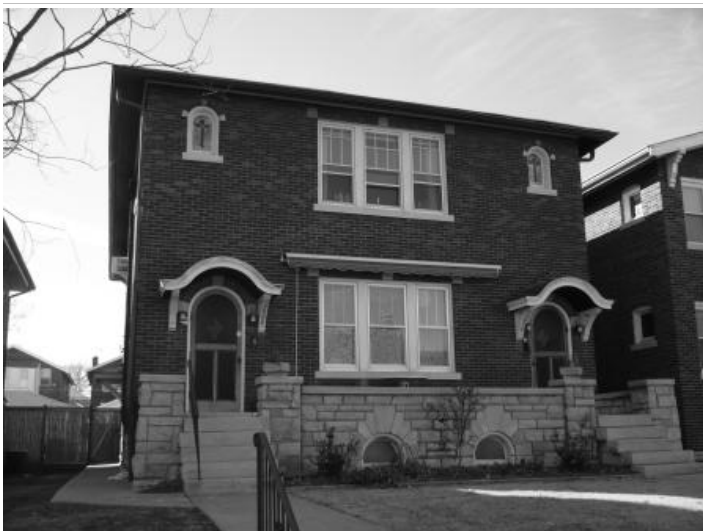
retractable awning over center bay, first story.

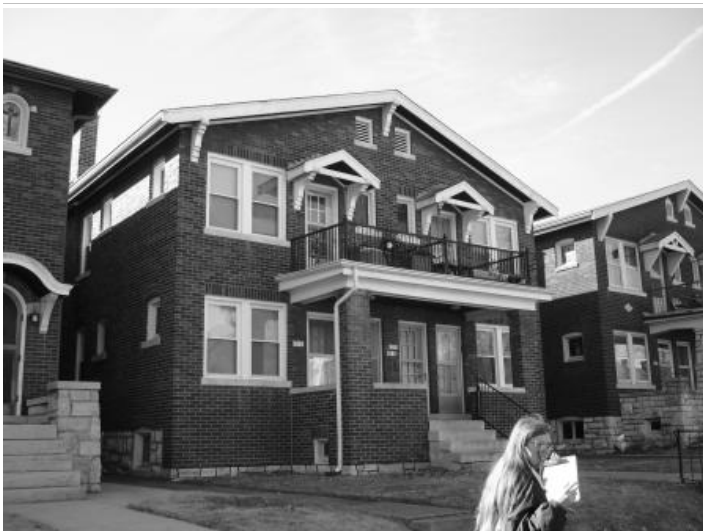
Replacement windows.

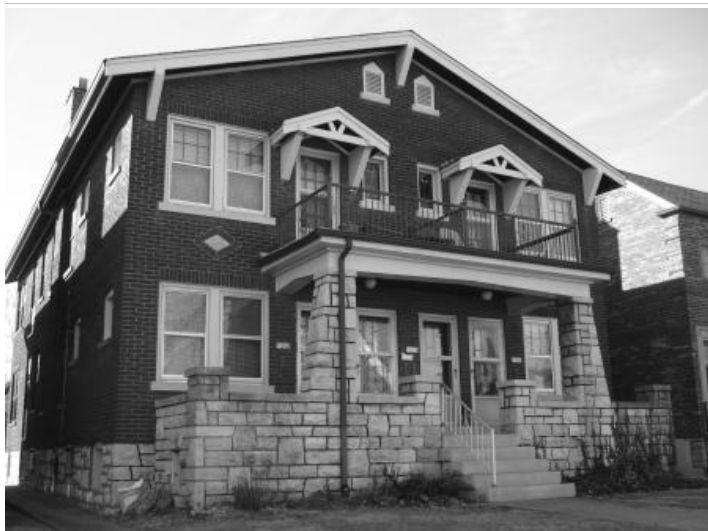
Vinyl covers porch entablature, 2nd story brackets and hoods.

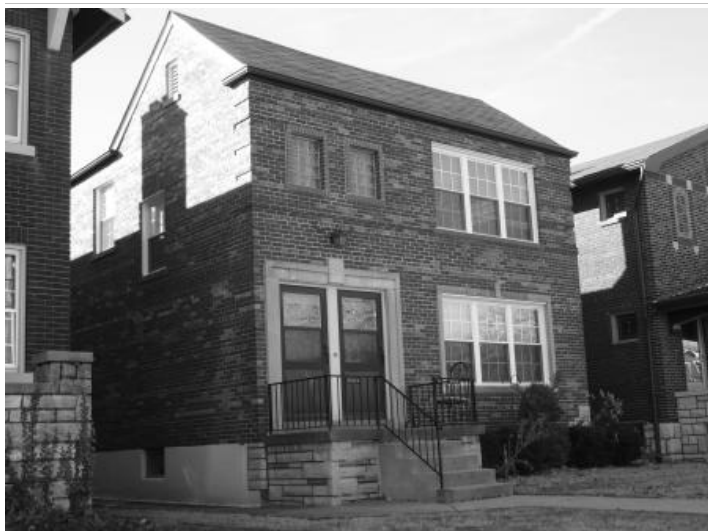
Replacement triple sets of windows at both stories of right bay.

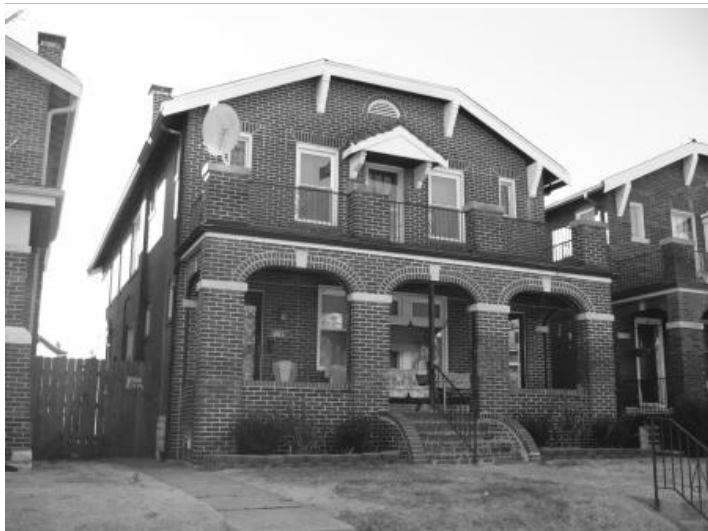
Replacement windows.

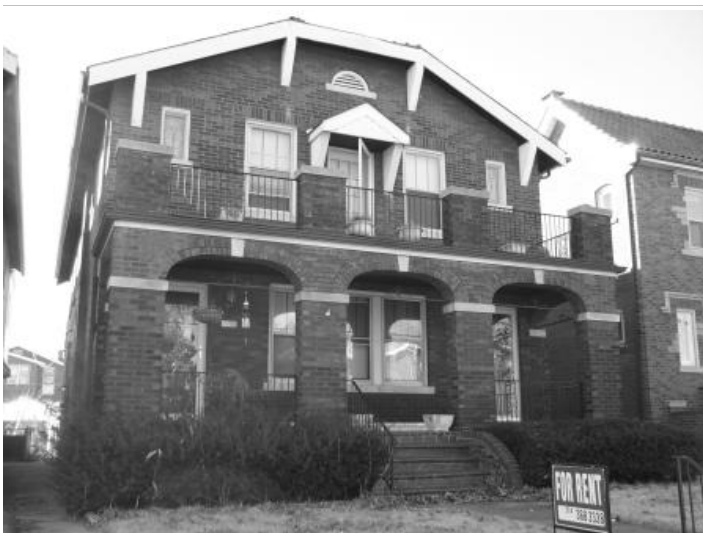
Gable hood and brackets at 2nd story sided.

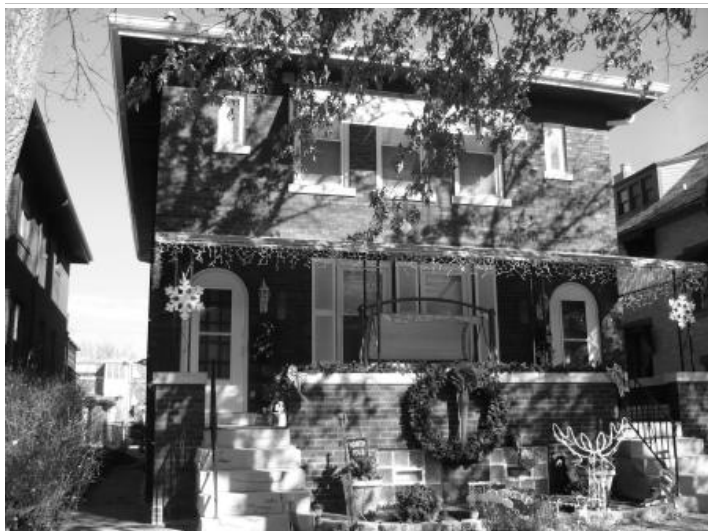
The brick front porch has a fiberglass awning roof on four trellis-style supports. Awning at 2nd story center windows. Replacement windows.

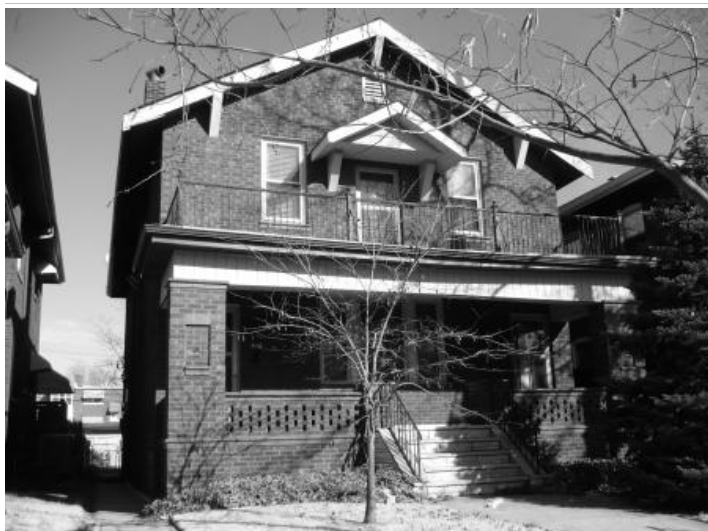
Replacement windows at first story; aluminum covers vergeboard, brackets, eaves.

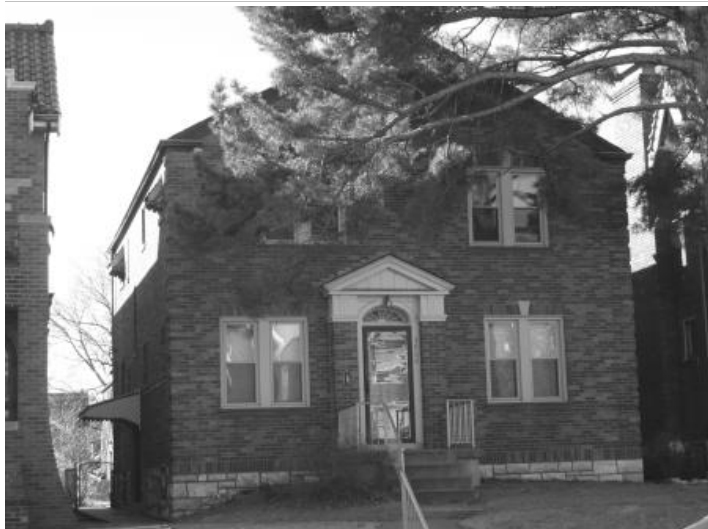
Paired façade windows are replacements.

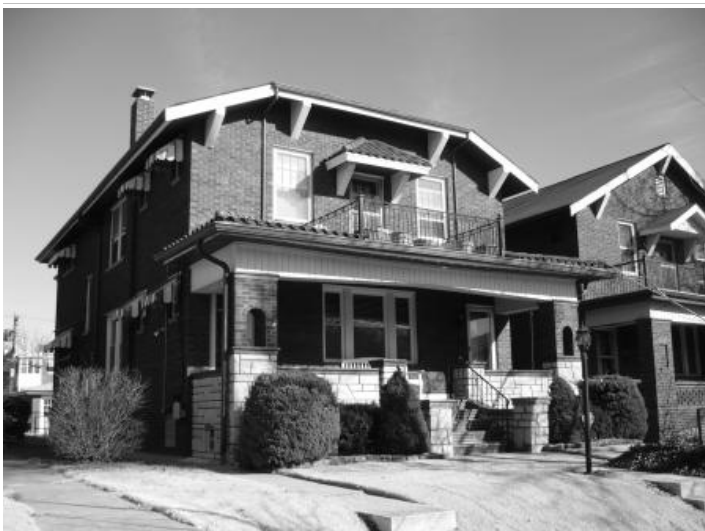
Replacement windows at first story; aluminum covers vergeboard, brackets, eaves.

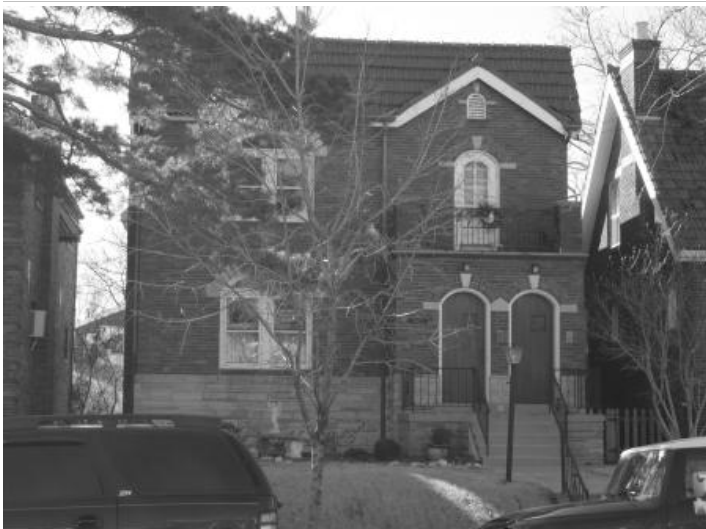
Imitation stone veneer at base may be added

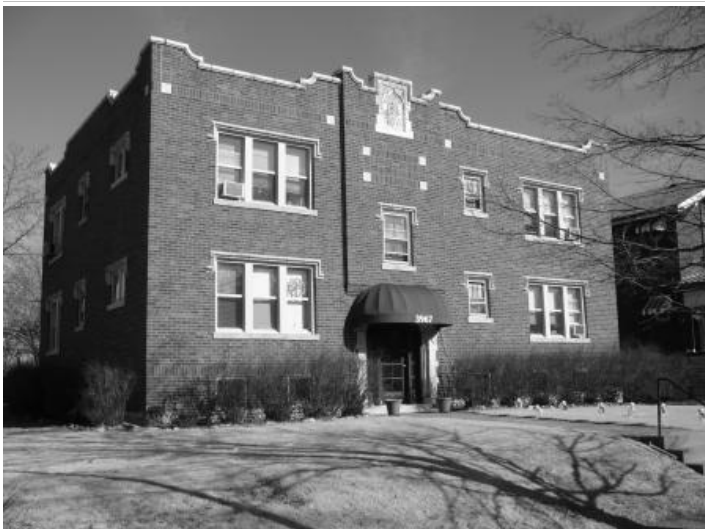
replacement windows; canvas awning over doors.

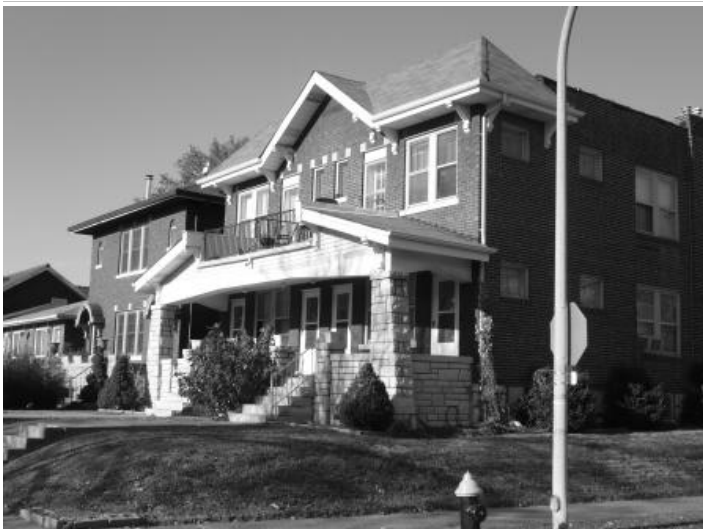
Siding covers the porch's gable end, vergeboards and eaves.

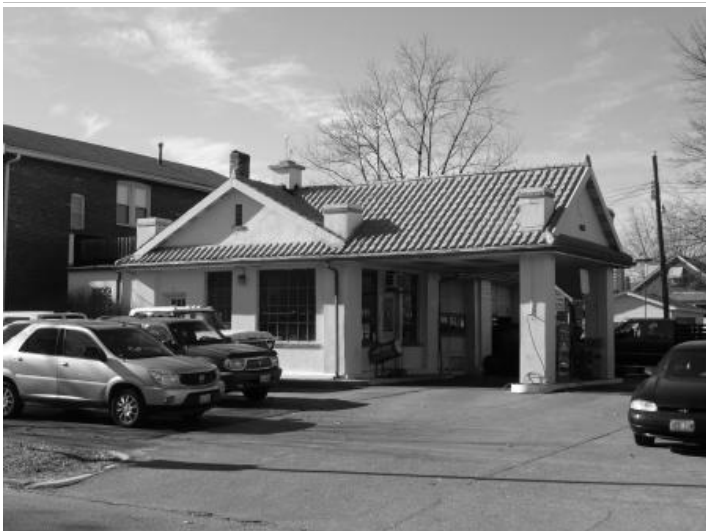
This stuccoed service station building has a gabled roof supported on piers over the bay in front of the office. Original wood windows intact. Tile roof intact but spalling. Brick rowlock detail.

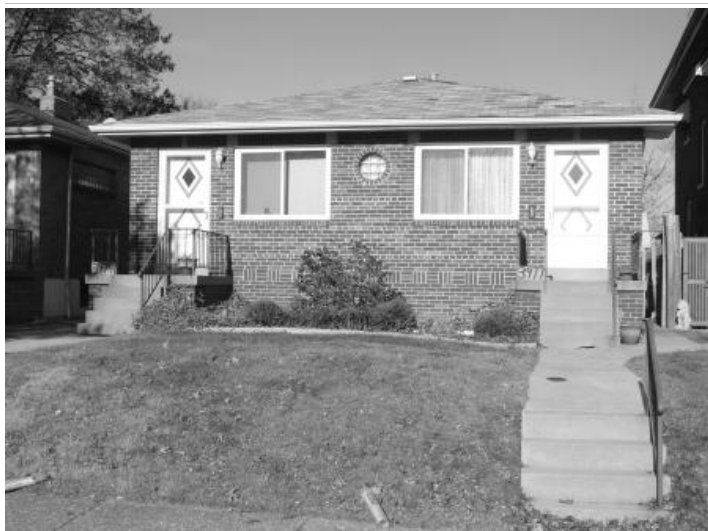
Windows are vinyl replacements.

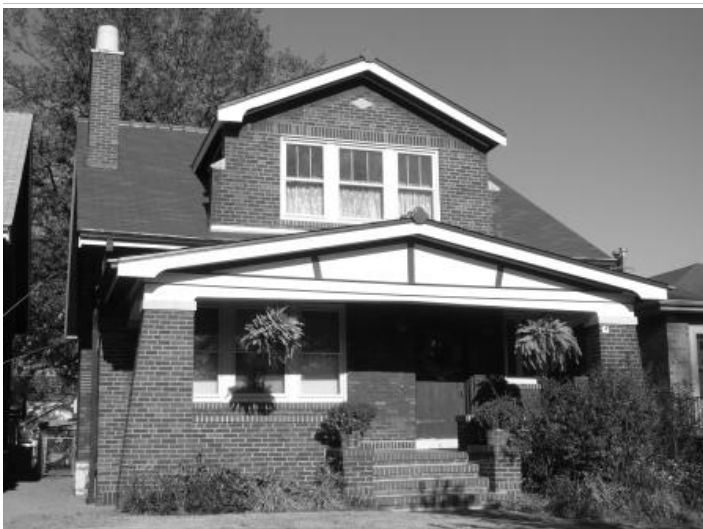
Some of the wood detail (window frame) is covered with siding.

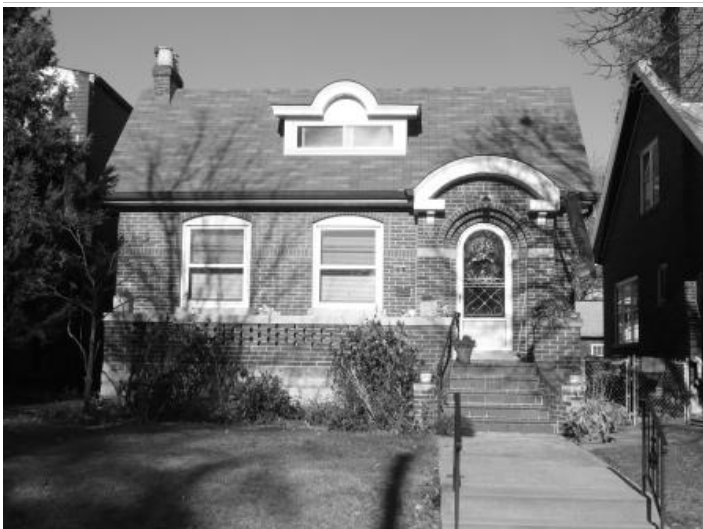
Replacement dormer window, aluminum siding wraps most wood trim.

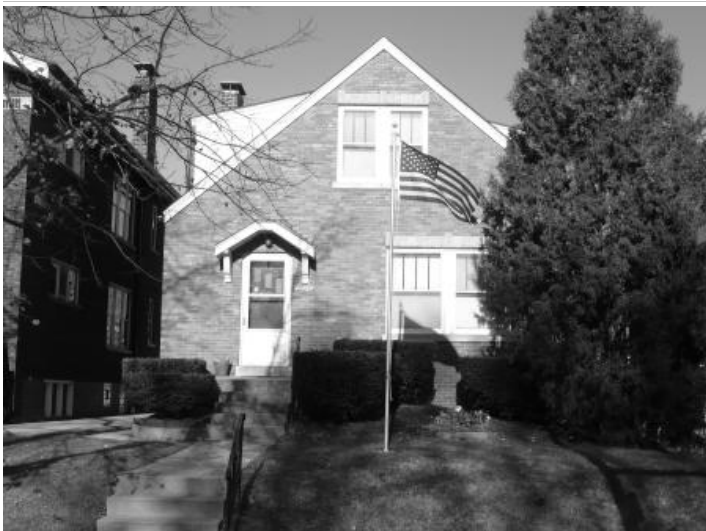
The front door's gabled hood is wrapped in siding, and the brick-faced dormers have modern horizontal siding on the sides facing the street.

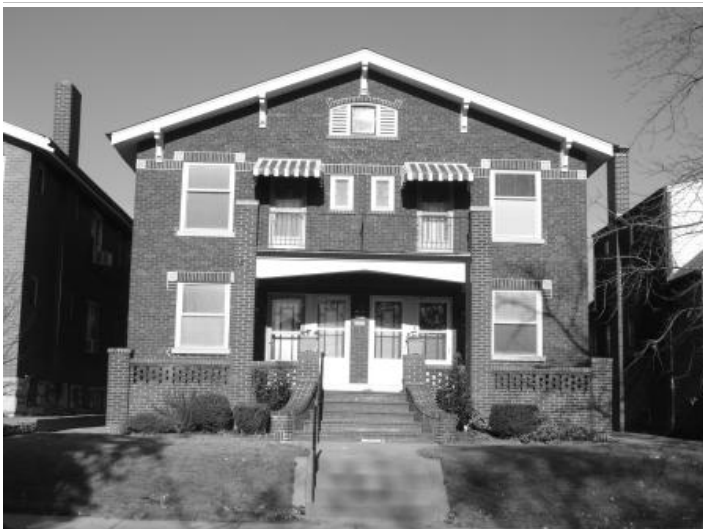
Wood trim is covered, and outer windows are replacements.

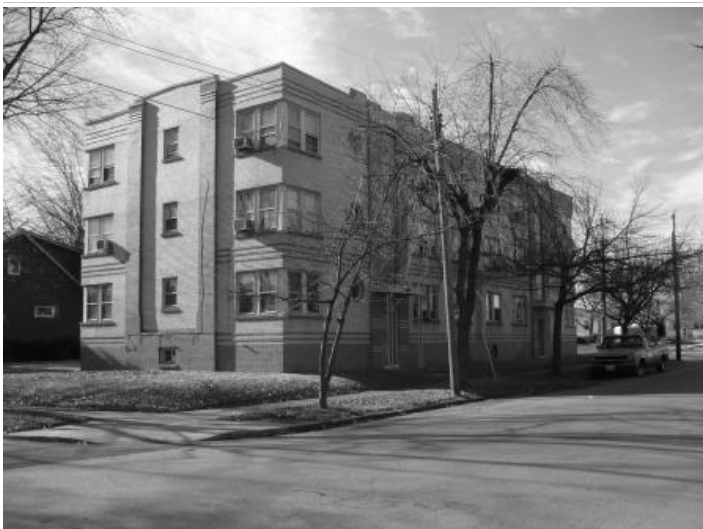
Aluminum coping. The two front doors appear to be later (midcentury) than the rest of the building.

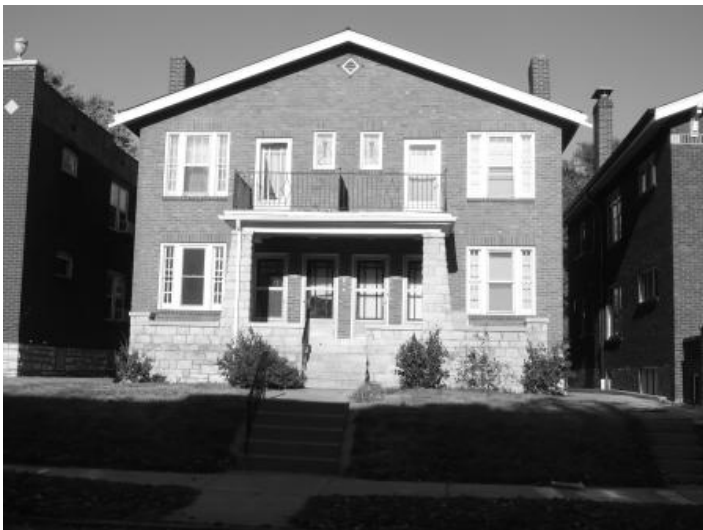
6/1 windows replaced by new 1/1s at first floor; wrapped porch soffits and trim.

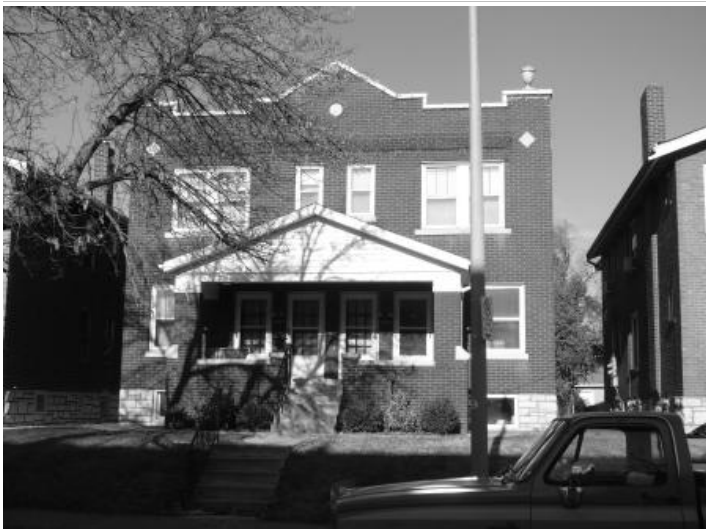
wrapped porch soffits and trim; modern horizontal siding over porch gable end.

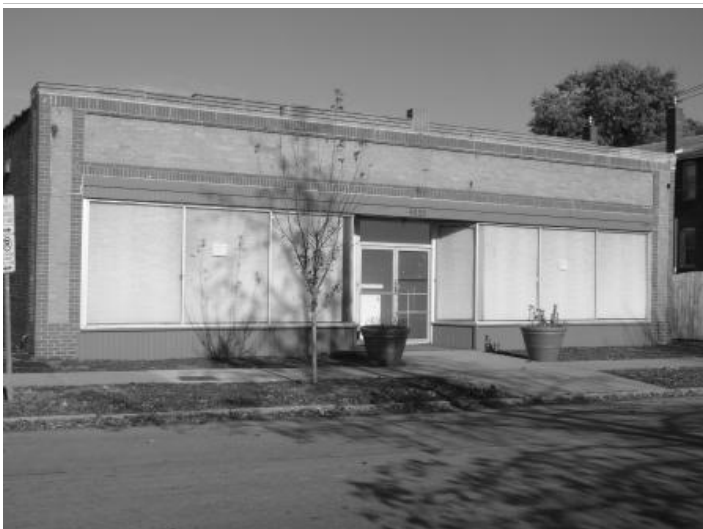
Intact storefront windows are unlikely to be original, and the bulkhead and transom areas are covered with wood paneling.

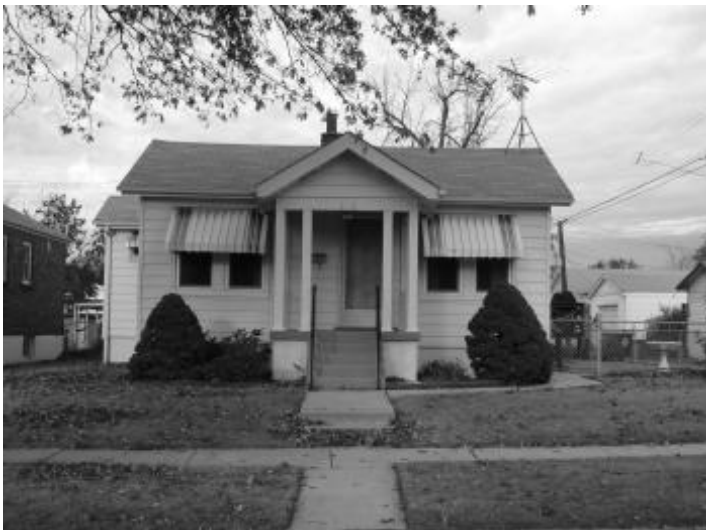
Replacement door; paired replacement windows to the left and right have metal awnings. Wood trim is covered mostly covered with siding/wrap.

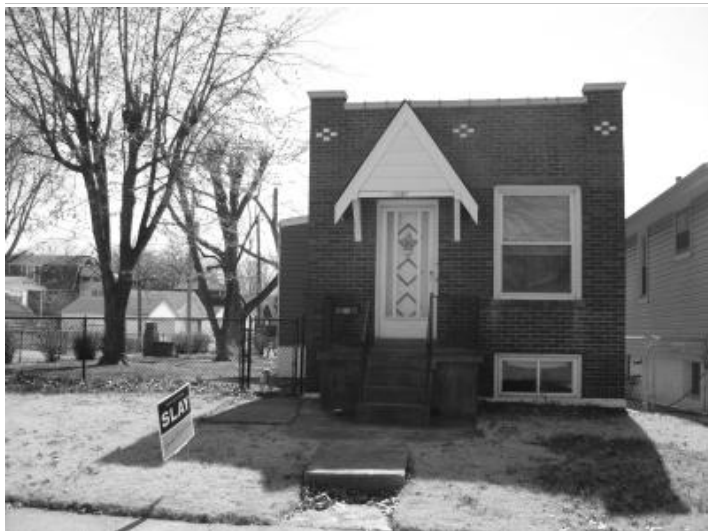
Front door is a 1950s-era replacement. Replacement façade window. Siding at gable end of hood.

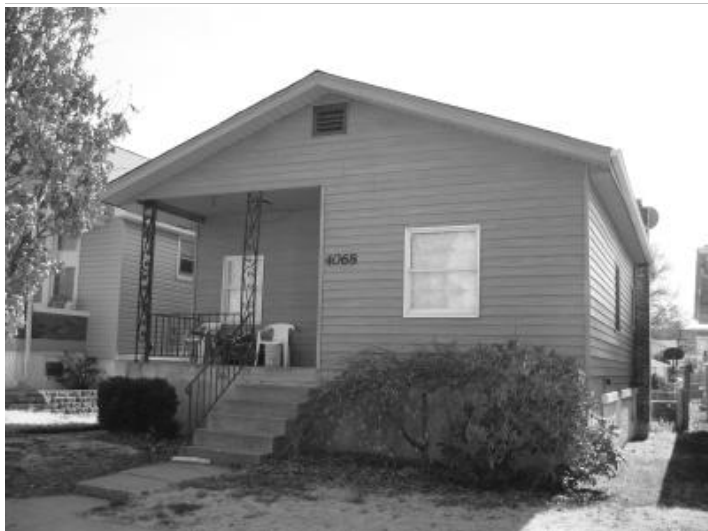
This front gabled house has an inset porch at the left side of the façade; two metal trellis-style supports replace the original posts.

Replacement windows and doors.

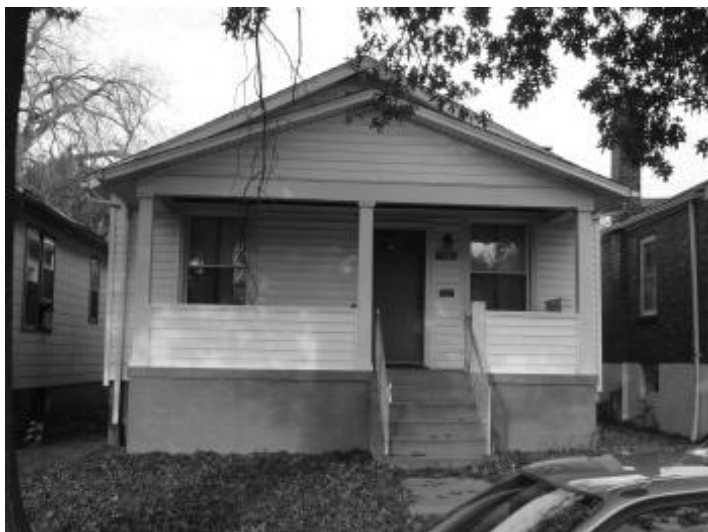
Facade is vinyl-sided; side elevations are covered with asbestos shingle. Replacement front door; left and right facade windows are replacements. No original wood trim is visible.

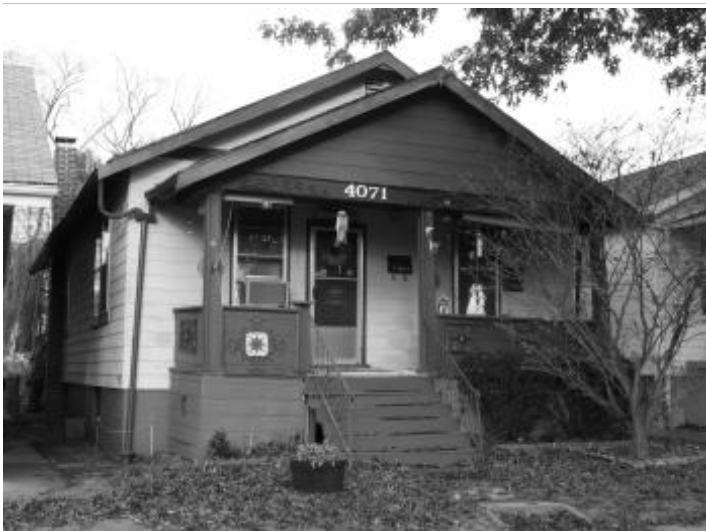
Replacement front door.

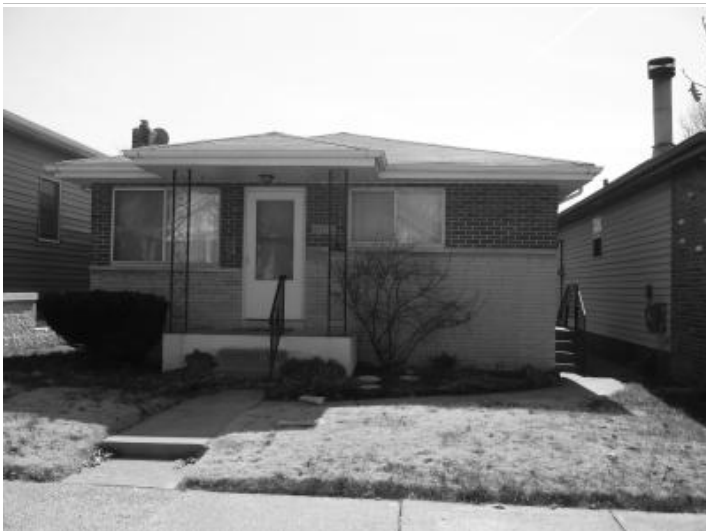
Replacement windows.

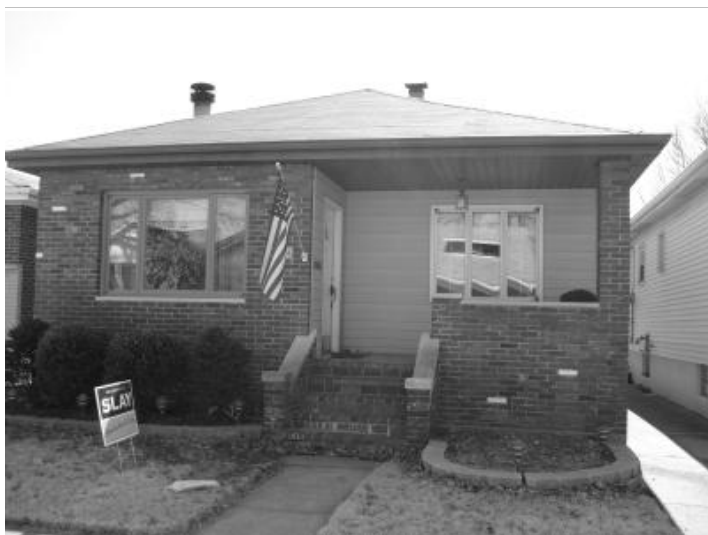
New windows and door

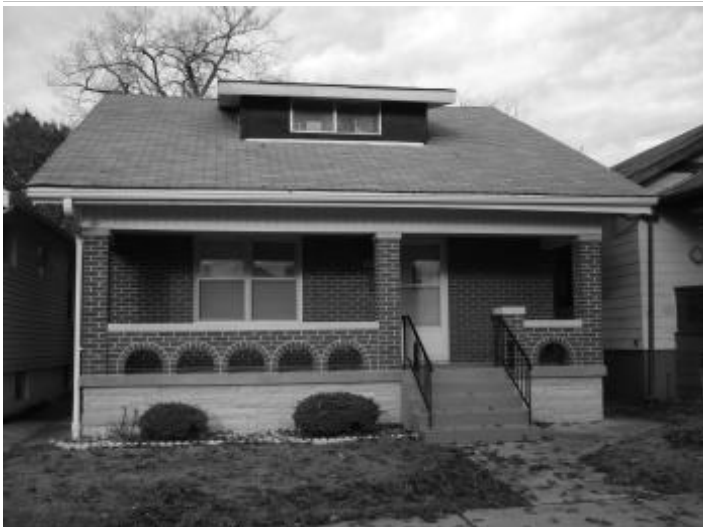
The front door is a replacement, as are the façade windows. Not original wood trim visible.

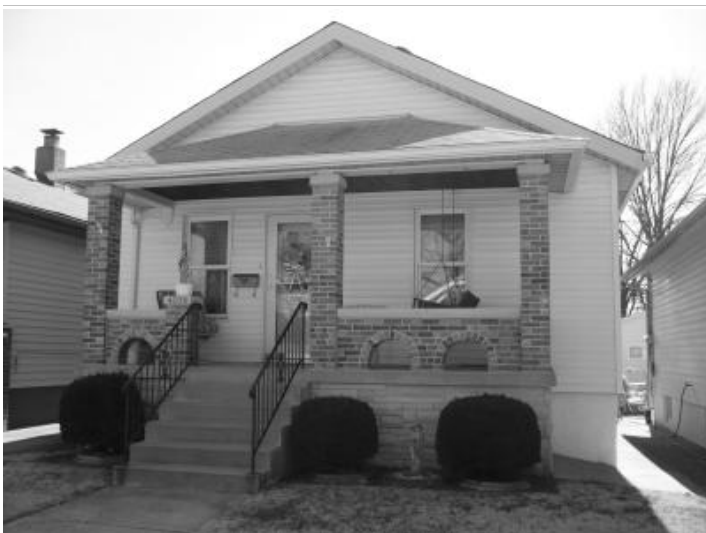
Replacement door and windows

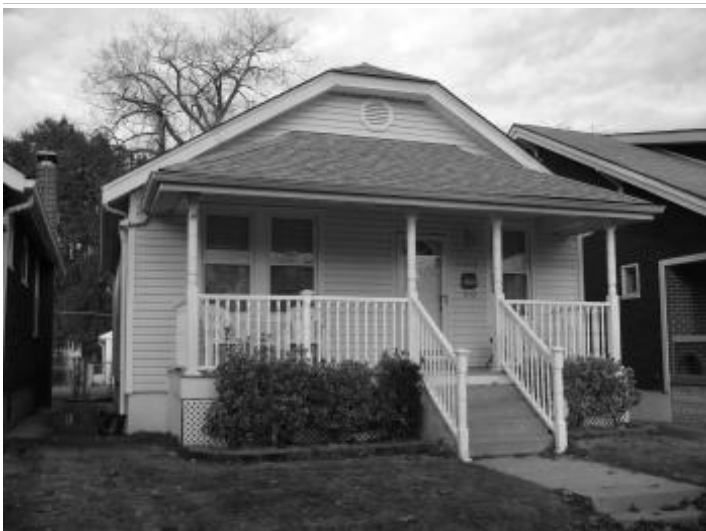
The wood porch has 4 replacement posts. Replacement windows and front door.

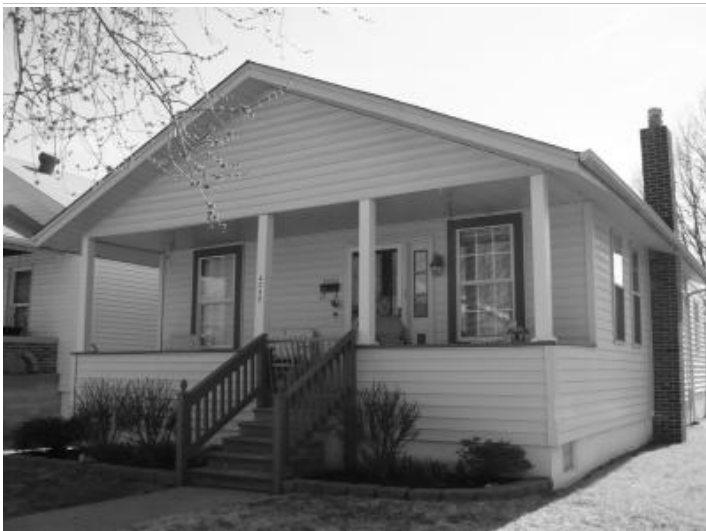
Replacement door and windows.

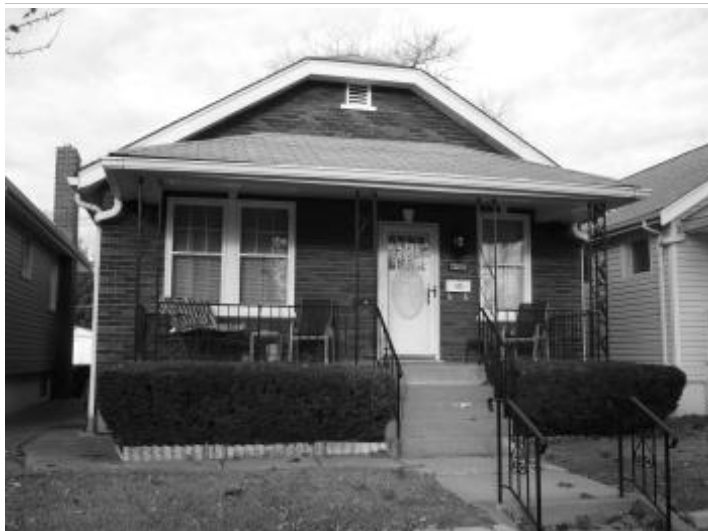
Asphalt siding imitates brick. Metal porch support on concrete porch.

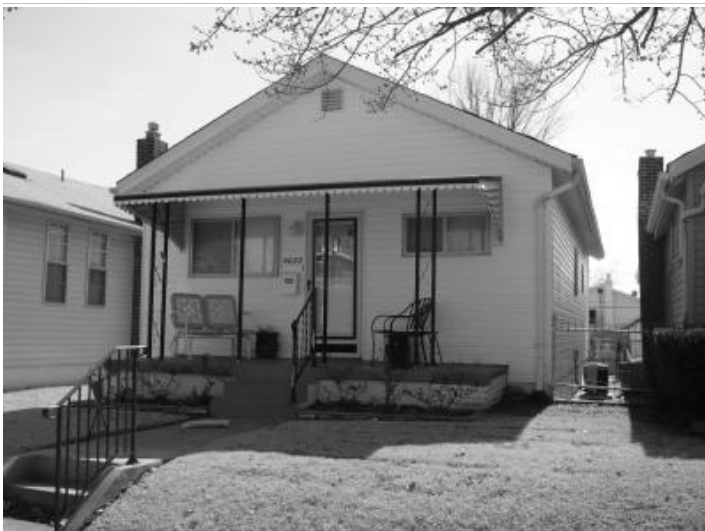
The front windows have been replaced with horizontal openings and slider windows.

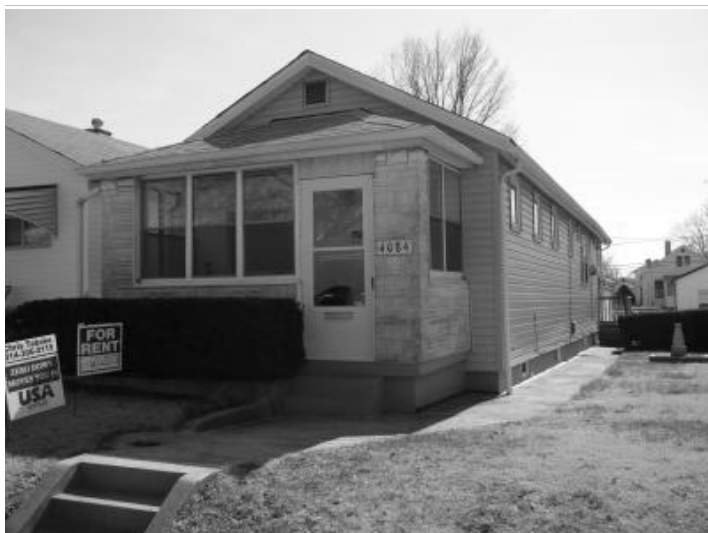
Vinyl picture window and new door.

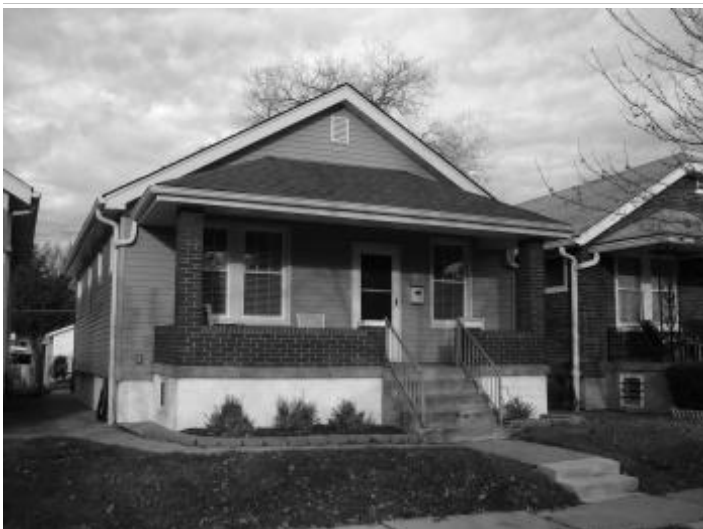
Replacement door and windows.

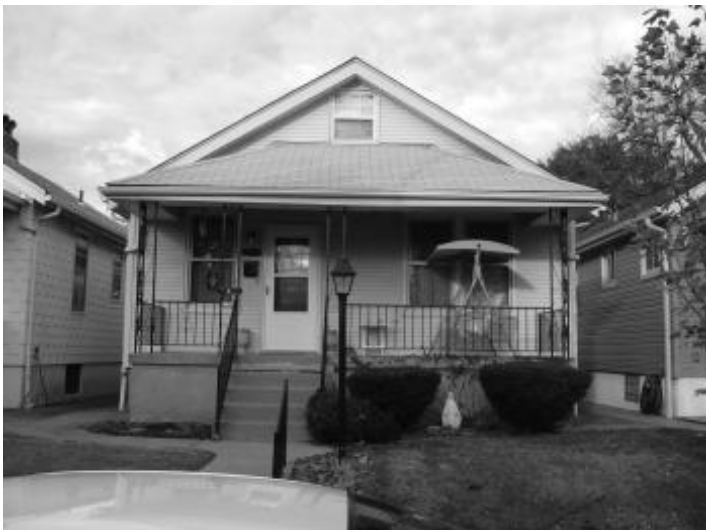
The front porch is on a concrete base and has four metal trellis-style supports. Vinyl siding covers part of window trim and other details. Replacement attic window.

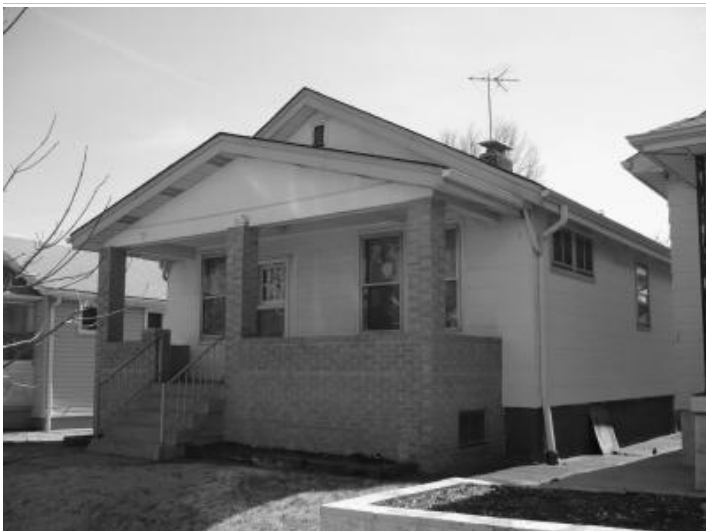
Replacement windows, eaves wrapped

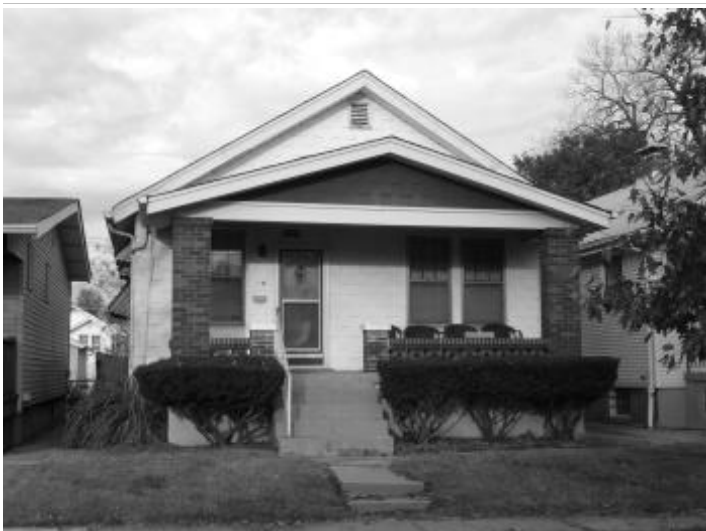
The front door is a replacement. Original wood trim is covered with siding.

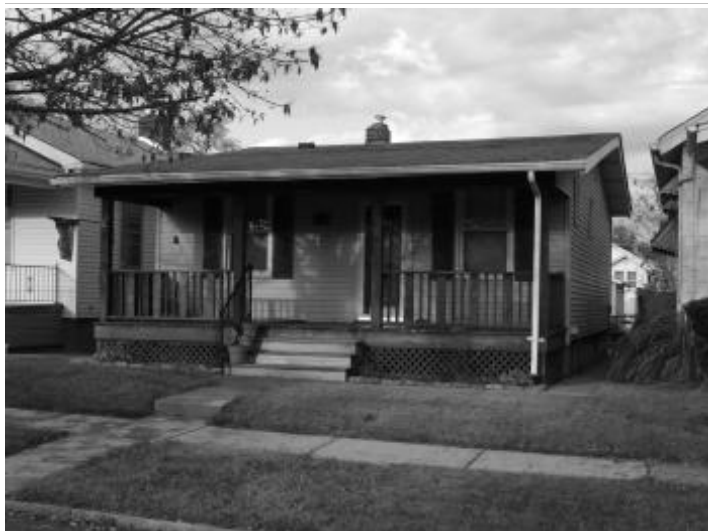
Replacement windows; wood trim obscured by siding. Shutters added.

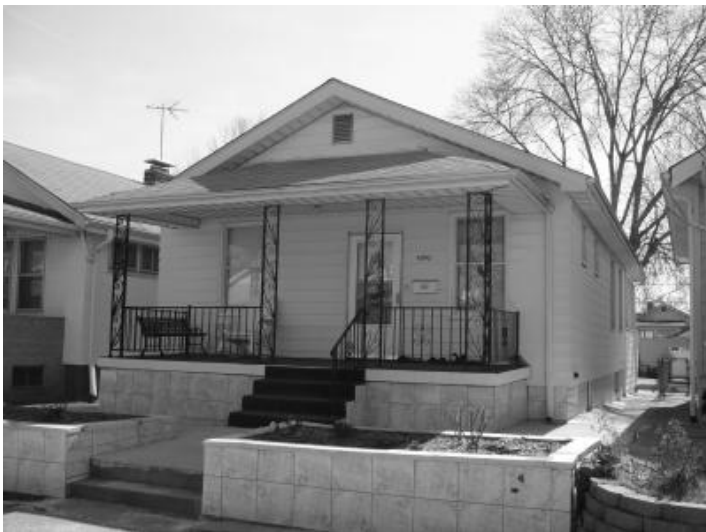
The foundation, retaining wall/planters, and concrete porch base are covered with 12" square ceramic floor tiles. Porch piers are replaced by metal trellis-style supports. Front door and windows are replacements.

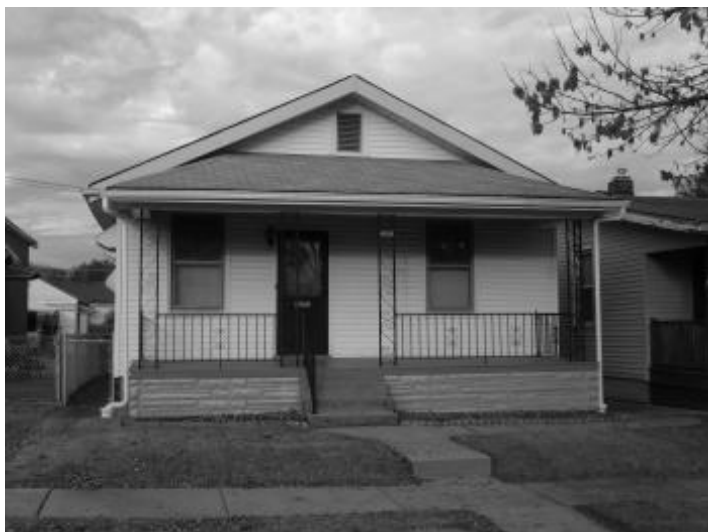
The front porch is on a concrete base (covered with imitation stone veneer) and has four metal trellis-style supports. The front door is a replacement. Wood trim is covered by siding or wrapped.

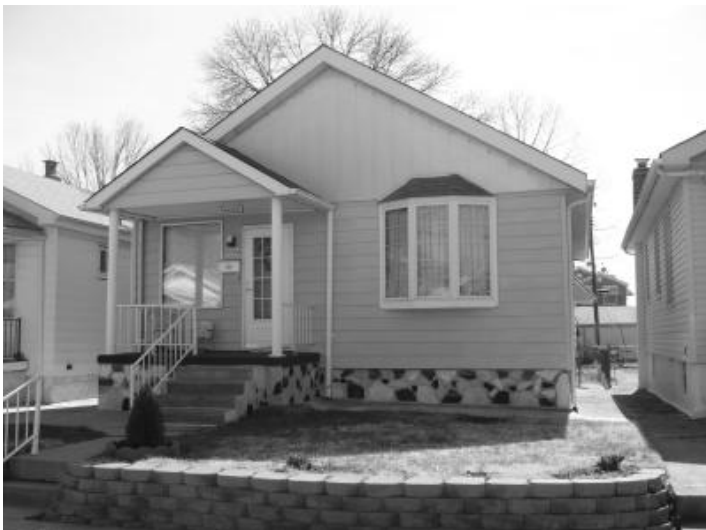
Replacement front door. Replacement windows are not historically appropriate. Vertical siding in house's gable end. Foundation and porch creatively faced with scrap polished stone pieces.

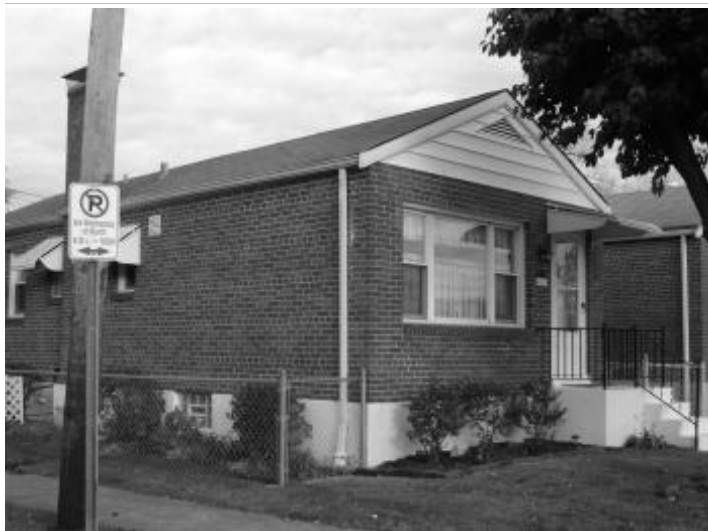
Windows are replacements. Painted fiberglass awnings.

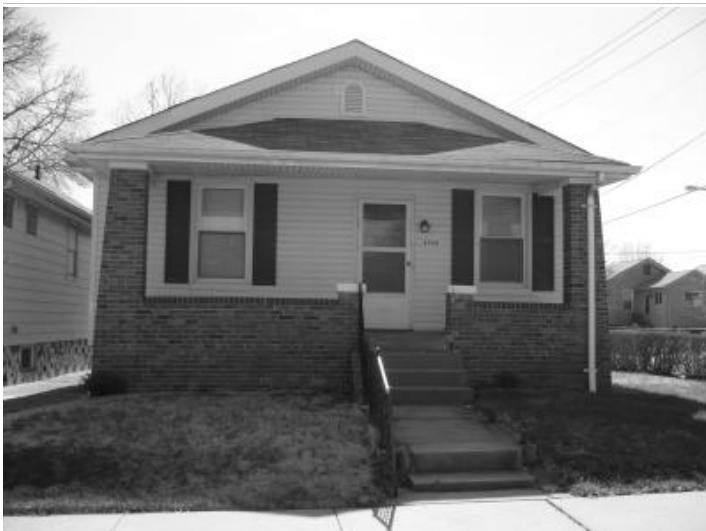
Replacement door and windows; window trim retains original proportions although wrapped.

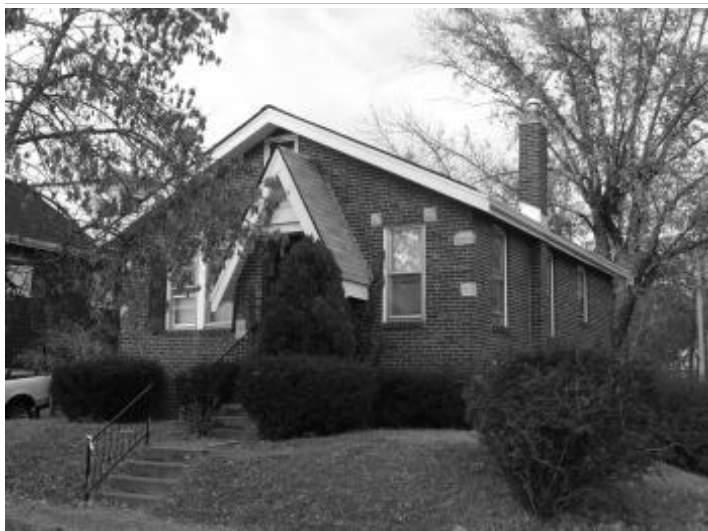
New windows; siding/wrapping over original wood trim.

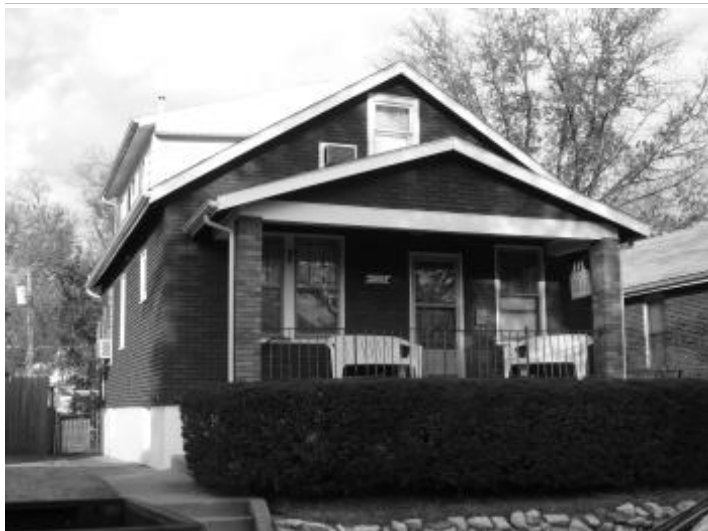
Front door is a replacement; odd dormer addition.

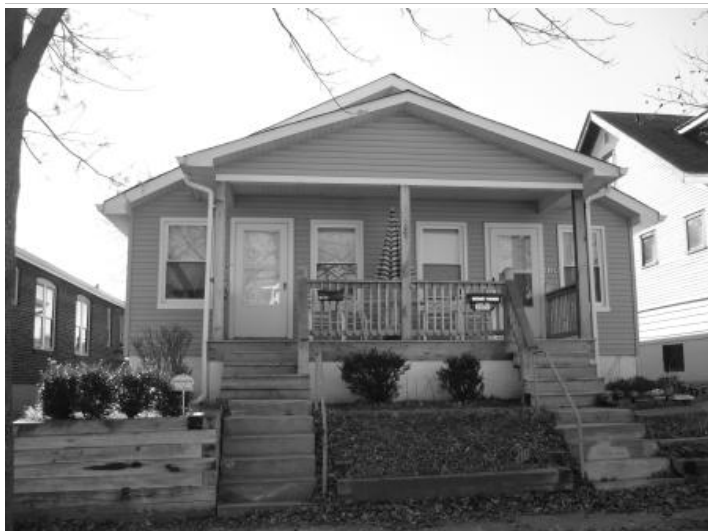
New doors and windows; vinyl siding

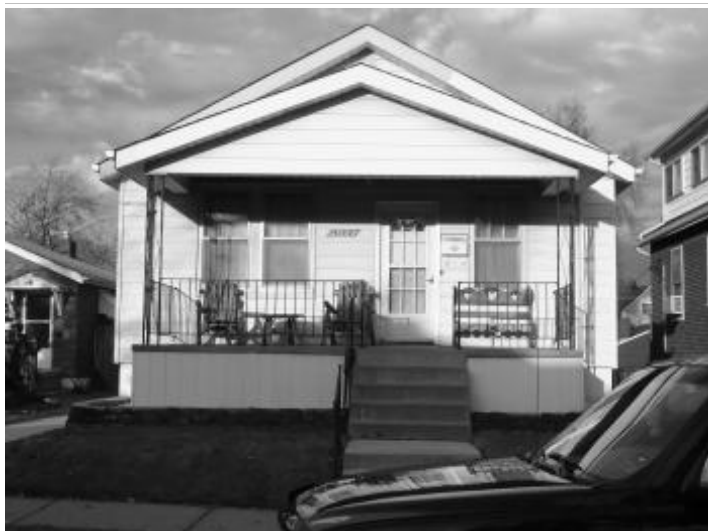
The front gabled house has a gabled front porch, just short of full-width, its roof supported on two replacement metal posts. The first story windows are original (a pair of 3/1s at the left and a single 4/1 at the right).

front door is a replacement.

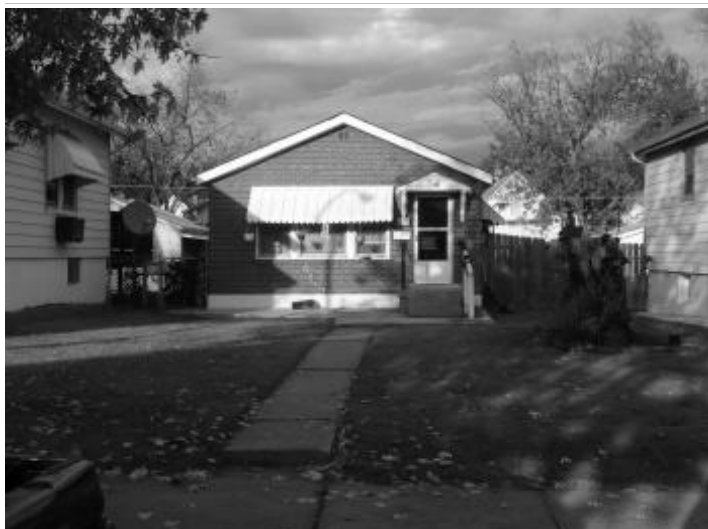
Awning over windows, left.

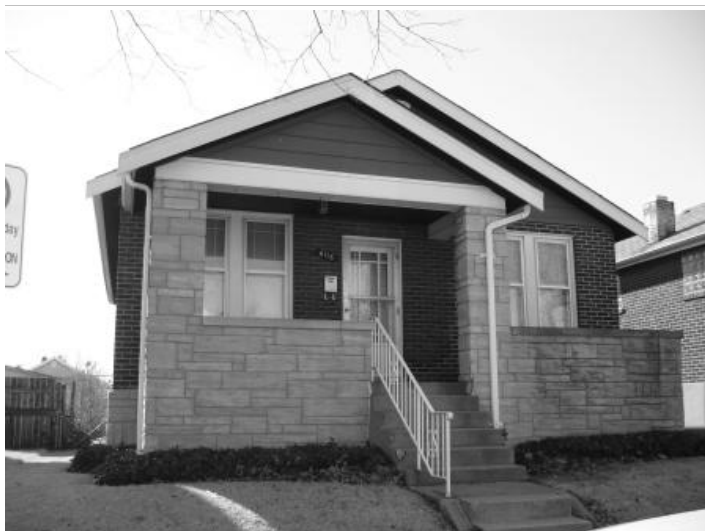
Horizontal siding in gable ends. Replacement windows. Imitation stone veneer covers porch.

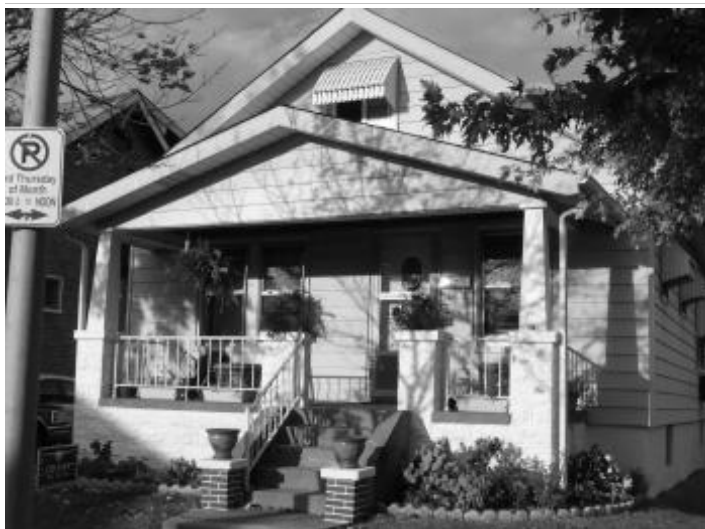
Replacement front door.
