City of St. Louis Cultural Resources Office

Holly Hills Neighborhood Survey

Lynn Josse and NiNi Harris
3/1/2010

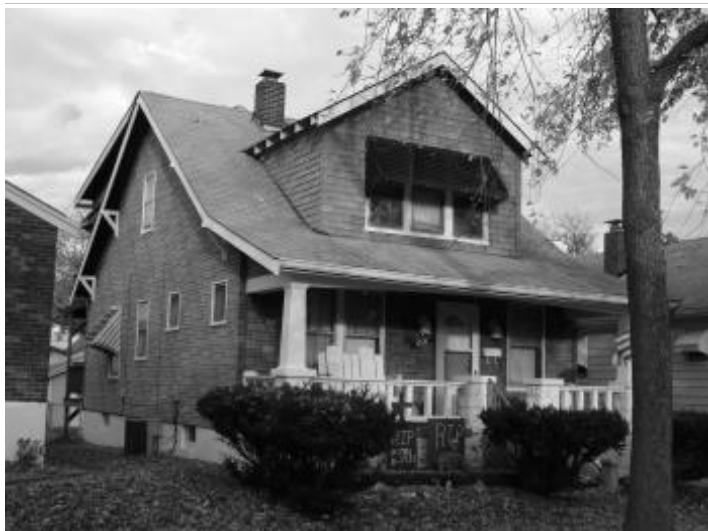
Replacement door.

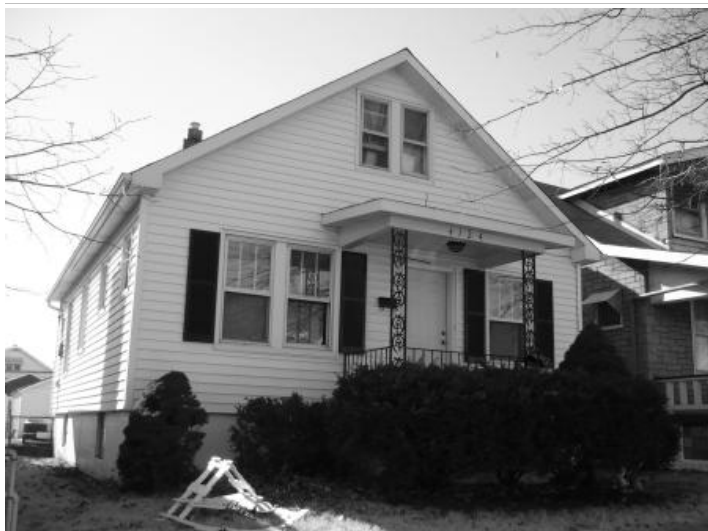
The front door is a replacement. Shed porch, center, on metal supports.

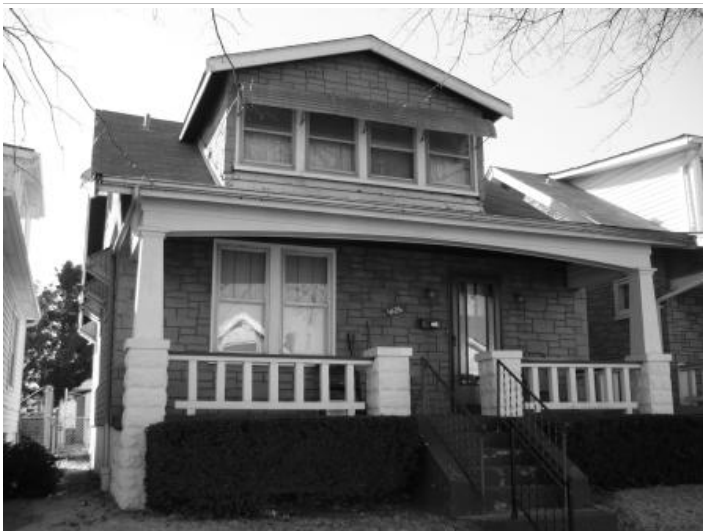
imitation stone veneer siding makes building non-contributing

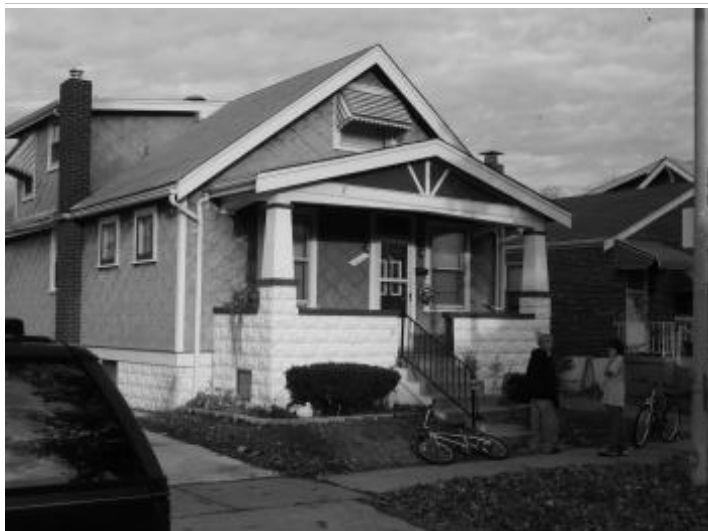
Cement shingles are non-historic; doors and windows are replaced.

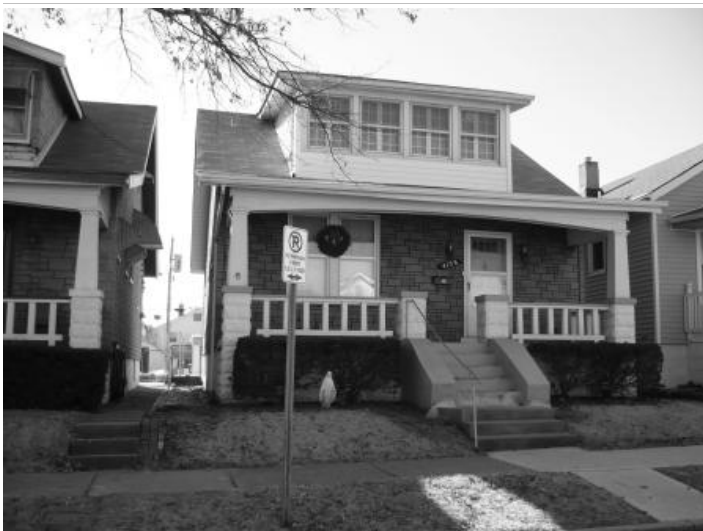
Asphalt siding (imitating stone) makes building non-contributing

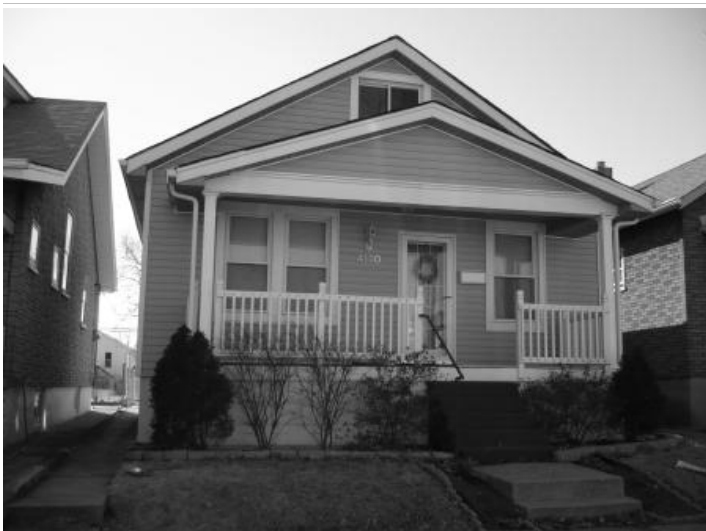
While no original materials are visible, original trim is wrapped rather than replaced.

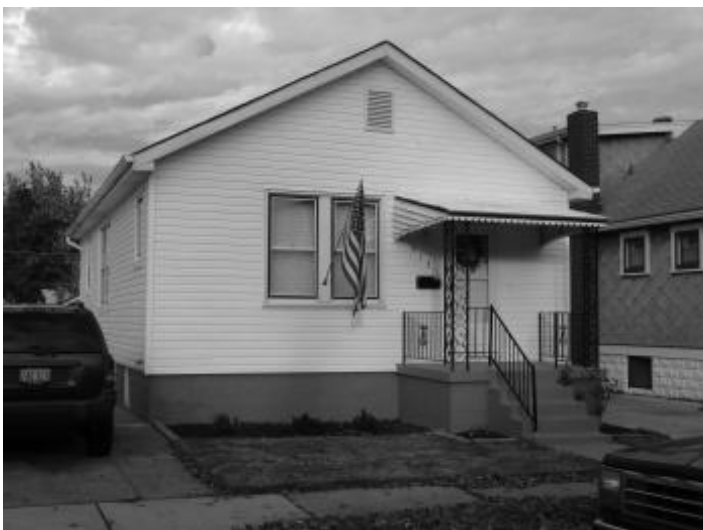
This front gabled house has a replacement concrete porch at the right side of the façade. There is a 1925 permit for this house but the bldg. does not match others from same permit.

Replacement porch has metal awning on two metal trellis-style supports. The façade's two 1/1 windows are not original. The front door is a replacement.

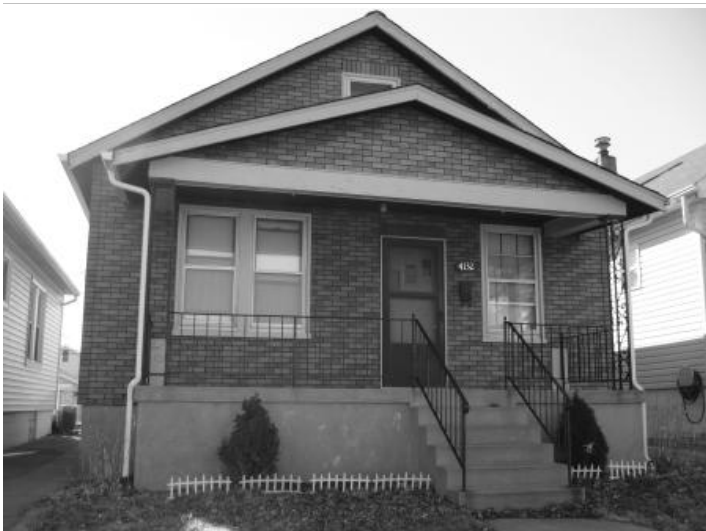
The front porch, just shy of full width, has a concrete base and metal supports. Replacement door. Imitation brick siding.

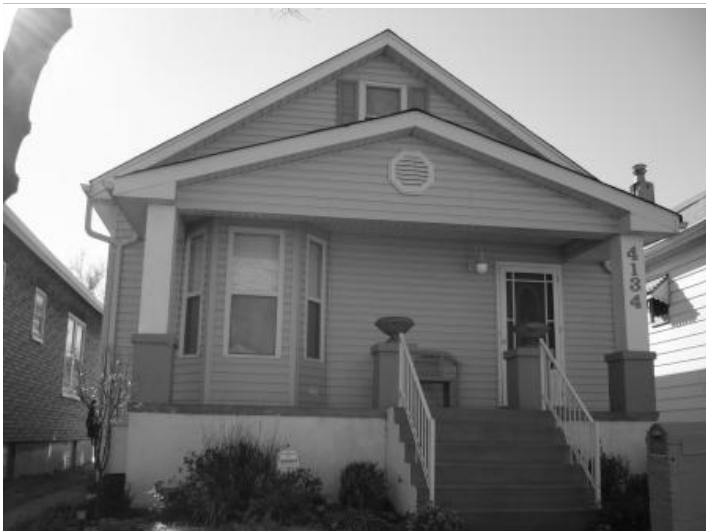
The front porch, just shy of full width, has a concrete base. Replacement door.

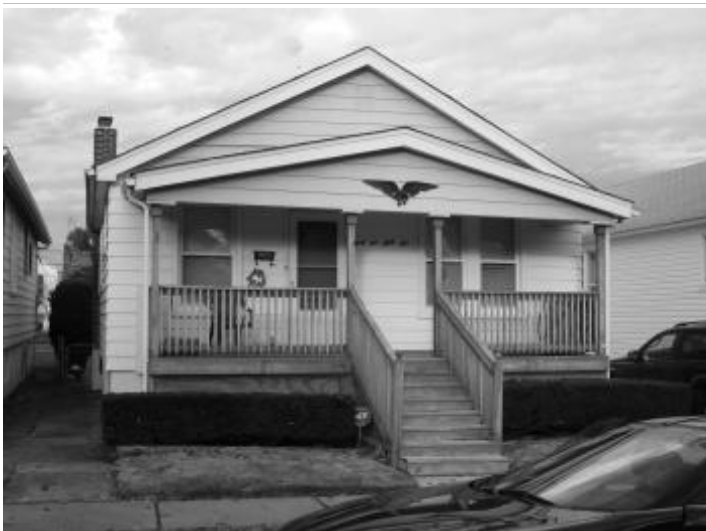
The porch roof is supported on four replacement wood posts on a wood base. The front door is a replacement., as are the façade windows.

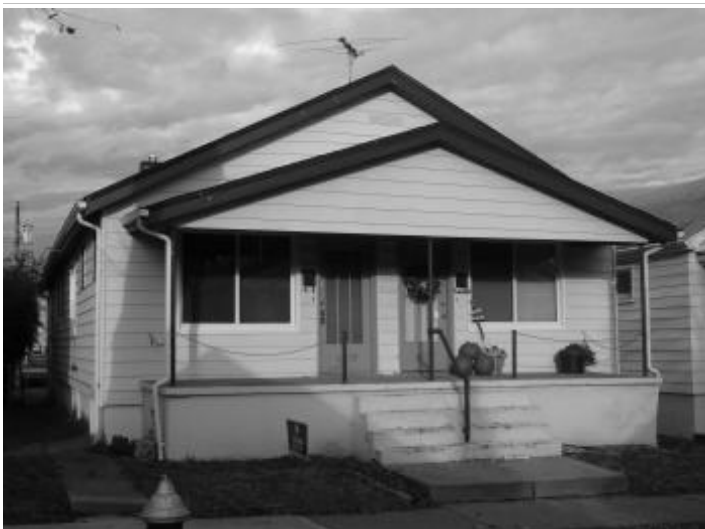
Picture windows replace originals. Concrete porch has metal pipes instead of columns.

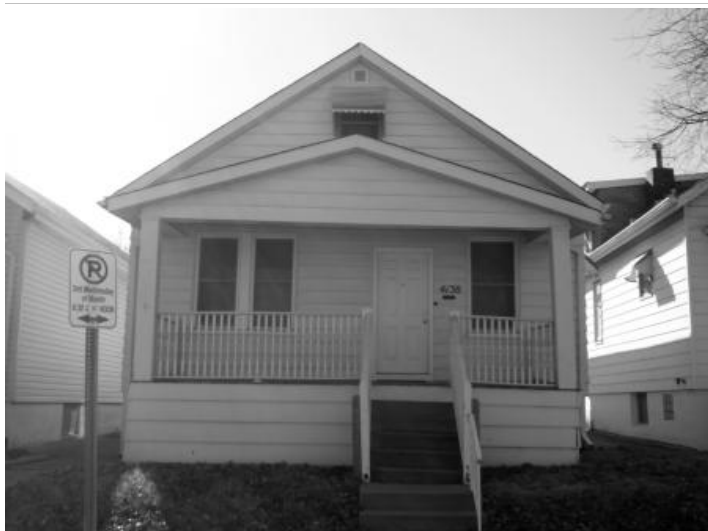
Replacement door. Window trim is covered over with wide siding.

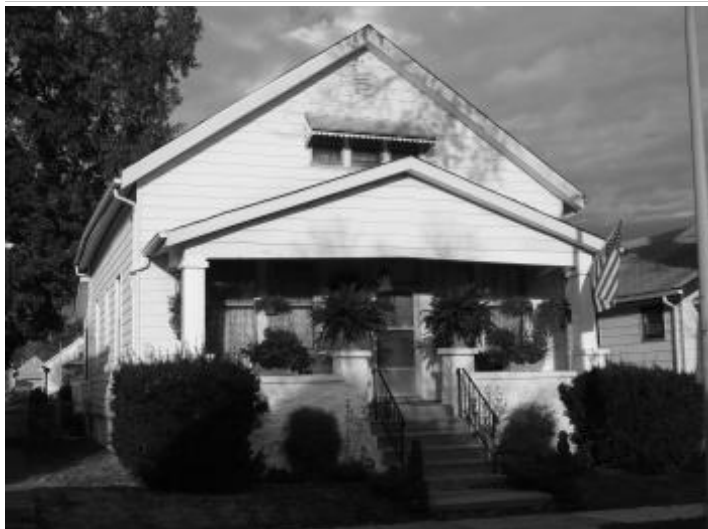
Most of the window trim is obscured by siding and the transom over the door is covered. A metal awning is over the second story windows.

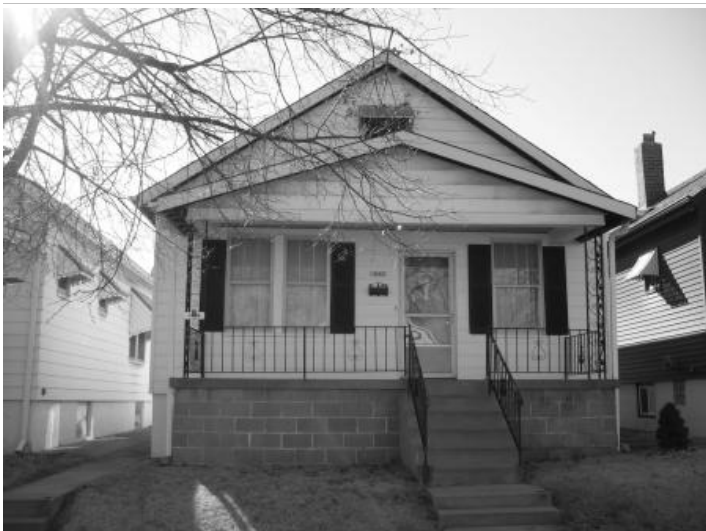
Concrete block porch base and metal supports. Inoperable shutters added. Window trim obscured by aluminum siding.

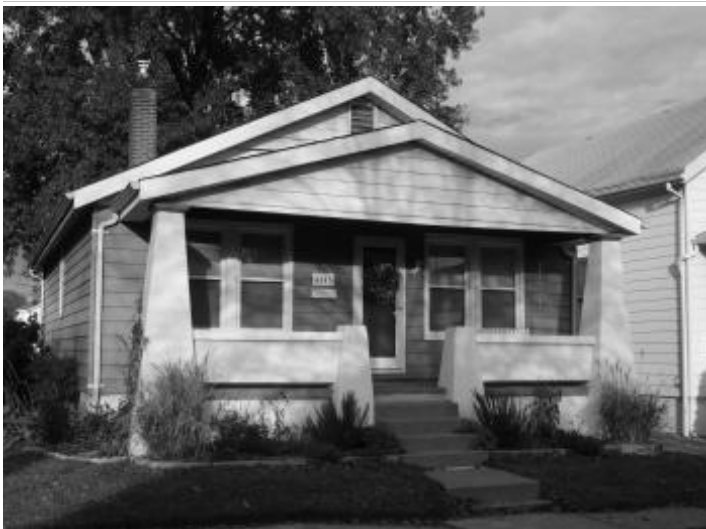
Siding fills the gable end; the front door and windows are replacements. None of the original wood trim is visible (it's either sided or wrapped).

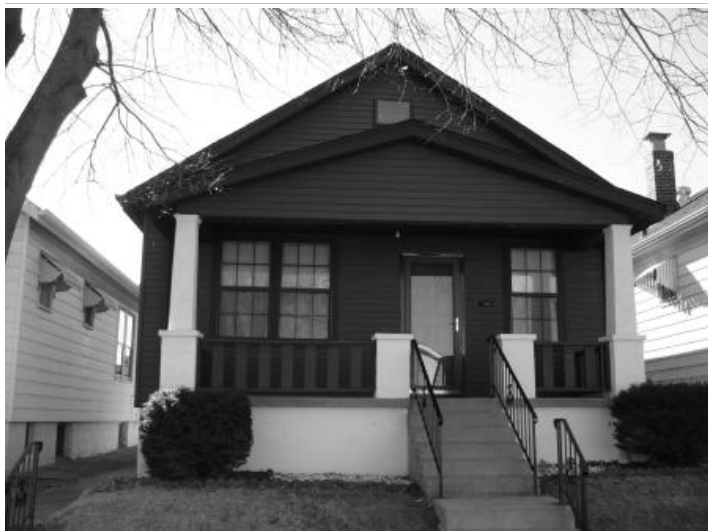
Replacement door and windows, but siding is believable and window trim OK.

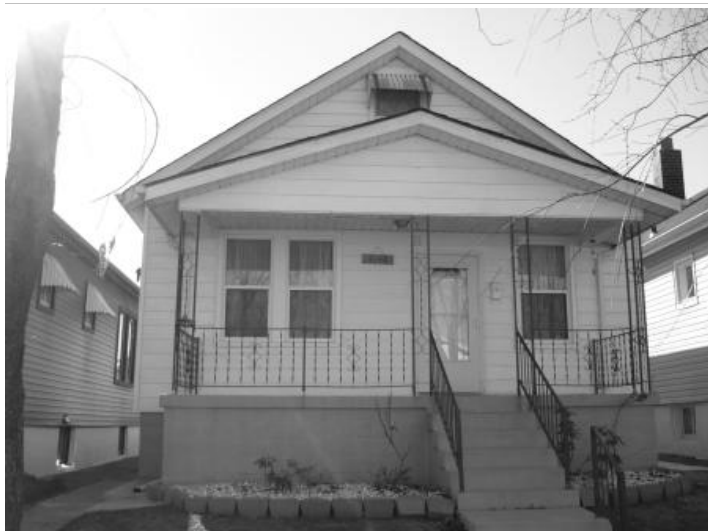
Concrete porch base has metal trellis-style supports. Replacement door and windows.

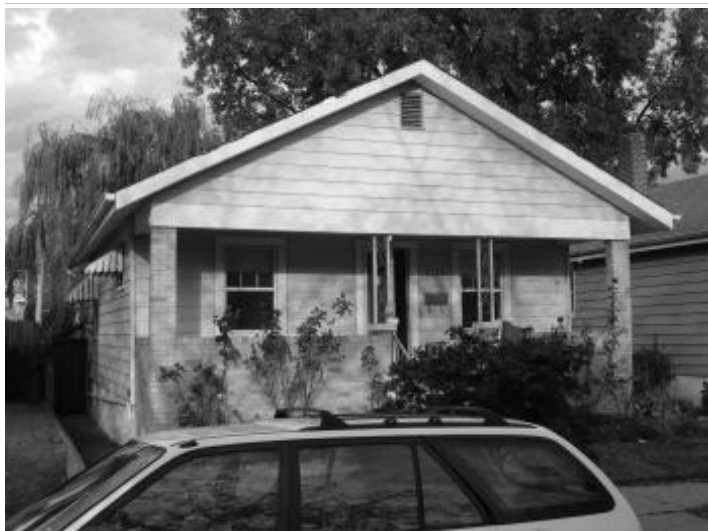
Two metal supports are added at the front porch. The front door is a replacement.

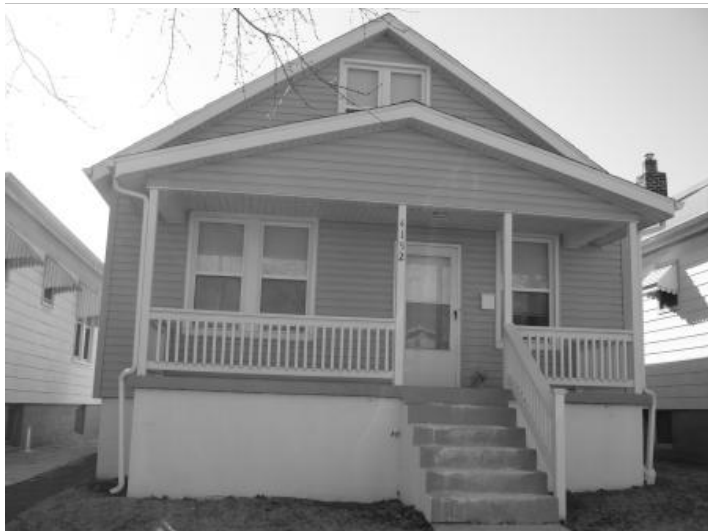
Concrete porch base has new wood supports. Replacement door and windows.

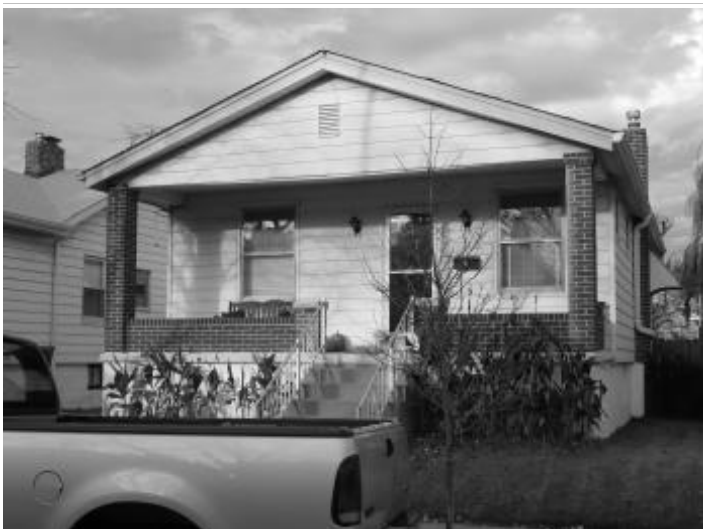
The front door is a replacement. Any wood trim is hidden by siding or wrapping.

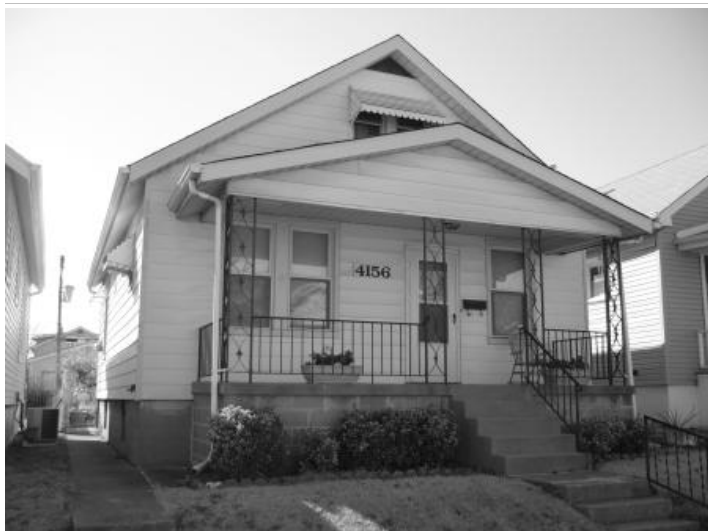
Concrete block porch base has metal trellis-style supports. Replacement door and windows.

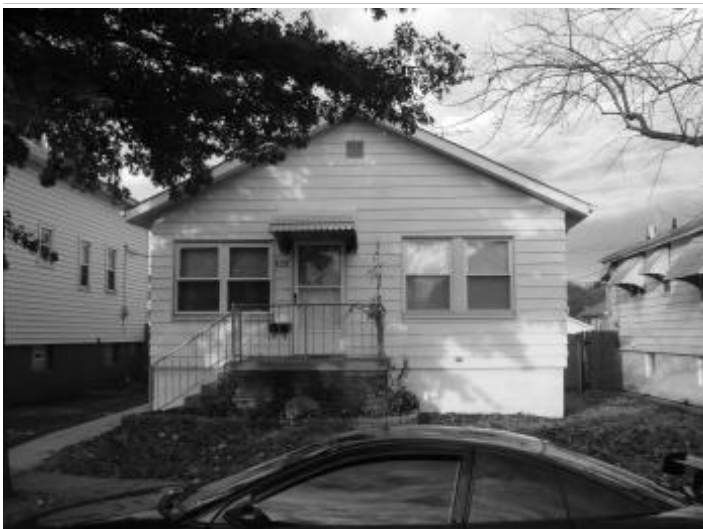
The front door and both façade windows are replacements.

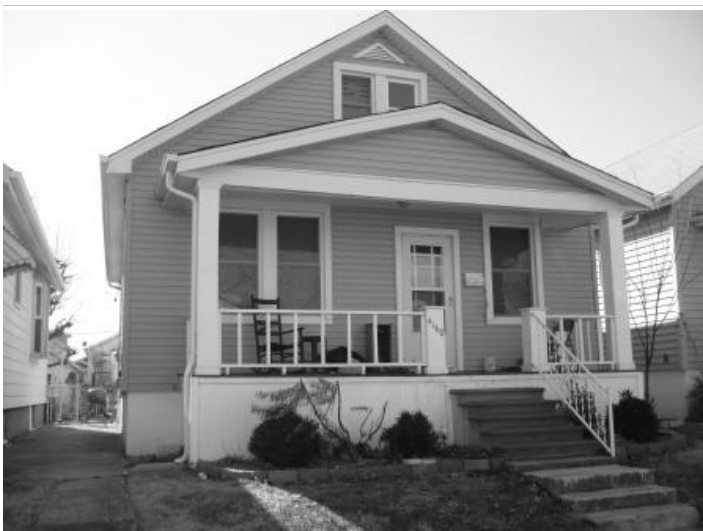
Replacement windows

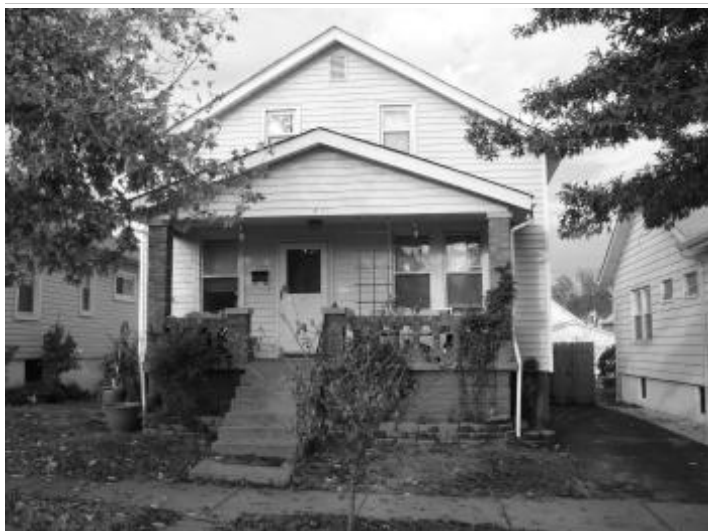
The front door and windows are replacements.

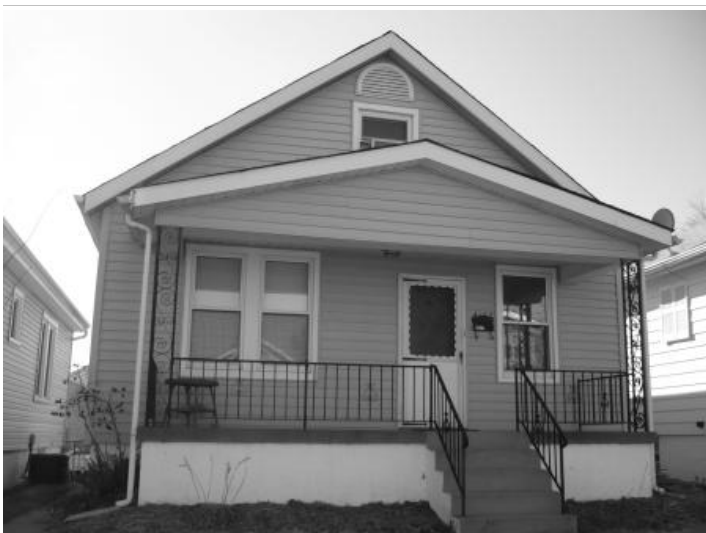
Concrete block porch base has metal trellis-style supports. Replacement door and windows.

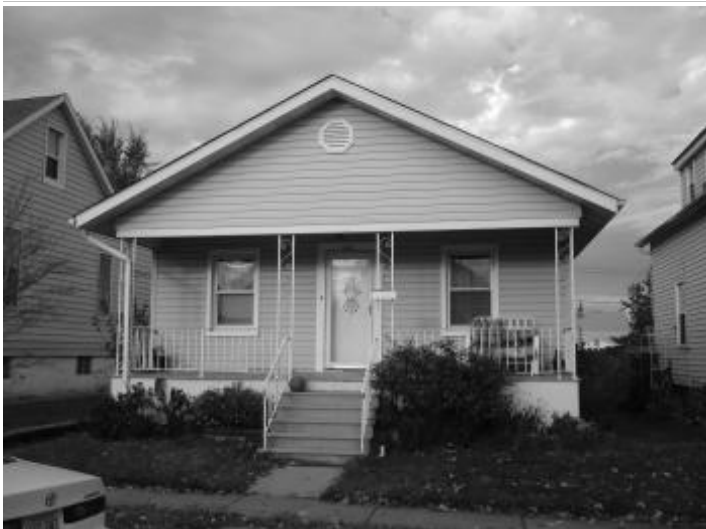
The roof is supported on four metal trellis-style supports. The front door and windows are replacements.

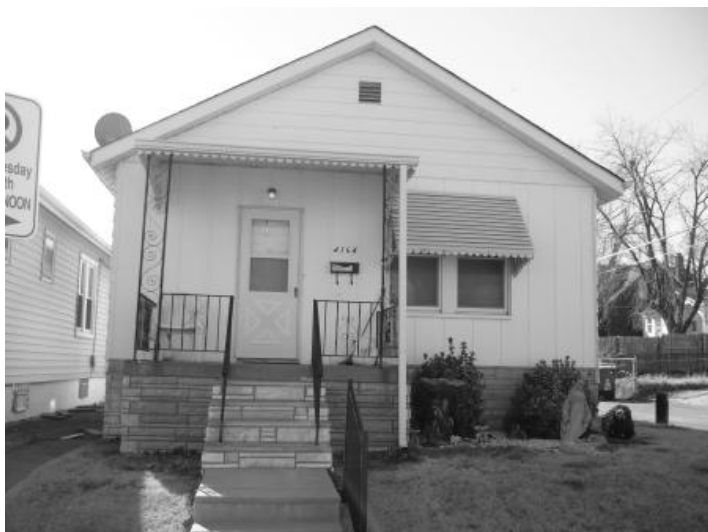
Base of façade and porch are clad with imitation stone veneer. New doors and windows. Porch, left, has metal trellis supports and metal awning-type roof.

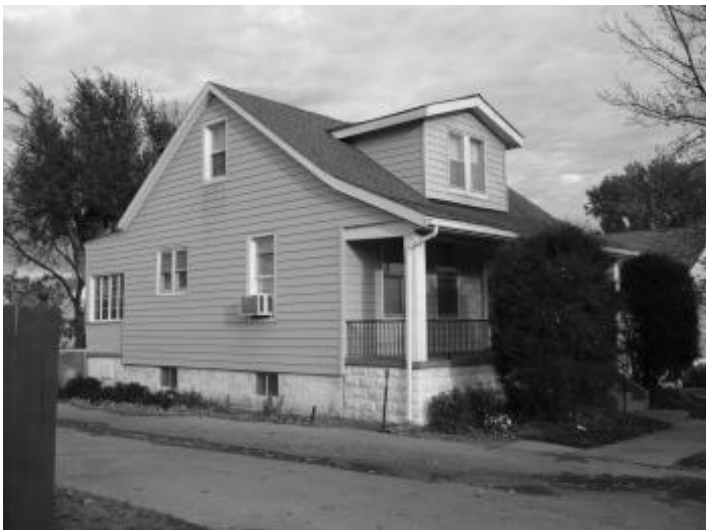
According to permit records, this house was moved from 5718 Morgan Ford in 1925. (Oral history in the neighborhood supports this.) Wood trim is obscured under siding.
